PANDORA MINE, TREFRIW, CONWY

ASESIAD ARCHEOLEGOL / ARCHAEOLOGICAL ASSESSMENT

Prosiect Rhif / Project No. G2682

Adroddiad Rhif / Report No. 1580

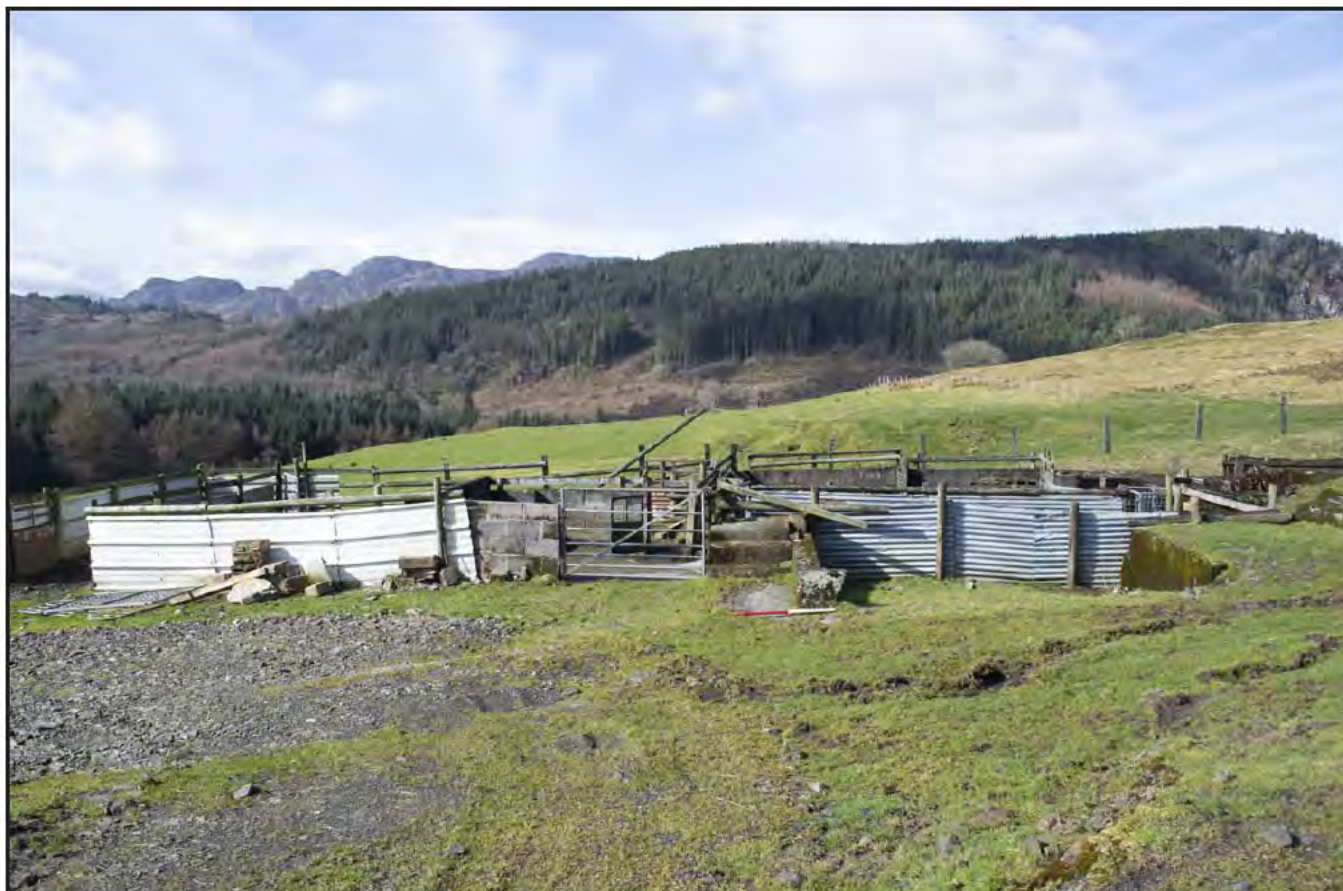
Feature Number	17
Site name	Eagle Flotation Mill, Pandora Mine
PRN number	91915
Grid reference	SH7668460268
Period	Post Medieval
Site type	Mind Building
Assessment category	D
Description	<p>Oil flotation mill constructed at Pandora mine by the Eagle Lead Co. between 1926 and 1928 (Dutton, Roberts & Vernon, 1995).</p> <p>Currently this area is being used as animal pens with very little concrete remains that relate to the oil flotation mill (Plate 11).</p>
Impact	None
Recommendation for further assessment/evaluation	None
Recommendation for mitigatory measures	Avoidance

Plate 11: Sheep pens at location of Oil flotation Mill; scale 1x1m; view from ESE (archive reference: G2682_023).

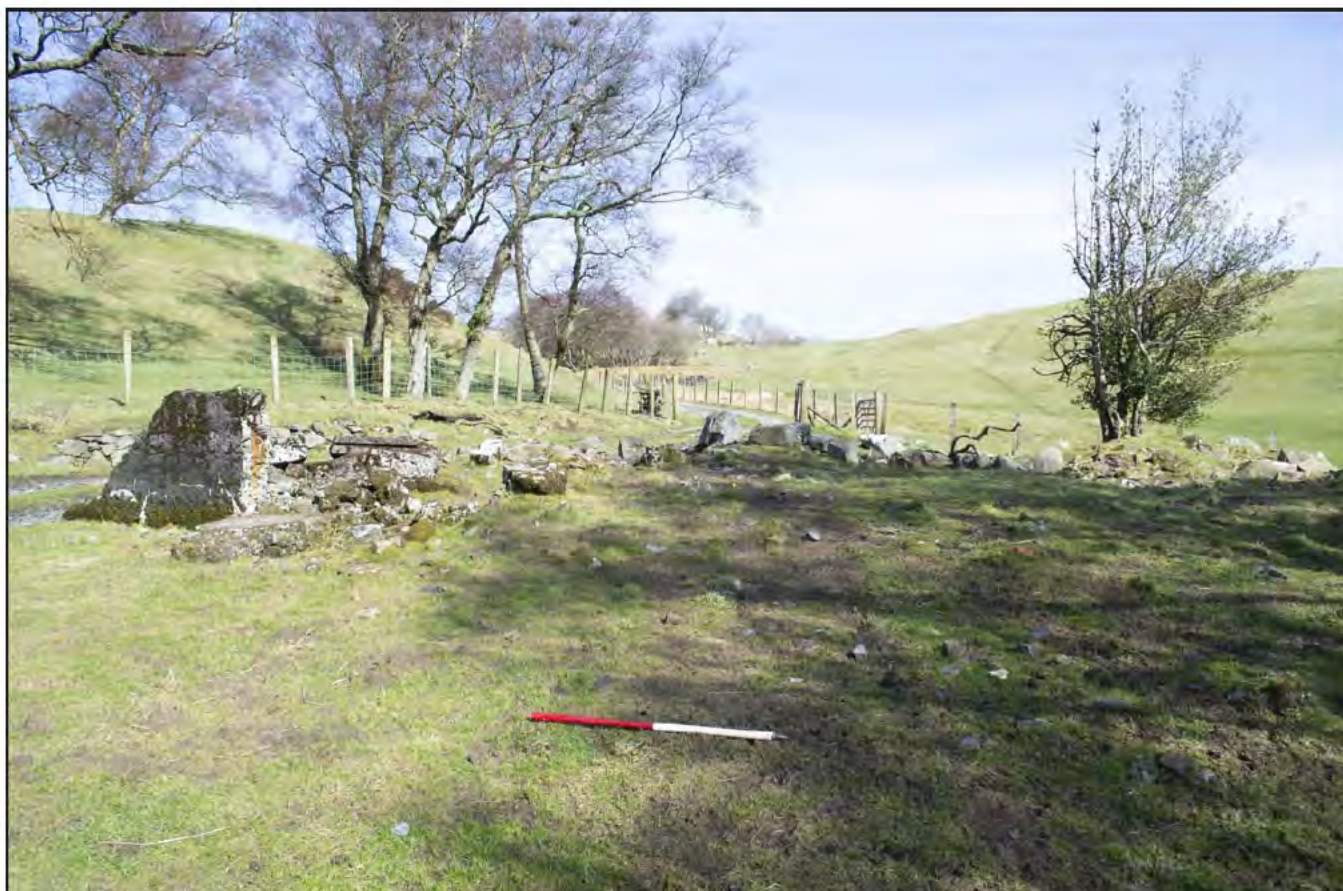
Feature Number	18
Site name	Managers house remains, Pandora Mine
PRN number	91916
Grid reference	SH7677360271
Period	Post Medieval
Site type	Mine Building
Assessment category	D
Description	<p>Remains of a stone and concrete building, from cartographic and photographic evidence it appears to be the remains of the house built for the Mine Captain by the Welsh Crown Spelter Company in 1901 (Bennett & Vernon, 1995; See Figure 04).</p> <p>Most of the building has now been removed, presumably robbed for stone (Plate 12).</p>
Impact	None
Recommendation for further assessment/evaluation	None
Recommendation for mitigatory measures	Avoidance

Plate 12: Ruined Building - Managers house; scale 1x1m; view from SW (archive reference: G2682_027).

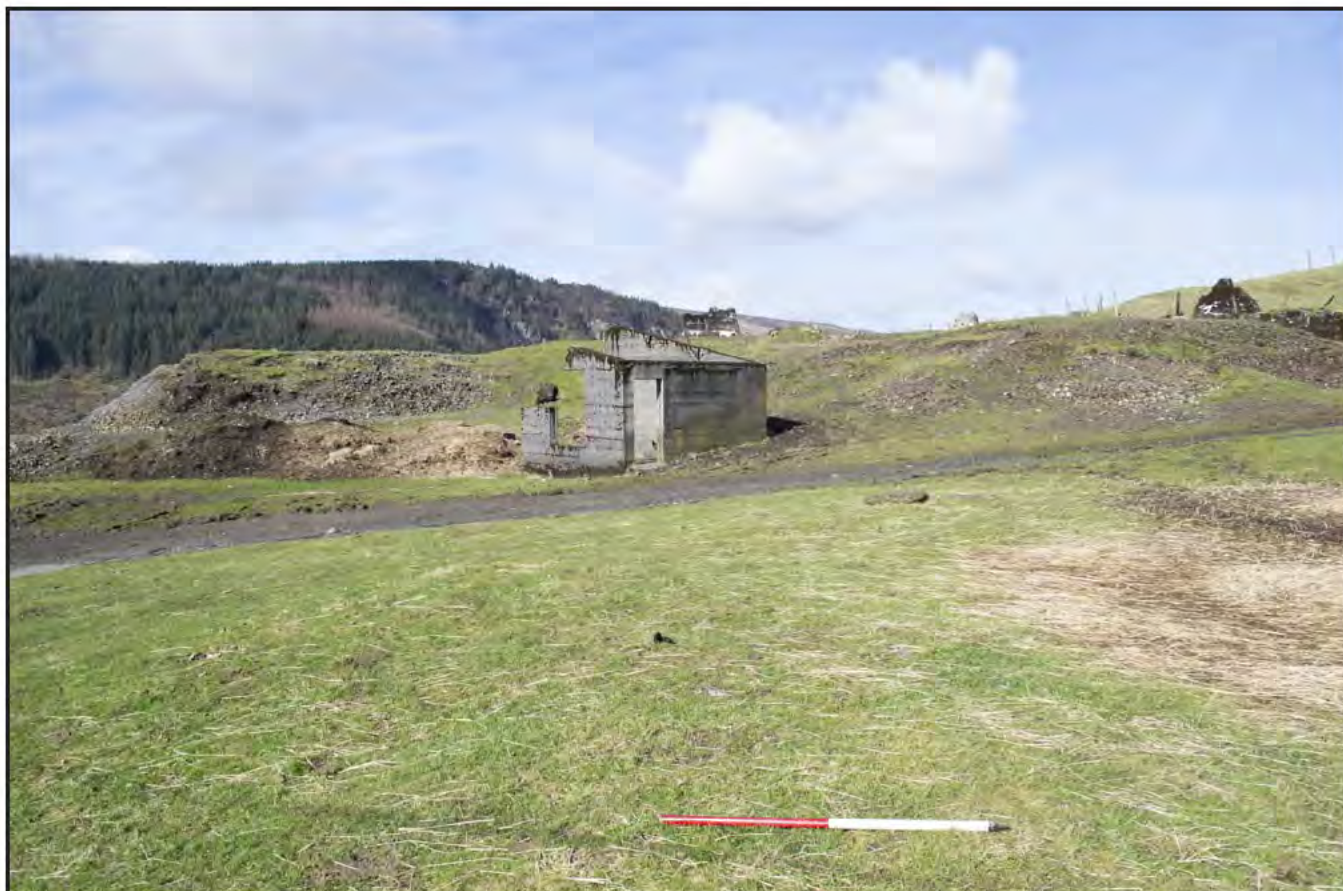
Feature Number	19
Site name	Mine Building, Pandora mine
PRN number	91917
Grid reference	SH7673560246
Period	Post Medieval
Site type	Mine Building
Assessment category	D
Description	Remains of a concrete building, probably the Survey/Assay Office (Plate 13) noted during the 1998 survey (Gwyn, 1998). Built by the Welsh Crown Spelter Co in 1901 (Dutton, Roberts & Vernon, 1995; See Figure 04).
Impact	None
Recommendation for further assessment/evaluation	None
Recommendation for mitigatory measures	Avoidance

Plate 13: Spoil Tip and Survey Office Remains; scale 1x1m; view from SE (archive reference: G2682_028).

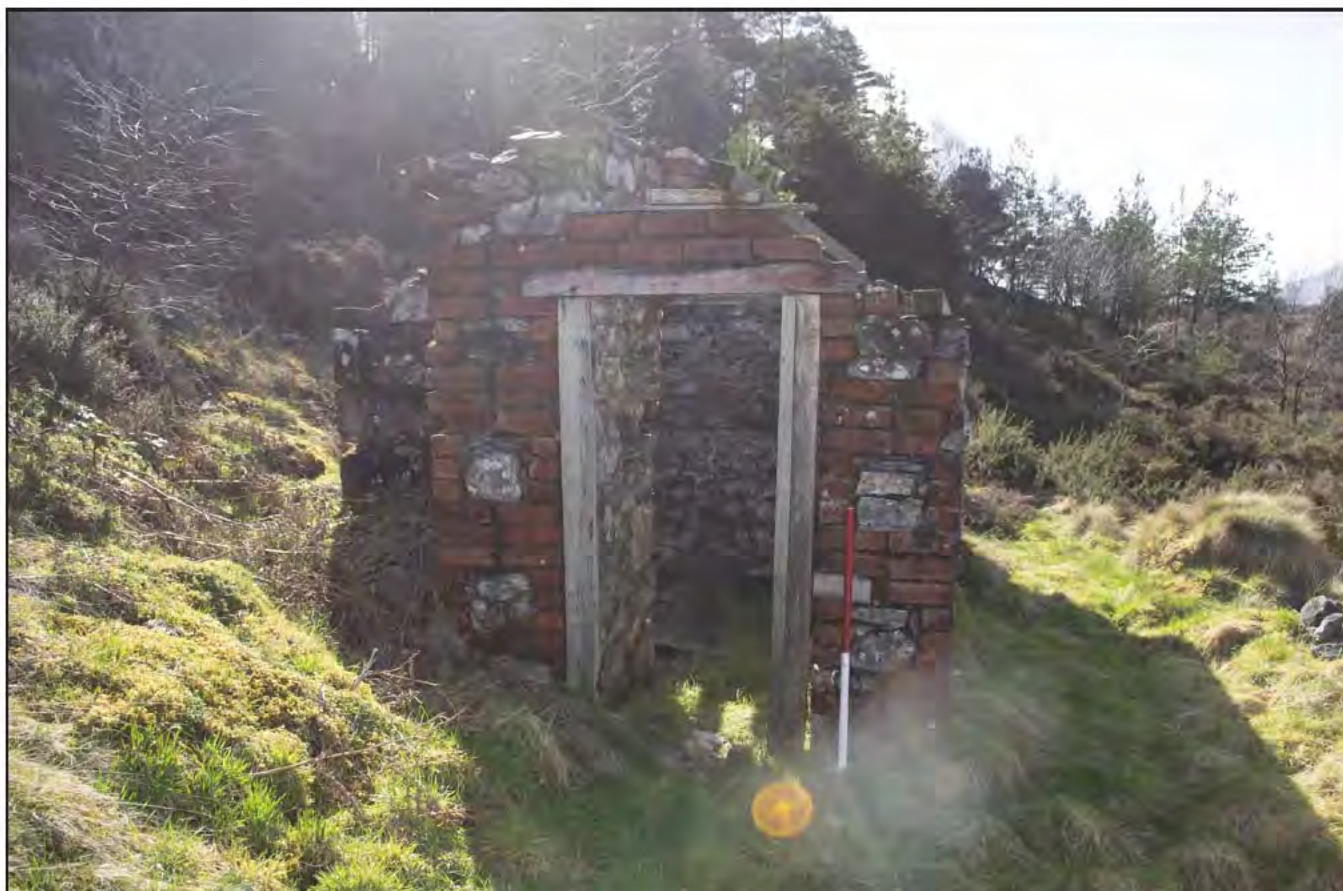
Feature Number	20
Site name	Powder Magazine, Pandora Mine
PRN number	91918
Grid reference	SH7666459918
Period	Post Medieval
Site type	Powder Magazine
Assessment category	C
Description	<p>The powder magazine shown of the map of the Pandora Mine (Willoughby Mine) of 1875 (Dutton, Roberts and Vernon, 1995; See Figure 03 & 04).</p> <p>The powder magazine was noted as having a roof in the survey undertaken by Gwyn in 1998.</p> <p>There is currently no roof on the powder magazine (Plate 14) though some new wood has been added in order to reinforce the entrance by the landowner who also plans on reinstating the roof (per comms).</p>
Impact	None
Recommendation for further assessment/evaluation	None
Recommendation for mitigatory measures	Avoidance

Plate 14: Powder magazine; scale 1x1m; view from N (archive reference: G2682_019).

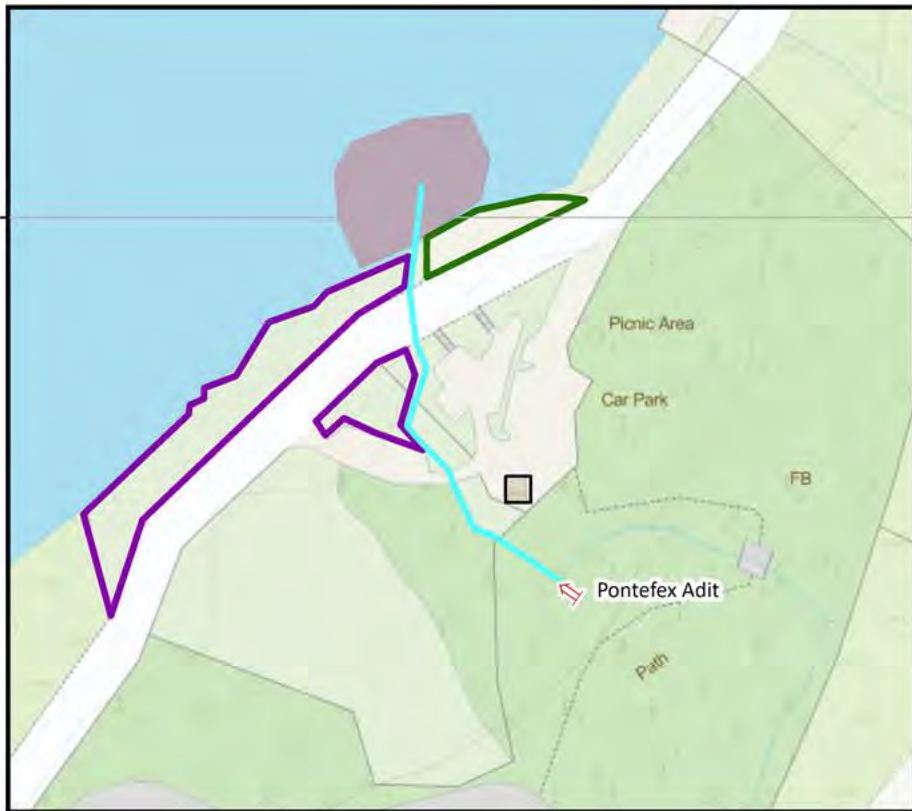
FIGURE 02

Pontifex Adit outflow, Llyn Geirionydd car park/day-use area and anticipated flow monitoring locations. Source: Binnies.

-   Public toilets
-   Shallow water zone
- frequented by bathers
-   Picnic area
-   Foreshore carpark with
make shift boat ramp
-   Mine water flow path
