# PARC PADARN, CHWAREL DINORWIG / PARC PADARN DINORWIG QUARRY

COFNOD ADEILAD HANESYDDOL /  
HISTORIC BUILDING RECORDING

Prif Gyfeirnod Yr Amgylchedd Hanesyddol yn Cofnodi /  
Historic Environment Record Event Primary Reference Number: 46695

Rhif Adroddiaf/ Report No. 1735

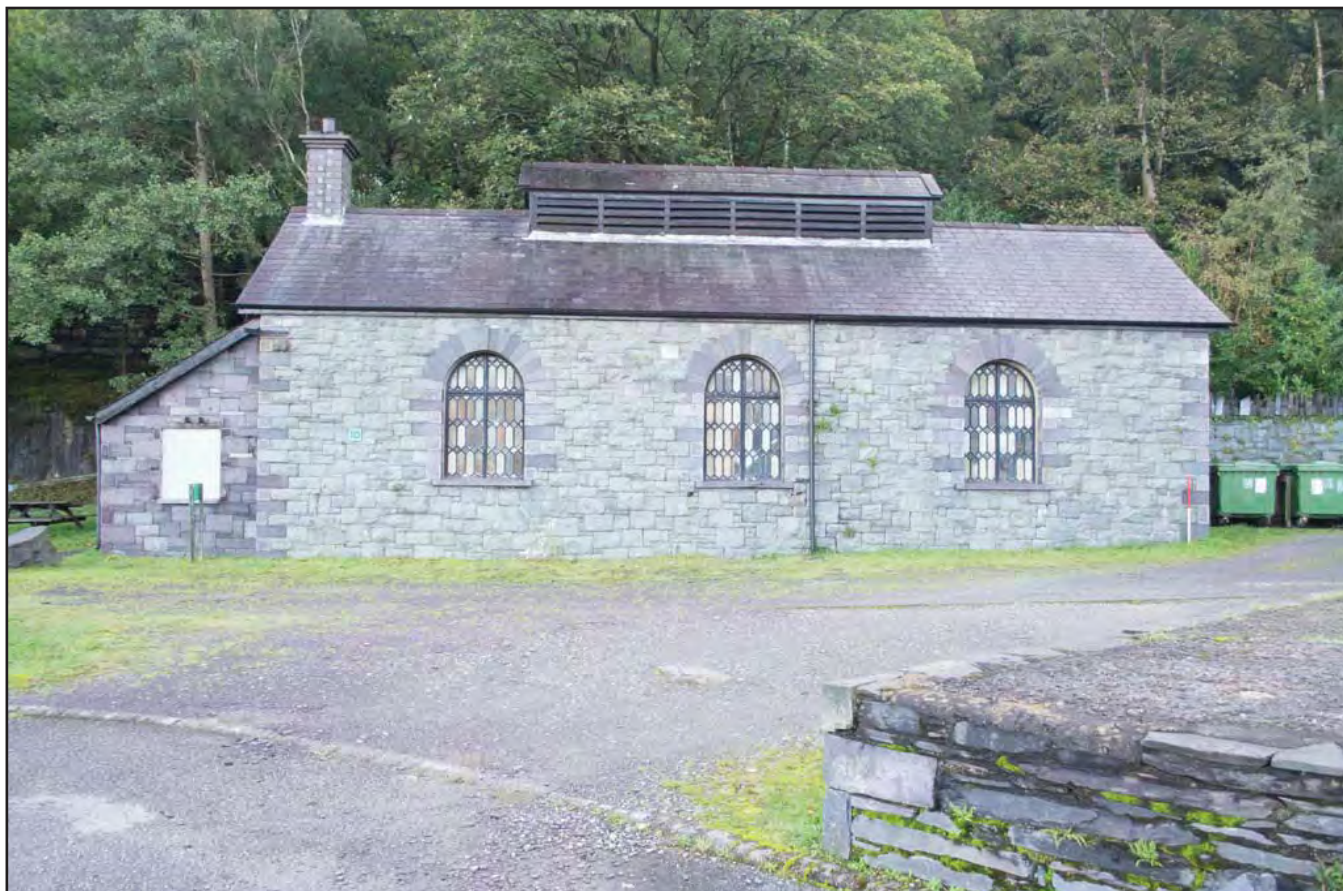
Plate 1: Fire Queen Locomotive Shed - Southern lateral side of Fire Queen shed; scale 1m; view from S (archive reference: G2805\_001).

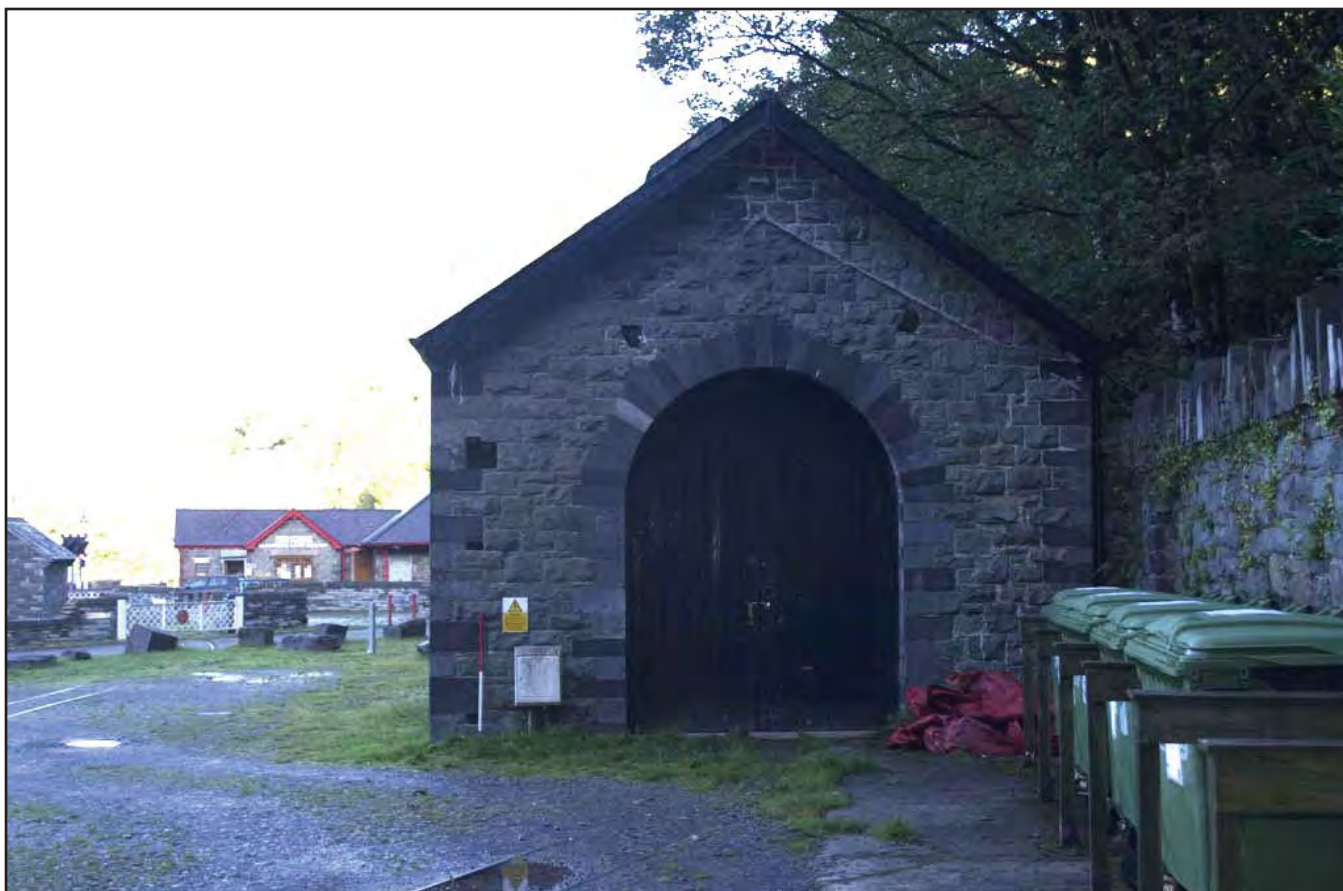
Plate 2: Fire Queen Locomotive Shed - Eastern gable end of locomotive shed; scale 1m; view from E (archive reference: G2805\_002).

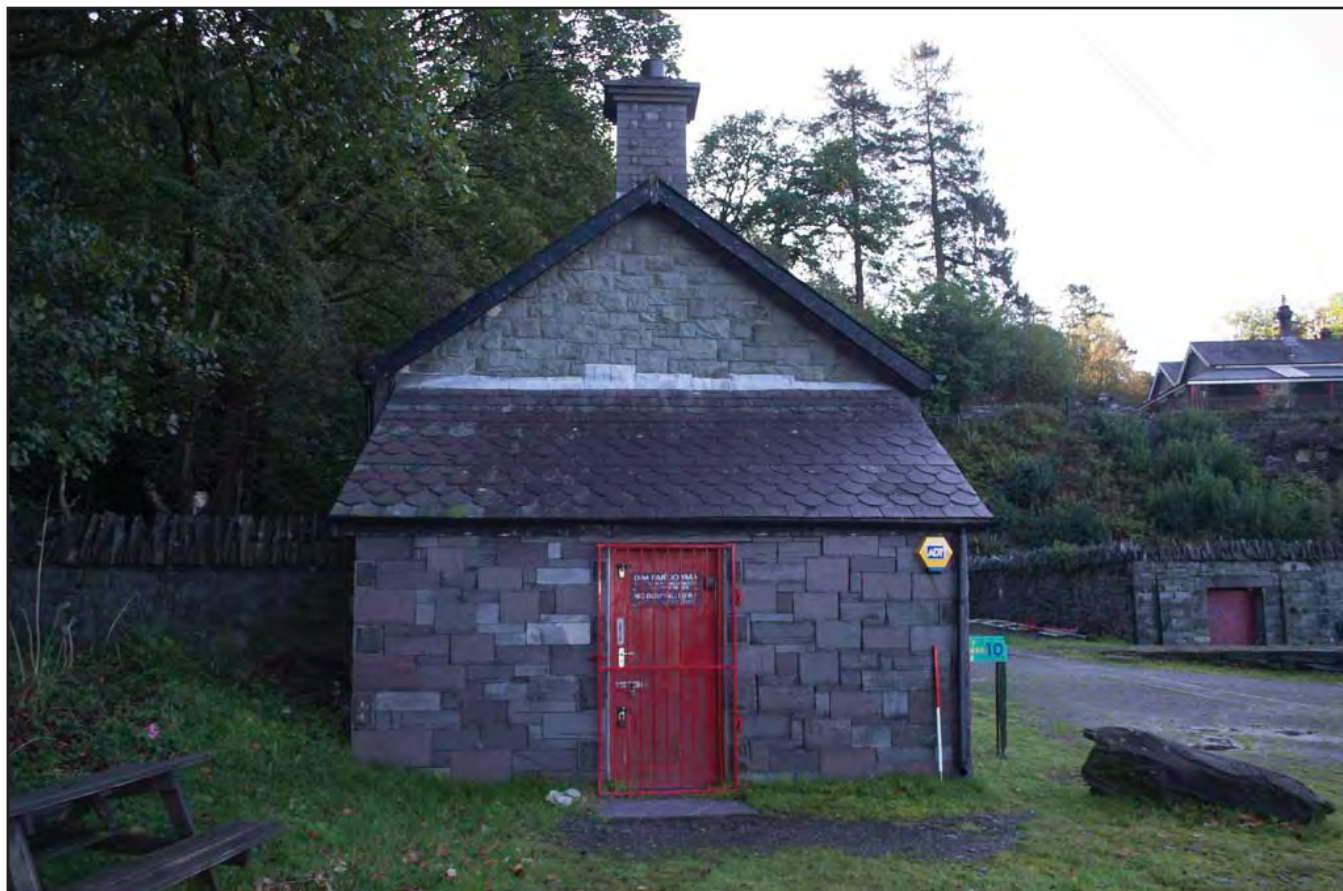
Plate 3: Fire Queen Locomotive Shed - Western gable end of locomotive shed Shed; scale 1m; view from W (archive reference: G2805\_003).

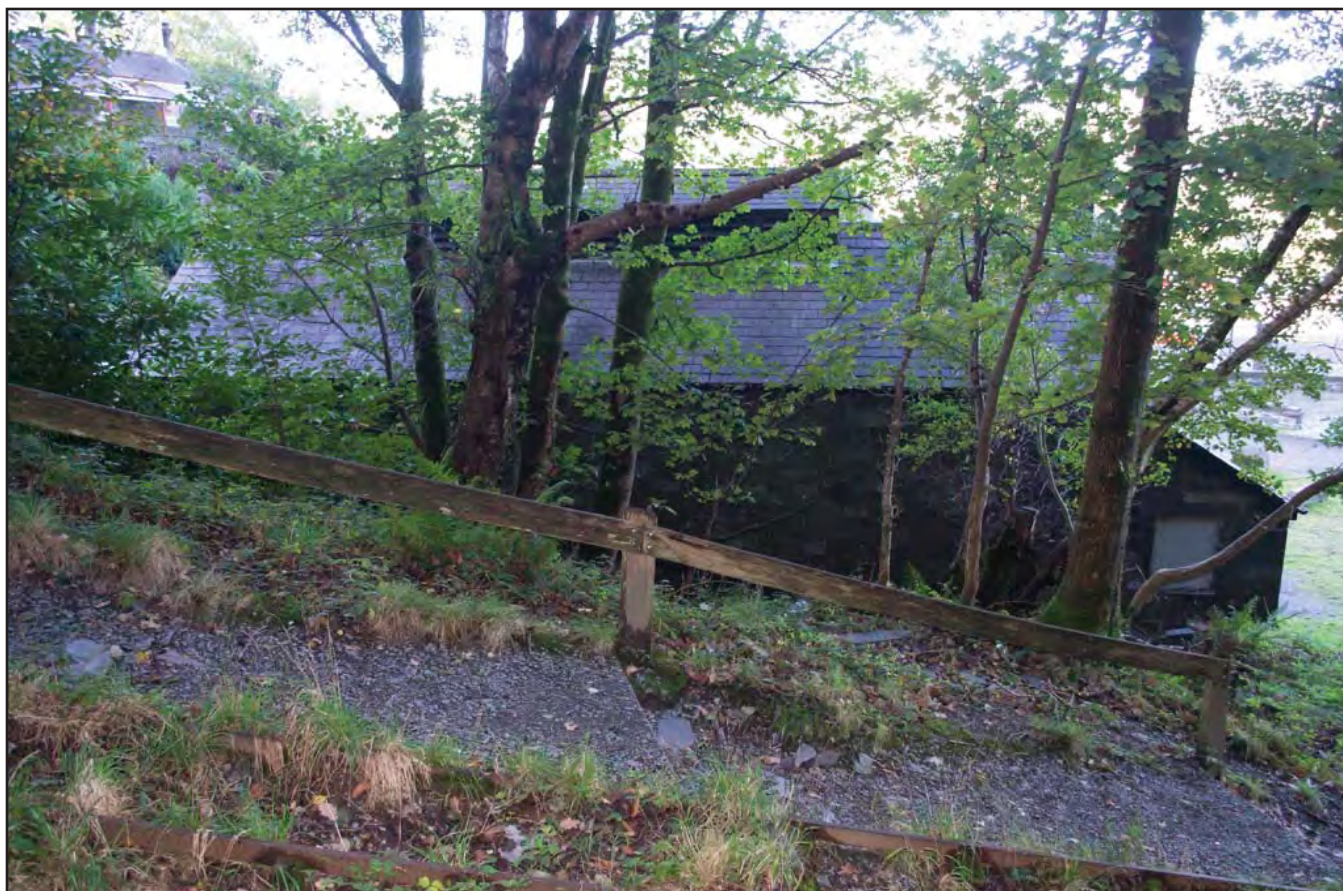
Plate 4: Fire Queen Locomotive Shed - Northern side of locomotive shed obscured by trees, taken from bottom of A-incline; scale not used; view from N (archive reference: G2805\_004).

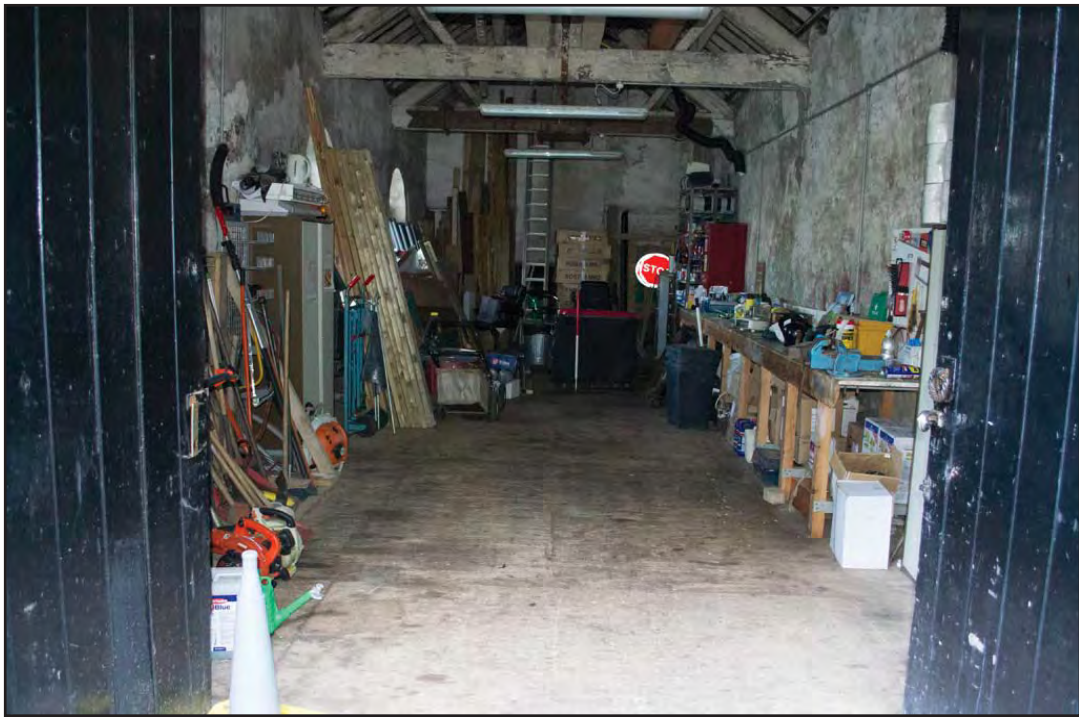
Plate 5: Fire Queen Locomotive Shed - Shot into interior of locomotive shed through doorway in eastern gable; scale 1m; view from E (archive reference: G2805\_005).

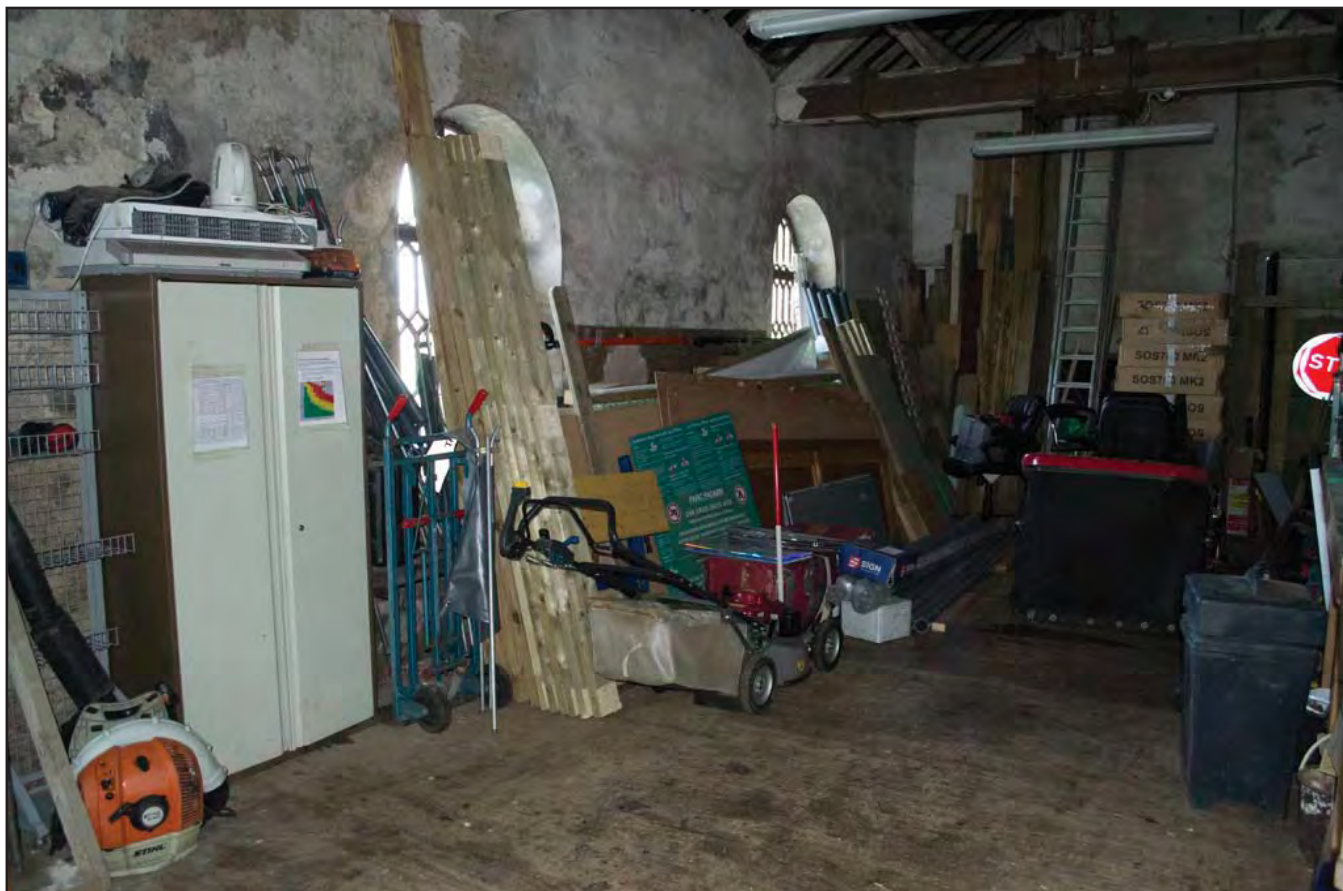
Plate 6: Fire Queen Locomotive Shed - Shot of eastern most window on southern lateral wall from interior (Partially obscured by gardening tools); scale 1m; view from N (archive reference: G2805\_006).

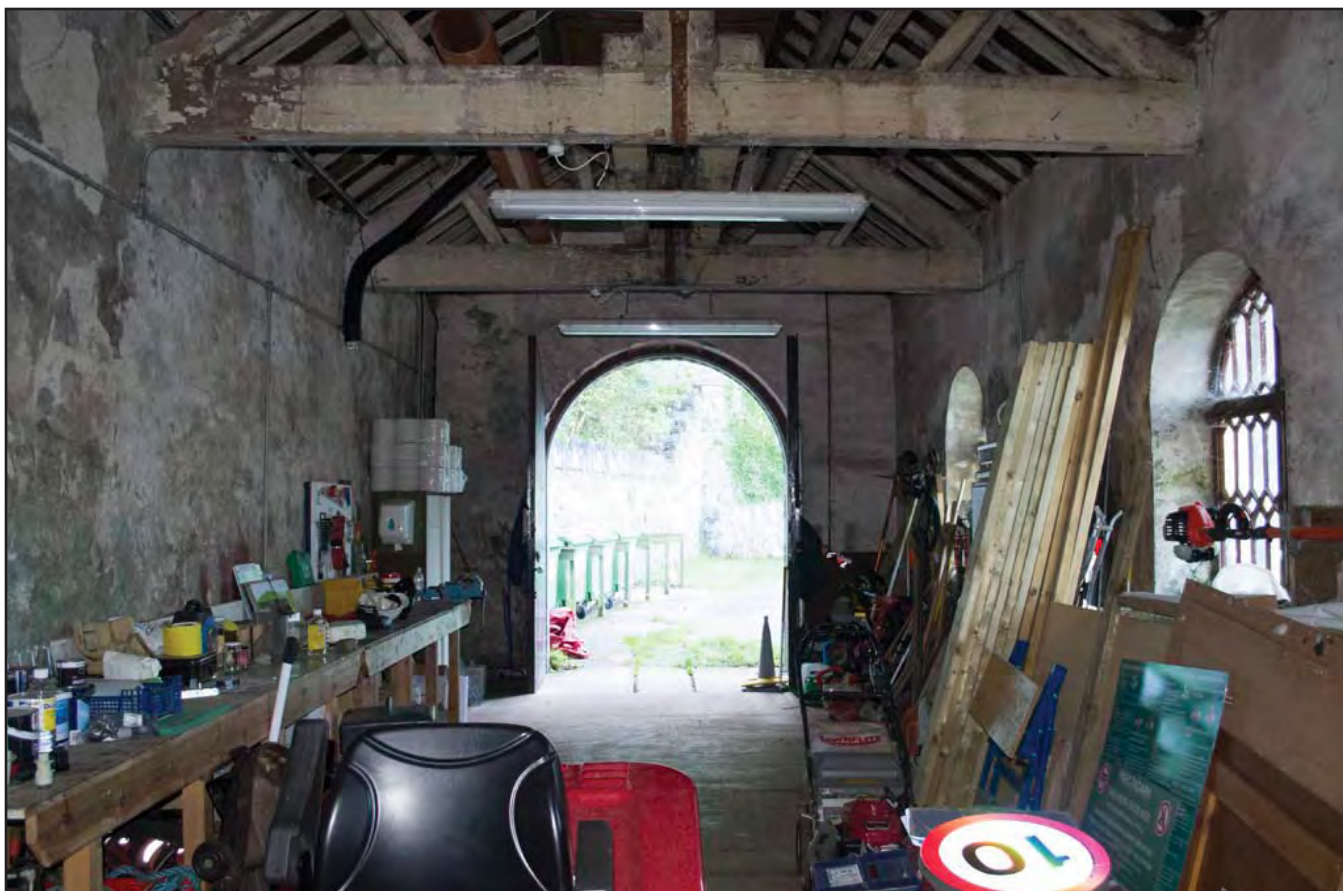
Plate 7: Fire Queen Locomotive Shed - Shot looking in SW corner of locomotive shed (showing current use as workshop); scale 1m; view from NE (archive reference: G2805\_007).

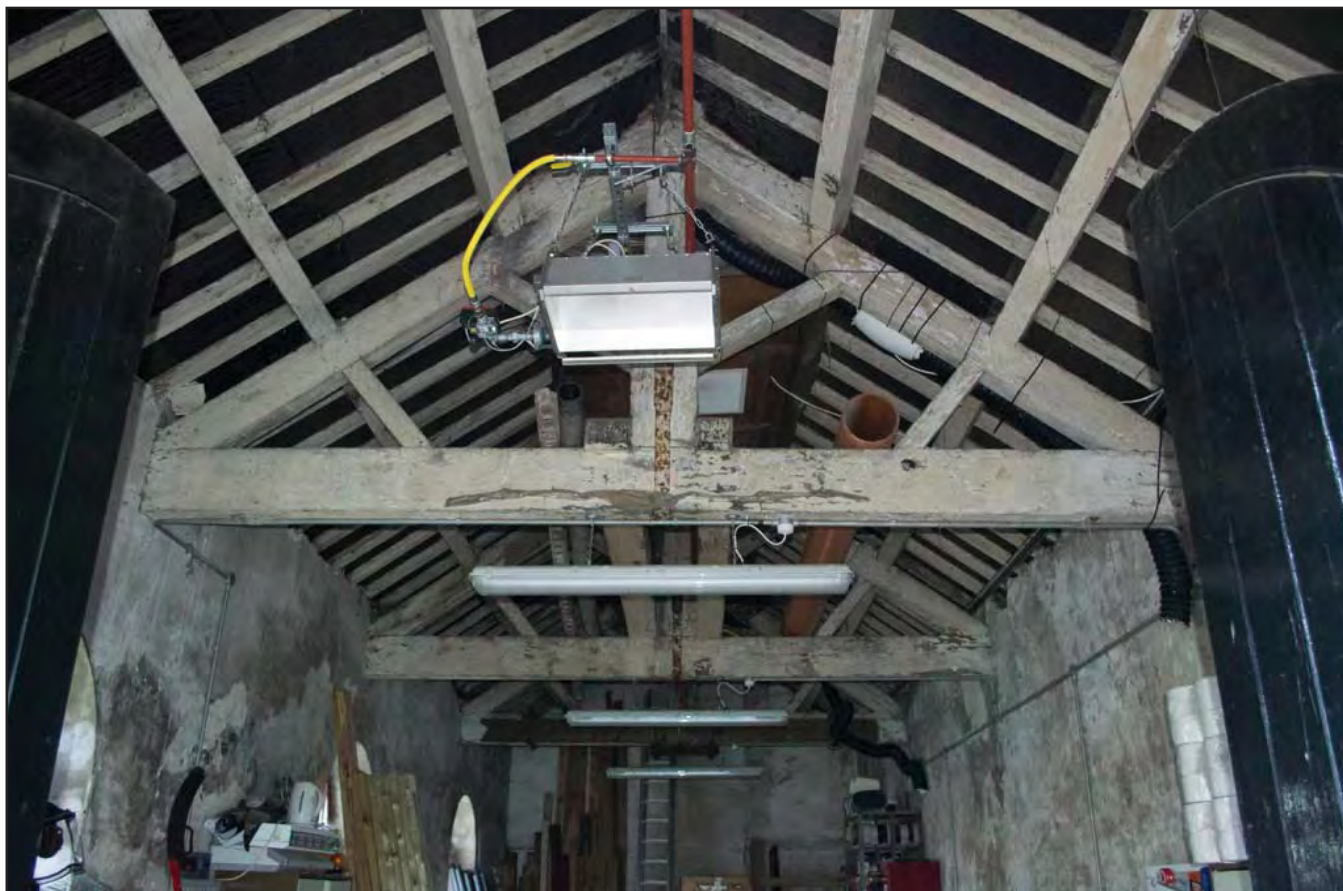
Plate 9: Fire Queen Locomotive Shed - shot of roof trusses taken from doorway; scale not used; view from E (archive reference: G2805\_009).

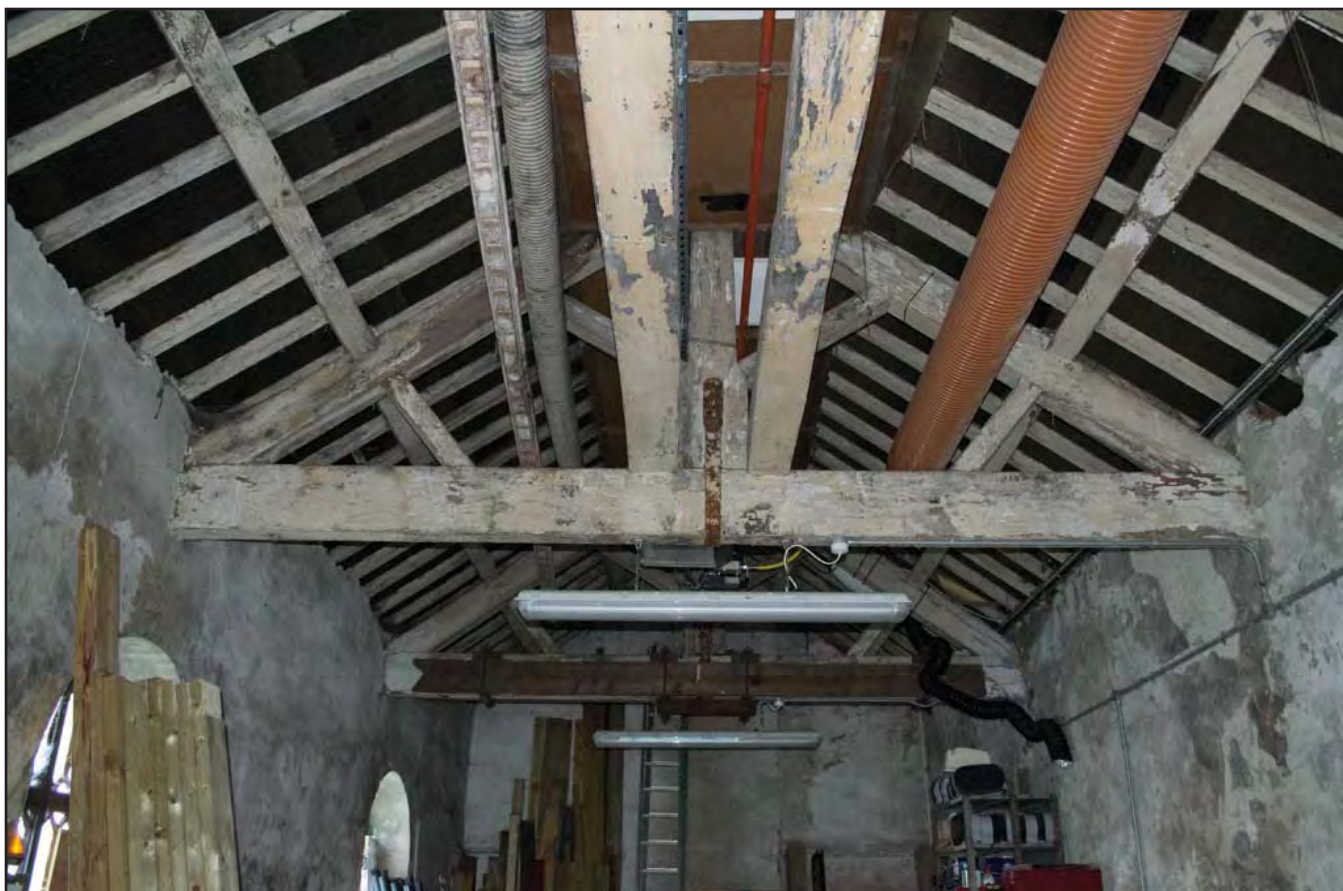
Plate 10: Fire Queen Locomotive Shed - shot of central roof truss and modern lighting and heater; scale not used; view from E (archive reference: G2805\_010).

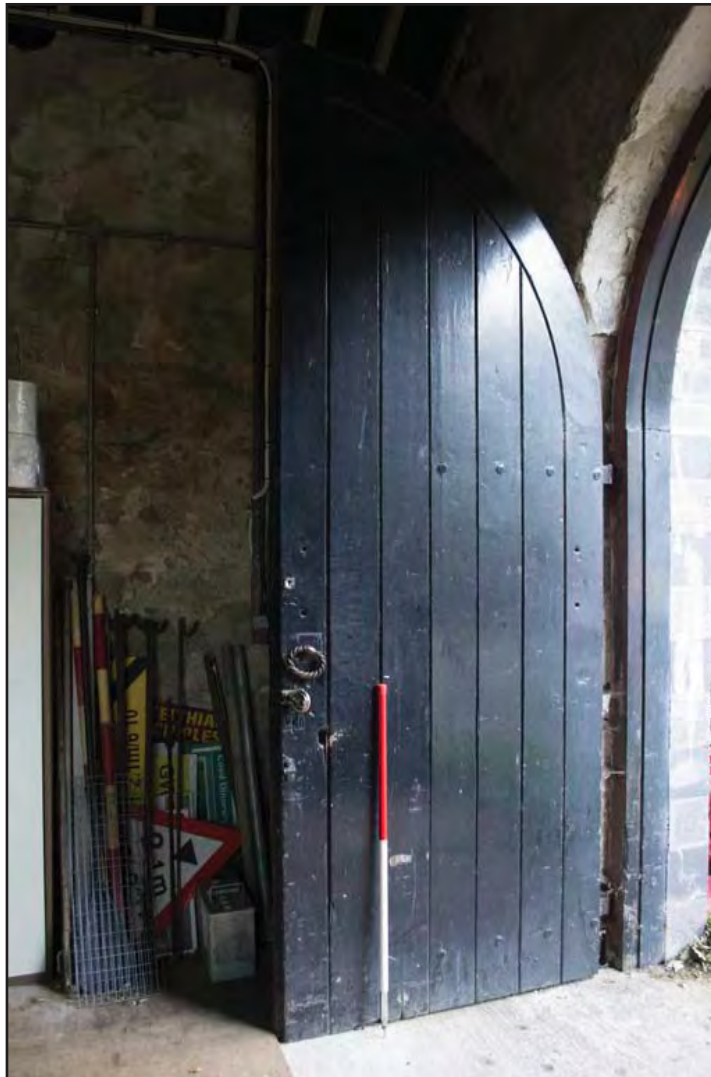
Plate 11: Fire Queen Locomotive Shed - Portrait shot of detail of door in eastern gable (note decorative door handle); scale 1m; view from SSW (archive reference: G2805\_011).

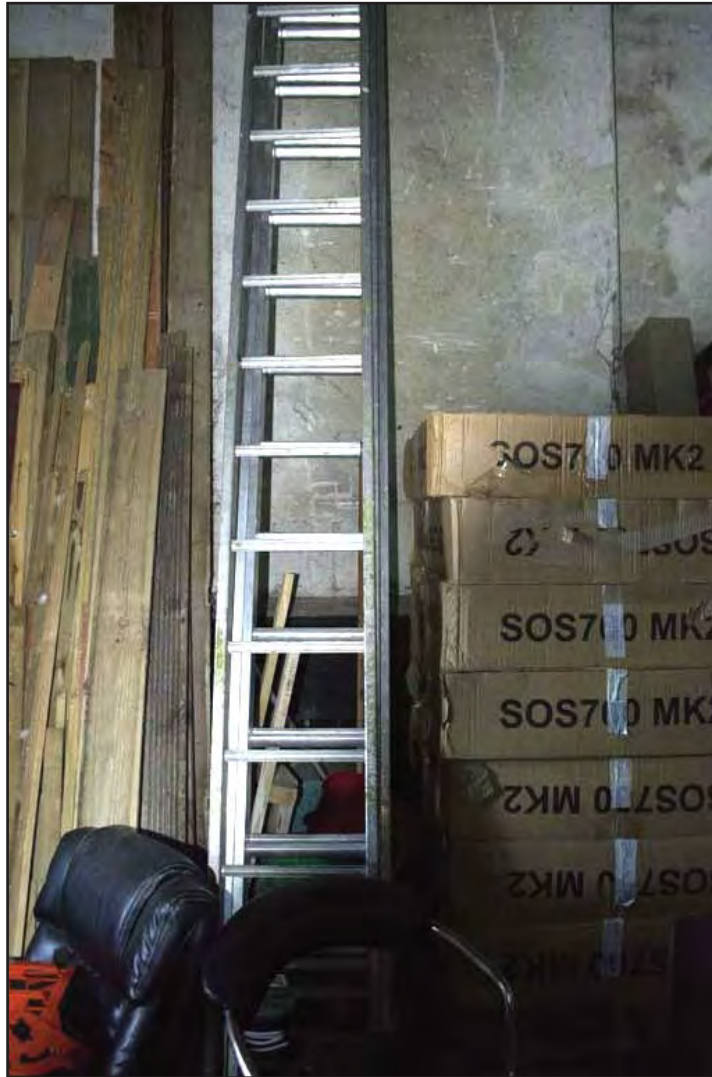
Plate 13: Fire Queen Locomotive Shed - Portrait of fireplace at western gable end (obscured by ladder and boxes); scale not used; view from E (archive reference: G2805\_013).

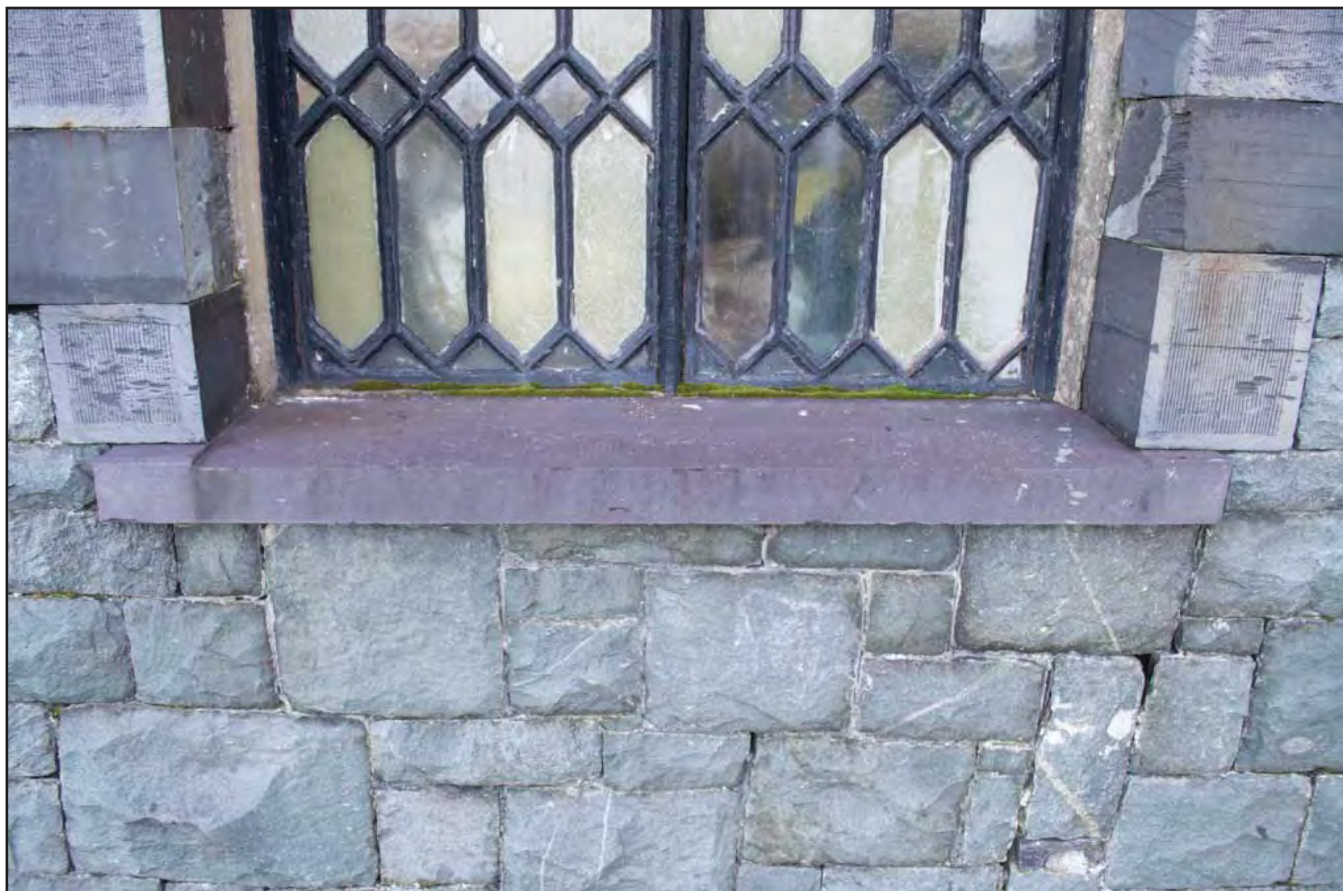
Plate 15: Fire Queen Locomotive Shed - Closeup of tooling on sill in eastern most window of southern lateral wall; scale not used; view from S (archive reference: G2805\_015).

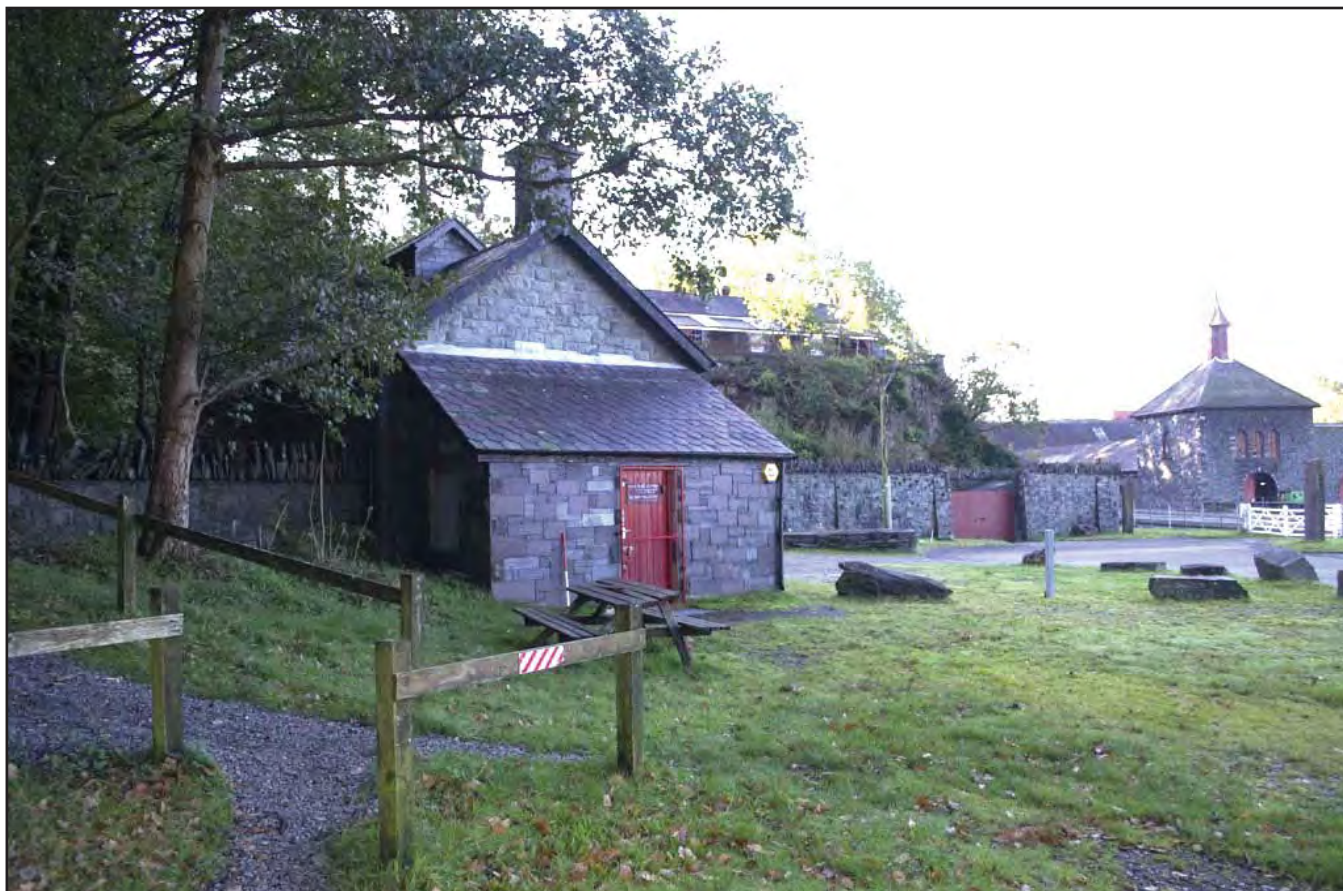
Plate 16: Fire Queen Locomotive Shed - Angled shot of SW corner of exterior of locomotive shed; scale 1m; view from SW (archive reference: G2805\_016).

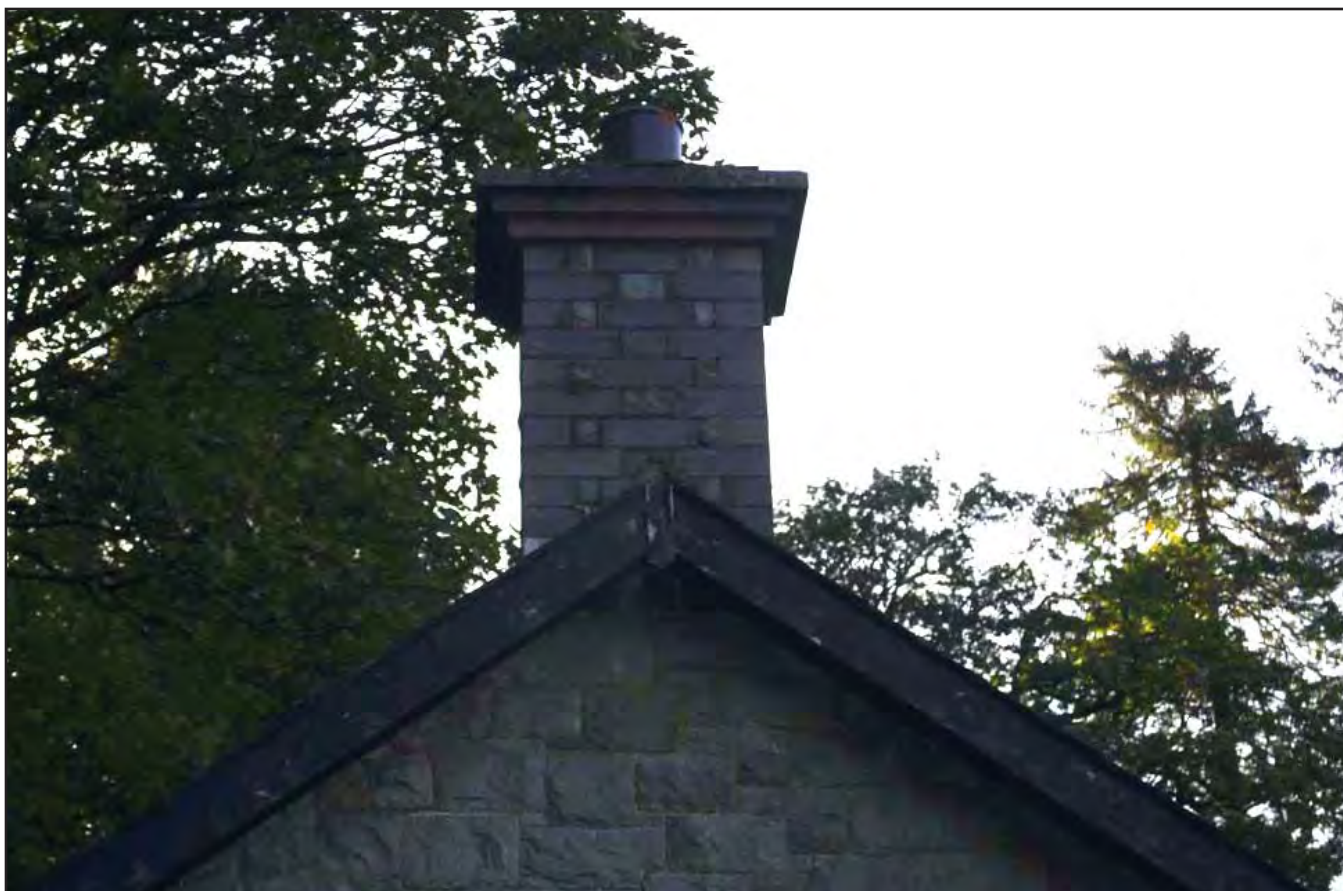
Plate 18: Fire Queen Locomotive Shed - Detail of chimney at western end of locomotive shed; scale 1m; view from W (archive reference: G2805\_018).

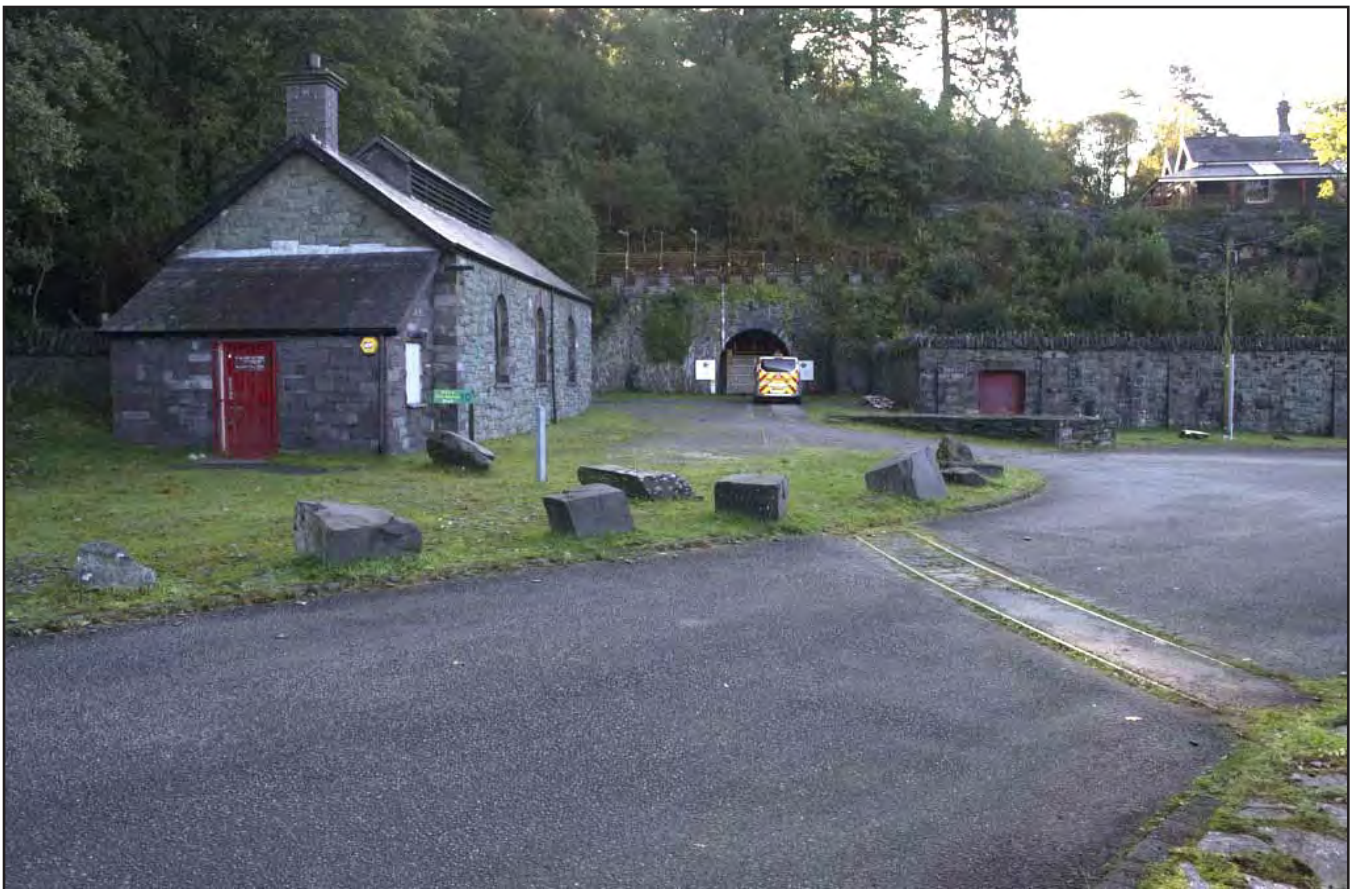
Plate 19: Fire Queen Locomotive Shed - Angled shot of SE corner of eastern gable end of locomotive shed; scale 1m; view from SE (archive reference: G2805\_019).

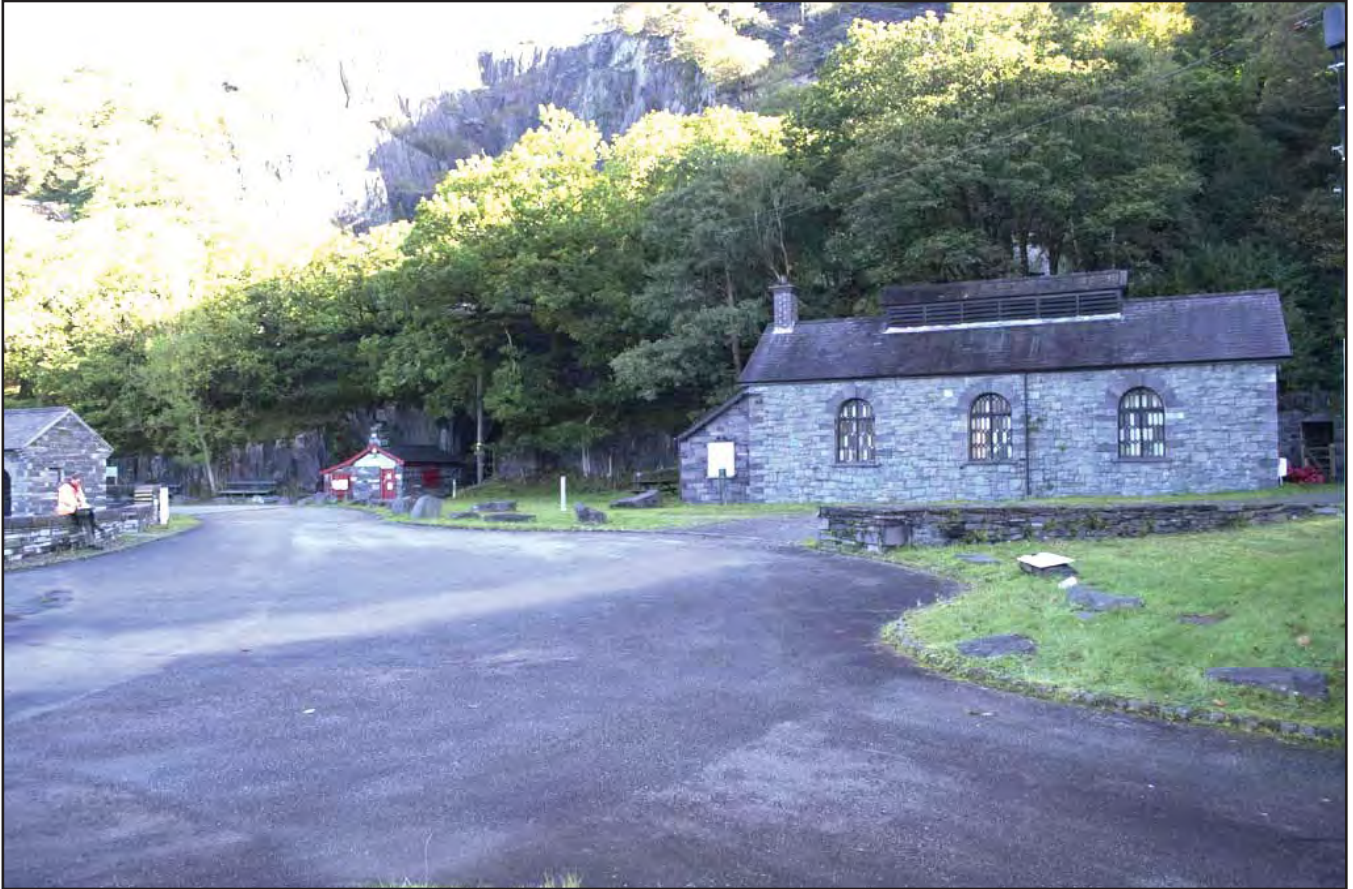
Plate 20: Fire Queen Locomotive Shed - Wide shot of locomotive shed showing relationship with tunnel to the east; scale not used; view from W (archive reference: G2805\_020).

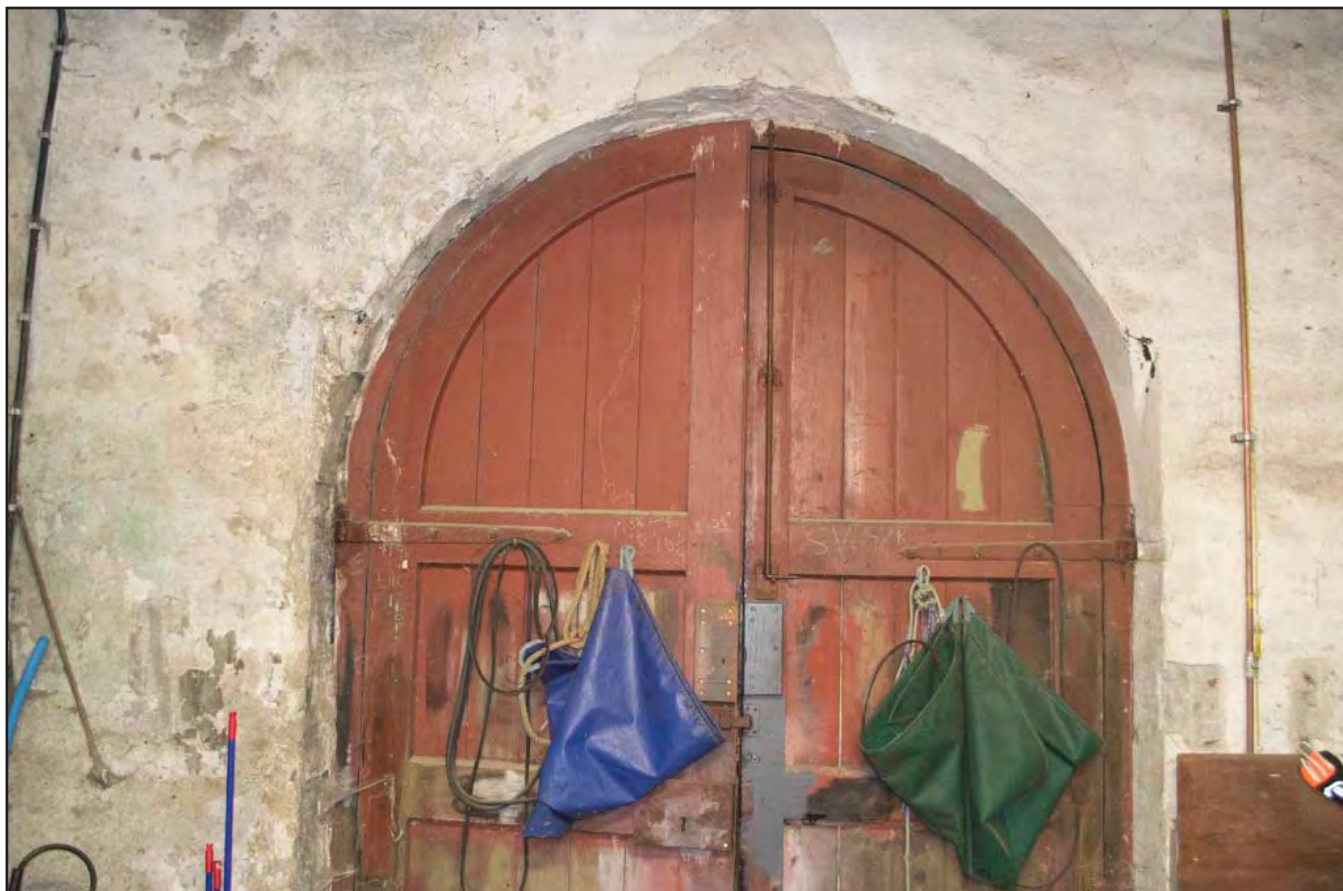
Plate 23: Fire Queen Locomotive Shed - View of inside of main doors to locomotive shed showing cut portions to allow doors to open fully; scale not used; view from W (archive reference: G2805\_051).

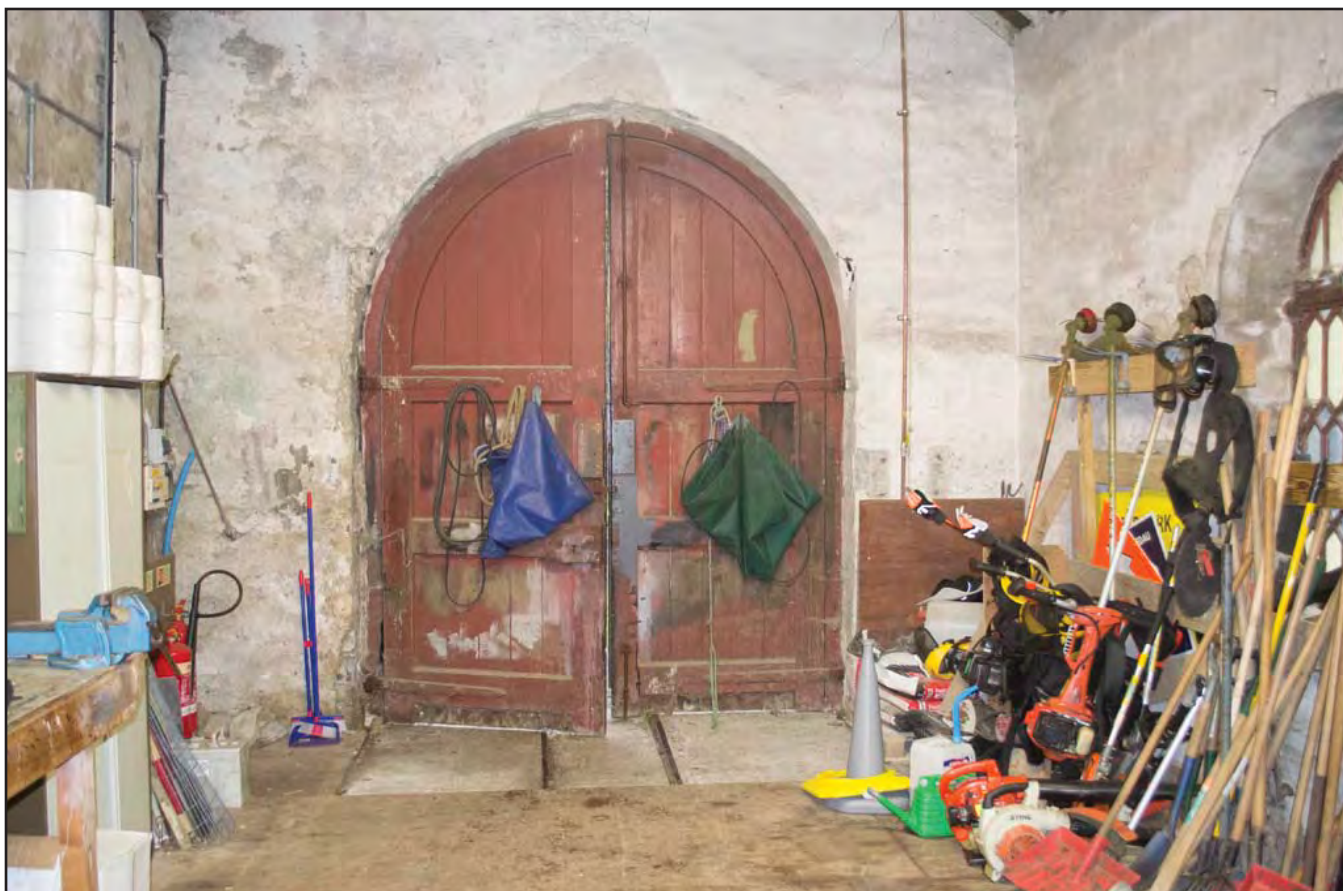
Plate 24: Fire Queen Locomotive Shed - View of inside of main doors to locomotive shed showing cut portions to allow doors to open fully; scale not used; view from W (archive reference: G2805\_052).

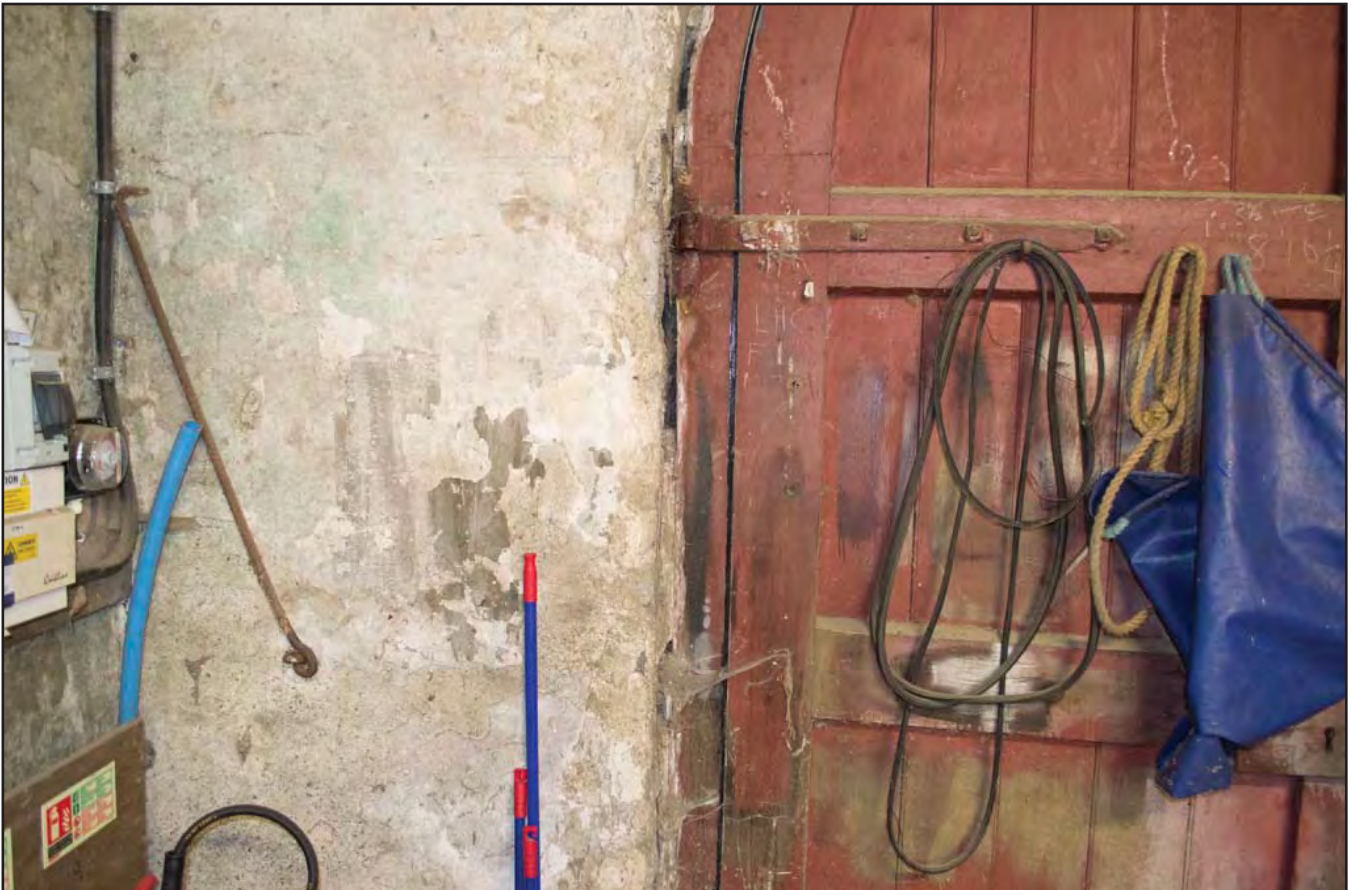
Plate 25: Fire Queen Locomotive Shed - View of bar latch on north side of entrance doors in the locomotive shed; scale not used; view from W (archive reference: G2805\_053).
