# PARC PADARN, CHWAREL DINORWIG / PARC PADARN DINORWIG QUARRY

COFNOD ADEILAD HANESYDDOL /  
HISTORIC BUILDING RECORDING

Prif Gyfeirnod Yr Amgylchedd Hanesyddol yn Cofnodi /  
Historic Environment Record Event Primary Reference Number: 46695

Rhif Adroddiaf/ Report No. 1735

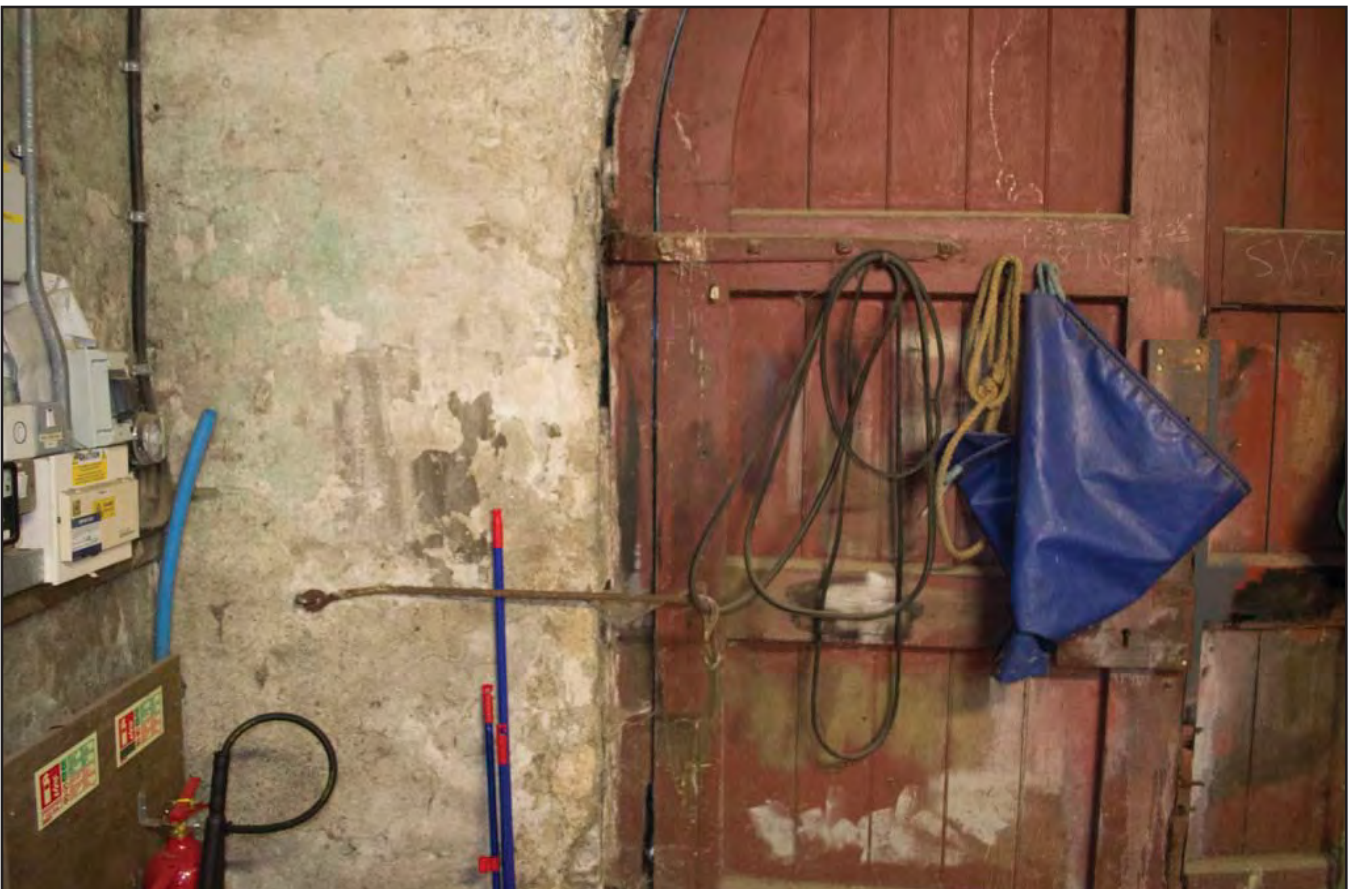
Plate 26: Fire Queen Locomotive Shed - View of bar latch on north side of entrance doors in the locomotive shed; scale not used; view from W (archive reference: G2805\_054).

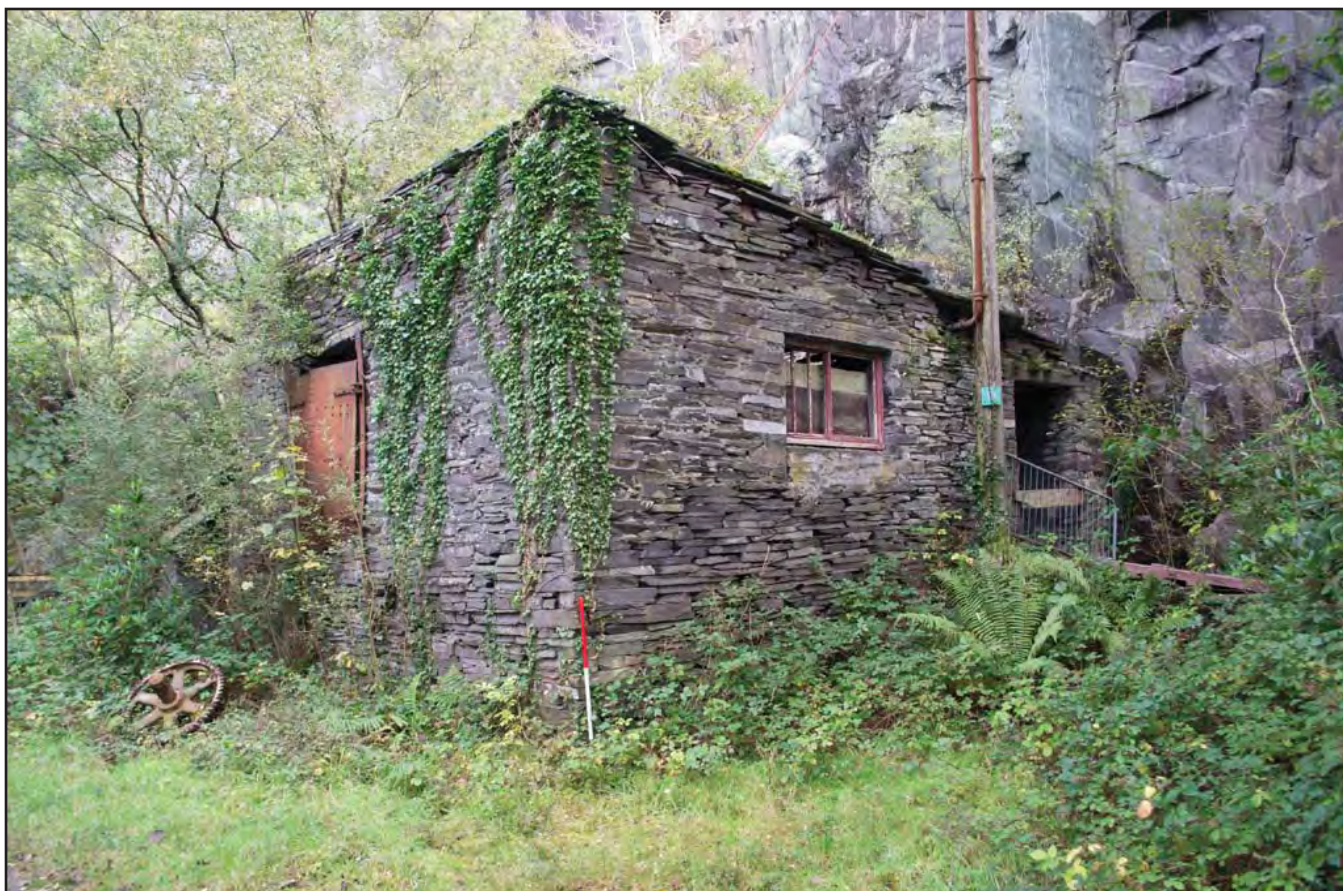
Plate 27: Vivian Quarry Utility Unit & Blast Shelter - Shot of southern lateral side of utility unit and blast shelter; scale 1m; view from S (archive reference: G2805\_023).

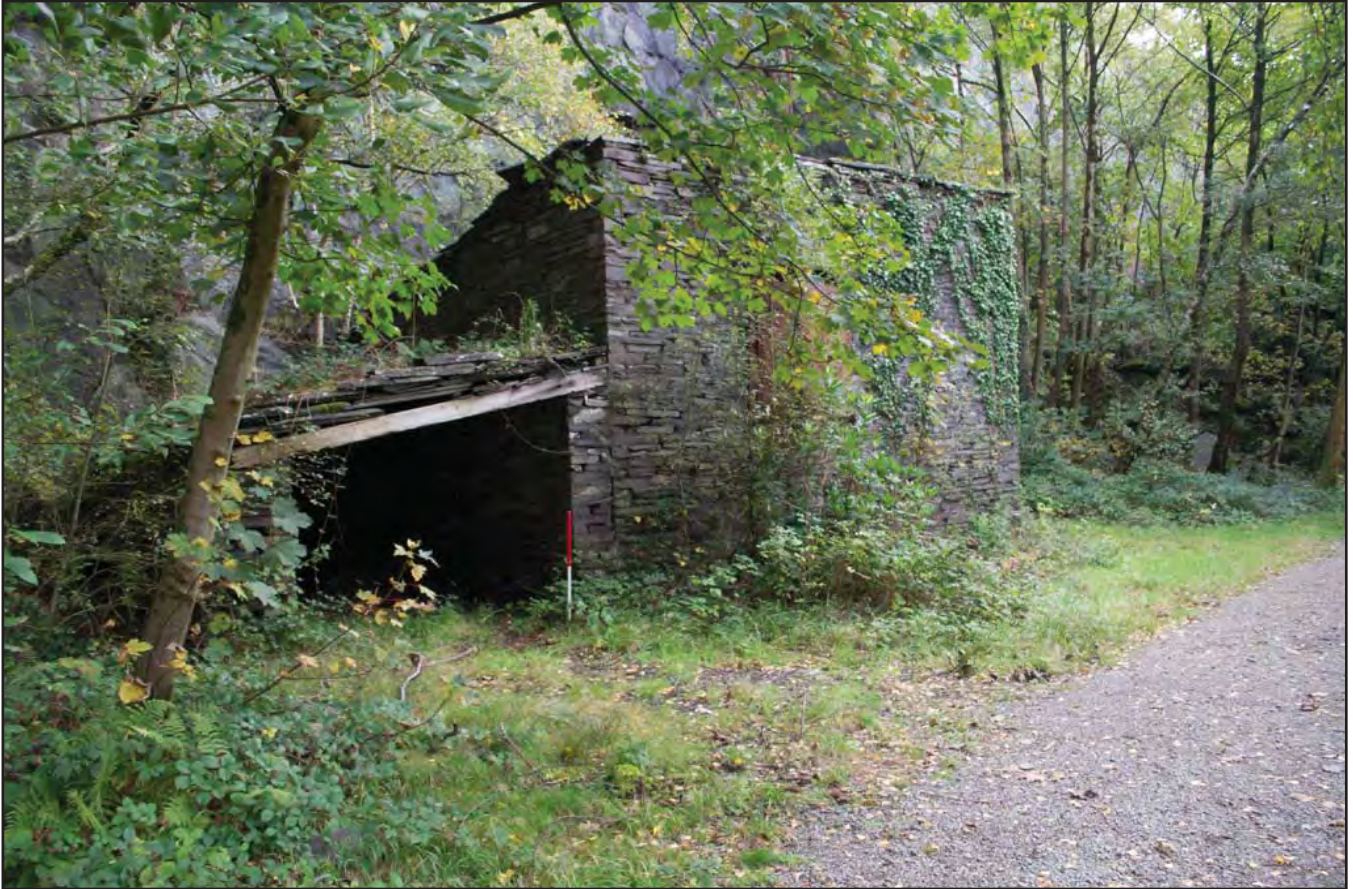
Plate 29: Vivian Quarry Utility Unit & Blast Shelter - Shot of blast shelter abutting the utility unit; scale 1m; view from NW (archive reference: G2805\_025).

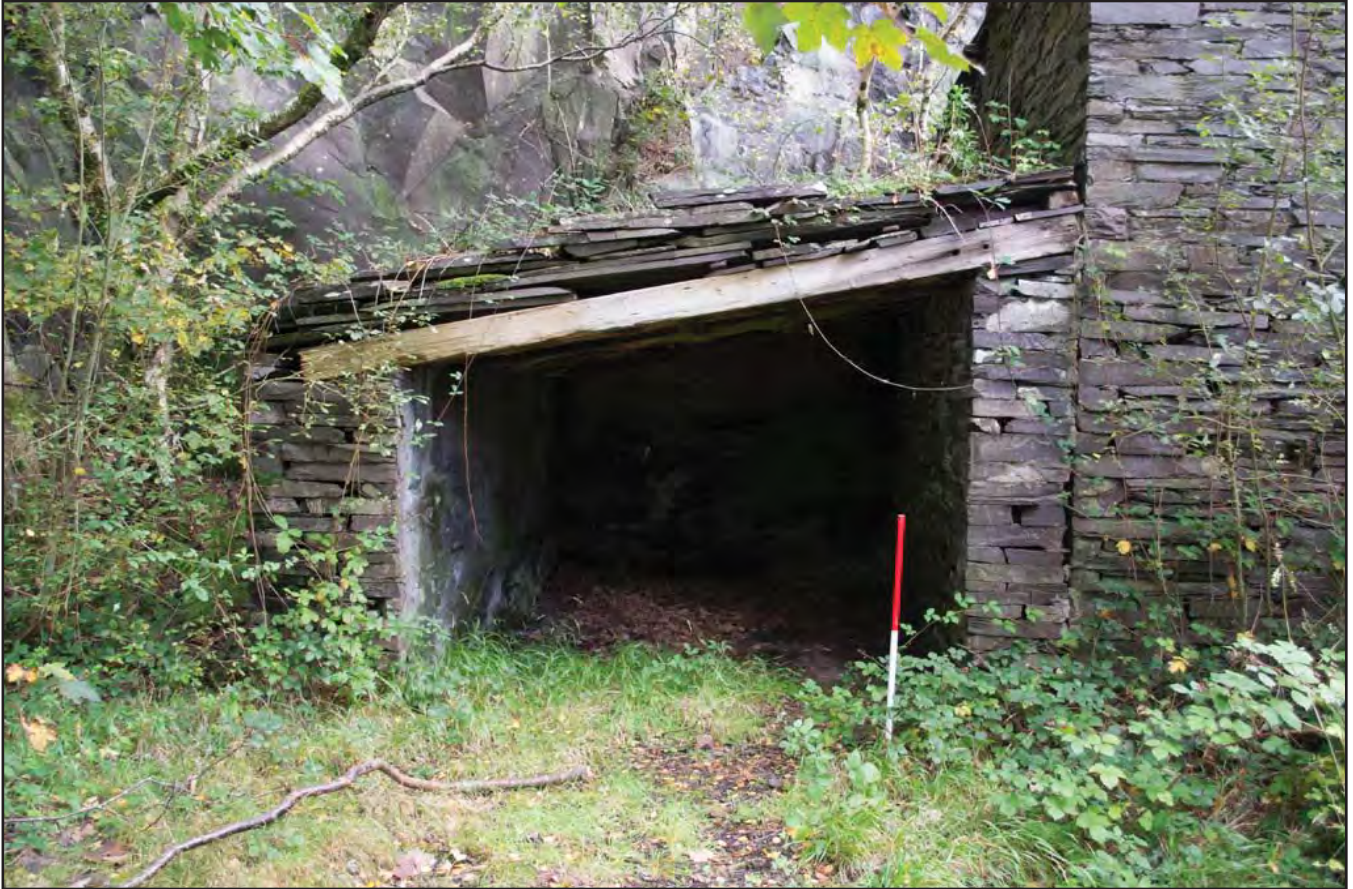
Plate 30: Vivian Quarry Utility Unit & Blast Shelter - Shot of blast shelter abutting the utility unit; scale 1m; view from W (archive reference: G2805\_026).

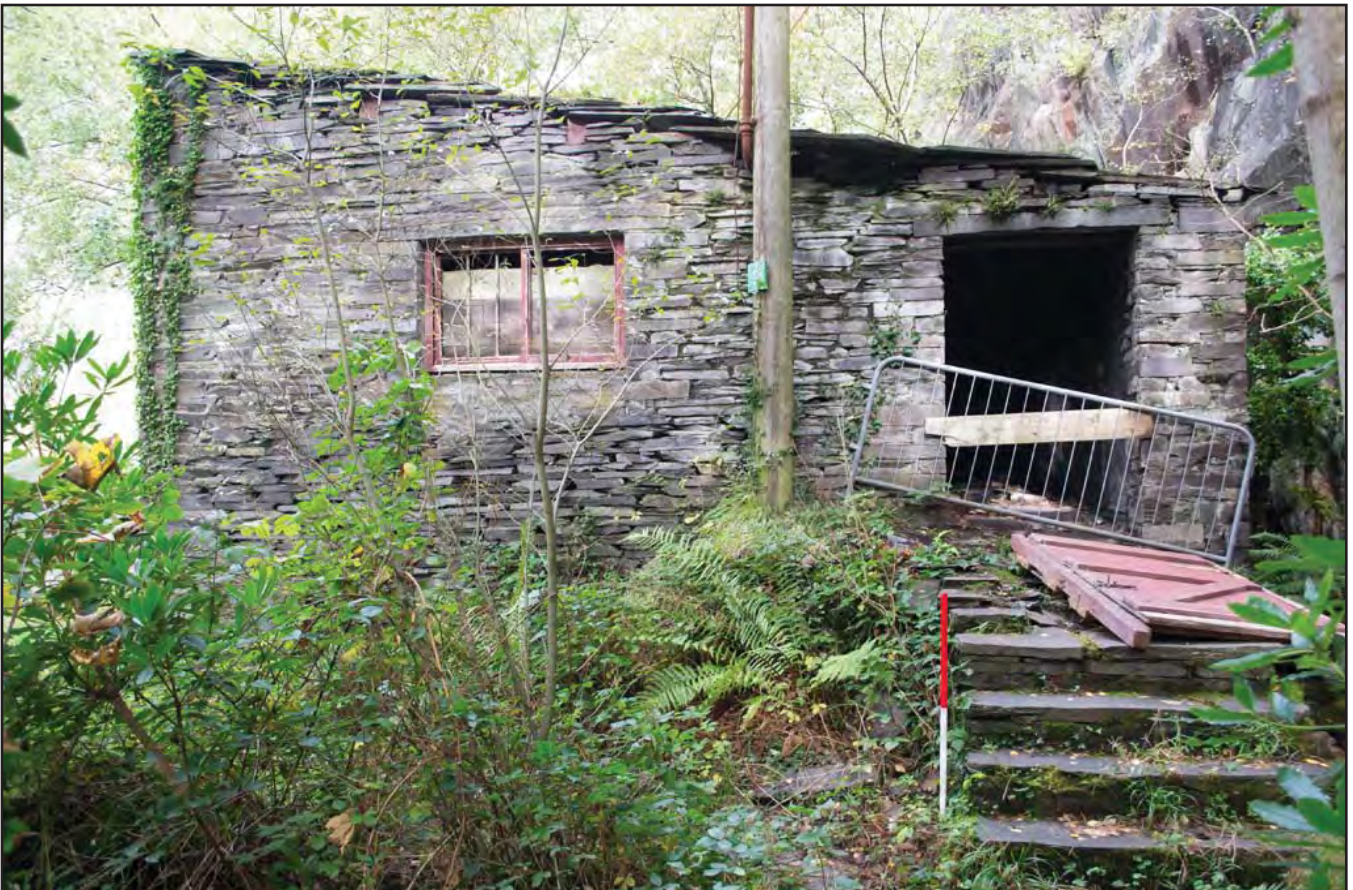
Plate 31: Vivian Quarry Utility Unit & Blast Shelter - Straight on shot of blast shelter; scale 1m; view from W (archive reference: G2805\_027).

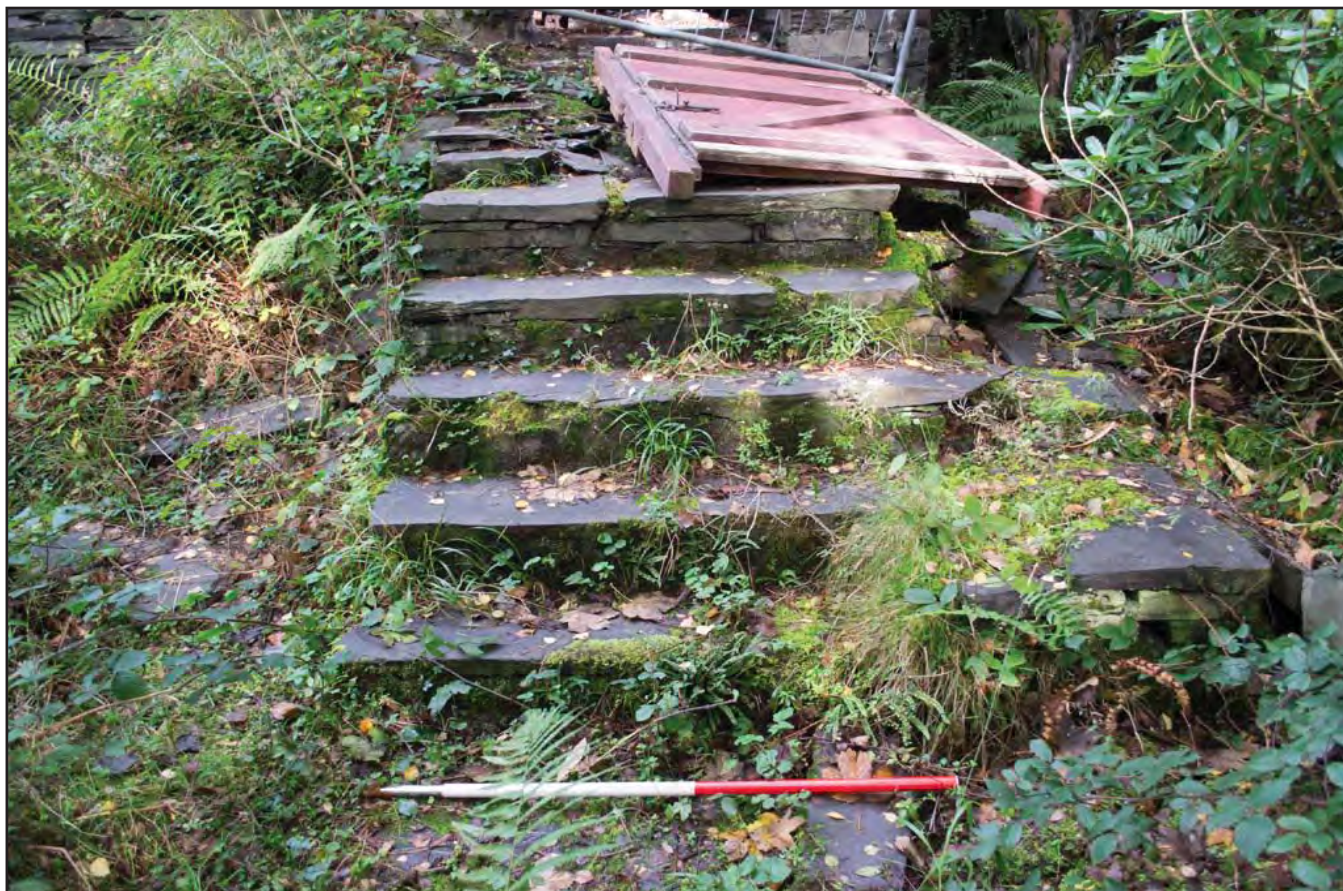
Plate 33: Vivian Quarry Utility Unit & Blast Shelter - Detail of steps into utility unit; scale 1m; view from S (archive reference: G2805\_029).

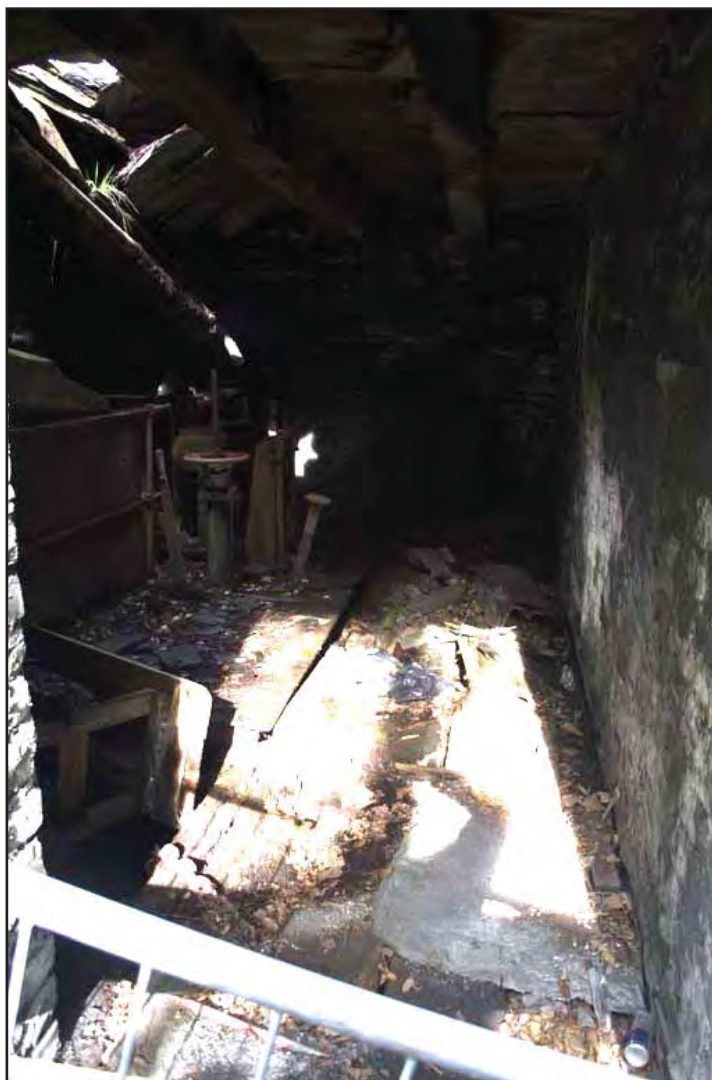
**Plate 35: Vivian Quarry Utility Unit & Blast Shelter - Shot through door of utility unit showing levers; scale not used; view from S (archive reference: G2805\_031).**

The Utility Unit was identified as a ropeway system winding house; it was in a dilapidated condition and unsafe to enter without the removal of the collapsed portions of the roof. Machinery associated with the winding mechanism was visible inside, with a cog wheel taken and reused on a telegraph pole to the south side of the building.

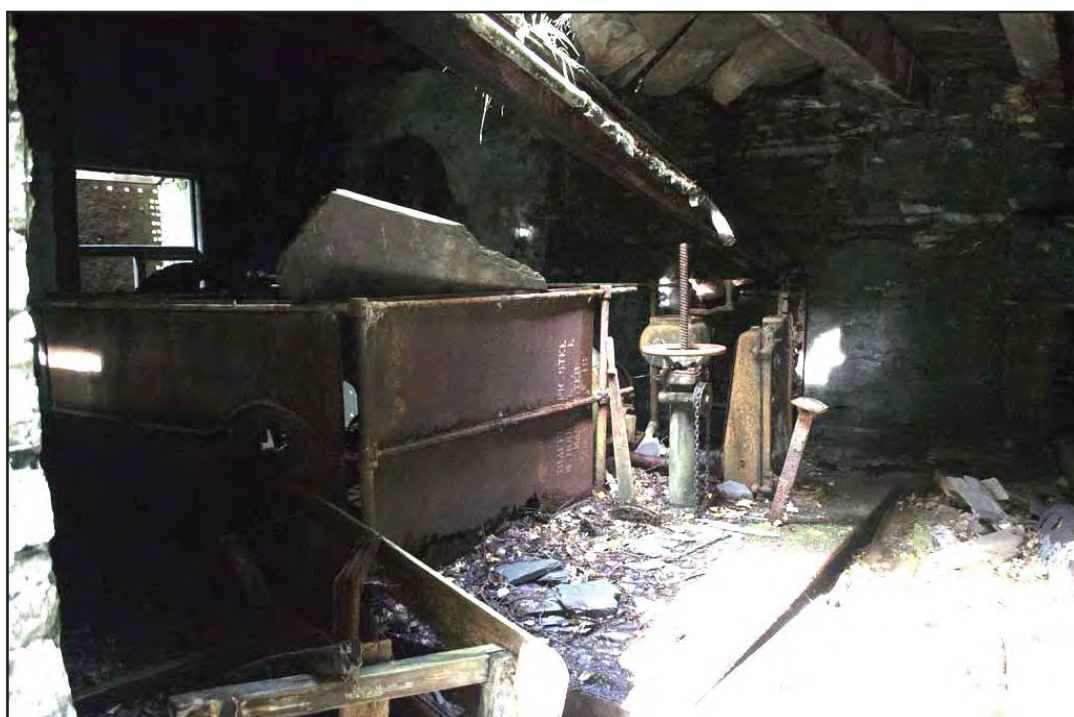
**Plate 36: Vivian Quarry Utility Unit & Blast Shelter - Shot through door showing machinery; scale not used; view from S (archive reference: G2805\_032).**

The rough-cut roof of the main structure of the Utility Unit has collapsed into the centre of the structure and lies partially on top of the machinery that powered the ropeway system that transported quarry carts across the opening of the quarry (now flooded and used as a diving training centre). For this reason access to the structure was impossible and unsafe with the internal elements recorded from the open doorway. The roof slates were supported by large timbers, now badly rotten and partially collapsed. The machinery seen within includes a foot switch, metal box and wheel handles which controlled a ropeway system in the Vivian Quarry.

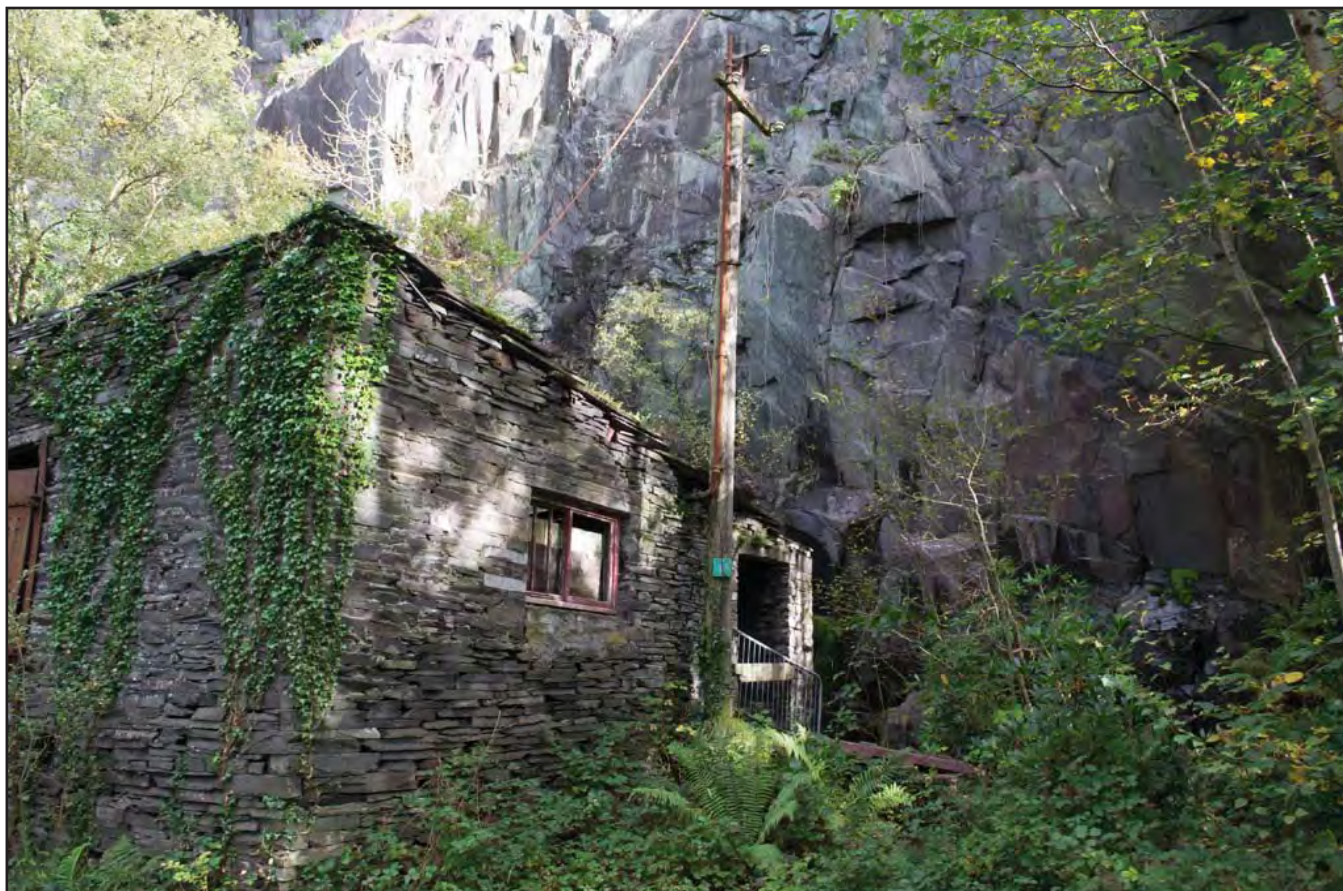
Plate 37: Vivian Quarry Utility Unit & Blast Shelter - View of telegraph pole on south side of utility building; scale not used; view from SW (archive reference: G2805\_033).

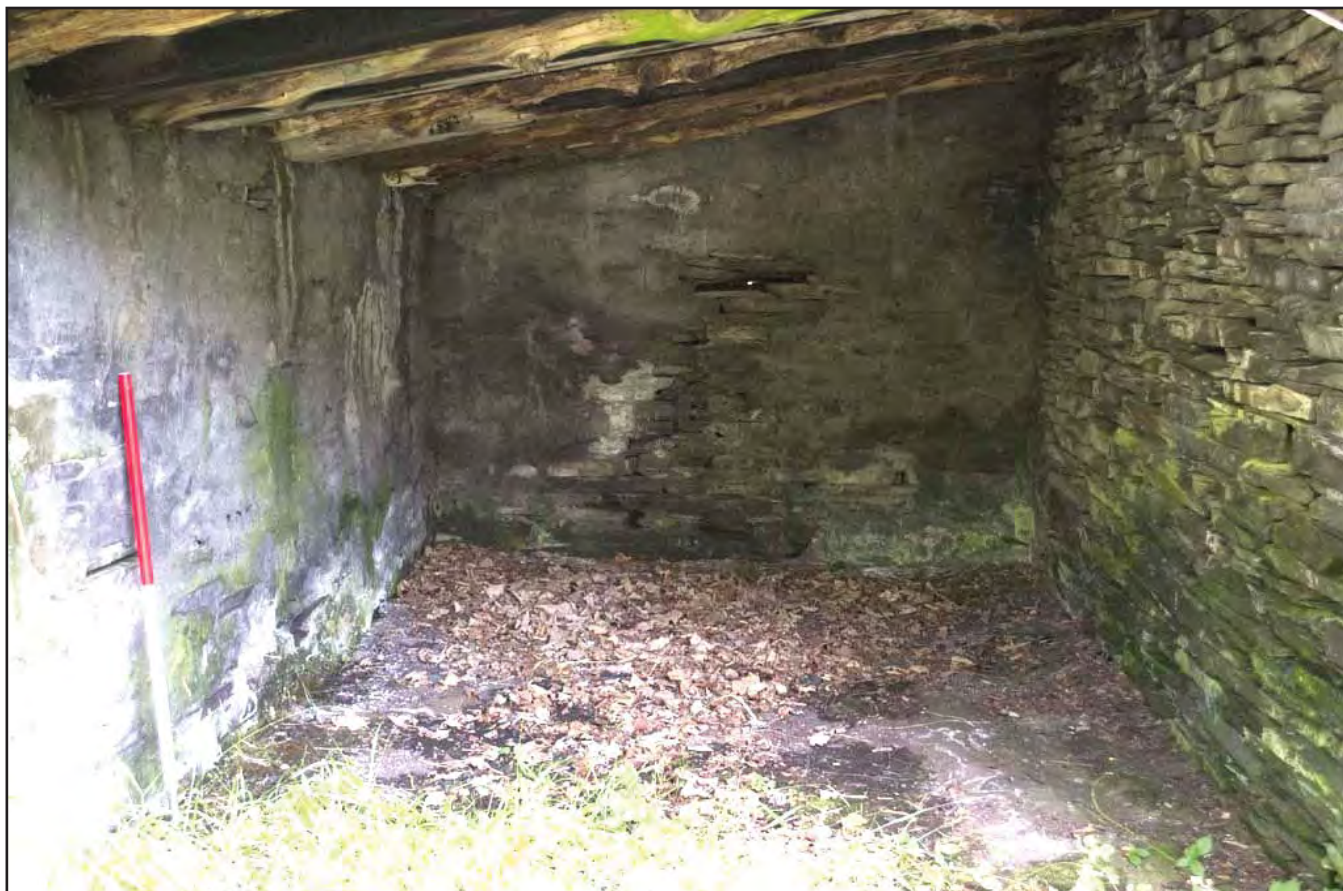
Plate 38: Vivian Quarry Utility Unit & Blast Shelter - View of north side of blast shelter; scale 1 m; view from N (archive reference: G2805\_034).

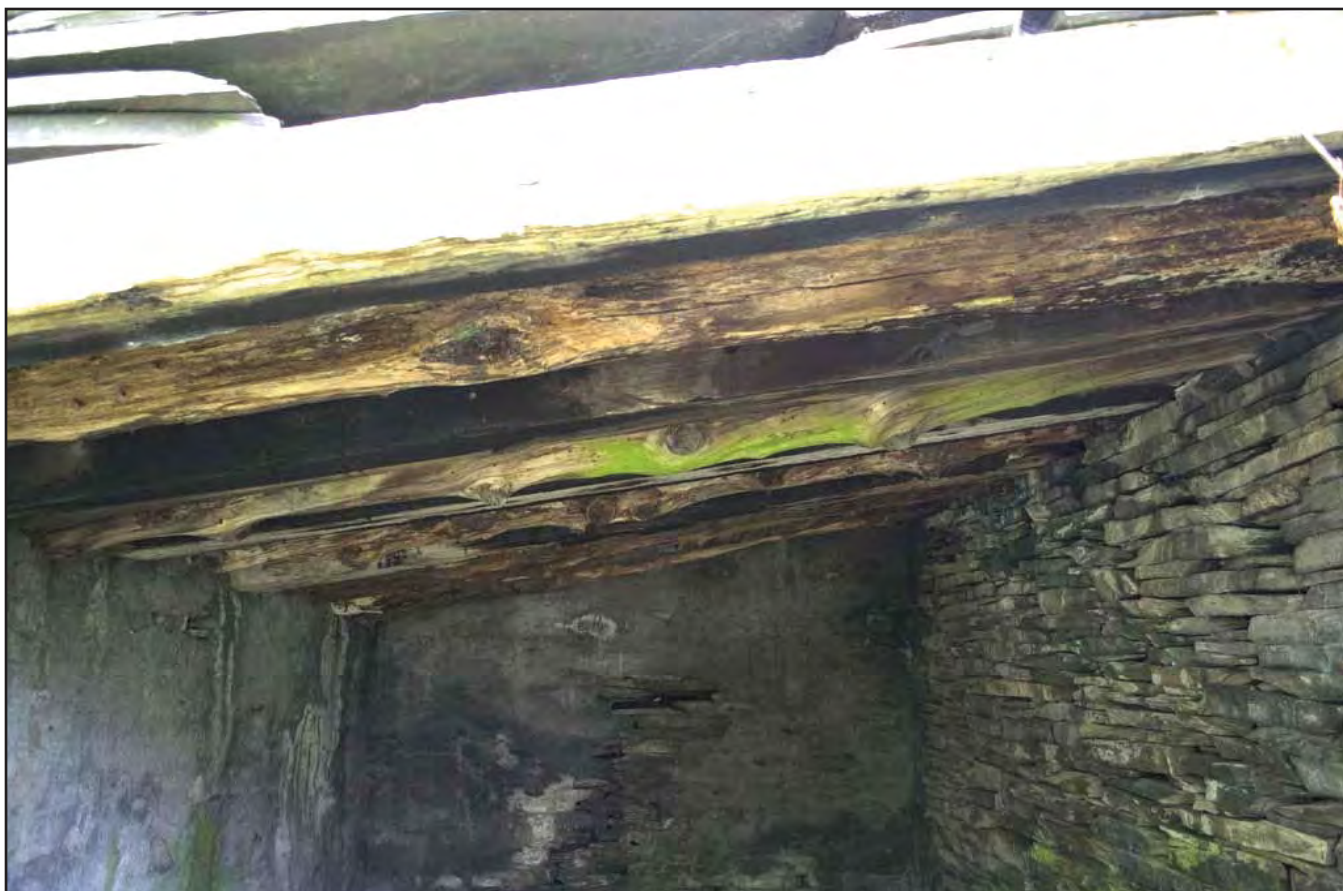
Plate 40: Vivian Quarry Utility Unit & Blast Shelter - Detail of roof structure within the blast shelter; scale not used; view from W (archive reference: G2805\_036).

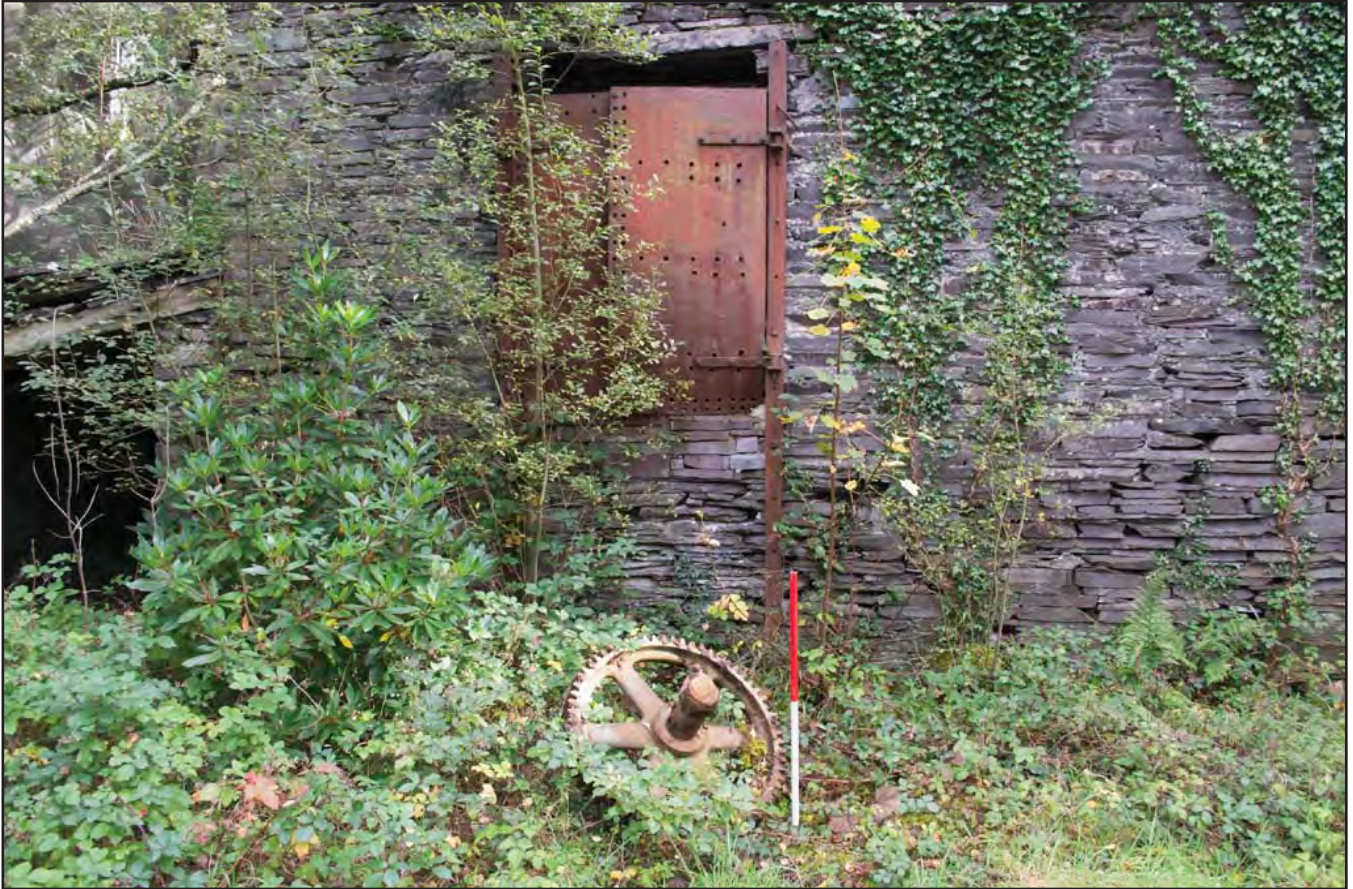
Plate 41: Vivian Quarry Utility Unit & Blast Shelter - Detail of iron doors and cog wheel on west side of utility building; scale 1m; view from W (archive reference: G2805\_037).

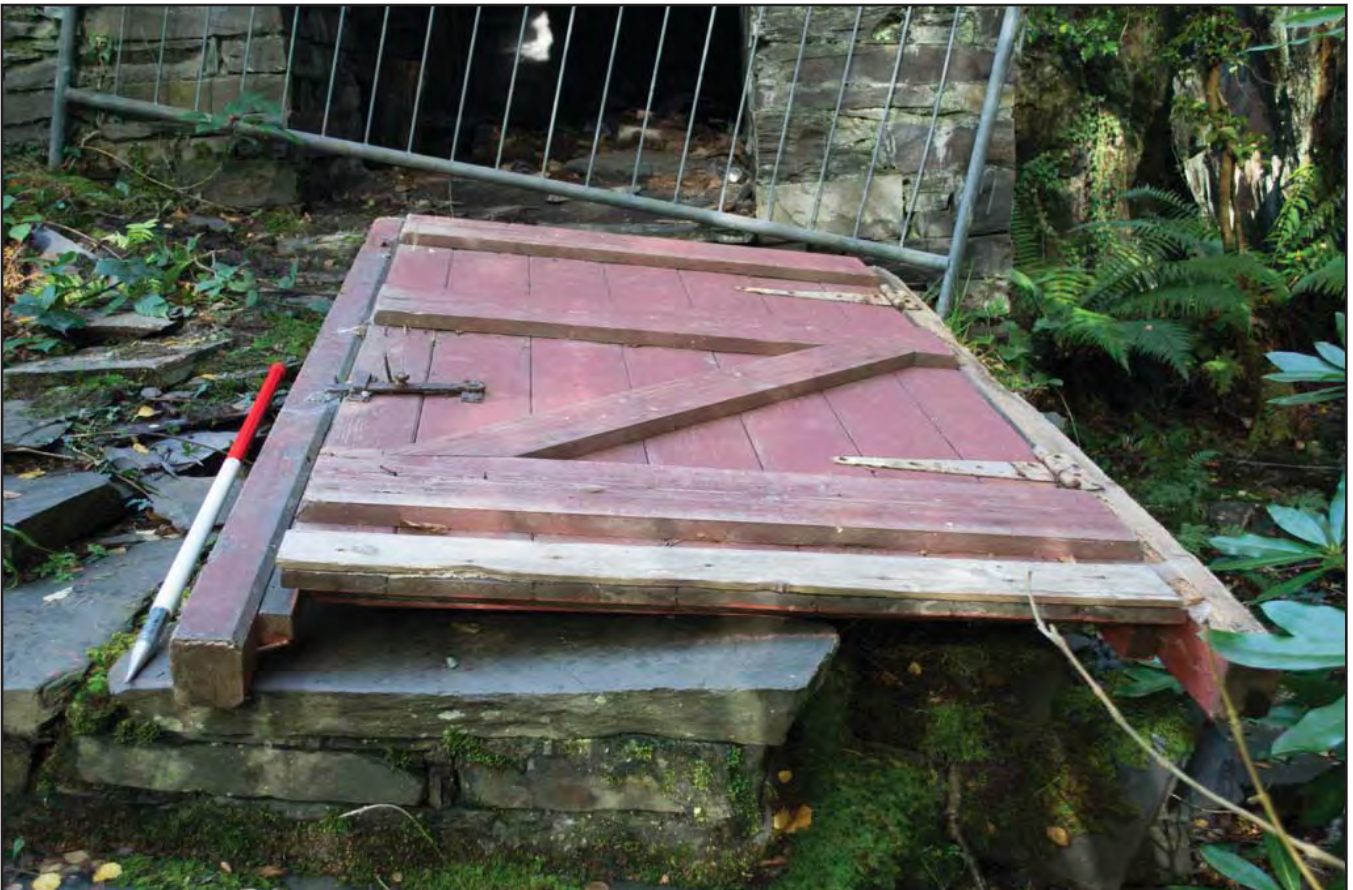
Plate 42: Vivian Quarry Utility Unit & Blast Shelter - Detail showing collapse door on steps; scale 1m; view from S (archive reference: G2805\_038).

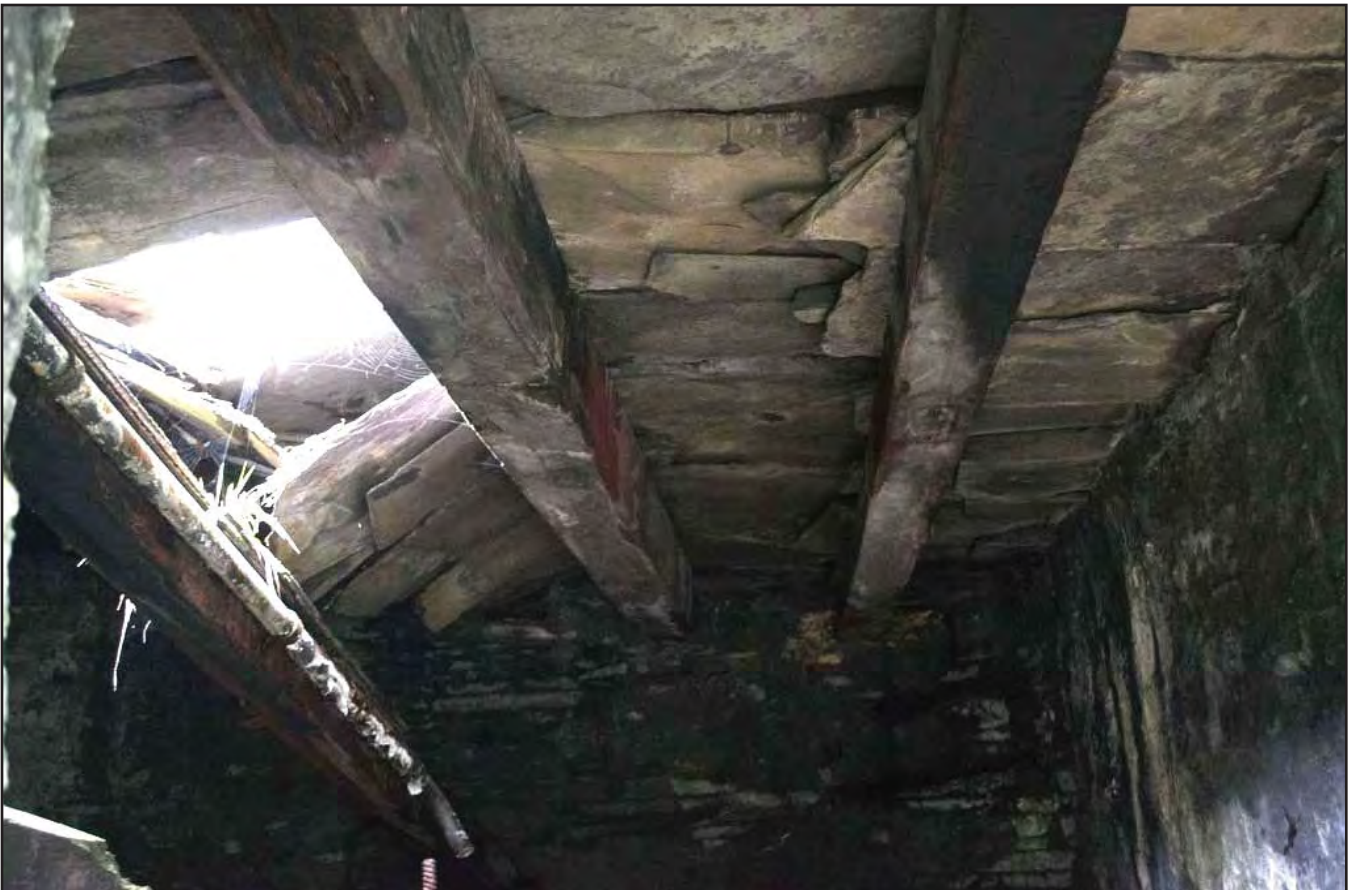
Plate 44: Vivian Quarry Utility Unit & Blast Shelter - View of collapsed roof above machinery in the utility unit; scale not used; view from S (archive reference: G2805\_049).

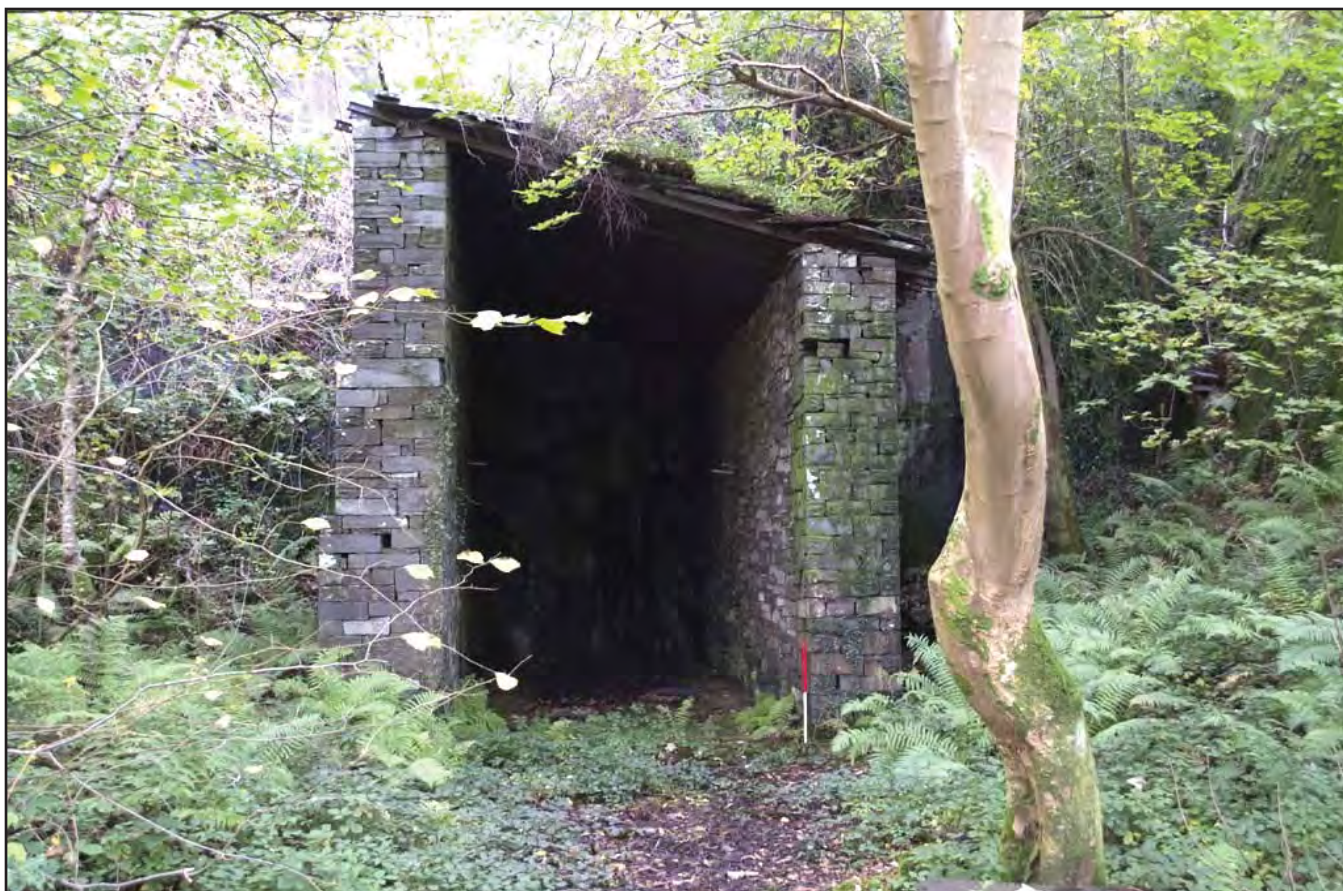
Plate 45: Vivian Quarry Utility Unit & Blast Shelter - General view of quarry pool; scale not used; view from N (archive reference: G2805\_050).

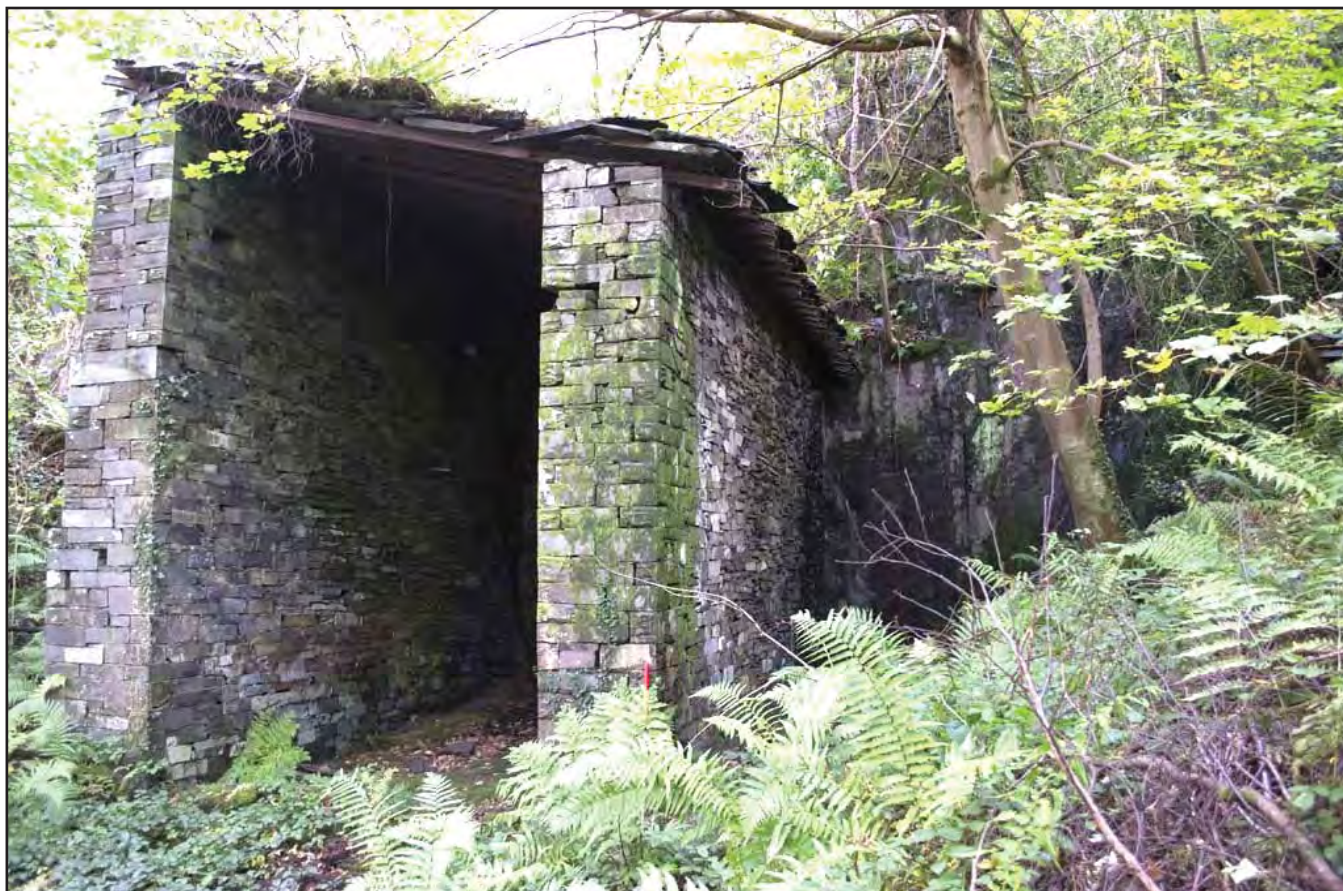
Plate 46: Vivian Quarry Storage Barn - General view into storage barn; scale 1m; view from W (archive reference: G2805\_040).

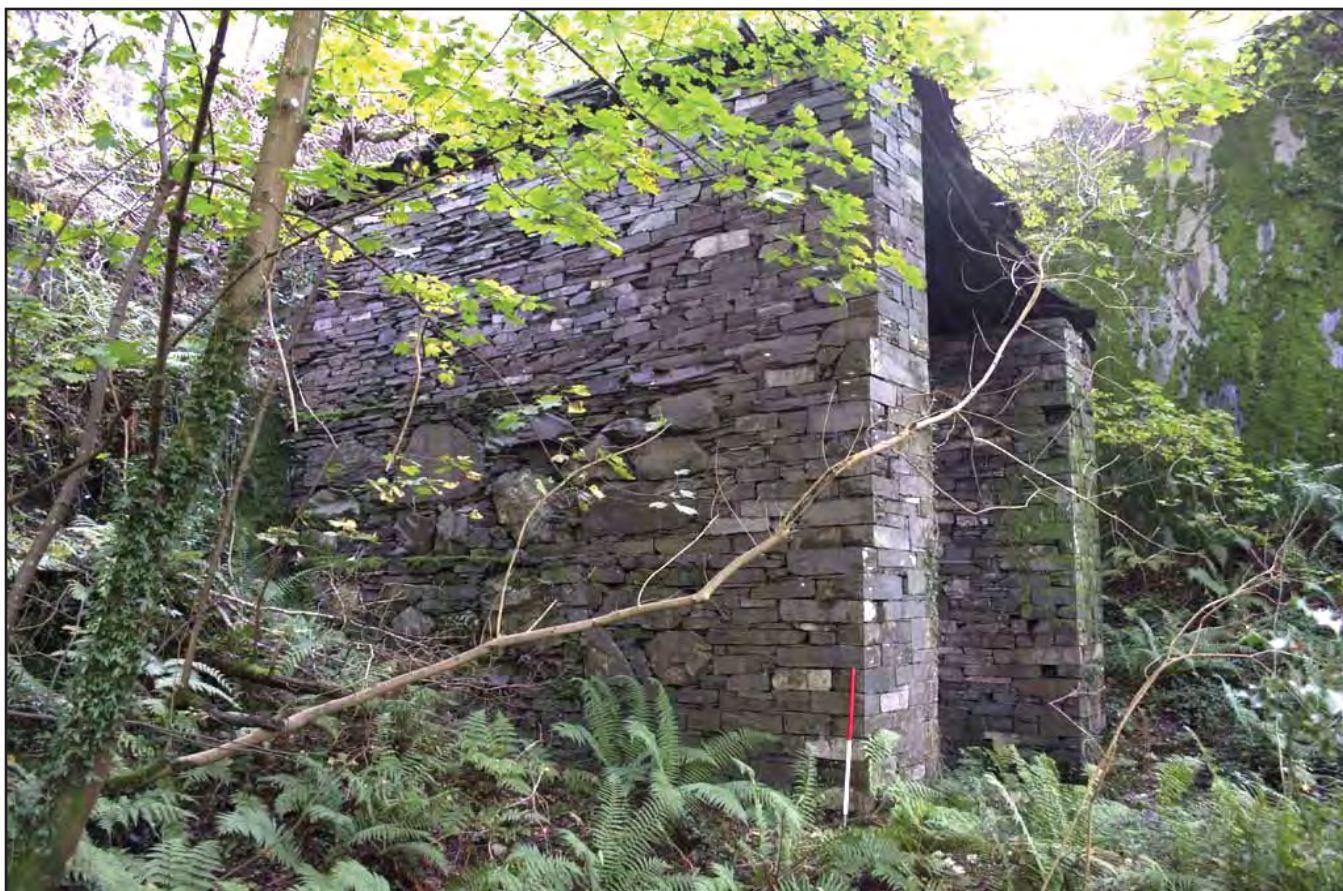
Plate 47: Vivian Quarry Storage Barn - Angled view of storage barn in Vivian Quarry; scale 1m; view from SE (archive reference: G2805\_041).

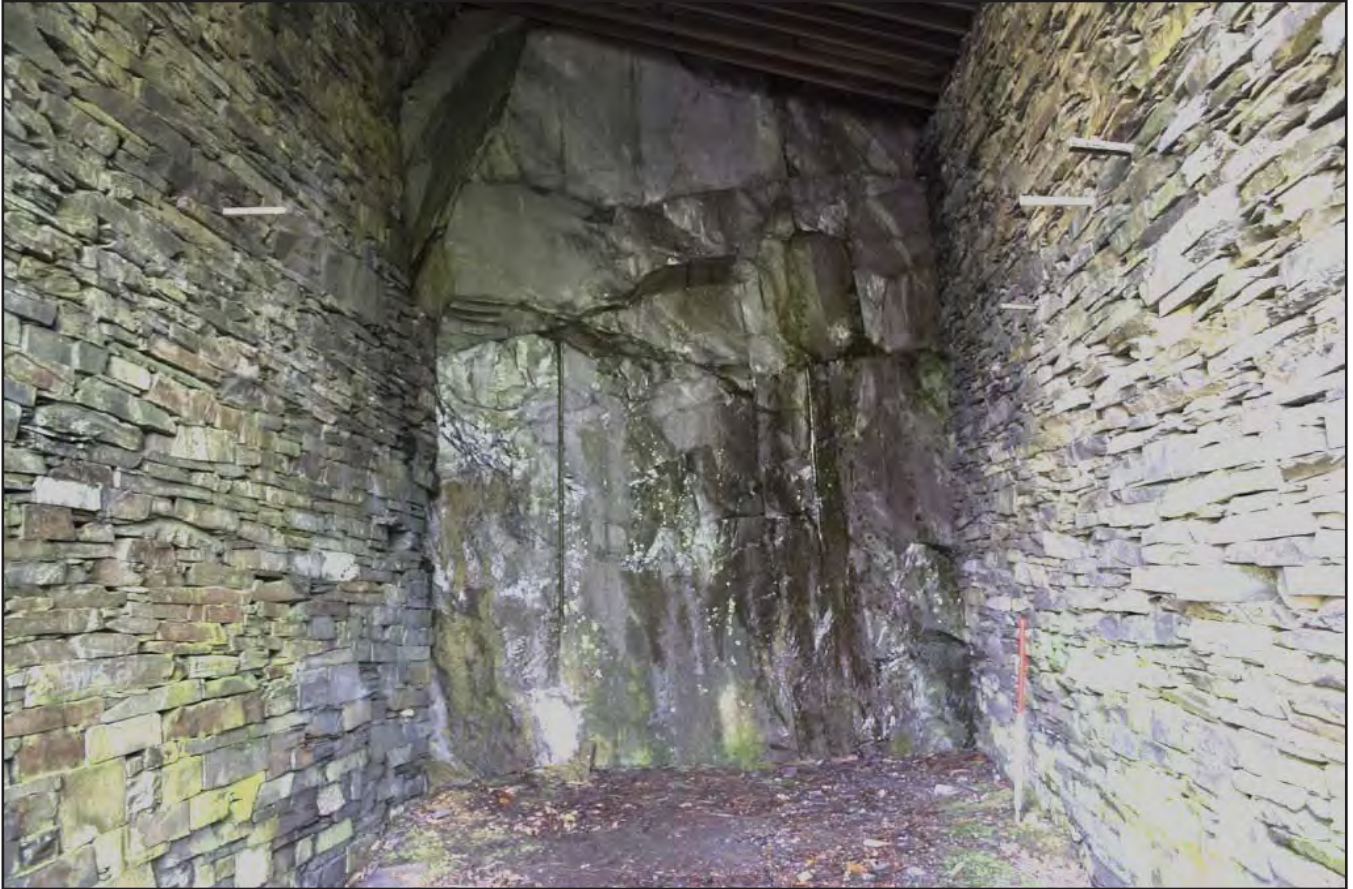
Plate 48: Vivian Quarry Storage Barn - Angled view of storage barn in Vivian Quarry; scale 1m; view from NW (archive reference: G2805\_042).

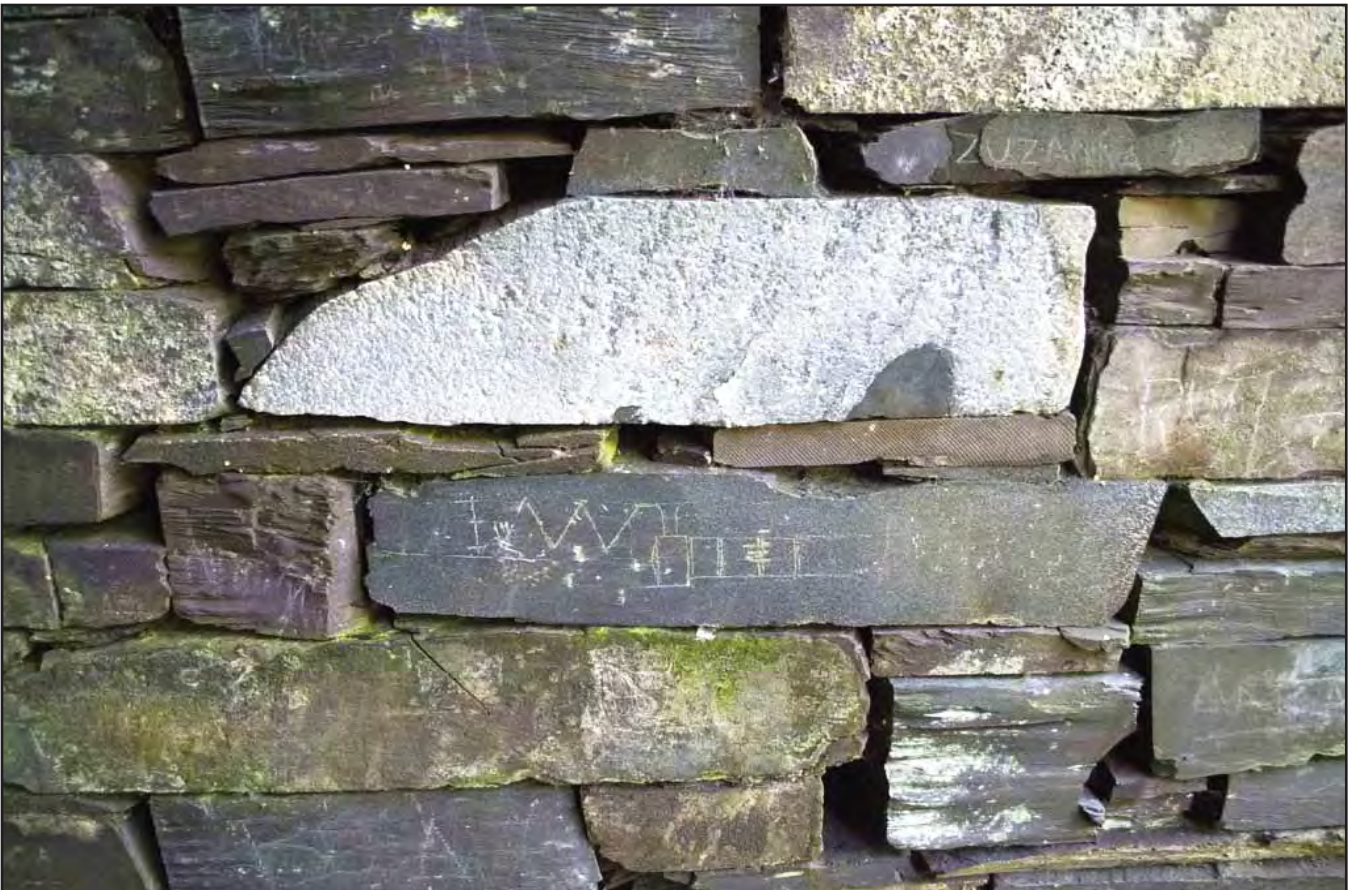
Plate 50: Vivian Quarry Storage Barn - Close up of initials and train graffiti on southern inside wall of storage barn; scale not used; view from N (archive reference: G2805\_044).

The Storage Barn has survived to a good condition other than the absence of the second floor. It was roofed with railway track re-used as rafters and covered with large rough slates, whilst graffiti of a steam train was visible on an interior wall. The graffiti of the steam train is an important archaeological feature and is comparable with the paddle steamer graffiti previously identified on the A-incline winding house (cf. report GAT\_1700).
