# PARC PADARN, CHWAREL DINORWIG / PARC PADARN DINORWIG QUARRY

COFNOD ADEILAD HANESYDDOL /  
HISTORIC BUILDING RECORDING

Prif Gyfeirnod Yr Amgylchedd Hanesyddol yn Cofnodi /  
Historic Environment Record Event Primary Reference Number: 46695

Rhif Adroddiaf/ Report No. 1735

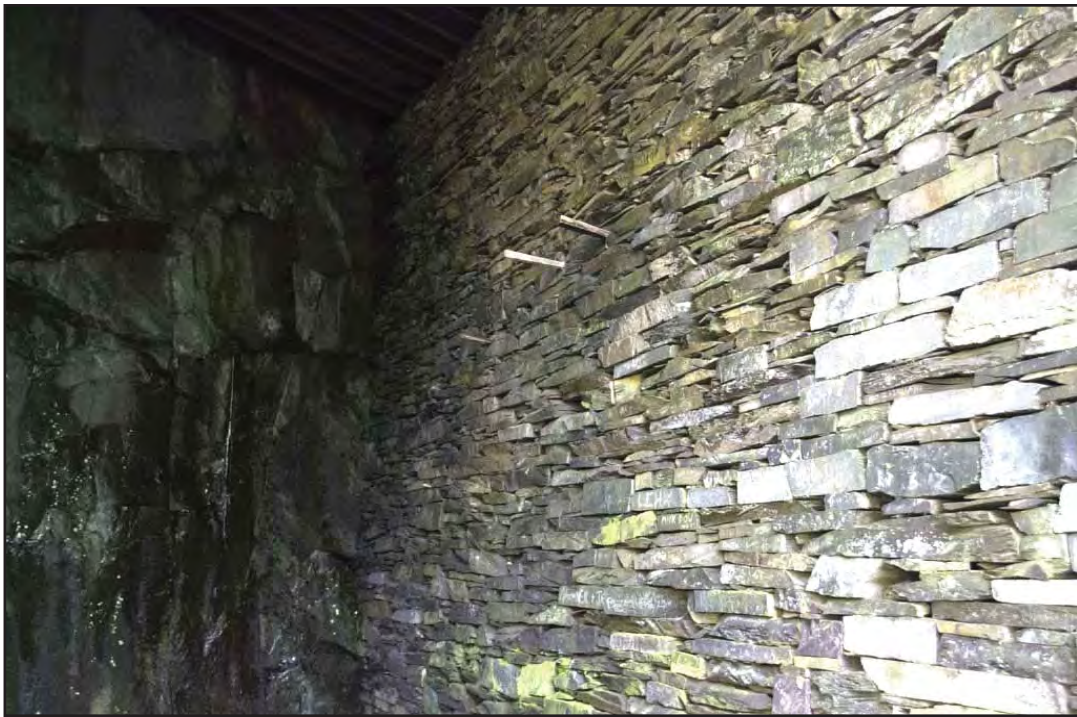
Plate 51: Vivian Quarry Storage Barn - Interior of storage barn showing relict second storey; scale not used; view from NW (archive reference: G2805\_045).

The Storage Barn has survived to a good condition other than the absence of the second floor. It was roofed with railway track re-used as rafters and covered with large rough slates, whilst graffiti of a steam train was visible on an interior wall. The graffiti of the steam train is an important archaeological feature and is comparable with the paddle steamer graffiti previously identified on the A-incline winding house (cf. report GAT\_1700).

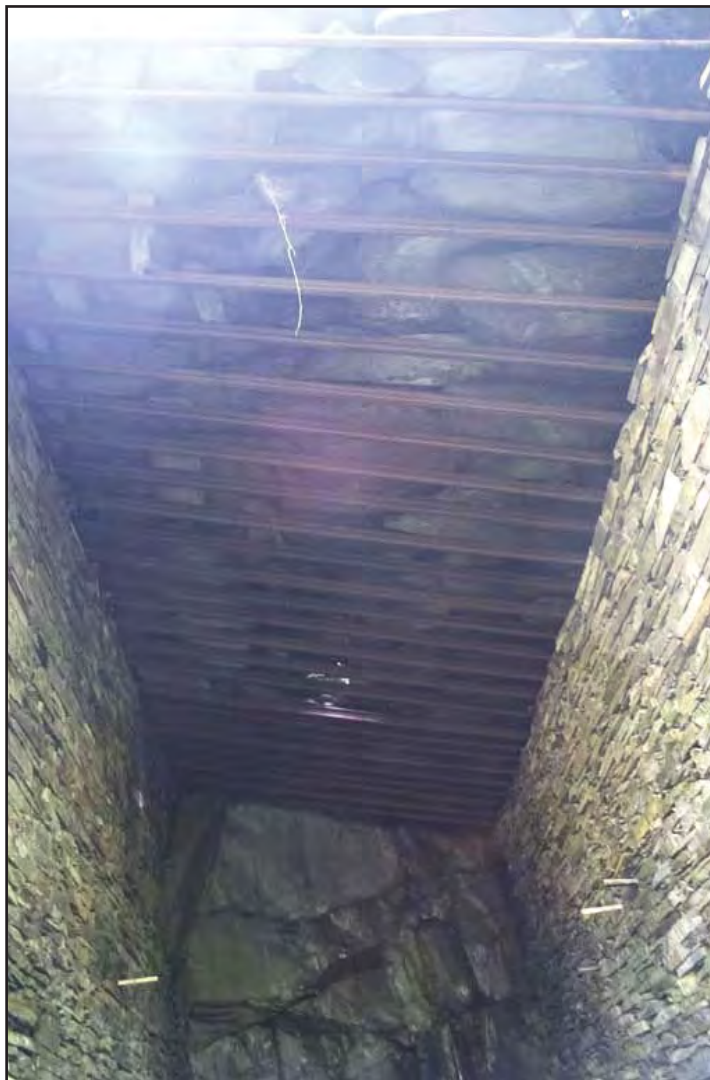
Plate 52: Vivian Quarry Storage Barn - Shot of roof from interior showing recycled rail tracks used as roof rafters; scale not used; view from NW (archive reference: G2805\_046).

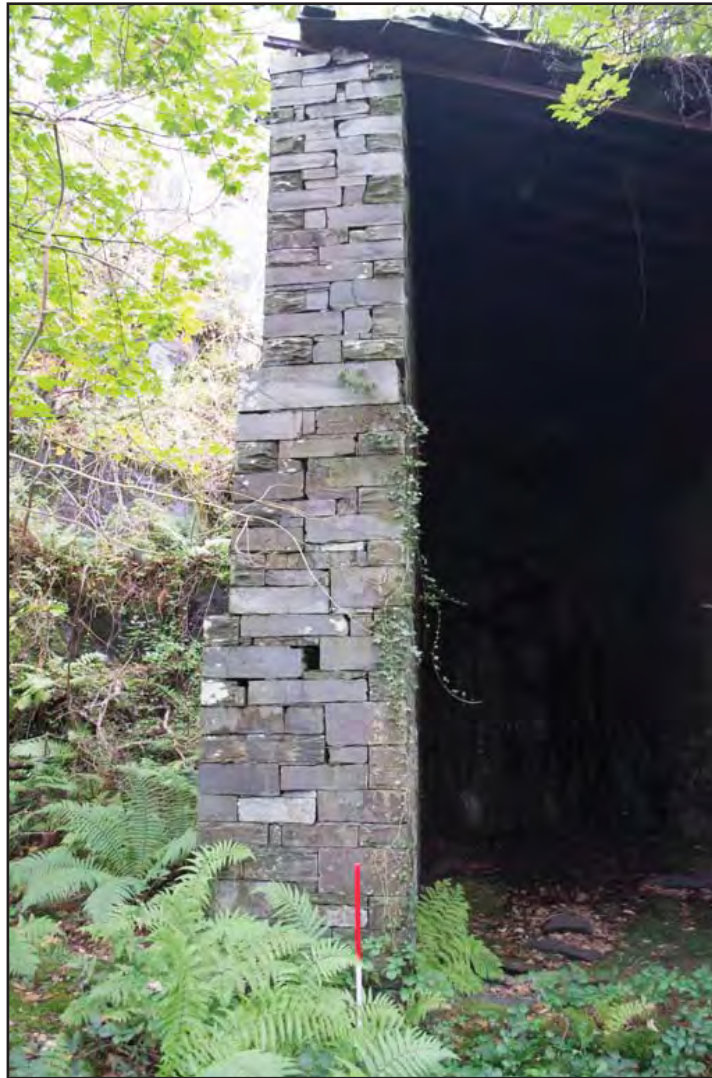
**Plate 53: Vivian Quarry Storage Barn - Shot of wider base of wall on northern side; scale 1m; view from W (archive reference: G2805\_047).**

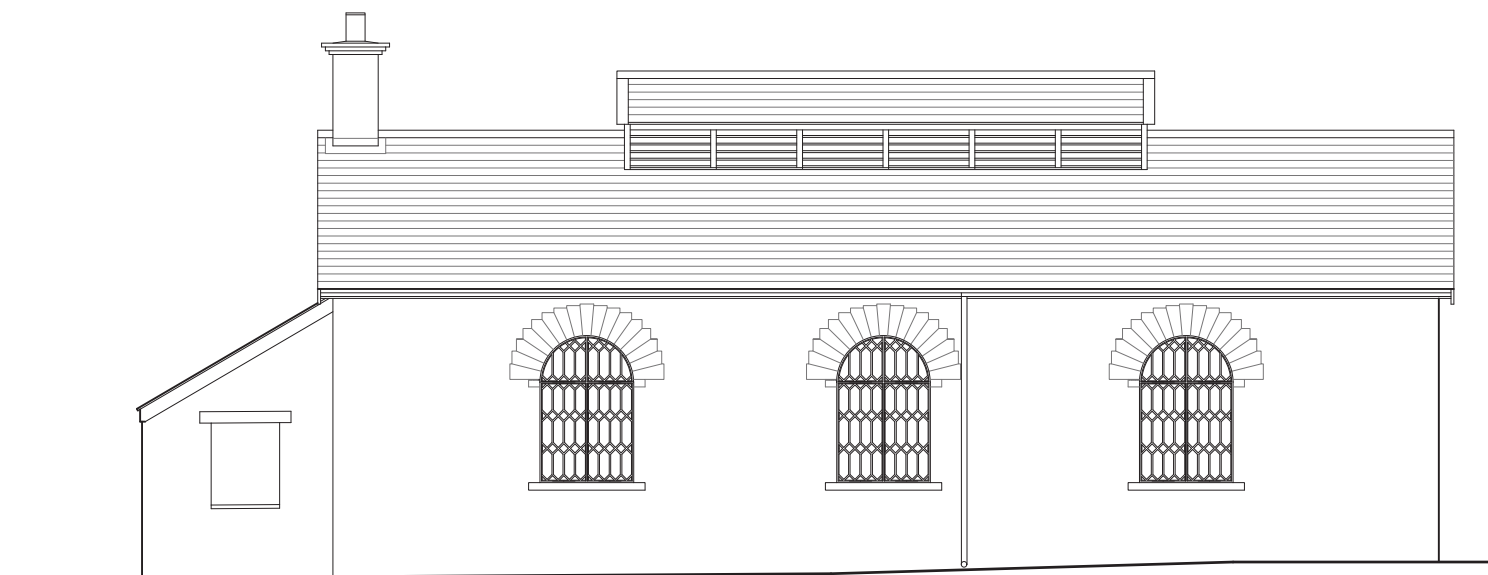
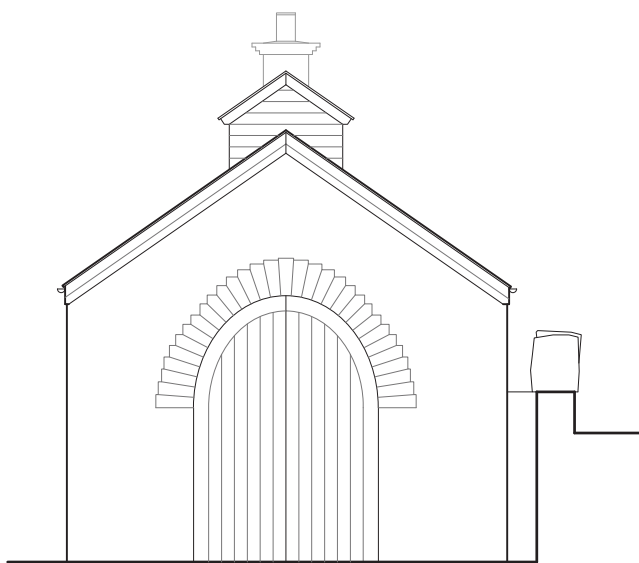
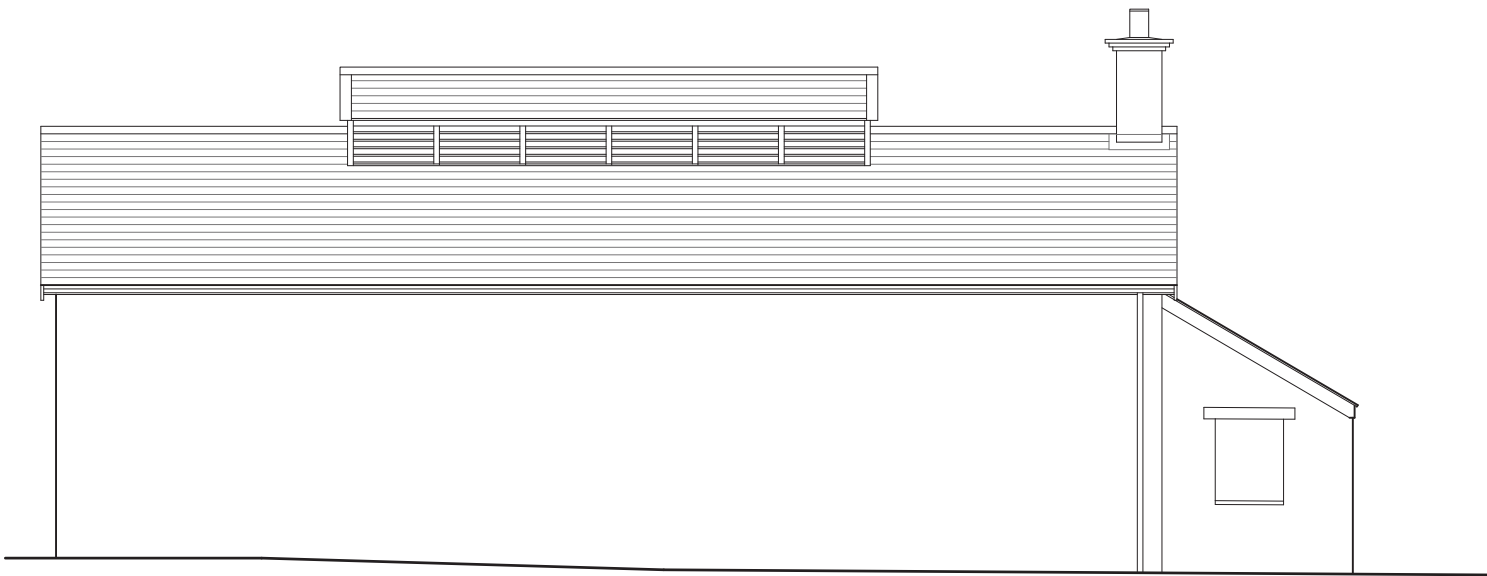
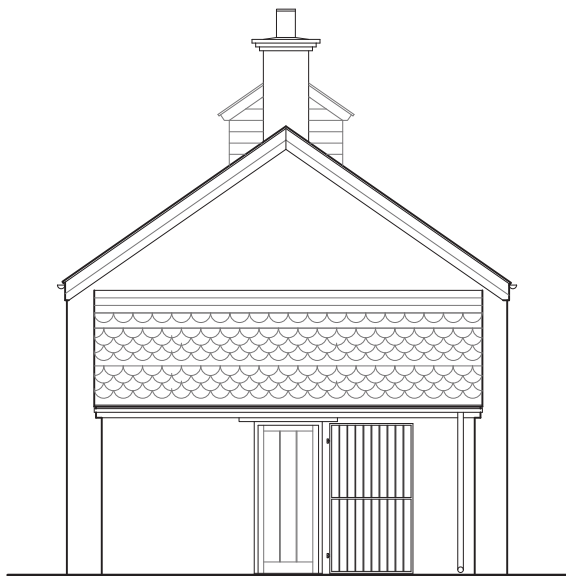
**Reproduction of *Chambers Conservation* Job Number LPCP.03 Drawing  
No. 02**

West Facing Elevation as Existing  
(1:100 at A3)

South Elevation as Existing  
(1:100 at A3)

East Facing Elevation as Existing  
(1:100 at A3)

North Elevation as Existing  
(1:100 at A3)
