**Mynydd Parys Copper Mine**  
**Archaeological Assessment (G1469)**

**Report No. 292**

Prepared for  
Cadw: Welsh Historic Monuments  
and  
Amlwch Industrial Heritage Trust

# PARYS MOUNTAIN COPPER MINE: ARCHAEOLOGICAL ASSESSMENT

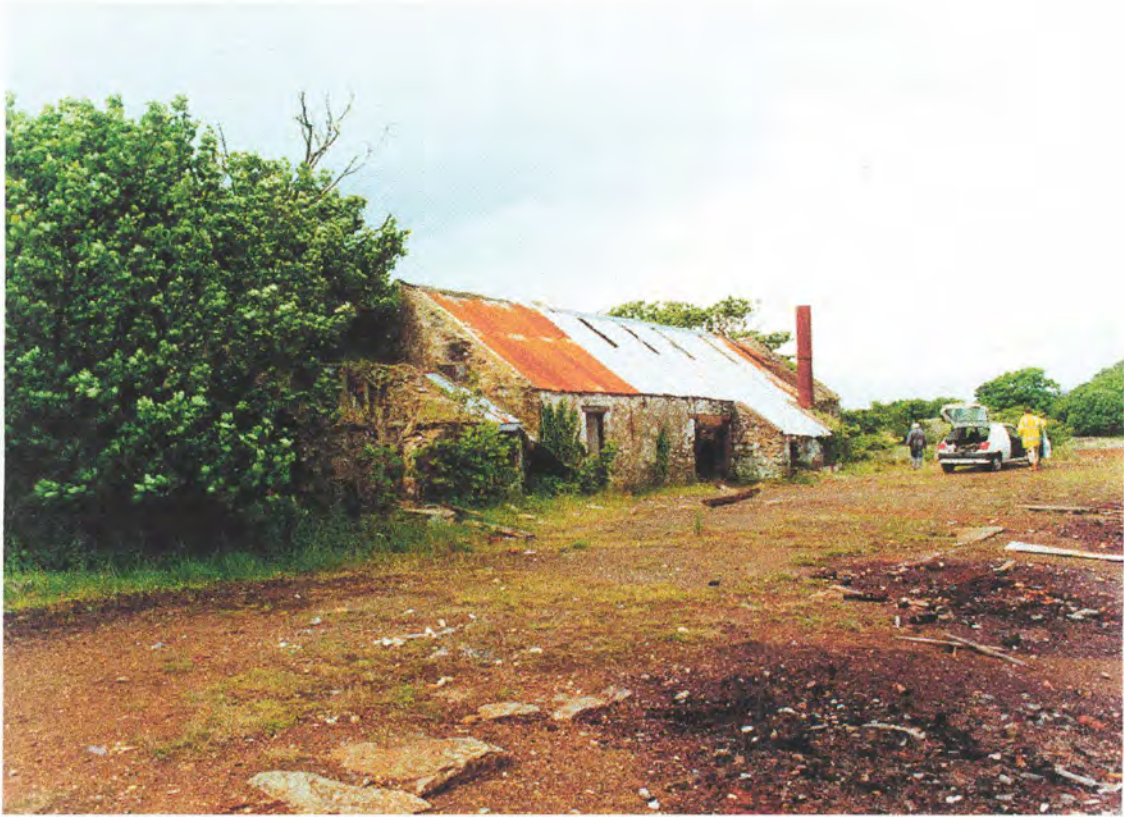
1 The Dyffryn Adda furnace (feature no. 387) was constructed in the early years of the nineteenth century for drying the copper precipitate from the Joint Level which drained both the Parys and the Mona mines. It remained in use until 1958, when the precipitation system was finally abandoned. Its situation near the Amlwch to Llanerchymedd road makes it an easy target for vandals.

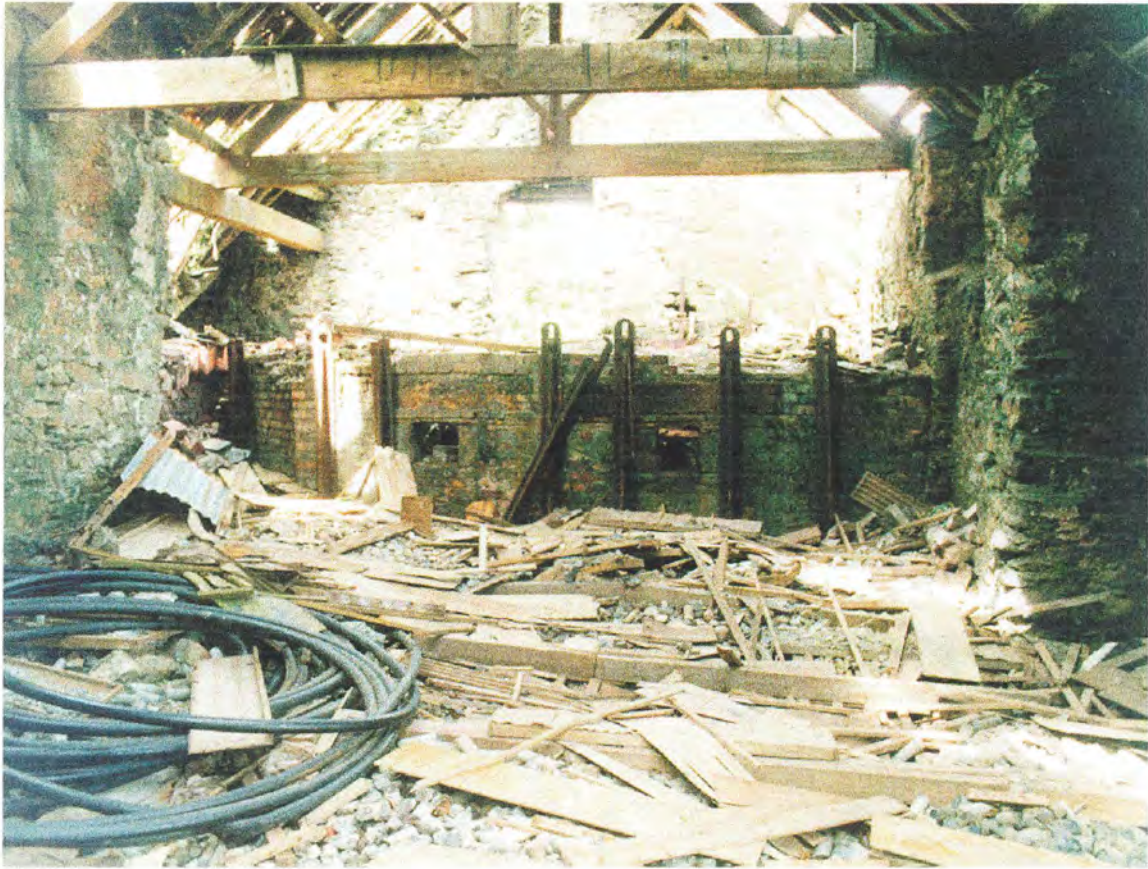
2 The interior of the Dyffryn Adda furnace (feature no. 387) showing the reverberatory furnace and the upstanding cast iron beams which hold it in place. The degree of recent damage to the furnace is apparent in this photograph.

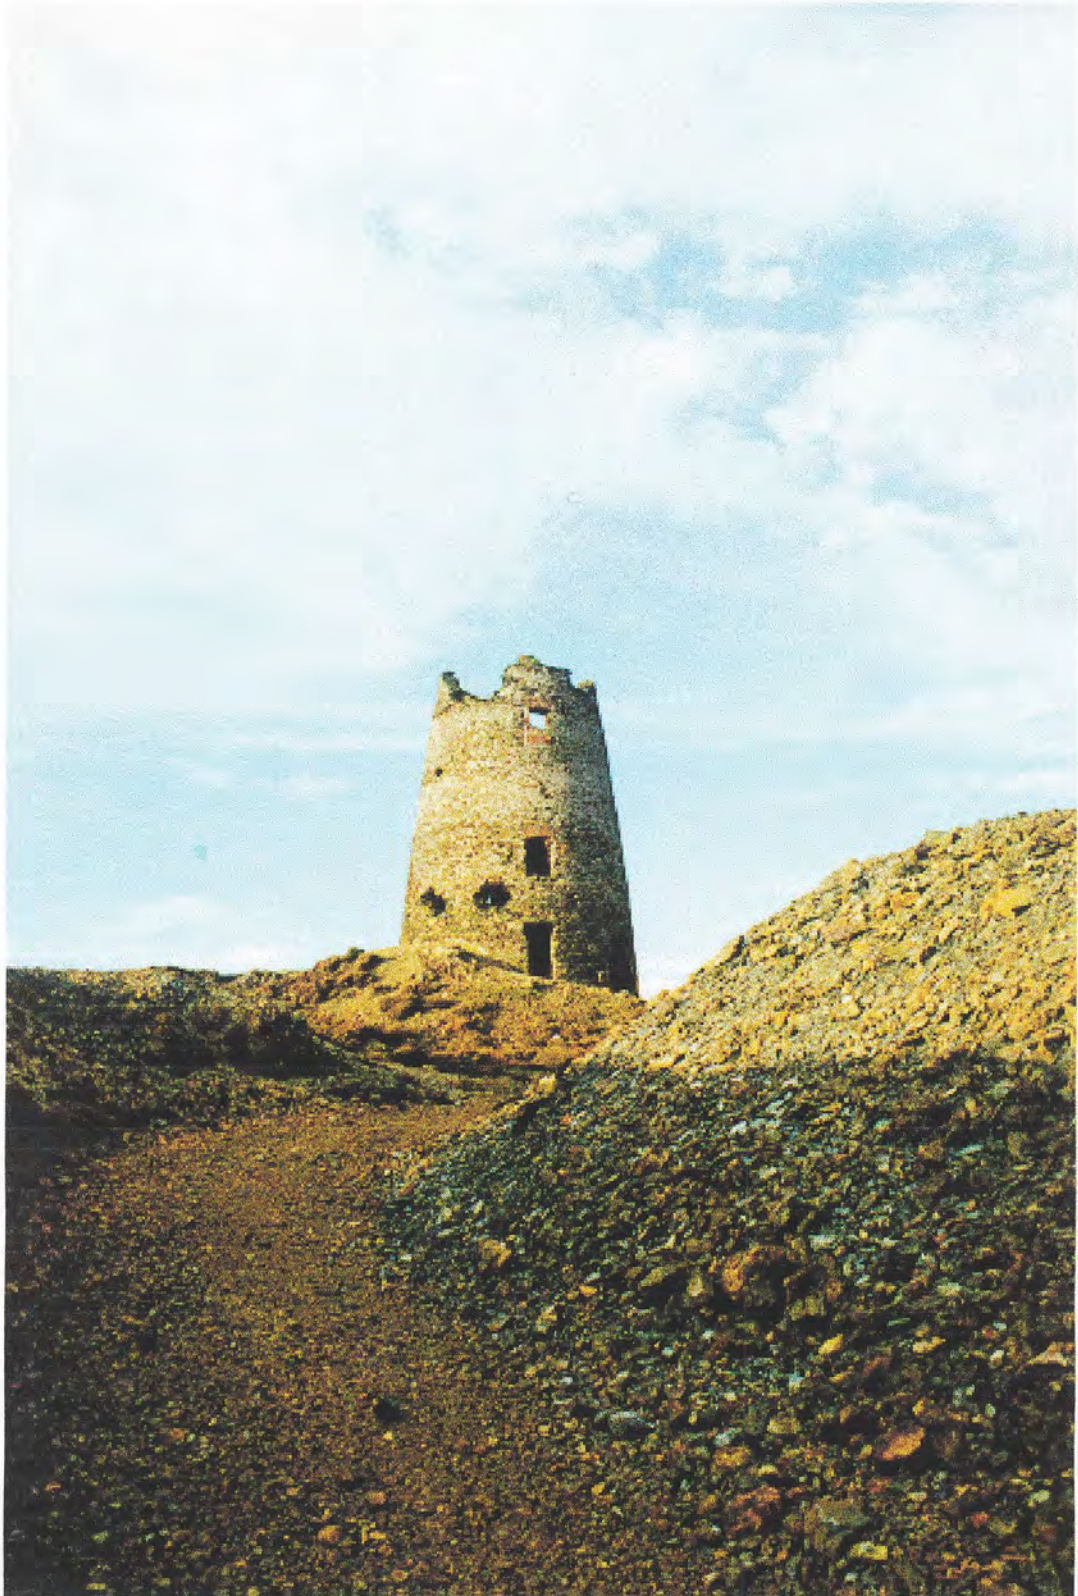
3 The Mona Mine windmill (feature no. 74) was constructed in 1878, and operated a pump by means of 200 feet of flat-rods. It was supplemented from 1880 by a steam engine. Uniquely for Anglesey, it was a five sail mill, and is believed to be the only surviving mine pump windmill in Britain. It is a Scheduled Ancient Monument.

This impressive feature is the single most prominent landmark on the mountain, and is visible over a considerable distance. It is a stone-built conical tower mill, which measures 8m in diameter across the base and stands approximately 20m high. Uniquely for Anglesey, it was a five-sailed mill; the cap and all the machinery are missing, but it is believed to have contained an upright shaft driven by bevel-gearing from the sail-shaft, which in turn operated 200’ of flat-rods by means of a crank in its foot. The flat-rods operated a pump in Cairns’ shaft, and were supported on intermediate dolly-posts. The windmill was still operating in 1901.<sup>99</sup> Its importance as the only surviving pump-windmill in an extractive industry in Britain was recognised by scheduling as an Ancient Monument in 1995.

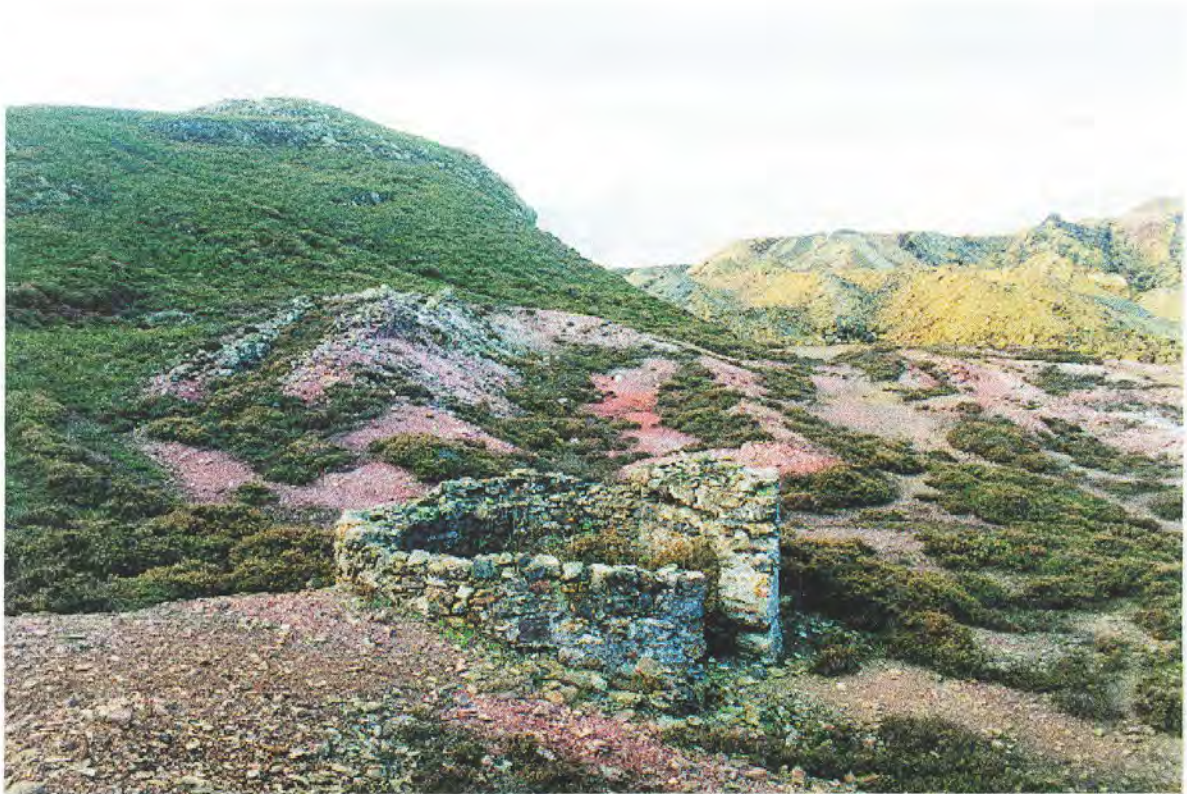
4 The Monna Mine, looking west. In the foreground stand the remains of the magazine (feature no. 293) and beyond a number of the sulphur calcination kilns and their associated stone-built flues (feature nos. 300-303). The distinctive pinkish spoil is a sign of calcination having been carried out.

A number of what appear to be later versions of these kilns survive, though the sulphur chambers are stone-built rather than brick. Four calcining kilns and their related flues and sulphur chambers were noted at Parys mines (4, 6-9, 11-13, 15-17), believed to be for copper ore, and eight at Mona (294-303), believed to be for iron ore, along with other structures on both mines that may also have been connected with calcining (263, 276). The kilns themselves are visible as rounded oval depressions, anything up to 17m long and 6m across, some of which appear to feed into long but barely defined flues and which are associated with sulphur sublimation chambers, visible as parallel stone walls, typically 16m long, 1m high, each 0.8m wide and 0.6m apart. Around the kiln-sites the spoil is a distinctive pinkish colour.

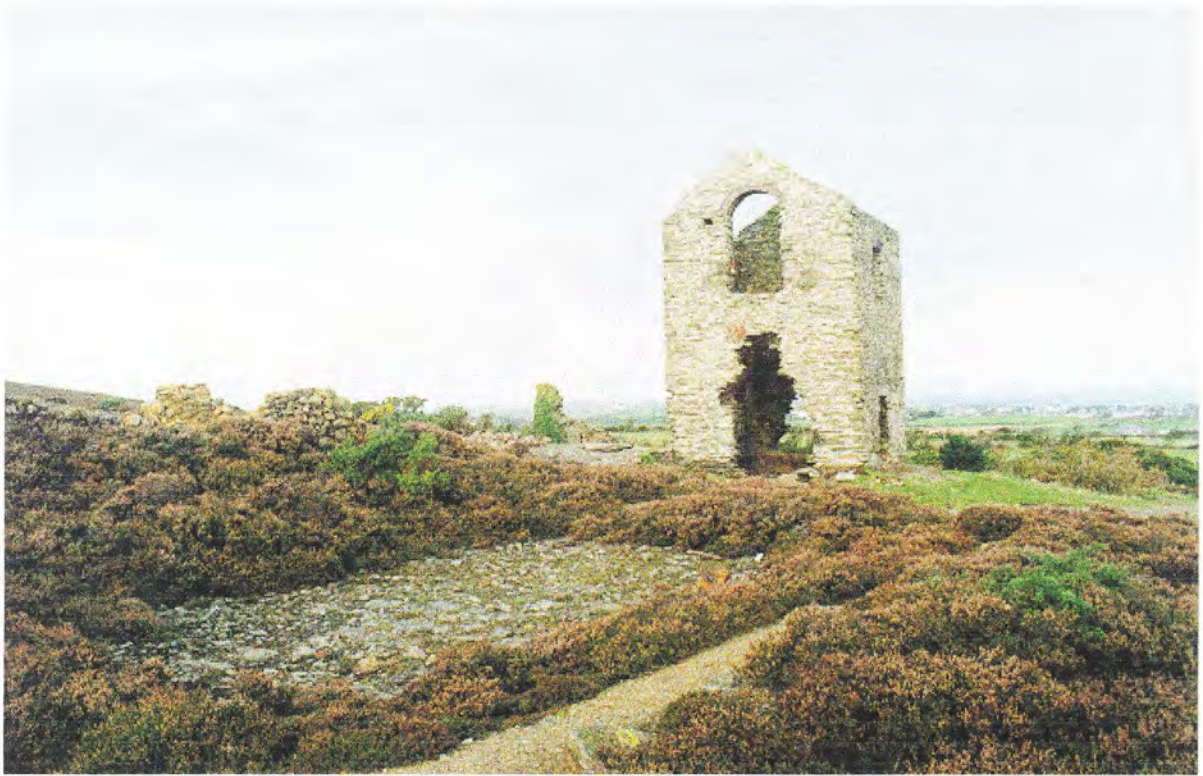
5 The Pearl engine house of 1818/19 (feature no. 122) is a Scheduled Ancient Monument -

This was the Cornish engine to pump the already existing Pearl shaft, installed in 1819 in a purpose-built engine house, believed to be the oldest surviving example in Wales,<sup>103</sup> and Scheduled as an Ancient Monument in 1995. It has recently been consolidated with grant-aid from Cadw. The engine was purchased by the Mona mine from Neath Abbey ironworks in 1819, and installed on the north-eastern perimeter of the site that year, where it replaced a horse-gin.<sup>104</sup> It first worked on 27-30 March 1819.<sup>105</sup> Faraday describes it as “a small steam engine employed to drain one of the workings of the mine ... good and preserved in very neat order within the house, the outdoor parts were of timber” but adds:

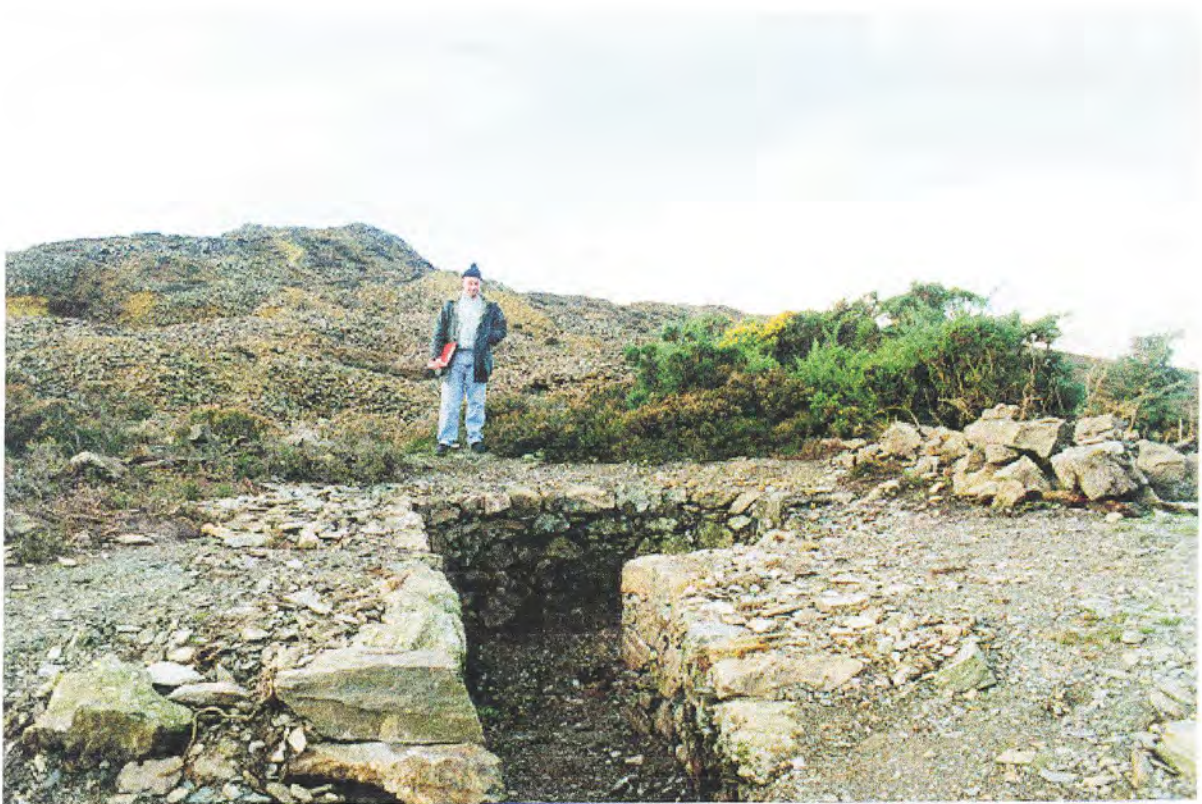
6 - but the associated capstan pit (feature no. 123) does not fall within the scheduled area.

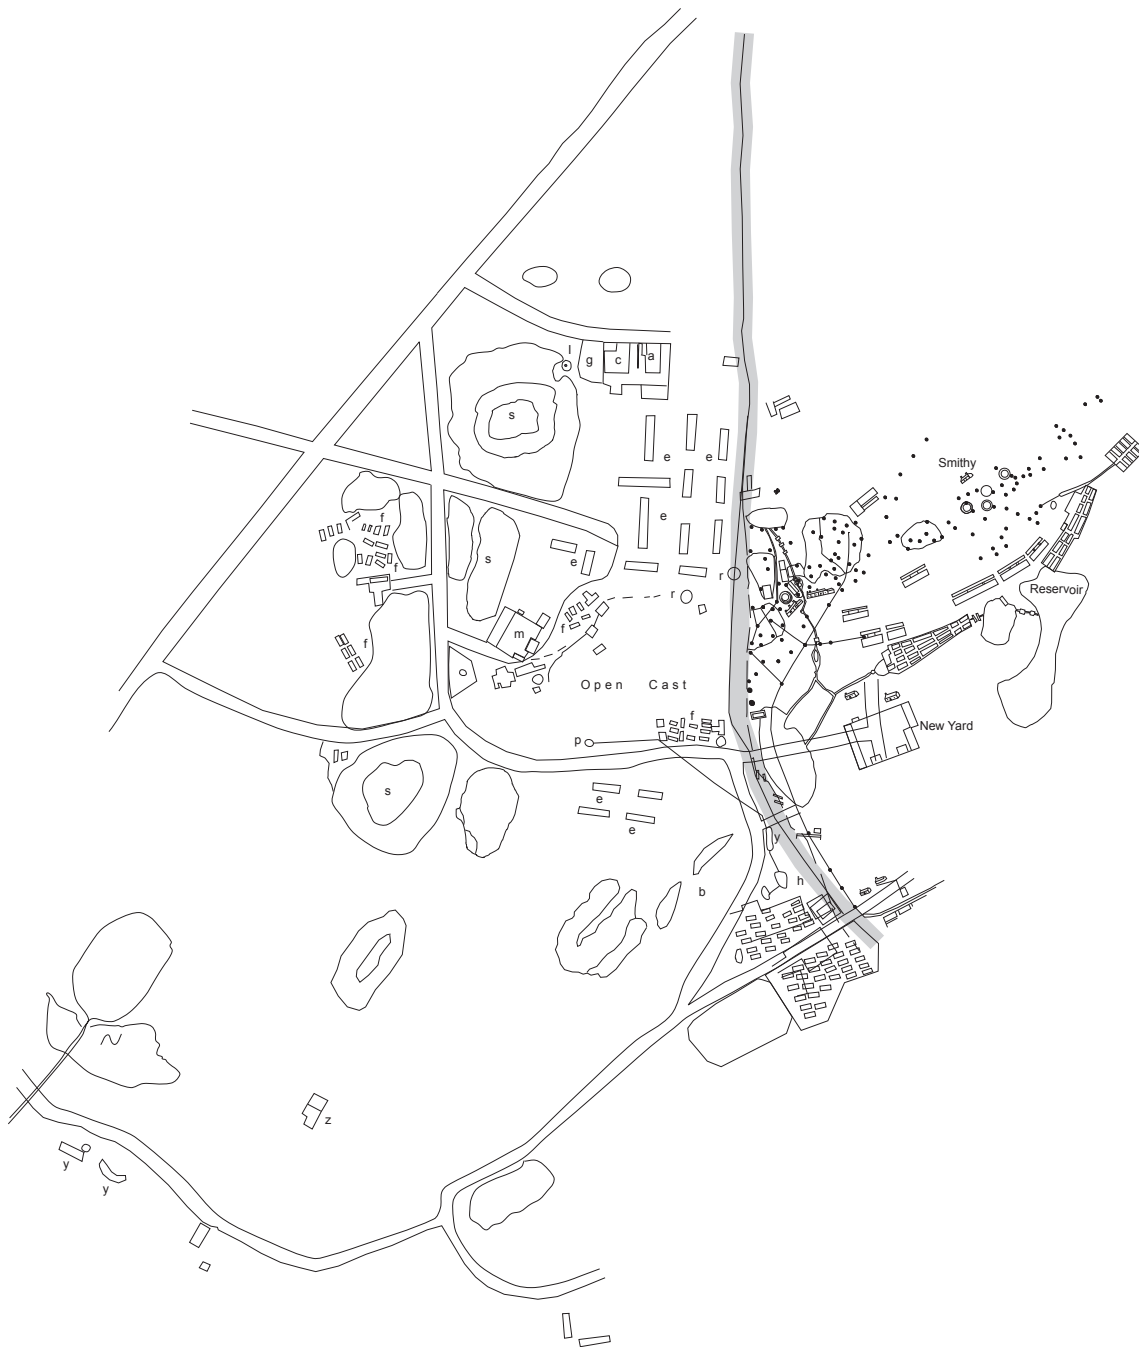
# Maps 1 and 2 Mona Mine, 1784 - 1786, Parys Mine 1815

A Boundary fall  
B Fall next Sir Nick's smithy  
C Champion's falls  
D Fall back of Mr Roose's house  
E Upper fall no 5  
F Fall back of assay office  
G Fall facing smithy door  
H Heap of rubbish  
I Opencast  
K Opencast  
L Deep level

Key to Map 2 (Bangor MS 31602)

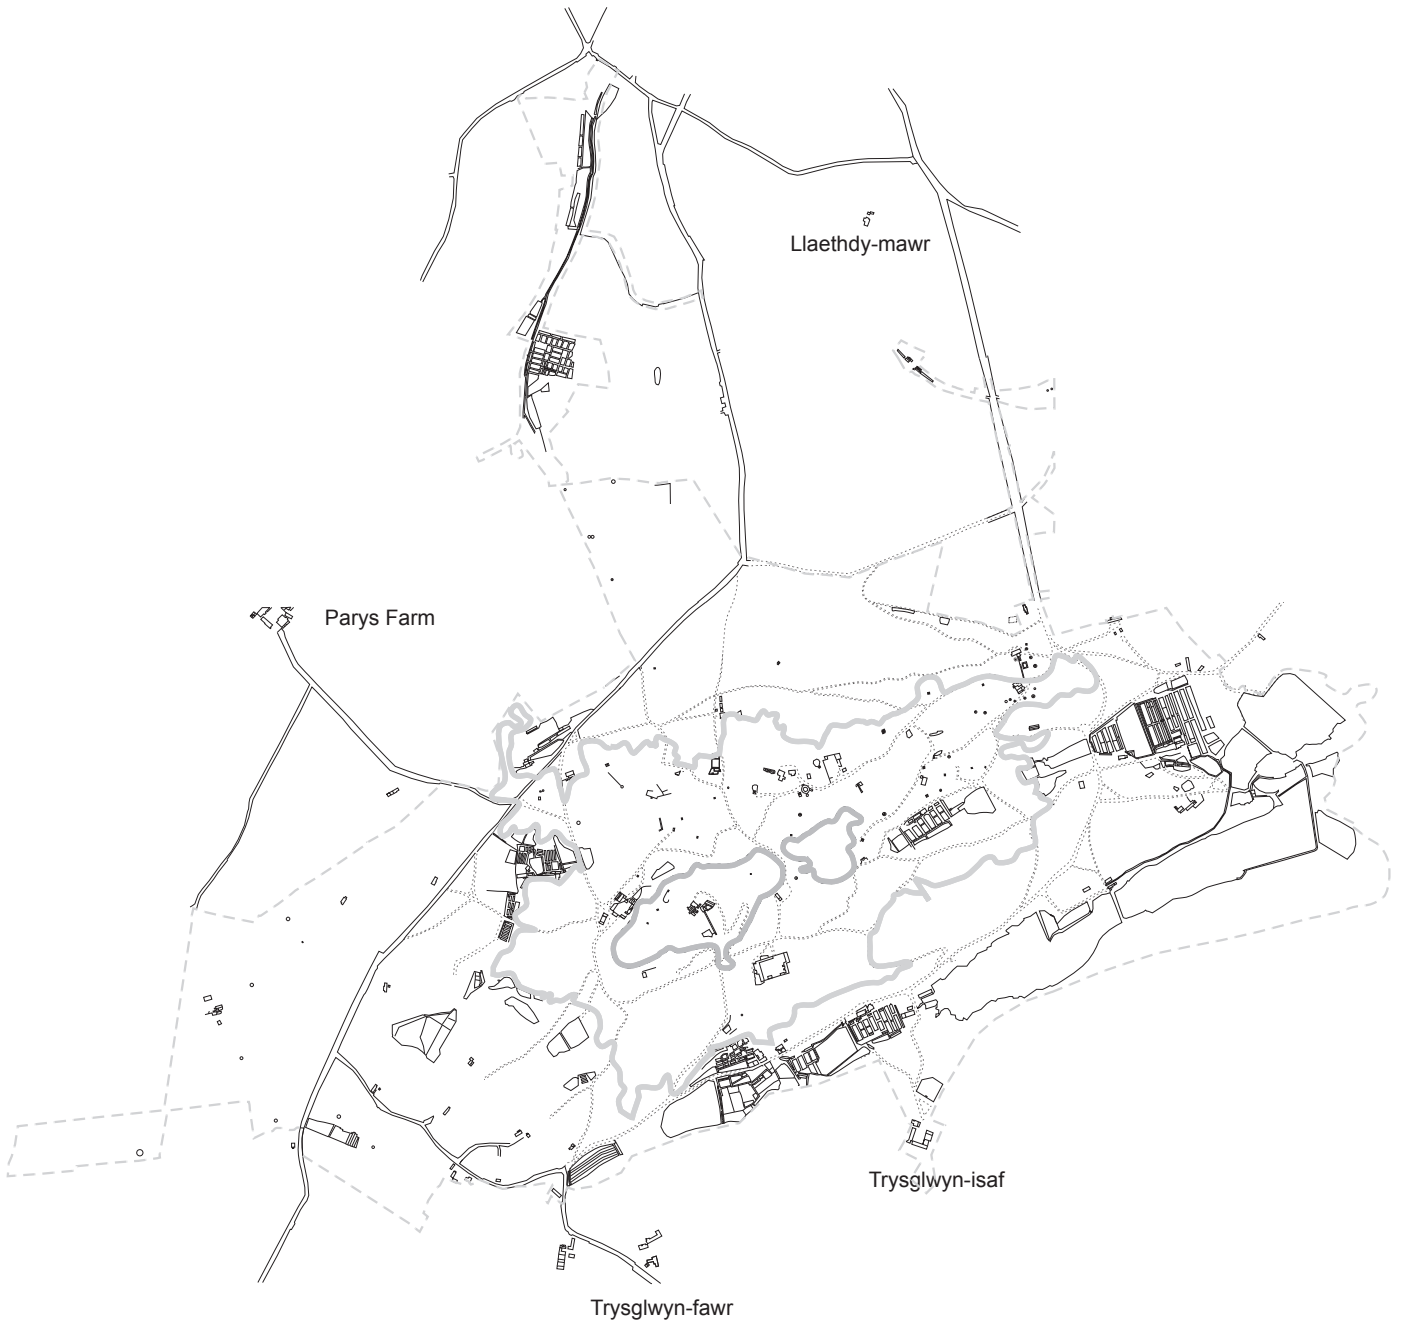
Map 5 Ordnance survey map, 1900

- Boundary of survey area
- ~~~~~ Boundary of Parys Mountain
- ~~~~~ Boundary of Great Opencast

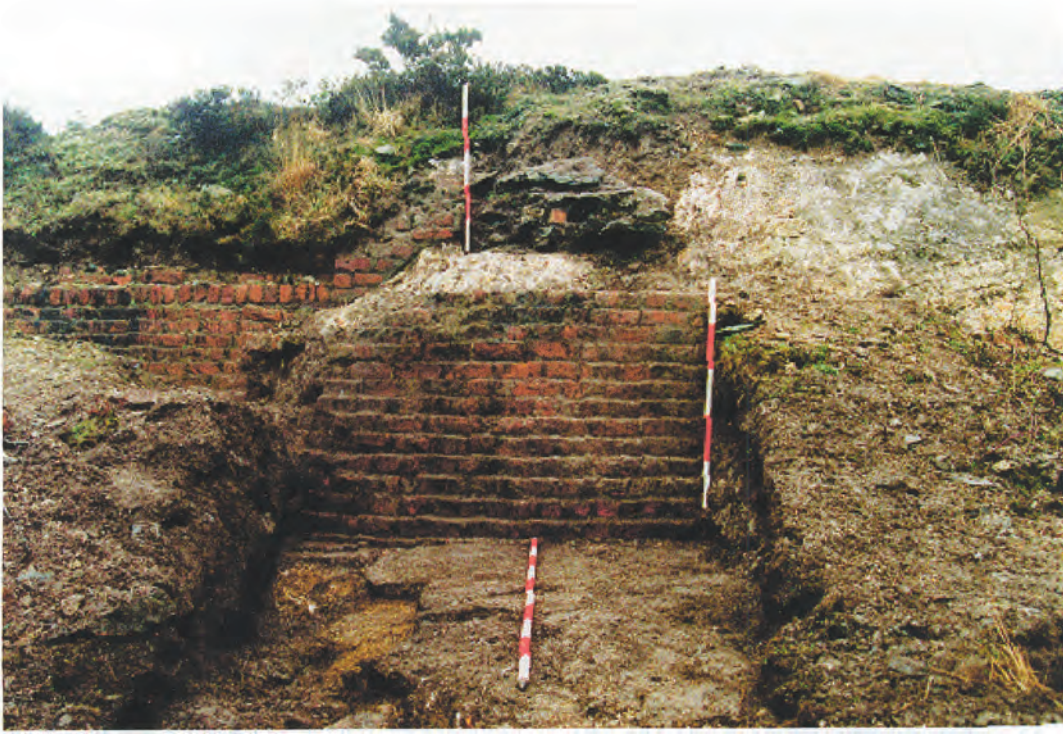
7 The Mona Mine Smelter (feature 352): the revetment after clearance
