**CADNANT SCHOOL, CONWY:  
DEMOLITION AND LANDSCAPING**

**ARCHAEOLOGICAL WATCHING BRIEF  
(G1740)**

**Report No. 448**

**Prepared for Conwy Council  
March 2002**

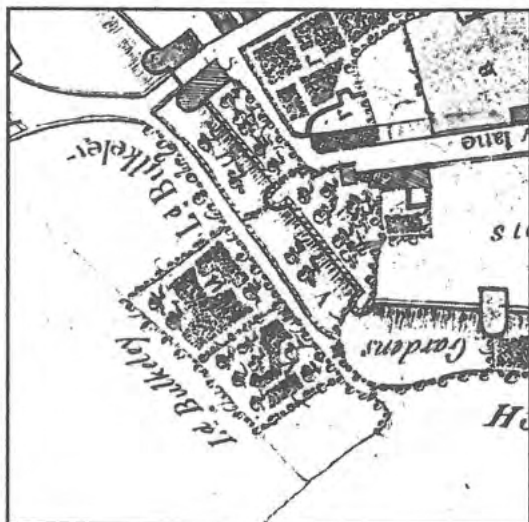
Fig. 4 Holland Estate map, 1776

The next available record of the area is that shown on a Holland Estate map of 1776 (UCNW Bangor, Gen. Ms No. 2383) shown in Fig. 4. This shows that the area later occupied by Cadnant School was then in several small parcels including four plots divided by a track connecting the road outside Porth Uchaf down to the Gyffin stream and Morfa Bach. The four plots were part of the estate and are marked U and V, belonging to two properties within the town walls on Burial Street (now Chapel Street. The Rental shows these two properties as: 'U House and 2 Gardens thro ye High Gate' (i.e.

outside Porth Uchaf); 'V House in two Dwellings and 3 gardens'. The two western plots are shown as gardens, lying at the south part of the area, where it was more level.

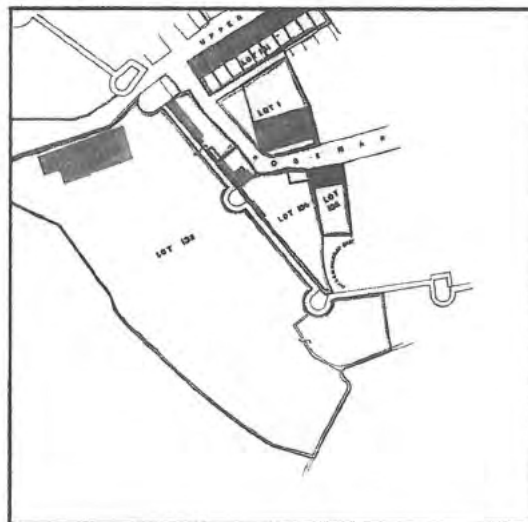
Fig. 5 Bodlondeb Estate map, 1865

The next record is that of a Bodlondeb Estate map of 1865 (Fig. 5) with various parts marked up for auction. This includes the Cadnant School area (Lot 132). Interestingly, this lot also includes a small parcel adjoining but on the inside of the town wall, that which was part of the recent school and still has a building used for education. At the northern edge of the Cadnant School plot is a long rectangular building. This is the Old College, seen on photographs of c. 1900 (Fig. 6) and c. 1920 (Fig. 7), an unusual building with a four-storey tower with a mock-medieval half-timbered, pinnacled top, complete with 'arrow slits' and rivalling the north-west town wall tower for the most prominent viewpoint of the town. A local historian, Mrs Pattinson, does not know to what institution the Old College belonged but says the Cadnant School land belonged to the Chapel, not the Church. On the Bodlondeb map the adjoining lots, 133, 134 and 135 are those belonging to the Roman Catholic church at present and possibly the Old College was also. It was probably built around the middle of the 19<sup>th</sup> century. Its main entrance was via the same gateway as that surviving today, into the base of the tower, which appears to have contained a very grand staircase. It is odd that such a large building is not better known and was still standing c. 1920, probably in poor repair (Fig. 7) but was forgotten when it was demolished to be replaced by the school, c. 1932.

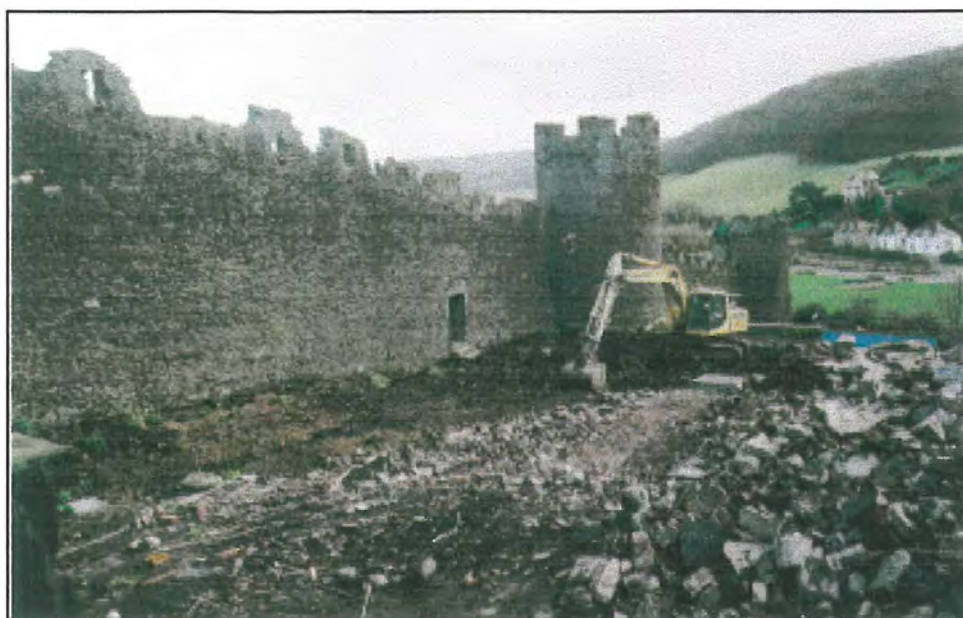
Fig. 9 Cadnant School during demolition and landscaping, Feb. 2002

The demolition of the school buildings and landscaping of the remaining surface (Fig. 9) were designed to provide a gently contoured surface close to the overall site ground profile, not to restore it to what it might have been like during the 13<sup>th</sup> century for instance, or prior to the construction of the Old College, when the town ditch may have still been visible. The landscaping was therefore carried out with the minimum of ground movement, apart from extraction of the main walls and foundations. Areas terraced into the slope, that is the main school building, were infilled with rubble and topped with soil.

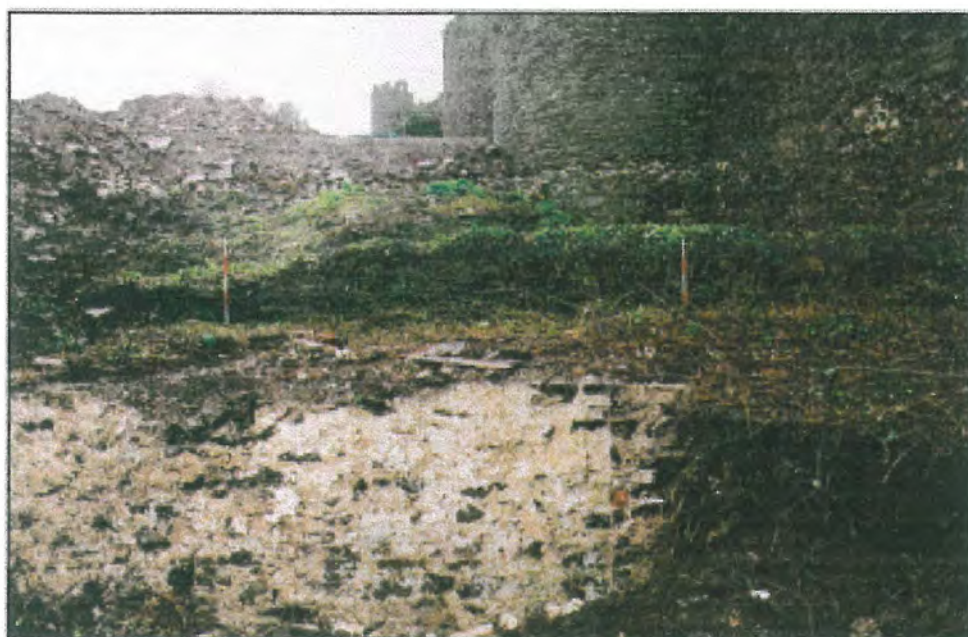
Fig. 10 19th century terrace walls, Feb. 2002

The terrace walls were low, the highest 1.2m high, their purpose mainly to provide more level beds for garden cultivation. The highest was that at the south, which seemed to mark the end of the kitchen garden cultivation area, the rest of the garden below was probably just orchards. The terrace walls were built in the same style as that of the wall re-facing described above and therefore part of the same phase of garden construction and not related to the possible terraces seen on the seventeenth century engraving (Fig. 3). They consisted of four lengths perpendicular to the town wall and three lengths that angles off to the south, becoming lower as they graded into a slight rise in slope, so that they ended by the time they reached the line of the footpath. The terrace walls were cleaned of vegetation, described and recorded by perpendicular photographs before being graded into the slope by machine.

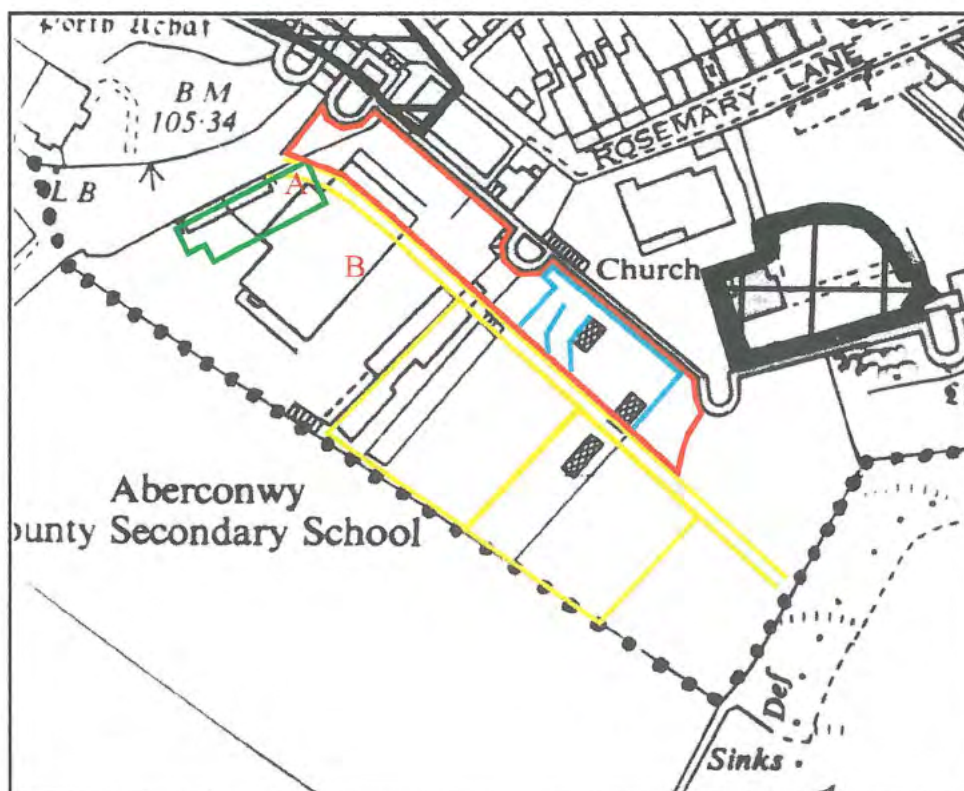
Fig. 11 Historic features related to modern plan

Natural shale bedrock was reached in two places, at the east end of the toilet block at the north, uphill end of the site, and below the southern, downhill edge of the school foundation platform (Fig. 11, A and B). The remainder areas exposed only made ground or were terraced cuts that were simply backfilled.

The foundations of the three glass-houses marked on recent OS maps (Fig. 11) were easily identifiable. The two southern ones were the most recent, with poured concrete foundations within low machine brick retaining walls. The northern was probably older, built against a stone terrace wall that revetted the slope.

- Old College
- 18th century gardens and track
- Town ditch
- 19th century terraces etc

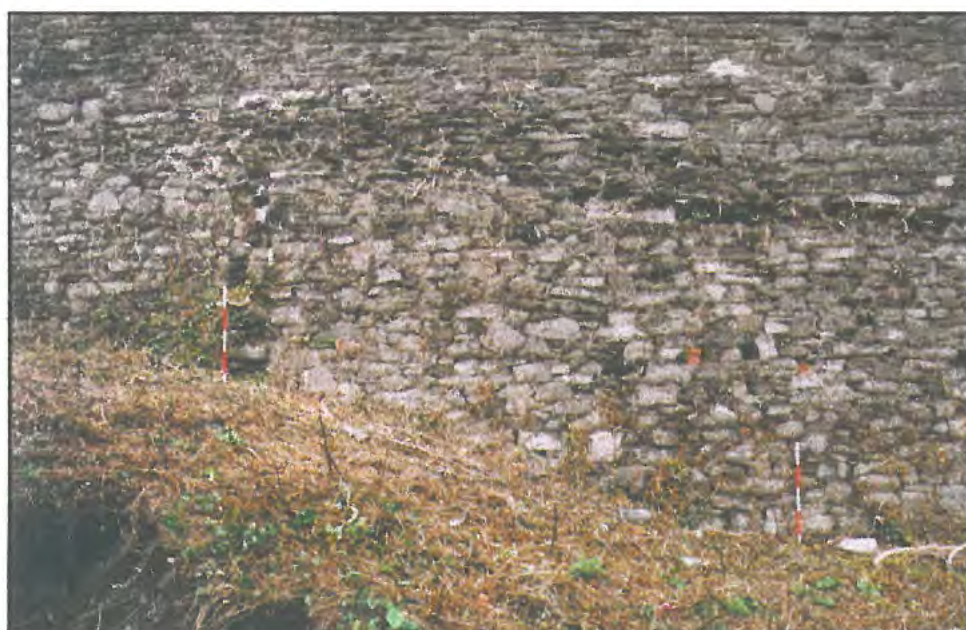
Fig. 12 Conwy town wall, showing 19th century re-facing and bonding for glass-house wall (1m scales 5m apart)

The area of town wall where this range of glass-house abutted was seen to be slightly different in character to that elsewhere. It was laid with similar gritstone slabs but in a slightly more random style, with no attempt at coursing. It was also laid using a brown sandy mortar, while the town walls used a shelly lime mortar. It appears that the town wall at this point was built on an exposed rock outcrop. This exposed rocky area was faced up with masonry to provide a reasonable back wall for the range of glass-houses. However, it was only a 'skin' of masonry, not keyed in, and had subsequently bowed out and subsided slightly, leaving a ragged masonry fault line above (Fig. 12). This area of stonework will be left in during the next phase of renovation by Cadw, but will have to be stabilised. The facing must have been built about the middle of the 19<sup>th</sup> century. Its association with the glass-houses is clear, because it incorporates the remains of a perpendicular offset wall that was a dividing wall of the range of glass-houses.

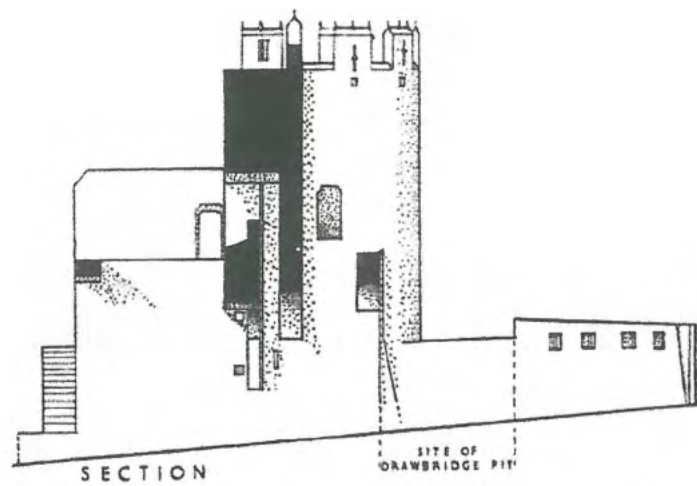
Fig. 13 Porth Uchaf, Conwy, Cross Section showing possible extent of drawbridge pit (RCAHMW 1956)

The town ditch was some 3m deep or more, as it approached Porth Uchaf. The barbican may then have been on a raised causeway and its appearance (Fig. 13) would have been quite similar to that seen at the East Gate, Caernarfon (Fig. 14), although a road now runs along the base of the ditch there. The 1776 estate map also indicates a more pronounced slope immediately in front of the town walls. It seems quite likely that the town wall, if exposed, might prove to be built on a 'raised' ridge of bedrock, as seen around Llywelyn's Tower. Originally, this may well have had clay 'glacis slope' and it may not have been intended that the rock should be exposed. It may simply have become exposed as a result of weathering. This may explain why, visually, the wall sits uncomfortably close to, or even overhangs the edge of the rock outcrop, north of Llywelyn's Tower. Although the rock outcrop is impressive it might be more historically accurate to provide a grassed slope, as has been created around the north side of Conwy and the east side of Caernarfon.
