# 44, CHURCH STREET, BEAUMARIS ARCHAEOLOGICAL ASSESSMENT AND EVALUATION

**Report No. 658  
GAT Project no. G1900**

**ARCHAEOLOGICAL ASSESSMENT and  
EVALUATION**

**GAT Report No. 658**

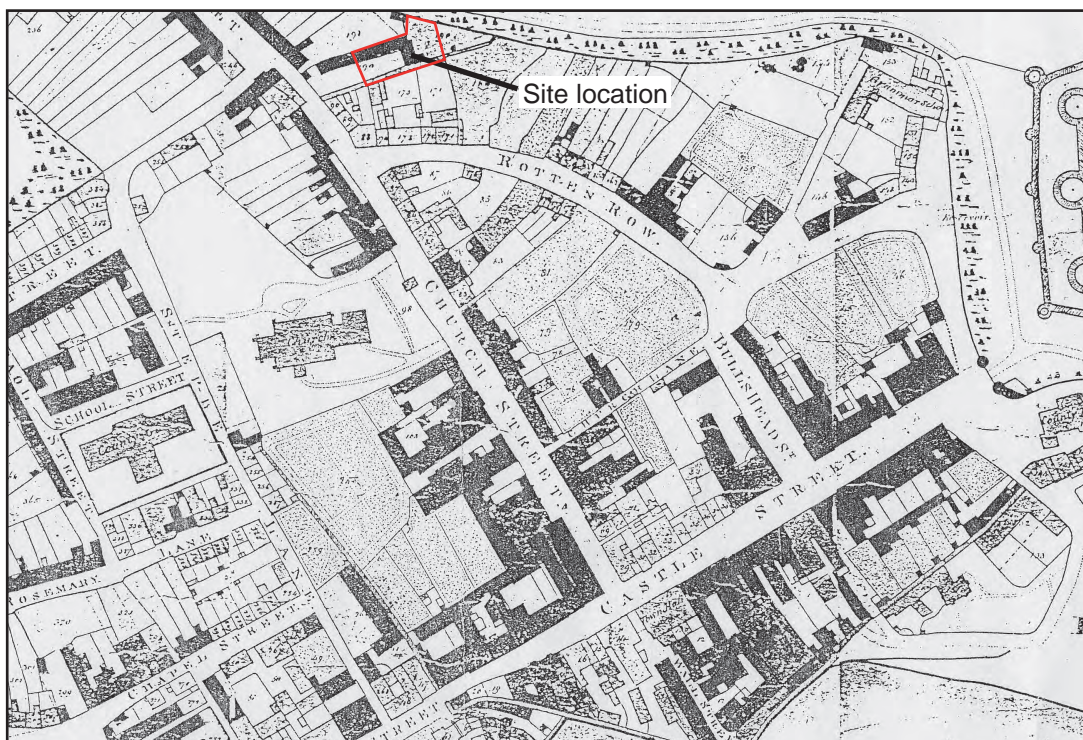
44, Church Street, Beaumaris Fig. 4 The location of the proposed development area in relation to the Baron Hill Estate Map 1829 (UWB 6496)

Fig. 4 The development area in relation to the Baron Hill estate map of Beaumaris of 1829 (BH 6496).

Speed's map indicates that there was a continuous line of houses along Church Street, or Wexam Street as it was then known, north of Rating Row across the line of the town ditch. However, Speed's map is not entirely accurate and a town map (BH 6496) made in 1829 for Sir Richard Bulkeley Williams Bulkeley shows that at that time there was no house where No. 44 Church Street now stands or on the equivalent area on the west side of the street (Fig. 4). This would be understandable if this area constituted the line of the former town defensive ditch, an area that would not be very suitable for building. The 1829 map shows a long narrow building along the north edge of the property, with another small building at its east end (Fig. 8). This property is listed in a series of rental records of the Baron Hill Estate, showing that it was not a dwelling but a Tan House (Tables 1 and 2). This would have been used for the processing of hides, a messy and smelly process that would have involved tanks for tanning liquid. This building may therefore have made use of a strip of land that was not otherwise useful for housing and which may have been used for the disposal of waste. The building at its east end may have been the outhouse listed in a rental of 1826 (Table 1).

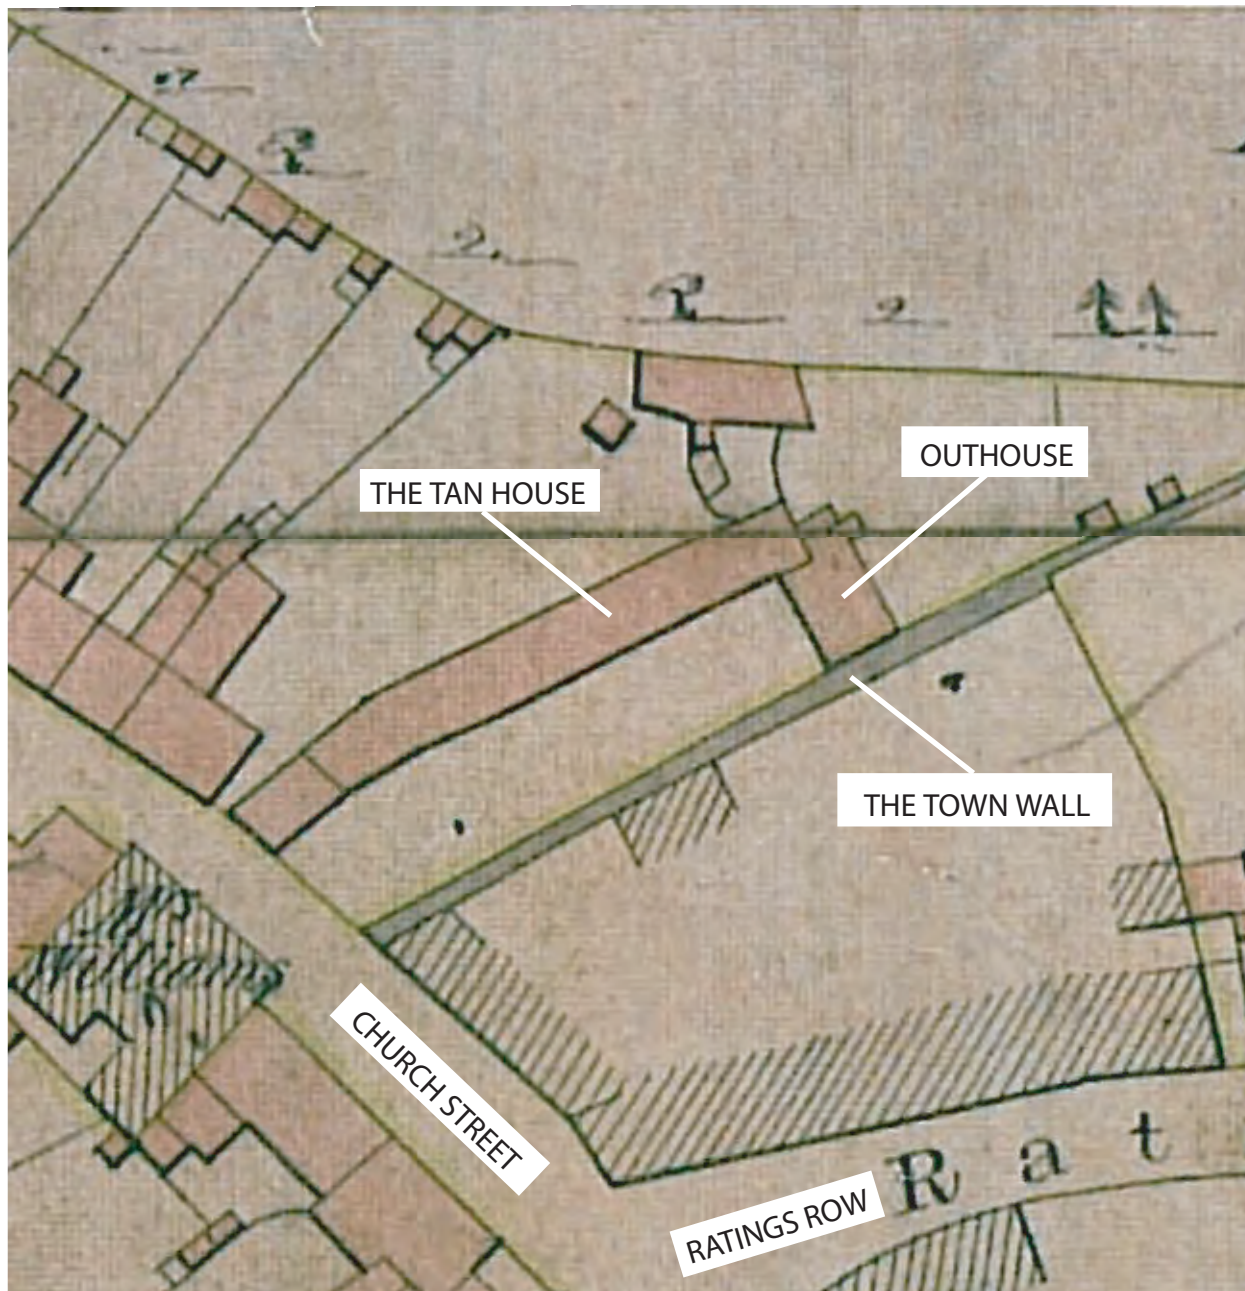
44, Church Street, Beaumaris  
Fig. 5 Plan of The Tan House and adjoining outbuilding.  
Detail from the Baron Hill map of 1861 (BH 8224)

The Tan House as shown on the 1829 map still survived at the time of a Baron Hill estate map of 1861, which shows it in more detail and suggests that the building at its east end was separate and perhaps an addition to the main building (Fig. 5). These buildings still existed at the time of the 1889 Ordnance Survey map (Fig. 6), but had been largely demolished and replaced by two houses fronting on Church Street, including 44, Church Street, by the time of the 1900 map (Fig. 7). Some remains of The Tan House still stood as a roofless ruin at the time of the first visit, although they had been demolished by the time of the assessment. The east wall was in quite good condition, of irregular mortared sub-angular stones and butted onto the north boundary wall and had a crudely blocked doorway at the south end (Fig. 10). The west wall was of similar build, also butted onto the north boundary wall, and with no doors or windows but a brick-built supporting buttress at the south corner. The south, long wall was similarly built but with a doorway at the west end and two low-cilled windows. These had slate cills and one had a timber lintel surviving (Fig. 11). The doorway had once had a timber frame. Observation of the demolished masonry, at the time of the assessment, showed a variety of material, including some re-used ashlar blocks of better quality stone, possibly robbed from the town wall or further afield. These are described later.

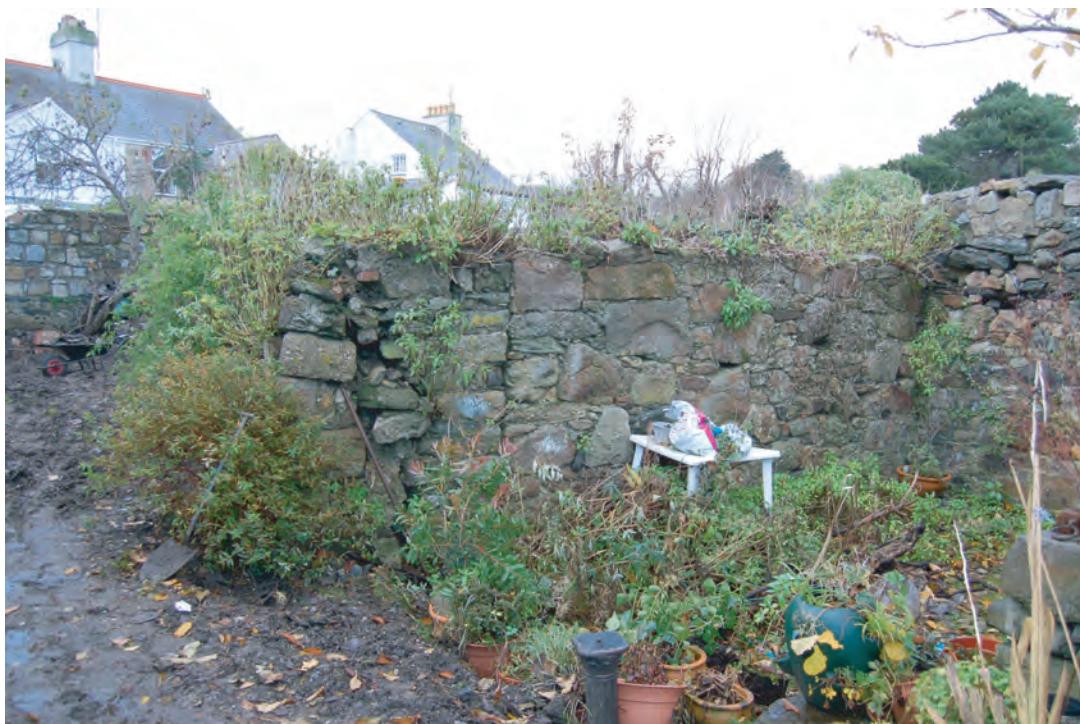
44, Church Street, Beaumaris  
 Fig. 10 Remains of the east wall of The Tan House before demolition

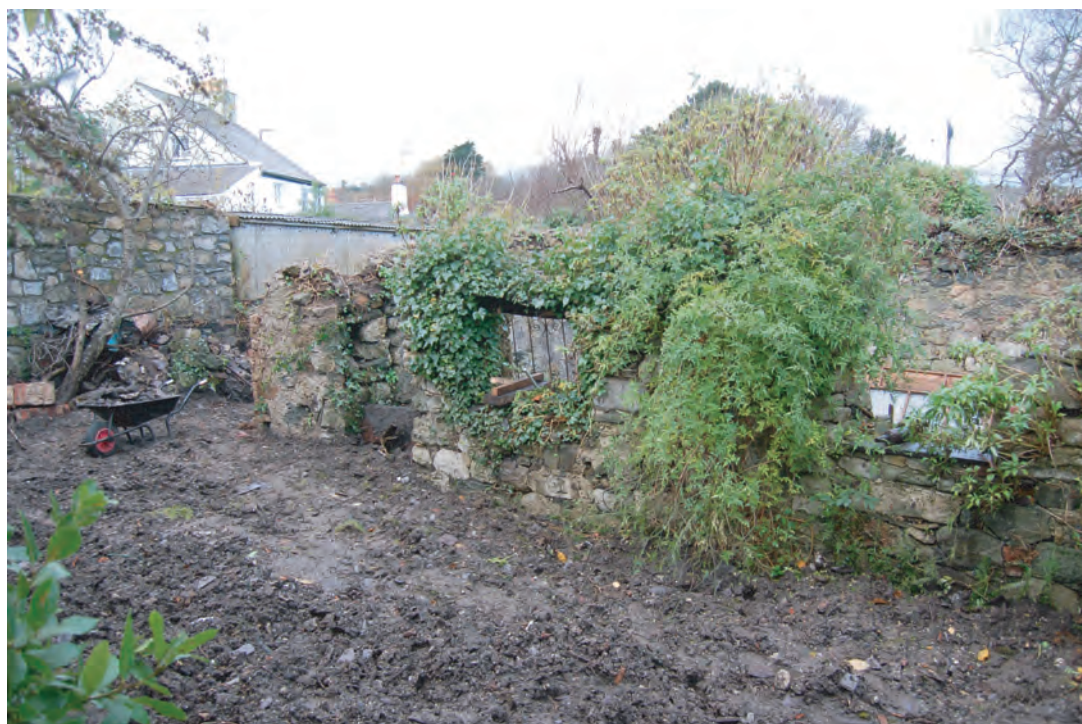
44, Church Street, Beaumaris  
 Fig. 11 Remains of the south wall of The Tan House before demolition

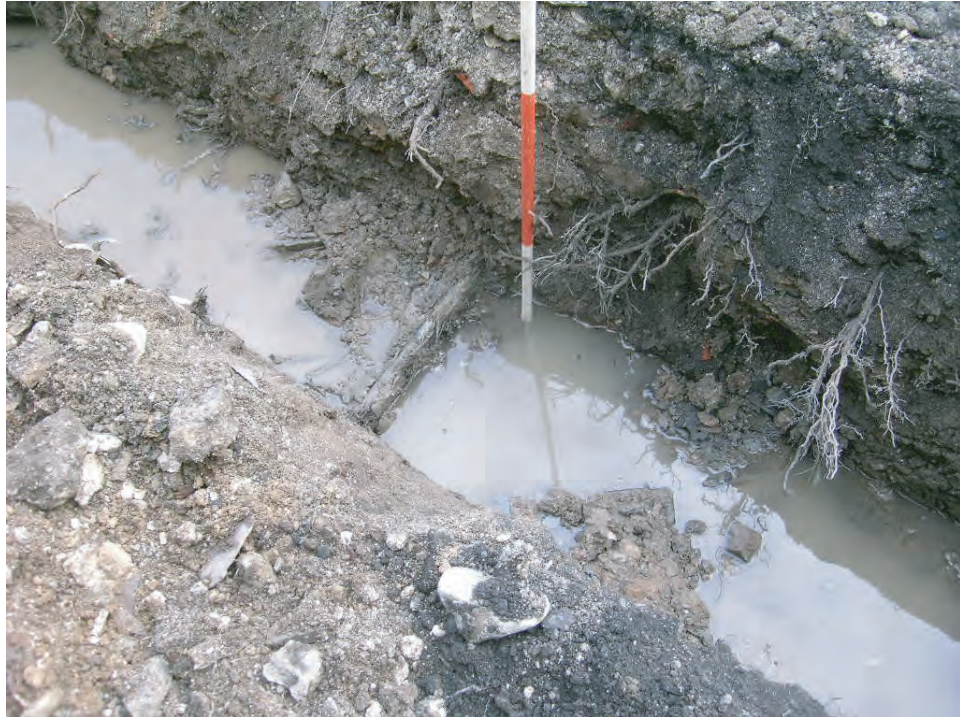
Fig. 15 In situ plank wall of timber tanning tank, Trench 1. Scale with 50cm divisions

West of wall [20] was a deep layer of mixed clay made-ground up to 0.7m deep. This proved to cover a row of substantial vertical timber planks. These planks were of pine softwood about 35mm thick and 300mm (1ft) wide. They proved to be the lowest surviving plank of a row of four adjoining rectangular timber tanks, each about 1.1m (4ft) wide. The north wall of one tank was revealed in one place just a little beyond the north face of the trench. The tank timbers were butt tenon jointed at the corners and the timbers tarred and lined with stiff grey clay. Further, wider-spaced timbers at the east suggested two larger tanks or two tanks of similar dimensions but set east-west. Probing with a rod showed that the timber floors of the tanks still survived, about 10-20cm below the base of the trench.

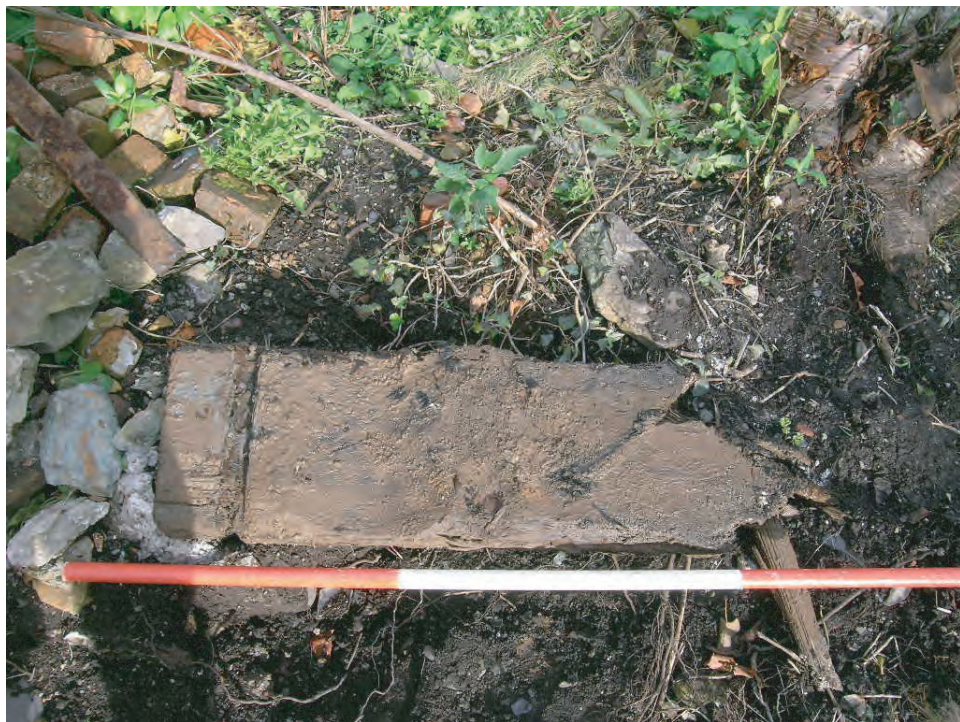
Fig. 16 Part of lower plank wall of timber tanning tank. Scale with 50cm divisions

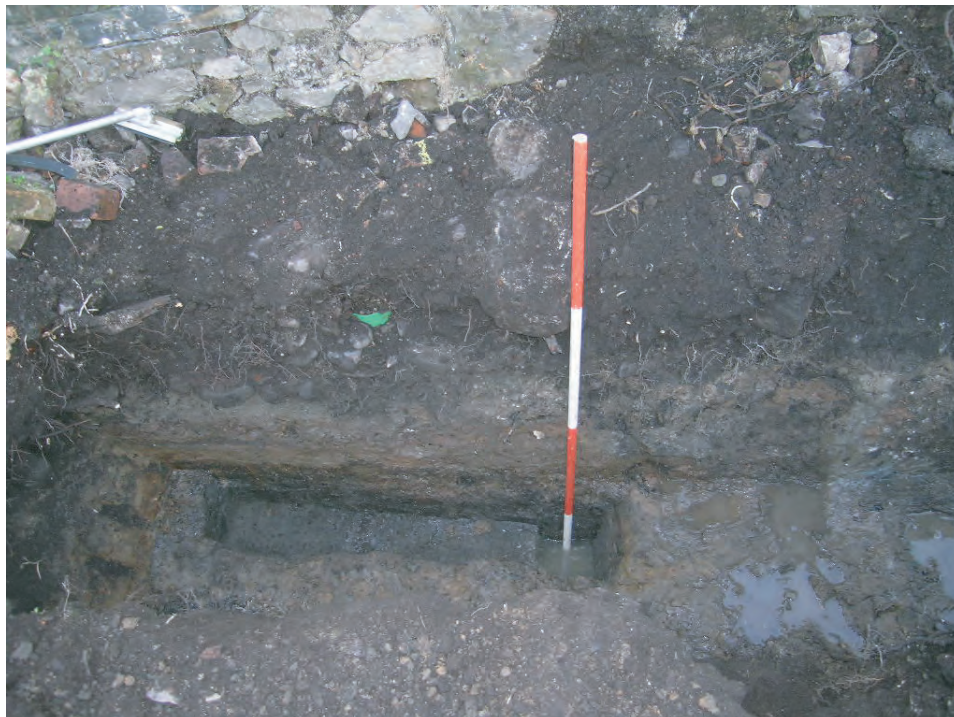
44, Church Street, Beaumaris  
 Fig. 17 Lowermost sand and buried soil layers at the south end of Trench 2.  
 Scale with 50cm divisions

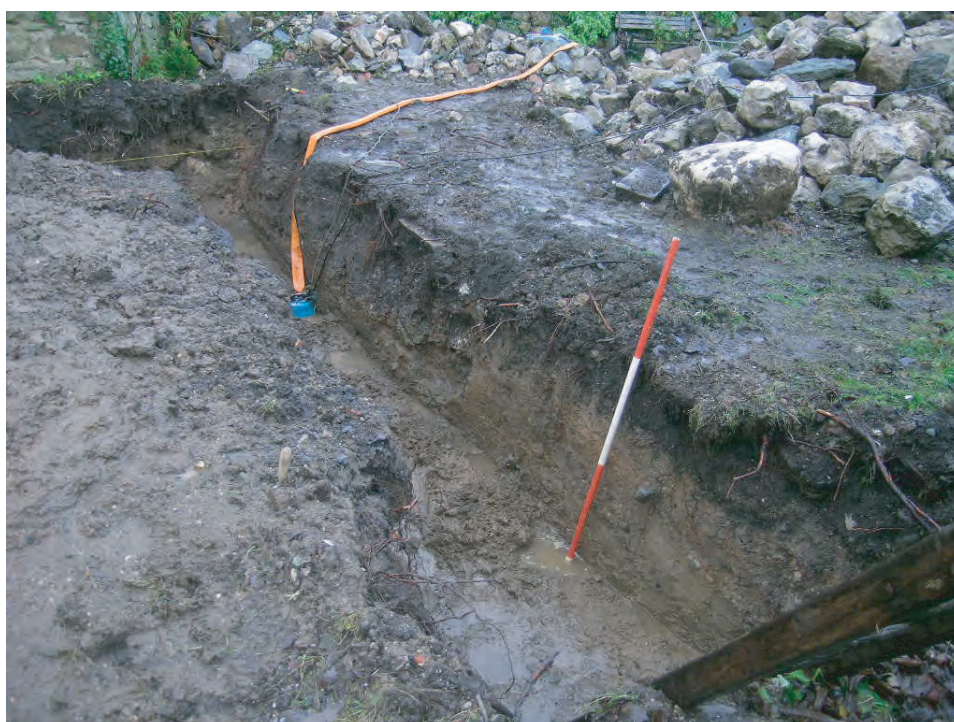
44, Church Street, Beaumaris  
 Fig. 18 Lowermost sand and buried soil layers at the south end of Trench 3.  
 Scale with 50cm divisions

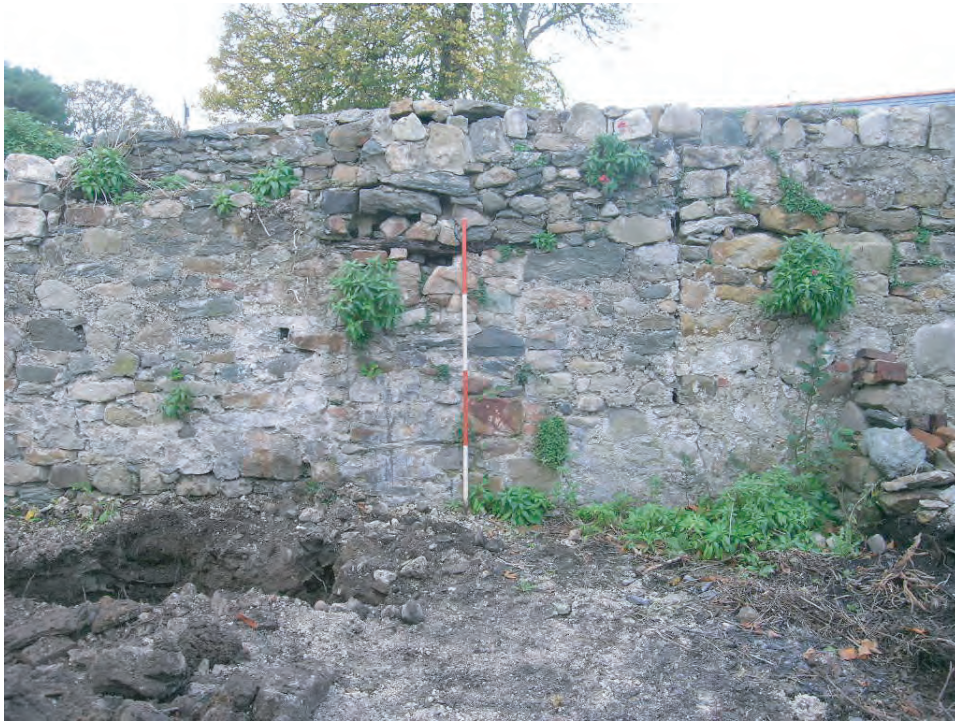
44, Church Street, Beaumaris  
 Fig. 19 Blocked window in north wall of former  
 Tan House, now the boundary wall

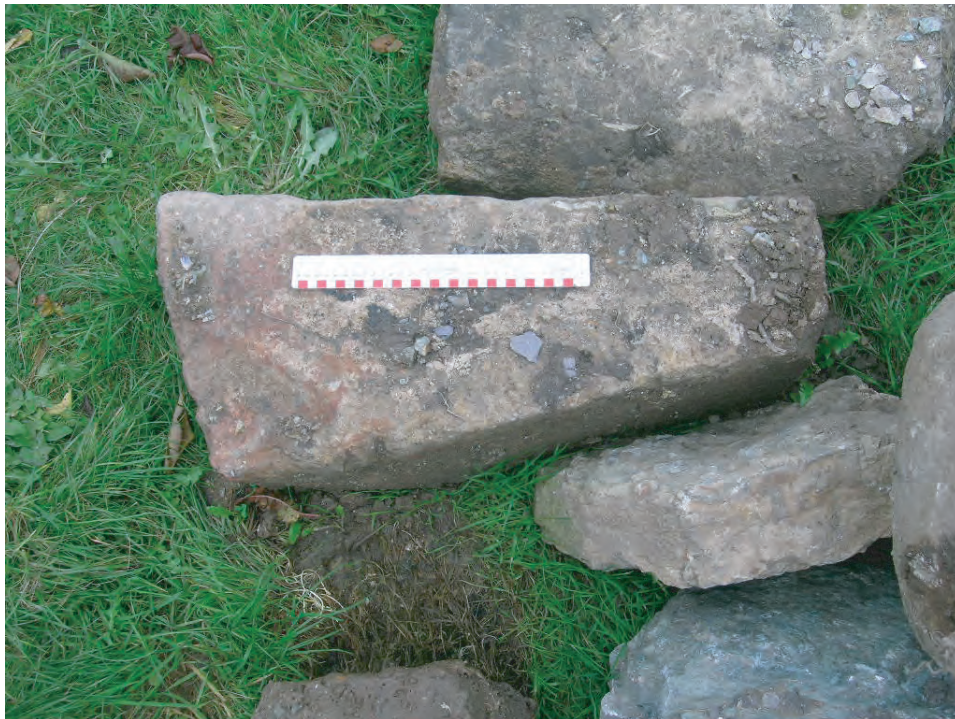
44, Church Street, Beaumaris  
 Fig. 20 Re-used architectural fragment 1 from the former Tan House. Scale with 1cm divisions
