AFON ADDA REFURBISHMENT DEANERY CAR PARK, BANGOR

ARCHAEOLOGICAL EVALUATION

GAT Project no. G1876

Report No. 669

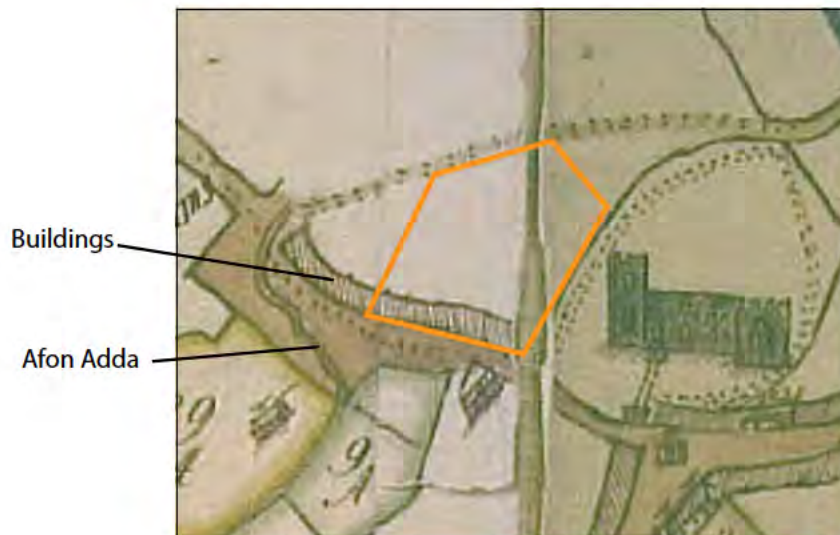
Fig. 4 Part of a Map of Bangor by Leigh for the Penrhyn Estate, 1768.
Approximate area of 2007 evaluation shown in orange outline

Fig. 4 Part of a map of Bangor by Leigh, for the Penrhyn Estate, 1768.

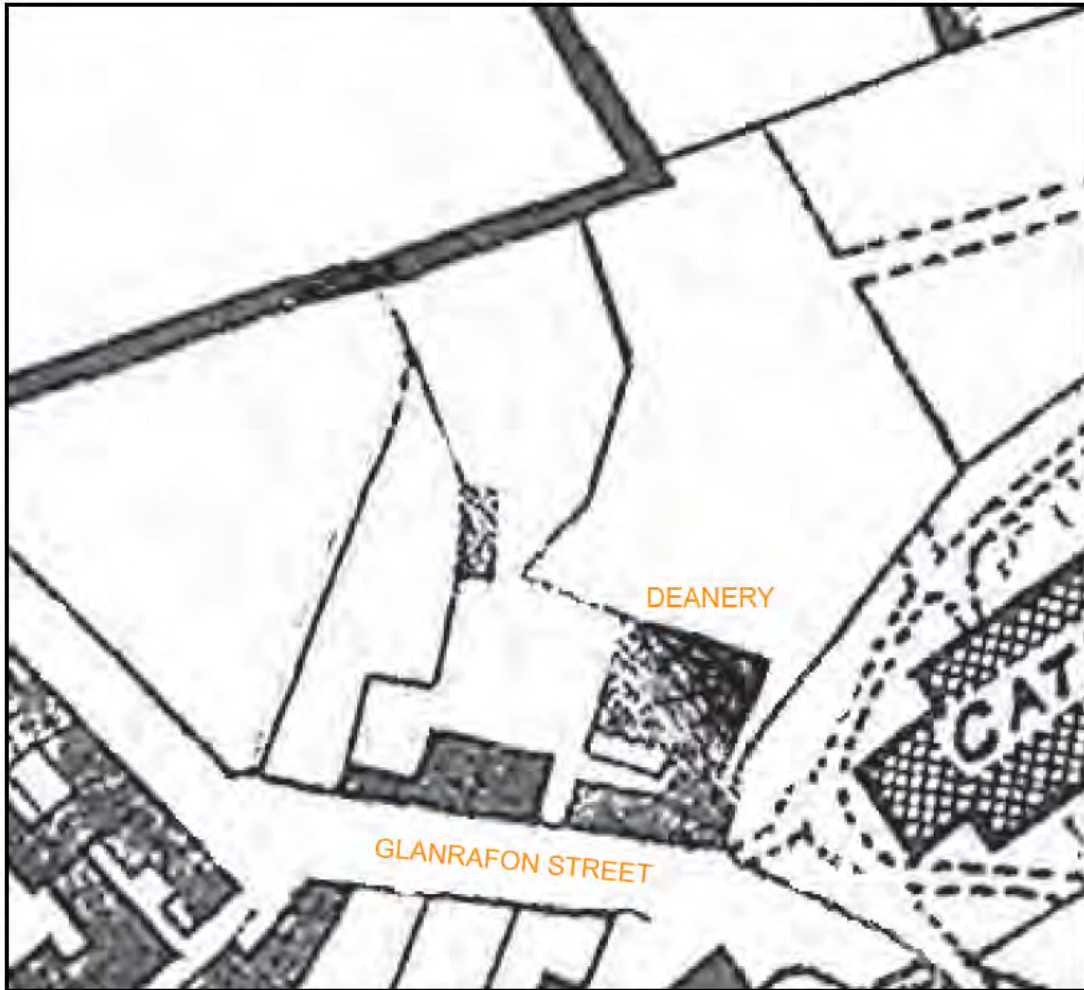
Fig. 6 Part of a map of Bangor produced for the Tithe Apportionment Survey, 1841, (with added annotation)

The present Deanery is largely 19th century but incorporates a smaller building erected by Dean Humphrey Humphreys about 1685 (RCAHMW 1960, 15). This earlier Deanery is that shown on maps of 1834 (Fig. 5), 1841 (Fig. 6) and 1854 (Fig. 7). In 1834 the Deanery was smaller than at present and its grounds were dominated by a large circular coach driveway at the front (north) side of the house, with coaches approaching through the grand Bishop's gate erected by Bishop Majendie in 1810, which still survives as the entrance to the Bible Garden. The gardens were extended and altered to a more formal, rectilinear design of beds and paths by the time of the 1854 map (Fig. 7). The house itself was extended and modified to its present form in 1863 (Clarke 1969, 93) and the gardens altered again to a

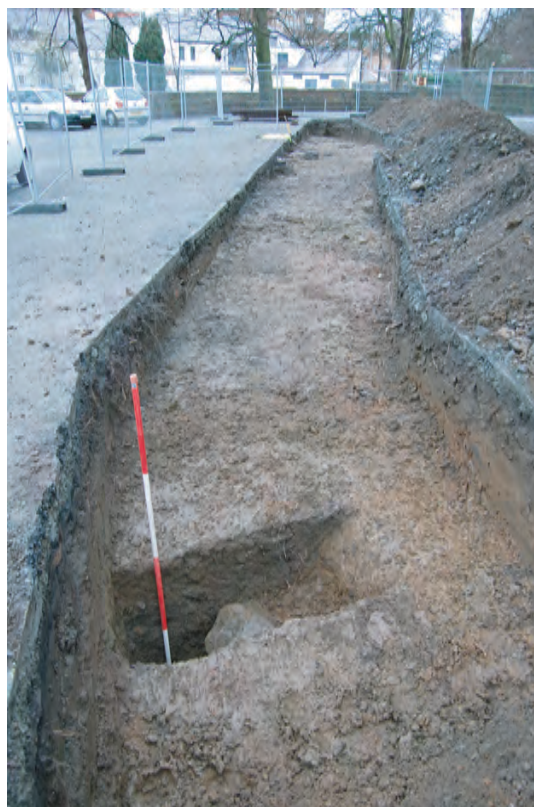
Fig. 13 Trench 2. General view, excavated to the subsoil surface. From the south. Cut through terrace 19 in foreground. Scale with 50cm divisions.

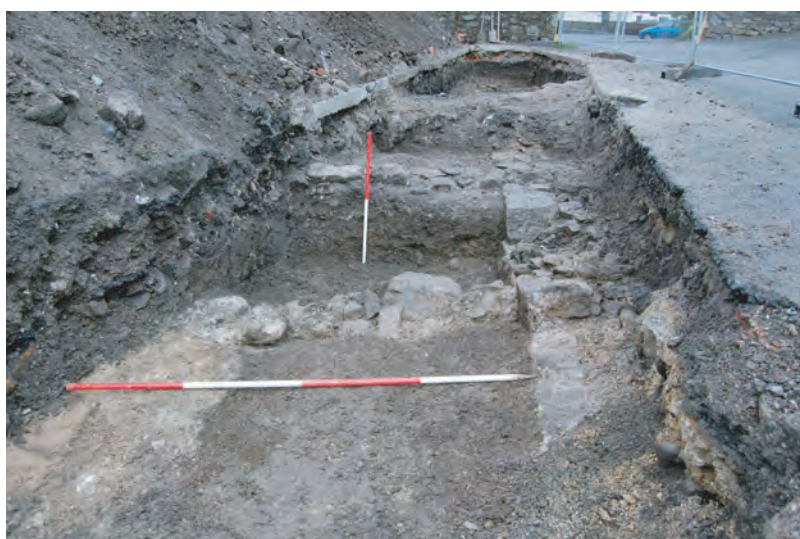
Fig. 14 Trench 1. Top of gravel surface 56 in foreground. Walls [50] and [51], behind. Wall [48] on right. From the south. Scale with 50cm divisions.

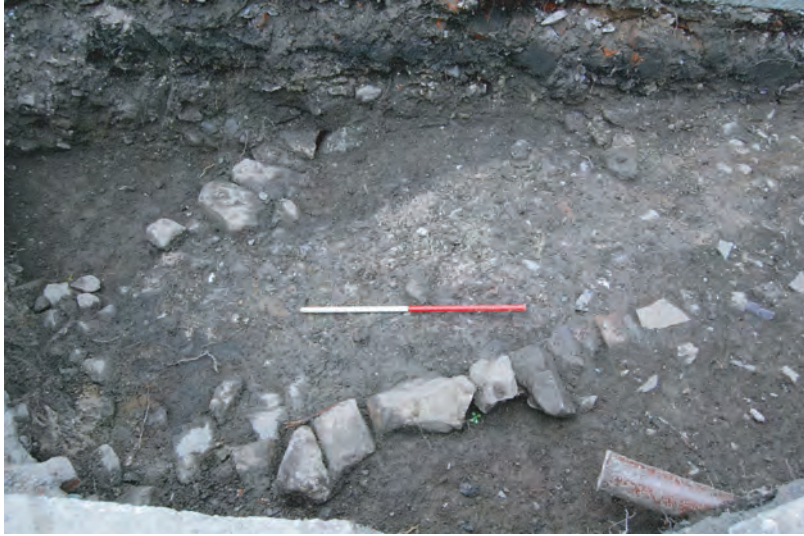
Fig. 18. Trench 2 Line of robbed-out wall 48 over culvert 43.
From the east. Scale with 50cm divisions

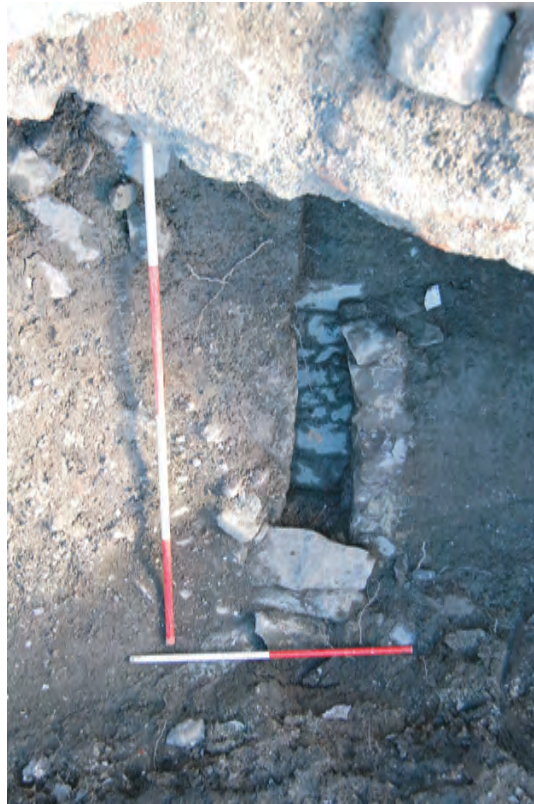
Fig. 19. Trench 2 Culvert 43 exposed beneath line of robbed-out wall 48.
From the east. Scales with 50cm divisions

The wall had originally continued through and beyond the north end of the trench although there it was completely robbed-out, but marked by a linear spread of mortar debris. It was robbed out here because it lay within what became a garden or pig yard after the construction of the pig sty about 1863. Here the wall had been associated with a series of stone and slate-lined drains (Figs 15 & 18). Two [45] and [46] lay on its east, uphill, side had been largely destroyed by later construction. Drain [46] collected water from the east, uphill side of wall [48] and drained into a larger lower drain or culvert [43]. This had been below the line of the former wall and continued beyond the trench to the north (Fig. 19).

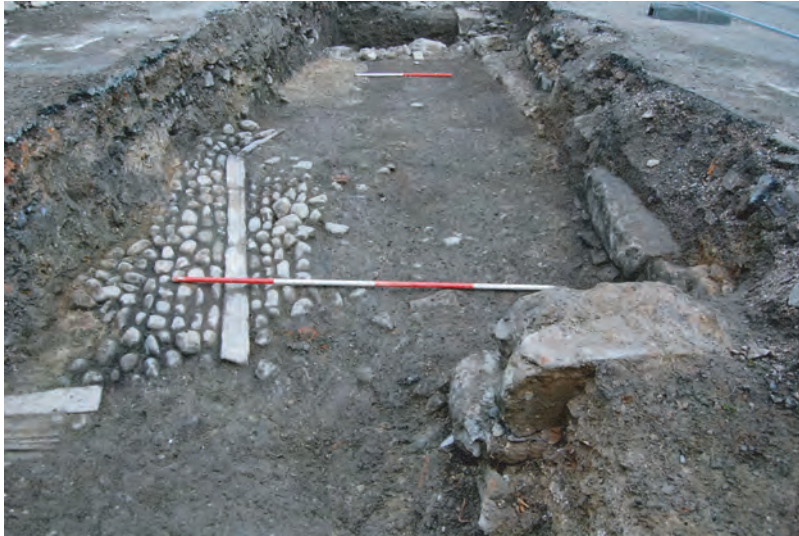
Fig. 20. Trench 2 Cobbled yard surface 53. Coach-house wall 52 in foreground.
From the south. Scales with 50cm divisions

To the west of walls [50] and [51] had been a sloping, neatly cobbled yard [53] of which only a small part survived lower down slope because much of it had been destroyed during insertion of a modern piped drainage system [55] (Figs 16 & 20).

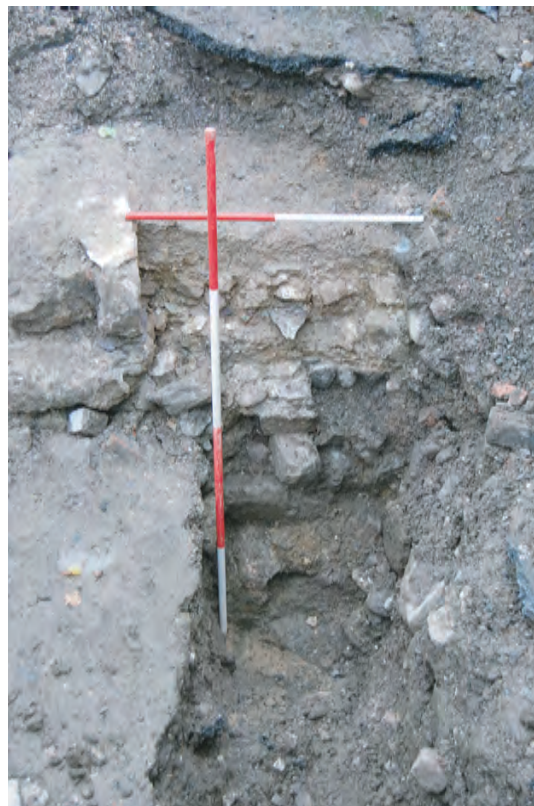
Fig. 21. Trench 2 . Section through modern pipe trench at south end of trench
showing depth of deposits inside coach-house (See section, Fig. 17).
From the west. Scale with 50cm divisions

The cobbled yard belonged with a former building at the west of the yard represented by a small length of wall [52] (Figs 17 & 21). This was the east wall of a long building, 16m by 6m, parallel to Glanrafon Street and erected as part of the 1863 renovations, seen first on the 1889 map and probably a coach-house and stables. This building survived until the 1930's when the pigsty and yard described above were demolished to make way for the present garage. Most of the wall line within the trench had been destroyed during insertion of a 20th century pipe drain. The drain had probably been inserted at the same time that the former coach-house was demolished and had made use of a doorway of the building, indicated by a slate drain channel in the cobbled yard (Fig. 16). The remainder of the building lay further to the west and if it survives now lies under the pavement beyond the Deanery wall, because the street was widened sometime before 1980 and the Deanery wall was rebuilt further to the north, where it is now.

At the south end of the trench the modern pipe trench through wall [52] was partly emptied to below the level of the footings of the wall. The footings of the wall were built on orange-brown clay at a depth of 1.75m below the modern yard surface and its depth matches with the depth of the probable subsoil found in the trial pit further to the north. Some depth of deposits thus survives in this area, where medieval buildings might have been, as indicated by Speed's map.

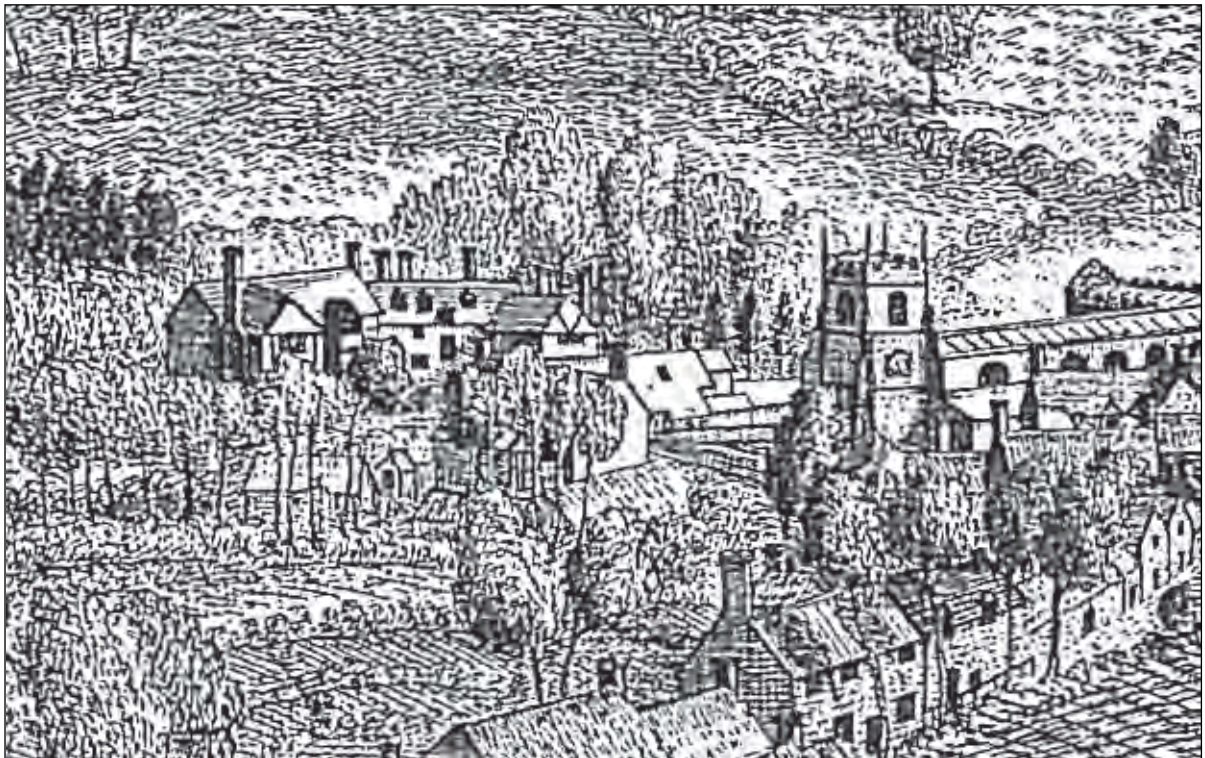
Fig. 23 Part of a view of Bangor, from the south-east, by J. Lewis, 1740, showing the Deanery buildings (to the left of the cathedral) and the Bishop's Palace behind.

Fig. 23 Detail from Lewis's engraving of Bangor, 1740, showing the cathedral, Deanery and Bishops' Palace.
