# Land at Tan y Coed: **Beaumaris, Anglesey**

## Archaeological Assessment

GAT Project No. 2103

Report No. 838

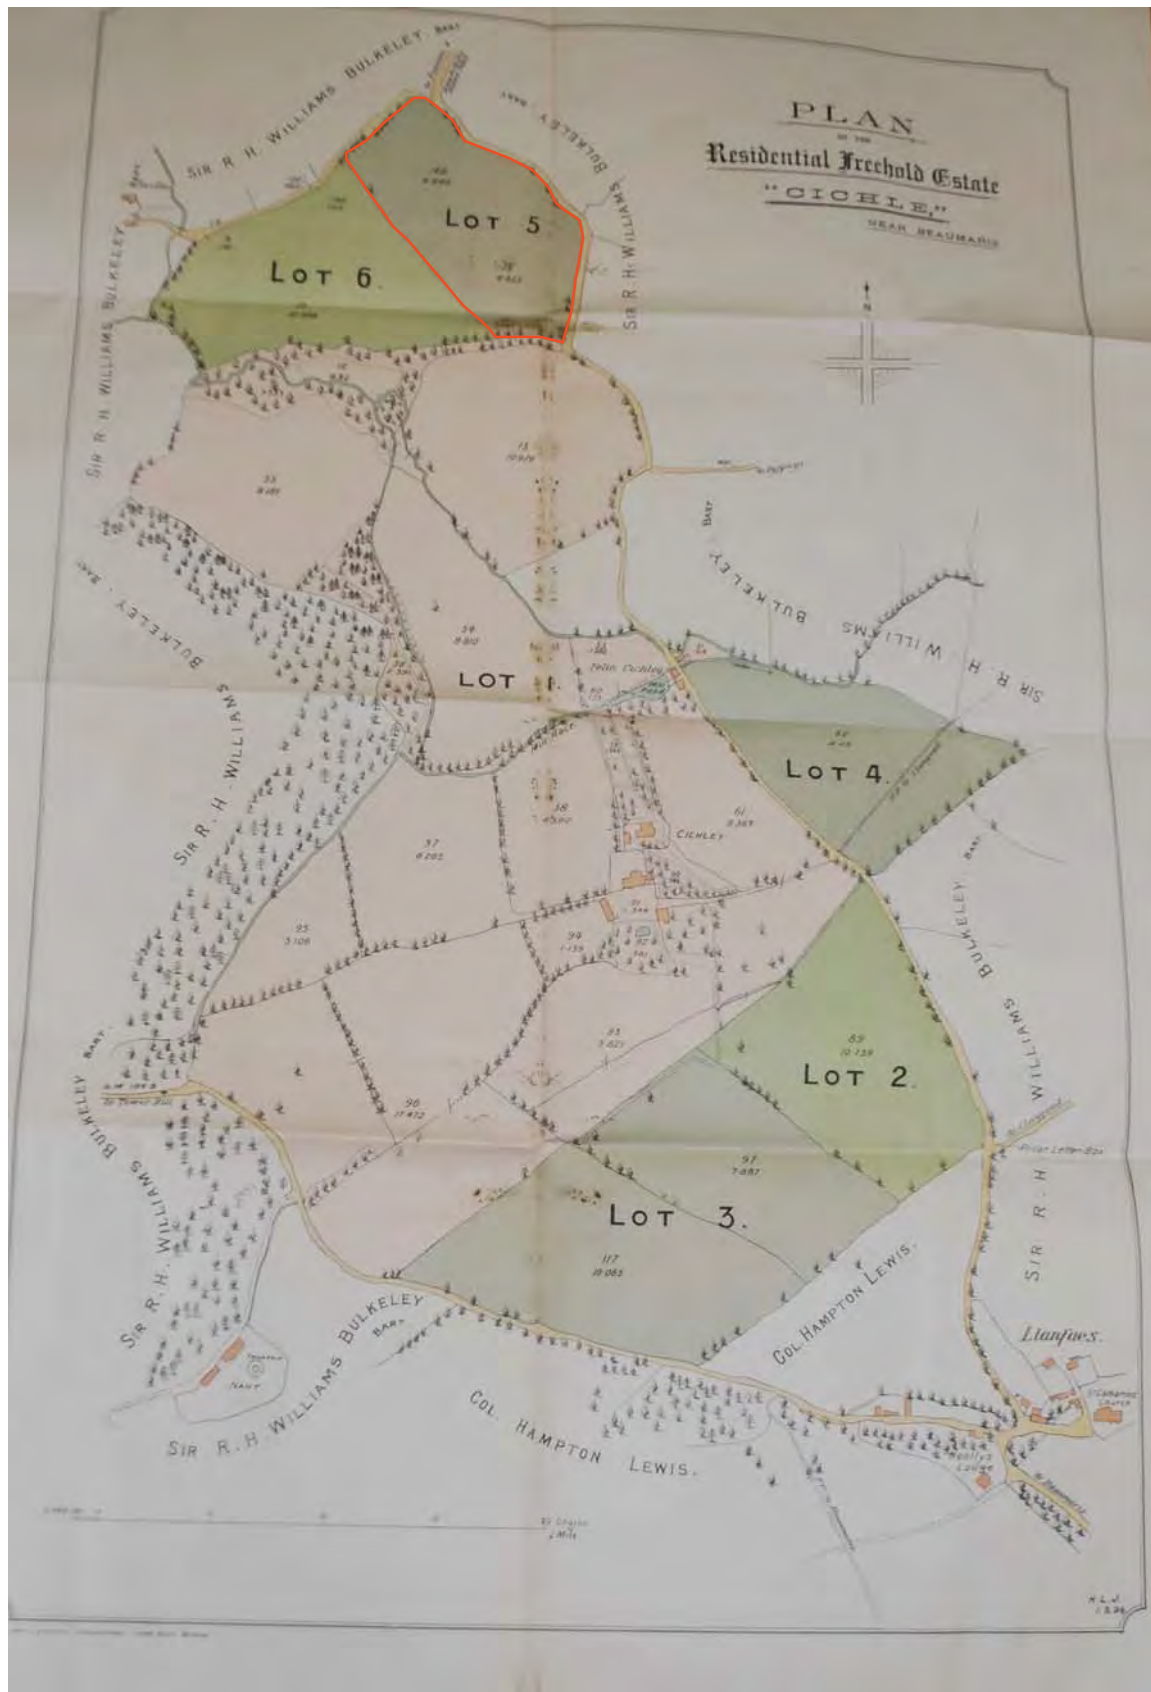
Fig. 4 Extract from the Llaniestyn tithe map of 1840 with study area outlined in red

A building of unknown date or purpose, noted on the Llaniestyn tithe map of 1840 (Fig. 4, Field 26), but not noted on the 1<sup>st</sup> edition 25 inch Ordnance Survey map of 1889 (Fig. 6), although a small enclosure that was possibly associated with it is shown. Its location suggests that it may be a post-medieval field barn, although this is speculative. This site was not observed on the ground on the walk over survey.

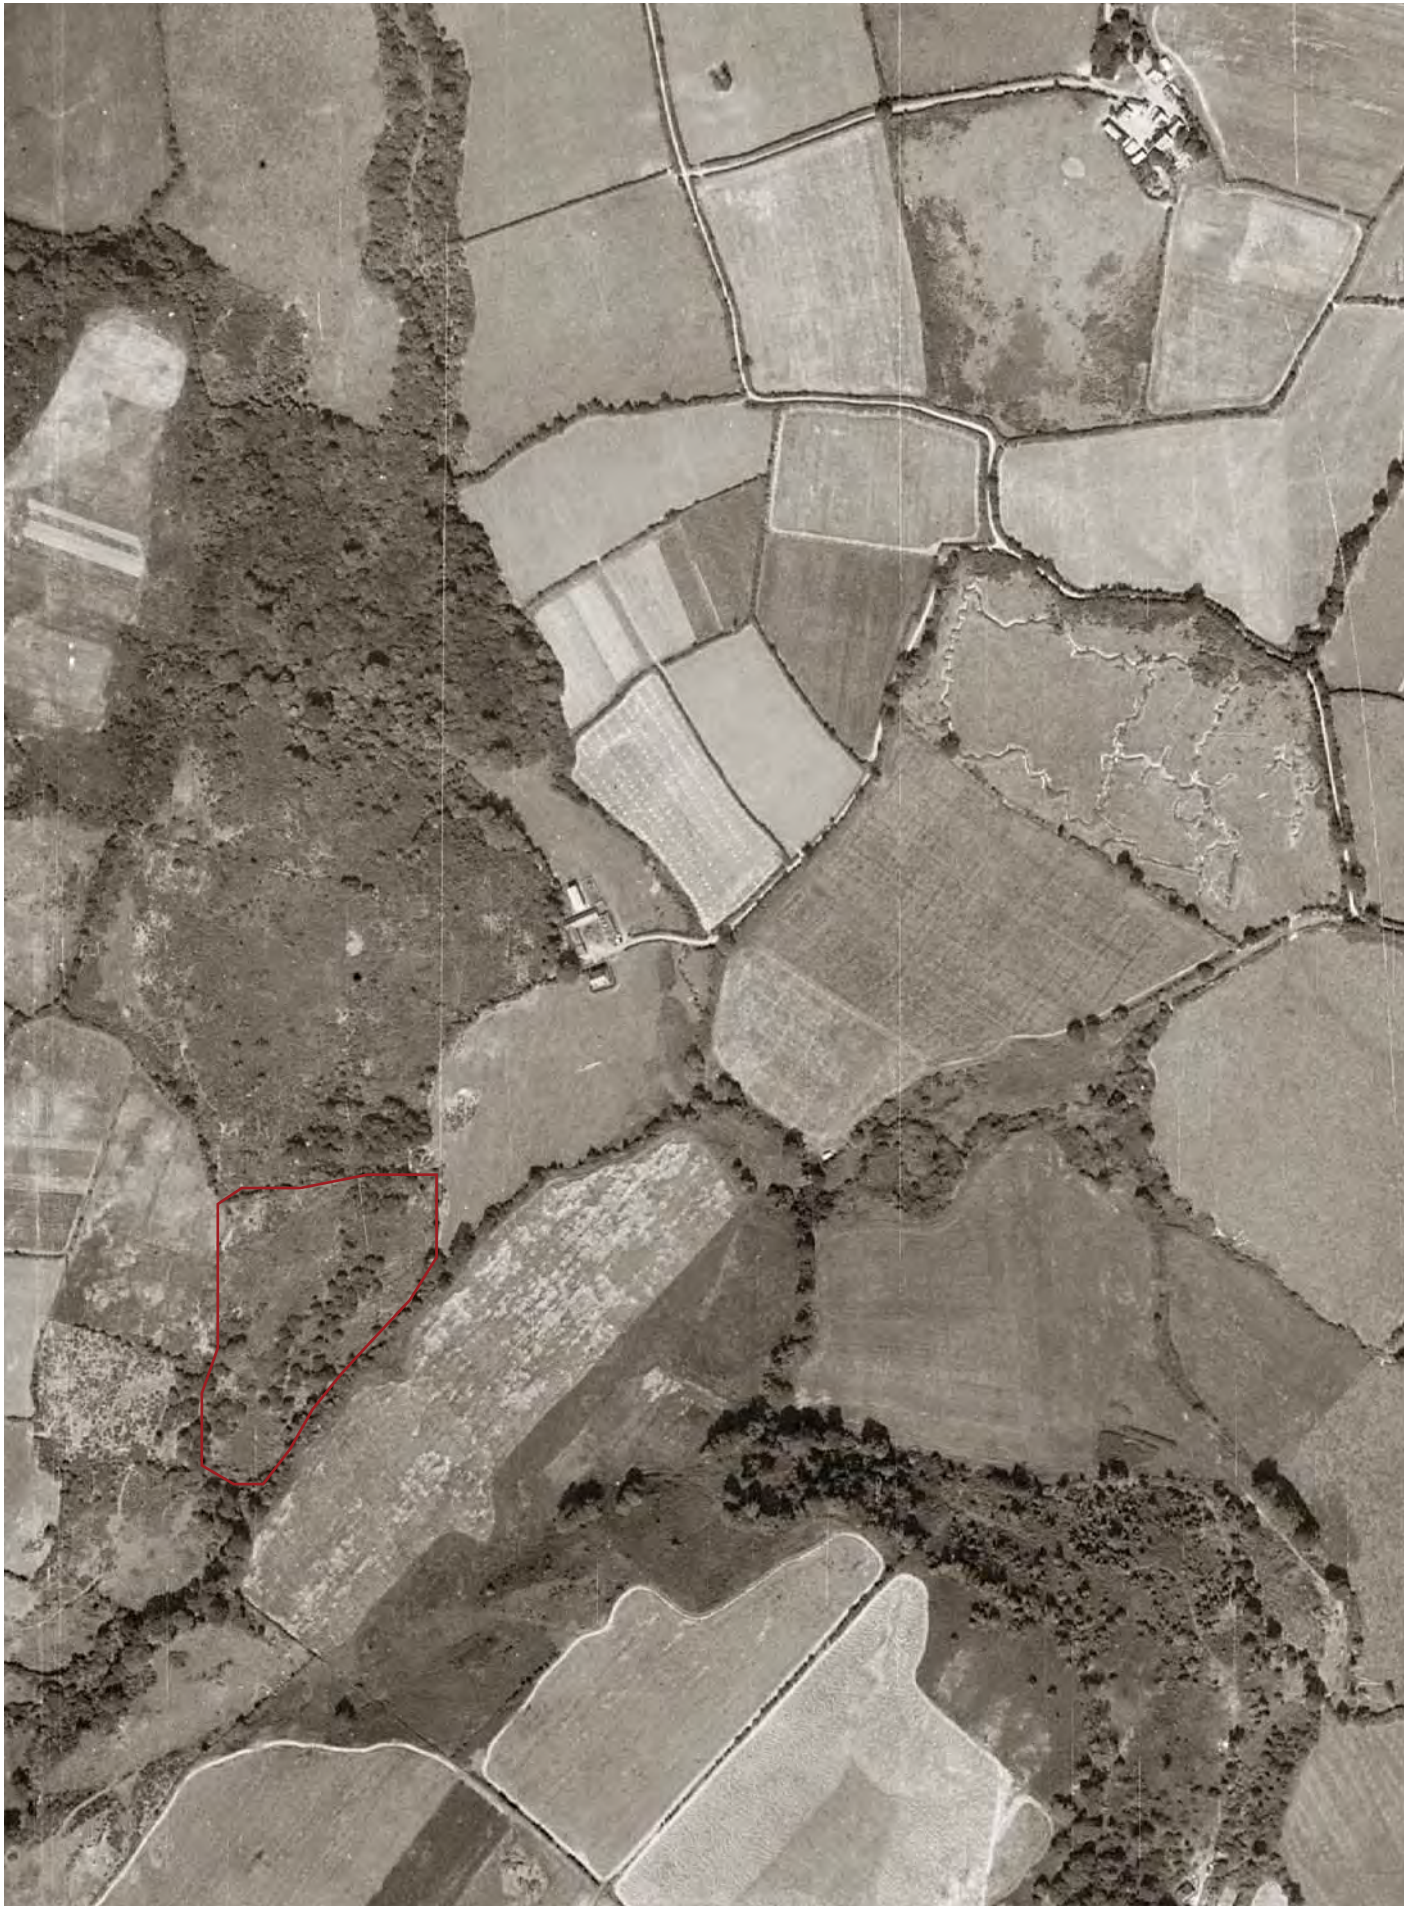
Fig. 8 Map extract from Sale catalogue of Baron Hill estate outlying portions in 1920 (NLW Sale Catalogues Angl. 115). Tan y Coed farm is coloured green and numbered lot 28.

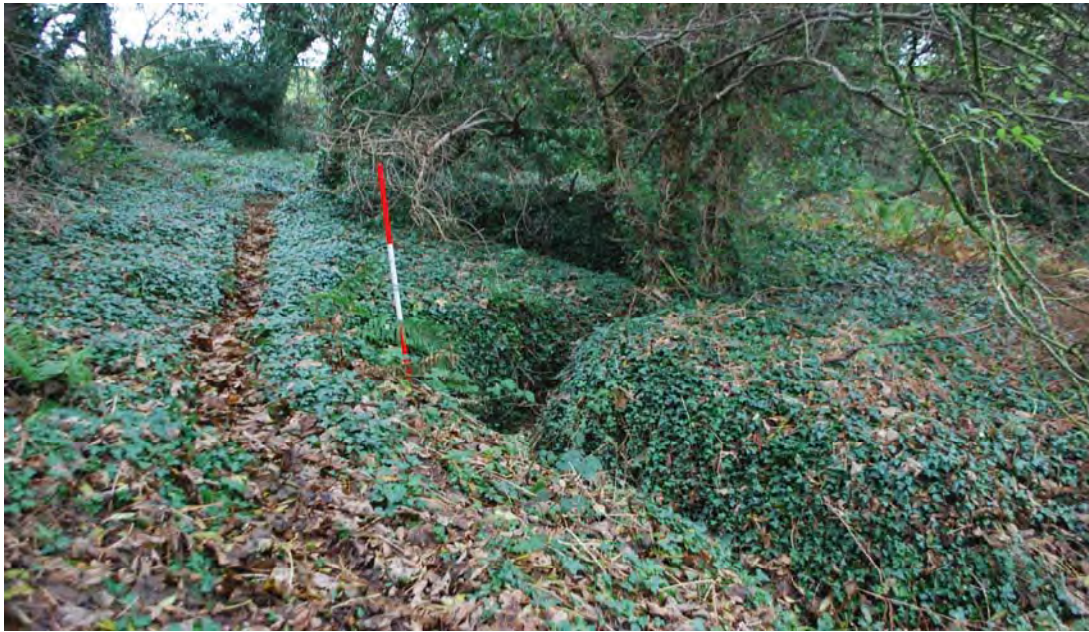
Plate 1 First World War Access trench (Feature 1), looking towards the front line.

To the west of Tan y Coed a remarkably complete set of practice trenches associated with this camp were dug (Plate 1). These seem to consist of a front line, or 'fire trench' down slope and service and zig-zag access or communication trenches running up slope behind it towards a support trench, linking both to a rear or reserve line. These trenches formed part of a trench training system used nationally and designed by Colonel Corry in 1915, based on his experiences in the Boer War and the Western Front in 1914 (Dawson 2007, 179), being an improvement on the methods recommended in the British General Staff Manual (Solano 1914). It is not thought likely that offensive and defensive military tactics were taught at Tan y Coed (Parry *pers. Comm.*). Other surviving examples are located at Penally in Pembrokeshire and Bodelwyddan in Flintshire (Driver 2007, 260-261). The practice trenches provided low-cost training to the million volunteers and later conscripts who served in the British Army. They were also seen as a propaganda tool, showing the level of preparedness of the army (Brown 2004). There must have been a certain amount of woodland clearance of the area to enable this work to be carried out, and the 1945 aerial photograph (Fig. 9) shows the woodland to be less dense than it is today. The area has since regenerated considerably and a significant amount of archaeology is probably obscured with scrubland. It was not unusual for practice trenches to be dug in woodland, at Pullingshill Wood, Marlow a considerable amount of tree felling was carried out in advance of entrenchment construction (Dawson 2007, 183-184).

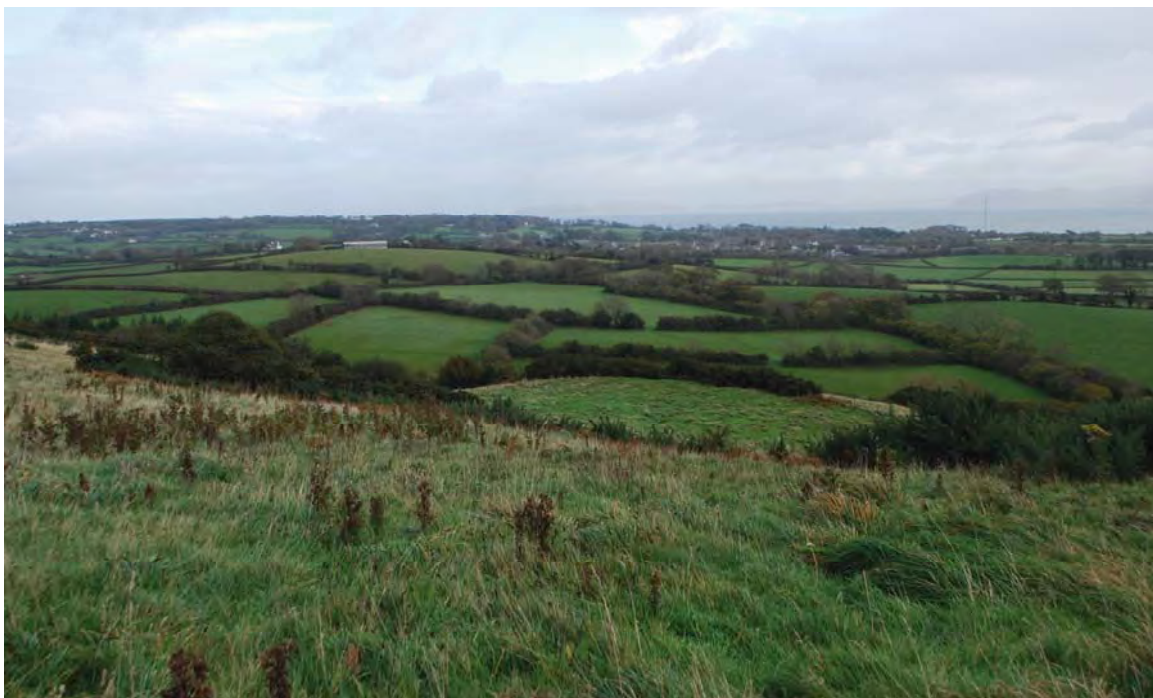
Plate 2 General view of improved fields to the east of Tan y Coed, the proposed location of most of the log cabin development.

It is recommended that a programme of field evaluation be carried out within the five fields to the east of Tan y Coed. This will be able to confirm the presence and nature of any surviving buried archaeology.

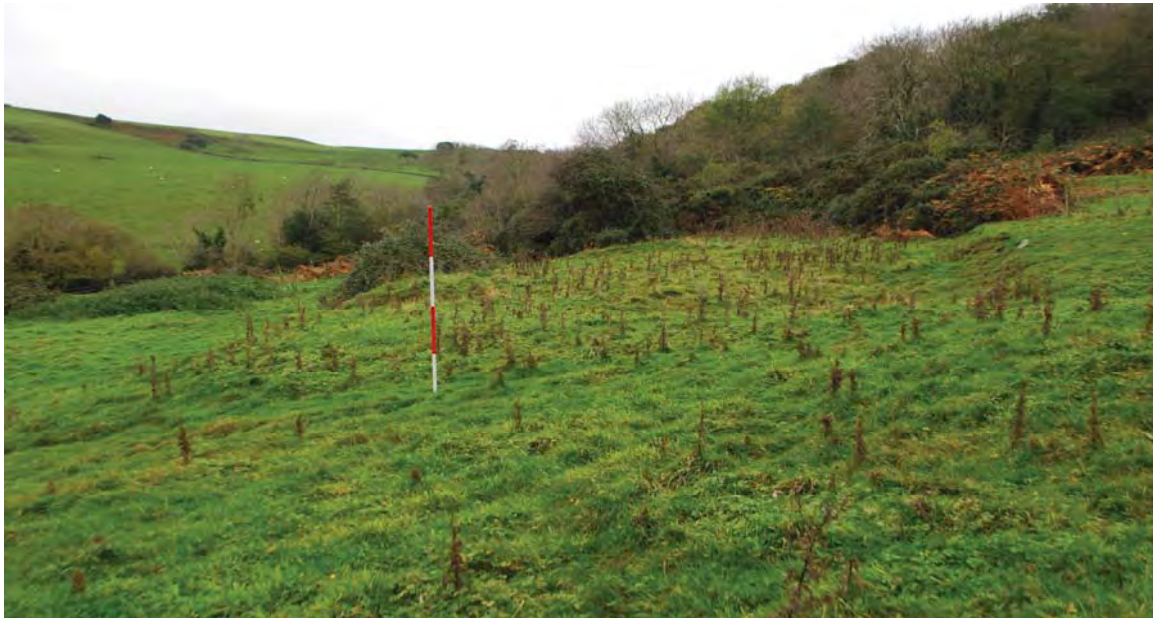
Plate 3 Rising ground to the north-east of Tan y Coed, showing possible evidence of terracing, or strip lynchets agriculture (Feature 2).

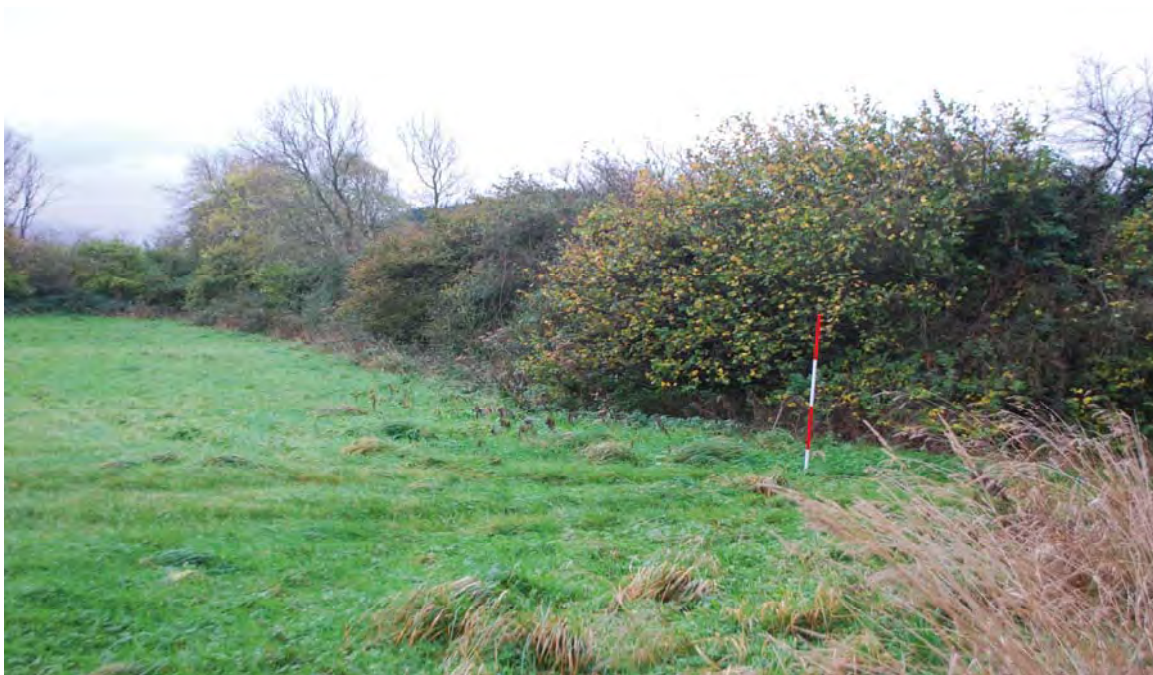
Plate 4 19<sup>th</sup> century hedgerow containing hawthorn, bilberry and sloe.

No hedgerows or field boundaries of pre 19<sup>th</sup> century date were definitely identified, and it would appear that the surviving examples date largely from agricultural improvements carried out between 1840 and 1889. However these are characteristic of the predominantly agricultural landscape and it is recommended that they be retained where possible.
