# Abererch Church: **Pwllheli, Gwynedd**

## Archaeological Watching Brief

GAT Project No. 2123

Report No. 851

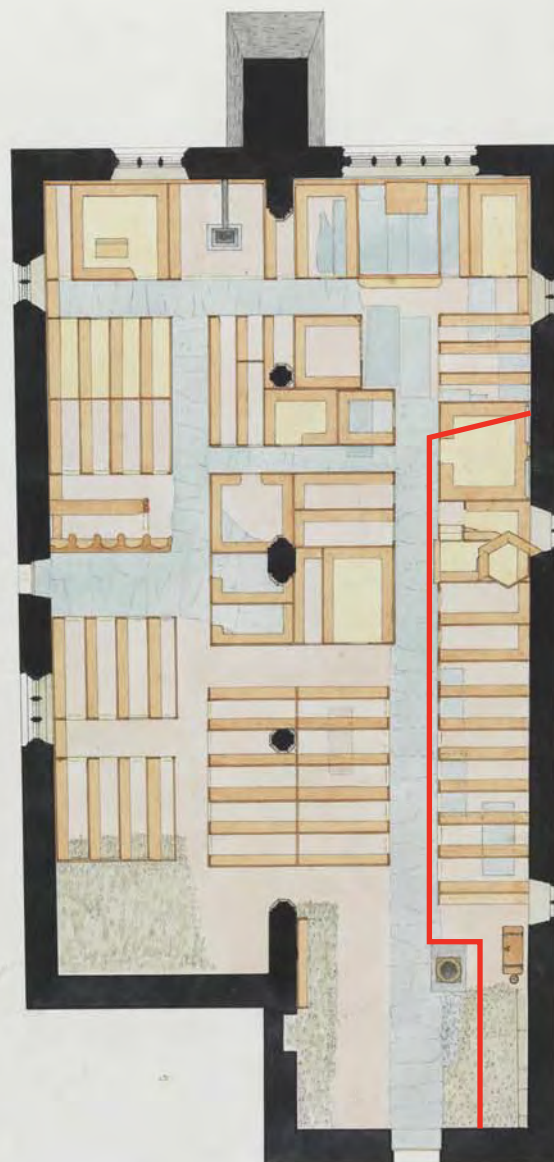
Fig. 3 Kennedy's 1879 Plan of the interior of Abererch Church, showing the layout prior to alterations with box pews. Grave slabs are marked in light blue (NLW PD 9702). Approximate study area overlaid in red

Four of the grave slabs contained inscriptions of which traces were visible, although only two had legible dates. These have been given individual numbers and these are discussed in section 6.1. It is difficult to match the location of the identified grave slabs with those that appear to be depicted on *Kennedy's* 1879 plan (Fig. 3).

The brick floor surface, revealed by the removal of the late 19<sup>th</sup> century pews in the nave, is almost certainly the floor surface shown on Kennedy's 1879 plan of the church floor (Fig. 3). The dates on the two dateable gravestones 1722 and 1785, demonstrate intra mural burials within the church in the 18<sup>th</sup> century. The manner in which the brick floor respects the grave slabs means that either they are contemporary or the brick floor post-dates the grave slabs.

The gravestones are interesting examples of their date and type, and probably represent the last intra mural burials within the church, set into what was possibly a beaten earth floor. Kennedy's plan shows irregular surfaces at the west end of the church, suggesting that parts were still earth at that date (Fig. 3). It is likely that the brick floor was laid prior to (and possibly immediately before) the insertion of the box pews and benches shown on Kennedy's plan. This must have taken place after 1785, the latest legible date on the grave slabs (Grave 3). However it has not been possible to fully correlate the location of the grave slabs with the grave slabs outlined on Kennedy's pre-restoration plan of the church.

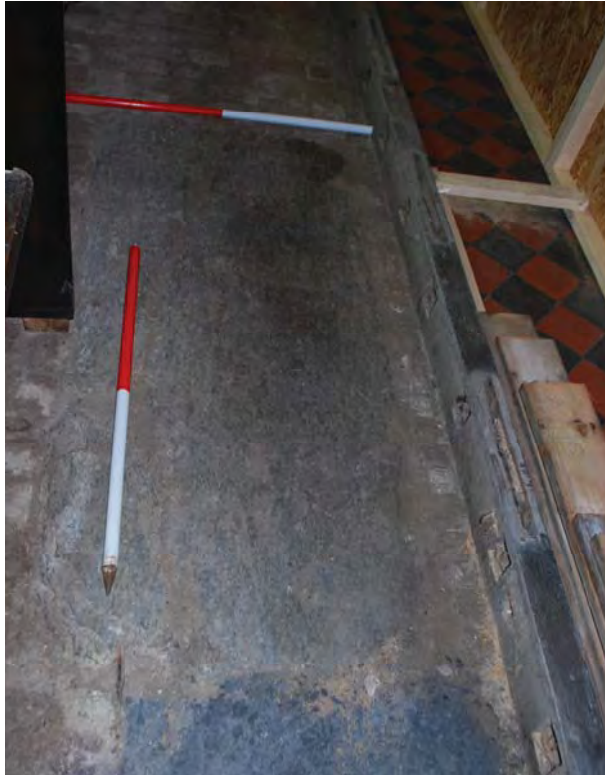
Stone number 1 is a ledger slab of mid greyish brown shale/schist, and is somewhat flaked. It is rectangular and 1.9m long by 0.84m wide. The surface of the stone is somewhat damaged, however most of the inscription can be made out. The upper case lettering has straight serifs, and occupies the first 0.5m of the stone:

HERE L[IET]H° THE

BODYS O[F] ° 3 CHILD [ER?/REN?]

BY W C .... & R P HIS

WIFE ° W W

**Fig. 4** Grave ledger slab 1, from the east. Scales 2 x 1m, with 50cm divisions

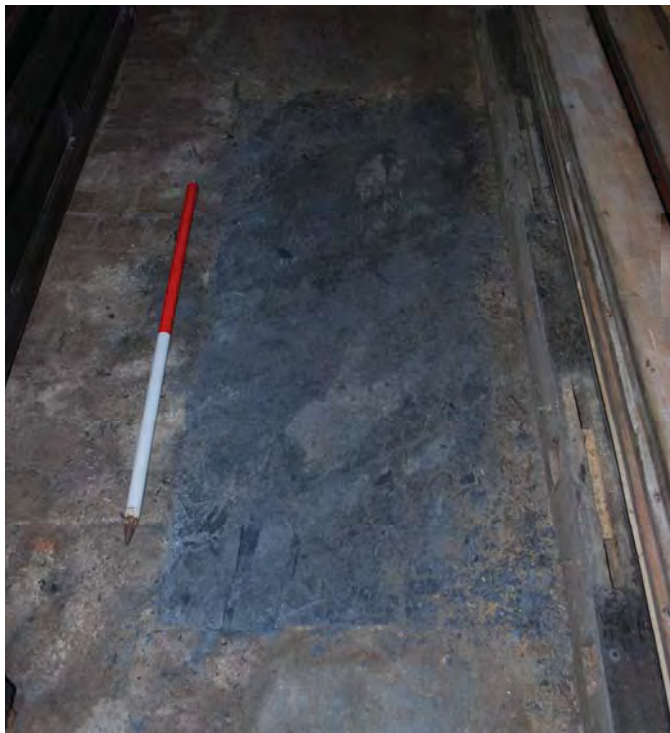
Stone number 2 is situated immediately east of number 1. It is made of mid grey shale and is in a very decayed state, and is 1.6m long by 0.7m wide. The letter style suggests a late 18<sup>th</sup> century date (Shoemith 1980, Mytum and Evans 2002), although no date was visible on the stone.

**Fig. 5** Grave ledger slab 2, from the east. Scale 1m, with 50cm divisions

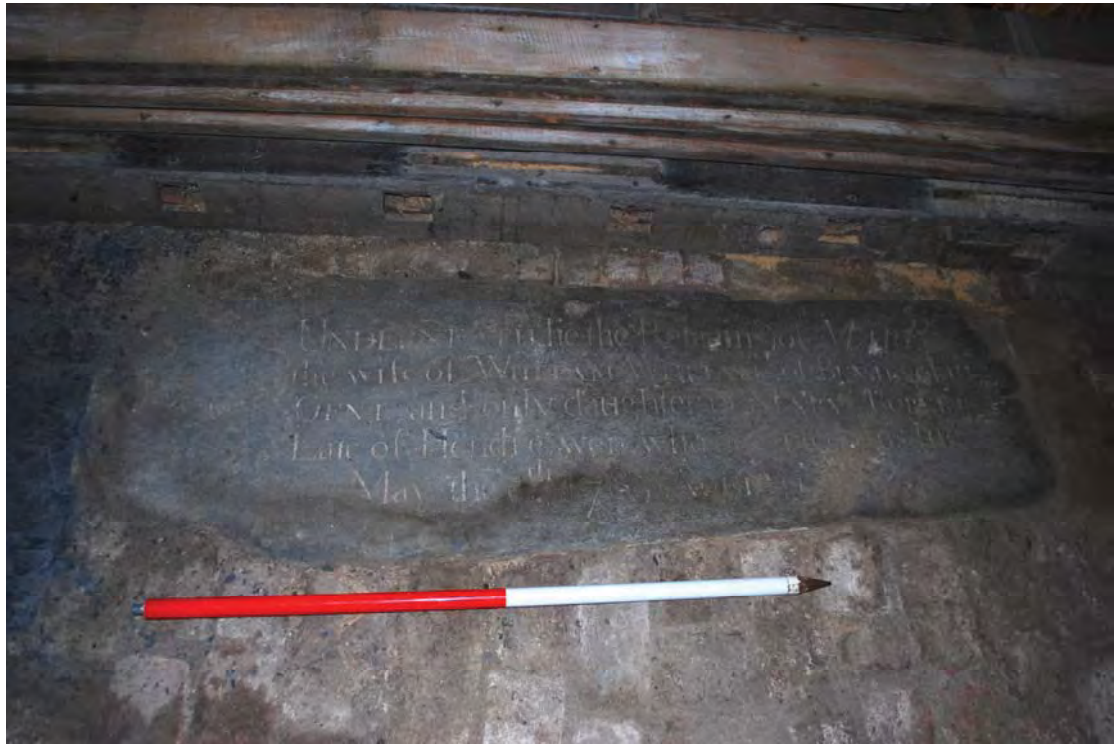
Stone number 3 situated immediately east of number 2, was a worn light yellowish brown limestone slab, of irregular shape, but approximately 1.53m along its northern edge and up to 0.4m wide. An angle along the southern edge of the stone divided that edge into lengths of 1.15m and 0.4m (Fig. 2, 6). The inscription, of Times New Roman type with serifs, ran east west along the length of the stone and was easily decipherable:

UNDERNEATH lie the Remains of *Mary*  
The wife of WILLIAM WILLIAMS of Bryngolau  
GENT. and only daughter of MARY ROBERTS  
Late of Hendre wen, who departed this life  
May the 9.th 1785 AGED 41 years

**Fig. 6** Grave ledger slab 3, from the south. Scale 1m, with 50cm divisions

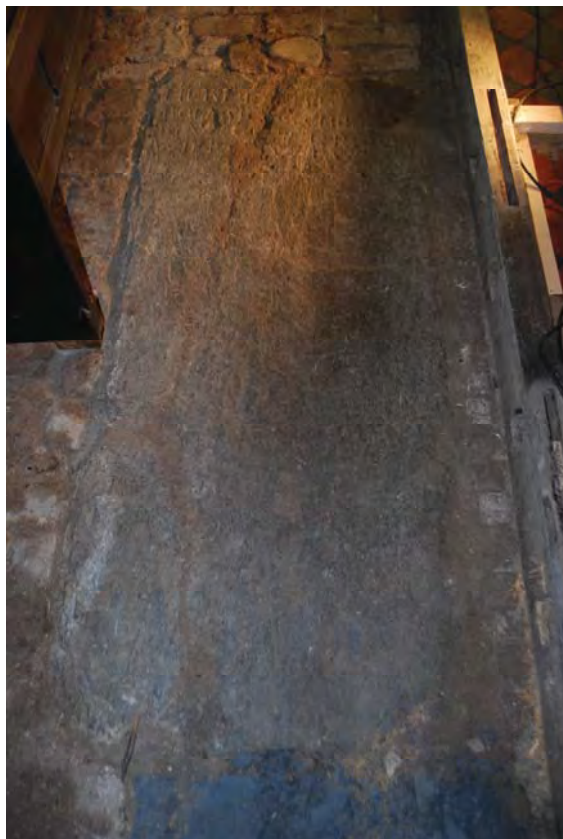
Stone number 4 was situated 3.8m east of stone 3, and slightly to the south of it. It consists of a dark yellowish brown limestone slab 1.5m long by 0.5m wide, and the inscription, written on the eastern portion of the stone, was clearly visible:

I W

Ty ynyna<sup>n</sup>t

1722

The superscript 'n' was clearly a correction of the carver's transcription error.

**Fig. 7** Grave ledger slab 4, from the east (oblique lighting used to help with the legibility of the inscription)

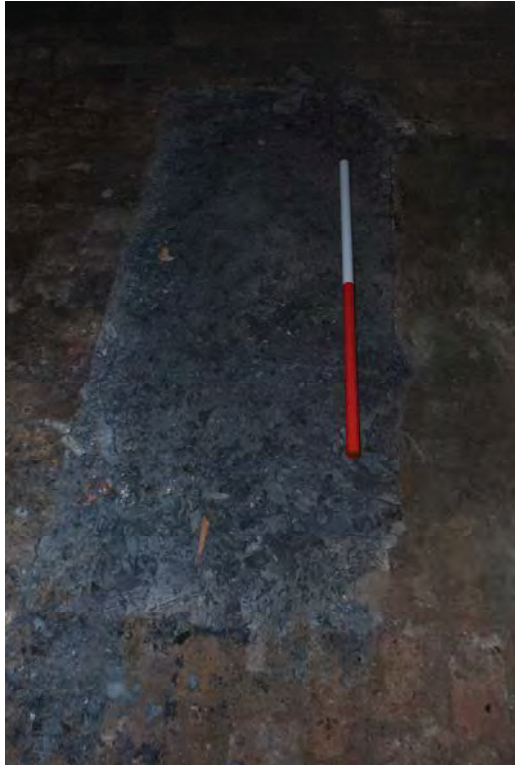
Stone 5 was adjacent to stone 4 to the south, although offset 0.7m west. It is a rectangular mid greyish brown shale slab 1.78m long by 0.6m wide. The surface of the stone was completely flaked and decayed, and no inscription was visible.

**Fig. 8** Grave ledger slab 5, from the east. Scale 1m with 50cm divisions

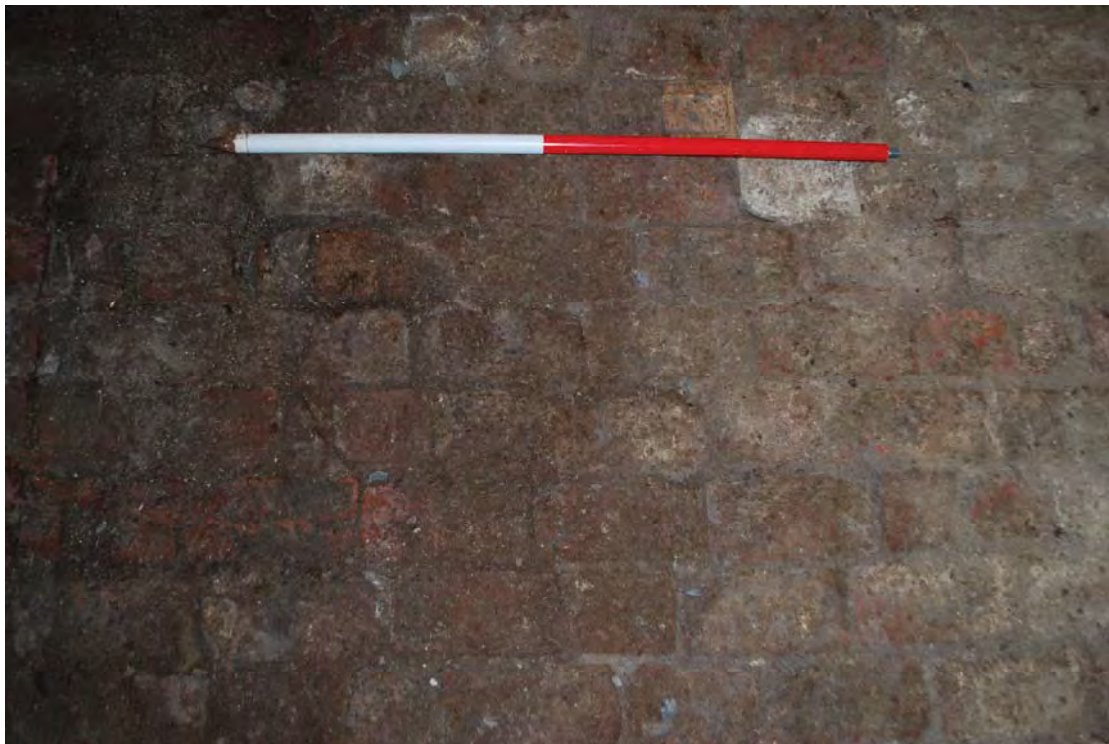
The bricks had an average dimension of 0.23m by 0.12m (Fig. 9). This floor abutted the south wall of the nave, and appeared to change in character just south (0.2m) of the pew plinth (Figs. 4 and 5), with a straight edge of bricks, laid in stretchers. Too little of this was visible for it to be possible to interpret this in any detail.

**Fig. 9** Detail showing character of brick flooring. Scale 1m with 50cm divisions

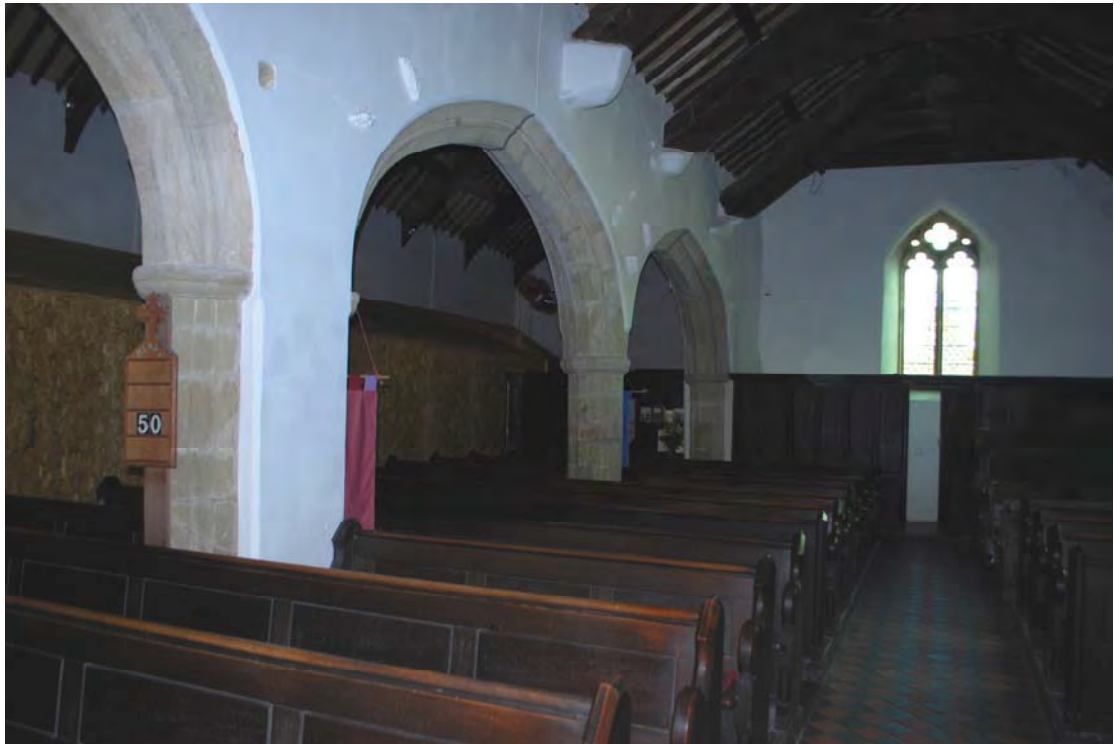
**Fig. 10** Interior of Abererch Church looking south-west. The area of investigation is in the boxed-in part of the nave to the south.

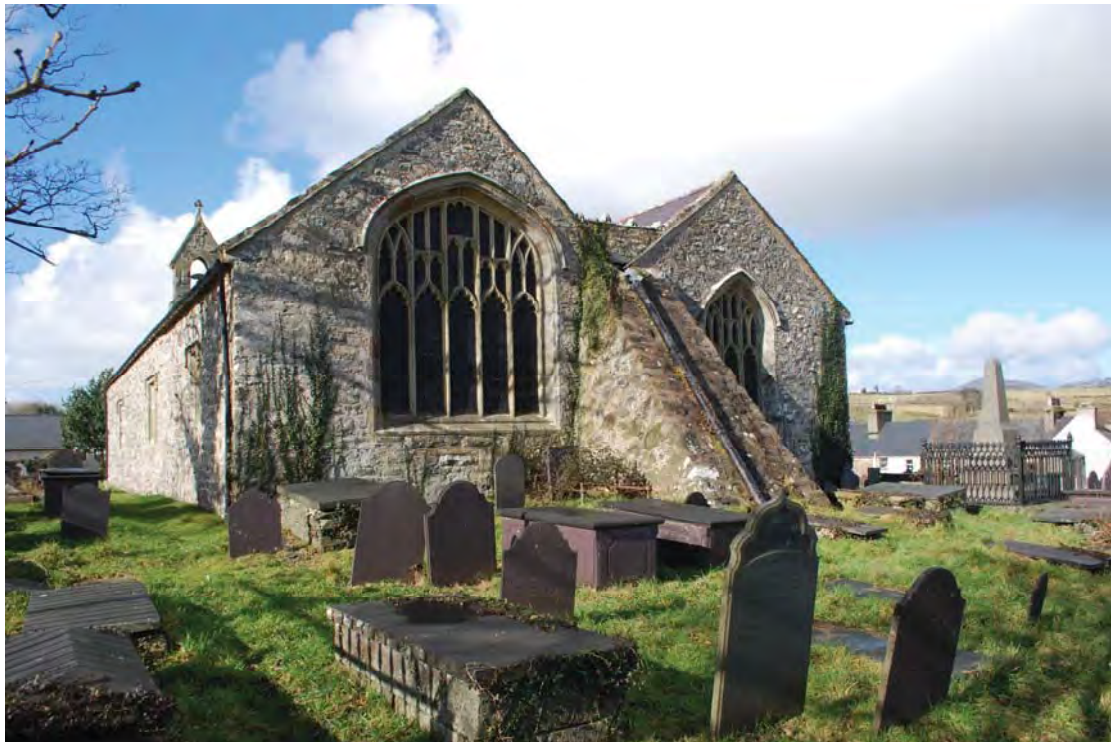
A massive buttress supports the building at the east end, along with a section of walling between the gable ends (Fig. 11). This obscures the junction between the nave and north aisle, hindering the interpretation of the building fabric. The date of this buttress is unknown, but it was present in 1856 (Jones 1856, 305).

**Fig. 11** General view of Abererch Church from the south east. The study area is immediately behind the south wall to the left of the picture.

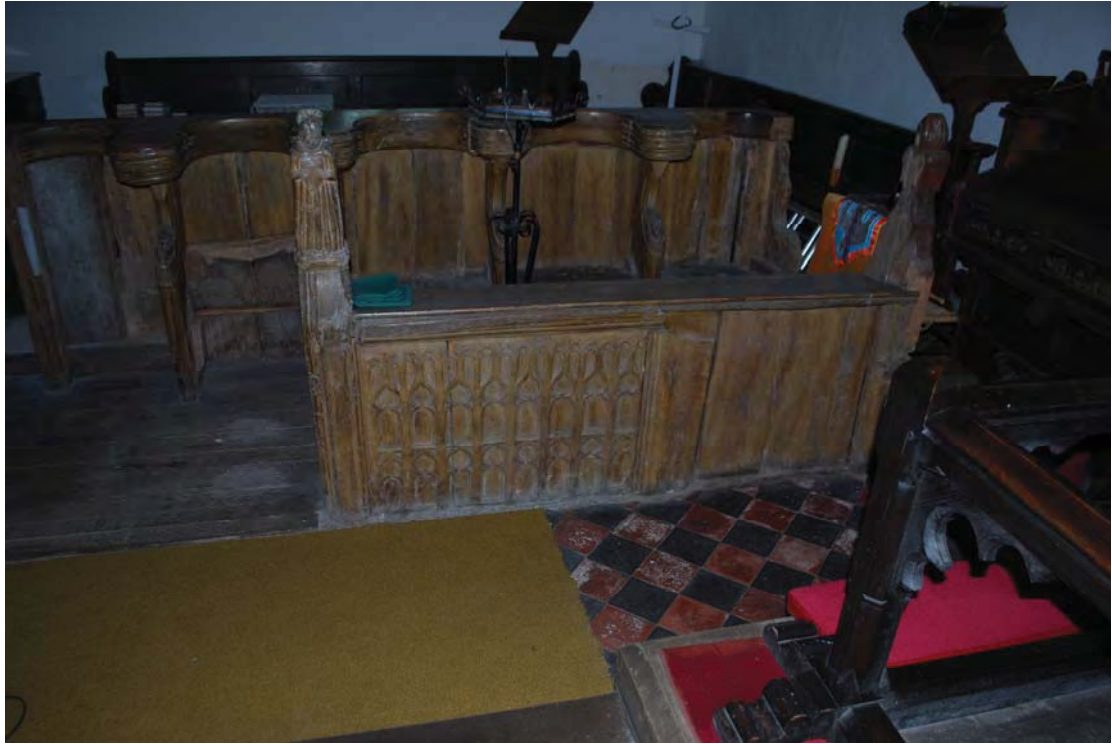
Late medieval fittings survive in the form of stall and a desk (Fig. 12), with misericords of water lilies and Tudor Roses, indicating a date of not earlier than c. 1490-1500 for them, which are described by Hyde-Hall as showing ‘the semi-barbarism of their contrivers’ (Hyde-Hall 1952, 257). The desk is carved at one end with standing figures. In 1879 (Fig.3) the stalls were located immediately east of the north doorway into the church, but was moved to the east end after Kennedy’s restoration. It is thought likely that the stalls form a reconstructed part of the former early 16<sup>th</sup> century rood screen, which originally had a form similar to that surviving at Clynnog Church (Davidson 2000, 5). Further fragments of the former screen can also be seen in the church, and it appears to have survived at least in part until 1856 (Jones 1856, 302).

**Fig. 12** Tudor stalls and desk at the east end of the north isle of the church
