# **Plas Pistyll, Pistyll**

## Archaeological Assessment

Report No. 935

Prepared for  
Natural Retreats

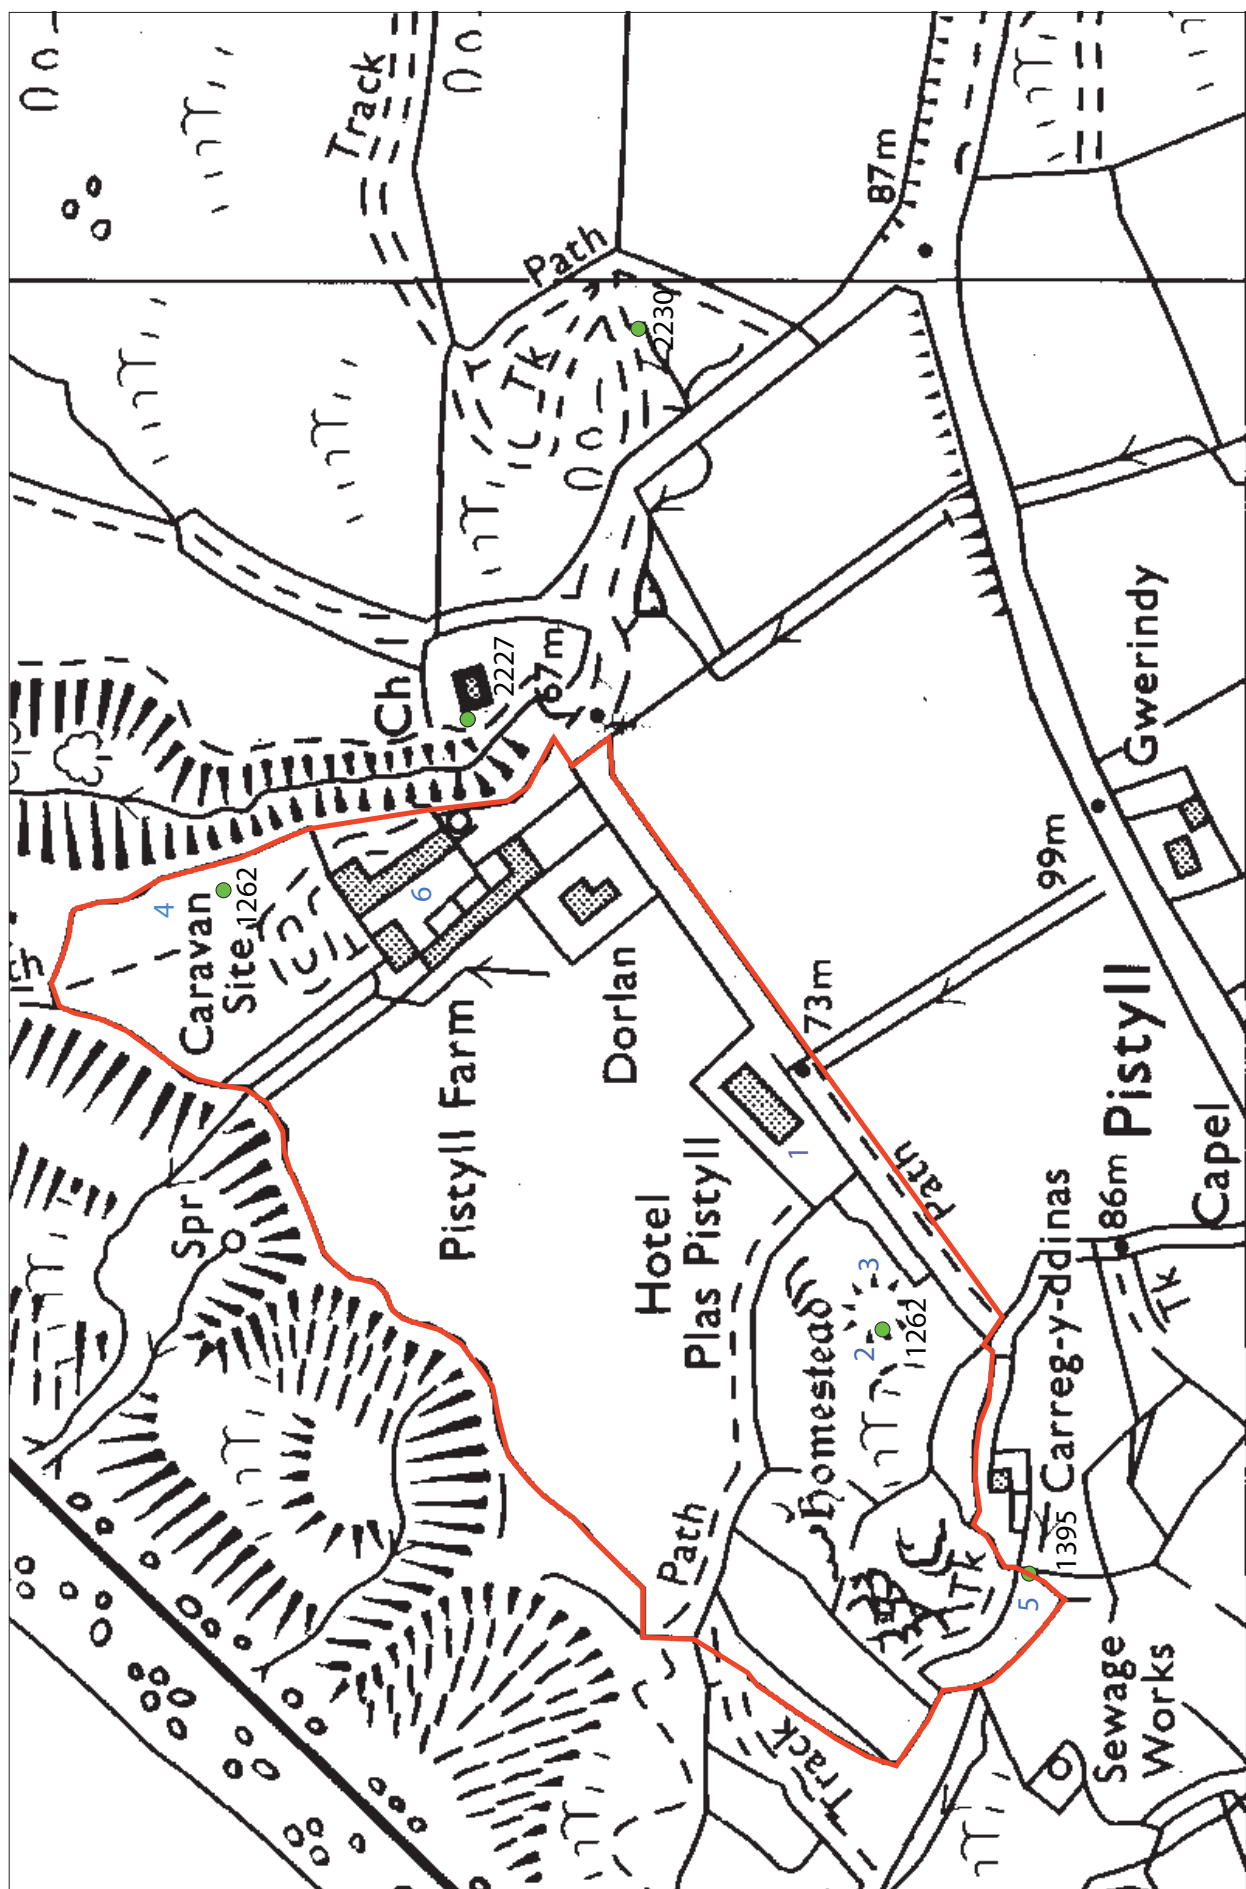
Fig. 1 Location of sites (numbered in blue). Green dots represent sites of the Gwynedd HER (numbered by PRN), and the study area is outlined in red. Scale 1:2500 Map taken from OD 1:10 000 sheet SH34 SW.

Sites, buildings and find spots listed in the GAT HER were identified (Fig. 1), with GAT HER referring to the unique Primary Record Number given to each individual site.

The archaeological survey lists sites identified within the study area (outlined in red on fig. 1) and within 100m of it.

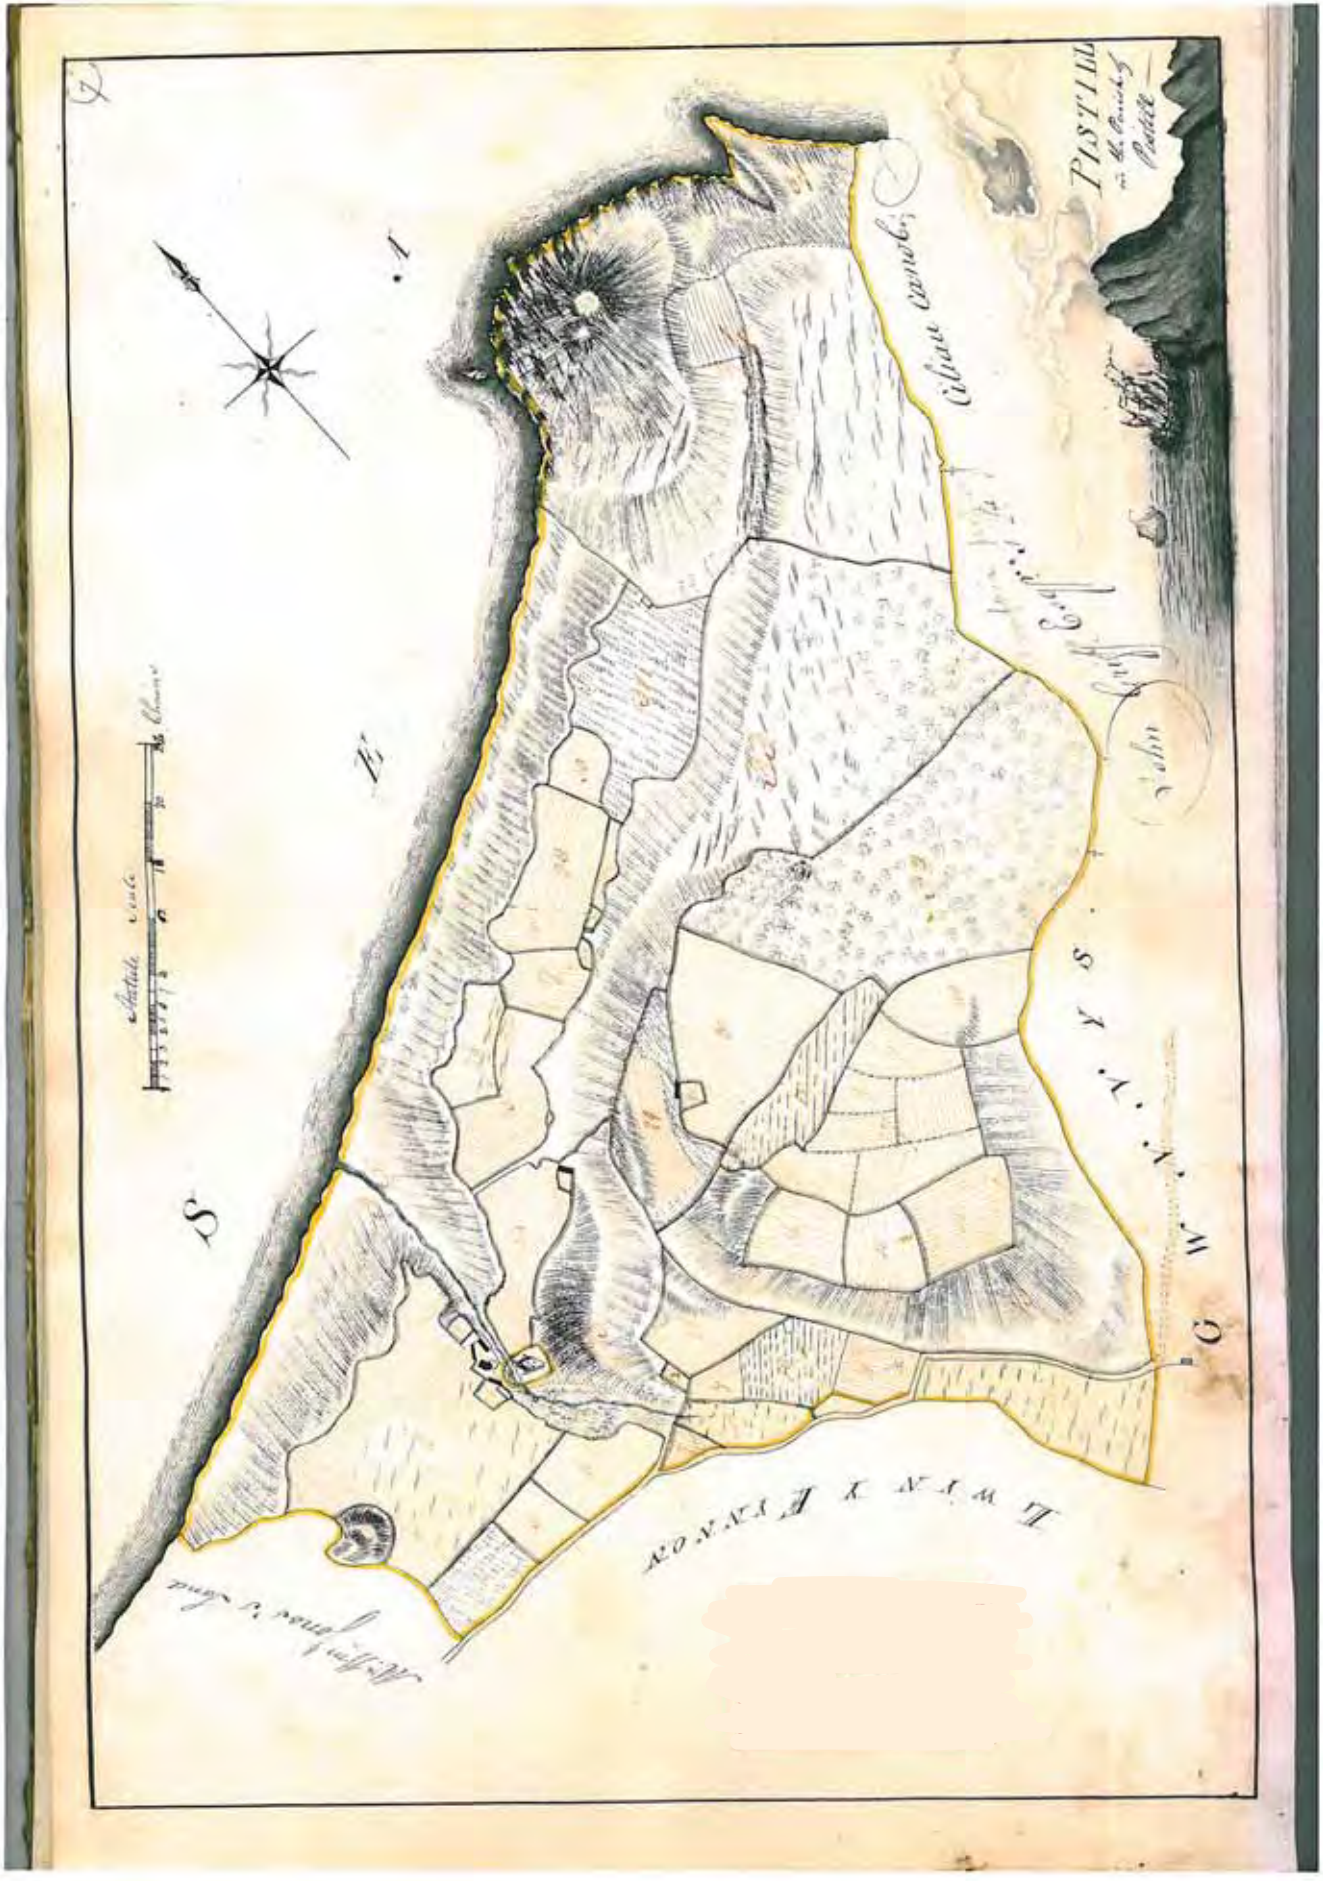
Fig. 2 Pistyll Farm from 'Survey, Plans and Reference of the Bodfel Estates belonging to William Hervey' (Gwynedd Archives, Vaynol 4212)

The extent of Pistyll farm is shown on an estate map of 1802, when the land formed part of the Bodvel Estate (Fig. 2; Vaynol 4142). Pistyll farm is shown at this date as a house with two outbuildings, possibly a barn and a byre (1 on Fig. 2). The area of land where Plas Pistyll was subsequently to be built is shown as a single large field, partly ploughed and partly marshy (2 on fig. 2) and described as a *Carreg y Dinas* on the schedule. The *dinas* element of the placename is likely to refer to the enclosed fort, though the remains actually lie within field 3, called *Clogwyn* on the schedule. The estate had come into the hands of the Assheton-Smith family of Vaynol by 1839.

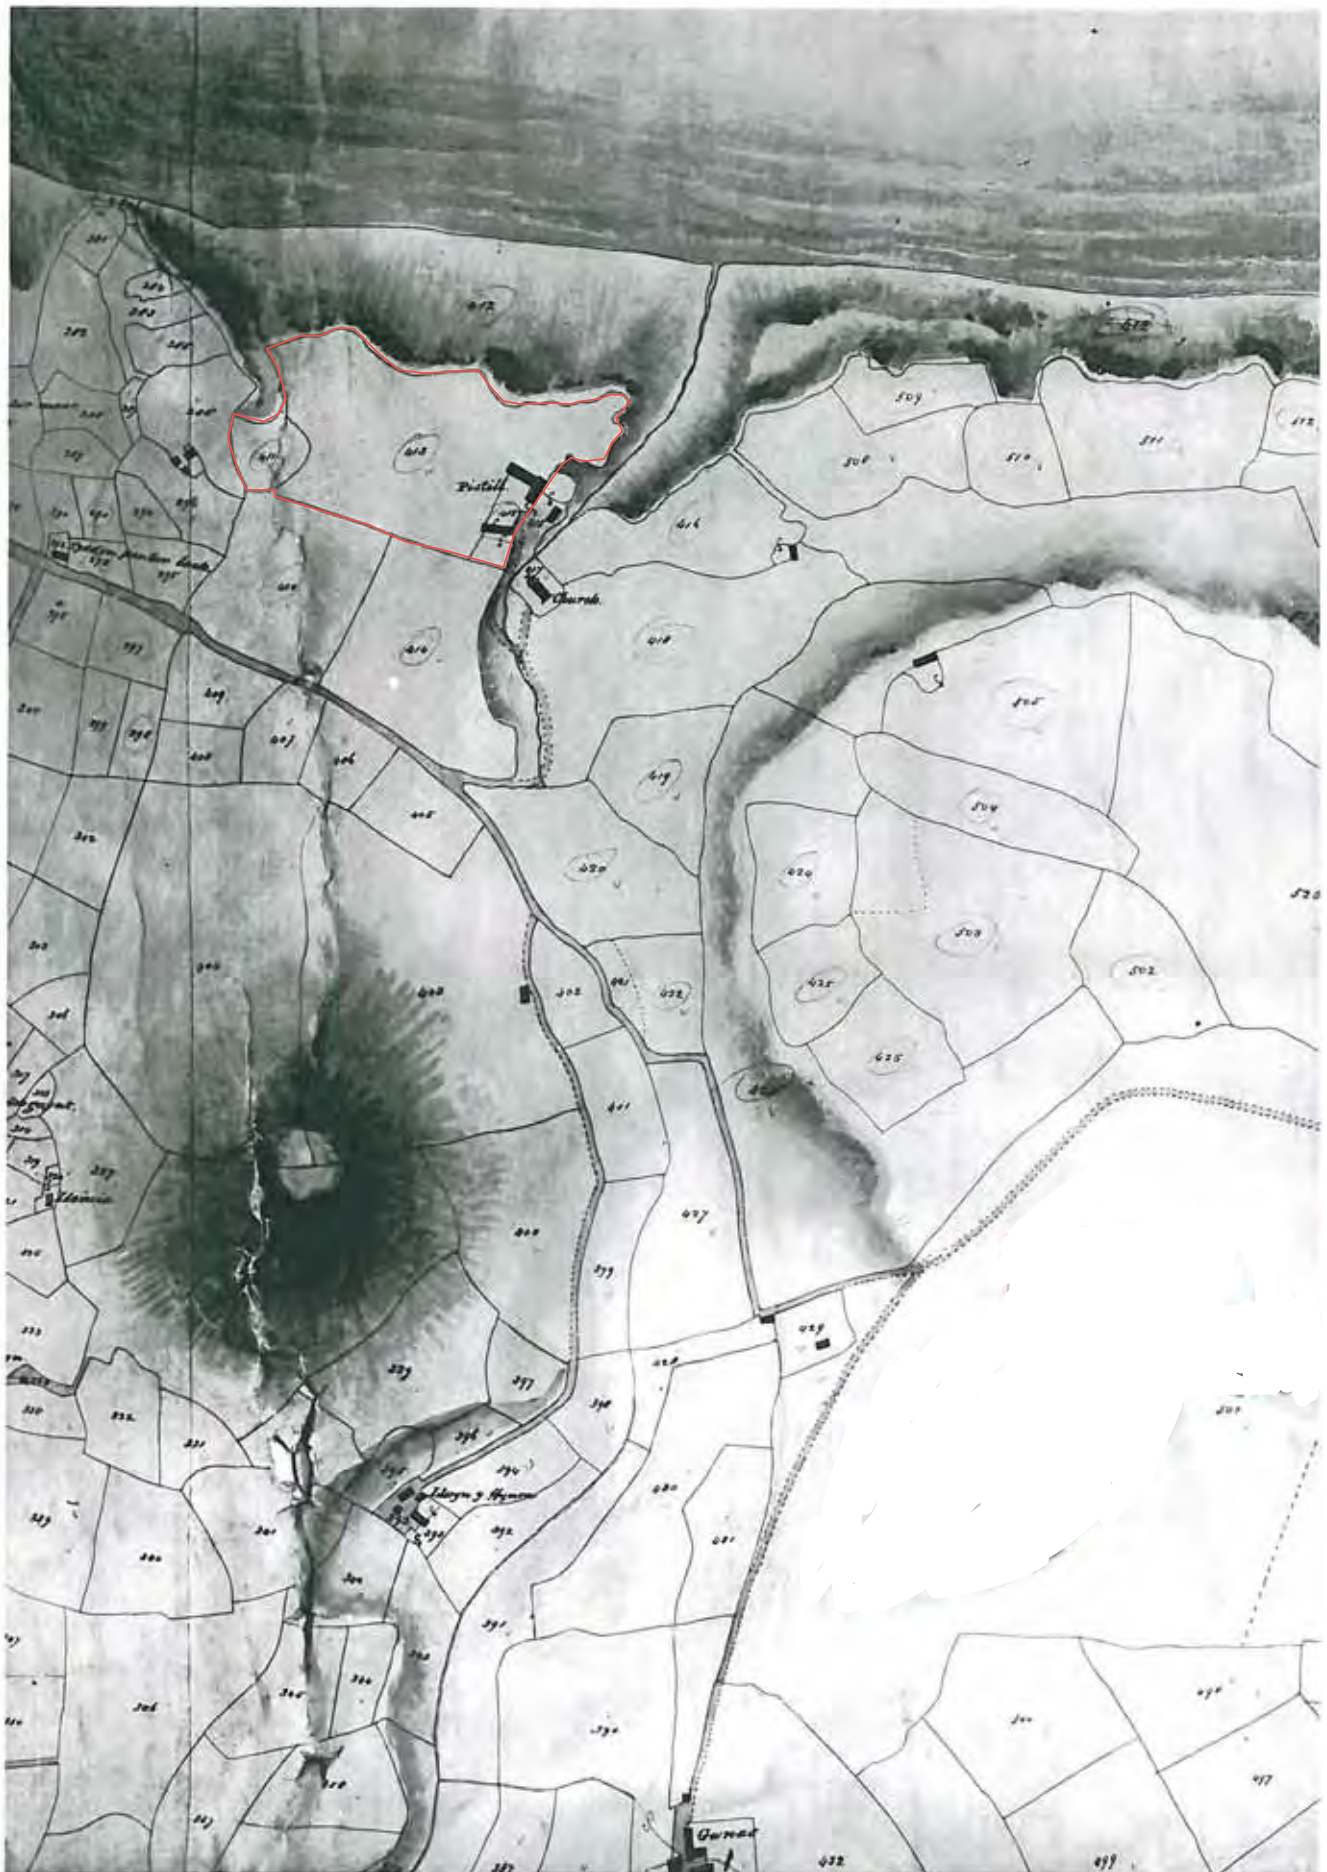
Fig. 3 Tithe map of the parish of Pistyll of 1840 (Gwynedd Archives) with the very approximate study area outlined in red

The tithe map of 1839 shows the same field pattern to that evidenced in 1802, although there appears to have been some slight rebuilding and alteration (Fig. 3).

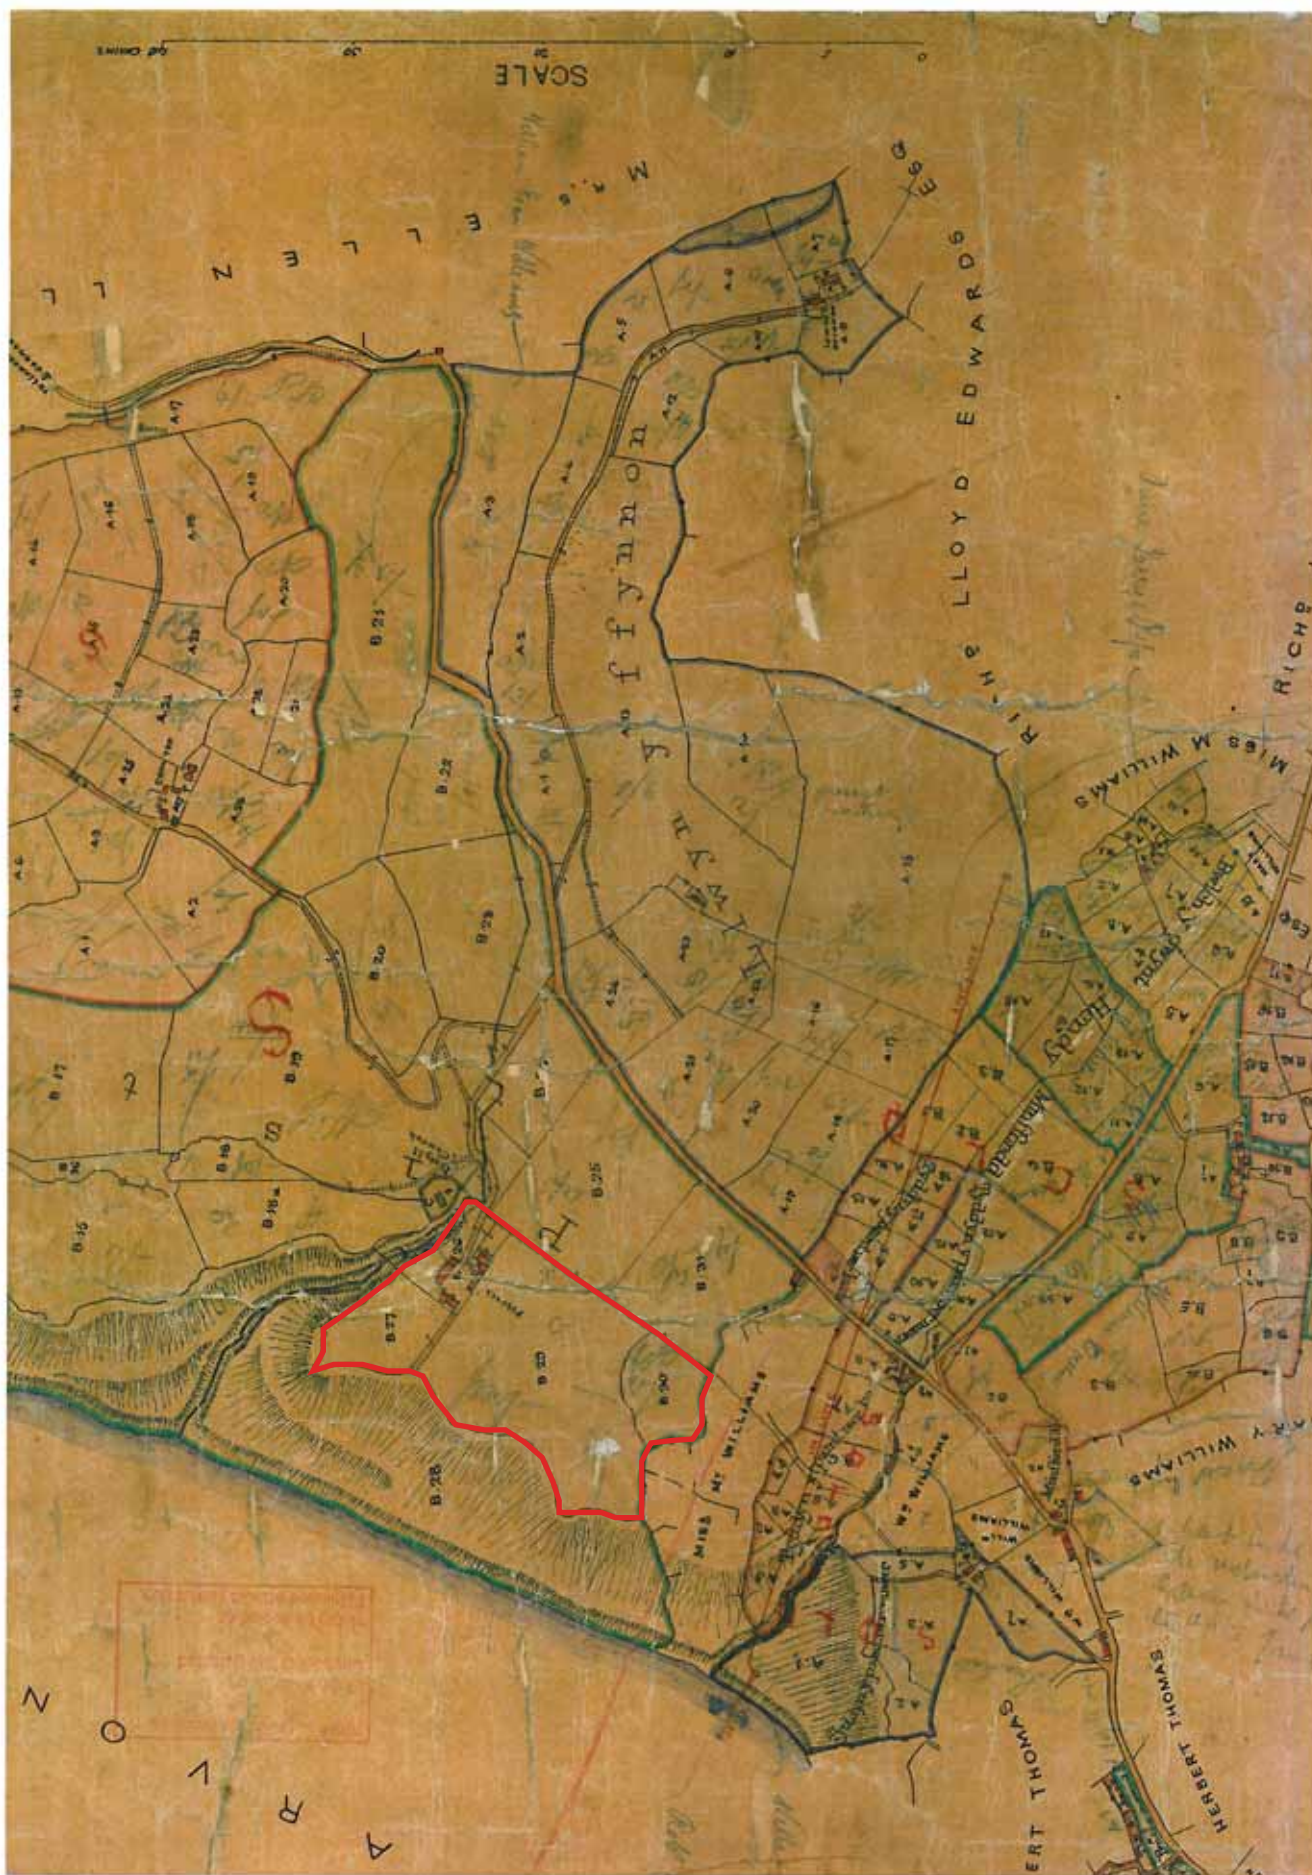
Fig. 4 Map of Farms in the parish of Pistyll 1868 (Vaynol 4178), the study area is outlined in red. Not to scale

In 1841 Pistyll farm was occupied by 14 people, including Thomas and Elizabeth Rees and their six children and six farm servants, indicating that it was a substantial farm holding (National Archives HO 107/1390/9). By 1868 Pistyll farm had acquired its current layout, having been improved by the Vaynol Estate and the track way that led subsequently to Plas Pistyll appears to have been developed (Fig. 4; Vaynol 4178). In 1871, although the farm had been improved it remained of similar size, with the Rees family and five servants (National Archives RG10/5710). In August 1898 the Vaynol Estate sold off some of its outlying portions (XD28/2894). Pistyll farm formed Lot 1, with farm buildings generally unaltered from those recorded in 1868. The farm consisted of 302 acres 2 roods and 25.5 perches and extended as far as Carreg y Llam to the east, and was purchased by the Goddard family of metal polish manufactures. The Goddards began to develop the area as a resort, and a substantial guest house, known as Plas Pistyll was constructed on the land of Plas Pistyll farm. This was a three storeyed building, with the eight principal rooms arranged off a central corridor. The first floor contained 15 bedrooms, two bathrooms, a housemaid's closet and linen room. The second floor had six bedrooms and four store rooms.

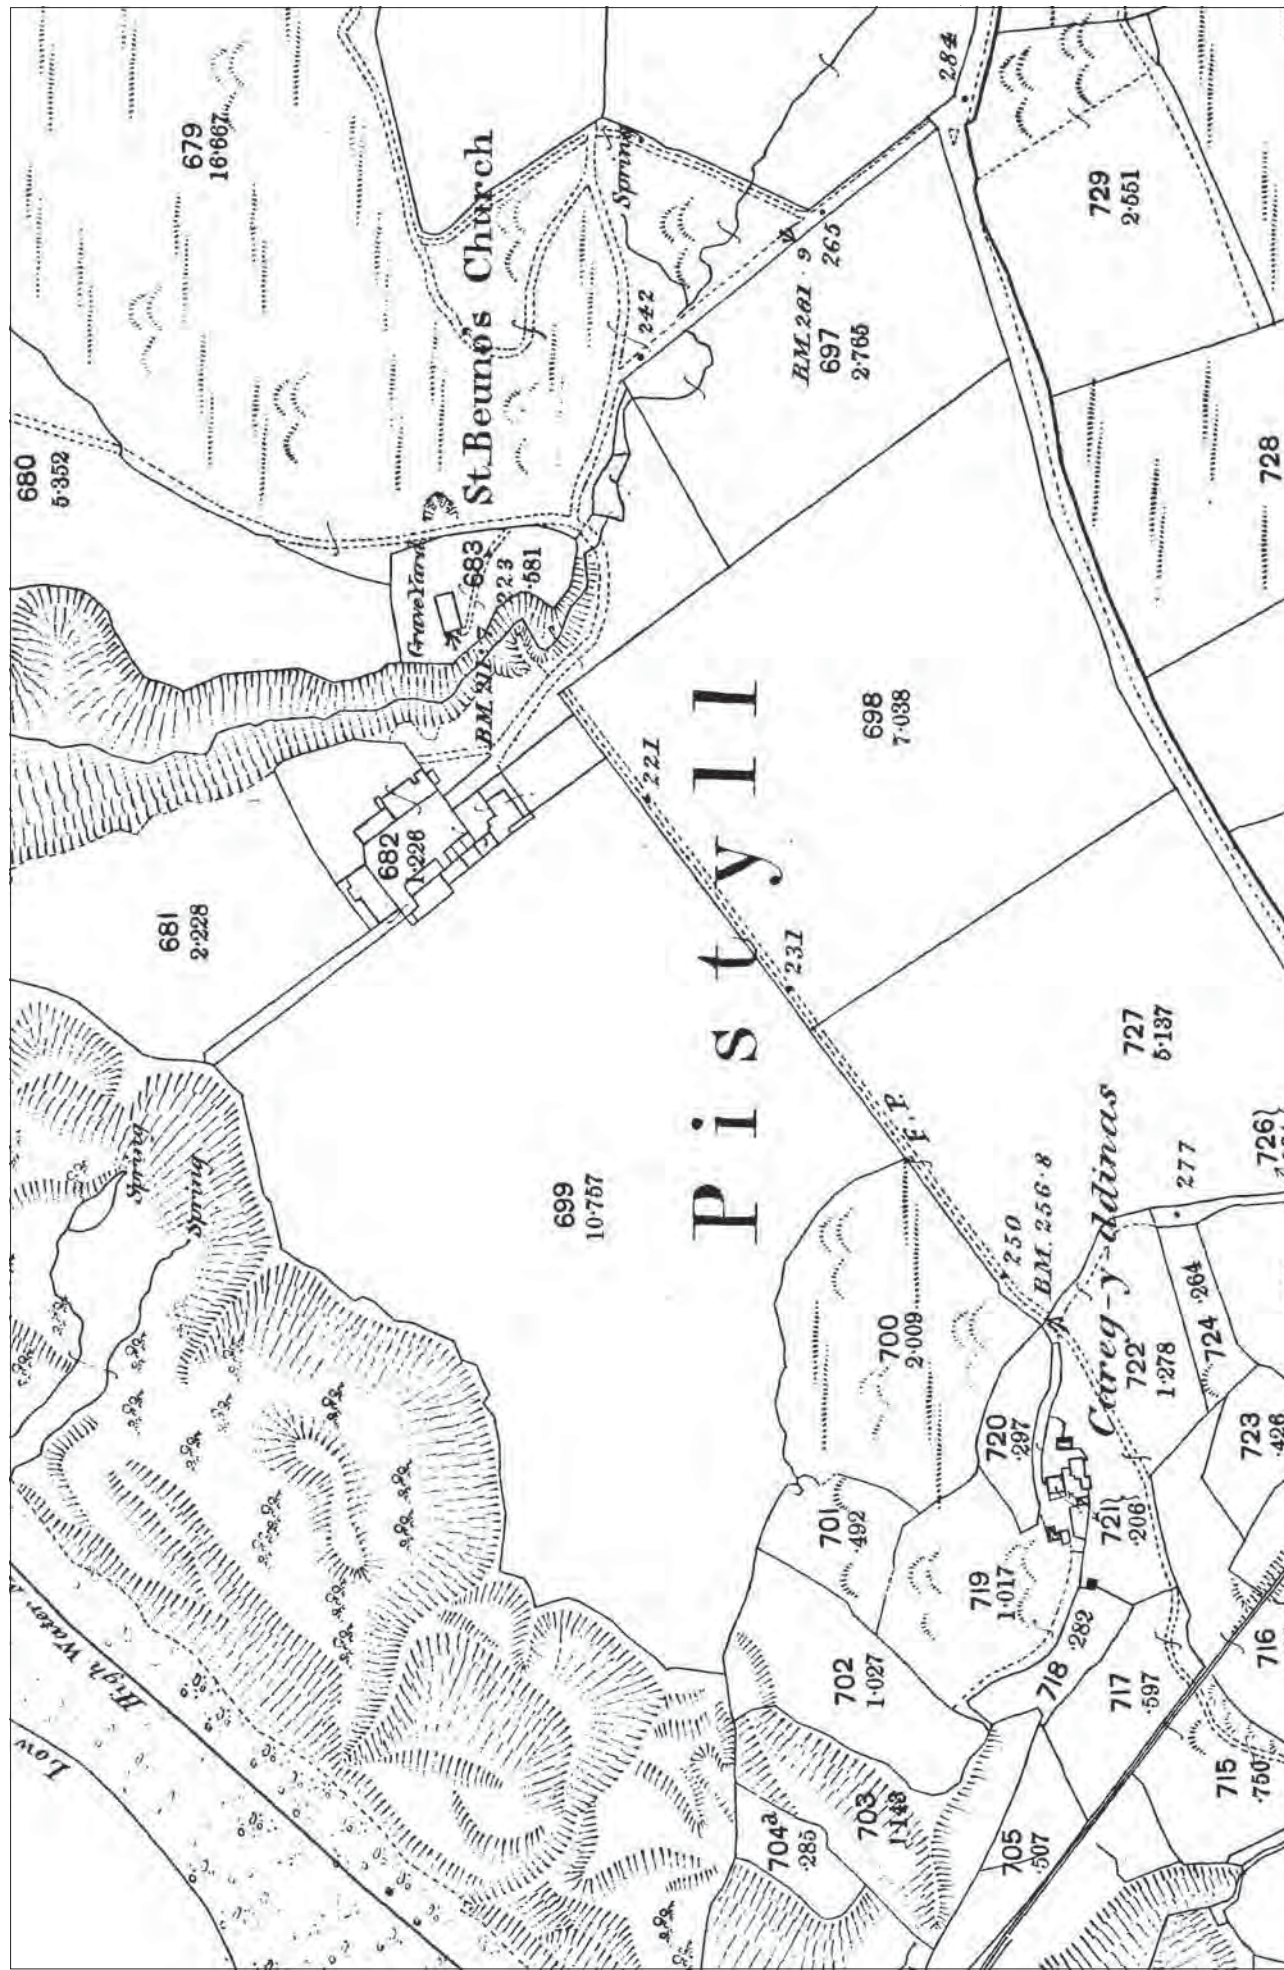
Fig. 5 Ordnance Survey 25 inch map of 1889 Caernarvonshire sheet XXII.6 showing study area. Scale 1:2500

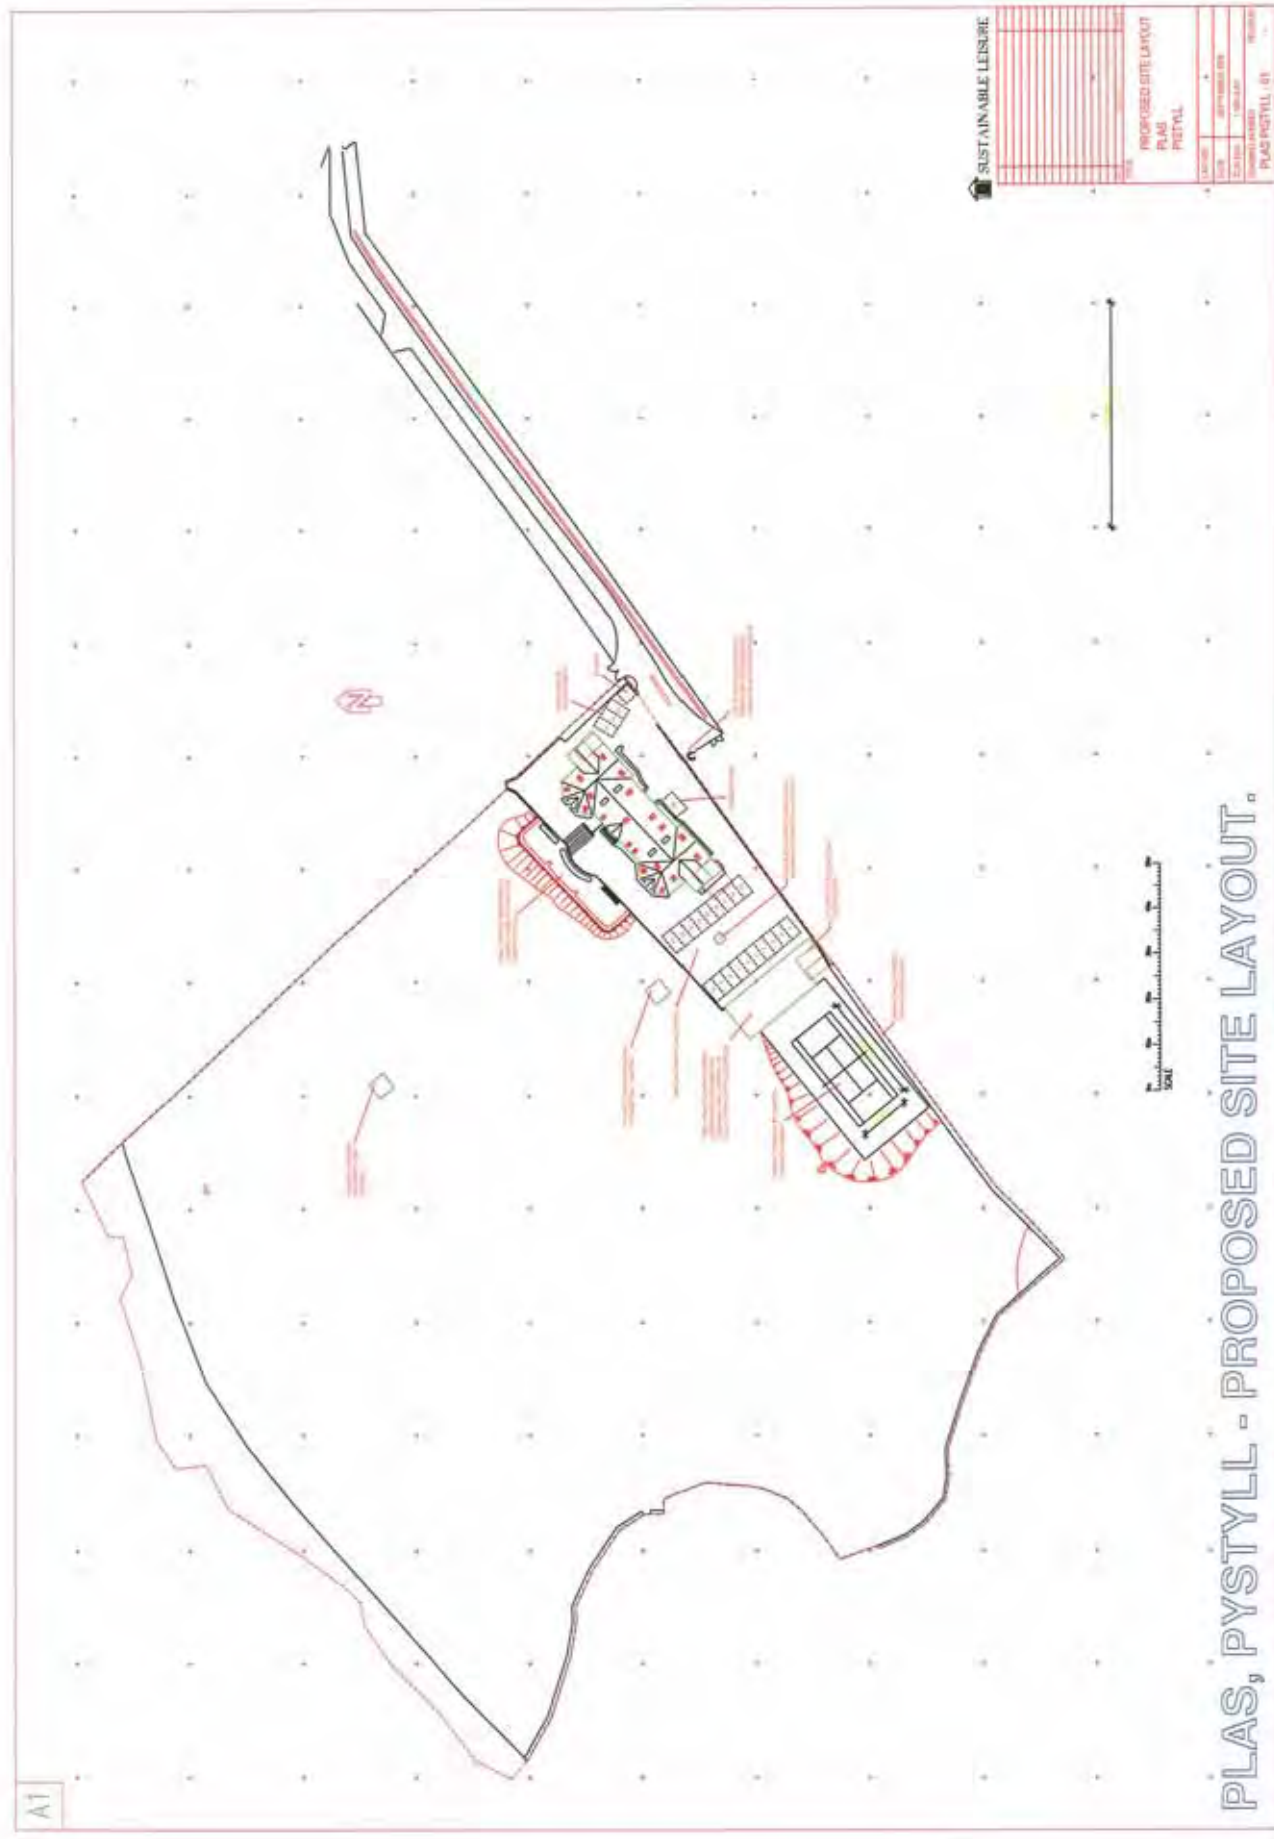
Fig. 6 Sustainable Leisure plan Plas Pistyll 01 showing proposed development

- It is noted that the ground works associated with the proposed tennis court (Fig. 6) impinge upon the enclosure (Feature 2), and possibly the small horseshoe shaped structure (Feature 3). It is recommended that the proposed developments be designed to avoid any impact on the archaeological features.

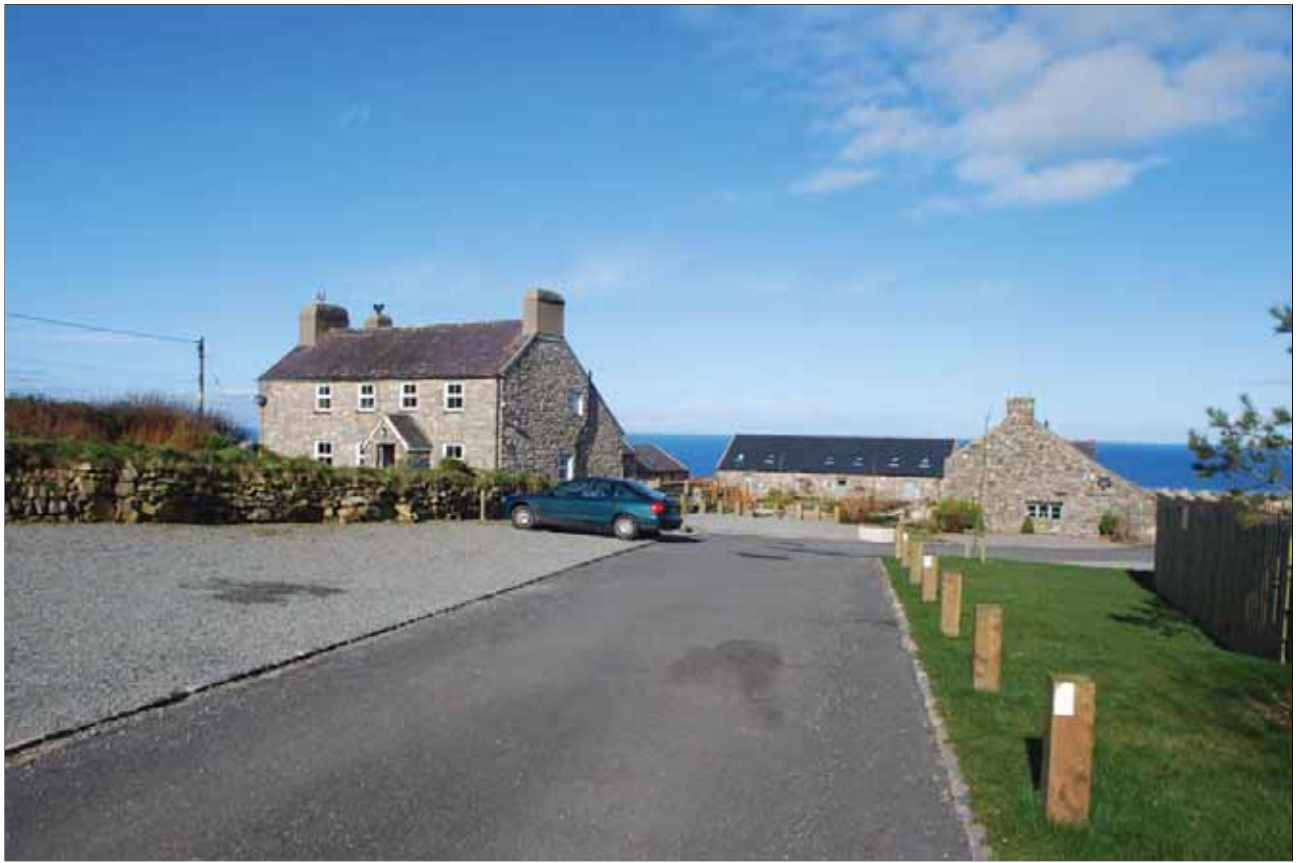
**Plate 1** Pistyll Farm from the south

An improved farmstead, with outbuildings situated around a courtyard to the north. The farm was rebuilt in the mid 19<sup>th</sup> century by the Vaynol estate. A mill building is located on the east side of the courtyard, and a wheel pit survives at the southern end of the buildings. The outbuildings have been converted to holiday accommodation, and the former farmhouse serves as the office.

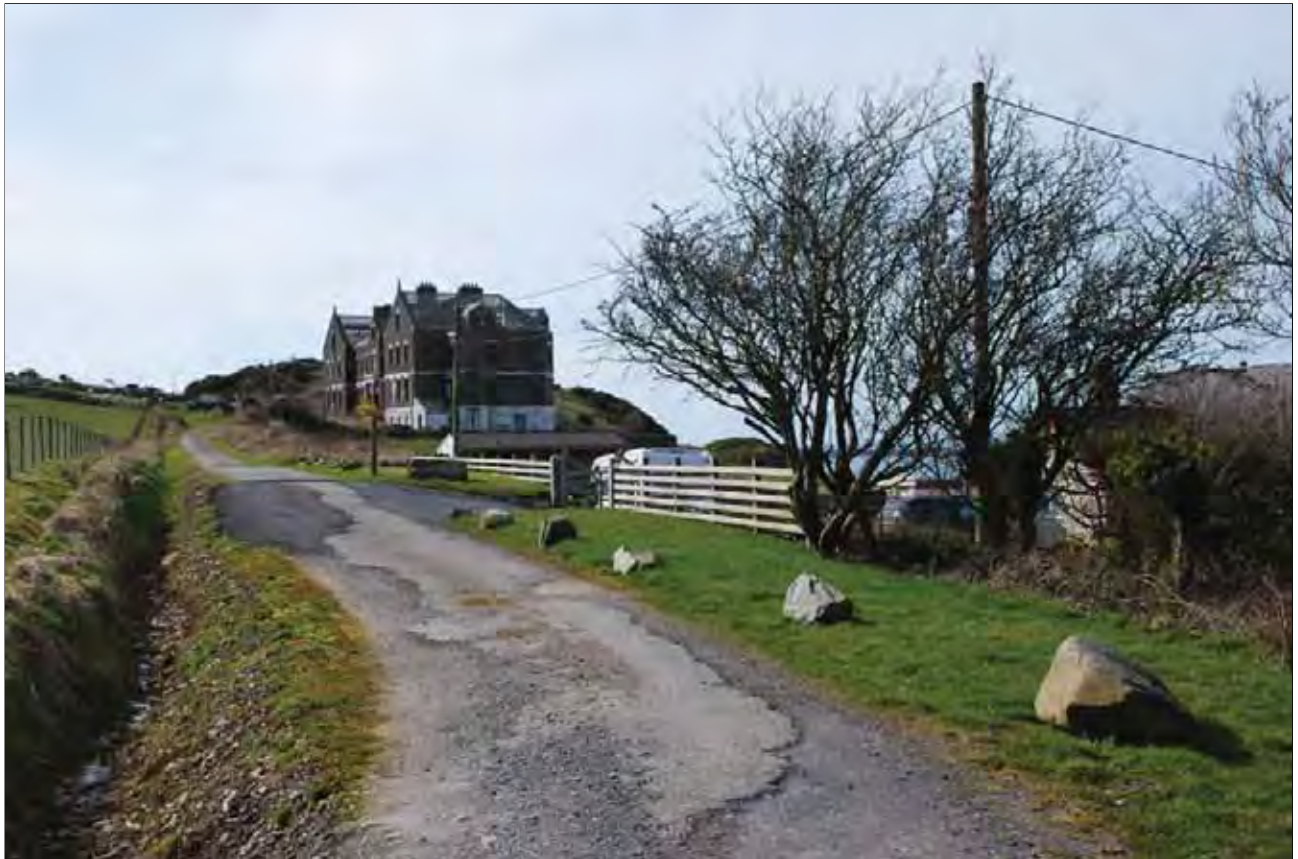
**Plate 2** View of Plas Pistyll along the track from the east

A three storey guest house, currently derelict, built in the years following 1898 by the Goddard family. A three storeyed building, with the eight principal rooms arranged off a central corridor. The first floor contained 15 bedrooms, two bathrooms, housemaid's closet and linen room. The second floor had six bedrooms and four store rooms. The building is centrally gabled on its north-west elevation and has bay windows at either end. The building has three gables on the south-east front. A number of original architectural details survive, including snecked granite columns around the entrance, finials to the gables, with four granite chimneys.

**Recommendations for mitigatory measures:** Basic Recording

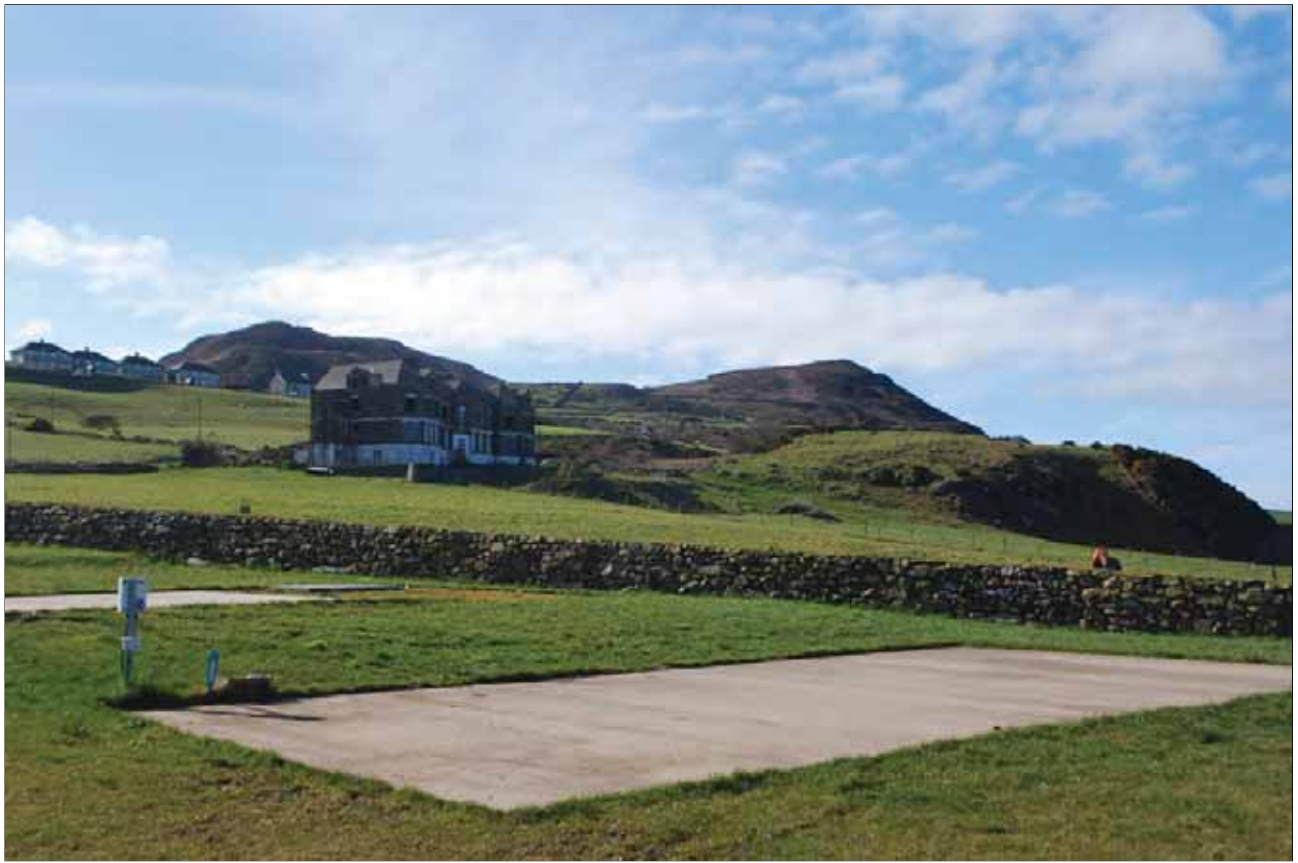
**Plate 3** Site of circles noted on aerial photograph, now developed (GAT HER 5217)

Circular features were noted at this location on aerial photographs. They are likely to have been completely destroyed when the area was improved for concrete or chalet bases, and there is nothing visible on the ground.

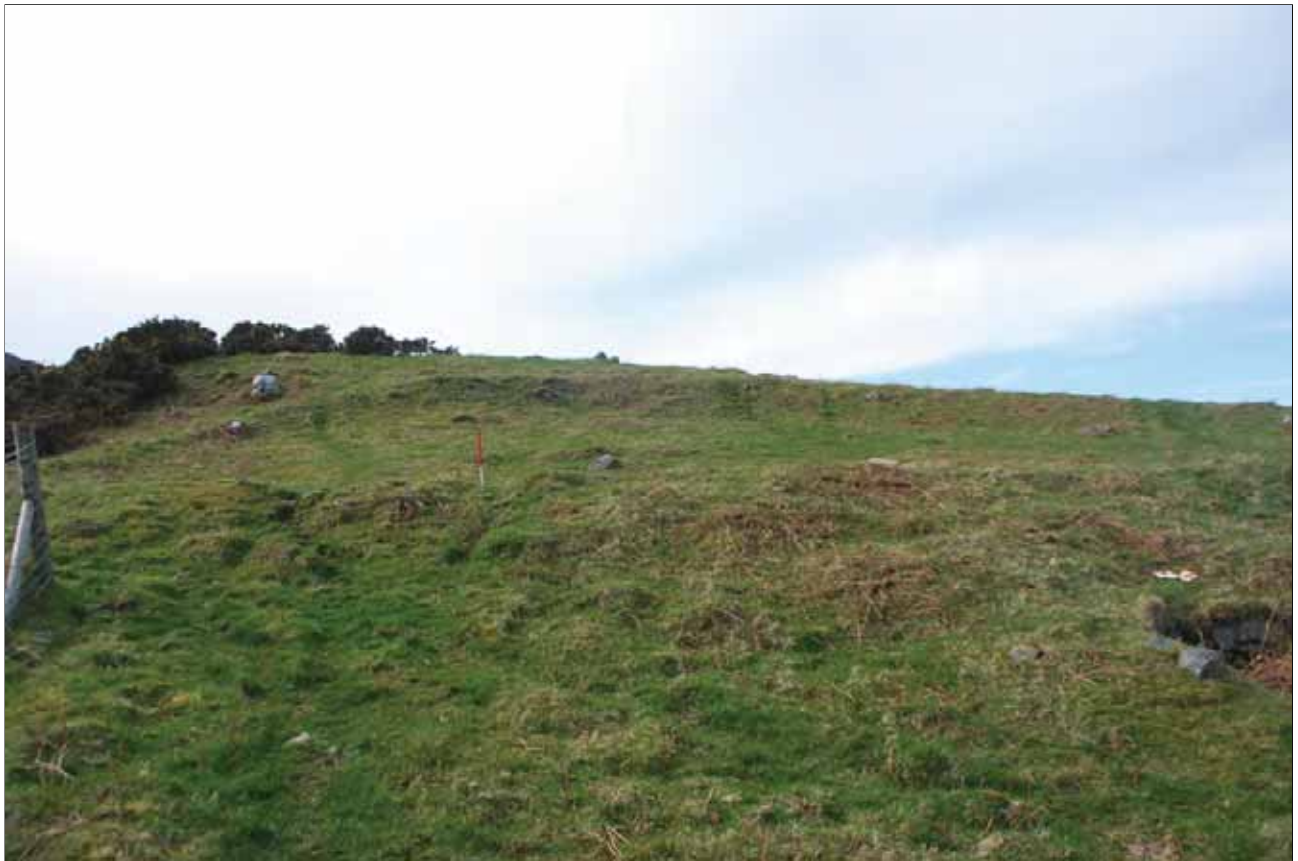
**Plate 7** The prehistoric enclosure (Feature 2) from the east, with the scale on the east rampart. Scale 1m

A 30m by 24m sub rectangular enclosure south-west of Plas Pistyll, with apparent stone ramparts, exposed through the turf covering about 1.2m wide and 0.5m high and with an apparent entrance to the north-west. It is located terraced into a north-east facing slope, and it appears that a hut platform is located on its western side (Plate 8), however is no surviving evidence of an enclosure ditch. It is best interpreted as a good example of a late prehistoric enclosed farmstead, of a type known throughout north-west Wales (Smith 1999). If this

interpretation is correct it can be considered of potential national importance. There is possibly fragmentary evidence of field systems associated with it.

**Recommendations for mitigatory measures:** The proposed development should be designed to avoid direct impact on the visible remains.

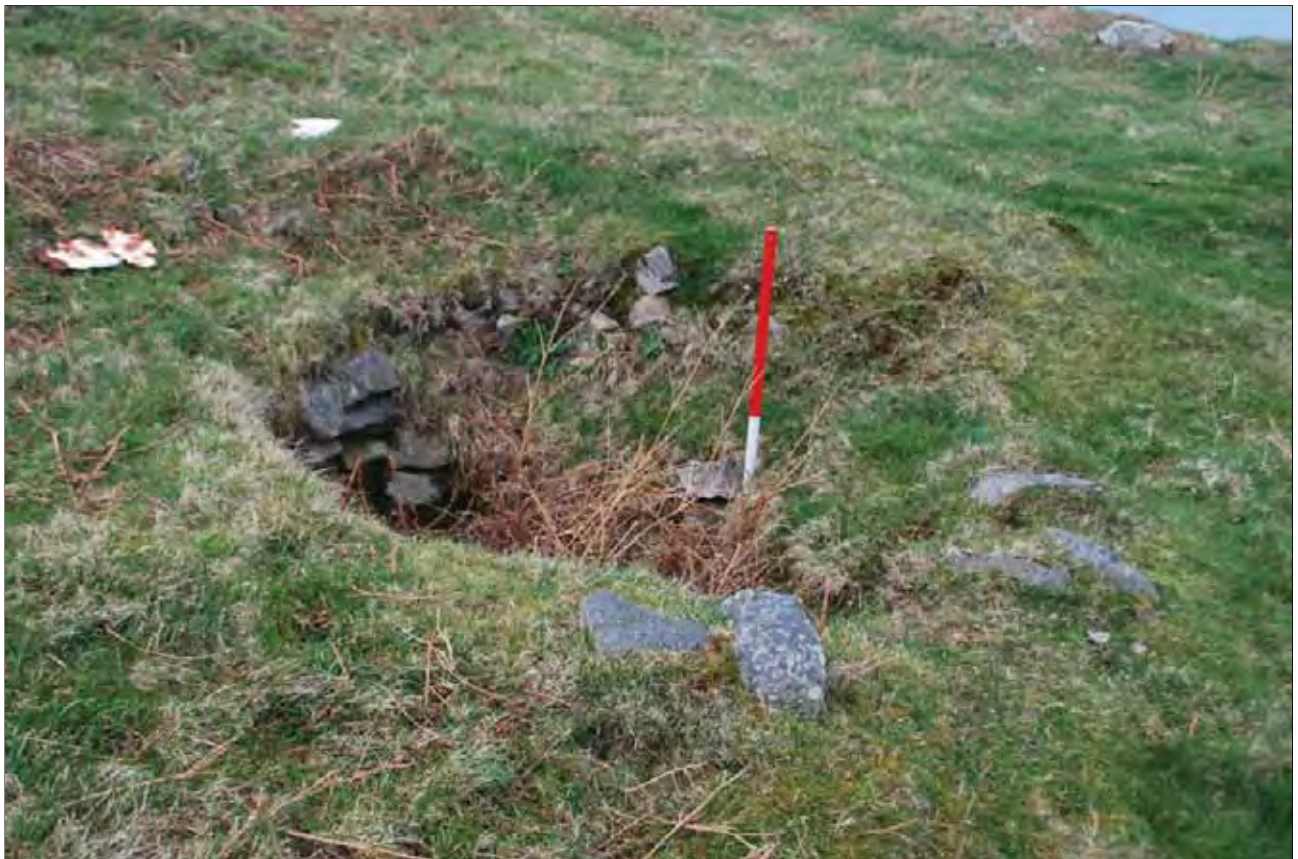
**Plate 8** The horseshoe shaped enclosure, a possible well (Feature 3), from the south east. Scale 1m

A small circular enclosure, forming a 'horseshoe' shape, about 2m in diameter, survives to a height of about 0.6m. It appears constructed of medium sized uncoursed rubble blocks, but it is hard to identify its purpose. It has been suggested that it may be a well (Hopewell pers. Comm.), but is currently completely filled in, and may be better interpreted as a corn drying kiln.

**Recommendations for mitigatory measures:** The proposed development should be designed to avoid direct impact on the visible remains.
