# **Plas Pistyll, Pistyll**

## Archaeological Assessment

Report No. 935

Prepared for  
Natural Retreats

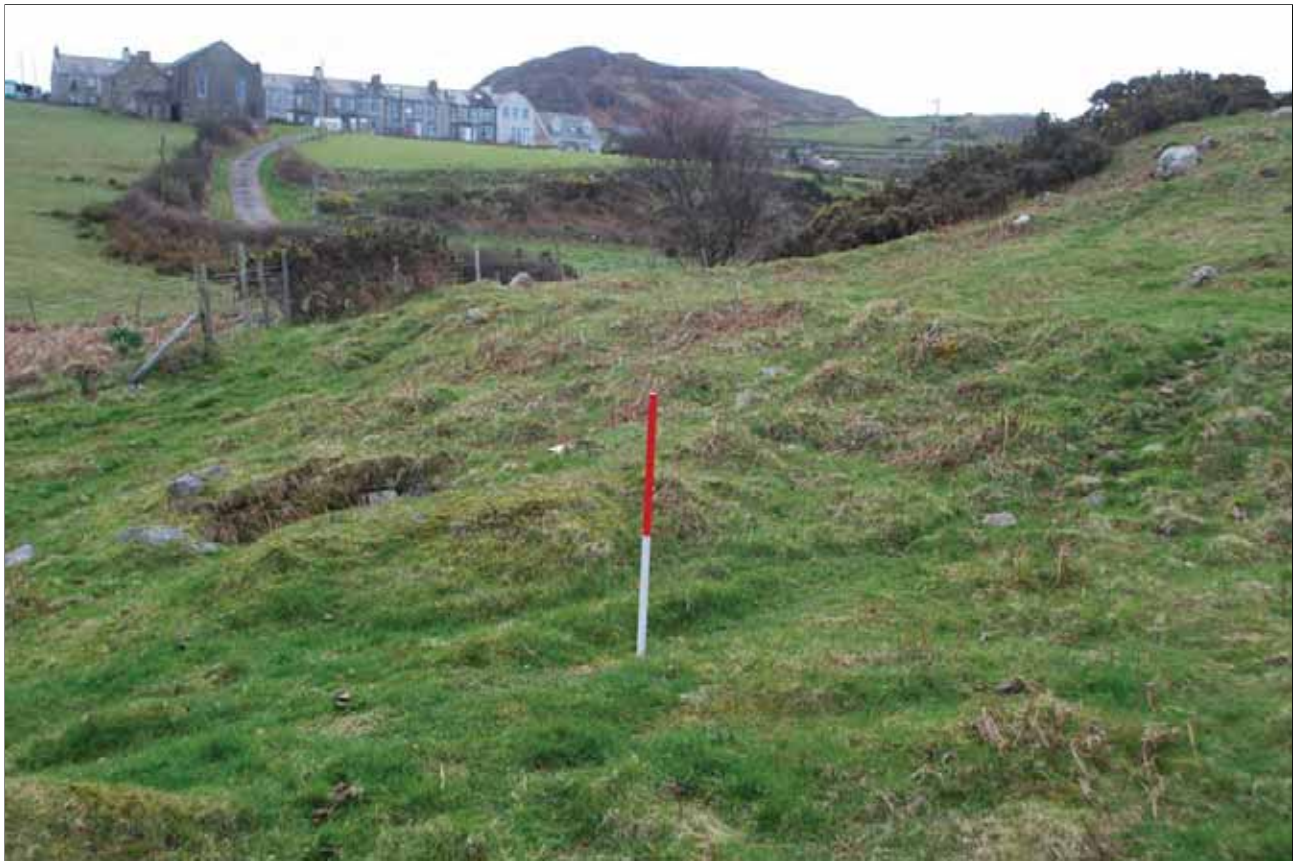
**Plate 9** The eastern rampart of Feature 2 and Feature 3 to the west of it looking south. Scale 1m

A 30m by 24m sub rectangular enclosure south-west of Plas Pistyll, with apparent stone ramparts, exposed through the turf covering about 1.2m wide and 0.5m high and with an apparent entrance to the north-west. It is located terraced into a north-east facing slope, and it appears that a hut platform is located on its western side (Plate 8), however is no surviving evidence of an enclosure ditch. It is best interpreted as a good example of a late prehistoric enclosed farmstead, of a type known throughout north-west Wales (Smith 1999). If this

A small circular enclosure, forming a 'horseshoe' shape, about 2m in diameter, survives to a height of about 0.6m. It appears constructed of medium sized uncoursed rubble blocks, but it is hard to identify its purpose. It has been suggested that it may be a well (Hopewell pers. Comm.), but is currently completely filled in, and may be better interpreted as a corn drying kiln.

**Recommendations for mitigatory measures:** The proposed development should be designed to avoid direct impact on the visible remains.
