# Cae Einion ISLAW'R-DREF, DOLGELLAU

## Archaeological Building Record

Project No. 2203

Report No. 969

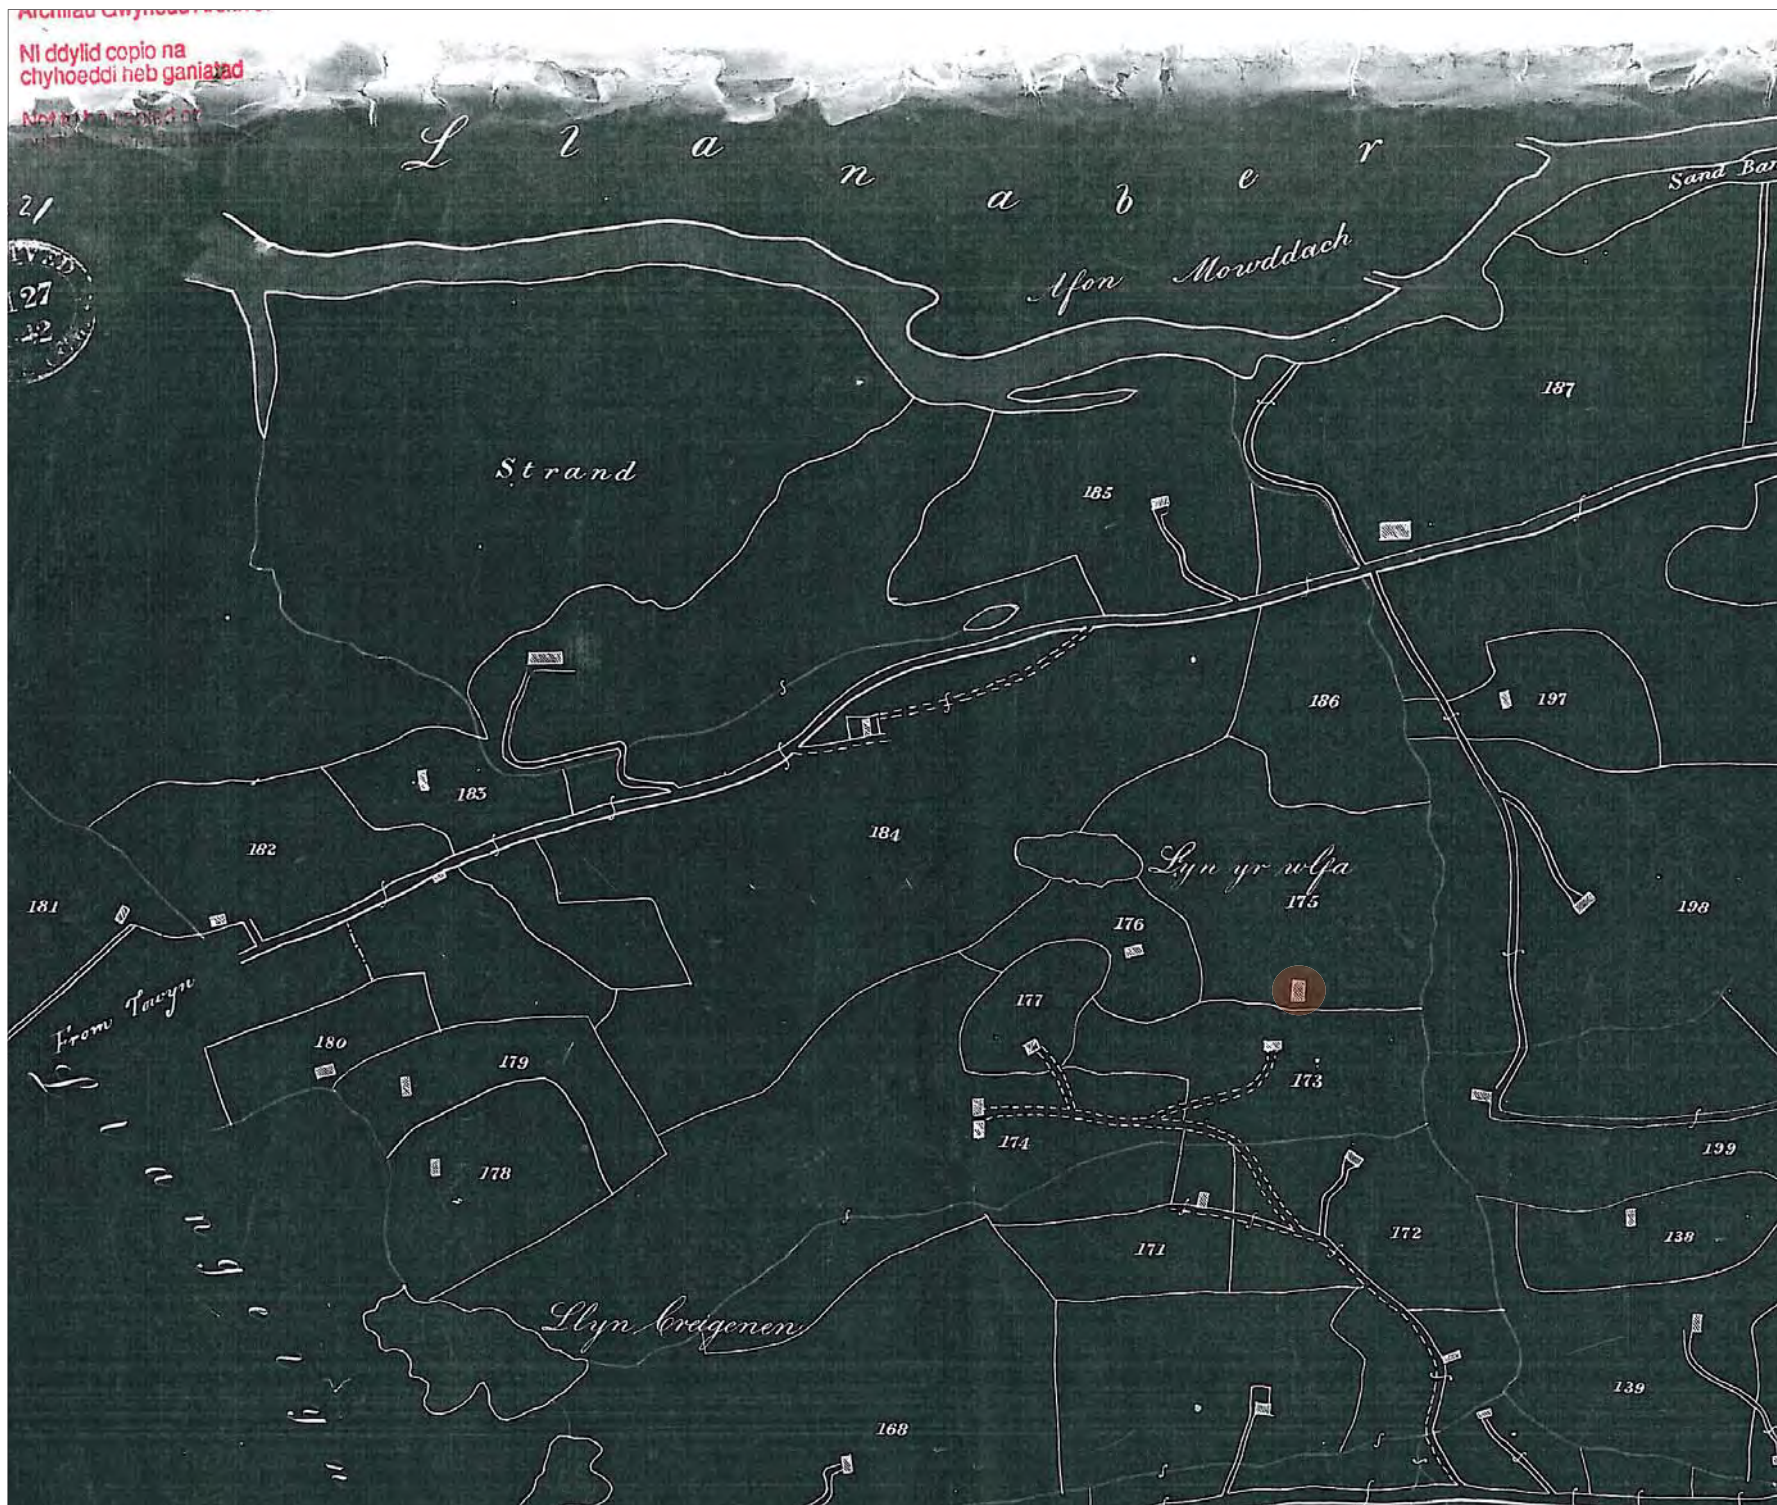
**Figure3: Cae Einion 1838  
 Tithe Map**

The cottage known as Cae Einion is first depicted cartographically on the tithe map of 1838 (see figure 3), with the tithe schedule listing the occupier as being a Richard Evans, with the land belonging to Hugh Jones Esq. Cae Einion is a Grade II listed late 17th or early 18th

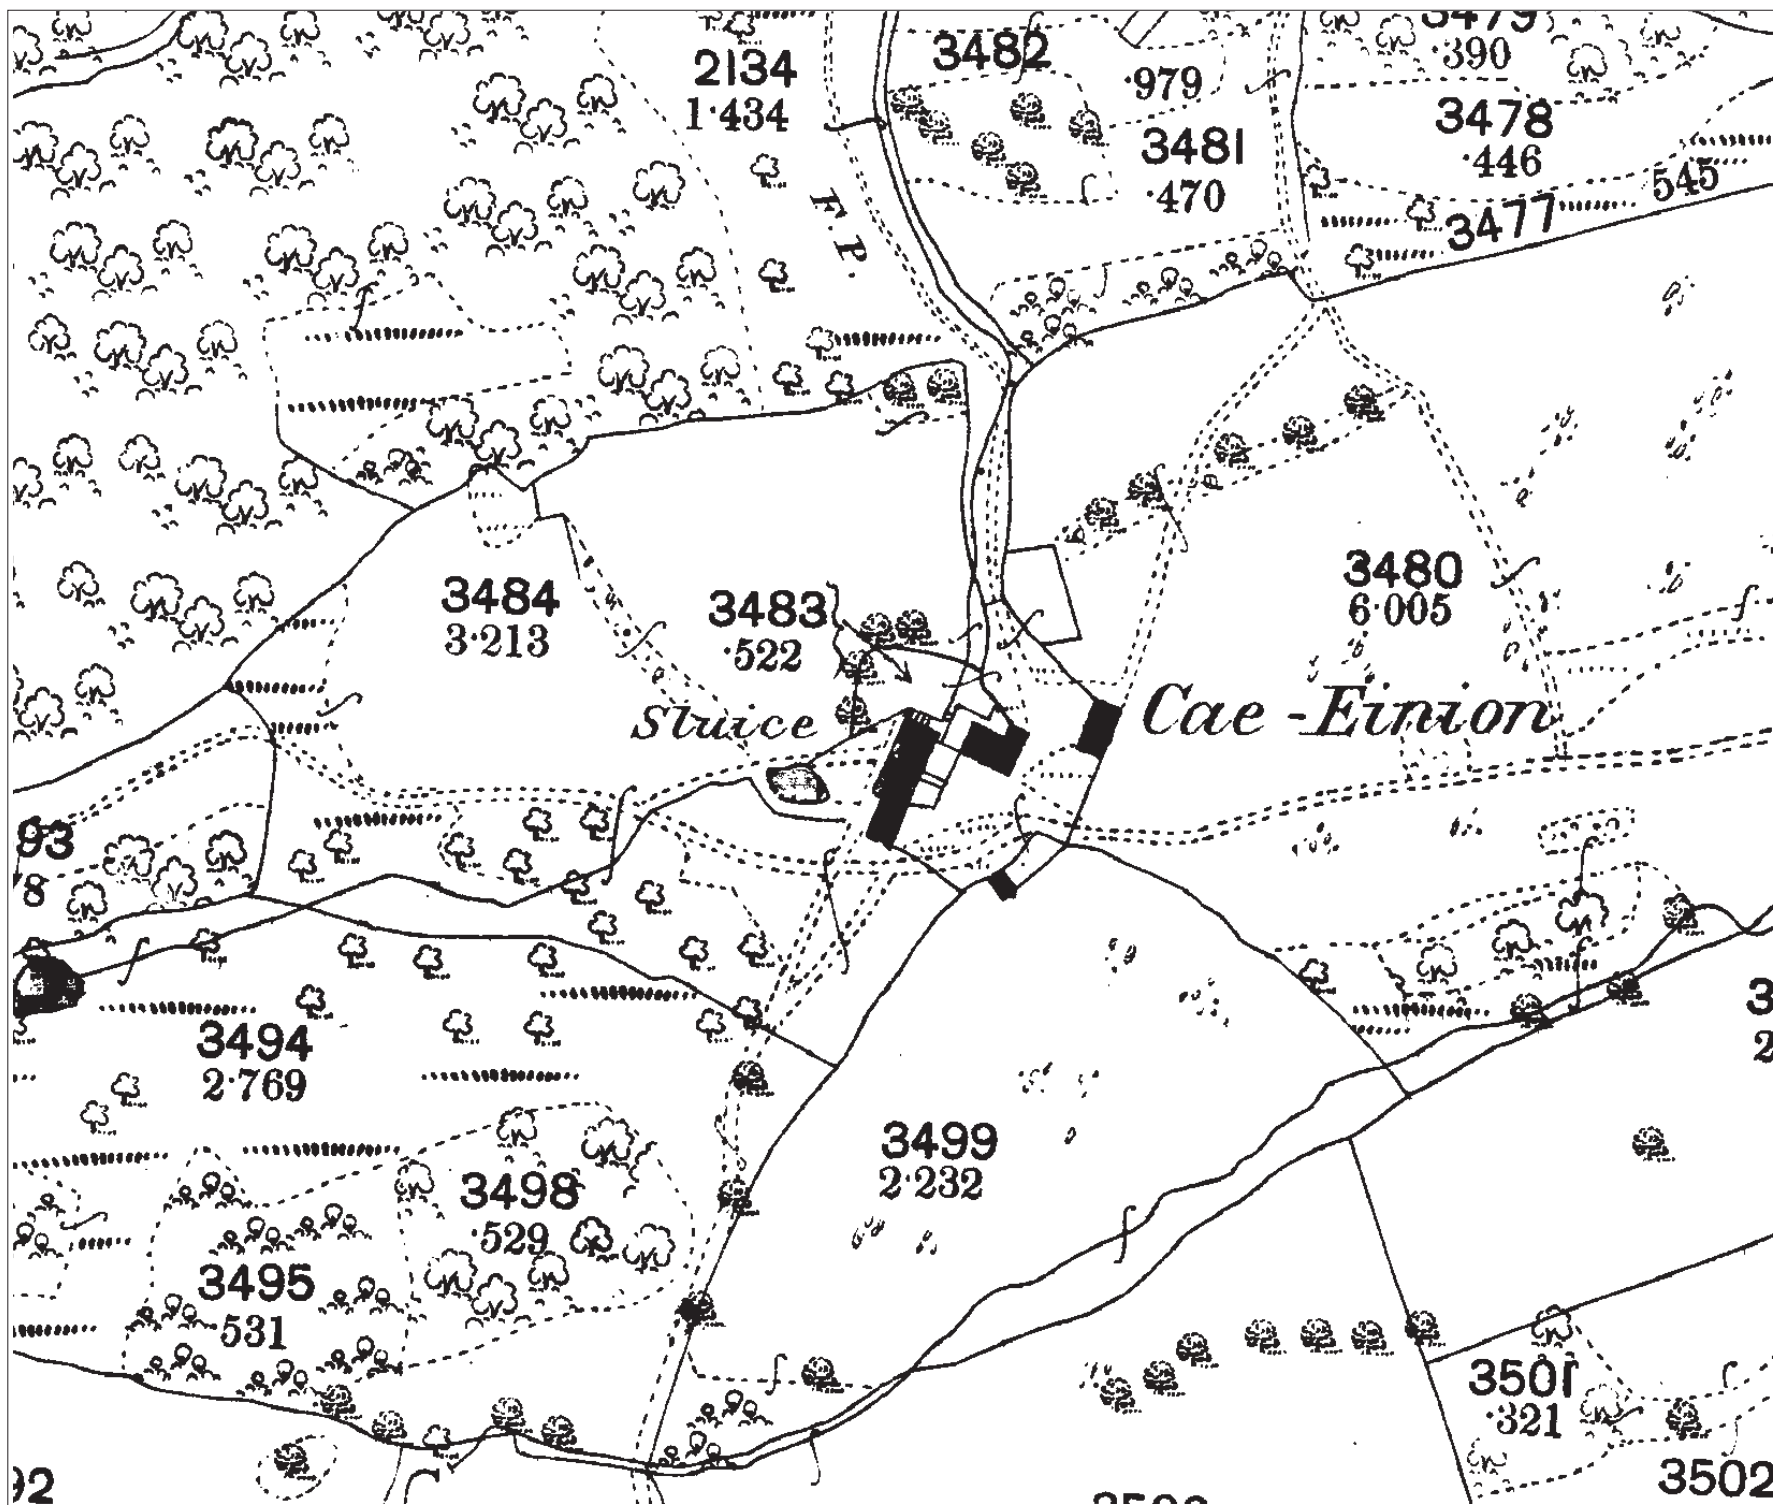
Figure 4: Cae Einion 1888  
OS Map

The 25" first edition 1888 Ordnance Survey map (see figure 4) depicts Cae Einion much as it exists today, with two large outbuildings and surrounded by trackways running through unenclosed fields. The OS map also depicts the former existence of an agricultural waterwheel on the north-eastern elevation of the cottage, and the area to the immediate west is labeled 'sluice'.

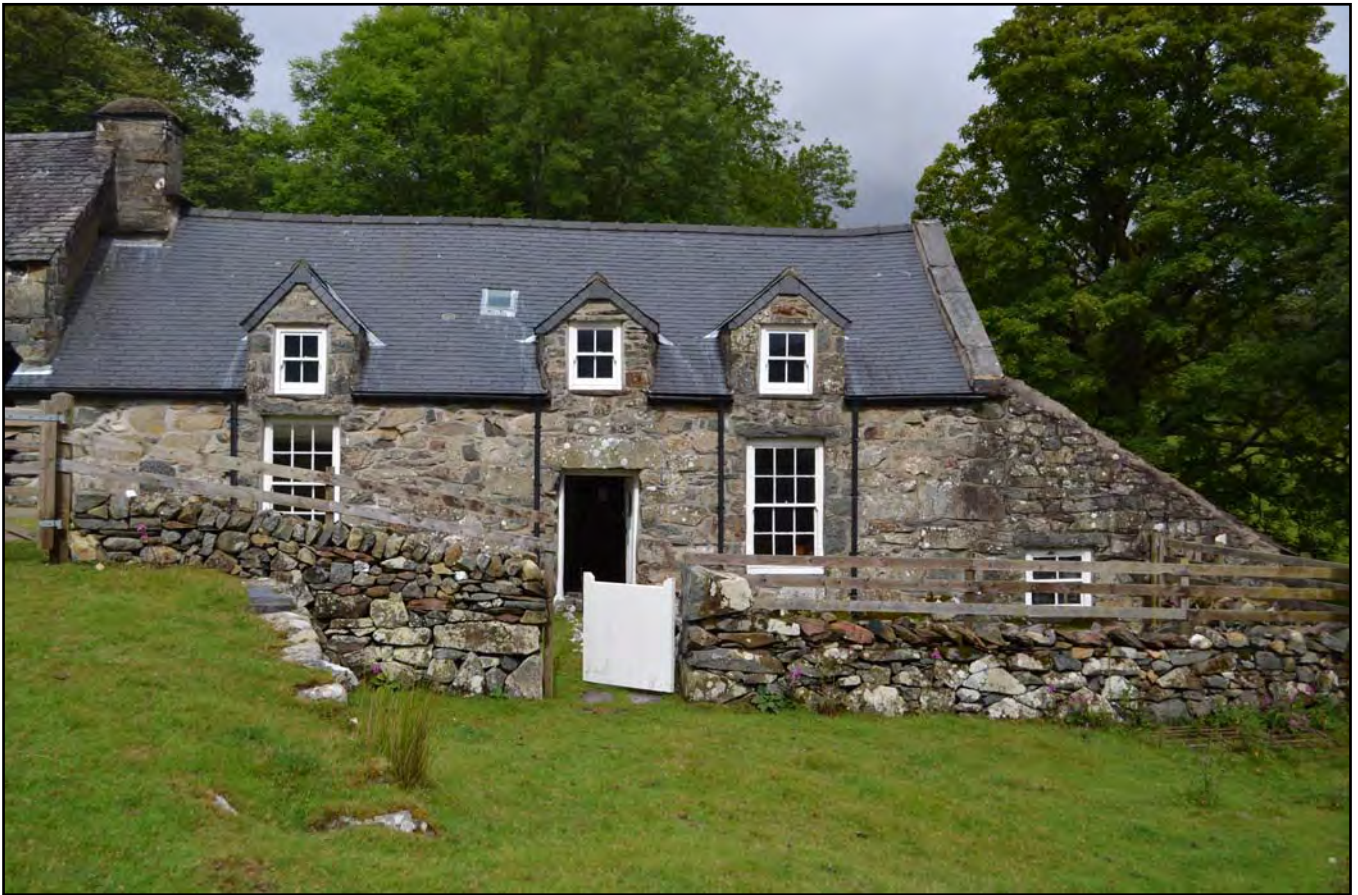
**Plate 1: Southeast facing external elevation**

The southeast elevation (plate 1) has three nineteenth century upstairs rubble gabled dormer windows, the west of which is slightly offset to the west. Each is a white painted, four-pane sash window with overlapping slate dormer heads, stone lintels and sills. Two white painted twelve pane recessed sash windows are aligned beneath the east and west upstairs dormer windows, again with stone lintels and sills. A stone lintel heads a pegged doorcase and a recessed, ribbed and boarded door with small glazed panel, aligned beneath the central upstairs dormer window.

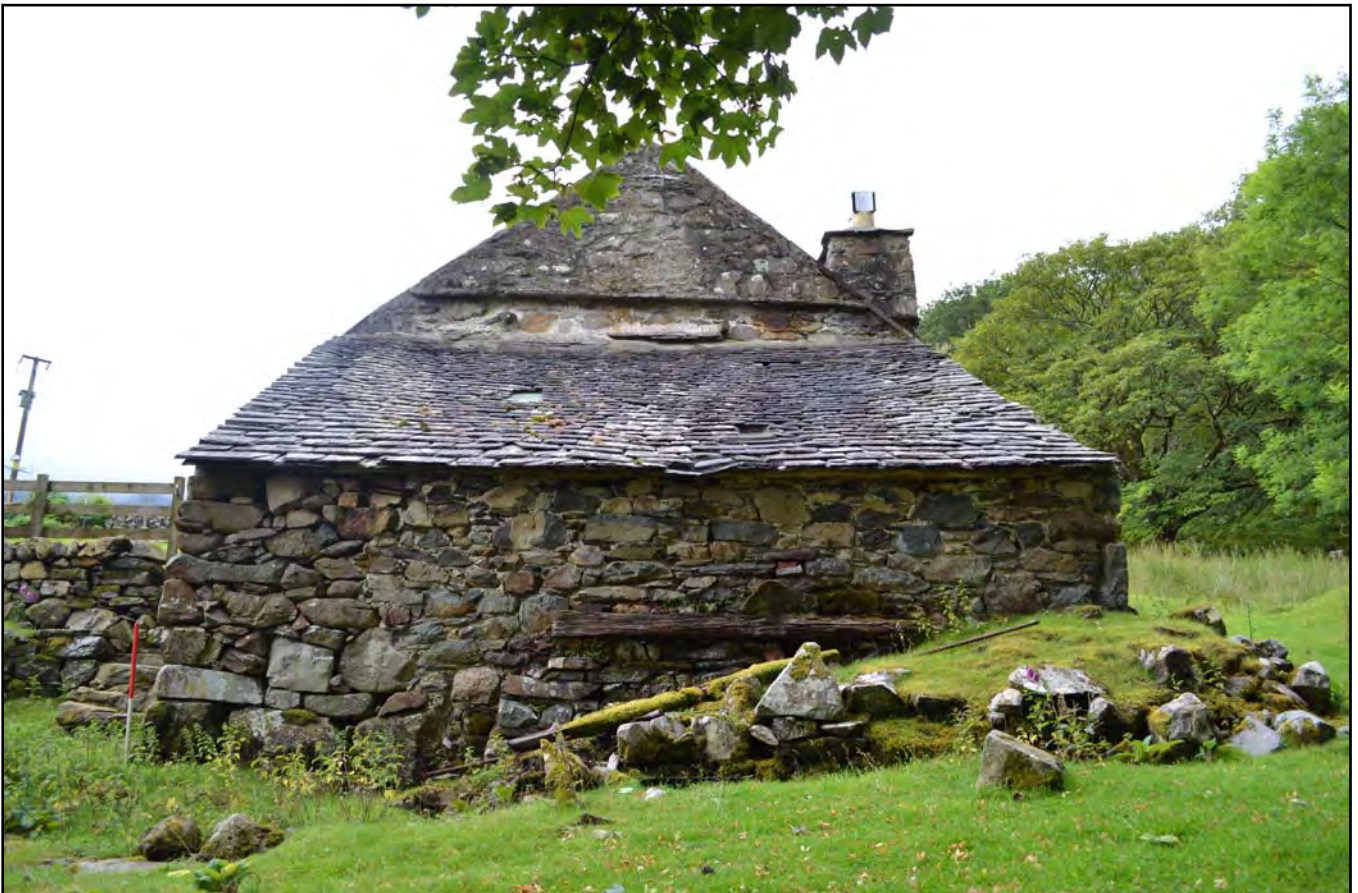
**Plate 2: Northeast external elevation showing waterwheel pit**

A rubble built lean-to extension is mortared on to the north-eastern gable (plate 2). The structure is roofed in blue-grey slate with two small roof-lights. The remains of a rubble built agricultural overshot waterwheel housing is located to the immediate northeast of the lean-to, driven by a sluice and race which tapped a nearby stream to the west.

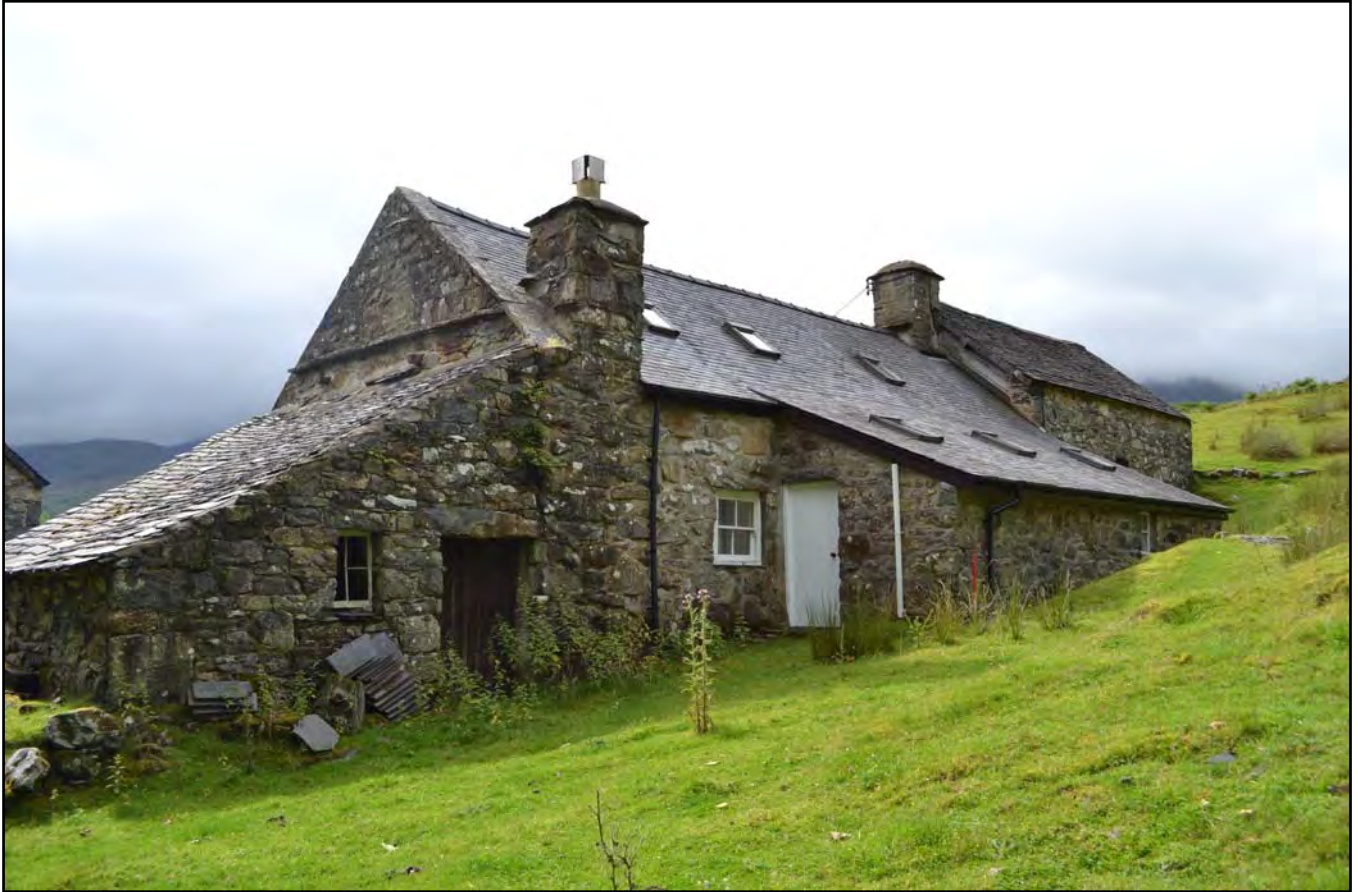
**Plate 3: Northwest facing external elevation**

The northwest elevation (plate 3) has a single nineteenth century, white painted four pane sash window with stone lintel and sill. A slightly less coarse, rubble built extension is bonded by mortar on to the northwest face of the cottage. A single nineteenth century, white painted two pane window with stone lintel and sill is located within the north-western elevation of the extension, and a white painted boarded door with stone lintel provides access through the northeast elevation of the extension.

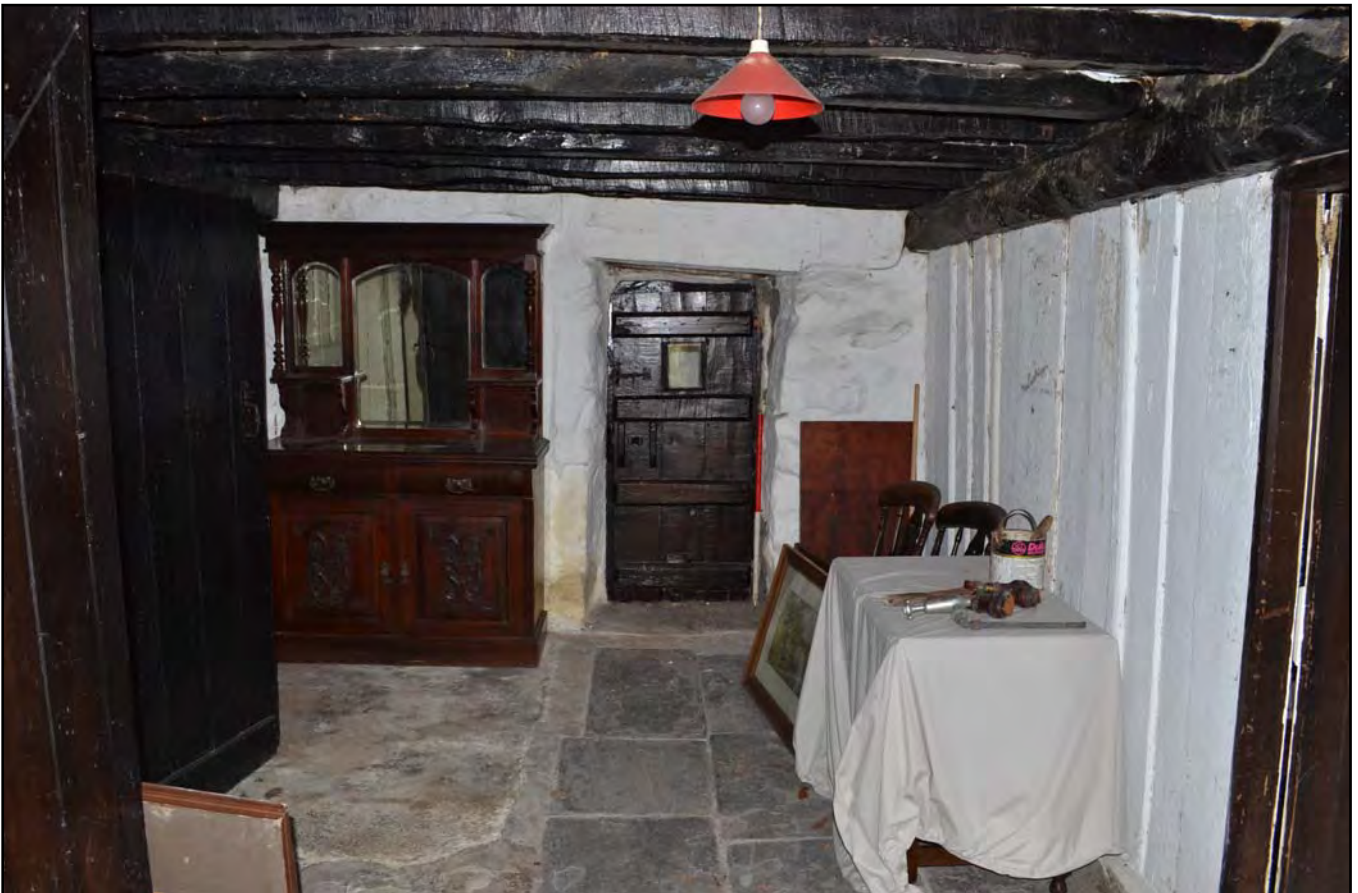
**Plate 4: Hallway from the southeast**

The southeast entrance gives way to a rectangular hallway (plate 4) measuring 6.0m by 3.0m, orientated northwest to southeast. The room is separated from the living room to the northeast and dining room to the southwest by two large roughly chamfered main beams with run-out stops, and connected by thinner rough split wooden beams. The upstairs floorboards are visible between, and are painted white. The internal partitions separating the living room and dining room are of post-and-panel screens, painted white and forming a cross-passage to an opposing entrance, and the original rear door to the cottage prior to the construction of the north-western extension. The door is a dark brown painted pegged doorcase with a recessed, ribbed and boarded door with small glazed panel. A part boarded nineteenth century stair with plain newels and stick balusters in the southern corner permits access to the upper level. The floor is of large slate slabs, and an area of concrete some 2.50m by 1.50m located in the western corner may suggest an earlier internal division.

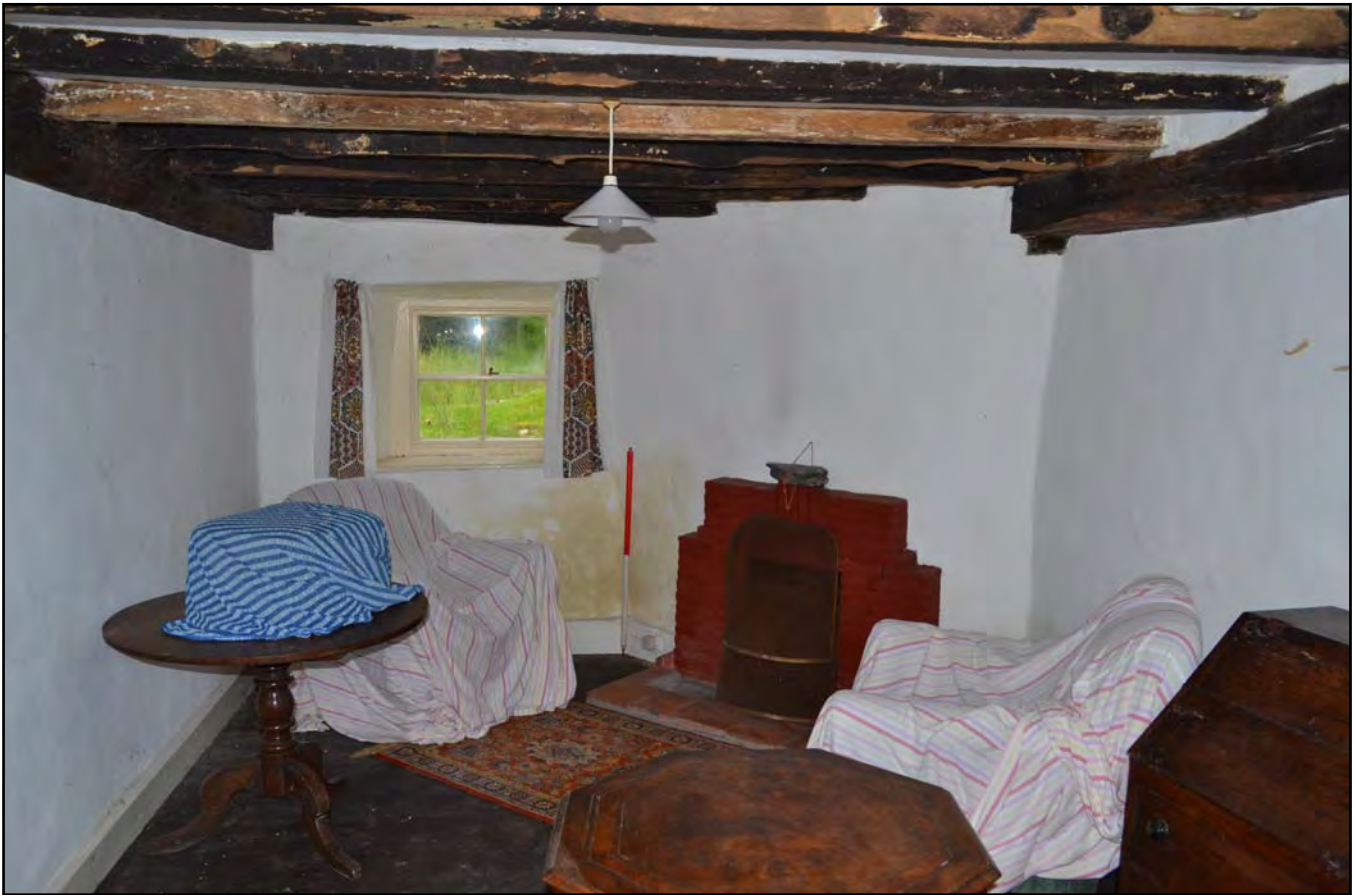
Plate 5: Parlour from the southeast

The parlour (plate 5) is located to the northeast of the hallway. The room is rectangular in shape, measuring 6.0m by 3.0m orientated on a northwest to southeast axis. The room is separated from the hallway to the southwest by a large wooden beam, with a second beam marking the external wall. These are connected by roughly split beams, with a white painted plastered ceiling. There is white painted plaster on all walls, with a four pane sash window in the northwest elevation and a twelve pane recessed sash window in the southeast. A fireplace is located on the northern corner wall, with a red brick and slate surround. The floor is of fairly narrow wooden boards.

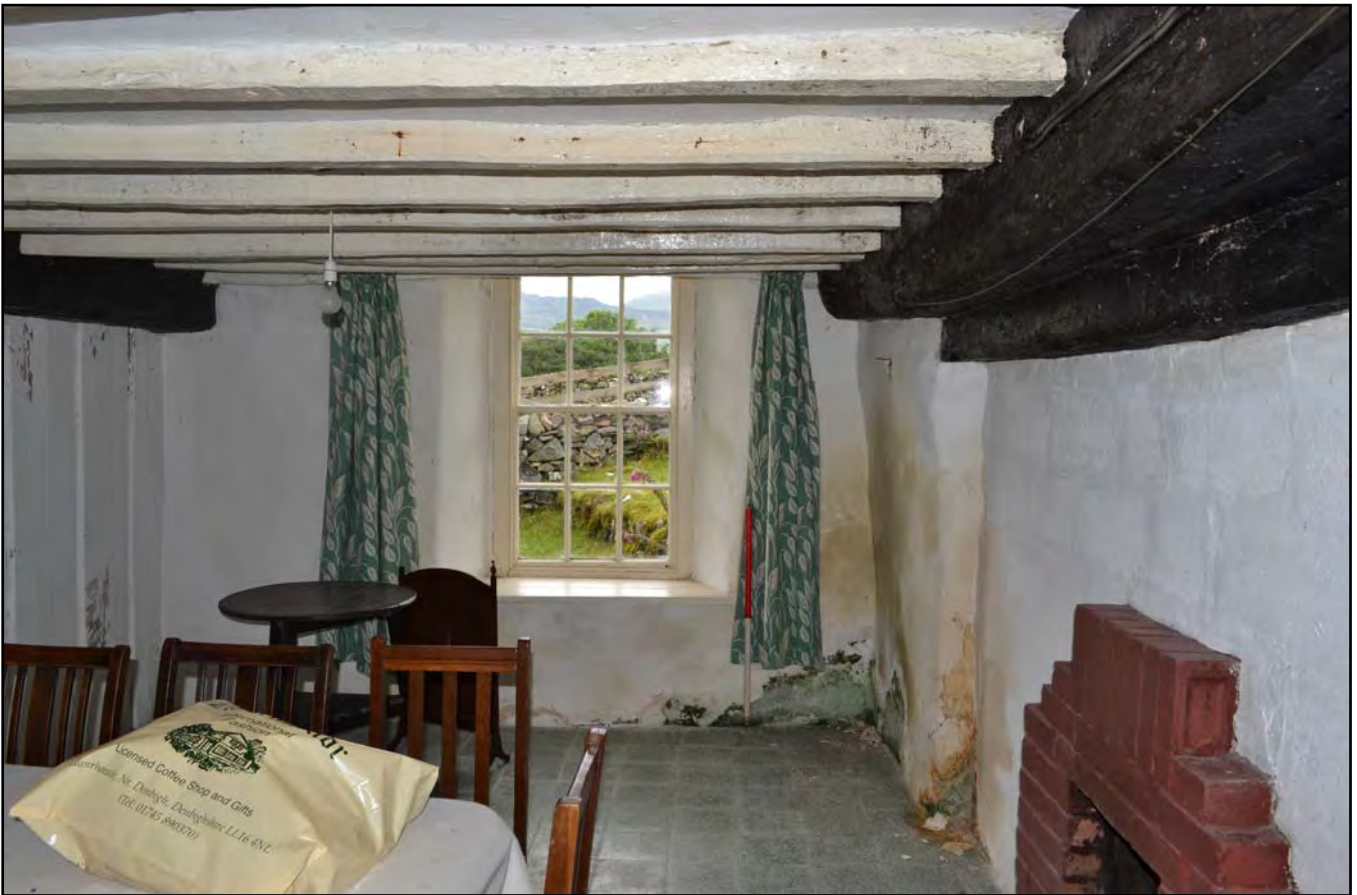
Plate 6: Former Hall from the northwest

The former hall/dining room (plate 6) is located to the southwest of the hallway, and is a rectangular room measuring 6.0m by 3.50m orientated on a northwest to southeast axis. The room is separated from the hallway to the northeast by a large wooden beam, with a second beam spanning the length of the southwest gable wall. The two beams are connected by roughly split beams, with the ceiling plastered and painted white. A second large wooden beam sits beneath the structural gable wall beam, and spans area some 3.0m in length marking the start of the inglenook fireplace which is currently blocked with breeze-blocks. An open fire is set into the blocked inglenook wall, with a red brick and tile surround. The south-eastern elevation has a twelve pane recessed sash window, and along with the southwest and northwest walls is of white painted, coarse rubble. Access is permitted through the north-western elevation into the later kitchen extension via a wooden board door. The floor is of speckled blue and grey terrazzo. It is probable that prior to the construction of the northwest extension to the cottage that this room functioned as the principle room, with meals being prepared and cooked on the large inglenook fireplace.

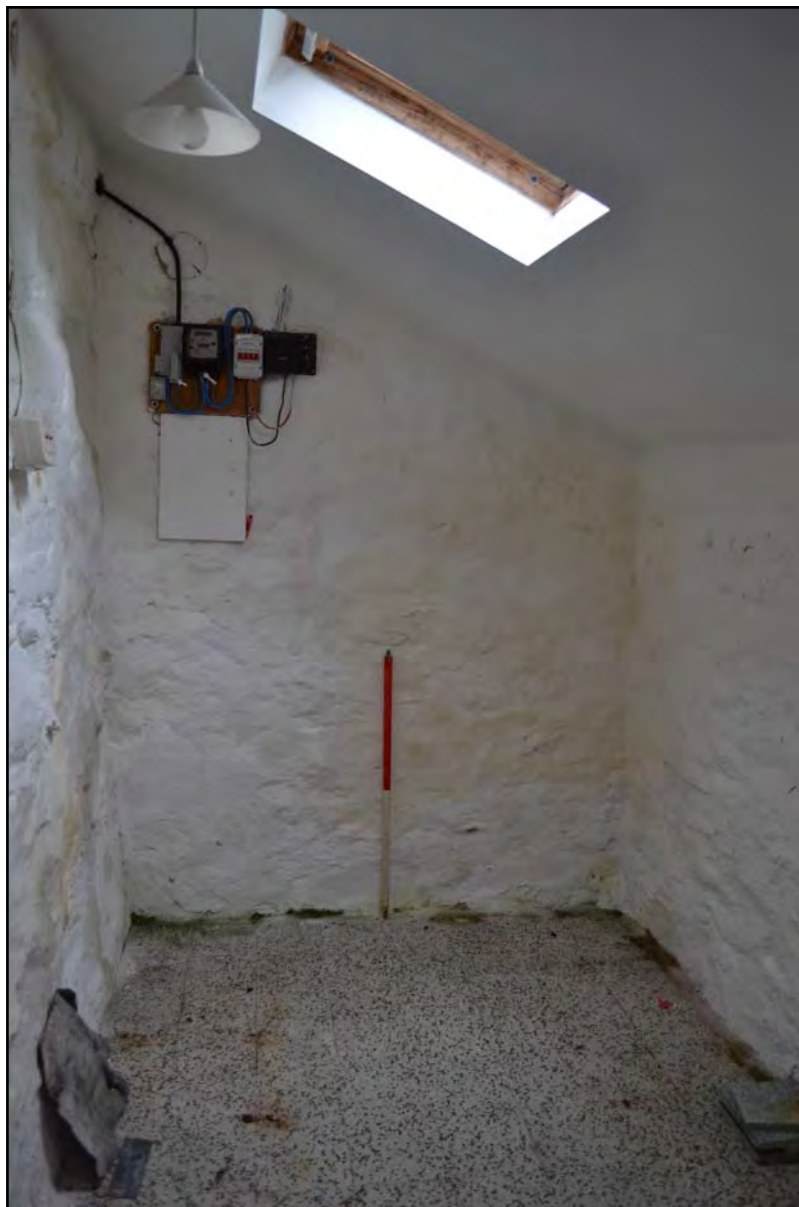
**Plate 7: Kitchen from the southwest**

The northwest extension to the cottage is accessed via the former hall, and served as a kitchen (plate 7) to the house once constructed. The room is rectangular and measures 3.0m by 2.0m orientated on a northeast to southwest axis. The ceiling slopes to the exterior wall to the northwest, is plastered and has a single inserted roof-light. The south-eastern, and originally external cottage wall, as well as the northwest and southwest elevations are all white painted plaster over coarse rubble. The kitchen is separated from a bathroom to the northeast by a white painted stud wall, with access through a green painted wood boarded door. A white painted two pane window is located on the northeast side of the northwest elevation, beneath which sits a white ceramic square sink, resting on a white painted brick plinth. The floor is of black and white terrazzo.

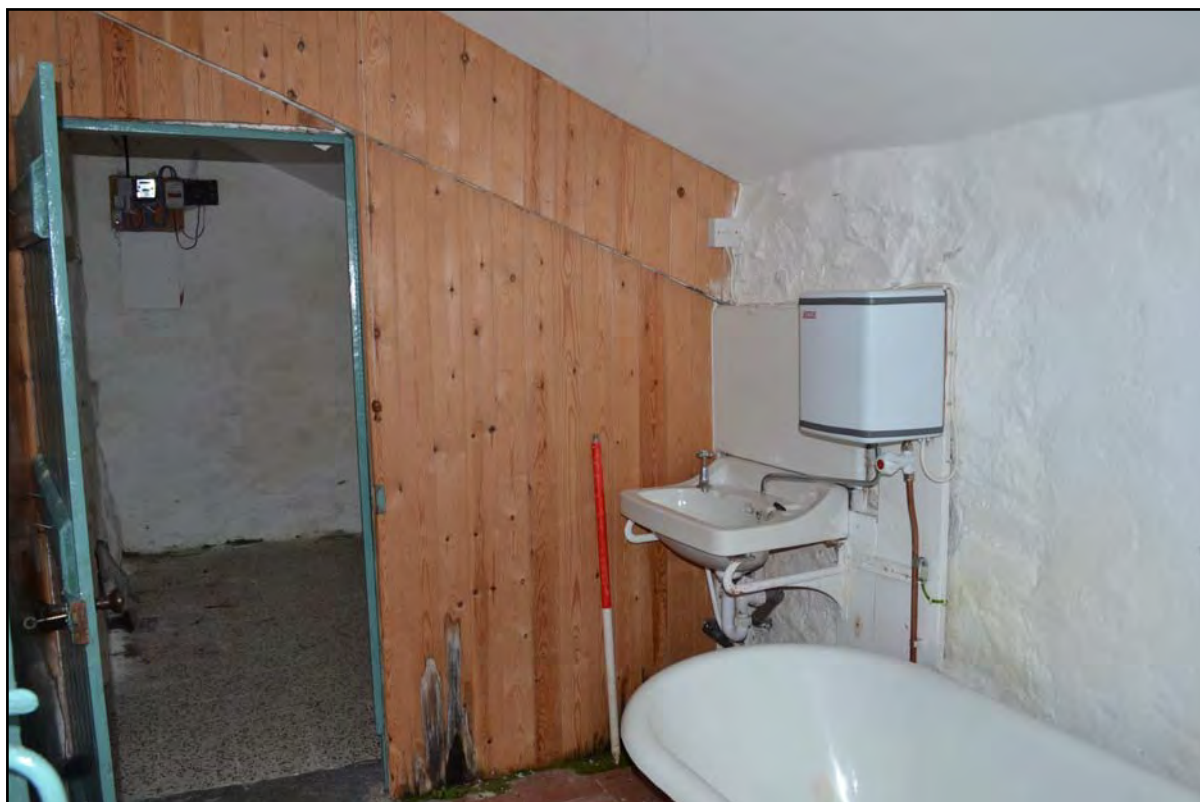
**Plate 8: Bathroom from the east**

The bathroom (plate 8) is located to the northeast of the kitchen, and is a rectangular room measuring 2.50m by 2.0m orientated southwest to northeast. The ceiling slopes to the exterior wall to the northwest, is plastered and has a single inserted roof-light. The south-eastern, and originally external cottage wall, is of plastered and white painted coarse rubble, while the

northwest and northeast elevations are of a smooth white painted plaster, covering the coarse rubble wall. The southwest elevation is a stud wall, while the northeast elevation gives access via a green painted wood boarded door to a small hallway. A white ceramic stand-alone bathtub stands against the northwest wall, as does a wall mounted white ceramic sink with electric water heater. The floor is of red-orange terracotta tile.

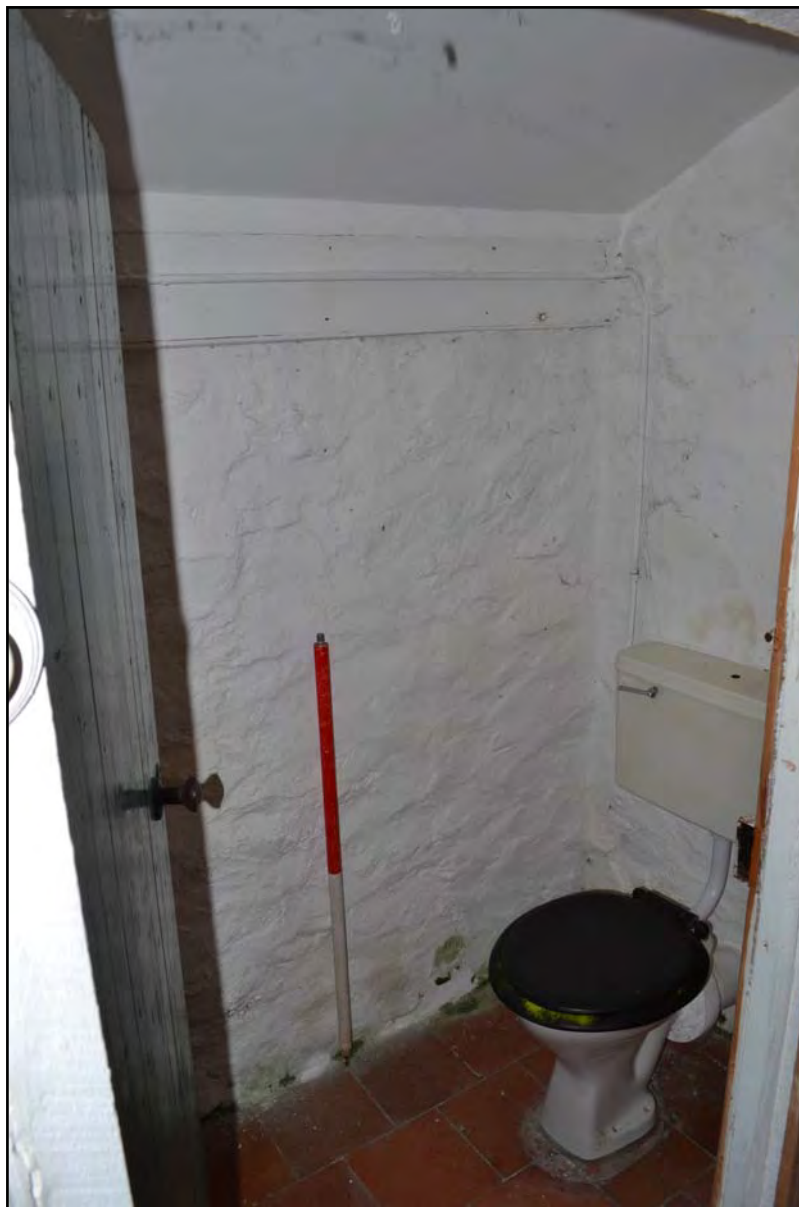
**Plate 9: Toilet from the south**

A toilet (plate 9) and small hallway occupies the northeast part of the cottage extension. The room measures 2.0m by 2.0m, with a plastered and white painted ceiling sloping towards the northwest elevation. An inserted roof-light is shared by the hallway and toilet, which are divided by a stud wall. All elevations are of a white painted coarse rubble, and a white painted wood boarded door gives access through the northeast elevation to the rear of the cottage. A white ceramic toilet with plastic cistern and black metal toilet seat is attached to the northeast elevation. The floor is of red-orange terracotta tile.

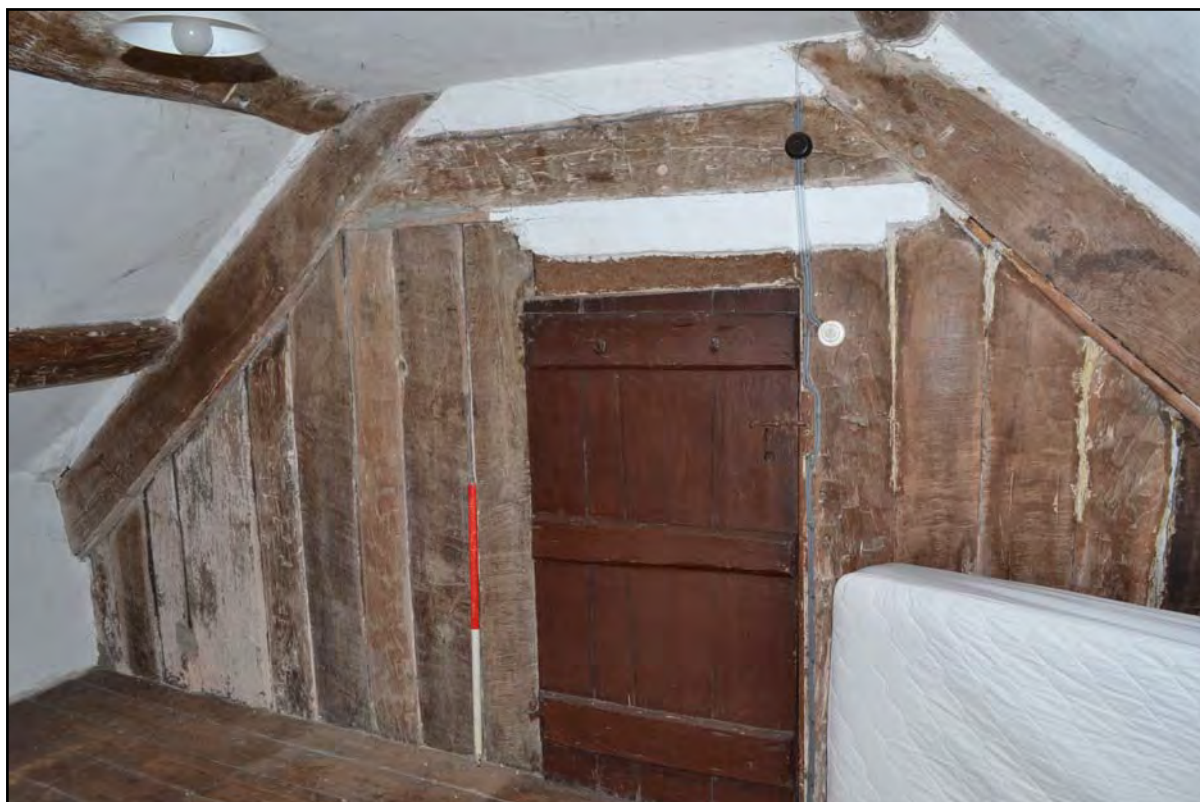
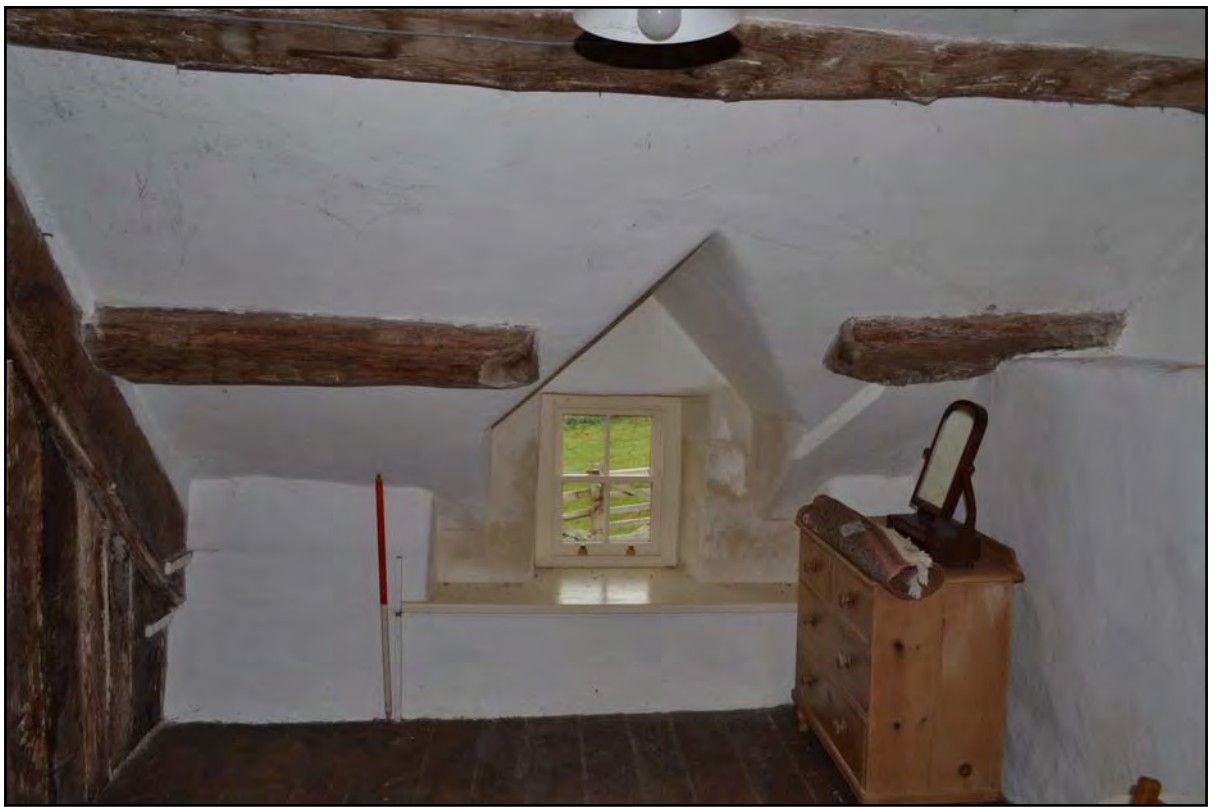
A large bedroom (Br1) (plate 10 and 11) occupies the upstairs southwest part of the cottage. It is a rectangular room set in the eaves, with four visible large split chamfered through-purlins, connecting the southwest gable with a partially visible, collar-beam truss with pegged mortise and tenon collars. The ceiling is plastered and painted white, and a single roof-light has been inserted in the northwest pitch. The southwest gable, northwest and southeast elevations are all of white painted plaster, with a gable dormer four pane sash window set in the southeast wall. The northeast elevation is boarded, with access to the upstairs landing via a dark brown painted pegged wood boarded door. The floor is of wooden boards.

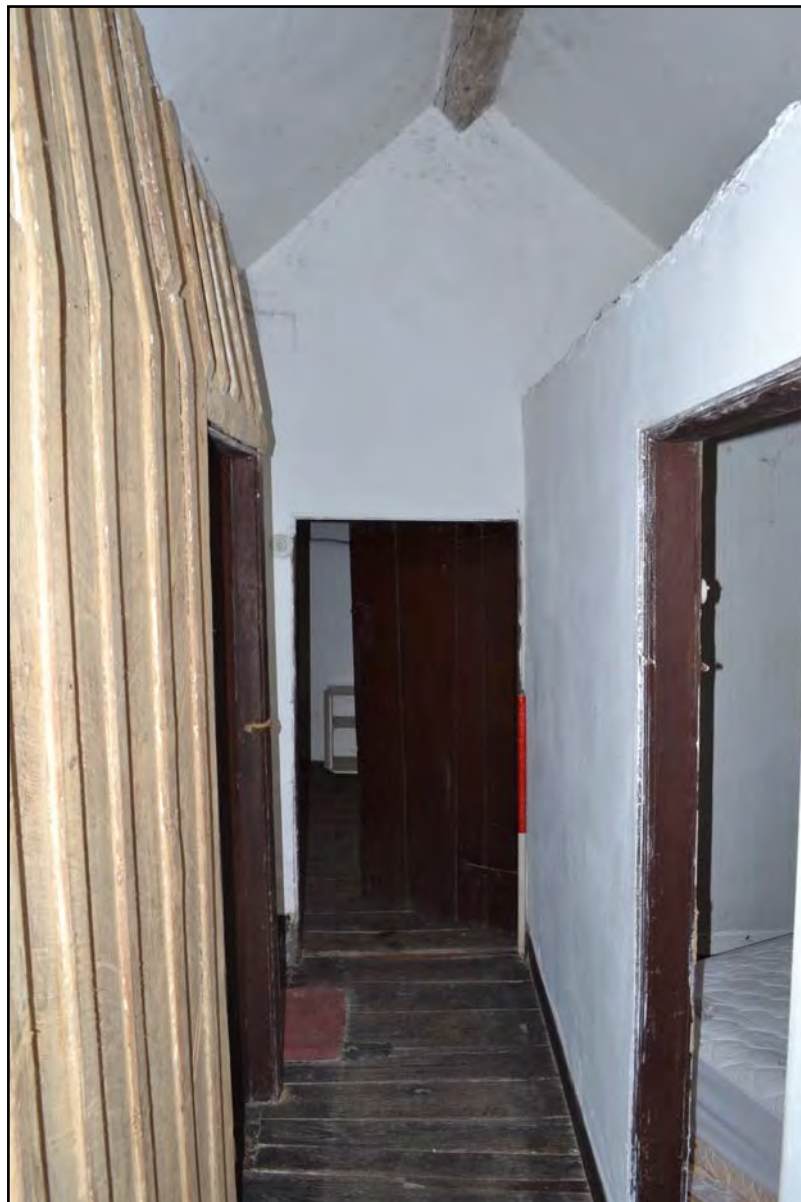
**Plate 12: Upstairs landing from the southwest**

The landing (plate 12) measures 4.0m by 1.0m orientated southwest to northeast, and has four through-purlins visible as well as a central ridge-piece. The ceiling is plastered and painted white, with a single inserted roof-light above the staircase. Thin stud partition walls to the northwest and southeast create two small bedrooms and a conventional cross-passage landing, in what would have been an open space in the eaves. Both rooms are accessed via dark brown painted wood boarded doors. The southeast bedroom (Br2) (plate 13) is quite small, measuring only 2.0m by 2.0m with the ceiling sloping to the southeast. A single chamfered through-purlin is visible, and the ceiling is plastered and painted white. The walls are plastered and painted white, and a four pane gable dormer sash window is in the southeast wall. The northwest (Br3) (plate 14) bedroom is rectangular in shape and measures 2.0m by 3.0m orientated southwest to northeast. The ceiling slopes down towards the northwest elevation and is plastered and painted white with a single inserted roof-light. A single chamfered through-purlin is visible but has been plastered and painted. The walls have been papered in light blue and white striped paper, with earlier floral patterns visible where parts have been stripped away. The floor is of wooden boards.

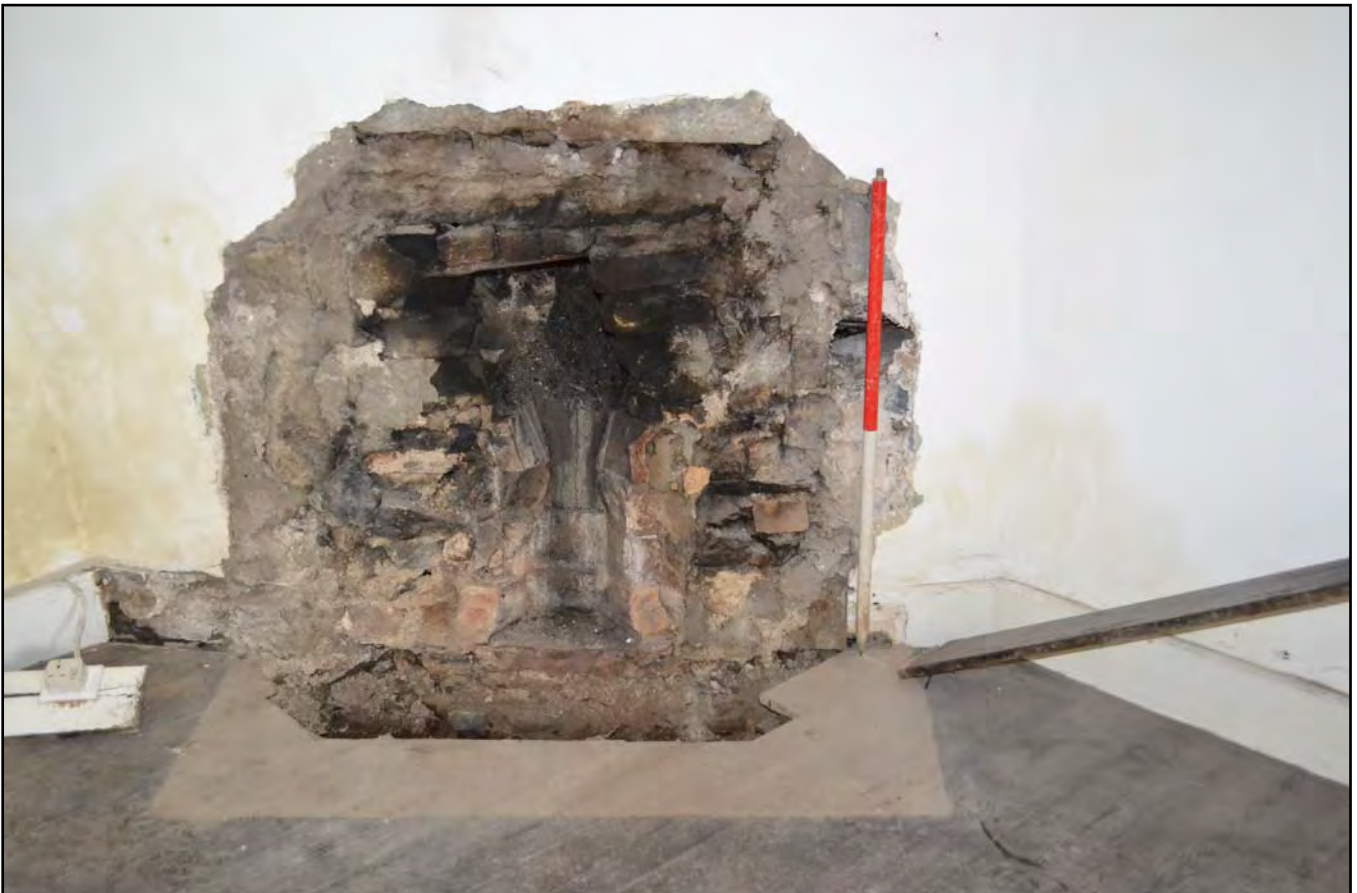
**Plate 18: Parlour fireplace removed, from the south**

The parlour fireplace (plate 18) had been removed revealing the flue. It was constructed from red-brick bonded on to the rubble stonework with an orange-grey mortar. Occasional red-brick repairs could be seen within the rubble wall where the plaster had been removed. The floorboards had also been lifted in places, revealing an earth and rubble floor.
