# Cae Einion ISLAW'R-DREF, DOLGELLAU

## Archaeological Building Record

Project No. 2203

Report No. 969

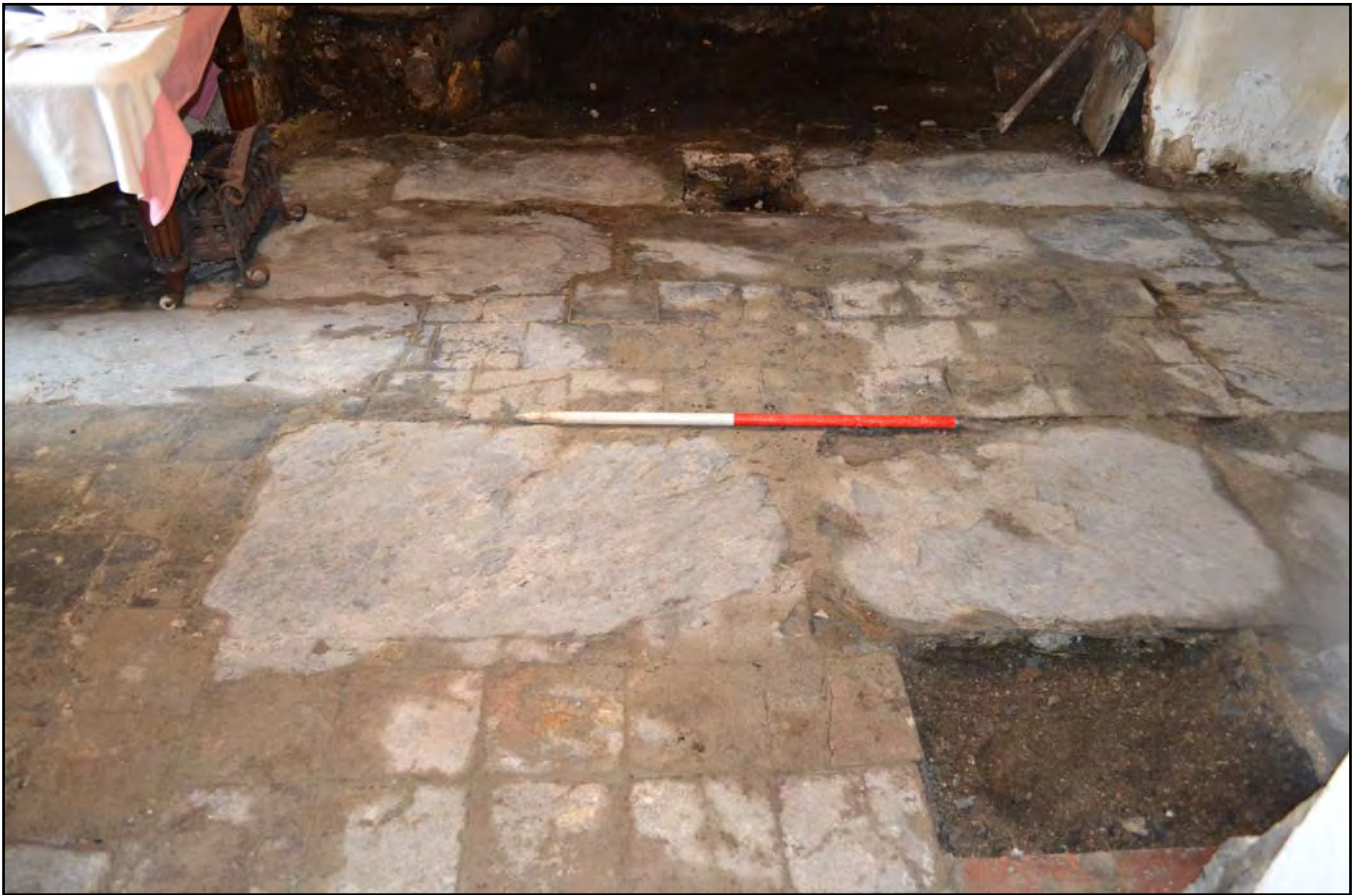
**Plate 19: Former Hall floor revealed, from the southeast**

In the former hall the terrazzo floor had been lifted (plate 19) revealing an uneven surface comprised from large and small slate slabs, and occasional small ceramic, red floor tiles with no clear arrangement. The slates and tiles rested upon a 0.07m thick layer of crushed slate, beneath which was bare earth. It appears likely that the floor surface is the original, and contemporary with the slate slabs found in the hallway.

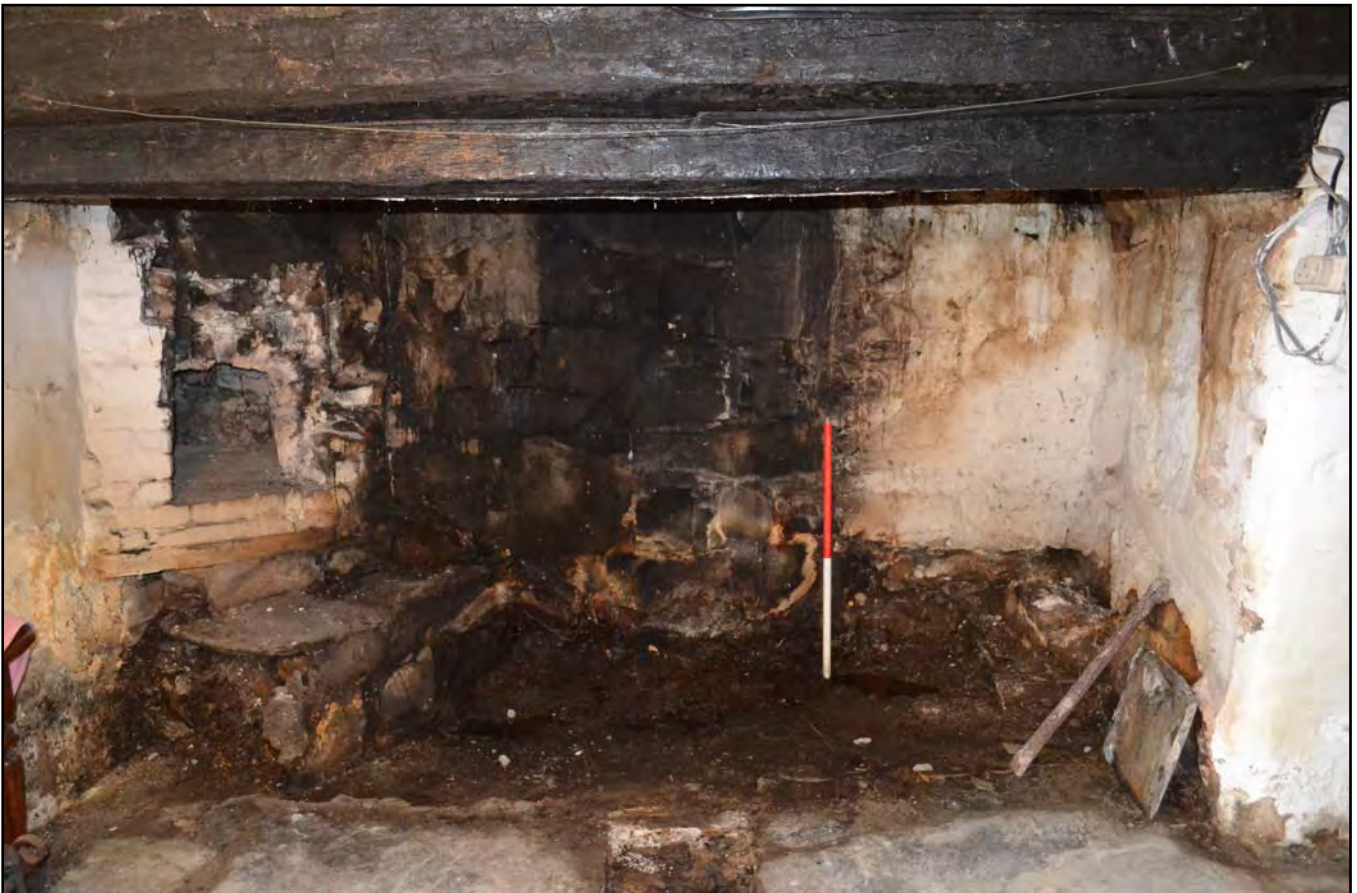
**Plate 20: Former Hall inglenook fireplace revealed, from the southeast**

The fireplace and breeze blocks had been removed, revealing a large inglenook fireplace (plate 20) measuring 1.37m deep and 3.15m wide. The hearth, presumably an iron brazier, was missing and the fireplace was partially plastered and painted white. The remains of a seat constructed from mortared rubble with a slate capping was on the left hand side, beneath an oven constructed from brick and painted white, set upon a wooden joist. The oven measured 1.05m in width by 1.20m in height, by 0.90m in depth. A small water filled drain with slate capstones lay in front of the fireplace but it was not clear whether this had been inserted due to water ingress down the large chimney, or whether it was original.
