**Charlotte Elizabeth Mill Hydro Scheme,
Gwyn-fynydd Mine, Mawddach,
Gwynedd.
June 2014**

Archaeological Assessment
Project Code: A0038.1
Report no. 0039

Archaeological Assessment
Aeon Archaeology
17 Cecil Street
Chester
CH3 5DP

Client: Carter Jonas LLP

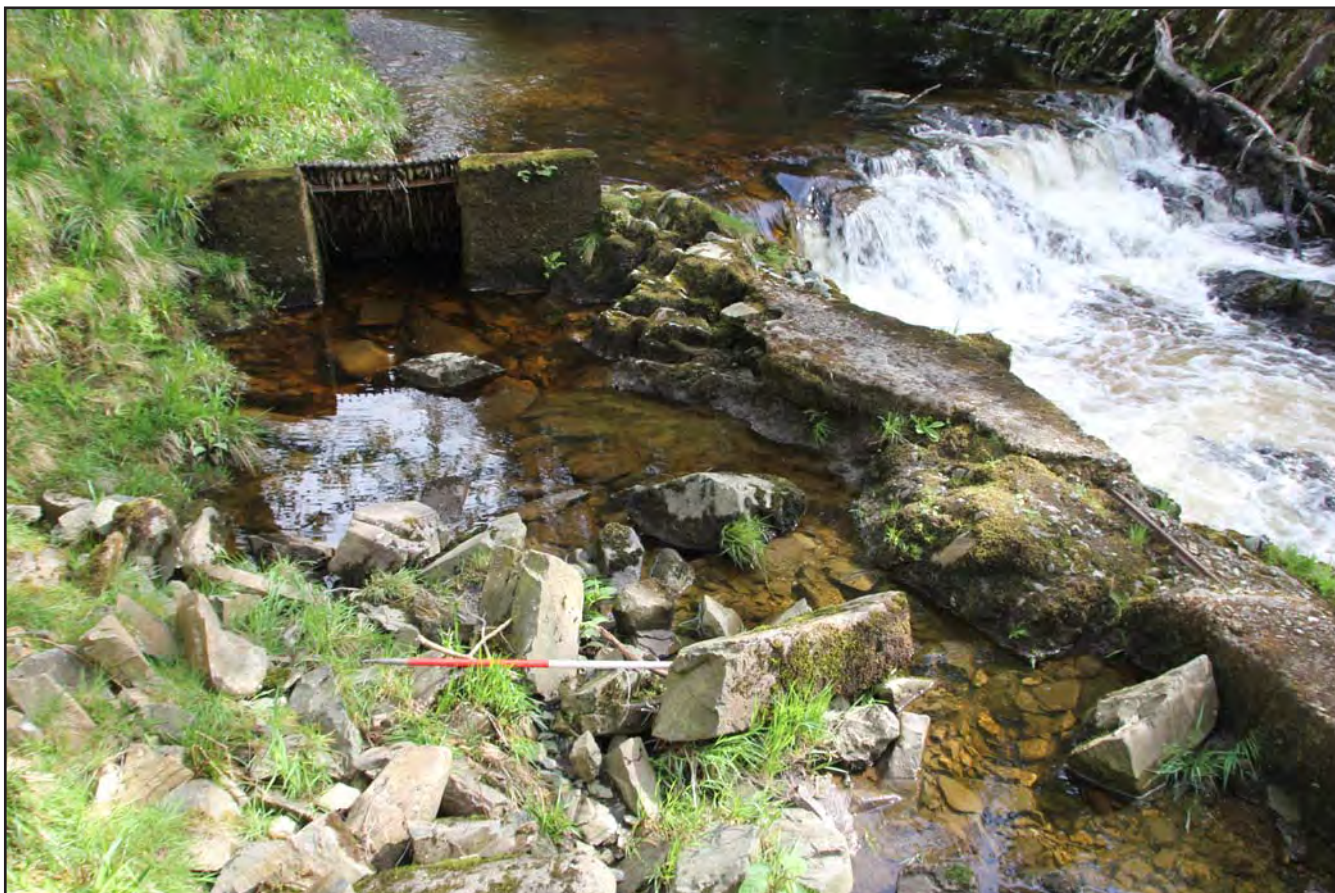
1. Sluice gate and pool	PRN: 59150
Figure: 7, 8, 9, and 13	Plate: 14
NGR: SH 73579 27520	Period: Post-medieval
<p>Description</p> <p>A sluice gate and pool is located at this point on the immediate western bank of the Afon Mawddach and approximately 56.0m north of the main mill complex. The sluice gate has been removed and replaced with iron grating to stop debris and is located at the northern end of the holding pool, which measures approximately 10.0m by 5.0m orientated northeast to southwest. The walls of the northern sluice are constructed from red brick clad in render and measure approximately 0.9m in height and 0.3m in width. A second outflow sluice is located at the southern end of the pool, also with the gate removed and with walls measuring approximately 2.0m in height and 0.3m in width also constructed from red brick clad in render. The walls of the pool are constructed from reinforced concrete and measure approximately 0.6m in width.</p> <p>The sluice and pool are first depicted on the first edition 25" Ordnance Survey map of 1889 and were installed to regulate the water feeding south to the waterwheel located on the eastern wall of the mill. The sluice and pool were installed at least as part of the 1887 mill but may date to the mill of the 1860s. The sluice and pool should be considered to be of national importance because of their contribution to the overall group value of the mill, its workings, and its ancillary structures.</p> <p>The current proposals are to remove the iron grating at the northern sluice along with the sluice walls. The base of the pool will be excavated so as to install a buried settling tank, and the western wall of the southern sluice gate will require removal. It is also proposed that the concrete wall of the pool to the east will have two channels excavated through it for the installation of two hand-off flow pipes.</p> <p>The overall direct physical impact of the hydro scheme on the sluice and pool is expected to be medium adverse resulting in a moderate or large adverse significance of effect. It is therefore recommended that a detailed photographic and descriptive record is taken of the feature prior to the commencement of works, however the record presented within this report should be seen as being commensurate with this level. In addition it is recommended that a watching brief is maintained during the ground disturbance works and that provision is made for the recording of any revealed features by a suitably qualified archaeologist.</p>

Plate 14: Sluice gate and pool feature 1, from the southwest. Scale 1.0m.

Category of importance: National	
Level of impact: Medium adverse direct physical	
Significance of effect: Moderate or large adverse	
Recommendations for further assessment: None	
Recommendations for further mitigatory measures: Detailed photographic and descriptive record (completed as part of report); watching brief during ground disturbance.

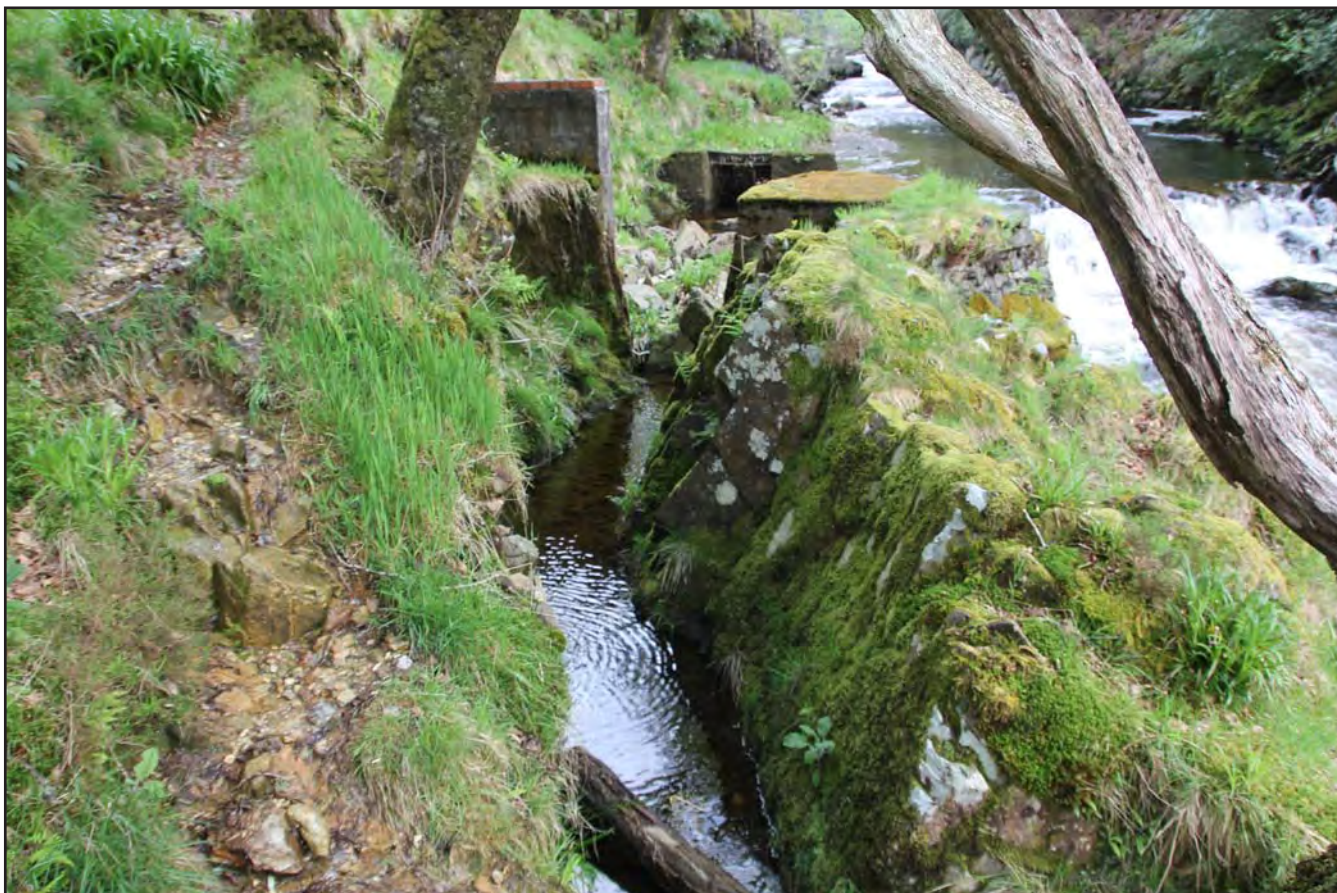
2. Leat	PRN: 59151
Figure: 7, 8, 9, and 13	Plate: 15
NGR: SH 73563 27511 – SH 73561 27496	Period: Post-medieval
<p>Description</p> <p>A leat cuts through the rock and runs south feeding water from the sluice and pool (feature 1) into the launder (feature 4). The leat measures 1.5m in width, up to 3.0m in depth in places, and approximately 15.0m in length. The eastern wall of the southern quarter of the leat is constructed from dry-stone angular slate blocks with an overflow back o the Afon Mawddach.</p> <p>The leat is first depicted on the first edition 25” Ordnance Survey map of 1889 and was installed at least as part of the 1887 mill but may date to the mill of the 1860s. The leat should be considered to be of national importance because of its contribution to the overall group value of the mill, its workings, and its ancillary structures.</p> <p>The current proposals are to trench the hydro pipe within the base of the leat for the initial 8.0m before cutting through the western rock wall of the leat.</p> <p>The overall direct physical impact of the hydro scheme on the leat is expected to be low adverse resulting in a moderate or slight adverse significance of effect. It is therefore recommended that a detailed photographic and descriptive record is taken of the feature prior to the commencement of works, however the record presented within this report should be seen as being commensurate with this level. In addition it is recommended that a watching brief is maintained during the ground disturbance works and that provision is made for the recording of any revealed features by a suitably qualified archaeologist.</p>

Plate 15: Leat feature 2, from the southwest.

Category of importance: National	
Level of impact: Low adverse direct physical	
Significance of effect: Moderate or slight adverse	
Recommendations for further assessment: None	
Recommendations for further mitigatory measures: Detailed photographic and descriptive record (completed as part of report); watching brief during ground disturbance.

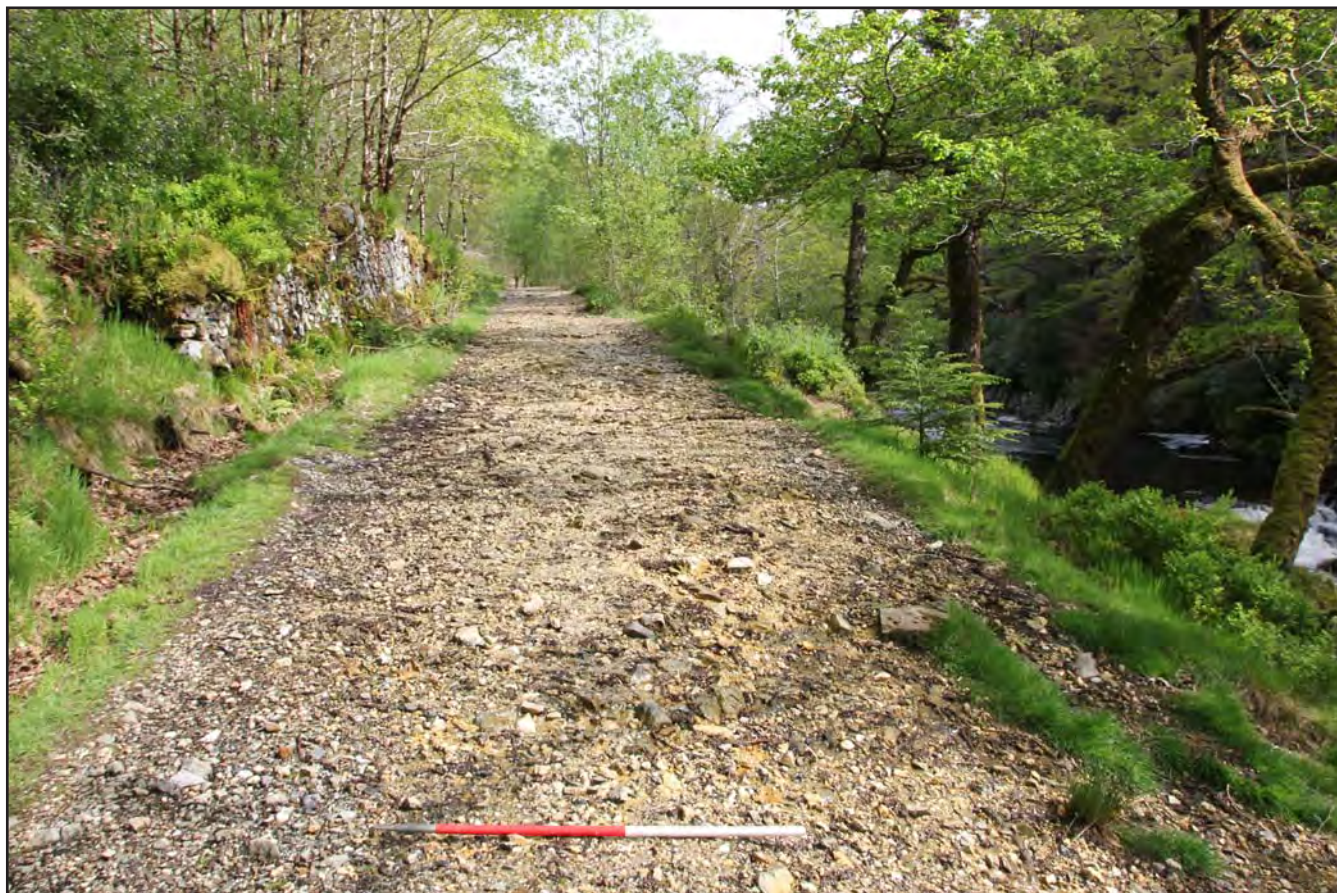
3. Trackway	PRN: 59152
Figure: 7, 8, 9, and 13	Plate: 16
NGR: SH 73549 26822 – SH 73669 28020	Period: Post-medieval
<p>Description</p> <p>A trackway measuring 3.0m in width runs to the immediate west of the mill site, connecting Tyddyn Gwladys in the south with the Gwynfynydd incline in the north. The trackway exists as a metalled surface of small rounded pebbles.</p> <p>The trackway is first depicted on the first edition 25" Ordnance Survey map of 1889 and was installed at least as part of the 1887 mill but may date to the mill of the 1860s. The trackway should be considered to be of national importance because of its contribution to the overall group value of the mill, its workings, and its ancillary structures.</p> <p>The current proposals are to construct an access track from the trackway to the leat (feature 2). In addition the new electric cable will be trenched within the trackway, crossing the Afon Cain by the existing bridge to a new transformer.</p> <p>The overall direct physical impact of the hydro scheme on the trackway is expected to be low adverse resulting in a moderate or slight adverse significance of effect. It is therefore recommended that a detailed photographic and descriptive record is taken of the feature prior to the commencement of works, however the record presented within this report should be seen as being commensurate with this level and as such no further mitigatory measures are recommended.</p>

Plate 16: Trackway feature 3, from the southwest. Scale 1.0m.

Category of importance: National	
Level of impact: Low adverse direct physical	
Significance of effect: Moderate or slight adverse	
Recommendations for further assessment: None	
Recommendations for further mitigatory measures: Detailed photographic and descriptive record (completed as part of report).

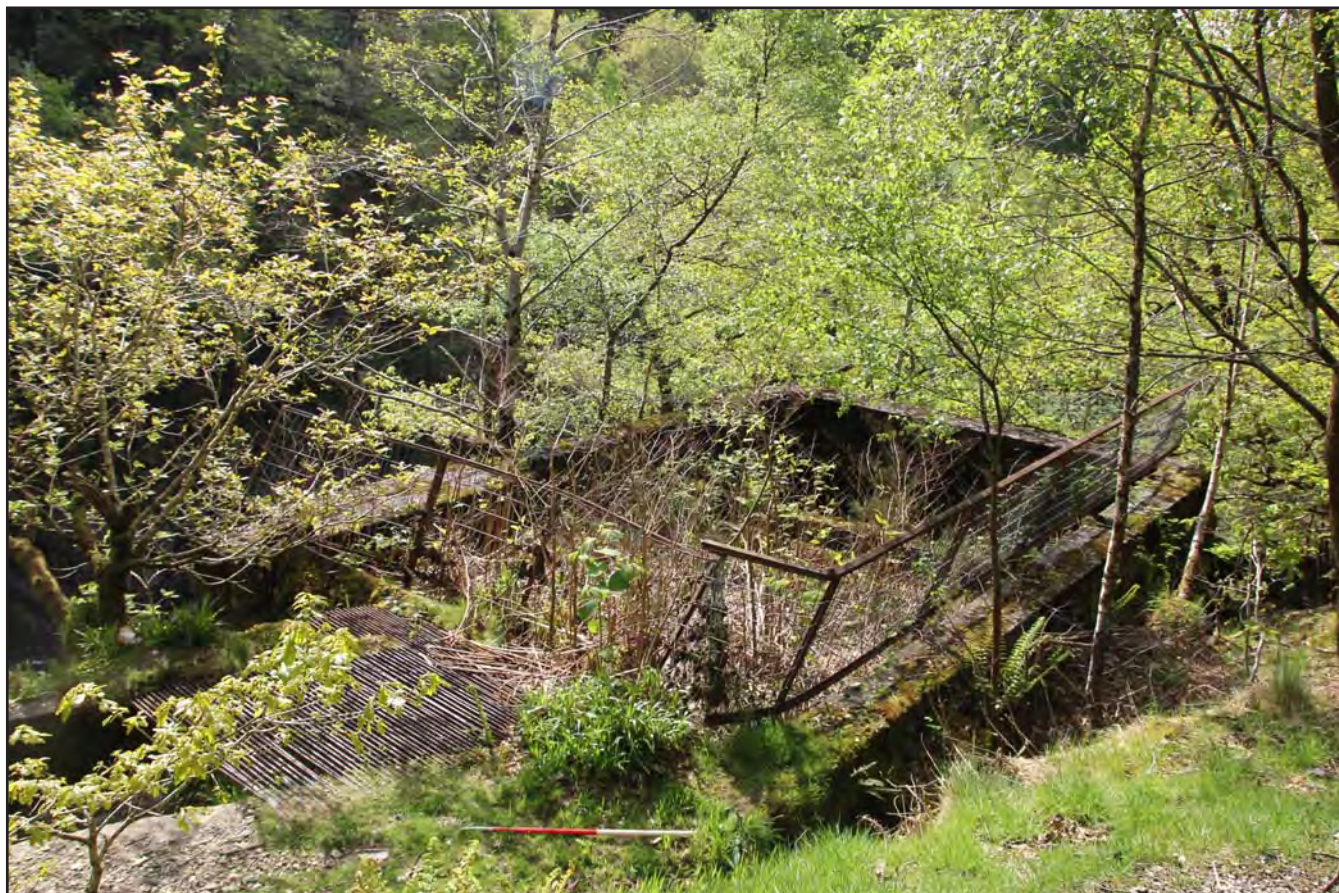
4. Launder	PRN: 59153
Figure: 7, 8, 9, and 13	Plate: 17
NGR: SH 73559 27493	Period: Post-medieval
<p>Description</p> <p>A launder tank measuring 7.0m by 4.0m and orientated north to south is located at this point. The launder is constructed from reinforced concrete but has stone built foundations suggesting that an earlier structure occupied the site, possibly a launder for the overshot waterwheel of the 1887 mill. The walls of the launder measure 0.3m and an iron grate is installed over the leat (feature 2) which feeds into it from the north. An iron pipe (feature 6) runs out of the southern face of the launder and carried water to the turbine (feature 9) of the 1888 mill. The depth of the launder is uncertain as it is currently overgrown with knotweed.</p> <p>The launder is not depicted on the first or second edition 25" Ordnance Survey maps of 1889 and 1901 respectively (figure 7 and 8), nor is it shown on the mine map of 1935 (figure 9). However a small rectangular structure is shown on the 1901 and 1935 map at the southern end of the leat. It is probable that the launder was considered too insignificant to depict on the maps and its early foundations are likely to date to the 1887 mill and possibly the mill of the 1860s. The launder should be considered to be of national importance because of its contribution to the overall group value of the mill, its workings, and its ancillary structures.</p> <p>Under the current hydro scheme proposals the launder tank will not be impacted upon and as such there are no recommendations made for further assessment or mitigatory measures aside from avoidance.</p>

Plate 17: Launder feature 4, from the northwest. Scale 1.0m.

Category of importance: National	
Level of impact: None	
Significance of effect: Neutral	
Recommendations for further assessment: None	
Recommendations for further mitigatory measures: None/ avoidance

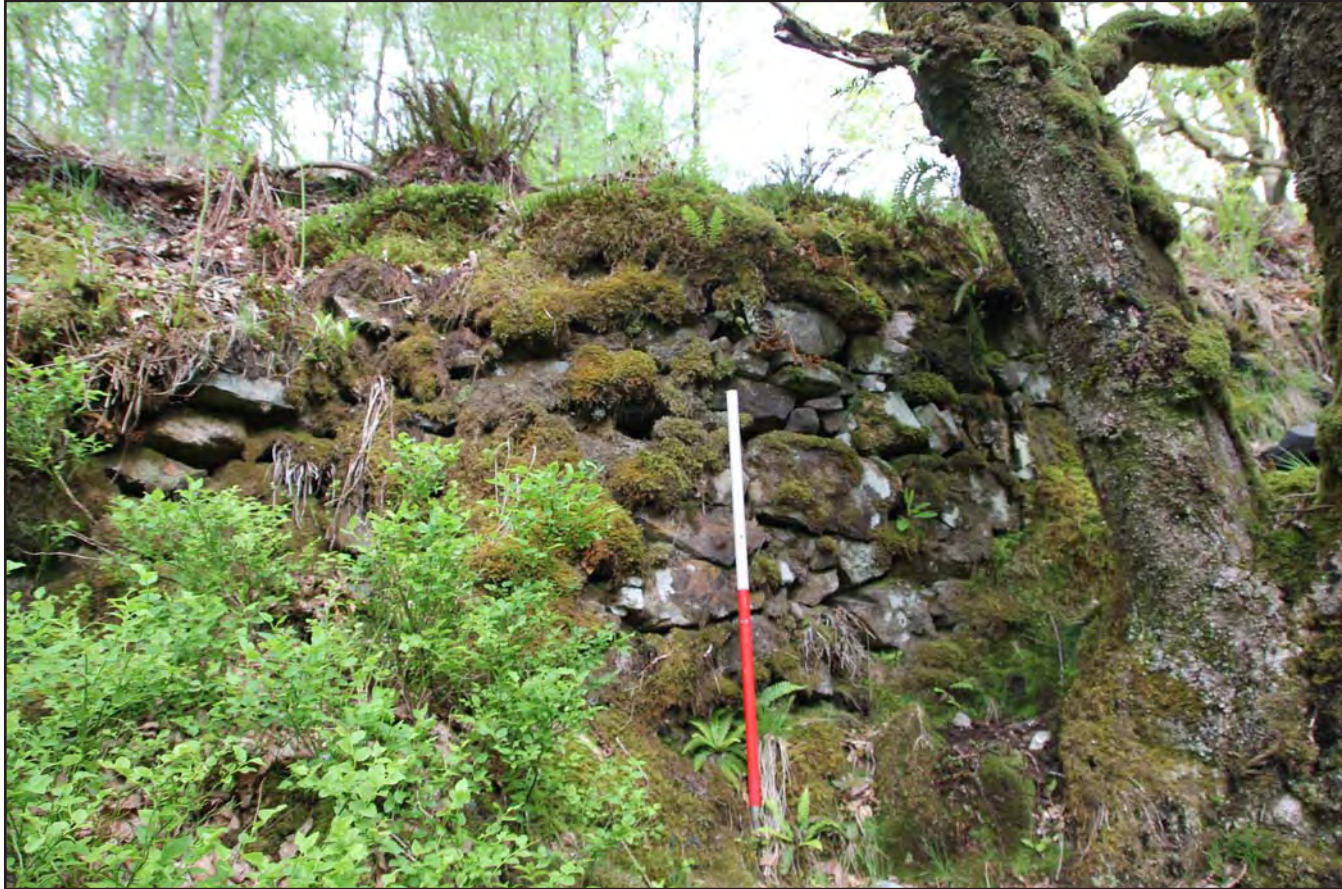
5. Stone retaining wall	PRN: 59154
Figure: 13	Plate: 18
NGR: SH 73555 27489 – SH 73545 27472	Period: Post-medieval
<p>Description</p> <p>A stone retaining wall measuring 1.5m in height, 0.3m in width, and approximately 20.0m in length runs from north to south providing a revetment for the trackway (feature 3) located to the immediate west. The wall is of dry-stone construction of medium and small sized angular stone blocks.</p> <p>The wall is not depicted on the first or second edition 25" Ordnance Survey maps of 1889 and 1901 respectively (figure 7 and 8), nor is it shown on the mine map of 1935 (figure 9). This is because the wall would have been considered too insignificant by the cartographers to depict and it is likely that the retaining wall dates to the earliest mill of the 1860s. The wall should be considered to be of national importance because of its contribution to the overall group value of the mill, its workings, and its ancillary structures.</p> <p>Under the current hydro scheme proposals the wall will not be impacted upon and as such there are no recommendations made for further assessment or mitigatory measures aside from avoidance.</p>

Plate 18: Stone retaining wall feature 5, from the south. Scale 1.0m.

Category of importance: National	
Level of impact: None	
Significance of effect: Neutral	
Recommendations for further assessment: None	
Recommendations for further mitigatory measures: None/ avoidance

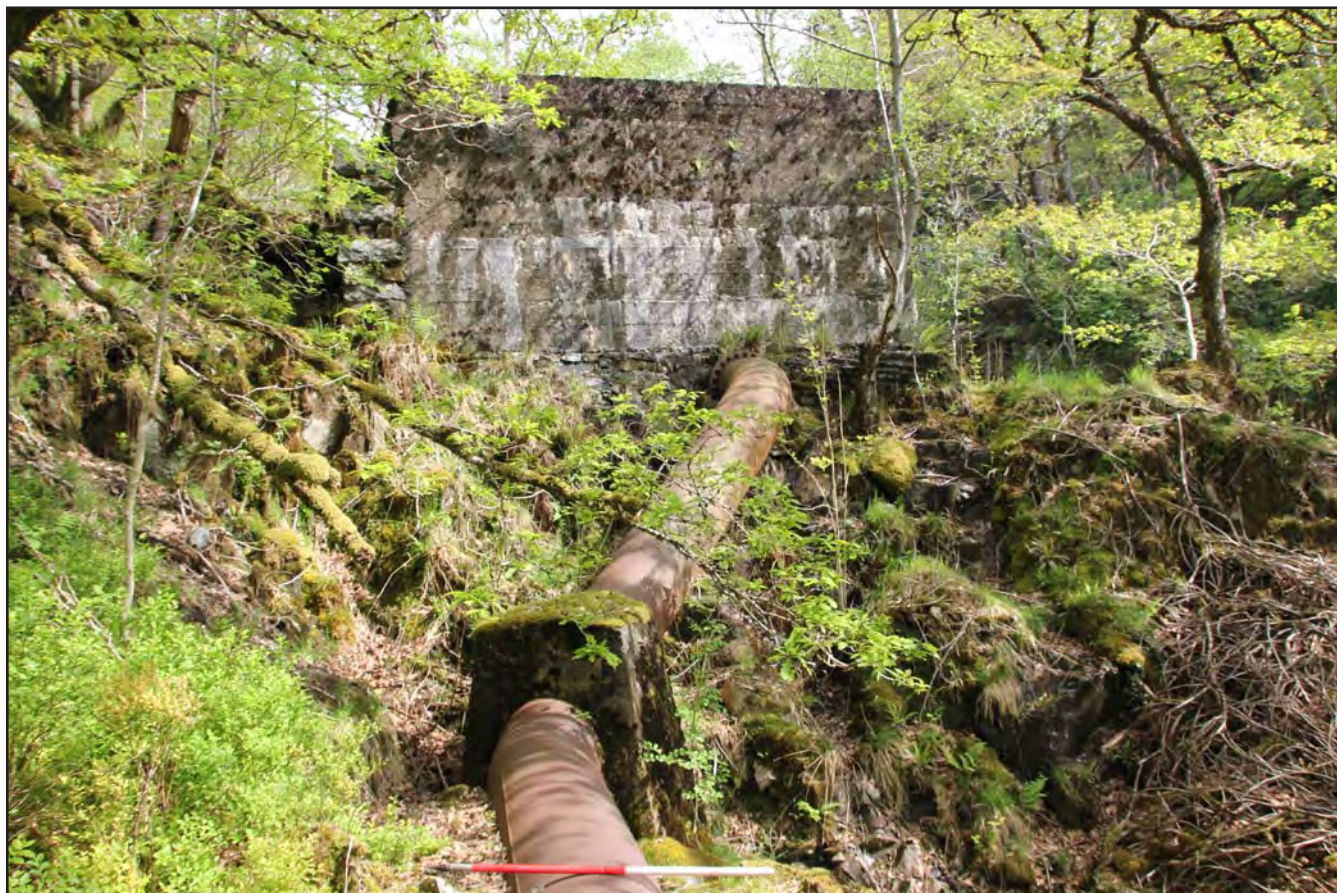
6. Iron pipe	PRN: 59155
Figure: 13	Plate: 19
NGR: SH 73559 27489 – SH 73559 27440	Period: Post-medieval
<p>Description</p> <p>An iron pipe measuring 0.5m in diameter and supported on concrete pillars runs south and downhill from the launder tank (feature 4) to the turbine (feature 9) located at the eastern side of the mill complex.</p> <p>The pipe is first depicted on the second edition 25” Ordnance Survey map of 1901 (figure 8) and was installed in 1888 by the New Morgan Gold Mining Company along with the Armfield turbine. The pipe should be considered to be of national importance because of its contribution to the overall group value of the mill, its workings, and its ancillary structures.</p> <p>Under the current hydro scheme proposals the pipe will require its outfall end to be removed to allow space for the construction of the new turbine house. The overall direct physical impact of the hydro scheme on the pipe is expected to be low adverse resulting in a moderate or slight adverse significance of effect. It is therefore recommended that a detailed photographic and descriptive record is taken of the feature prior to the commencement of works, however the record presented within this report should be seen as being commensurate with this level and as such no further mitigatory measures are recommended.</p>

Plate 19: Iron pipe feature 6, from the southwest. Scale 1.0m.

Category of importance: National	
Level of impact: Low adverse direct physical	
Significance of effect: Moderate or slight adverse	
Recommendations for further assessment: None	
Recommendations for further mitigatory measures: Detailed photographic and descriptive record (completed as part of report).

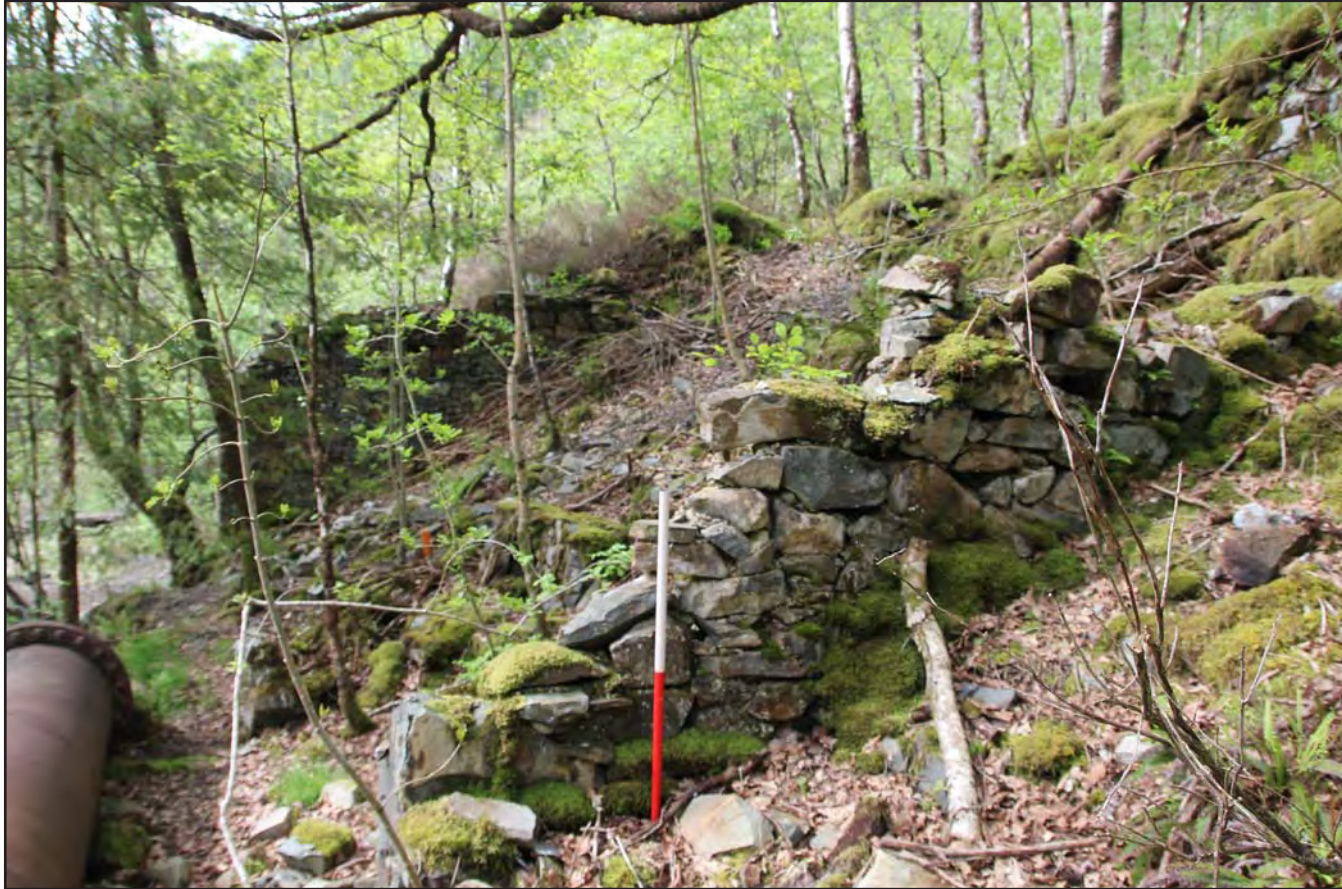
7. Ruined structure	PRN: 59156
Figure: 7, 8, 9, and 13	Plate: 20
NGR: SH 73551 27473	Period: Post-medieval
<p>Description</p> <p>A ruined structure measuring 10.0m by 4.5m and orientated from north to south is located to the immediate north of the main mill complex. The building appears to have been revetted into the slope at the western end and only the north and south gable walls now stand to a height of 1.3m. The structure is roofless and the standing walls are in a poor state of preservation, constructed from large angular stone blocks of dry-stone bond. The remains of a stone-built hearth measuring 0.5m in width and height is located towards the centre of the structure and the interior of the building is littered with collapsed wall stones.</p> <p>The structure is first depicted on the first edition 25" Ordnance Survey map of 1889 (figure 7) and is also shown on the second edition map of 1901 (figure 8) and the mine map of 1935 (figure 9). The function of the building is uncertain but it may have been an office to the mill. The structure should be considered to be of national importance because of its contribution to the overall group value of the mill, its workings, and its ancillary structures.</p> <p>The current proposals are to trench the hydro pipe through the remains of the northern gable wall. This will almost certainly mean the demolition of this wall as part of the works as well as trenching the hydro pipe through the interior of the structure.</p> <p>The overall direct physical impact of the hydro scheme on the structure is expected to be medium to high adverse resulting in a large adverse significance of effect. It is therefore recommended that a detailed photographic and descriptive record is taken of the feature prior to the commencement of works, however the record presented within this report should be seen as being commensurate with this level. In addition it is recommended that a watching brief is maintained during the trenching of the hydro pipe through the structure and that provision is made for the recording of any revealed features by a suitably qualified archaeologist. Furthermore, it is recommended that the upstanding remains of the northern gable wall are reinstated upon completion of the works.</p>

Plate 20: Ruined building feature 7, from the northeast. Scale 1.0m.

Category of importance: National	
Level of impact: Medium to high adverse direct physical	
Significance of effect: Large adverse	
Recommendations for further assessment: None	
Recommendations for further mitigatory measures: Detailed photographic and descriptive record (completed as part of report); watching brief during ground disturbance; reinstatement of gable wall upon completion of works.

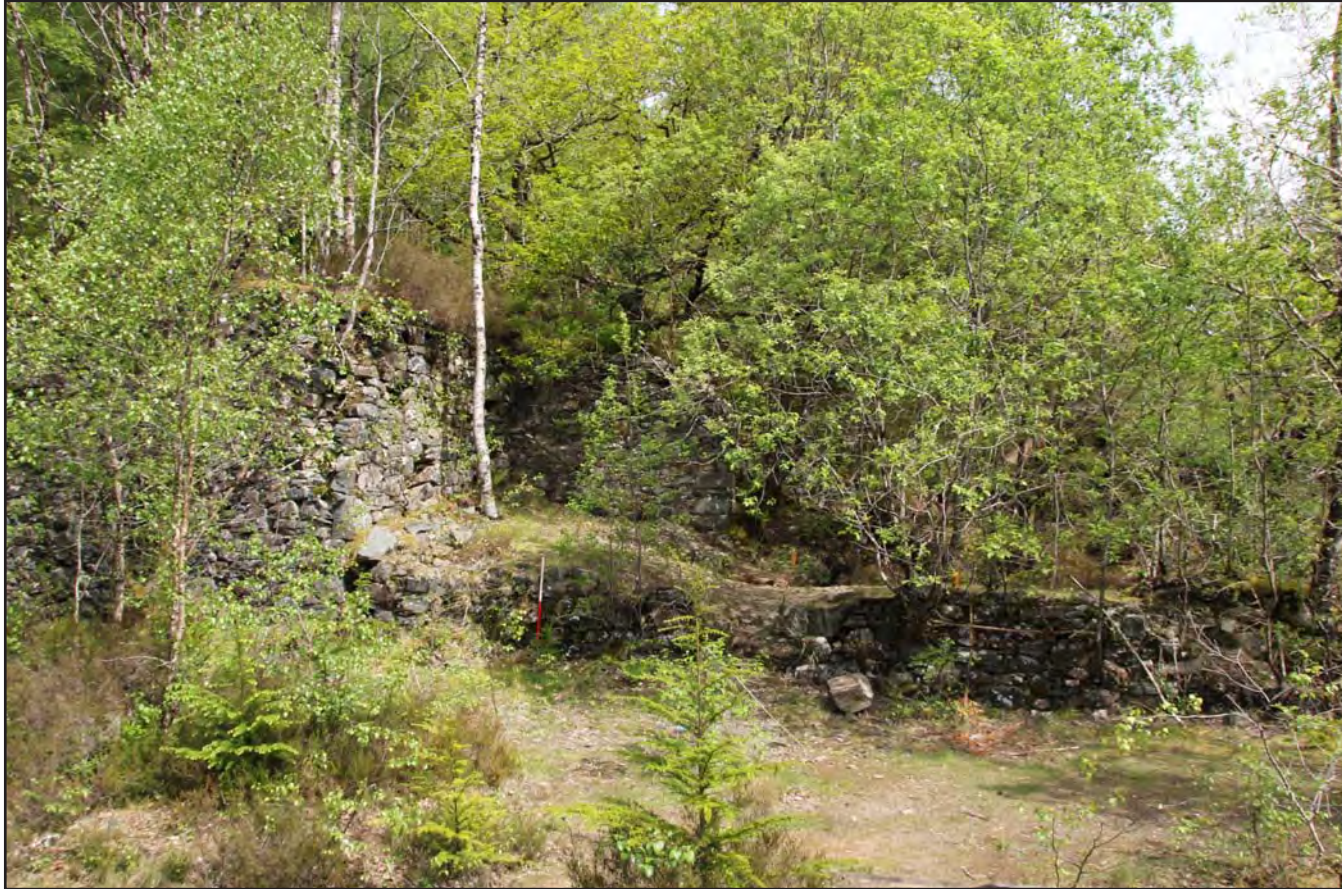
8. Mill complex	PRN: 59157
Figure: 7, 8, 9, 10, 11, 12 and 13	Plate: 21-29
NGR: SH 73545 27460	Period: Post-medieval
<p>Description</p> <p>The mill remains consist now of stone rubble walls bonded by lime mortar. A survey carried out by the RCAHMW in 1977 identified the machine bases within the mill although these are now mostly missing, aside from some amalgamating table bolts (plate 22), the occasional remains of the stamp frames (plate 23), and part of the stamp battery shaft (plate 25). The mill site has been revetted but probably exaggerated the natural terrace and has been built up with spoil from the tramway system. Several working levels can be identified at the mill site. The mill of 1887 (figure 10) would have had ore delivered by an incline plane which was then delivered to the Marsden stone-breaker at the northern part of the mill. This would have been driven by an overhead shaft which was in turn driven by a countershaft transmitting belt-drive from the overshot water wheel. The crushed ore would have been fed down into 3 sets of Sandycroft 5-head stamp batteries, also powered by the main waterwheel, and then would have fed into amalgamating tables and vanners driven by a smaller pelton waterwheel.</p> <p>When the mill was extended in 1888 the waterwheel was replaced with a turbine which would have transferred power via a counter-shaft to the stamp battery shaft and stone-breaker counter-shaft. An aerial tramway (feature 17) would have deposited the ore into hoppers which would feed into two Marsden stone-breakers situated at a high level at the northern part of the mill complex. This would have then automatically fed into the main mill floor level and its 8 California 5-head stamp 750 lb batteries. Gold was amalgamated on outside plates and the battery tailings were passed over Frue vanners and Wilfley tables. Batches of high-grade ore were processed in Britten pans and smelting was carried out at the mill (figure 12). The mill was also extended to the west to include an assay office and steam engine. A structure depicted to the immediate south of the mill but no longer in existence is likely to have been the bullion room and electric light room.</p> <p>The mill complex is first depicted on the first edition 25" Ordnance Survey map of 1889 (figure 7) and is also shown on the second edition map of 1901 (figure 8) and the mine map of 1935 (figure 9) after its extension by The New Morgan Mining Company in 1888. A more detailed account of the mill, its development and function is provided in section 5.2. The mill complex although destroyed largely by fire in 1935 exists as a series of walls that can easily be interpreted, and the mill is considered to be of national importance as part of the gold production of the late 19th Century Wales gold-rush.</p> <p>The current proposals are to trench the hydro pipe through the upstanding stone built base of the mill, where it will head southeast and down through the masonry built belting chute to the turbine shaft. As part of the proposals the eastern wall of the mill building that divides the vanner house from the turbine shaft (feature 9) will require bracing and supporting by a scaffold structure tied back to secure ground, due to safety reasons of working below it in the turbine shaft (plate 29).</p> <p>The overall direct physical impact of the hydro scheme on the structure is expected to be medium adverse resulting in a moderate or large adverse significance of effect. It is therefore recommended that a detailed photographic and descriptive record is taken of the mill prior to the commencement of works, however the record presented within this report should be seen as being commensurate with this level. In addition it is recommended that a watching brief is maintained during the trenching of the hydro pipe through the structure and that provision is made for the recording of any revealed features by a suitably qualified archaeologist.</p>

Plate 21: Mill central floor feature 8, from the southeast. Scale 1.0m.

It is also recommended that the mill floor, working levels, and belting chute are reinstated upon the completion of works. The SNPA Archaeologist has also requested that the client considers funding an information board to interpret the mill's history and function to the general public.

Recommendations for further mitigatory measures: Detailed photographic and descriptive record (completed as part of report); watching brief during ground disturbance; bracing of east mill wall; reinstatement of mill floor, working levels, and masonry belt chute upon completion of works; installation of information panel.

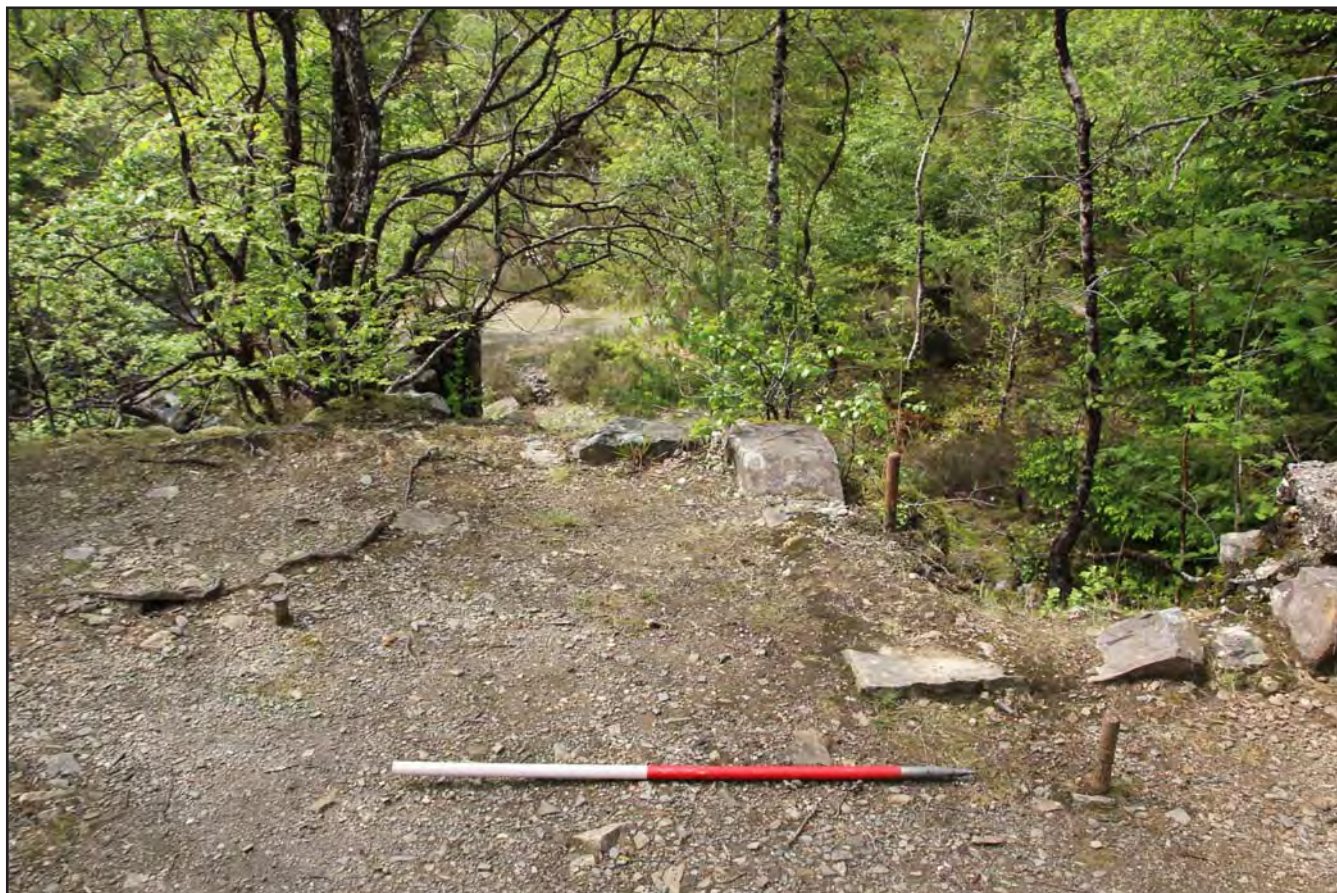
Plate 22: Mill central floor feature 8 showing amalgamating table bolts, from the north. Scale 1.0m.

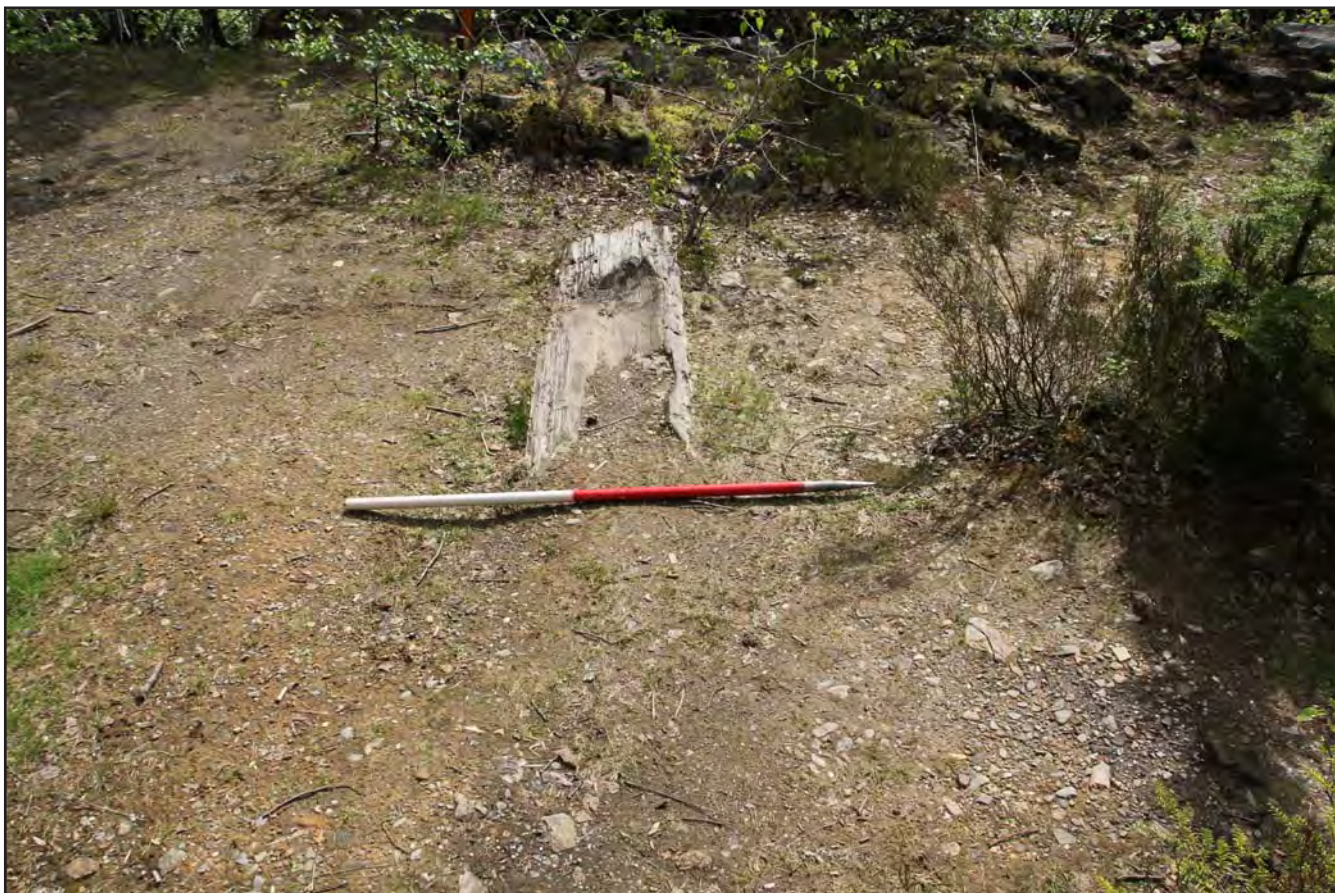
Plate 23: Mill central floor feature 8 showing remains of stamp frames, from the east. Scale 1.0m.

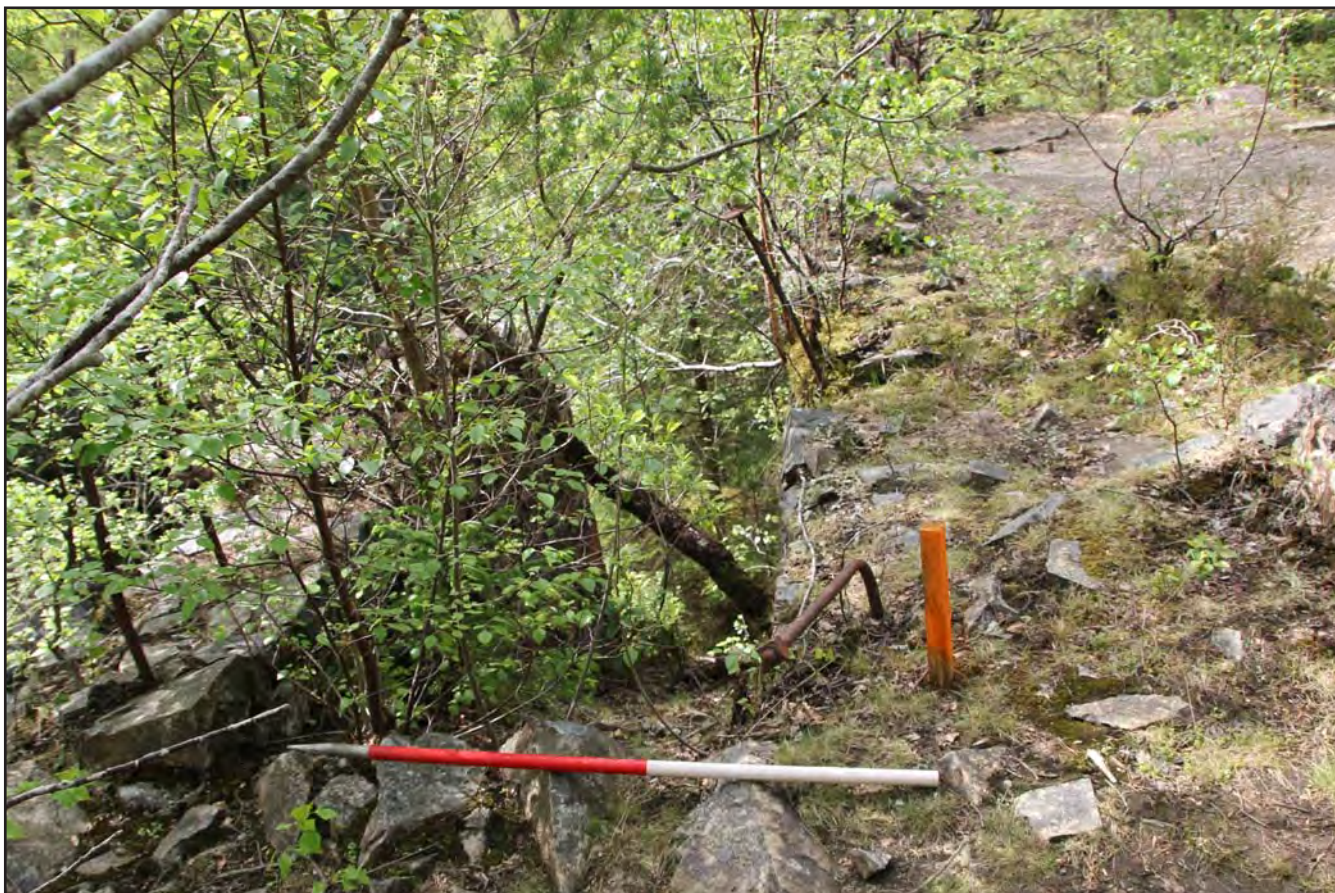
Plate 24: Mill central floor feature 8 showing belting chute to stamps, from the north. Scale 1.0m.

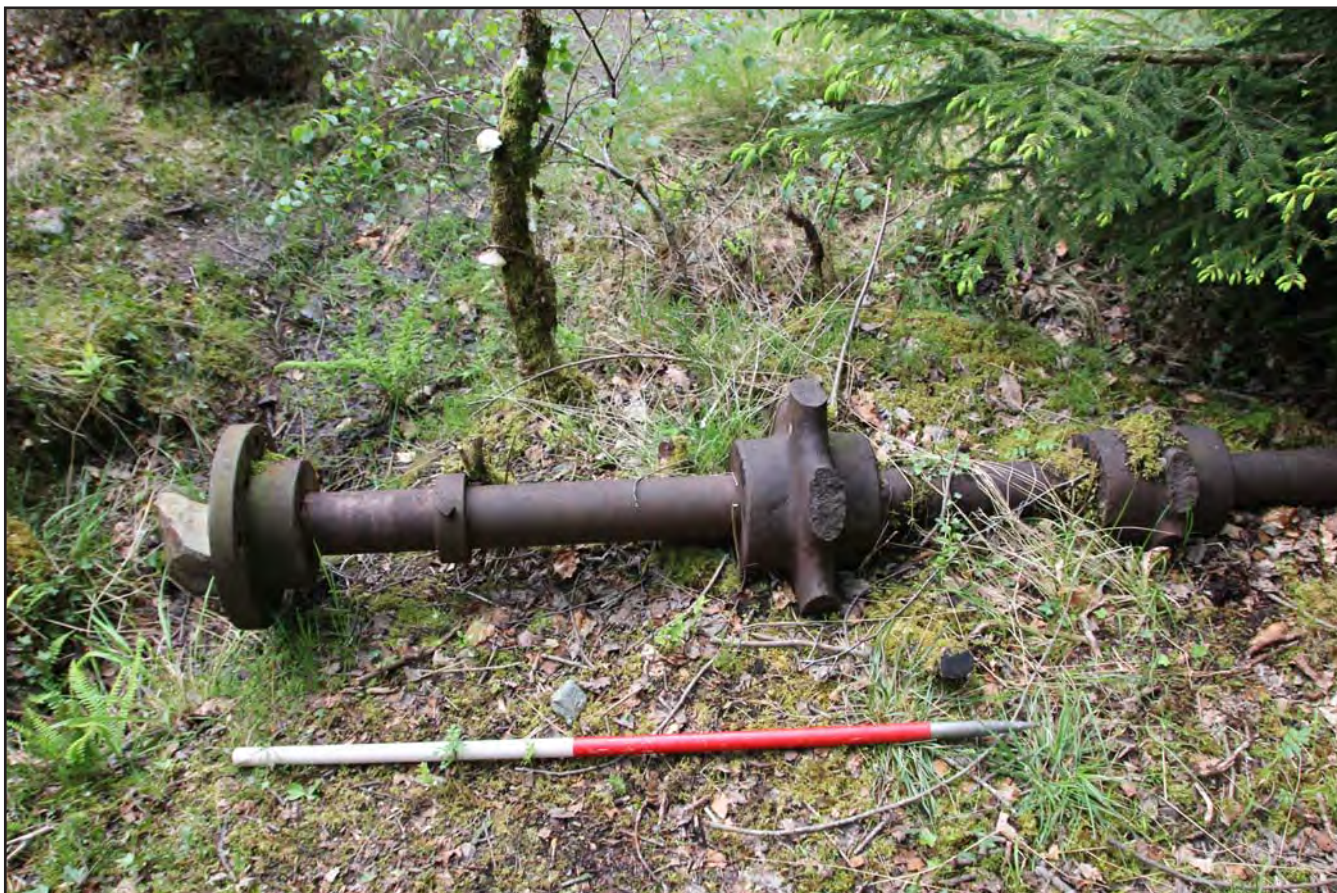
Plate 25: Mill central floor feature 8 showing stamp battery shaft, from the north. Scale 1.0m.

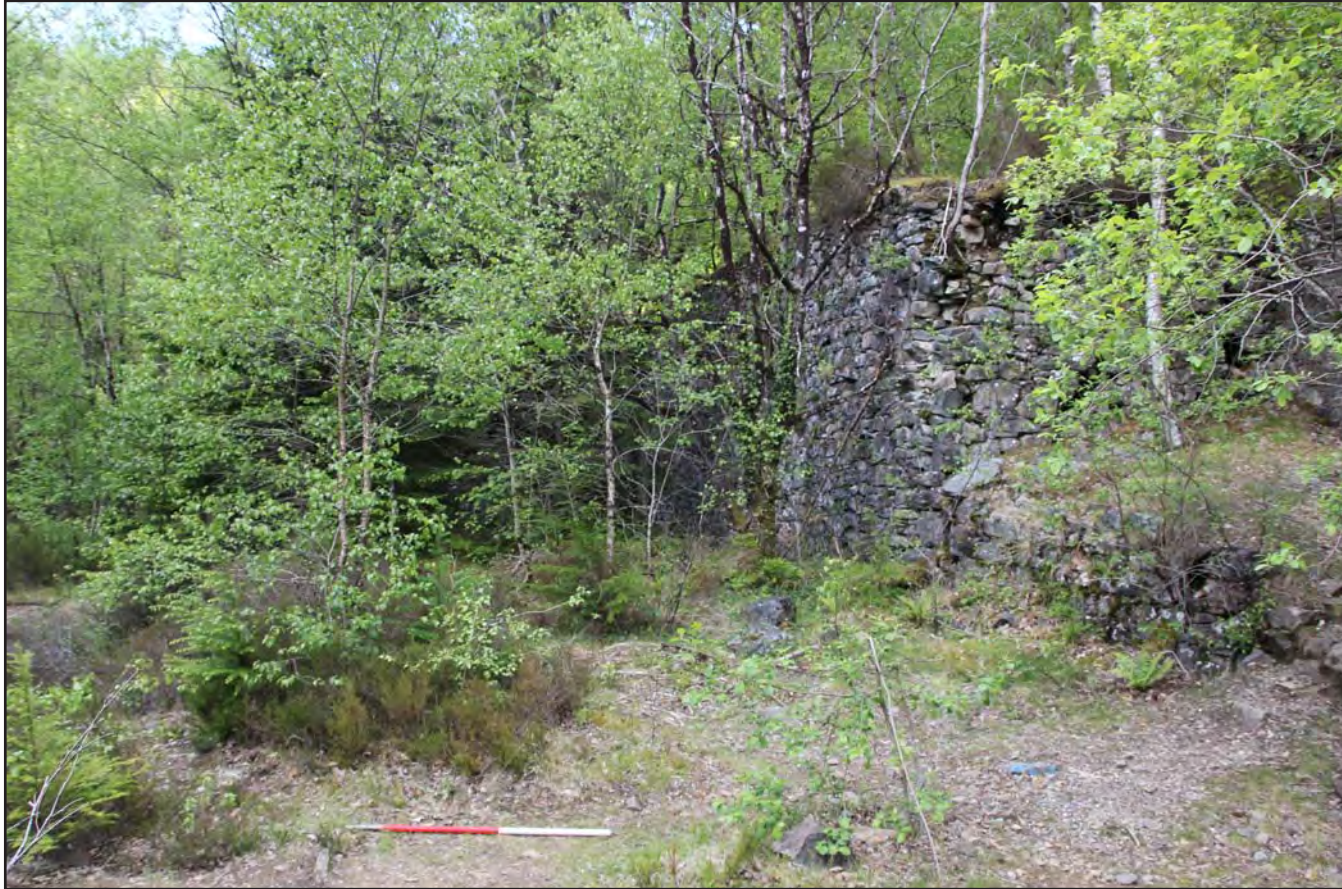
Plate 26: Mill central floor feature 8 showing location of stamp batteries, from the east. Scale 1.0m.

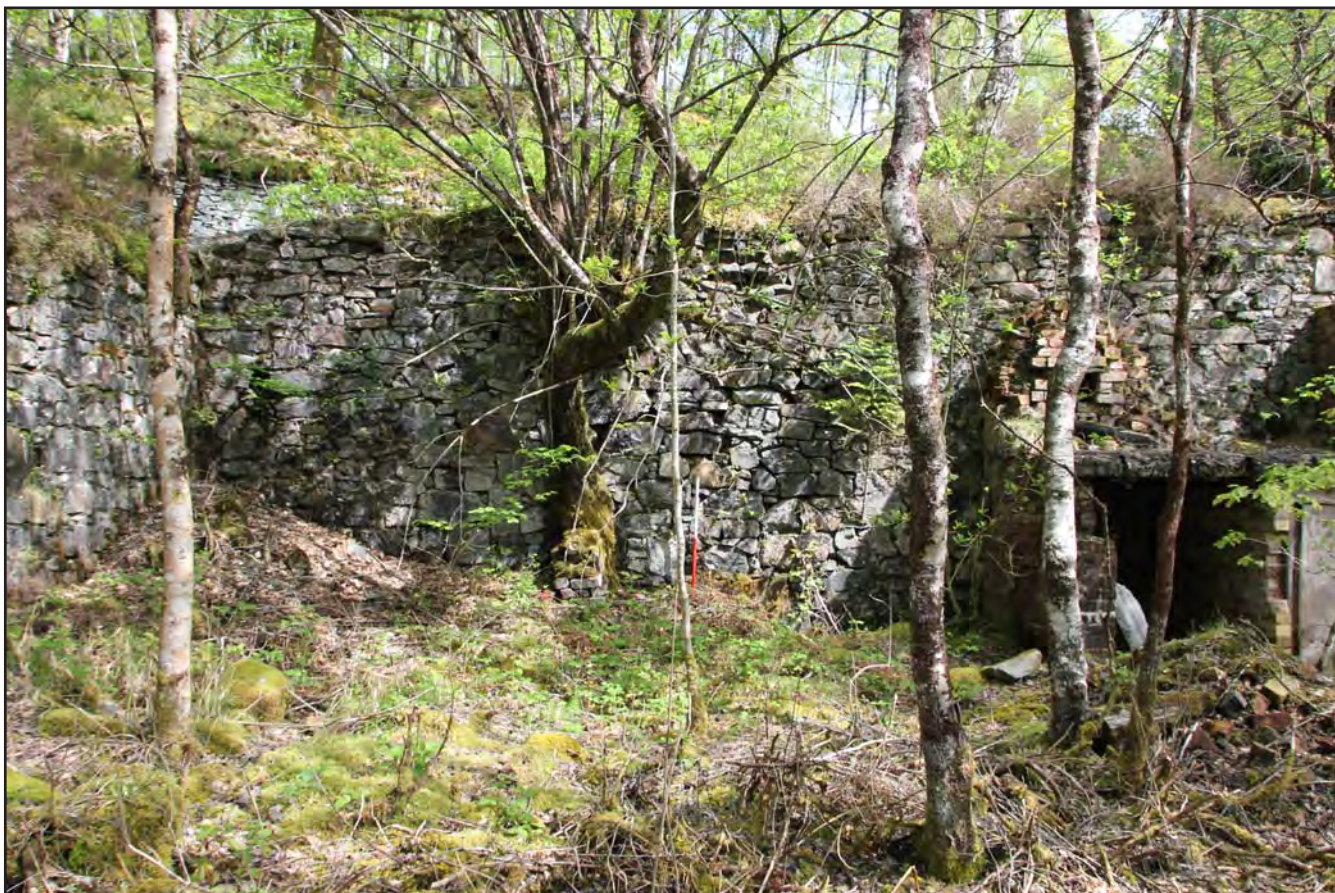
Plate 27: Mill west-wing assay office feature 8 showing probable steam engine location and brick bunkers, from the south. Scale 1.0m.

It has been proposed that the western end of the mill building (feature 8) which contained the assay office and steam engine be cleared of trees and utilised as a lay-down area for the working compound and that spoil from the pipe trench is deposited here. It is recommended that if trees are to be cleared it is done so through mechanical cutting with stumps left to rot down and it is strongly recommended that an alternative site is utilised for the deposition of spoil.
