**Charlotte Elizabeth Mill Hydro Scheme,
Gwyn-fynydd Mine, Mawddach,
Gwynedd.
June 2014**

Archaeological Assessment
Project Code: A0038.1
Report no. 0039

Archaeological Assessment
Aeon Archaeology
17 Cecil Street
Chester
CH3 5DP

Client: Carter Jonas LLP

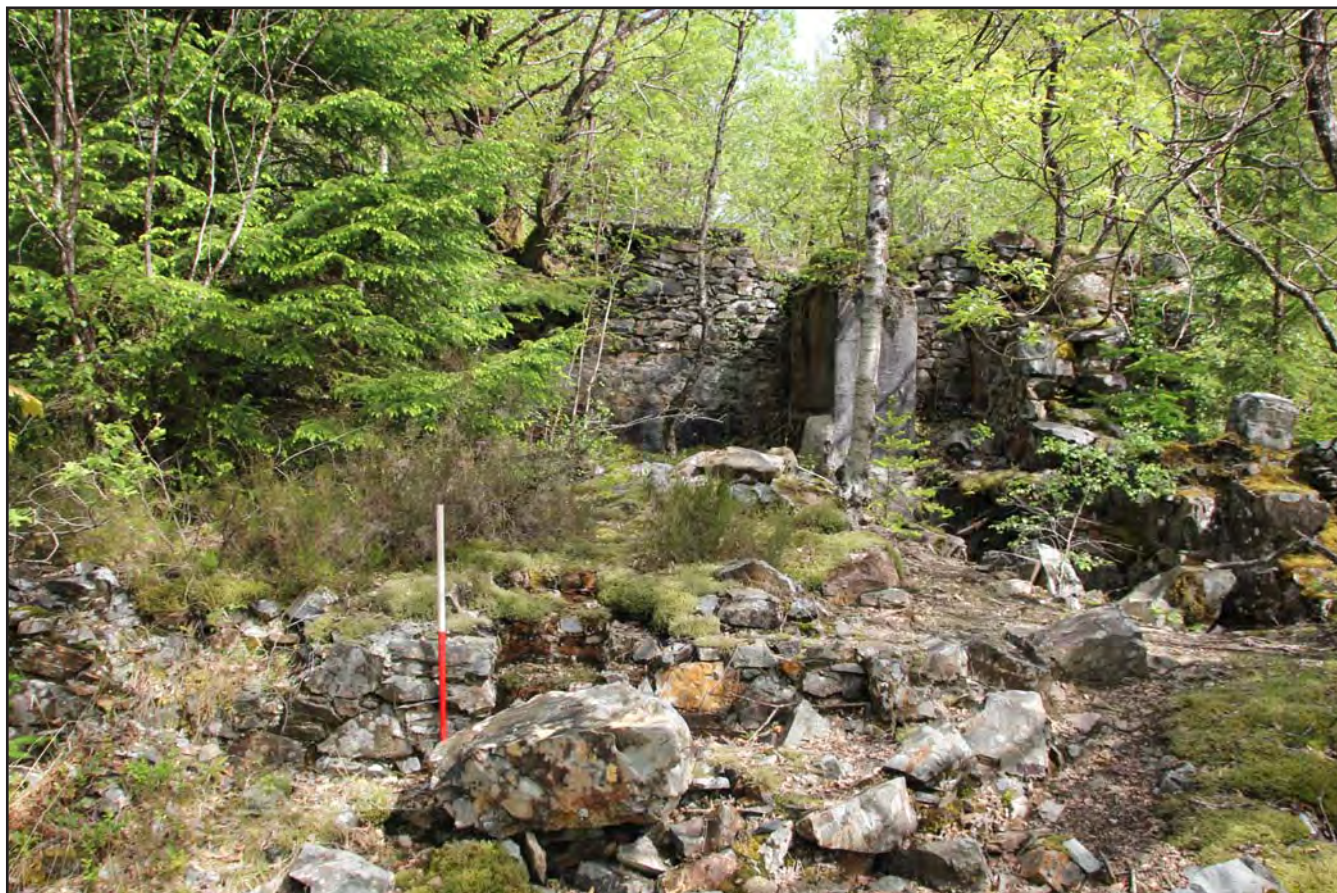
Plate 28: Mill lower floor feature 8 showing location of vanner house and britten pans, from the south. Scale 1.0m.

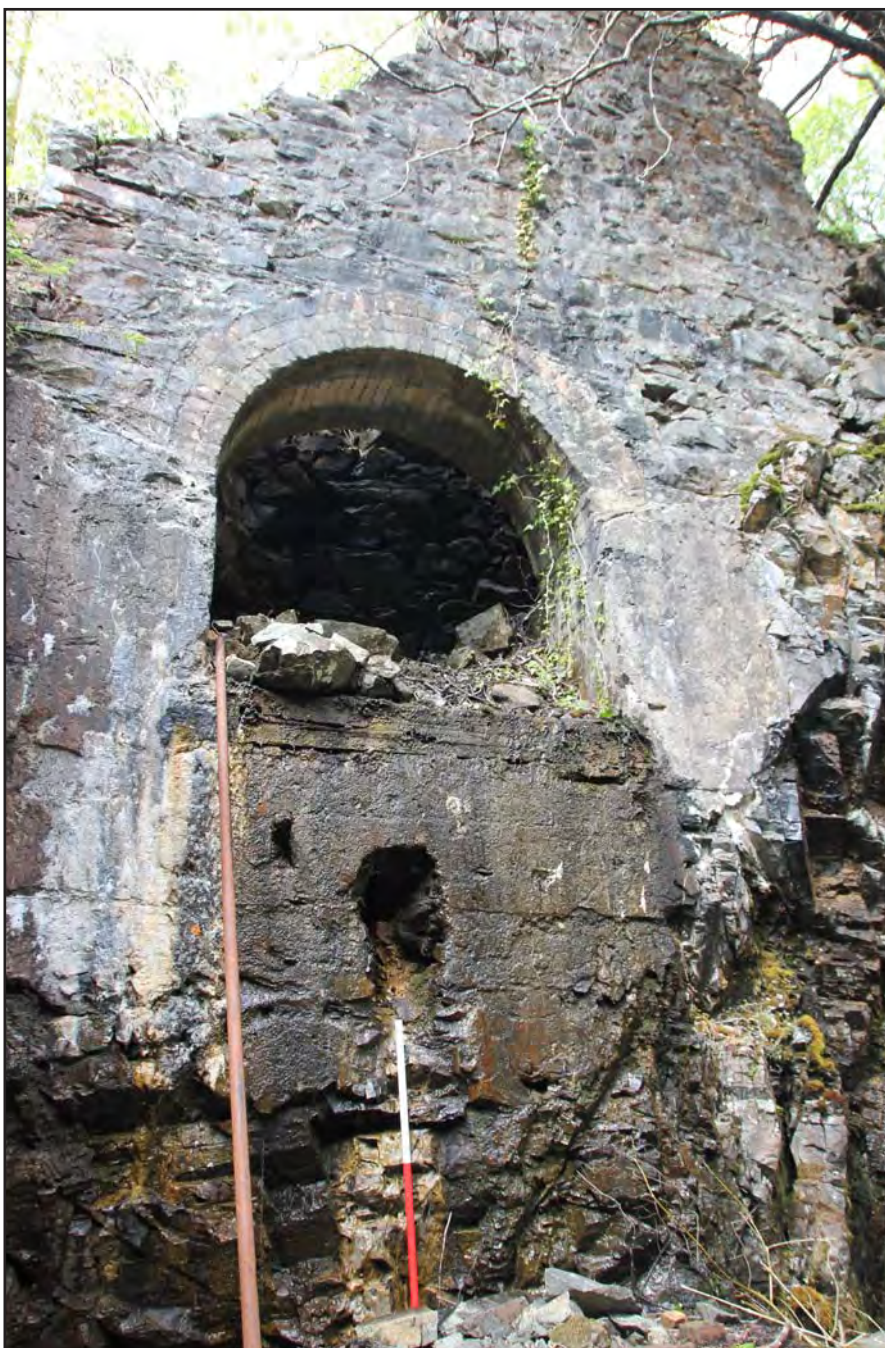
9. Turbine shaft	PRN: 59158
Figure: 8, 9, 12 and 13	Plate: 29 and 30
NGR: SH 73559 27439	Period: Post-medieval
<p>Description</p> <p>The turbine shaft of the 1888 mill occupies the site of the original waterwheel pit of the 1869 mill. The shaft measures approximately 4.0m in length and width and is towered over by the rock cut shaft and mill wall to the west, standing approximately 6.0m above the turbine shaft base. A rock cut adit provides an overflow east from the turbine to the Afon Mawddach. The remains of the Armfield turbine is located within the base of the shaft and is fed by the iron pipe (feature 6). The rectangular valve plate slid on rollers and was moved by cogs acting on racks on the top surface of the plate. The cogs were turned by a larger cog on the outside of the casing which was turned by a gear at the bottom of an upright rod, itself turned by a wheel handle on the end of a long control rod. Below the valve and inside the bolted casing was a pelton wheel of approximately 2 foot diameter, the shaft for which drove a wide belt pulley within the belting chute which drove the shaft for the stamps and stone-breakers.</p> <p>The turbine shaft is first depicted on the second edition 25" Ordnance Survey map of 1901 (figure 8) and is also shown on the mine map of 1935 (figure 9). The turbine and shaft should be considered to be of national importance because of its contribution to the overall group value of the mill, its workings, and its ancillary structures.</p> <p>The current proposals are to remove the remains of the Armfield turbine and to excavate the turbine shaft to accommodate the proposed turbine building.</p> <p>The overall direct physical impact of the hydro scheme on the turbine and shaft is expected to be high adverse resulting in a large or very large adverse significance of effect. It is therefore recommended that a detailed photographic and descriptive record is taken of the feature prior to the commencement of works, however the record presented within this report should be seen as being commensurate with this level. In addition it is recommended that a watching brief is maintained during the excavation of the shaft.</p>

Plate 29: Turbine shaft feature 9 showing mill eastern wall to be demolished, from the east. Scale 1.0m.

Category of importance: National	
Level of impact: High adverse direct physical	
Significance of effect: Large or very large adverse	
Recommendations for further assessment: None	
Recommendations for further mitigatory measures: Detailed photographic and descriptive record (completed as part of report); watching brief during ground disturbance.

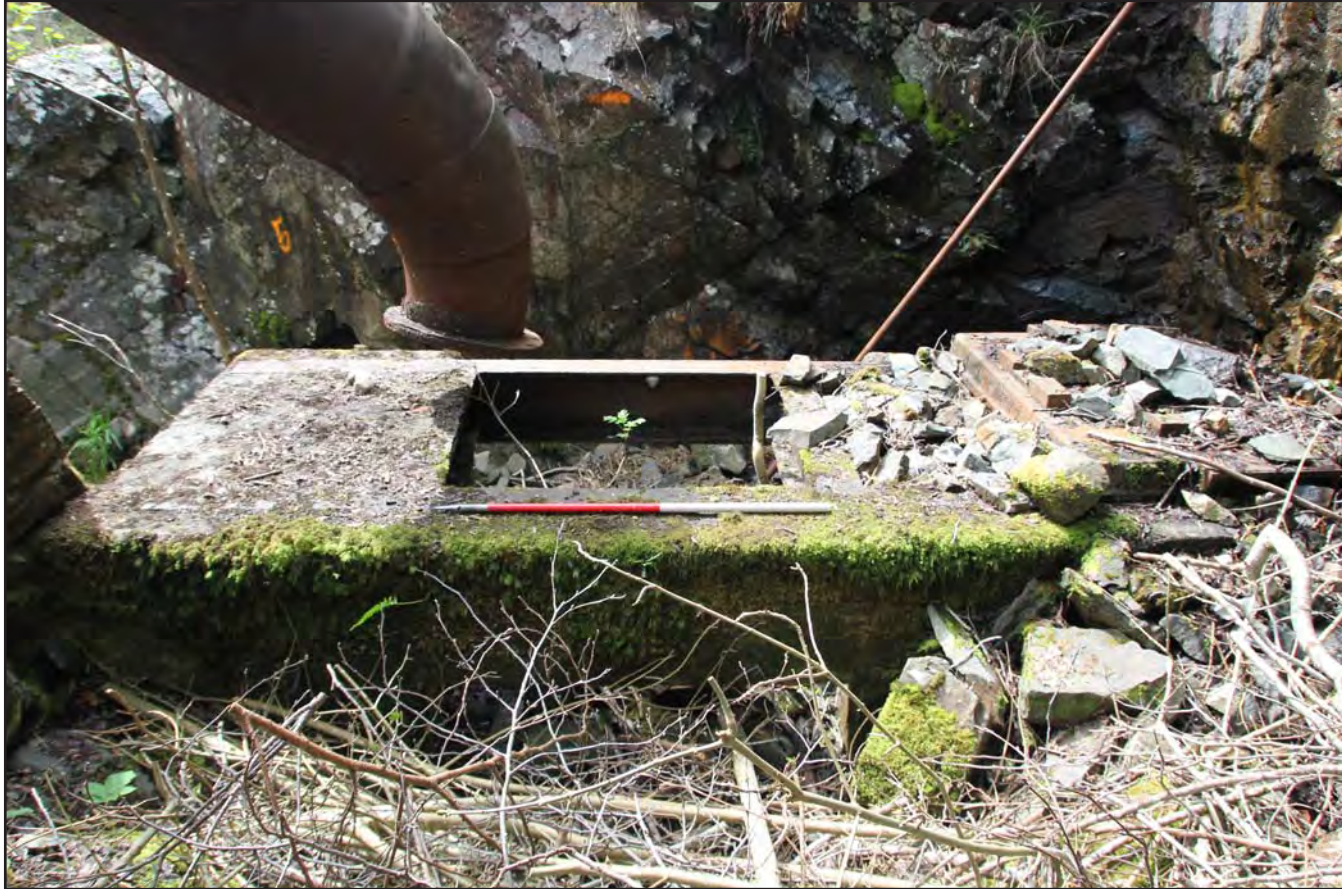
Plate 30: Turbine shaft feature 9 showing Armfield of Ringwood turbine base, from the north. Scale 1.0m.

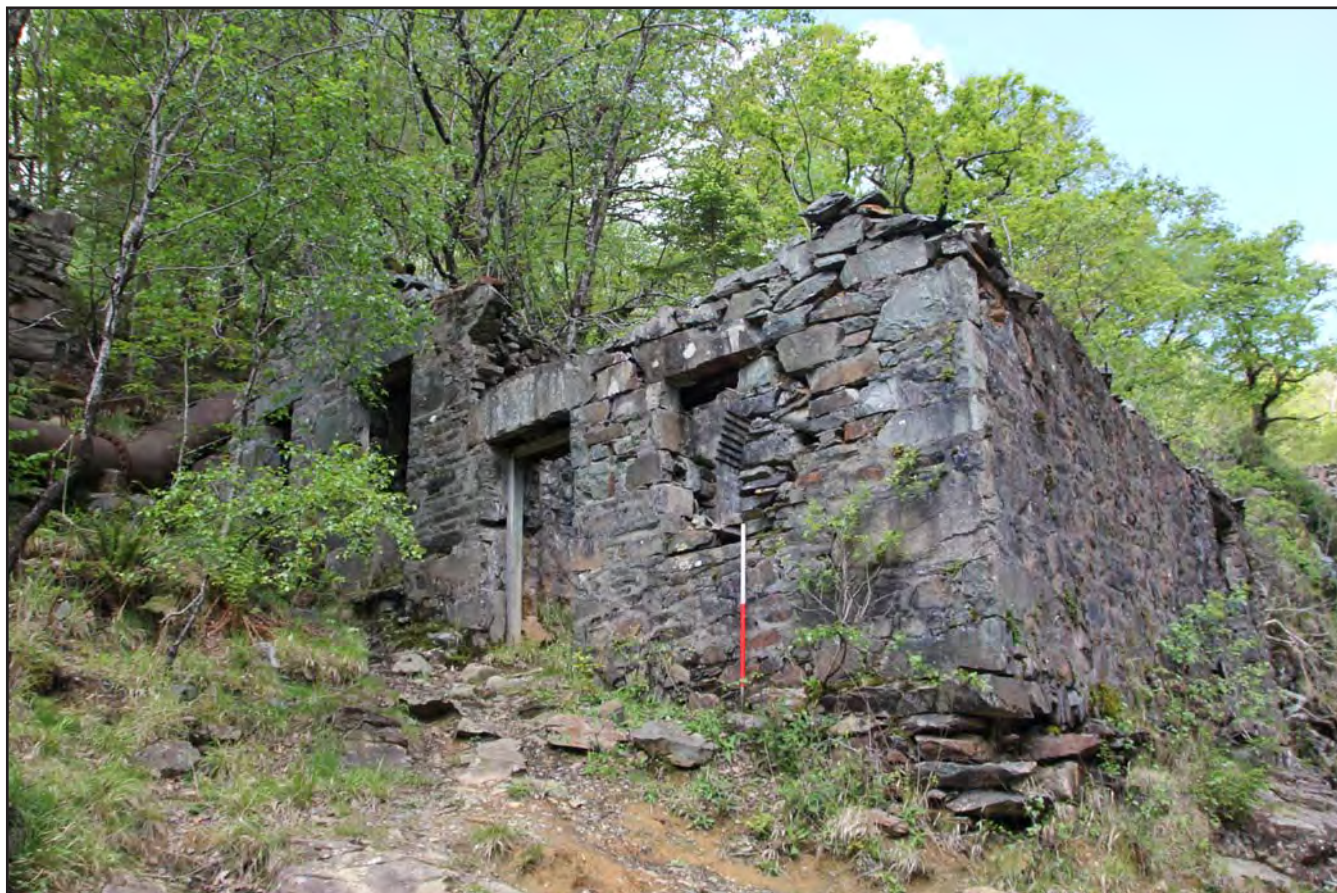
10. Smithy	PRN: 59159
Figure: 7, 8, 9, and 13	Plate: 31
NGR: SH 73564 27469	Period: Post-medieval
<p>Description</p> <p>A roofless structure measuring 10.0m in length and width is located to the northeast of the mill complex and adjacent to the Mawddach falls. The building has walls standing to approximately 2.5m constructed from medium sized angular stone blocks bonded by lime mortar. The roof appears to have been of corrugated metal but has long since collapsed into the building along with the trusses. The structure is divided into two rooms by an internal stone wall that runs from north-south down the centre of the building. There are two doorways in the southern wall and also two windows in the same wall and a third in the eastern wall. The interior of each compartment is approximately 9.0m by 4.5m in size and each has a chimney and hearth located on the western walls. The chimney in the western compartment is constructed from stone and brick and the one in the eastern compartment is solely of brick construction.</p> <p>The building is depicted on the first and second edition 25" Ordnance Survey maps of 1889 and 1901 respectively (figure 7 and 8), and is shown on the mine map of 1935 (figure 9). The building appears to date to at least the mill of 1887 but may have earlier origins from the mill of the 1860s. It has been identified in the past as a store but is in fact more likely to be a smithy building. The smithy should be considered to be of national importance because of its contribution to the overall group value of the mill, its workings, and its ancillary structures.</p> <p>Under the current hydro scheme proposals the smithy will not be impacted upon and as such there are no recommendations made for further assessment or mitigatory measures aside from avoidance.</p>

Plate 31: Smithy buildings feature 10, from the southeast. Scale 1.0m.

Category of importance: National	
Level of impact: None	
Significance of effect: Neutral	
Recommendations for further assessment: None	
Recommendations for further mitigatory measures: None/ avoidance

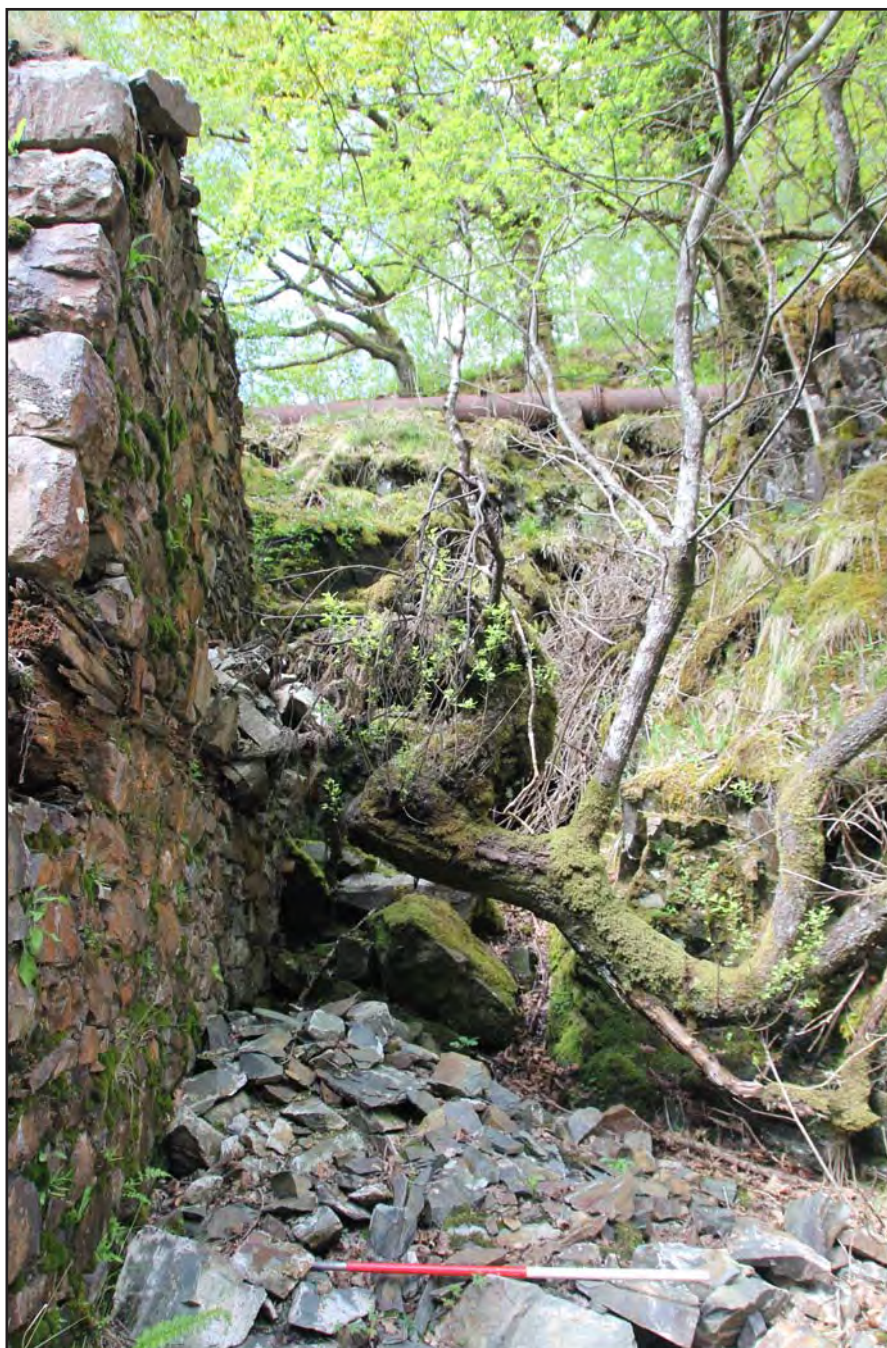
11. Smithy waterwheel pit	PRN: 59160
Figure: 7, 8, 9, and 13	Plate: 32
NGR: SH 73565 27475	Period: Post-medieval
<p>Description</p> <p>A thick wall measuring 0.5m in width and 3.0m in height butts up against the northern gable wall of the Smithy building. The wall is constructed from large angular stone blocks bonded by a lime mortar. An old trial adit measuring approximately 2.5m in width lies to the immediate north and it is possible that this feature represents a waterwheel pit. The wheel may have powered the smithy to the immediate south but appears to be situated too low to have done so. The site of the original mill of 1863 which had four Britten pans driven by a waterwheel has been assumed in the past to have been located at the Charlotte Elizabeth mill site, but it can be theorised that this building may have indeed been the site of the first mill. This is purely conjectural on the part of the author.</p> <p>The building is depicted on the first and second edition 25" Ordnance Survey maps of 1889 and 1901 respectively (figure 7 and 8), and is shown on the mine map of 1935 (figure 9). The smithy waterwheel pit should be considered to be of national importance because of its contribution to the overall group value of the mill, its workings, and its ancillary structures.</p> <p>Under the current hydro scheme proposals the smithy will not be impacted upon and as such there are no recommendations made for further assessment or mitigatory measures aside from avoidance.</p>

Plate 32: Possible water wheel pit feature 11, from the east. Scale 1.0m.

Category of importance: National	
Level of impact: None	
Significance of effect: Neutral	
Recommendations for further assessment: None	
Recommendations for further mitigatory measures: None/ avoidance

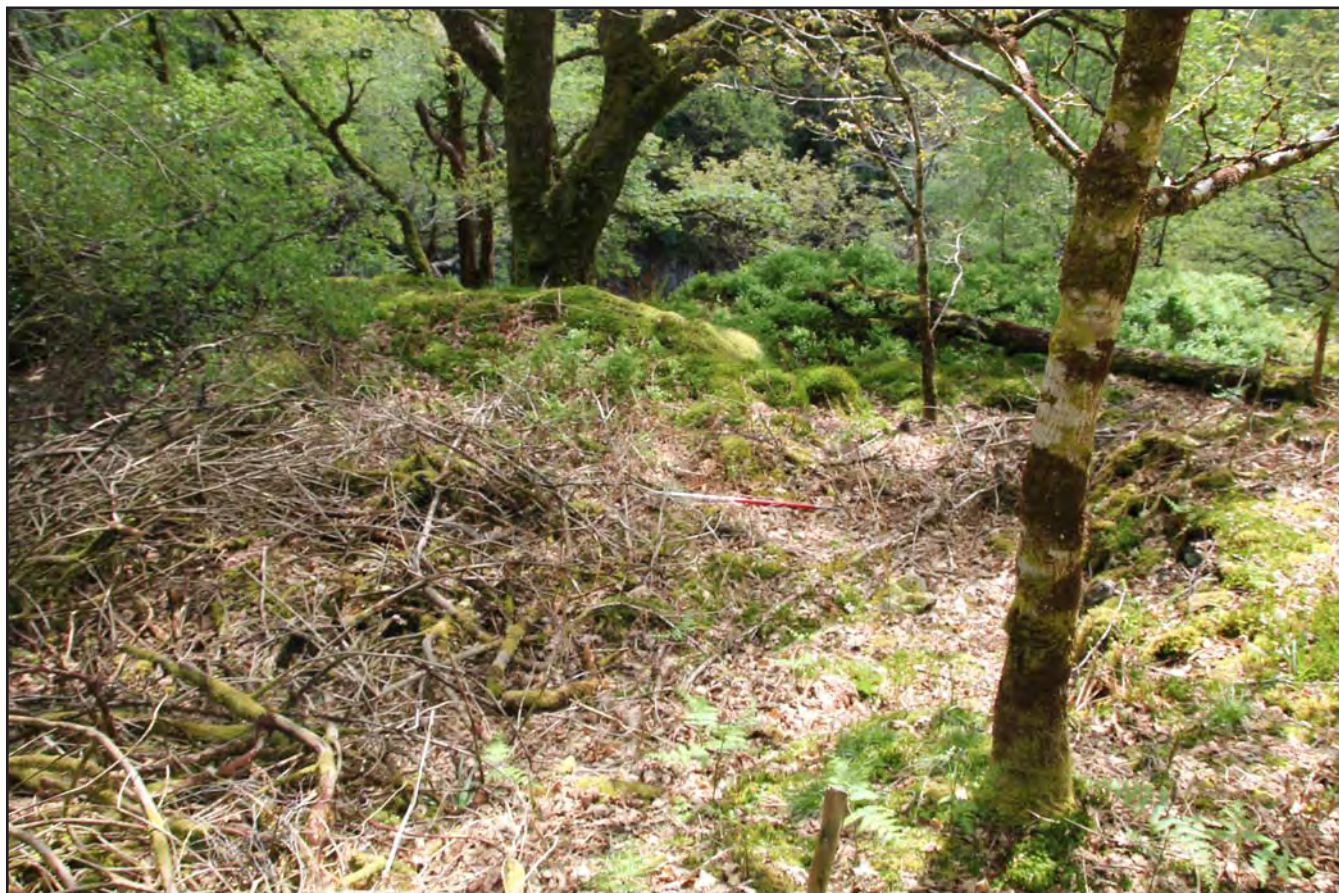
12. Ruined structure	PRN: 59161
Figure: 8, 9, and 13	Plate: 33
NGR: SH 73548 27513	Period: Post-medieval
<p>Description</p> <p>A square structure is depicted on the second edition 25" Ordnance Survey map of 1901 (figure 8), and is shown on the mine map of 1935 (figure 9). The structure exists today as a mound in the grass measuring approximately 4.0m square. The function of the building is unclear but appears to have been constructed as part of the 1888 mill extension. The structure should be considered to be of national importance because of its contribution to the overall group value of the mill, its workings, and its ancillary structures.</p> <p>Under the current hydro scheme proposals the structure will not be impacted upon and as such there are no recommendations made for further assessment or mitigatory measures aside from avoidance.</p>	
Category of importance: National	
Level of impact: None

Plate 33: Structure feature 12, from the west. Scale 1.0m.

Significance of effect: Neutral	
Recommendations for further assessment: None	
Recommendations for further mitigatory measures: None/ avoidance

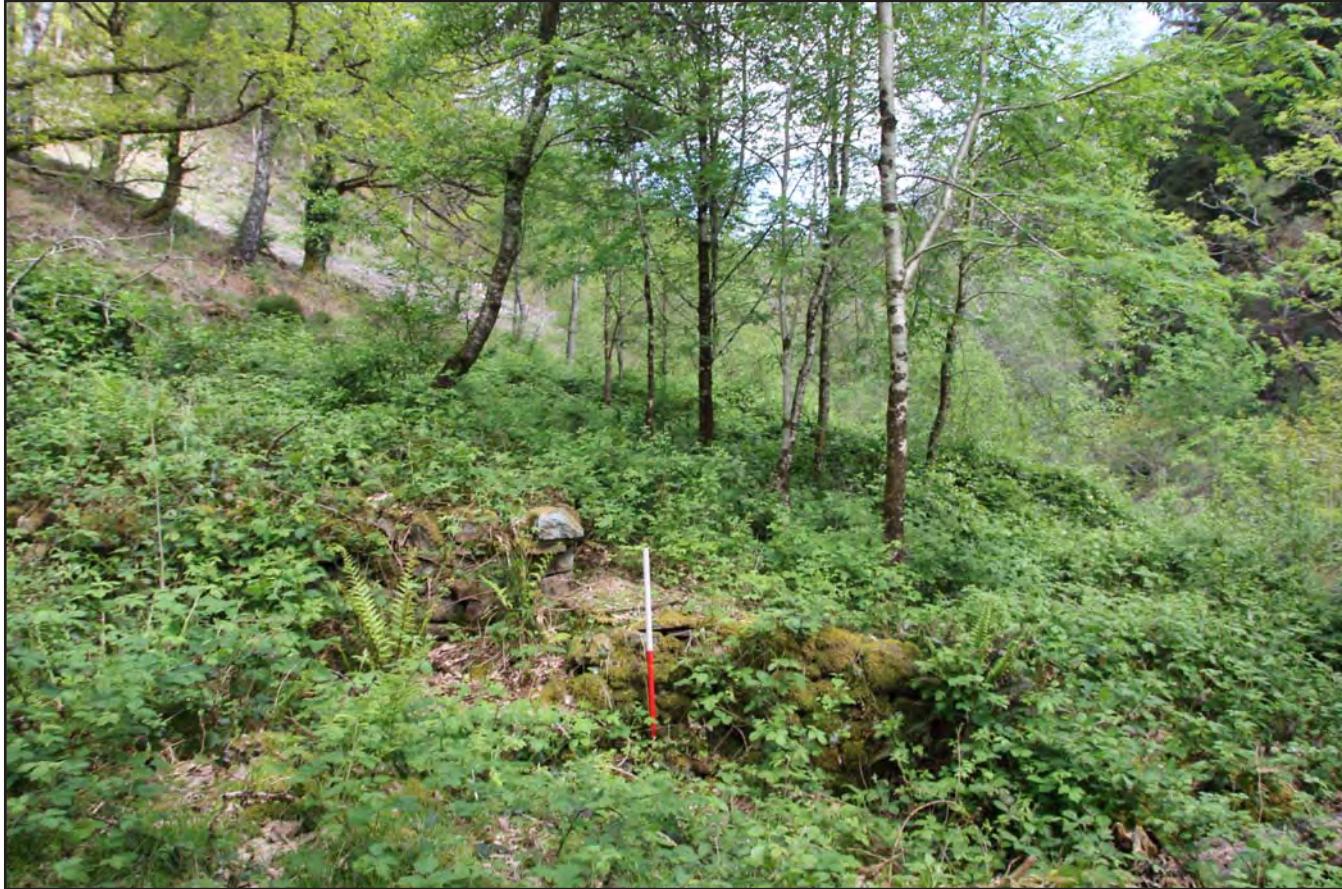
13. Offices	PRN: 59162
Figure: 8, 9, and 13	Plate: 34
NGR: SH 73548 27513	Period: Post-medieval
<p>Description</p> <p>A rectangular structure orientated north to south is depicted on the second edition 25" Ordnance Survey map of 1901 (figure 8), and is shown on the mine map of 1935 (figure 9). The structure exists today as a series of low walls approximately 0.5m in height and heavily overgrown with bracken. The building was almost certainly the mill office and appears to have been constructed as part of the 1888 mill extension. The structure should be considered to be of national importance because of its contribution to the overall group value of the mill, its workings, and its ancillary structures.</p> <p>Under the current hydro scheme proposals the structure will not be impacted upon and as such there are no recommendations made for further assessment or mitigatory measures aside from avoidance.</p>

Plate 34: Offices feature 13, from the south. Scale 1.0m.

Category of importance: National	
Level of impact: None	
Significance of effect: Neutral	
Recommendations for further assessment: None	
Recommendations for further mitigatory measures: None/ avoidance

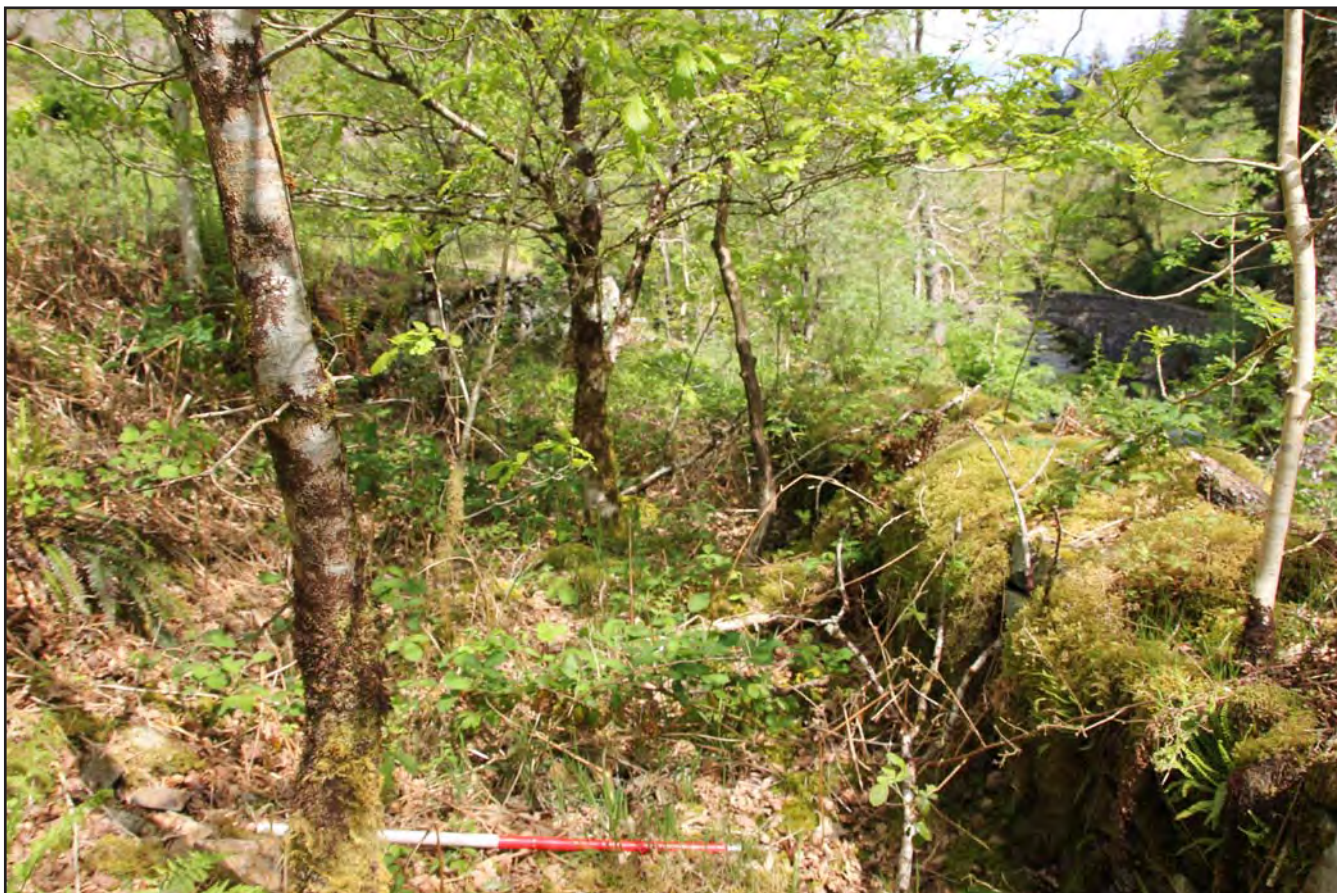
14. Trackway	PRN: 59163
Figure: 8, 9, and 13	Plate: 35
NGR: SH 73573 27556	Period: Post-medieval
<p>Description</p> <p>A grassed over trackway measuring 4.0m in width leads down from the present track (feature 3) in a southwest to northeast direction to the compressor house (feature 15). The track is depicted on the second edition 25" Ordnance Survey map of 1901 (figure 8), and is shown on the mine map of 1935 (figure 9). The trackway appears to have been constructed as part of the 1888 mill extension. The structure should be considered to be of national importance because of its contribution to the overall group value of the mill, its workings, and its ancillary structures.</p> <p>Under the current hydro scheme proposals the structure will not be impacted upon and as such there are no recommendations made for further assessment or mitigatory measures aside from avoidance.</p>	
Category of importance: National

Plate 35: Trackway feature 14, from the south. Scale 1.0m.

Level of impact: None	
Significance of effect: Neutral	
Recommendations for further assessment: None	
Recommendations for further mitigatory measures: None/ avoidance

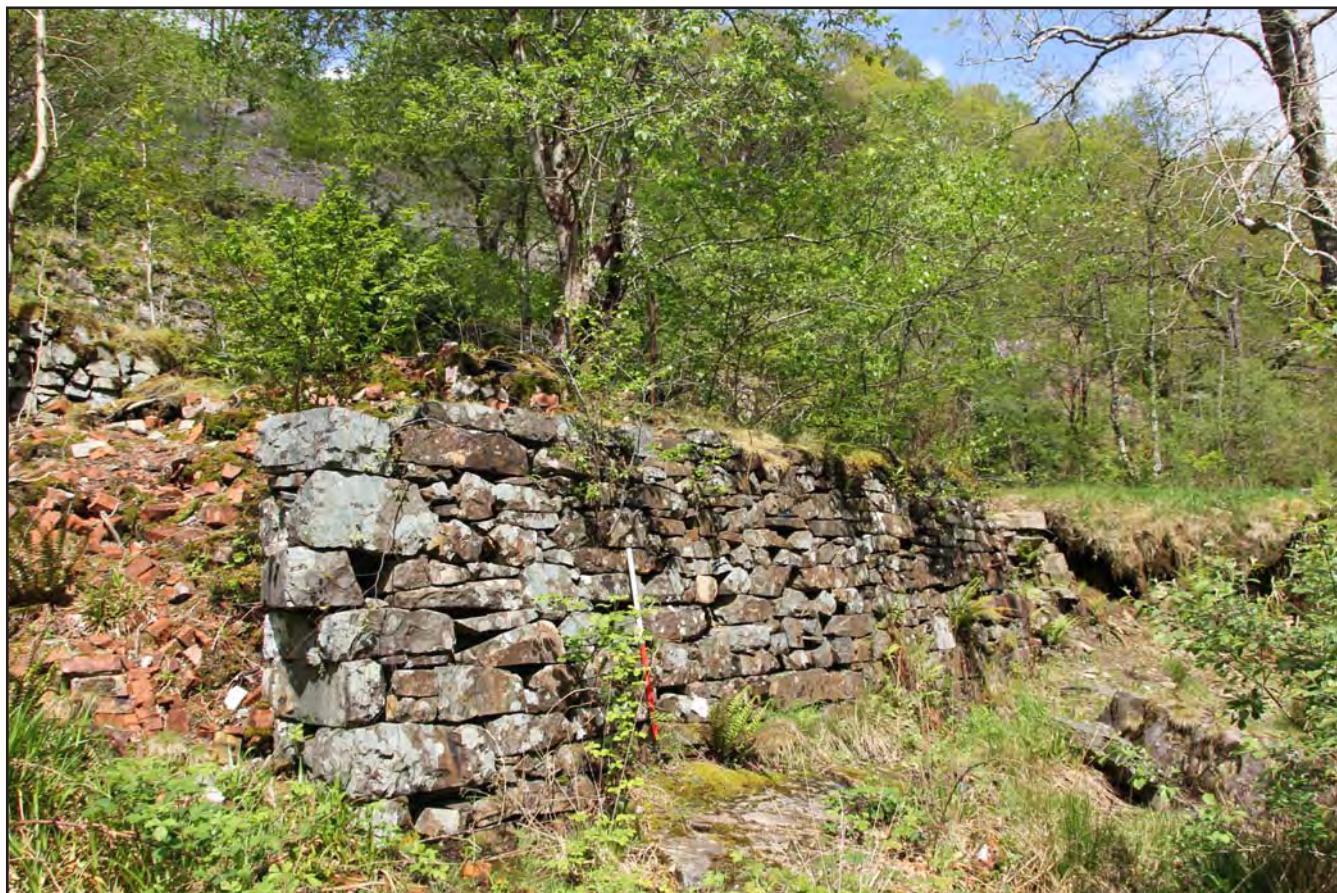
15. Compressor House	PRN: 59164
Figure: 8, 9, and 13	Plate: 36
NGR: SH 73580 27577	Period: Post-medieval
<p>Description</p> <p>A revetted platform located directly on the eastern bank of the Afon Mawddach is constructed from dry-stone bonded large angular stone blocks measuring 1.6m in height and is the location of the compressor house. The building is depicted on the second edition 25" Ordnance Survey map of 1901 (figure 8), and is shown on the mine map of 1935 (figure 9). The compressor house appears to have been constructed as part of the 1888 mill extension. The structure should be considered to be of national importance because of its contribution to the overall group value of the mill, its workings, and its ancillary structures.</p> <p>Under the current hydro scheme proposals the structure will not be impacted upon and as such there are no recommendations made for further assessment or mitigatory measures aside from avoidance.</p>

Plate 36: Compressor house base feature 15, from the southeast. Scale 1.0m.

Category of importance: National	
Level of impact: None	
Significance of effect: Neutral	
Recommendations for further assessment: None	
Recommendations for further mitigatory measures: None/ avoidance

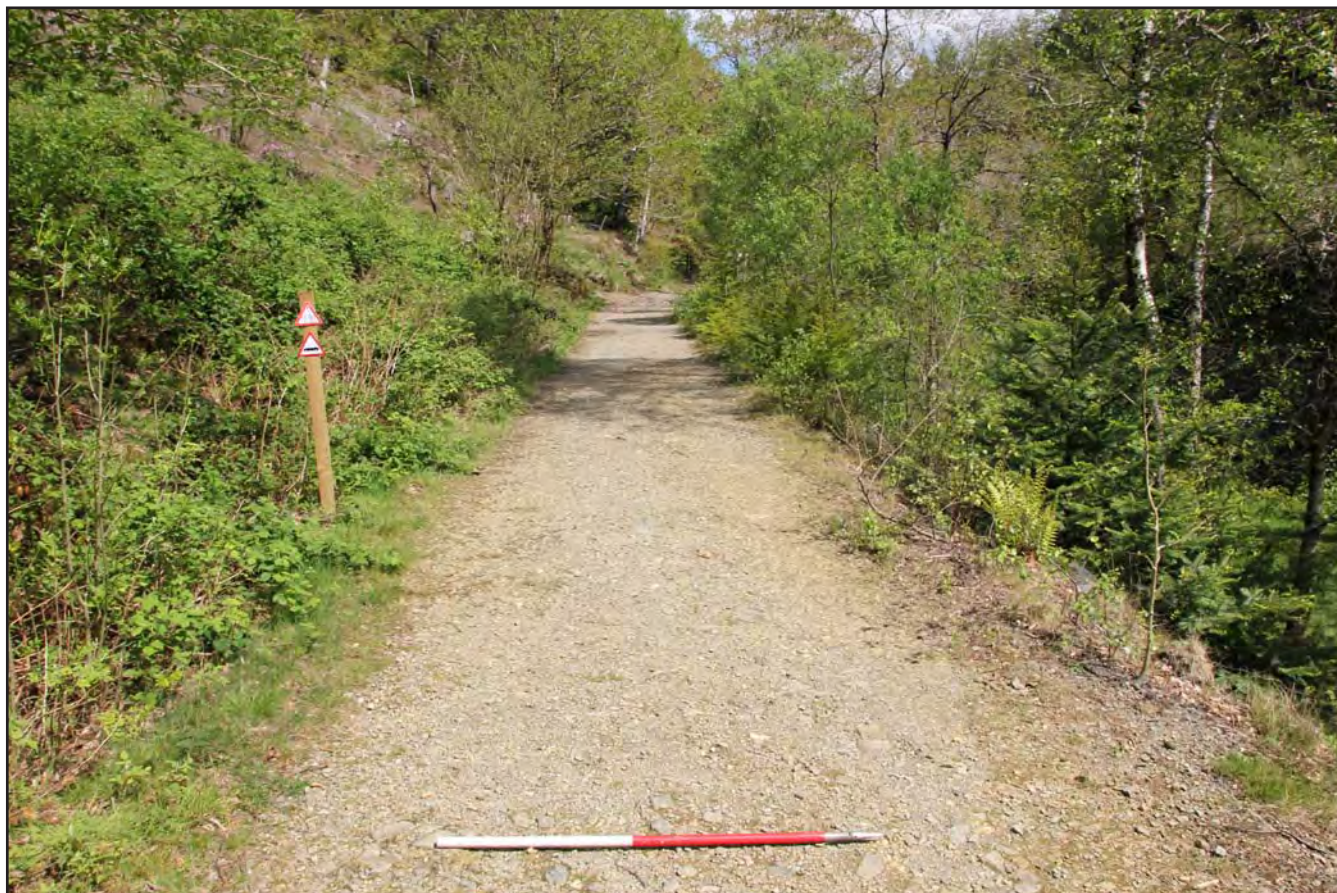
16. Tramway	PRN: 59165
Figure: 7, 8, 9, and 13	Plate: 37
NGR: SH 73557 27549	Period: Post-medieval
<p>Description</p> <p>A revetted trackway running parallel with the river follows the line of the trackway at this point. The revetment measures up to 3.0m in height in places and acted as a tramway to transport ore from the mine in the north to the mill.</p> <p>The tramway is depicted on the first and second edition 25" Ordnance Survey maps of 1889 and 1901 respectively (figure 7 and 8), and is shown on the mine map of 1935 (figure 9). The tramway route should be considered to be of national importance because of its contribution to the overall group value of the mill, its workings, and its ancillary structures.</p> <p>Under the current hydro scheme proposals the structure will not be impacted upon and as such there are no recommendations made for further assessment or mitigatory measures aside from avoidance.</p>

Plate 37: Tramway feature 16, from the south. Scale 1.0m.

Category of importance: National	
Level of impact: None	
Significance of effect: Neutral	
Recommendations for further assessment: None	
Recommendations for further mitigatory measures: None/ avoidance
