**Afon Craig Las Hydro, Nantlle,
Gwynedd.
March 2015
V 1.0**

Archaeological Assessment
Project Code: A0056.1
Report no. 0059

Archaeological Assessment

Client: Greenearth Hydro Ltd

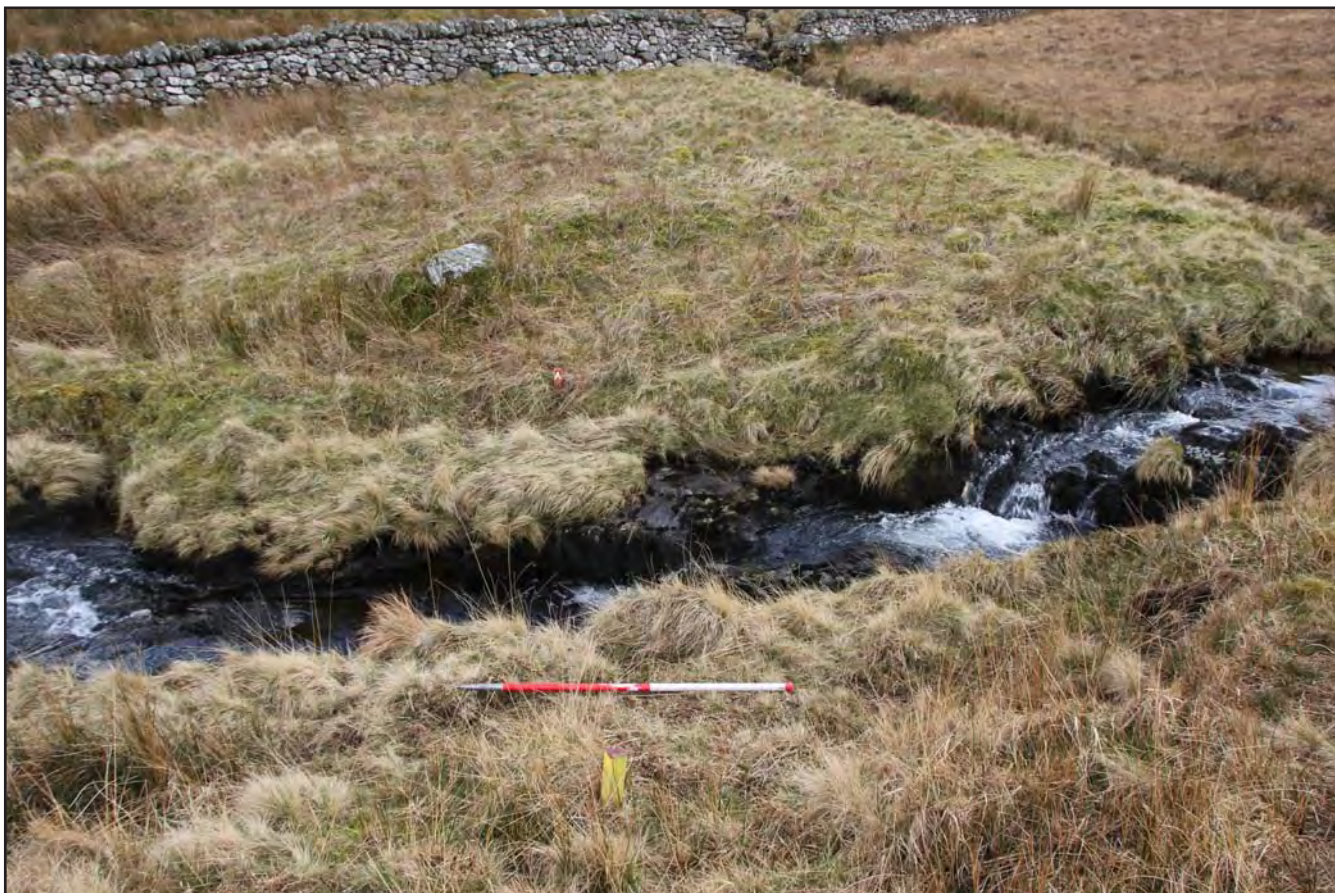
Plate 01: Proposed hydro intake location, from the northwest. Scale 1.0m.

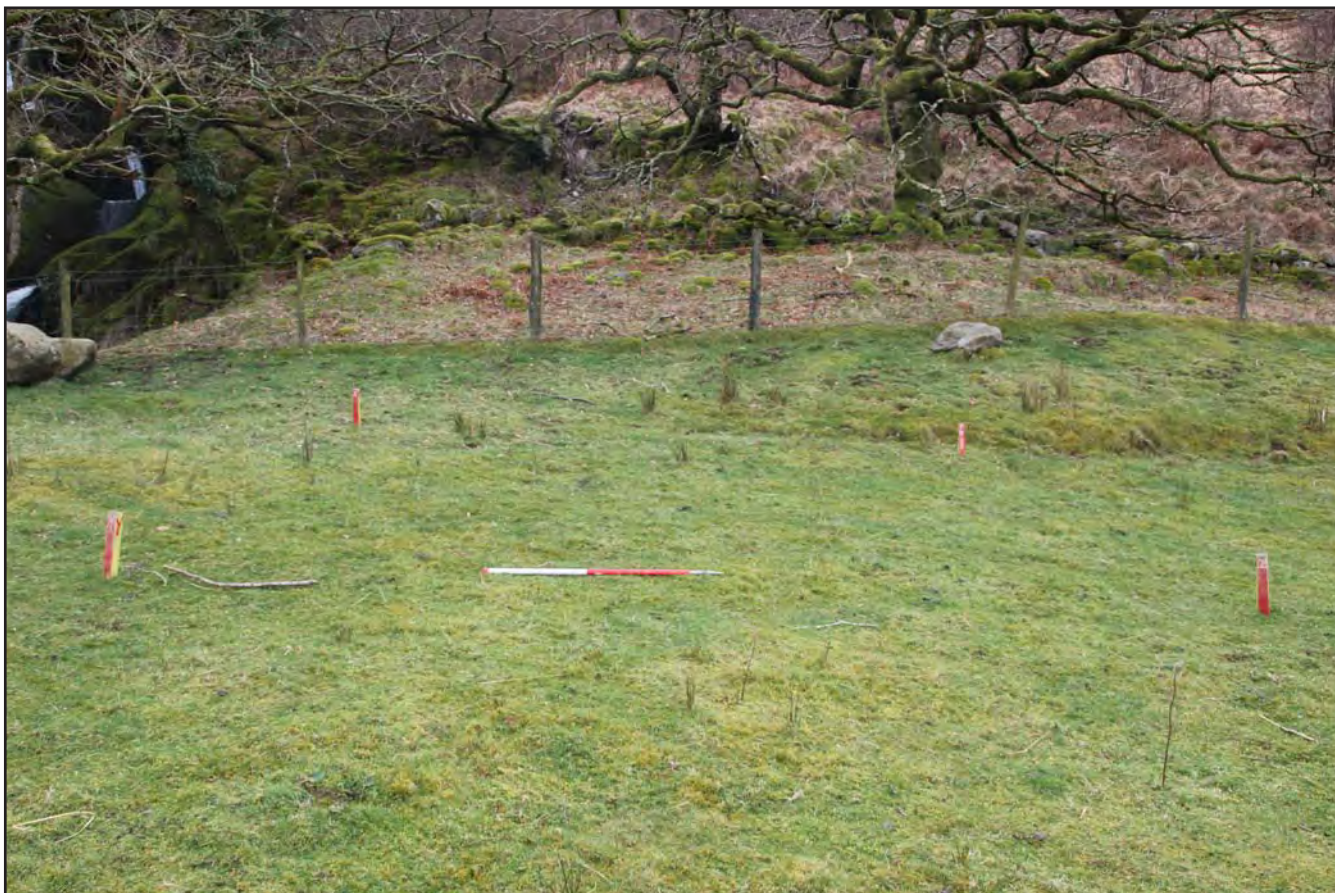
Plate 02: Proposed turbine house location, from the north. Scale 1.0m.

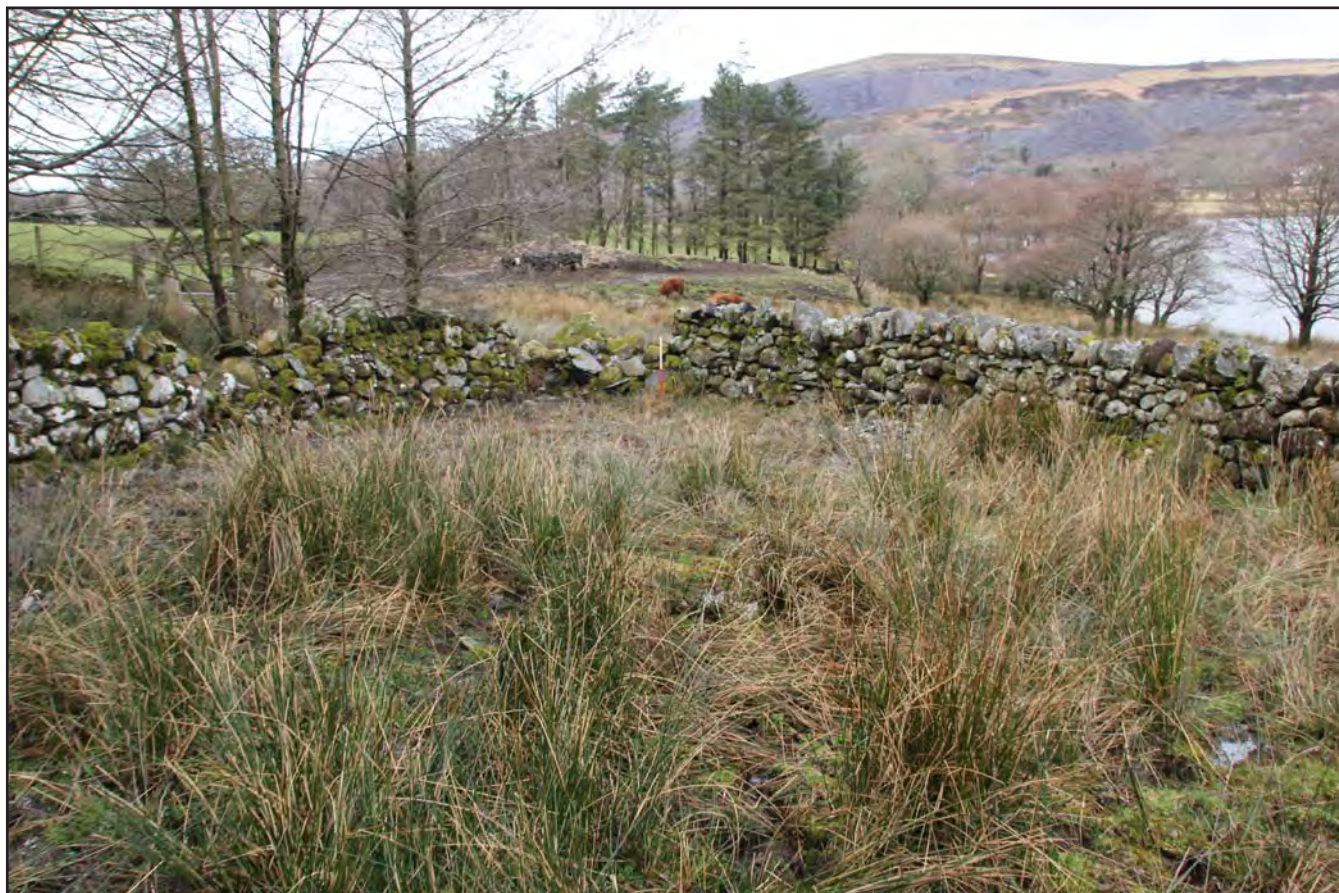
Plate 03: Sheepfold (feature 1), from the southeast. Scale 1.0m.

Significance of effect: Neutral	
Recommendations for further assessment: None	
Recommendations for further mitigatory measures: None

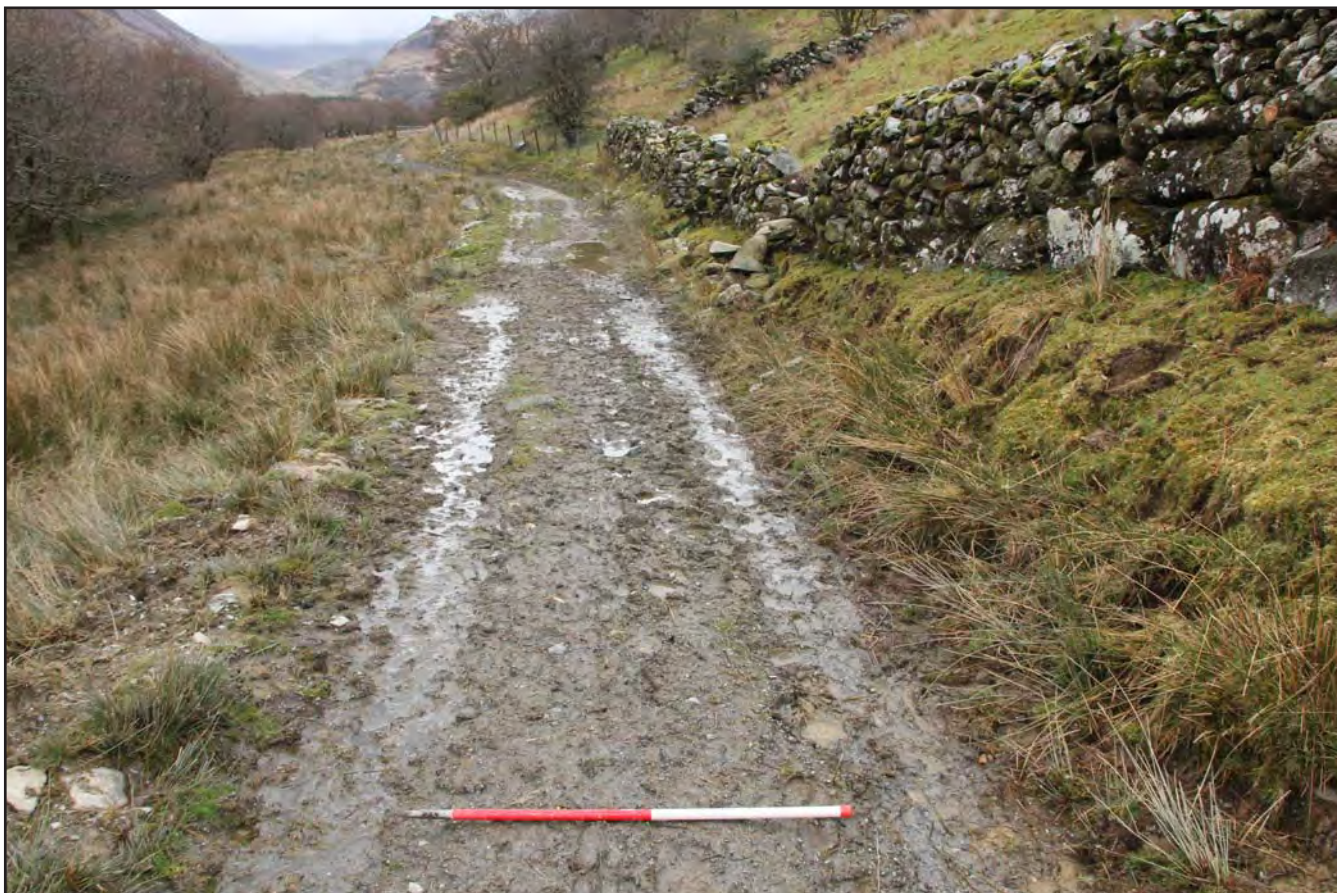
2. Trackway	PRN: 60155
Figure: 7	Plate: 4
NGR: SH 51098 52793 – SH 51931 52789	Period: Post-medieval
<p>Description</p> <p>A trackway measuring 2.0m in width runs from Fridd Farm in the west along the southern bank of Llyn Nantlle to the enclosed grazing fields in the east. The trackway is made up of deposited stone rubble and is depicted on the first, second and third edition Ordnance Survey 25" County Series maps of 1889, 1900 and 1916 respectively (figures 4, 5 and 6).</p> <p>The trackway is most likely post-medieval although an earlier date is also possible, and it is considered to be of local importance. The new electrical cable will be trenched into the trackway for approximately 1.0km and as such will have a medium adverse direct physical impact upon the feature resulting in a slight adverse significance of effect during the construction phase. There will not be any further impact upon completion of the works.</p> <p>It is proposed that a basic record of the trackway be taken prior to the commencement of works, however the record presented in this report should be seen as being commensurate with a basic record level and as such no further assessment or mitigatory measures are proposed.</p>

Plate 02: Trackway (feature 2), from the west. Scale 1.0m.

Category of importance: Local	
Level of impact: Medium adverse direct physical (during construction phase)	
Significance of effect: Slight adverse (during construction phase)	
Recommendations for further assessment: None	
Recommendations for further mitigatory measures: Basic record – completed as part of the assessment

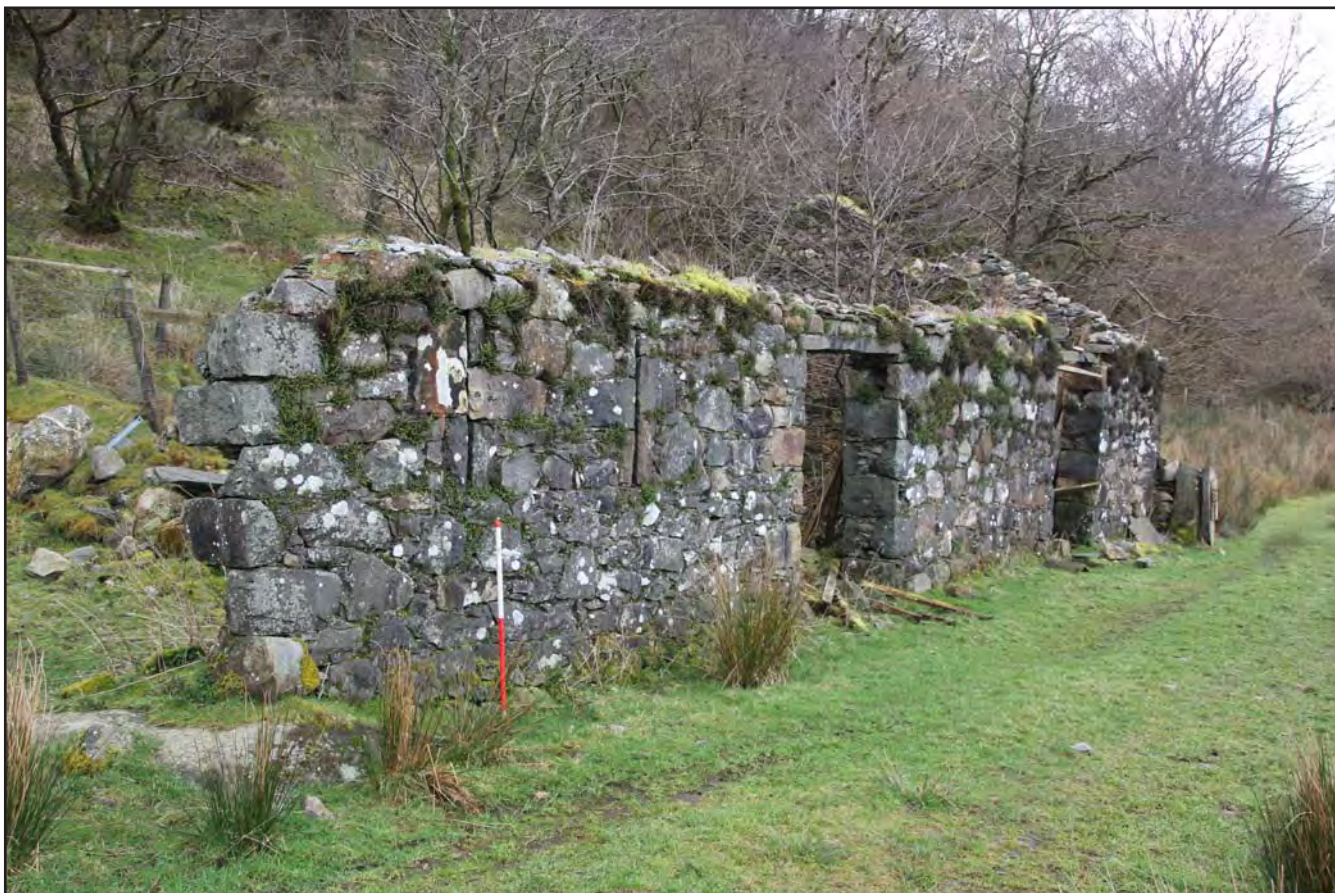
3. Ruined Farmstead	PRN: 22531
Figure: 7	Plate: 5
NGR: SH 51799 52772	Period: Post-medieval
<p>Description</p> <p>A cow shelter is recorded on the Gwynedd HER at this point, however the structure is in fact a ruined farmstead. The structure measures approximately 24.0m in length by 8.0m in width orientated east to west. The walls are constructed from dry-stone single-skin medium sized sub-rounded cobbles surviving generally to 2.0m in height, with the exception of the western gable which stands 3.5m to the eaves. The western half of the structure is occupied by the former dwelling, with the eastern half given over to an animal barn. The structure is roofless and becoming overgrown.</p> <p>The farmstead is depicted on the first, second and third edition Ordnance Survey 25" County Series maps of 1889, 1900 and 1916 respectively (figures 4, 5 and 6) and is of post-medieval date. The structure will not be impacted upon by the proposed works and as such there are no further recommendations for assessment or mitigatory measures.</p>

Plate 05: Ruined cottage (feature 3), from the northeast. Scale 1.0m.

Category of importance: Local	
Level of impact: None	
Significance of effect: Neutral	
Recommendations for further assessment: None	
Recommendations for further mitigatory measures: None

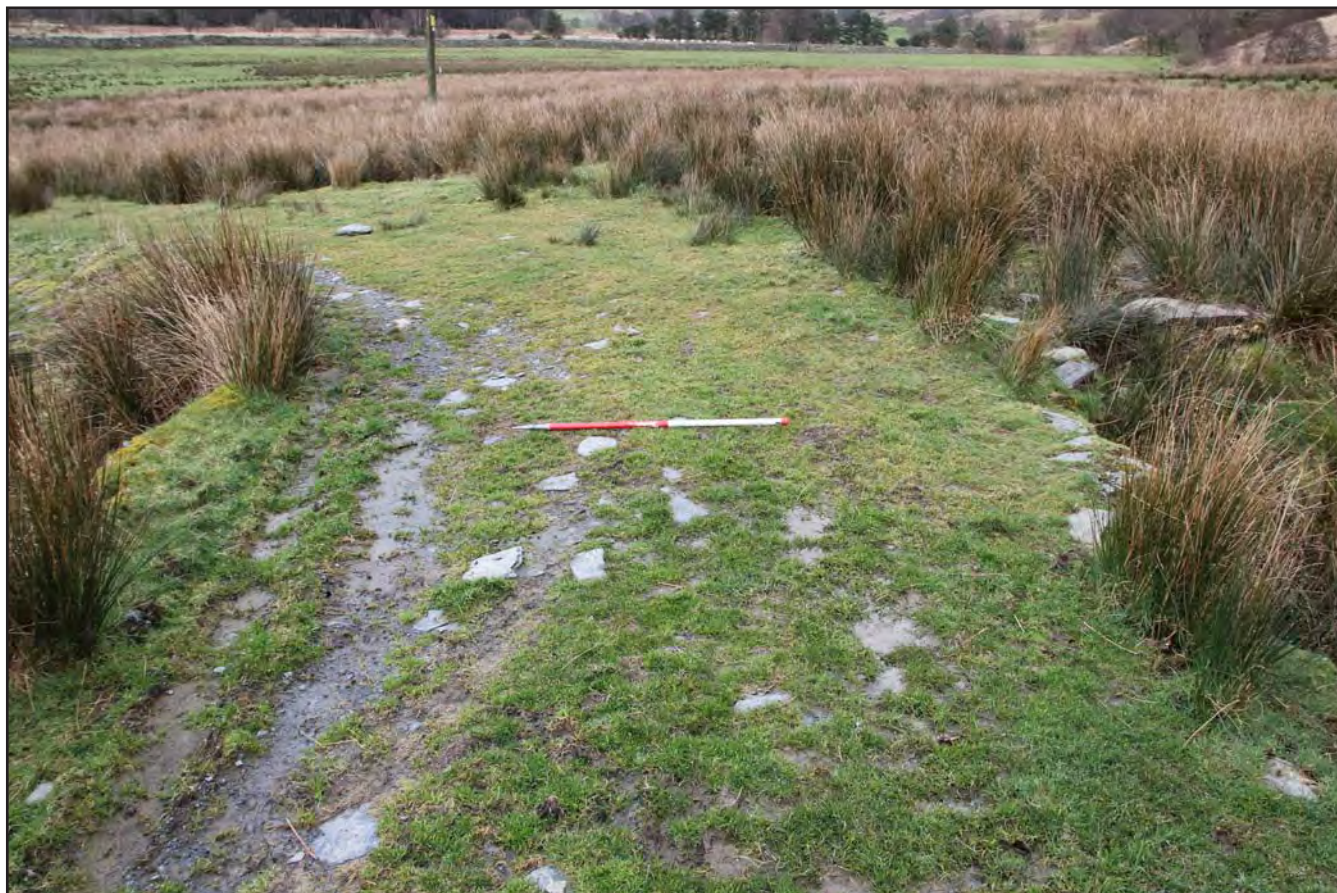
4. Fridd Footbridge 1	PRN: 22532
Figure: 7	Plate: 6
NGR: SH 51946 52789	Period: Post-medieval
Description A footbridge constructed from dry-stone medium sized sub-rounded cobbles and measuring 3.0m spans the stream at this point. The bridge is shown on the first, second and third edition Ordnance Survey 25" County Series maps of 1889, 1900 and 1916 respectively (figures 4, 5 and 6) and is almost certainly post-medieval in date. The new cable route will be trenched alongside the bridge and as such it will not be impacted upon by the proposed scheme. No further assessment or mitigatory measures are proposed.	
Category of importance: Local	
Level of impact: None	
Significance of effect: Neutral	
Recommendations for further assessment: None	
Recommendations for further mitigatory measures: None

Plate 06: Footbridge (feature 4), from the west. Scale 1.0m.

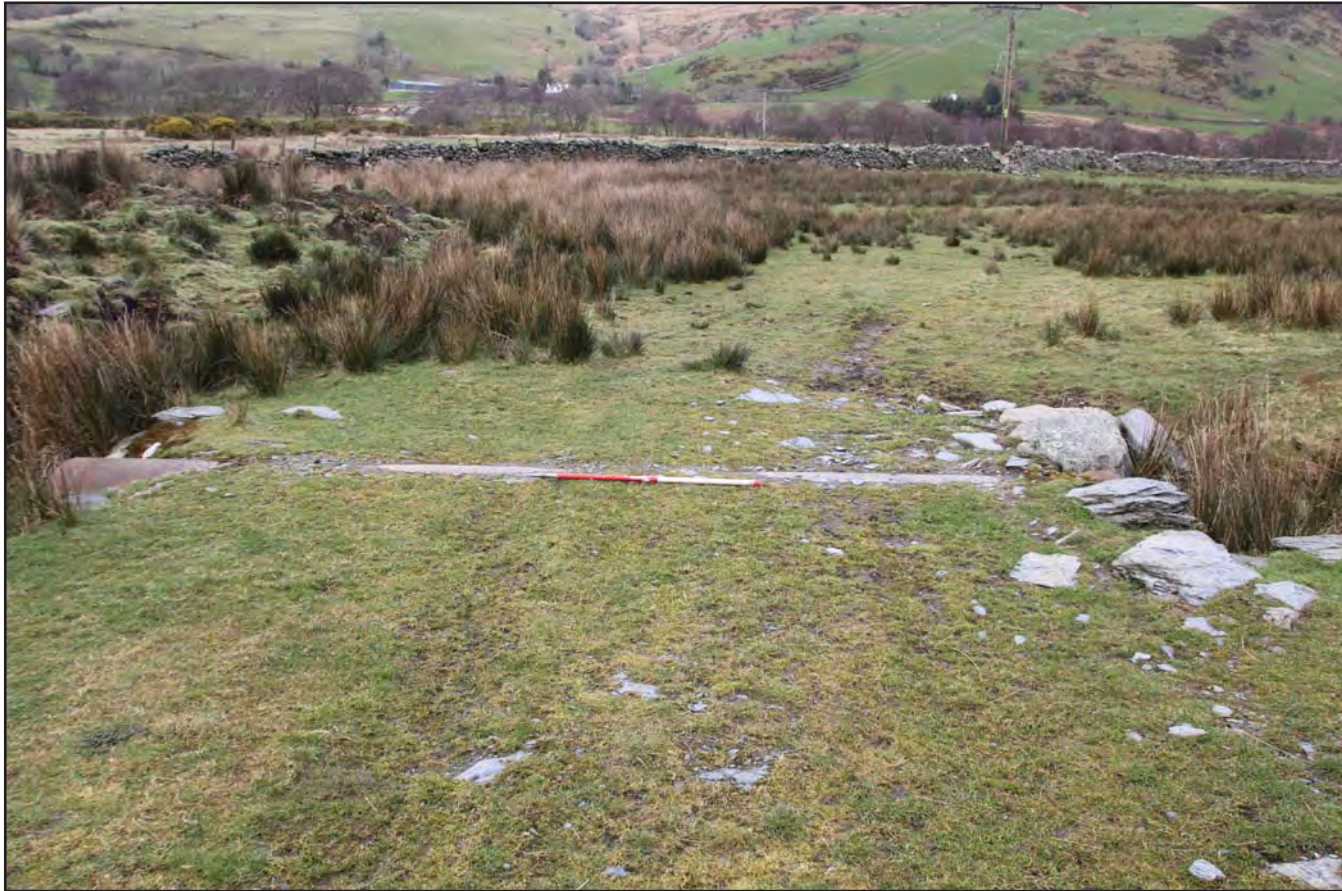
5. Fridd Footbridge 2	PRN: 22533
Figure: 7	Plate: 7
NGR: SH 51989 52794	Period: Post-medieval
<p>Description A footbridge constructed from dry-stone medium sized sub-rounded cobbles and measuring 3.0m spans the stream at this point. The bridge is shown on the first, second and third edition Ordnance Survey 25" County Series maps of 1889, 1900 and 1916 respectively (figures 4, 5 and 6) and is almost certainly post-medieval in date.</p> <p>The new cable route will be trenched approximately 13.0m south of the bridge and as such it will not be impacted upon by the proposed scheme. No further assessment or mitigatory measures are proposed.</p>	
Category of importance: Local	
Level of impact: None	
Significance of effect: Neutral	
Recommendations for further assessment: None	
Recommendations for further mitigatory measures: None

Plate 07: Footbridge (feature 5), from the southwest. Scale 1.0m.

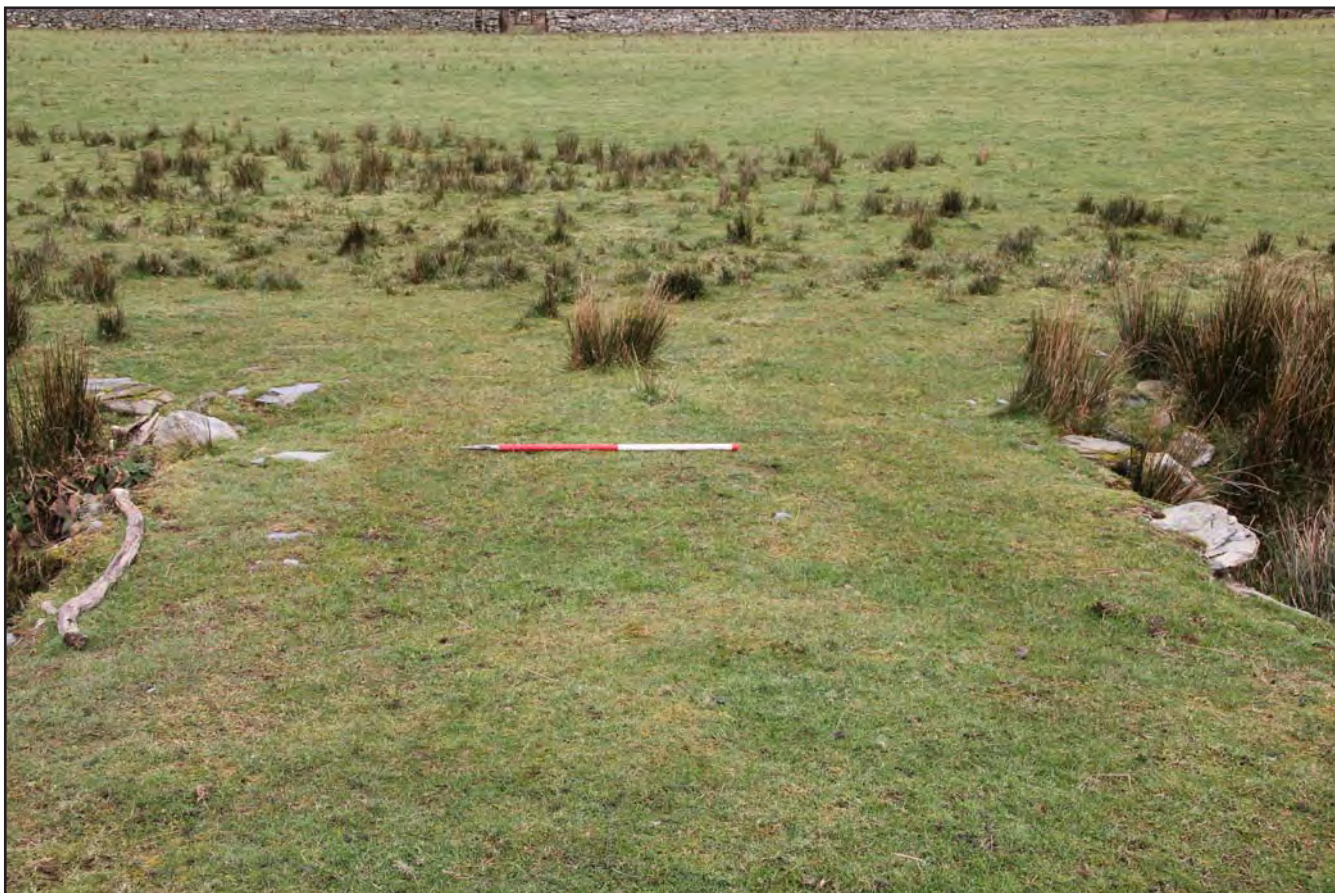
6. Fridd Footbridge 3	PRN: 60156
Figure: 7	Plate: 8
NGR: SH 52034 52769	Period: Post-medieval
Description A footbridge constructed from dry-stone medium sized sub-rounded cobbles and measuring 3.0m spans the stream at this point. The bridge is shown on the first, second and third edition Ordnance Survey 25" County Series maps of 1889, 1900 and 1916 respectively (figures 4, 5 and 6) and is almost certainly post-medieval in date. The new cable route will be trenched alongside the bridge and as such it will not be impacted upon by the proposed scheme. No further assessment or mitigatory measures are proposed.	
Category of importance: Local	
Level of impact: None	
Significance of effect: Neutral	
Recommendations for further assessment: None	
Recommendations for further mitigatory measures: None

Plate 08: Footbridge (feature 6), from the west. Scale 1.0m.

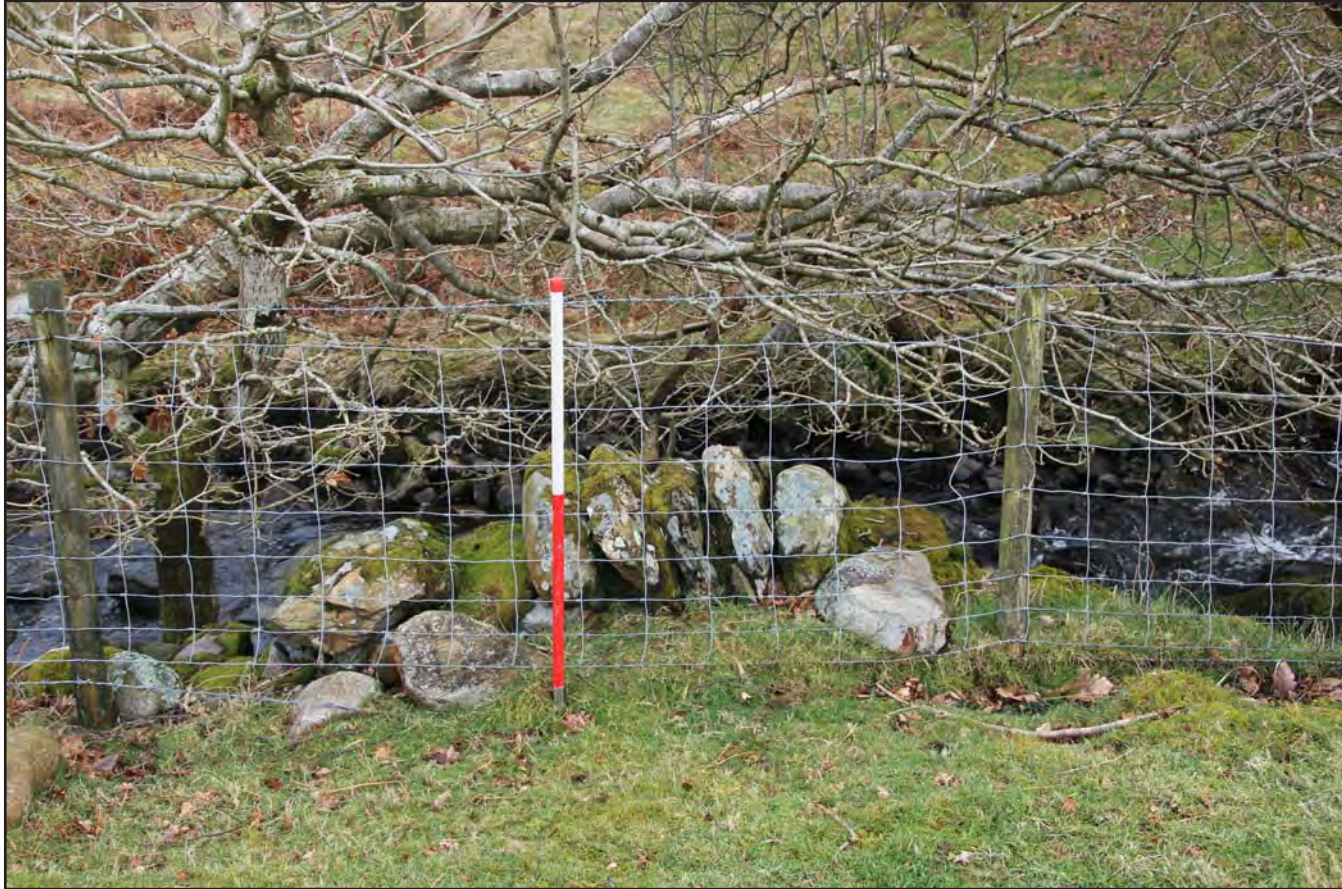
7. Stream Revetment Wall	PRN: 60157
Figure: 7	Plate: 9
NGR: SH 52208 52748	Period: Post-medieval
<p>Description</p> <p>A stock-proof dry-stone revetment wall is located on the western bank of the Afon Craig Las to the immediate east of the turbine house location. The wall measures approximately 1.0m in height on the stream side and has upstanding remains approximately 0.5m in height on the field side. It is constructed from medium sized sub-angular cobbles and has been reinforced by a modern wooden post and wire fence.</p> <p>The wall is not depicted on the first, second and third edition Ordnance Survey 25" County Series maps of 1889, 1900 and 1916 respectively (figures 4, 5 and 6) but is likely to have been in existence at the time, forming a continuation of the eastern field boundary. The wall is almost certainly post-medieval in date and considered to be of local importance.</p> <p>The fallout pipe from the new turbine house will be required to be trenched through the revetment wall and thus it is expected that there will be a medium adverse direct physical impact resulting in a slight adverse significance of effect during the construction phase. As such it is recommended that a photographic record of the breached wall section be taken during the works and that the wall be reinstated upon completion.</p>

Plate 09: Stream revetment wall (feature 7), from the west. Scale 1.0m.

Category of importance: Local	
Level of impact: Medium adverse direct physical (during construction phase)	
Significance of effect: Slight adverse (during construction phase)	
Recommendations for further assessment: None	
Recommendations for further mitigatory measures: Photographic record during breach and reinstatement upon completion of works

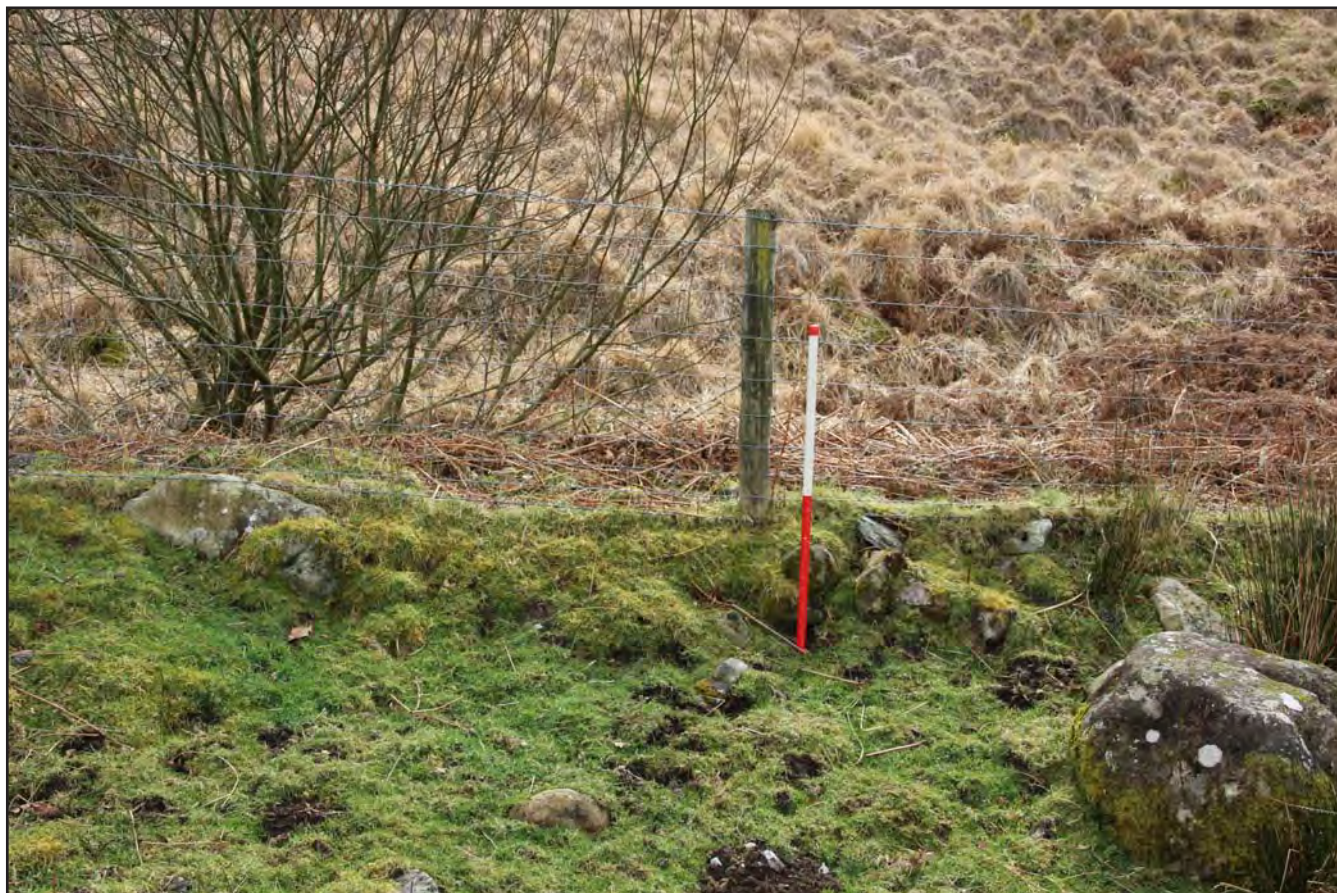
8. Field Boundary Wall	PRN: 60158
Figure: 7	Plate: 10
NGR: SH 52203 52734 – SH 52132 52747	Period: Post-medieval
<p>Description</p> <p>The remains of a dry-stone field boundary wall measuring approximately 0.5m in height and running from east to west marks the southern boundary of the enclosed grazing field at this point. The wall is constructed from medium and occasionally large sized sub-rounded cobbles and has become overgrown with turf. The wall has fallen out of use and been replaced with a modern wooden post and wire fence.</p> <p>The wall is depicted on the first, second and third edition Ordnance Survey 25" County Series maps of 1889, 1900 and 1916 respectively (figures 4, 5 and 6) and is likely to have been established as part of land improvements during the 18th-19th Centuries resulting in the reclamation of the immediate land surrounding Llyn Nantlle. As such the wall is considered to be of local importance.</p> <p>The hydro pipe will be required to be trenched through the boundary wall and thus it is expected that there will be a low adverse direct physical impact resulting in a neutral or slight adverse significance of effect during the construction phase. As such it is recommended that a photographic record of the breached wall section be taken during the works and that the wall be reinstated upon completion.</p>

Plate 10: Field wall (feature 8), from the north. Scale 1.0m.

Category of importance: Local	
Level of impact: Low adverse direct physical (during construction phase)	
Significance of effect: Neutral or slight adverse (during construction phase)	
Recommendations for further assessment: None	
Recommendations for further mitigatory measures: Photographic record during breach and reinstatement upon completion of works

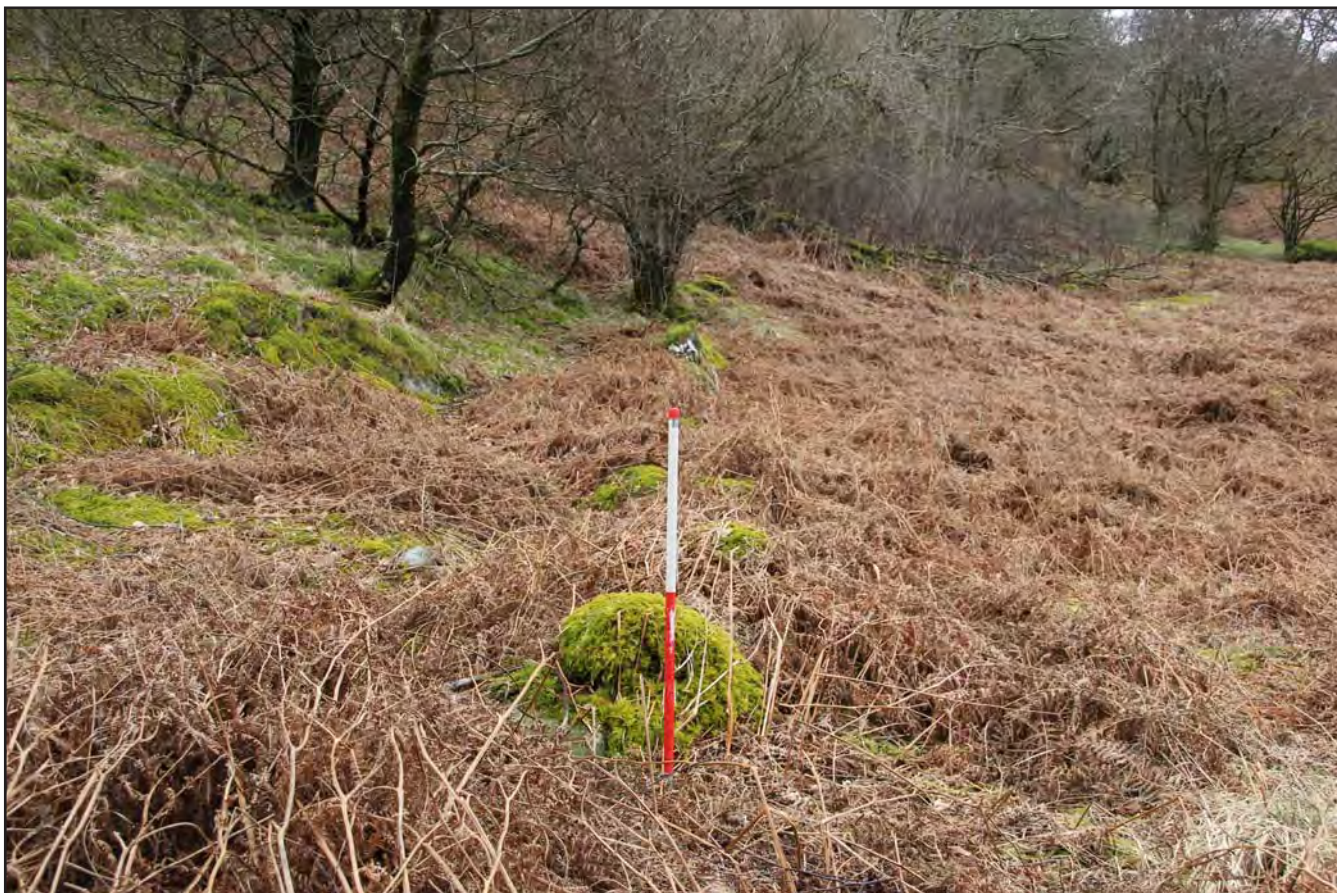
9. Former Field Wall	PRN: 60159
Figure: 7	Plate: 11
NGR: SH 52132 52747 – SH 52070 52654	Period: Post-medieval
<p>Description</p> <p>The remains of a dry-stone field boundary wall measuring approximately 0.5m in height and running from north to south meanders up the steep wooded slope at this point. The wall is constructed from medium and occasionally large sized sub-rounded cobbles and has become overgrown with turf and moss. The wall has fallen out of use and has become ruinous and diffuse in places.</p> <p>The wall is depicted on the first, second and third edition Ordnance Survey 25" County Series maps of 1889, 1900 and 1916 respectively (figures 4, 5 and 6) and originally formed the western boundary of a large grazing field.</p> <p>The hydro pipe will be required to be trenched through the boundary wall and thus it is expected that there will be a low adverse direct physical impact resulting in a neutral or slight adverse significance of effect during the construction phase. As such it is recommended that a photographic record of the breached wall section be taken during the works and that the wall be reinstated upon completion.</p>

Plate 11: Ruined field wall (feature 9), from the north. Scale 1.0m.

Category of importance: Local	
Level of impact: Low adverse direct physical (during construction phase)	
Significance of effect: Neutral or slight adverse (during construction phase)	
Recommendations for further assessment: None	
Recommendations for further mitigatory measures: Photographic record during breach and reinstatement upon completion of works

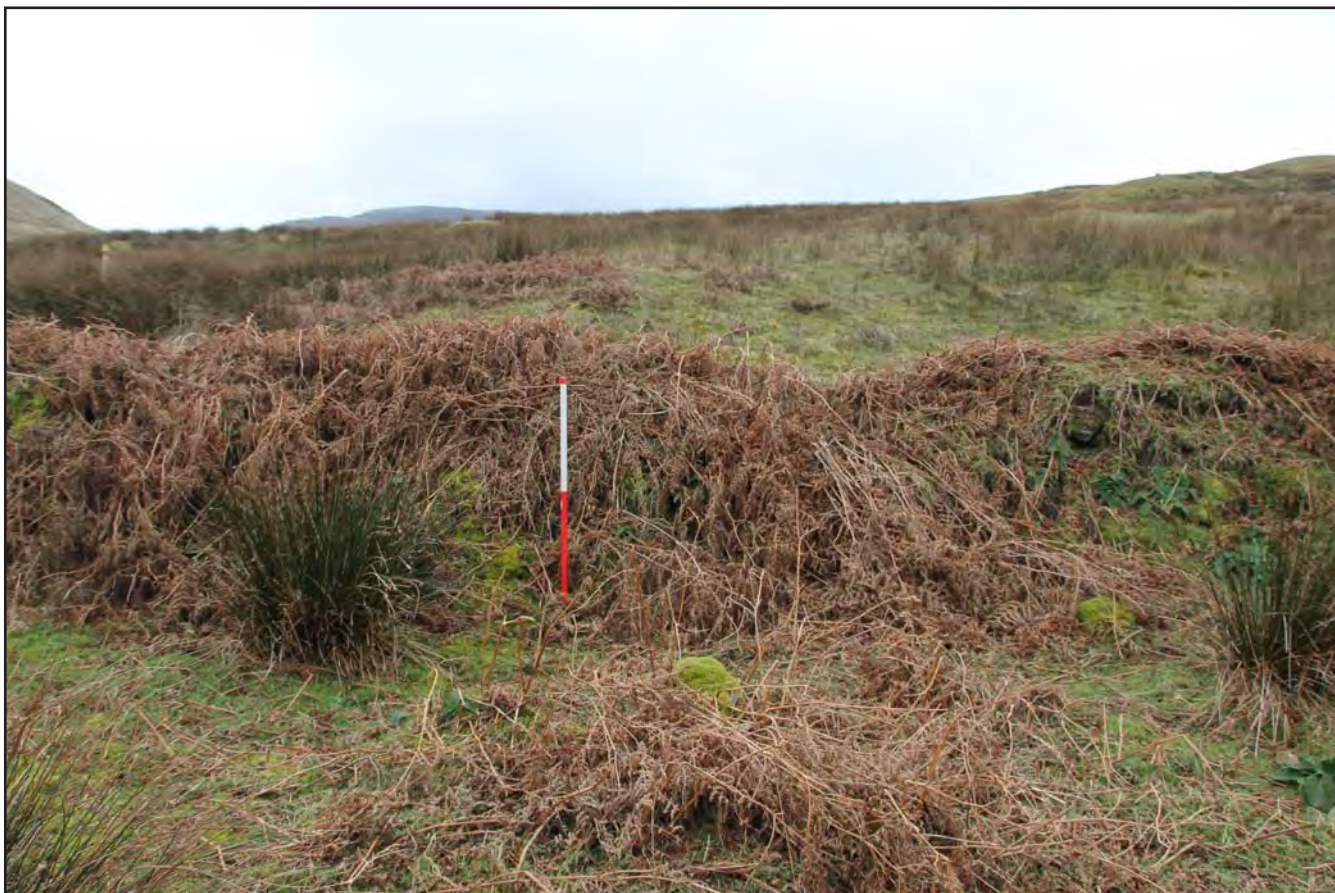
10. Relict Field Wall	PRN: 60160
Figure: 7	Plate: 12
NGR: SH 52191 52555 – SH 51920 52560	Period: Unknown (Roman/medieval)
<p>Description</p> <p>The remains of a dry-stone field boundary wall measuring approximately 1.0m in height, 1.0m in width and running from east to west is located at this point. The wall is constructed from medium sized sub-rounded cobbles and has become very overgrown with turf and bracken. The wall has fallen out of use and has become ruinous and diffuse in places.</p> <p>The wall is depicted on the first, second and third edition Ordnance Survey 25" County Series maps of 1889, 1900 and 1916 respectively (figures 4, 5 and 6) and originally formed the northern boundary of a large grazing field.</p> <p>The wall appears to run parallel with a series of features identified from aerial photographs that are believed to be Roman or possibly medieval paddocks (see feature 22) and as such this wall may have such origins.</p> <p>The hydro pipe will be required to be trenched through the boundary wall and thus it is expected that there will be a low adverse direct physical impact resulting in a neutral or slight adverse significance of effect during the construction phase. As the wall is potentially of regional importance it is recommended that a watching brief be maintained during the works and that a photographic record of the revealed wall section be taken.</p>

Plate 12: Ruined field wall (feature 10), from the north. Scale 1.0m.

Category of importance: Unknown (regional)	
Level of impact: Low adverse direct physical (during construction phase)	
Significance of effect: Slight adverse (during construction phase)	
Recommendations for further assessment: None	
Recommendations for further mitigatory measures: Watching brief during wall breach; photographic record of revealed section and reinstatement upon completion of works.

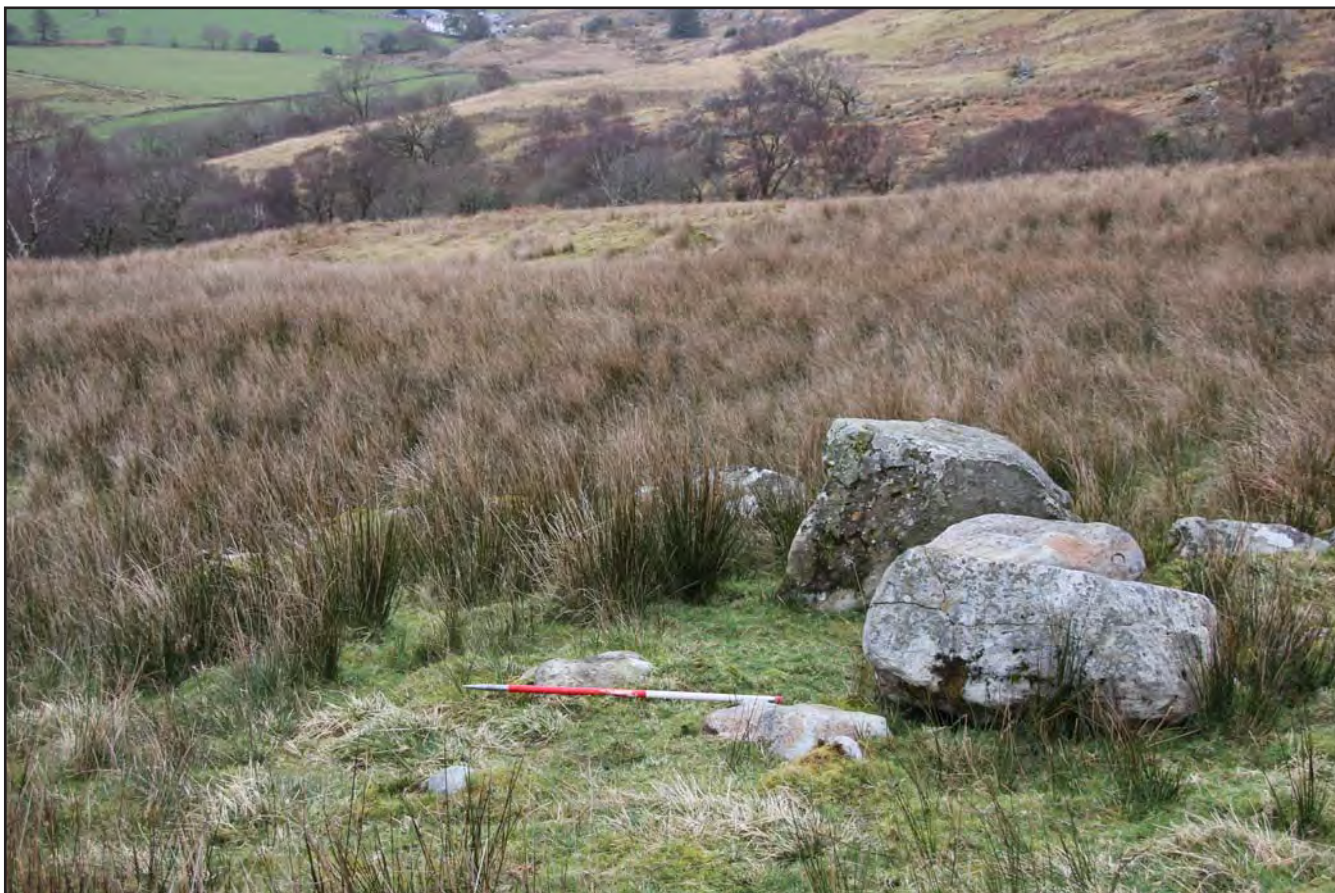
11. Rectangular Hut	PRN: 60161
Figure: 7	Plate: 13
NGR: SH 52043 52439	Period: Unknown (Roman/medieval)
<p>Description</p> <p>The remains of a rectangular hut measuring approximately 3.0m in width by 4.0m in length and orientated east to west is located at this point. The upstanding wall remains measure on average 0.25m in height by 0.5m in width and appear to be partly formed from in-situ glacial boulders. A relict wall of possible Roman or medieval date lies approximately 11.0m to the south and is likely to be associated with the rectangular hut.</p> <p>The hut is not depicted on the first, second and third edition Ordnance Survey 25" County Series maps of 1889, 1900 and 1916 respectively (figures 4, 5 and 6) however the rectangular form and dimensions of the structure would suggest a Roman or medieval origin.</p> <p>The structure lies approximately 16.0m to the west of the proposed hydro pipe route and as such will not be impacted by it. No further assessment or mitigatory measures are proposed aside from avoidance.</p>

Plate 13: Possible rectangular hut (feature 11), from the west. Scale 1.0m.

Category of importance: Unknown (regional/national)	
Level of impact: None	
Significance of effect: Neutral	
Recommendations for further assessment: None	
Recommendations for further mitigatory measures: Avoidance

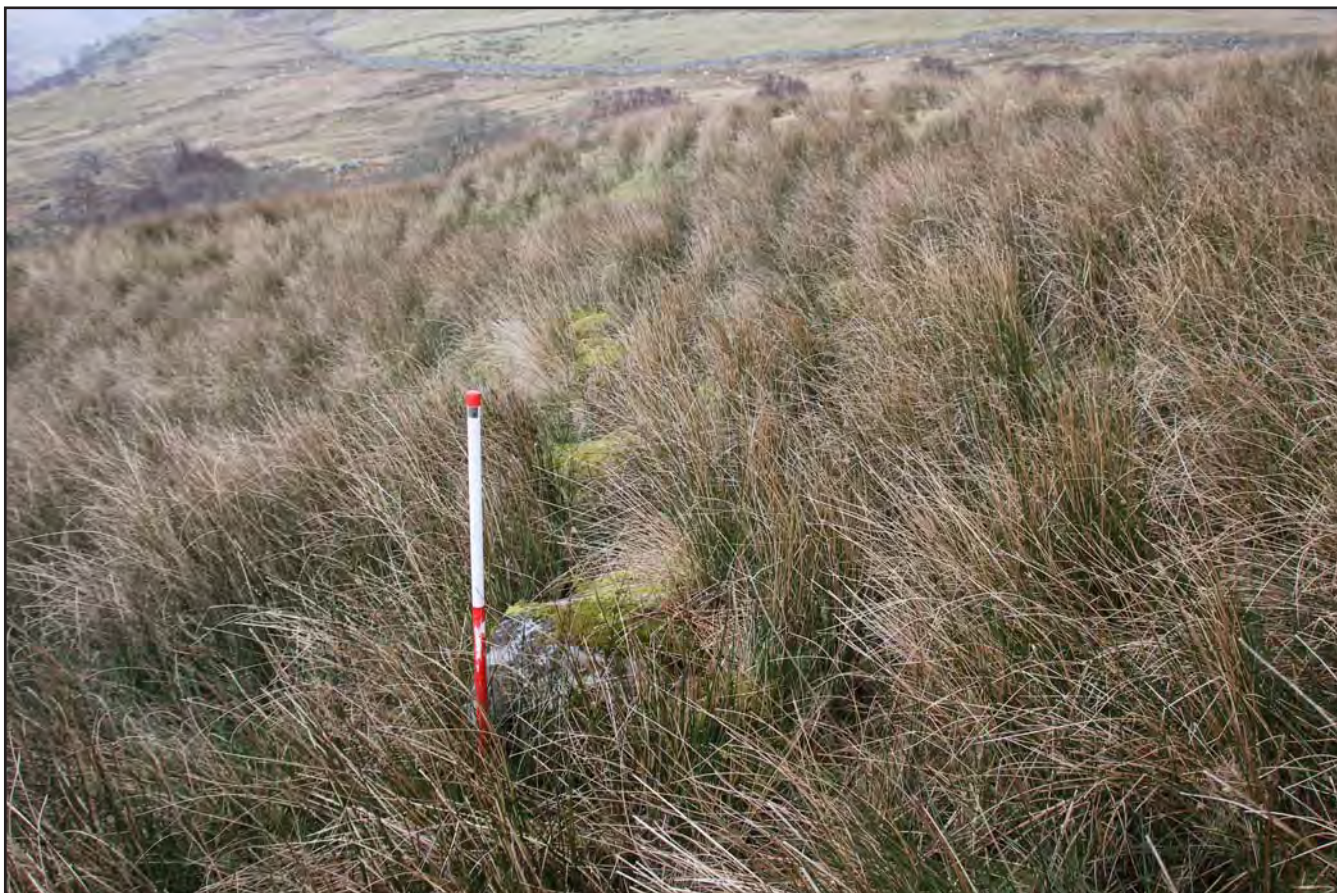
12. Relict Field Wall	PRN: 60162
Figure: 7	Plate: 14
NGR: SH 52053 52435 - SH 52076 52432	Period: Unknown (Roman/medieval)
<p>Description</p> <p>A relict field wall measuring 0.5m in height by 0.5m in width runs from east to west across the grazing field. The western end of the wall appears to terminate close to a rectangular hut of possible Roman or medieval date and it is likely that this field wall was contemporary with it. The wall is constructed from medium sized sub-angular glacial boulders to one course high and of single-skin construction. Parts of the wall have become overgrown with long grass and have become difficult to see on the ground.</p> <p>The wall is not depicted on the first, second and third edition Ordnance Survey 25" County Series maps of 1889, 1900 and 1916 respectively (figures 4, 5 and 6) however it does run parallel with relict wall (feature 17) to the south, as well as with field walls identified from aerial photographs to the north (feature 22). It is therefore likely that this wall forms part of a series of paddocks across this part of the site which may well be of Roman or medieval date and considered to be of regional or even national importance.</p> <p>The wall crosses the proposed penstock route and as such it is expected that there will be a low to medium adverse direct physical impact upon the wall, resulting in a moderate adverse significance of effect during the construction phase. It is therefore recommended that the penstock route be moved towards the west to avoid breaching this feature. If this is not possible then a programme of archaeological excavation across the point where the penstock breaches the wall will be required in advance of the associated works so that the form and structure of the wall can be fully recorded thus ensuring its preservation by record. Every attempt should also be made to reinstate the wall at this point.</p>

Plate 14: Relict wall (feature 12), from the west. Scale 1.0m.

Category of importance: Unknown (regional/national)	
Level of impact: Low to medium adverse direct physical (during construction phase)	
Significance of effect: Moderate adverse (during construction phase)	
Recommendations for further assessment: None	
Recommendations for further mitigatory measures: 1. Avoidance by rerouting the penstock route to the west <u>or</u> 2. Archaeological excavation across wall in advance of works and reinstatement upon completion.
