**Afon Craig Las Hydro, Nantlle,
Gwynedd.
March 2015
V 1.0**

Archaeological Assessment
Project Code: A0056.1
Report no. 0059

Archaeological Assessment

Client: Greenearth Hydro Ltd

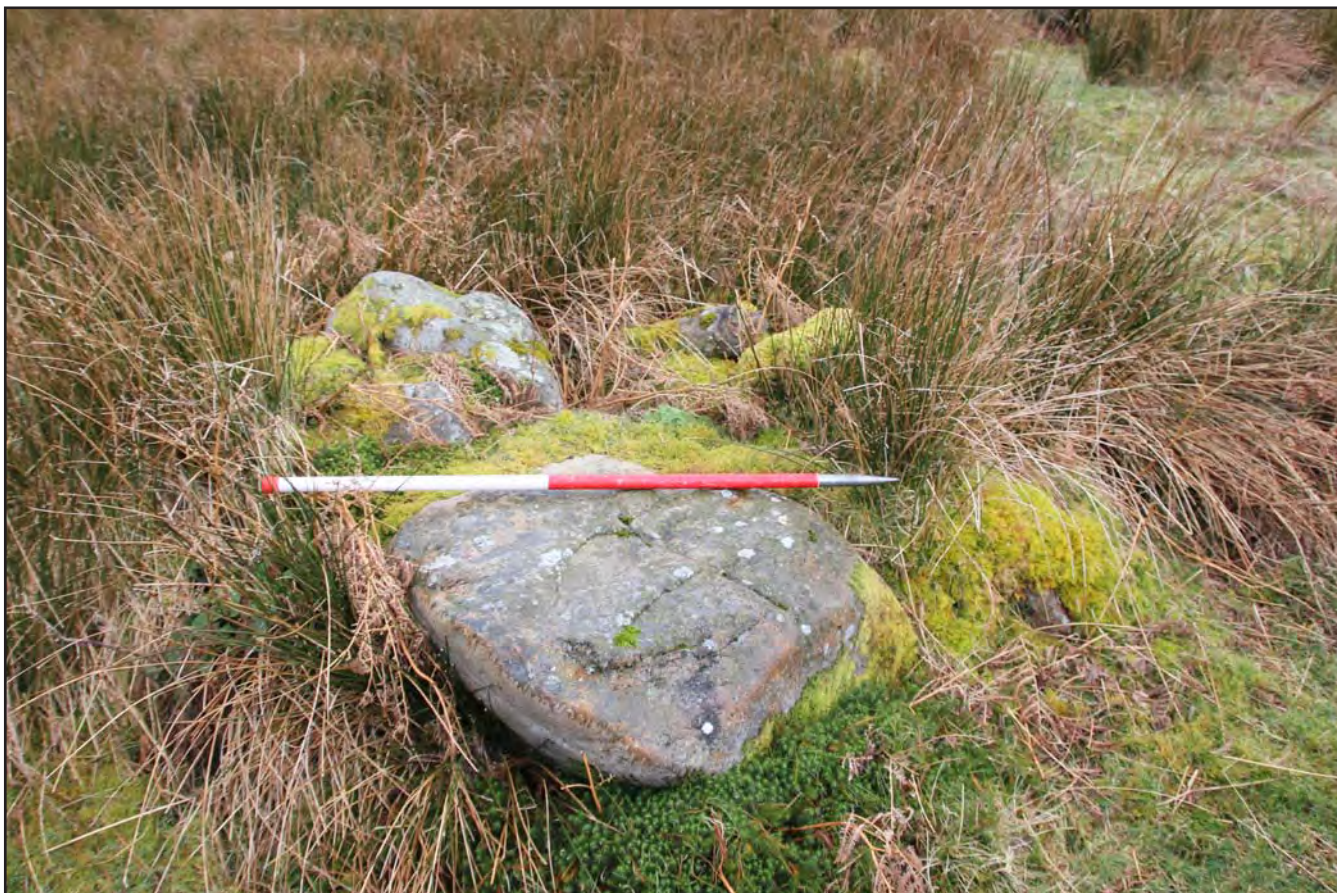
13. Stone Clearance Cairn	PRN: 60163
Figure: 7	Plate: 15
NGR: SH 52068 52412	Period: Medieval
<p>Description</p> <p>A stone clearance cairn measuring 1.5m square and made up from medium and large sub-rounded cobbles is located at this point. The cairn has no apparent structural element and is partly overgrown with mosses and long grass suggesting a probable medieval date.</p> <p>The cairn is not depicted on the first, second and third edition Ordnance Survey 25" County Series maps of 1889, 1900 and 1916 respectively (figures 4, 5 and 6) although it would have certainly been too ephemeral a feature to have been depicted.</p> <p>The cairn lies approximately 9.0m east of the proposed penstock route and as such will not be impacted upon by the proposed works. No further assessment or mitigatory measures are therefore proposed aside from avoidance.</p>	
Category of importance: Local	
Level of impact: None

Plate 15: Stone clearance cairn (feature 13), from the northeast. Scale 1.0m.

Significance of effect: Neutral	
Recommendations for further assessment: None	
Recommendations for further mitigatory measures: None/avoidance

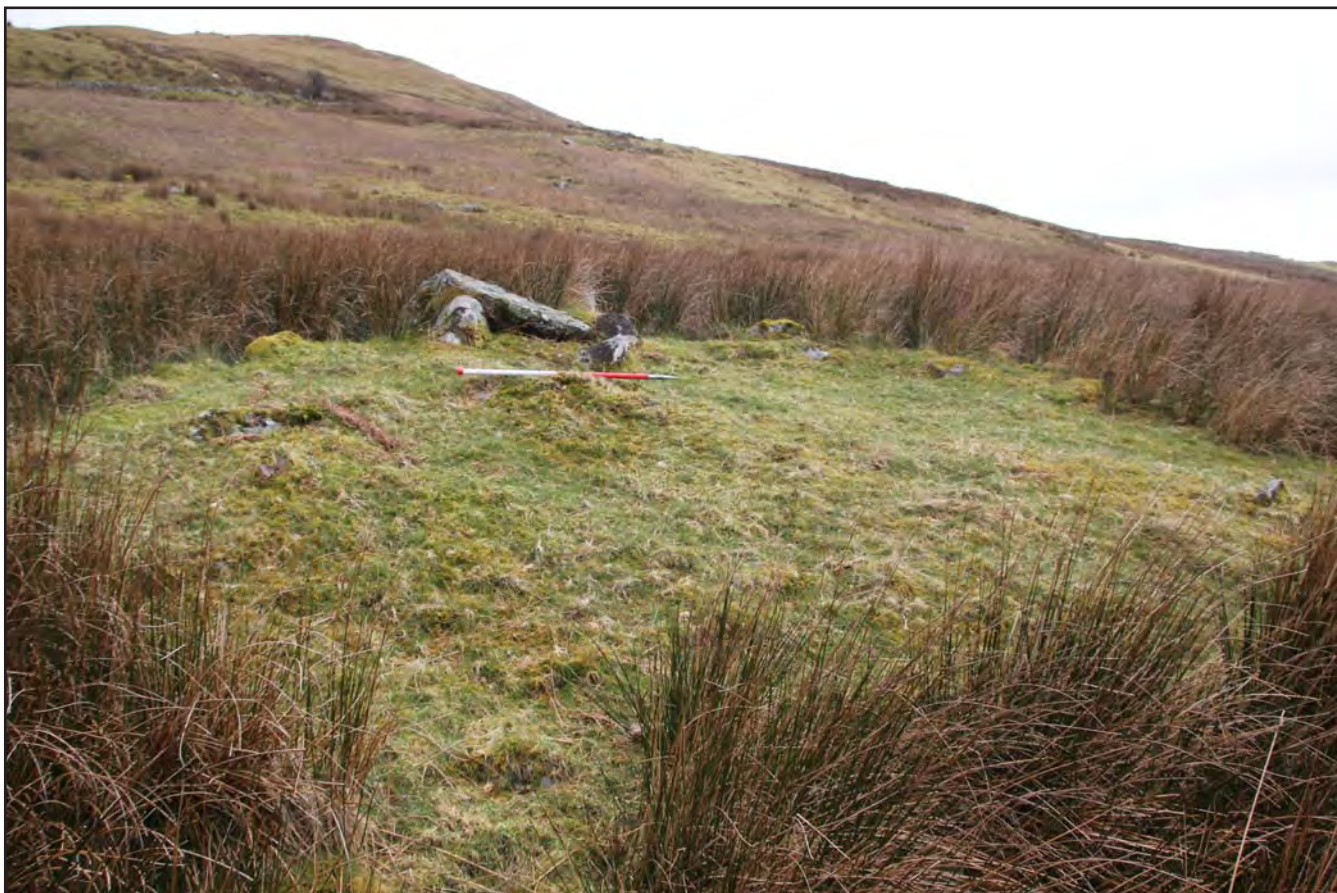
14. Possible Round Hut	PRN: 60164
Figure: 7	Plate: 16
NGR: SH 52045 52410	Period: Prehistoric/Roman
<p>Description</p> <p>A possible round hut measuring 5.0m external diameter is located at this point. The walls of the hut are barely visible as medium sized sub-rounded cobbles projecting from the turf as well as some larger glacial boulders that have been incorporated into the structure. The hut lies within an area of long-grass although the grass has not encroached into the structure whose buried remains must create conditions unsuitable for its growth.</p> <p>The round hut is not depicted on the first, second and third edition Ordnance Survey 25" County Series maps of 1889, 1900 and 1916 respectively (figures 4, 5 and 6) although it would have certainly been too ephemeral a feature to have been depicted. The round hut is either prehistoric or Roman in date and is considered to be of national importance.</p> <p>The hut lies approximately 12.0m west of the proposed penstock route and as such will not be impacted upon by the proposed works. No further assessment or mitigatory measures are therefore proposed aside from avoidance.</p>

Plate 16: Possible round hut (feature 14), from the northeast. Scale 1.0m.

Category of importance: National	
Level of impact: None	
Significance of effect: Neutral	
Recommendations for further assessment: None	
Recommendations for further mitigatory measures: None/avoidance

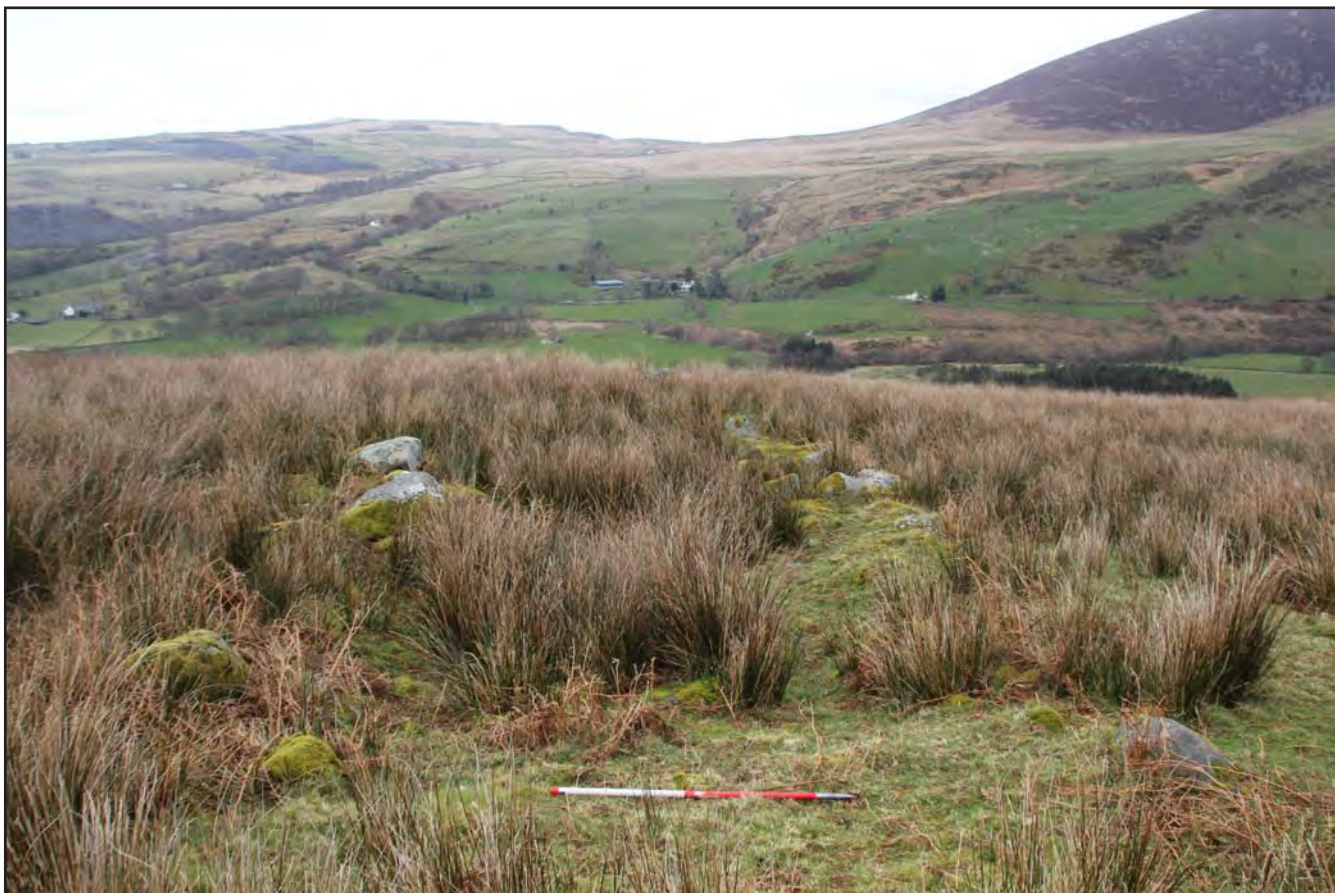
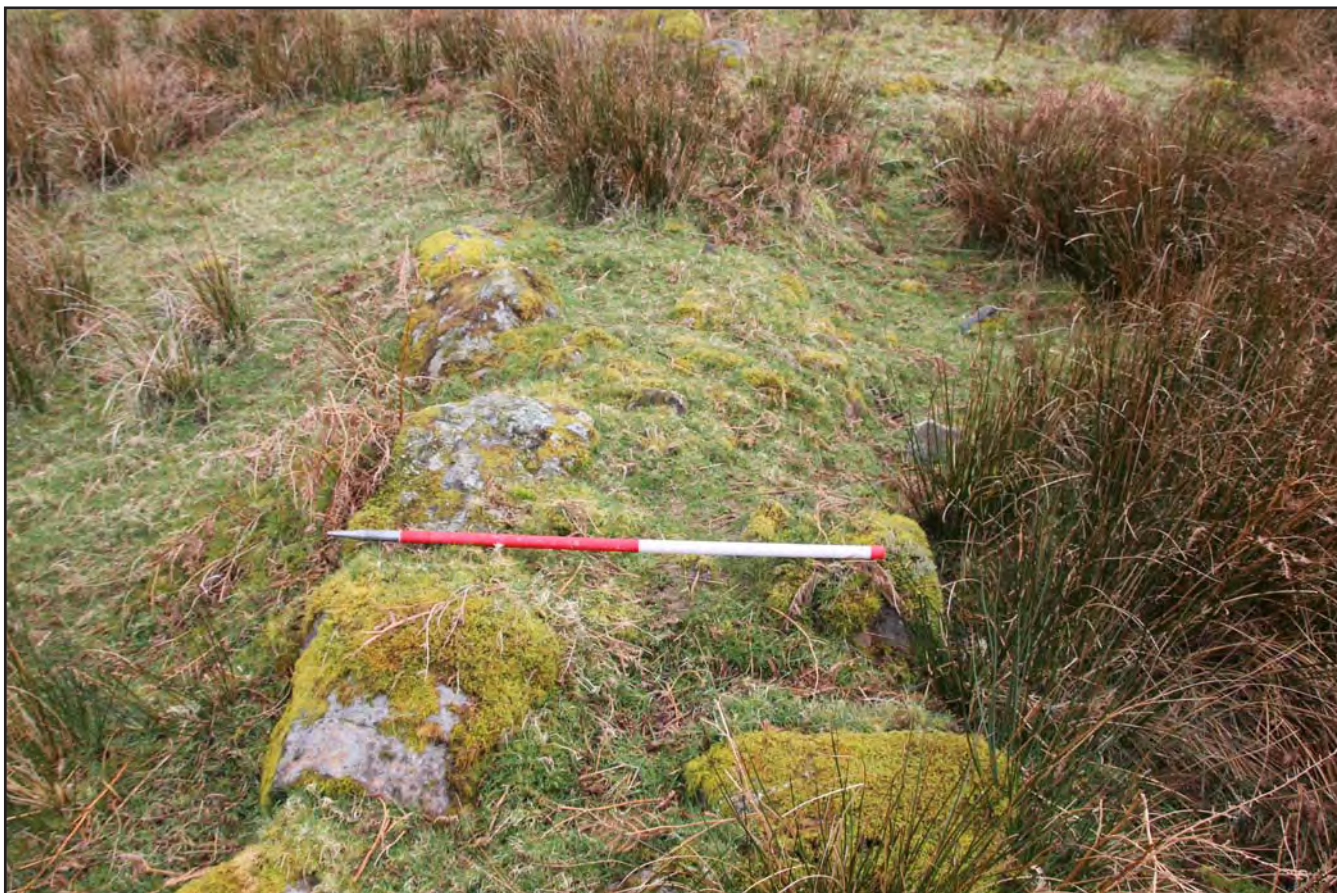
15. Large Rectangular Hut	PRN: 60165
Figure: 7	Plate: 17 and 18
NGR: SH 52032 52364	Period: Roman/medieval
<p>Description</p> <p>A large rectangular hut measuring 12.0m in length by 5.0m in width and orientated north to south is located at this point. The walls of the structure measure 1.0m in width and stand to an average of 0.3m in height with a double-skin of facing stones between which is a rubble wall core. The internal area of the structure is recessed to approximately 0.5m beneath ground level. There is no visible entrance into the structure.</p> <p>The rectangular hut is not depicted on the first, second and third edition Ordnance Survey 25" County Series maps of 1889, 1900 and 1916 respectively (figures 4, 5 and 6) although the well-constructed walls and rectangular shape in plan would suggest either a Roman or medieval structure and as such is considered to be of national importance.</p> <p>The hut lies approximately 15.0m west of the proposed penstock route and as such will not be impacted upon by the proposed works. No further assessment or mitigatory measures are therefore proposed aside from avoidance.</p>

Plate 17: Large rectangular hut (feature 15), from the south. Scale 1.0m.

Plate 18: Walls of large rectangular hut (feature 15), from the north. Scale 1.0m.

Category of importance: National	
Level of impact: None	
Significance of effect: Neutral	
Recommendations for further assessment: None	
Recommendations for further mitigatory measures: None/avoidance

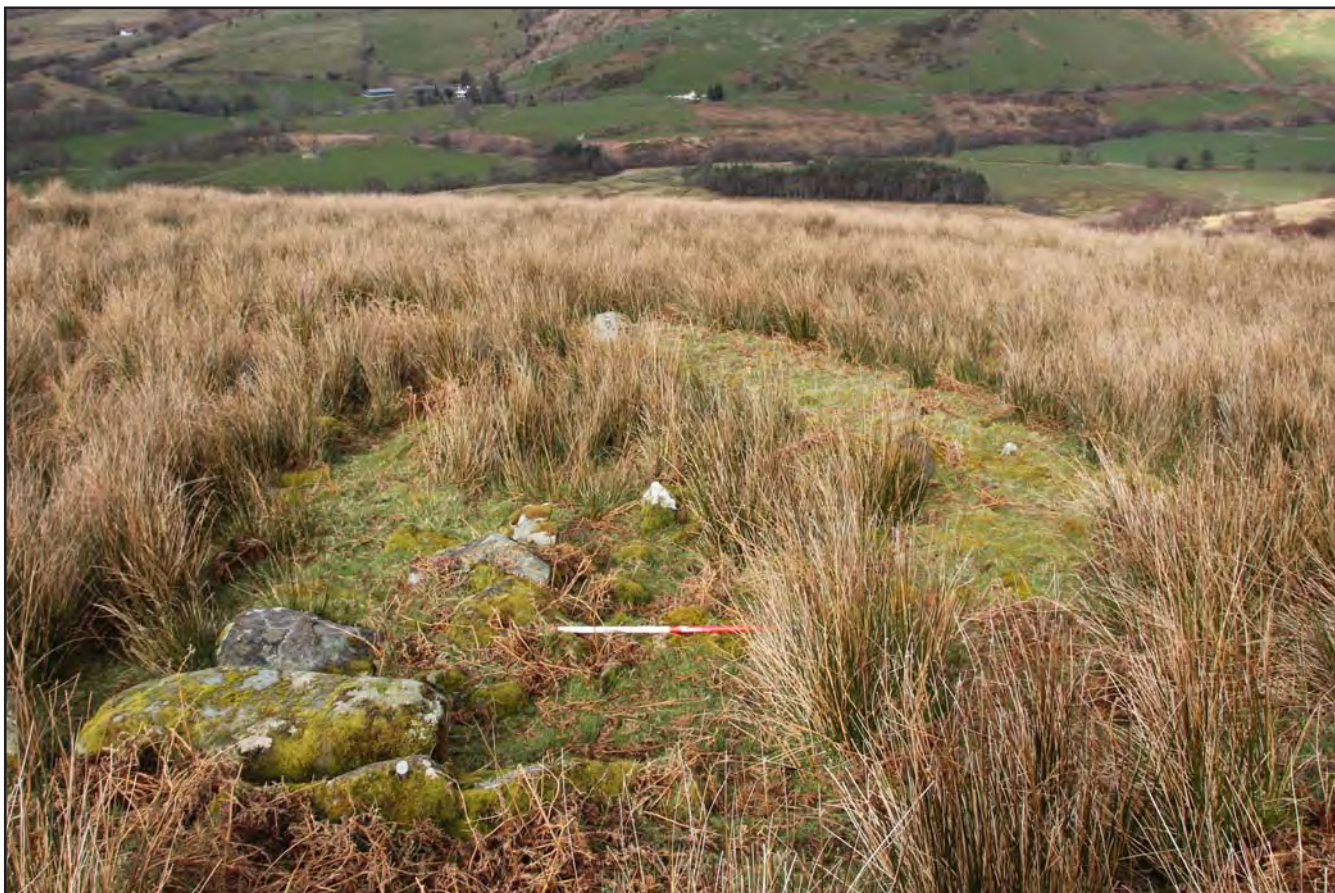
16. Possible Long Hut	PRN: 60166
Figure: 7	Plate: 19
NGR: SH 52078 52376	Period: Medieval
<p>Description</p> <p>A rectangular hut measuring approximately 6.0m in length by 3.5m in width and orientated north to south is located at this point. The walls of the structure measure approximately 0.75m in width and stand to an average of 0.2m in height, although the actual structural form of the walls could not be ascertained due to a poor level of preservation.</p> <p>The rectangular hut is not depicted on the first, second and third edition Ordnance Survey 25" County Series maps of 1889, 1900 and 1916 respectively (figures 4, 5 and 6) although the form and dimensions of the hut would suggest that it is a medieval long-hut and as such of national importance. The hut lies in the north-eastern corner of an enclosed area and probably formed part of a small settlement.</p> <p>The hut lies approximately 19.0m east of the proposed penstock route and as such will not be impacted upon by the proposed works. No further assessment or mitigatory measures are therefore proposed aside from avoidance.</p>

Plate 19: Possible long hut (feature 16), from the north. Scale 1.0m.

Category of importance: National	
Level of impact: None	
Significance of effect: Neutral	
Recommendations for further assessment: None	
Recommendations for further mitigatory measures: None/avoidance

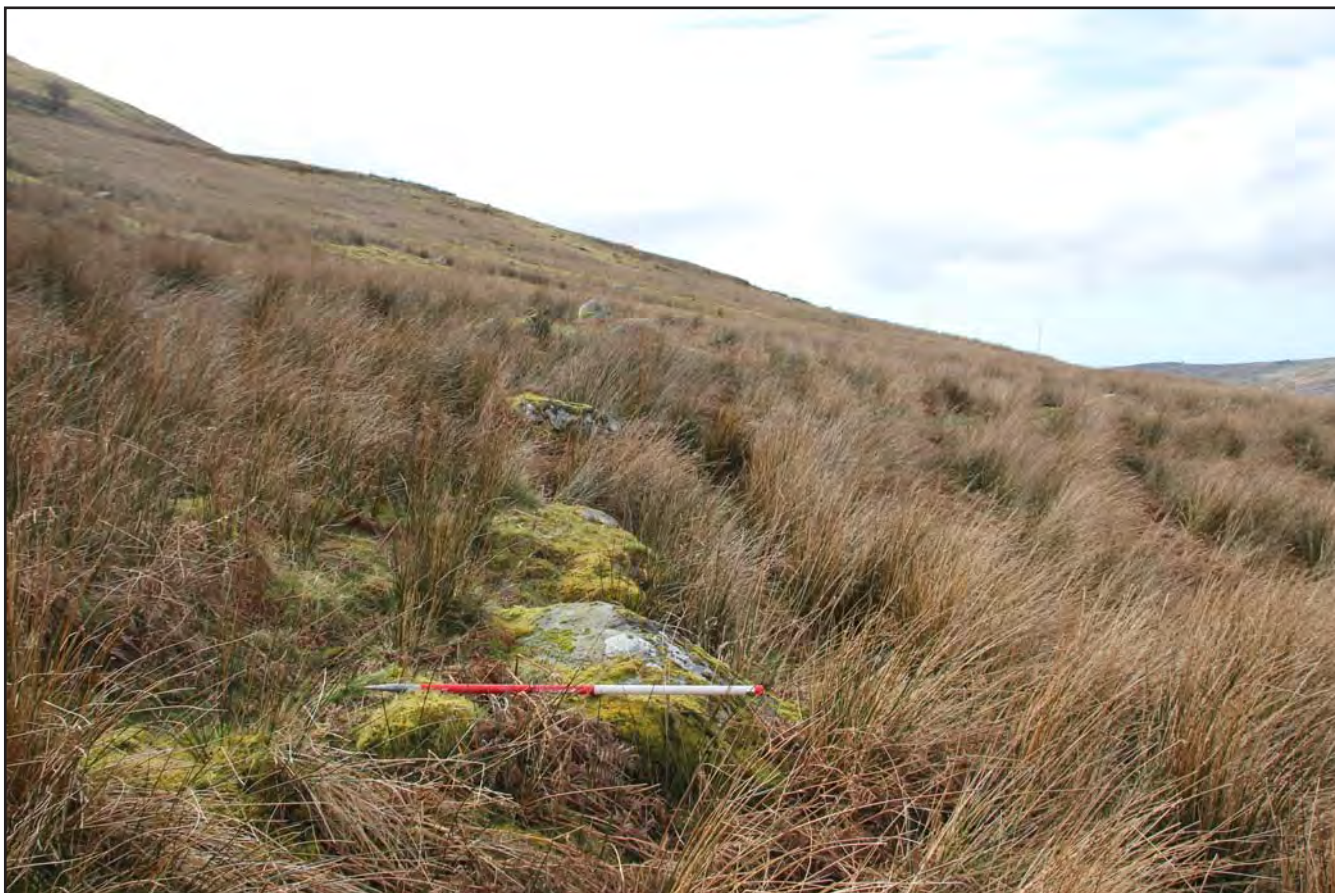
17. Relict Enclosure Wall	PRN: 60167
Figure: 7	Plate: 20
NGR: SH 52079 52379 – SH 52045 52382 – SH 52044 52363 – SH 52071 52359	Period: Unknown (Roman/medieval)
<p>Description</p> <p>A relict wall measuring 1.0m in width by 0.5m in height and constructed from medium and large sized sub-rounded glacial boulders encloses an area of approximately 620 square metres. The wall is overgrown with long grass in places and towards its north-eastern edge appears to become a revetment wall, perhaps reinforcing an existing scarp in the landscape at this point. The relict wall encloses a possible medieval long-hut (feature 16) in the northeast corner, and a square structure of unknown date towards the southwest. The enclosure is of unknown date but is suspected to be from the Roman or medieval periods.</p> <p>The enclosure is not depicted on the first, second and third edition Ordnance Survey 25" County Series maps of 1889, 1900 and 1916 respectively (figures 4, 5 and 6) and it is likely that it had long fallen out of use by this point in time. The enclosure runs parallel with another relict field wall to the north (feature 12) as well as with enclosure walls identified on aerial photographs (feature 22) suggesting part of a larger settlement site.</p> <p>The wall crosses the proposed penstock route and as such it is expected that there will be a medium adverse direct physical impact upon the wall as it is breached on the north and south returns, resulting in a moderate or large adverse significance of effect during the construction phase. It is therefore recommended that the penstock route be moved towards the west to avoid breaching this feature. If this is not possible then a programme of archaeological excavation across the point where the penstock breaches the wall will be required in advance of the associated works so that the form and structure of the wall can be fully recorded thus ensuring its preservation by record. A watching brief would also be required during the excavation of the pipe trench within the enclosure. Every attempt should also be made to reinstate the wall at this point.</p>

Plate 20: Relict enclosure wall (feature 17), from the east. Scale 1.0m.

Category of importance: National	
Level of impact: Medium adverse direct physical (during construction phase)	
Significance of effect: Moderate or Large adverse (during construction phase)	
Recommendations for further assessment: None	
Recommendations for further mitigatory measures: 1. Avoidance by rerouting the penstock route to the west or 2. Archaeological excavation across wall in advance of works, watching brief during trenching within enclosure, and reinstatement upon completion.

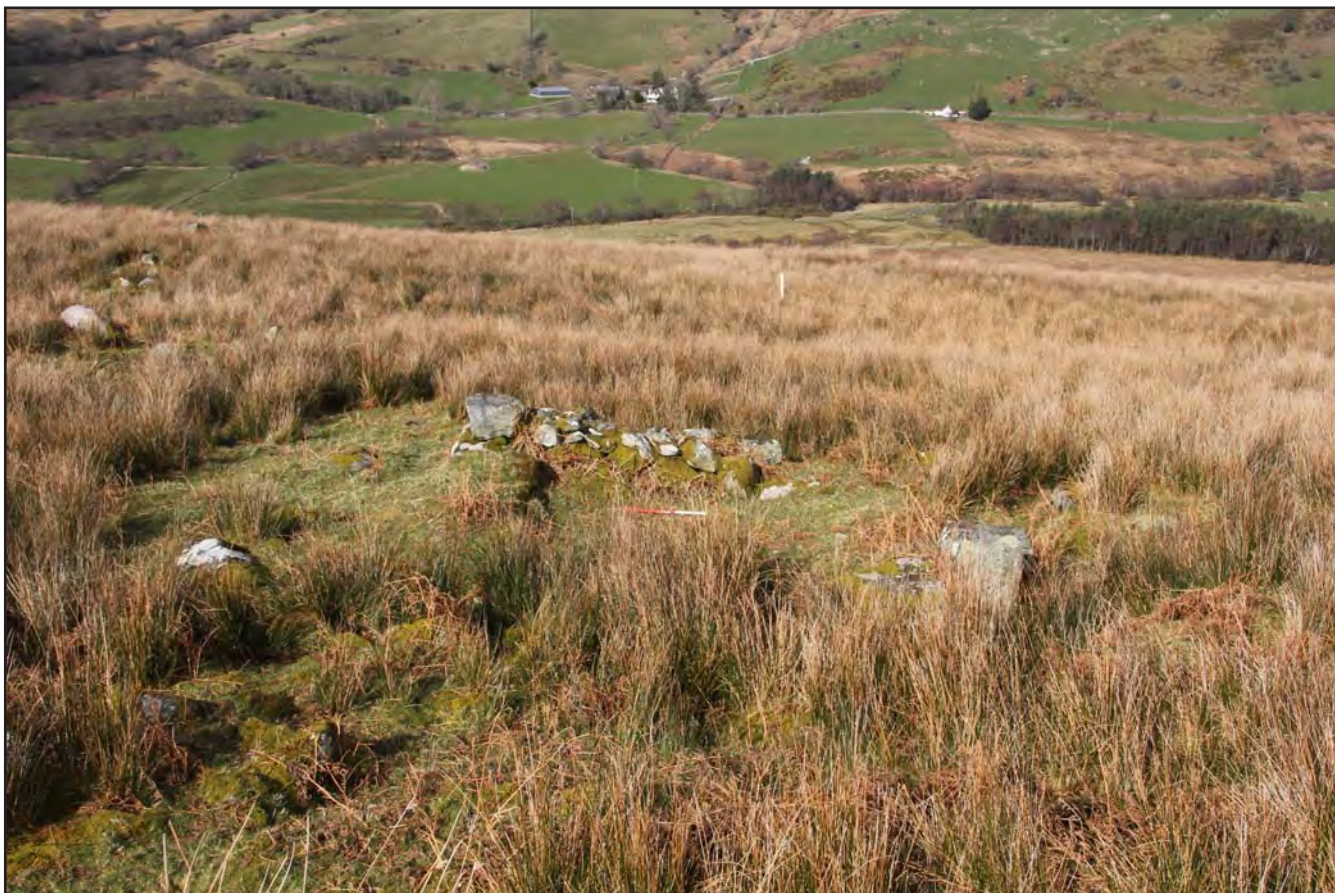
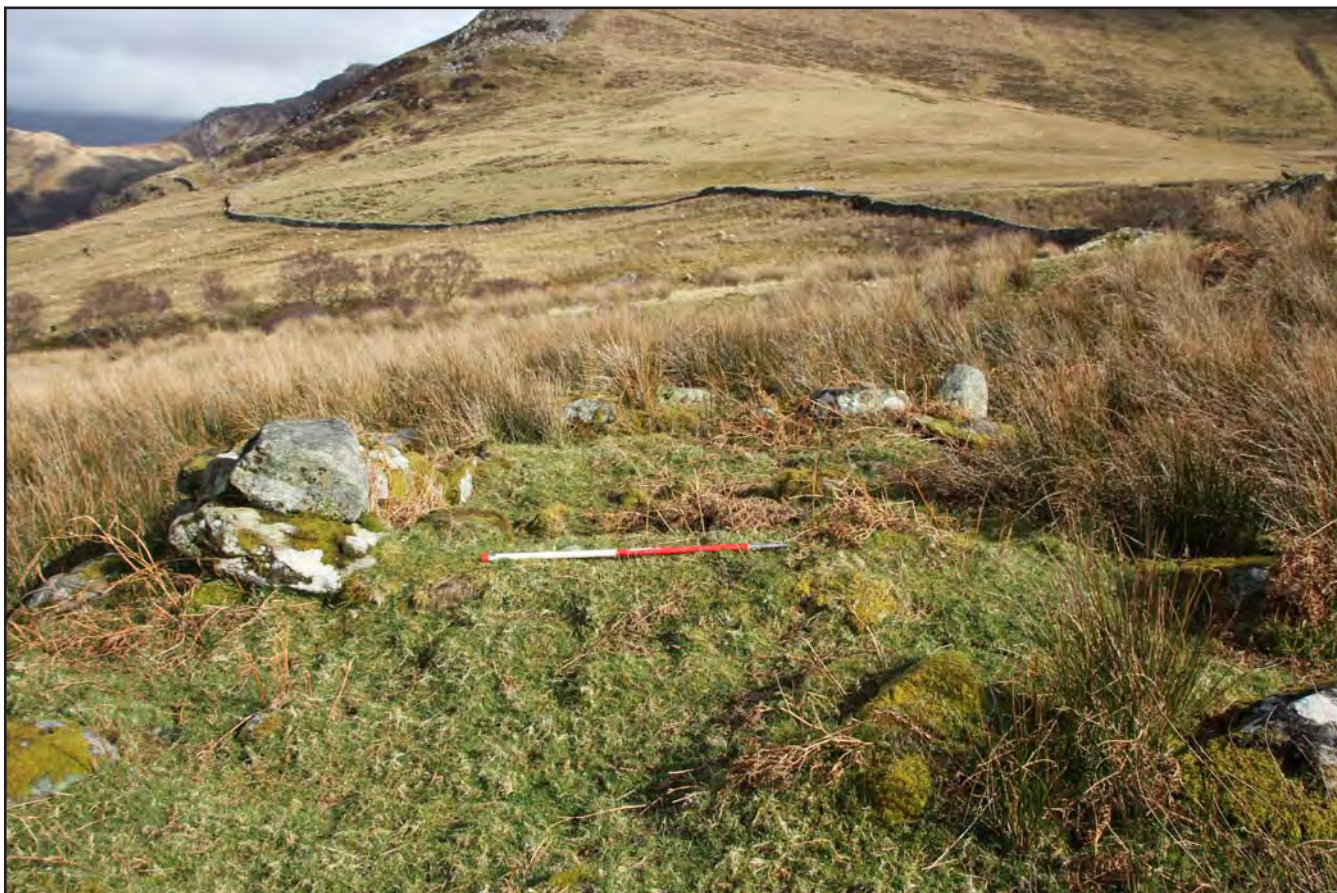
18. Square Structure	PRN: 60168
Figure: 7	Plate: 21 and 22
NGR: SH 52052 52369	Period: Unknown (Prehistoric/Roman/medieval)
<p>Description</p> <p>A square structure measuring 4.0m square and with walls surviving to 0.6m is located at this point. The structure is made from dry-stone medium sized sub-angular cobbles of double-skin construction and measuring 1.0m in width. The structure is surrounded by a gap devoid of stone or possibly a ditch measuring 1.0m in width before being encircled by the remains of a roughly circular wall measuring 1.0m in width and enclosing an area approximately 9.0 to 10.0m in diameter.</p> <p>The structure is not depicted on the first, second and third edition Ordnance Survey 25" County Series maps of 1889, 1900 and 1916 respectively (figures 4, 5 and 6) and it is likely that it had long fallen out of use by this point in time. The structure lies within an enclosure suspected to be of Roman or medieval date (feature 17) along with a possible medieval long-hut (feature 16).</p> <p>It appears likely that this feature was originally a round hut of prehistoric or Roman date that was later modified, perhaps in the medieval or post-medieval periods, to become a sheepfold or shepherd's hut structure.</p> <p>The hut lies approximately 4.0m west of the proposed penstock route and as such will not be impacted upon by the proposed works. No further assessment or mitigatory measures are therefore proposed aside from avoidance.</p>

Plate 21: Square structure (feature 18), from the south. Scale 1.0m.

Plate 22: Square structure (feature 18), from the west. Scale 1.0m.

Category of importance: National	
Level of impact: None	
Significance of effect: Neutral	
Recommendations for further assessment: None	
Recommendations for further mitigatory measures: None/avoidance

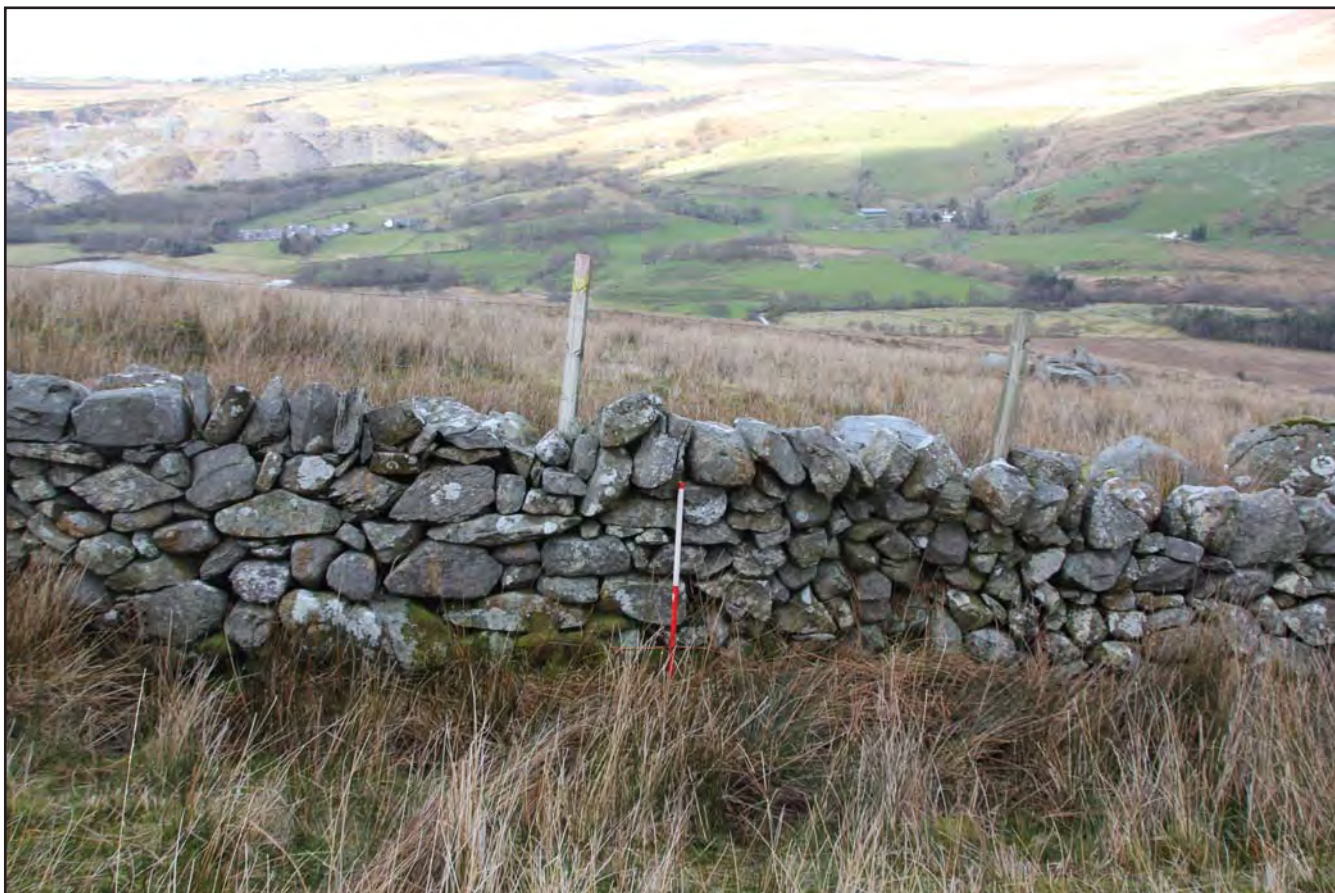
19. Field Wall	PRN: 60169
Figure: 7	Plate: 23
NGR: SH 52061 52309	Period: Post-medieval
<p>Description</p> <p>A stock-proof field wall measuring 1.3m in height by 0.5m in width and constructed from medium sized sub-angular cobbles runs from east to west forming the southern boundary of the enclosed grazing field. The wall has clearly been rebuilt in modern times and is reinforced by a wooden post and wire fence.</p> <p>The wall is depicted on the first, second and third edition Ordnance Survey 25" County Series maps of 1889, 1900 and 1916 respectively (figures 4, 5 and 6) and it is likely to be of post-medieval date.</p> <p>The field wall will require breaching by the proposed scheme and as such there will be a low adverse direct physical impact resulting in a neutral or slight adverse significance of effect. It is recommended that a photographic record of the revealed wall section is taken during the works and that the wall is reinstated upon completion.</p>

Plate 23: Field wall (feature 19), from the south. Scale 1.0m.

Category of importance: Local	
Level of impact: Low adverse direct physical (during construction phase)	
Significance of effect: Neutral or slight adverse (during construction phase)	
Recommendations for further assessment: None	
Recommendations for further mitigatory measures: Photographic record of wall section during breach.

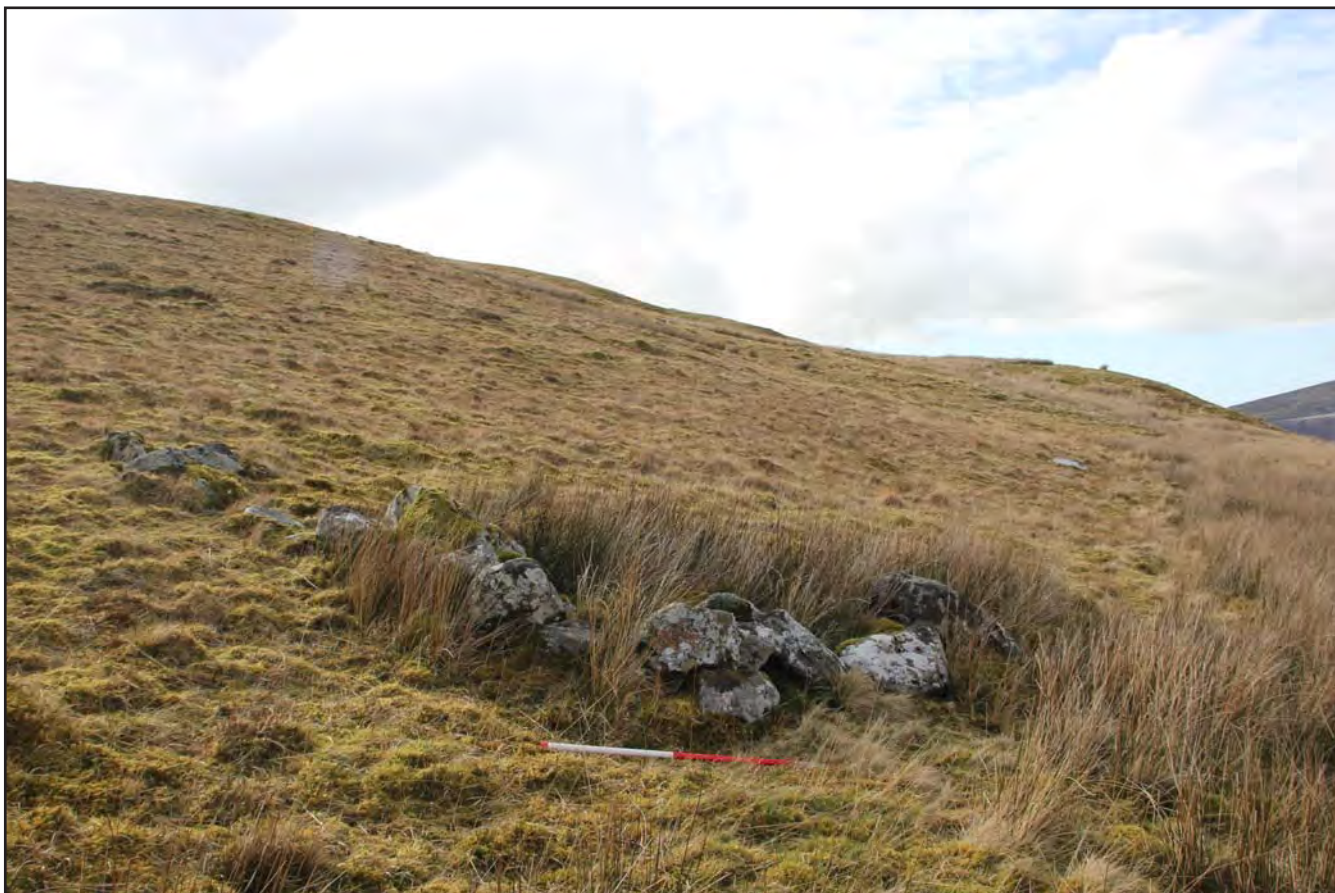
20. Ruined Sheepfold	PRN: 60170
Figure: 7	Plate: 24
NGR: SH 52079 52191	Period: Post-medieval
<p>Description</p> <p>The northeast corner of a rectangular ruined sheepfold is located at this point. The surviving wall remains consist of a single-skin dry-stone construction utilising medium and small sized sub-angular cobbles and measuring 0.5m in height by 0.5m in width. The structure would have measured approximately 4.0m in length by 3.0m in width.</p> <p>The sheepfold is not depicted on the first, second and third edition Ordnance Survey 25" County Series maps of 1889, 1900 and 1916 respectively (figures 4, 5 and 6) although it is likely that it was too ephemeral to depict.</p> <p>The sheepfold lies approximately 7.0m east of the proposed penstock route and as such will not be impacted upon by the proposed works. No further assessment or mitigatory measures are proposed.</p>	
Category of importance: Local

Plate 24: Ruined sheepfold (feature 20), from the northeast. Scale 1.0m.

Level of impact: None	
Significance of effect: Neutral	
Recommendations for further assessment: None	
Recommendations for further mitigatory measures: None

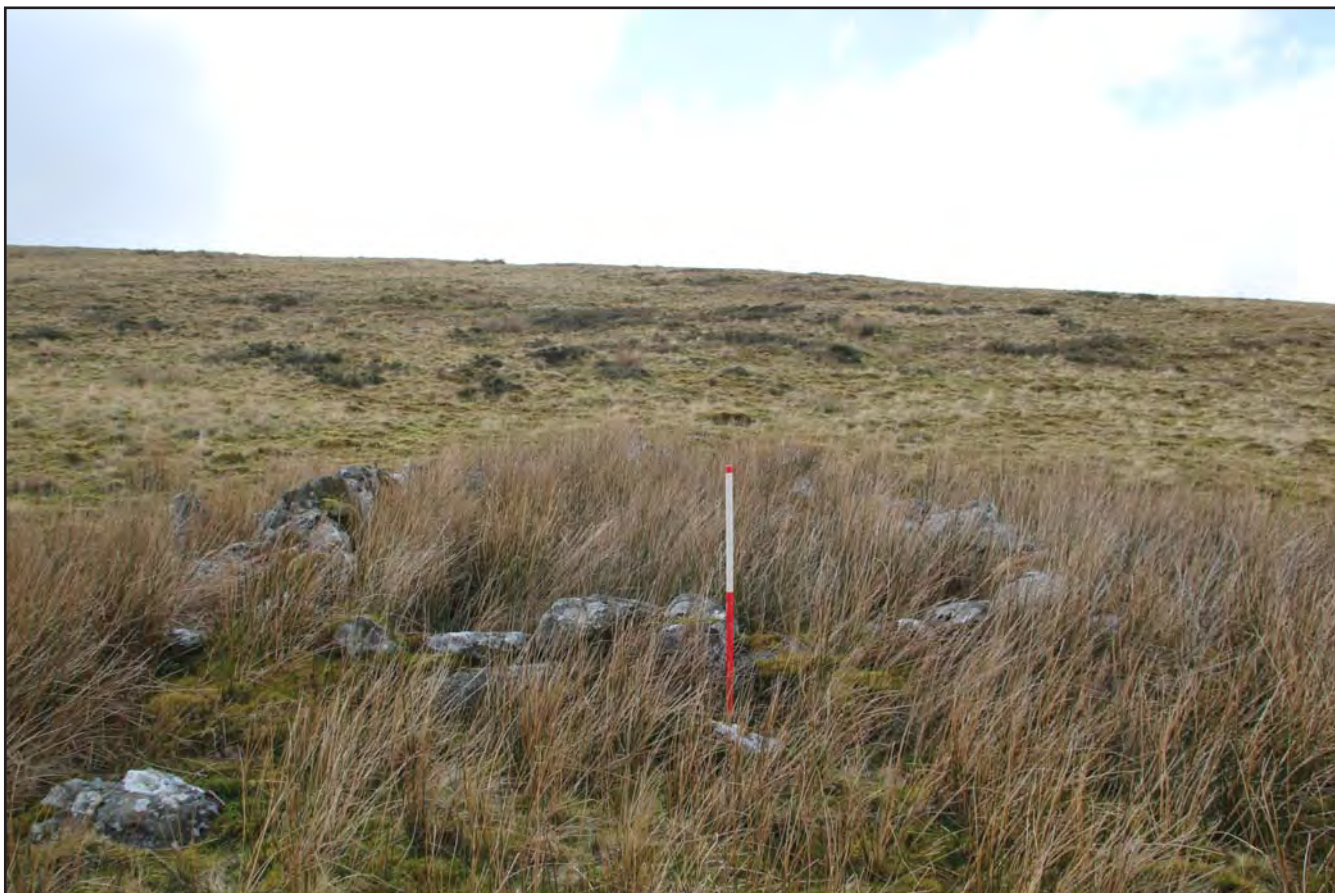
21. Ruined Sheepfold	PRN: 287278
Figure: 7	Plate: 25
NGR: SH 52055 52091	Period: Post-medieval
<p>Description</p> <p>The remains of a ruined sheepfold is located at this point. The surviving wall remains consist of a single-skin dry-stone construction utilising medium and small sized sub-angular cobbles and measuring 0.5m in height by 0.5m in width. The structure would have measured approximately 4.0m in length by 3.0m in width orientated east to west.</p> <p>The sheepfold is not depicted on the first, second and third edition Ordnance Survey 25" County Series maps of 1889, 1900 and 1916 respectively (figures 4, 5 and 6) although it is likely that it was too ephemeral to depict.</p> <p>The sheepfold lies approximately 6.0m west of the proposed penstock route and as such will not be impacted upon by the proposed works. No further assessment or mitigatory measures are proposed.</p>	
Category of importance: Local

Plate 25: Ruined sheepfold (feature 21), from the east. Scale 1.0m.

Level of impact: None	
Significance of effect: Neutral	
Recommendations for further assessment: None	
Recommendations for further mitigatory measures: None
