**Cleifiog Fawr, Gorad Road, Valley,
Isle of Anglesey, LL65 3BG.
November 2016
V 1.0**

Level 2/3 Historic Building Record

Project Code: A0101.1

Client: Sylfaen Associates

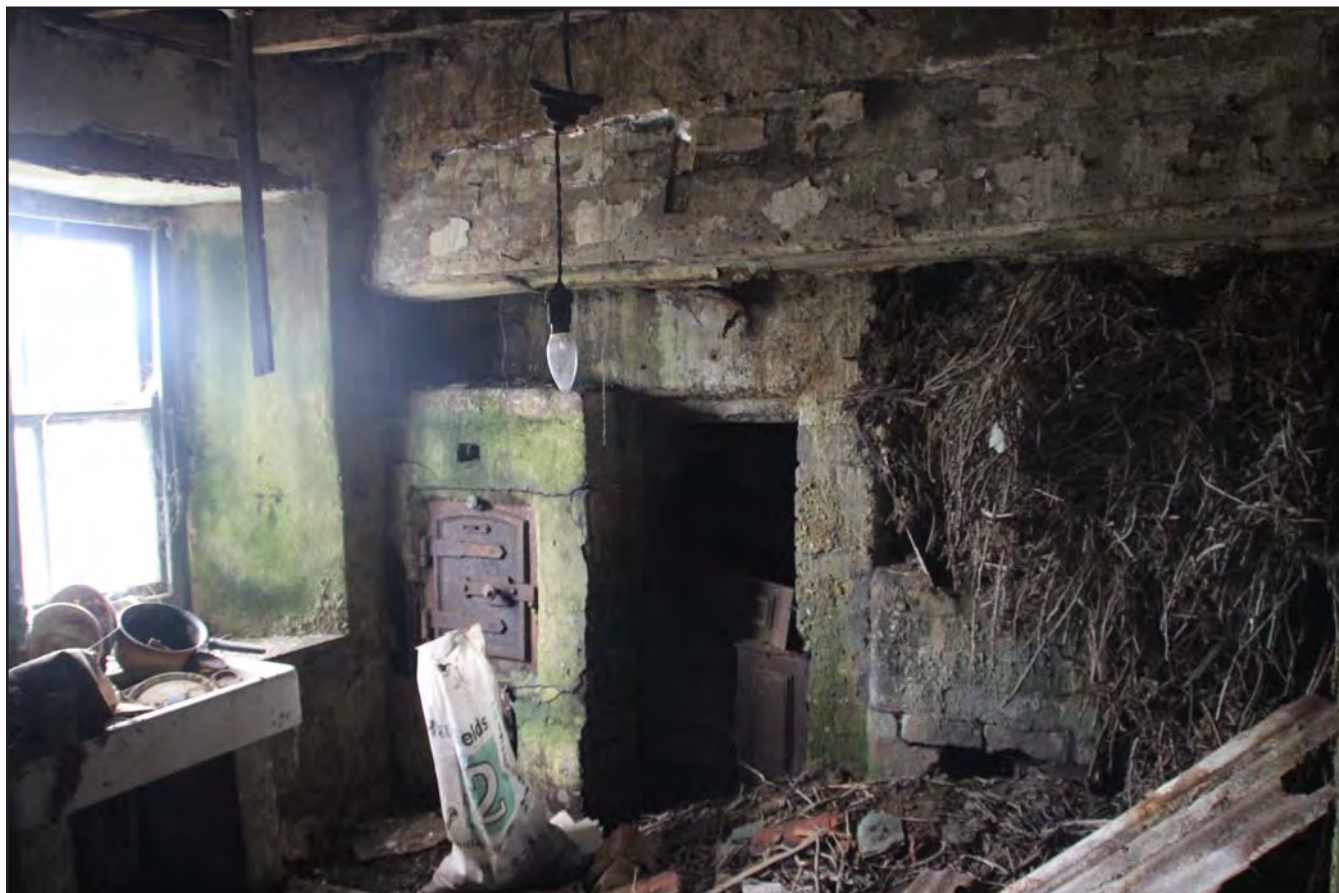
Plate B-09: Cleifiog Fawr Unit 1 Kitchen 1, from the southeast.

Kitchen 1 is a square shaped room measuring 4.0m square. The ceiling boards have fallen away revealing sawn wooden joists orientated east to west and there is the remains of a single centralised pendulum electric light fitting. All of the walls are plastered but heavily degraded.

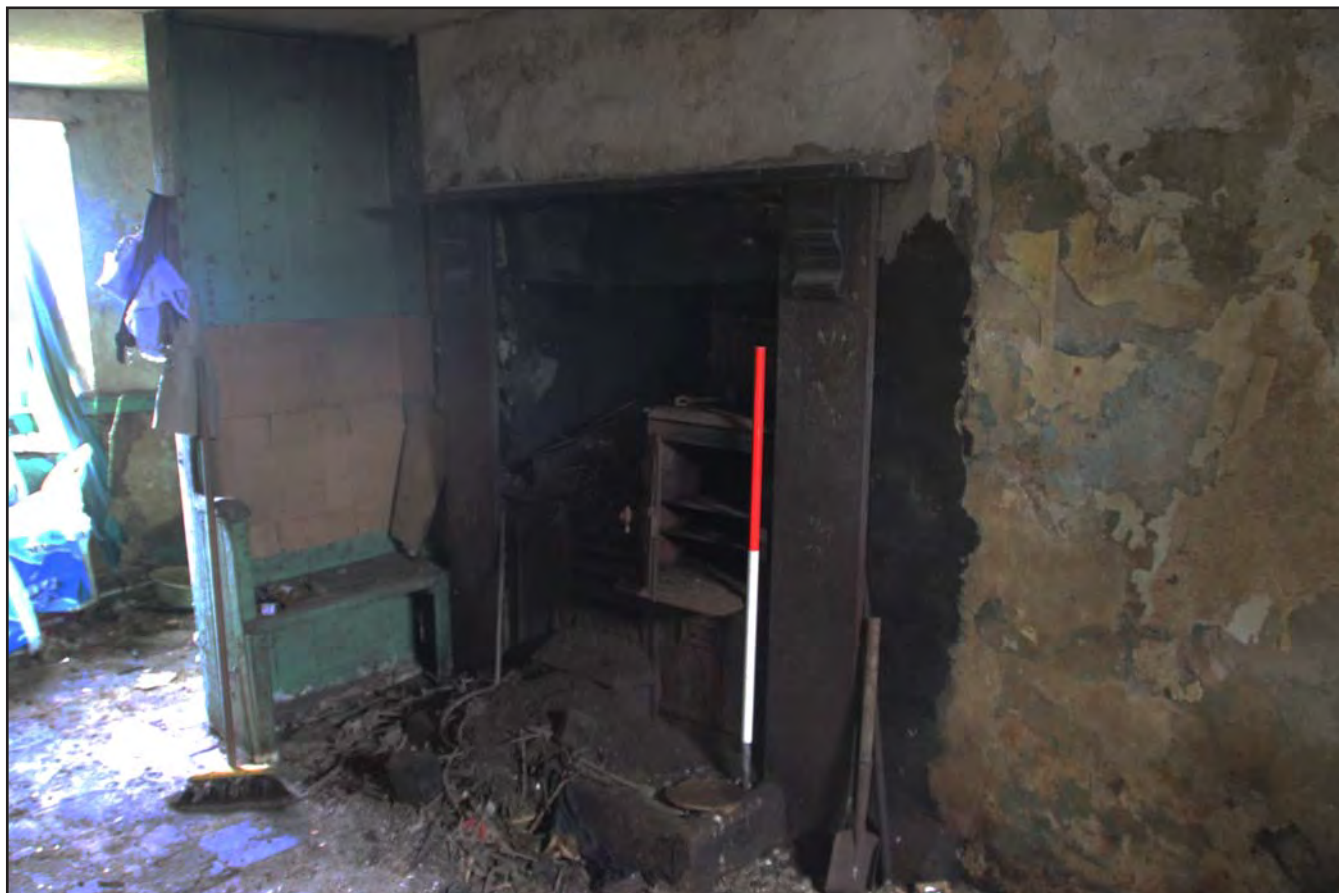
Plate B-13: Cleifiog Fawr Unit 1 Kitchen 2 showing fireplace, from the southeast. Scale 1.0m.

The northern elevation has a single doorway at the left-hand end that permit access into kitchen 1 via a green painted wooden door and frame. There is a centralised fireplace with dark stained wooden mantle and cast iron Aga, to the left of this is a green painted wooden bench which forms a small partition. At the right-hand end is a single doorway that permits access to the store via a green-painted wooden board door and frame.

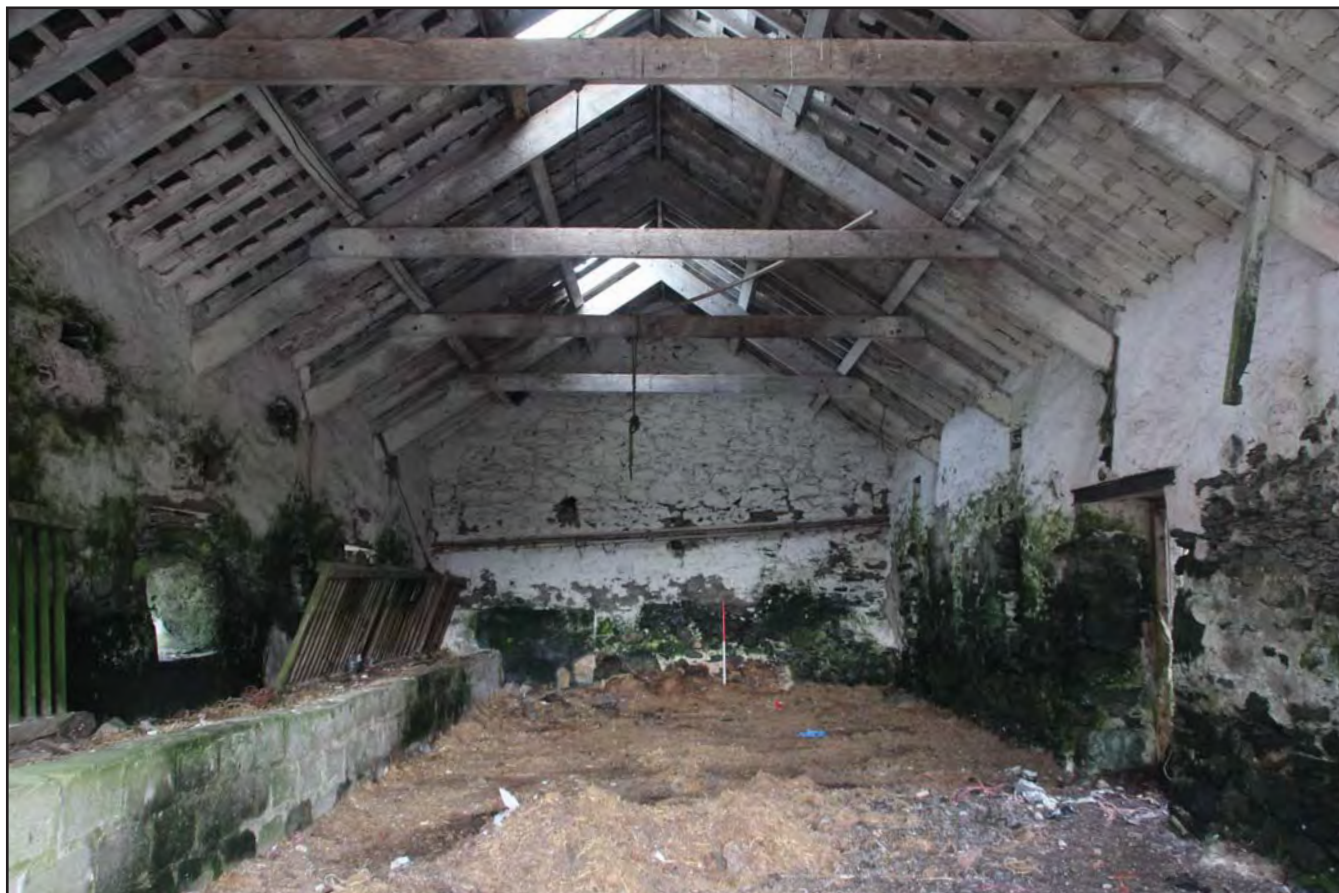
Plate D-04: Cleifiog Fawr Unit 3 Barn 1, from the south. Scale 1.0m.

The southern elevation has a centralised wide opening with iron rail lintel, permitting access into the barn and above which repair work has been undertaken with red-brick.
