# Outbuildings at Gaer Gerrig, Llangwm, Conwy LL21 OPE.

Historic Building Record Level 2

Report no. 0349

# **Outbuildings at Gaer Gerrig, Llangwm, Conwy LL21 OPE (0/46680).**

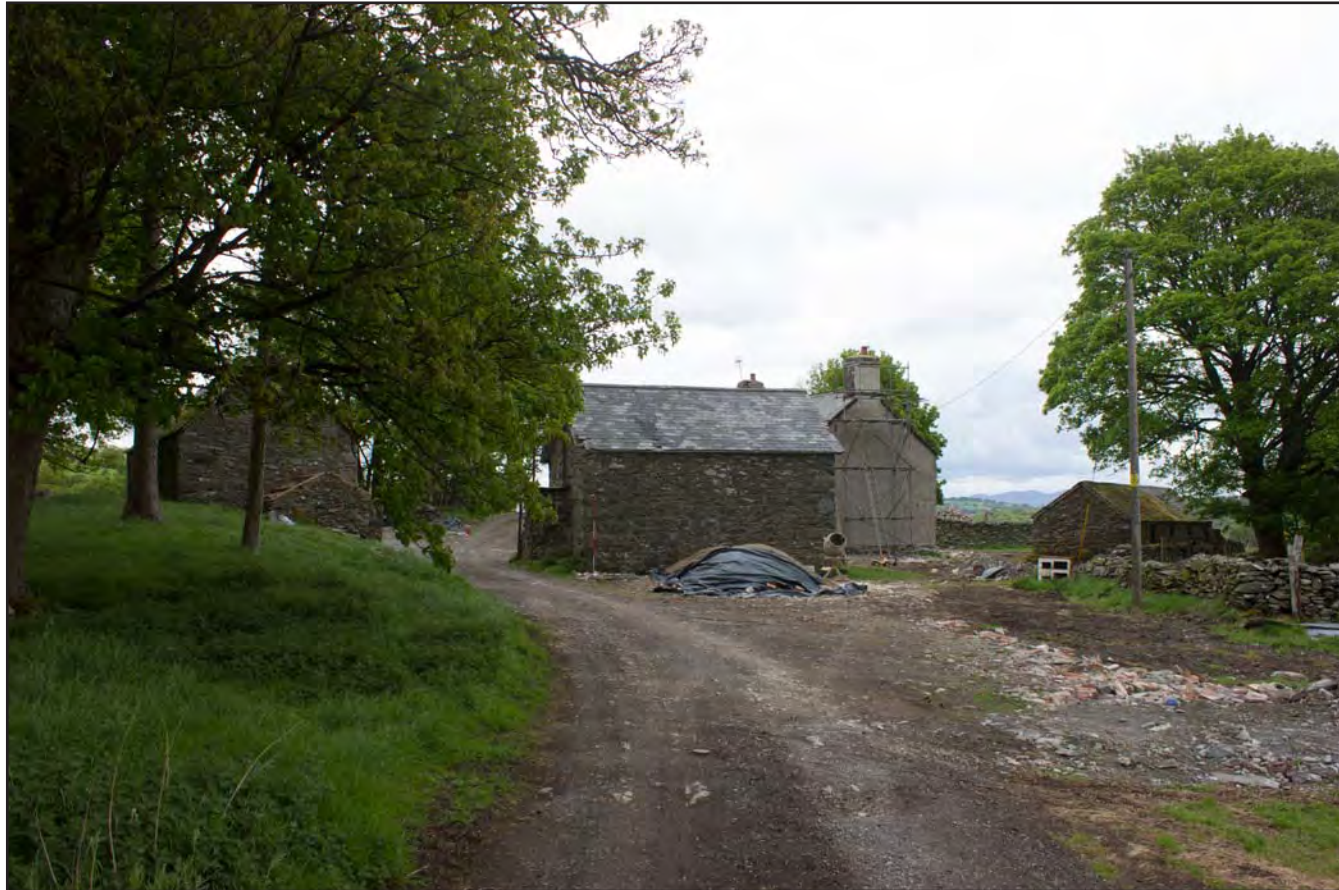
**Plate A:** Context shot of Gaer Gerrig farm complex - Llangwm, Conwy - from the west-southwest - 2.00m scale

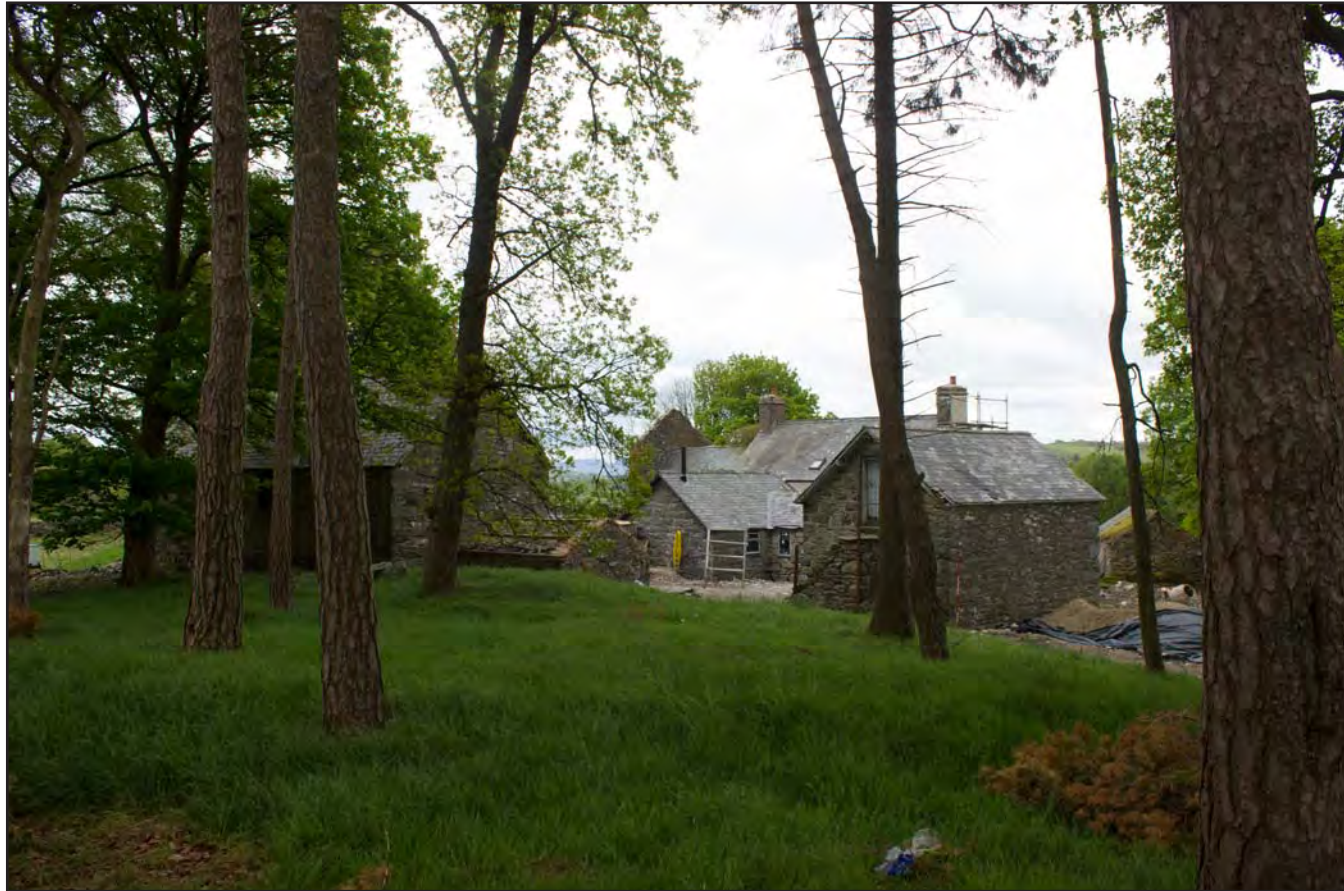
**Plate B:** Context shot of Gaer Gerrig farm complex - Llangwm, Conwy - from the west-northwest - 2.00m scale

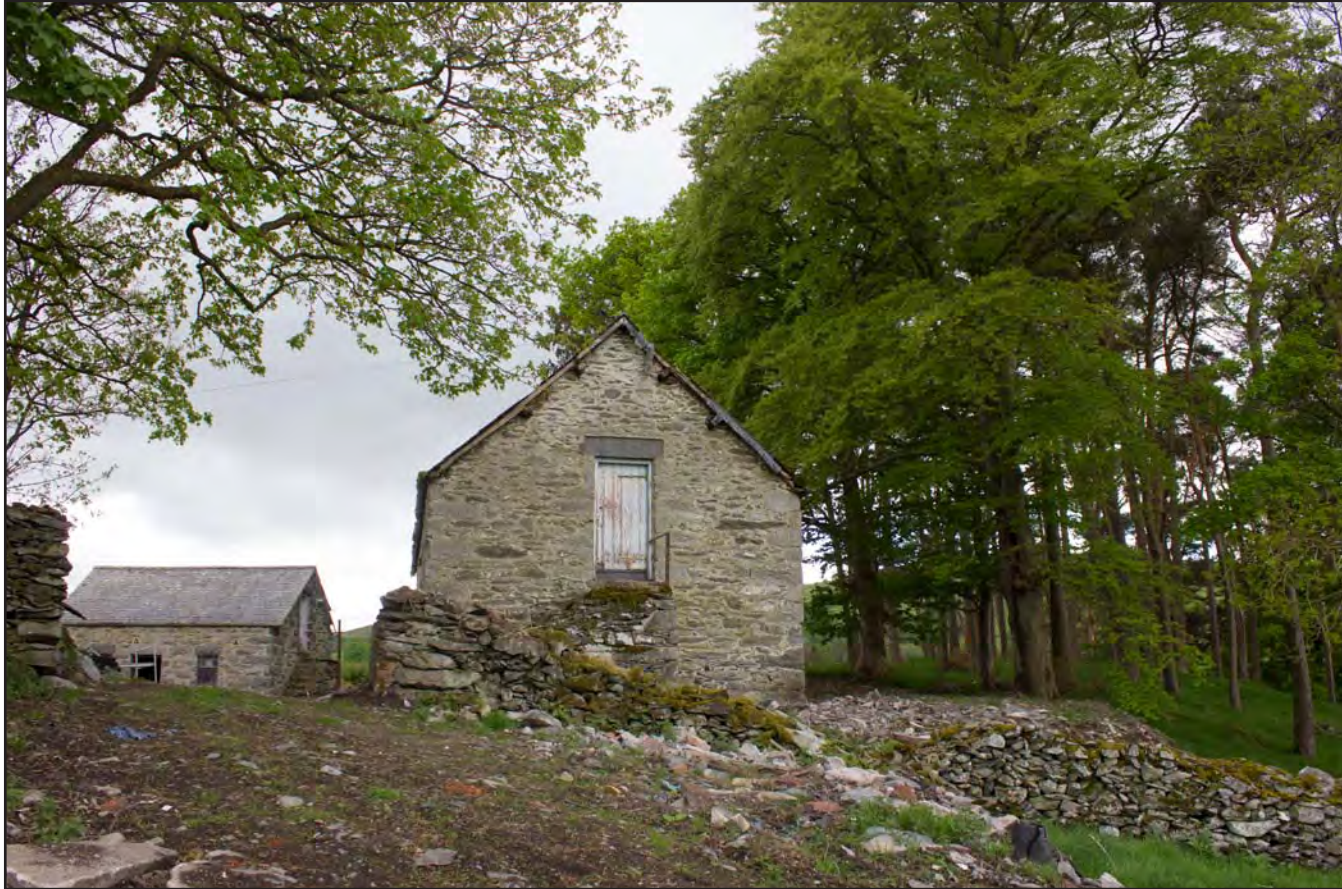
**Plate C:** Context shot of Gaer Gerrig farm complex - Llangwm, Conwy - from the northeast - 2.00m scale

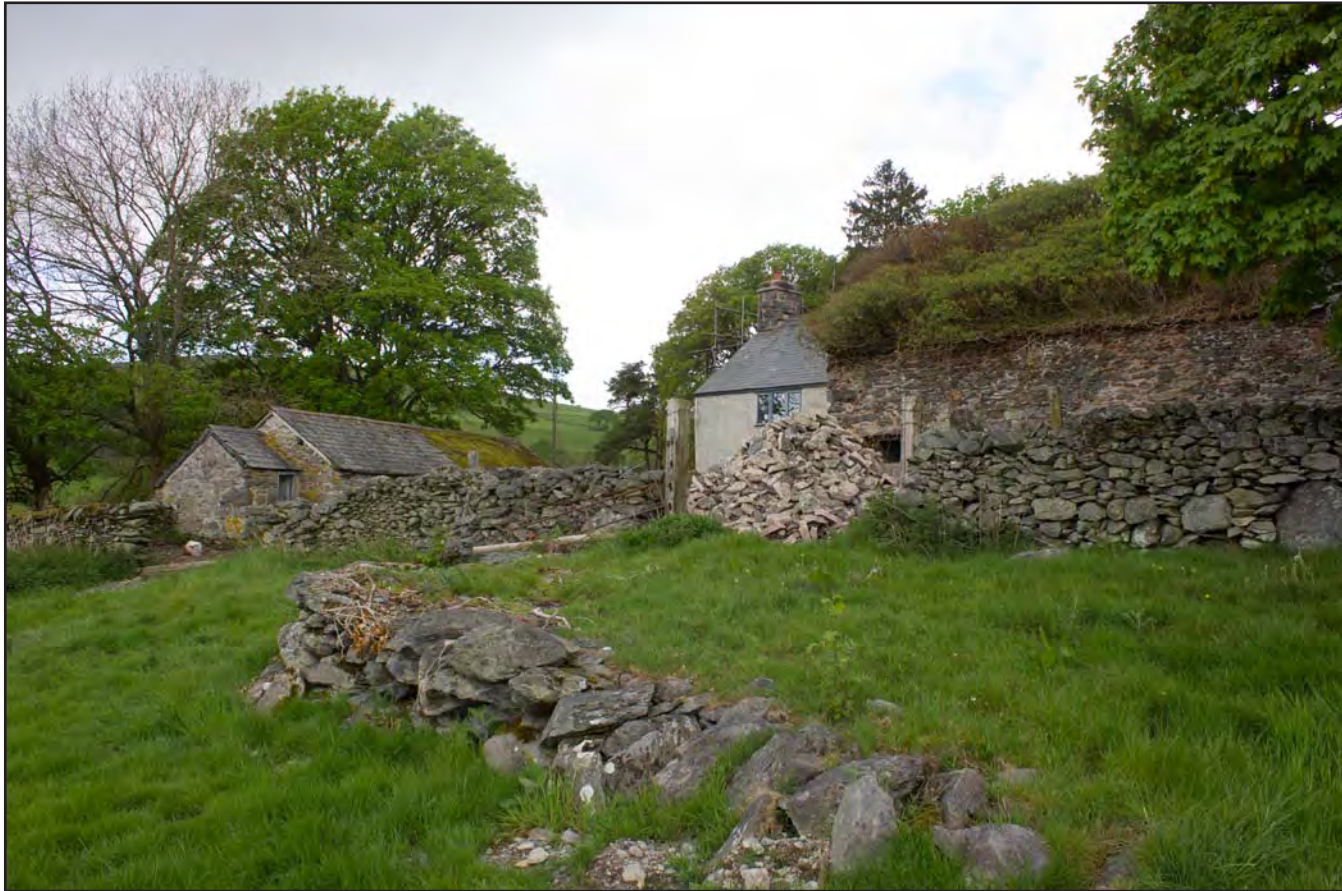
**Plate D:** Context shot of Gaer Gerrig farm complex - Llangwm, Conwy - from the east - 2.00m scale

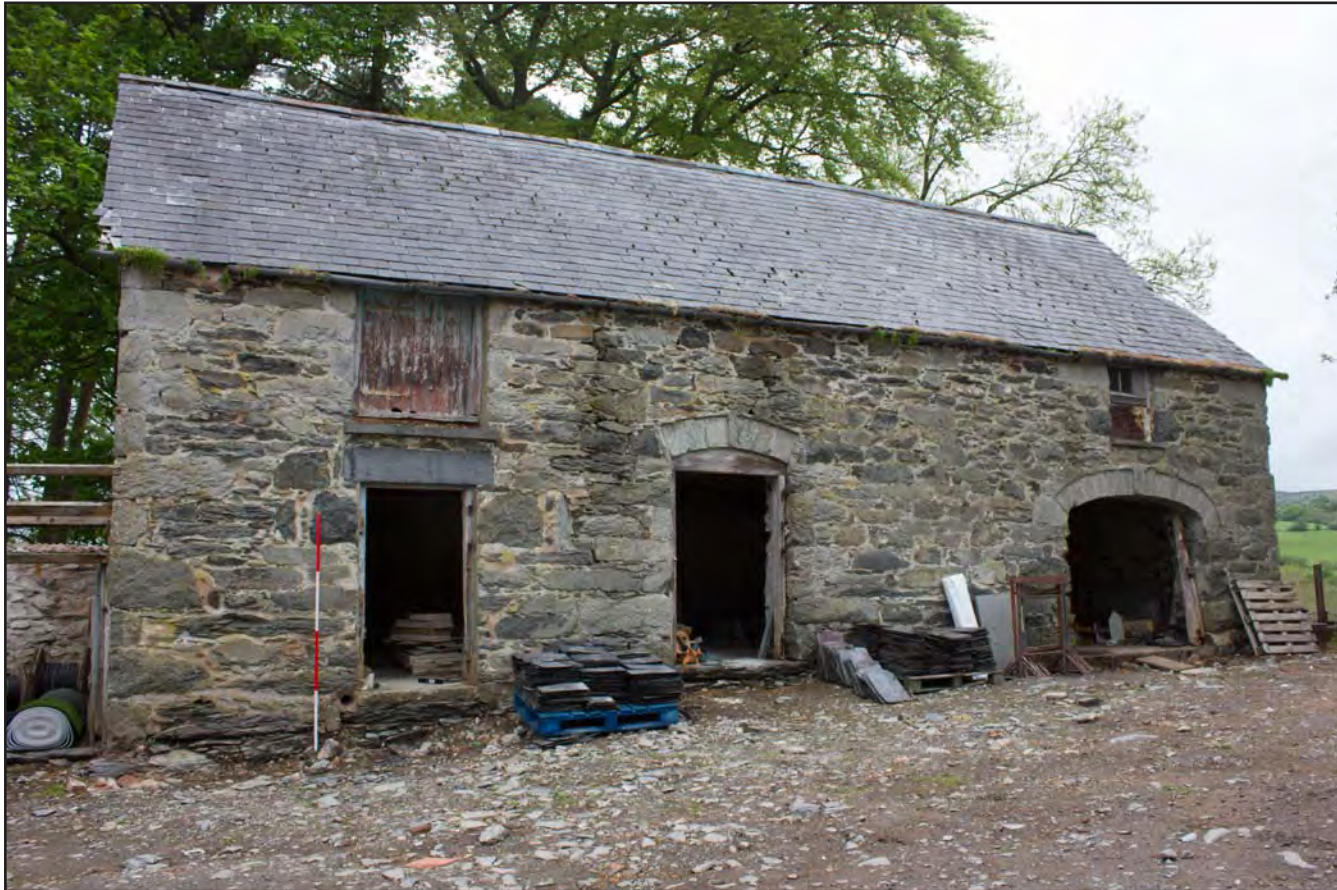
**Plate 01:** Southeast elevation of Building 1 - Cart and Threshing Barn at Gaer Gerrig, Llangwm, Conwy - from the southeast - 2.00m scale

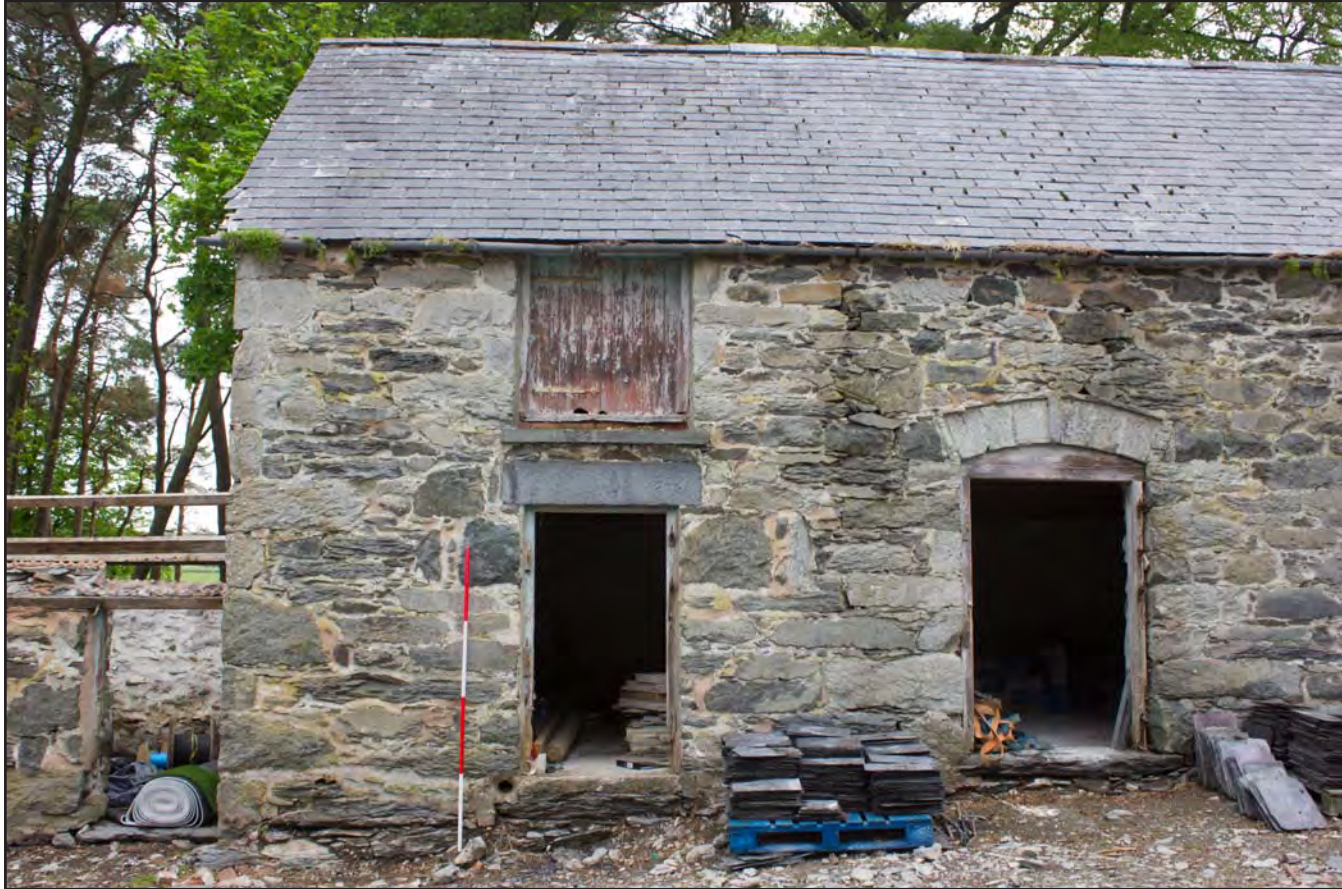
**Plate 02:** Southeast elevation (left) of Building 1 - Cart and Threshing Barn at Gaer Gerrig, Llangwm, Conwy - from the southeast - 2.00m scale

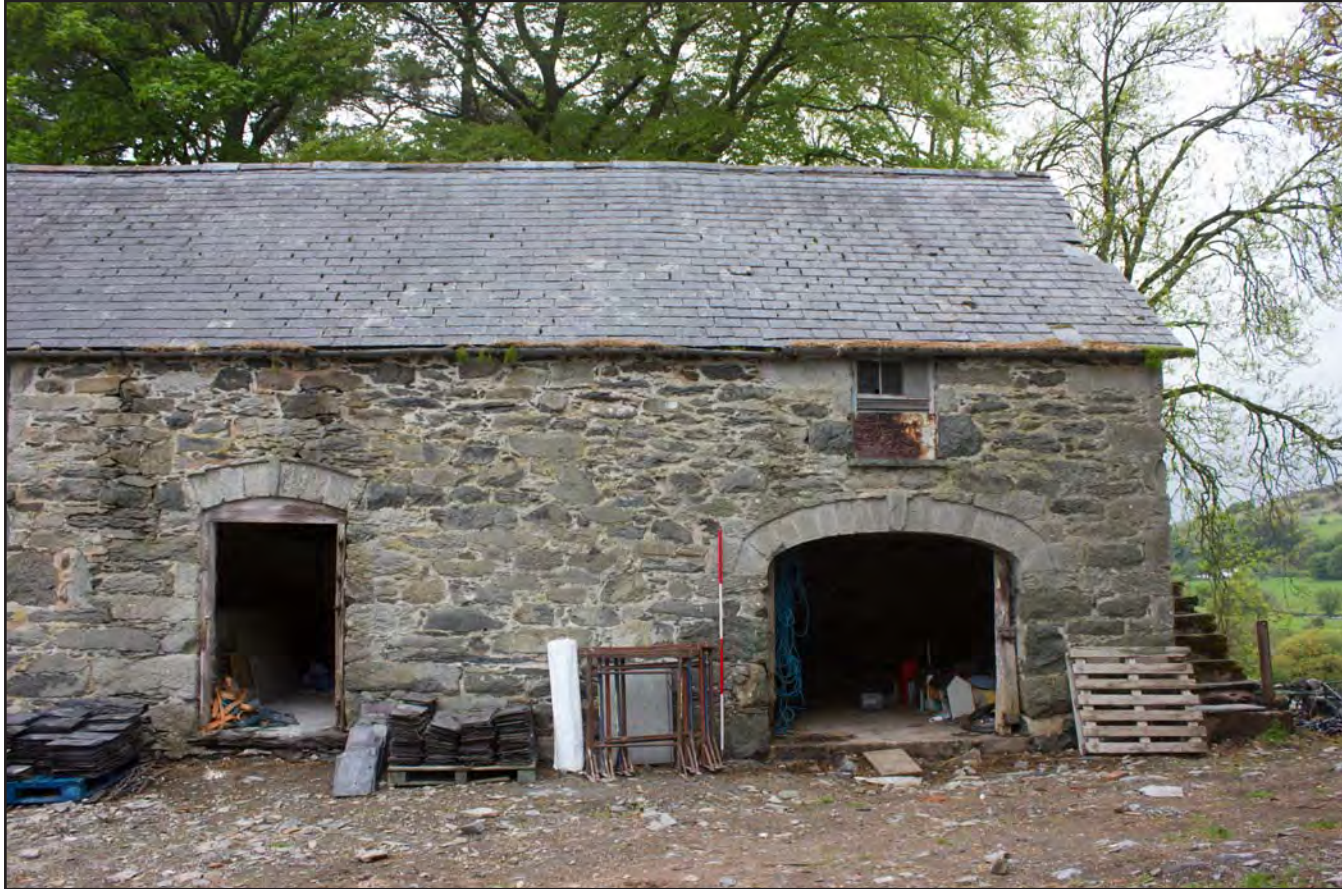
**Plate 03:** Southeast elevation (right) of Building 1 - Cart and Threshing Barn at Gaer Gerrig, Llangwm, Conwy - from the southeast - 2.00m scale

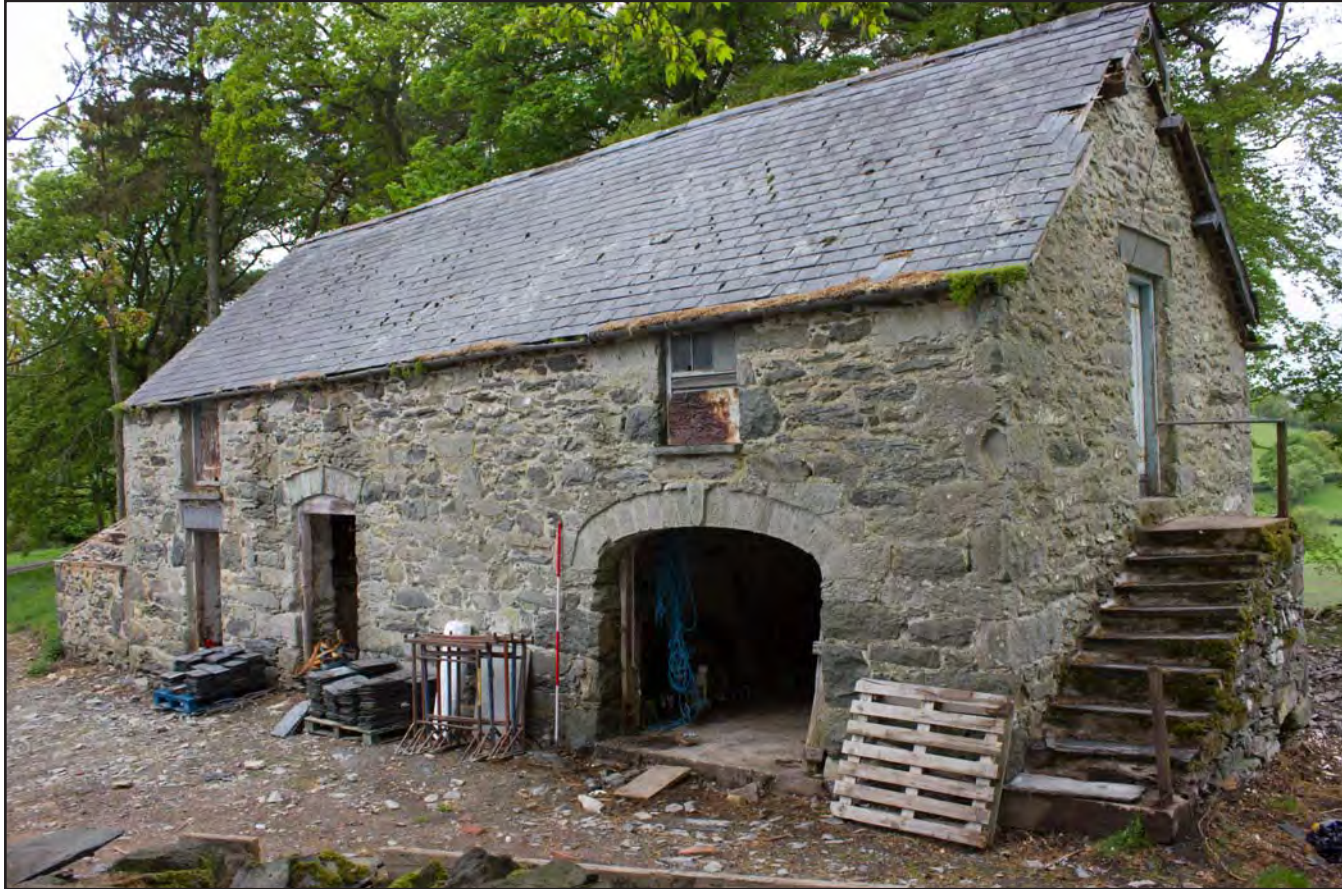
**Plate 04:** Oblique shot of southeast & northeast elevations of Building 1 - Cart and Threshing Barn at Gaer Gerrig, Llangwm, Conwy - from the east - 2.00m scale

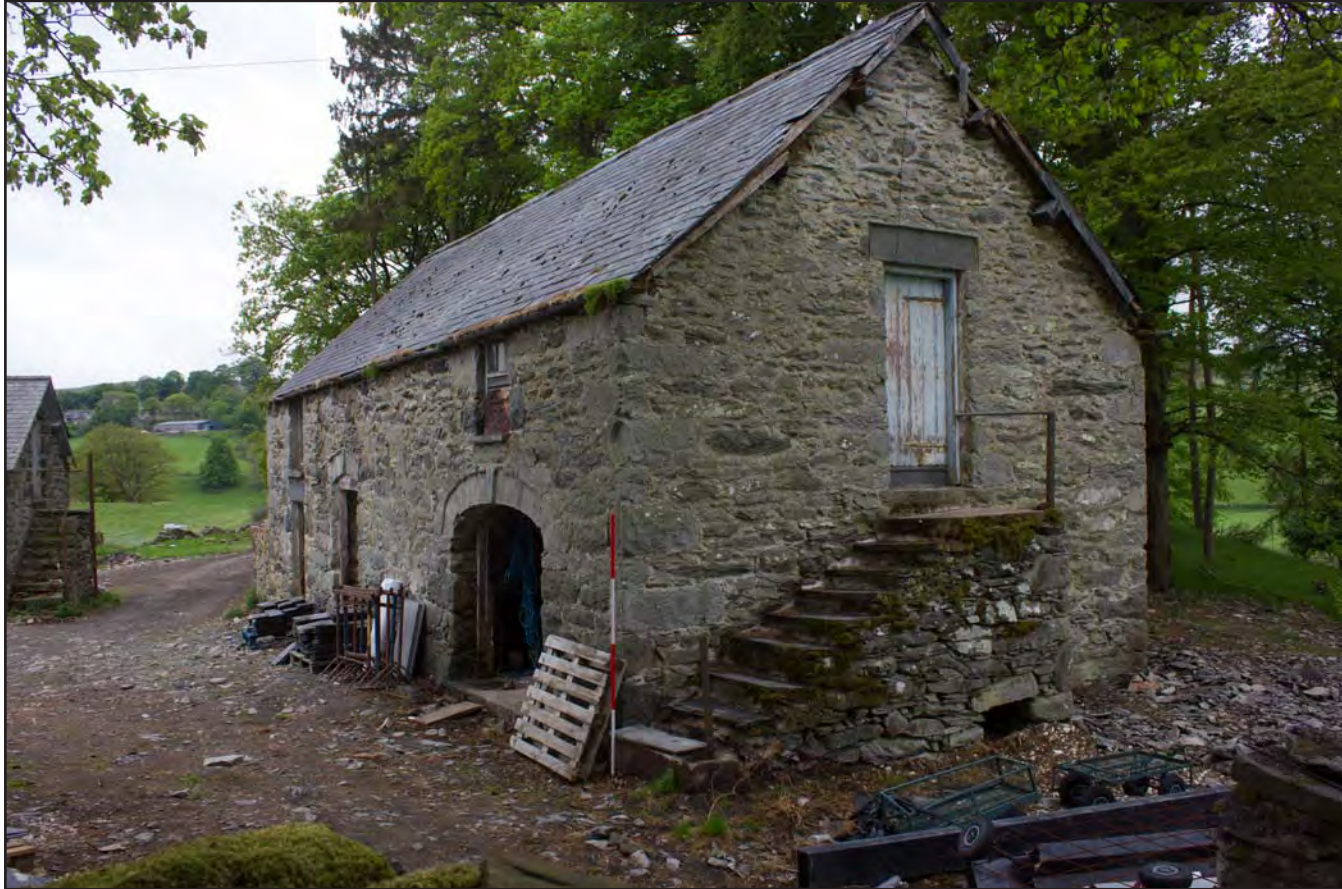
**Plate 05:** Oblique shot of southeast & northeast elevations of Building 1 - Cart and Threshing Barn at Gaer Gerrig, Llangwm, Conwy - from the east-northeast - 2.00m scale

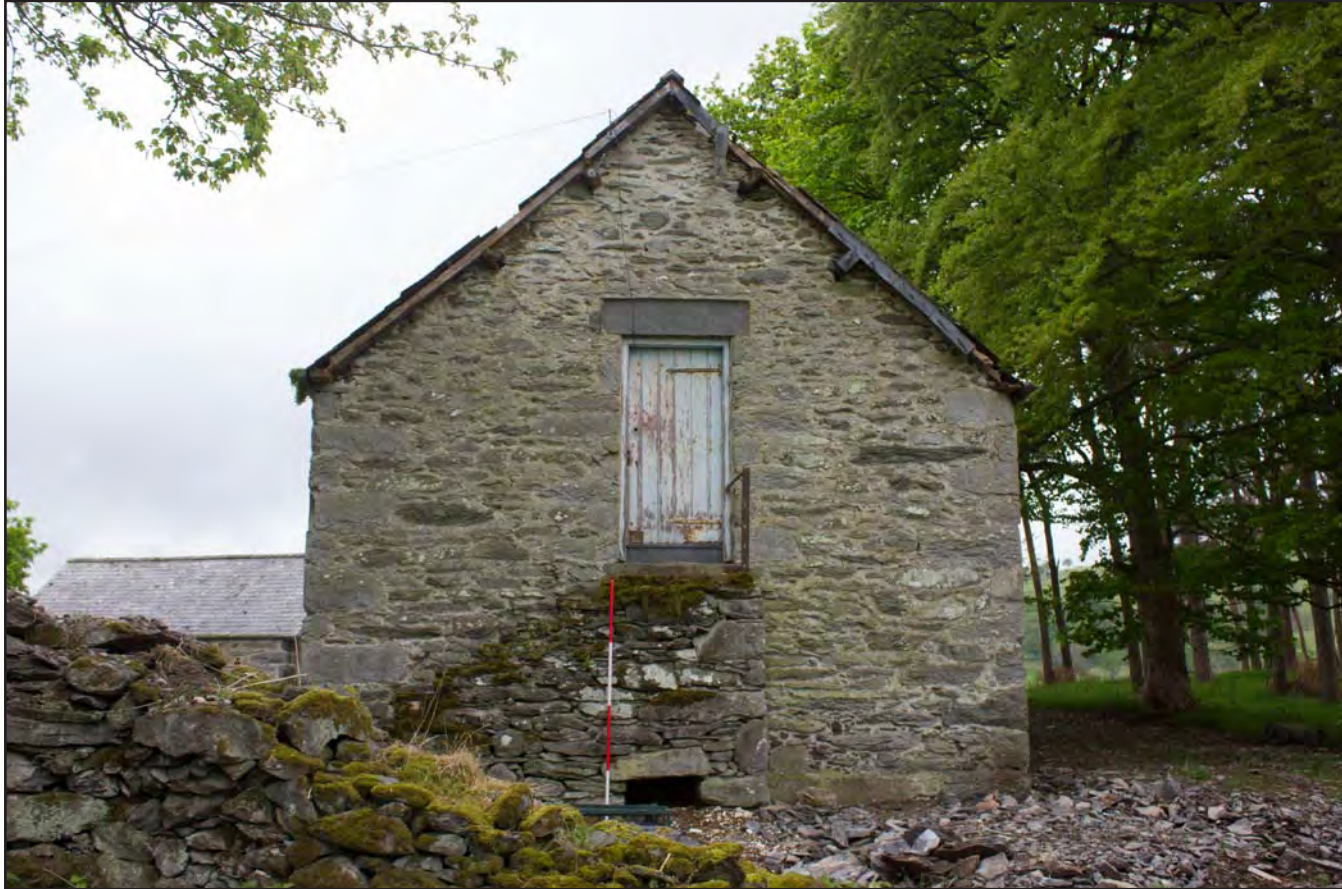
**Plate 06:** Northeast elevation of Building 1 - Cart and Threshing Barn at Gaer Gerrig, Llangwm, Conwy - from the north  
- 2.00m scale

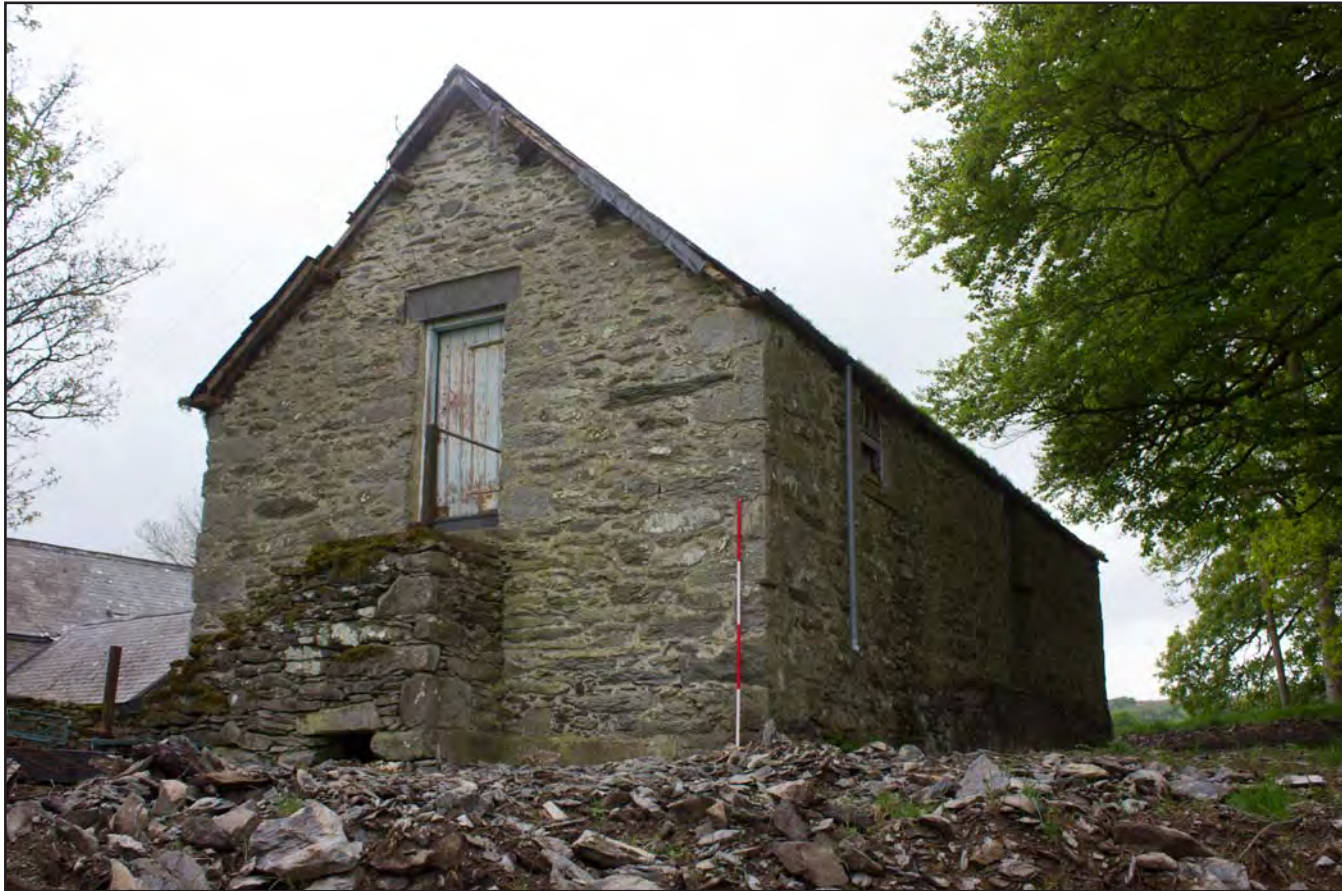
**Plate 07:** Oblique shot of northeast & northwest elevations of Building 1 - Cart and Threshing Barn at Gaer Gerrig, Llangwm, Conwy - from the north - 2.00m scale

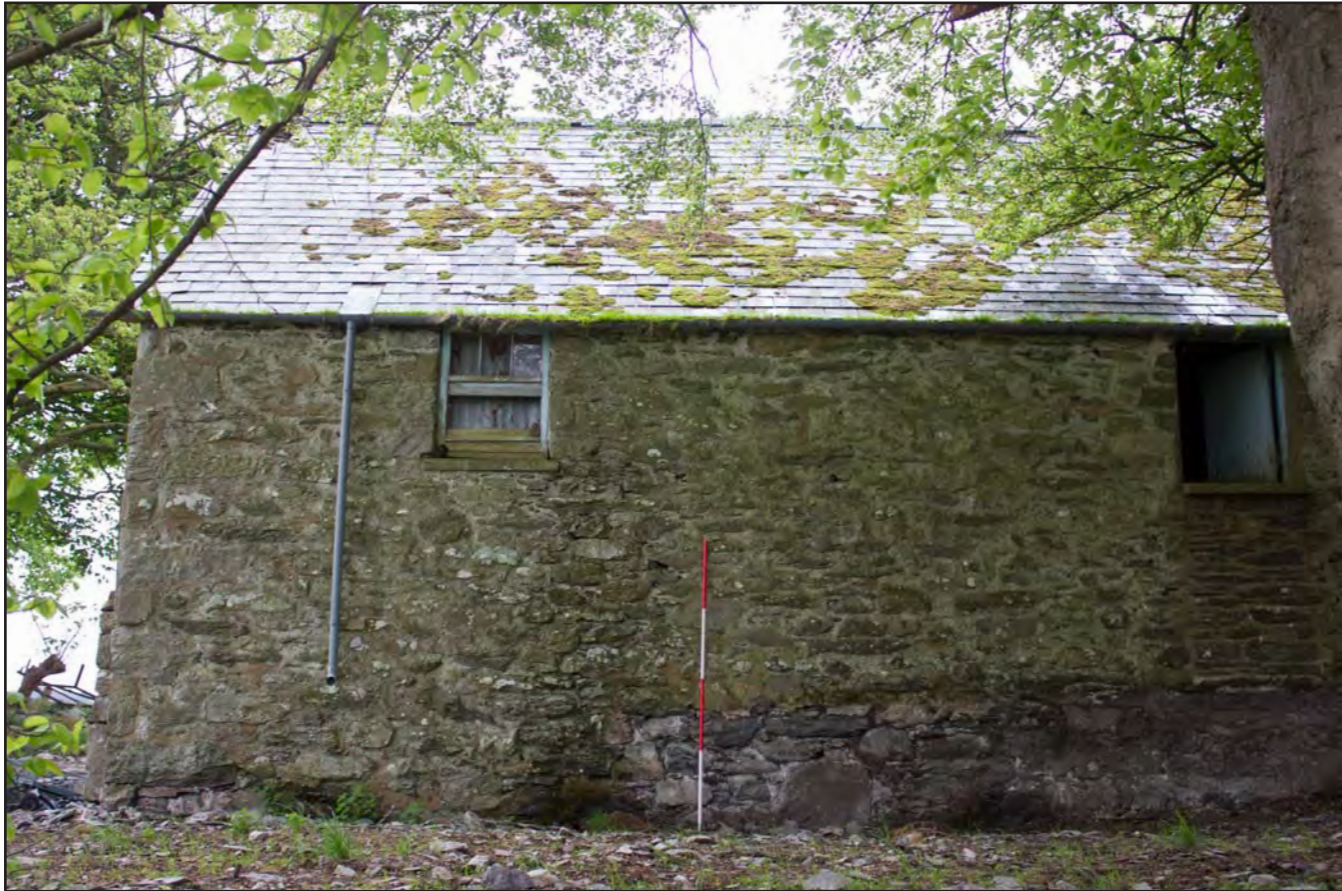
**Plate 08:** Northwest elevation (left) of Building 1 - Cart and Threshing Barn at Gaer Gerrig, Llangwm, Conwy - from the northwest - 2.00m scale

The north western elevation is comprised of sub-angular, stone rubble bonded by mortar and has been stained green by moss and the trees of the woods to the north. However, visible at the base and to the right-hand side of the elevation the stonework appears not to be stained and appears fresh which suggest suggests that there was once a low structure here which is now since been removed.

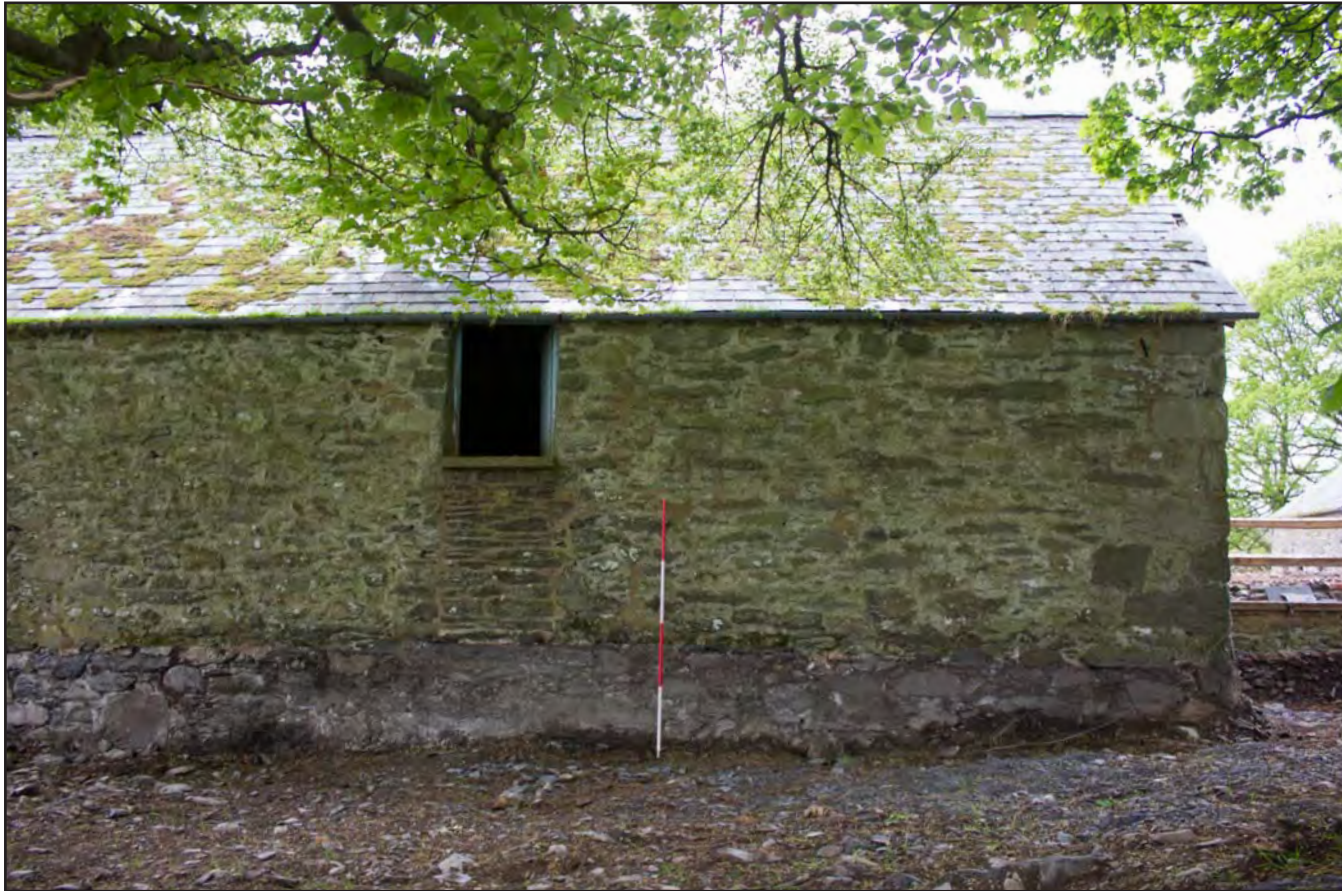
**Plate 09:** Northwest elevation (right) of Building 1 - Cart and Threshing Barn at Gaer Gerrig, Llangwm, Conwy - from the northwest - 2.00m scale

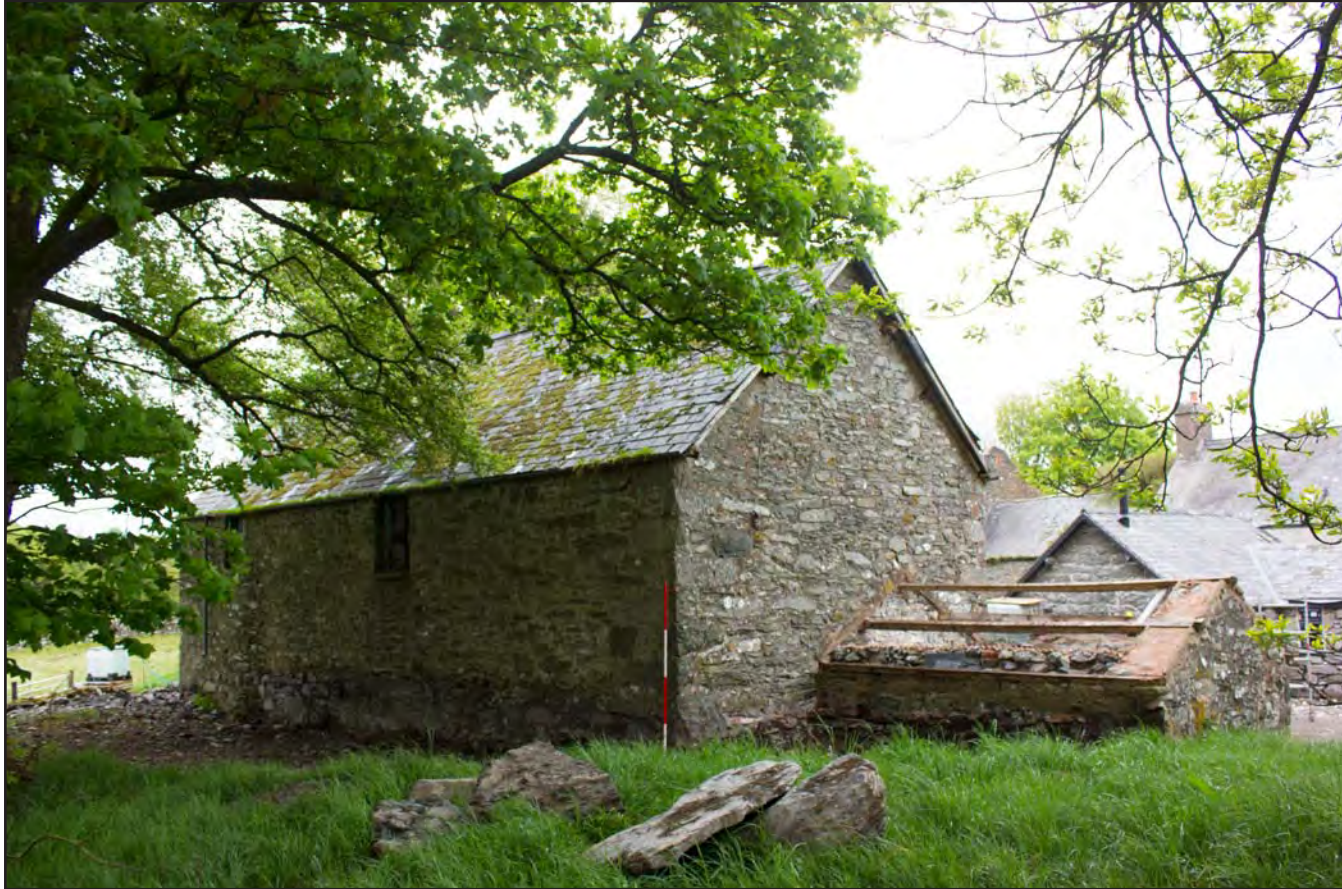
**Plate 10:** Oblique shot of northwest & southwest elevations of Building 1 - Cart and Threshing Barn at Gaer Gerrig, Llangwm, Conwy - from the west - 2.00m scale

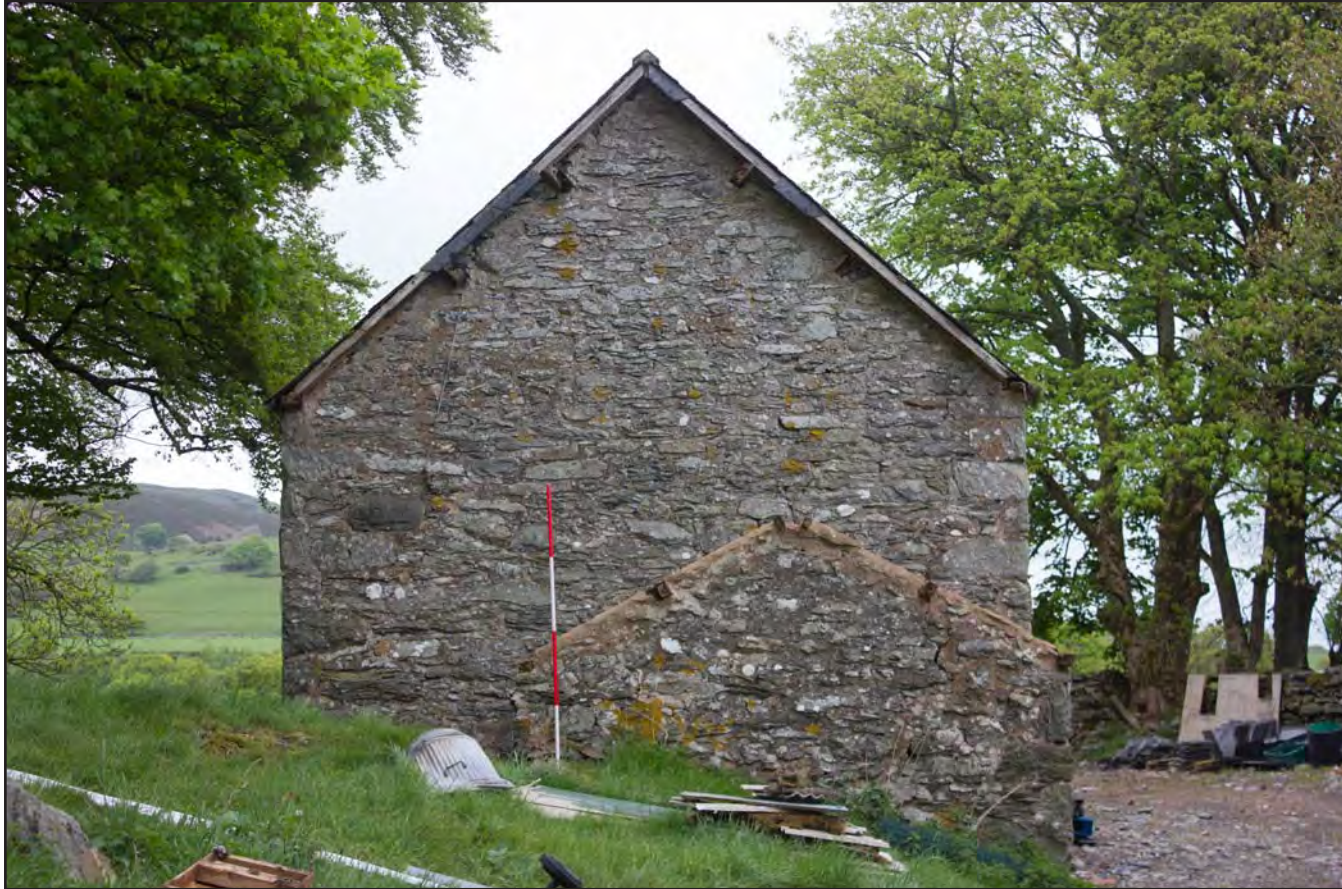
**Plate 11:** Southwest elevation of Building 1 - Cart and Threshing Barn at Gaer Gerrig, Llangwm, Conwy - from the southwest  
- 2.00m scale

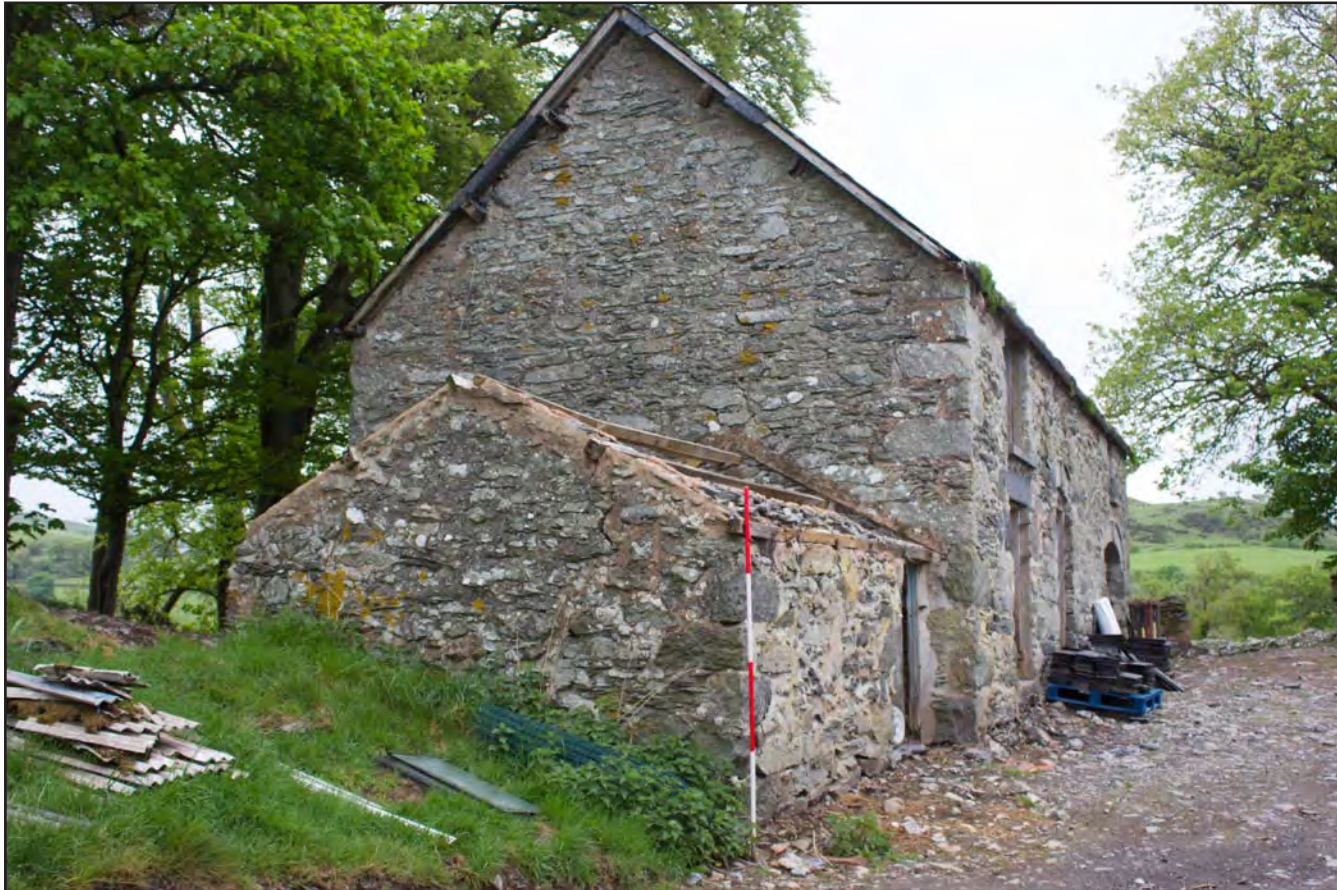
**Plate 12:** Oblique shot of southwest & southeast elevations of Building 1 - Cart and Threshing Barn at Gaer Gerrig, Llangwm, Conwy - from the south-southeast - 2.00m scale

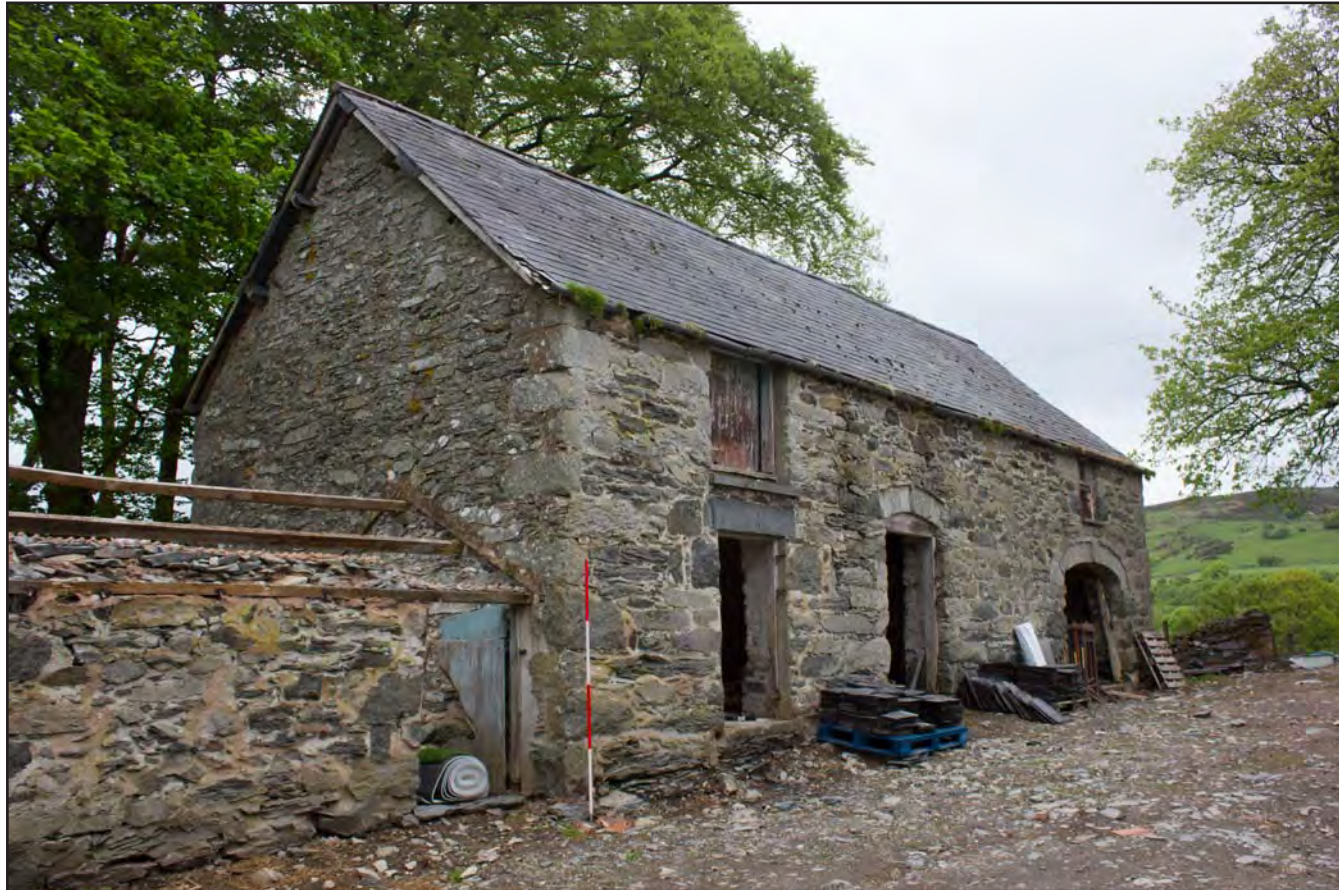
**Plate 13:** Oblique shot of southwest & southeast elevations of Building 1 - Cart and Threshing Barn at Gaer Gerrig, Llangwm, Conwy - from the southeast - 2.00m scale

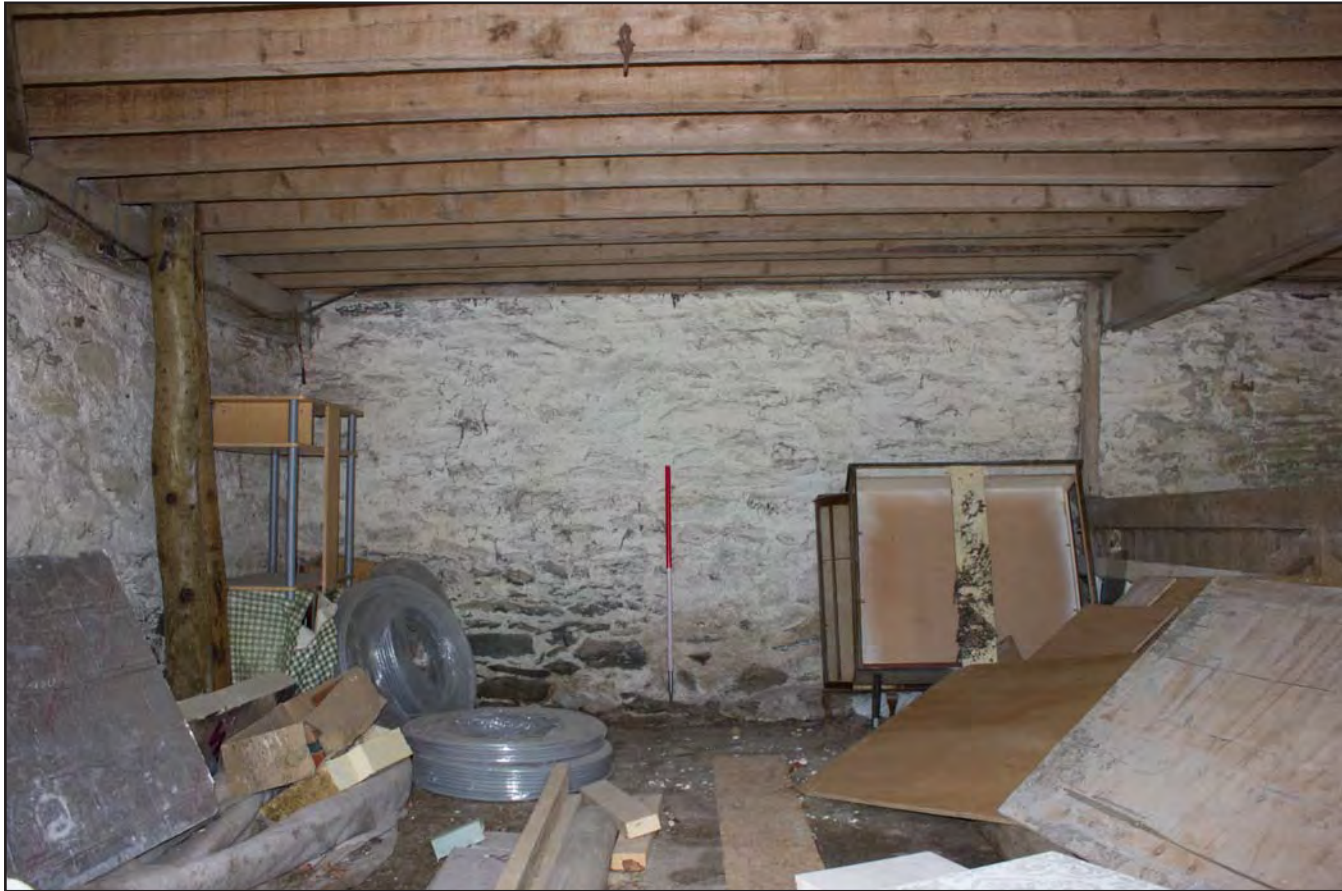
**Plate 14:** Former threshing floor (south western room) within Building 1 - Cart and Threshing Barn at Gaer Gerrig, Llangwm, Conwy - from the southeast - 1.00m scale
