# Outbuildings at Gaer Gerrig, Llangwm, Conwy LL21 OPE.

Historic Building Record Level 2

Report no. 0349

# **Outbuildings at Gaer Gerrig, Llangwm, Conwy LL21 OPE (0/46680).**

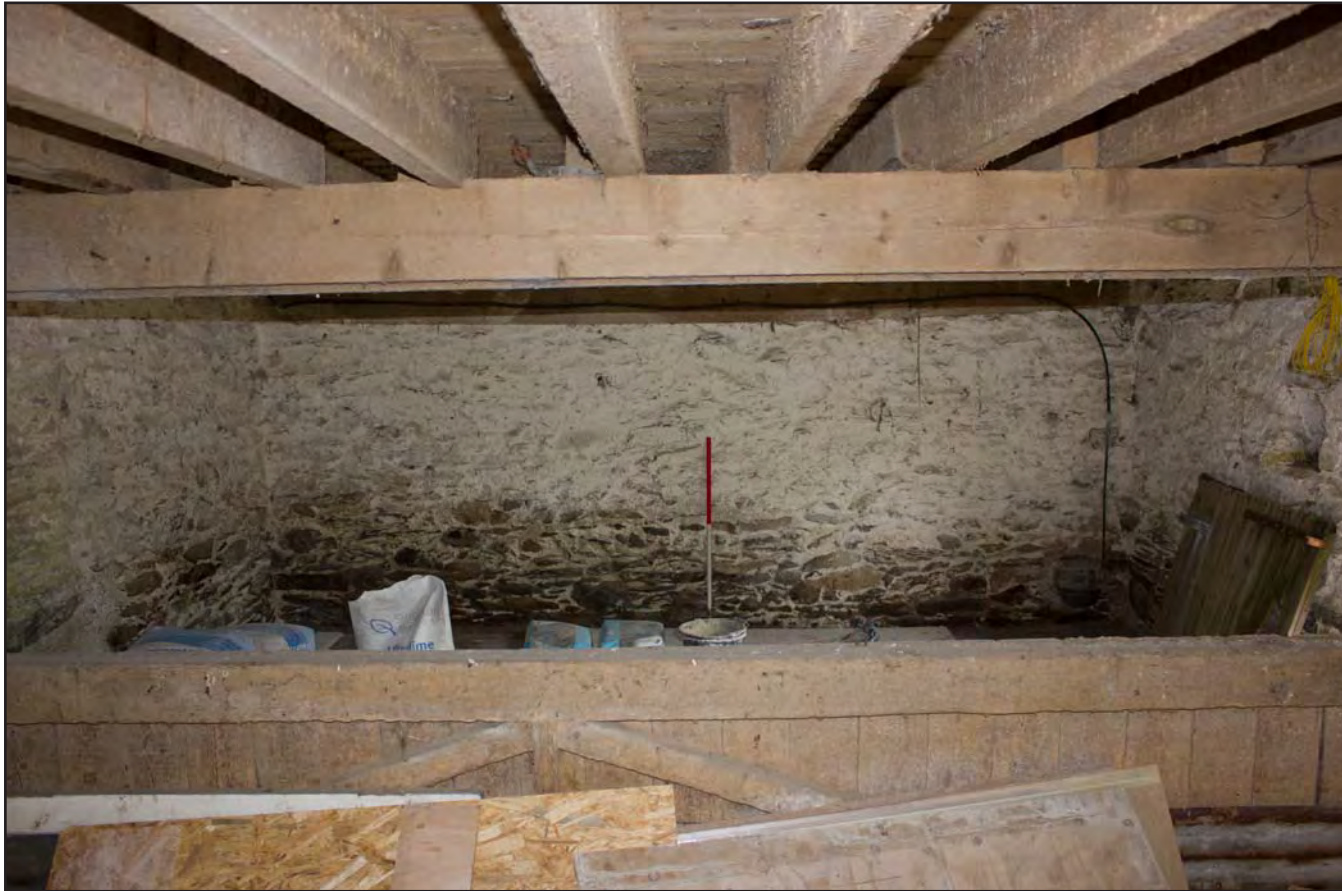
**Plate 15:** Former threshing floor within Building 1 - Cart and Threshing Barn at Gaer Gerrig, Llangwm, Conwy - from the southwest - 1.00m scale

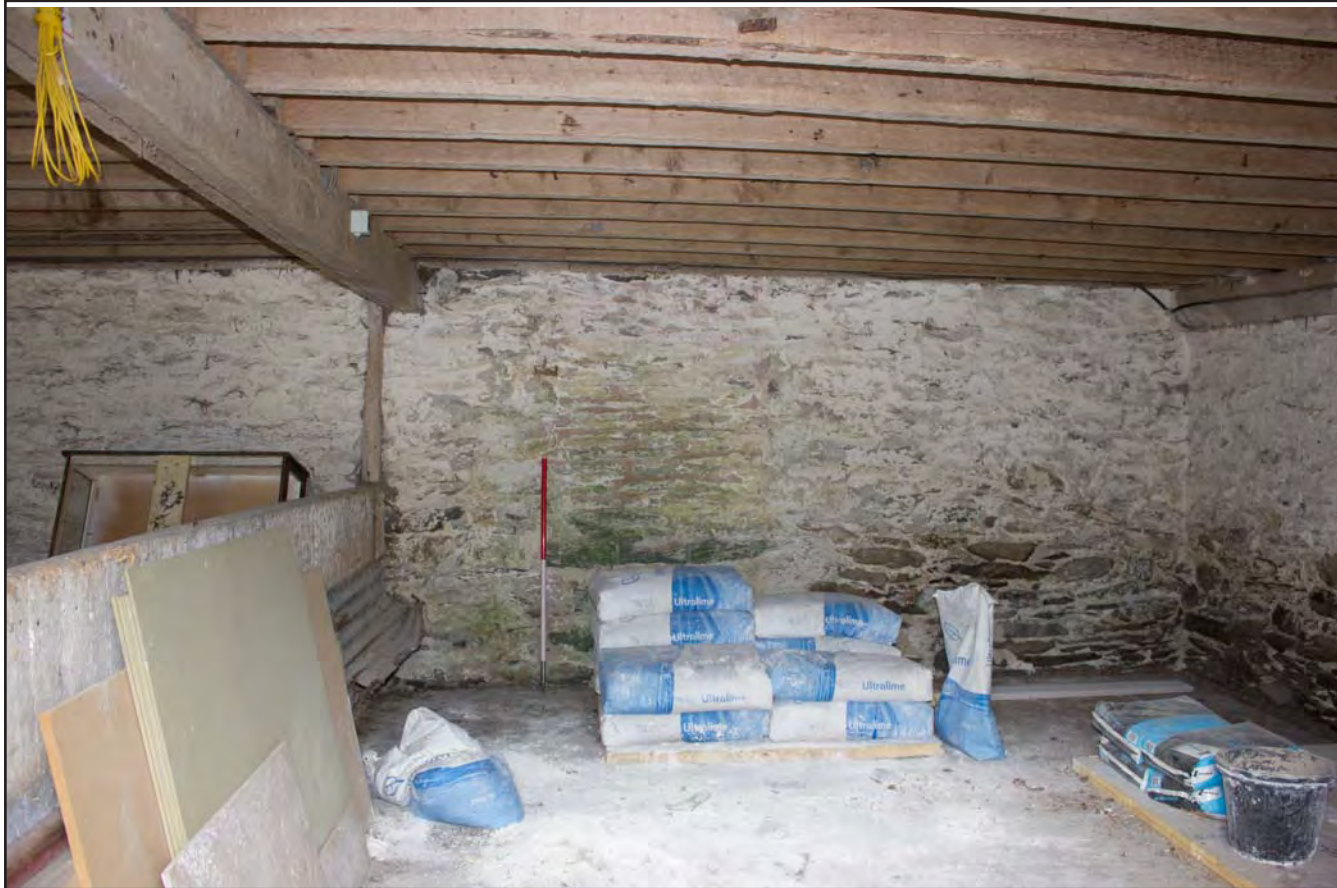
**Plate 16:** Former threshing floor (central room) within Building 1 - Cart and Threshing Barn at Gaer Gerrig, Llangwm, Conwy - from the southeast - 1.00m scale

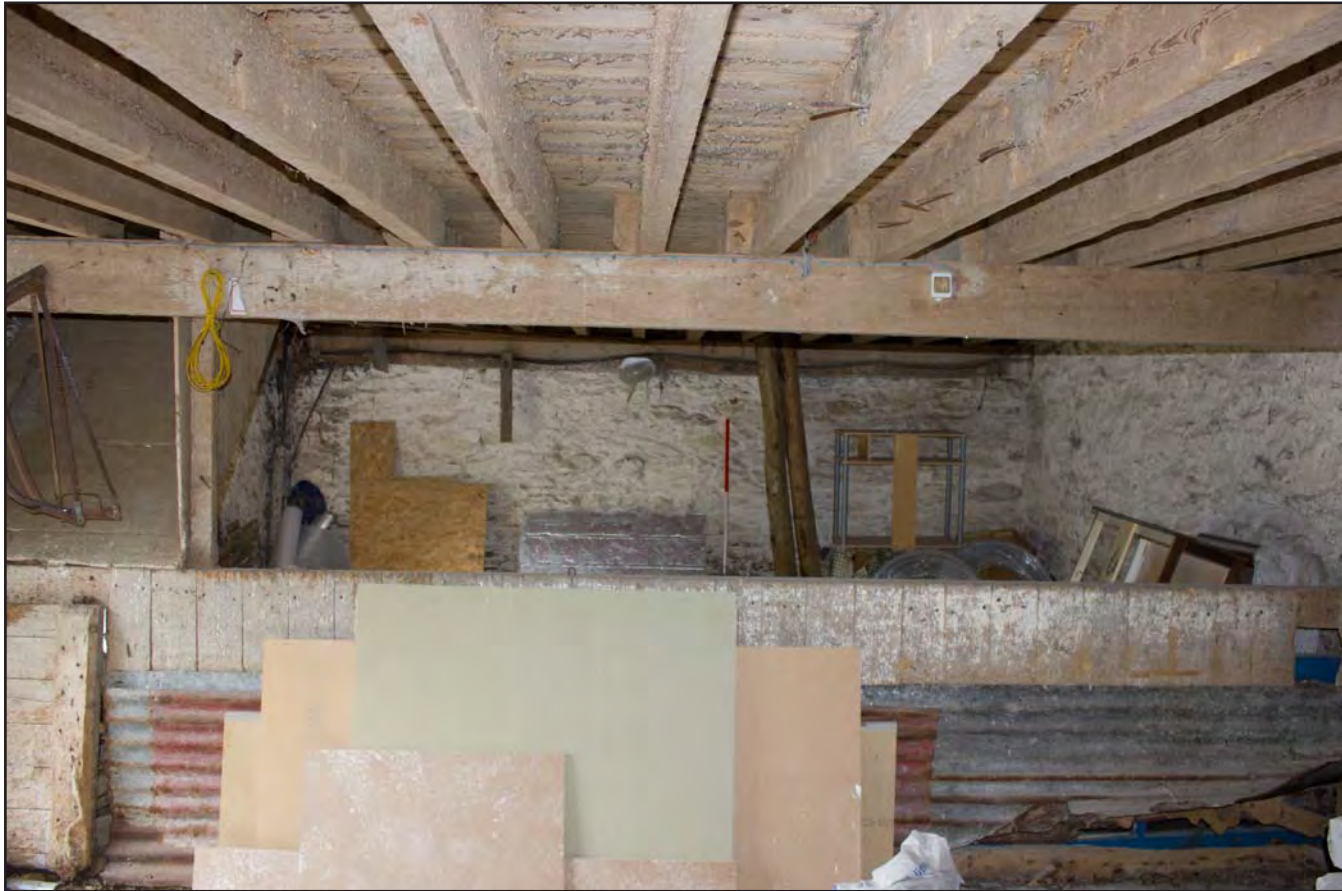
**Plate 17:** Former threshing floor within Building 1 - Cart and Threshing Barn at Gaer Gerrig, Llangwm, Conwy - from the northeast - 1.00m scale

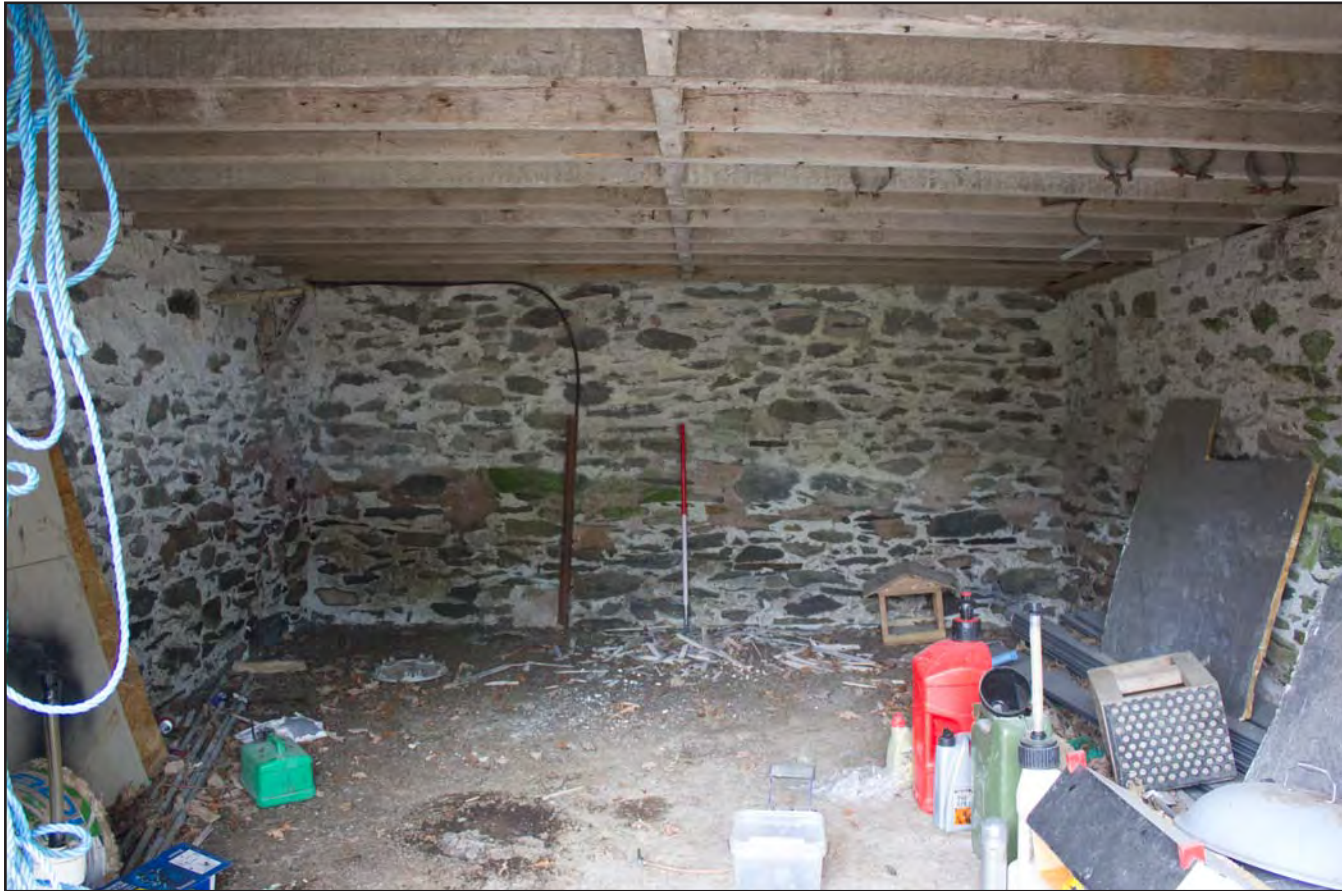
**Plate 18:** Cart Barn within Building 1 - Cart and Threshing Barn at Gaer Gerrig, Llangwm, Conwy - from the southeast - 1.00m scale

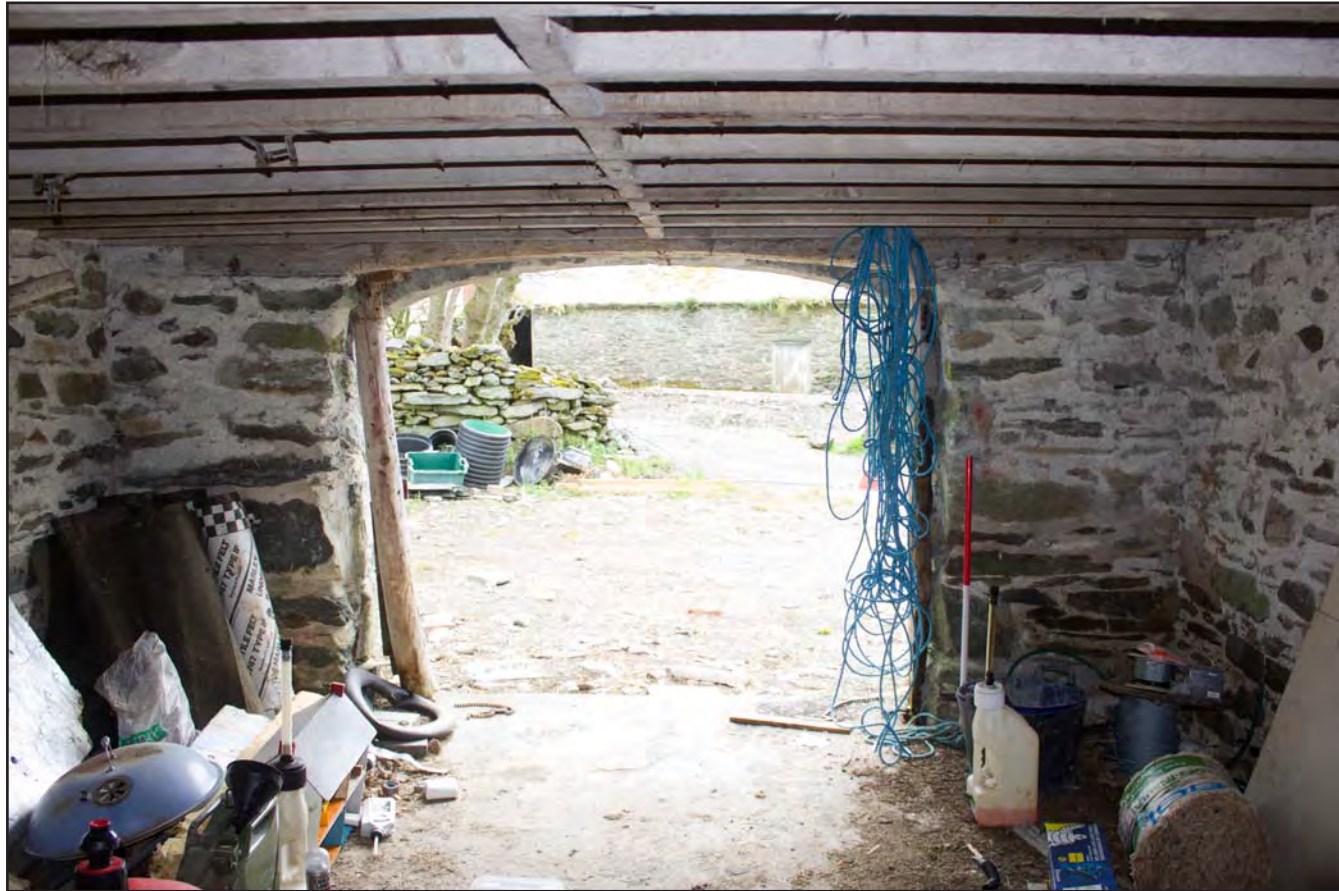
**Plate 19:** Cart Barn within Building 1 - Cart and Threshing Barn at Gaer Gerrig, Llangwm, Conwy - from the northwest - 1.00m scale

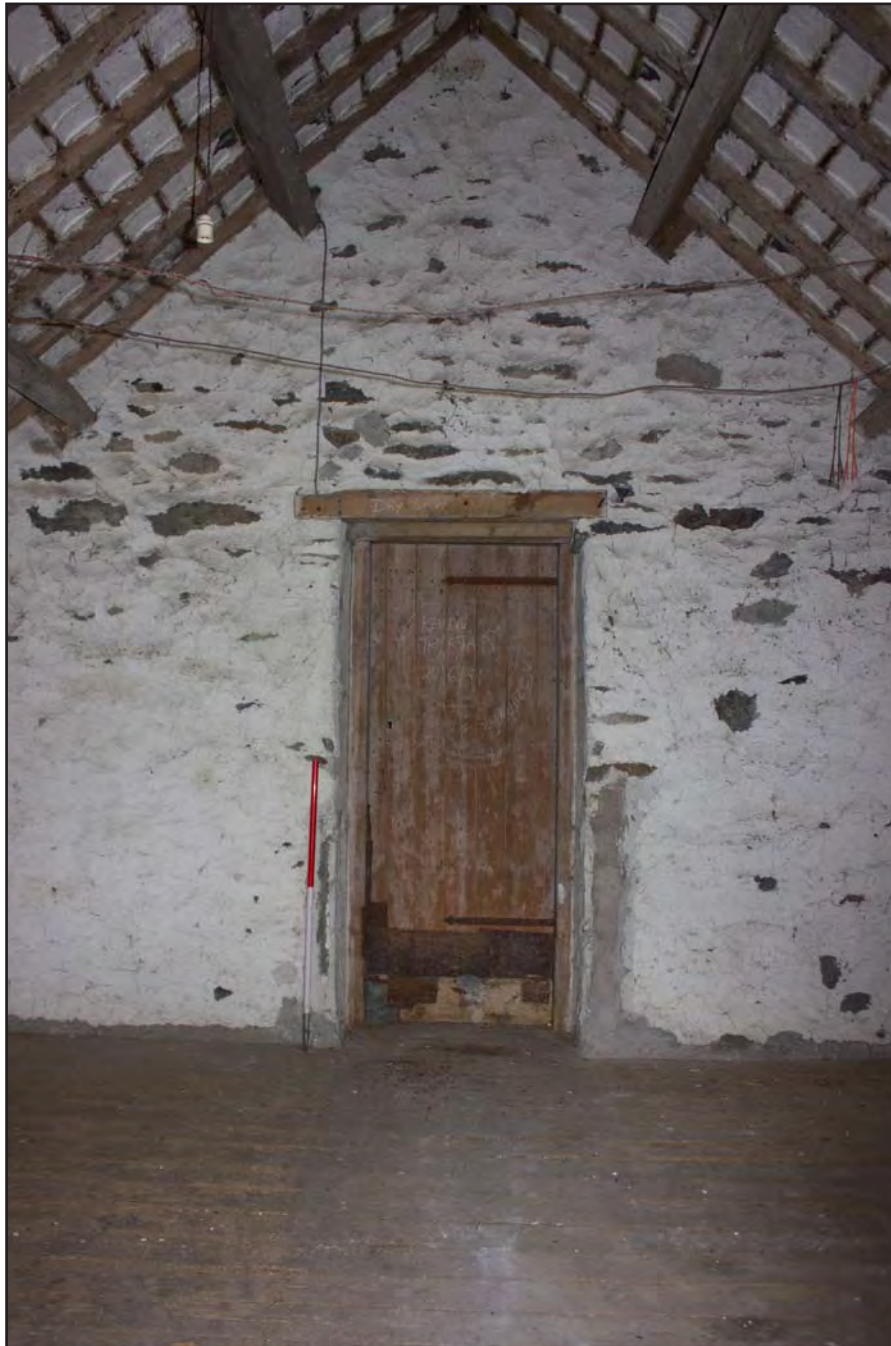
**Plate 20:** Store 1 on first floor within Building 1 - Cart and Threshing Barn at Gaer Gerrig, Llangwm, Conwy - from the northeast - 1.00m scale

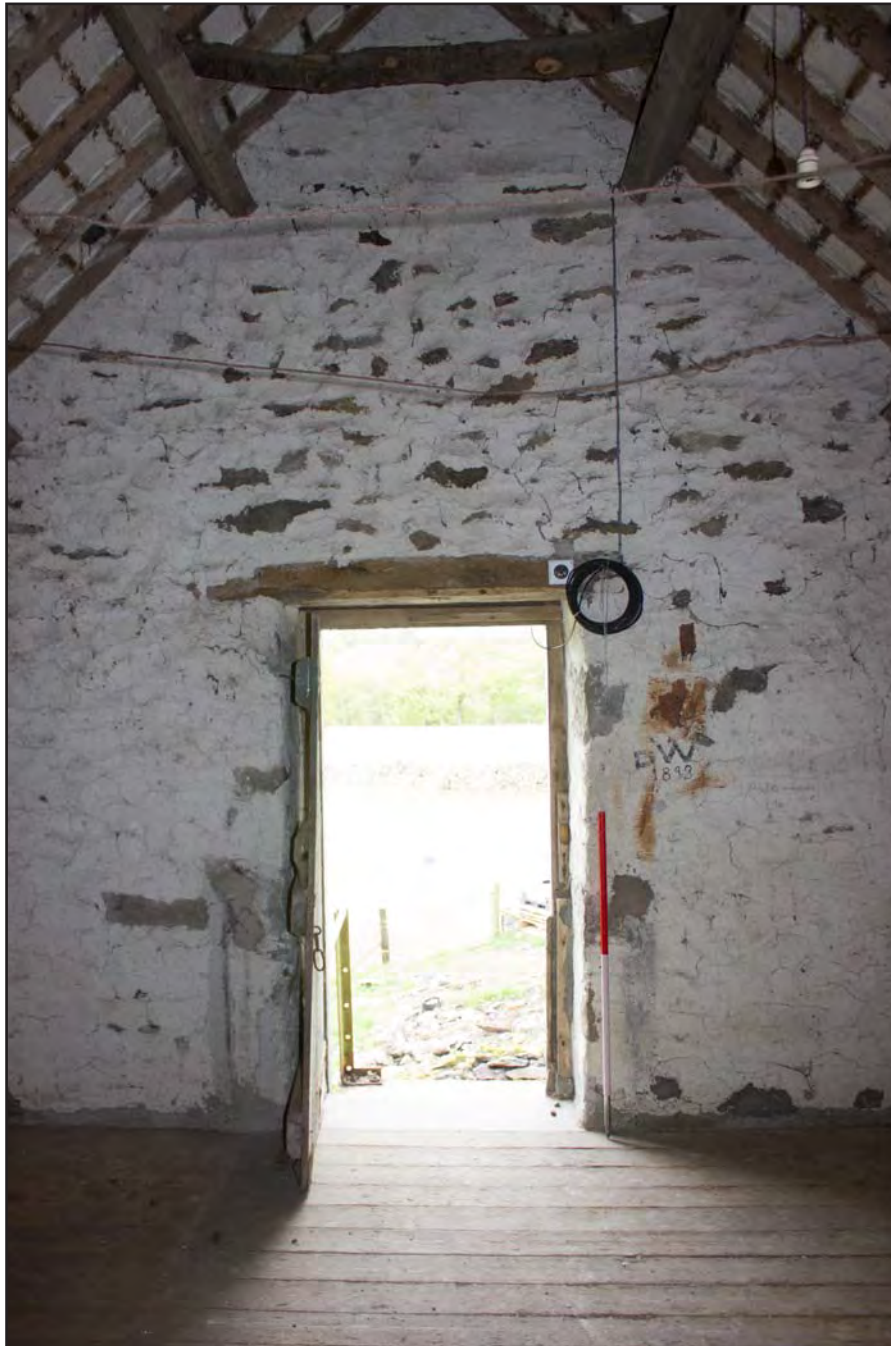
**Plate 21:** Store 1, First floor, within Building 1 - Cart and Threshing Barn at Gaer Gerrig, Llangwm, Conwy - from the southwest- 1.00m scale

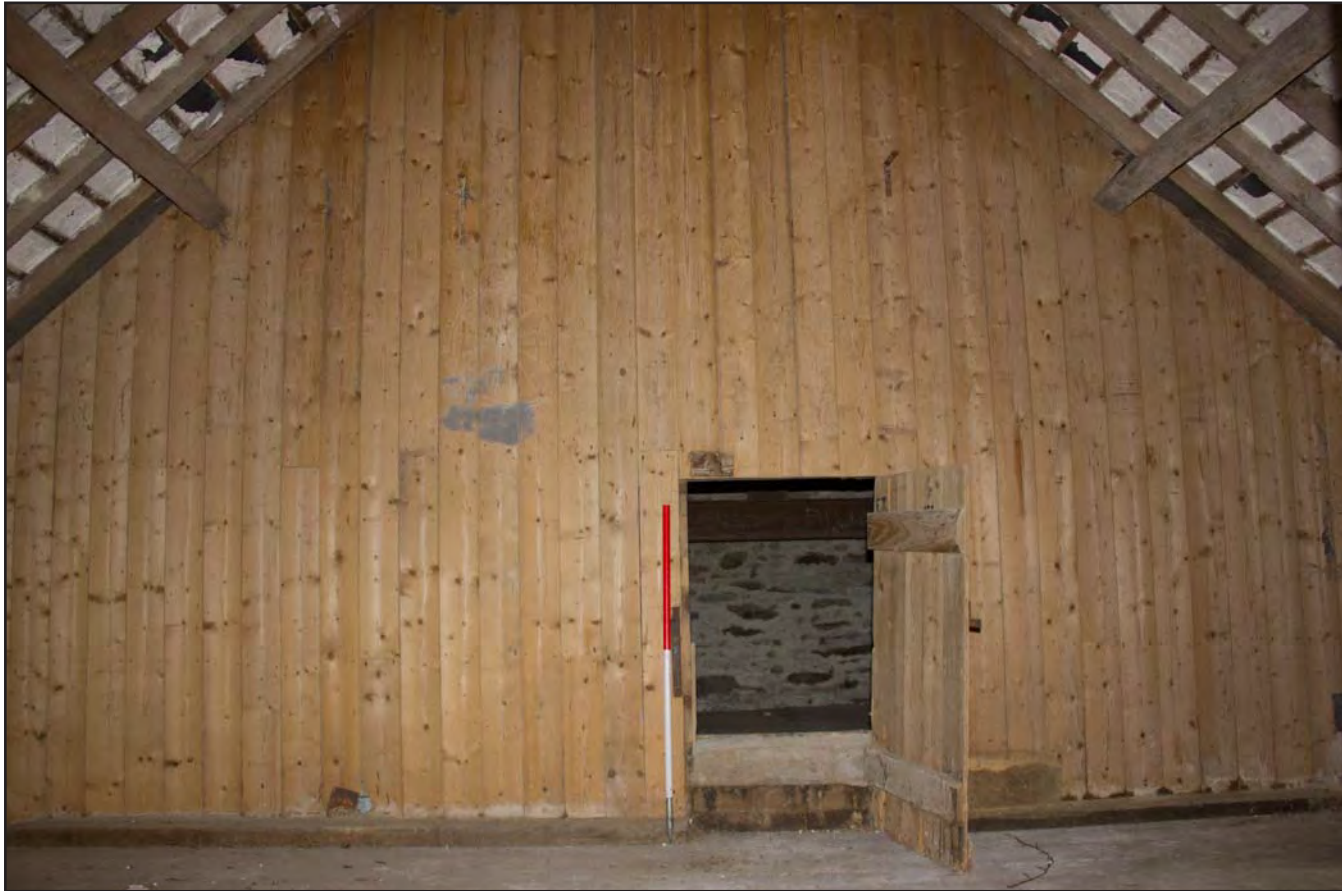
**Plate 22:** Store 2, First Floor, within Building 1 - Cart and Threshing Barn at Gaer Gerrig, Llangwm, Conwy - from the northeast  
- 1.00m scale

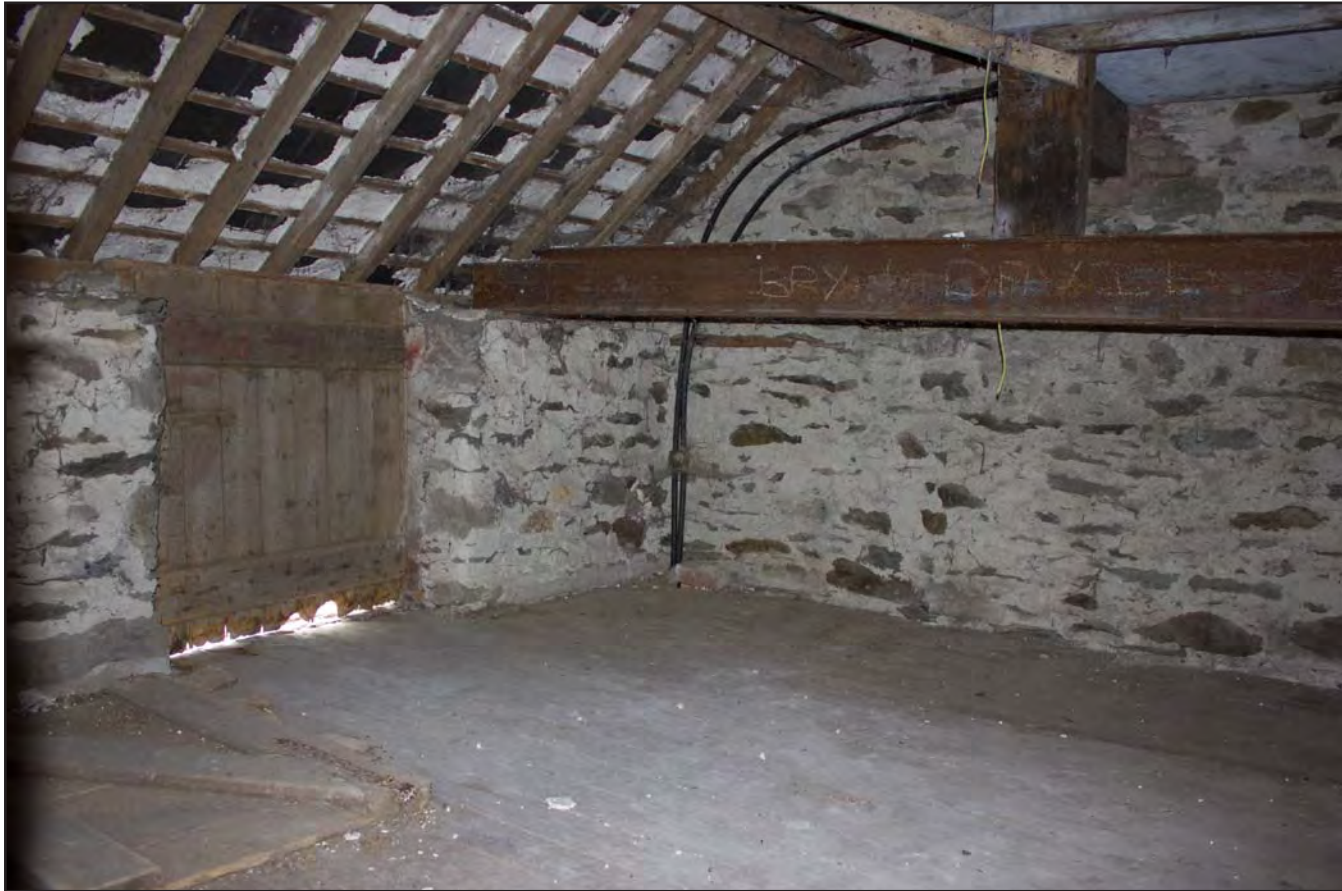
**Plate 23:** Store 3, First Floor, within Building 1 - Cart and Threshing Barn at Gaer Gerrig, Llangwm, Conwy - from the west  
- 1.00m scale

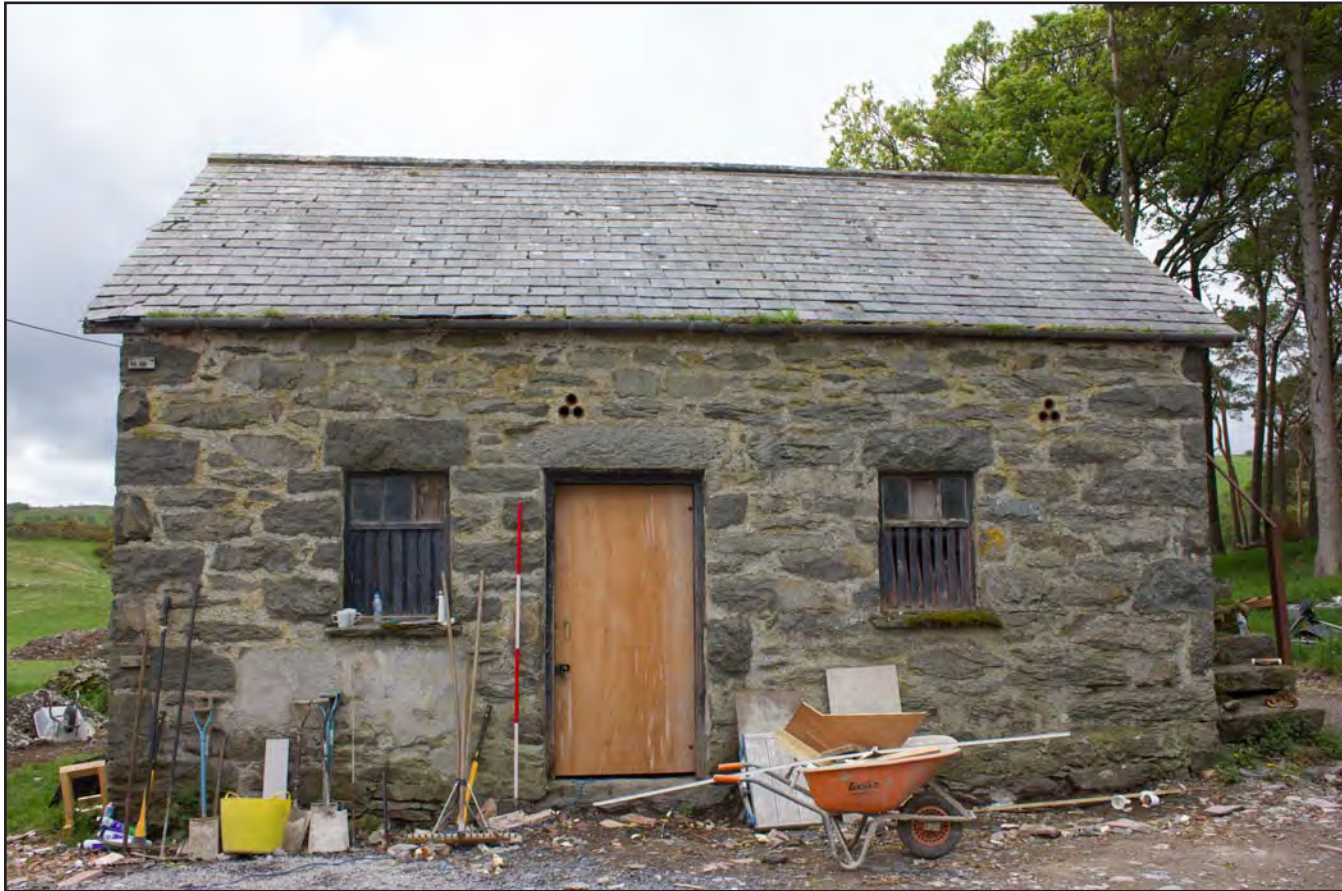
**Plate 24:** Northeast elevation of Building 2 - Horse/Pony Stable at Gaer Gerrig, Llangwm, Conwy - from the northeast  
- 2.00m scale

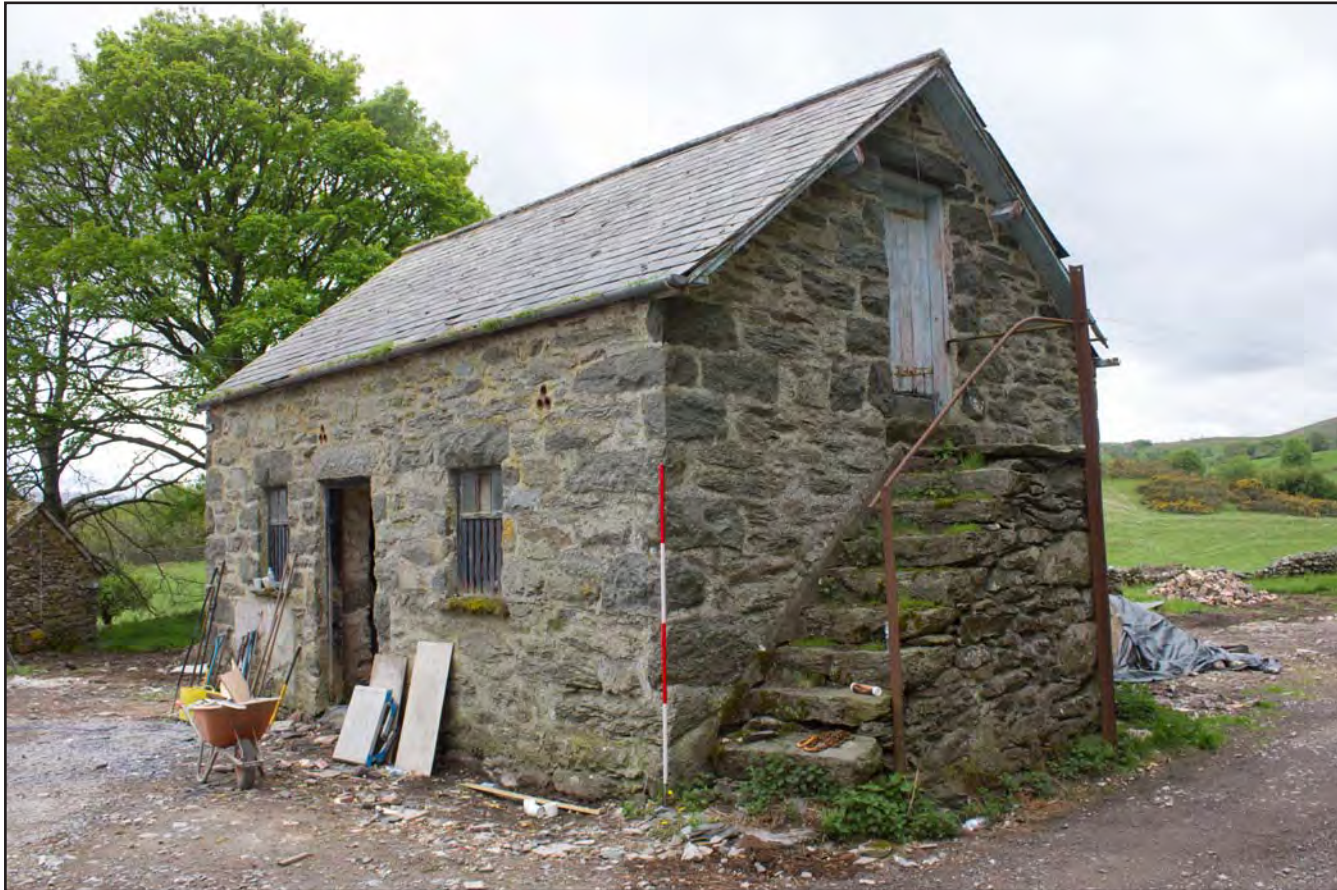
**Plate 25:** Oblique shot of northeast & northwest elevations of Building 2 - Horse/Pony Stable at Gaer Gerrig, Llangwm, Conwy - from the north - 2.00m scale

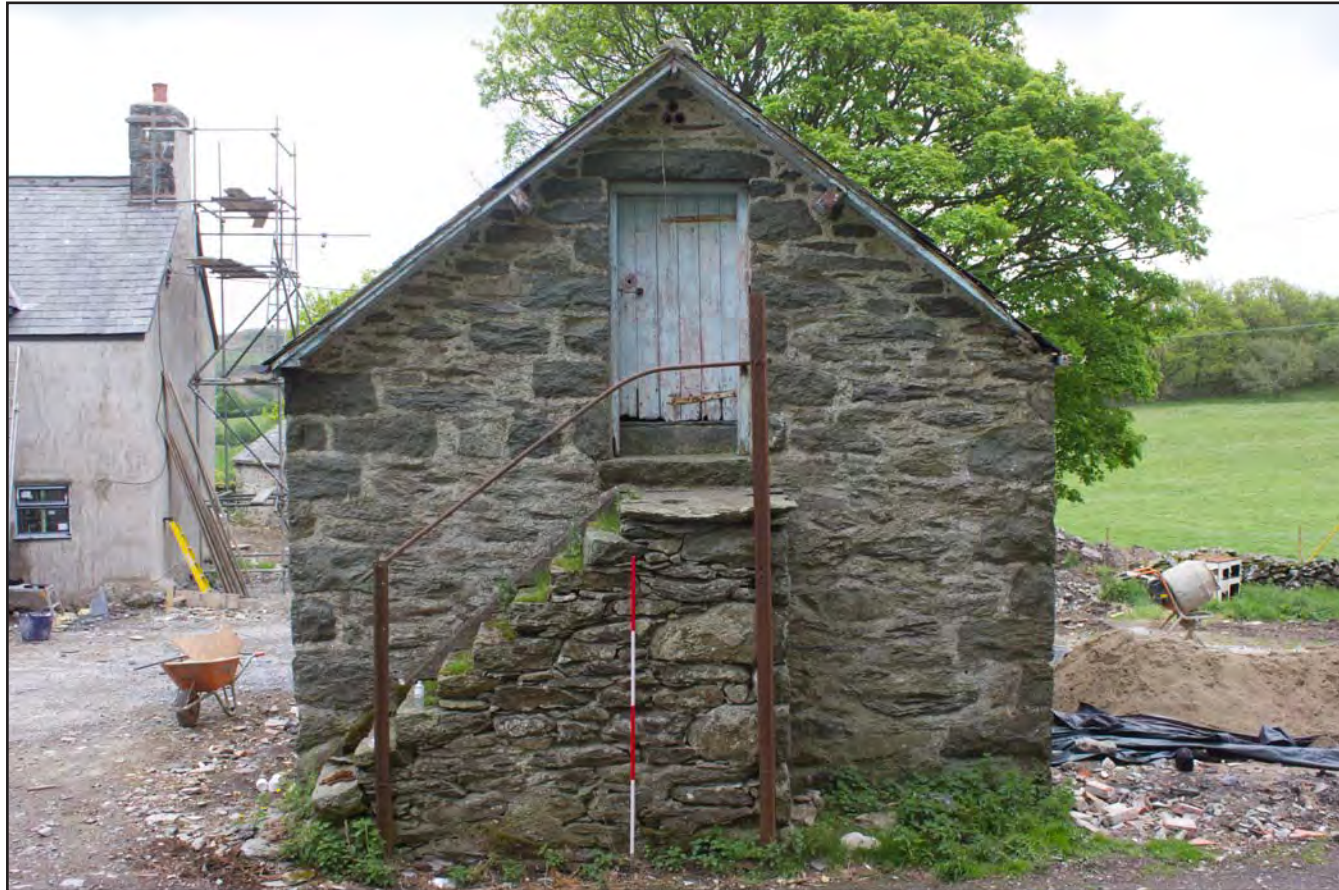
**Plate 26:** Northwest elevation of Building 2 - Horse/Pony Stable at Gaer Gerrig, Llangwm, Conwy - from the northwest  
- 2.00m scale

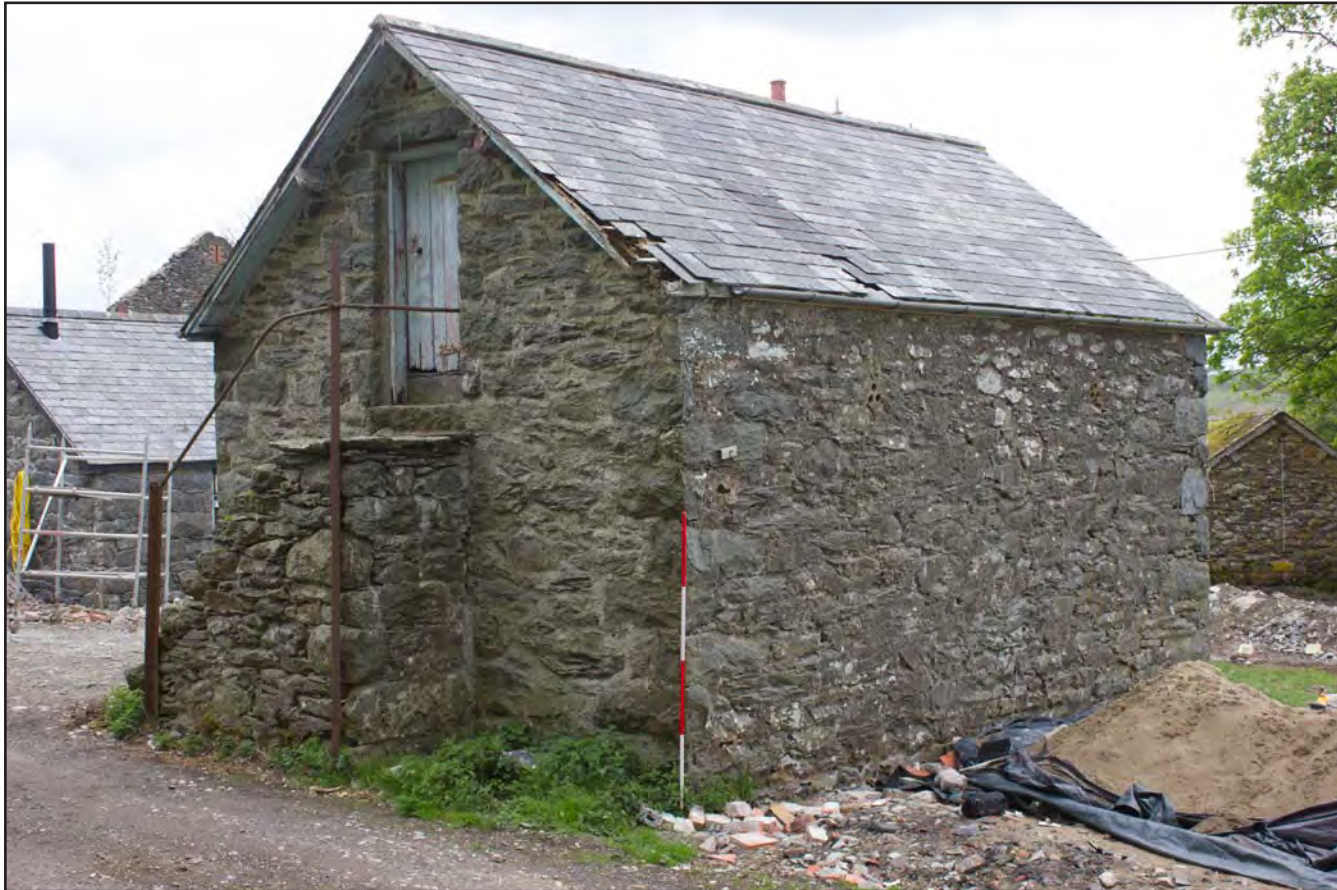
**Plate 27:** Oblique shot of northwest & southwest elevations of Building 2- Horse/Pony Stable at Gaer Gerrig, Llangwm, Conwy - from the west - 2.00m scale

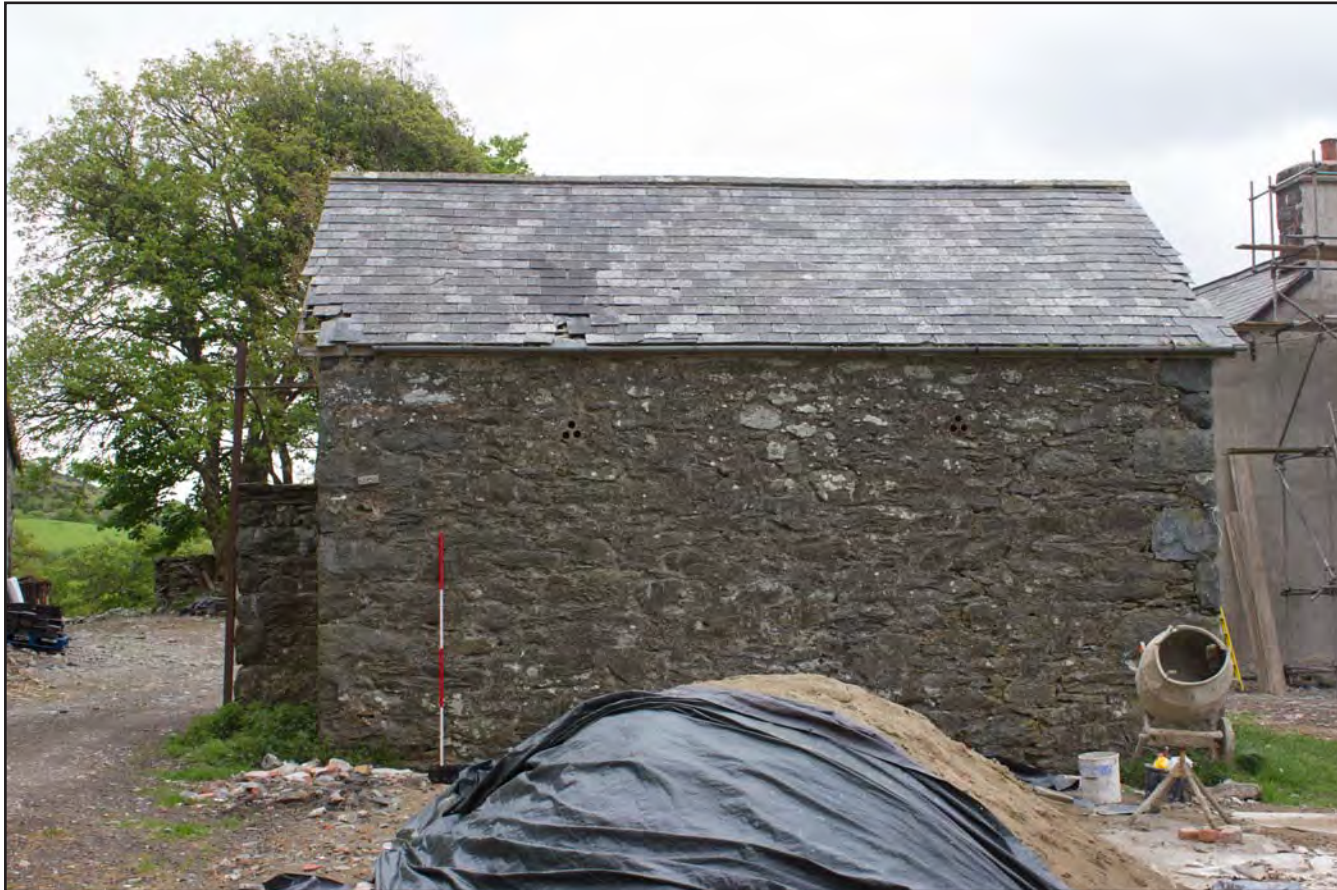
**Plate 28:** Southwest elevation of Building 2 - Horse/Pony Stable at Gaer Gerrig, Llangwm, Conwy - from the southwest  
- 2.00m scale

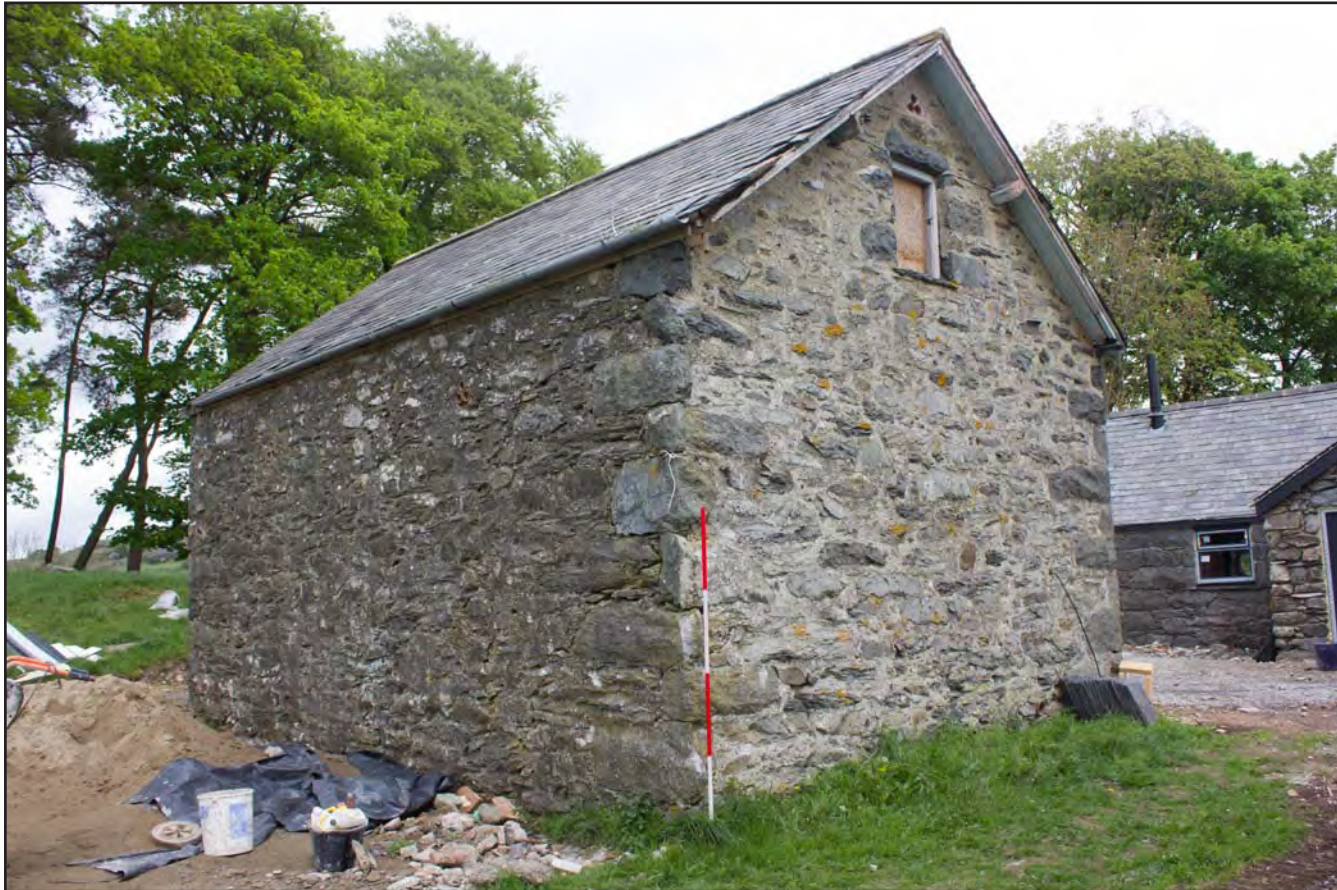
**Plate 29:** Oblique shot of southwest & southeast elevations of Building 2 - Horse/Pony Stable at Gaer Gerrig, Llangwm, Conwy - from the south - 2.00m scale

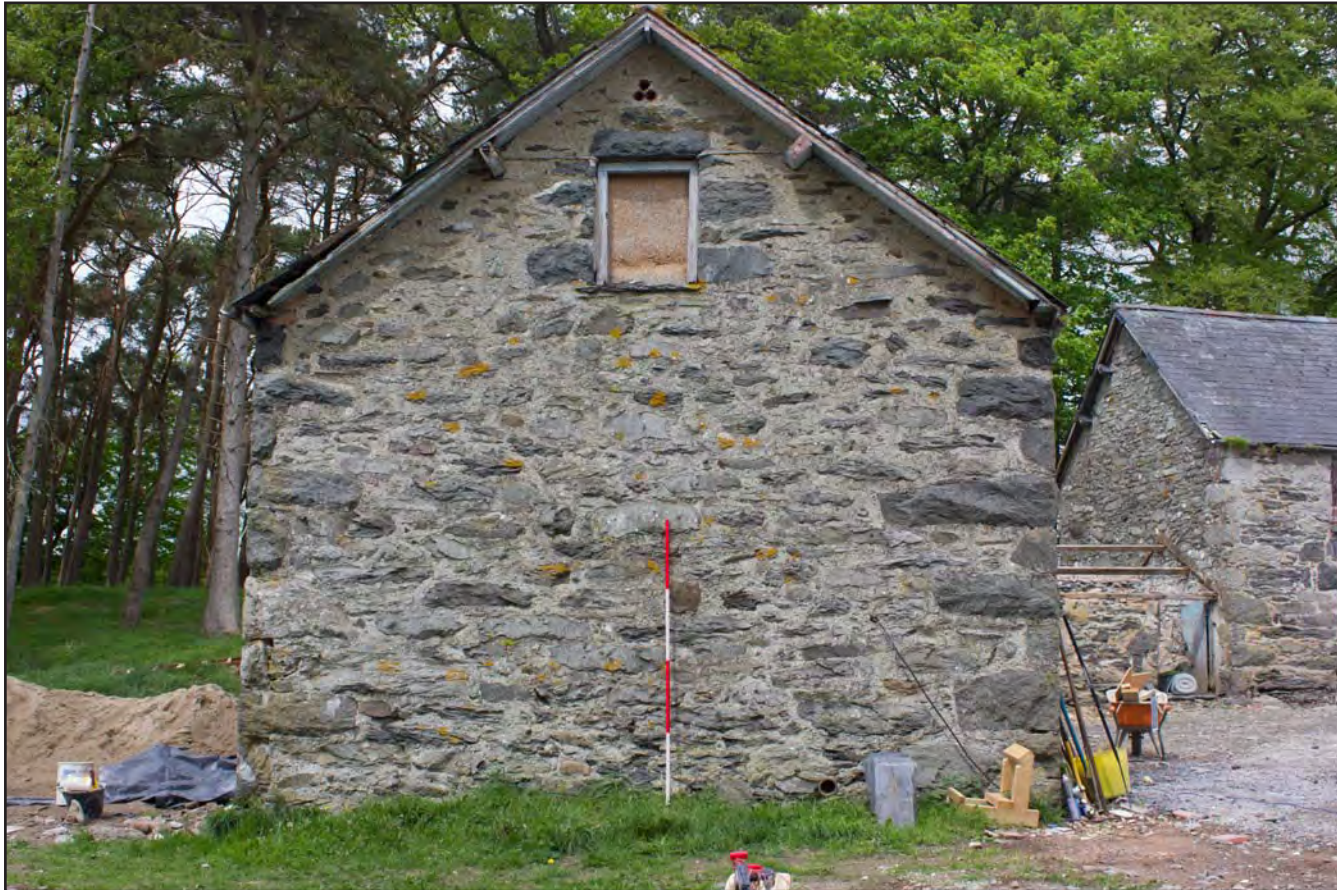
**Plate 30:** Southeast elevation of Building 2 - Horse/Pony Stable at Gaer Gerrig, Llangwm, Conwy - from the southeast  
- 2.00m scale

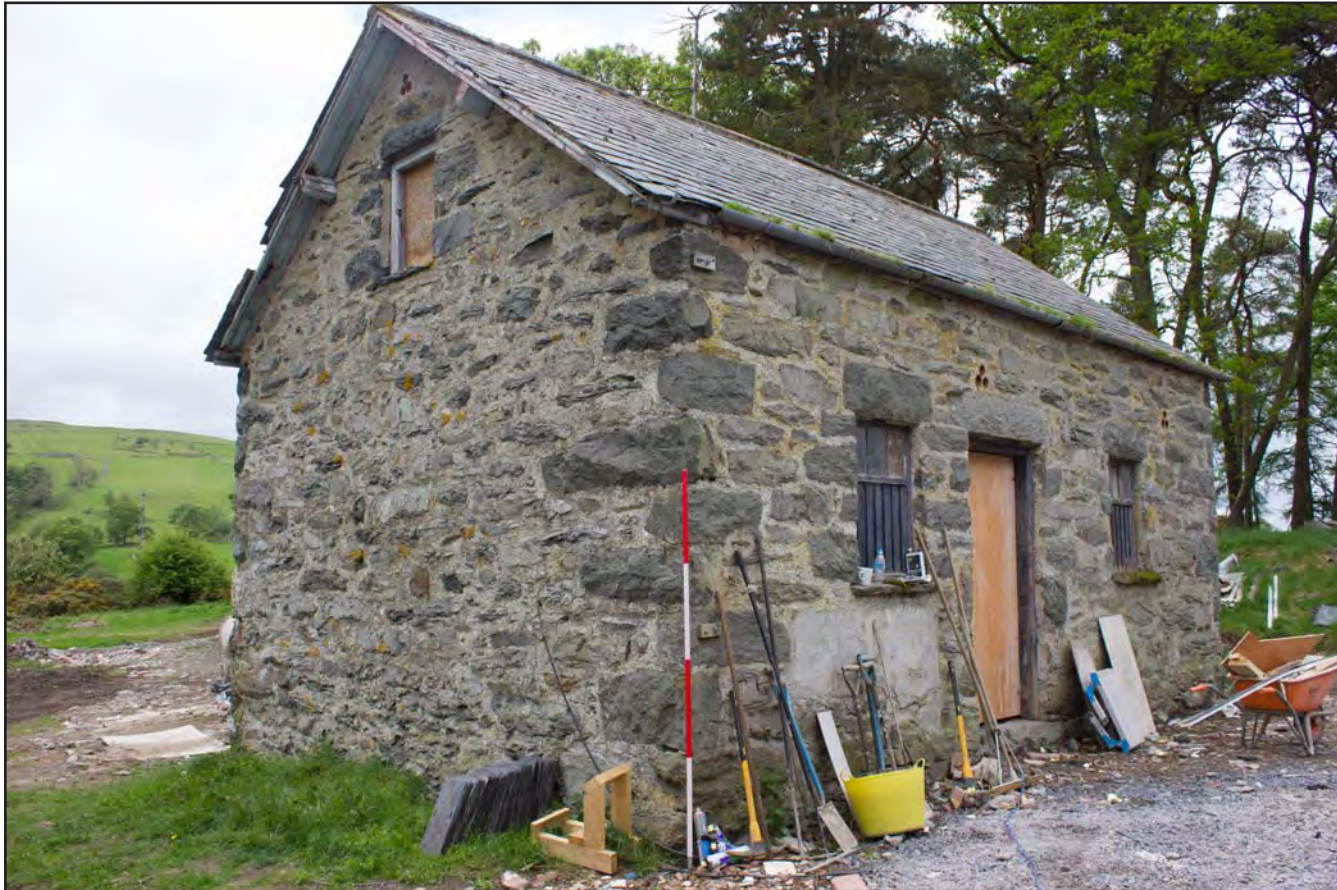
**Plate 31:** Oblique shot of southeast & northeast elevations of Building 2 - Horse/Pony Stable at Gaer Gerrig, Llangwm, Conwy - from the east- 2.00m scale

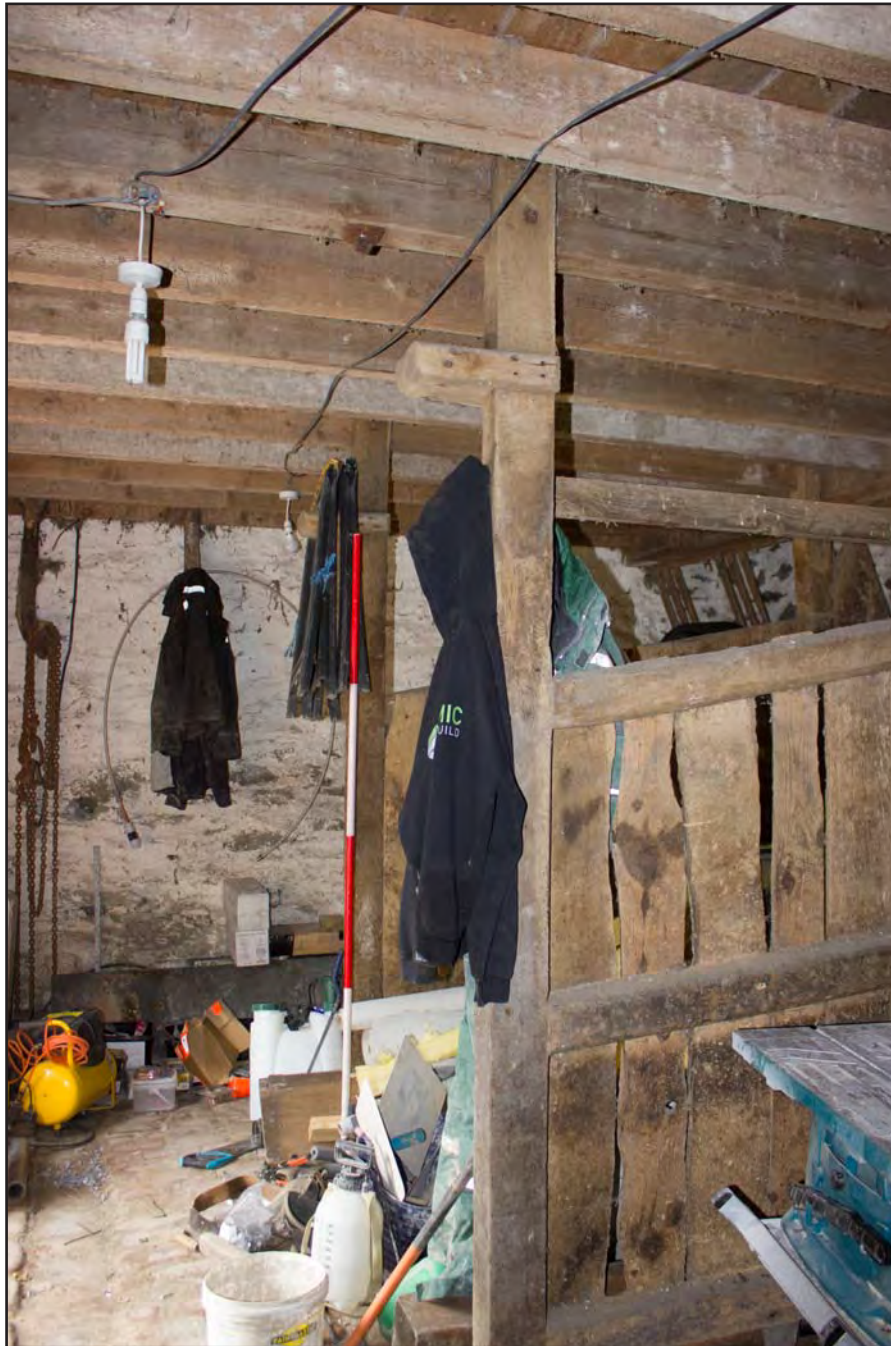
**Plate 32:** Oblique shot of interior of Building 2 - Horse/Pony Stable at Gaer Gerrig, Llangwm, Conwy - from the northwest - 2.00m scale
