# Outbuildings at Gaer Gerrig, Llangwm, Conwy LL21 OPE.

Historic Building Record Level 2

Report no. 0349

# **Outbuildings at Gaer Gerrig, Llangwm, Conwy LL21 OPE (0/46680).**

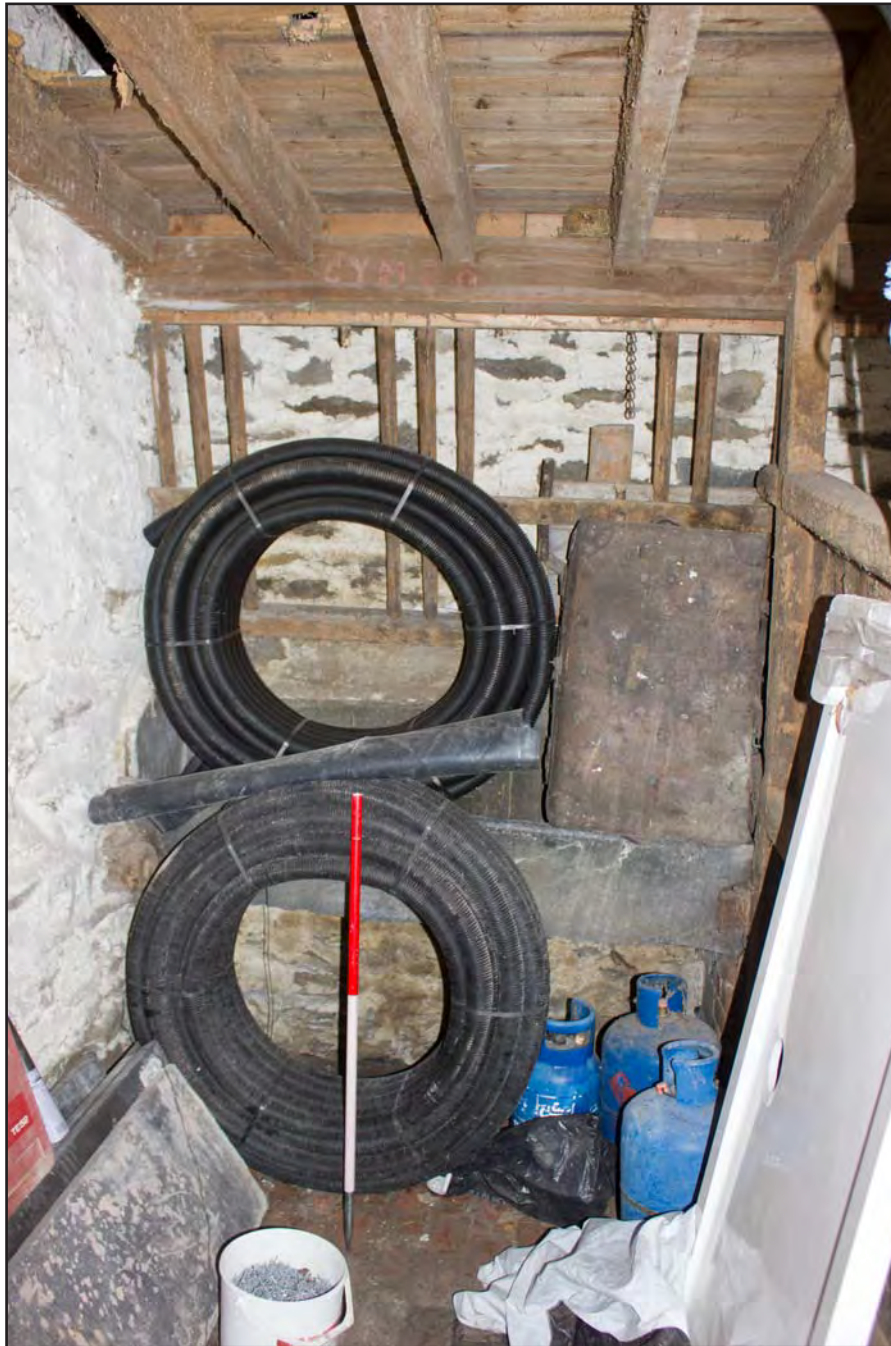
**Plate 33:** Horse stall (left) within Building 2 - Horse/Pony Stable at Gaer Gerrig, Llangwm, Conwy - from the northeast - 1.00m scale

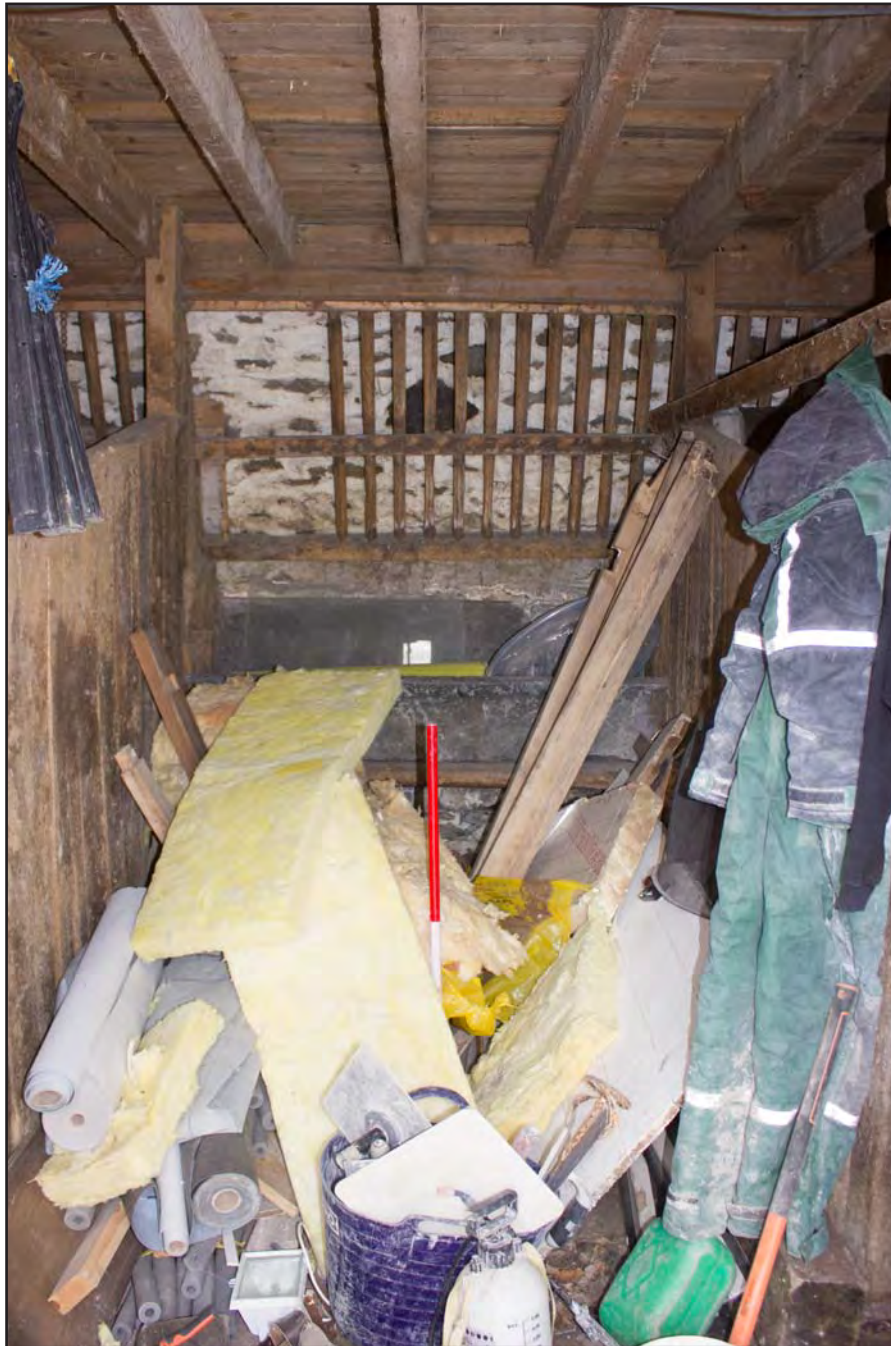
**Plate 34:** Horse stall (central) within Building 2 - Horse/Pony Stable at Gaer Gerrig, Llangwm, Conwy - from the northeast - 1.00m scale

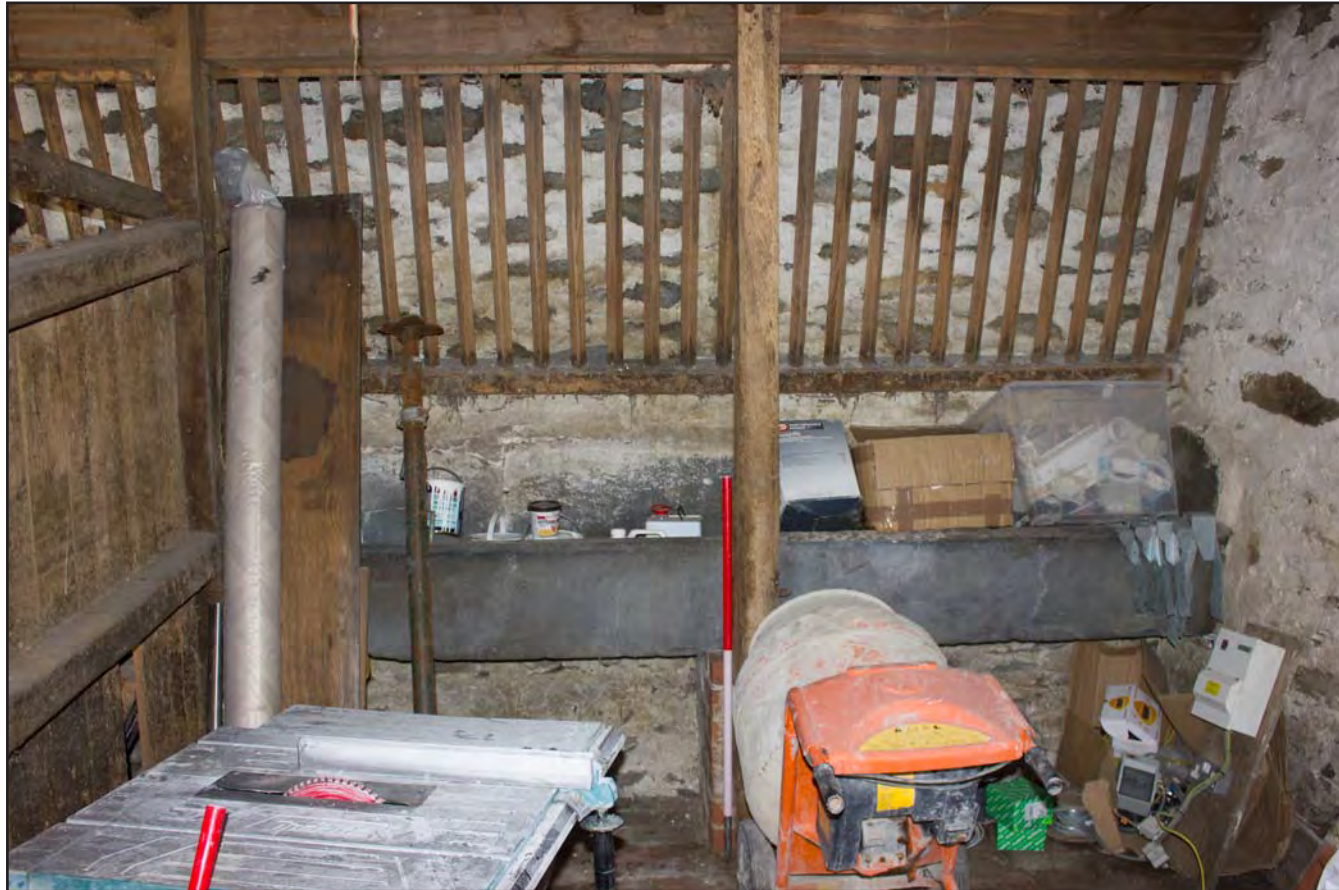
**Plate 35:** Horse stall (right) within Building 2 - Horse/Pony Stable at Gaer Gerrig, Llangwm, Conwy - from the northeast  
- 1.00m scale

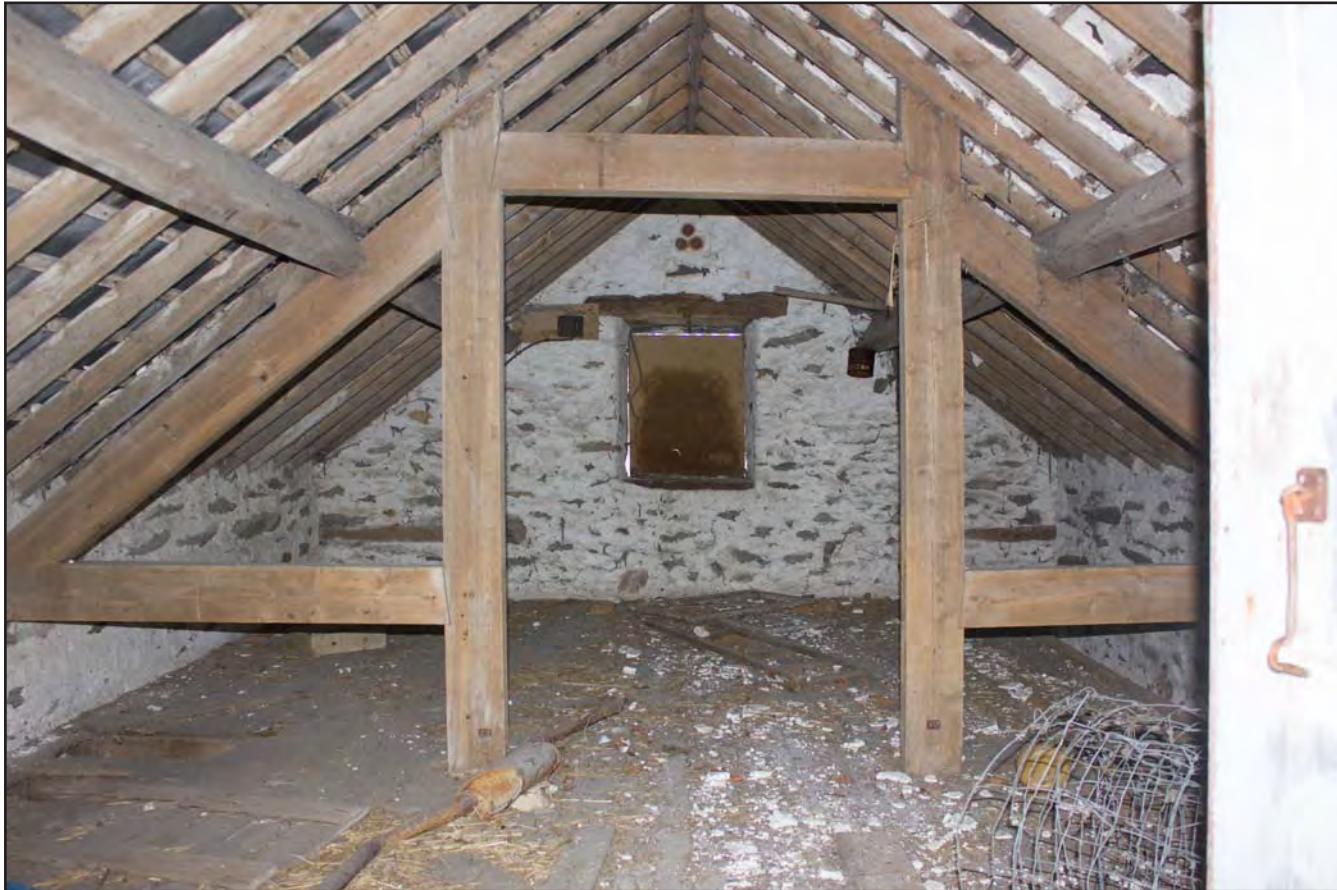
**Plate 36:** Hayloft, First floor, within Building 2 - Horse/Pony Stable at Gaer Gerrig, Llangwm, Conwy - from the northwest  
- no scale

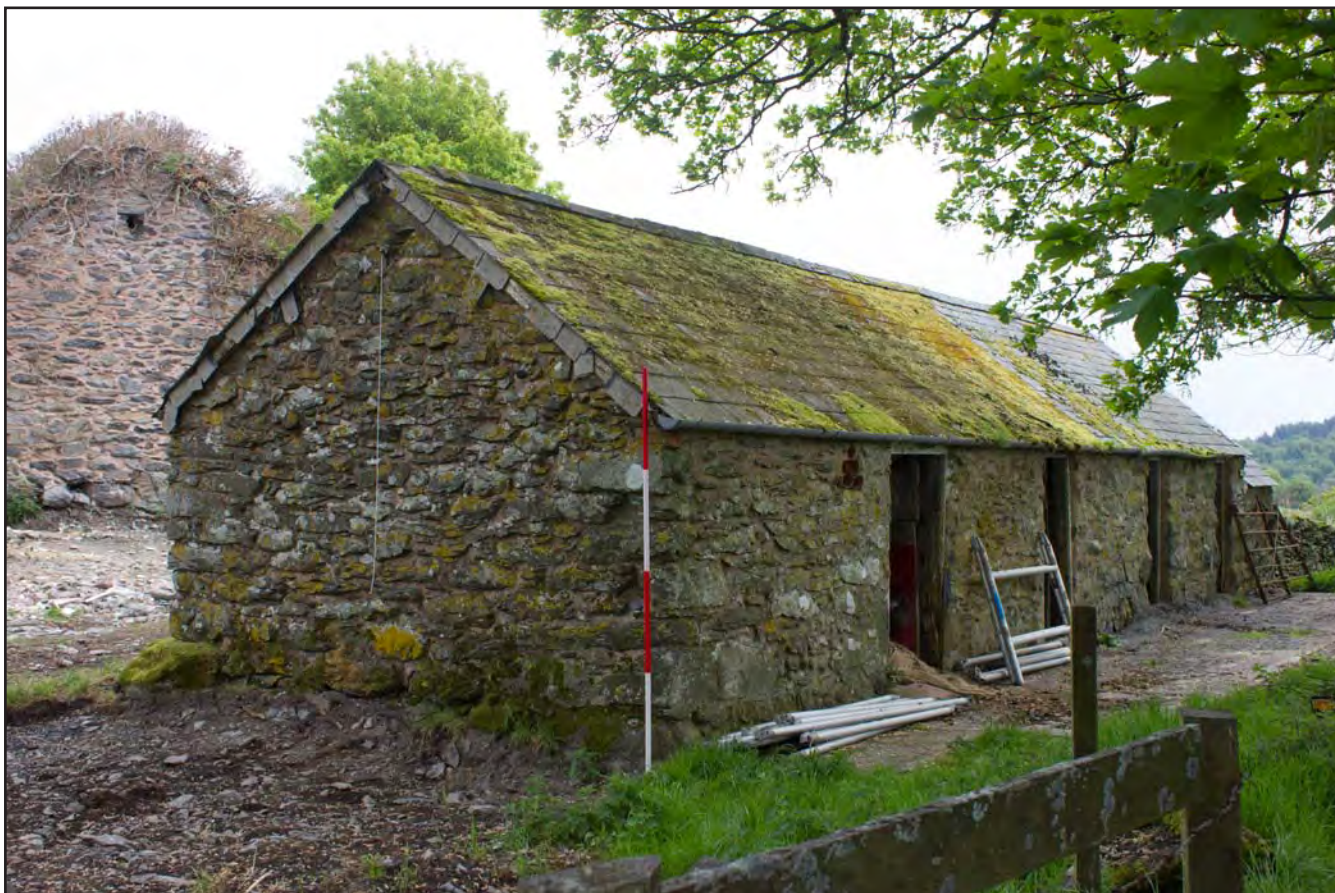
**Plate 37:** Oblique shot of northwest & southwest elevations of Building 3 - Pigsties at Gaer Gerrig, Llangwm, Conwy - from the southwest - 2.00m scale

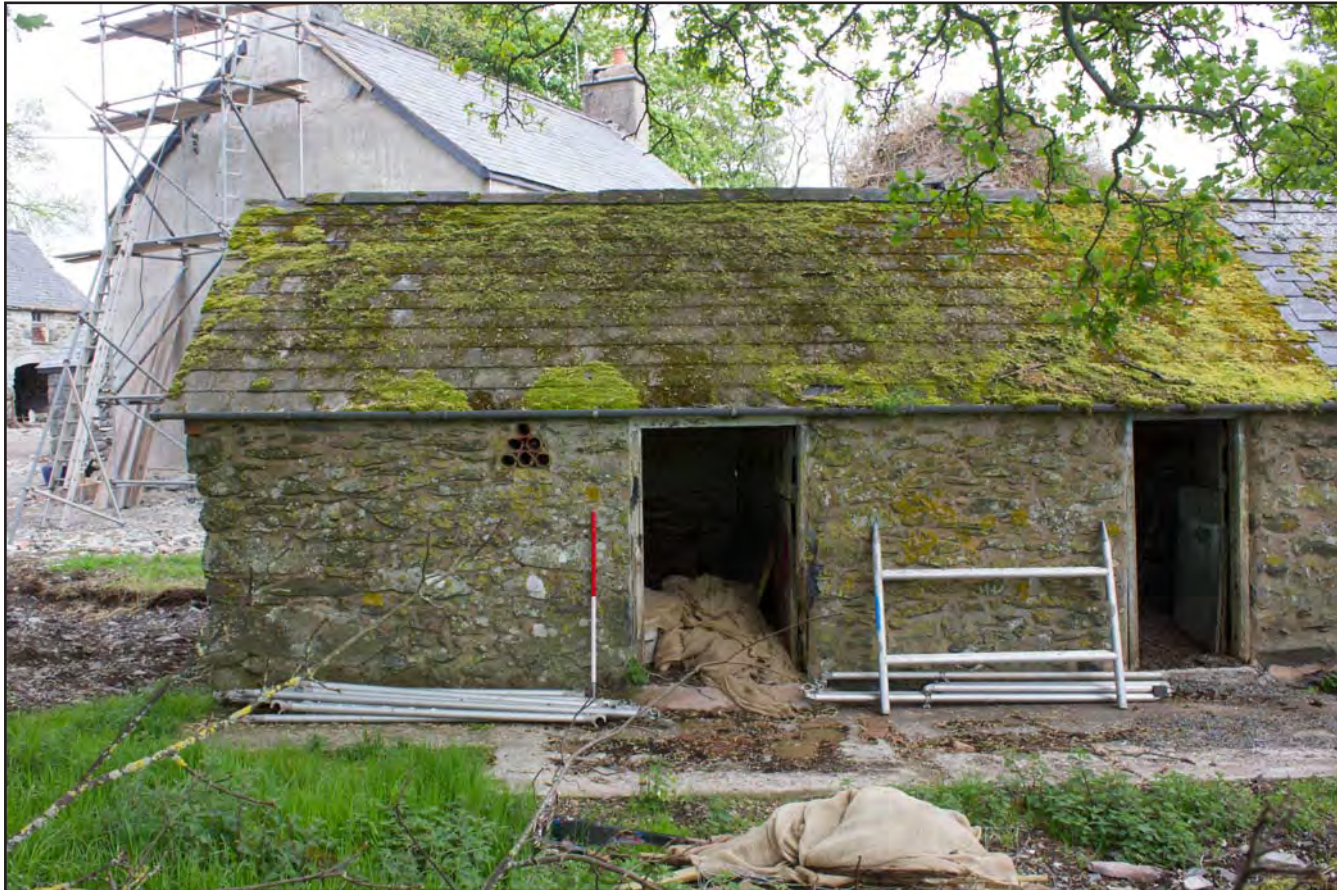
**Plate 38:** Southwest elevation (left) of Building 3 - Pigsties at Gaer Gerrig, Llangwm, Conwy - from the southwest - 1.00m scale

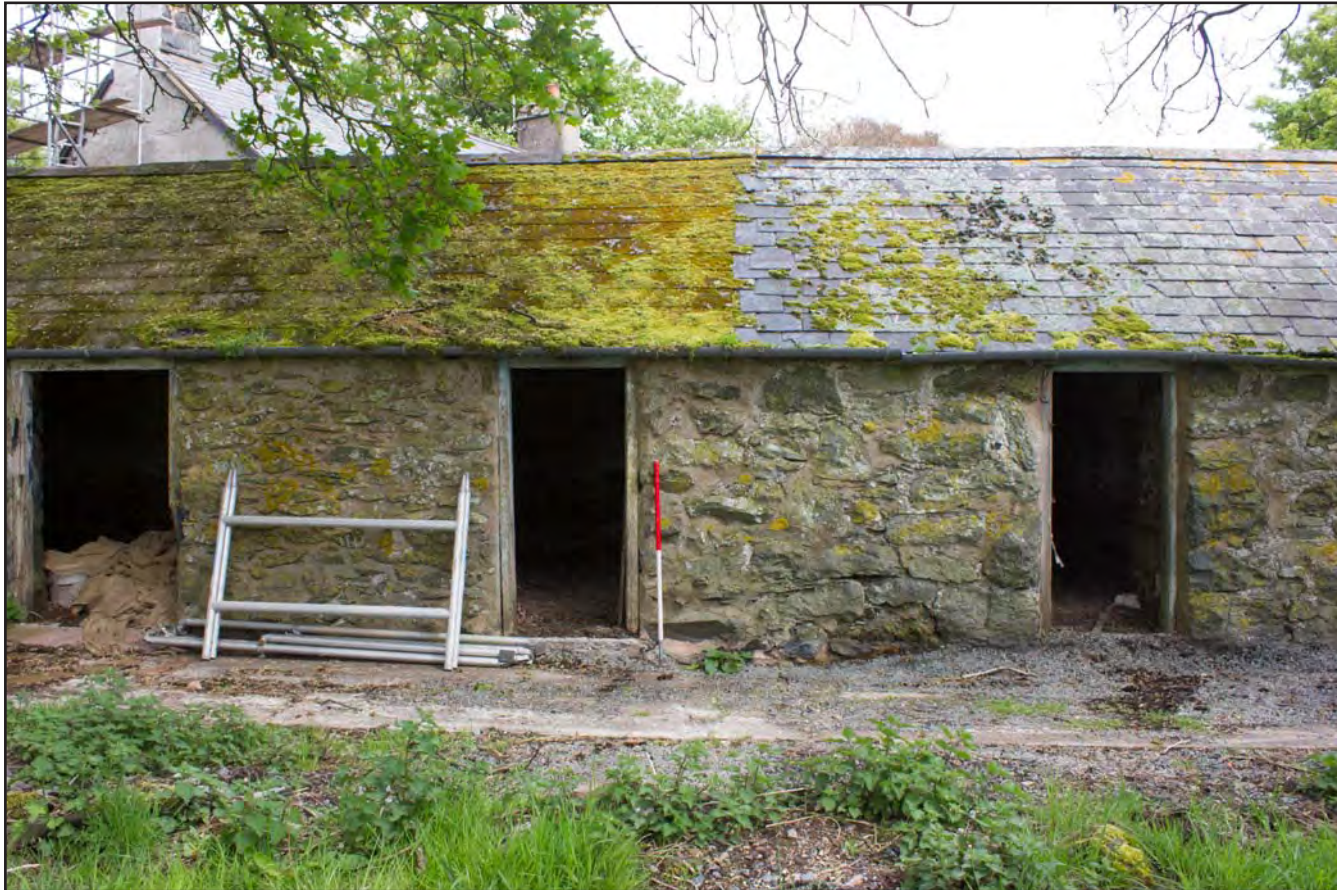
**Plate 39:** Southwest elevation (centre) of Building 3 - Pigsties at Gaer Gerrig, Llangwm, Conwy - from the southwest - 1.00m scale

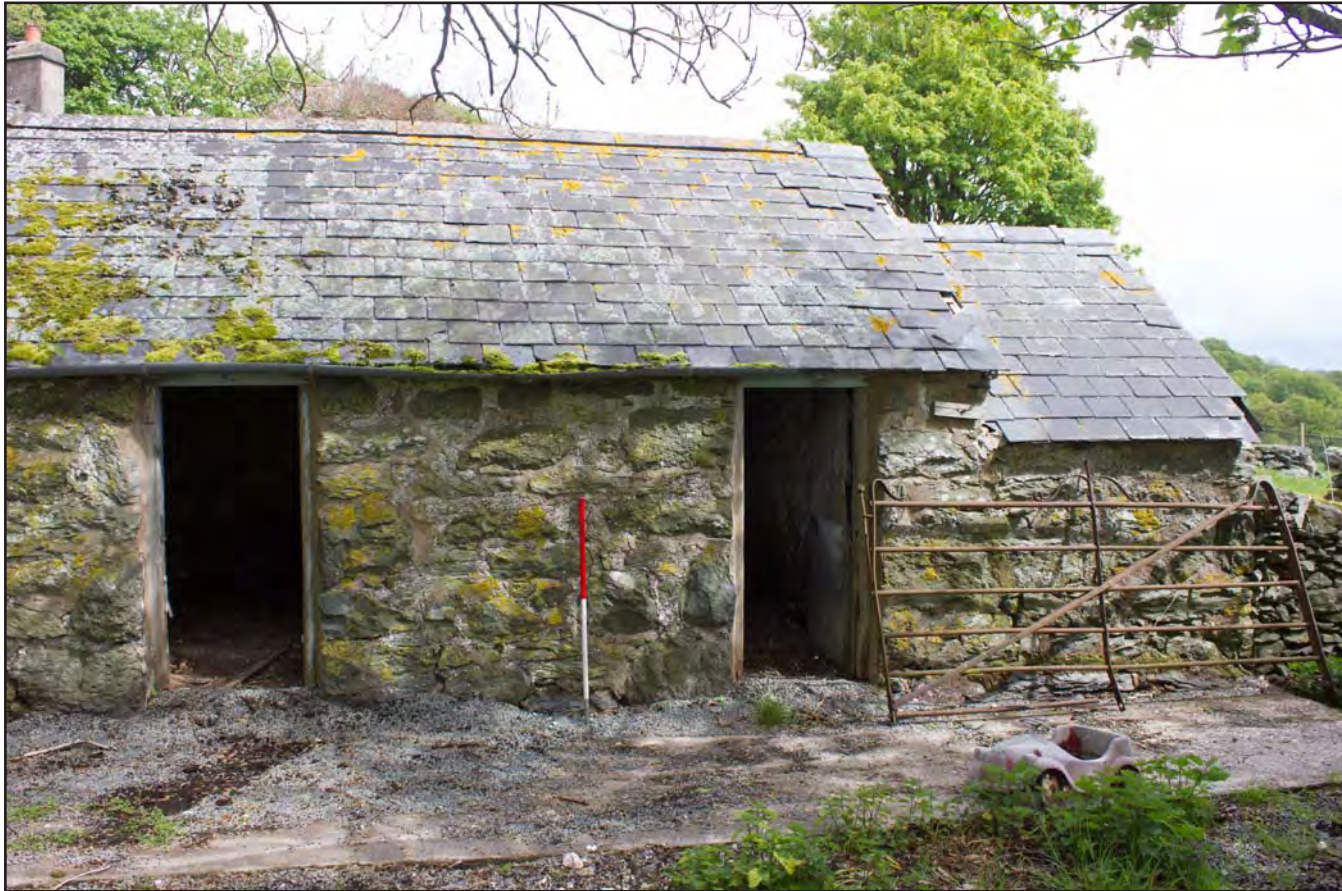
**Plate 40:** Southwest elevation (right) of Building 3 - Pigsties at Gaer Gerrig, Llangwm, Conwy - from the southwest - 1.00m scale

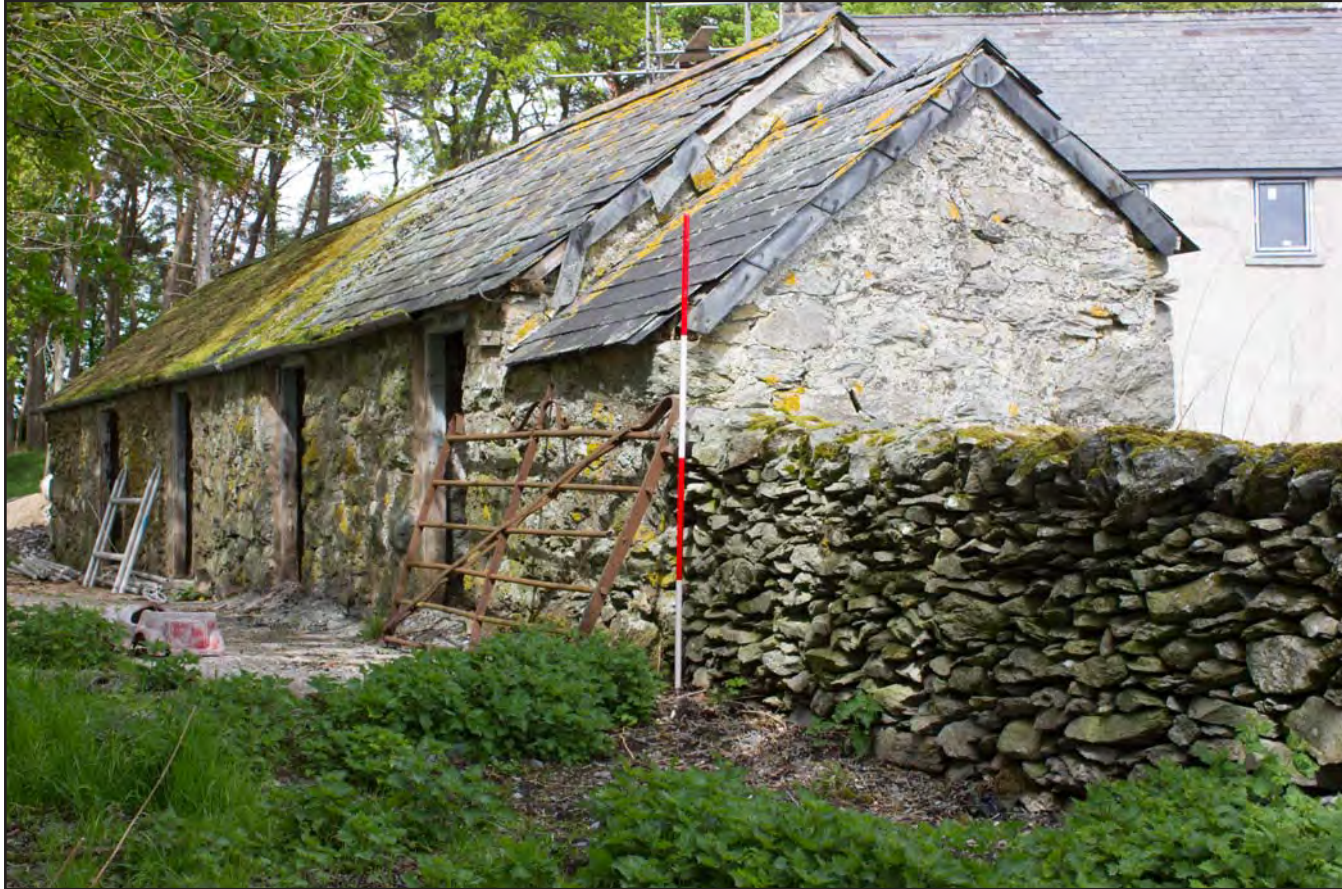
**Plate 41:** Oblique shot of northwest & southwest elevations of Building 3 - Pigsties at Gaer Gerrig, Llangwm, Conwy - from the southeast - 2.00m scale

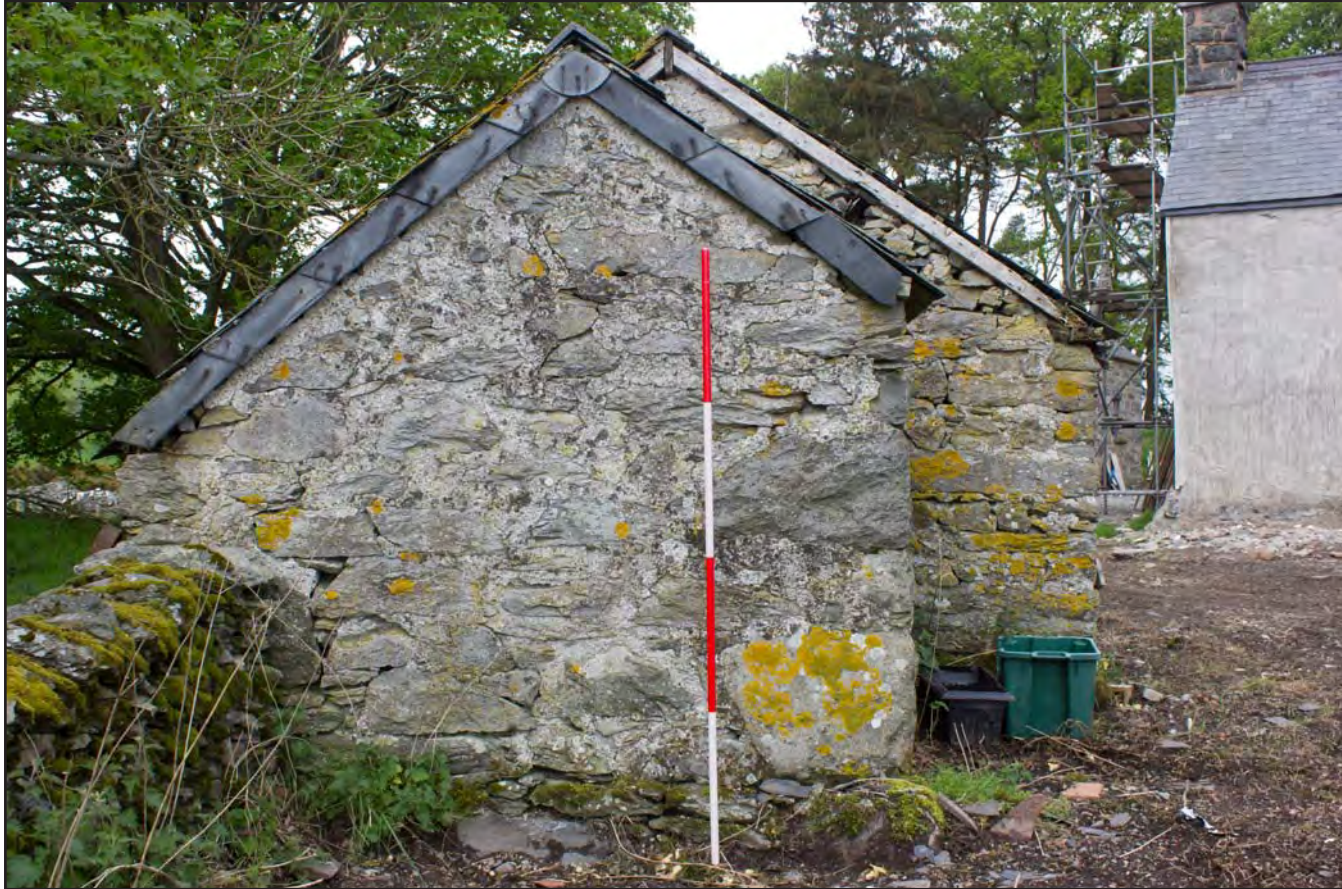
**Plate 42:** Southeast elevation of Building 3 - Pigsties at Gaer Gerrig, Llangwm, Conwy - from the southeast - 2.00m scale

The southeast elevation presents as a double gable: that of the building proper which is obscured by the gable of the outhouse extension. Both have been constructed from stone rubble bonded by lime mortar and present with grey and yellow lichens. The north east facing elevation of the building is comprised of stone rubble bonded by lime mortar, however apart from this the elevation is featureless. At the left-hand end of the north eastern elevation and recessed slightly, the outhouse extension has a single doorway opening at the right hand side with an unpainted wooden frame and a white painted wooden board door. This allows access to the former outhouse. There is some evidence for some repointing on this elevation. Apart from these details the elevation is featureless.

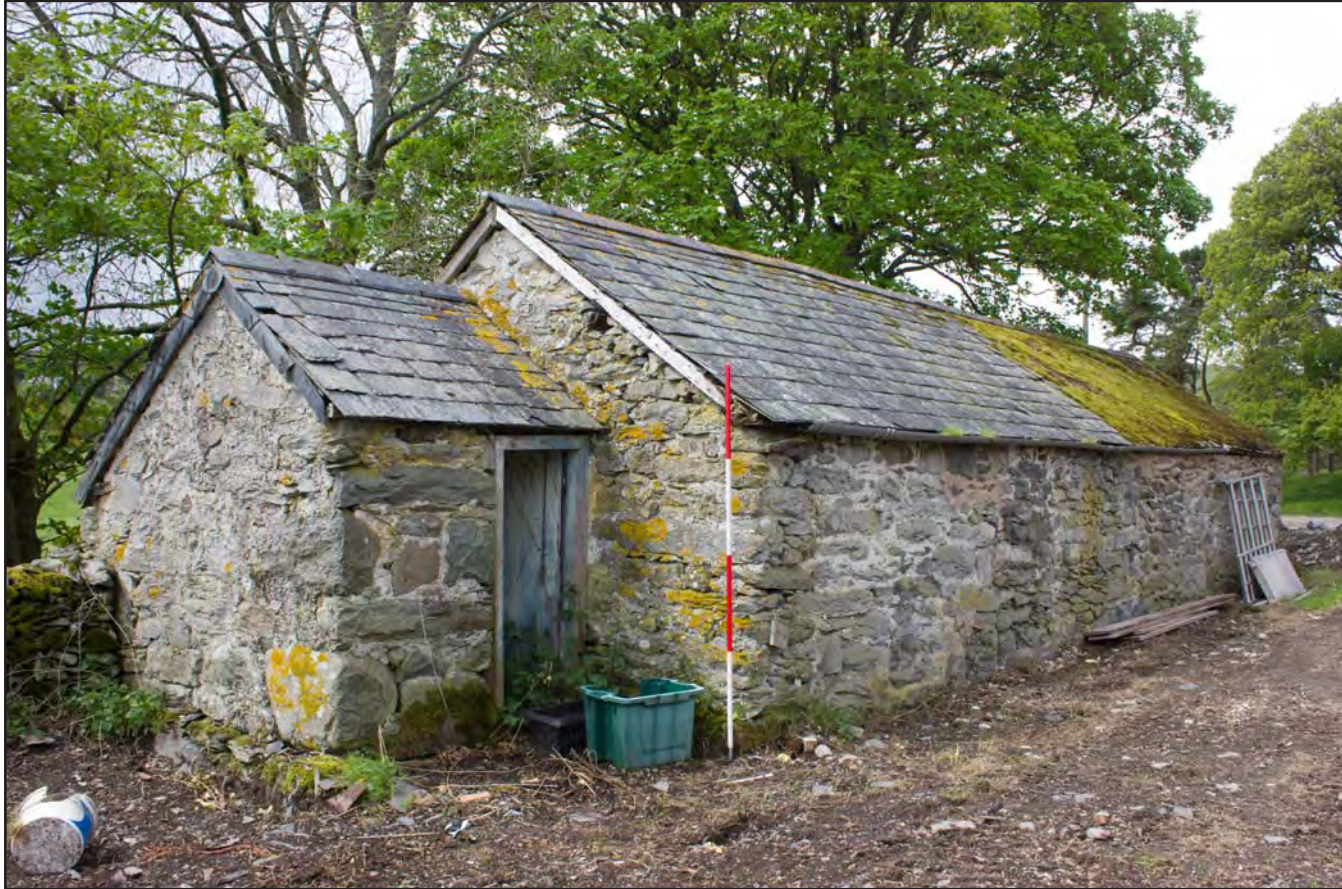
**Plate 43:** Oblique shot of southeast & northeast elevations of Building 3 - Pigsties at Gaer Gerrig, Llangwm, Conwy - from the southeast - 2.00m scale

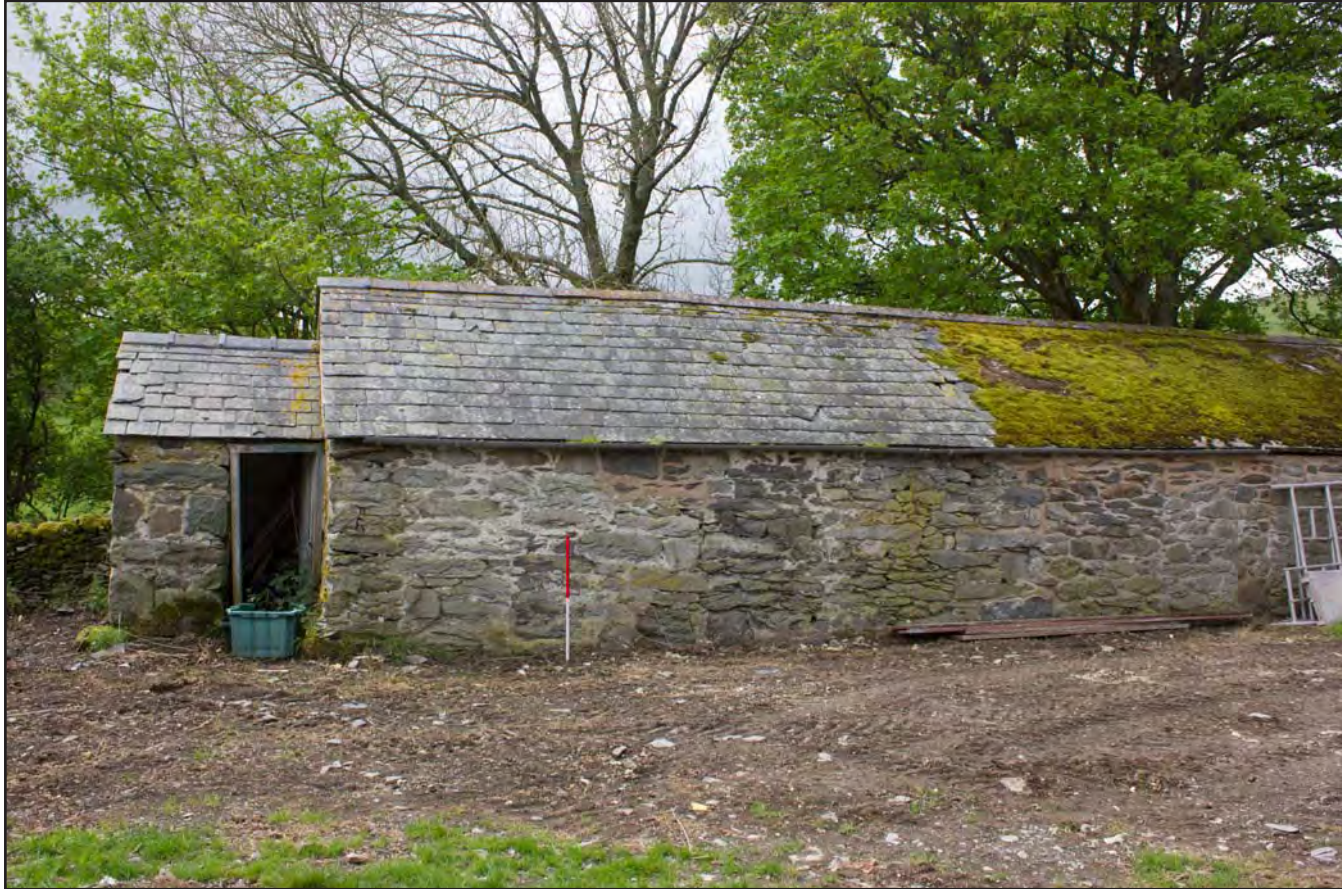
**Plate 44:** Northeast elevation (left) of Building 3 - Pigstiesat Gaer Gerrig, Llangwm, Conwy - from the northeast - 1.00m scale

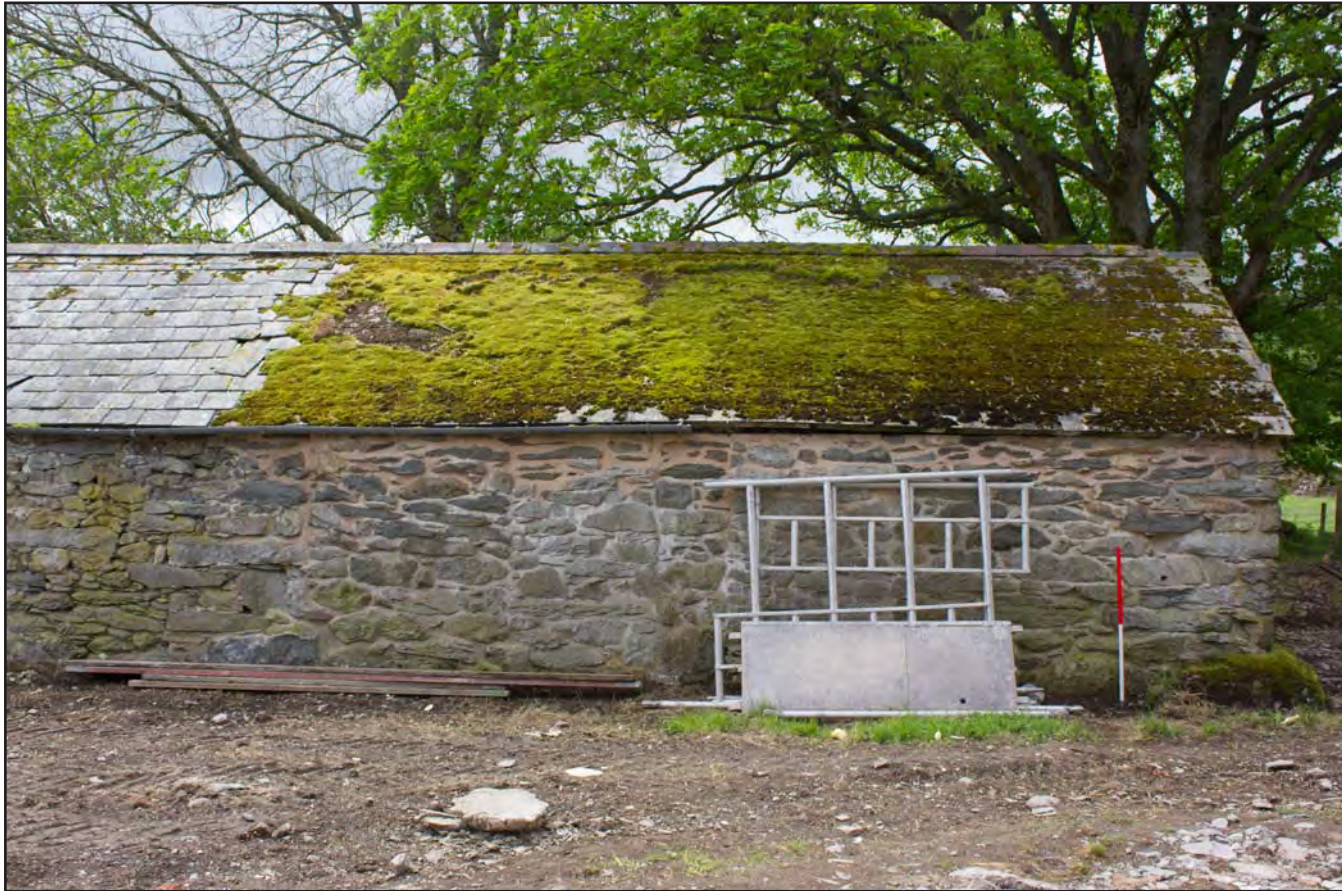
**Plate 45:** Northeast elevation (right) of Building 3 - Pigstiesat Gaer Gerrig, Llangwm, Conwy - from the northeast - 1.00m scale

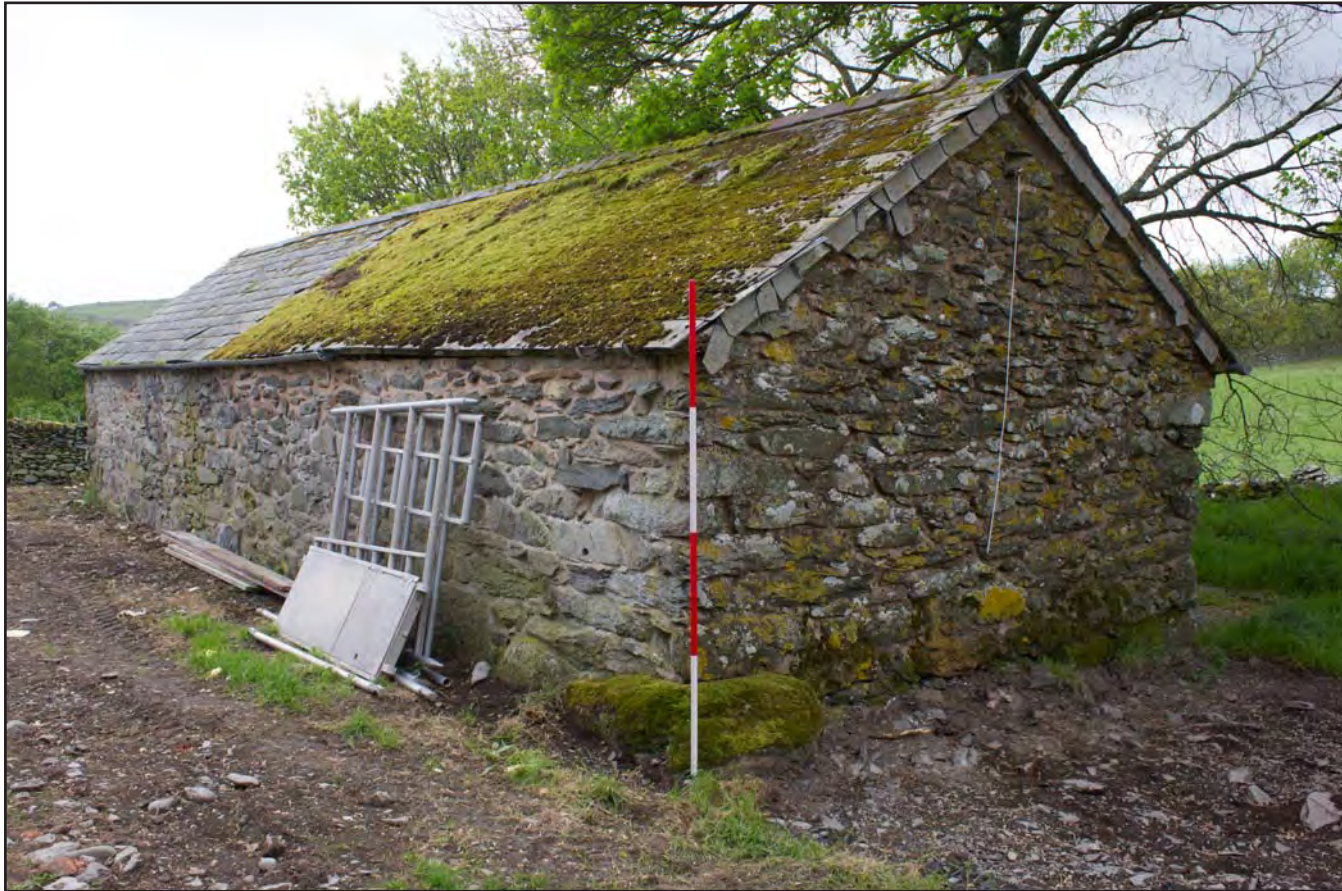
**Plate 46:** Oblique shot of northeast & northwest elevations of Building 3 - Pigsties at Gaer Gerrig, Llangwm, Conwy - from the north - 2.00m scale

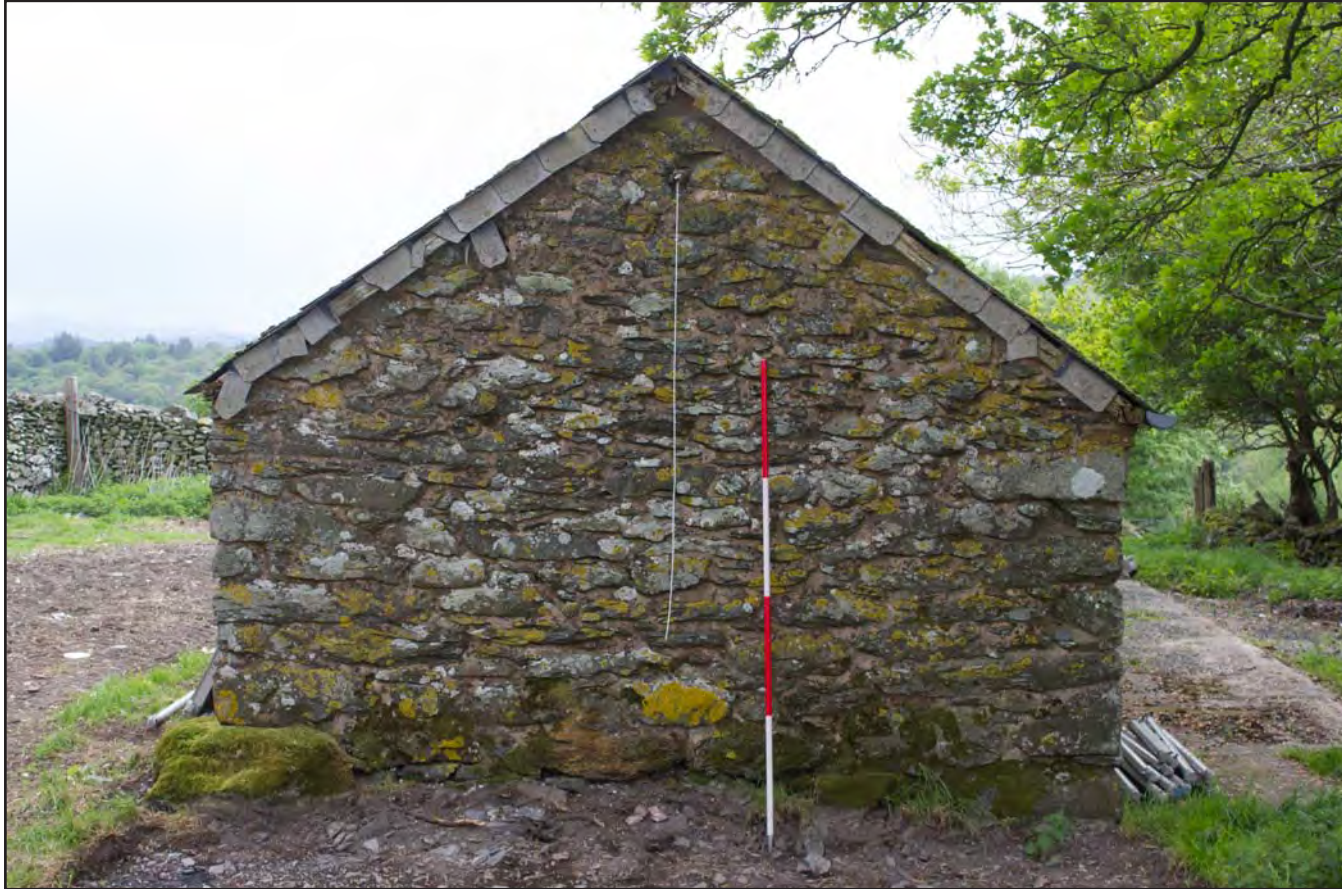
**Plate 47:** Northwest elevation of Building 3 - Pigsties at Gaer Gerrig, Llangwm, Conwy - from the northwest - 2.00m scale

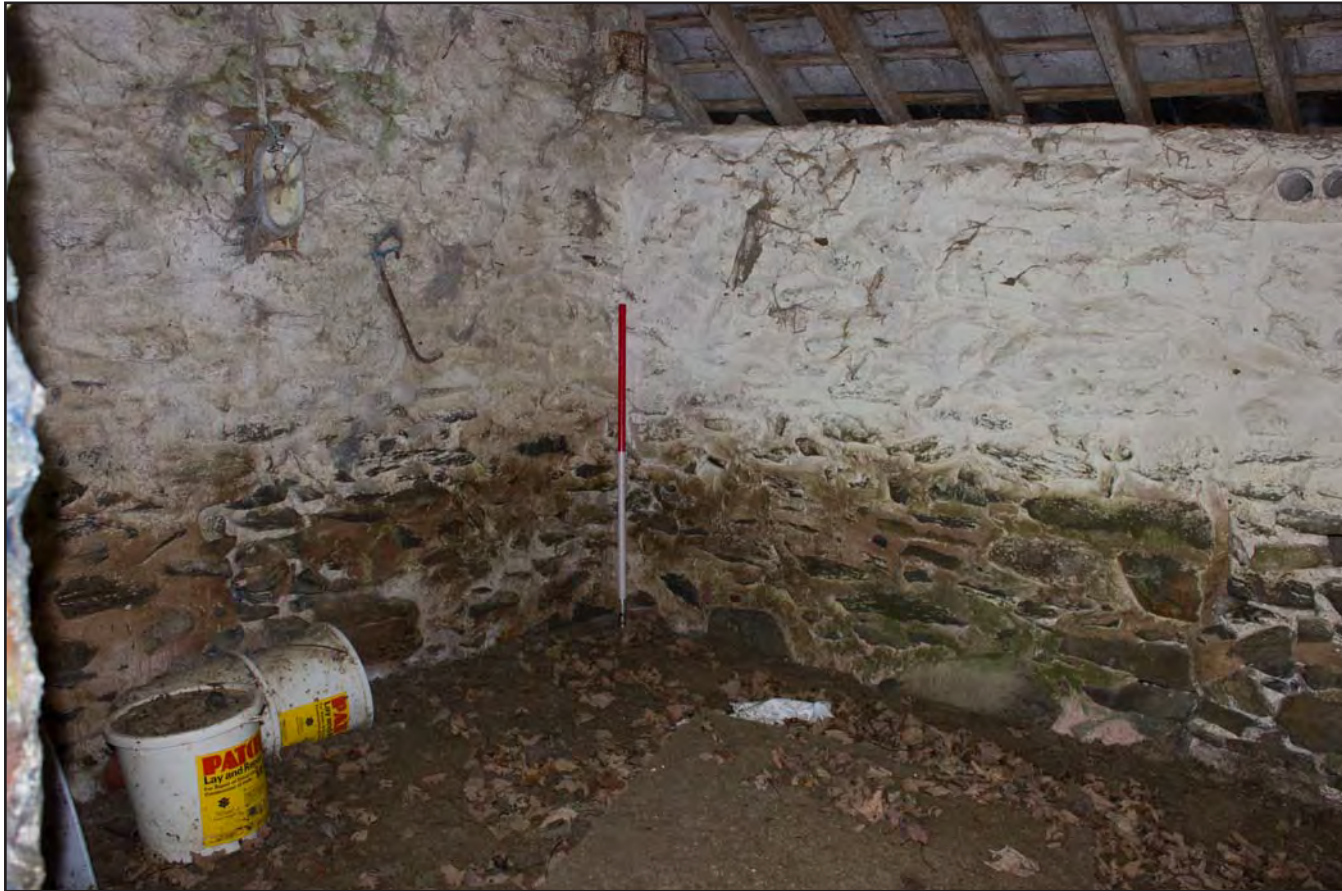
**Plate 48:** Internal shot Pigsty 1 within Building 3 - Pigsties at Gaer Gerrig, Llangwm, Conwy - from the southeast - 1.00m scale

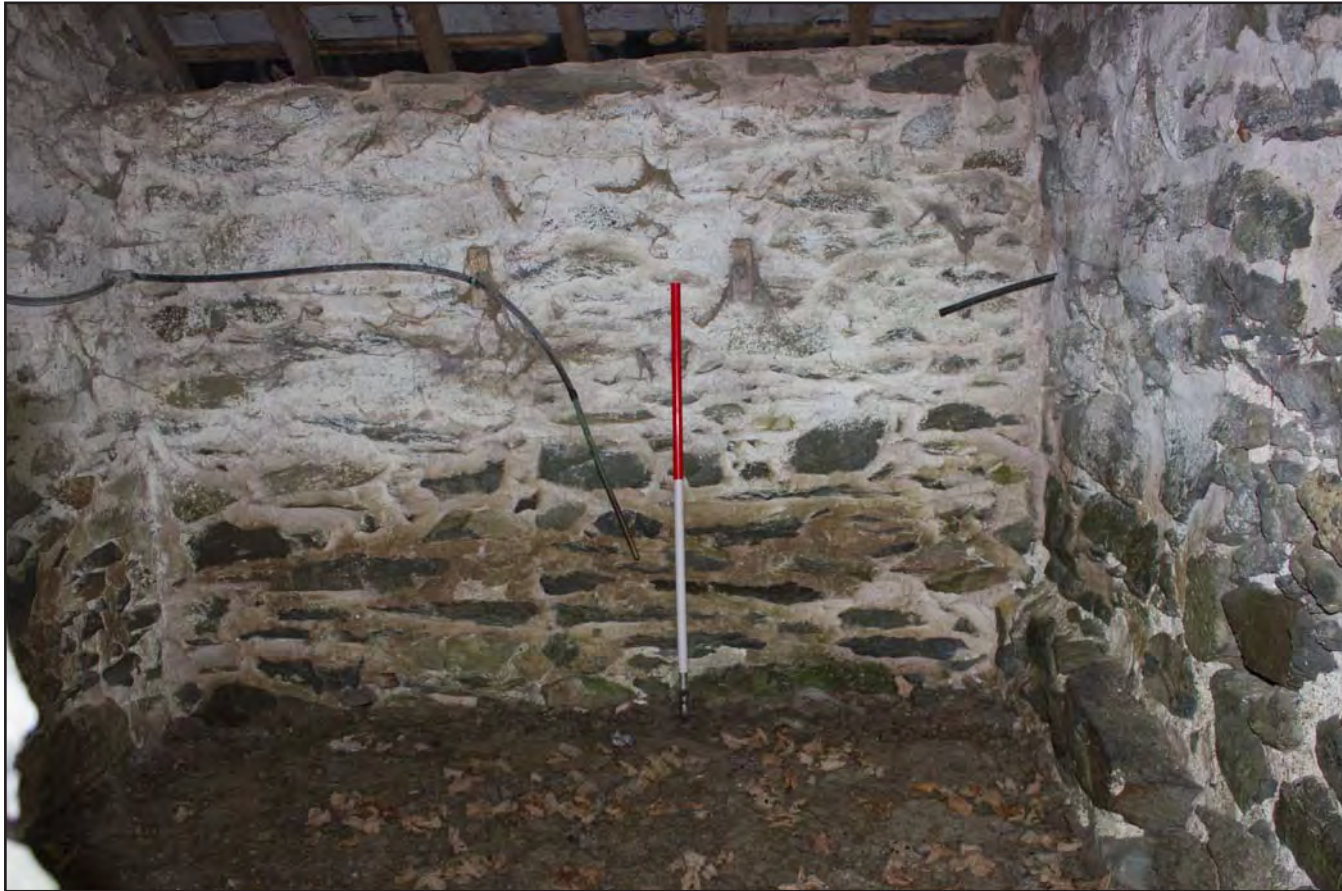
**Plate 49:** Internal shot Pigsty 2 within Building 3 - Pigsties at Gaer Gerrig, Llangwm, Conwy - from the south - 1.00m scale

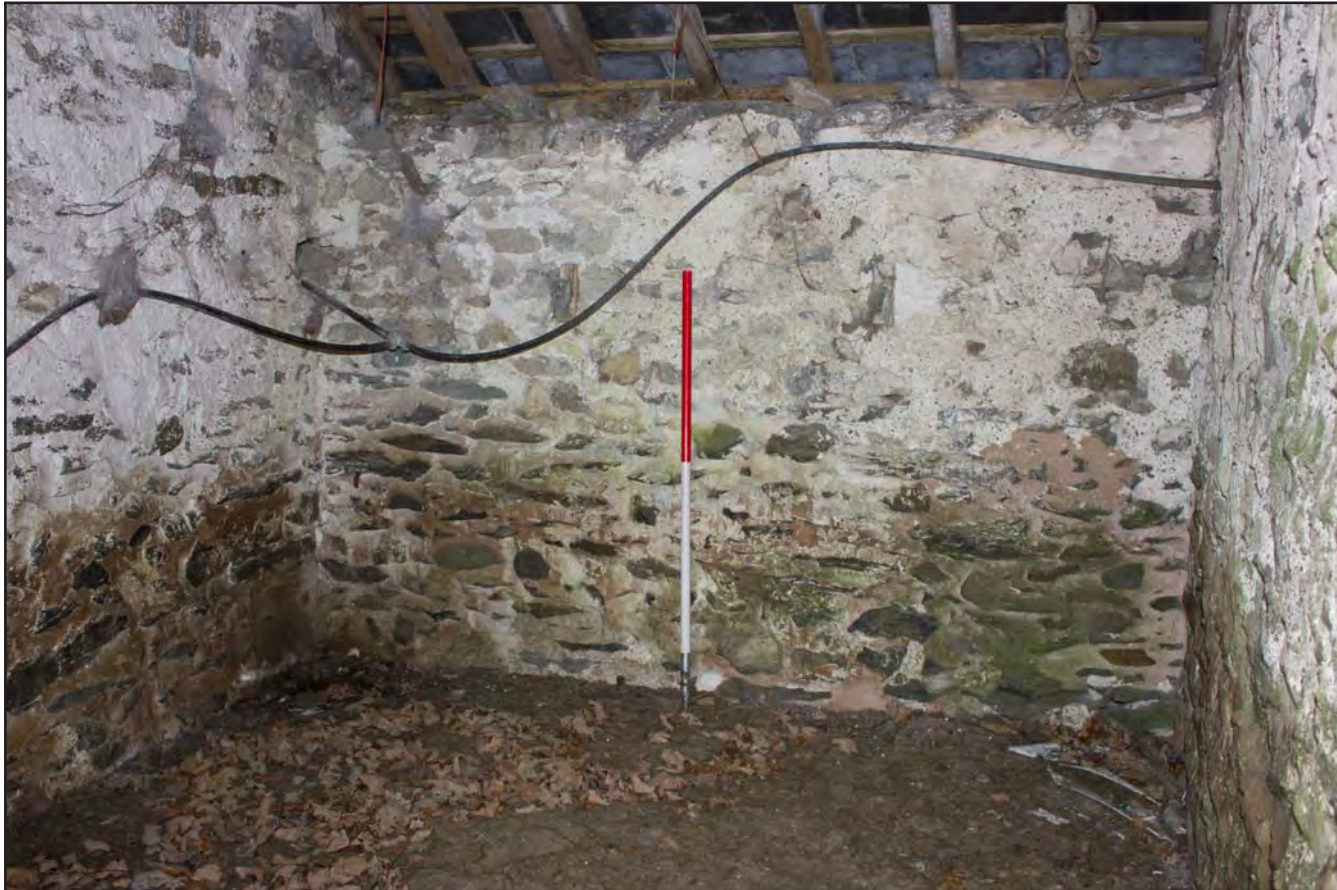
**Plate 50:** Internal shot Pigsty 3 within Building 3 - Pigsties at Gaer Gerrig, Llangwm, Conwy - from the south - 1.00m scale
