# Outbuildings at Gaer Gerrig, Llangwm, Conwy LL21 OPE.

Historic Building Record Level 2

Report no. 0349

# **Outbuildings at Gaer Gerrig, Llangwm, Conwy LL21 OPE (0/46680).**

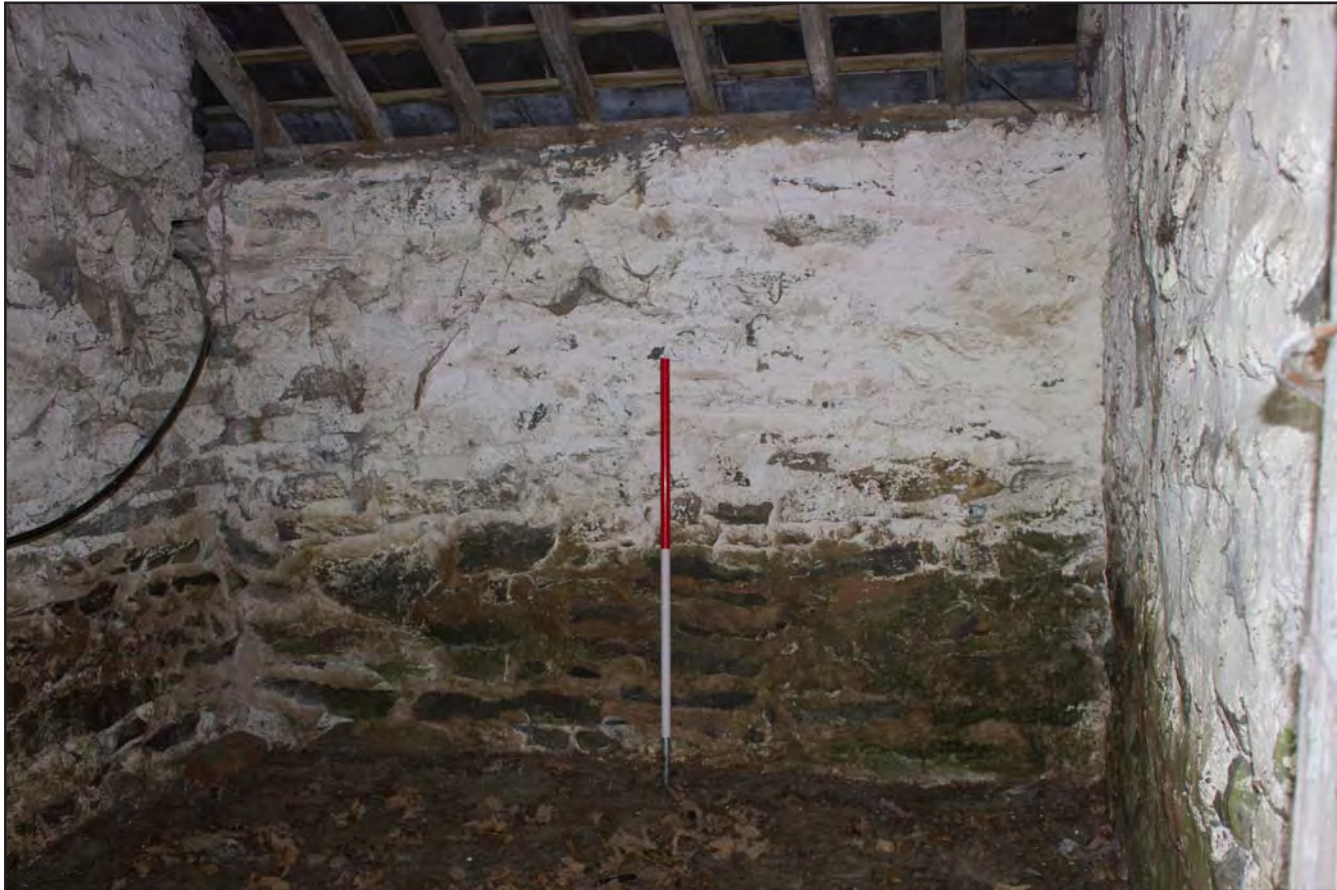
**Plate 51:** Internal shot Pigsty 4 within Building 3 - Pigsties at Gaer Gerrig, Llangwm, Conwy - from the south - 1.00m scale

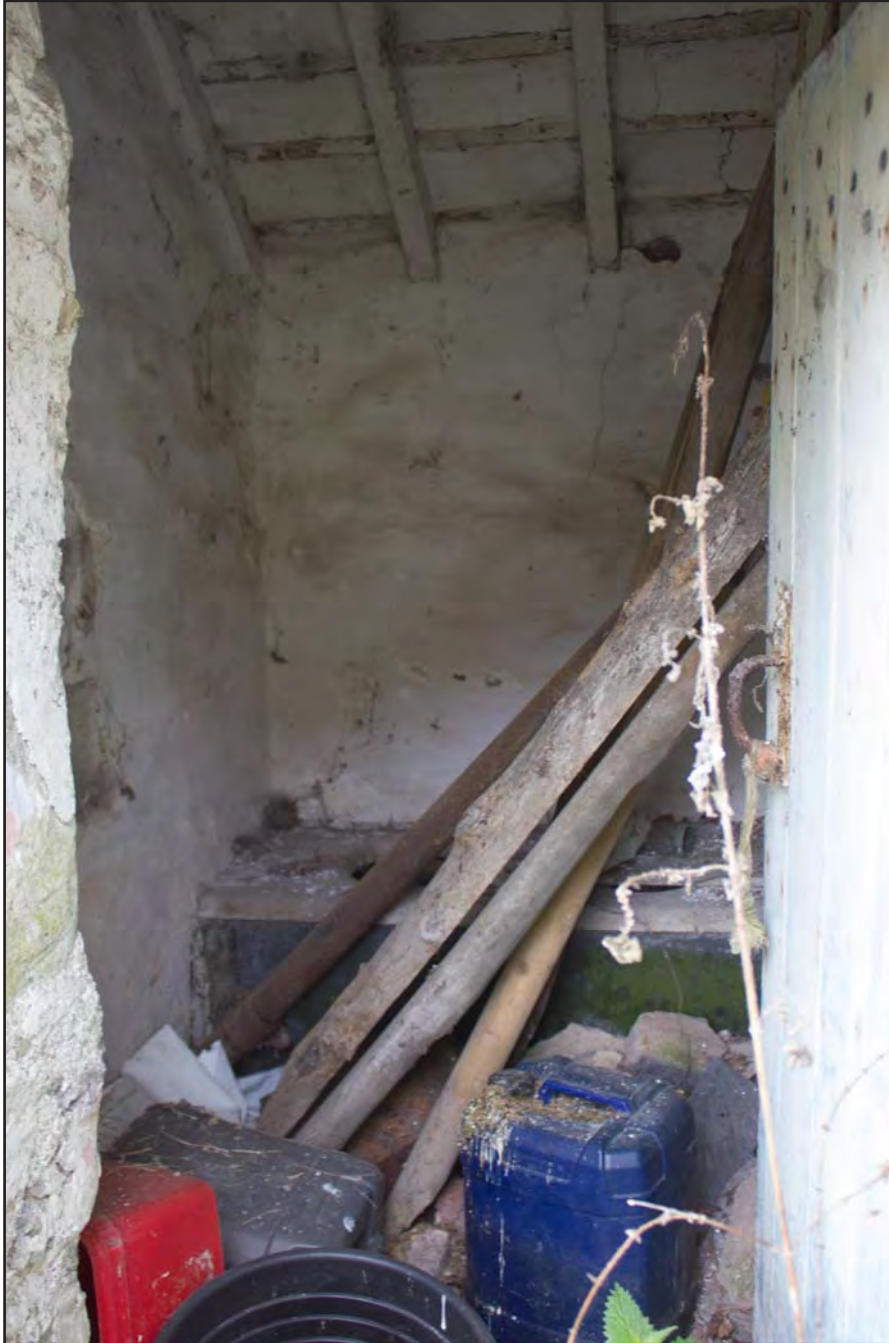
**Plate 52:** Internal shot outhouse within Building 3 - Pigsties at Gaer Gerrig, Llangwm, Conwy - from the north - 1.00m scale

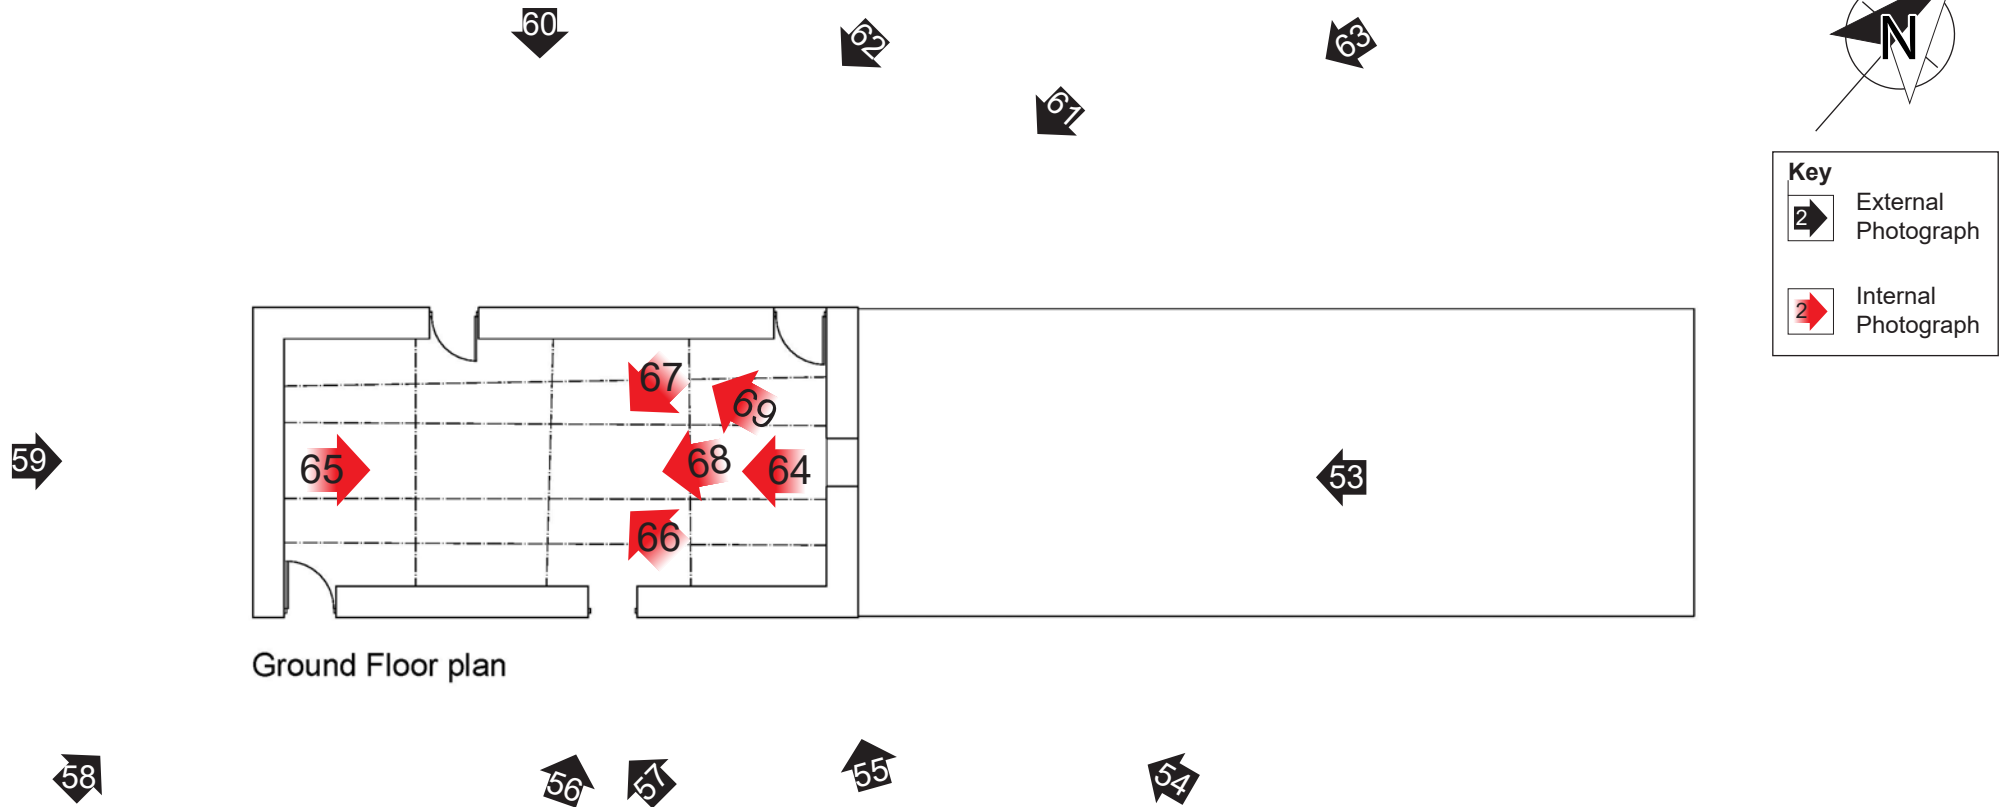
Ground Floor plan

**BUILDING 4 - COWHOUSE/SHIPPON - *Beudy***

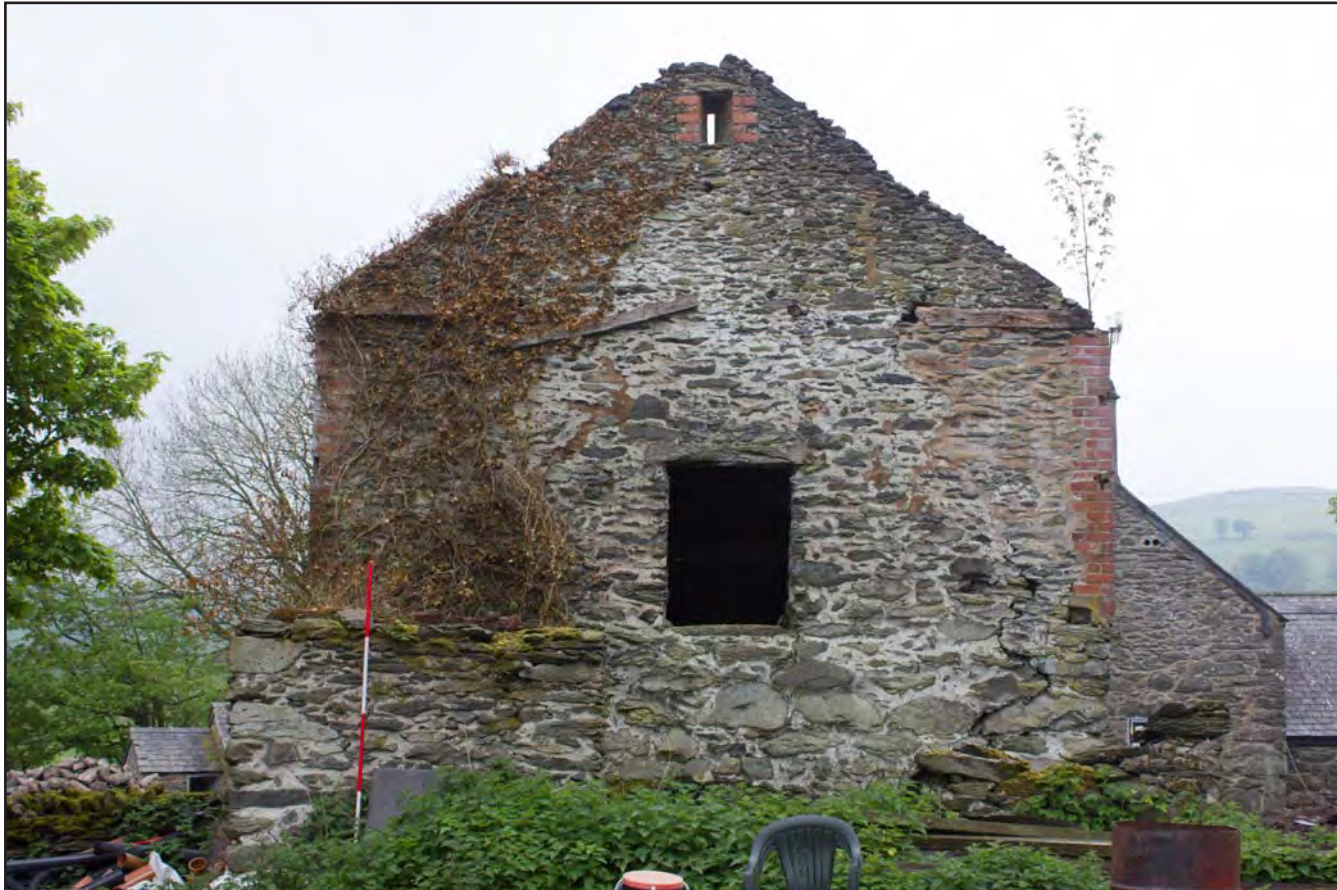
**Plate 53:** Northeast elevation of Building 4 - Cowhouse/Shippon at Gaer Gerrig, Llangwm, Conwy - from the northeast - 2.00m scale

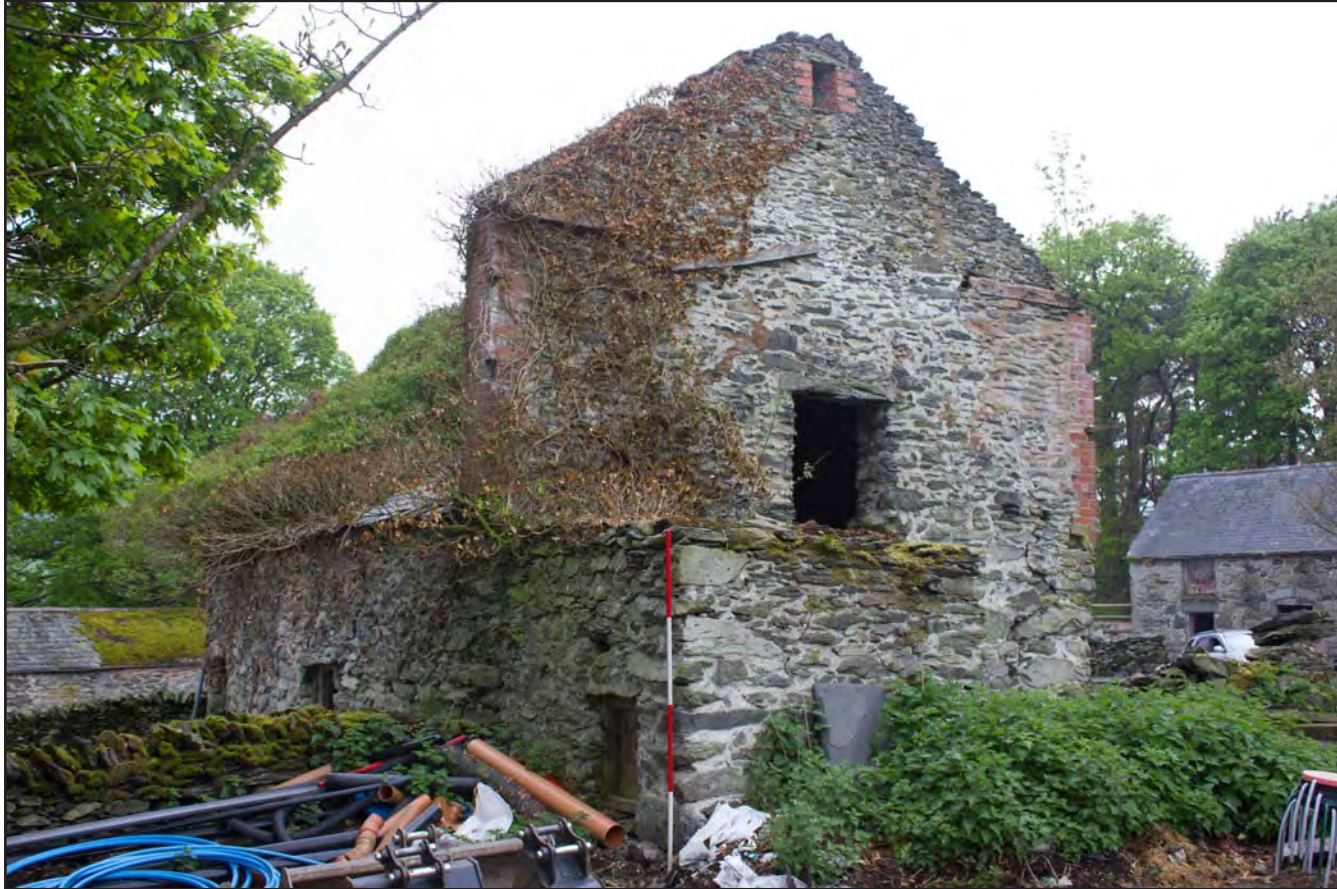
**Plate 54:** Oblique shot of northeast & southeast elevations of Building 4 - Cowhouse/Shippon at Gaer Gerrig, Llangwm, Conwy - from the north-northeast - 2.00m scale

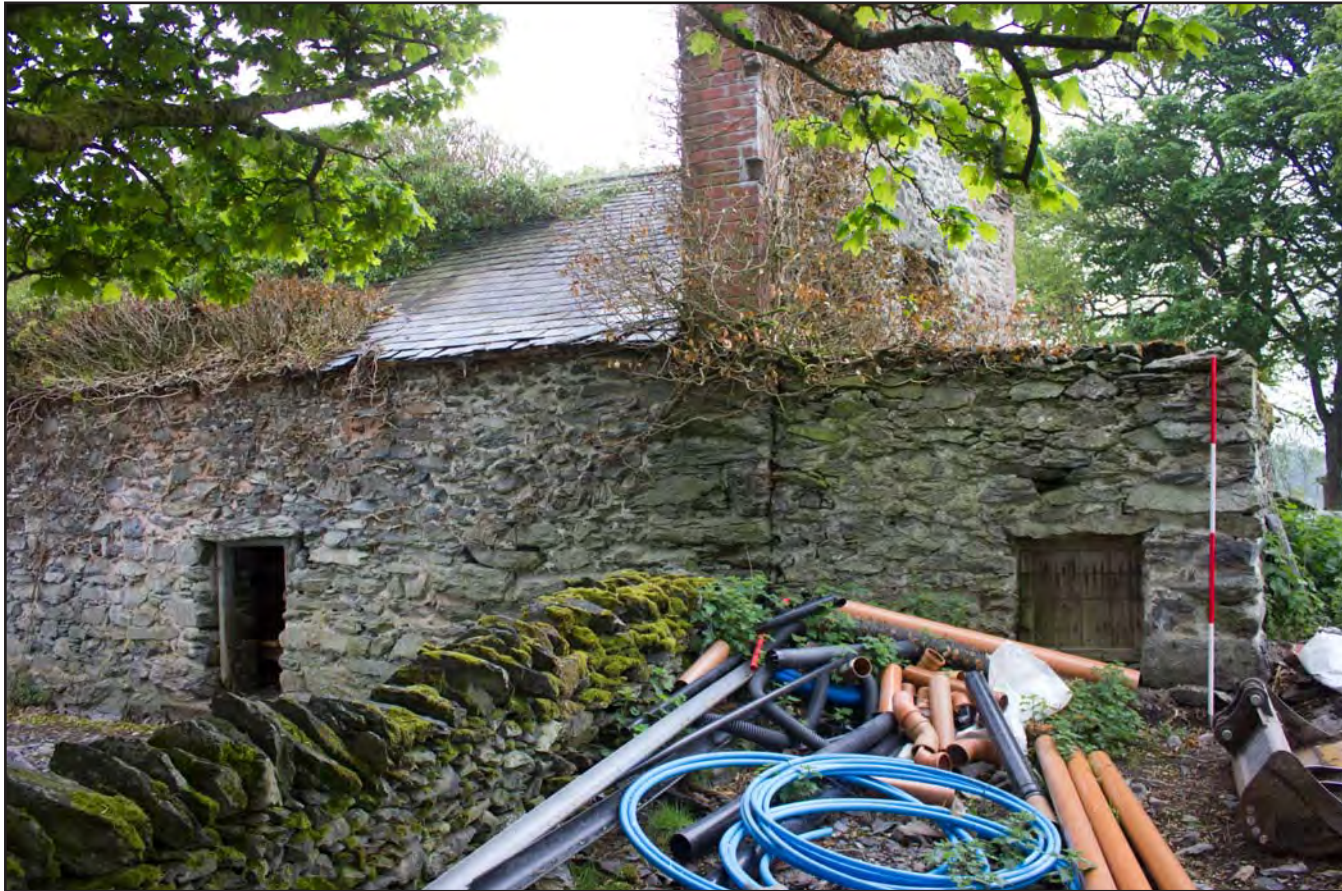
**Plate 55:** Southeast elevation (right) of Building 4 - Cowhouse/Shippon at Gaer Gerrig, Llangwm, Conwy - from the east - 2.00m scale

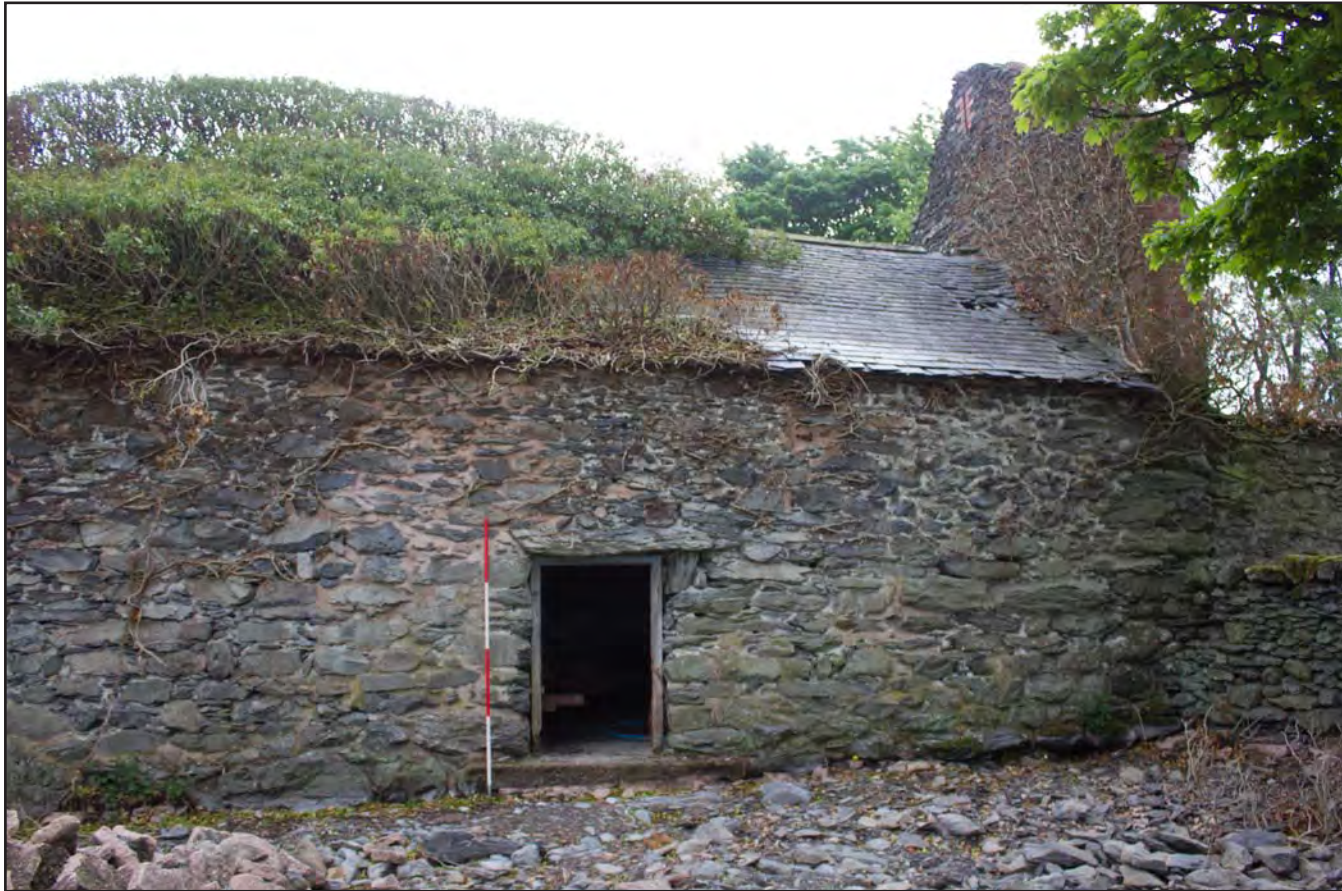
**Plate 56:** Southeast elevation (centre) of Building 4 - Cowhouse/Shippon at Gaer Gerrig, Llangwm, Conwy - from the southeast - 2.00m scale

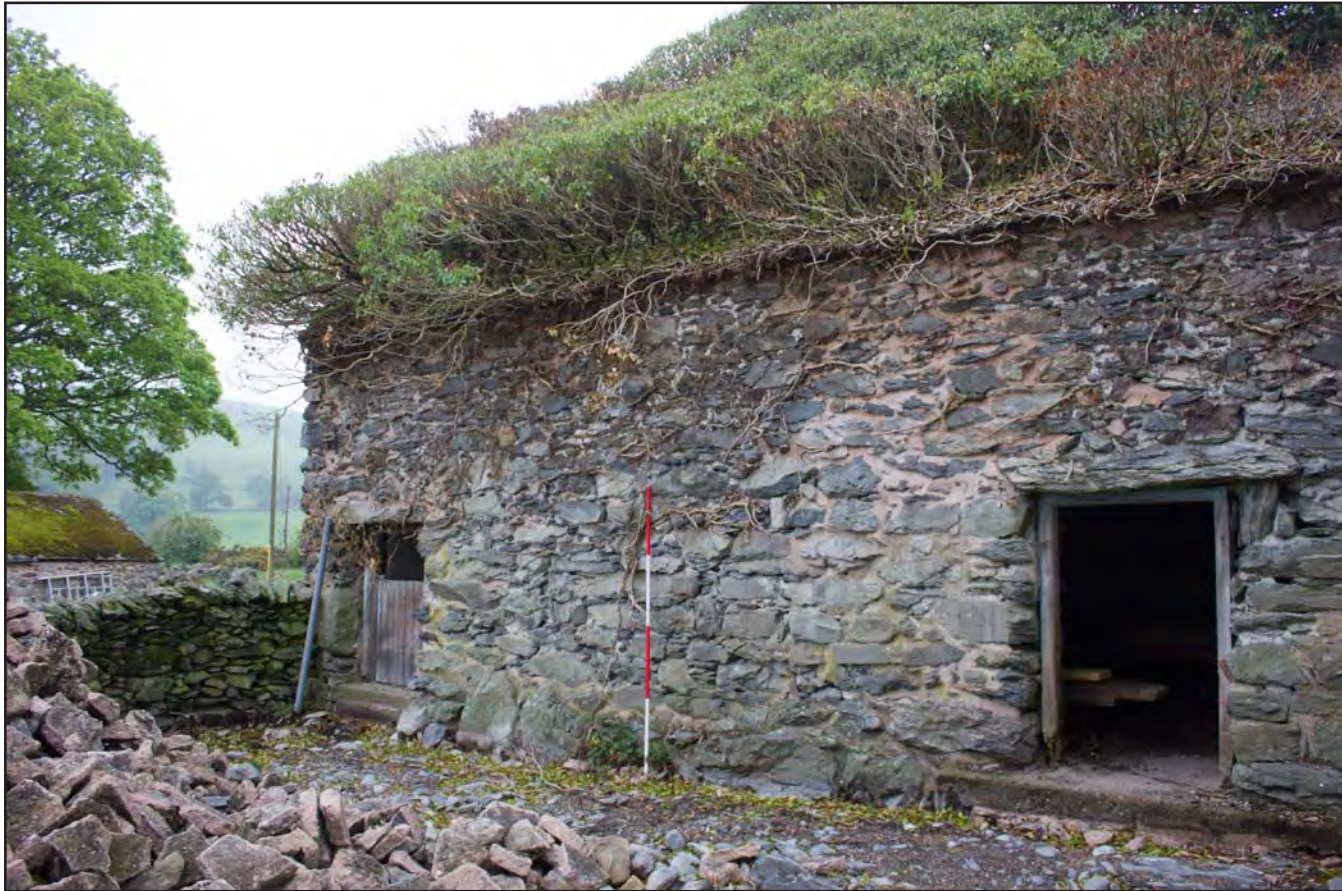
**Plate 57:** Southeast elevation (left) of Building 4 - Cowhouse/Shippon at Gaer Gerrig, Llangwm, Conwy - from the north - 2.00m scale

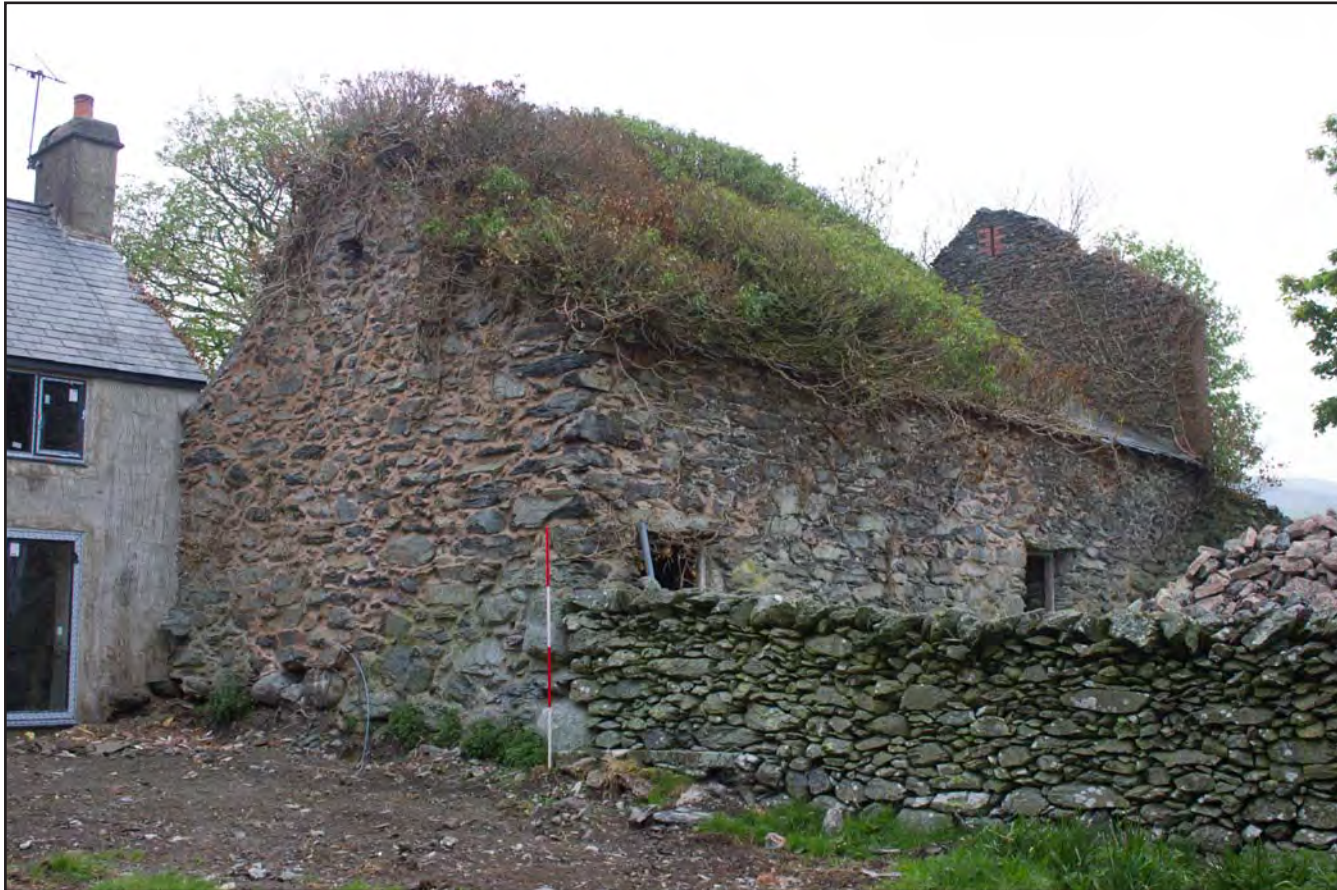
**Plate 58:** Oblique shot of southwest & northeast elevations of Building 4 - Cowhouse/Shippon at Gaer Gerrig, Llangwm, Conwy - from the south - 2.00m scale

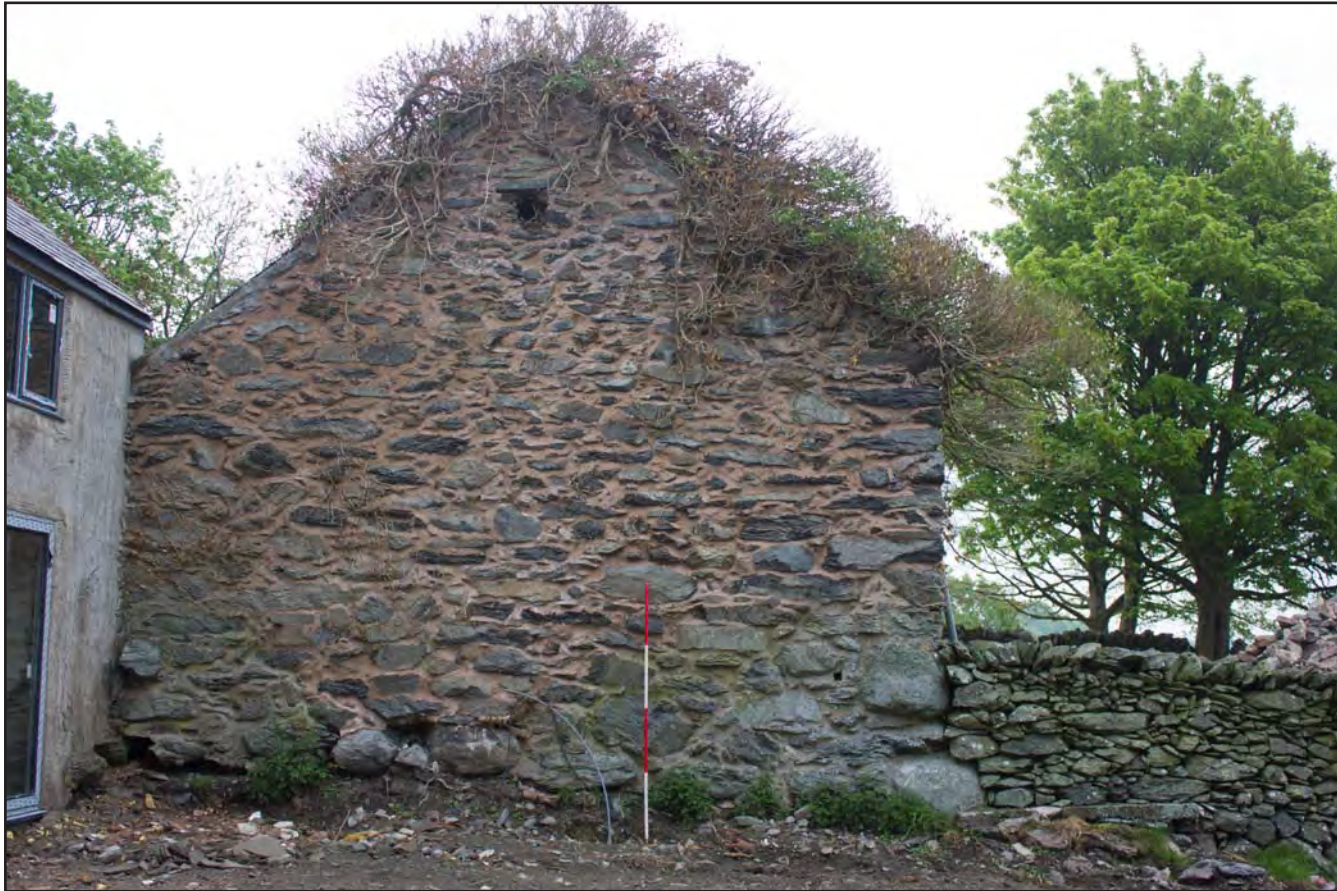
**Plate 59:** Southwest elevation of Building 4 - Cowhouse/Shippon at Gaer Gerrig, Llangwm, Conwy - from the southwest - 2.00m scale

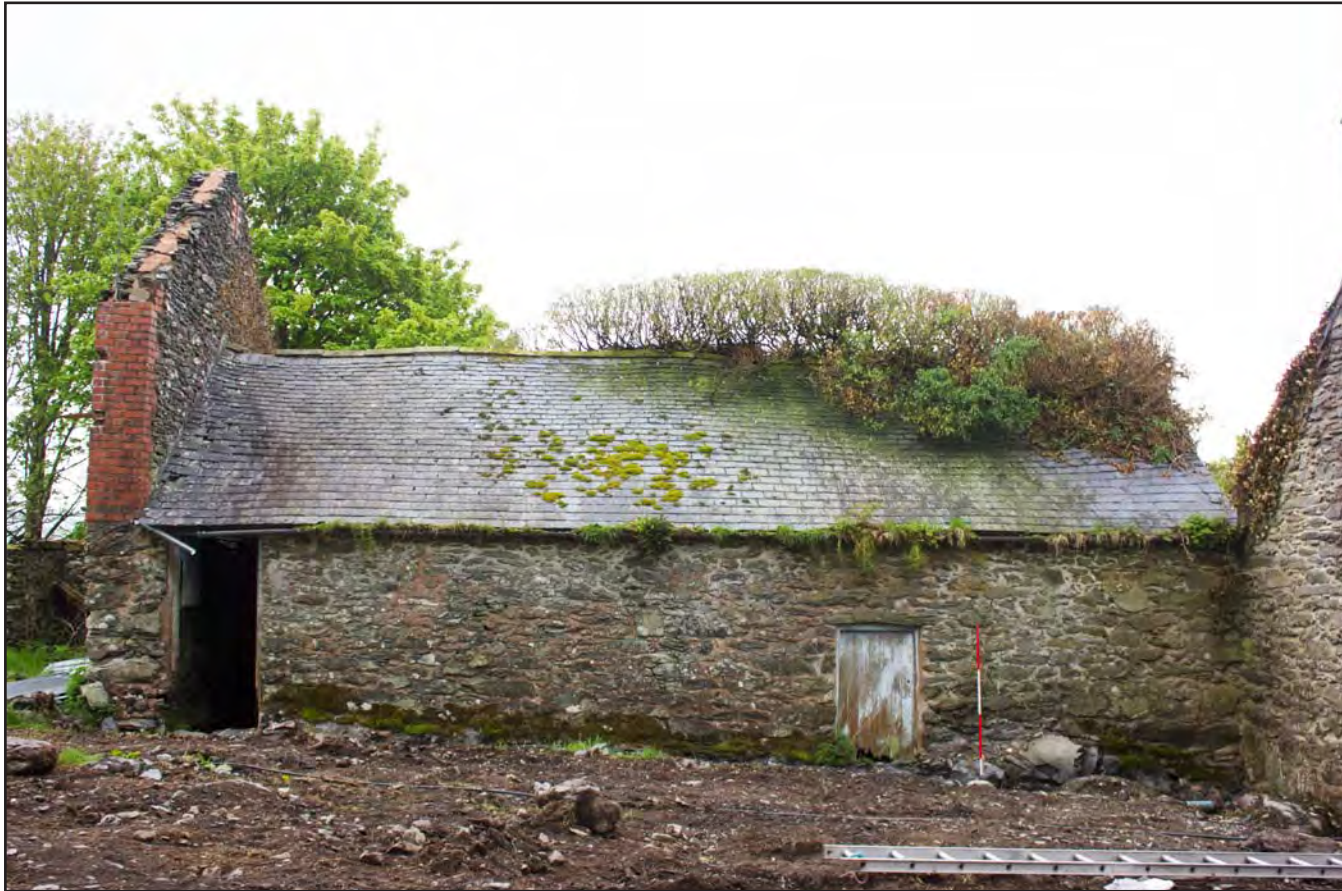
**Plate 60:** Northwest elevation of Building 4 - Cowhouse/Shippon at Gaer Gerrig, Llangwm, Conwy - from the northwest - 2.00m scale

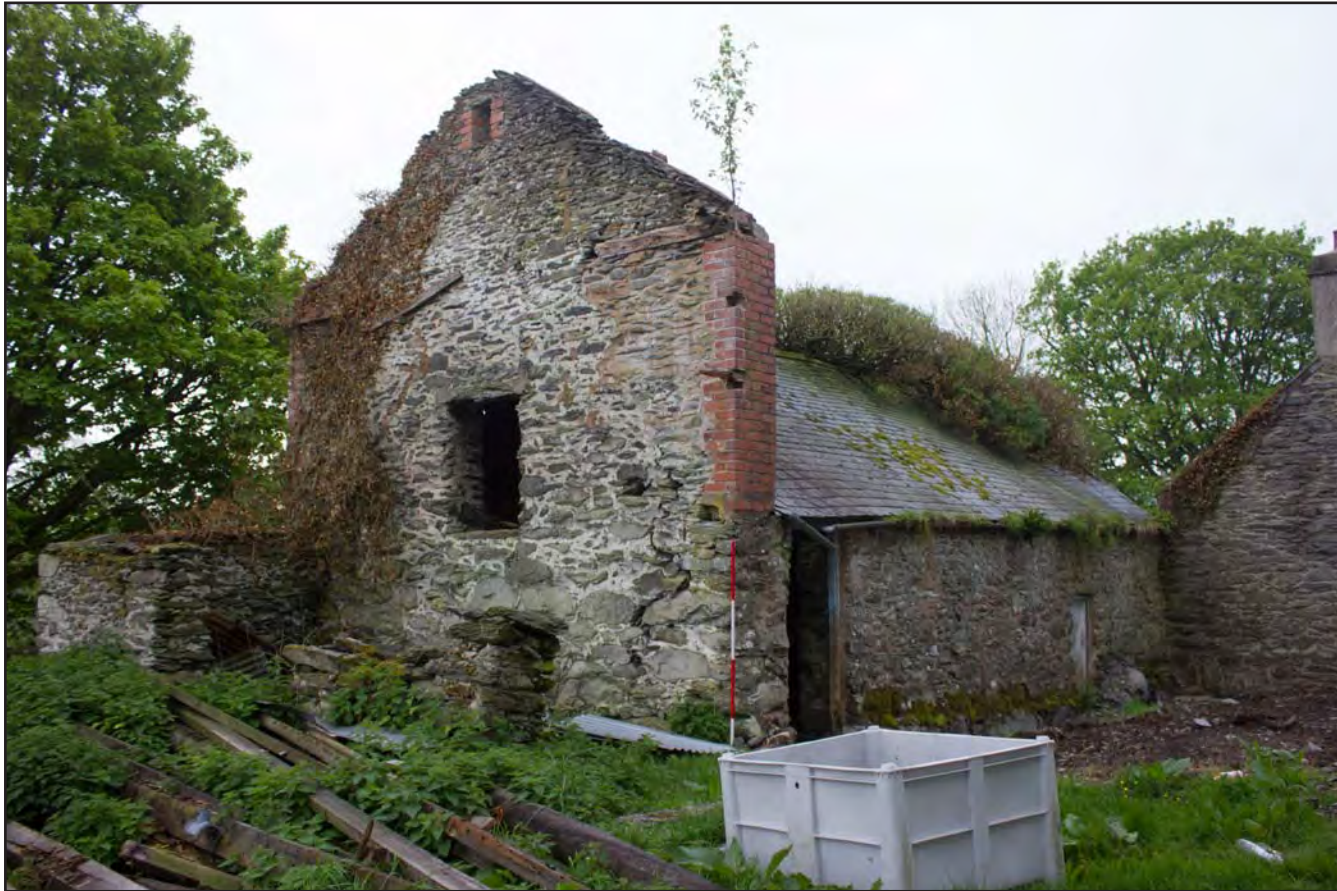
**Plate 61:** Oblique shot of northeast & northwest elevations of Building 4 - Cowhouse/Shippon at Gaer Gerrig, Llangwm, Conwy - from the east - 2.00m scale

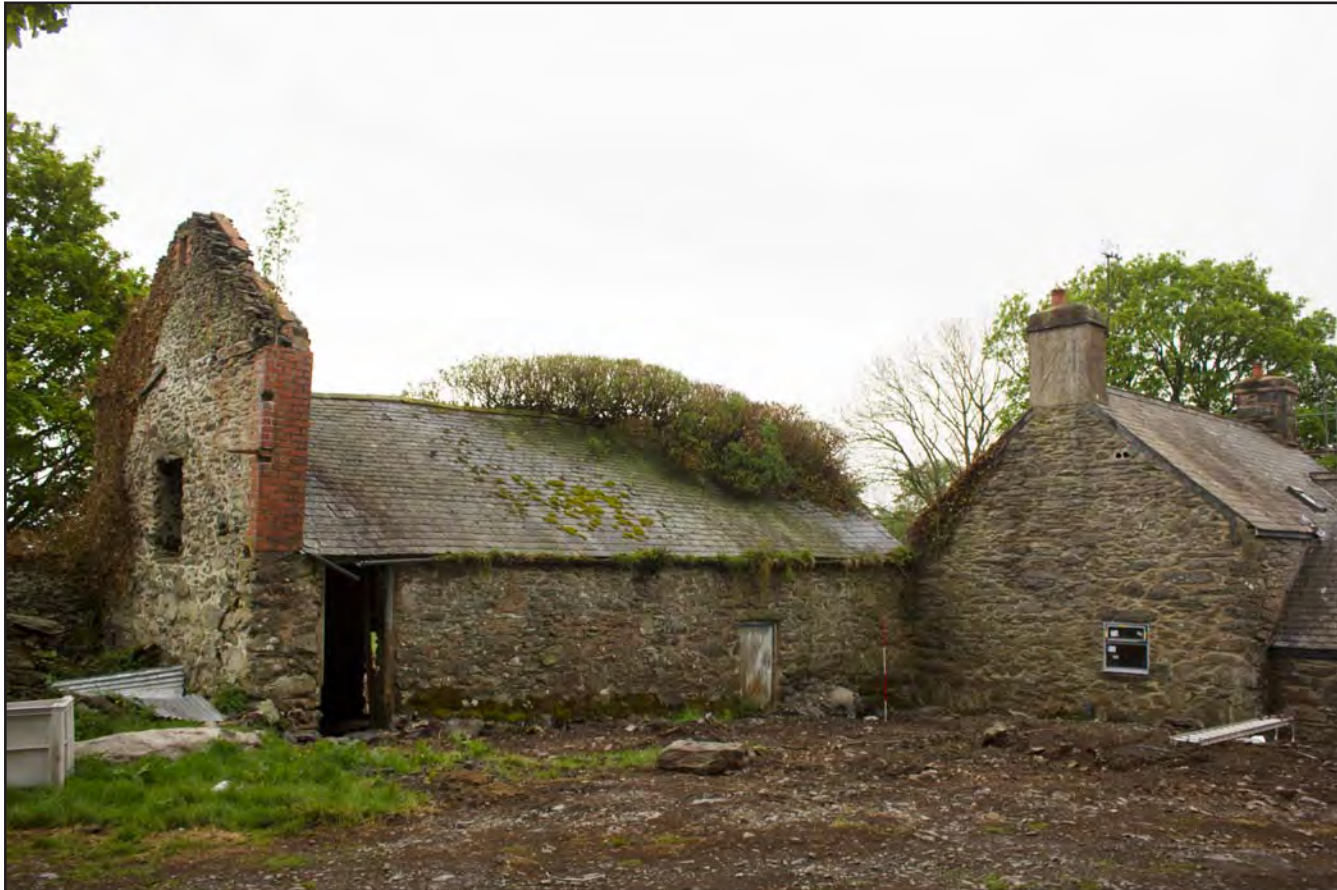
**Plate 62:** Context shot of Farmhouse and Building 4 - Cowhouse/Shippon at Gaer Gerrig, Llangwm, Conwy - from the north  
- 2.00m scale

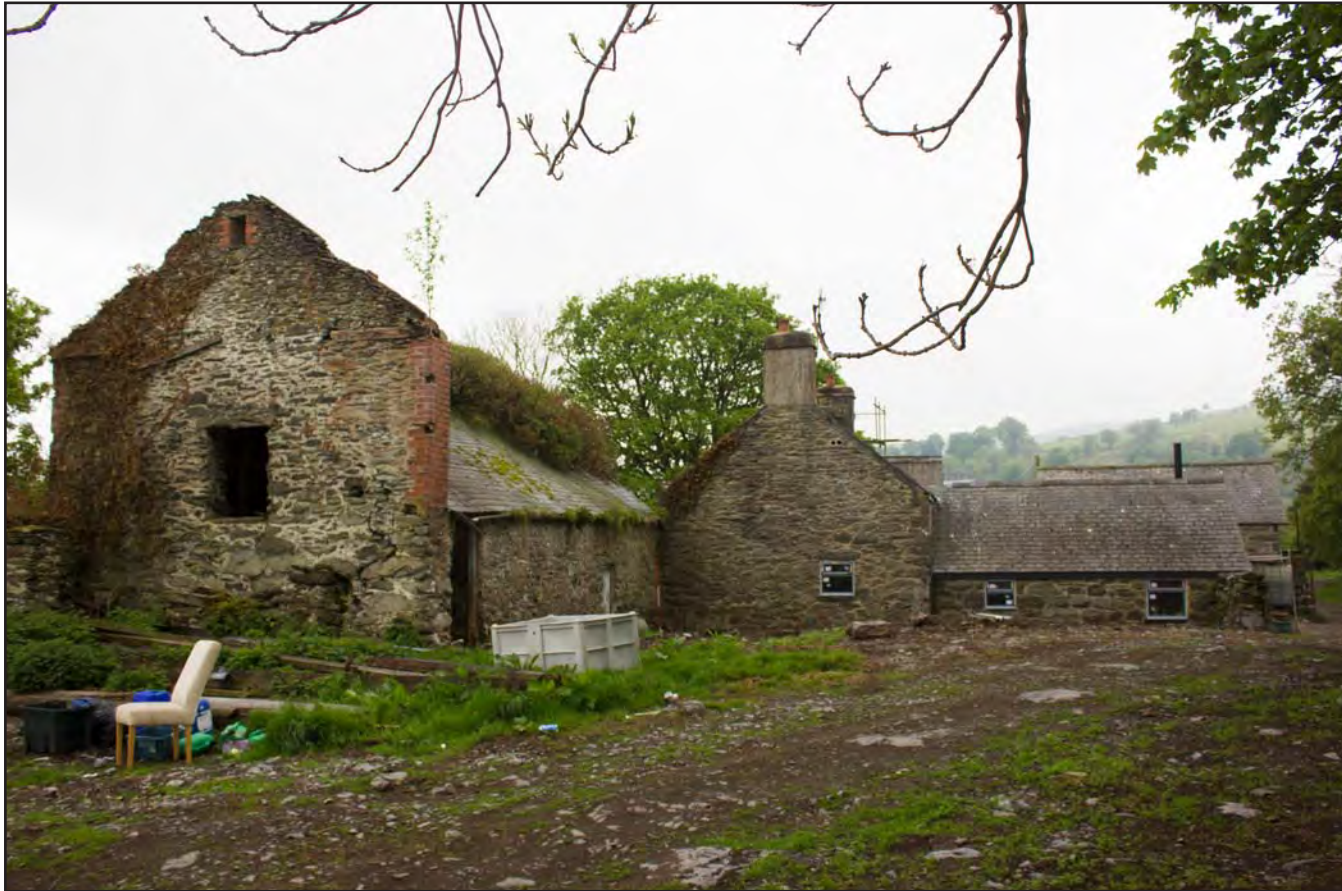
**Plate 63:** Context shot of Farmhouse and Building 4 - Cowhouse/Shippon at Gaer Gerrig, Llangwm, Conwy - from the northeast - 2.00m scale

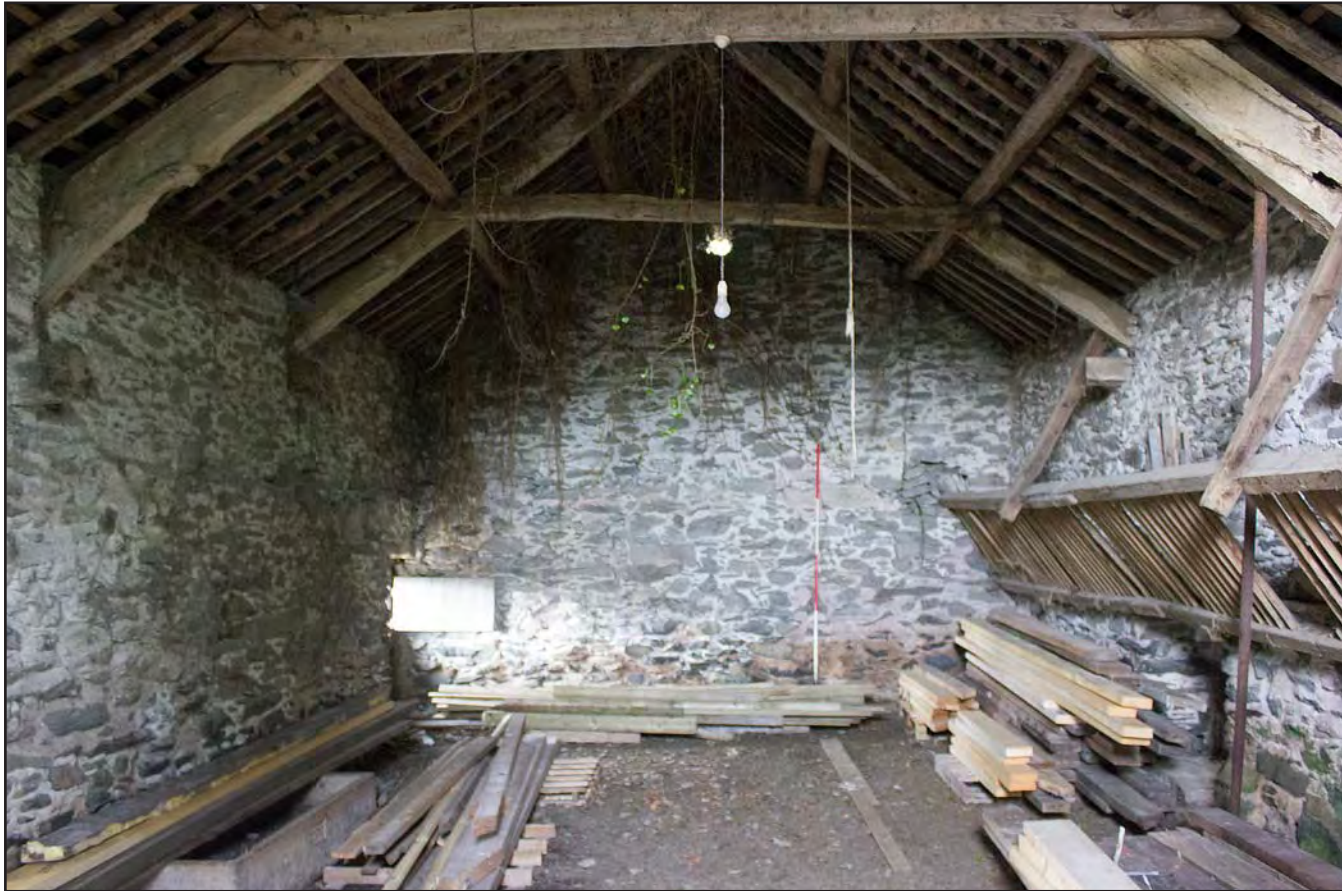
**Plate 64:** Internal shot of Building 4 - Cowhouse/Shippon at Gaer Gerrig, Llangwm, Conwy - from the northeast - 2.00m scale

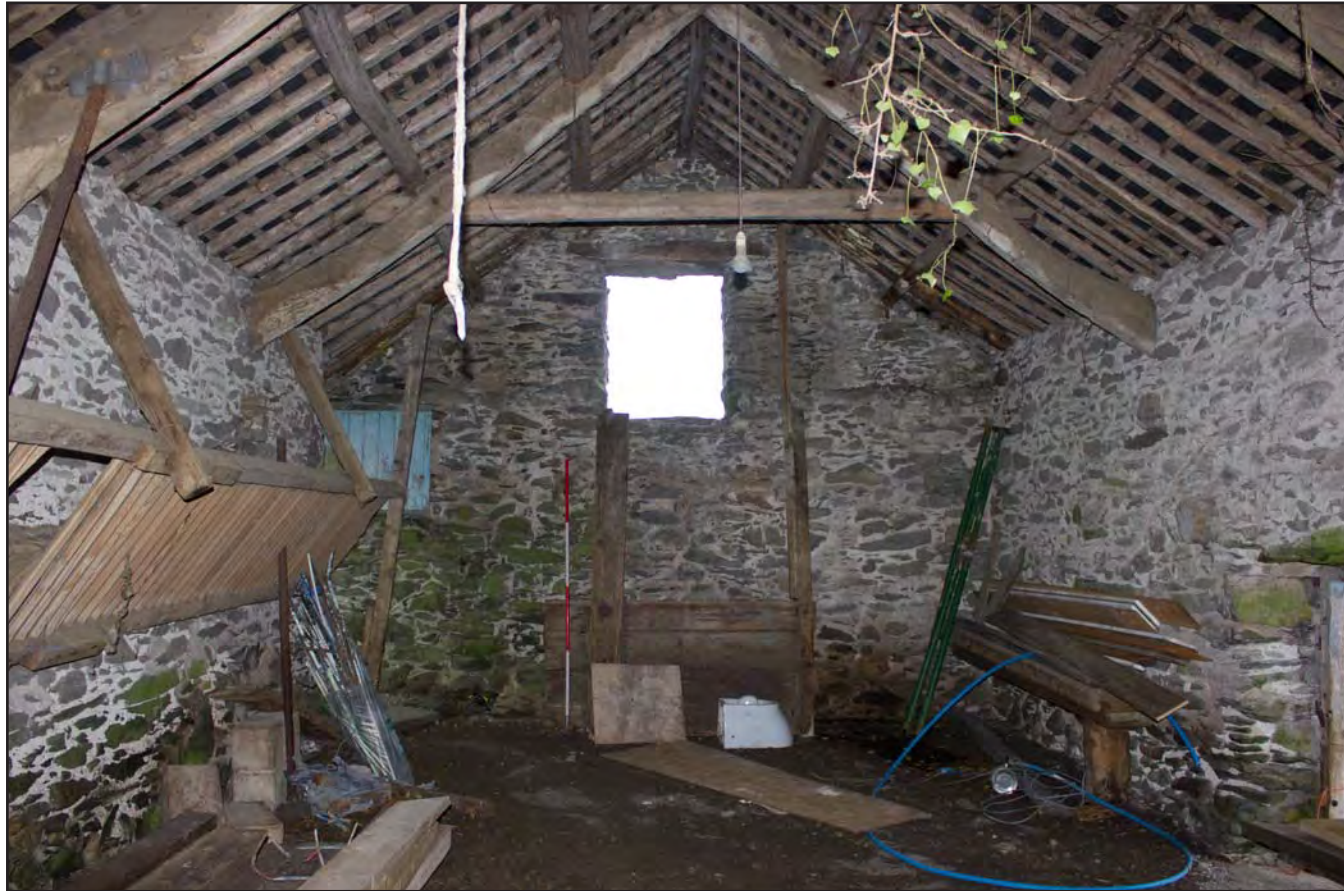
**Plate 65:** Internal shot of Building 4 - Cowhouse/Shippon at Gaer Gerrig, Llangwm, Conwy - from the northeast - 2.00m scale

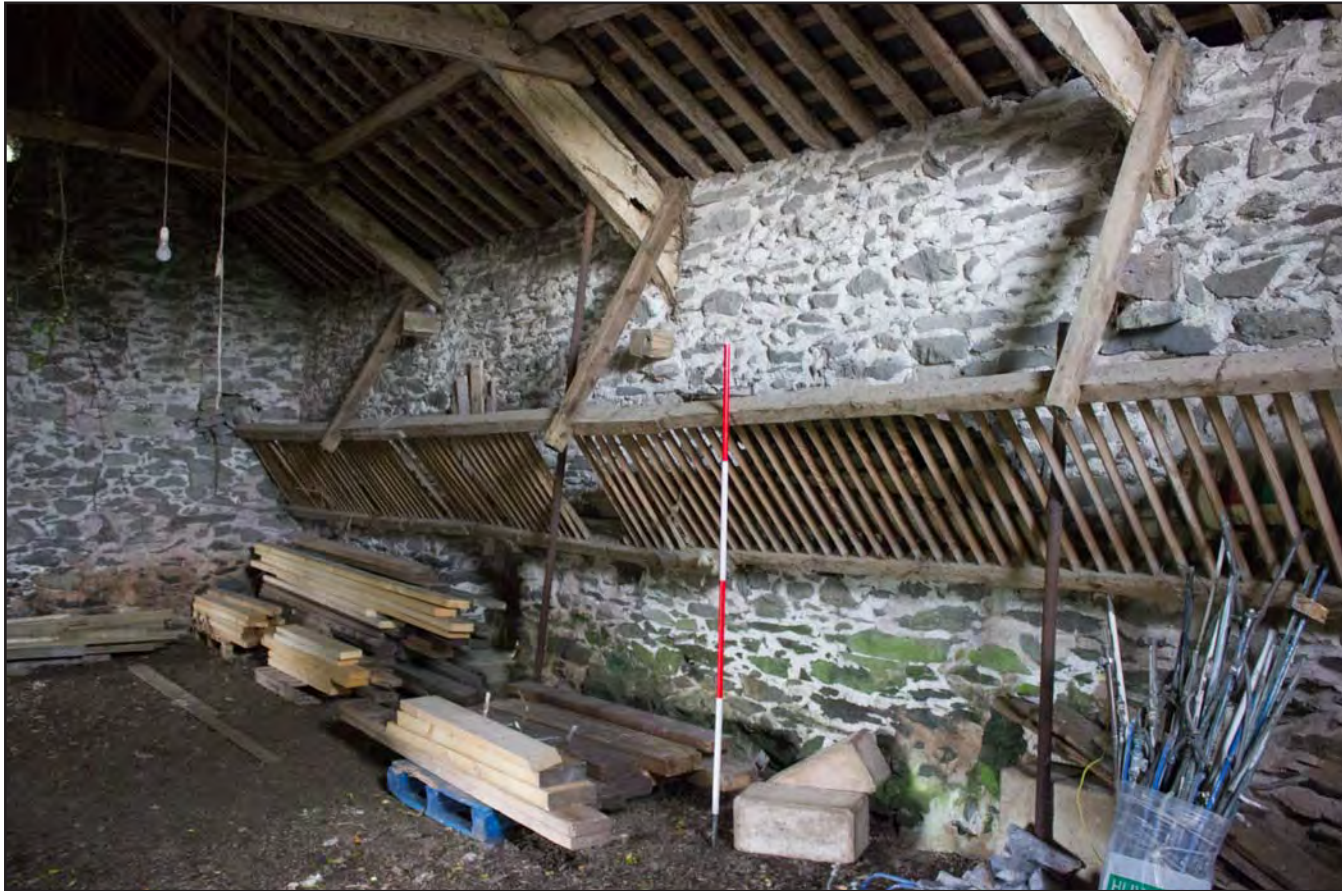
**Plate 66:** Oblique internal shot of Building 4 - Cowhouse/Shippon at Gaer Gerrig, Llangwm, Conwy - from the northeast - 2.00m scale

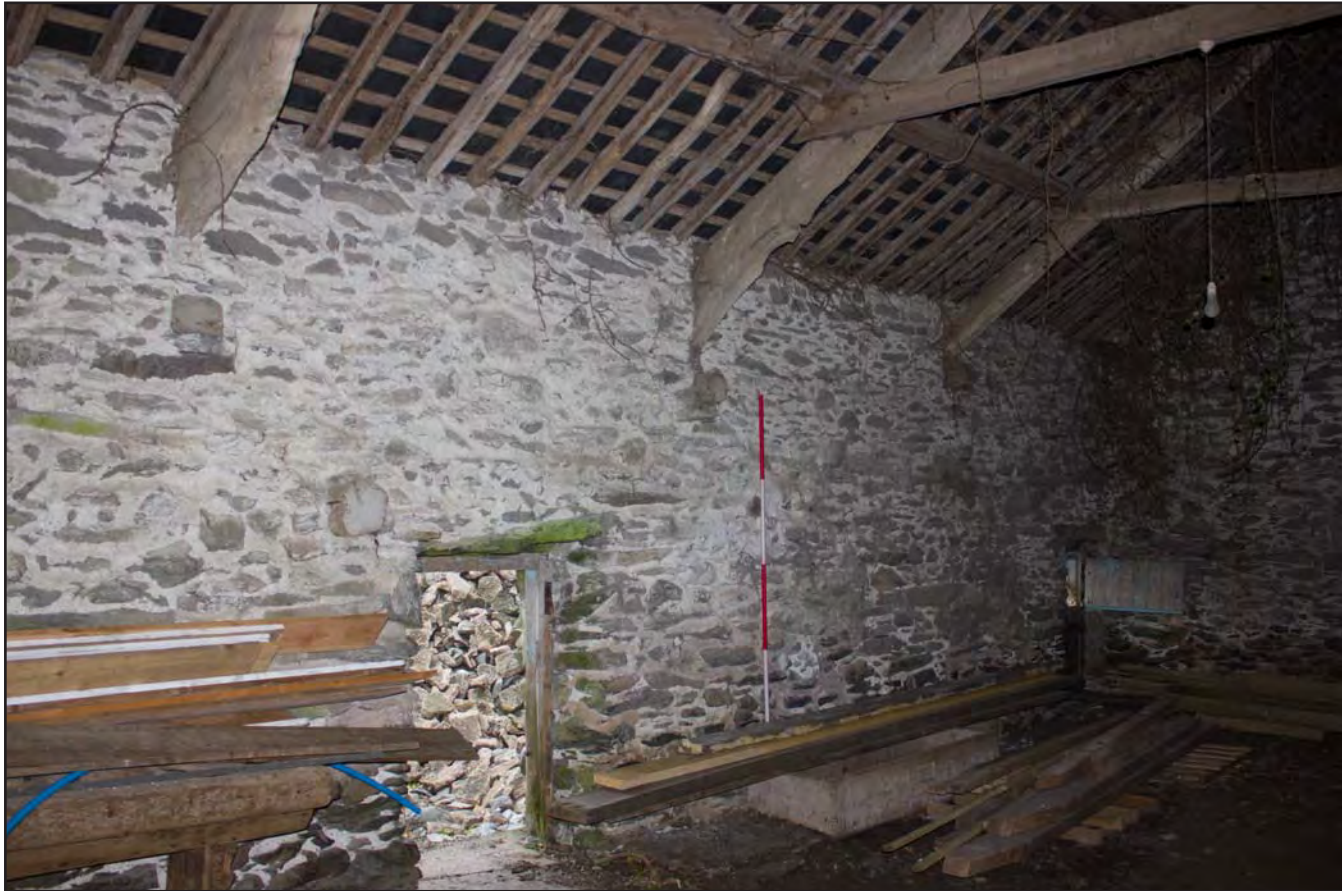
**Plate 67:** Oblique internal shot of Building 4 - Cowhouse/Shippon at Gaer Gerrig, Llangwm, Conwy - from the northeast - 2.00m scale
