# Outbuildings at Gaer Gerrig, Llangwm, Conwy LL21 OPE.

Historic Building Record Level 2

Report no. 0349

# **Outbuildings at Gaer Gerrig, Llangwm, Conwy LL21 OPE (0/46680).**

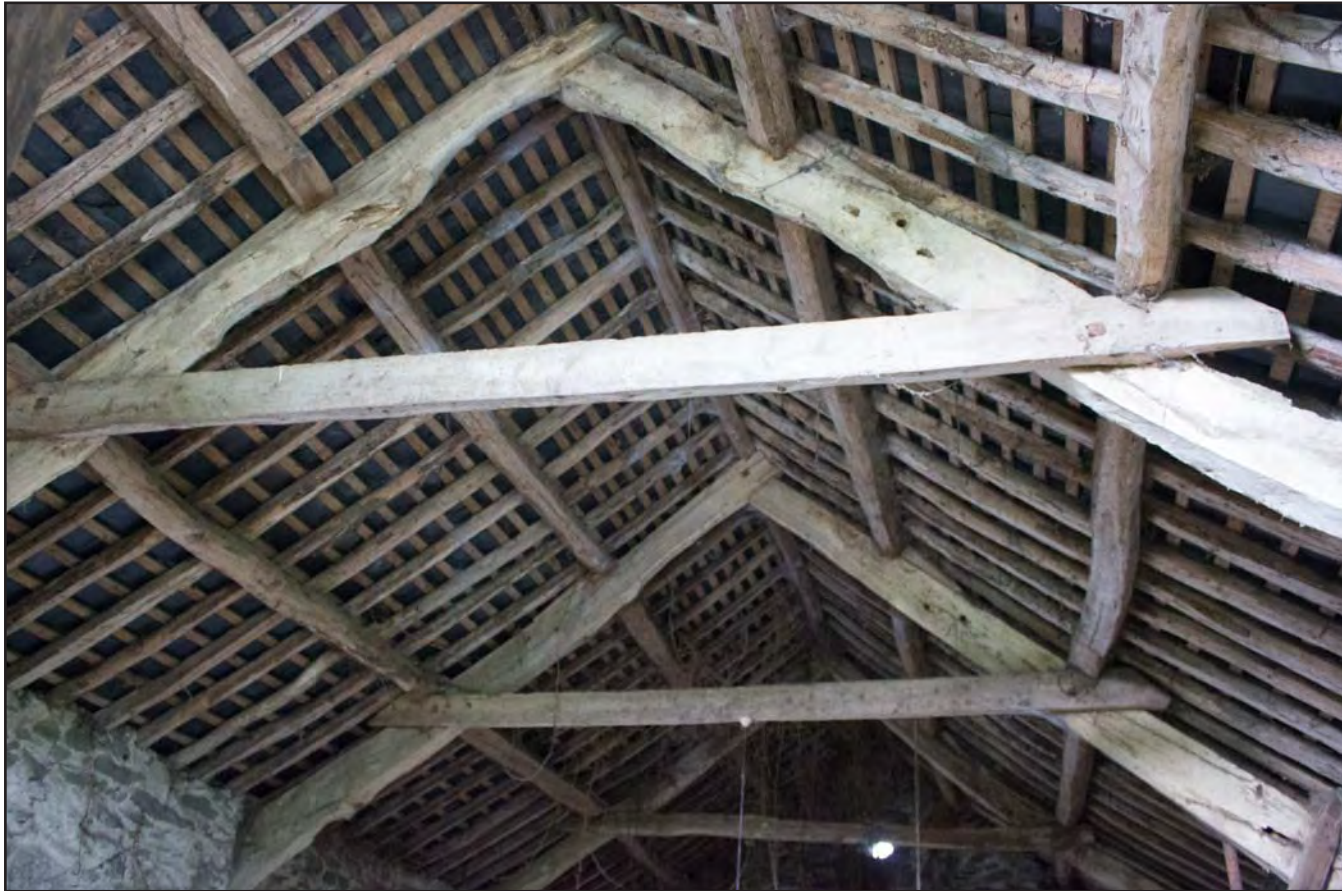
**Plate 68:** Ceiling within Building 4 - Cowhouse/Shippon at Gaer Gerrig, Llangwm, Conwy - from the northeast - 2.00m scale

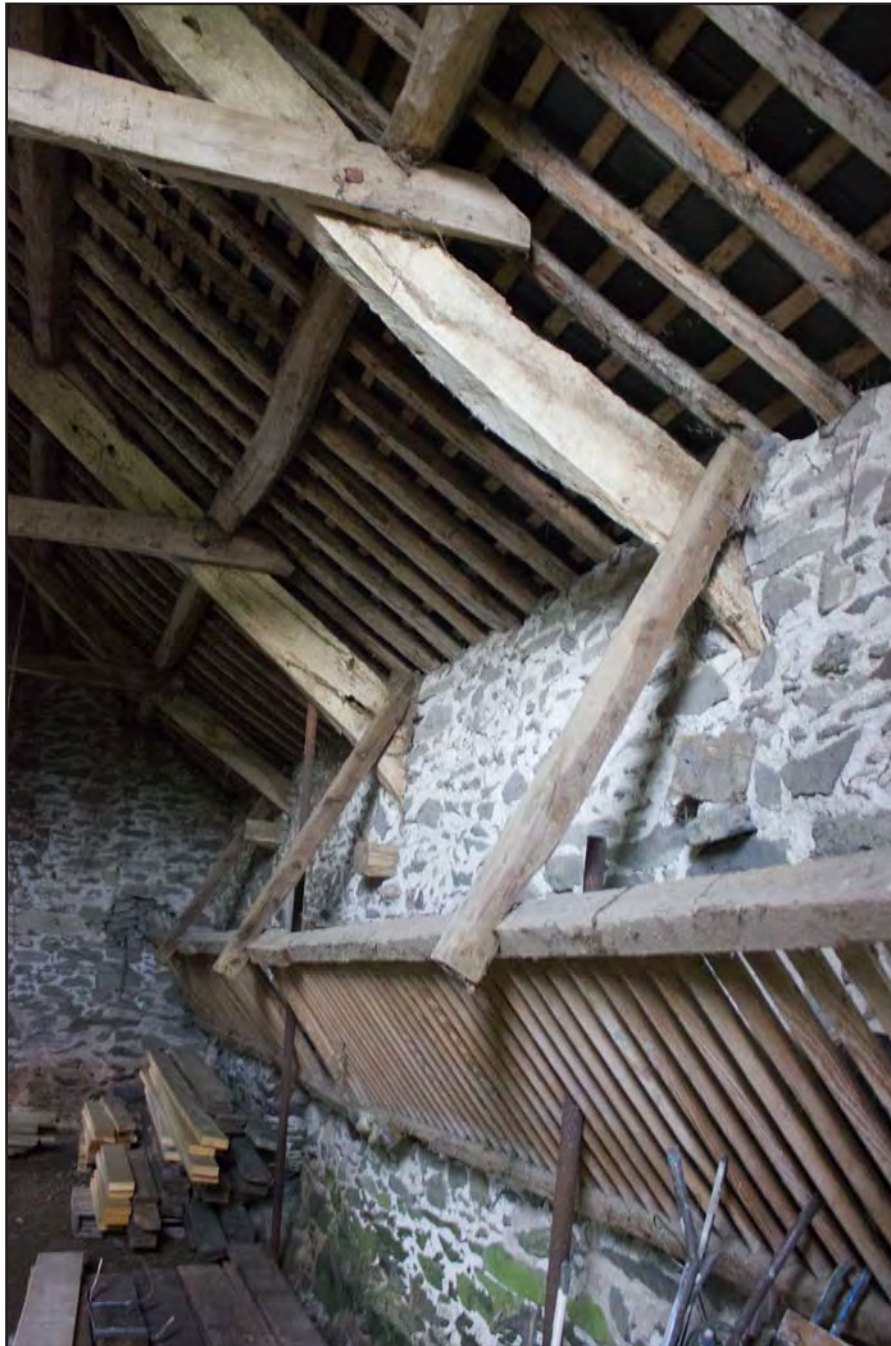
**Plate 69:** Wooden feeder in Building 4 - Cowhouse/Shippon at Gaer Gerrig, Llangwm, Conwy - from the northeast - 2.00m scale
