Archaeological Monitoring and Recording: Llyn Celyn Reservoir, Gwynedd

Report No. 2252

Prepared for Dŵr Cymru Welsh Water

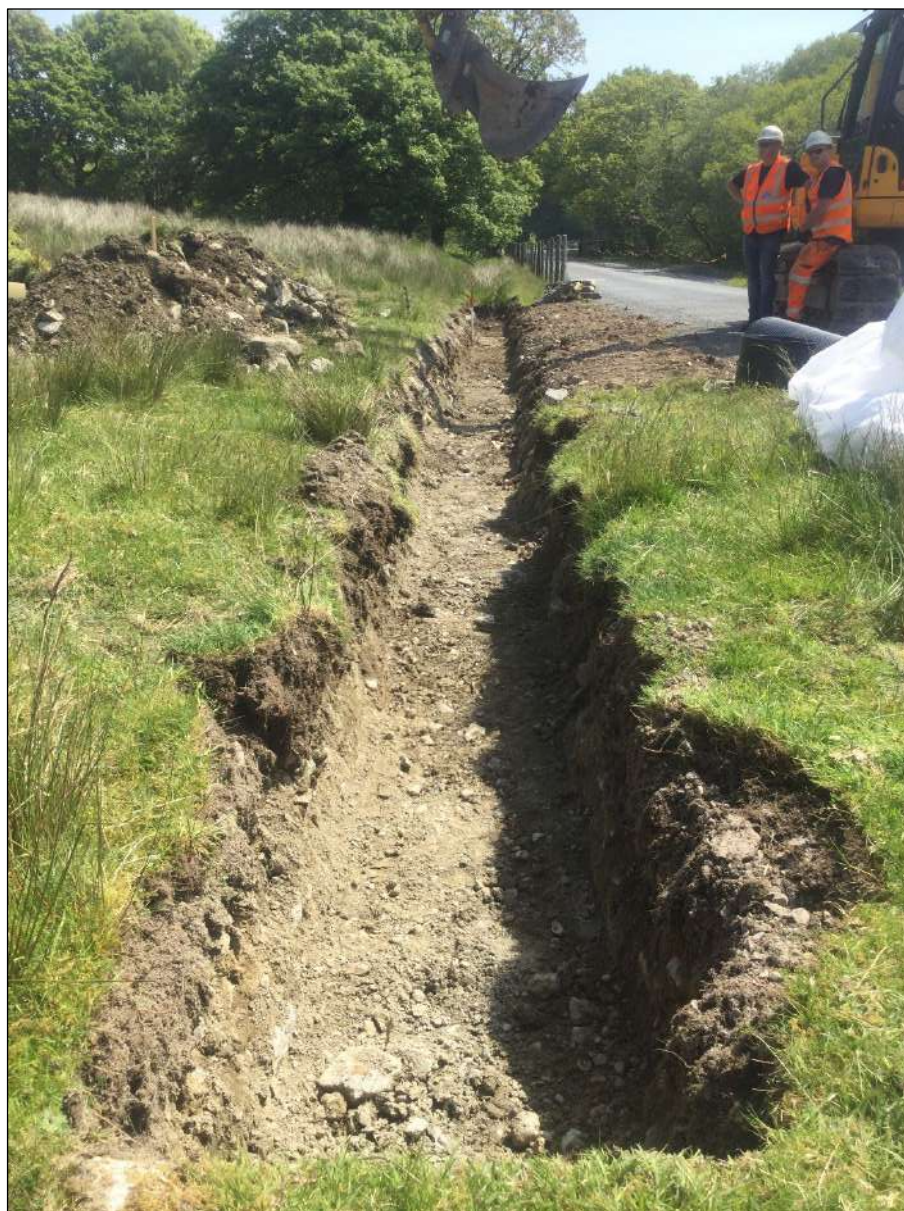
Plate 8. Silt trap at base of Area B, looking east.

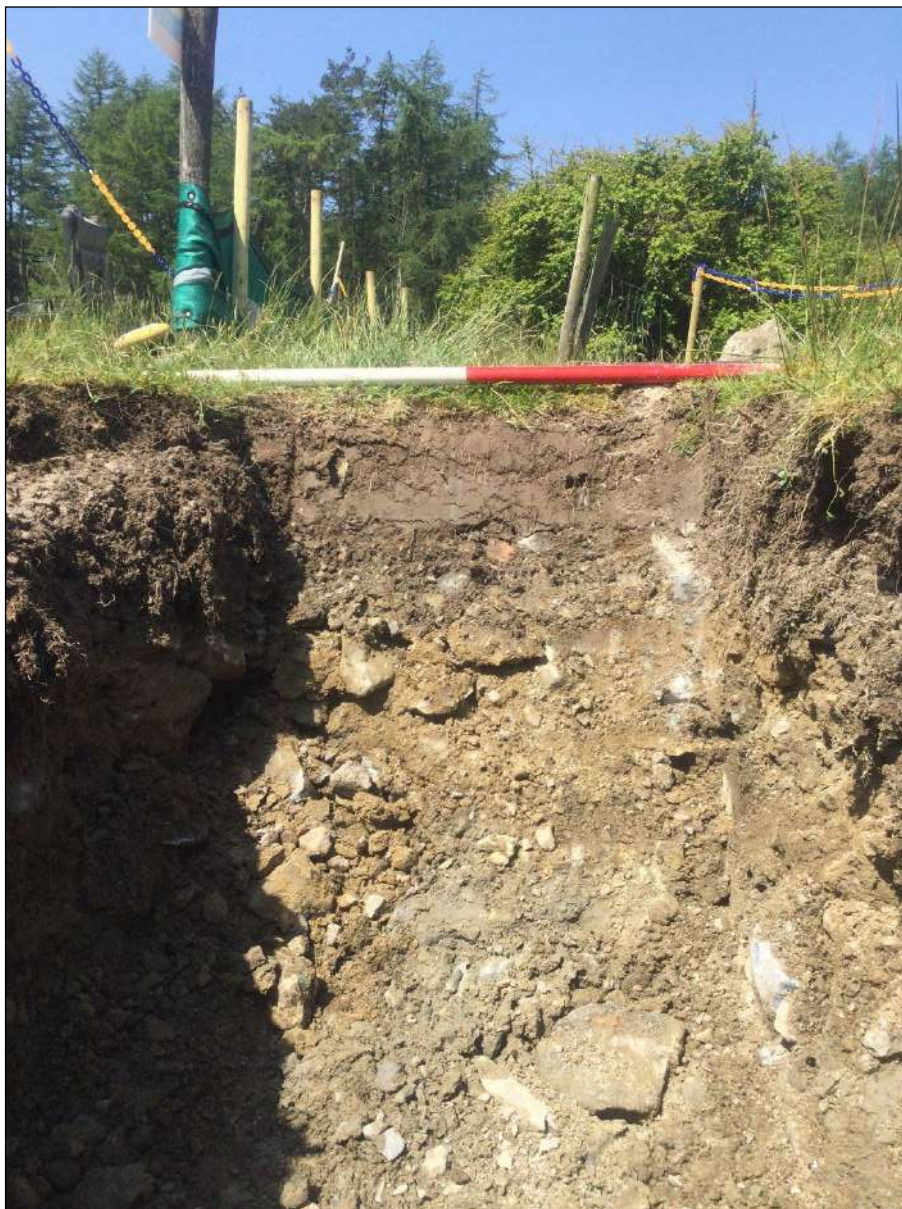
Plate 9. East-facing section of silt trap.

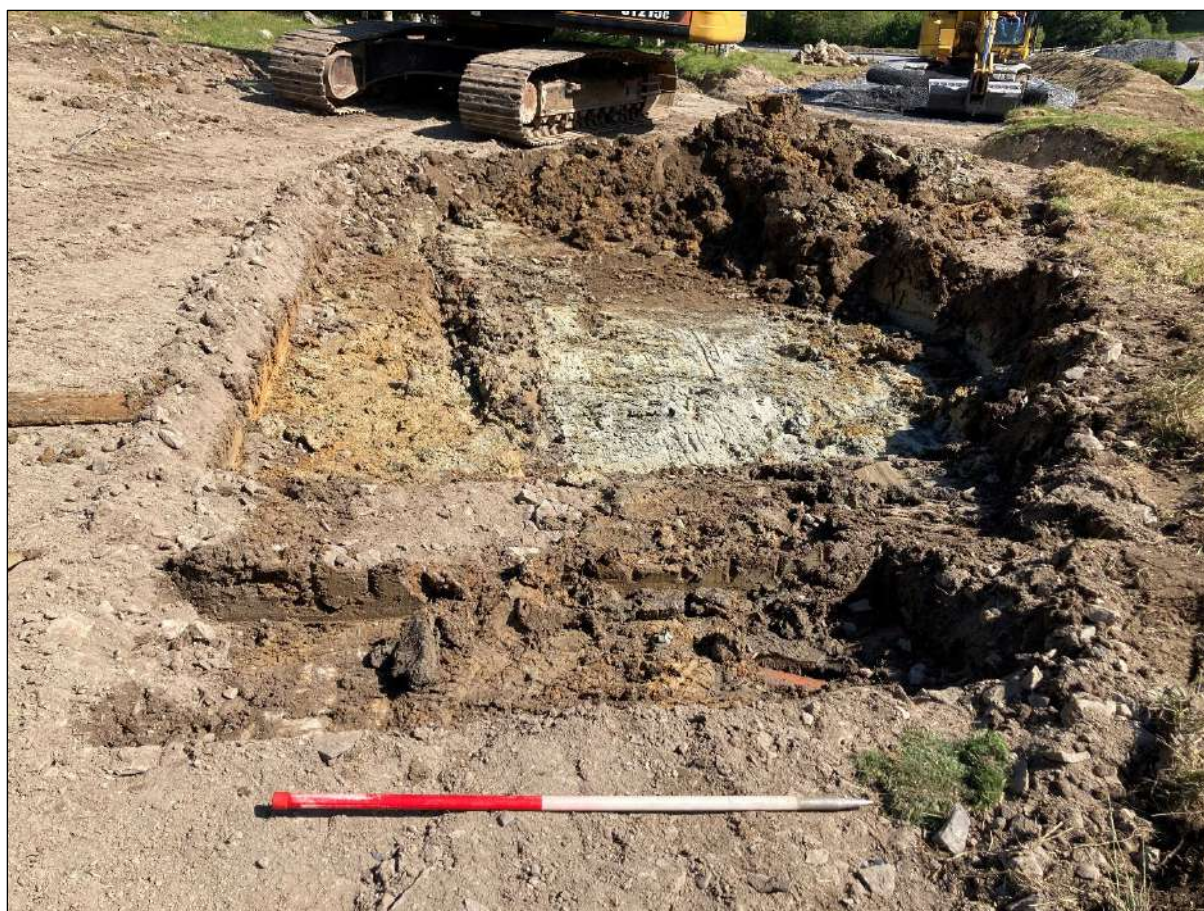
- 5.3.1. A linear area from the northwestern tip of Area B up to Area C was stripped to construct the haulage road. A sondage, 3m by 1.8m was dug to a maximum depth of 0.8m, prior to excavation in order to judge ground conditions. The final excavated area covered 140m in length by 7m wide and was generally dug to an average depth of 0.8m.
- 5.3.2. The lower deposit encountered (201) was a compacted pale yellow-brown silty clay with pockets of light grey friable clay within its matrix. Frequent medium angular and sub-angular stones were noted throughout. This layer was interpreted as redeposited natural associated with the construction of the

Plate 12. Sondage dug within roadway to judge ground conditions.

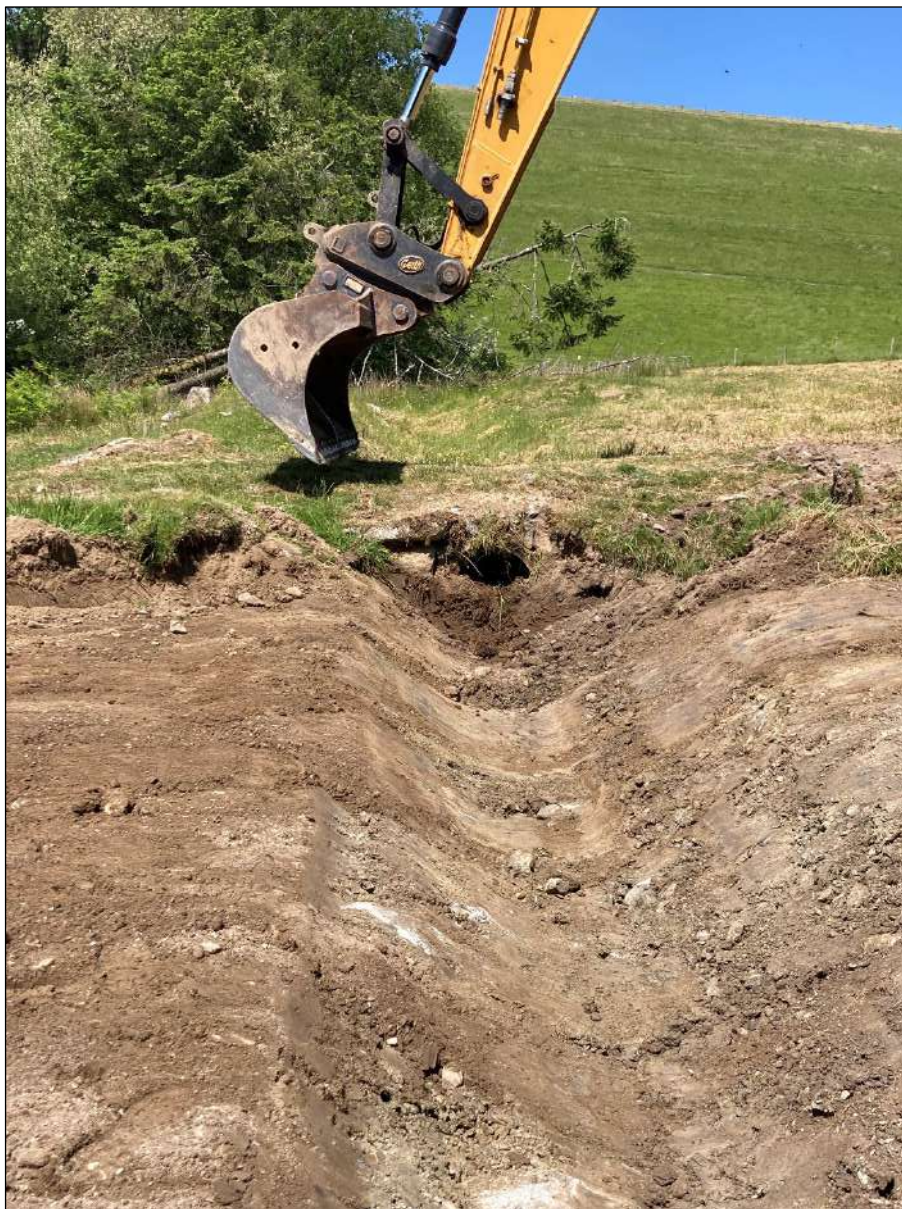
- 5.3.3. At the southern end of the roadway, where it met Area B, the topsoil (200) and subsoil (201) were cut by a linear gully [202]. This feature measured 38m in length, 2.5m in width, and was excavated to a depth of 0.8m. It was oriented roughly north/south and continued to the east beyond the limit of excavation. In order to construct [202] deposit (201) had been dug through and had been heaped to the south, forming a slight bank, 0.3m in height by 1m wide. The bank had in turn had been capped by (200).

Plate 13. Drainage gully (202) under excavation, looking west.

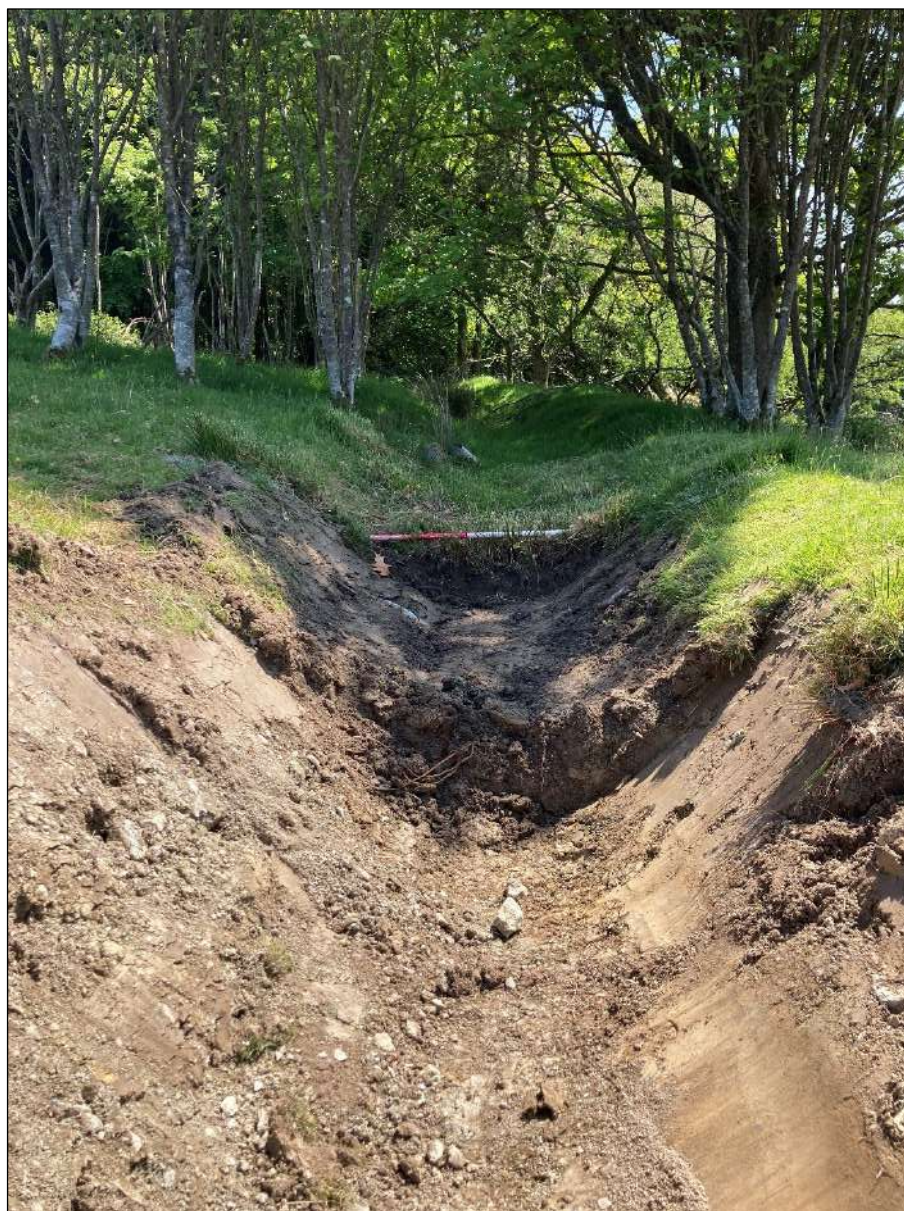
- 5.3.4. A thin lens, comprised of dark brownish silty humus (203), had built up within the dip of [202] to a maximum depth of 0.15m.
- 5.3.5. Midway along [202] a 6.5m wide section had been infilled to form a pathway over the feature. This fill (204) contained a section of metal piping, 2m in length, with a circumference of 0.5m. This would seem to have been packed into place and capped by flat angular stones set within a yellow-brown silty clay matrix. As elsewhere, the deposit had been overlain by (200). The feature was identified as a drainage gully associated with the dam construction.

Plate 14. View to the east along drainage gully (202), showing deposit (200).

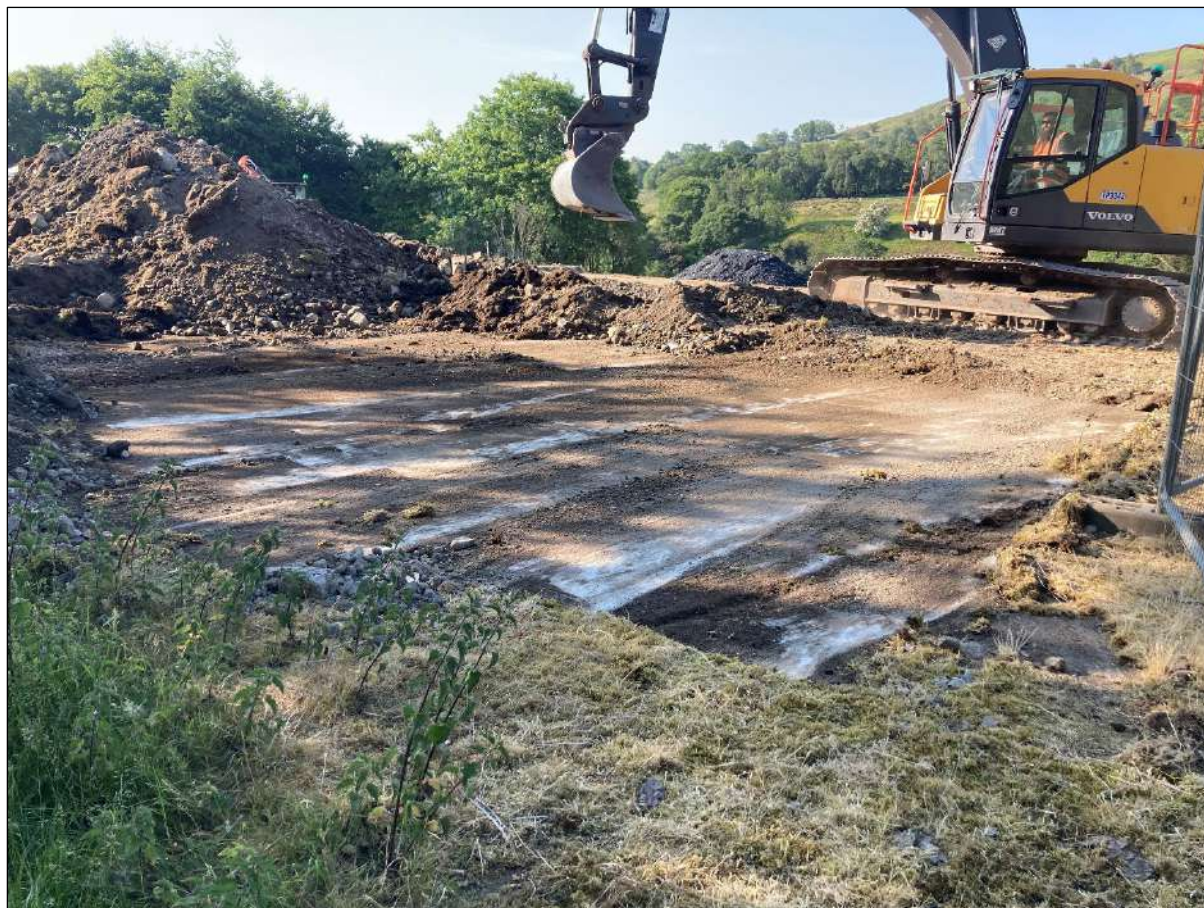
- 5.4.2. This stratigraphy was noted across almost the full extent of Area C, however, along the northern boundary, overlying the made ground deposit (301), was a series of concrete aprons. The northernmost, [302] was linear in plan, oriented north-west/south-east, and measured 50m in length, by 7m in width. A smaller rectilinear structure, 1m in width, by 2m in length, extended out to the south from the midsection of the structures southern edge.

Plate 17. Exposure of concrete apron [302] in Area C.

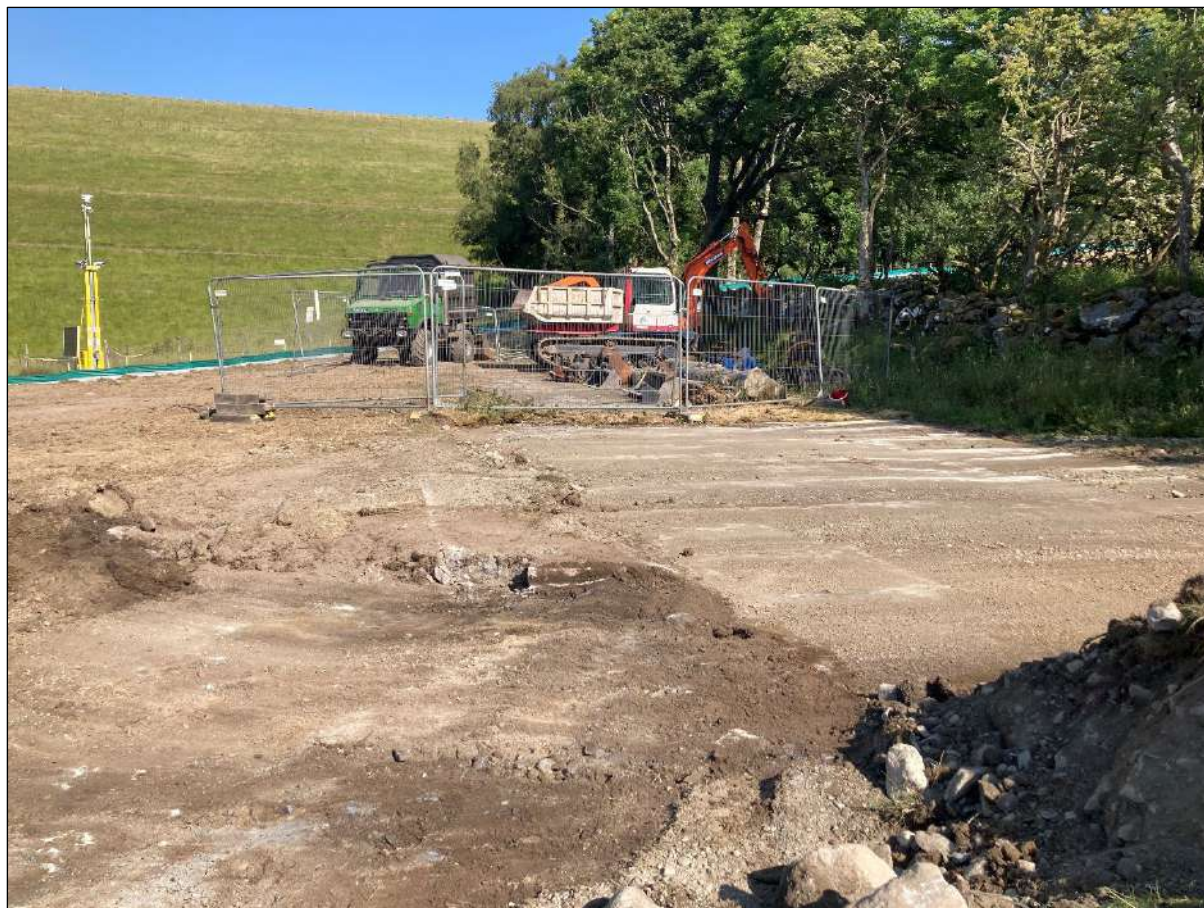
Plate 18. [302] original 1960's construction works building, looking west.

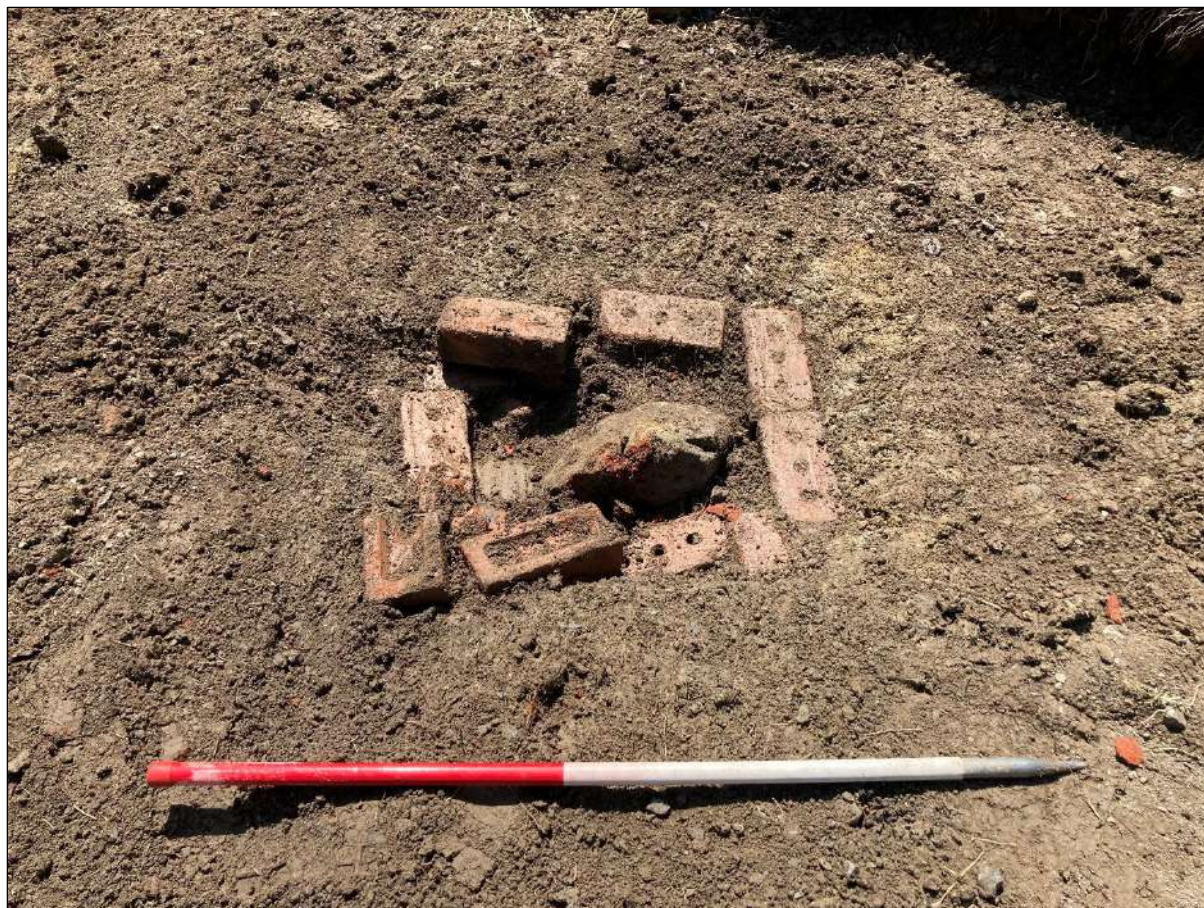
- 5.4.4. Further to the east, a vague square shaped cut (304), measuring 0.85m by 0.8m, had been dug into the redeposited subsoil (301). Within the cut a series of bricks [305], two along each side, had been laid out to form a rough square feature 0.5m by 0.5m. Two courses of bricks were exposed, however, none showed evidence of being bonded. Surrounding [305], and infilling the cut, was (306) a compacted pale yellow silty clay. The central void of feature [305] was filled by medium sized sub rounded cobbles within a soft and friable dark brown silty clay (307). This feature was sealed by the extant topsoil layer (300), a soft and friable dark greyish-brown clay silt. This contained occasional stone fragments and charcoal flecks, was root disturbed and measured between 0.1m and 0.2m in depth. This feature was interpreted as a small cesspit and was not fully excavated and remained in situ.

Plate 21. Feature [305].

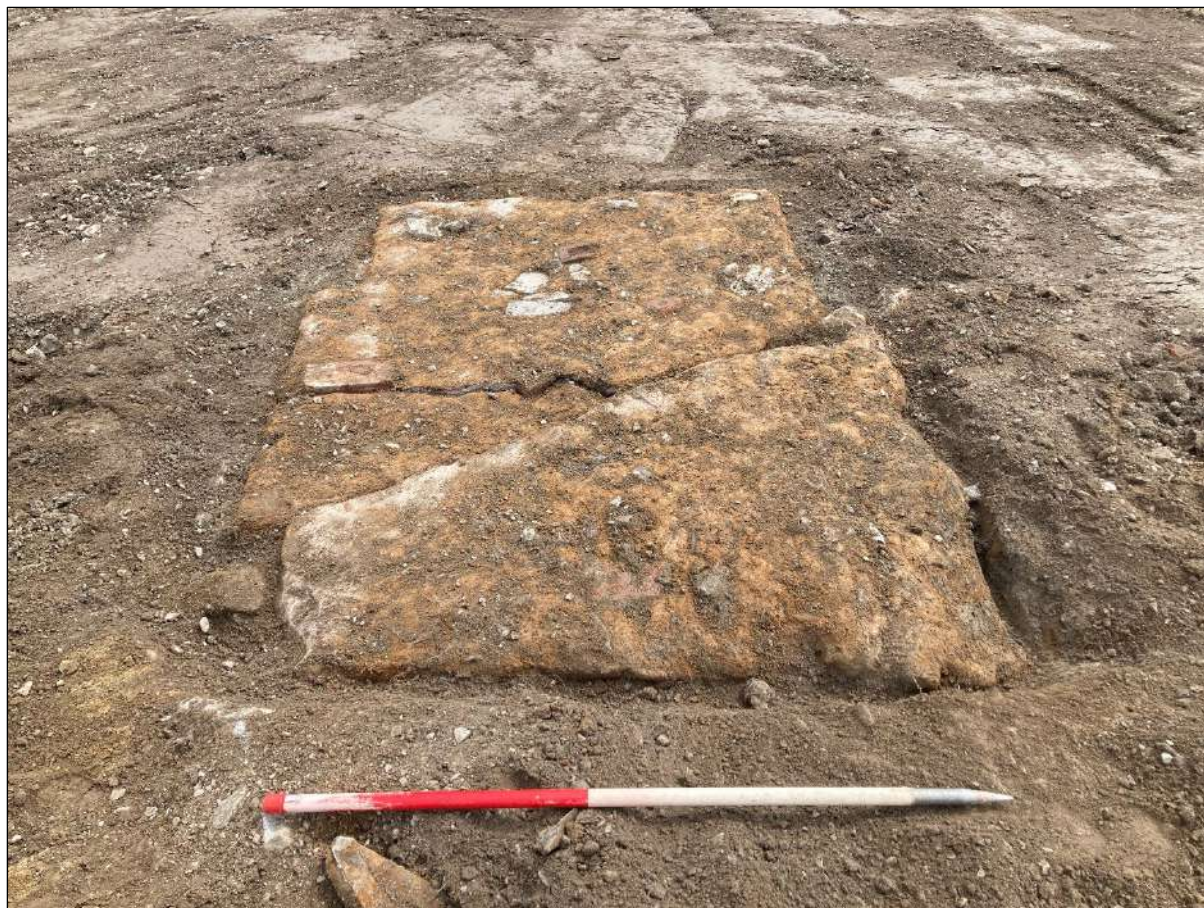
- 5.5.3. A rough rectangular concrete slab [402] set within (401) was exposed towards the centre of Area D. This feature, though unknown in use, was in the general location of one of the structures identified from the aerial photographs. The slab was 1.5m by 1m in size and was of a coarse construct, inset with brick fragments and stone inclusions. The feature was not fully excavated and remained in situ. Lying a short distance to the north-west of [402] was the remains of a rectangular timber frame, still with remnants of white paint. This measured 0.5m by 1m and was interpreted as a window surround, possibly from the adjacent structure. As to the other structures identified from aerial photographs, there was no evidence.

Plate 27. Feature [402]

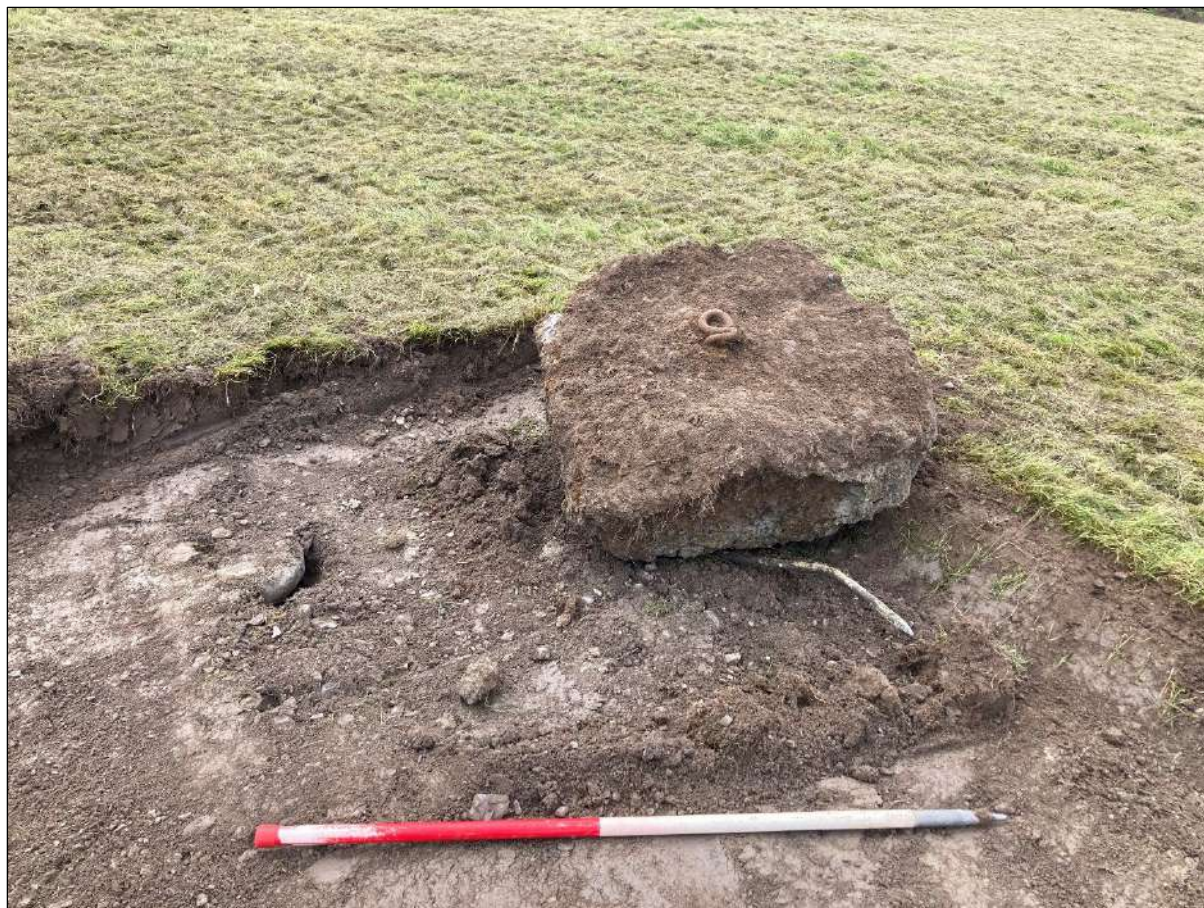
- 5.5.4. The only other sub-surface features noted were two field drains, one of modern orange plastic piping and the other of French style. The remains of a square concrete block, 0.5m by 0.5m and 0.35m in thickness, inset with an iron hoop was also discovered within the area during the top strip.

Plate 29. Concrete block. Area D.

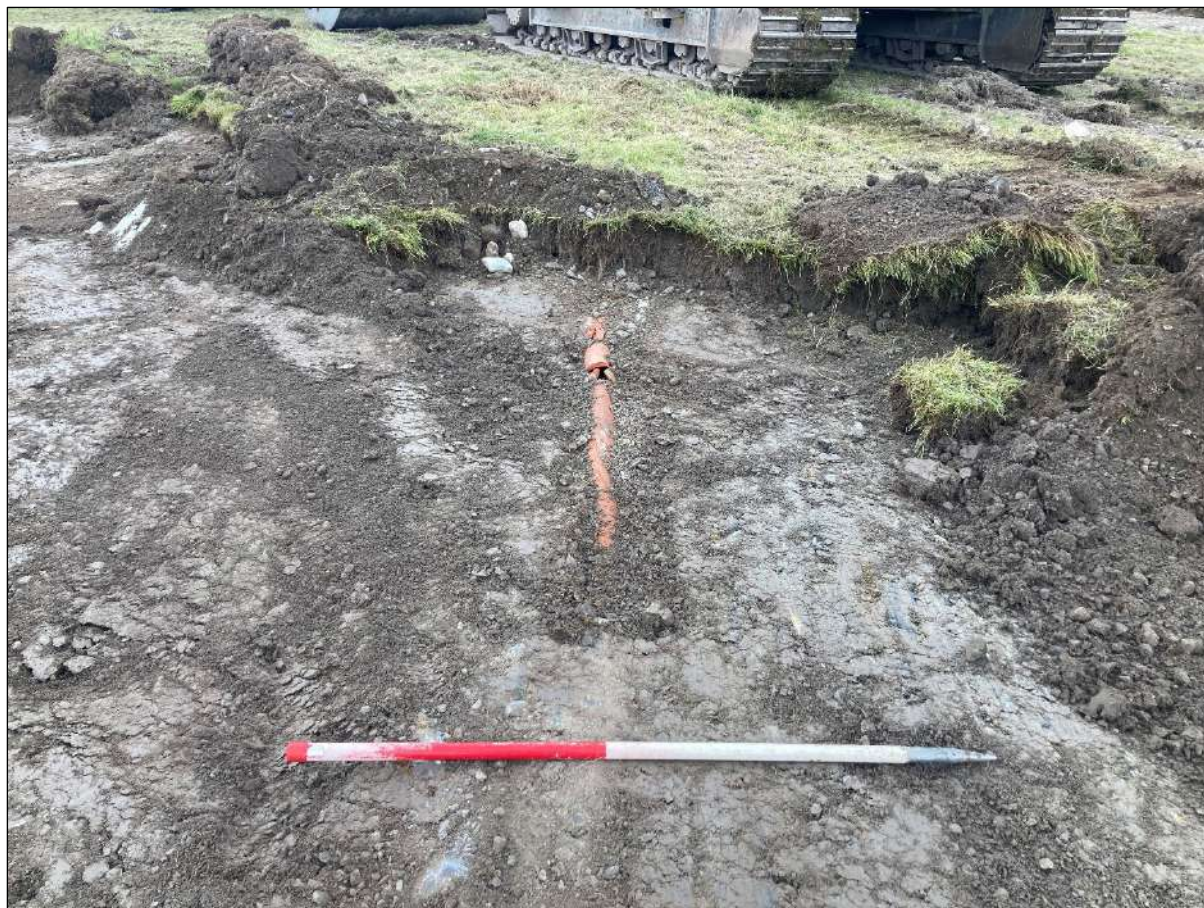
Plate 30. Remains of modern field drain, Area D.

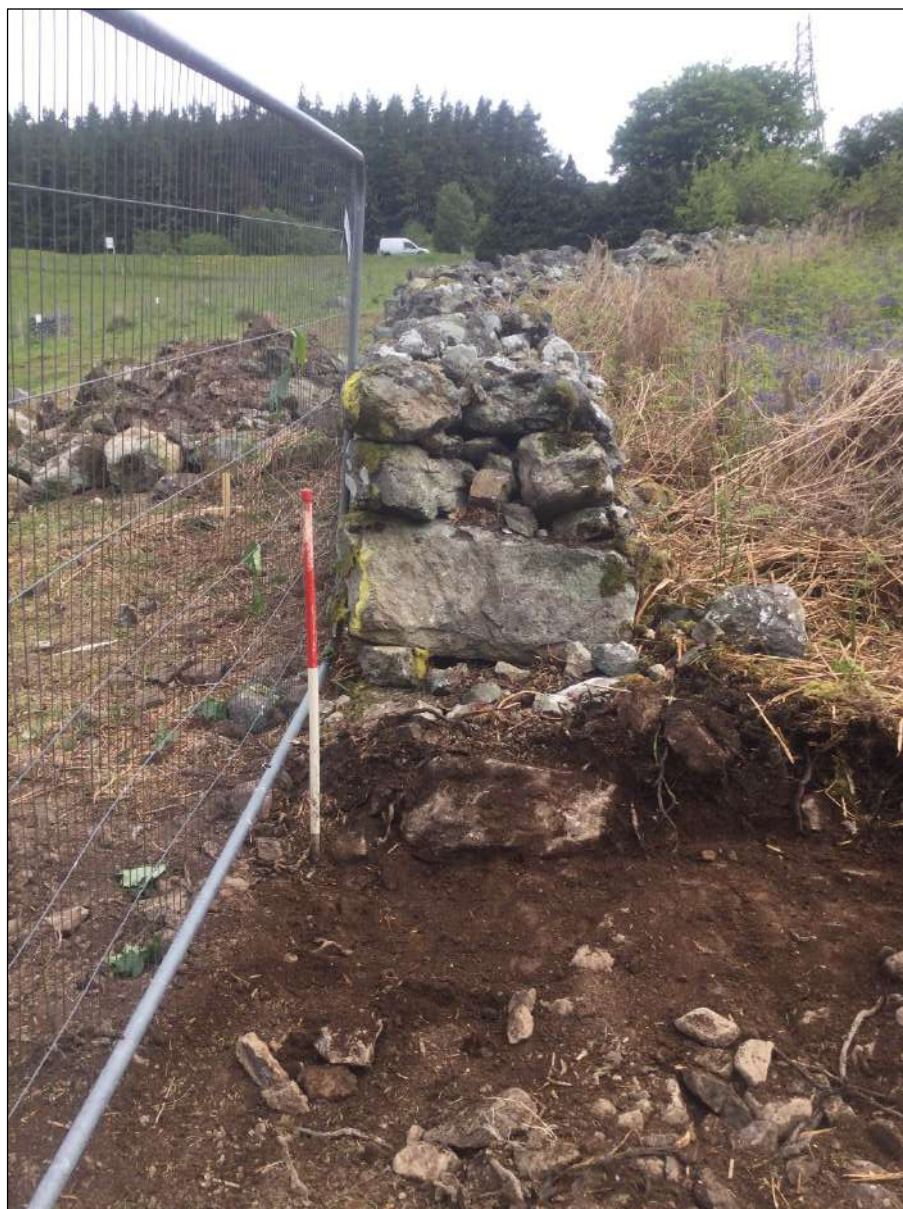
Plate 40. South-facing section of wall [600] showing traditional dry stone build.

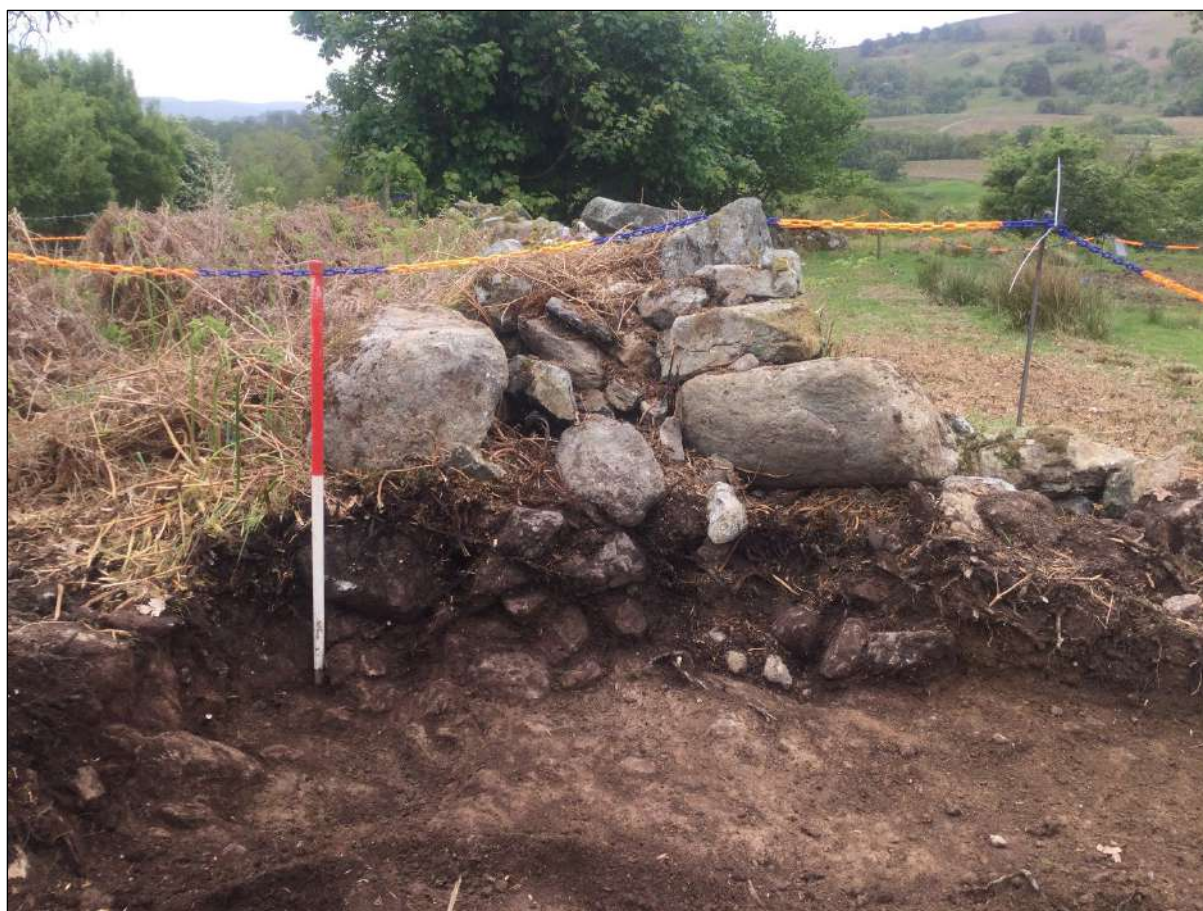
Plate 41. North-facing section of wall [600] showing clawdd construction.

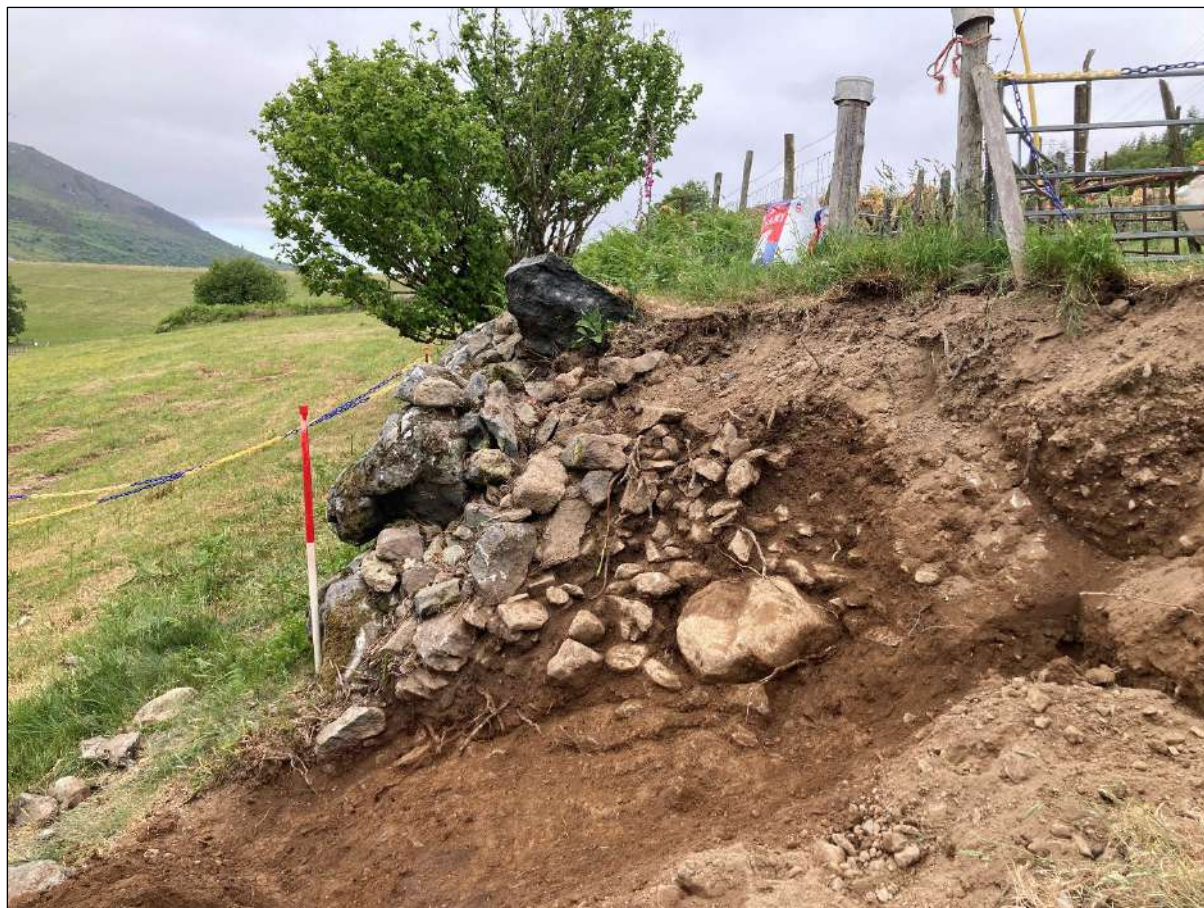
- 5.7.4. No finds or features of archaeological significance were found during the deconstruction of the wall.
- 5.7.5. The second section of drystone wall [700] was located at NGR SH 88263 40300 and ran along the ridge of a natural south-facing slope. Here the construction was more akin to a containing wall or reveting, with rocks arranged against an earth embankment and held together by their own weight. The structure was approximately 1.8m tall and 0.5m wide at its crown. In section the wall was seen to have three phases of construction. Phase one, (703) a dark brown silty clay backfill, with sub-angular stones 0.5-0.7m in size. At the base of the backfill was a large, rounded boulder, against this, and set at an angle of 45 degrees was (702) a band of flat and angular stones, approximately 1m tall by 0.25m wide. This stone deposit, being two stones wide, were all placed roughly parallel to ground and packed between with smaller stones. Against this was (701) a 0.2m wide strip of dark brown silty clay with frequent sub-angular stones 0.1-0.2m in size. Lying against this were [700] the main outer face of wall stones.

Plate 44. East-facing section of wall [700] showing construction technique.

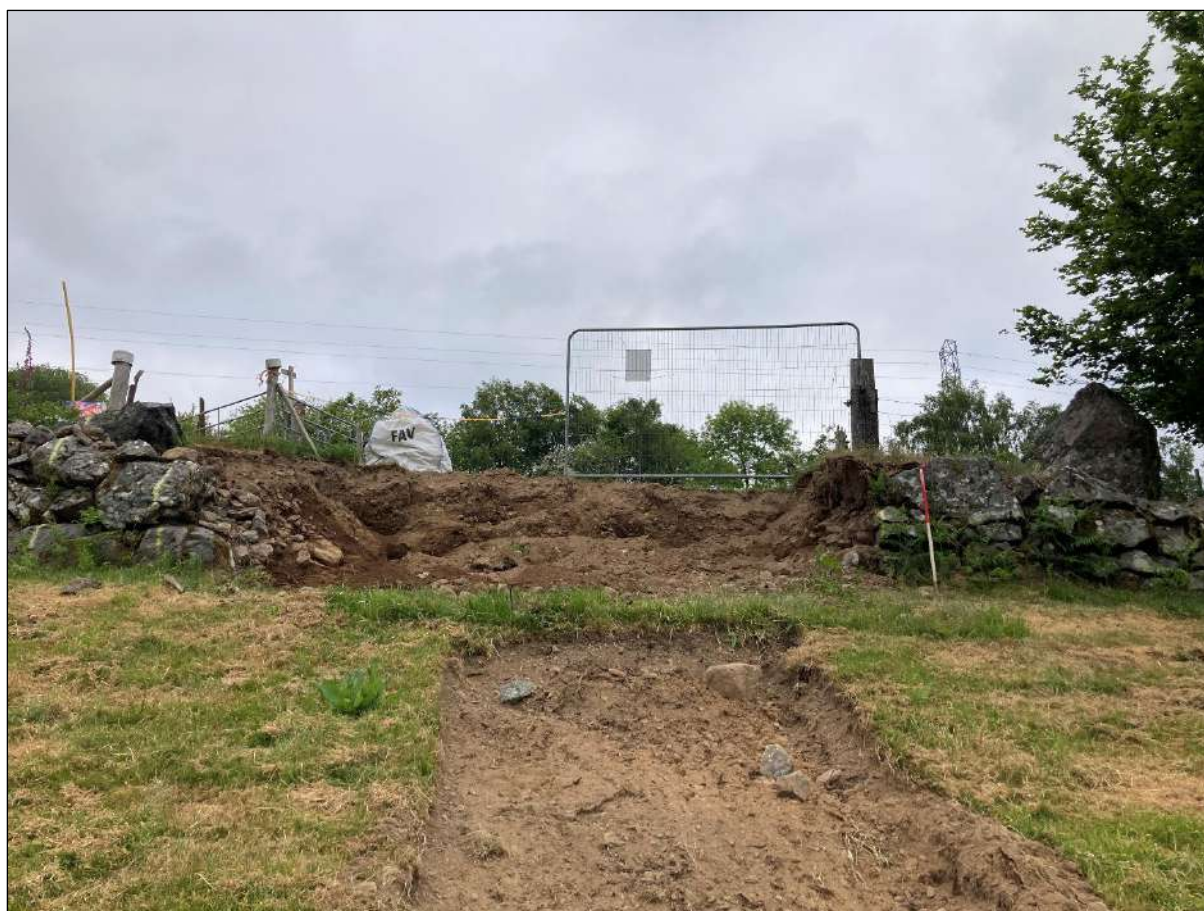
Plate 45. Section through drystone wall [700], looking north.

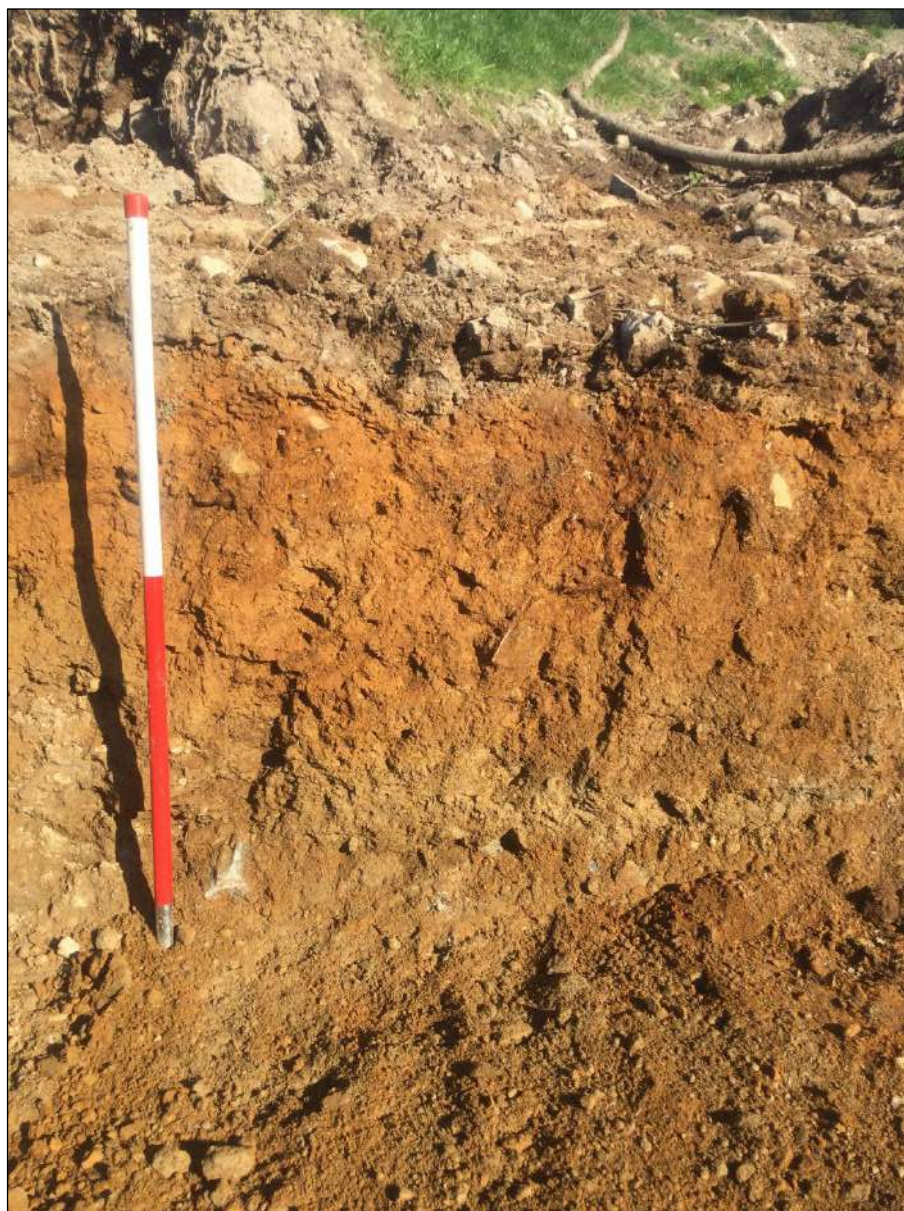
- 5.8.1. A trench was excavated to divert a High Voltage cable around the spillway construction. The trench for this was 217m in length and stepped, being 1.8m wide at the mouth and 0.8m at the base. It extended from the edge of Area E in the north-east, running south-west till it met the roadway between areas D and E.
- 5.8.2. The basal deposit (802) noted varied in thickness from approximately 0.2m and was composed of a mid-greyish brown sandy clay with moderate pebble

Plate 49. Representative section through the HV trench.

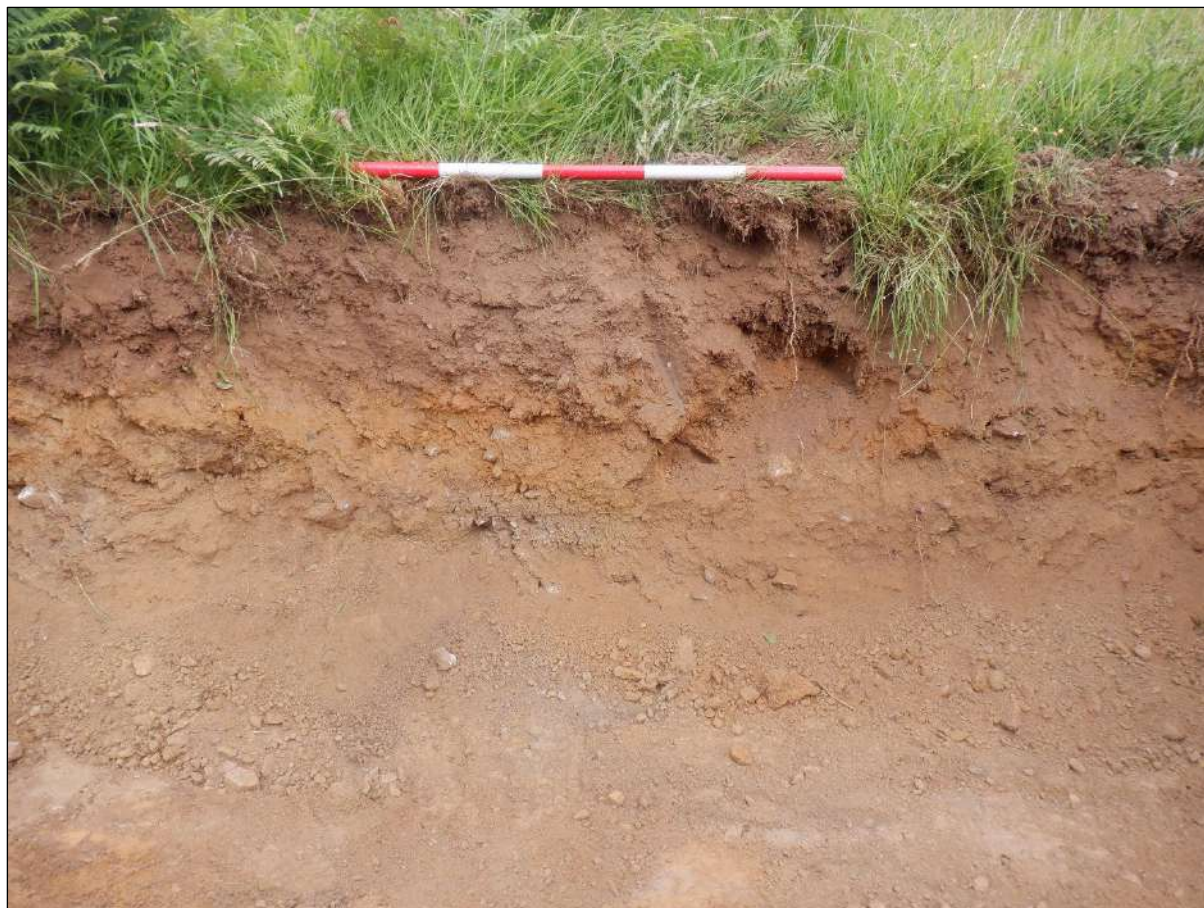
- 5.9.2. The lower deposit encountered (902) was a compacted pale yellow-brown silty clay with frequent medium to large angular and sub-angular stones throughout. This layer was interpreted as either natural or redeposited natural laid down during the construction of the dam. Overlying this was (901) a friable orange/brownish silty clay subsoil. This layer was 0.2m in thickness and was noted across the full extent of the exposed roadway. Capping all, was the topsoil (900) comprised of dark brownish silty humus.

Plate 53. Representative section through the roadway.

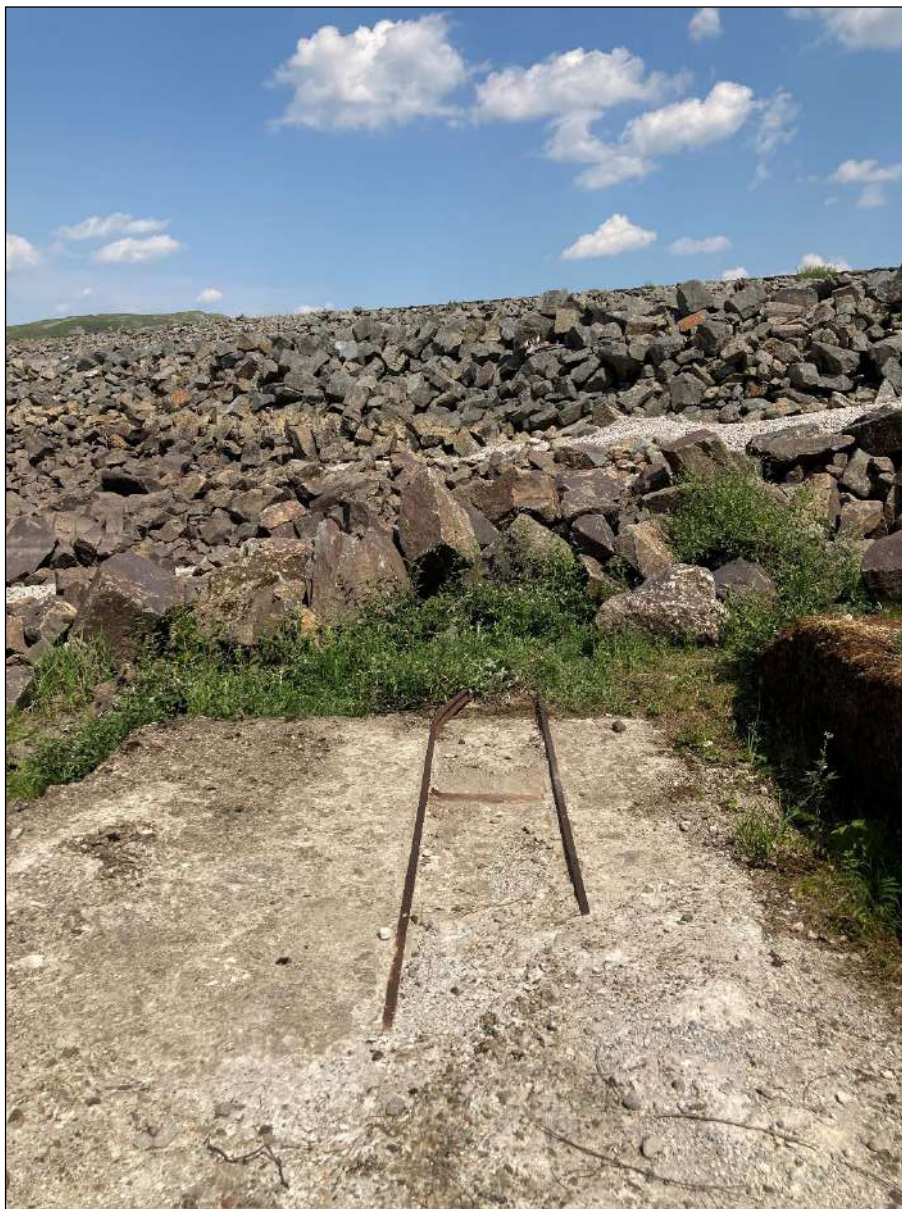
Plate 65. Remains of boggy track used to transport material during construction of the reservoir, exposed during the work.

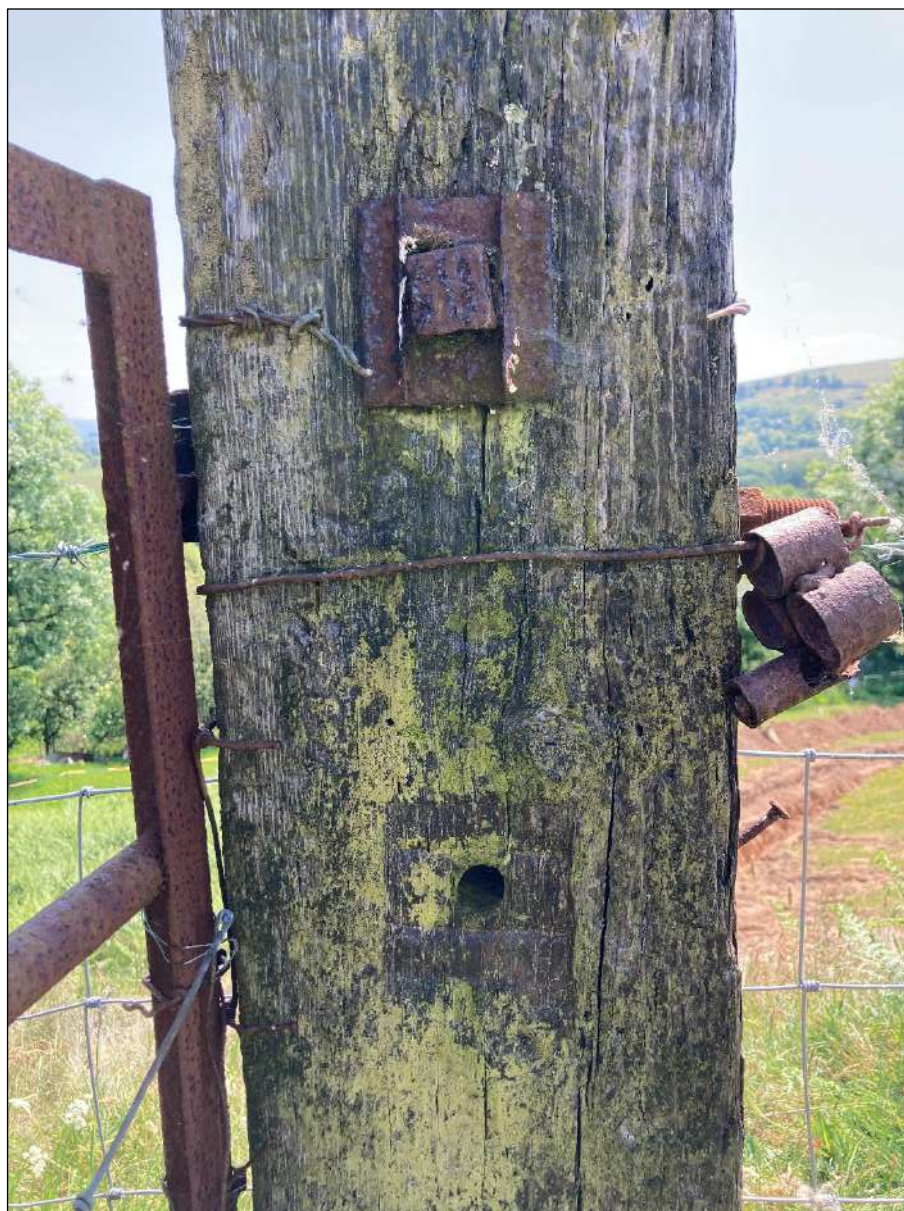
- 7.1.3. No physical evidence could be found of the Bala/Ffestiniog Railway that once ran through Area B. Though the reappropriated remains of railway sleepers and a rail (Plates 74 and 75) had been utilised as fence posts along a boundary to the east of Area C. Maybe these too, lay deeper that the works undertaken within this area.

Plate 74. Repurposed railway sleeper.
