Archaeological Monitoring and Recording: Llyn Celyn Reservoir, Gwynedd

Report No. 2252

Prepared for Dŵr Cymru Welsh Water

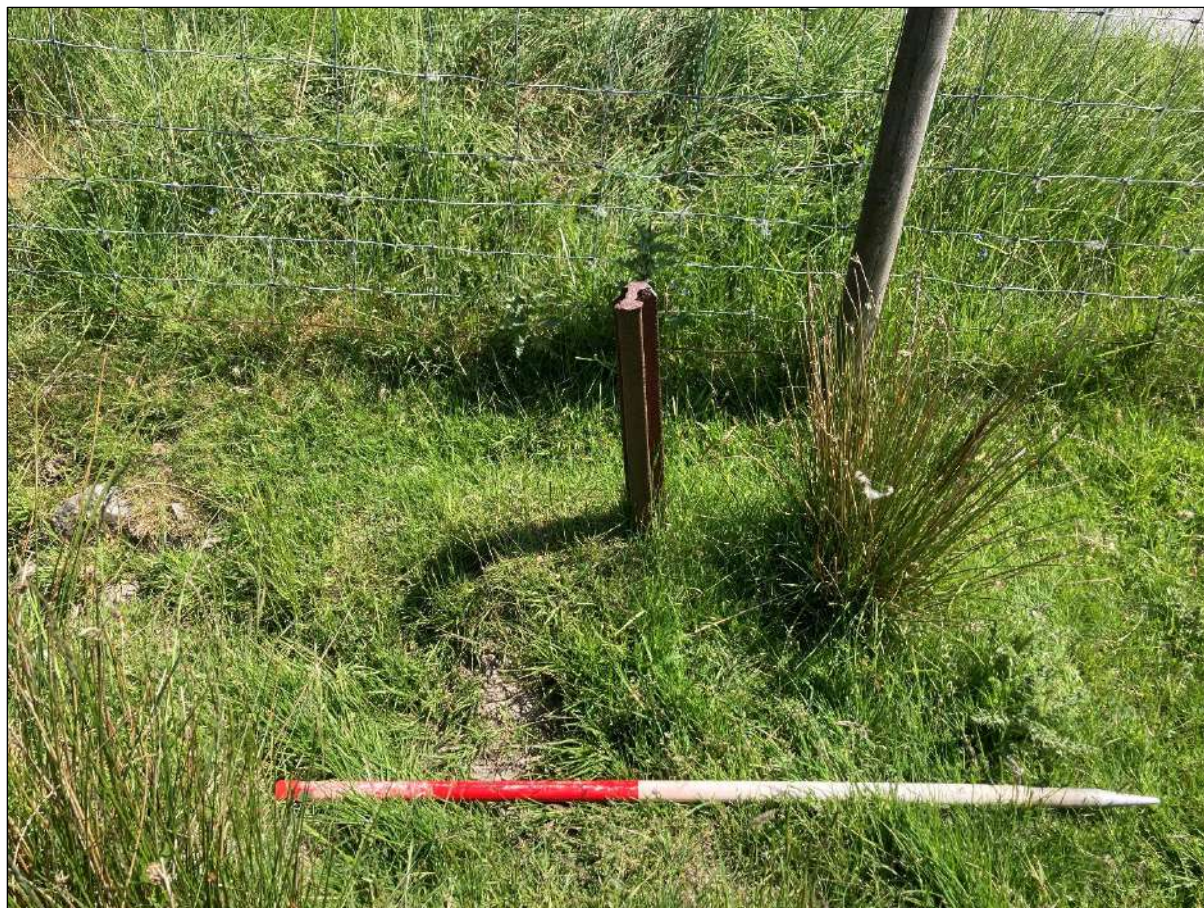
- 7.1.3. No physical evidence could be found of the Bala/Ffestiniog Railway that once ran through Area B. Though the reappropriated remains of railway sleepers and a rail (Plates 74 and 75) had been utilised as fence posts along a boundary to the east of Area C. Maybe these too, lay deeper that the works undertaken within this area.

Plate 75. Reused rail noted to the east of Area C.
