**Mount Pleasant Gas Main Replacement  
Conwy  
Conwy**

**Archaeological Watching Brief**

CA Project: 4535  
CA Report: 13715

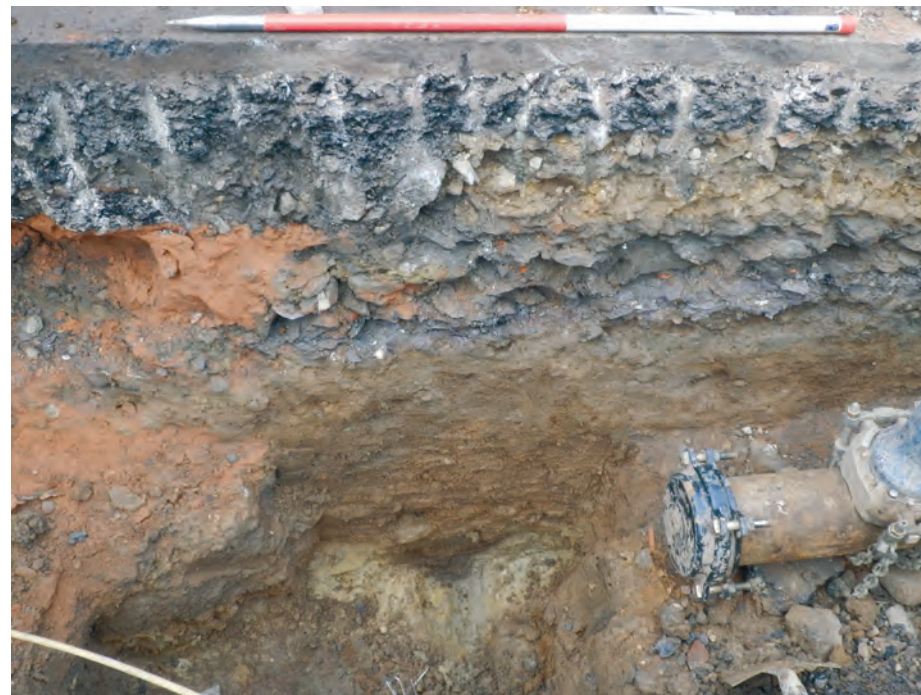
South-east facing section of Trench 1 (scale 1m)

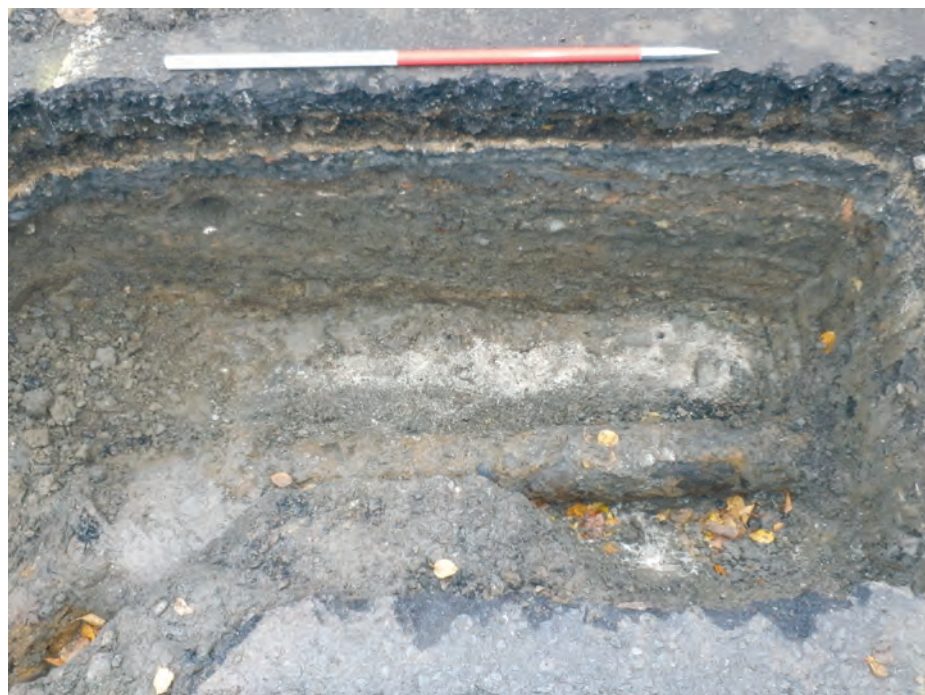
North-west facing section of Trench 3 (scale 1m)

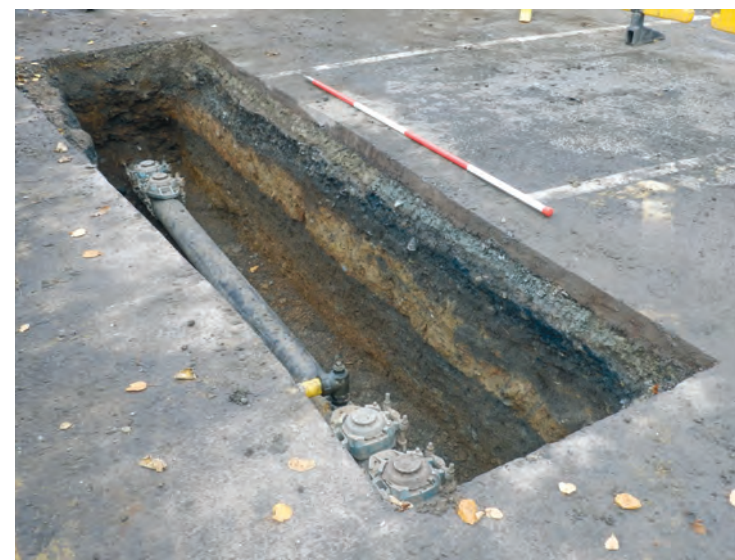
South-west facing section of Trench 4 (scale 2m)

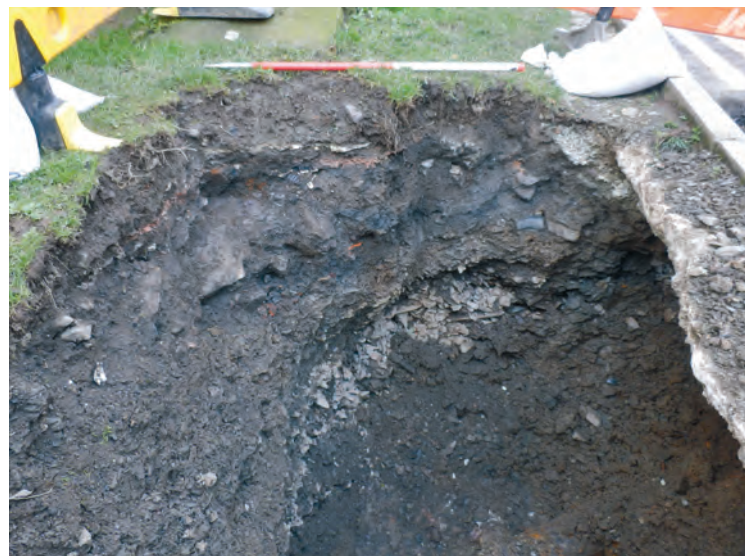
North-east facing section (FF) within Trench 8, north of watch tower (scale 1m)

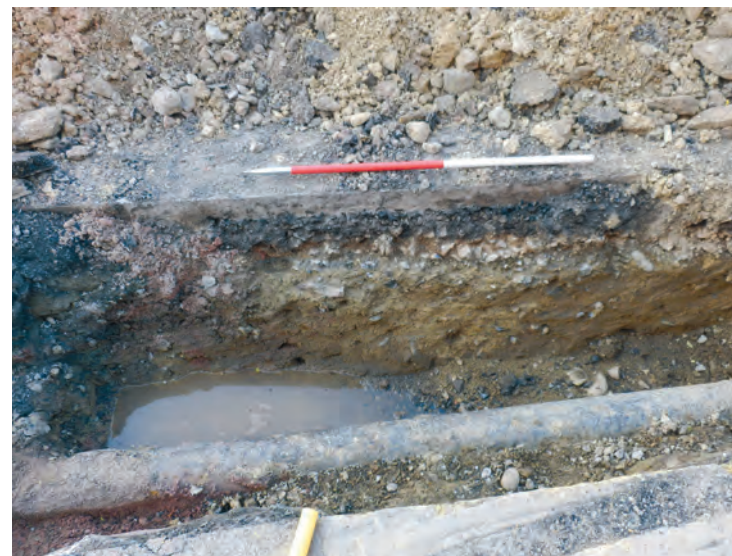
North facing section (HH) of Trench 9 within Sychant Pass Road (scale 1m)
