# Results of Archaeological Works at Harlech Castle – The Gatehouse Passage

**Project Number CR121-2018**

<b>Planning Application Number:</b>	N/A
<b>Scheduled Monument Number:</b>	ME044
<b>National Grid Reference:</b>	SH 58115 31245
<b>Client:</b>	Grosvenor Construction
<b>Report Authors:</b>	C. Rees & M. Jones
<b>Report Number:</b>	CR121-2018
<b>Date:</b>	10-10-2018

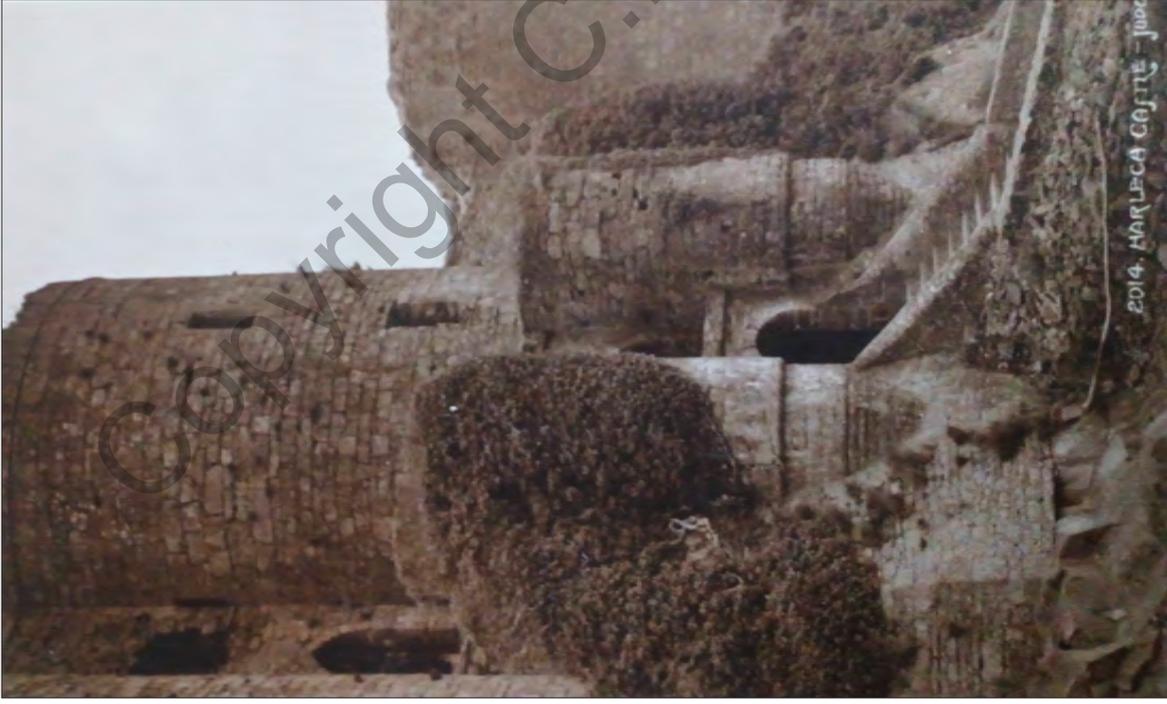
**Figure 3.** Early Twentieth Century Postcard Showing The Gatehouse Following the 1869 Remodelling (Source: C.R Archaeology Collection)

**5.1.7** Images of the remodelled entranceway into the castle is shown as figures 3 – 4.

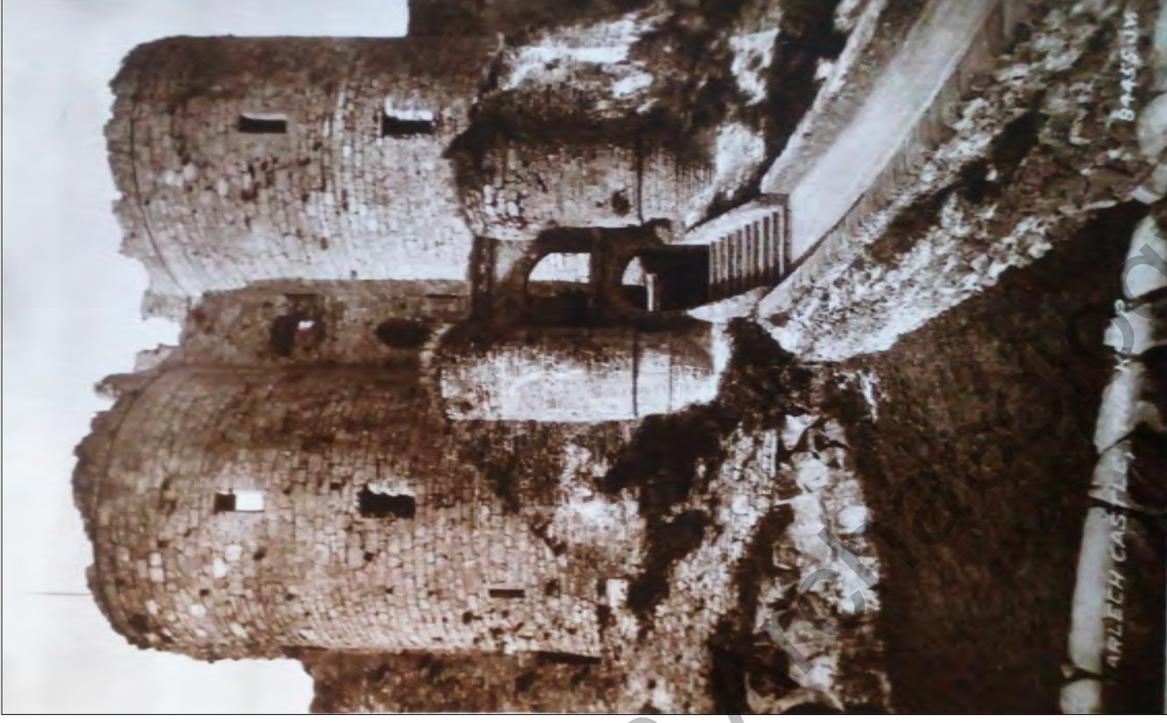
**Figure 4.** Early Twentieth Century Postcard Showing The Gatehouse Following the 1869 Remodelling (Source: C.R Archaeology Collection)

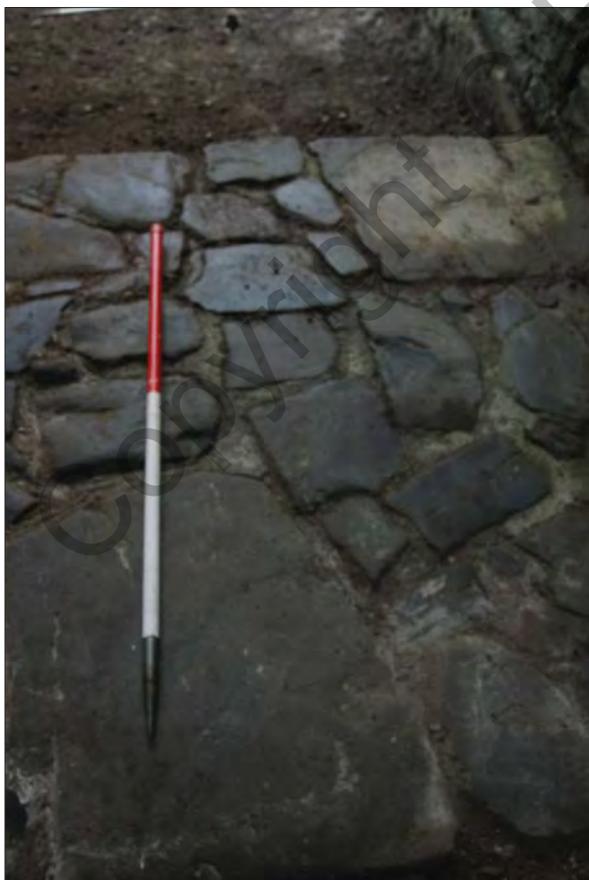
**Plate 3.** Internal Step into Inner Ward Showing Steps to be Removed

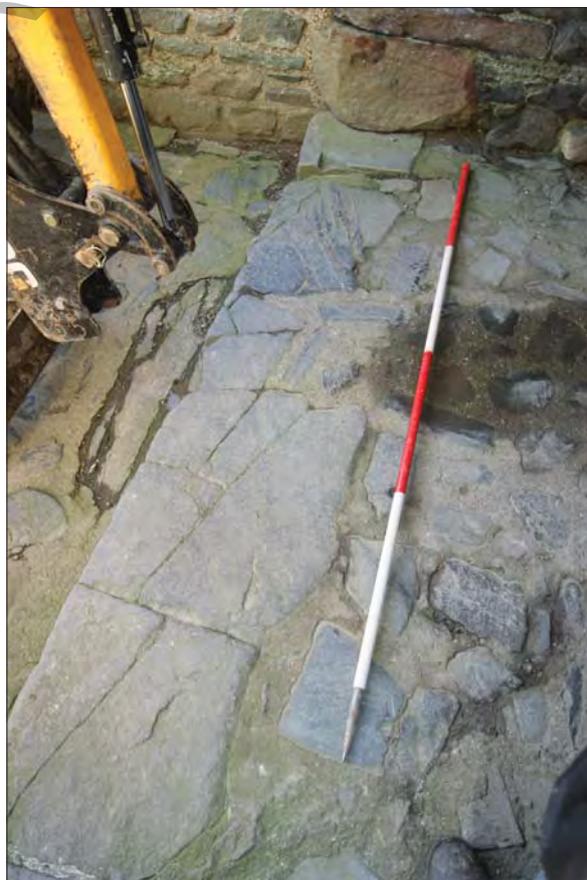
**Plate 4.** Step into Gatehouse - Pre-excavation

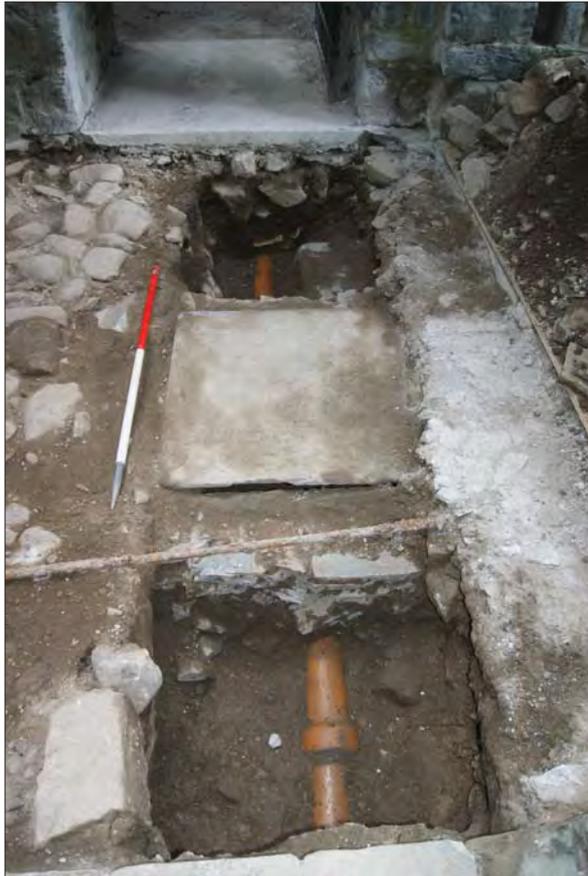
**Plate 5.** South Facing View of Cross Trench Showing Earlier Services

**6.1.4** Centrally to the disturbed cross-trench area was a large concrete chamber (context 10 - see plates 5 – 7) with a cut slate cover. Two ceramic pipes (context 11) were recorded at the base of the trench either side of this feature running under the two opposing doorways (see plates 9 And 10). A third pipe ran from the concrete chamber runs along the passage way and was recorded discharging at the trench limit (plate 25). That pipe appears to have been “pushed under” the cobbled surfaces although it is possible that they may have been re-laid in the mid-twentieth century.

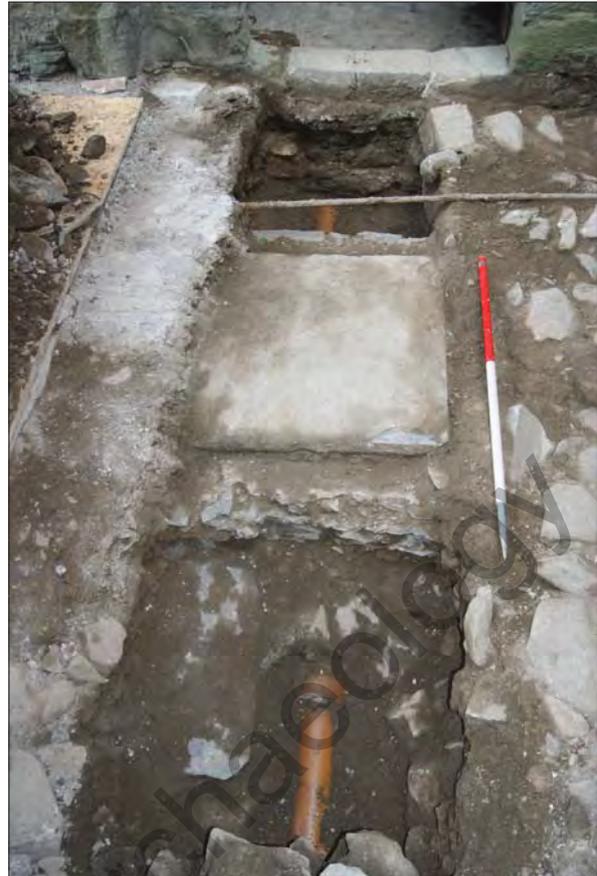
**Plate 6.** North Facing View of Cross Trench Showing Earlier Services

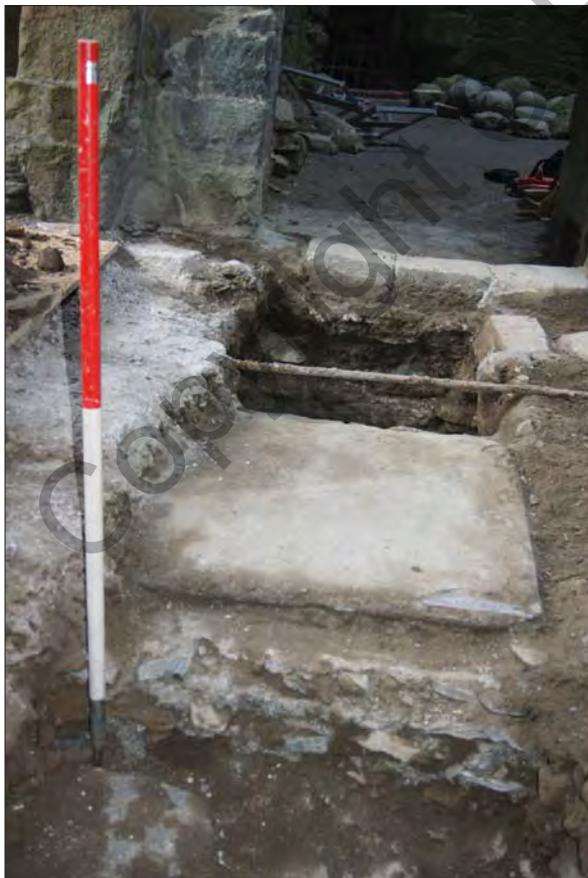
**Plate 7.** Slate and Concrete Drain Cover  
Slate Cist Slab Visible Bottom Left

**6.1.5** Built into the southern side of the concrete chamber (10), and using the same slate as capping, was small stone-built chamber (context 21). The slate cover (context 22) had a 0.03m layer of concrete as part of its matrix and was bonded with the construction of the concrete chamber (see plates 8 – 10).

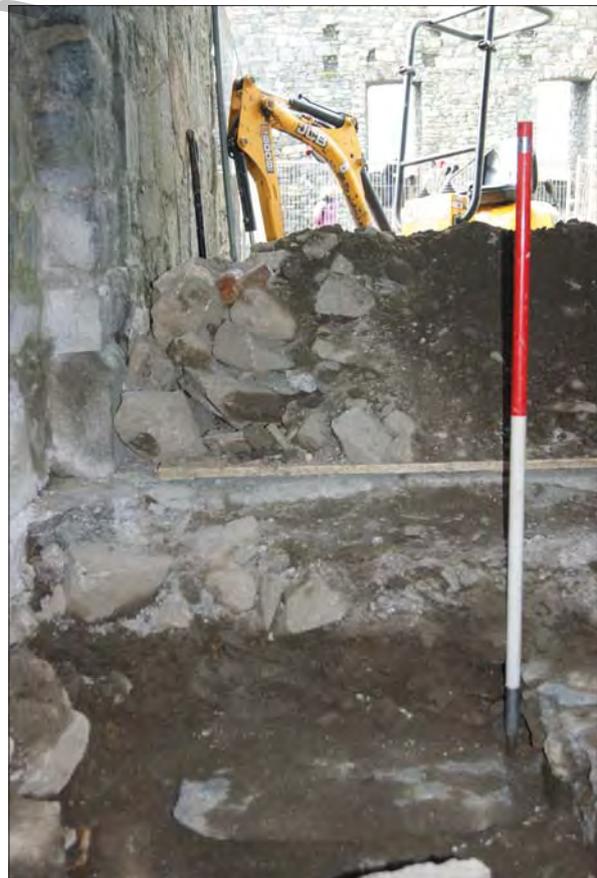
**Plate 8.** Slate Cist Capping

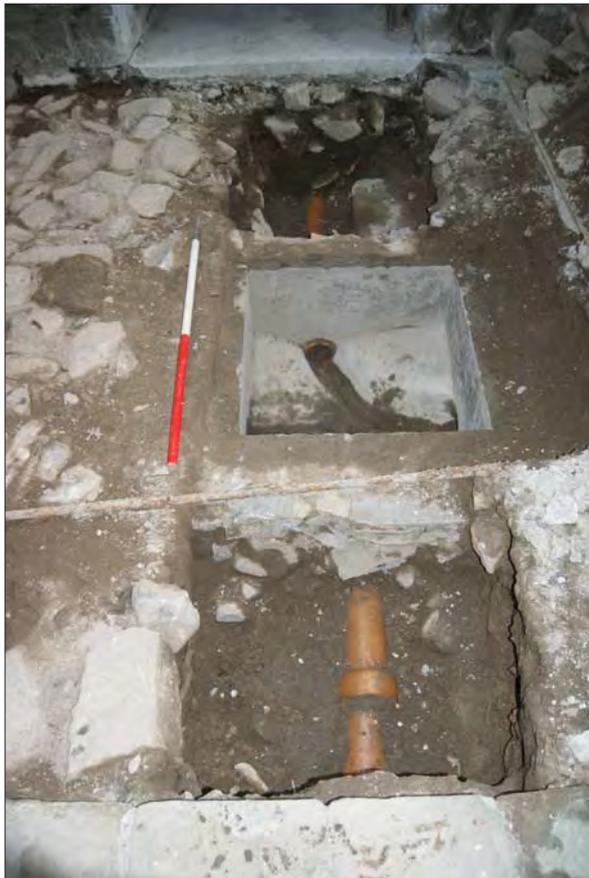
**Plate 9.** Cross-passage Trench Showing Modern Drainage and Disturbance (Facing South)

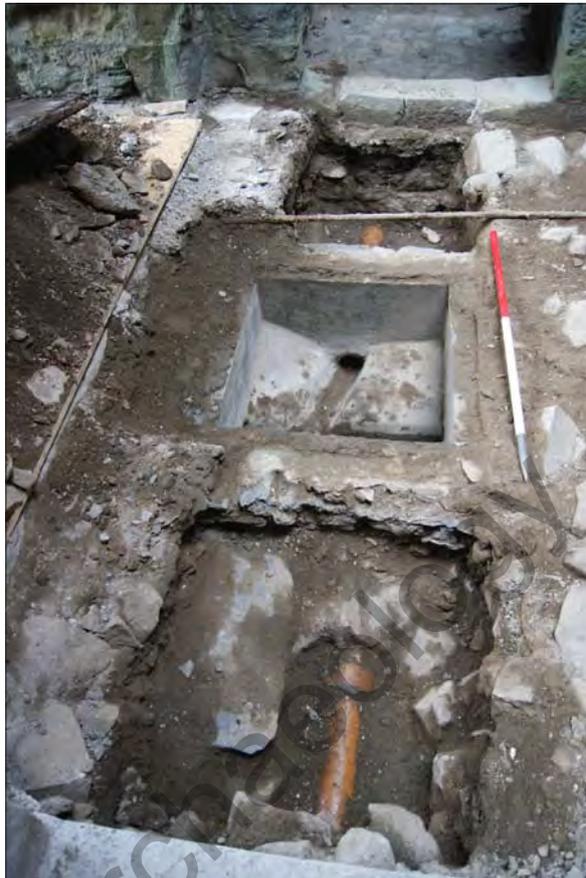
**Plate 10.** Cross-passage Trench Showing Modern Drainage and Disturbance (Facing North). Note Slate Cap Stone to Left in Foreground

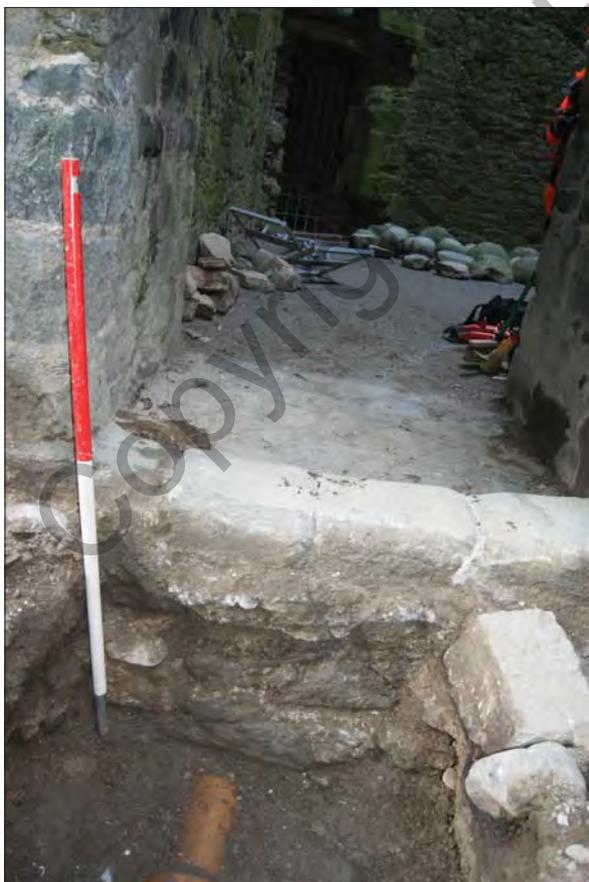
**Plate 11.** South Facing Section Showing Dressed Stone Step

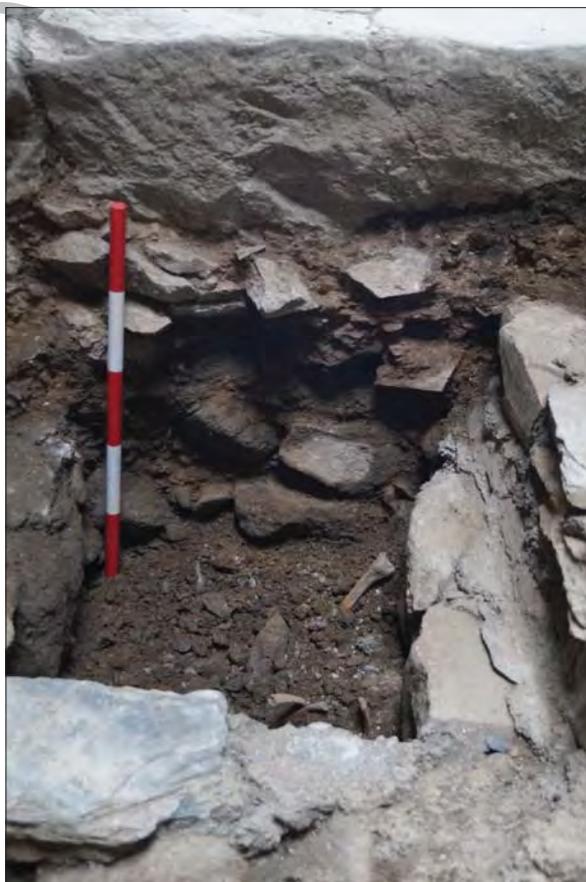
**Plate 12.** Human Remains Exposed Following The Lifting of Slate Capping Shown in P10

**6.1.7** The chamber contained a single loose clay and gravel fill (context 19) which contained disarticulated human remains along with fragments of concrete and slate (see plates 12 – 15). Two iron nails were also recovered from this fill.

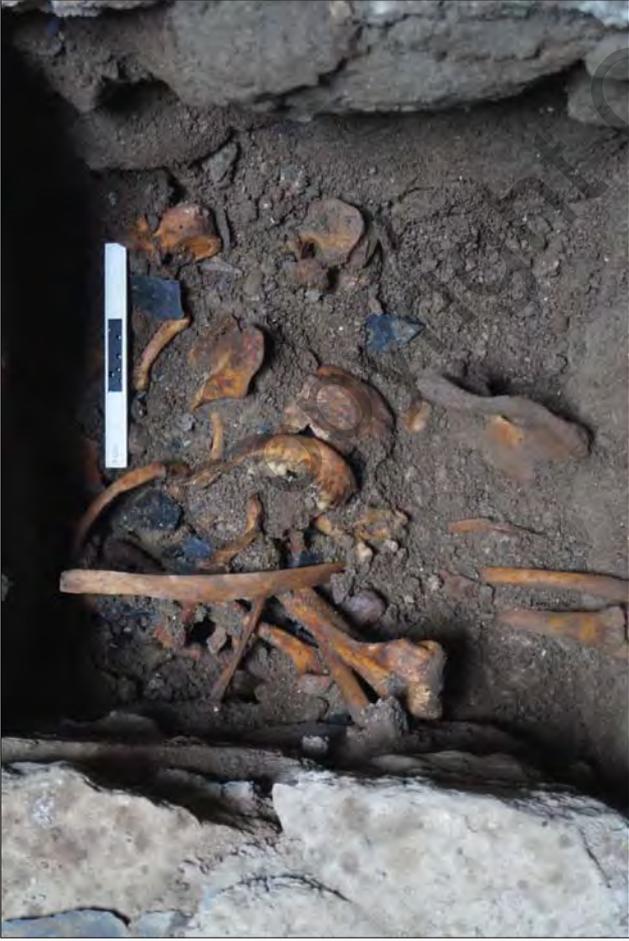
**Plate 13.** Disarticulated Human Remains Exposed Within Rough Stone Chamber Beneath Slate Capping in Cross Passage Trench

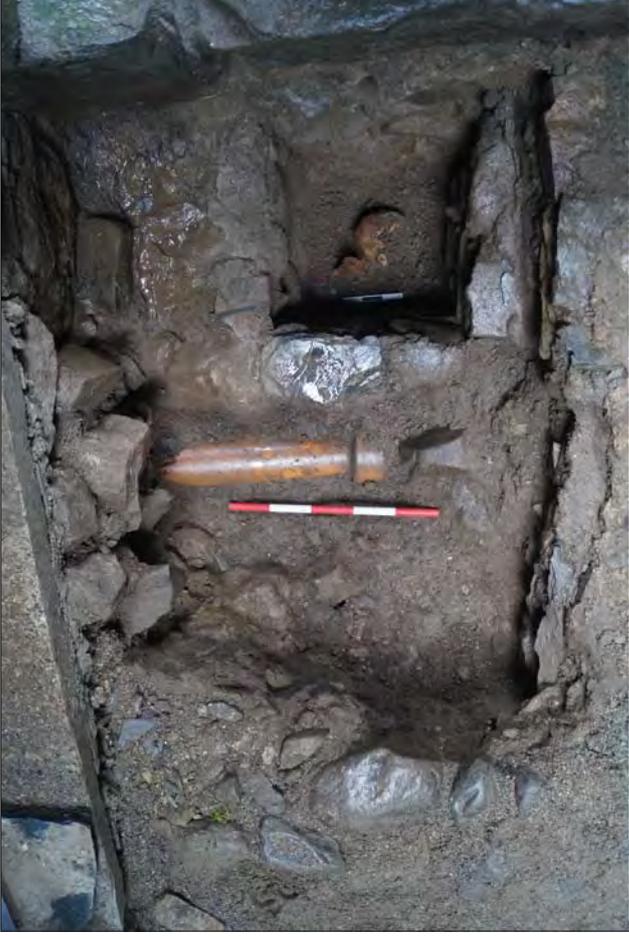
**Plate 14.** Stone Chamber Within Wider Setting Showing Level of Modern Disturbance in Cross Trench

**6.1.6** Following the removal of the slate cover (context 22), a small stone-built chamber (context 21) which measured 0.48m by 0.39m. The chamber was 0.54m in depth and was constructed using predominantly rounded beach stone. There was no base to the structure.

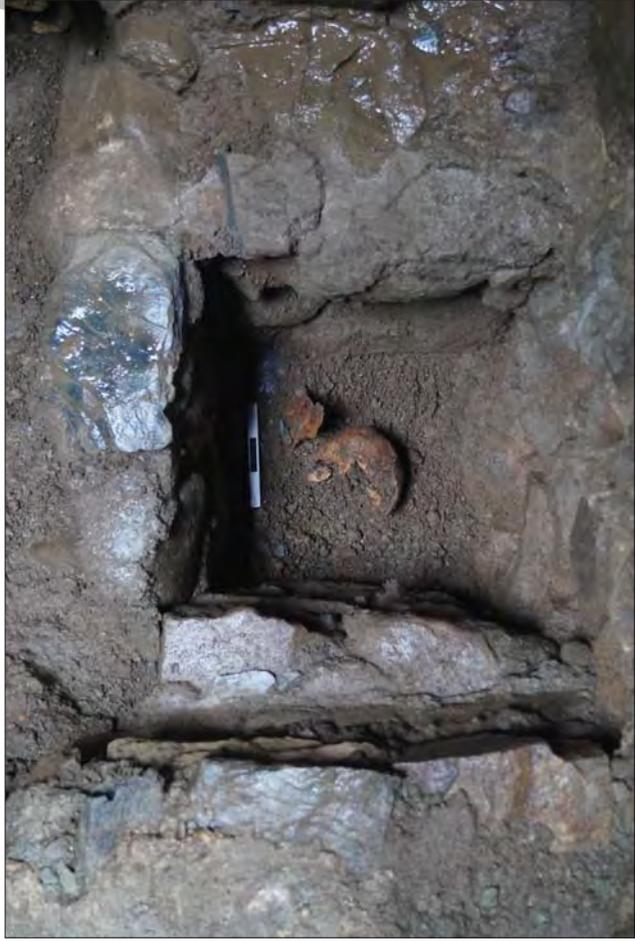
**Plate 15.** Disarticulated Human Remains at Base of Stone Chamber

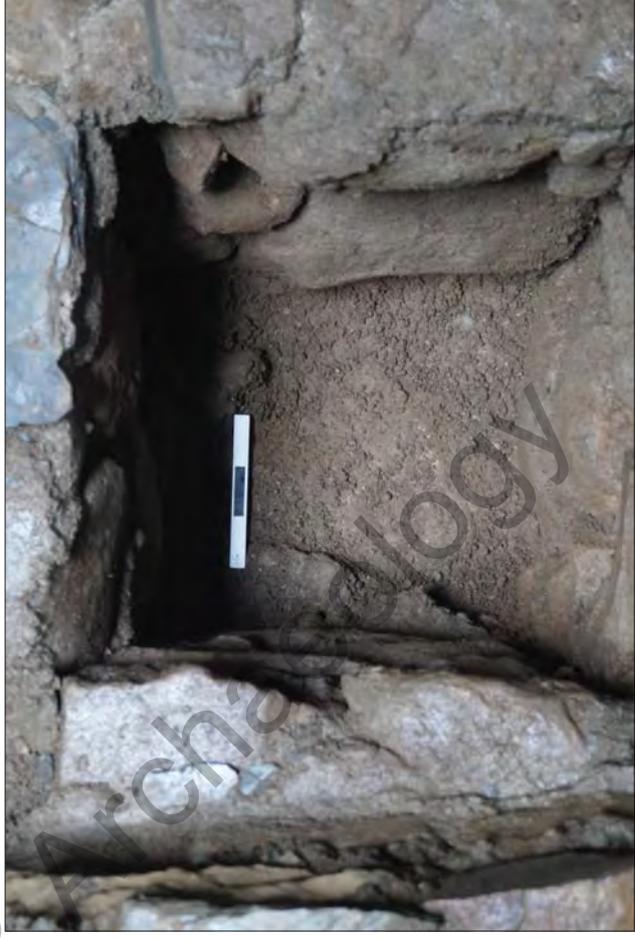
**Plate 16.** Post-Excavation Plan View of Stone Chamber

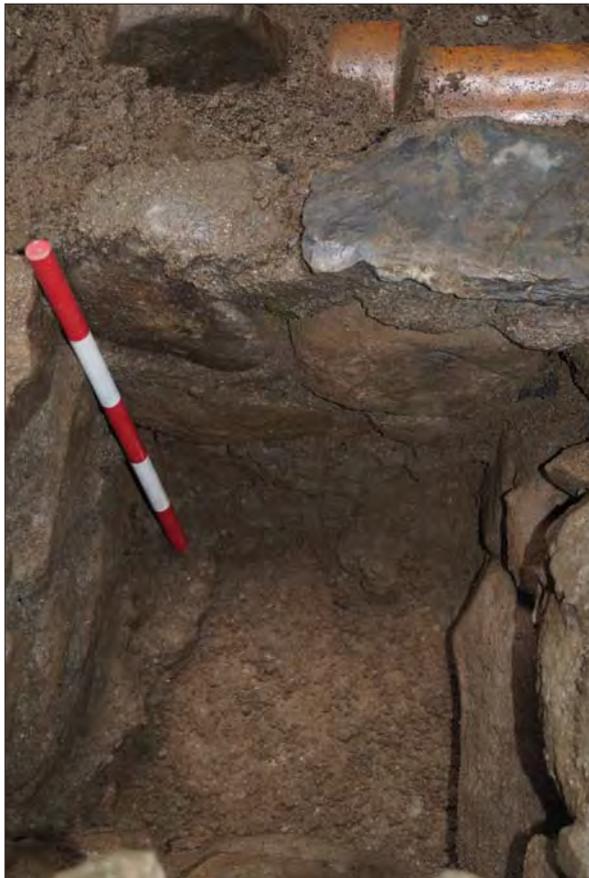
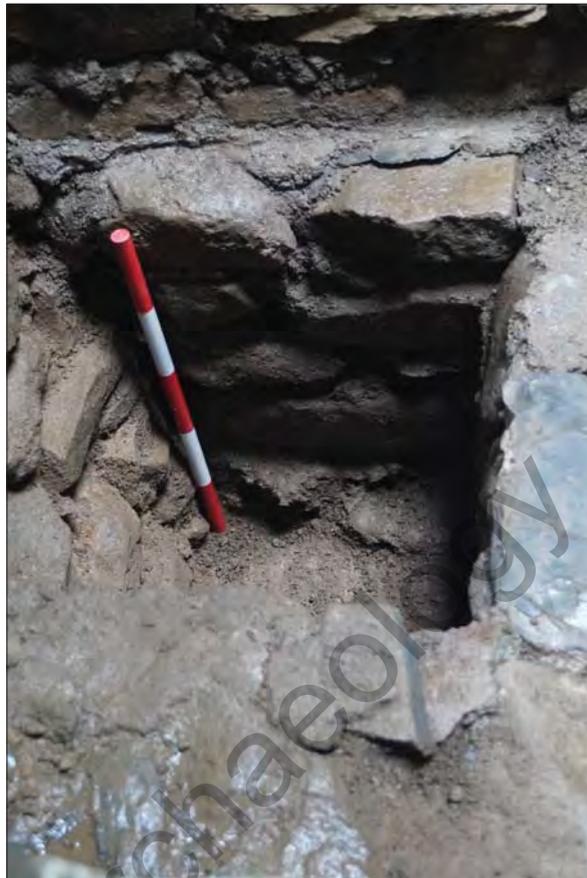
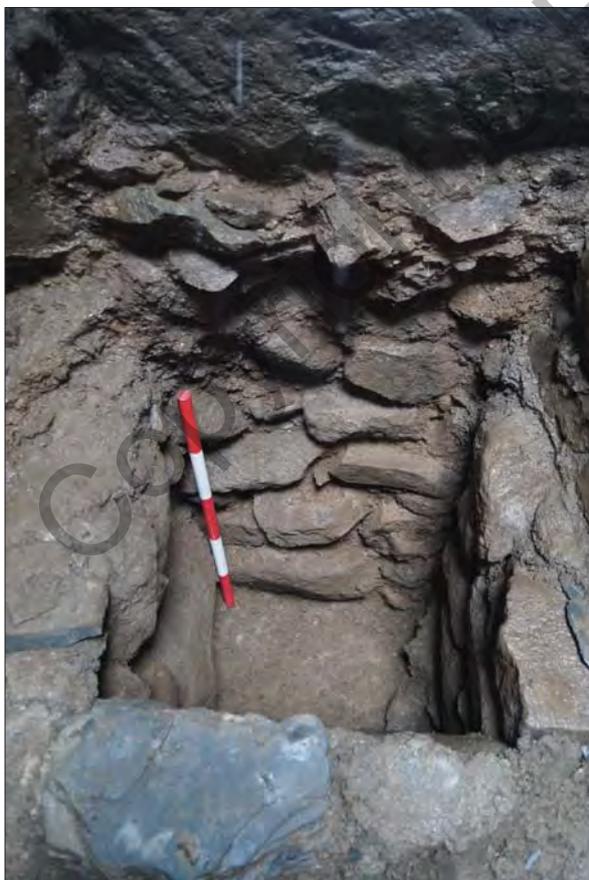
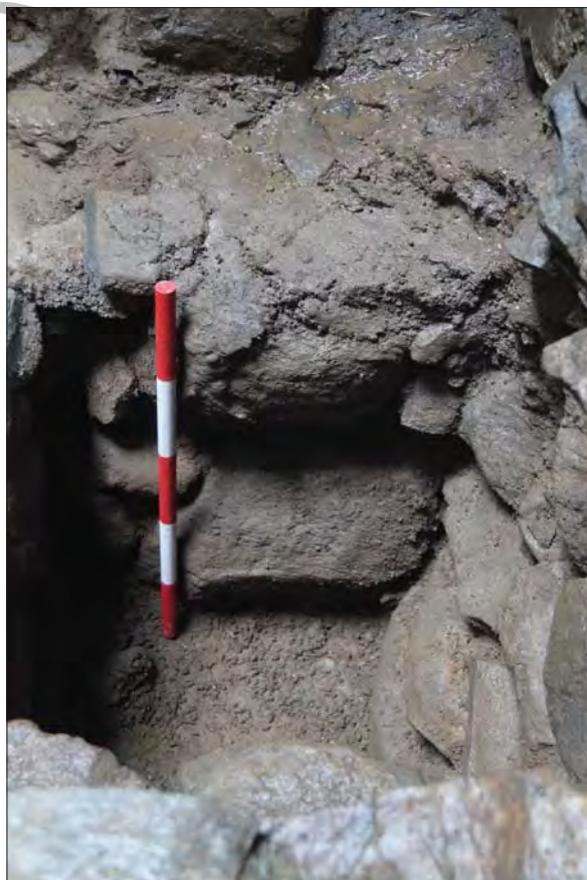
**Plate 17.** West Facing Elevation of Stone Chamber. Note Cement in Pointing

**Plate 18.** South Facing Elevation of Stone Chamber. Note Cement in Pointing

**Plate 19.** East Facing Elevation of Stone Chamber. Note Cement in Pointing

**Plate 20.** North Facing Elevation of Stone Chamber. Note Cement in Pointing

Fragments of slate had been placed between the larger stones, and in places the stones appear to have been bonded using the same concrete as was used in the pipe chamber.

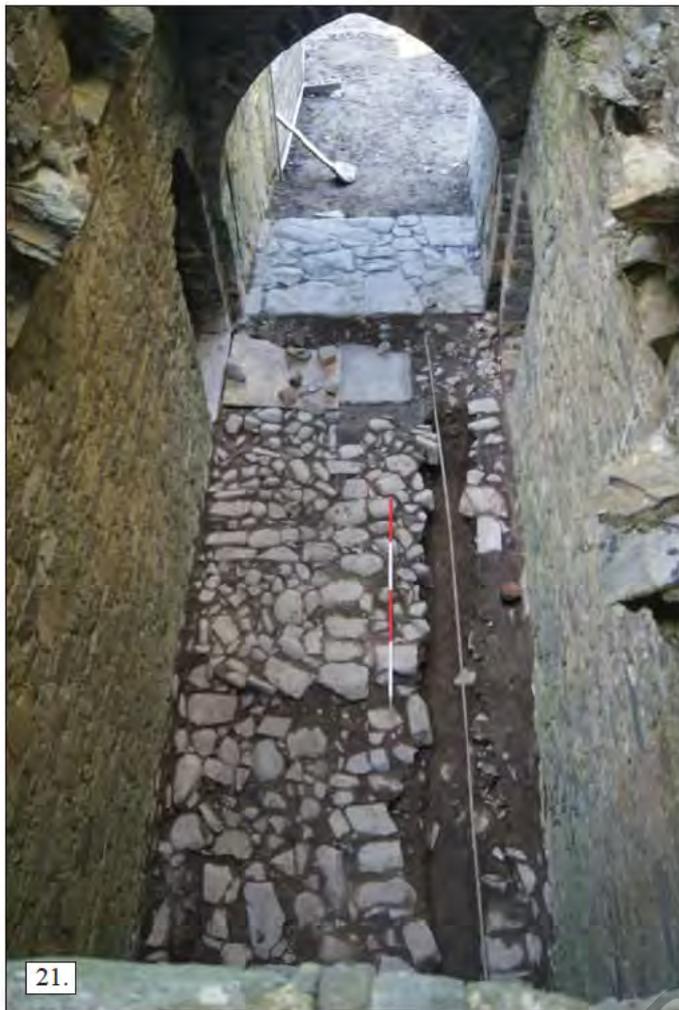
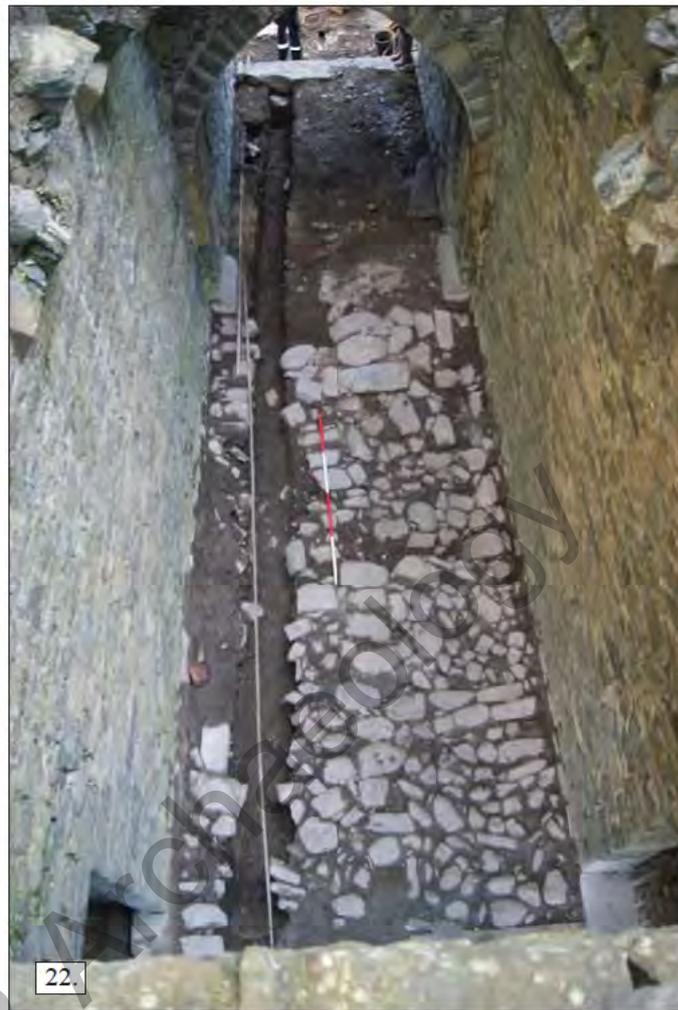
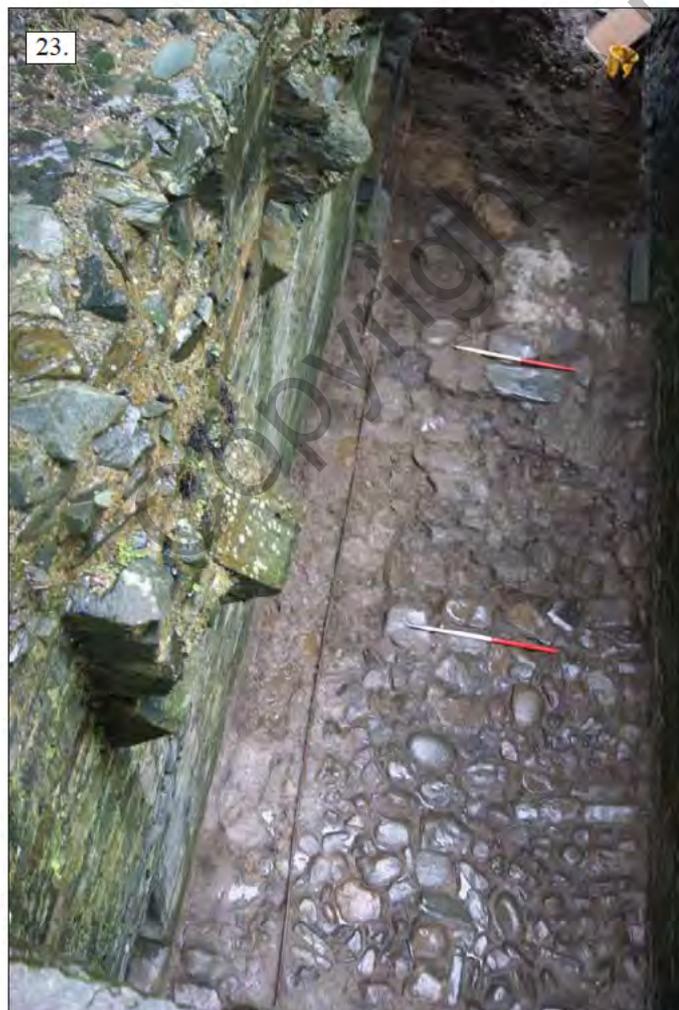
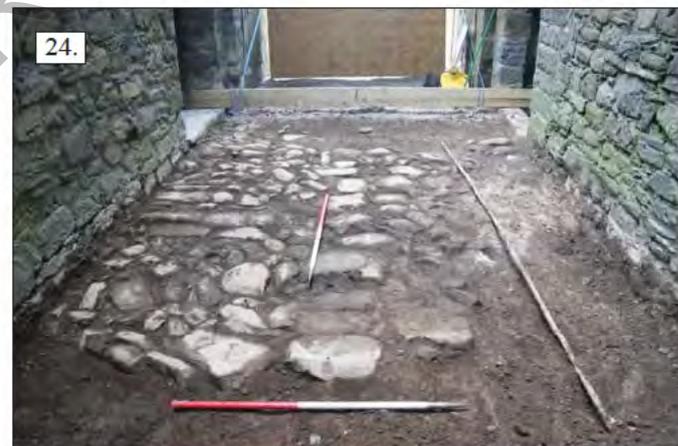
**Plates 21 - 24. Cobbled Surfaces (03) & (06)**  
**Plate 25. Remains of Ceramic Waste Water Pipe**

**6.2.4** Below context 01 was an irregular cobbled surface (context 03). The surface measured a maximum of 2.80m in length and survived to a maximum width of 2.20m. The surface did not reach the internal entrance way to the west as it was truncated by the modern services identified in the cross-trench described above. Incorporated within the cobbles were two large stone shots – one was recovered and is described in section 7 and the other left insitu. Very small fragments of Buckley Ware were found whilst cleaning between the stones. Although these were undiagnostic and could be intrusive, they would be consistent with a later nineteenth century date for the surface.

**6.2.5** A second smaller cobbled surface (context 06) measured a maximum of 2.40m in length and 1.80m in width. The stones used in this cobbled area were also irregular and contained three very large stones. Very small fragments of Buckley Ware were found whilst cleaning between the stones. Although these were undiagnostic and could be intrusive, they would be consistent with a later nineteenth century date for the surface.

**6.5.2** It would seem likely that the cobbled surfaces exposed (contexts 03 & 06) were laid as part of the late 1860's work around the gatehouse, with later disturbances associated with the use of the area as a tourist venue during the mid-twentieth century when visitor toilets were installed. It must however be noted that there does remain the possibility that this surface is mid-twentieth century as there is a waste water pipe running from the cross-trench to the eastern limits of the excavation area. It was not clear whether this had been "pushed under" along the passageway or whether the cobbles had been relaid.

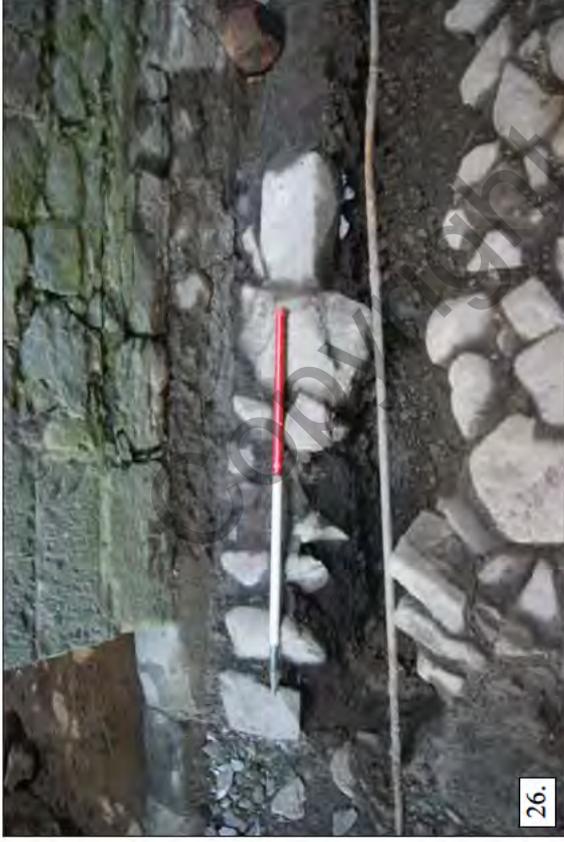
26.

**Plate 26.** Sample of Section Exposed by Service Trench

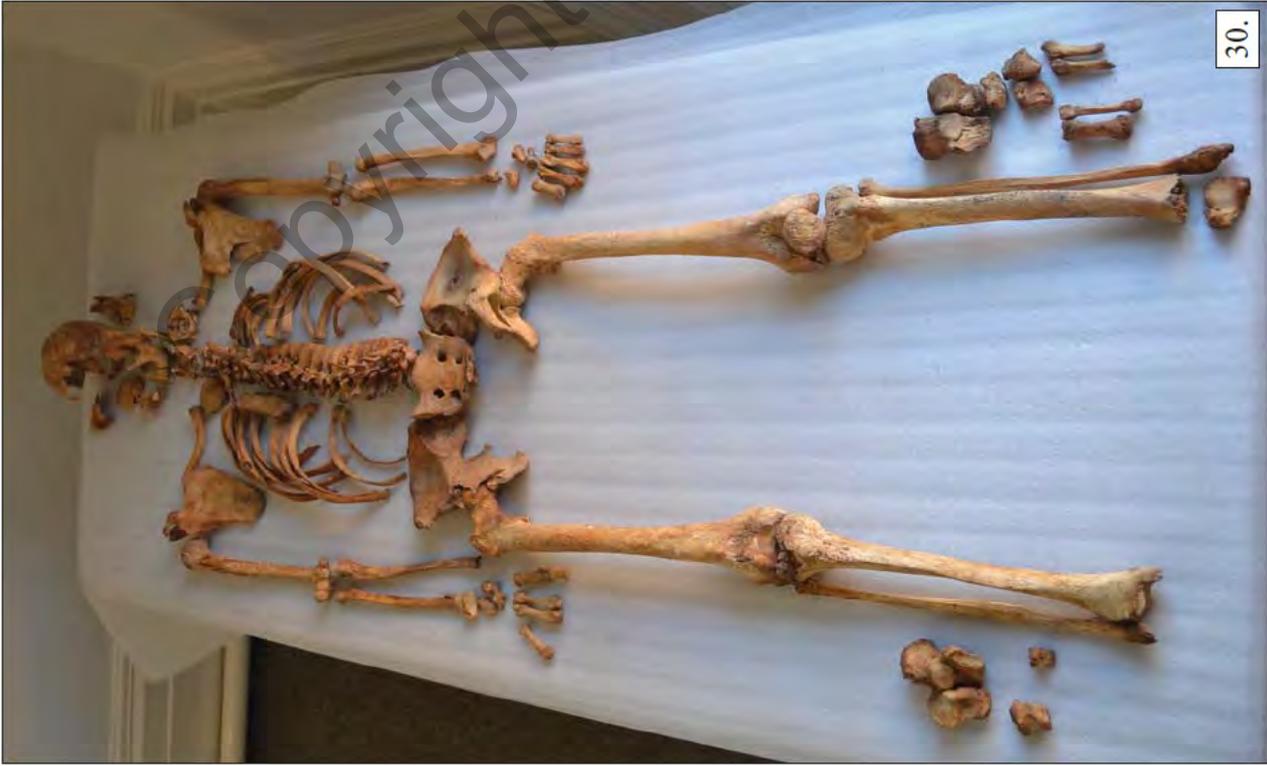
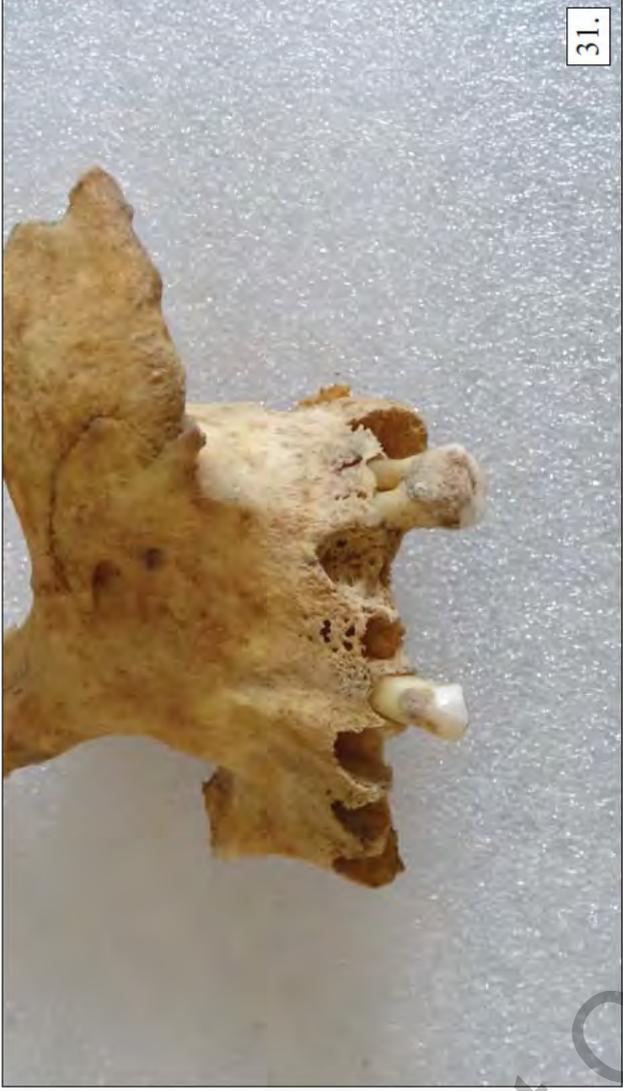
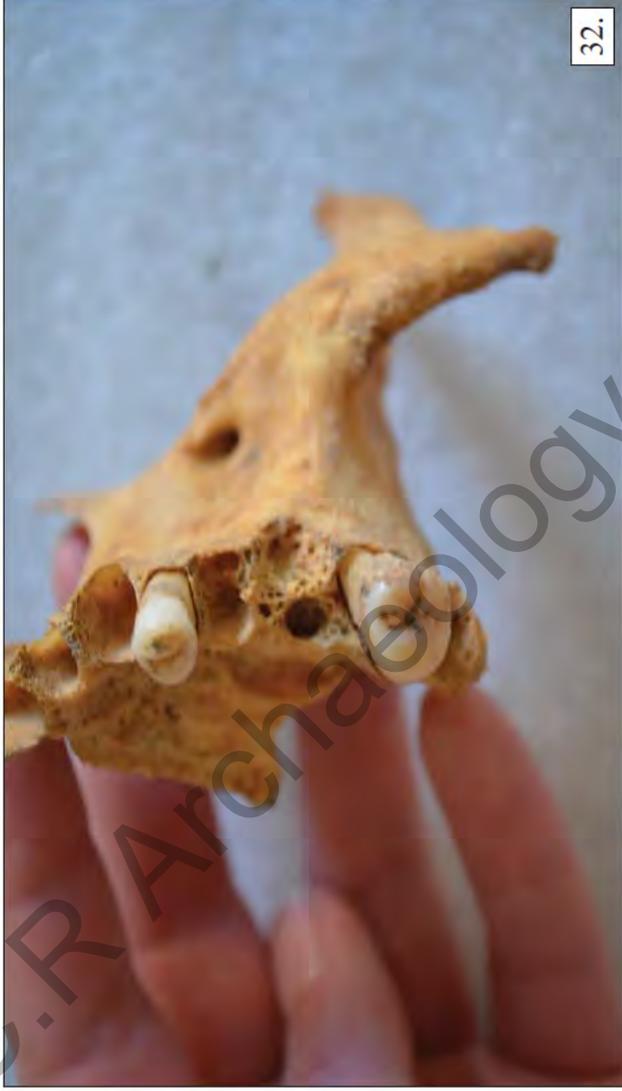
**7.1.5.1** The only pathology observed was in the dentition; supra-gingival calculus scored 2, using the criteria of Dobney and Brothwell (1987). There is evidence that the M1<sup>L</sup> had been

**Plate 30.** Harlech Skeleton as Laid out by S. Vincent  
**Plates 31 & 32.** Details of Dental Wear  
Photograph Credit S. Vincent

lost prior to death, the tooth itself is missing and the area around the socket has begun to heal. This indicates the tooth had been lost some time before death occurred.

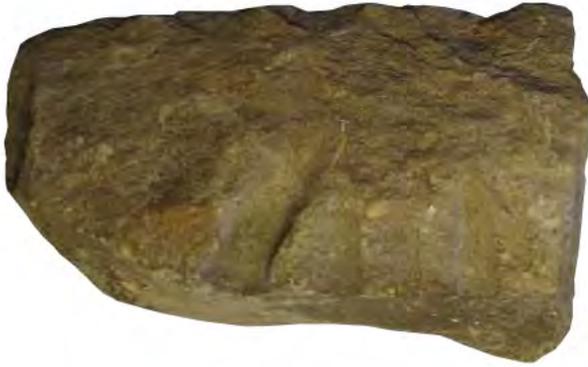
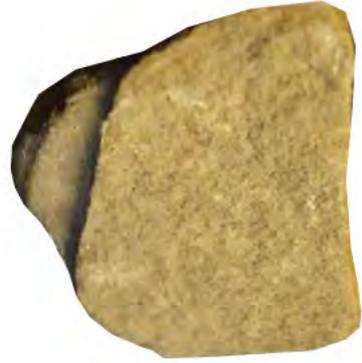
**7.2.1.3.1** Stone fragment SF3 is also local sandstone, approximately triangular in plan, and is wedge-shaped when viewed from the side. One face appears carved and weathered and can be treated as the “outward” face of the stone. Dimensions (with this worn face upwards) are 0.13m long, 0.12m high, and 0.065m thick at the thickest point of the wedge. The worn face has a groove separating it into a flat rectangular band and another raised area that appears to be curved. The narrow end, where the curved area tapers into the groove, has lime mortar on it. The edge adjacent to the flat band is also weathered and is the thick end of the wedge profile. The other edge (opposite the mortared edge) has been broken and forms a sharp reverse angle towards the rear face, which is smooth and clearly dressed.

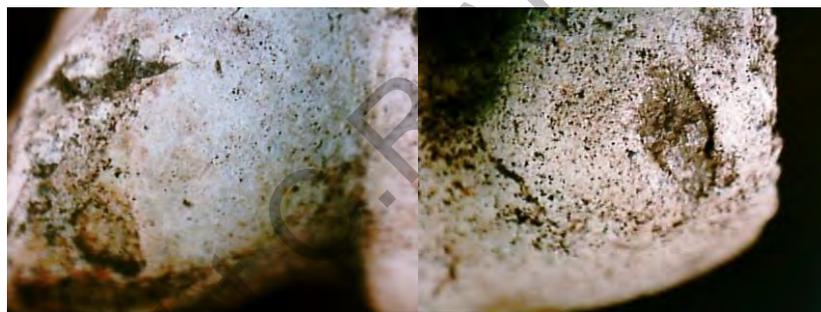
*Figure 2, cut mark and depression, distal articular surface*

*Figure 3, depression on distal articular surface*

**7.2.3.2** The inner ward (context 14) assemblage consisted of mostly Bovine phalanges which could have come from the same animal according to age at the time of death, and relative size and form. As low meat yield bones, these could have been the remains of primary butchery, as supported by the cut marks on one of the first phalanges. Both complete Ph1 also show slight depressions on the distal articular surface, which according to a recent study could represent rapid growth, (Thomas, R. & Johannsen, N. 2011), (Fig.2 & 3).

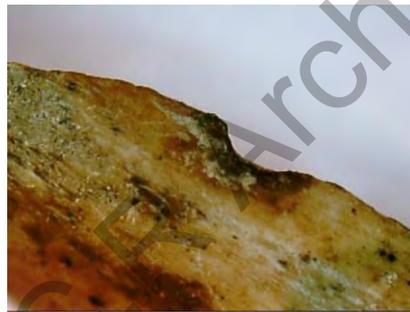
*Figure 5*, possible tooth puncture mark on an Ovine/Caprine tibia

**7.2.3.6** One other bone, an Ovine/Caprine tibia fragment also had evidence of a possible puncture mark, (*Fig. 5*).

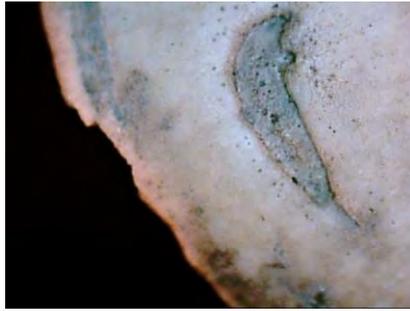
*Figure 6, depression on the distal articular surface of a Bovine Ph1*

**7.2.3.7** Many of the bones in this context showed evidence of gnawing, with one small ungulate rib fragment showing rodent teeth marks. One Ovine/Caprine rib body fragment had cut marks showing that it had taken more than one attempt to remove it from the carcass. Two fragments, both Bovine, from a rib body and mandible showed radial fractures coming from chop marks, meaning they must have been hit with considerable force. Two Bovine 1<sup>st</sup> phalanges and a 2<sup>nd</sup> phalanx showed small amounts of extra bone growth around the articulations, (which may be evidence for traction animals), and one of the 1<sup>st</sup> phalanges showed a healed depression on the distal articulation, (*Fig. 6*), which could be associated with rapid growth and limited diet, (*Thomas, R. & Johannsen, N. 2011*). However, with only one example of each pathology this cannot be proven, as it could be a peculiarity of this particular animal.

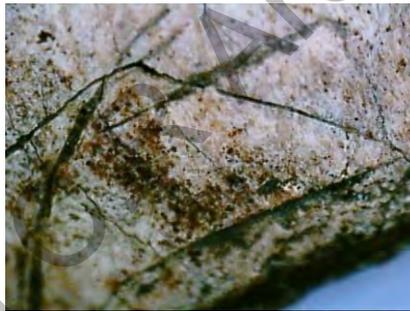
*Figure 7, cut marks and radial fractures to a Bovine mandible*

**7.2.3.9** The most heavily butchered elements in this context were all Bovine, with a section of mandible and a vertebral body warranting special mention. The mandible had chop marks severing both sides of the lower M3, with radial fractures emanating from the caudal cut, (*Fig. 7*), and some smaller cut marks on the buccal surface.
