**Results of Historic Building Recording at**  
**Prince of Wales Hotel & ATS Euromaster,**  
**Caernarfon**

**Report Number CR41-2013**

## **Results of Archaeological Building Recording at Prince of Wales Hotel & ATS Euromaster, Caernarfon**

<b>Planning Application Number:</b>	C12/1142/14/LL
<b>National Grid Reference:</b>	SH 247998 363000
<b>Client:</b>	Commercial Development Projects Ltd
<b>Report Author:</b>	Catherine Rees
<b>Report Number:</b>	CR41-2012
<b>Date:</b>	03/07/2013

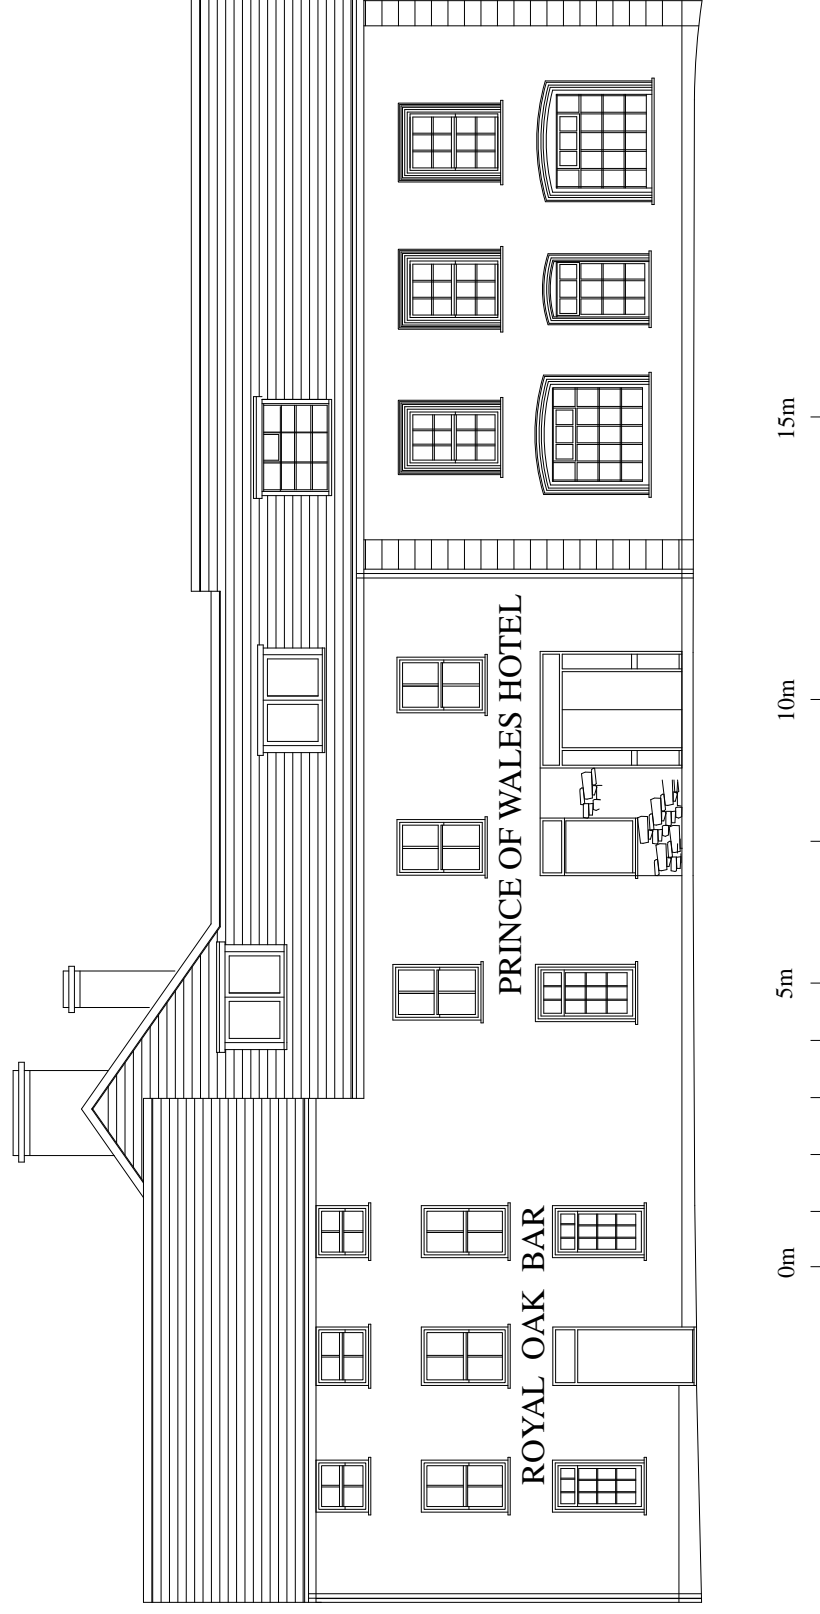
**Figure 16.** Prince of Wales, Caernarfon Existing Front Elevation. Produced by and © Pritchard Bond Architects, Bangor

As with the remainder of the building, the façade has been altered overtime. At ground floor level the central doorway has been converted into a window and the curved window details – although shown on a 1900's photograph are not believed to greatly pre-date this period. The windows themselves were examined from inside the building and are believed to be modern replacements within an older surround.

At first floor level the sash windows pre-date those surviving in the two other building elements. These windows are believed to be original as these window forms are of the six-over-six pattern of glazing panes which are characteristic of this part of the Georgian Period. There is a slight confusion over this however as, as mentioned above, the cartographic evidence appears to show that the frontage of the building was originally stepped back and not moved in line with it's neighbour until after 1849. No evidence of the replacement of the façade was found on either the building exterior or interior.

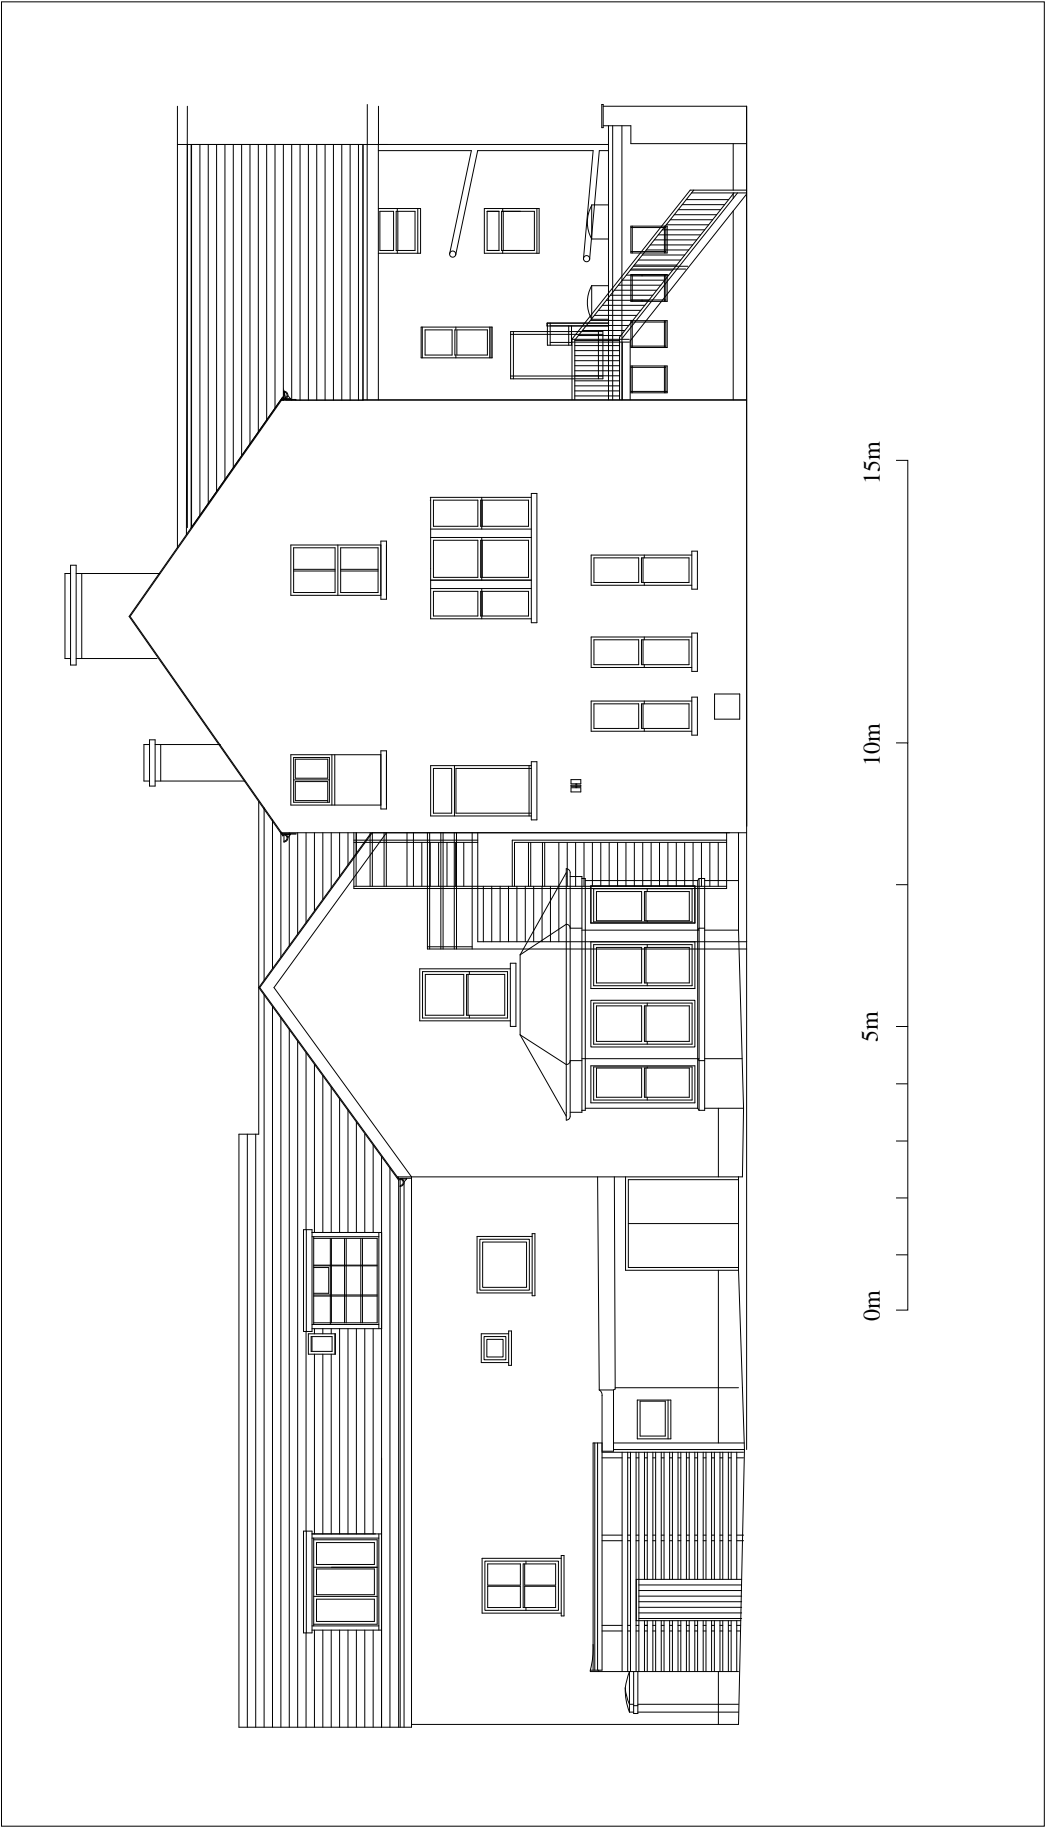
**Figure 17.** Prince of Wales, Caernarfon Existing Rear Elevation. Produced by and © Pritchard Bond Architects, Bangor

The rear (western elevation) of the building could not be accessed but it was possible to photograph the majority of the rear and side building elevations from the street - it was not possible to study the majority of the windows from outside and these details are discussed by room. This area of the building had been painted in the same cream colour scheme as the front elevation. The two flanking properties have been left without render and the exposed stonework has been painted. The dining room extension and 1890-1900 extension have both been cement rendered.

Of interest on the 1890-1900 extension wing was the remains of a loading hoist allowing goods to be unloaded at the rear of the property. It was positioned directly above the barrel drop recorded at the cellar level.

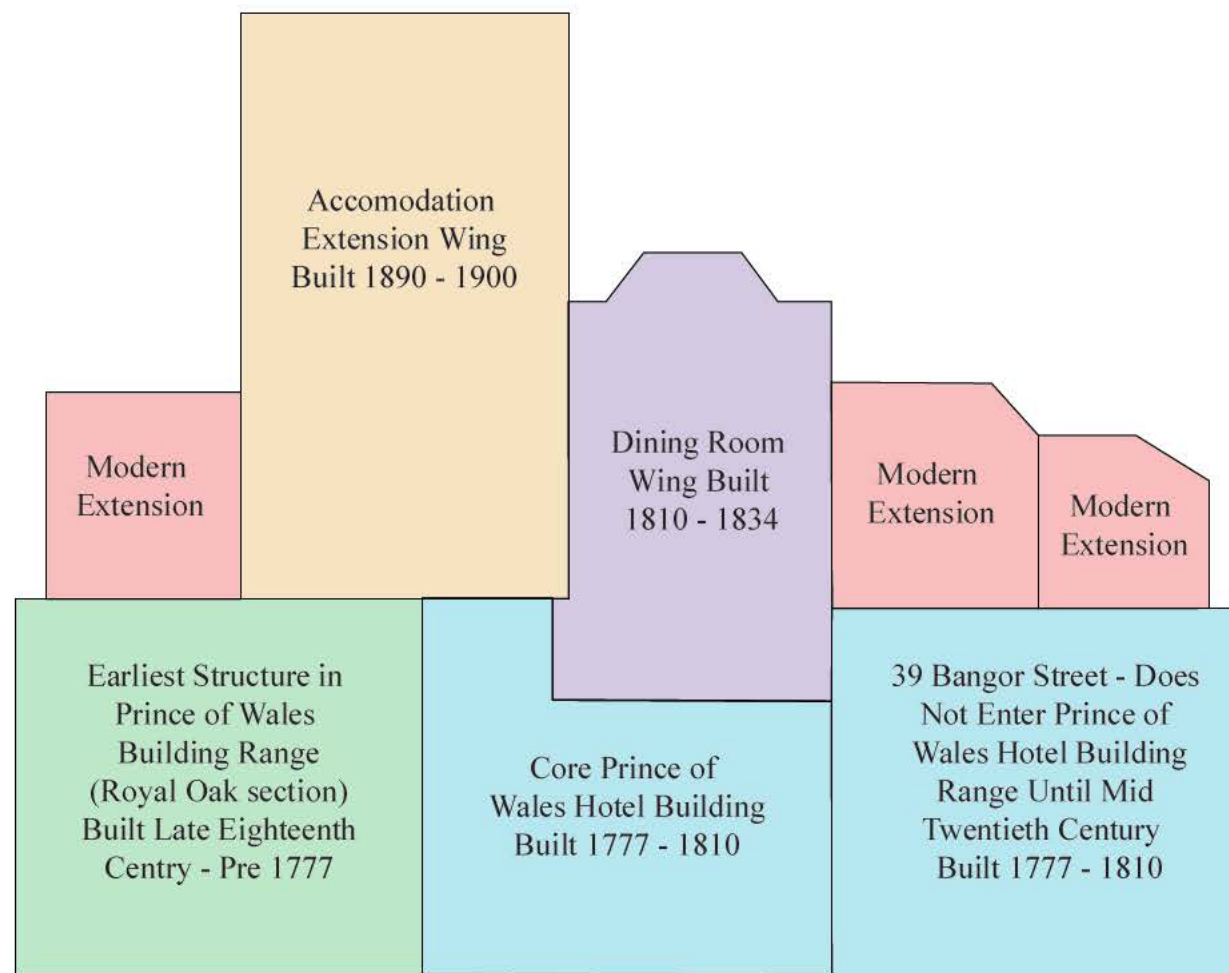
**Figure 24.** Broad Phasing/ Dates of Buildings in Existing Prince of Wales Building Range

Elevation drawings are included as figures 16 – 19 and floor plans as figures 20 – 23. Figure 24 is a schematic plan of the current buildings within the Prince of Wales Hotel suite showing the broad phasing/dates of these structures.

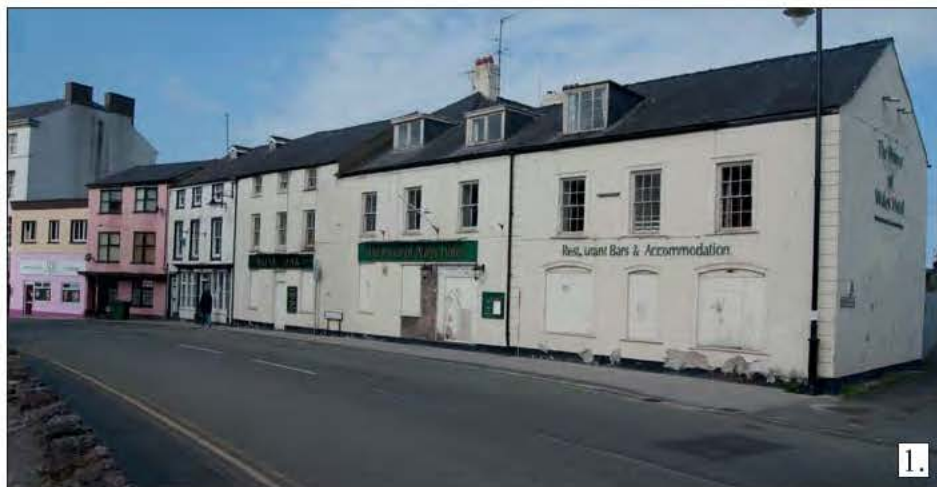
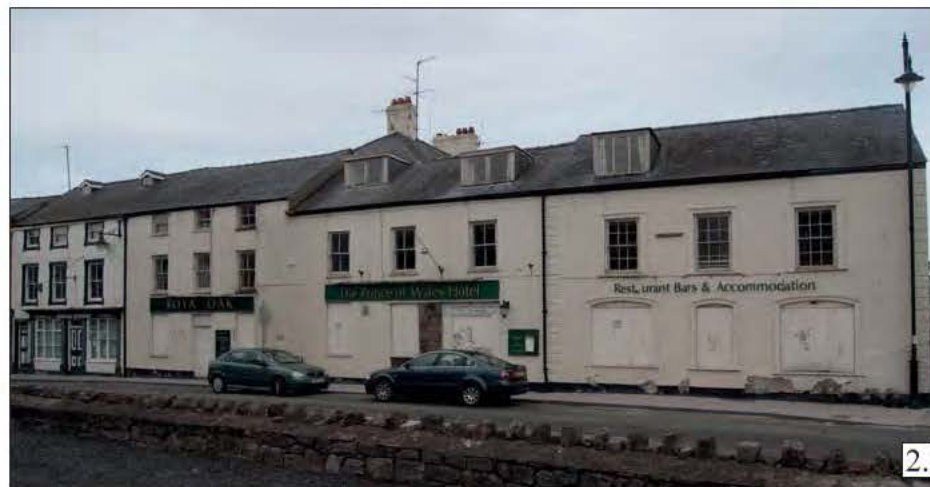
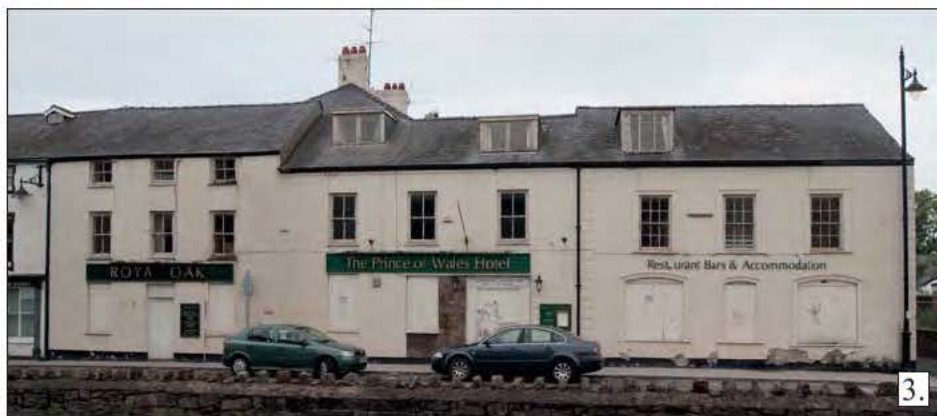
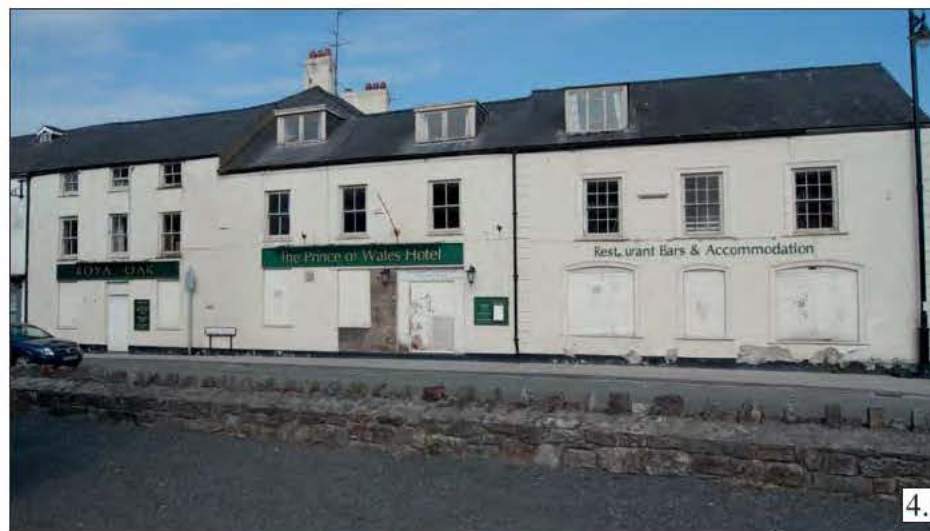
**Plates 1 - 4. Royal Oak and Prince of Wales Hotel**  
Front Elevation

The ground floor openings had all been covered with boarding due to vandalism but an examination of the windows and doors from the building interior revealed that all were modern replacements. When comparing the current ground floor openings against those shown in historic photographs (figure 10 & 15) was evident that the door had been replaced post 1969 with a far less elaborate surround. The layout of the ground floor door and windows remained unchanged from those shown in the aforementioned photographs but it must be noted that the other structure of the building pair (the aforementioned dental surgery) has an additional door opening and an elaborate Victorian shop frontage. No evidence of an additional doorway was noted inside the building but this area was covered and would only be visible should the interior render be stripped.

The roof space for this part of the building could not be accessed but it could be seen from the ground floor level that this part of the building had been re-roofed relatively recently. The same was found to be true for the rest of the building where the roof space could be seen and new slates, wood and felt were recorded. The slate used almost certainly replicates the original material although the shape and size of the slates may deviate from the historically produced material. A chimney is shown in the 1901 photograph which has since been removed.

The central building element of the range was built between 1777 and 1810 and as with the Royal Oak was of rough stone construction covered with a smooth cement render. This section had a lower roof level than its neighbour and was a two storey structure into which two flat roofed dormer windows had later been added. The insertion of these windows was undertaken between the early and mid twentieth century as they are not shown on the early 1900's photograph (figure 10) but are shown on the 1969 advertisement (figure 15). It is possible that these dormers replaced earlier skylights but this cannot be proven.

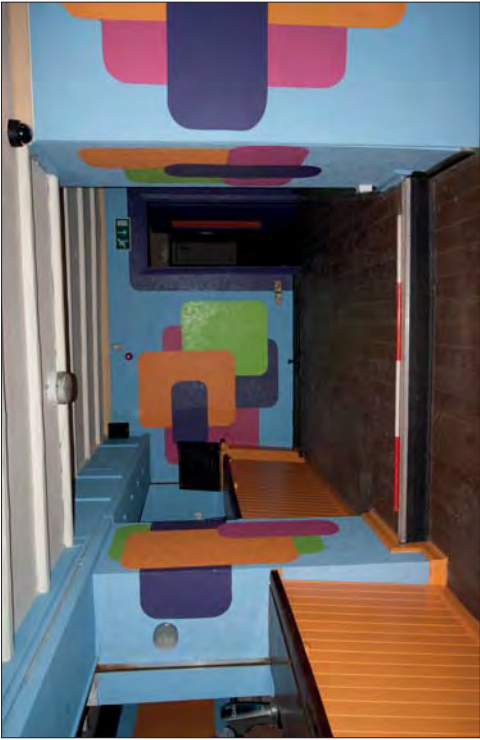
**Plate 53.** Walkway Between Ground Floor Rooms 8 & 9 Showing Bar Areas

Room 8 was an open empty space and part of the Royal Oak building element. It had been stripped out to provide an open pub/club area and other than the chimney breast in the southern elevation no features of note were retained. The entry porch was a modern addition and the doors and windows in the eastern or street facing elevation were modern replacements. Rooms 26 & 27 (modern toilets) are accessed via this room.

Room 9 was located in the central, original Prince of Wales area of the building and was an extension of Room 8 and used as a pub/club area. Behind the bar area it was possible to access the kitchens and the stairs to both the cellar and first floor levels. The window was a modern replacement and there were no features of note in this room.

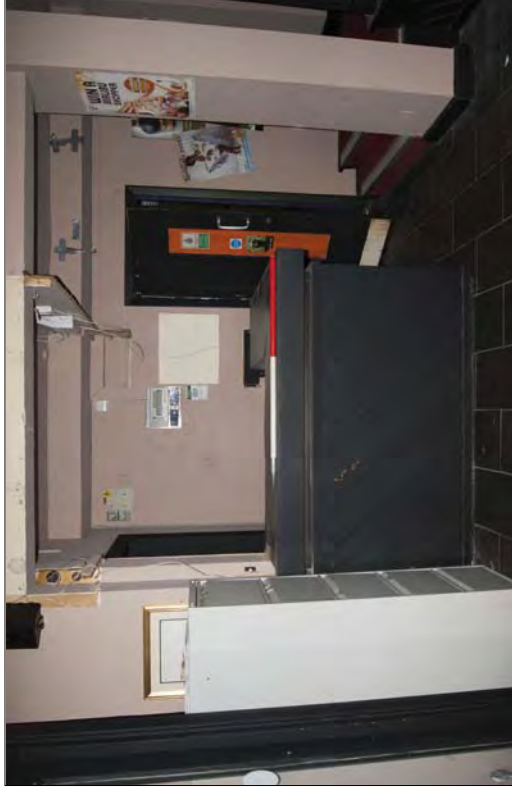
**Plate 60.** Reception Desk & Area Ground Floor Room 11

Room 11 served as a reception/ entrance lobby area. As with most of this area of the building it had been heavily modified and the windows and doors were modern replacements. The stairs were modern and are not believed to be in their original position. There are no features of note in this room.

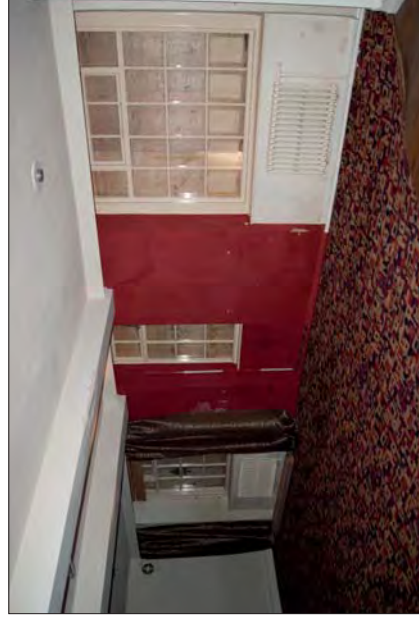
**Plate 69.** Rooms 12 & 13 Front elevation  
Showing Modern Replacement Windows

Rooms 12 and 13 made up the original ground floor area of 39 Bangor Street and the area had been utilised as a lounge bar. Most features of any antiquity had been removed although the chimney breast in the northern elevation was still evident. There was a small fireplace in the southern elevation which, although an obviously modern item, was likely to be located in the position of its original counterpart. The central window replaces the original doorway onto Bangor Street and the windows although possibly early twentieth century are most likely modern replicas.

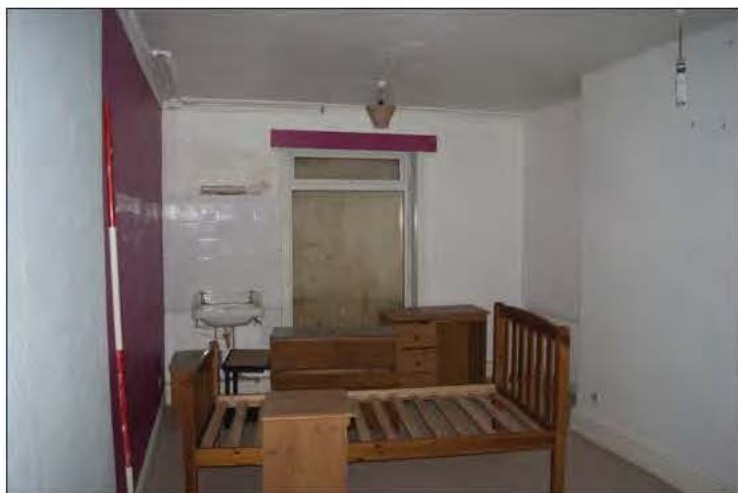
**Plate 131.** Room 51 Showing Modern Window

Rooms 51, 53 & 54 were guest bedrooms, Room 52 was a kitchen area and Room 55 a bathroom. These rooms occupied the 1890-1900 accommodation extension wing. The room divisions do broadly correspond with those found at basement level and may reflect the layout as built. The stairs leading to this level are original, including the banisters etc. The windows in this area of the building were modern replacements predominately with UPVC double glazing.
