**Results of Archaeological Watching Brief at
Llandrygarn Church, Anglesey**

Report Number CR80-2015

C.R Archaeology

Compiled by M. Jones & C. Rees
on Behalf of The Church in Wales

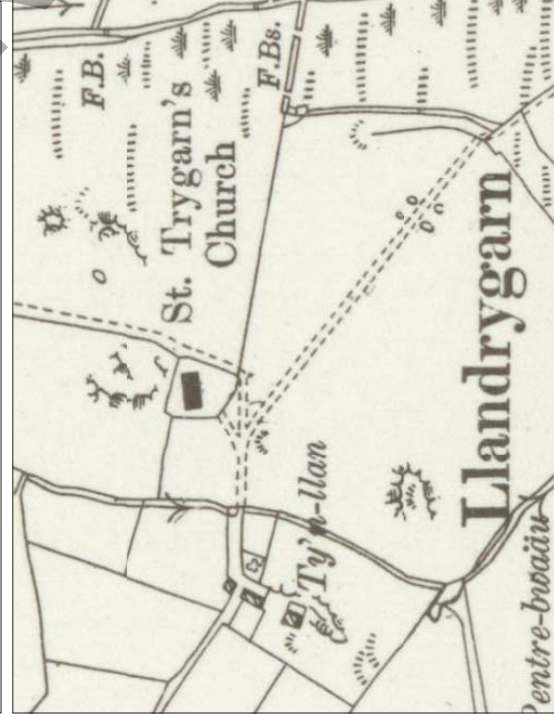
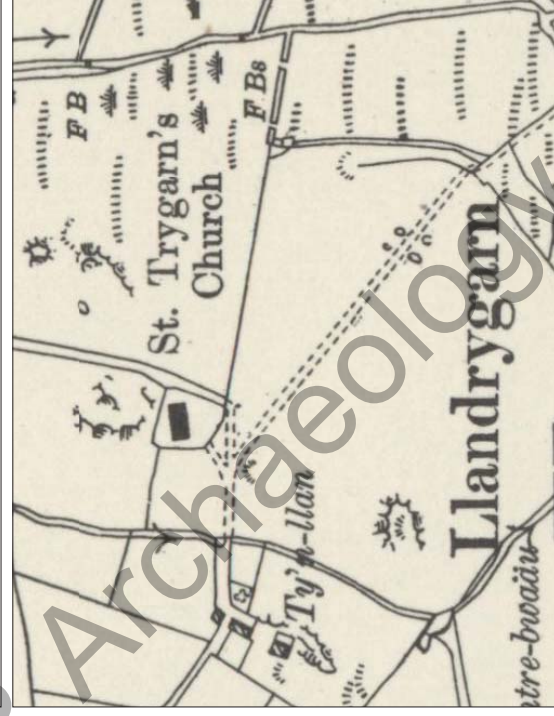
Ordnance Survey Maps 1887 – 1949 (figures 5-8)

A single change is shown to the church between the first and second map editions when the trees which are located around the southern churchyard boundary are removed. The outbuilding which was demolished as part of the current scheme of works is not shown on any of the map editions. Given the location of the trees it is unlikely to have been built during the first edition and not drawn, and it is entirely possible that as it does not appear on later documents that the erection of this building is of modern date.

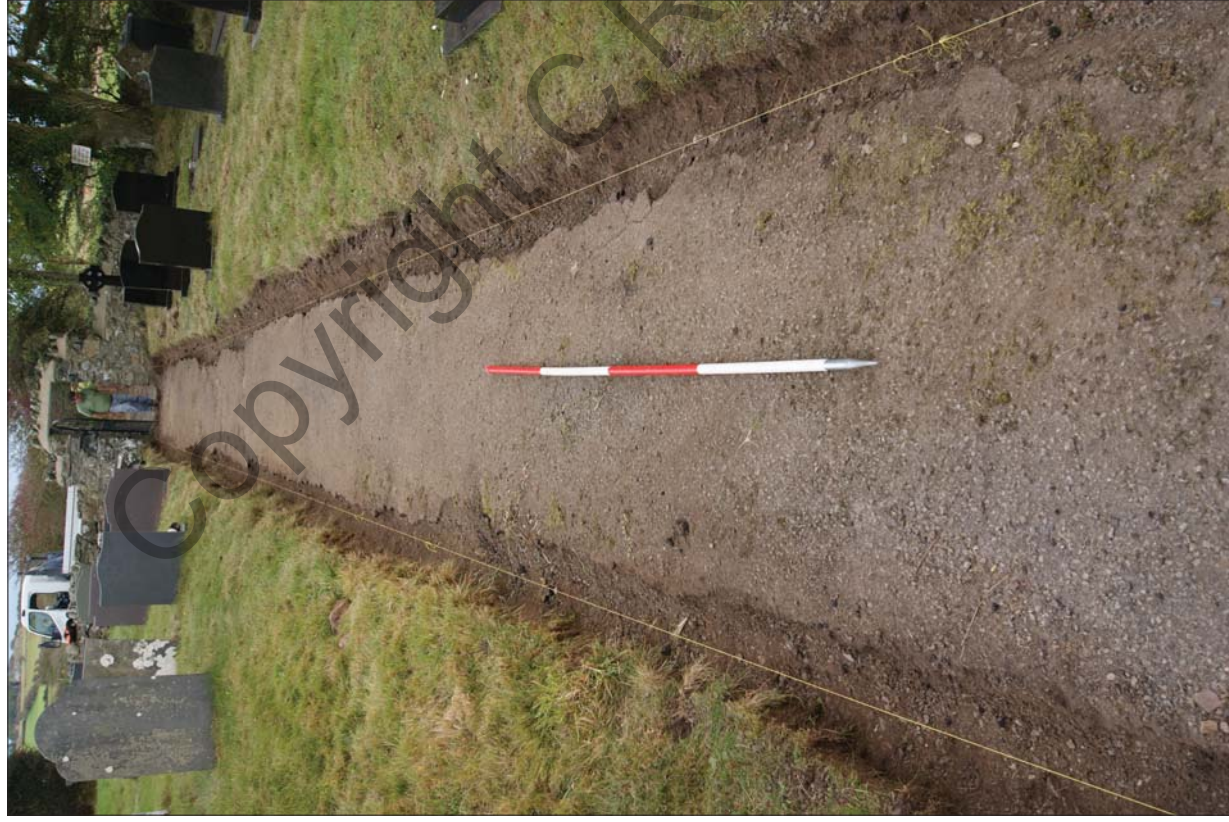
Plate 1. Post-excavation Shot of Pathway
Facing Towards Graveyard Entrance

The new curbing that was used to line the path was a standard pre-cast concrete 'half battered' type which was set along both edges of the path. The laying of this new curbing involved the hand excavation of a 0.20m deep by 0.30m wide slot either side of the existing path. This work included some cutting back of the grassy areas of the church yard. This work was carried out under an archaeological watching brief.

Upon excavation it was clear that the area either side of the path had been heavily disturbed and there was evidence of disused service pipes on both sides of the path. There was no evidence of any undisturbed features insitu exposed within the slots.

The only evidence of a possible grave near the surface was the noting of skull fragments in the service cut on the west side of the path approximately eight meters from the entrance and the discovery of fragmentary toes bones in the corresponding area of the opposite slot. It is possible that these two elements could represent a single burial which lies beneath the path but as noted above these remains had been disturbed by the later service trenches and it is difficult to reach a definitive conclusion given the limited excavation area.

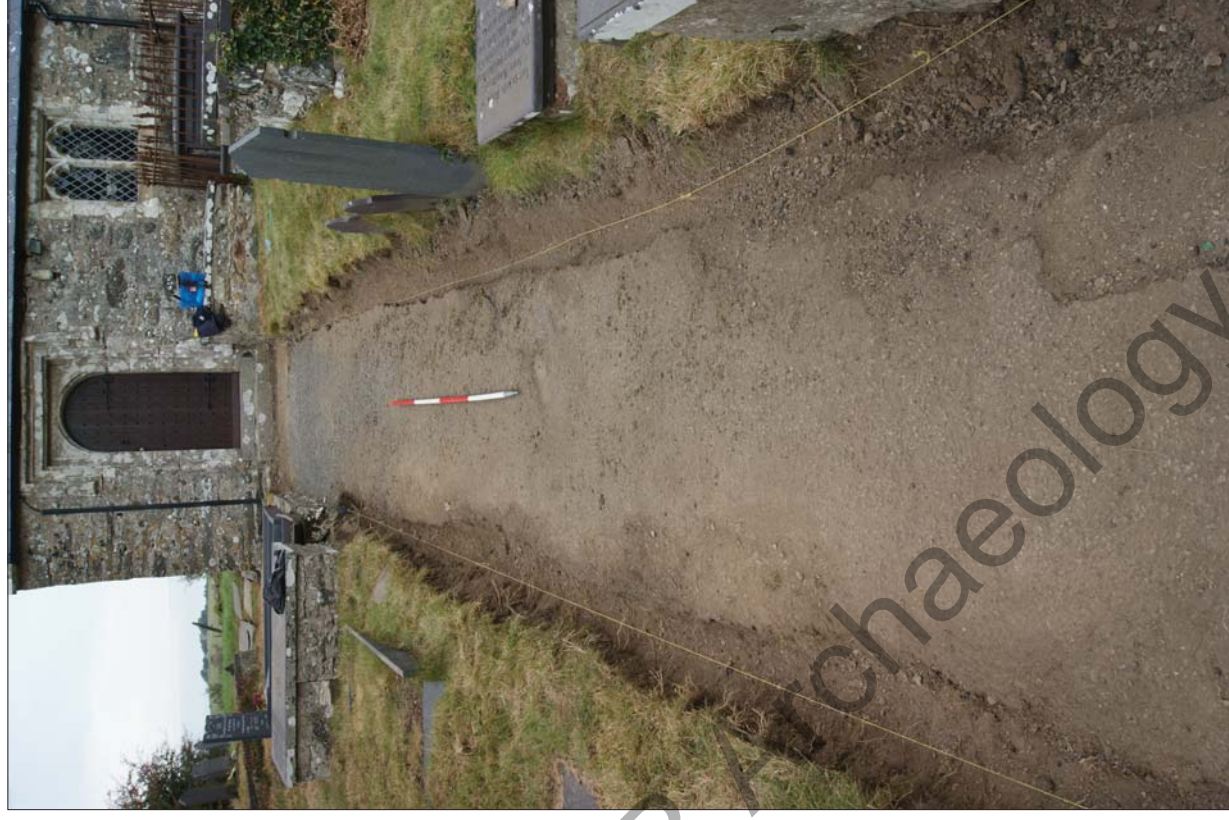
Plate 2. Post-excavation Shot of Pathway
Facing Towards Church Doorway

Further disturbed, disarticulated human remains were uncovered elsewhere within the curb trenches. A 10cm long broken leg bone was recovered 12.9m from the door way at a bend in the path. Again the remains were within the earlier service trench, as was a molar found c.2m to the east of this point. Several smaller, harder to identify bone fragments, were recovered within the back fill of the earlier service trench which would suggest that previous works had dug deeper than the foundation trench for the kerbs. It is also likely that given the graveyard has been in use for over eight hundred years there is an underlying concentration of bone fragments within the church yard soil.

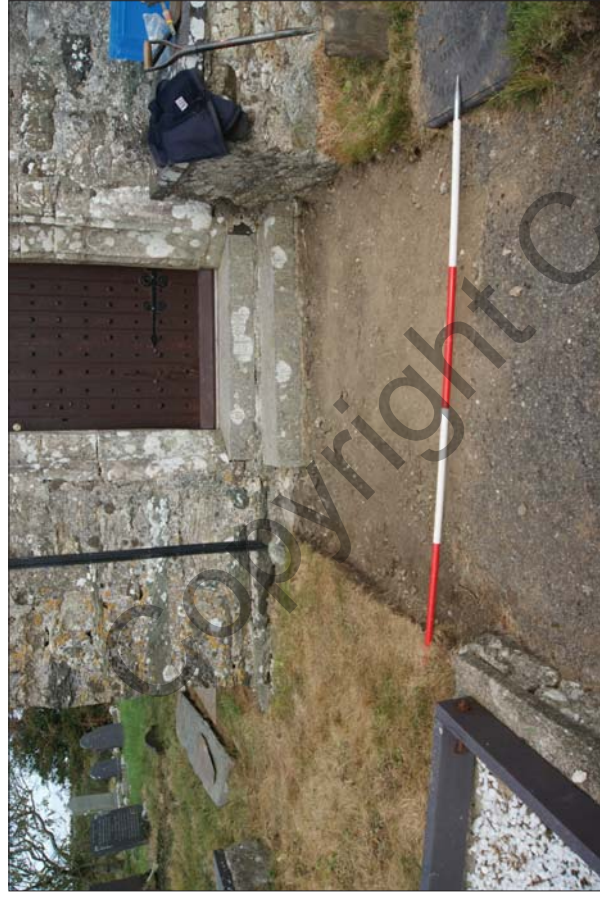
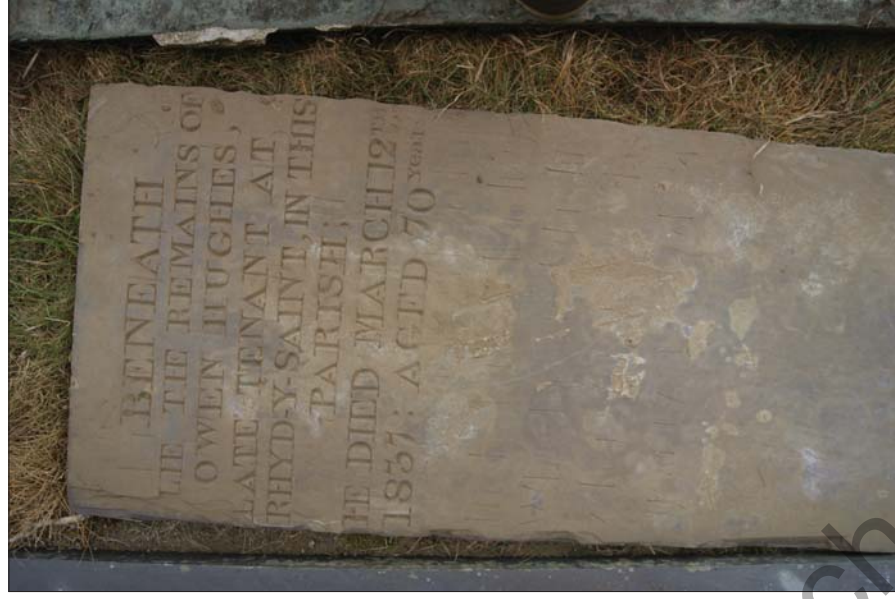
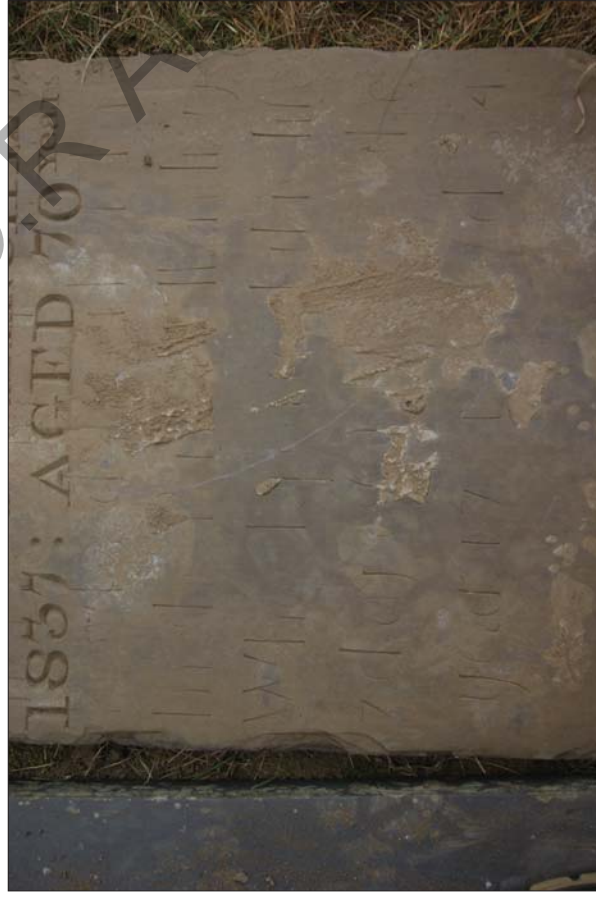
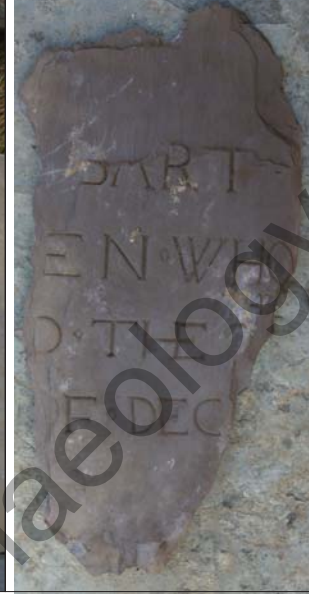
Plates 3-6. Churchyard Steps Prior to Excavation and Gravestones Uncovered During Their Removal

The two steps leading to the church entrance were found to have been constructed using reused slate grave stones (plates 4-6). One grave stone was complete and measured approximately a meter in length and was half a meter in width. The inscription was dated 1837 and records the death of Owen Hughes of the parish who died at the age of 70. This grave stone shows clear evidence of having been re-used and the slate appears to have had it's original inscription 'split'/removed before the Owen Hughes inscription was cut over the top. The ghost of the earlier inscription can still be made out in places and it appears to contain a date beginning 17.. and is inscribed in a different font.

The second stone is a small fragment with the surviving writing being written of a similar font to that which had a 18th century date and had been overwritten by a 1837 inscription.

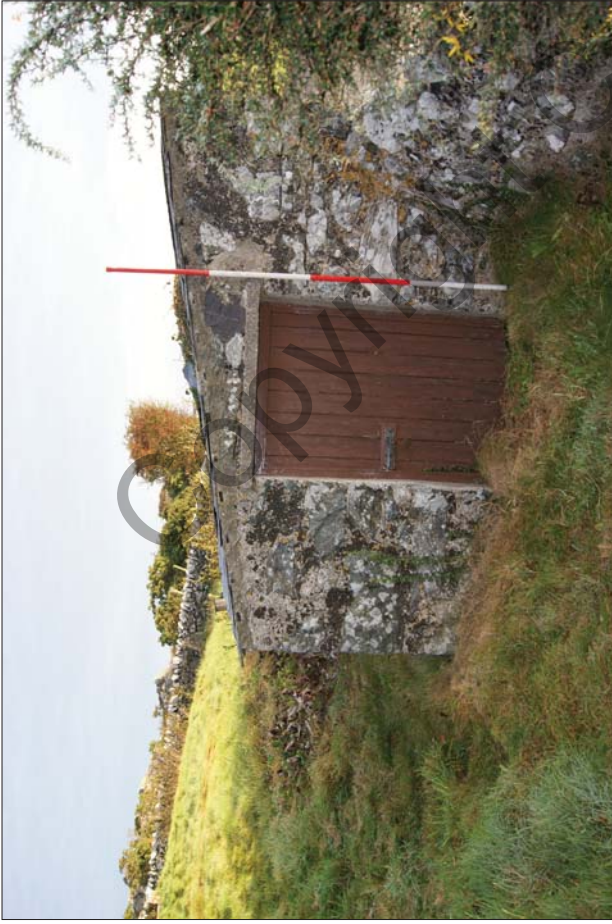
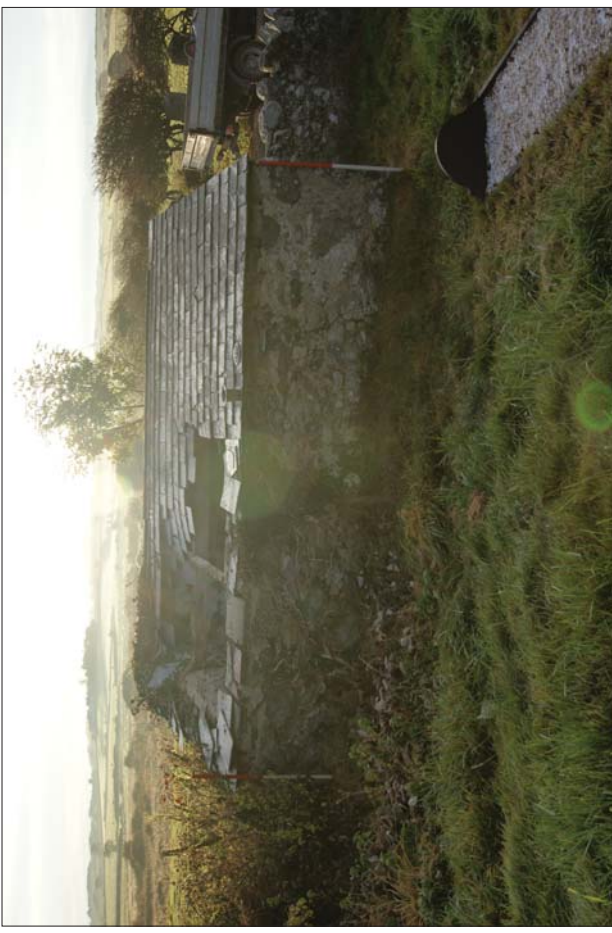
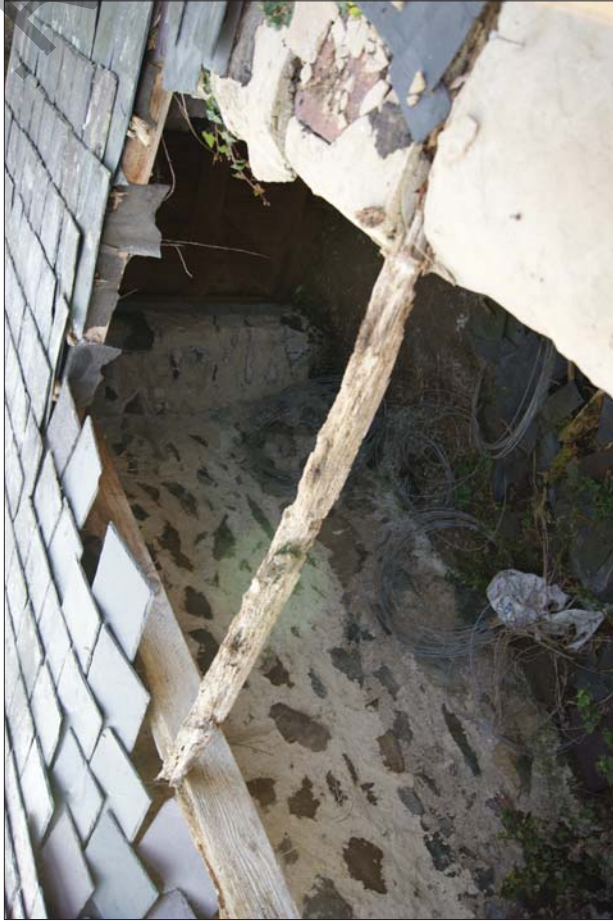
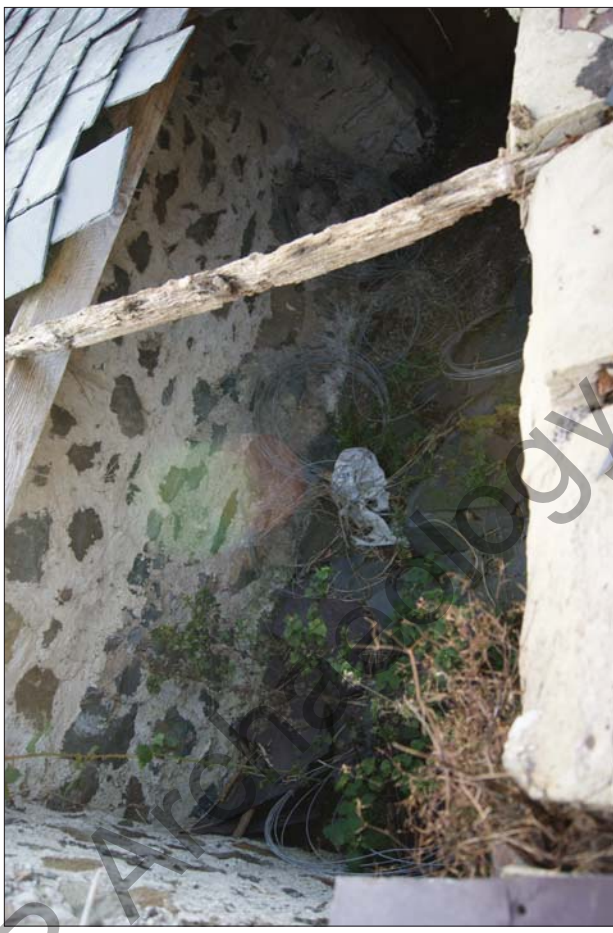
Plates 7 - 10. Lean-to Building Prior to Demolition

The stone shed was built against the churchyard wall and it is believed to be a relatively modern addition, almost certainly built after 1900 and quite likely built in the 1930's – 50's. It was made of the same local schist that was utilised in the wall construction and had a slate roof. Plates 7 – 10 and the cover shot show the building prior to it's demolition.

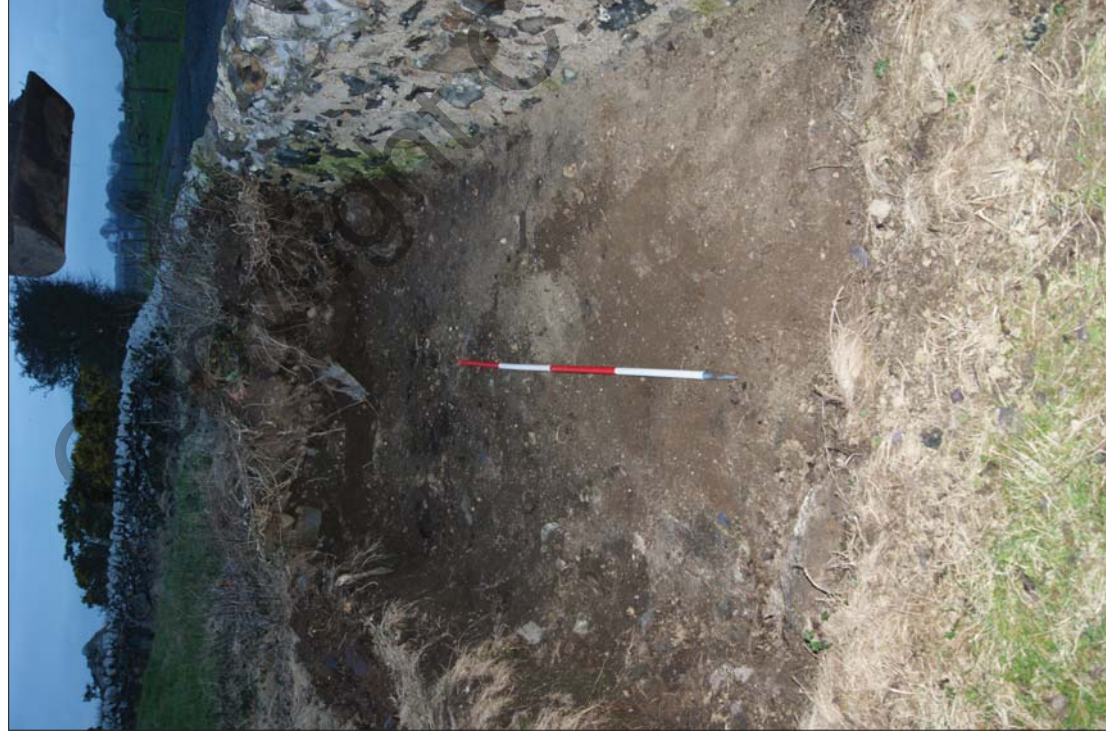
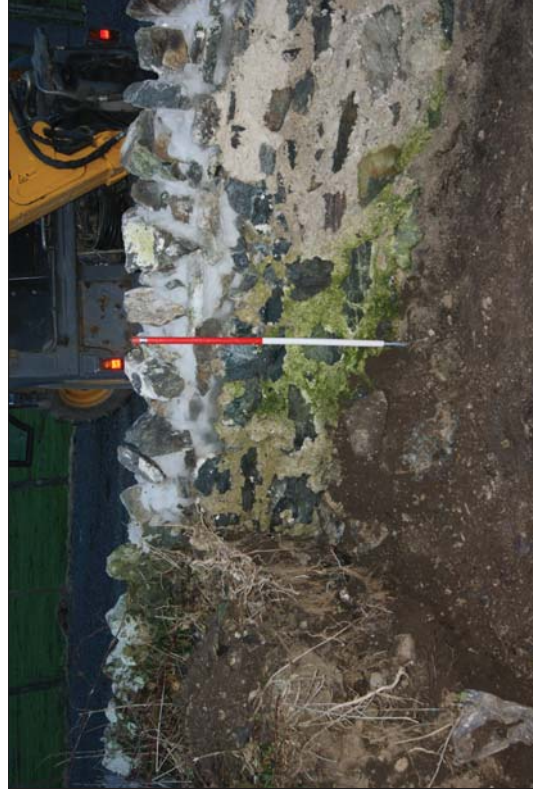
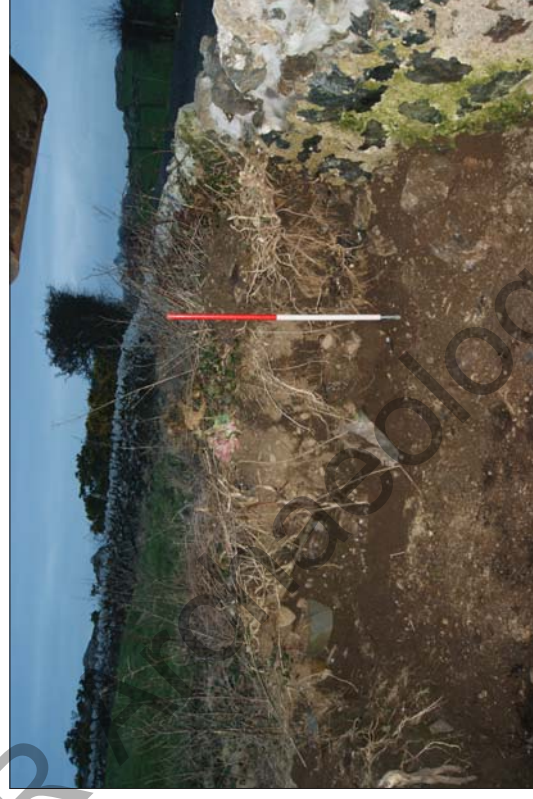
Plates 11 - 13. Area Beneath the Demolished Church Outbuilding and Material Accumulated Against Building

The stone shed was demolished using a eight tonne mechanical digger to the level of its concrete floor. The concrete floor was removed by mechanical digger under archaeological watching brief conditions. The area was then cleared by hand to see if there was any visible features below the construction layer. When this was completed it was clear that the building foundations had been cut to a depth below the ground layer and some build up of modern material was observed on the northern elevation. This material contained glass sherds from a Lucozade bottle with a metal cap. This type of bottle was replaced by a plastic bottle in 1989 as part of re-branding exercise.

Below the floor level the ground was predominantly bed rock which appears to have been slightly cut into during construction. No features were cut into this bed rock. Plates 11 – 13 show the area following the clearance of the building rubble.
