**PLAS EITHIN HOTEL
(FORMER TY MAWR FARMSTEAD)**

LLANFAIR P.G.

HISTORIC BUILDING RECORDING

APRIL 2006

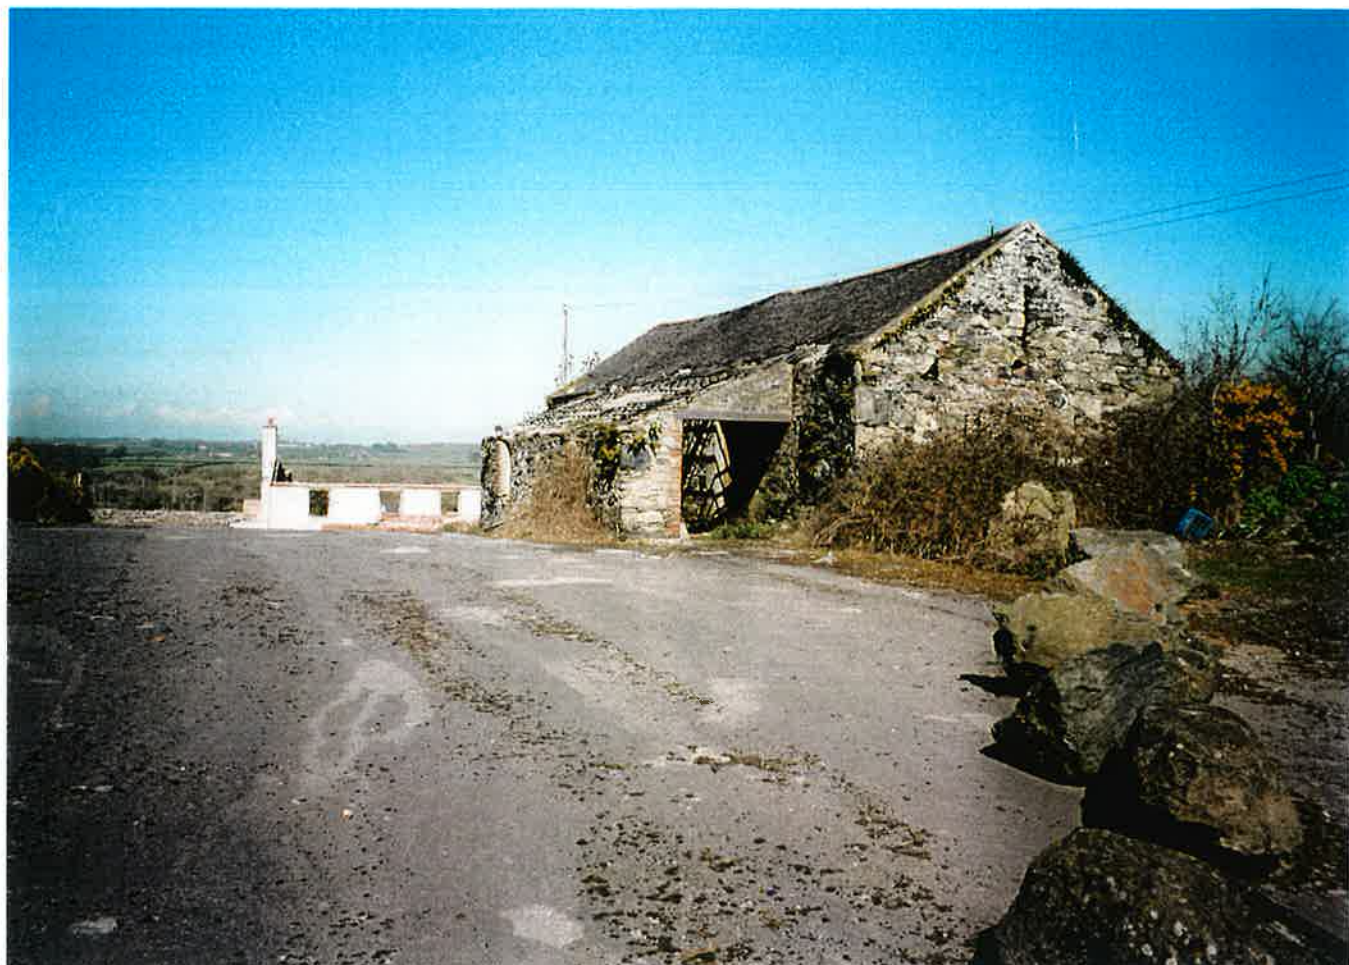
4.6 It is clear from the cartographic evidence and the above description that the modern hotel replaced the former farmhouse on this low-lying position (*Plates 1 & 2*). Of the above buildings only the Barn 'B2' survives on site (*see 5.2 following*).

Plate 1 *above*: Site viewed from the southeast towards the two-compartment stone barn, identified as B2 on Fig. 1 and, in the background, the derelict Plas Eithin Hotel, built on the former site of Ty Mawr farmhouse (see Figs 3 & 4).

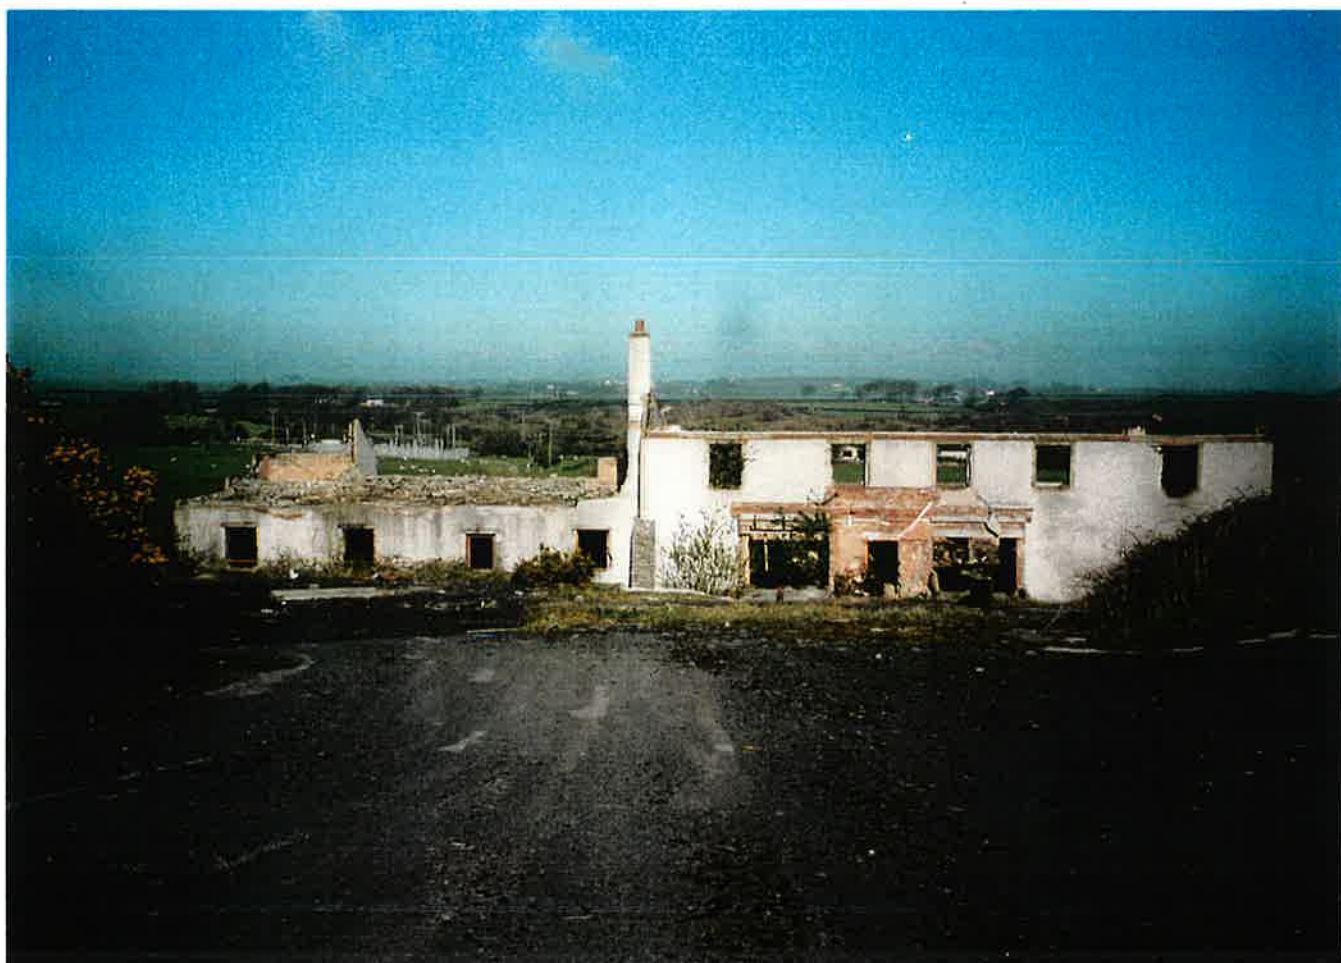
The former hotel building is identified as B1 on Fig. 1 (*Plates 1 & 2*). The main structure is of red brick with concrete facing and all visible building materials appear to relate to the late 1960s / 70s period. The building is enclosed on three sides by rubblestone walls (*Plates 5 & 6*) which are not part of the proposed demolition works. A small orchard appears to have been sited on the east side of the building.

Plate 2 *below*: Derelict Plas Eithin Hotel - identified as B1 on Fig. 1

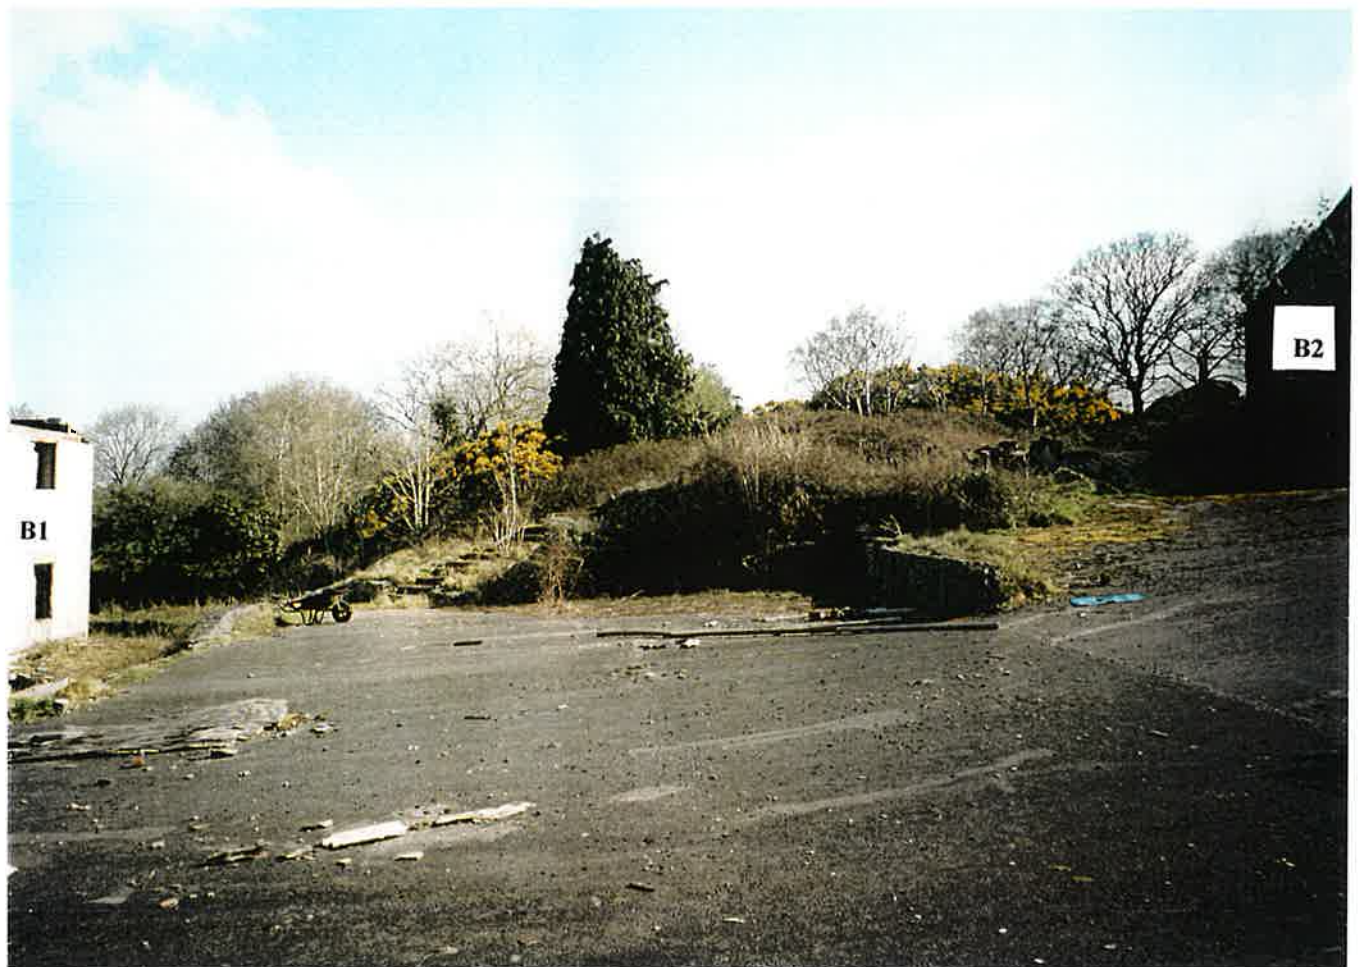
On the south side of the building, the series of retaining walls and steps appear also to be of 1960s / 70s construction, built in rubblestone which is also concrete faced. The structures are identified as B3 & 4 on Fig. 1 (*Plates 3 & 4*) and will be demolished as part of the current works.

Plate 3 above: View from the southwest towards the modern stone revetment walls & stepped area, identified as B3 & B4 on Fig. 1.

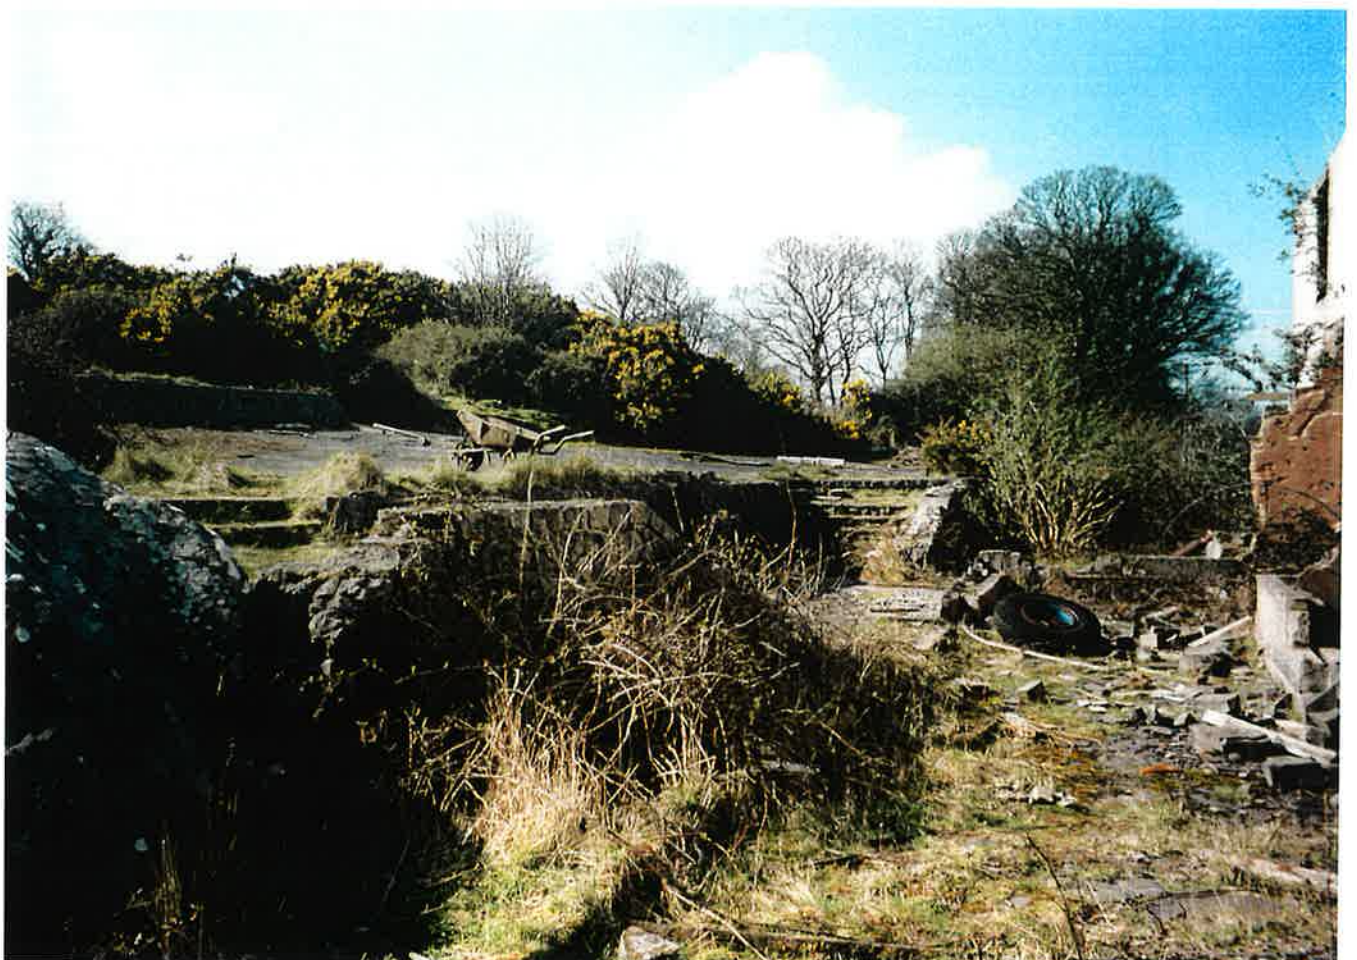
Plate 4 below: View from the northeast towards B3 & B4 walls & steps to be demolished.

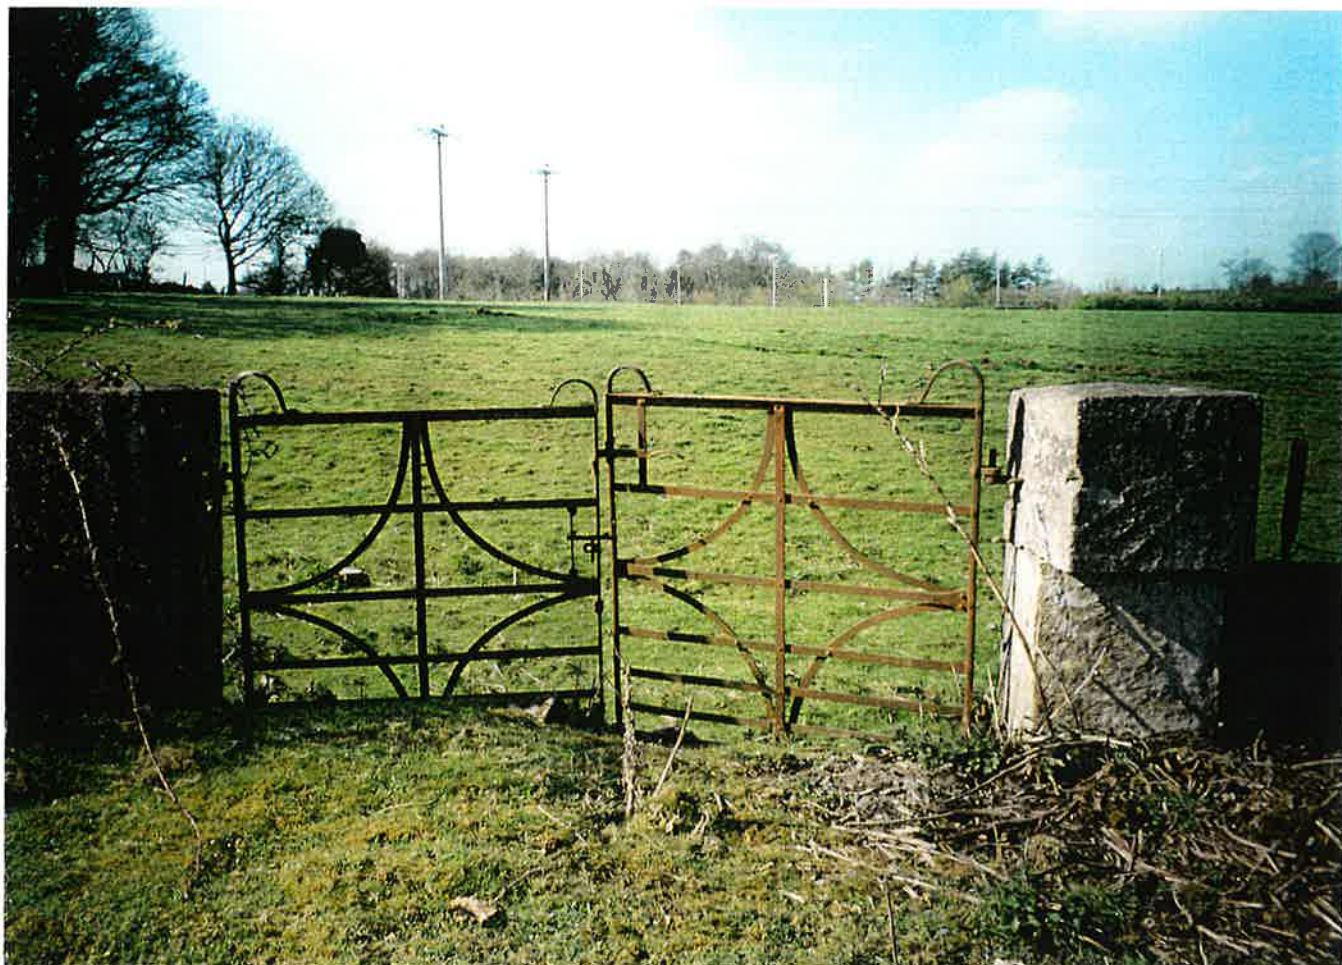
Plate 5 above: Sample section of rubblestone boundary wall & field gate, enclosing the west side of the derelict Hotel building. Not part of the current demolition programme.

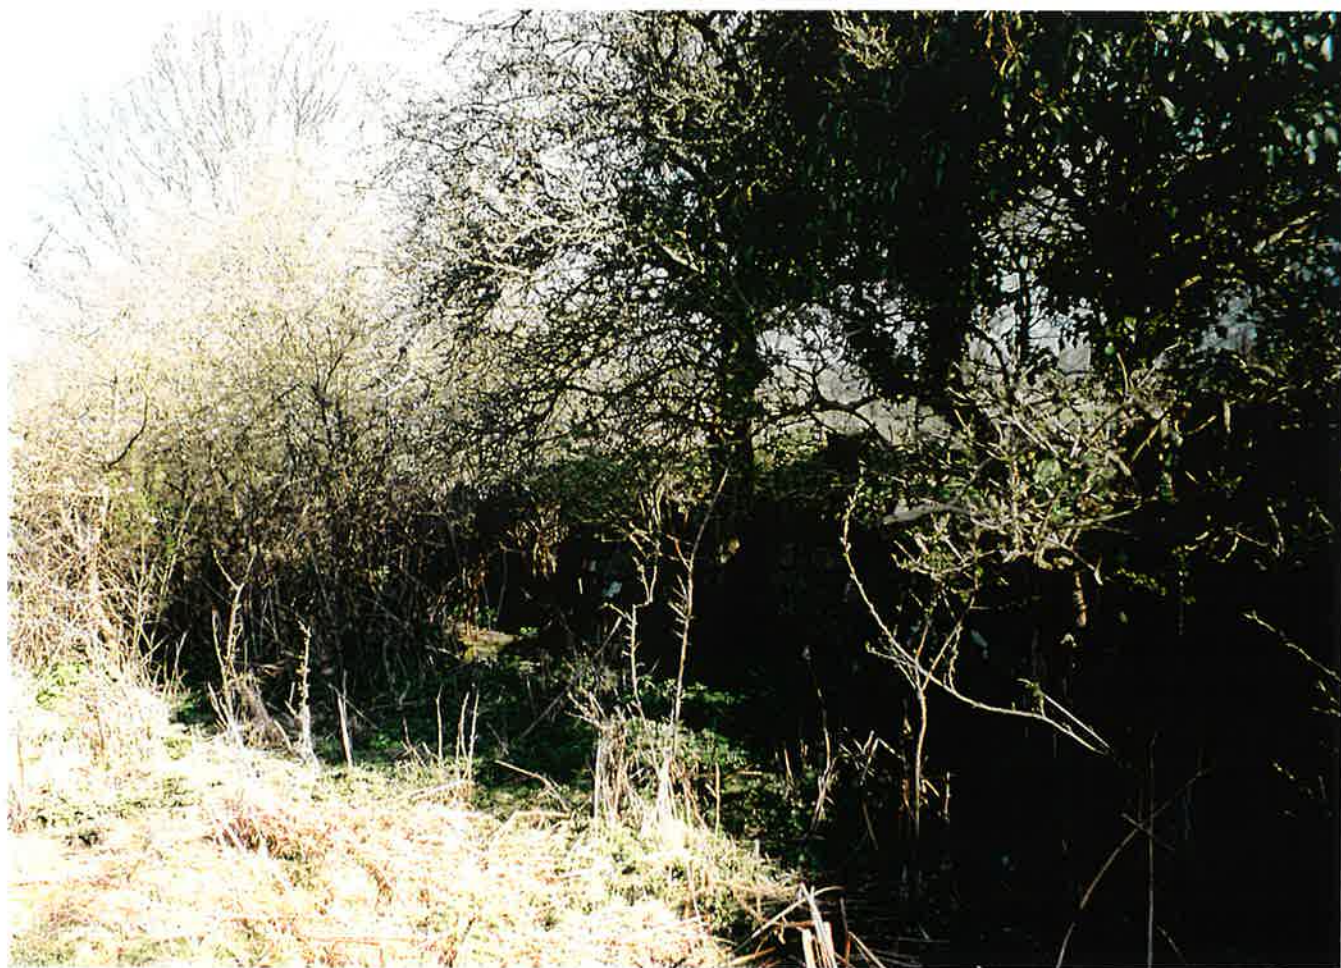
Plate 6 below: Eastern boundary wall, not part of the current demolition programme.

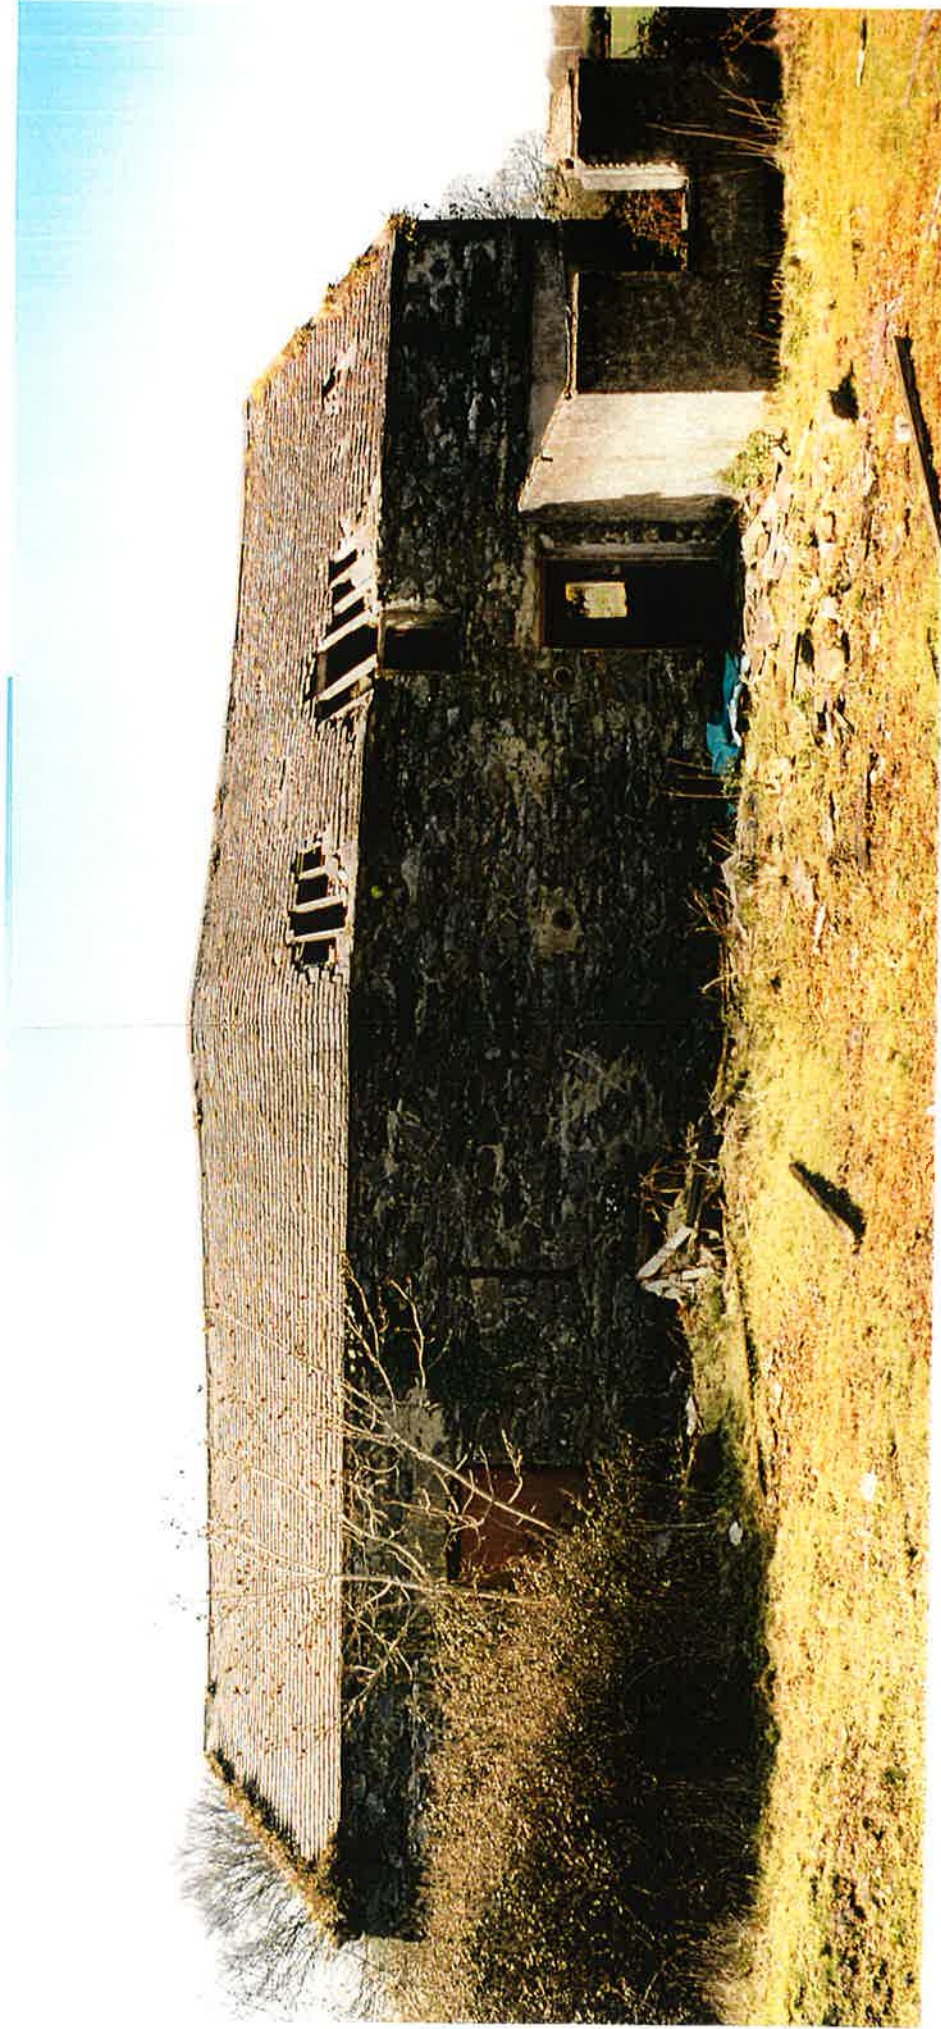
Plate 7: The two-compartment barn identified as B2 on Fig. 1.

The slate plaque confirms the ownership and lease in 1818, as recorded in the Land Tax returns (*4.1 previous*). The opposing east door has a plain quartzite lintel (*Plate 7*).

5.7 A roofless concrete structure, presumably a store, adjoins the northeast side of the barn, as recorded on *Plate 7*.

View from the northeast shows the roofless modern concrete store added to the northeast corner.

The vertically planked door set below a quartzite lintel and the vertical ventilation slit, indicate that part of the barn built in 1818.

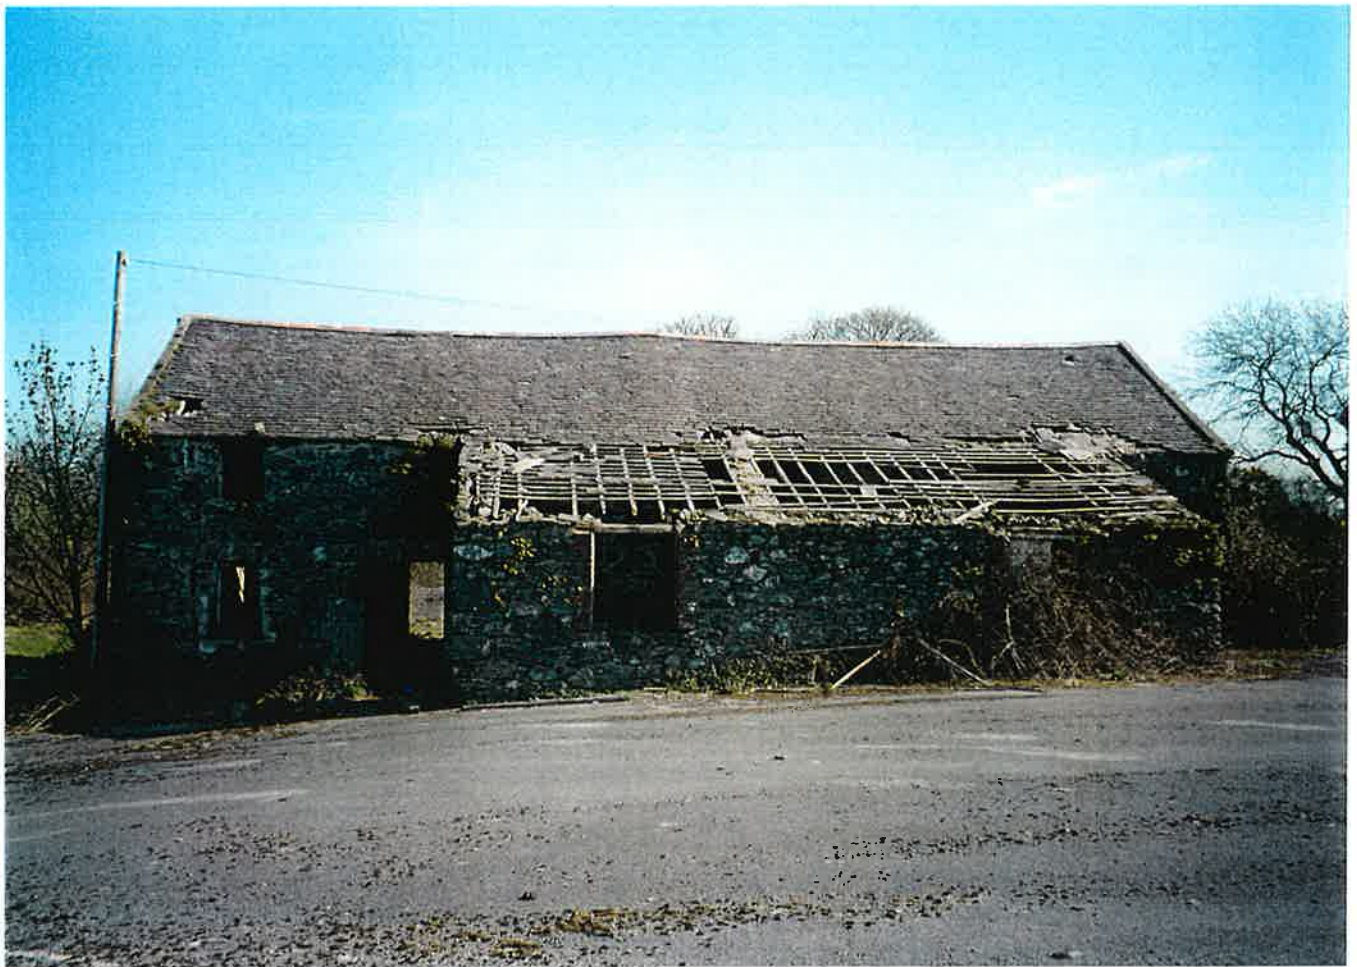
Plate 8 Barn B2, viewed from the southwest across the yard / car parking area. The two-compartment addition to the southwest side was built in 1923 as a root store (*left*) and an engine house (*right*).

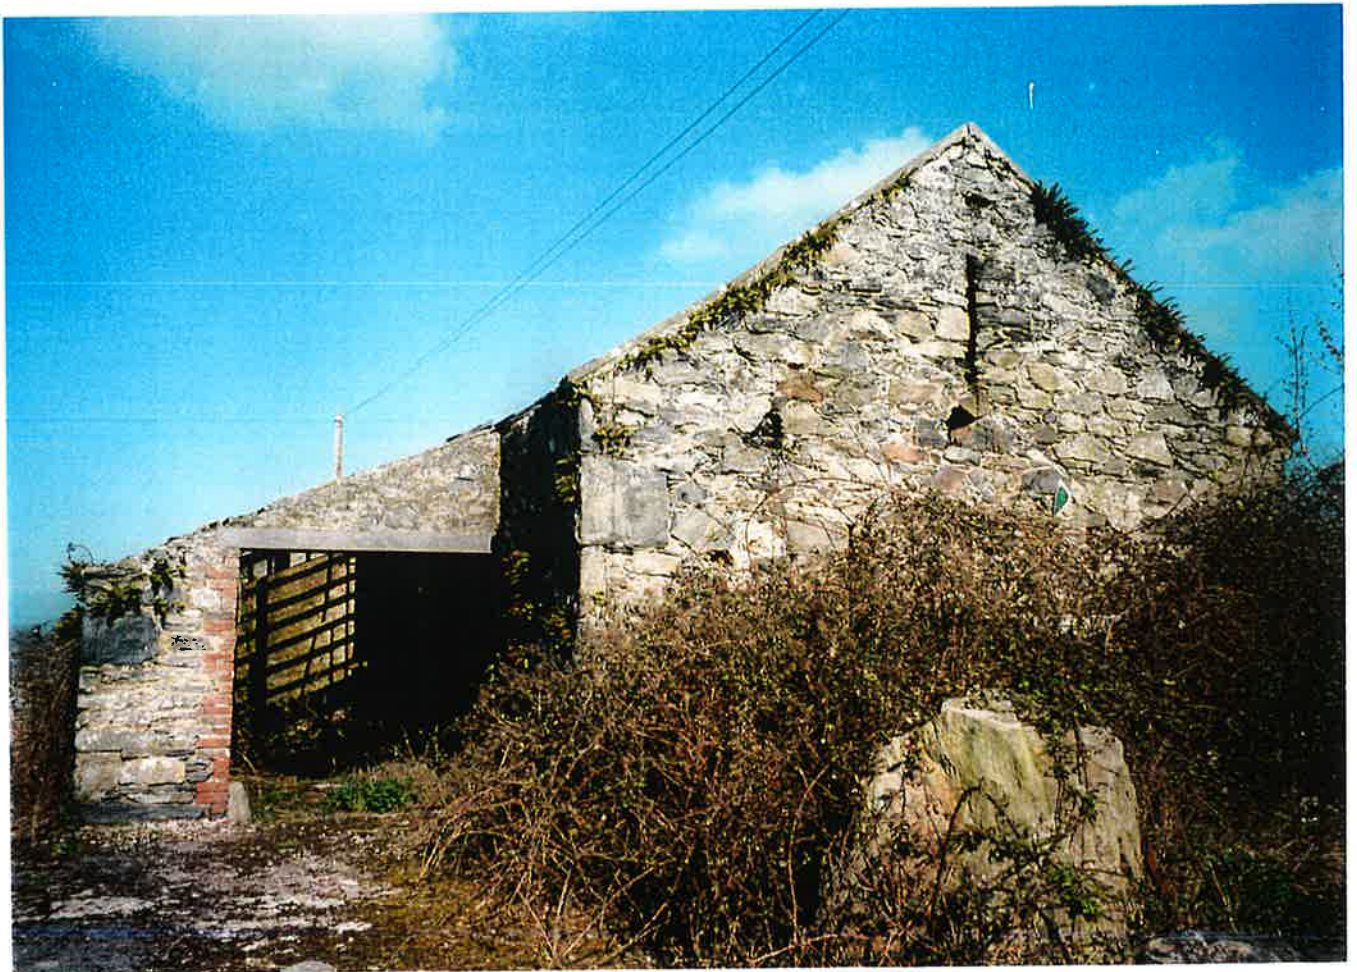
5.6 The 1923 lean-to measures 11m long by 3.4m wide with a 2.3m high front wall, constructed as an engine house and root store. Evidence on site suggests the southeast side housed a portable engine, which powered a series of belt drives. The 16" belt drive wheel located on the external wall of the southern compartment rotates an axle which passes through the west wall to 10", 12" and two 16" wheels, which themselves would have transferred power by belt drives to machinery, which is likely to have ground animal feed (*Plates 13 – 15*). One of the wheels is a crude wooden one, presumably replacing a faulty cast-iron wheel. The existing wide doorway with red brick trim 2.13m wide by 1.53m high (*5ft x 7ft*) leads into the engine house (*Plate 9*).

Plate 9 Barn B2, southeast compartment, viewed from the southeast towards the wide portable engine compartment doorway.

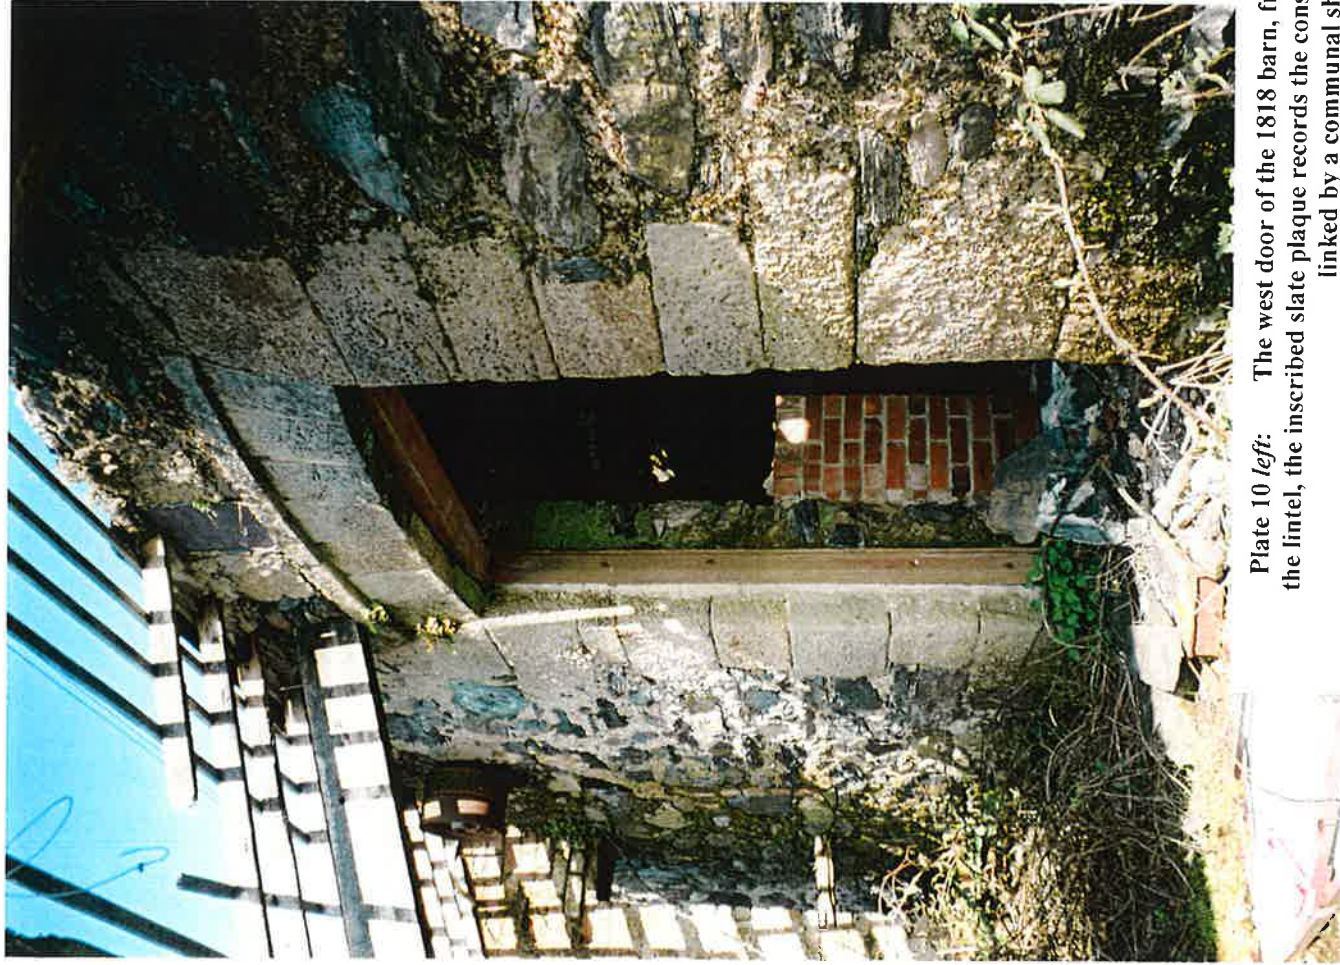
5.3 The south-eastern compartment of the barn measures 9.35m by 5.57m wide internally with walls c.0.57m thick. The original floor surface has been skimmed with concrete. The compartment has been subdivided into stalls by the construction of low red brick walls, which are mid-20th century in date. The barn would have been used for storing grain and fodder for the animals during the winter months. The series of ventilation slits (*Plate 11*) would have ensured a flow of air ensuring that the grain did not go mouldy, while keeping out the bad weather. The ventilation slits measure c.0.97m high by 0.44m wide by 0.57m deep. The barn is constructed in local rubblestone randomly laid with lime mortar. The west door is framed with dressed coarse grained quartzite quoins and, above the lintel, an inscribed slate plaque records the construction date of 1818 (*Plates 10 & 12*).

Plate 10 *left*: The west door of the 1818 barn, framed with dressed coarse grained quartzite quoins. Above the lintel, the inscribed slate plaque records the construction date. In the background, the 16" belt drive wheel is linked by a communal shaft to the wheels inside the barn.

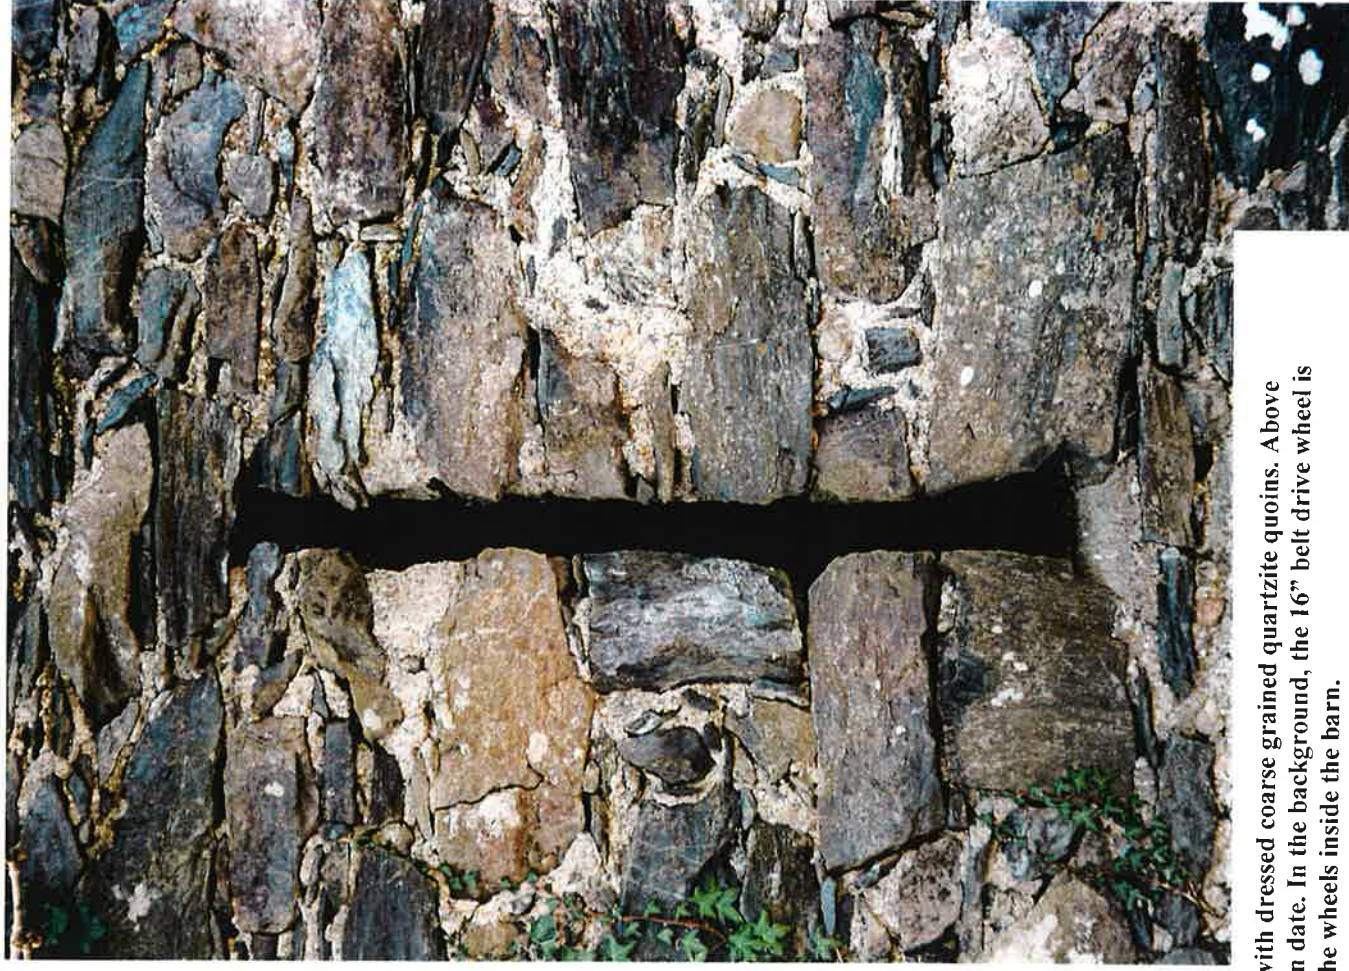
Plate 11 *right*: Sample ventilation slit in the 1818 barn. Slits measure 0.97m high by 0.44m wide by 0.57m deep

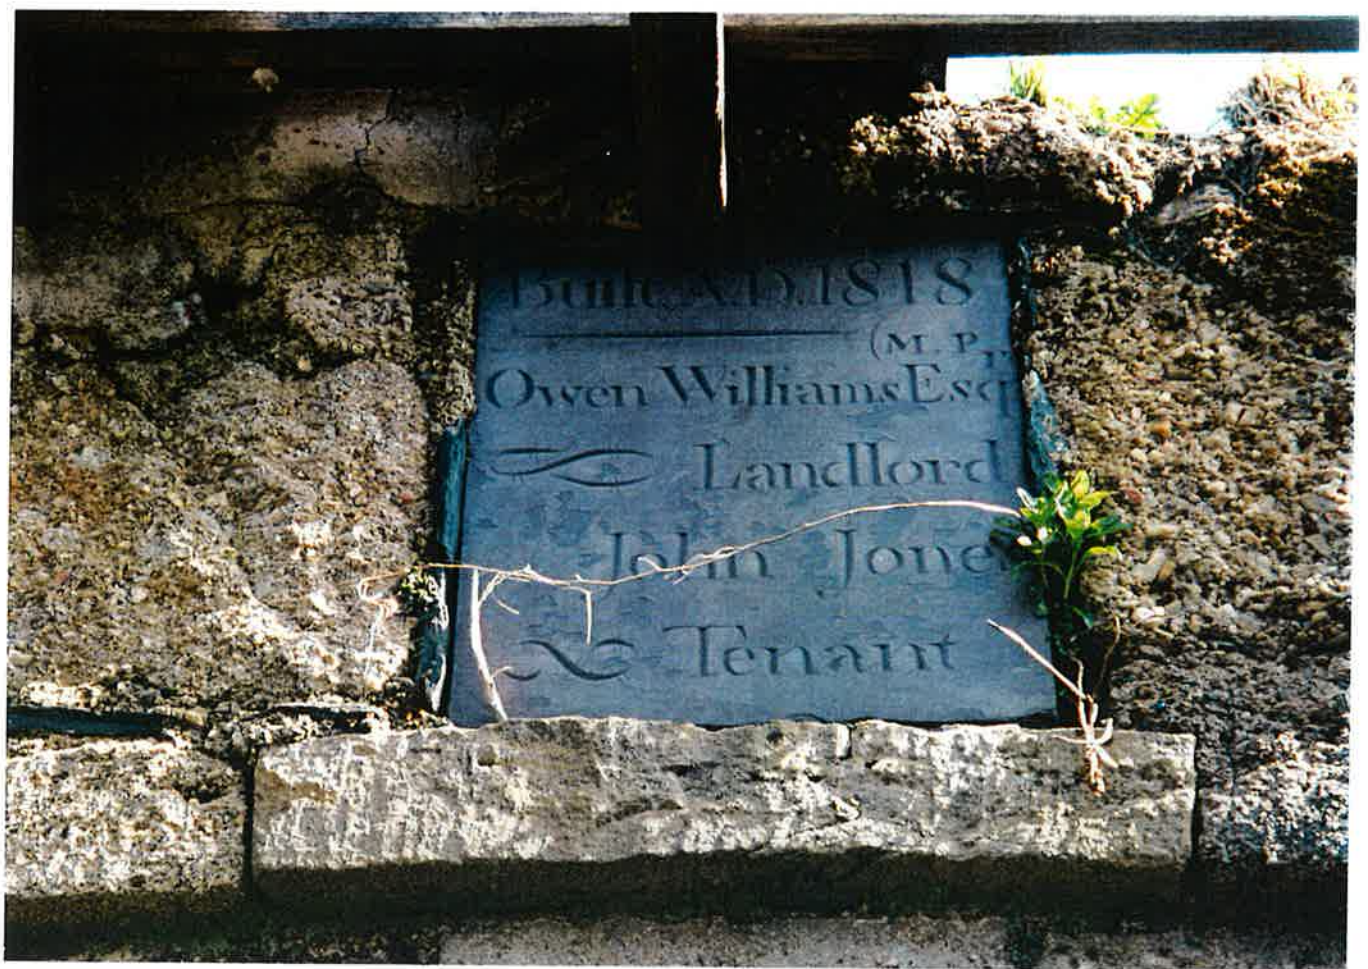
Plate 12 above: The inscribed slate plaque recording the construction date:

Built AD 1818	Mr Owen Williams Esq. M.P.	Landlord	John Jones	Tenant
---------------	----------------------------	----------	------------	--------

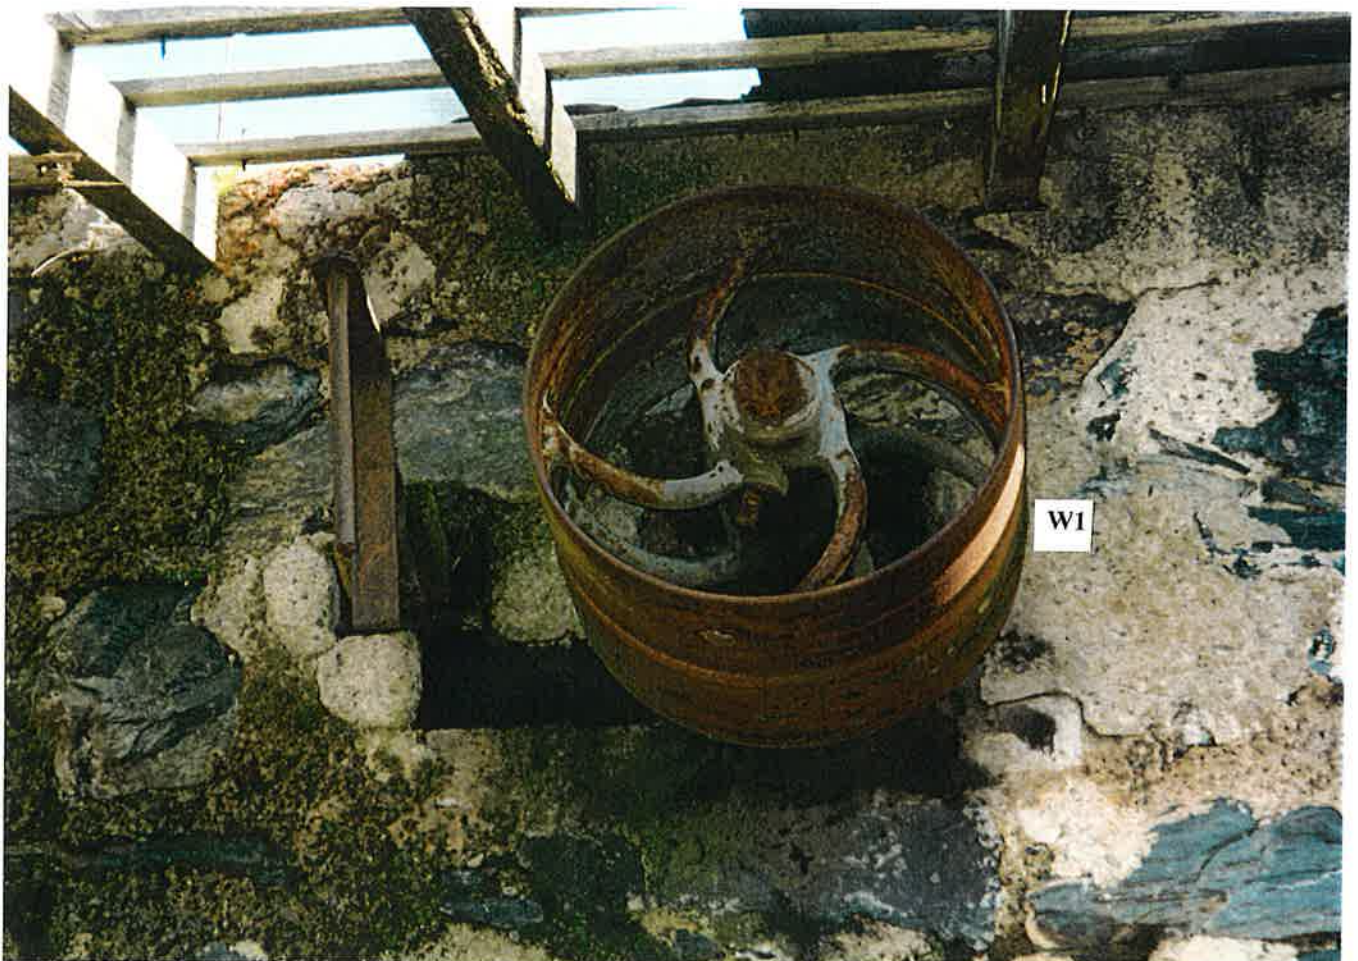
Plate 13 below: The cast iron 16" diameter belt drive wheel located on the outside wall of the barn, inside the lean-to engine compartment.

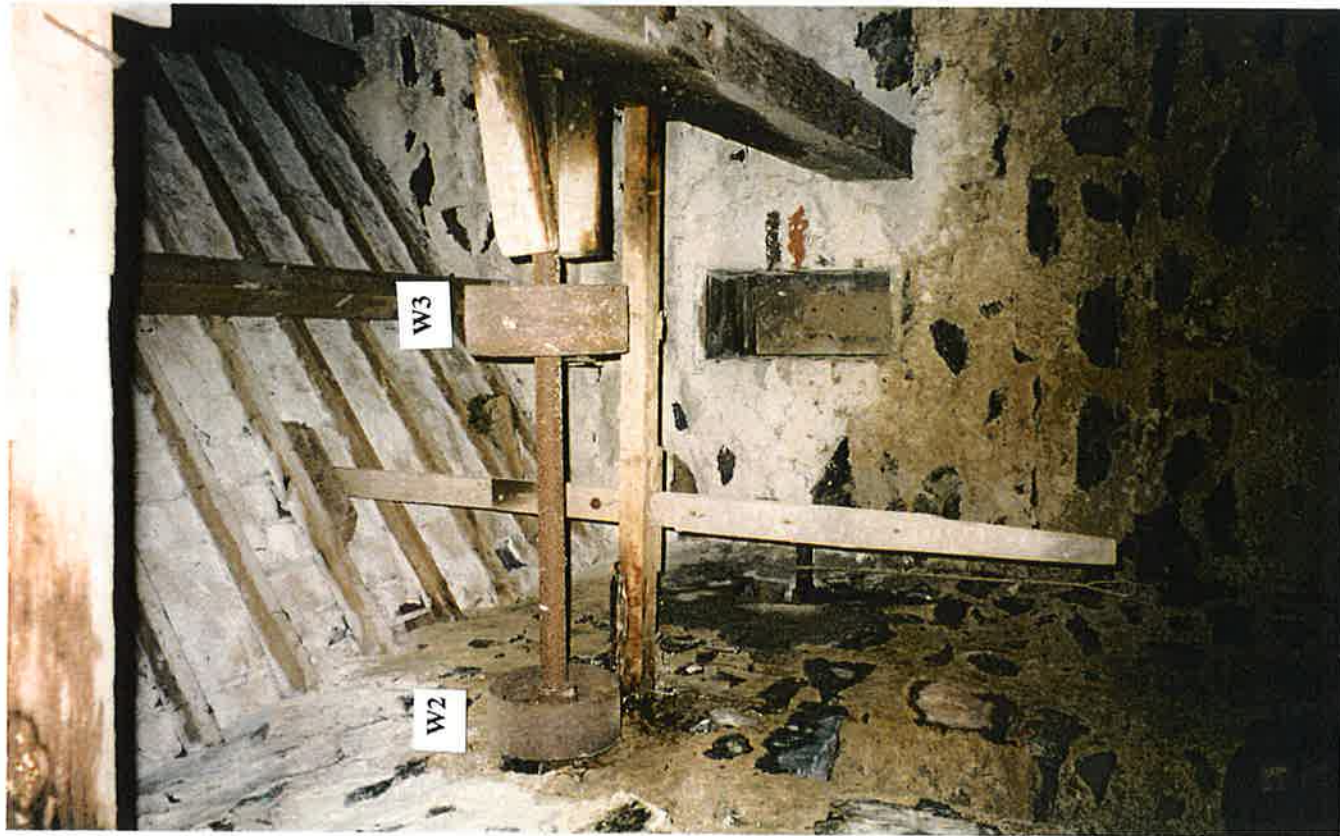
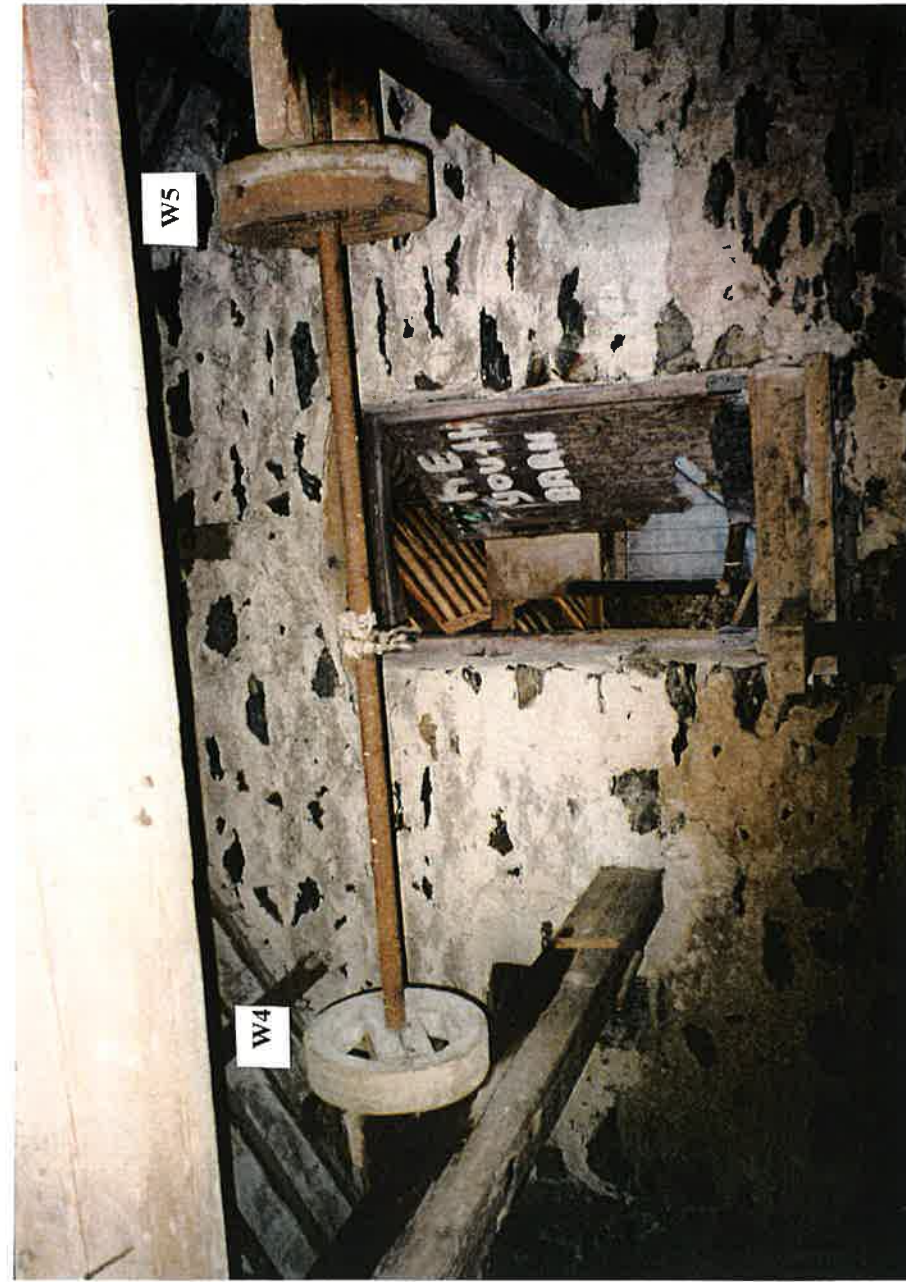
The interior of the 1818 barn.

Plates 14 & 15: showing the drive shaft extending through the south wall of the barn (*Plate 14 left*), connecting to four belt drive wheels.

View from the south towards the loft door, inserted in the original north wall, when the northern compartment was added.

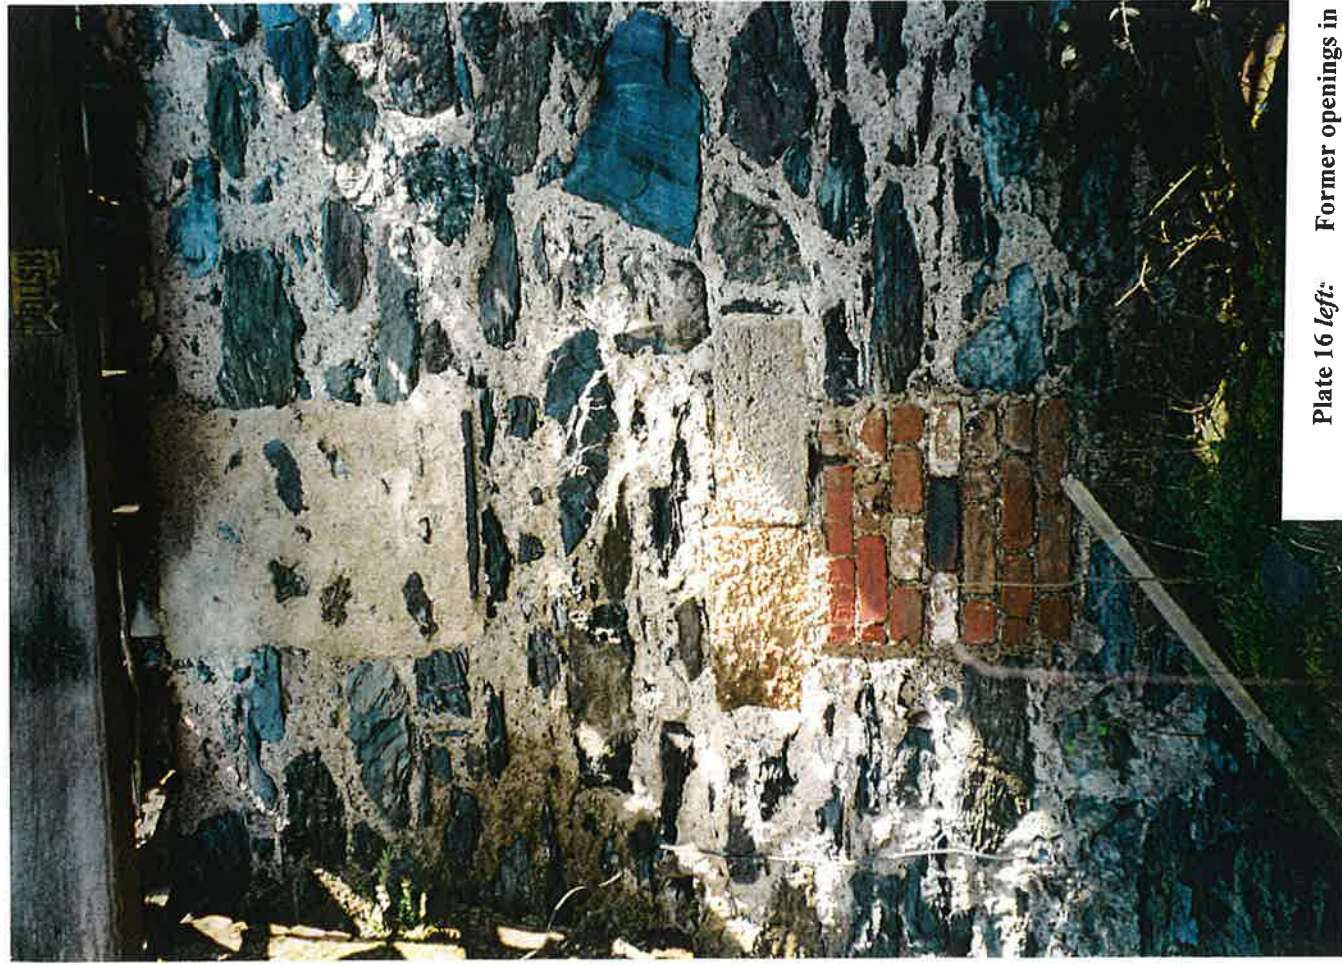
Plate 16 *left*: Former openings in the northwest compartment barn, blocked in 1923, when the root store was added.
