**PLAS EITHIN HOTEL
(FORMER TY MAWR FARMSTEAD)**

LLANFAIR P.G.

HISTORIC BUILDING RECORDING

APRIL 2006

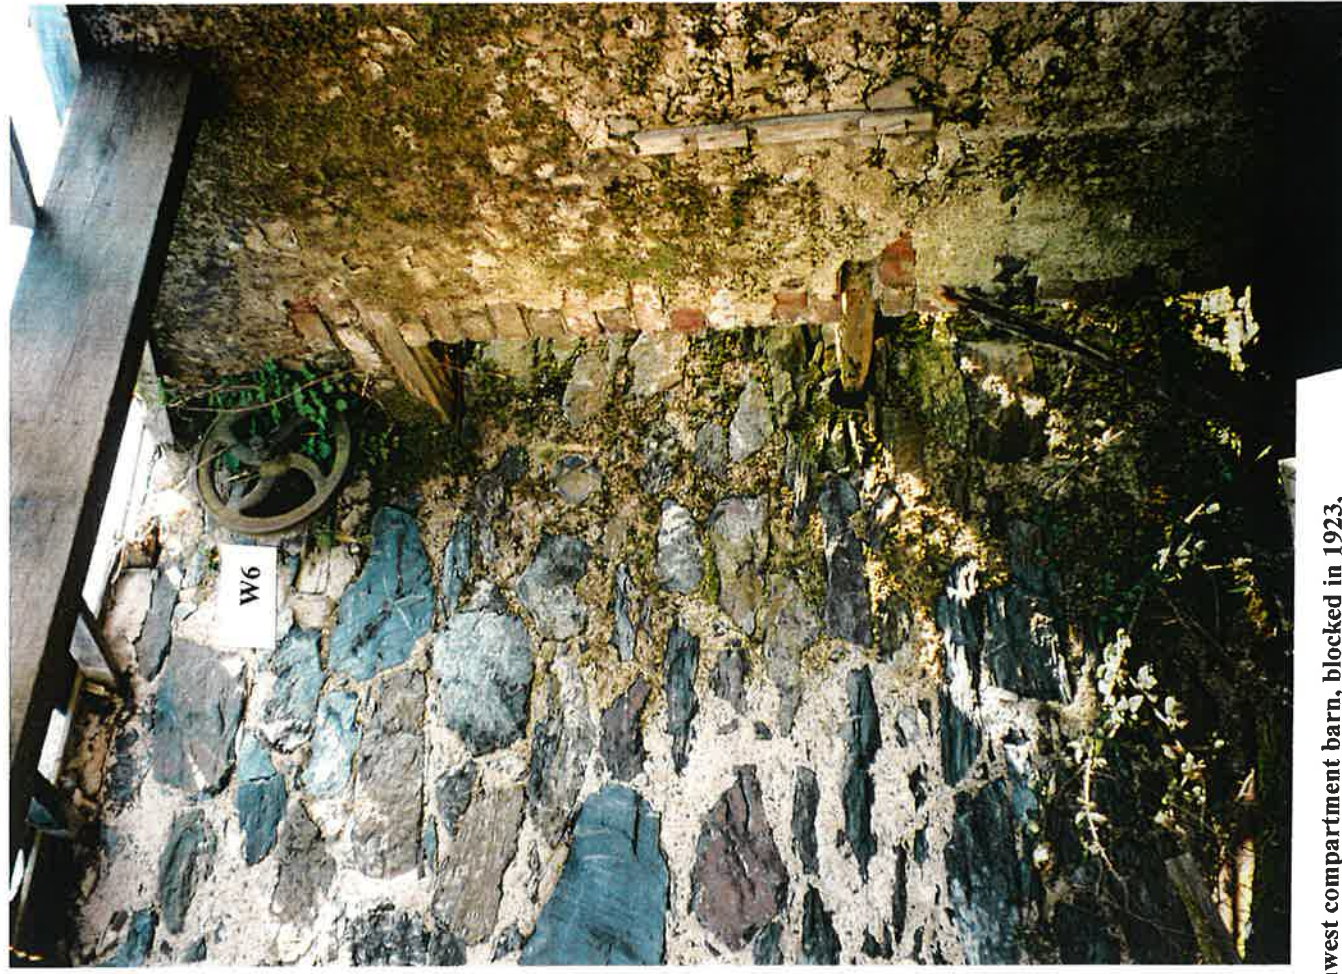
Plate 17 *right*: Rope wheel located in the root store, presumably load sacks for storage.

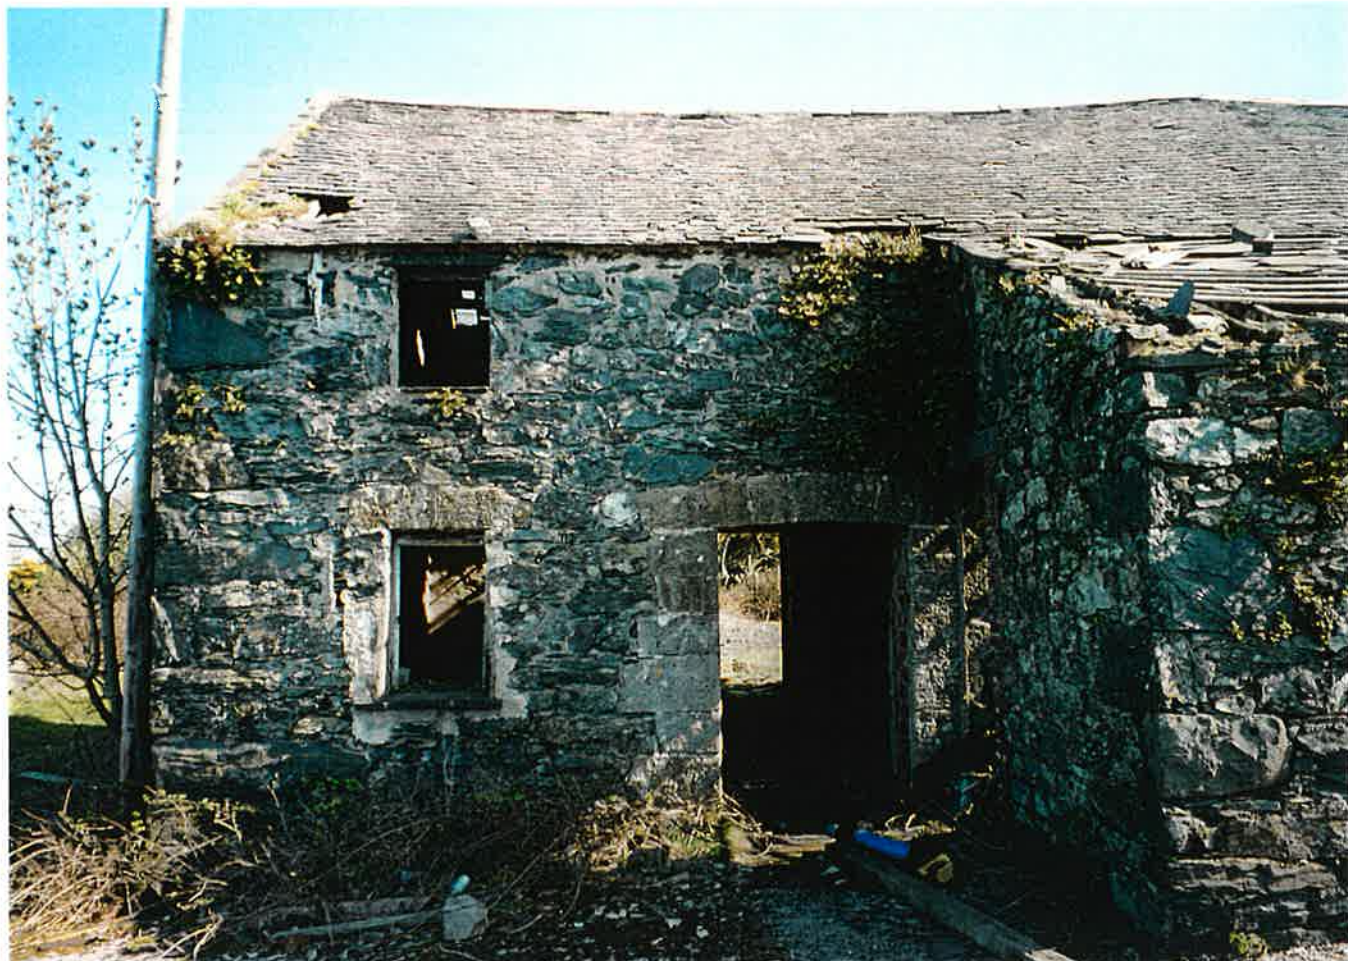
Plate 18 *above*:

5.4 Sometime in the mid to late 19th century, the northern compartment has been added, as indicated on the OS map dated 1900 (*Fig. 3*). The compartment has been constructed in similar materials to the 1818 barn with quartzite dressing framing the rectangular window openings with wooden frames (*Plate 18*). The walls of the northern compartment measure a regular 0.64m thick (*2ft*).

The northwest compartment,
viewed from the southwest.

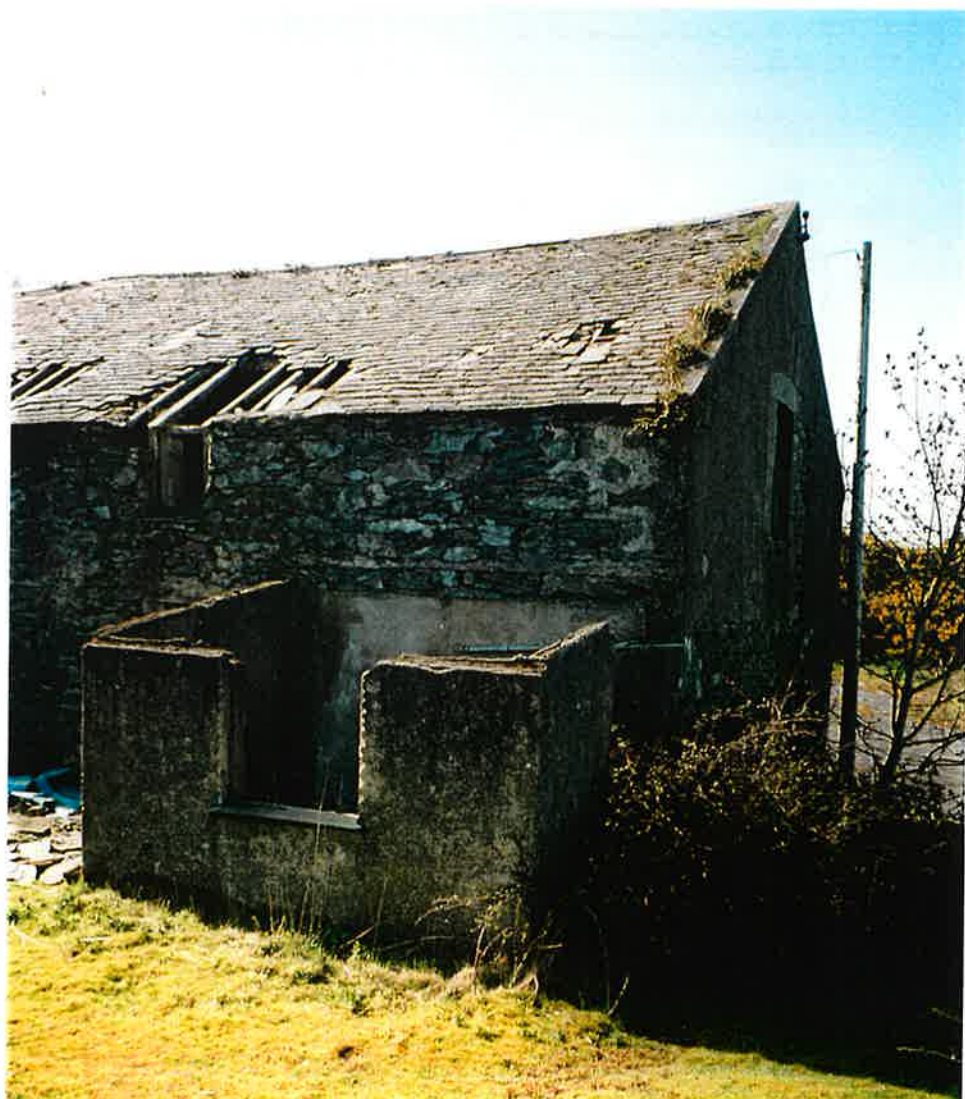
Plate 19 *left*:

as above, viewed from
the northeast.
