*Maes y Priordy, Llandderfel  
Archaeological Watching Brief*

*August 2008*

**EAS Client Report 2008/15**

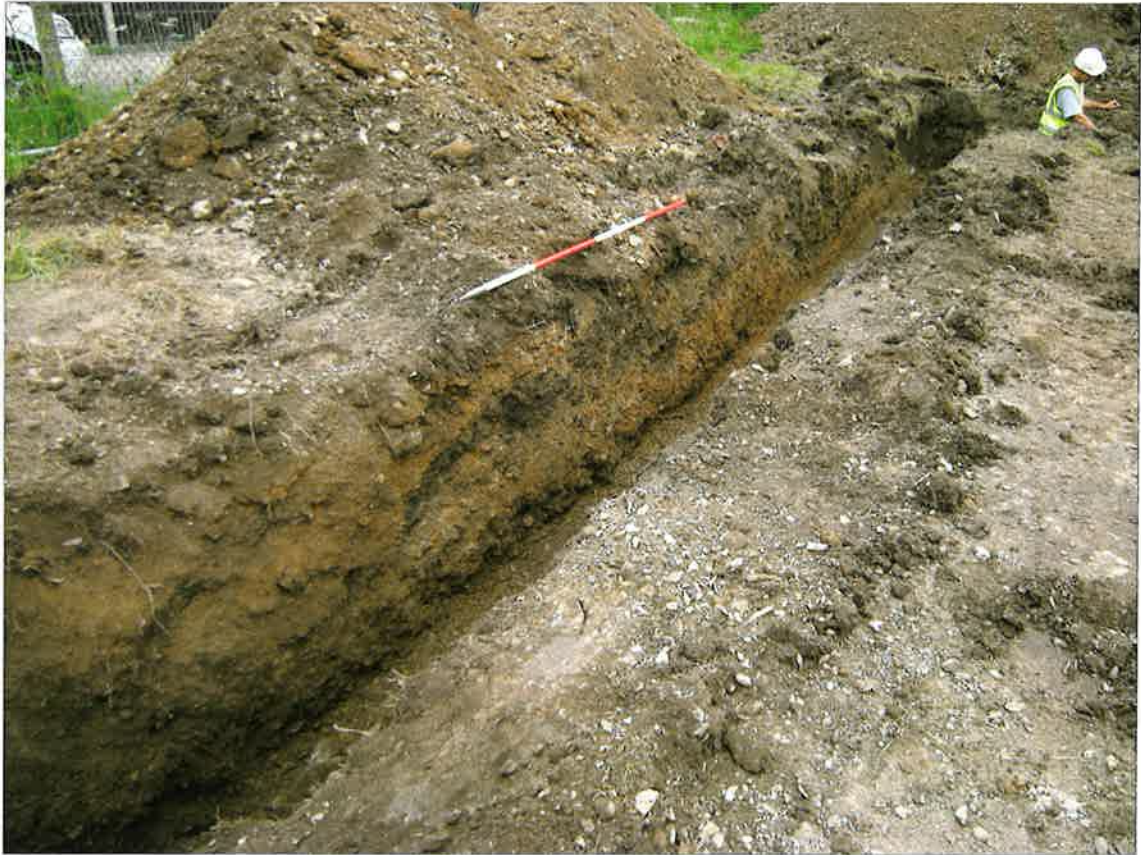
Plate 5: Feature 10

*Feature 10 only occurred in the north eastern face of the footings of Plot 1. It would appear to*

*represent a linear feature which just impinges with the area disturbed by the ground works. It does not appear in the opposite face of the footings trench, nor the trenches at right angles, thus it is likely that the original features either curves slightly or turns to the north east. The feature is at least 0.65 m deep and extends for 3.3 m along the footings. It was filled by a layer of clast supported gravel up to 0.40 m thick (Context 8) over a grey/brown silt deposit (Context 9). Unfortunately no finds or dating materials were recovered from this feature. It is possible that the feature is aligned on the extension of Maes y Priordy and that the feature is therefore relatively modern, however not enough of this feature was exposed to confirm this assumption.*

*Only one feature of archaeological interest was recorded. This linear feature was only exposed in the north eastern footing of Plot 1. Its possible alignment would suggest that it may be associated with the modern construction of the extension to Maes y Priordy towards the south east. No dating evidence, however, was recovered from this feature and it is therefore also possible that the feature may be much earlier. All other features recorded were modern in origins.*
