***Former Council Depot, Wexham
Street, Beaumaris
Watching Brief***

July 2010

EAS Client Report 2010/21

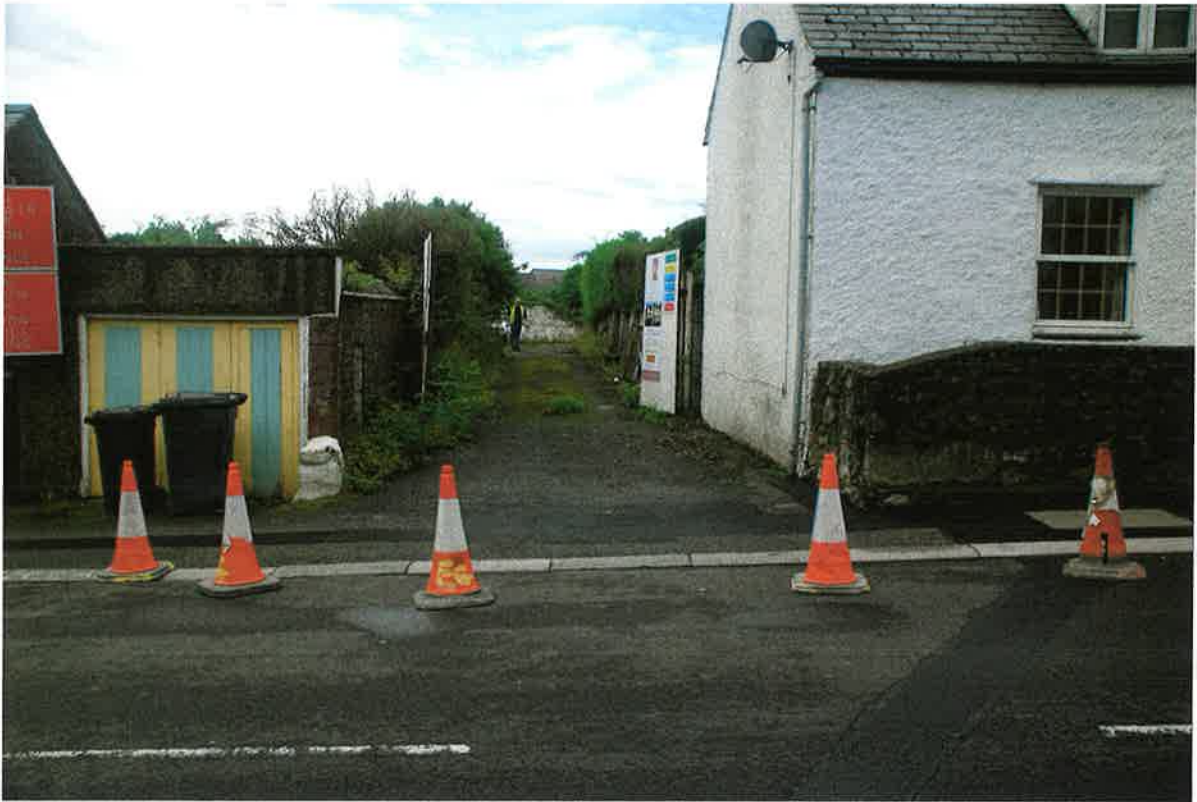
Plate 1: Entrance Passageway

Three main areas were recorded consisting of the passageway leading to the site (Plate 1), Plot 1 covering the site of the Old Council Depot (Plate 2) and Plot 3 behind 43 and 45 Wexham Street (Plate 3) (Figure 2). The works in the passageway consisted of the construction of a new drain along the length of the passage. In both Plots 1 and 2 the footing for the new houses were observed together with the drainage works associated with these buildings.

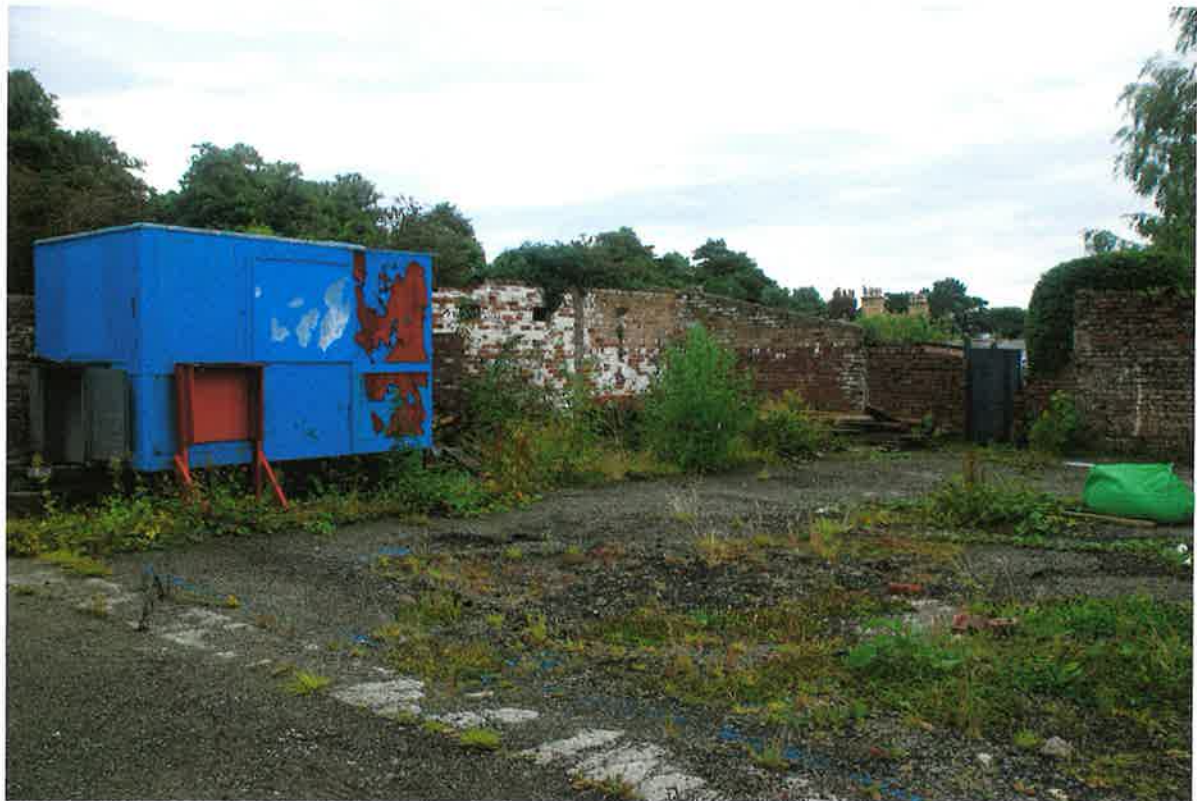
Plate 2: Plot 1

Within Plot 1, the footings for the houses and the associated drainage works proved this area to be highly disturbed by modern services which cut through a layer of disturbed soil up to 1 m thick (Context 7) and no other visible features.

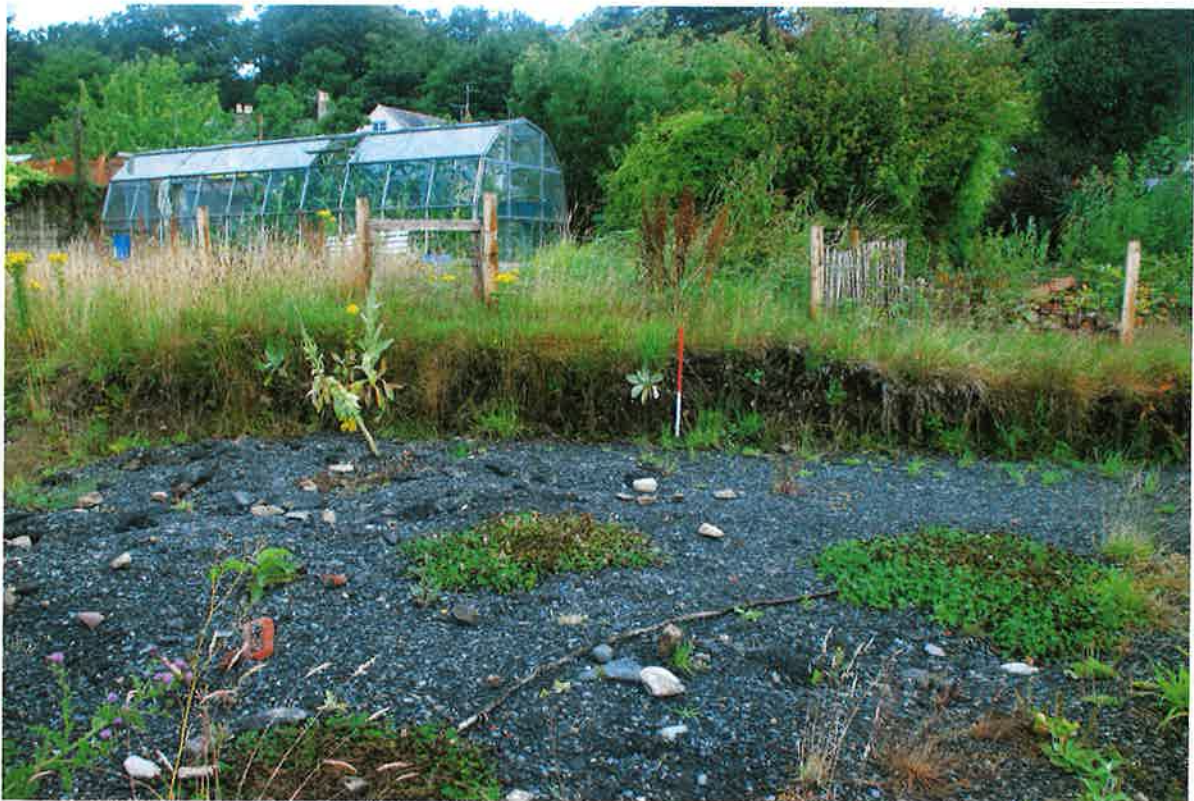
Plot 2 proved to have been previously disturbed, between 0.5 and 1.0 m of deposits had been removed over the whole of the plot (Plate 4), indeed the level of destruction proved to be greater than initially expected as a layer of crushed

Plate 4: Plot 2, level of previous disturbance.

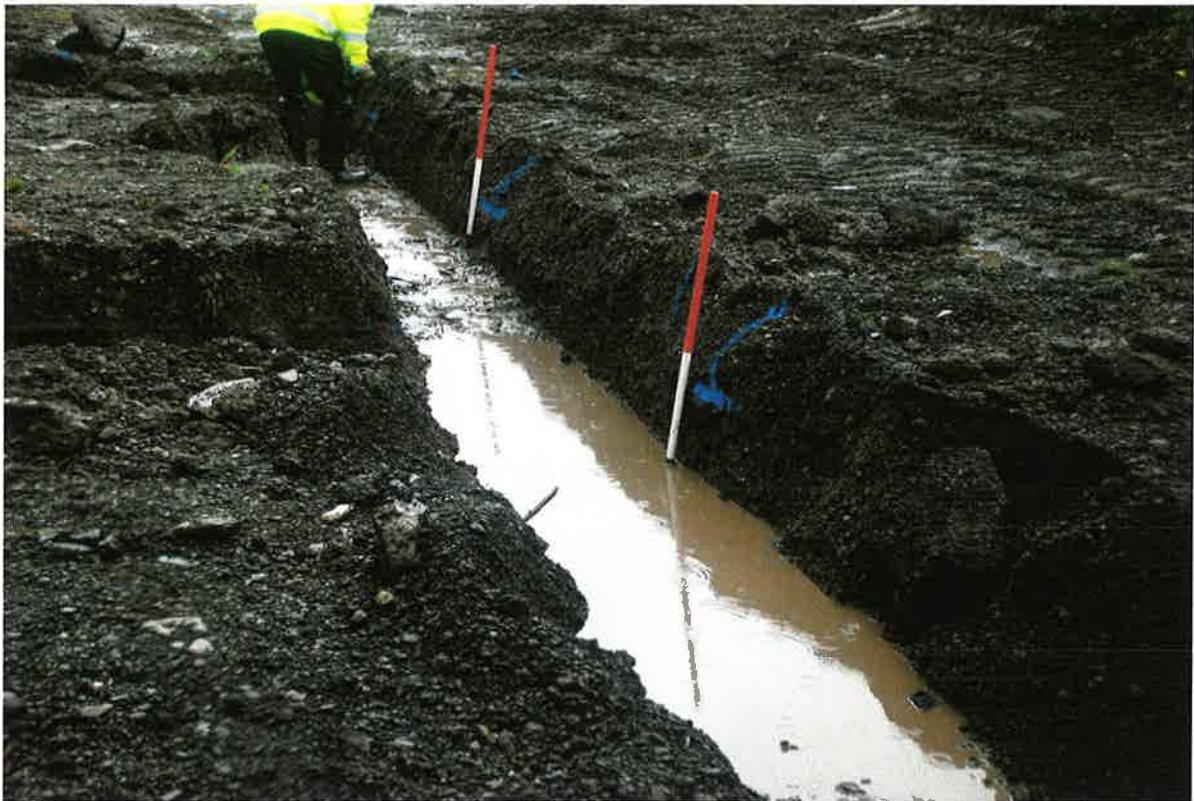
tarmac and other modern building debris up to 0.5 m thick (Plate 5) had been imported onto the plot. A hint of existence possible features in disturbed area was recorded in the standing section at the northern end of the plot. Here the remains of a "French Drain" were observed. It consisted of a trench lined with slate and filled with cobbles (Context 6, Plate 6). When this section was cut back, this feature disappeared suggesting that only the north western end of this feature had survived. Neither the direction of this drain, nor its extent, are known. The use of slate to line the drain would suggest a modern date for this feature.

Plate 5: Depth of imported material in Plot 2

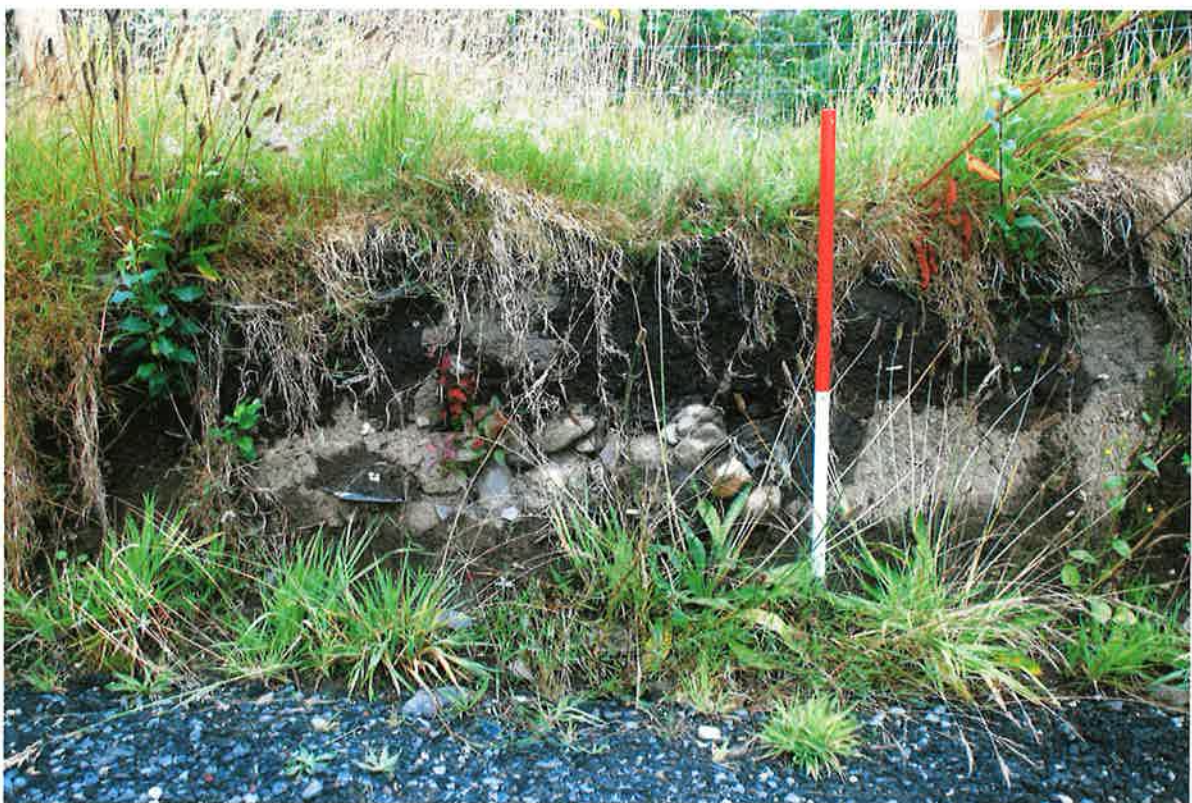
Plate 6: Drain disturbed by previous works

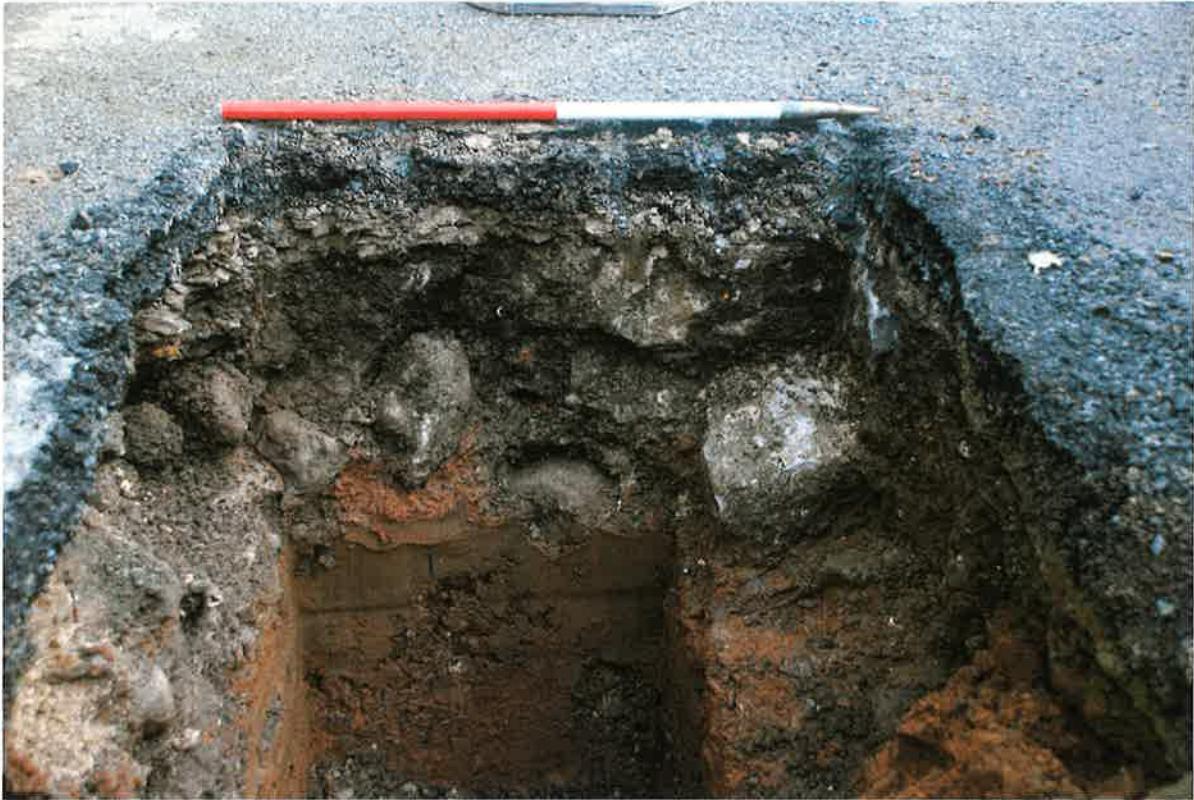
At the northern end of the passageway the remains of two walls were recorded. Context 3 ran across the line of the passageway and continued the line of the street frontage on either side of the development area (Figures 3 and 4). This wall was disturbed by a drain running down the length of the passageway, but it appeared to be a well-constructed wall of limestone block in a pale yellow mortar (Figure 5, Plate 7).

Plate 7: Remain of Wall (Context 3) at north end of passageway

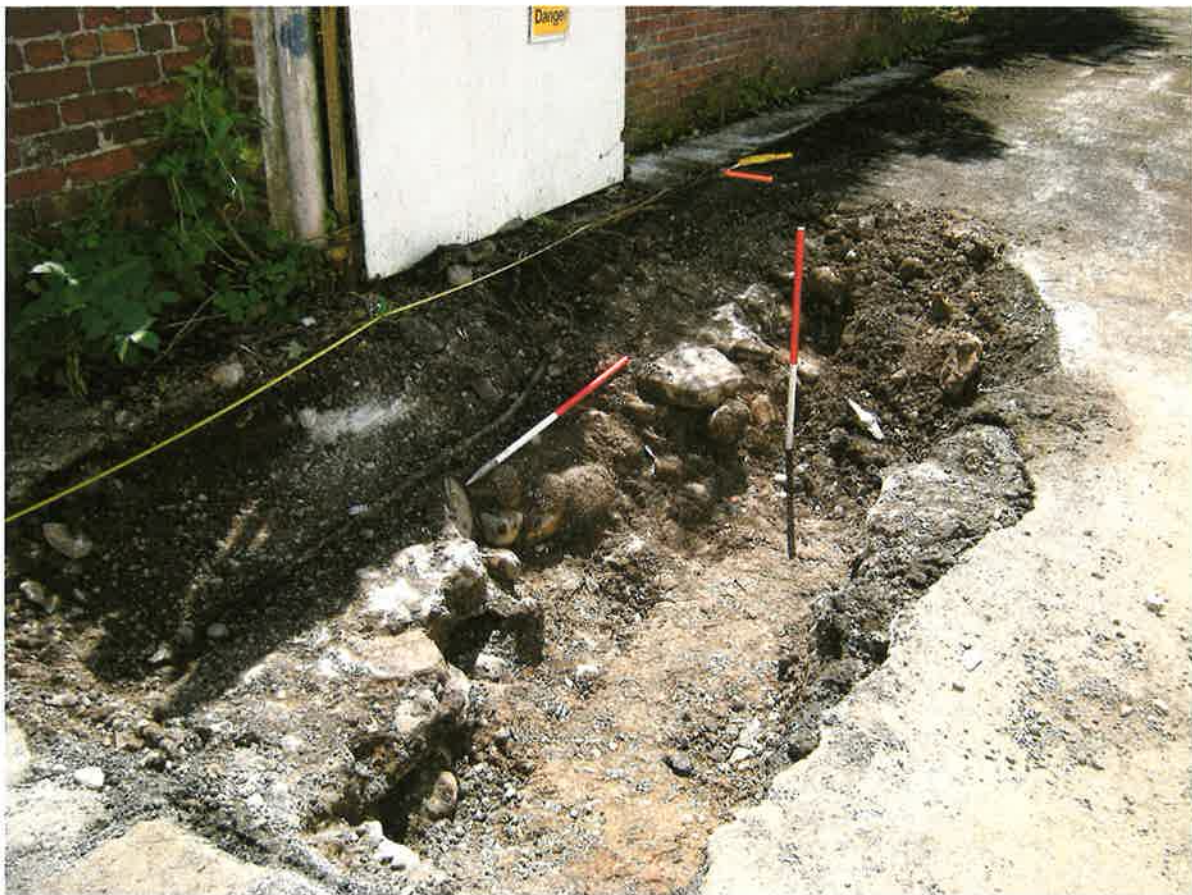
Plate 8: Wall (Context 5)

A second wall (Context 5) ran along the length of the passageway (Figure 4). In all a 12.8 m length of this wall was observed, although the relationship with Context 3 was uncertain. The character of this wall was different to that of Context 3. It consisted of a series of rounded boulders with the occasional squared block. Only the occasional patch of pale yellow mortar was recorded, however there were many voids within the structure of this wall. This relatively poor construction may only mark the footing of this wall. The line of the wall was at a slight angle to the line of the passageway, possibly suggesting that it

related to a previous land division system. No dating evidence was recorded from either of the wall observed.
