**Beaumaris Castle Visitor Centre
Archaeological Watching Brief**

I.P. Brooks

EAS Client report 2019/012

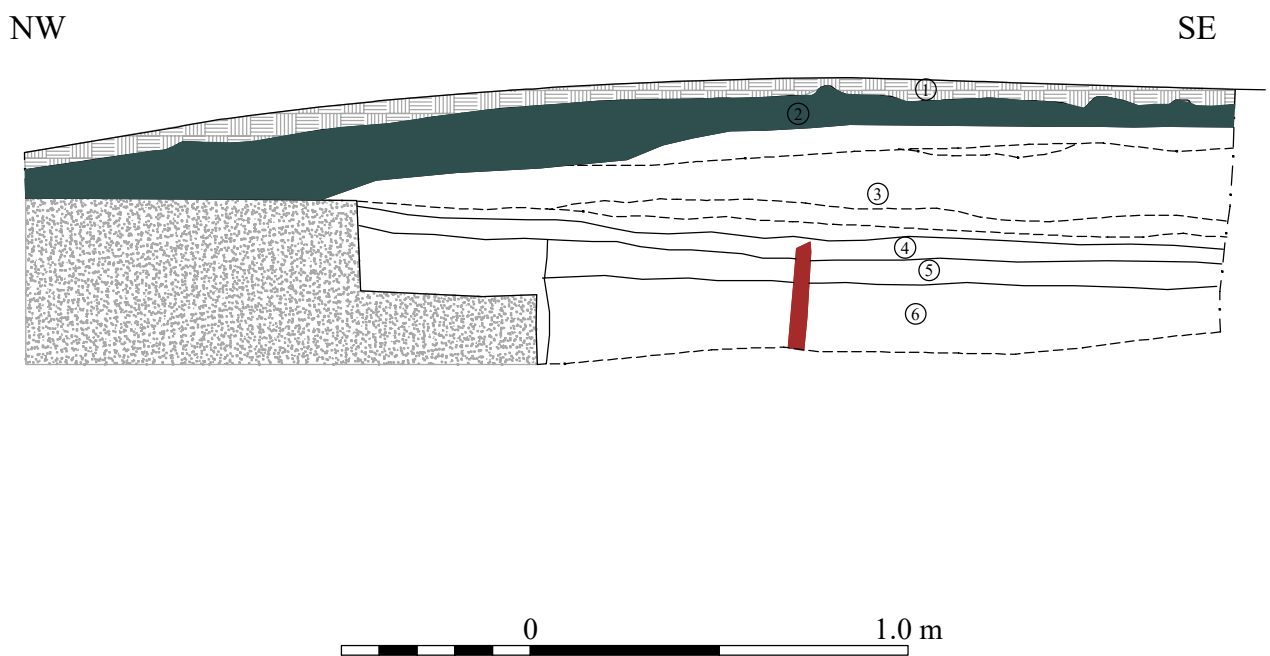
Figure 2: Extension Trench Section
Scale 1:20

The top 0.52 m of the trench dug for the new extension (Figure 2, Plate 2) consisted of modern deposits associated with the construction of the current visitor centre in 2007 and the use of the site thereafter. Below a layer of tarmac (Context 1) was a layer of shales chippings (Context 2), 100 mm thick that acted as a base for the tarmac. Below this was a deep deposit of crushed limestone up to 300 mm thick (Context 3). It was made up of a series of tips of material separated by bands of yellow sandy material. This layer was over a thin layer of mid brown clayey soil (Context 4) which is assumed to be a trampled layer formed during the creation of the make-up layer above. Below Context 4 was a layer of yellow/orange gravel (Context 5).

It was only at the base of the trench that any deposits not associated with the construction of the visitor's centre were revealed. This was a single layer of dark grey brown soil (Context 6) of nineteenth, or early twentieth century date, as it included fragments of blue and white transfer printed pottery and fragments of glass beer bottles stamped with the inscription that included the words "Bangor" and "Llangefni". This deposit had been near to the surface when the current visitor's centre was built as it was cut by three wooden pegs which are assumed to be part of the marking-out pens or levelling boards for the construction of the building.

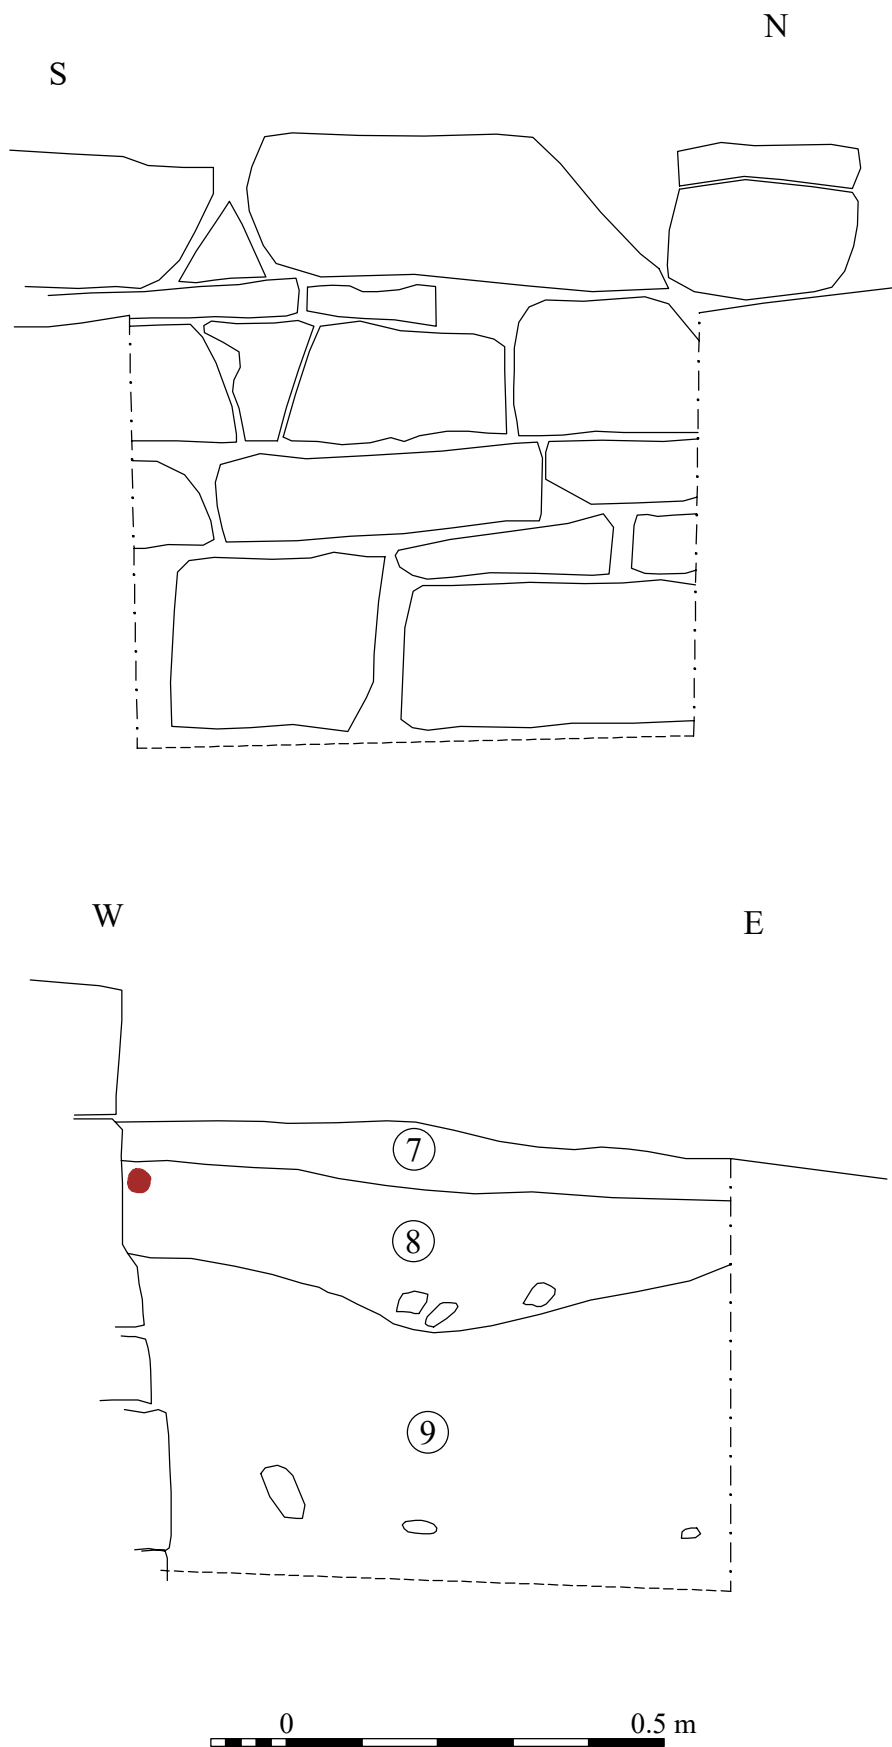
Figure 3: Reception Trench Sections
Scale 1:10

A very simple stratigraphy was recorded in the small trench dug as a reception pit for the gas pipe (Figure 3, Plates 4 and 5). Below 100 mm of topsoil (Context 7) was up to 180 mm of a dark grey brown clayey silt (Context 8). This layer tended to be slightly thicker in the middle of the trench, however the top of this trench was highly disturbed by the roots of the ivy which grows on the boundary wall to the site. The bottom 430 mm of the trench consists of a single layer of yellowish-brown clayey silt (Context 9) which contained the rare fragment of nineteenth or early twentieth century ceramics. There was no sign of a cut between Context 9 and the boundary wall to the site, suggesting it probably was deposited against a standing structure.

The boundary wall (Figure 3, Plate 4) appears to extend to below the level of the excavation. However, when the gas pipe was driven through the wall, no significant resistance was met. This was at a level just below the excavated level suggesting the base of the wall was at, or just below the level of the excavation.

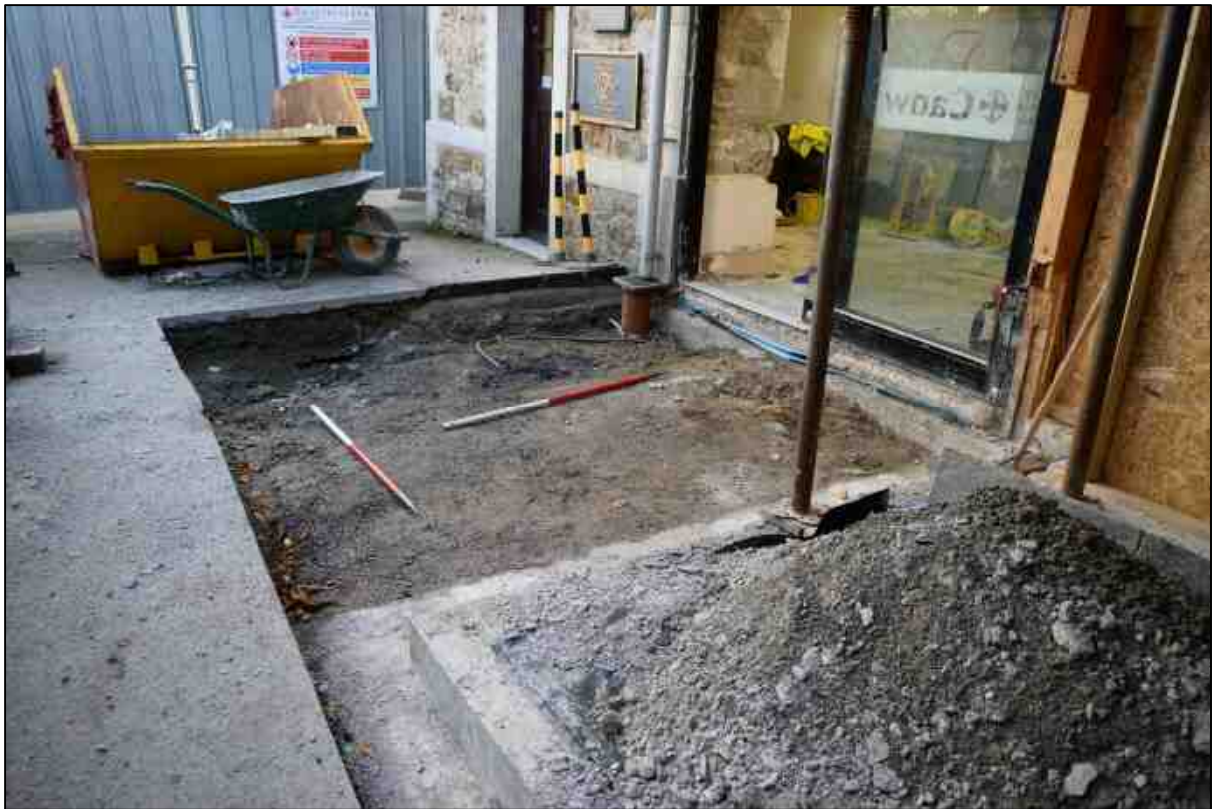
Plate 1: Location of the visitor centre extension

At the time of the fieldwork (November – December 2019) Cadw were in the process of extending and improving the visitor centre attached to Beaumaris Castle. Siting between the western moat and Castle Street the existing visitor’s centre incorporates the Ticket Office originally built in 1954 (<https://cadwpublic-api.azurewebsites.net/reports/listedbuilding/FullReport?lang=&id=84771>). The Ticket Office was extended in 2007 to provide a more extensive shop and visitor’s centre. As part of this work, a new extension is being added to the north eastern side of the building (Plate 1). The work also required the re-positioning of the gas supply, to the site, and thus a small archaeological trench was dug, within the scheduled area, to act as a reception pit for the gas pipe (Plate 3) and a trench was dug in the pavement of Castle Street to extend the line of the existing gas pipe (Plate 6).

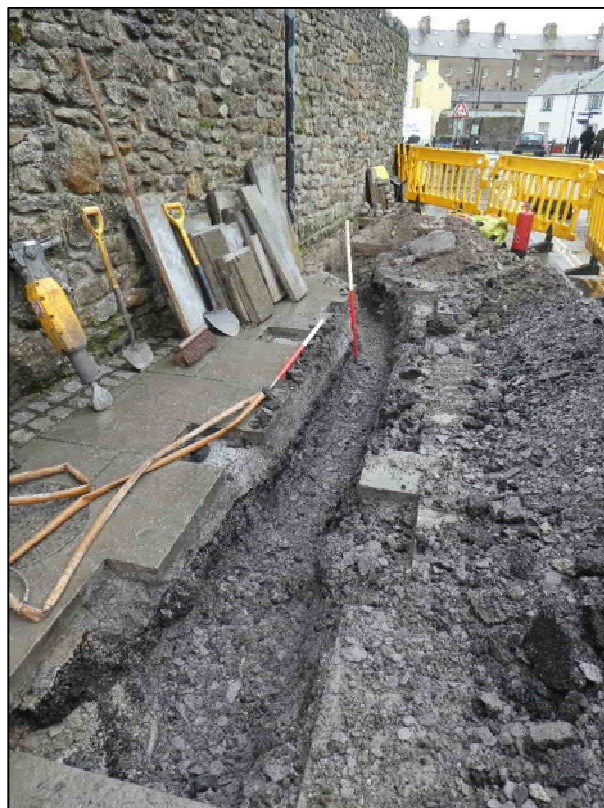
Plate 6: Trench for the gas main

The re-design of the visitor's centre required its gas supply to be re-located. This resulted in a trench approximately 9.7 m long and 450 mm wide being dug in the pavement to Castle Street (Plate 6). Over much of this length this trench was 500 mm deep. Through out the majority of the trench was cut through modern deposits associated with the pavement and the

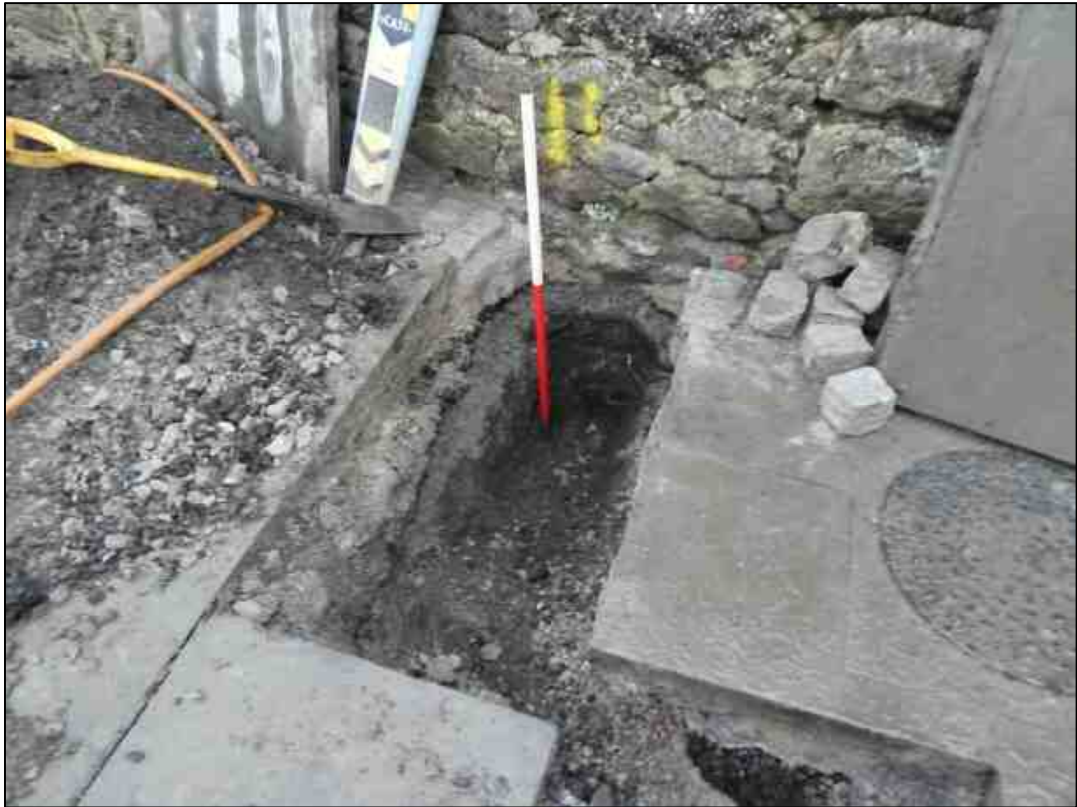
Plate 7: Section of gas main trench adjacent to the boundary wall

underlying sewer. The exception to this was encountered at the northern end of the trench where the pipe was driven through the boundary wall (Plate 7)

Below approximately 200 mm of modern deposits was a layer of yellowish-brown clayey silt which is similar to Context 9 (see above) and it contained the rare fragment of nineteenth or early twentieth century ceramics.
