**Wenallt Wool Factory  
Standing Building Survey**

***EAS Client report 2022/04***

**Grwp yr Aran**

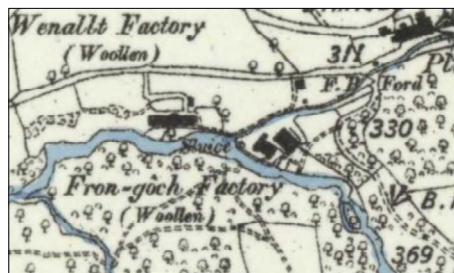
1888 Ordnance Survey Merionethshire XXXVII.NE

The range of historic Ordnance Survey mapping between 1887 and 1954 show the decline of the site (Figure 2). Within the First Edition mapping, surveyed in 1887 and published in 1888, the buildings on the site are all shown as roofed, however, by the Second Edition (revised in 1900 and published in 1902) some of the buildings have lost their roofs. This pattern is maintained in the edition surveyed in 1938, but published almost a decade later. By edition surveyed in 1949 and published in 1954, all of the buildings are now roofless.

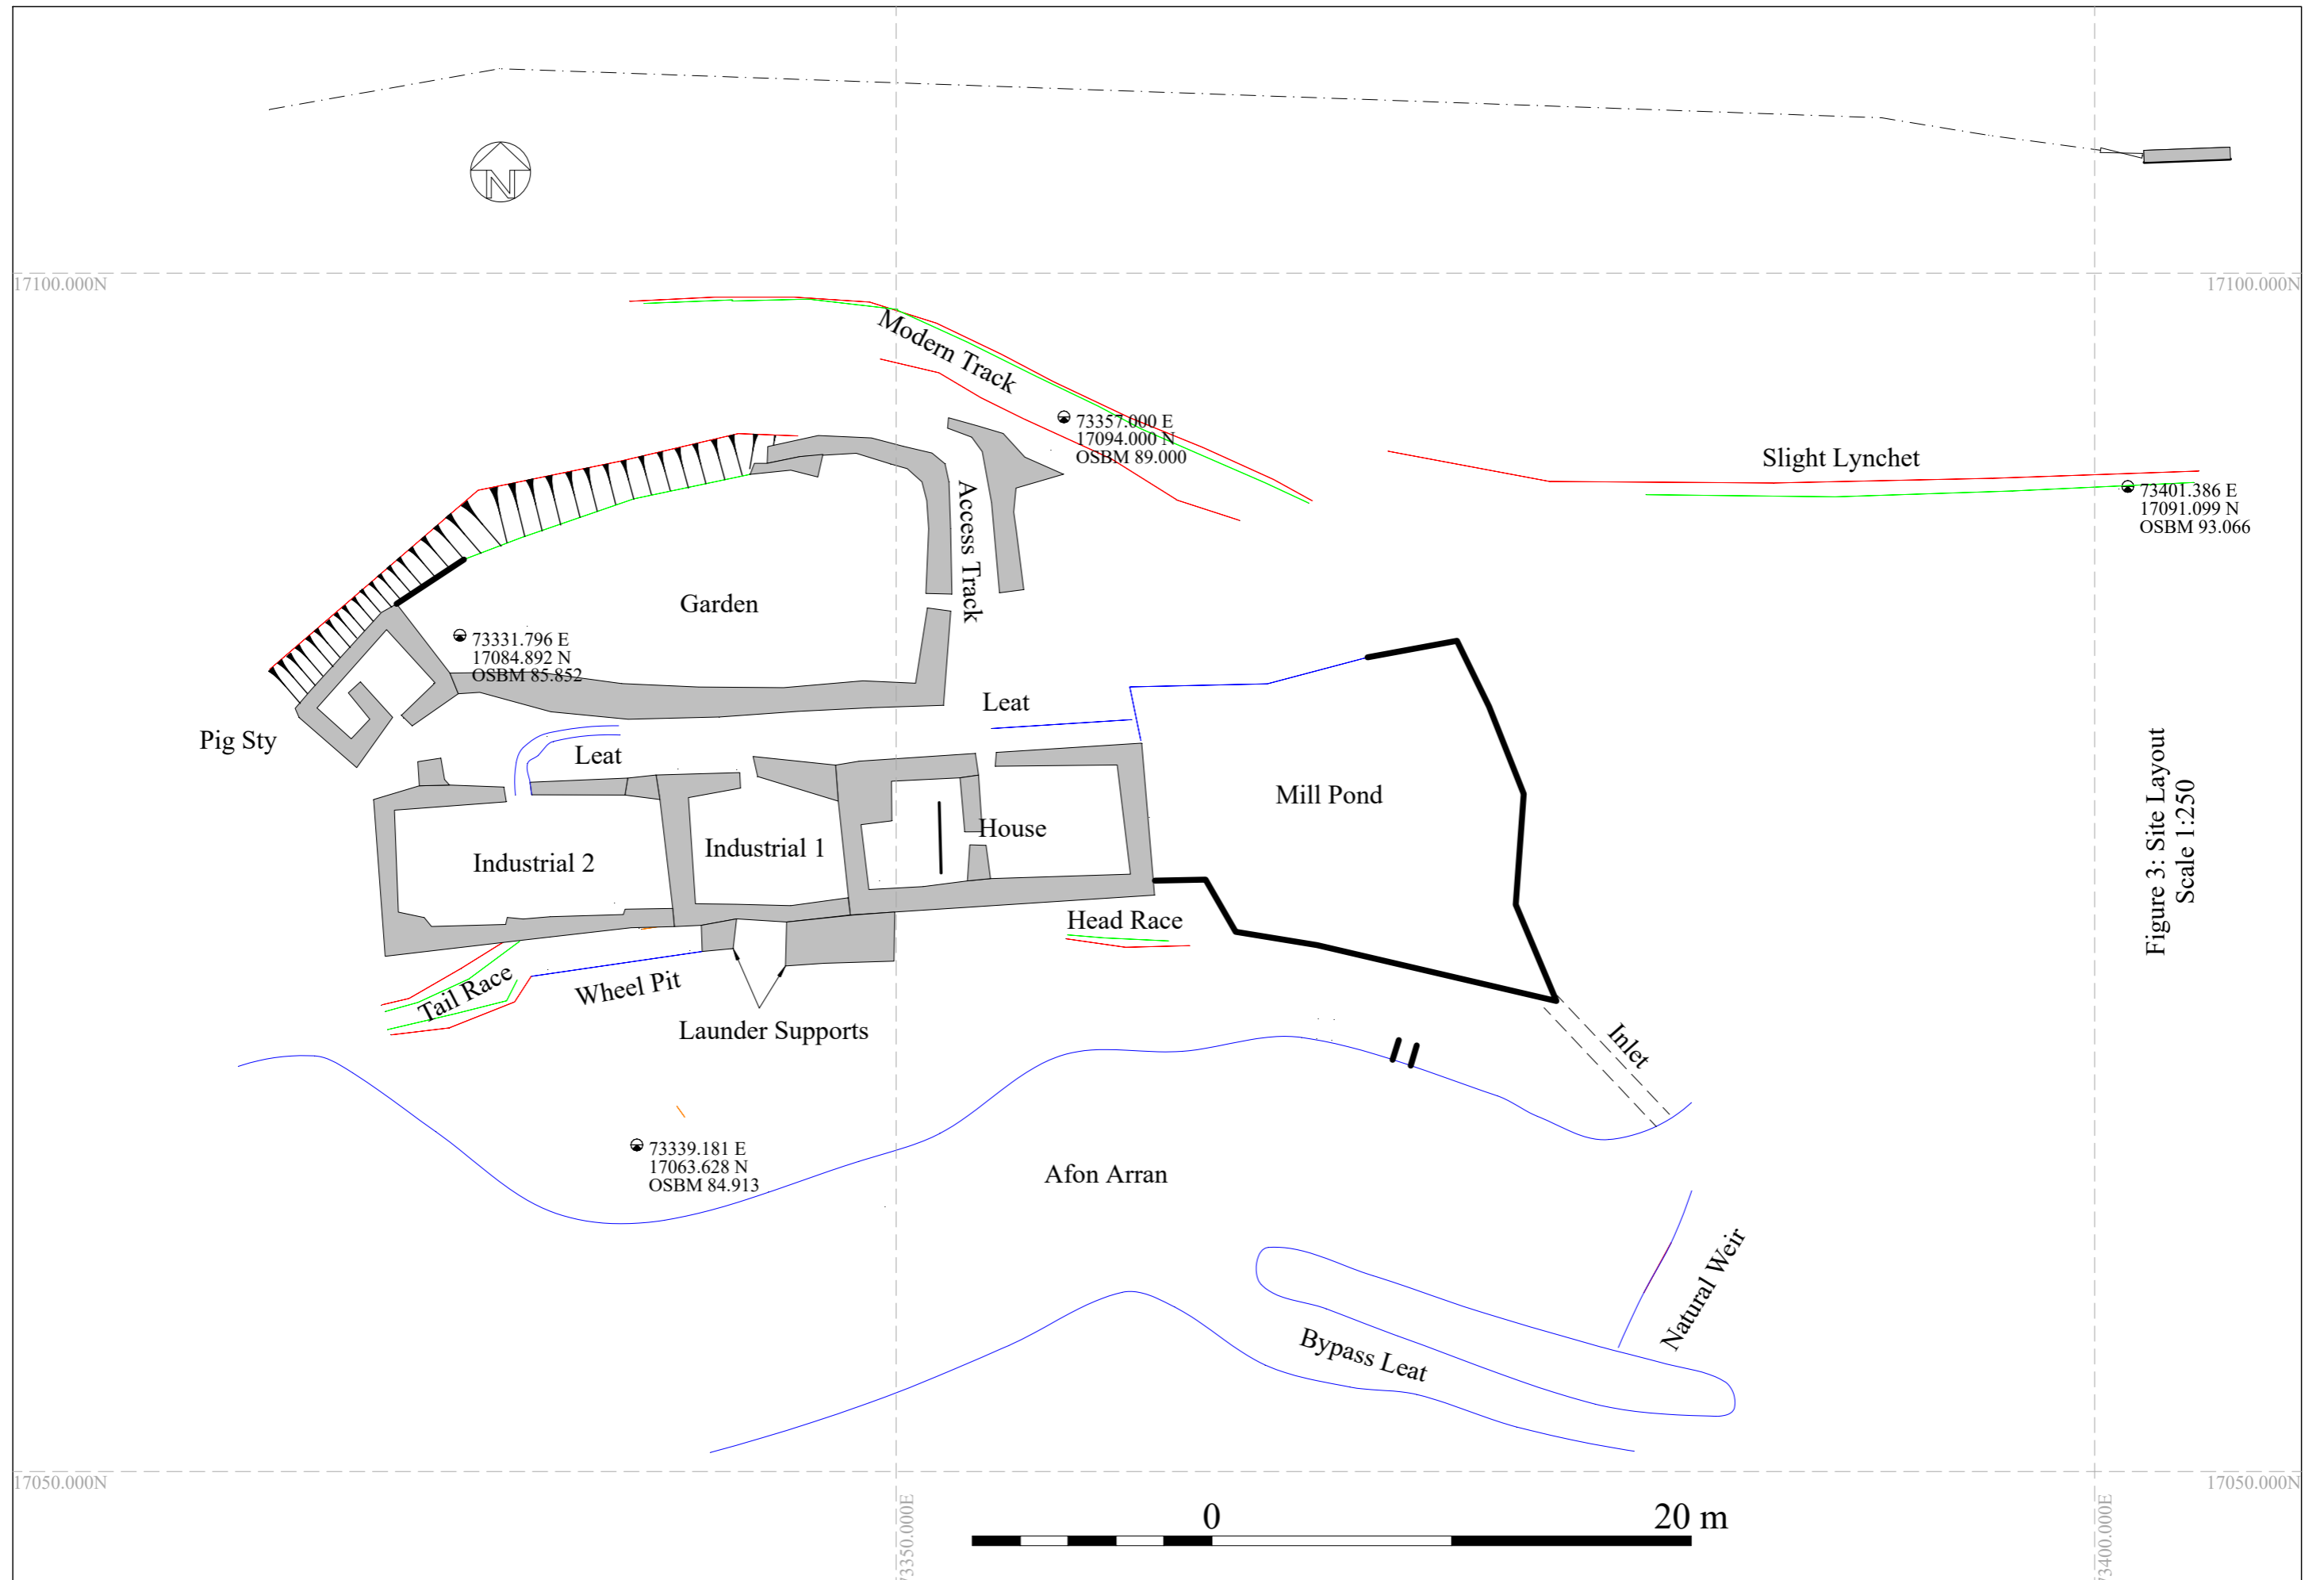
Figure 3: Site Layout  
Scale 1:250

The surviving remains of the Woollen Factory (Figure 3) consist of a linear range of buildings 32.05 x 6.47 m in size which can be shown to consist of three separate units constructed at different times (Figure 4). Outside the main range there is evidence of the water power system used in the final phase of activity, a possible pigsty and a series of boundary walls forming an enclosure 22.6 x 9.45 m in size. This enclosure forms one side of the access track to the buildings and has what is probably a set of steps between it and the access track.

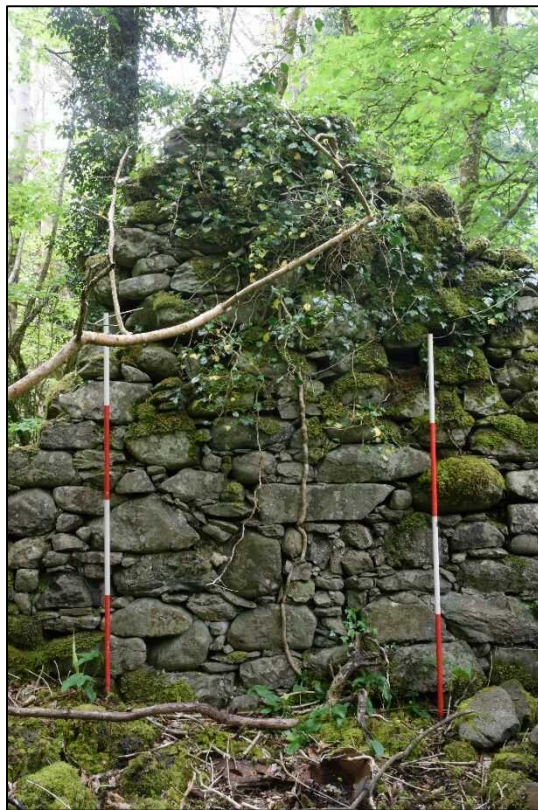
At the eastern end of the building range is the earliest phase of building. This is a probable house, 12.59 x 6.36 m in size, with a fireplace in its western gable. Generally constructed of large boulders with the exception of the western gable end (Plate 2) which includes smaller, broken stone inserted between the boulders. This gable also includes a fireplace 2.82 x 1.3 m in size placed adjacent to the southern wall of the building. There is a central doorway in the northern wall (Plate 3) and three windows, one of which has been blocked. In the south wall is a large window (Plate 4), 1.83 m wide with a slight internal splay. In the northern wall are two windows (Plates 5 and 6), one of which was blocked (Plate 6). These windows are 0.83 and 0.75 m wide, with the eastern window having an internal splay.

Plate 2: Western gable wall of the house, looking east

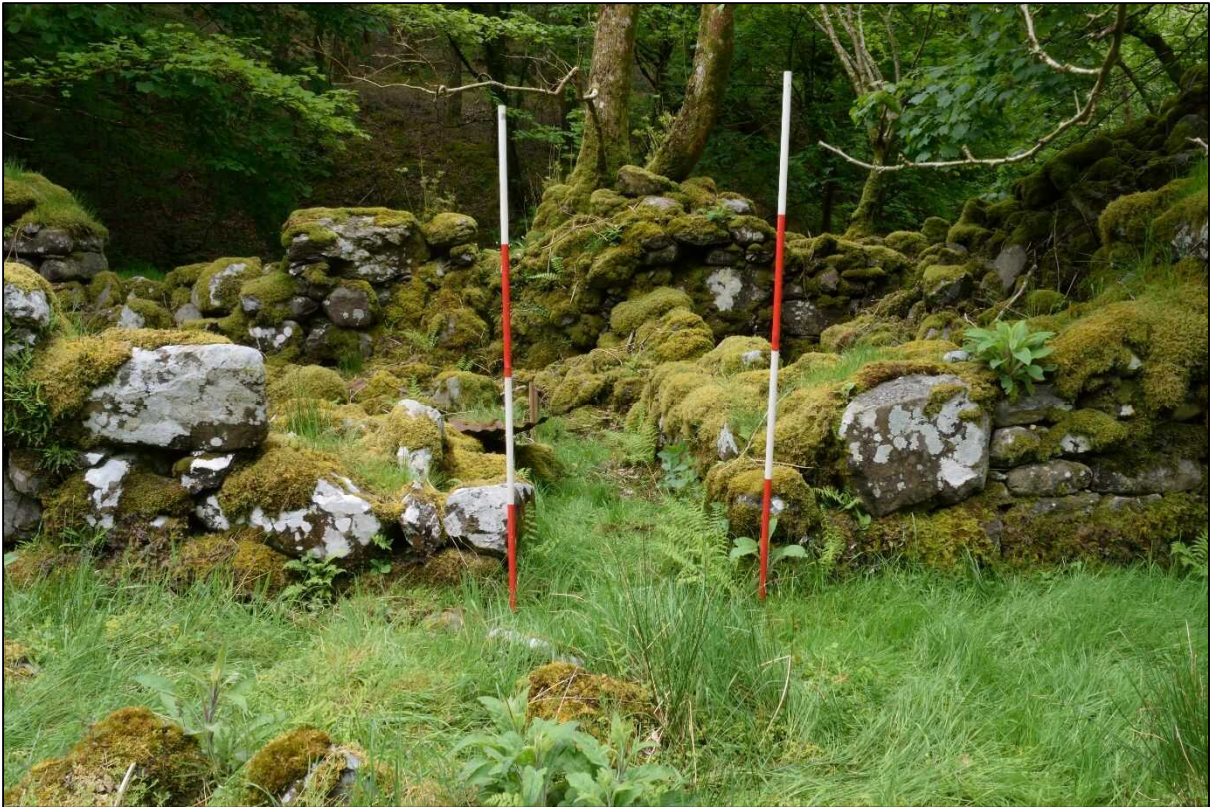
The house is divided into two rooms by a narrow wall (Plates 3 and 8) which appears to be a later insertion into the building. This wall is only 0.7 m wide which can be compared to the 0.9 m of the main structure. It has a central doorway, 0.6 m wide. There is also another short length of walling exposed beneath the tumble from the western gable, the function of which is unknown. Both the dividing wall and the length of wall buried below the collapse are rather close to the fireplace and are, therefore, of a later date.

Plate 3: Doorway to the house

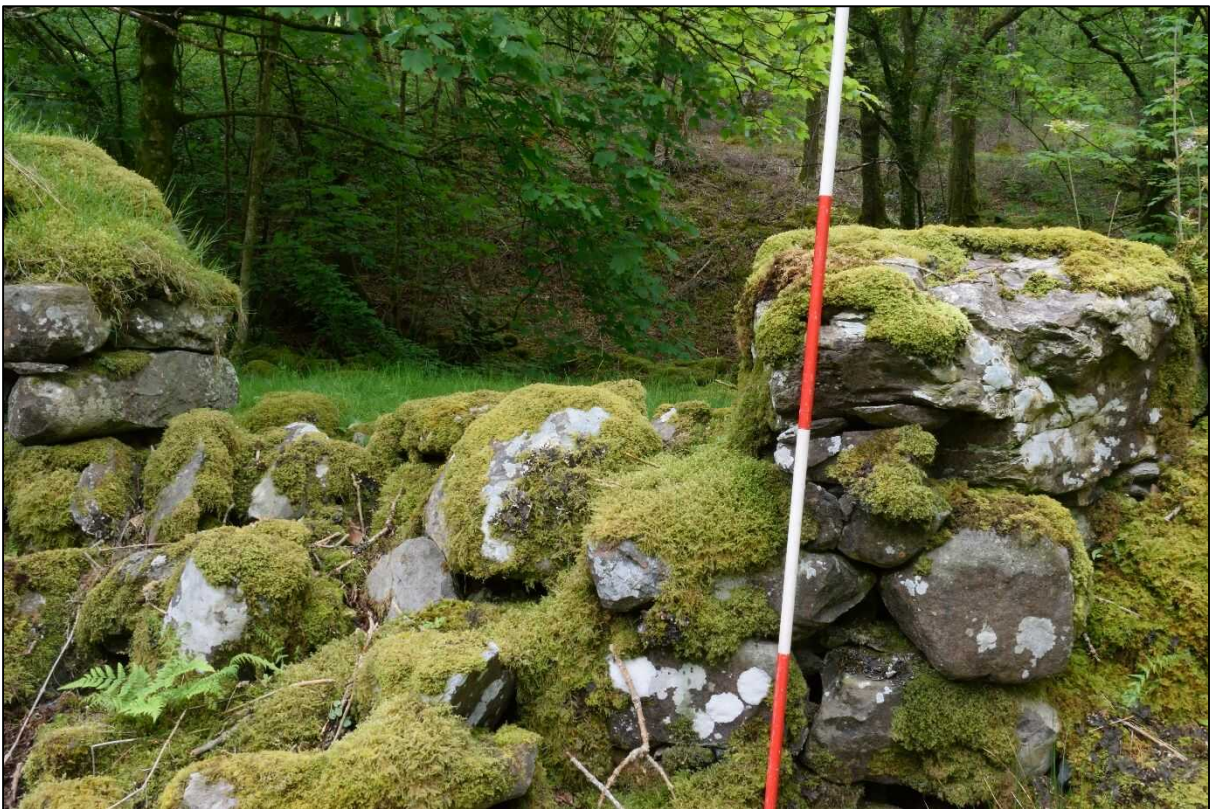
Plate 4: Window in the south wall of the house, looking south

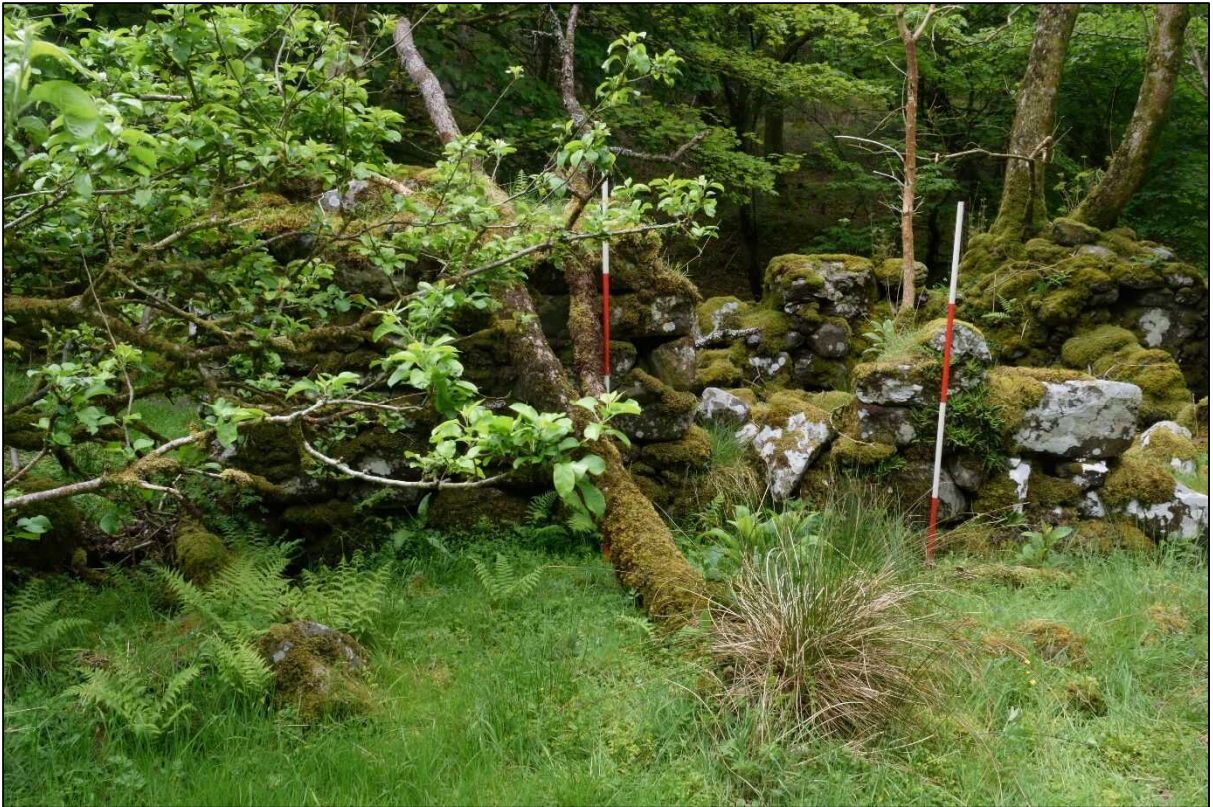
Plate 5: Window in the northern wall of the house, looking south

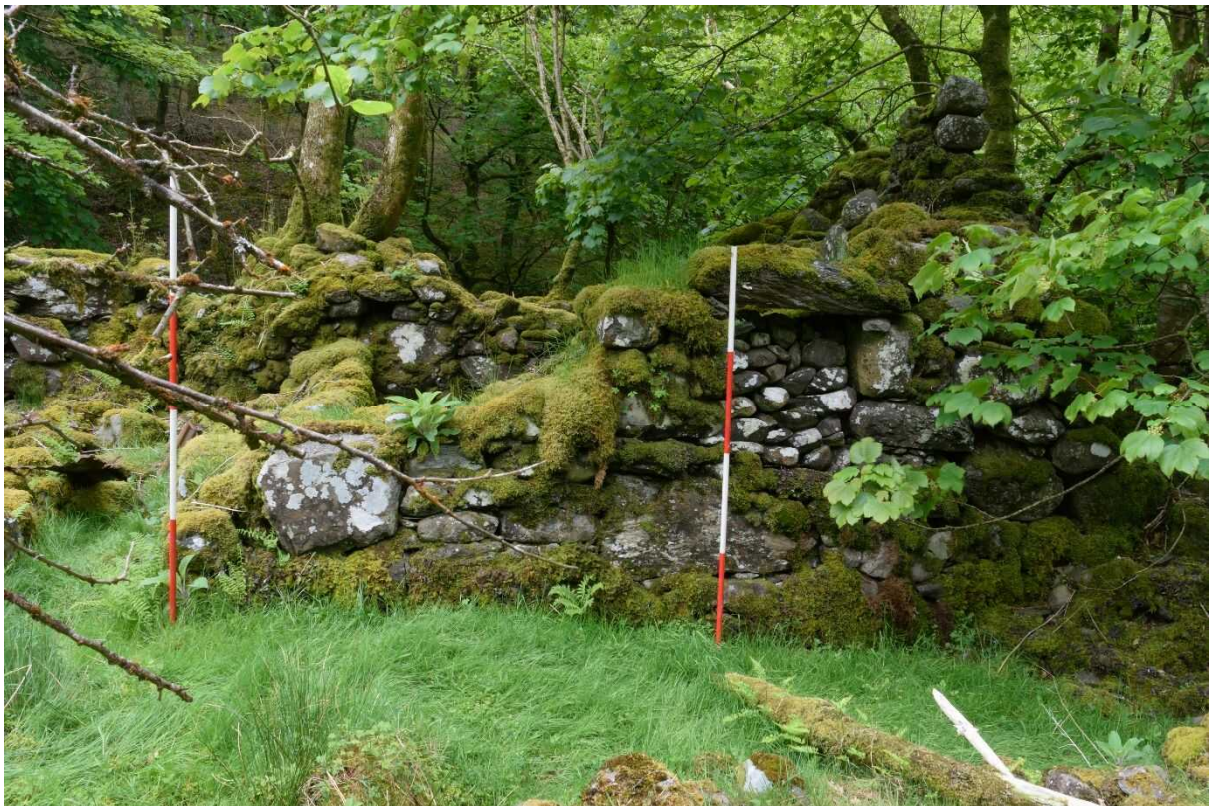
Plate 6: Blocked window in the northern wall of the house, looking south

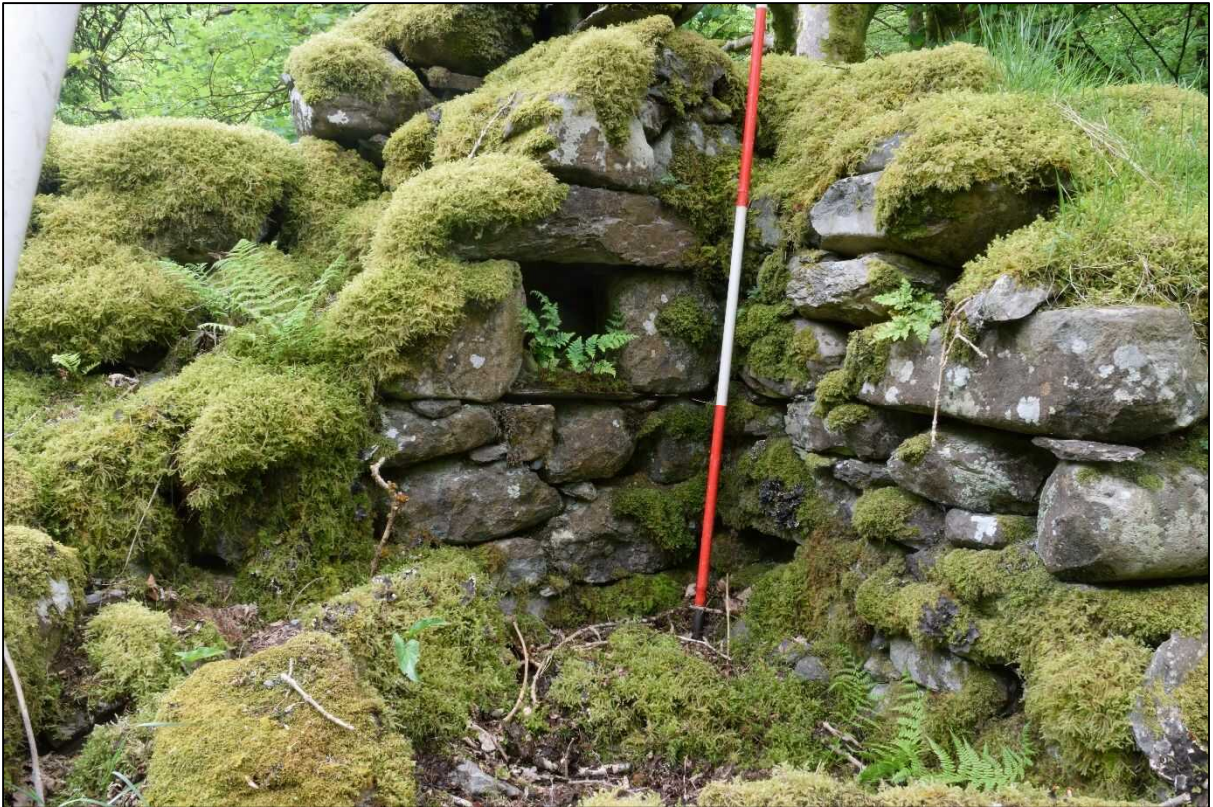
There is a socket in the eastern gable wall (Plate 7) 0.3 m wide and 0.5 m deep the function for which is unknown. It does not seem likely that this socket supported a timber for an upper storey giving its depth and position only 0.28 m from the southern wall of the house.

Plate 7: Socket in the eastern gable wall of the house

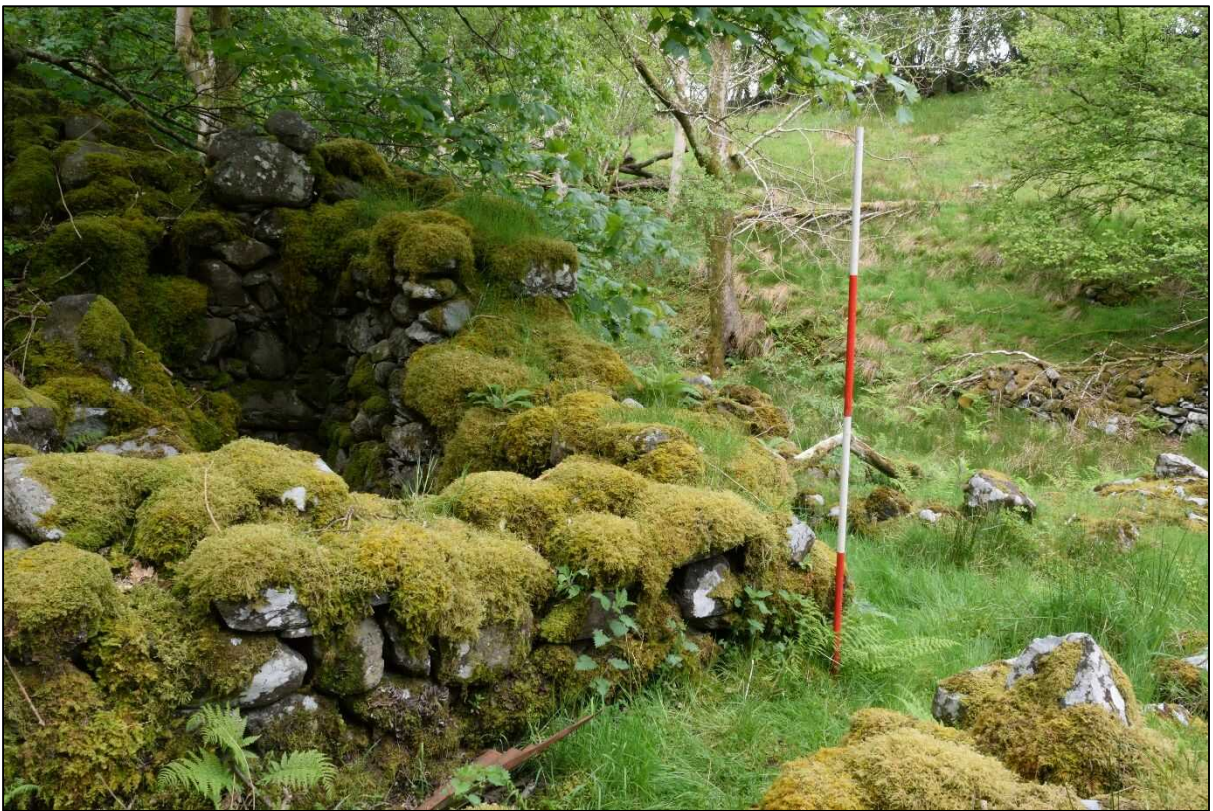
Plate 8: The dividing wall of the house

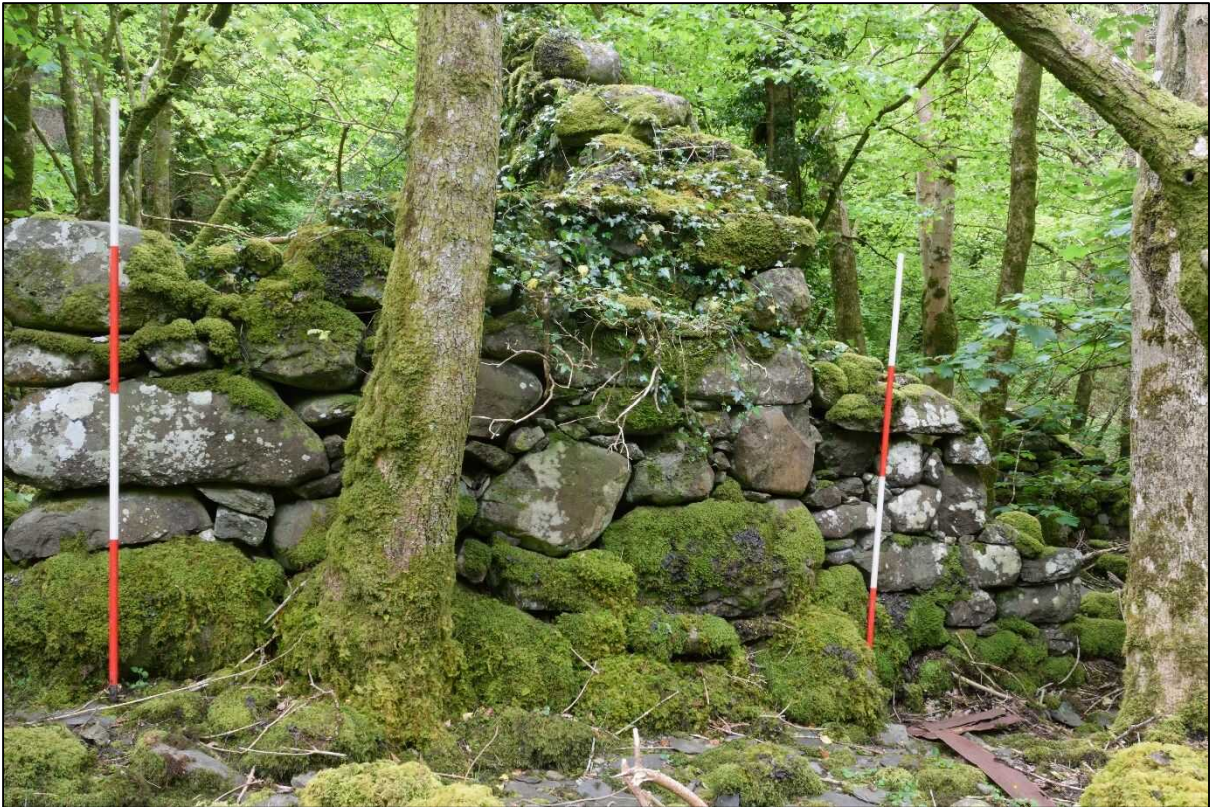
Added to the western gable wall was the first of “industrial” buildings (Plates 9 and 10) which was constructed of large boulders. This is of a relatively moderate size being only 7.49 x 6.28 m in size. A central door exists in the southern wall and there is a blocked opening in the southern wall which is 3.3 m wide. Typically, the gable walls are best preserved (Plate 11) with the western gable wall standing to a height of approximately 3.2 m

Plate 9: Western end of Industrial Building 1

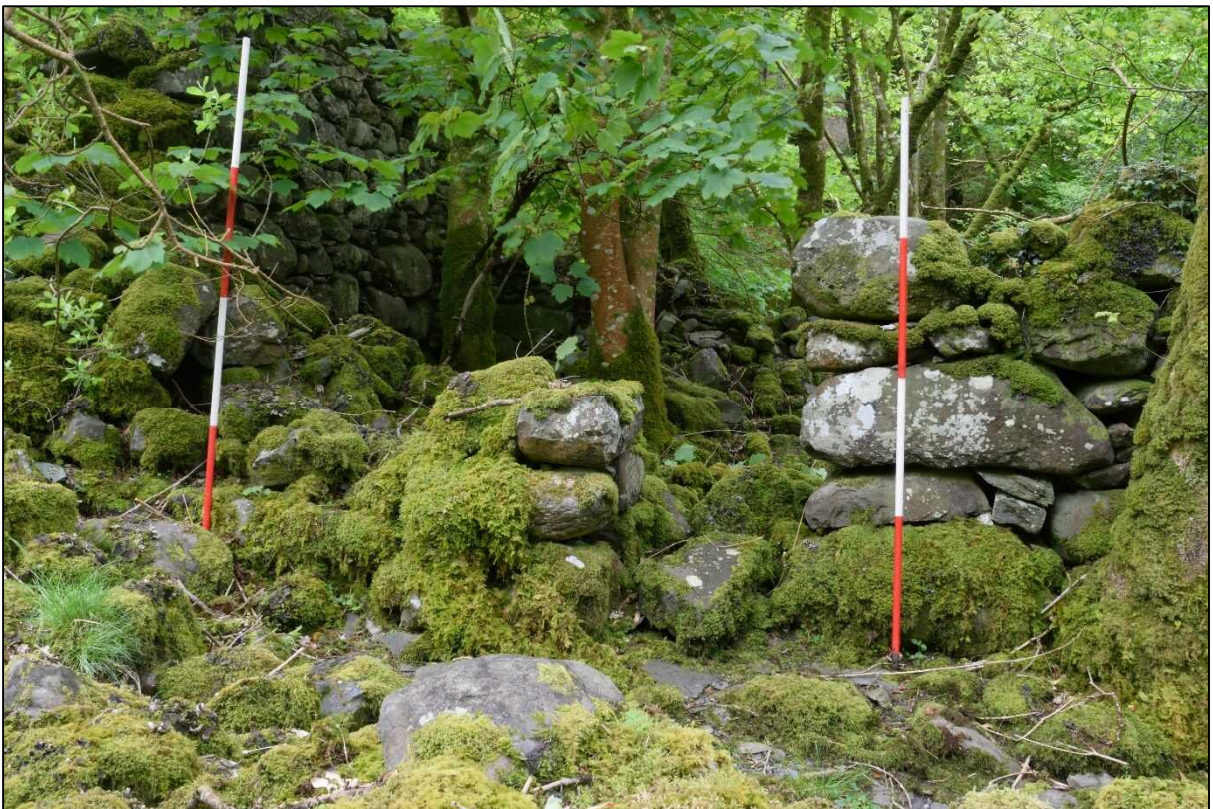
Plate 10: Door to Industrial Building 1, looking south

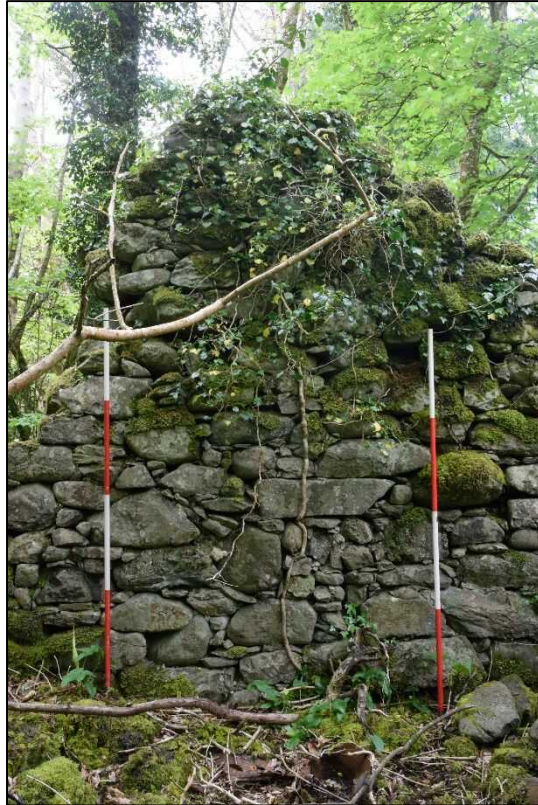
Plate 11: Western gable wall of Industrial Building 1, looking west

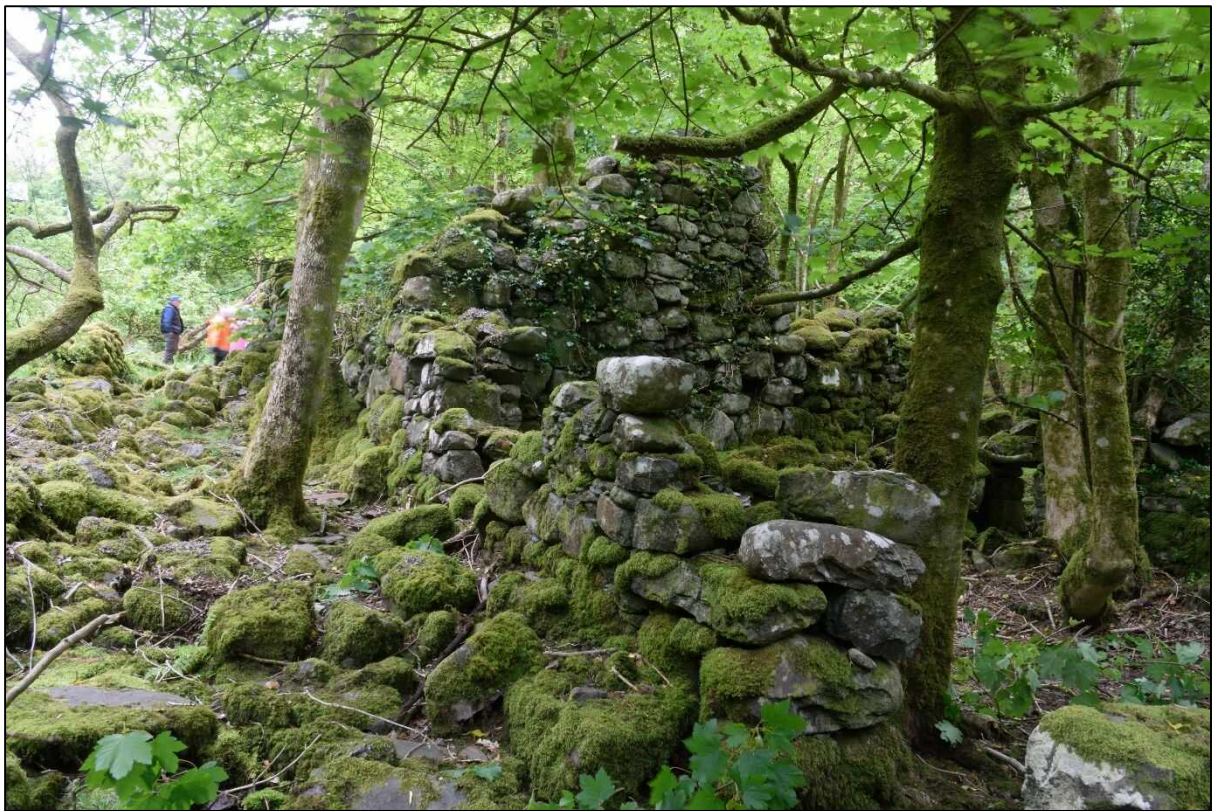
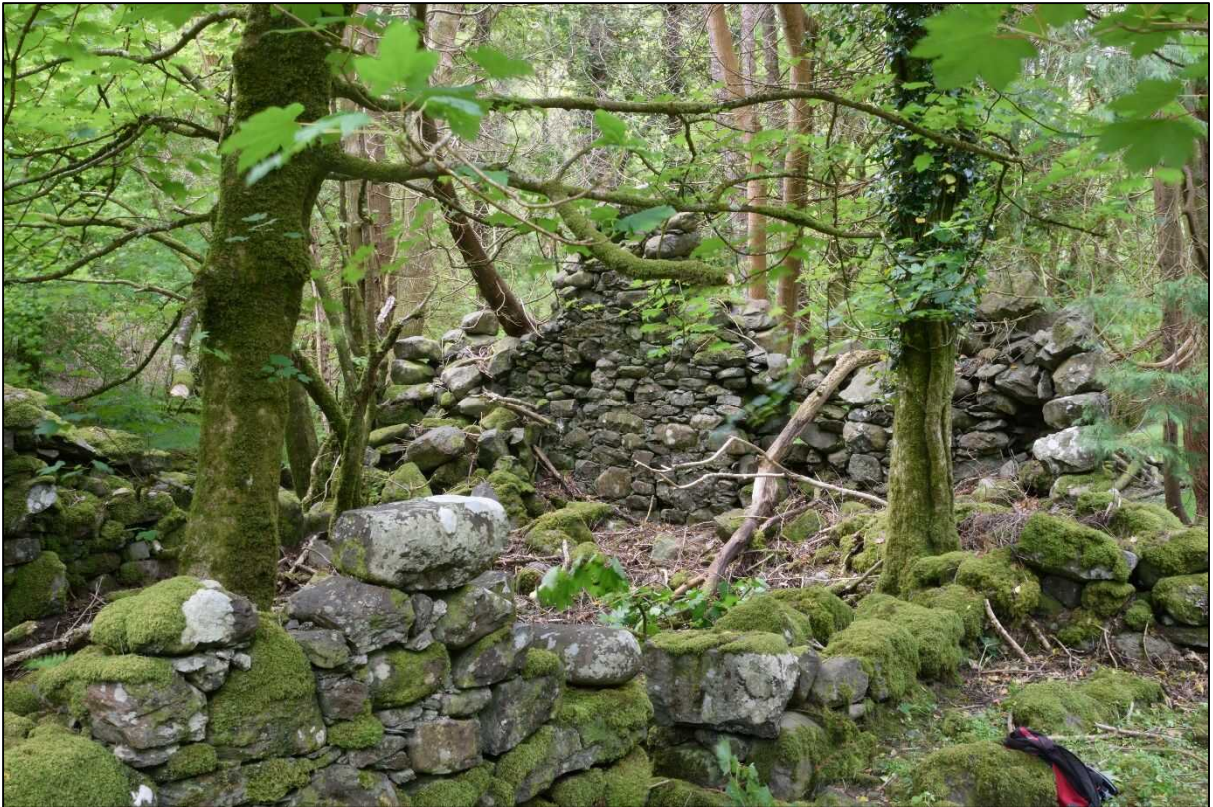
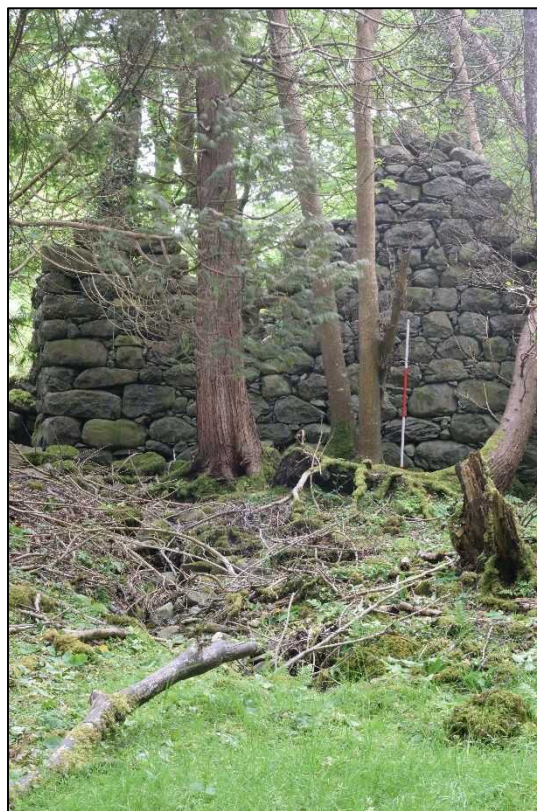
Added to the western end of Industrial Building 1 was a much larger unit (11.83 x 6.56 m in size) (Industrial Unit 2, Plates 12 - 14). This has two openings in its northern wall, a central doorway and a single window. The doorway is 1.10 m wide whilst the window is also 1.1 m wide. There are also two openings in the southern wall, one of which is a window (0.9 m wide), whilst the other is a slot through the wall (0.44 m wide) which is assumed to be the

Plate 12: Industrial Building 2, looking SE

Plate 13: Industrial Building 2, looking SW

Plate 14: Gable wall of Industrial Building 2, looking east

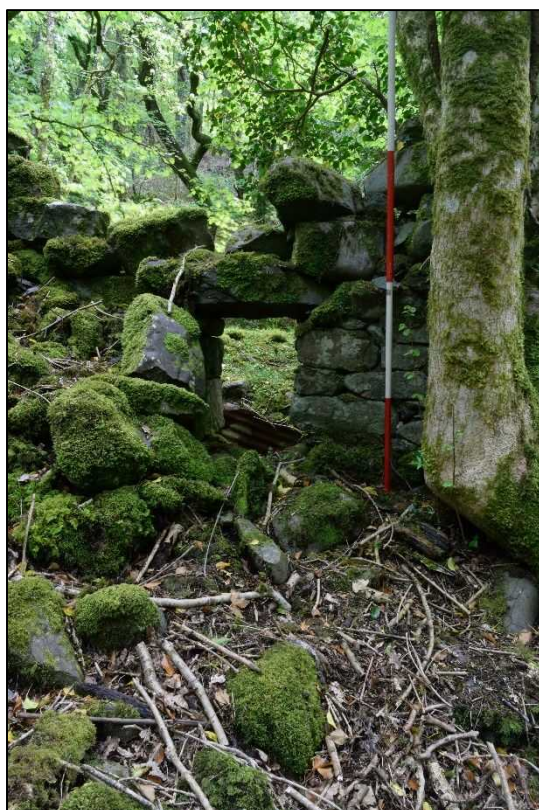
location of the drive shaft from the water wheel (Plates 15 and 16). Adjacent to this slot, on the outside of the wall, is a metal plate with a series of holes along its length (Plate 16). It is assumed this was part of the control system adjusting the water flow onto the waterwheel.

Plate 15: Slot for the drive shaft of the waterwheel, looking south

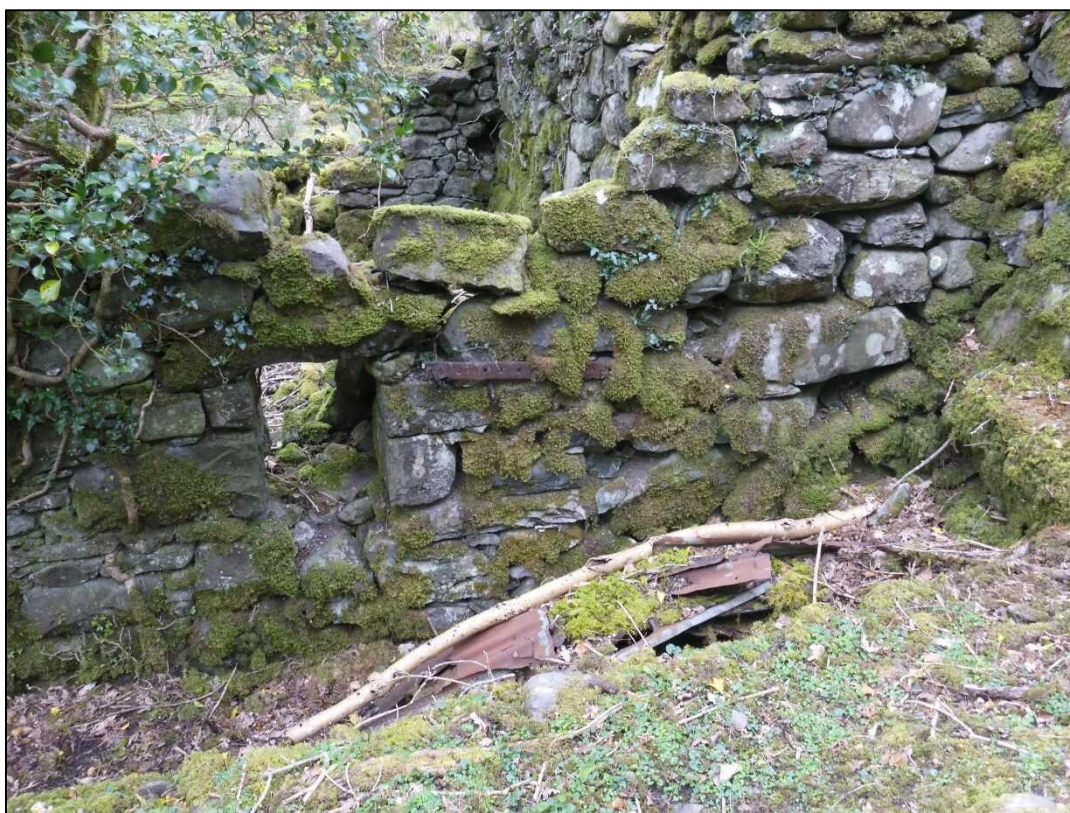
Plate 16: Slot for the drive shaft of the waterwheel, looking north

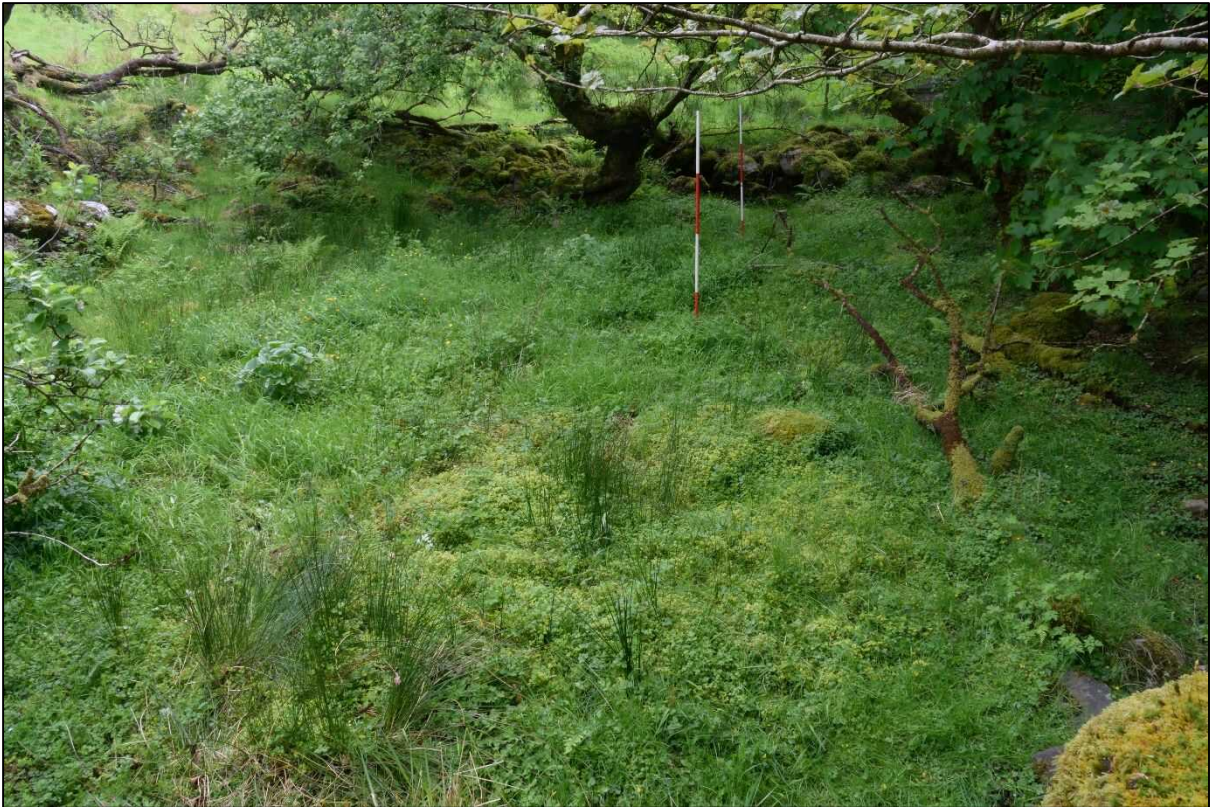
The factory was clearly water driven, at least in its final phase of production, with water extracted from the Afon Aran, probably adjacent to a natural weir, and fed into a mill pond (Plate 17) which was defined, at least part of its circumference by a rough stone wall (Plate 18). Adjacent to the probable natural weir is a bypass channel along the southern bank of the Afon Aran, which was presumably used to control water flow to the mill pond and over the weir.

Plate 17: Mill Pond, looking east

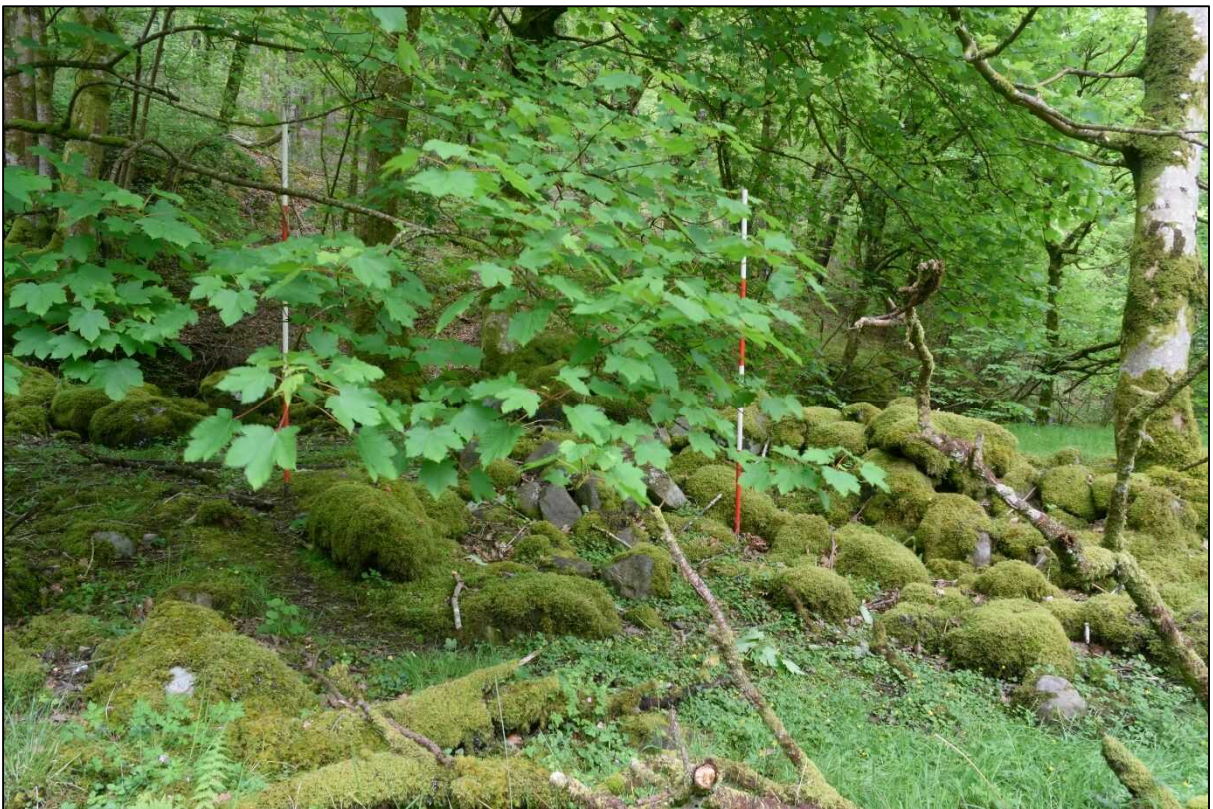
Plate 18: Rough wall around the mill pond

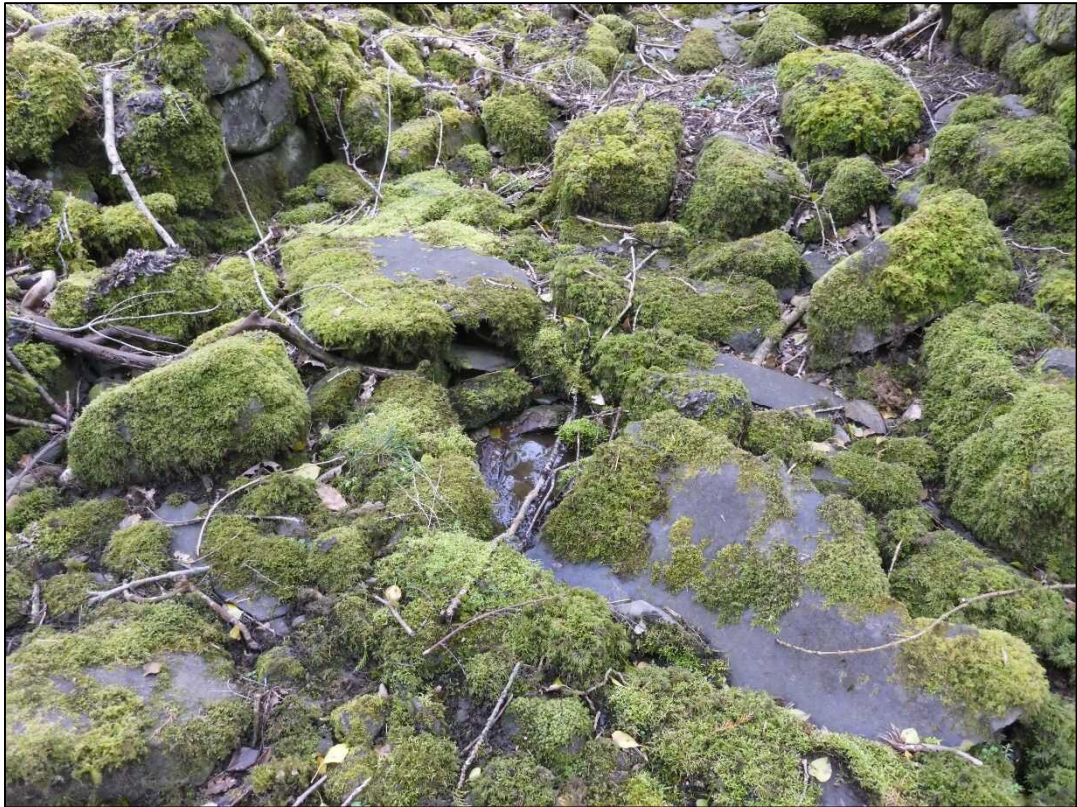
The pond fed two leats. To the north of the buildings the leat is partly covered but slate slabs, but runs in front of the buildings before turning through the doorway to Industrial Building 2 (Plate 19). It is not certain where this leat runs after this point, but presumably ran across Industrial Building 2 before exiting into the tail race on the southern side of the building.

Plate 19: Leat in front of Industrial Building 2

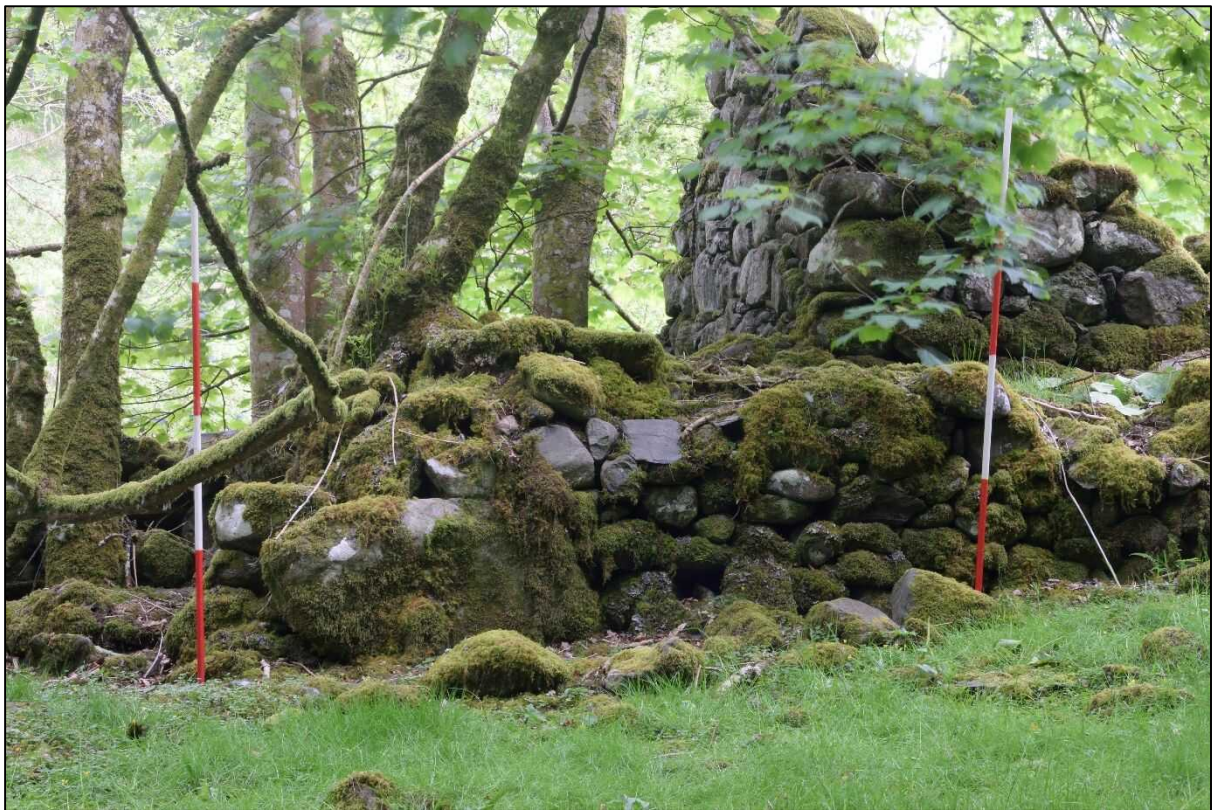
To the south of the building range, the mill pond fed the head race to the water wheel. This was slightly cut into the ground near to the pond before passing over two, stone-built, launder supports (Plates 20 and 21), probably in a wooden trough. The eastern support largely blocks a possible opening in the northern wall of Industrial Building 2, demonstrating the development of the complex. The leat probably fed an overshot wheel, from which the water was drained back into the river via a tail race. None of the wheel structure appears to survive, however, parts of the wheel may exist below the corrugated iron and other debris which has been dumped into the wheel pit.

Plate 20: The eastern launder support

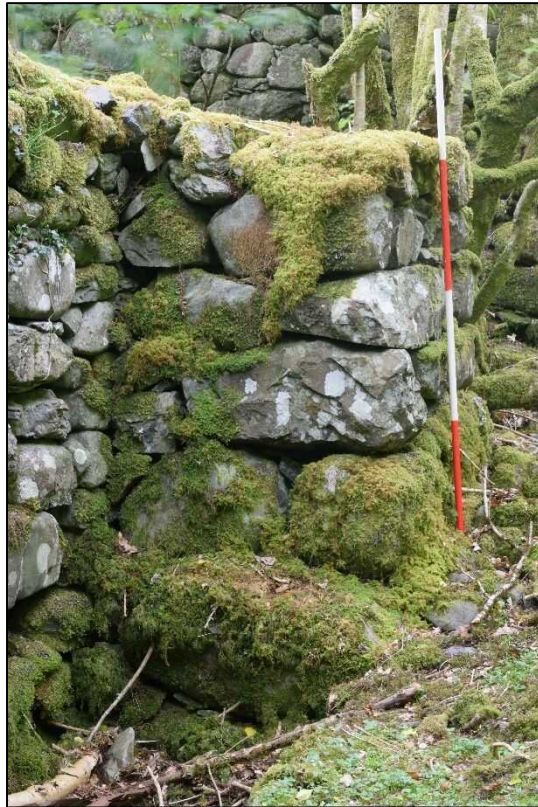
Plate 21: The western launder support.
