**Wenallt Wool Factory  
Standing Building Survey**

***EAS Client report 2022/04***

**Grwp yr Aran**

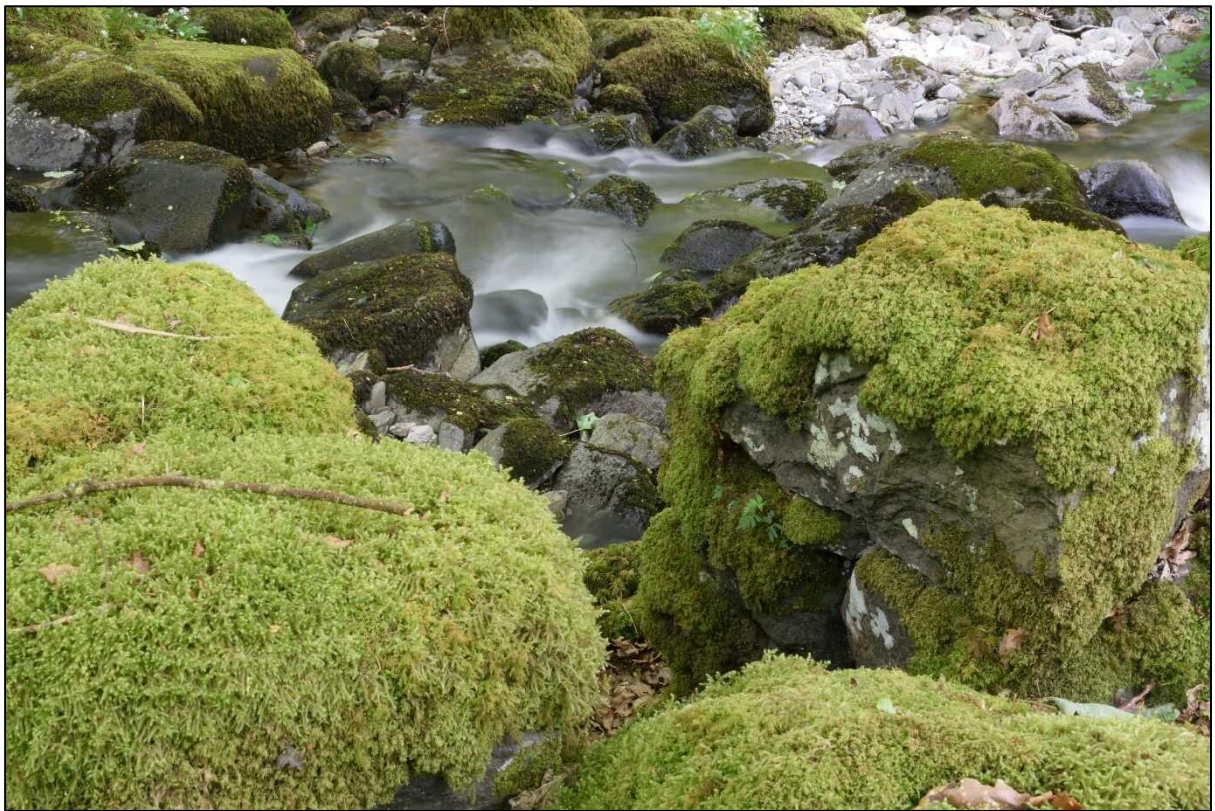
There is also a stone wall lined slot (Plate 22) through the river bank which is of unknown function.

Plate 22: Stone wall lined slot in the river bank

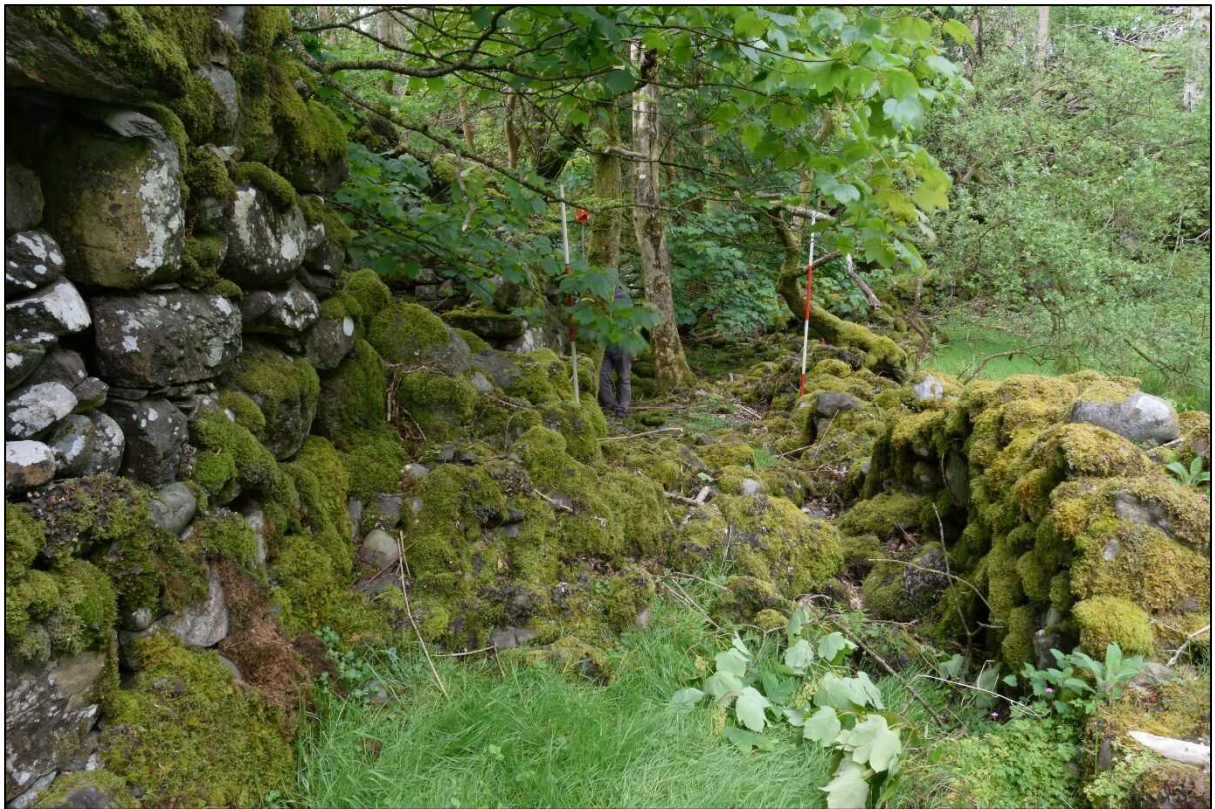
To the north of the building range, and separated from the buildings by a pathway (Plate 23), is a pear-shaped enclosure approximately 21 m long and 10 m wide, largely terraced into the hillside and defined by dry stone walls to the south and east. On the northern side, is a block of masonry which is assumed to have been a set of steps up to the access track to the site. It is noticeable that there is no direct access to the industrial buildings with the only gateway opening to the east onto the access track. This would suggest that the enclosure may have been associated with the house, possibly as a garden. The presence of the occasional fruit tree with the area to the north of the house is presumably related to the domestic use of this building. The track also runs along the eastern side of the enclosure where its eastern side is also defined by a dry-stone wall. At the western end of the enclosure is a smaller enclosure (5.54 x 3.57 m in size which incorporates a small building within its western half. This is likely to have been a pig sty.

Plate 23: Passage between Industrial Building 1 and the enclosure

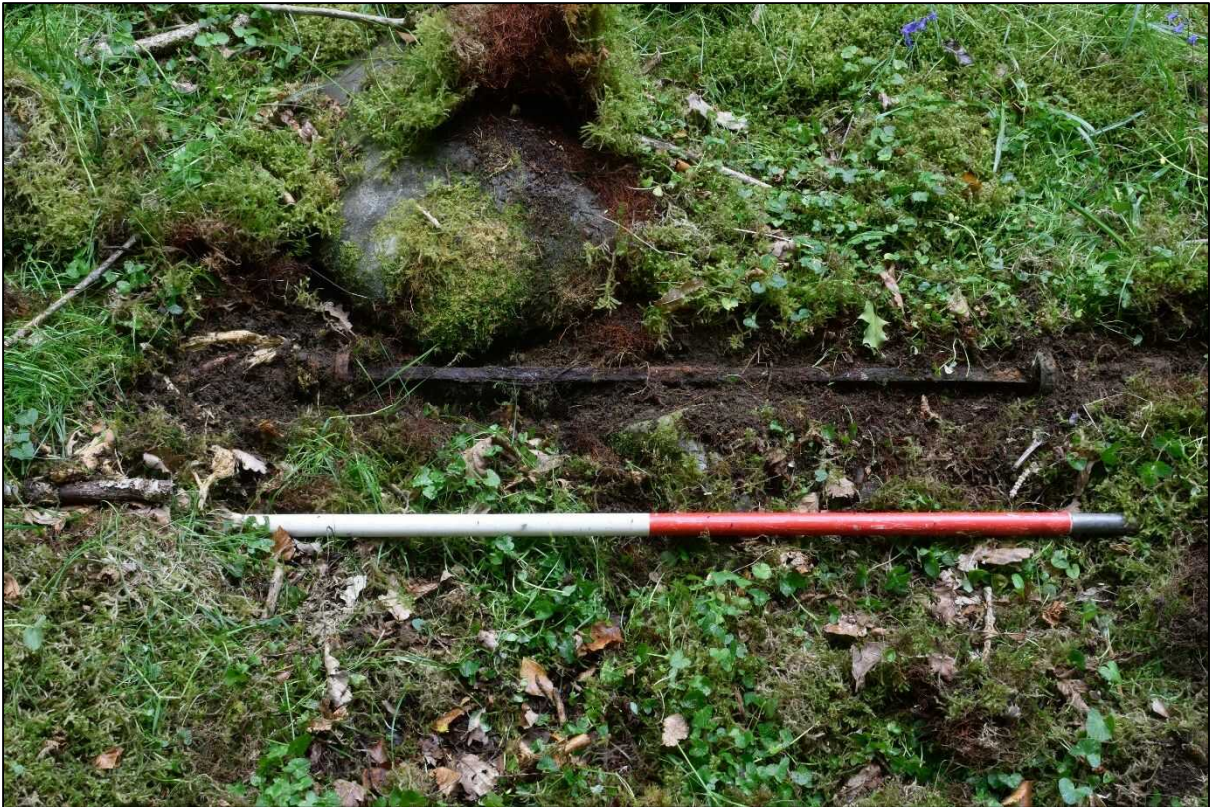
Whilst no obvious machinery survives on the site, to the south of the buildings a metal bar with fittings is partly buried in the ground (Plate 25). This appears to have been a spindle of some sort, possibly for part of the mechanism.

Plate 25: Iron object partly buried to the south of the buildings
