Engineering Archaeological Services Ltd.

Brynmor, Penmaenmawr
Standing Building Record

EAS Client Report 20243/05

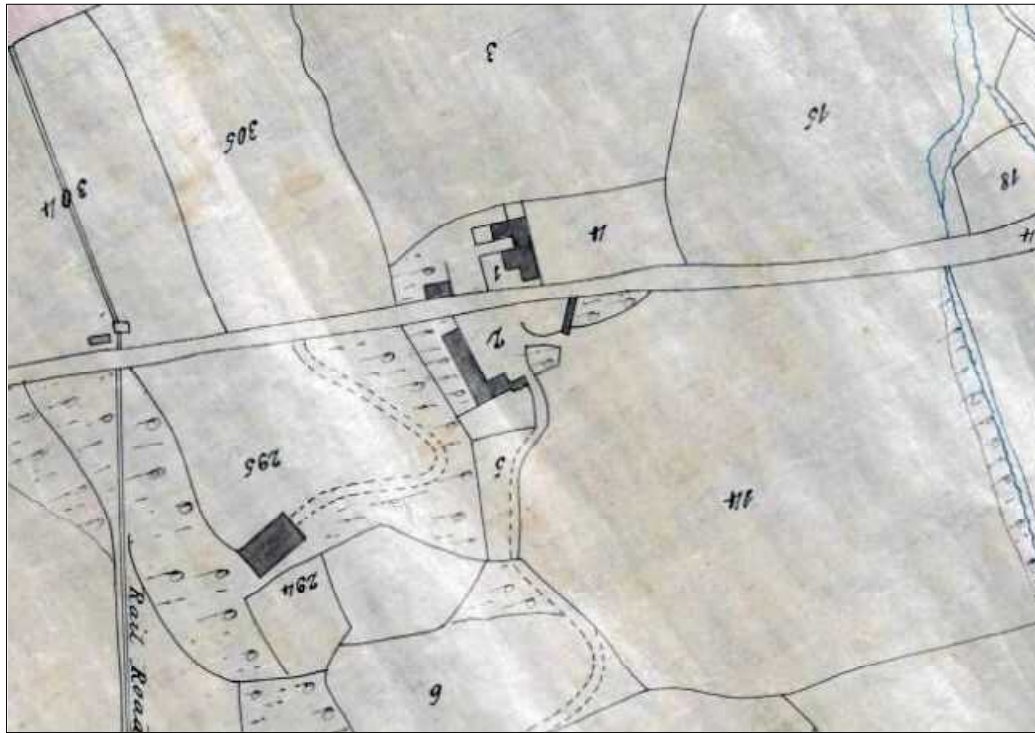
4.1: Extract of the 1839 Tithe Map of Dwygyfylchi
Not to Scale

By the Tithe map of 1839 (Figure 4.1) the building complex appears to be more developed with the two rear ranges shown as having unequal length and the southern range offset to the north (similar to the current layout). There is also a building shown on the southern boundary of the rear garden. This appears to be of a size that it could be a separate house, rather than an agricultural building.

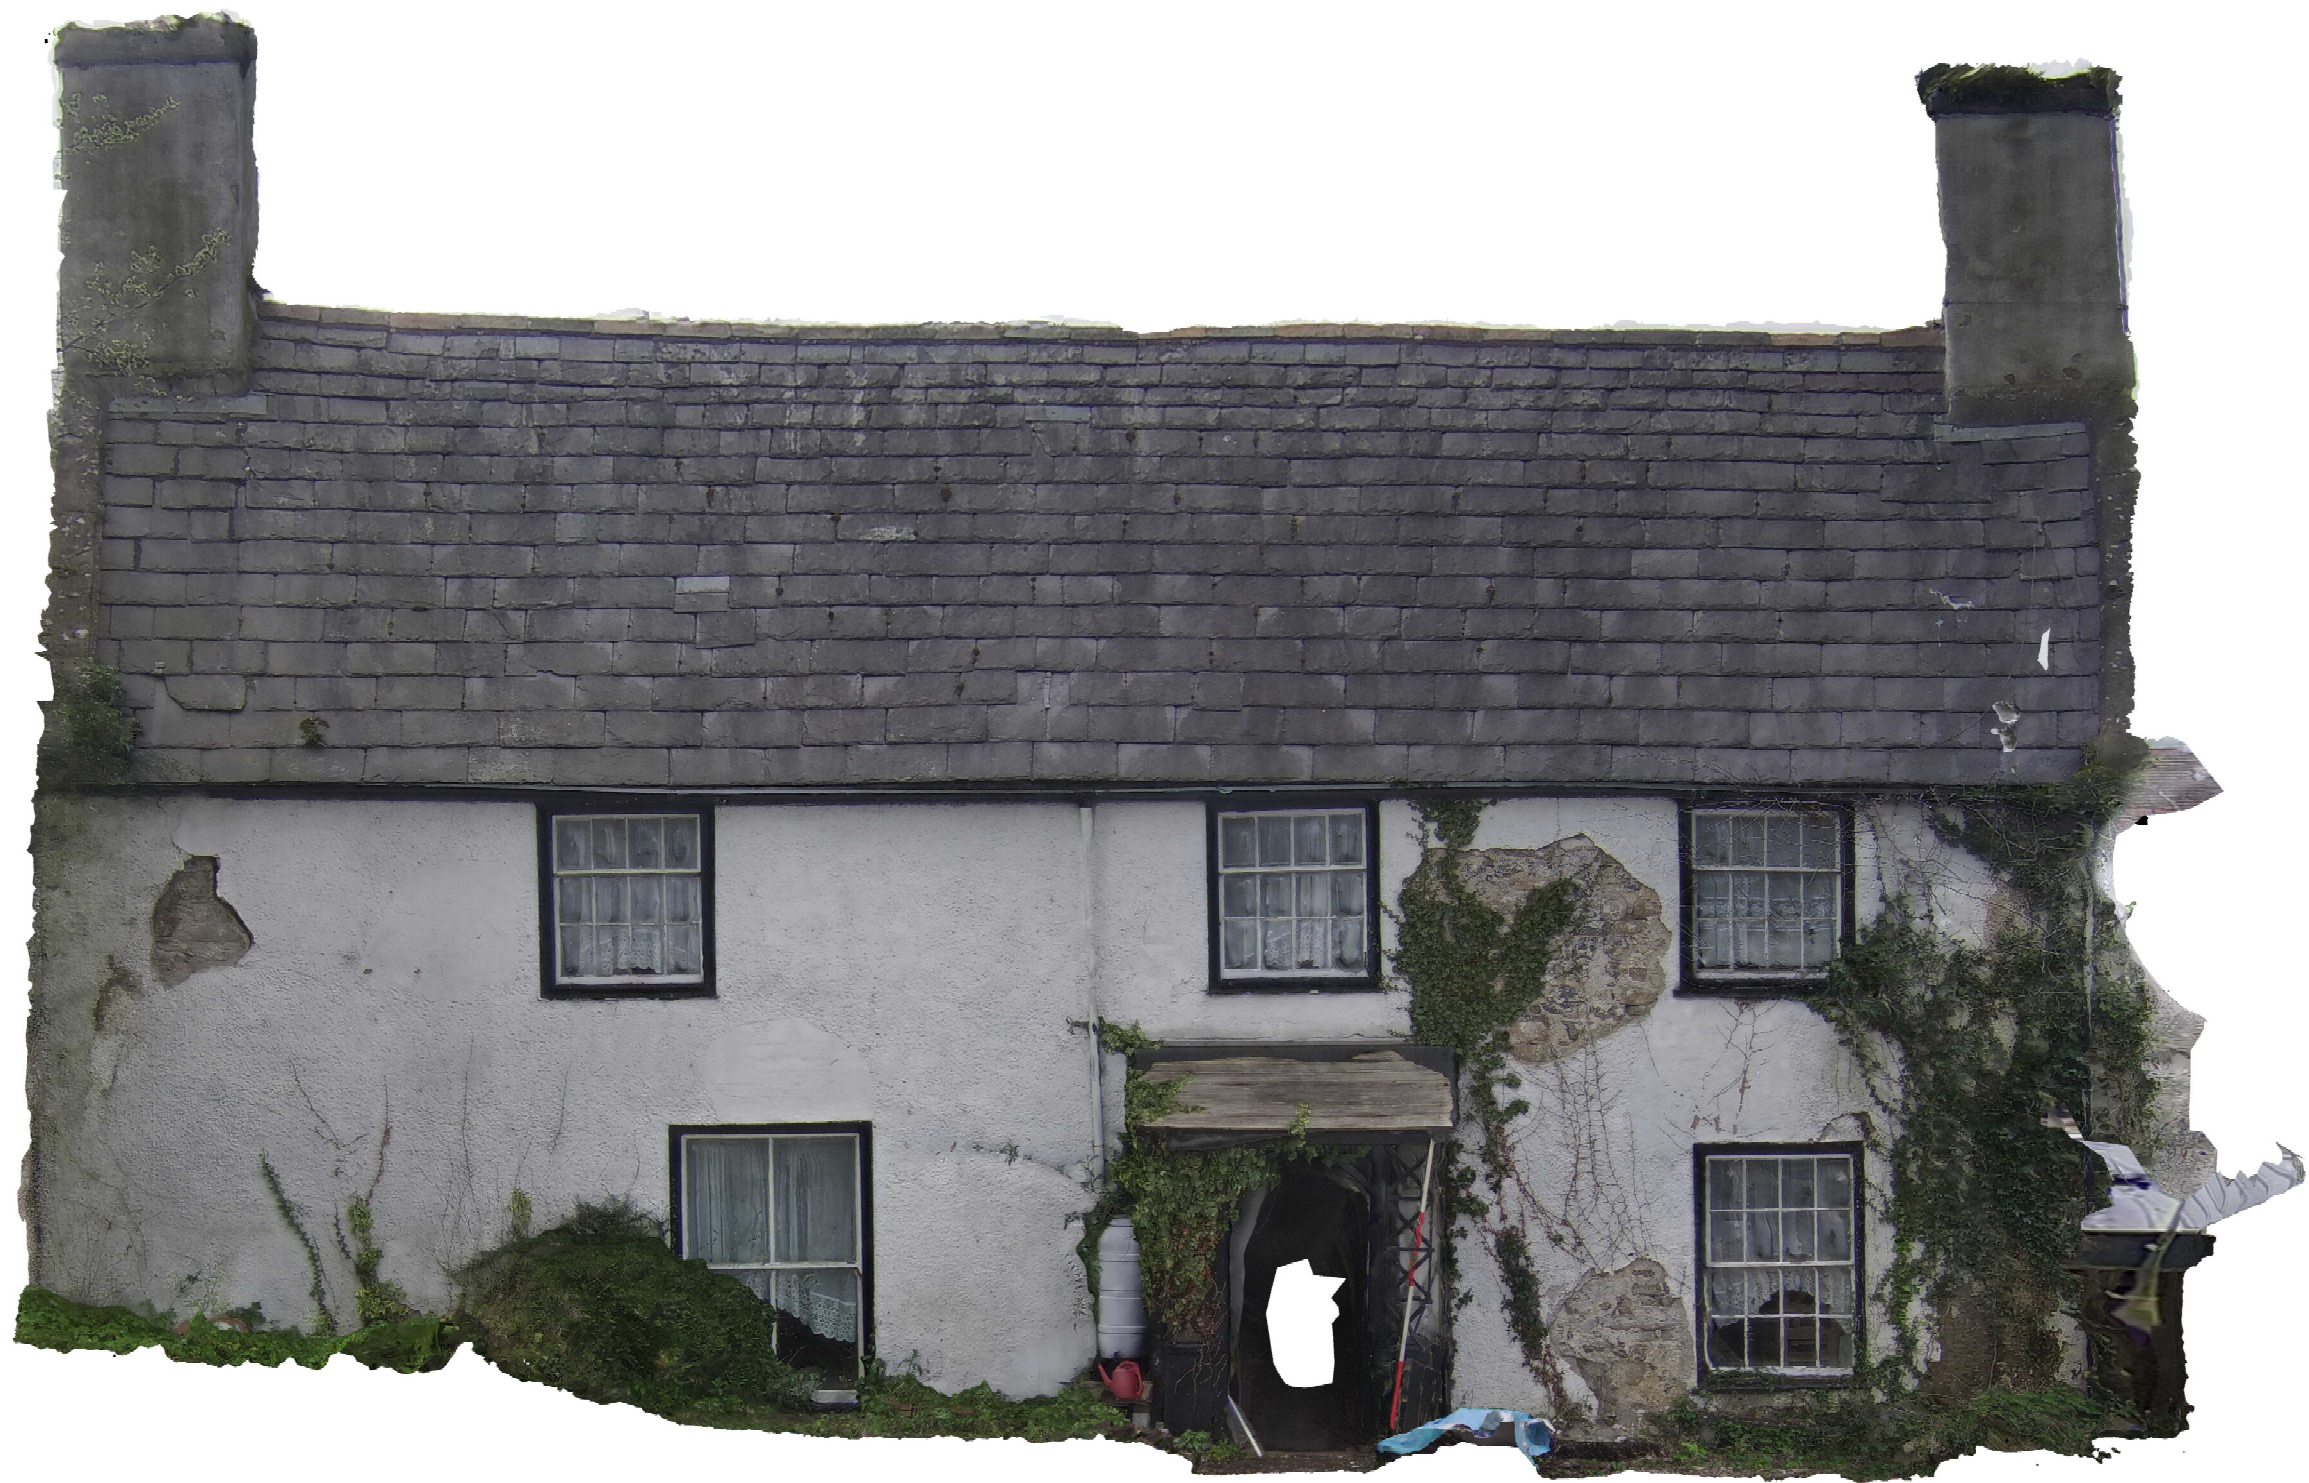
Figure 7: Front Elevation
Scale 1:50

The main elevation (Plate 1, Figure 7) has square chimneys on each of the gable ends and a slate covered roof. The wall is rendered, although this has flaked off in places revealing a random stone wall constructed largely of rounded boulders. The render on this face appears to be a lime-based slurry which has later been painted.

The main door is offset to the north with a lattice-work porch with a slate, single pitched roof (Plate 3). To the north of the door are two multi-paned sash windows (Plate 2), set one above the other. The lower window is a 16-paned sash, whilst that on the first-floor level is shorter with 12 panes. This is a pattern which is reflected in the rest of this elevation with the first-floor windows being set immediately below the eaves. There is also a twelve-pane sash window above the door.

To the south of the door are only two windows, slightly offset from each other with a larger, four-paned sash on the ground floor and a shorter, twelve-paned sash on the first-floor level.

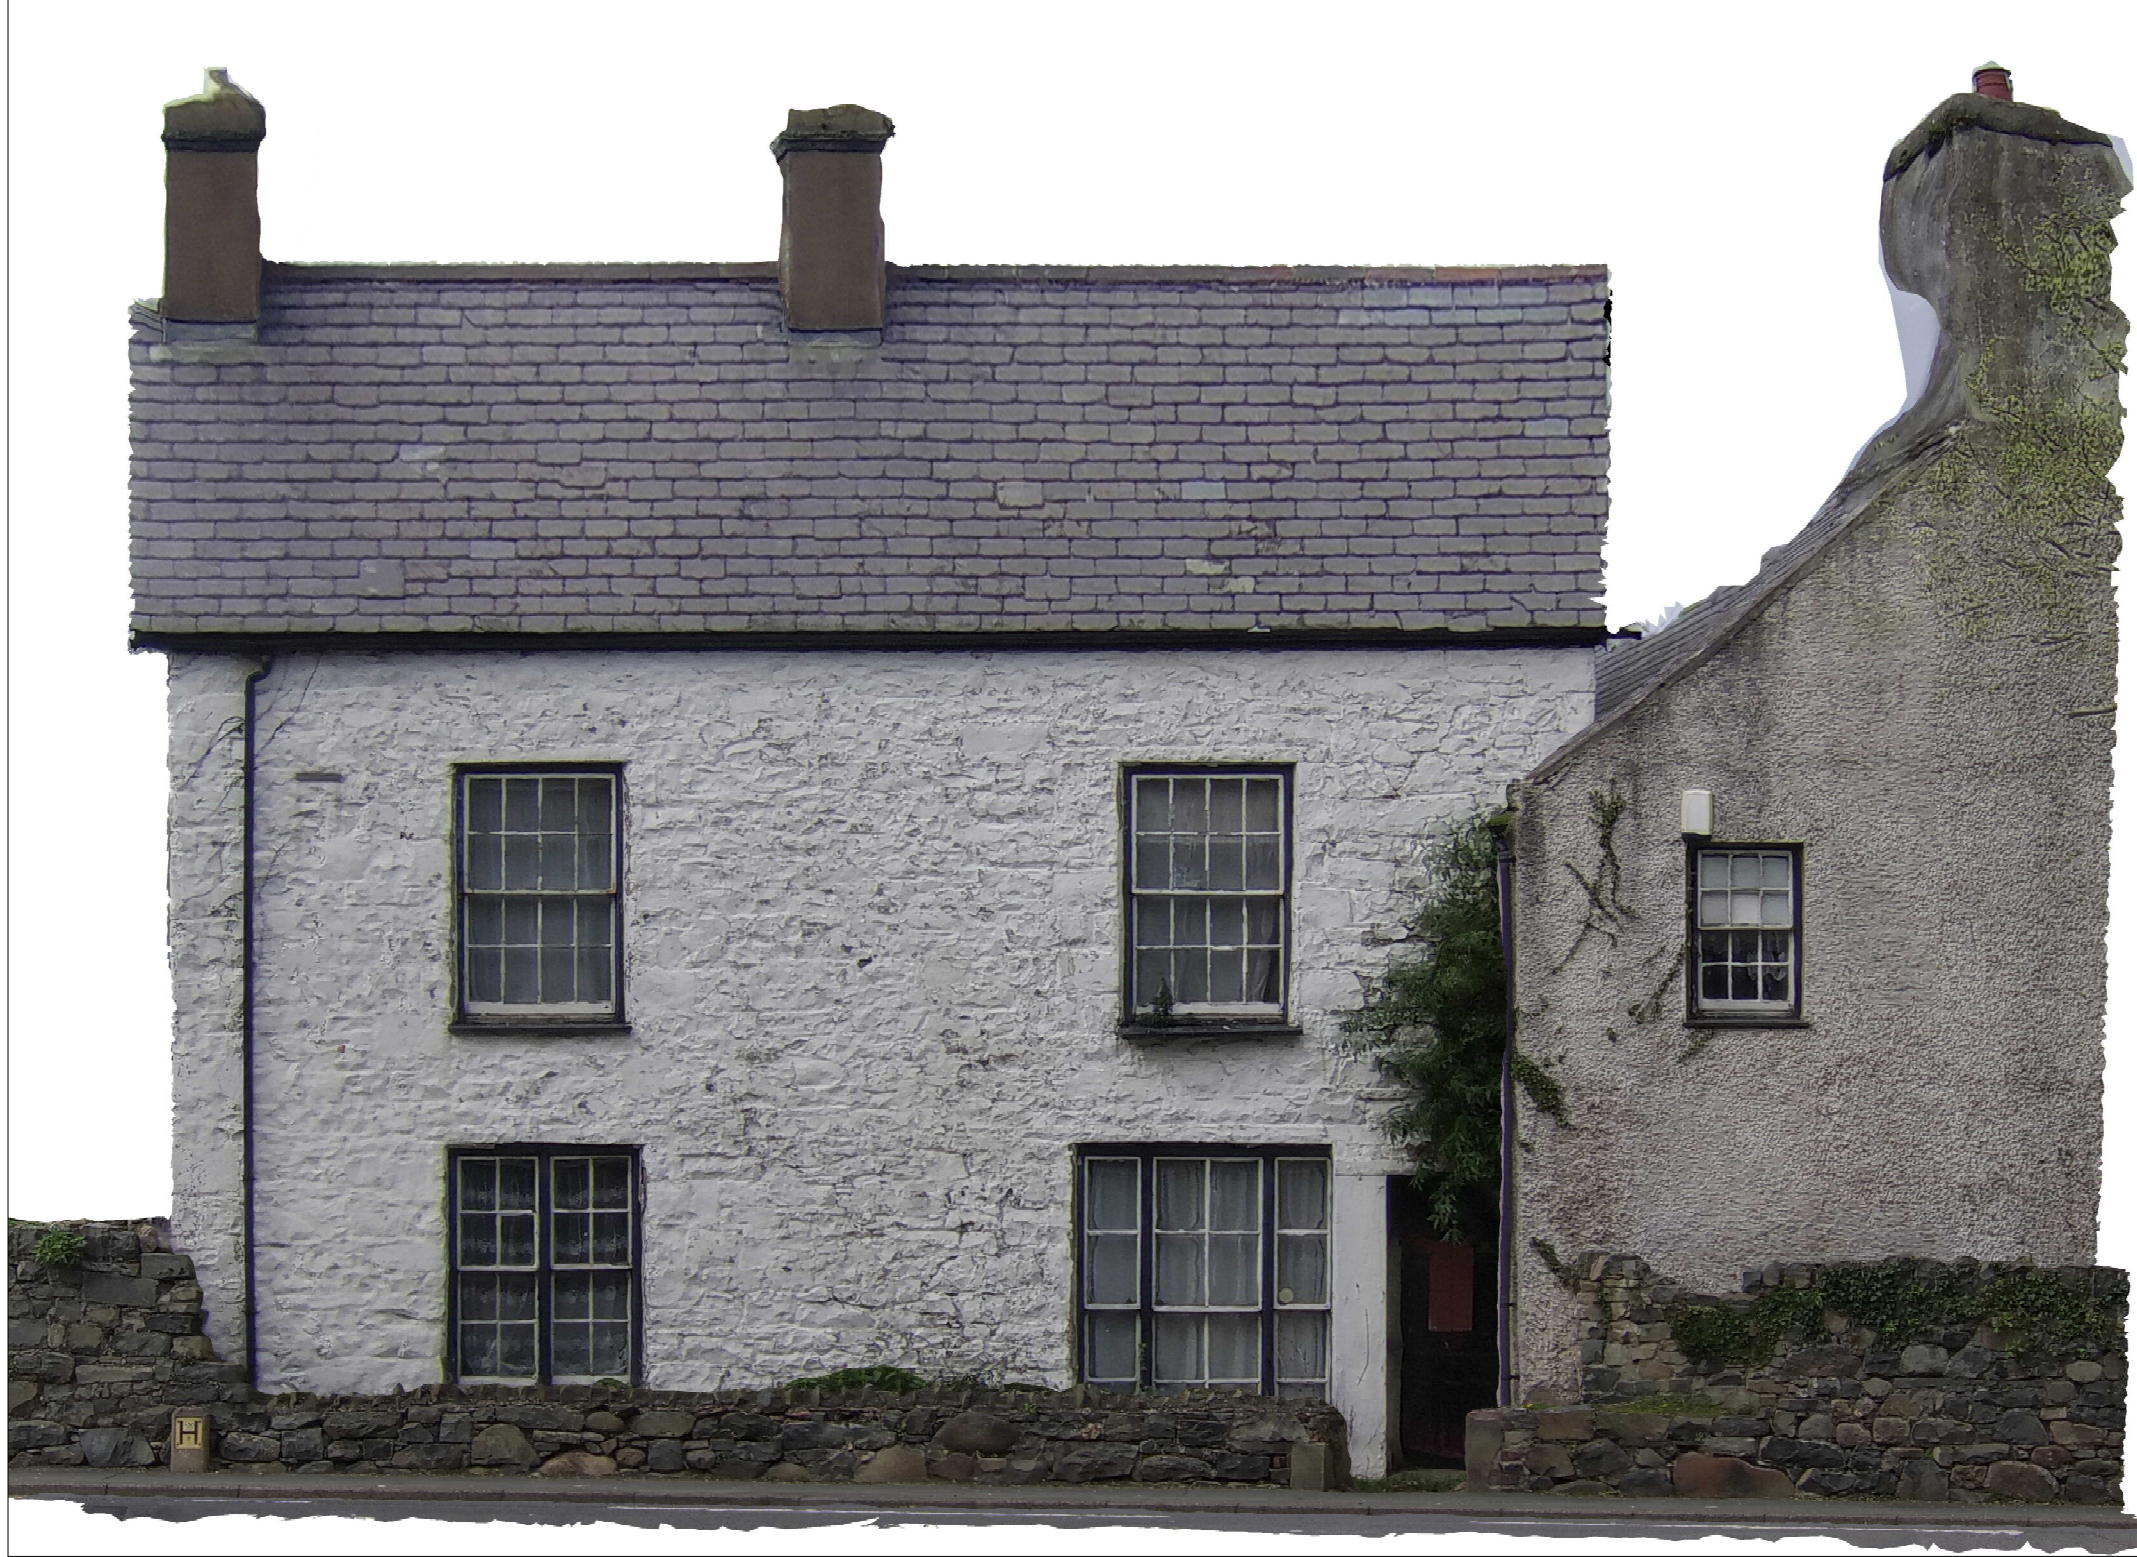
Figure 8: Elevation of Service Range

Set back from the southern gable of the main range by 1.45 m is the later, service range which is taller than the main range by approximately 1.05 m (Figure 8, Plate 6). It has one gable end chimney and one central, ridge chimney. The wall is of random, angular stones with square quoins. This wall has been white-washed. The door (Plate 7) is set at the eastern end of the elevation consisting of a panelled door with a central glazed panel. Most of the door furniture is modern, however, a central, turned, wooden knob is probably contemporary with the door. There are two windows on each of the ground and first floors with larger windows on the ground floor. The largest window is adjacent to the door, consisting of a sixteen-paned opening, divided into three sash windows. The other large window lights the kitchen, consisting of sixteen panes divided into two sashes. Both of the first-floor windows are of a similar size, both with sixteen panes in single sashes.

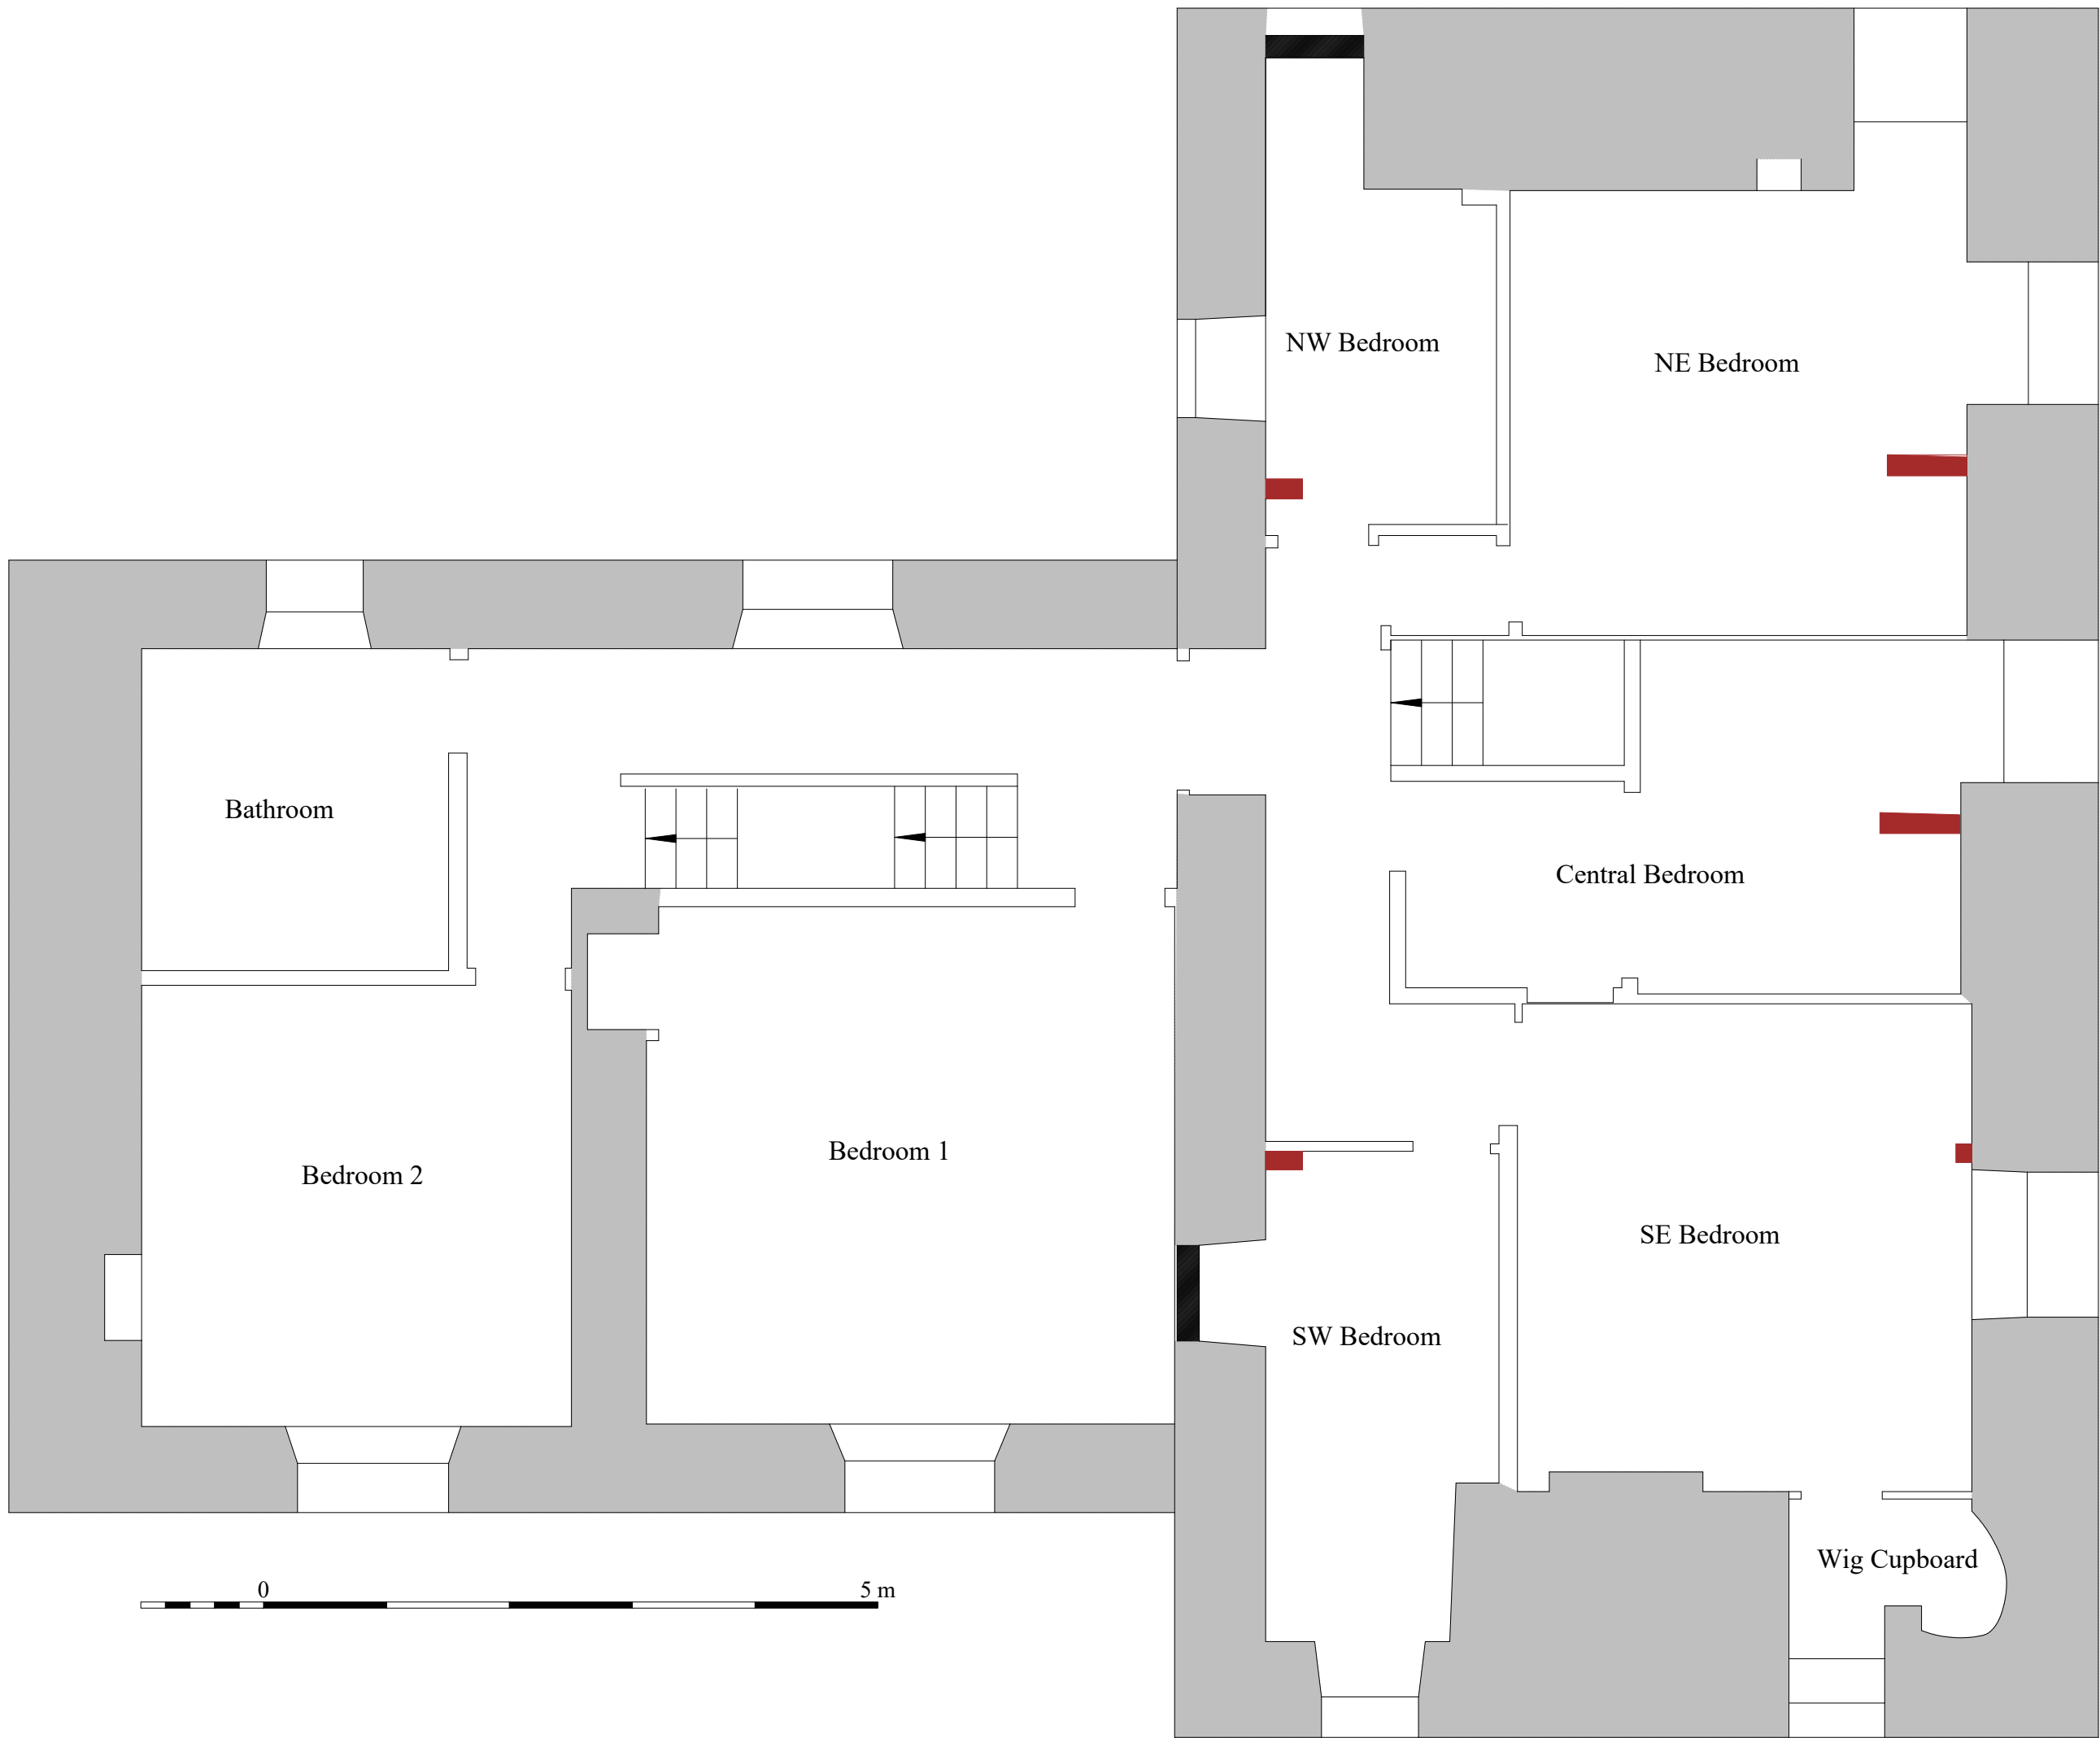
Figure 10: First Floor Plan
Scale 1:50

The first-floor level (Figure 10) of the main house contains two room at each end of the house linked by a landing from the staircase. In the south east corner of the main range is a bedroom which has a wooden partition with a door in its SE corner (Plate 24). This gives access to what was the intramural staircase, adjacent to the fireplace. This space was re-purposed as a “Wig Cupboard” (Plates 25 – 26) in the eighteenth century. Above the inner face of the door are a series of pine shelves with surviving supports (Plate 27). Adjacent to

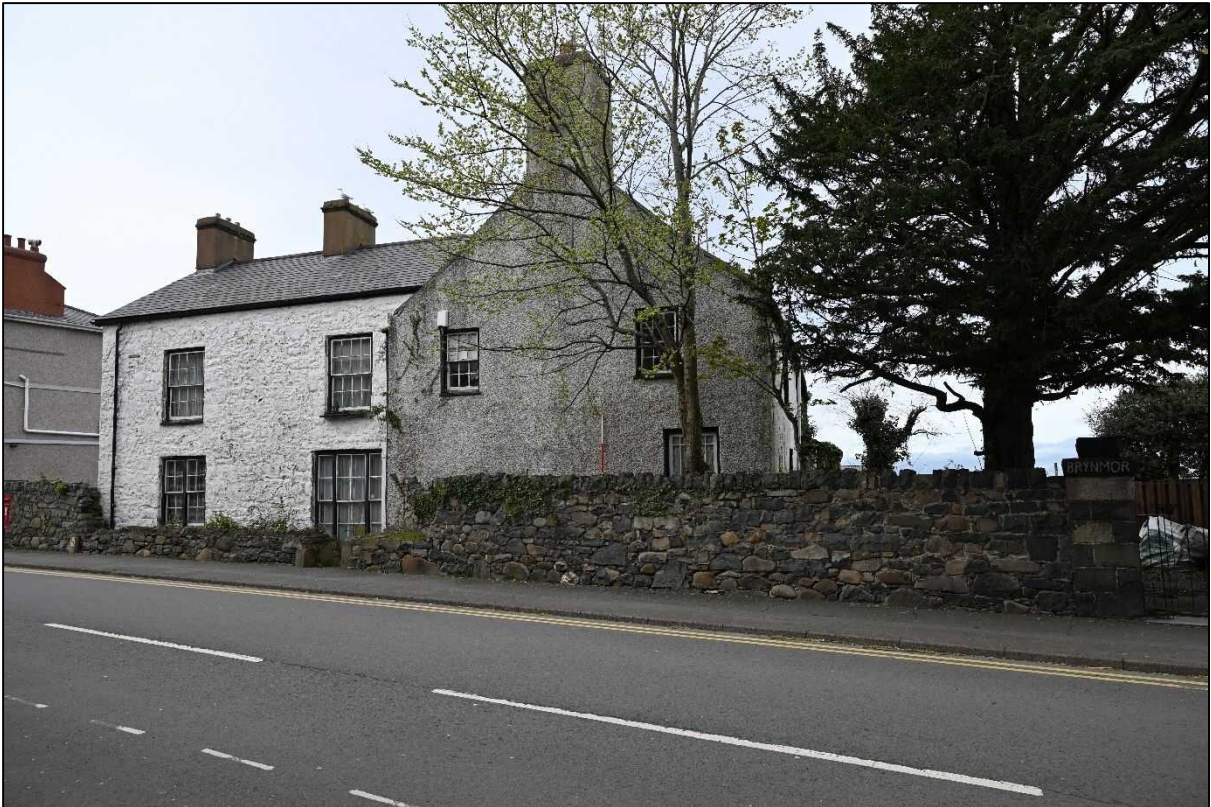
Plate 5: Gable end of the main range

The southern gable (Plate 5) is also rendered, although this appears to be a cement based, rough cast render. There are three openings, with a single nine-paned window on the ground floor and two, twelve-paned sash windows on the first floor.

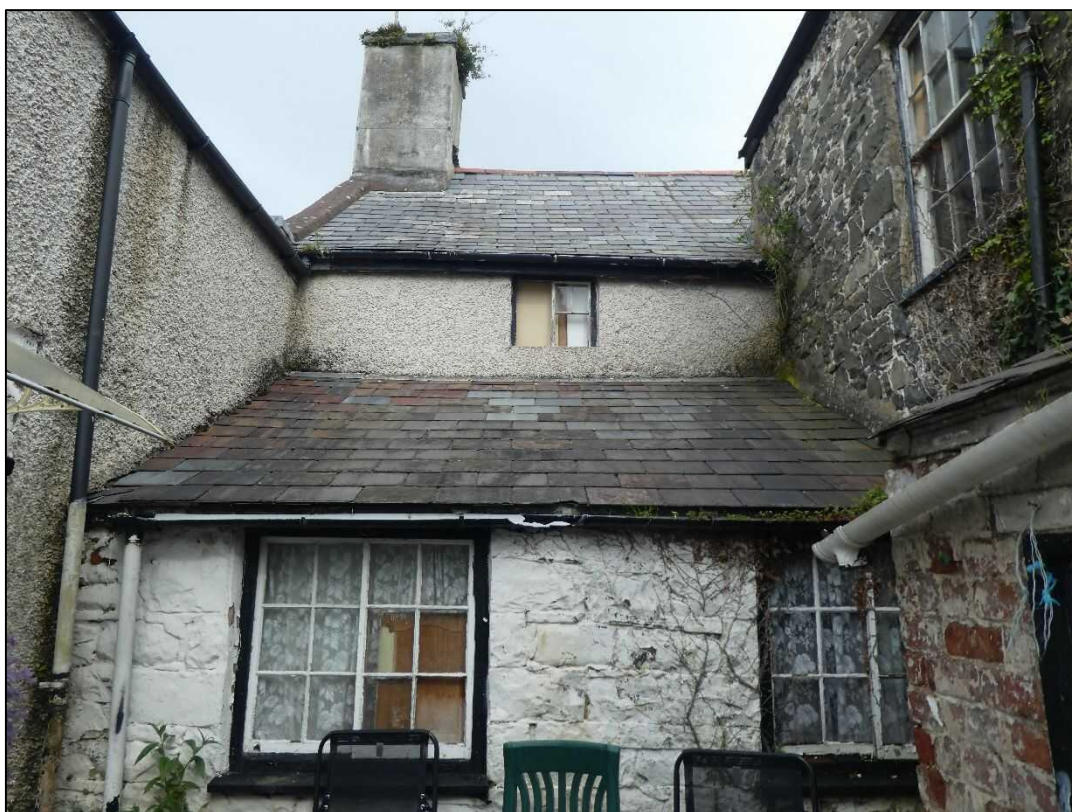
Plate 9: Rear elevation of the main range

Between the service wing and Brynmor Cottage is a small yard (Plates 9 and 10). At the rear of the main range is a lean-to extension (Plate 9) with a single pitch slate roof and a semi-coursed stone wall of angular blocks which have been white-washed. There are two, twelve-paned casement windows in this extension. Behind the “Service Wing” there is also a brick built shed (Plate 10) with a single pitch slate roof.

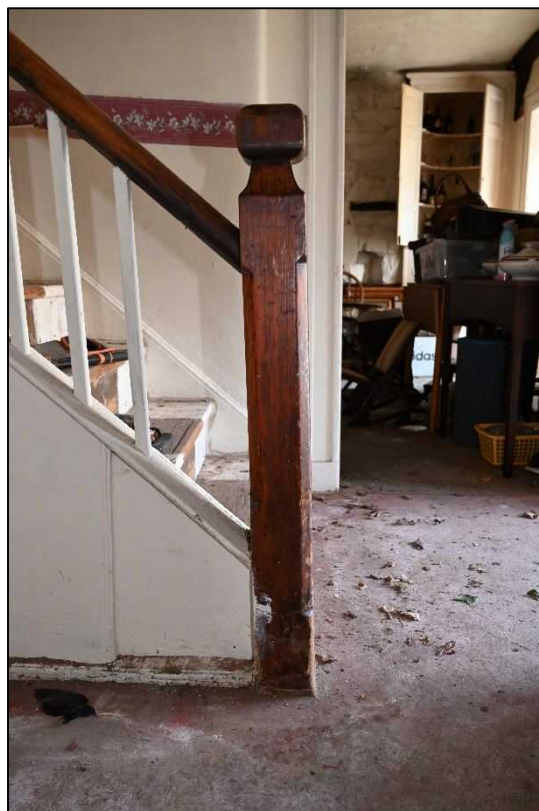
Plate 12: The newel post

straight flight, adjacent to the northern wall of the hallway. It has a square section newel post with a cushion cap and stick baluster rails with rounded curved edges (Plate 12). These features would suggest an early 19th century date for the construction of the current stairs (Hall 2005, 120). Whilst the upper and outer surfaces of the staircase are well finished, below the stairs there is some evidence for the re-use of timbers with fragments of a post and panel partition having been re-used to construct the stairs (Plates 13 and 14). To the south of the staircase is a passage (Plate 15) leading to an alcove with a flattened arch over and access to the service wing via a doorway behind the stairs.

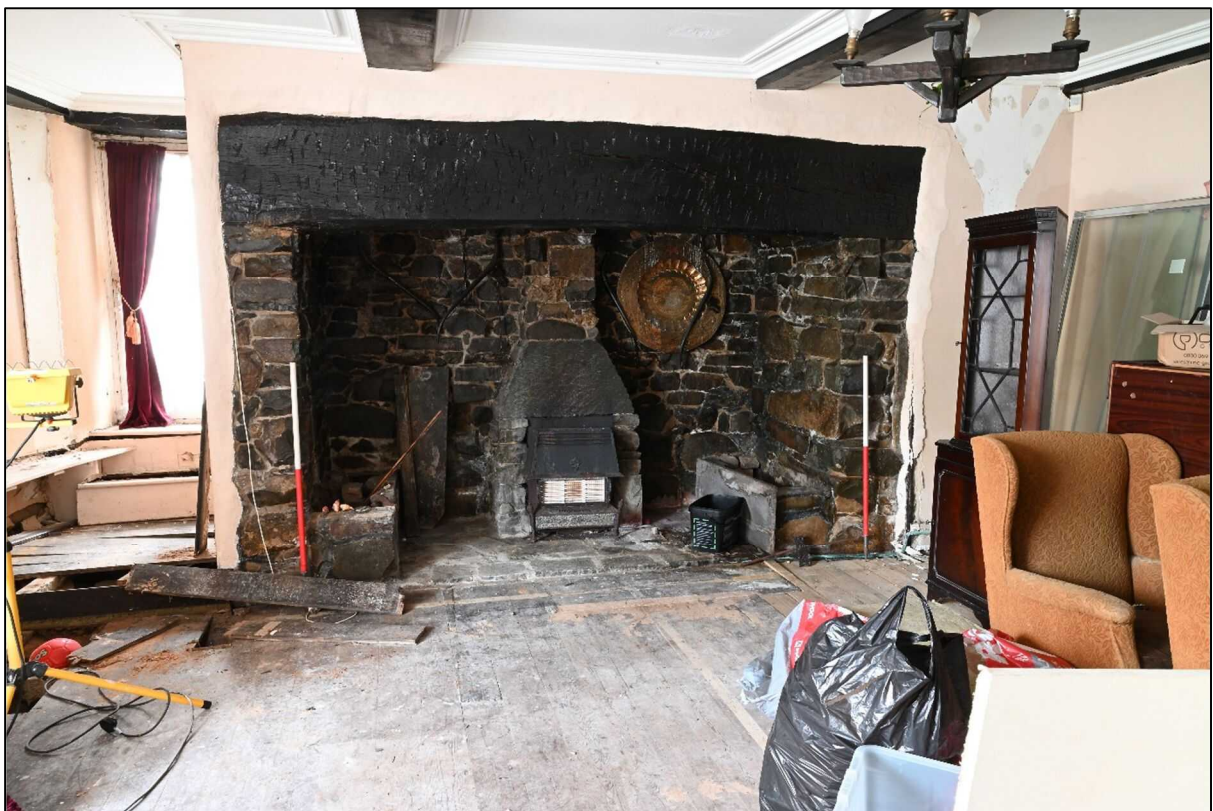
Plate 16: Fireplace in the parlour

There are two rooms off the hallway, to the south is the parlour which has a large inglenook fireplace on its southern wall with a large wooden lintel which is moderately chamfered with runout stops (Plate 16). To the east of the fireplace is a space with one curved wall which was the site of an intramural staircase, now missing (Plate 17). It is now occupied by a seating area with a wooden bench running along the curved, eastern wall. The ceiling of the parlour (Plate 18) has three beams crossing it which have been plastered and painted. These are lined by a moulded edge to the plaster ceiling, giving the impression of a possible eighteenth-century phase to the house. The mock timberwork on the wall of this room (Plate 18), together with the central bedroom on the first floor (Plate 32) and Bedrooms 1 and 3 (Plates 63 and 70) are merely strips of timber attached to the walls about 10 years ago as decorative features (Angela Caldecott Evans *pers. comm.*).

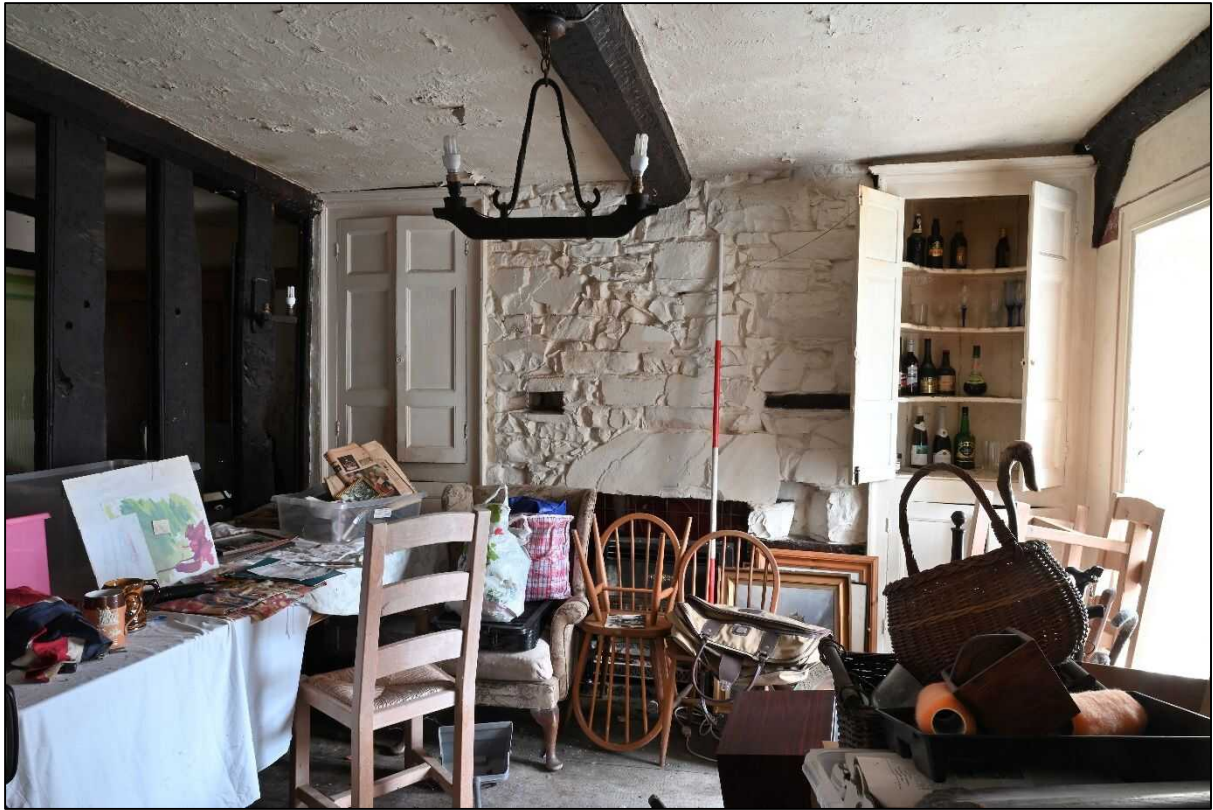
Plate 19: Room to the north of the hallway

To the north of the hallway is a room (Plate 19), partly divided by a series of upright planks (Plate 20). The room has a fireplace on its north room with flanking cupboards and two slots within the wall of the chimney breast (Plate 19). The current fireplace is a relatively modern replacement and the re-built section of walling above the stone lintel of the fireplace is evident. There are two rectangular recesses on the chimney breast, the function of the which is unknown, but they may have been the sockets for some sort of over mantel or structure in front of the fire. The partition partly dividing the room consists of five planks set upright (Plate 20), each of which has a mortice along its side (Plate 21). Although there is a rail along the ceiling holding the planks in place it is clear that this is not the original position of a partition. This can be seen in the relationship between the ceiling beam, running east-west across the room where the rail holding the top of the planks overlaps the beam. The beam (Plate 23) has a slot cut into its lower surface which varies in width in order to hold both the planks and posts of a screen. There is no gap in the slot suggesting that any doorway would have had its door head at a lower level. There is a cupboard in the NW corner of the room which has been built in front of a blocked opening which would have been a doorway to what is now Brynmor Cottage.

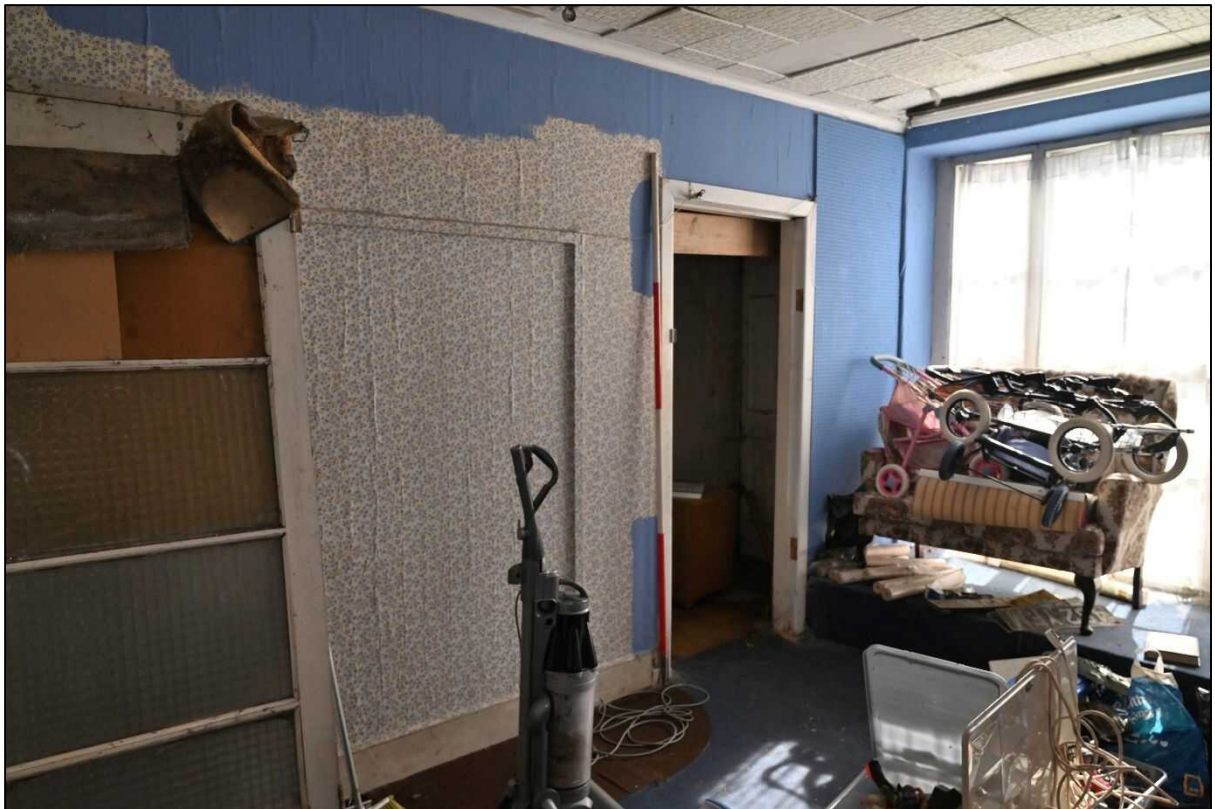
Plate 55: Sitting Room, looking SE

A short passage, parallel with the main service passage, runs to a cupboard below the stairs and a Sitting Room (Plate 55 and 56). The coving in this room is on three side of the room, but passes through the eastern wall, continuing in the passage which joins the front door of the Service Range to the stairs to the first floor (Plate 57 and 58). This would suggest that this wall was a later addition.

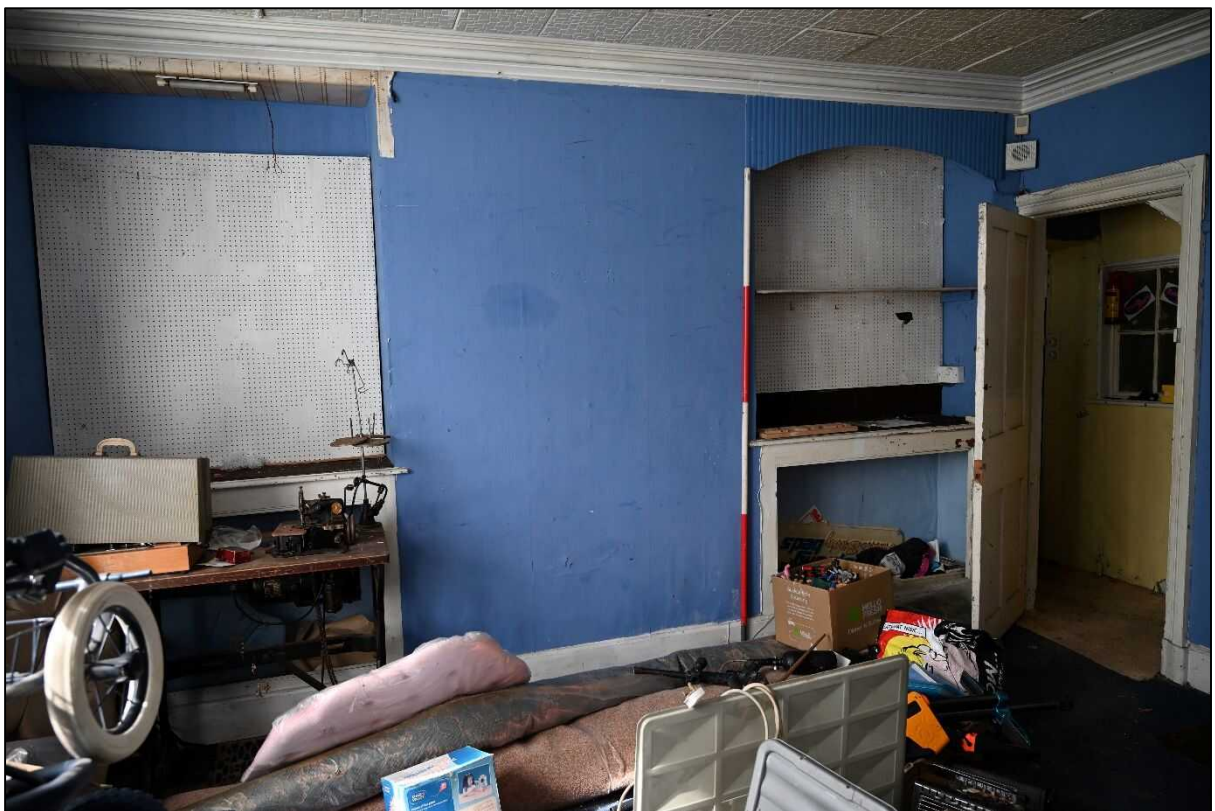
Plate 56: Sitting Room, looking NW

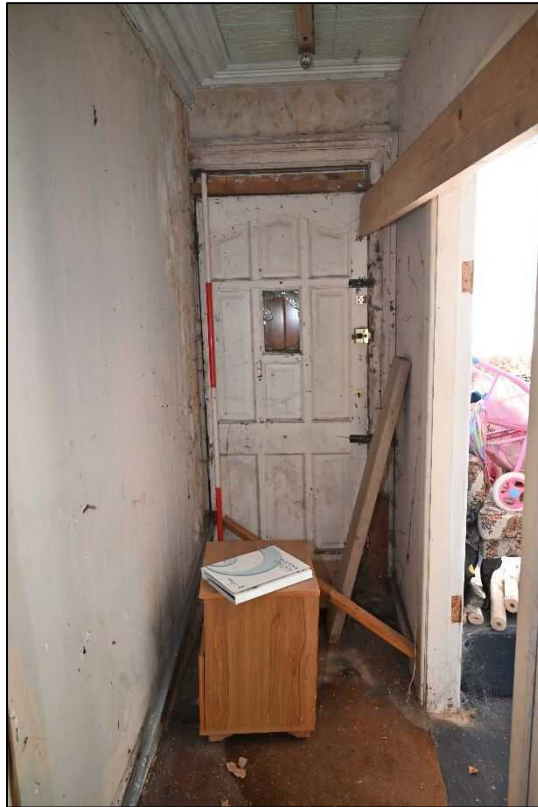
Plate 57: Front door to the Service Range

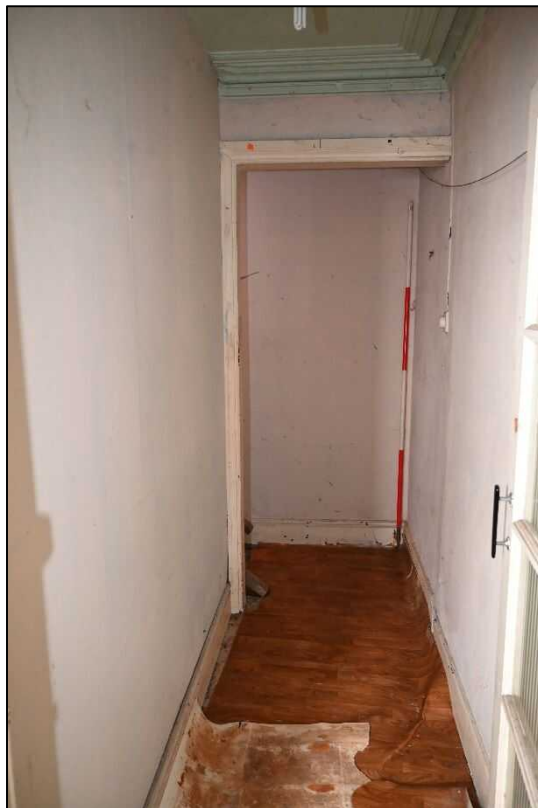
Plate 58: Passage to the rear stairs

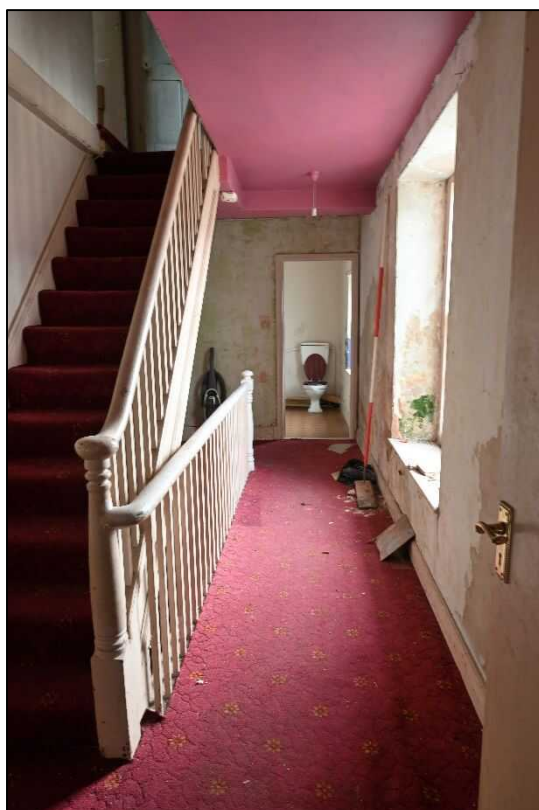
Plate 59: First Floor landing in the Service Range

On the First Floor (Figure 10) the “Service Range” can be access from a short corridor opposite the stairs in the Main Range, or via the stairs at the end of the passage from the front door of the “Service Range”. It consists of two bedrooms and a bathroom grouped around a landing which has staircases both down to the ground floor and up to the second floor (Plates 59 – 62). There is a common style of stair rails with turned newel posts and square section, stick, balusters supporting a curved section rail throughout the Service Range. Staircases of this style are typically from the first half of the 19th century (Hall 2005, 131).

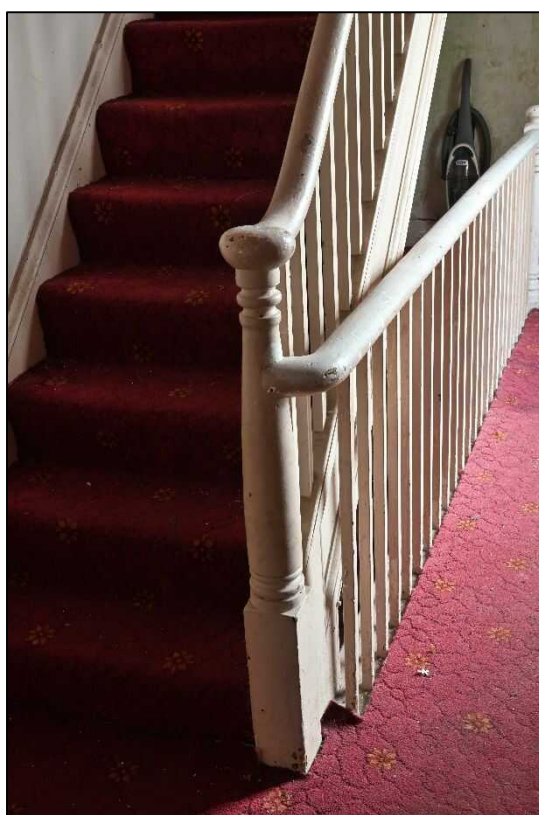
Plate 60: Newel post for stairs to Second Floor

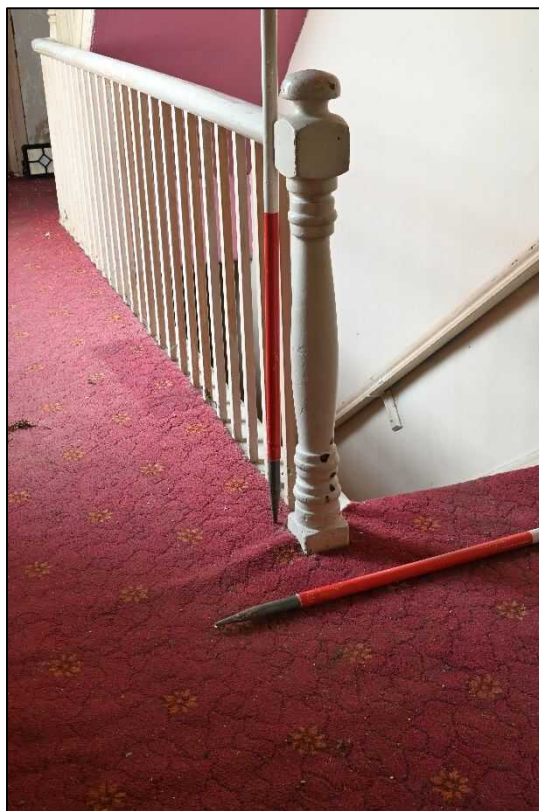
Plate 62: Newel post for Stairs to the Ground Floor

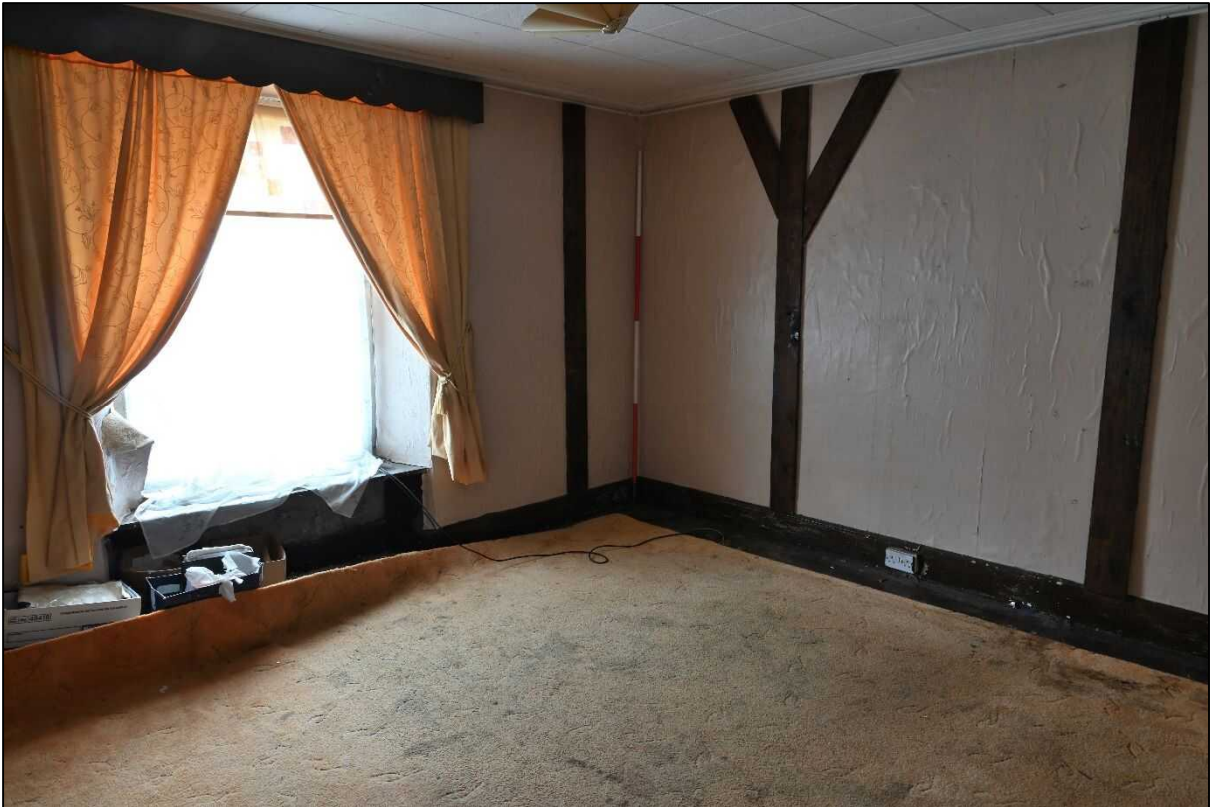
Plate 63: Bedroom 1, looking SW

Bedroom 1, in the south east corner of the “Service Range” is relatively plain (Plate 63), however Bedroom 2, in the south west corner, has the remains of a small fireplace in the gable wall (Plate 64), an airing cupboard in the NW corner and a sink unit on the northern wall (Plate 65). This sink is of a design more typical in a kitchen possibly suggesting that this room was used as a bed-sit in the recent past.
