Engineering Archaeological Services Ltd.

Brynmor, Penmaenmawr
Standing Building Record

EAS Client Report 20243/05

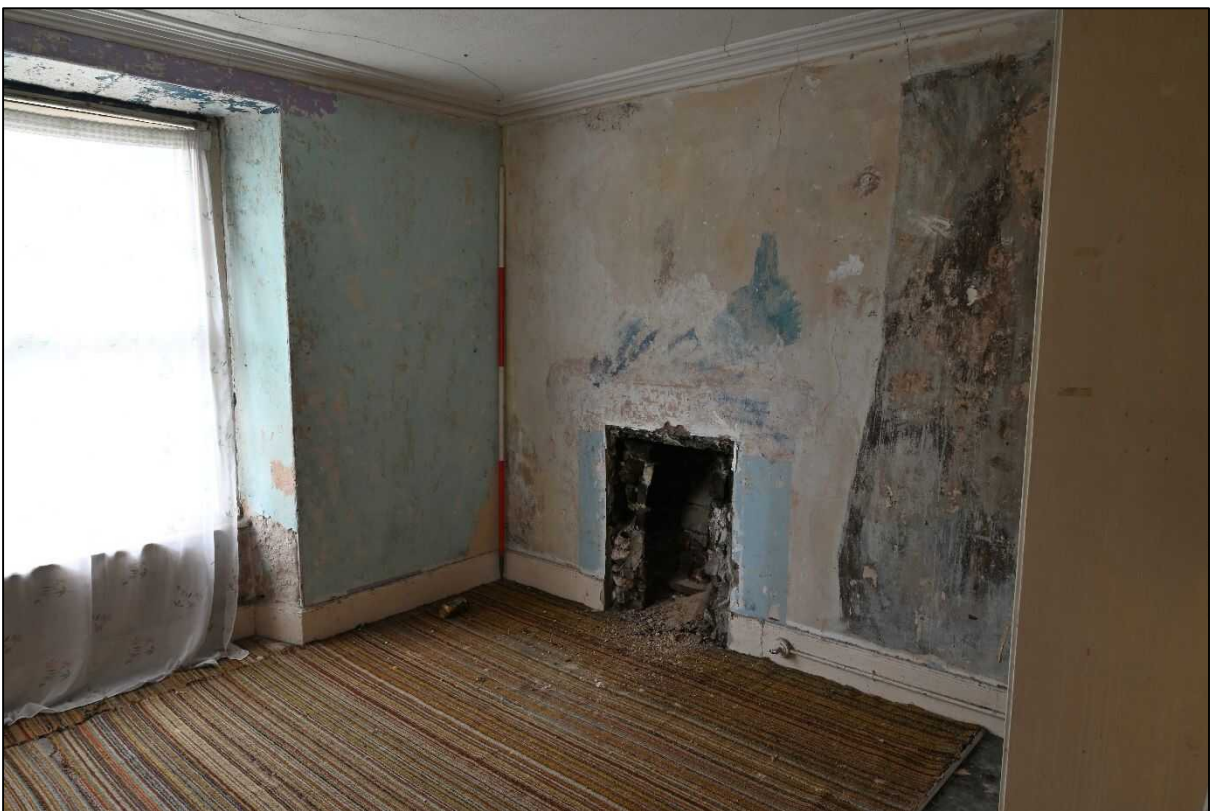
Plate 64: Bedroom 2, looking SW

Bedroom 1, in the south east corner of the “Service Range” is relatively plain (Plate 63), however Bedroom 2, in the south west corner, has the remains of a small fireplace in the gable wall (Plate 64), an airing cupboard in the NW corner and a sink unit on the northern wall (Plate 65). This sink is of a design more typical in a kitchen possibly suggesting that this room was used as a bed-sit in the recent past.

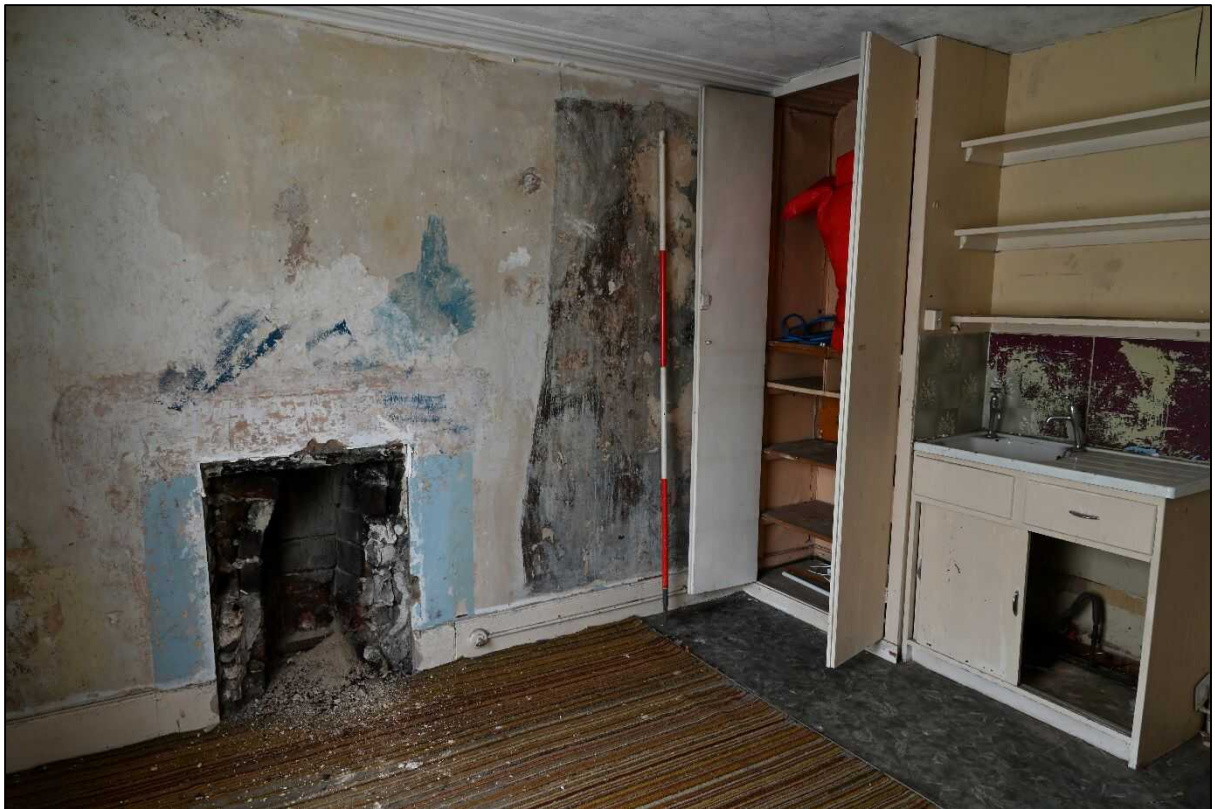
Plate 65: Bedroom 2, looking NW

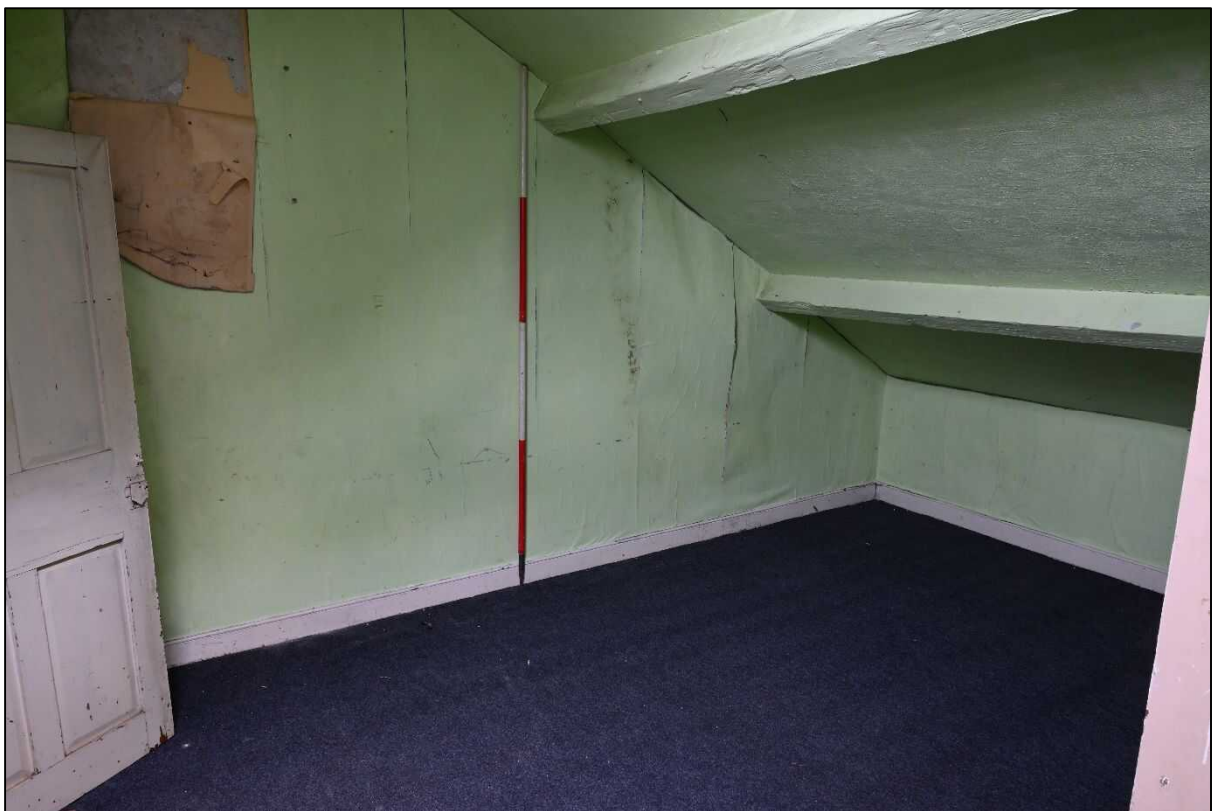
Plate 66: Bedroom 4, looking NW

On the Second Floor (Figure 11) there are two further bedrooms and three smaller rooms, under the eaves, which were probably used as storage rooms. Bedrooms 3 and 4 are accessed off a small landing set at right angles to the staircase. Bedroom 4 (Plates 66 and 67) has two purlins exposed along its northern side. There is also access to Store 1 from this room (Plate 68).

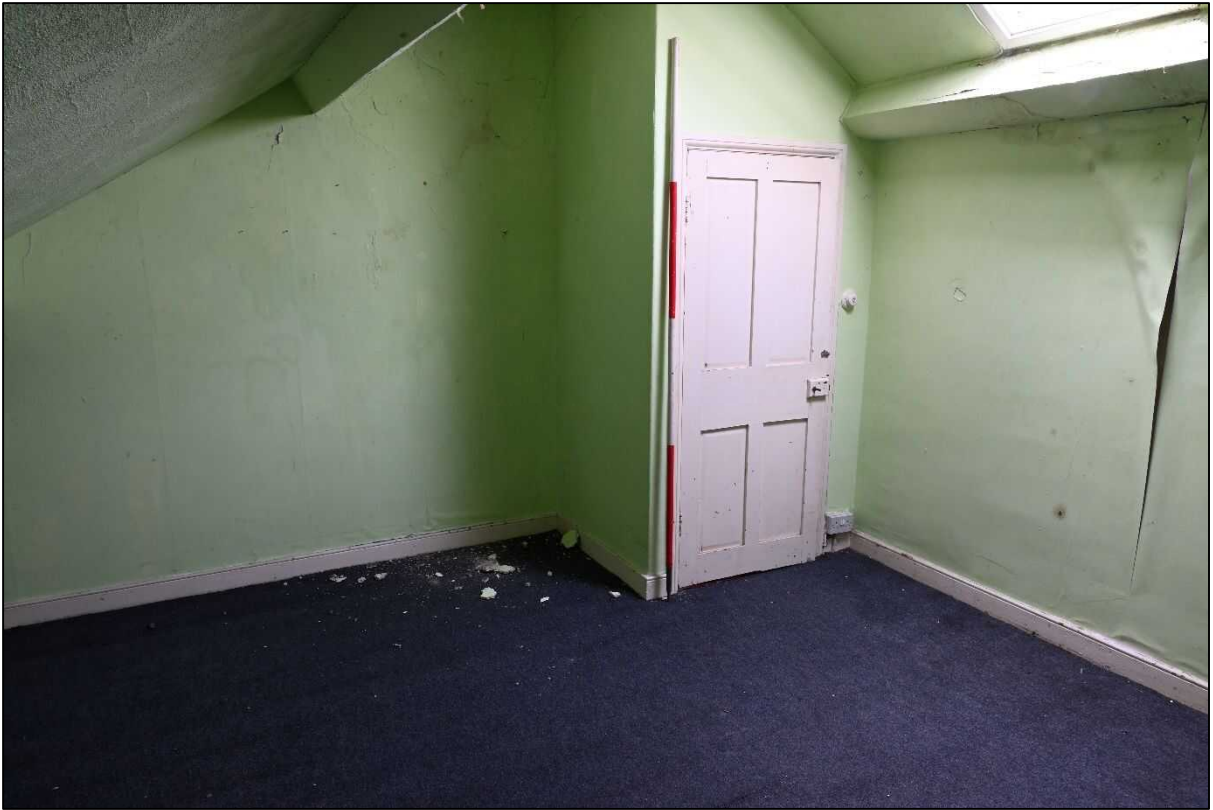
Plate 67: Bedroom 4, looking SE

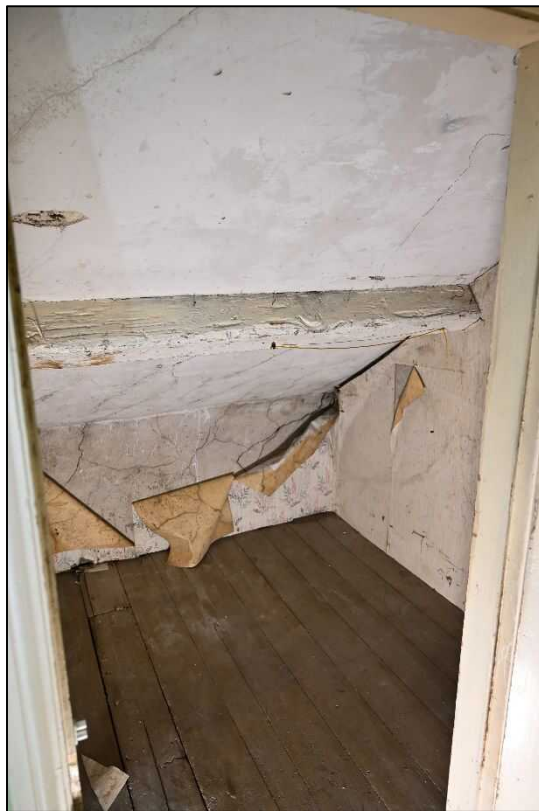
Plate 68: Store 1

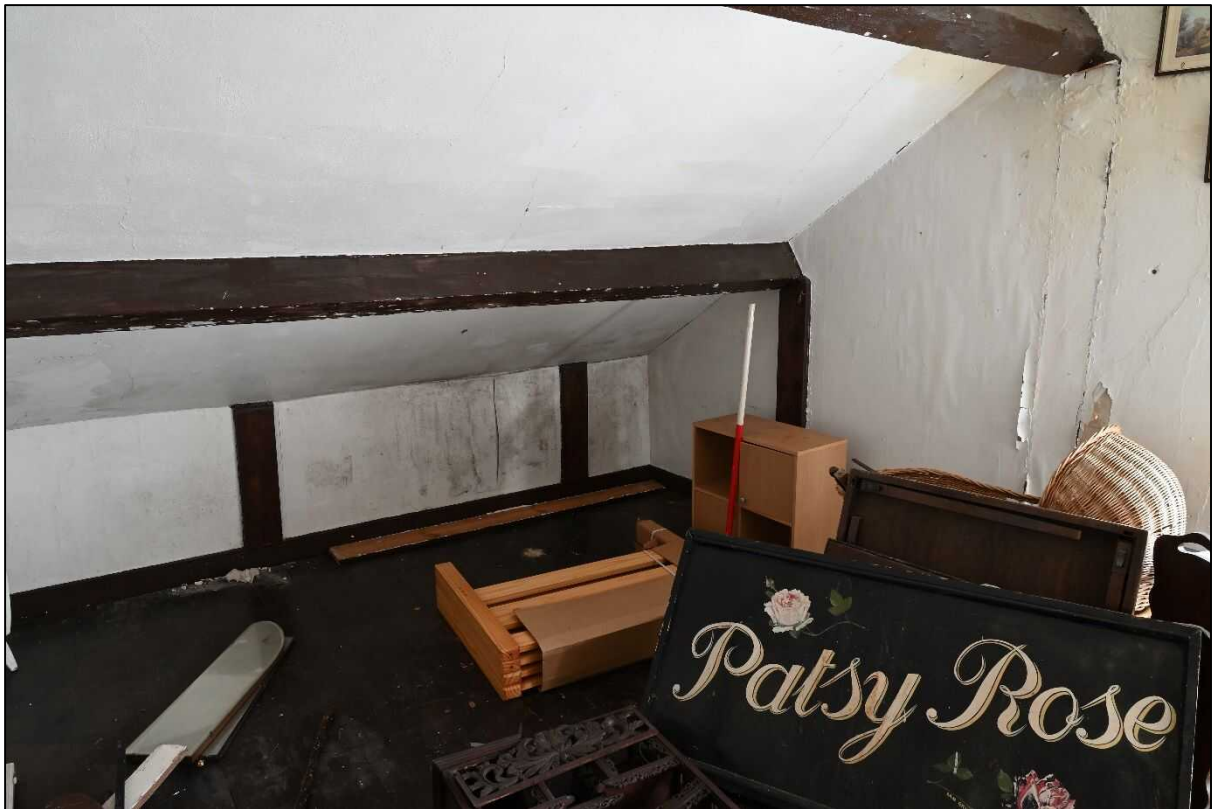
Plate 69: Bedroom 3, looking NE

Bedroom 3 (Plates 69 and 70) gives access to Store 3 in the south east corner of this range (Plate 71). The purlin in this store is notable as nineteenth century newspapers have been pasted along its length. This includes a copy of the Liverpool Journal of May 7th 1859 (Plate 72).

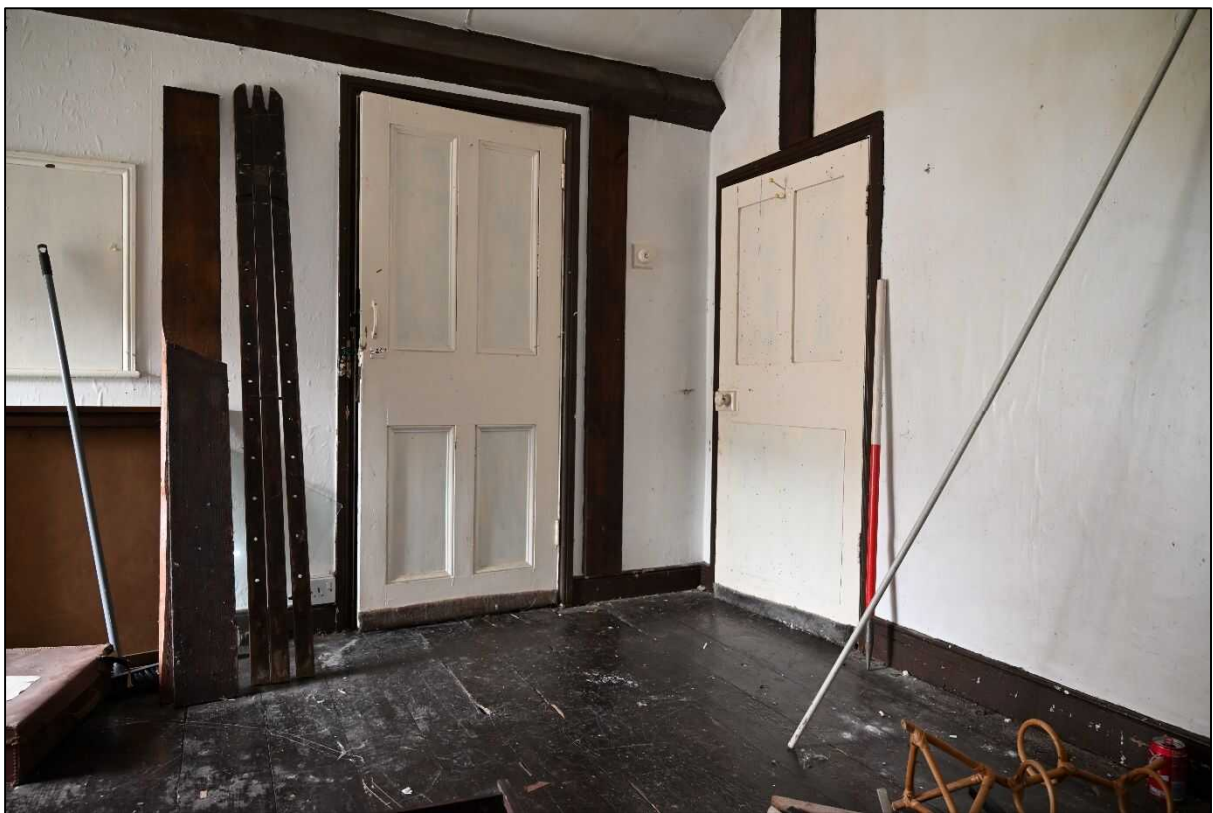
Plate 70: Bedroom 3, looking SW

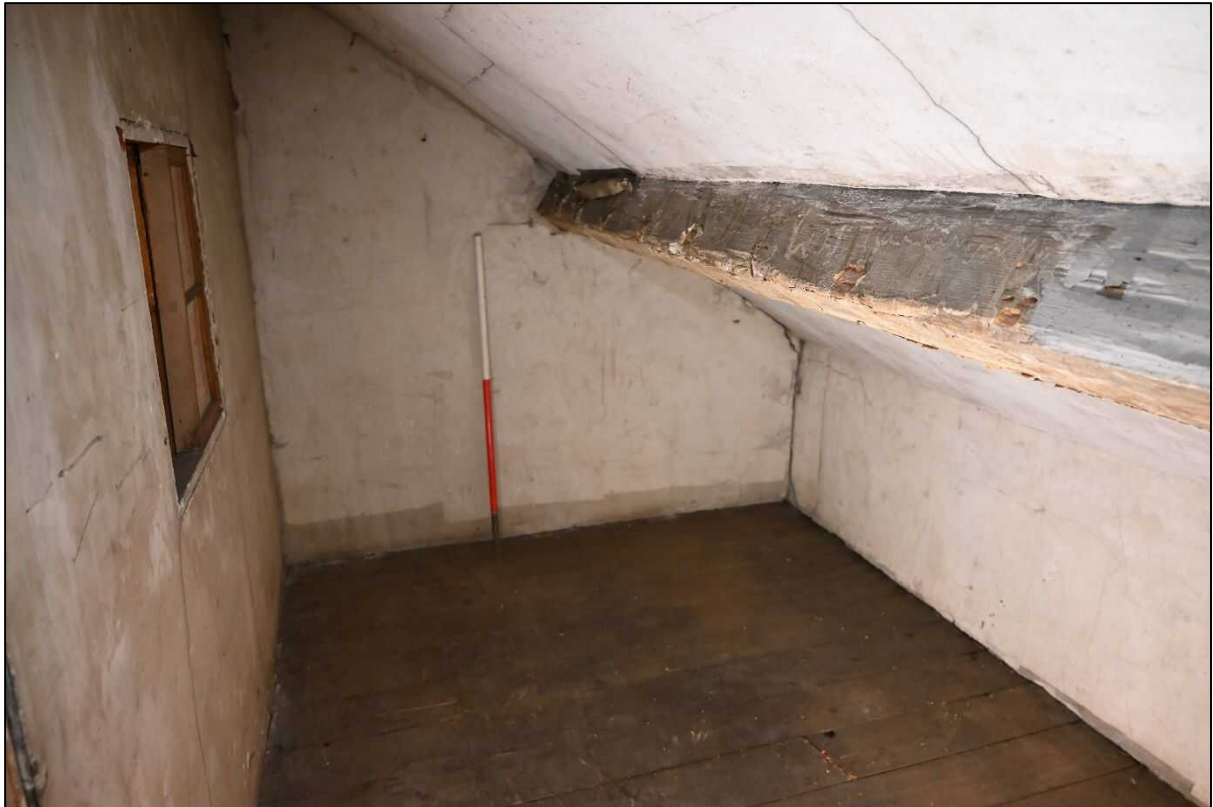
Plate 71: Store 3, looking SE
