Engineering Archaeological Services Ltd.

**The Oval, Caernarfon
Archaeological Watching Brief**

EAS Client report 2025/08

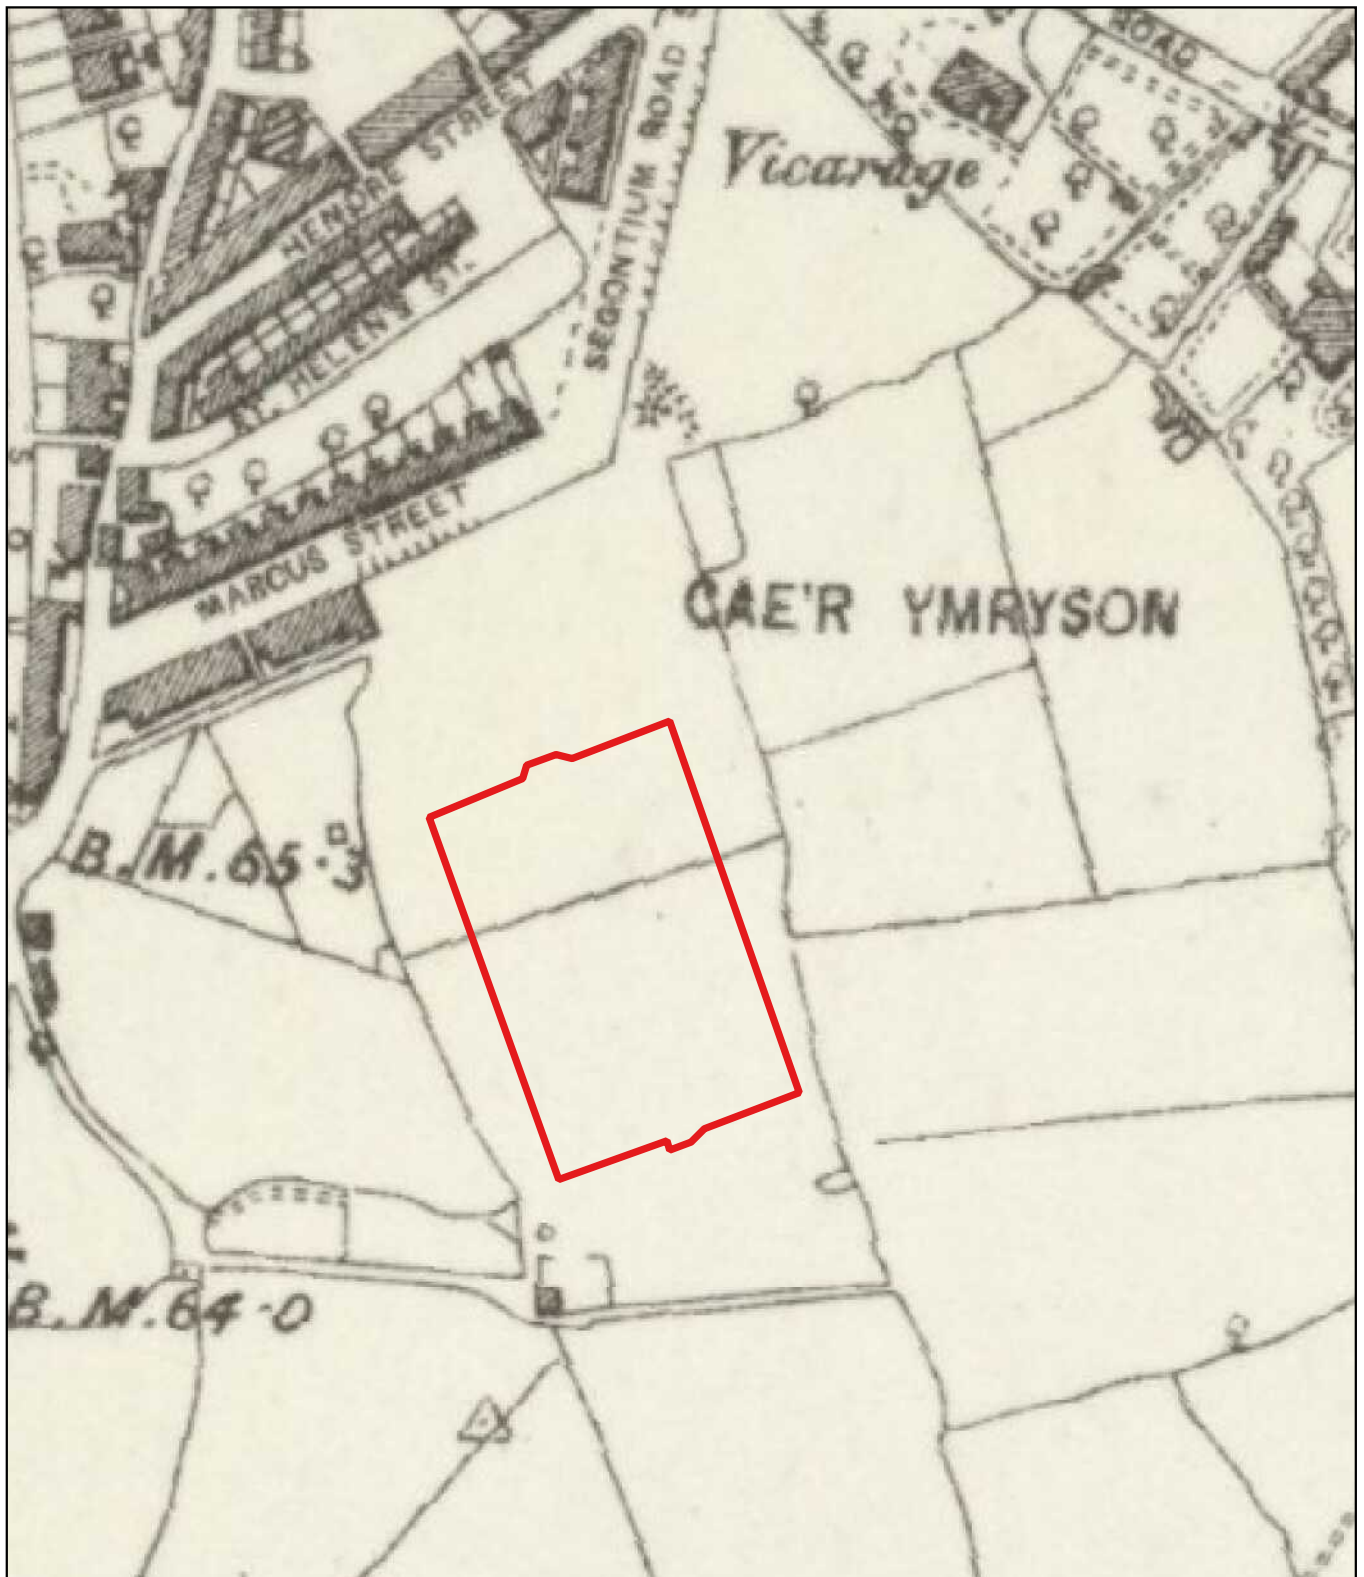
Figure 4: Extract from the 1841 Tithe Map
Rescaled to 1:2000

The earliest mapping located was the Tithe map of Llanbeblig in the County of Carnarvon (Figure 4) from 1841. The site of what was to become The Oval consists of two fields, Cae pella and Cae nina, both occupied by J Griffith and Richard Mathias Preece and owned by Thomas Assheton Smith.

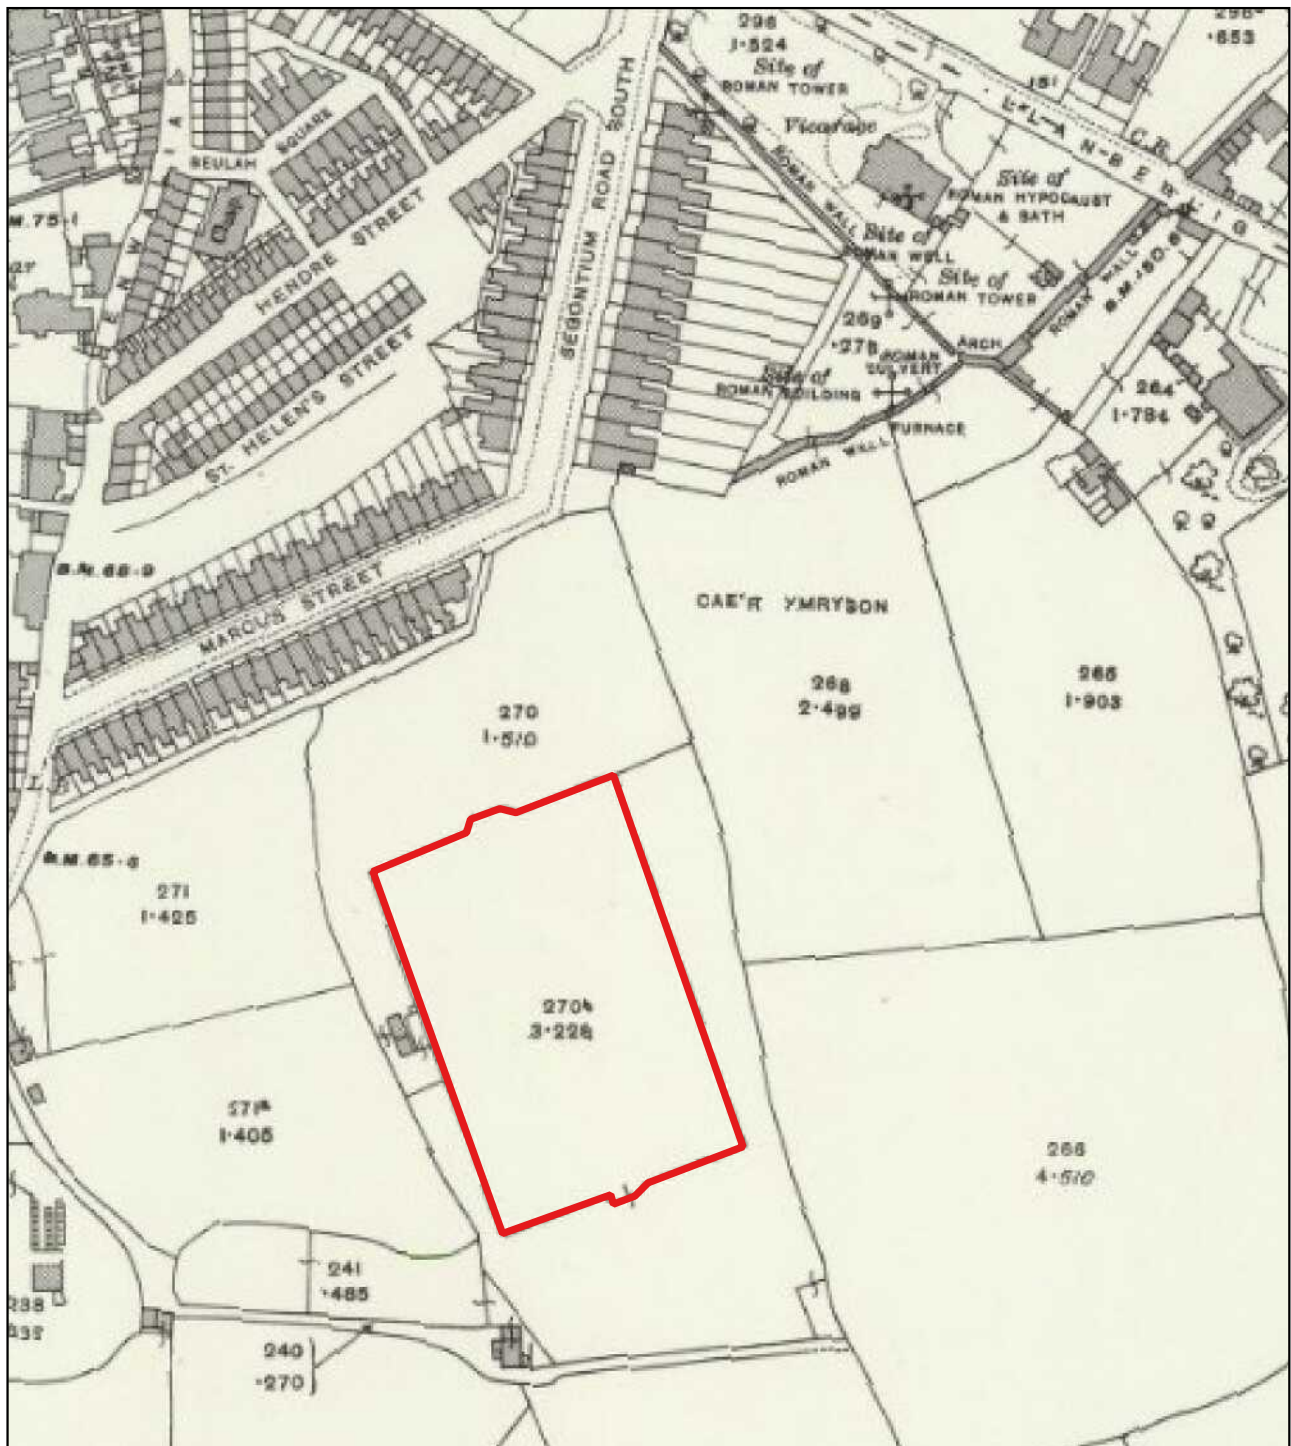
Figure 7: Extract of the 1911 Ordnance Survey Carnarvonshire XV.4. Map
Rescaled to 1:2000

1846) showed a significant building outside the walls of the Roman fort, between the south east corner of Segontium and The Oval. This building was more accurately mapped in 1921 by Wheeler (Wheeler 1921) (Figure 3). The site of this building and a, presumably, associated wall, are also shown on the Ordnance Survey mapping from 1889 (Figure 6), 1911 (Figure 7) and 1918 (Figure 8)

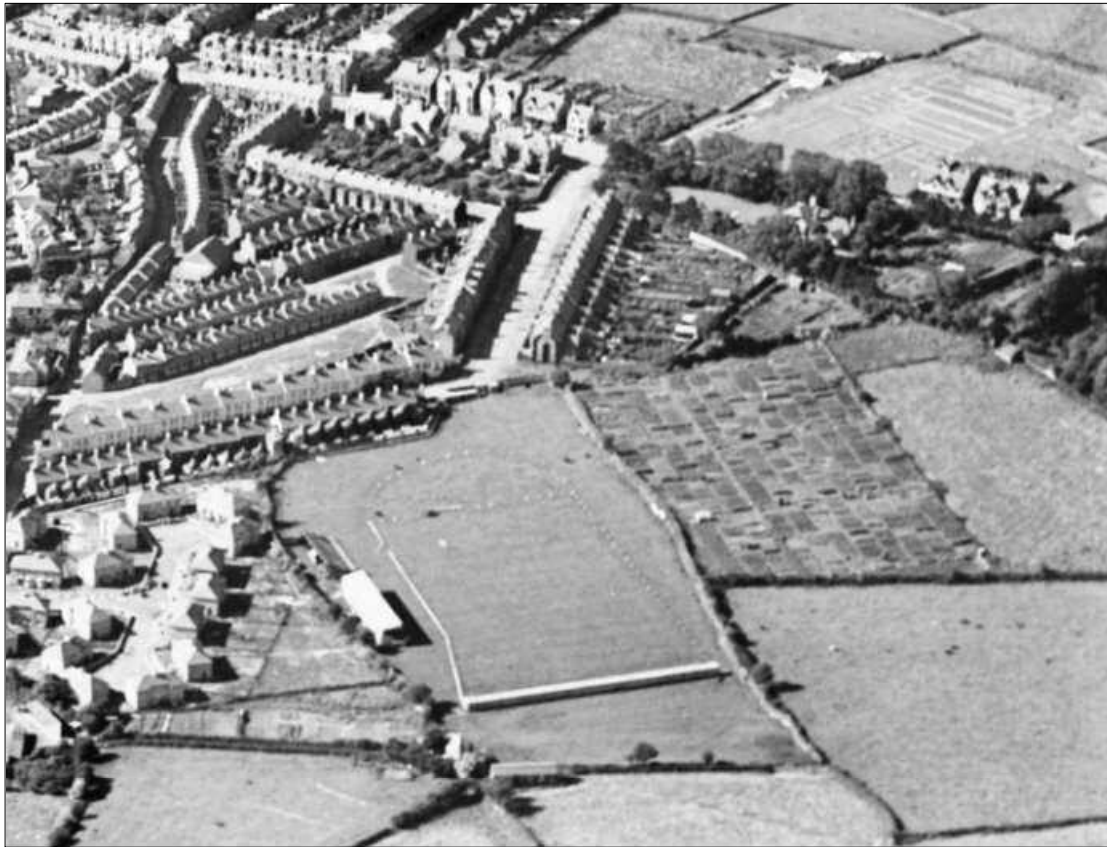
Figure 10: Extract from the 1972 Ordnance Survey SH 4862 map
Rescaled to 1:2000

The most detailed of the early mapping is the Ordnance Survey mapping Caernarvon - Carnarvonshire XV.4.19 and XV.4.24, published in 1889 and printed at 1:500 (Figure 6). These show the site of The Oval was still divided into two fields and also marks the Roman walling, the site of a building and a furnace between Segontium, itself and the site of the, later, football pitch. Indeed, it is not until the mapping published in 1911 (Figure 7) that the site of the pitch is a single field and the mapping published in 1918, but revised in 1913, (Figure 8) that the pitch itself is mapped. The mapping published in 1965 and 1972 (Figures 9 and 10) shows the addition of stands to the west and terraces to the south of the pitch.

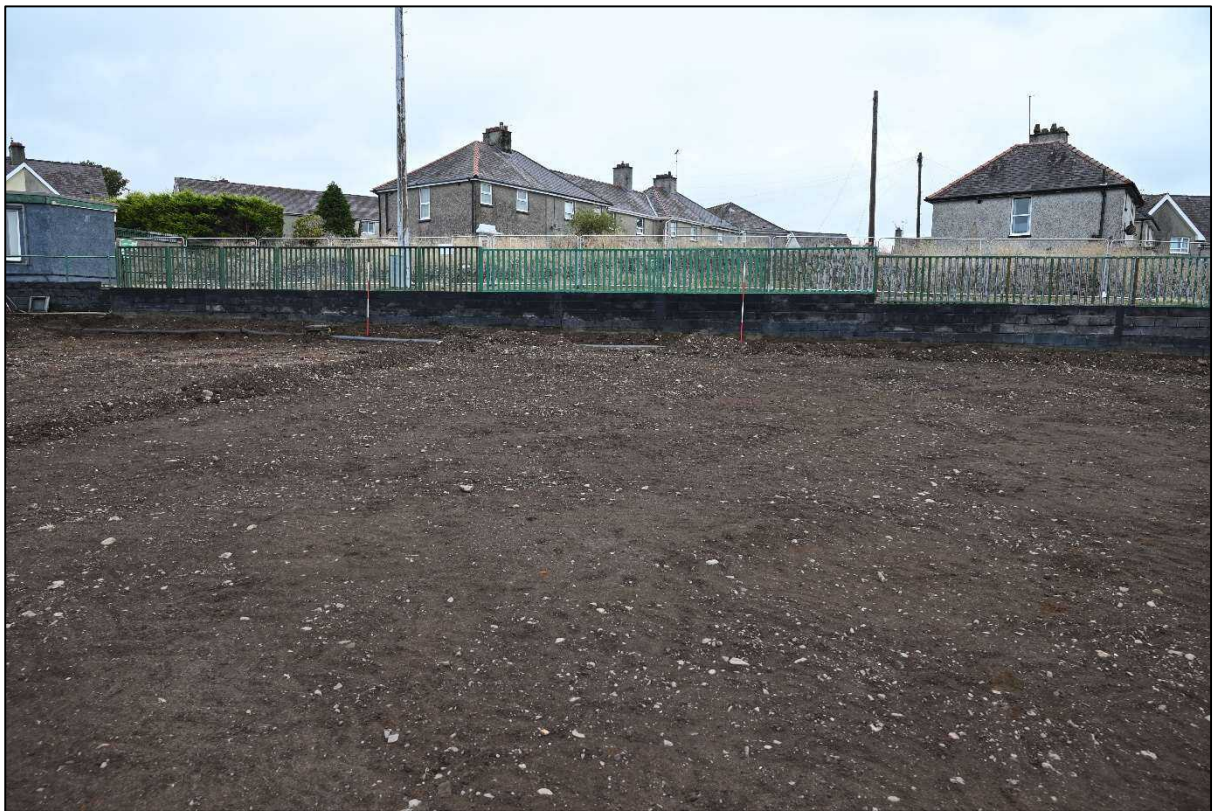
Plate 2: Wall along the eastern side of the pitch

After the levelling had taken place the retaining wall along the eastern side of the pitch (Plate 2) was demolished, together with the concrete steps behind, and the spoil behind the wall reduced in level. The middle of the eastern side of the pitch is occupied by a short set of seats with a platform for the press and television cameras over (Plate 3). This structure was not demolished or moved. Thus, the levelling took place either side of the stand where the edge of the pitch was cut back.

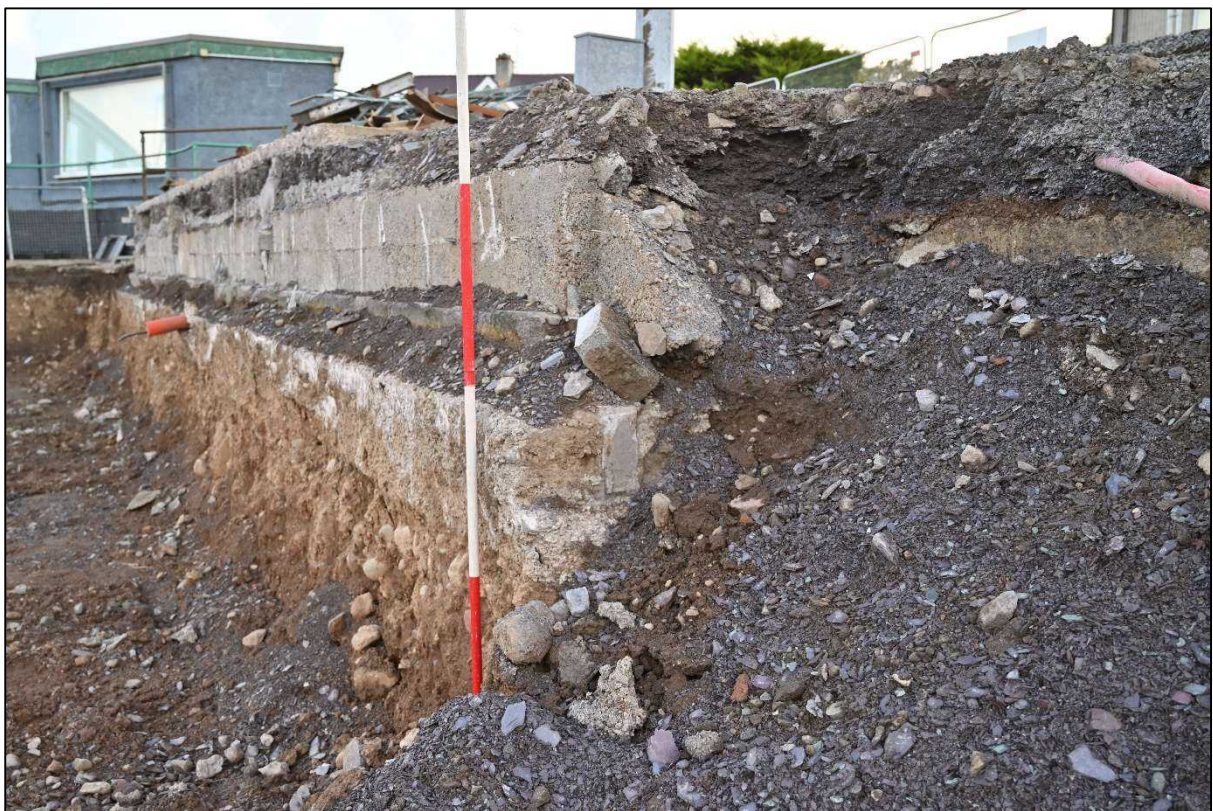
Plate 4: Remnant of the concrete steps behind the retaining wall

Immediately behind the retaining wall along the eastern side of the pitch were a series of at least two concrete steps. These appeared on both sides of the central stand and presumably originally ran along the whole length of the pitch. Their construction varied along its length with the northern end the steps being made of poured concrete (Plate 4), whilst in the middle of the run it was constructed of, probably reused, bricks with a concrete skim (Plate 5). As the section was cut back, beyond the level of the steps it revealed the stratigraphy behind (Plate 6, Figure 13). Below a thin layer of pale grey stone chipping, 80 mm thick (Context 12) was a layer of crushed slate waste (Context 13) which acted as a base for the overlying stone chippings. The next layer (Context 14) was a dump of yellowish-brown clayey gravel, up to 280 mm thick, with the occasional boulder, pockets of mortar, slate, modern bricks and tiles. Context 14 merged with Context 15 below which was a dump of building rubble including large angular block, up to 400 mm, slate blocks and beams (some decorated) (Plate 7) crushed mortar, glass, crushed paint can etc. Layer up to 470 mm thick, but tending to thin towards the south where it becomes only 200 mm thick. Both Contexts 14 and 15 are designed to increase the level of the land behind the concrete steps.

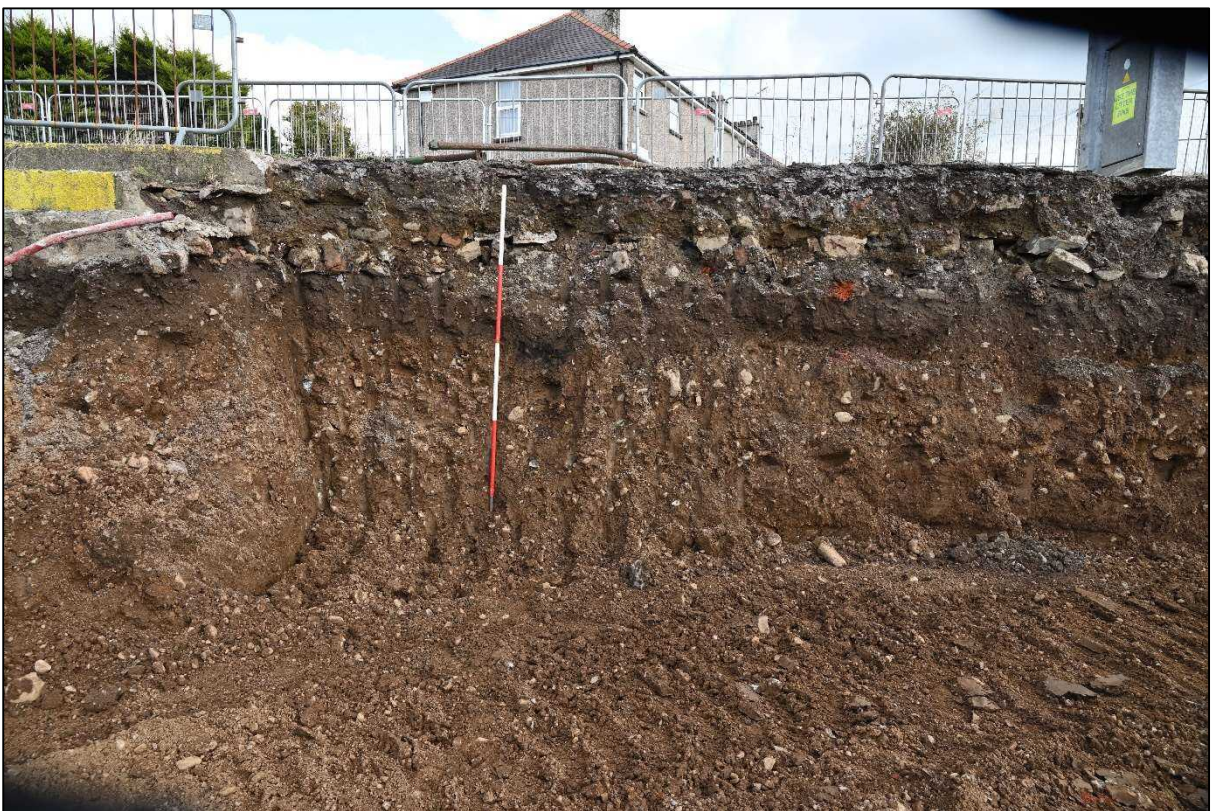
Plate 6: Build-up of deposits behind the retaining wall

Context 15 was dumped on a layer of soil (Context 16) which is considered to be the original topsoil before the site was developed. The layer was a mid-brown clayey silt, 280 mm thick, with the occasional fleck of charcoal, some post-medieval finds including clay pipe, occasional small (up to 50 mm) rounded stone. The level of this layer appears to be slightly higher than the topsoil of the pitch (Context 1), possibly suggesting the pitch had been partly levelled at some point in the past.

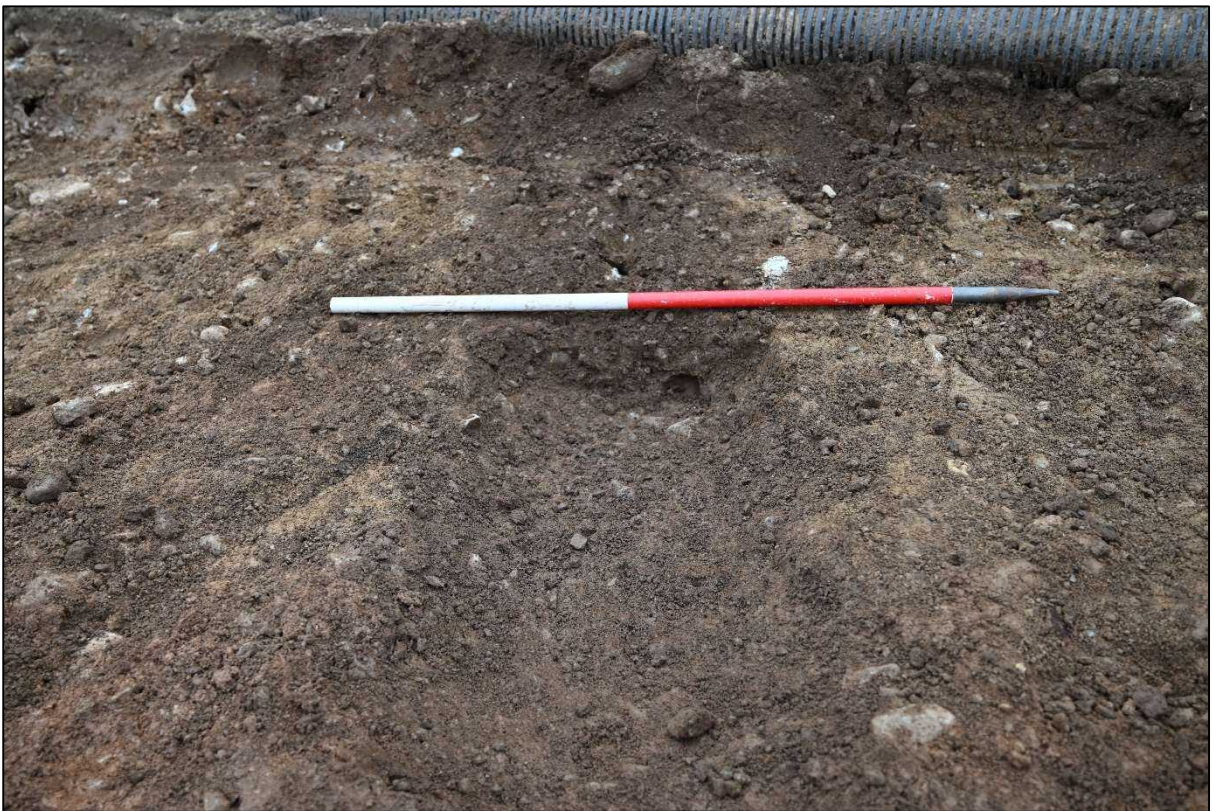
Plate 12: Linear feature Context 20

A single linear, feature or gully, was located near to the eastern stand (Figures 12 and 13, Plate 12). It was up to 470 mm wide and 150 mm deep with sloping sides and a rounded base running in a SW-NE direction. It was filled with a mid-yellowish-brown clayey silt with a moderate density of small (up to 60 mm) angular and sub-angular stones. This feature corresponds with the boundary shown of the Tithe and 1889 Ordnance Survey mapping (Figures 4 and 5)

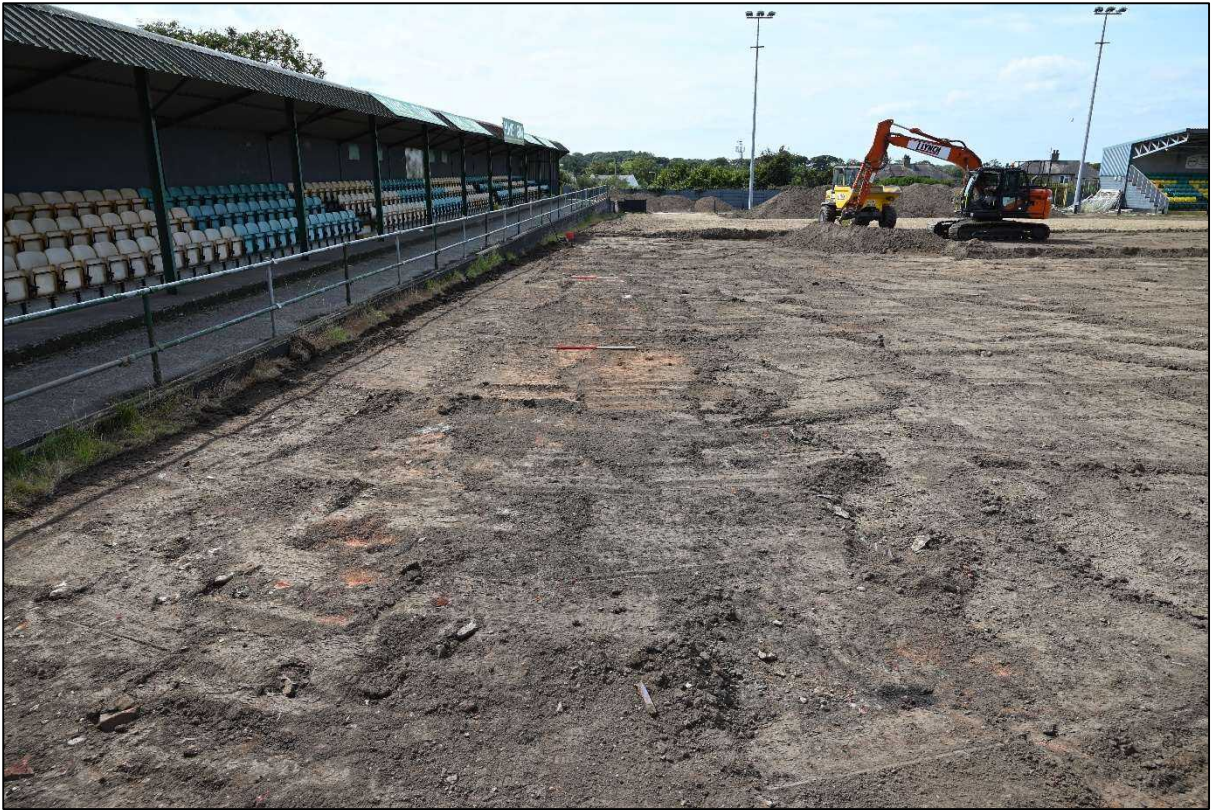
Plate 13: Band of crushed brick rubble (Context 4)

A series of “modern” features were located along the southern side of the pitch (Figure 12). These consisted of a band of crushed brick rubble and coal fragments (Context 4, Plate 13) forming a band approximately 1.8 m wide leading to Contexts 5 – 7.

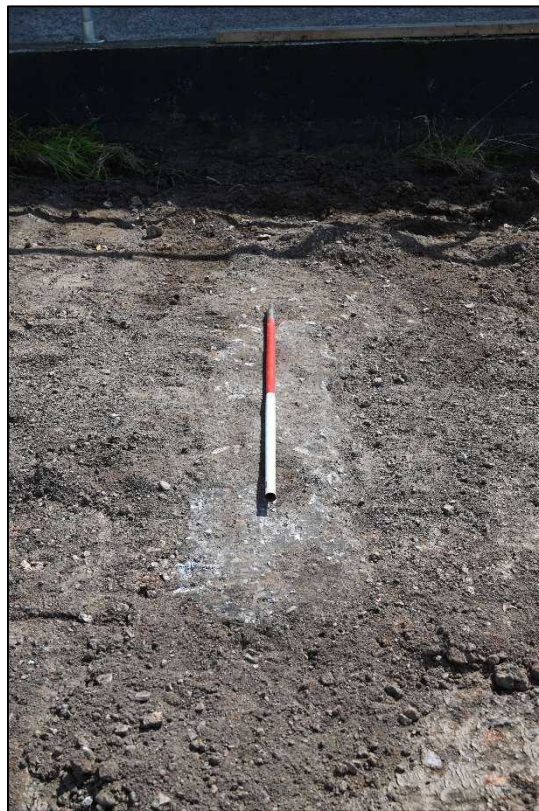
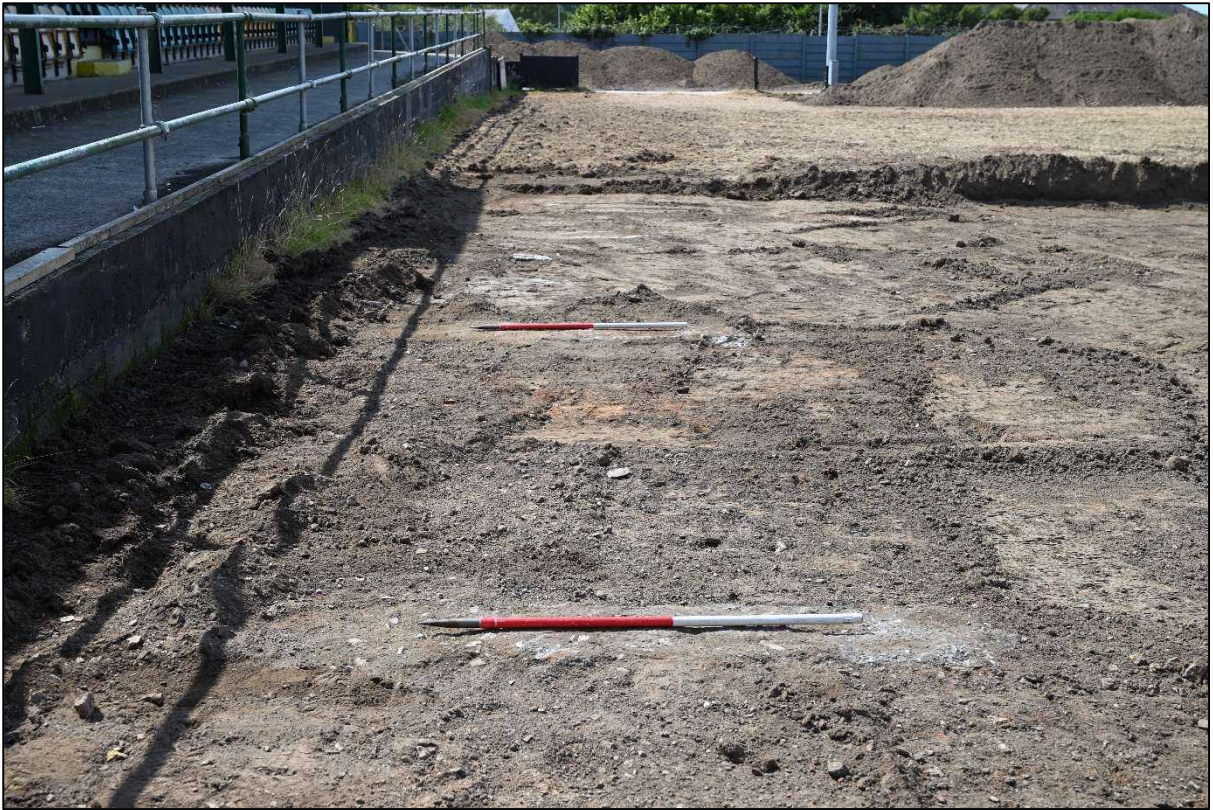
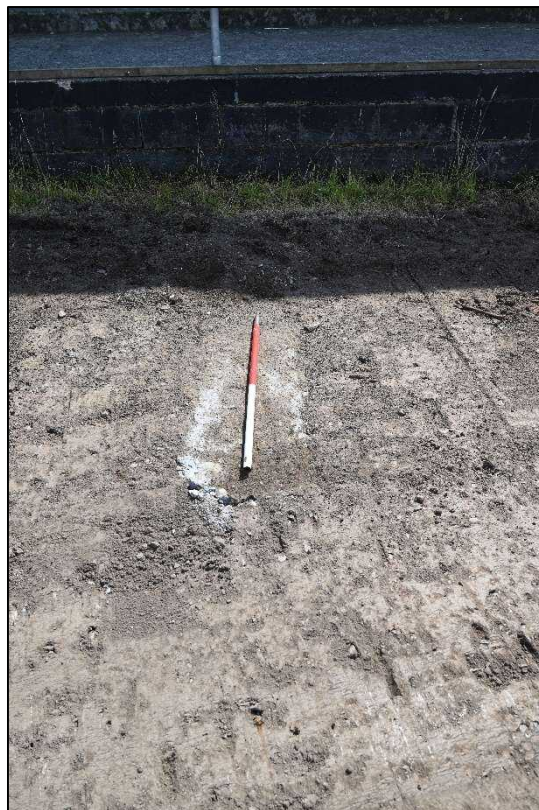
Plate 14: Concrete pad, Context 5

Contexts 5, 6 and 7 were concrete pads, set at right angles to the southern edge of the pitch at roughly 4.2 m intervals. Context 5 (Plate 14) was 2.83 m long and 0.37 m wide, Context 6 (Plate 15) 2.77 m long and 0.42 m and Context 7 (Plate 16) 2.30 m long and 0.41 m wide. Given their similarity in form and composition and the regularity in their layout it is likely they are contemporary, possibly the support for structure shown on the 1935 aerial photograph (Figure 11).

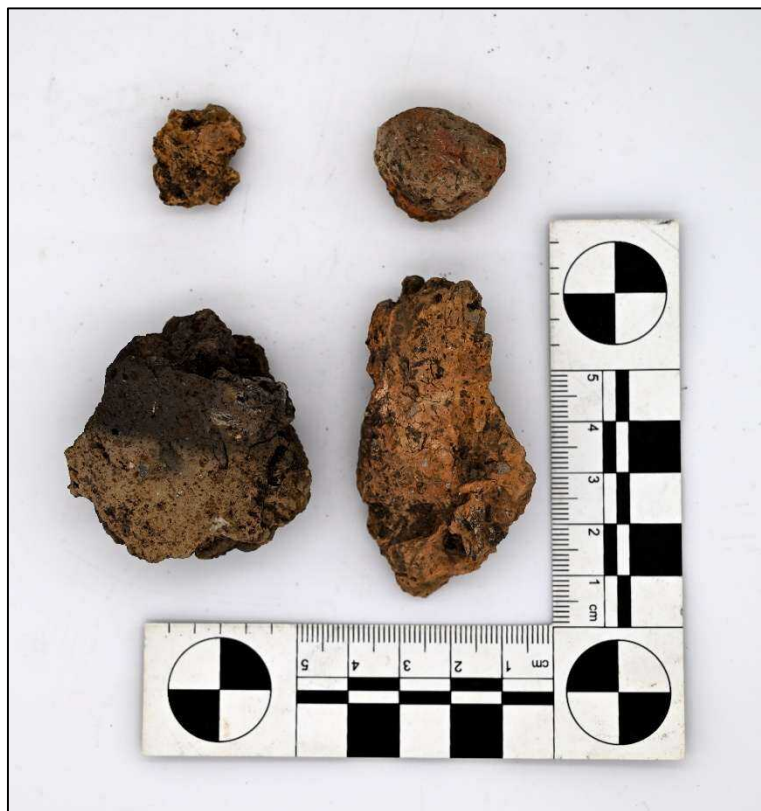
Plate 18: Burnt clay artefacts

Four fragments of burnt clay (Plate 18) were recovered from Context 18, the fill of a small feature (Context 17). These consist of:

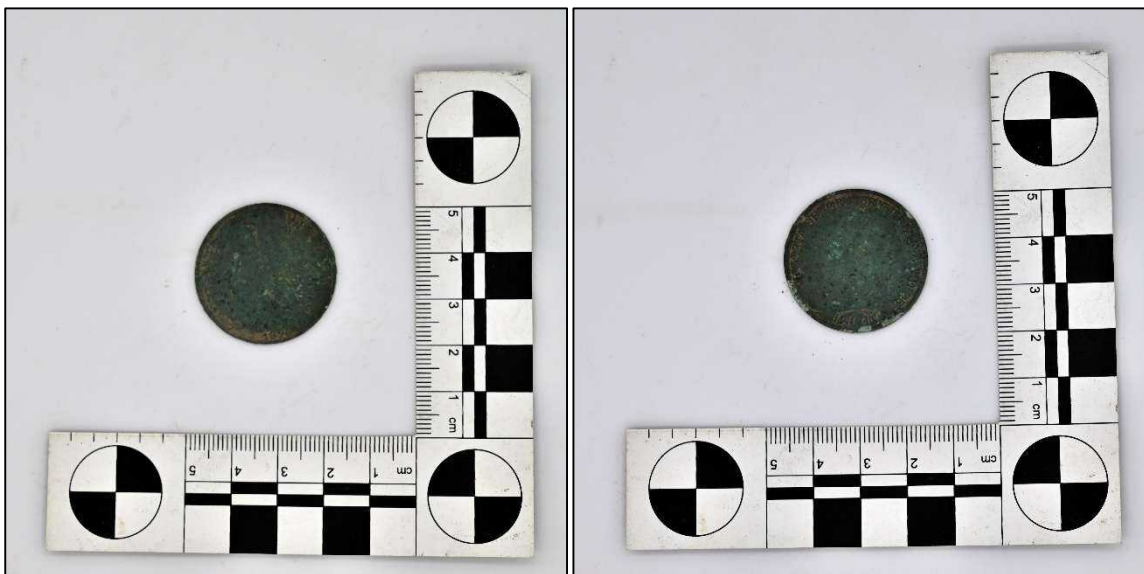
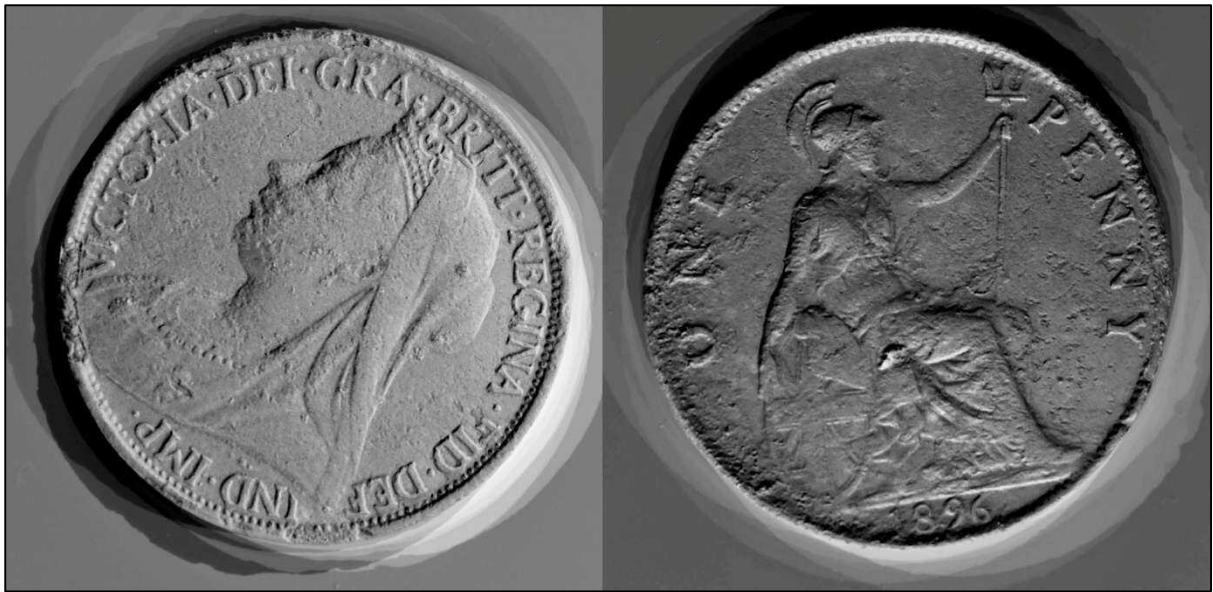
Plate 120: The coin

A single Victorian penny was recovered from the fill associated with the conduit carrying the electricity supply to the floodlights. The coin is heavily rubbed and worn, but Reflectance Transformation Imaging (RTI) reveals this to be an 1896 penny.
