# Gas Pipeline Replacement: Pwllheli City Gate PRI to Blaenau Ffestiniog PRI

Archaeological assessment of potential  
for analysis report

Project No. G2148

Report No. 1020

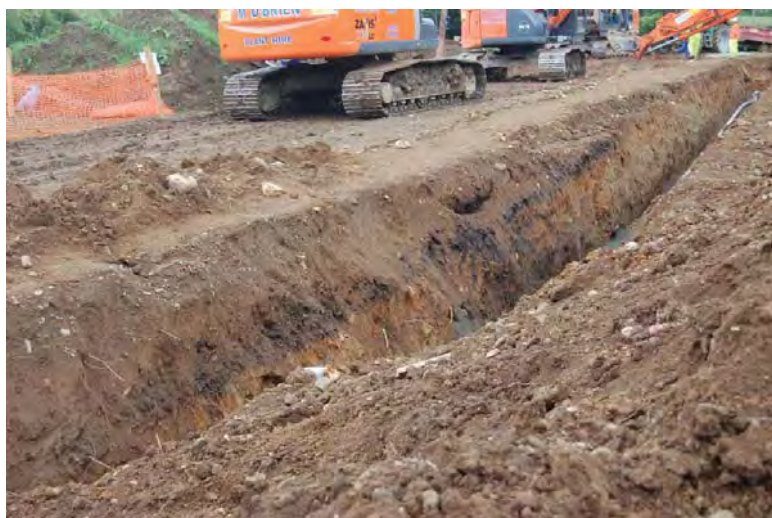
A linear stone feature was found running north-north-east to south-south-west parallel to the track. This was composed of large sub-angular stones, up to 0.74m in length, some of which were laid flat. Other stones that lay at an angle had probably originally been flat but had either collapsed into the feature or been disturbed by the plough. Under these was a quantity of densely packed smaller stones.

Plate 2: Section through probable stone-filled drain in plot 0/1

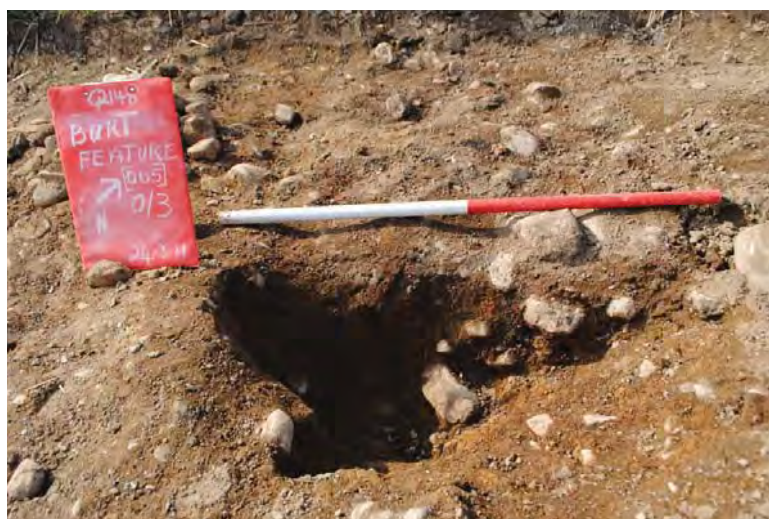
Buried beneath between 0.2m and 0.7m of grey-brown stony silt was a black, charcoal rich layer containing burnt stones. For a considerable depth beneath this the natural subsoil had been reddened by the heat. The black layer showed up most clearly in the south-western side of the trench and it extended for 12-13m. It was closest to the ground surface at the south-western end and sloped down towards the north-east.

Plate 3: Burnt mound seen in section of pipe trench in plot 0/2

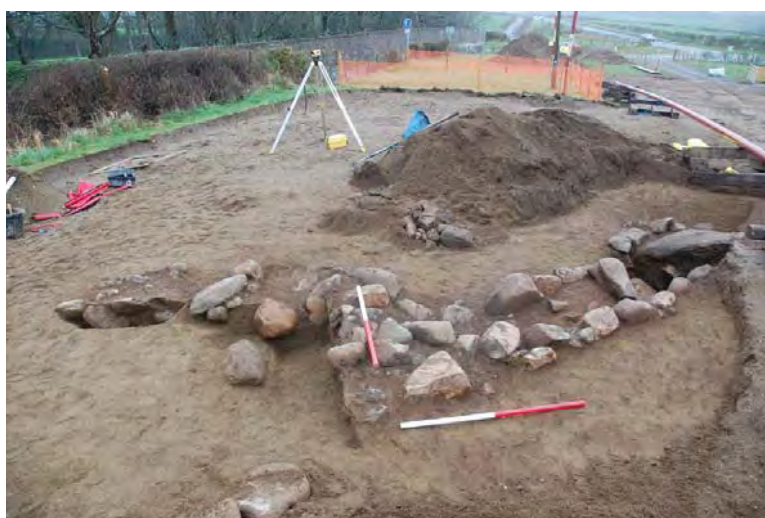
A dark grey layer was recorded in the side of the pipe trench. This was about 1.6m below the present ground surface and extended for nearly 30m. The layer contained few stones, although occasional stones thought to be burnt were noted towards the edge of the deposit. It is possible that this was the edge of a burnt mound but there does not seem to have been the distinctive burnt stone layer typical of these features.

Plate 7: Traces of a possible burnt mound seen in the pipe trench section in plot 0/11

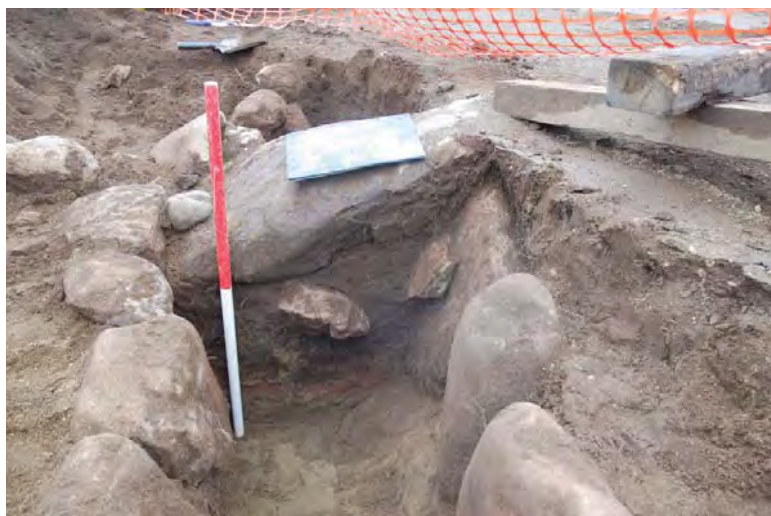
Many of the lining stones, especially in the joining channel, appeared heat altered, although stones resistant to heat fracture had obviously been chosen and few were cracked. In the base of the channel, especially under the capstone (32006), was a burnt reddened silt with some charcoal. In the west-north-western chamber there was a layer of fairly flat stones (32025) in its base, which may have formed a rough surface, although it would have been quite irregular. This chamber seems to have filled partly by erosion (32020) then a dense group of stones were dumped into it (32024). These stones were generally not heat-altered, but may have originated from the upper part of the structure. The channel seems also to have filled in by erosion with some structural stones collapsing in. The east-south-eastern chamber had an erosion layer in its base mixed with some charcoal, but with no traces of *in situ* burning. The remainder of the fill was the same as the rest of the feature.

This feature was probably a corn drier (PRN 34081). The fire seems to have been lit under the large capstone. There is no firm evidence for burning in the east-south-eastern chamber so this may have been used mainly for access. The heat of the fire would be drawn through the channel, which would act as a flue, to the west-north-western chamber. A loose layer of branches would probably have been laid over this end on which a cloth containing the grain could be placed.

Plate 10: Corn drier 32009 in plot 3/2, from SE end showing chamber and capping stone 32006

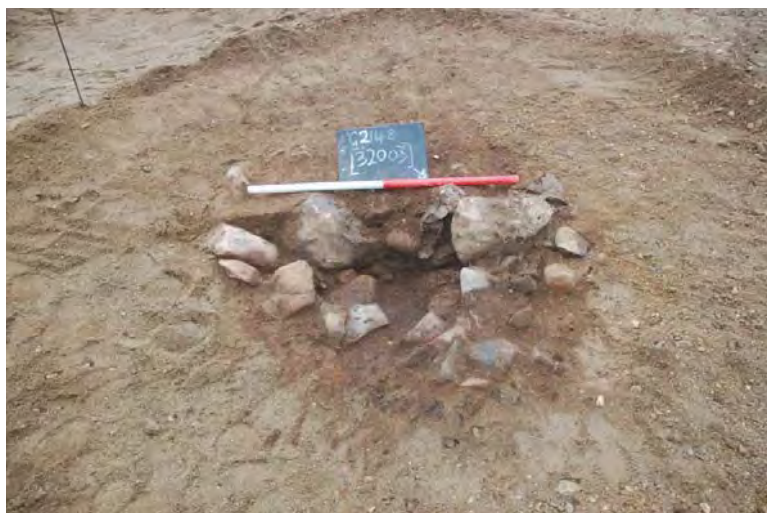
Plate 11: Section of corn drier 32009 in plot 3/2, showing capping stone 32006 and traces of burning in base of flue

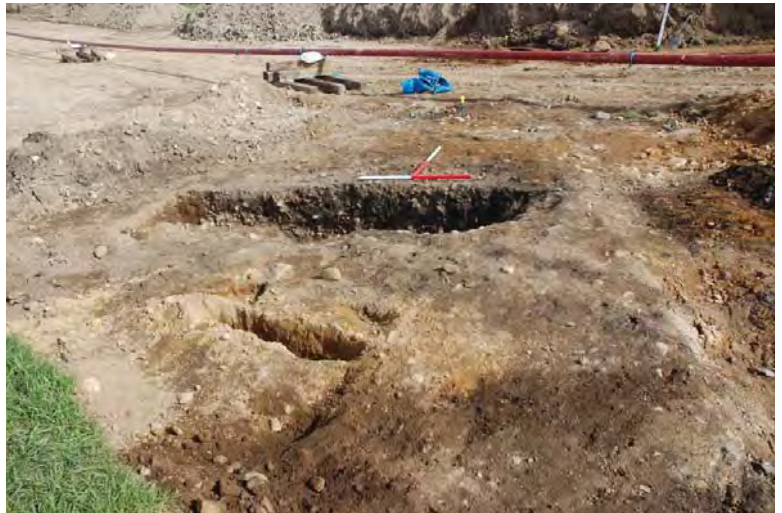
A sub-rectangular pit [36002] was found, aligned roughly east-west, and measuring 1.70m by 0.58m, with a depth of 0.22m. The long sides were straight and parallel and the short ends were fairly rounded. The sides of the cut were steep and the base flat. The feature was well-defined. Its dark grey silty fill contained numerous stones, many heat-shattered and lenses and patches of charcoal.

Plate 13: Feature 36002 in plot 3/6

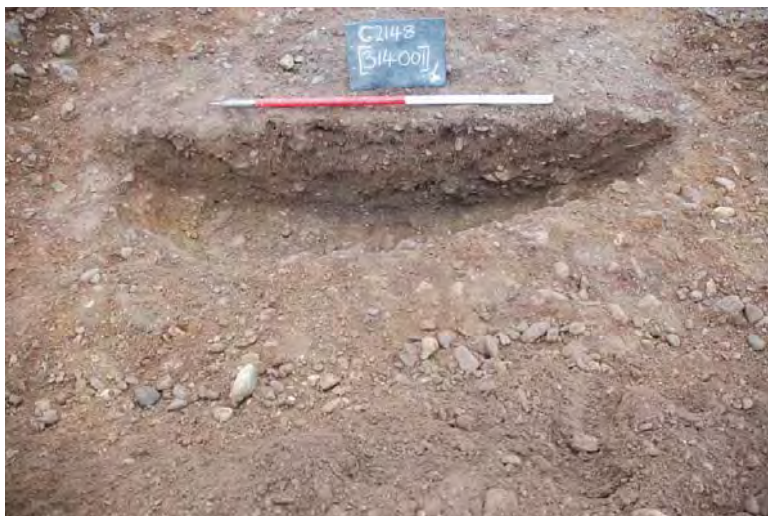
Plate 14: Burnt mound trough 310001 in plot 3/10

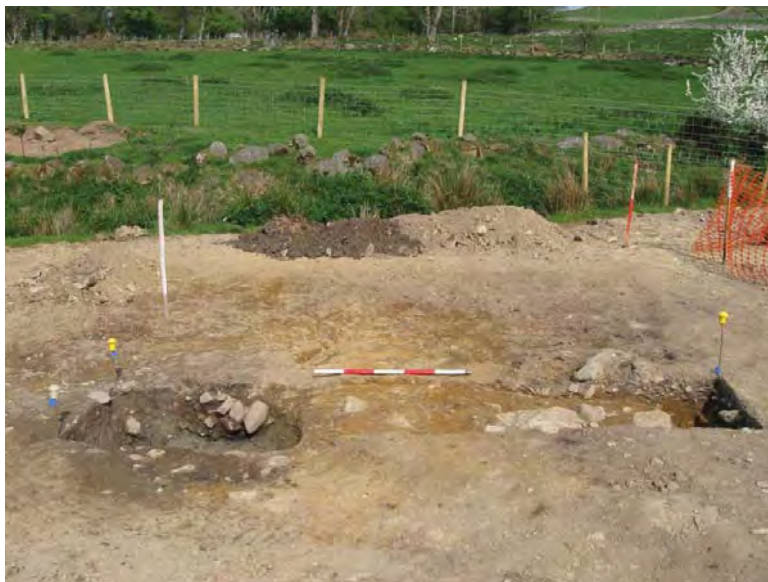
Plate 21: Sondage through burnt mound 66003 and trough 66011 in plot 6/6, from the SE

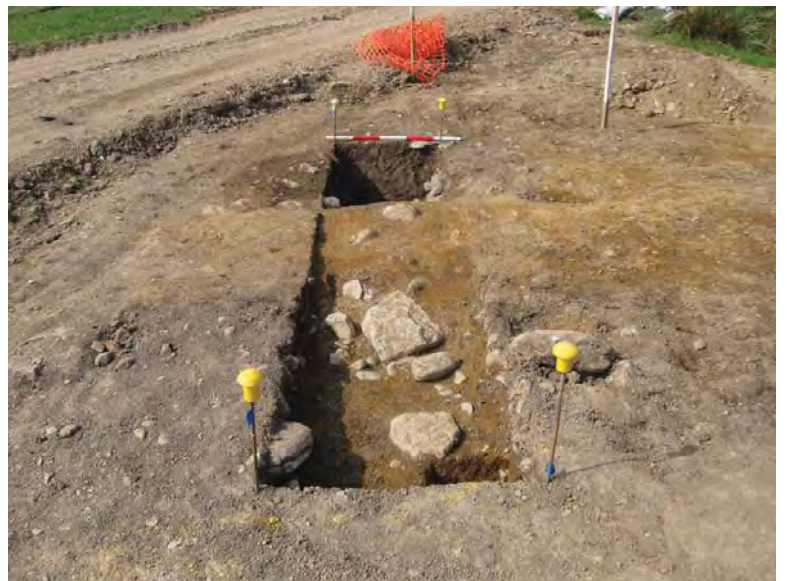
Plate 22: Sondage through burnt mound 66003 and trough 66011 in plot 6/6, from the NE

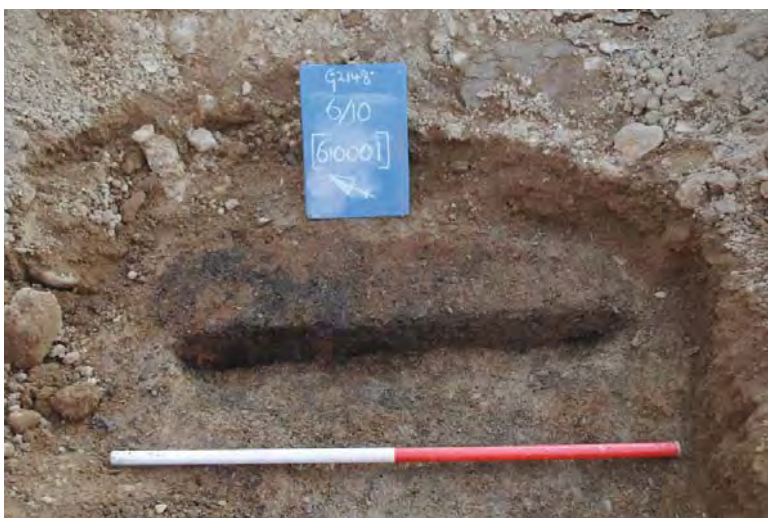
Plate 23: Possible small corn drier 610001 in plot 6/10

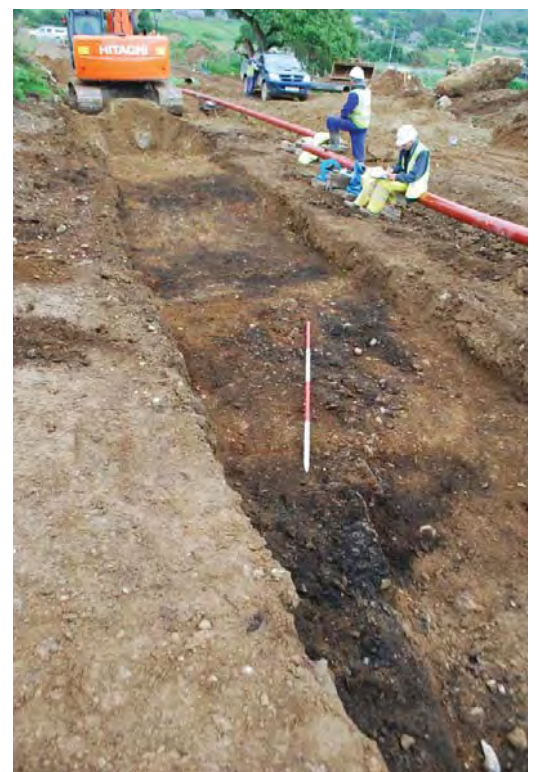
Plate 24: Burnt mound in plot 6/21

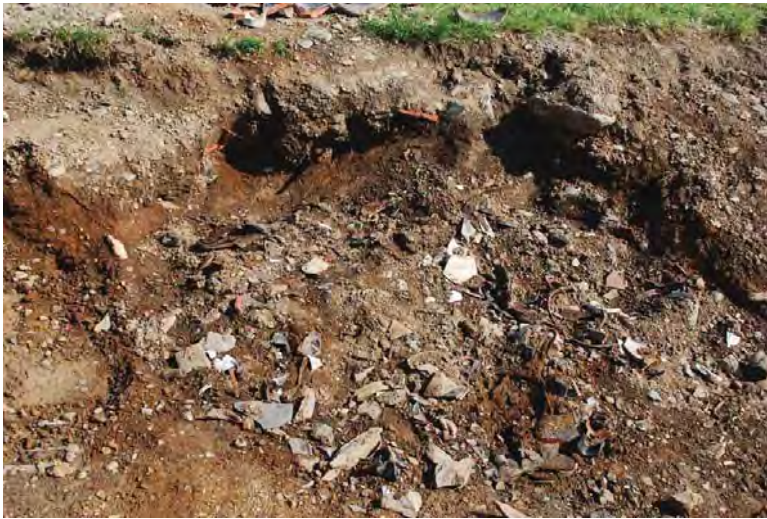
Plate 25: Midden deposit in plot 6/22

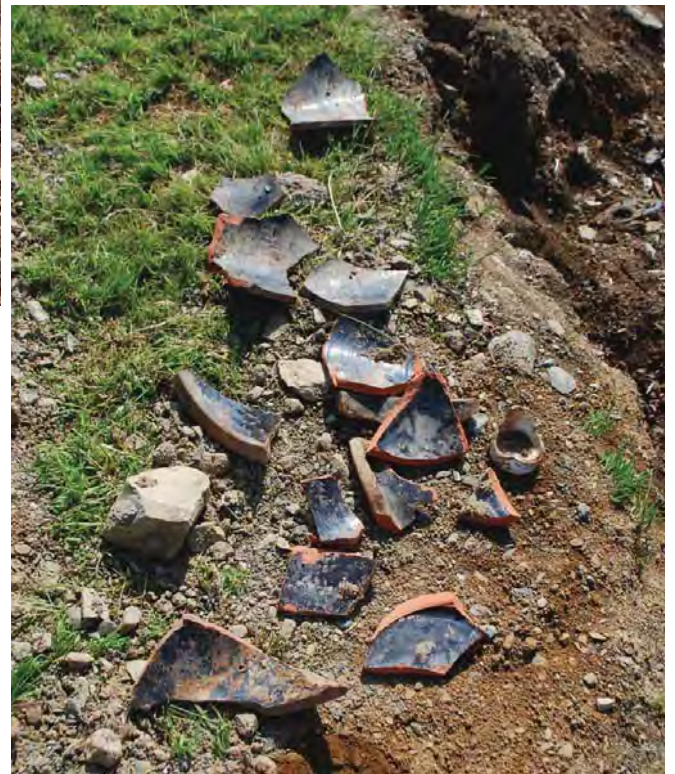
Plate 26: Buckley ware from midden in plot 6/22

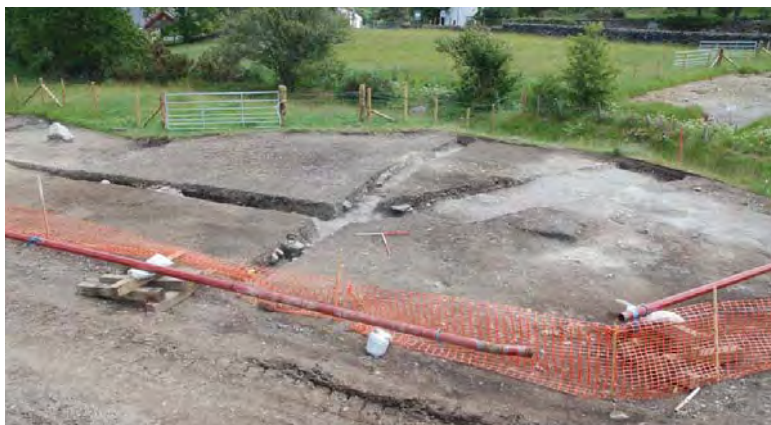
Plate 33: The main burnt mound in south end of plot 6/29.4

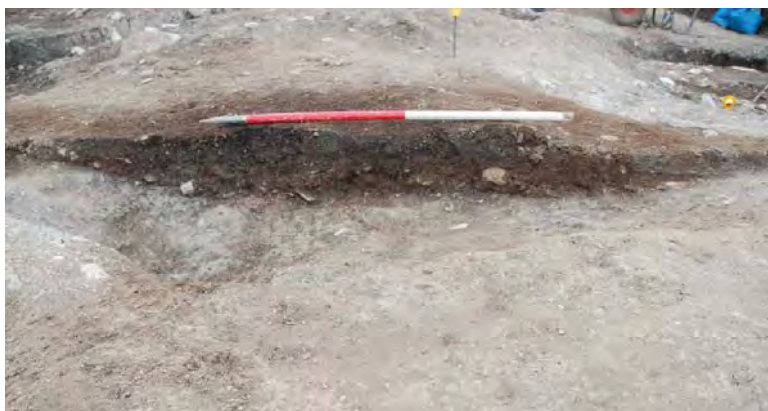
Plate 34: Pit 4022 in plot 6/29.4, half sectioned

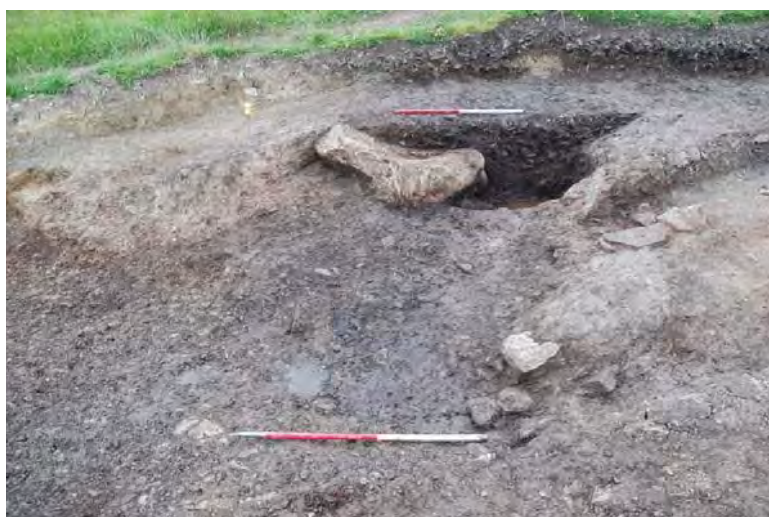
Plate 40: Natural channel 4195 in plot 6/29.4, with burnt mound material in section

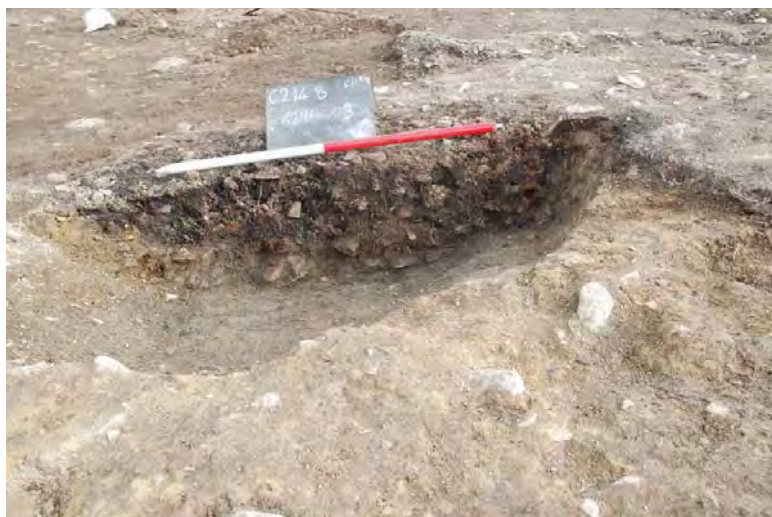
Plate 41: Pit 4003, half excavated, in plot 6/29.4

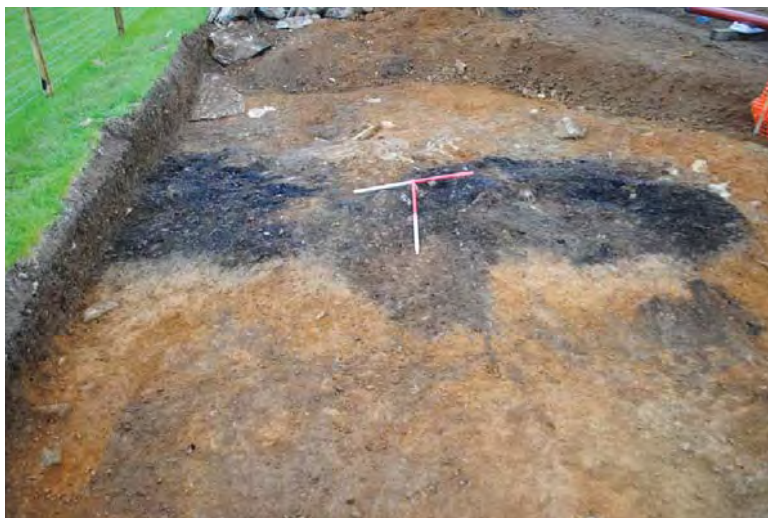
Plate 42: Burnt mound 633012 in plot 6/33

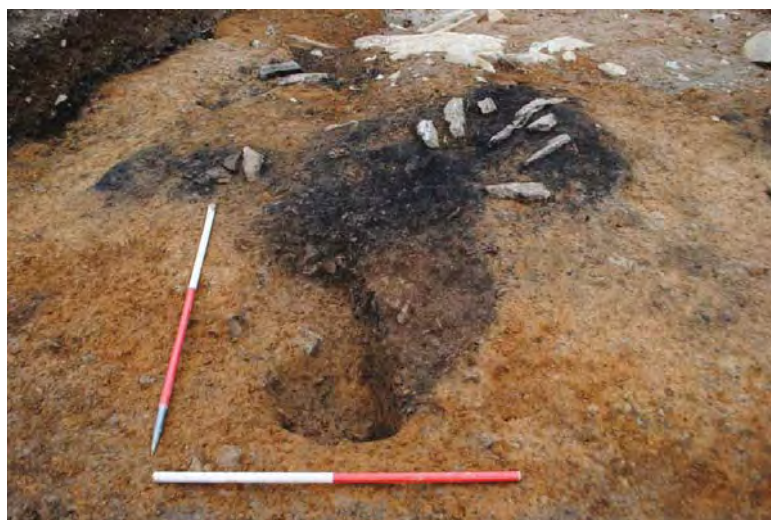
Plate 43: Burnt mound 633012 in plot 6/33, with upper layers removed showing stones protruding and animal burrow 633018

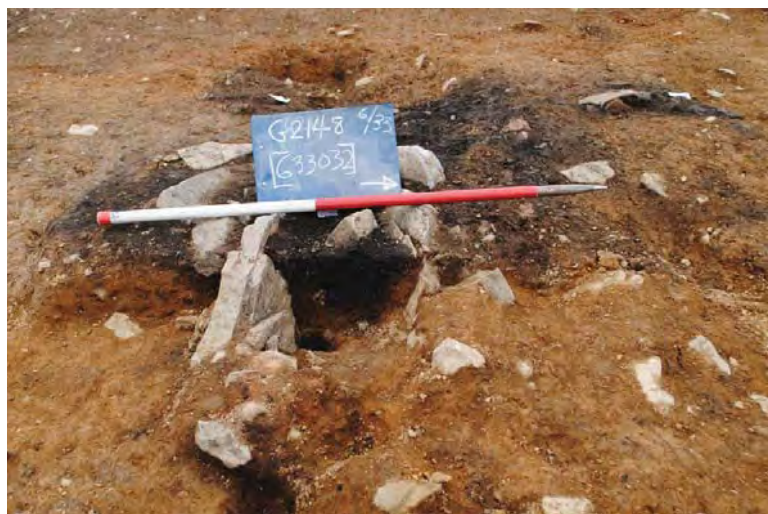
Plate 44: Stones 633020 protruding from natural through hollow 633032, in plot 6/33

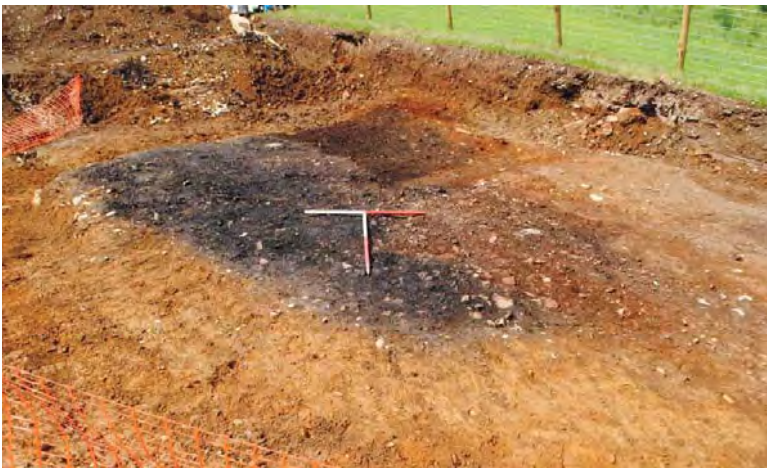
Plate 45: Burnt mound 633015 in plot 6/33

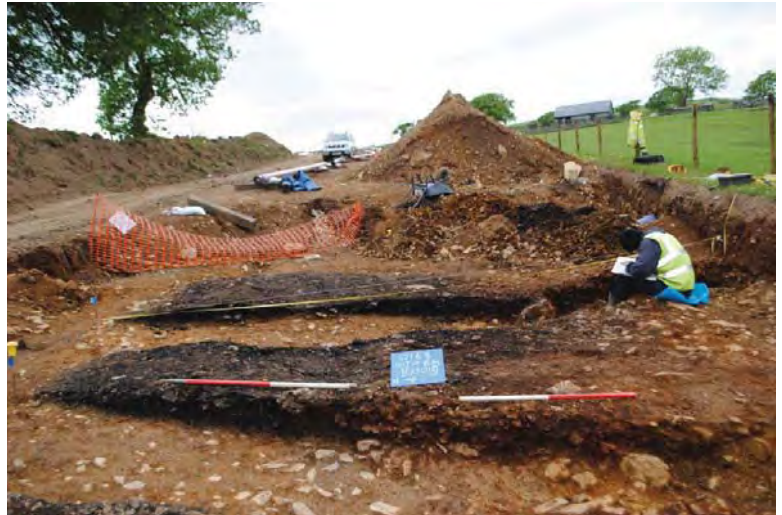
Plate 46: Burnt mound 633015 in plot 6/33, showing sections of mound

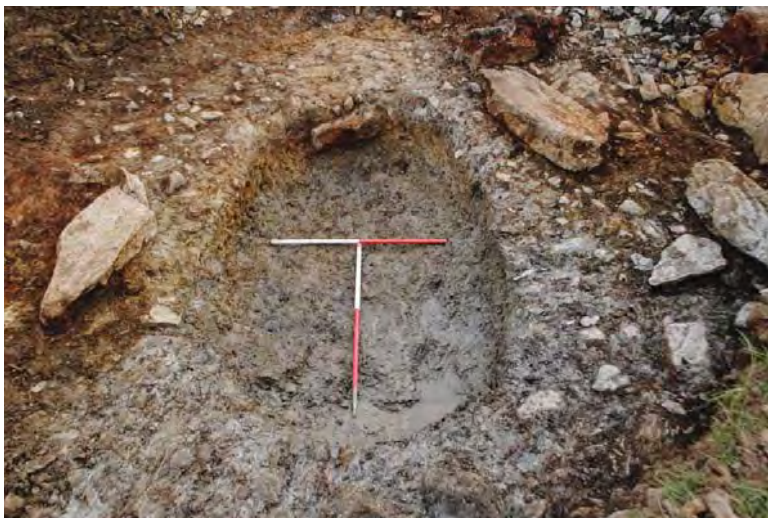
Plate 47: Trough 633034 in plot 6/33

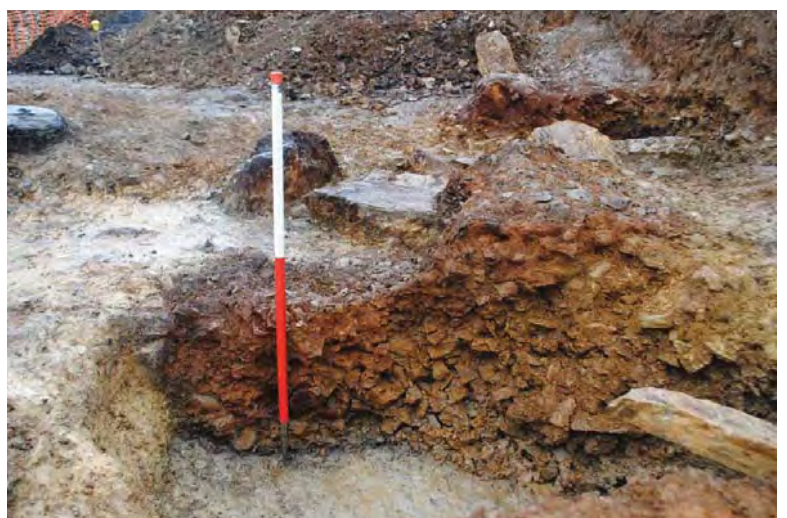
Plate 48: Section showing fill of trough 633034 in plot 6/33

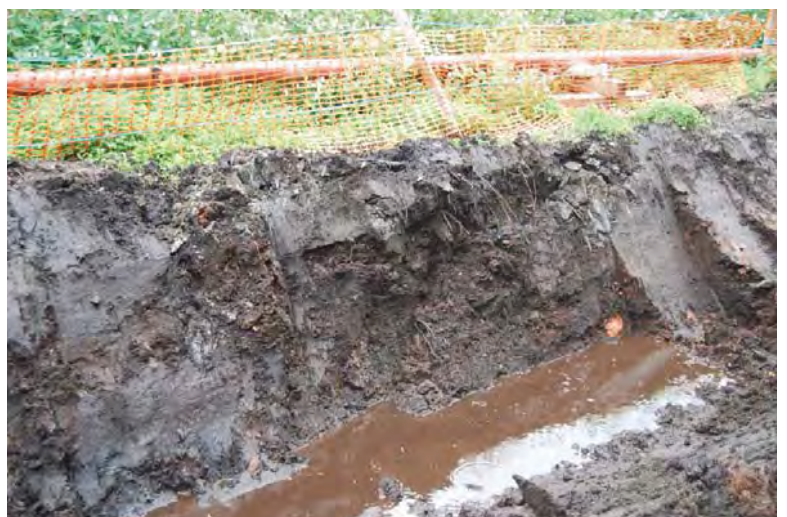
Plate 60: Woody peat deposit exposed in pipe trench in plot 11/3

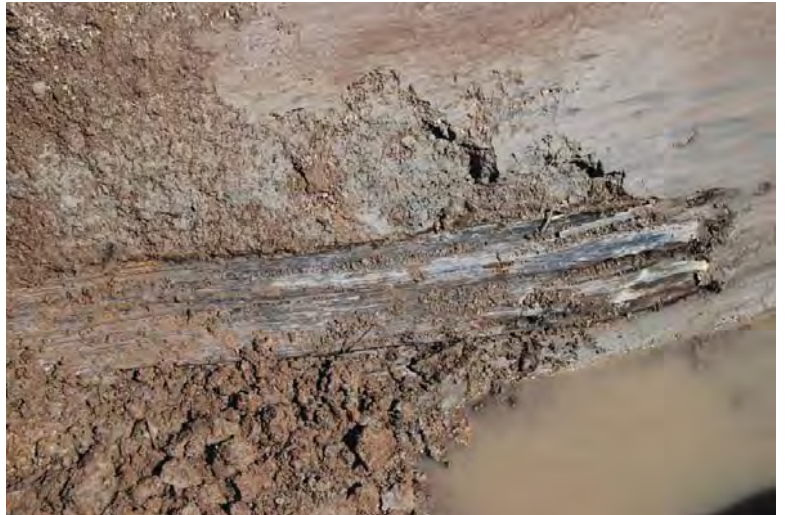
Plate 62: Timber found in base of pipe trench in plot 13/30

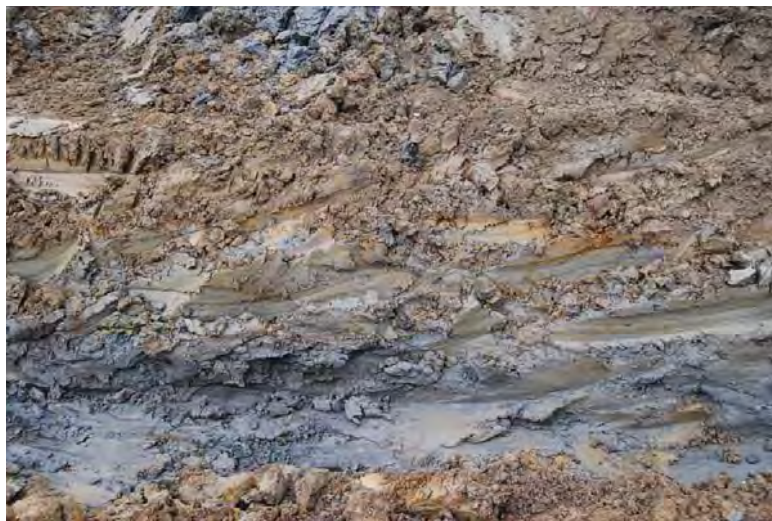
Plate 63: Clay deposit in plot 14/1

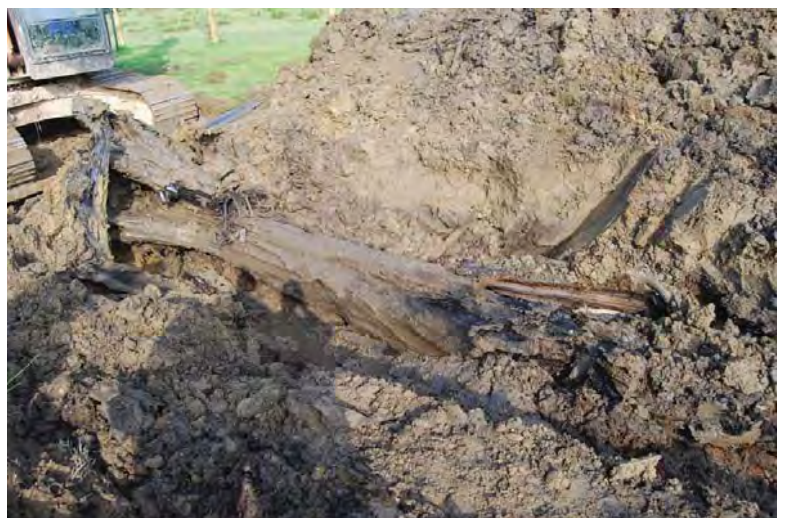
Plate 64: Large unworked branch being removed from pipe trench in plot 14/4

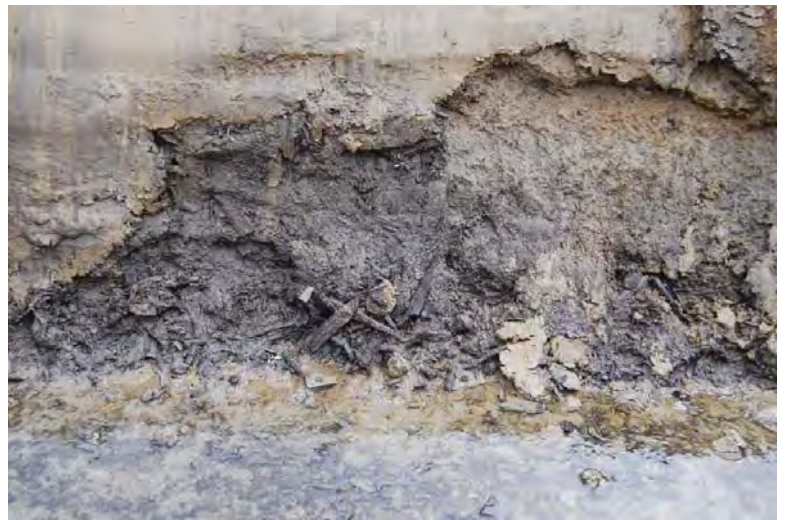
Plate 66: Deposit of wood and branches in plot 14/7
