WYLFA POTABLE WATER PIPELINE ROUTE, ANGLESEY PHASE 1 TRENCHING

ARCHAEOLOGICAL EVALUATION

commissioned by SWECO

January 2018

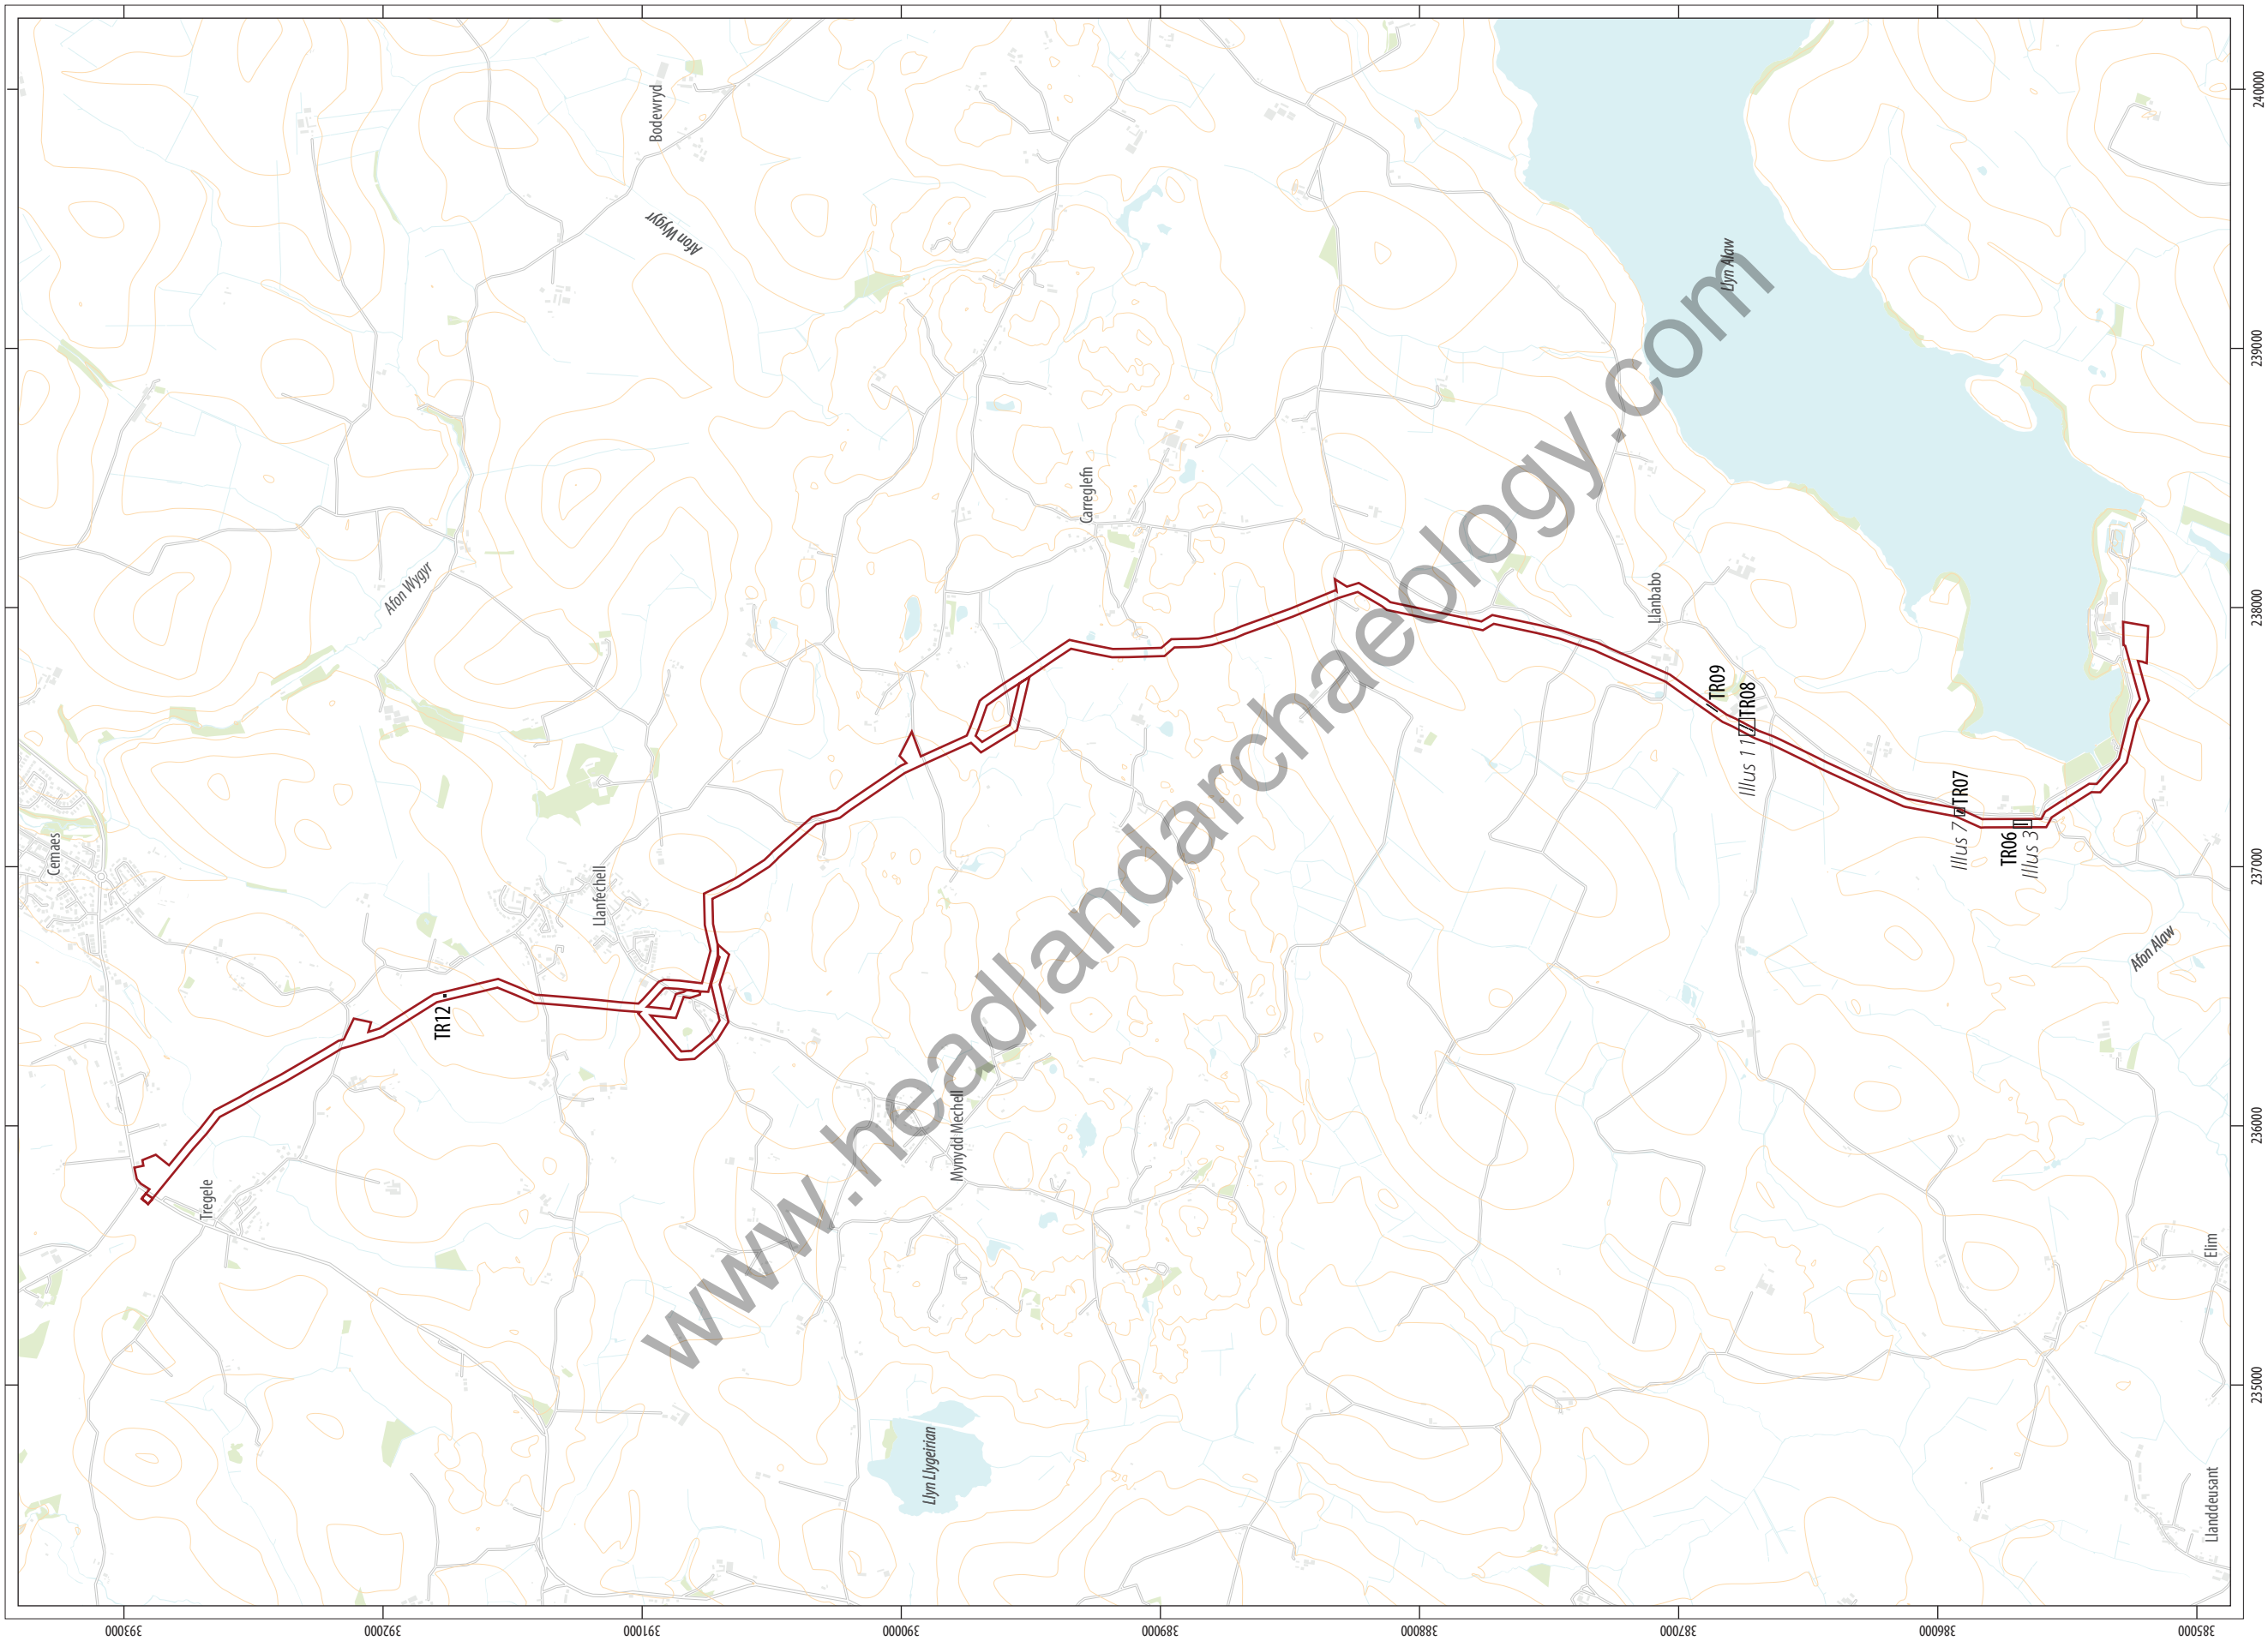
ILLUS 2 Trench location plan

Trenching across the route was designed to take place in three phases. Phases 1a and 1b are the subjects of this report with Phase 2 to commence early in 2018. Phase 1a was undertaken between the 31st October and 3rd November 2017 and Phase 1b between the 14th and 16th November 2017. The excavated trenches and reasons for positioning are outlined in Table 1 and their positions are shown on Illus 2.

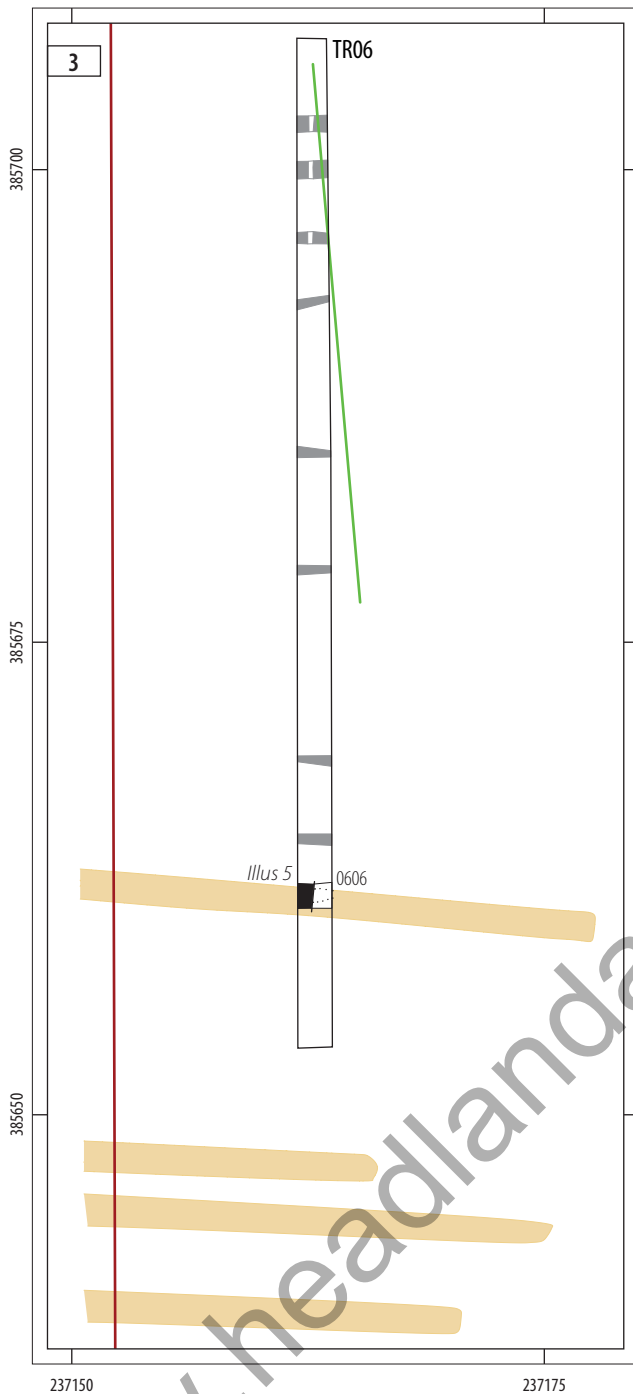
ILLUS 3 Post-excavation plan of Trench 6 showing geophysical anomalies
ILLUS 4 General view of ditch [0606] looking east
ILLUS 5 West facing section through [0606] showing general stratigraphy
ILLUS 6 Plan view surviving Ridge and Furrow [0605]

A series of east-west oriented linear features [0605] were identified cutting the glacial till and identified as representing the remnants of a former ridge and furrow agricultural system. During machine excavation of the trench, the surviving tops of the furrows were just visible within the subsoil and sealed by topsoil deposits. The furrows measured between 0.75 and 0.95m wide across their bases and survived to a maximum 0.05m depth within the geological deposits (Illus 6). Variable truncation was observed with furrows surviving only as a scar in the geology towards the southern extent of the trench. A broad spacing of 2.50 to 3.00m was apparent, though this appeared closer at the northern end of the trench. A single fill (0604) was observed very similar in character to the subsoil. No dateable material was recovered from interventions in the surviving remnants or during machine excavation.

4.2 TRENCH 6 – FIELD 8 (ILLUS 3)

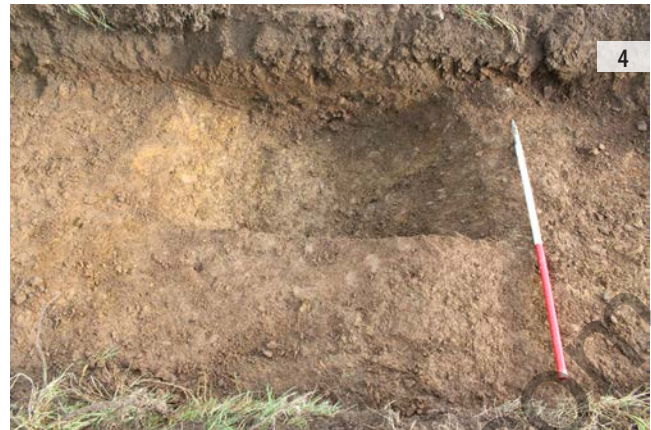
Oriented east-west and located 6.50m from the southern end of the trench, a 1.30m wide x 0.28m deep ditch [0606] was recorded (Illus 4 and 5). The ditch contained a single fill of greyish brown silty

clay with frequent sub-rounded stones (0607). No dateable material was recovered from the fill. The ditch correlated with an east-west anomaly identified by the geophysical survey.

A ditch within Trench 6 [0606] may have served a similar function and was also noted to align with remnants of a hedgerow on the opposite side of the road to the east, possibly suggesting a former field boundary. This could relate to larger earlier post-medieval field systems, broken up into smaller holdings as was observed and discussed within the Desk Based Assessment for the route (Richards 2017).

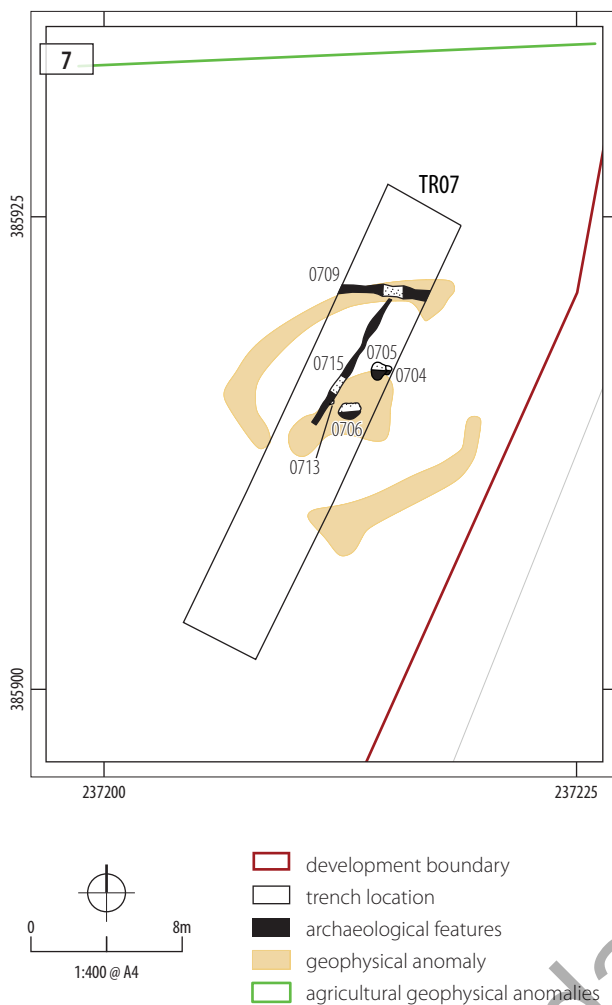
ILLUS 7 Post-excavation plan of Trench 7 showing geophysical anomalies

Towards the northern end of the trench, a slightly curving linear feature [0709] broadly corresponding with a geophysical anomaly was recorded and observed to extend beyond the limits of the trench to the east and west. The feature was oriented broadly east-west and measured 0.64m wide x 0.27m deep with a steep 'u' shaped profile (Illus 9). A mottled light greyish brown and light yellowish brown silty clay (0710) filled the cut. Large stones (c 0.20m long) were concentrated towards the base of the cut, with smaller stones randomly distributed within the fill. The stones may have been placed to assist drainage or represented collapse or fall into the ditch. No dateable material was recovered.

Trench 7 provided a positive correlation with geophysical anomalies which highlighted a probable small enclosed area. The evaluation established a narrow ditch aligning with the north-westernmost

anomaly and a possible 'fire-pit' and post-holes corresponding with a central area of magnetic disturbance. A second geophysical anomaly lay outwith the eastern edge of the trench and may be associated with the identified features creating a small enclosed area. The limited exposure of the remains renders full interpretation difficult but it is possible that the 'firepit' and post-holes are bounded by an encircling or segmented ditch, defining an area of activity, the purpose or nature of which cannot presently be unequivocally defined.

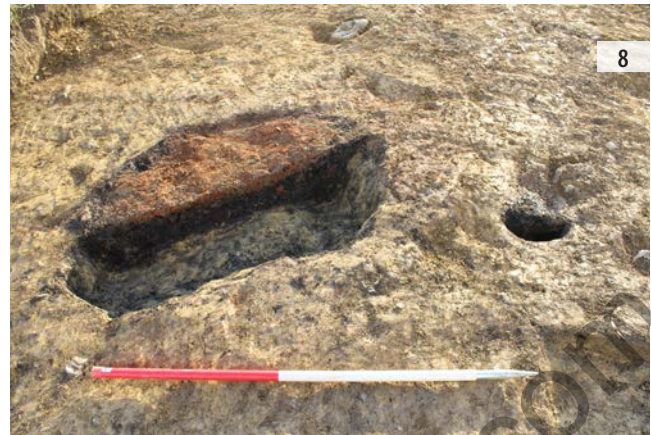
ILLUS 8 General post-excavation view of [0706 and 0713] looking south

Located centrally within the trench, a sub-circular feature [0706] measuring 1.13m x 0.82m and 0.24m deep was recorded (Illus 8). The feature was interpreted as a 'fire pit' and contained a primary fill of dark brownish black silty clay and heat affected stones (0707) overlain by a 0.05m thick brownish orange silty clay (0708). The secondary fill appeared relatively highly fired, possibly representing in situ burning or remnants of burnt remains. An environmental sample taken from the deposit (ES 001) contained no environmental indicators, with fired clay recovered being undiagnostic nor indicative of function. A further sample from the primary fill (ES 002) contained no environmental indicators (other than charcoal) or dateable material. A small amount of fuel-ash slag material was recovered from the primary fill, too small to conclusively identify, but in the absence of other environmental indicators could imply a more industrial than domestic function for the feature. The geology immediately to the east end of the feature also displayed evidence of being heat affected with a light orange hue, possibly resulting from activity associated with the feature.

Approximately 0.50m to the west of the fire-pit, a post-hole [0713] measuring 0.24 x 0.22m and 0.12m deep was recorded (Illus 8). The post-hole was steep sided with a rounded base and suggested a vertically set post. A dark brownish black silty clay and small heat affected stones (0714) filled the cut. This appeared similar in character to (0707) potentially suggesting a level of contemporaneity, with an ingress of material filling the void of a decayed post base. No dateable material was recovered from either feature.

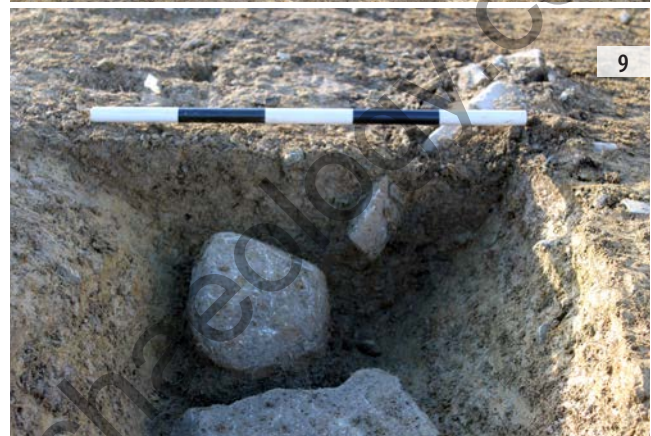
ILLUS 9 East facing section through ditch [0709] **ILLUS 10** North facing section through [0704 and 0705]

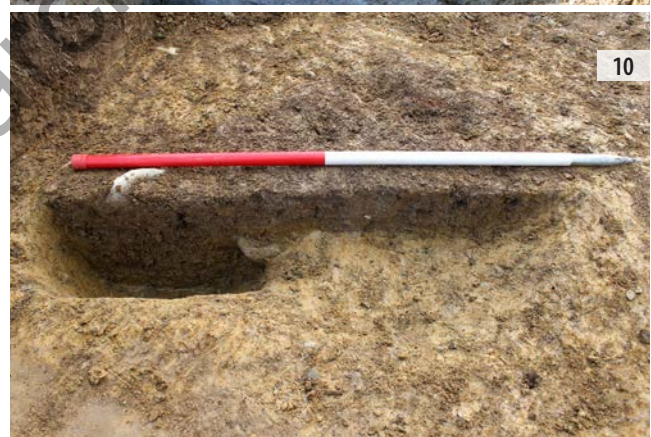
Approximately 1.50m north-east of the 'hearth' [0706] a further post-hole [0704] measuring 0.45 x 0.43m and 0.30m deep was identified and contained a single silty clay fill (0711) containing rare small stones. The post-hole was cut on its western edge by a sub-circular feature [0705] (Illus 10) measuring 0.80 x 0.79m and 0.12m deep. The cut contained a single mid-greyish yellow silty clay fill (0712). No dateable material was recovered from either feature and no function could be ascribed to [0705].

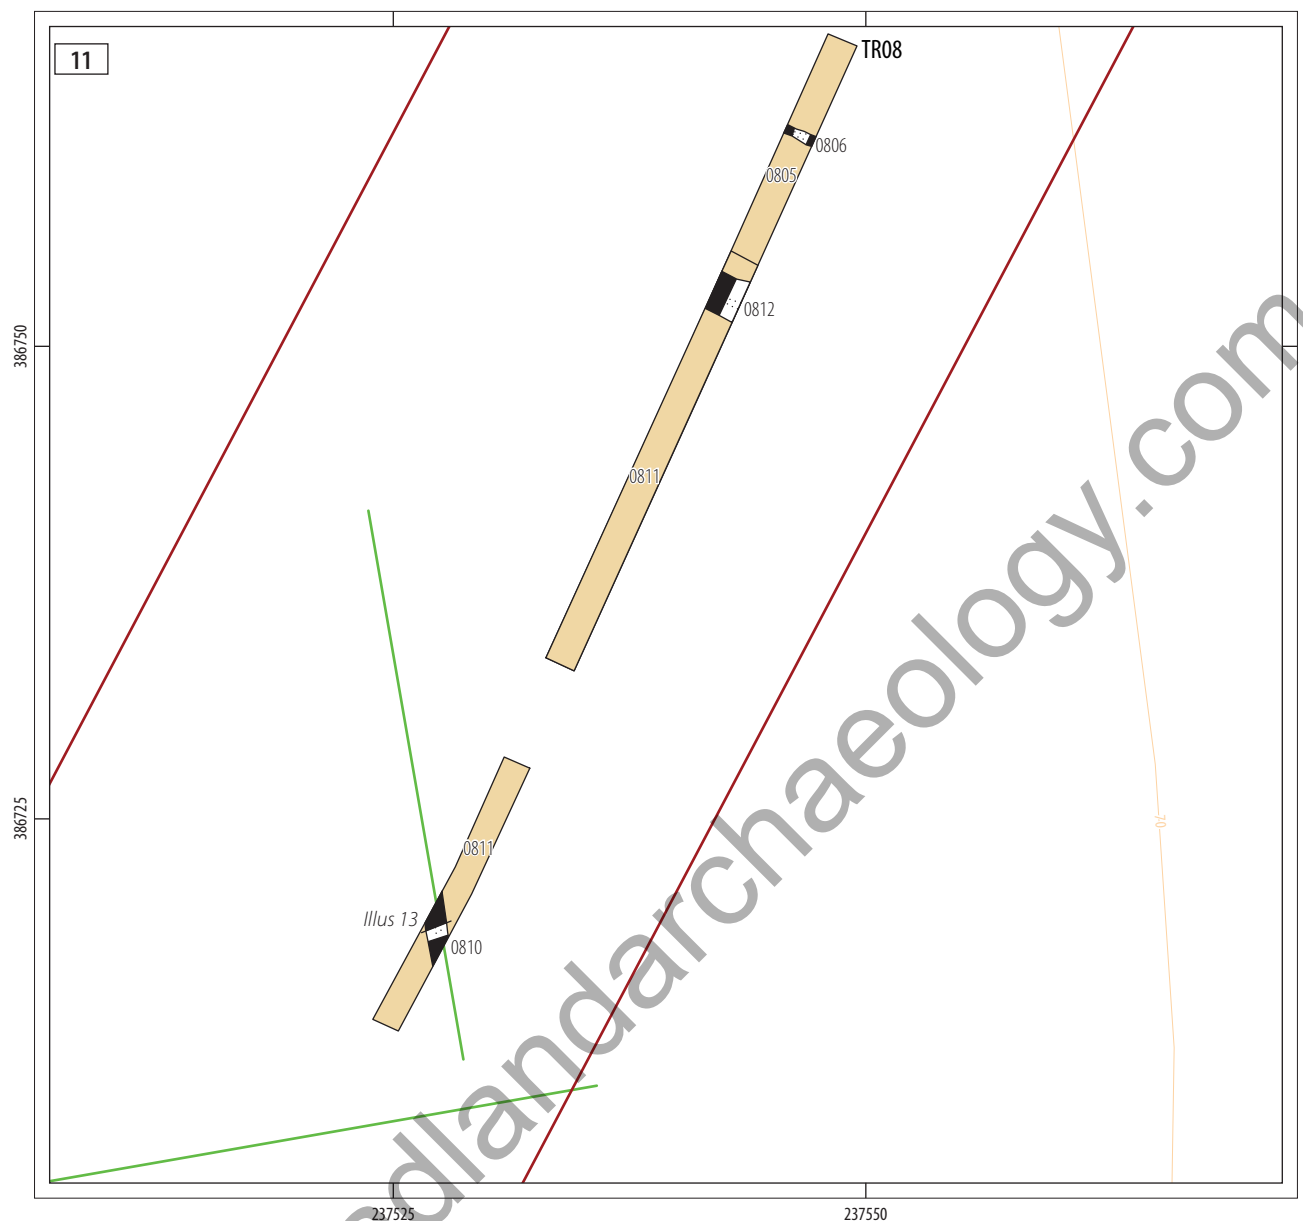
Oriented broadly north-west/south-east and located at the northern end of the trench, a linear cut [0806] was identified as a ditch and measured 0.55m wide and 0.16m deep. The ditch contained a single fill (0807) and was sealed by colluvial deposits.

ILLUS 11 Post-excitation plan of Trench 8 ILLUS 12 North-west facing section through [0812]

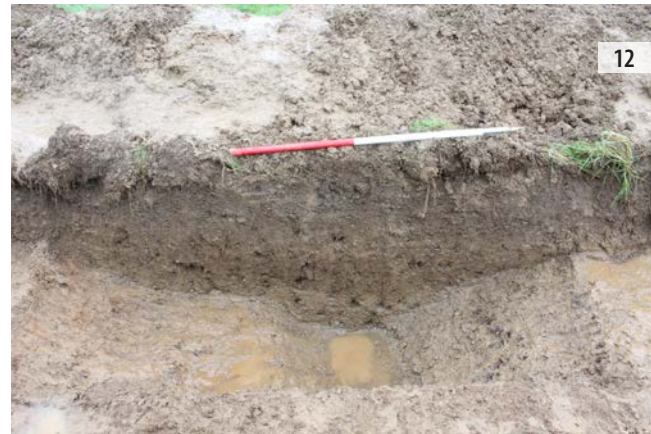
Approximately 8.00m to the south, a further ditch [0812] was also oriented north-west/south-east and measured 2.35m wide and 0.51m deep (Illus 12). The ditch was slightly stepped on its northern edge with a broad concave base. The ditch contained a primary and secondary fill (0813 and 0814) which suggested lower energy gradual sedimentation. No dateable material was recovered with an absence of charcoal noted within the fill.

0812 Linear cut – NW-SE orientation, 2.35m wide x 0.51m deep, uneven sides, rounded base – Drainage ditch – agricultural boundary 0.46

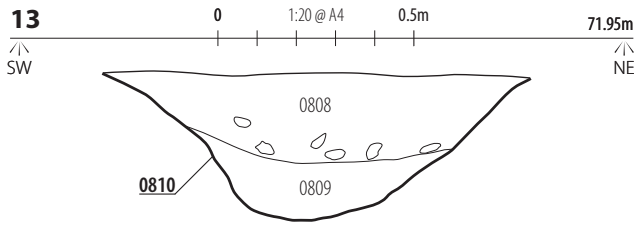
In the southern segment of the trench, a further ditch [0810] (Illus 13 and 14) was recorded on an approximate north-south orientation. The ditch measured 1.10m wide and 0.40m deep. A primary fill (0809) contained lenses of redeposited glacial clays suggesting an element of erosion and/or weathering and collapse of up-cast possibly associated with a former bank. A secondary fill (0808) related to general sedimentation within the ditch. No dateable material was recovered from the ditch.

ILLUS 13 South-east facing section through [0810] **ILLUS 14** General view ditch [0810] looking north-west
