**MINLLYN SLATE QUARRY
WITH
CAE ABATTY**

(SH 853 140)

**SURVEY OF AUGUST 2011
REPORTS AND DIAGRAMMS**

Andrew Hurrell, August 2011

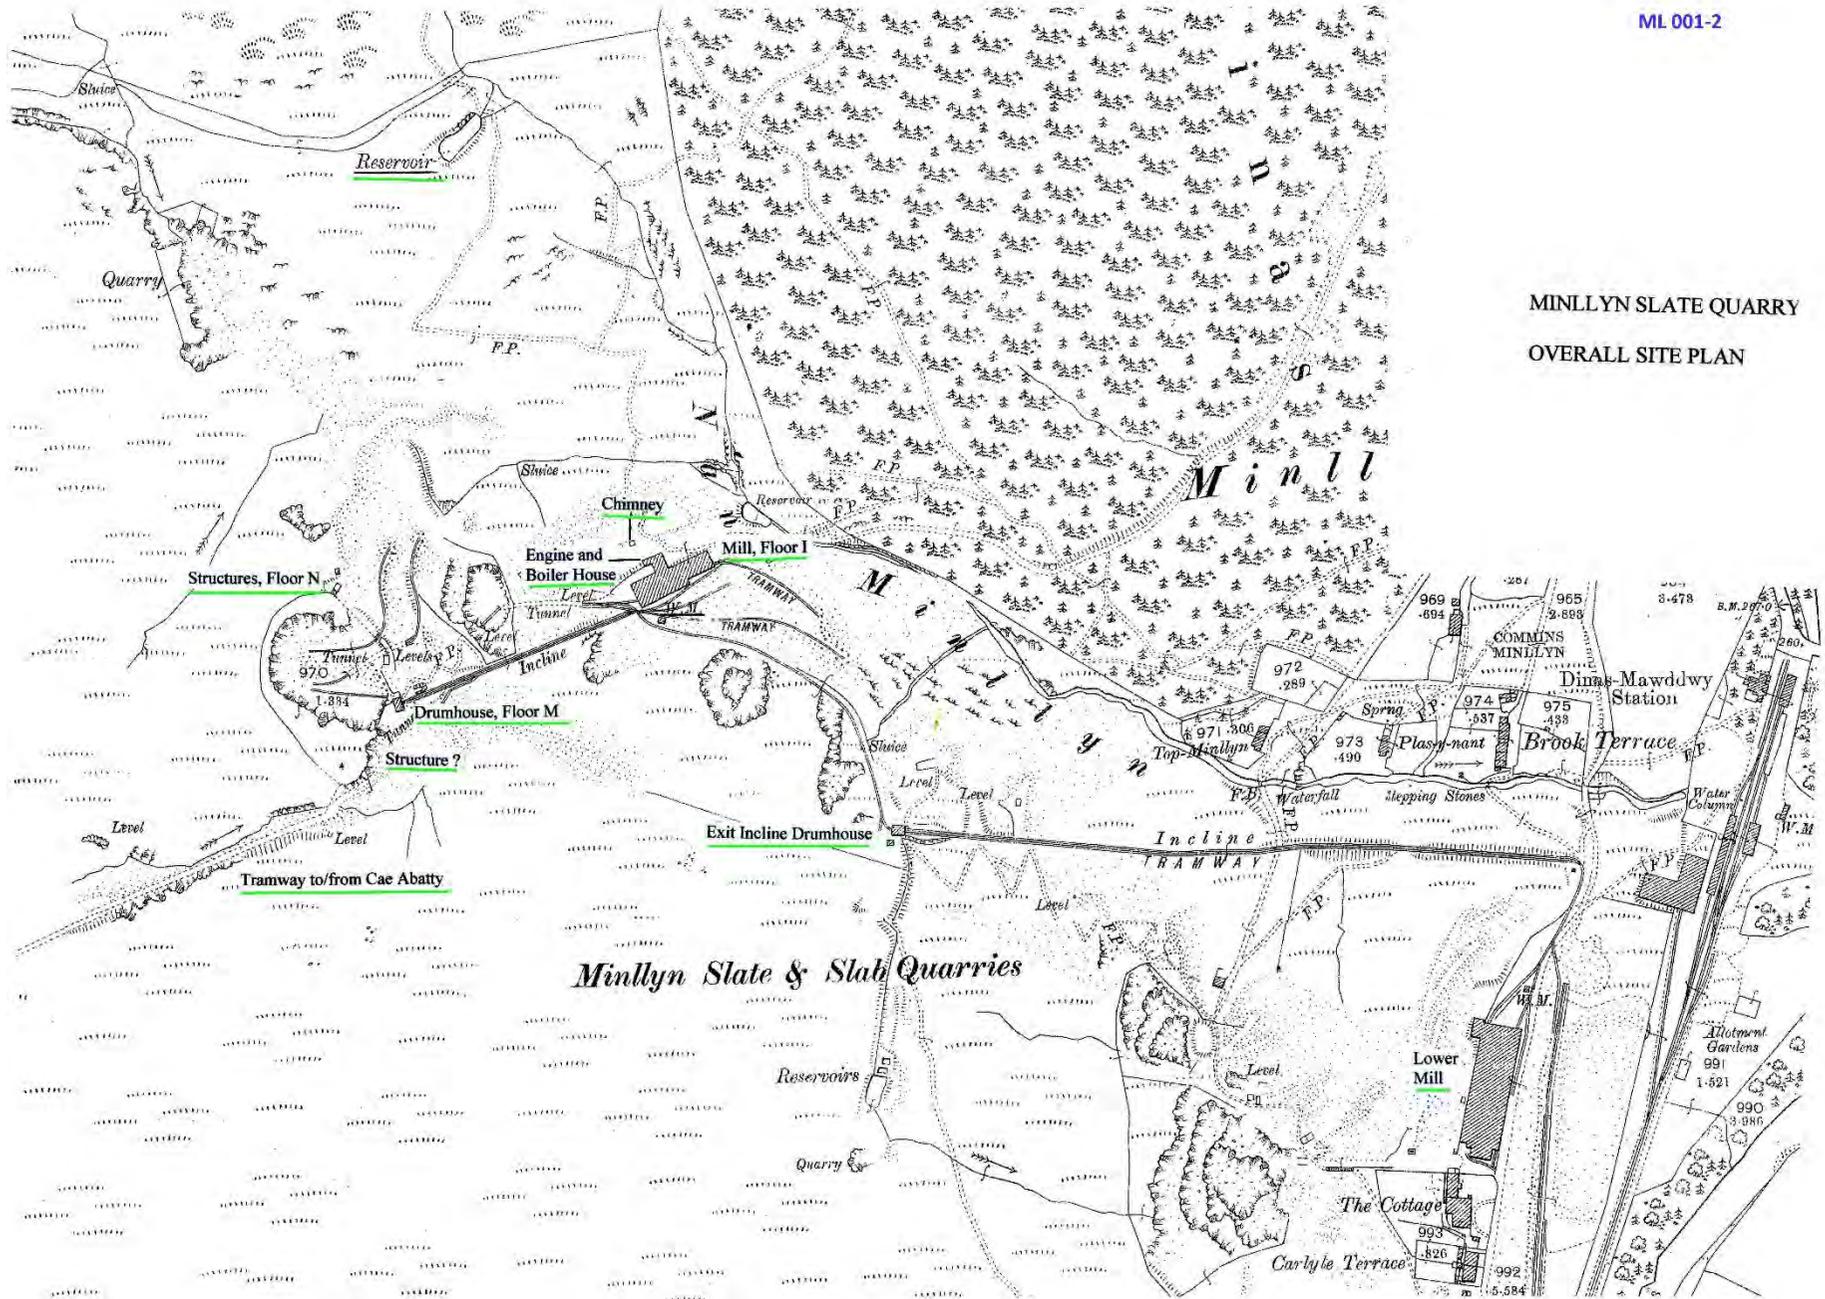
MINLLYN SLATE QUARRY
OVERALL SITE PLAN

Site	Minllyn Slate Quarry		Doc No	ML001-2
Subject	Overall Site Plan			
Doc Date	2011	See also		
Doc Type	map	Grid ref	SH 853 140	
Drawing Type	plan	Scale	25in to 1 mile	
Drawing Medium	photocopy	Author(s)	OS	
Doc Material	paper	Source	Plas Course	
Doc Status	Original	Doc Size	A3	
Notes

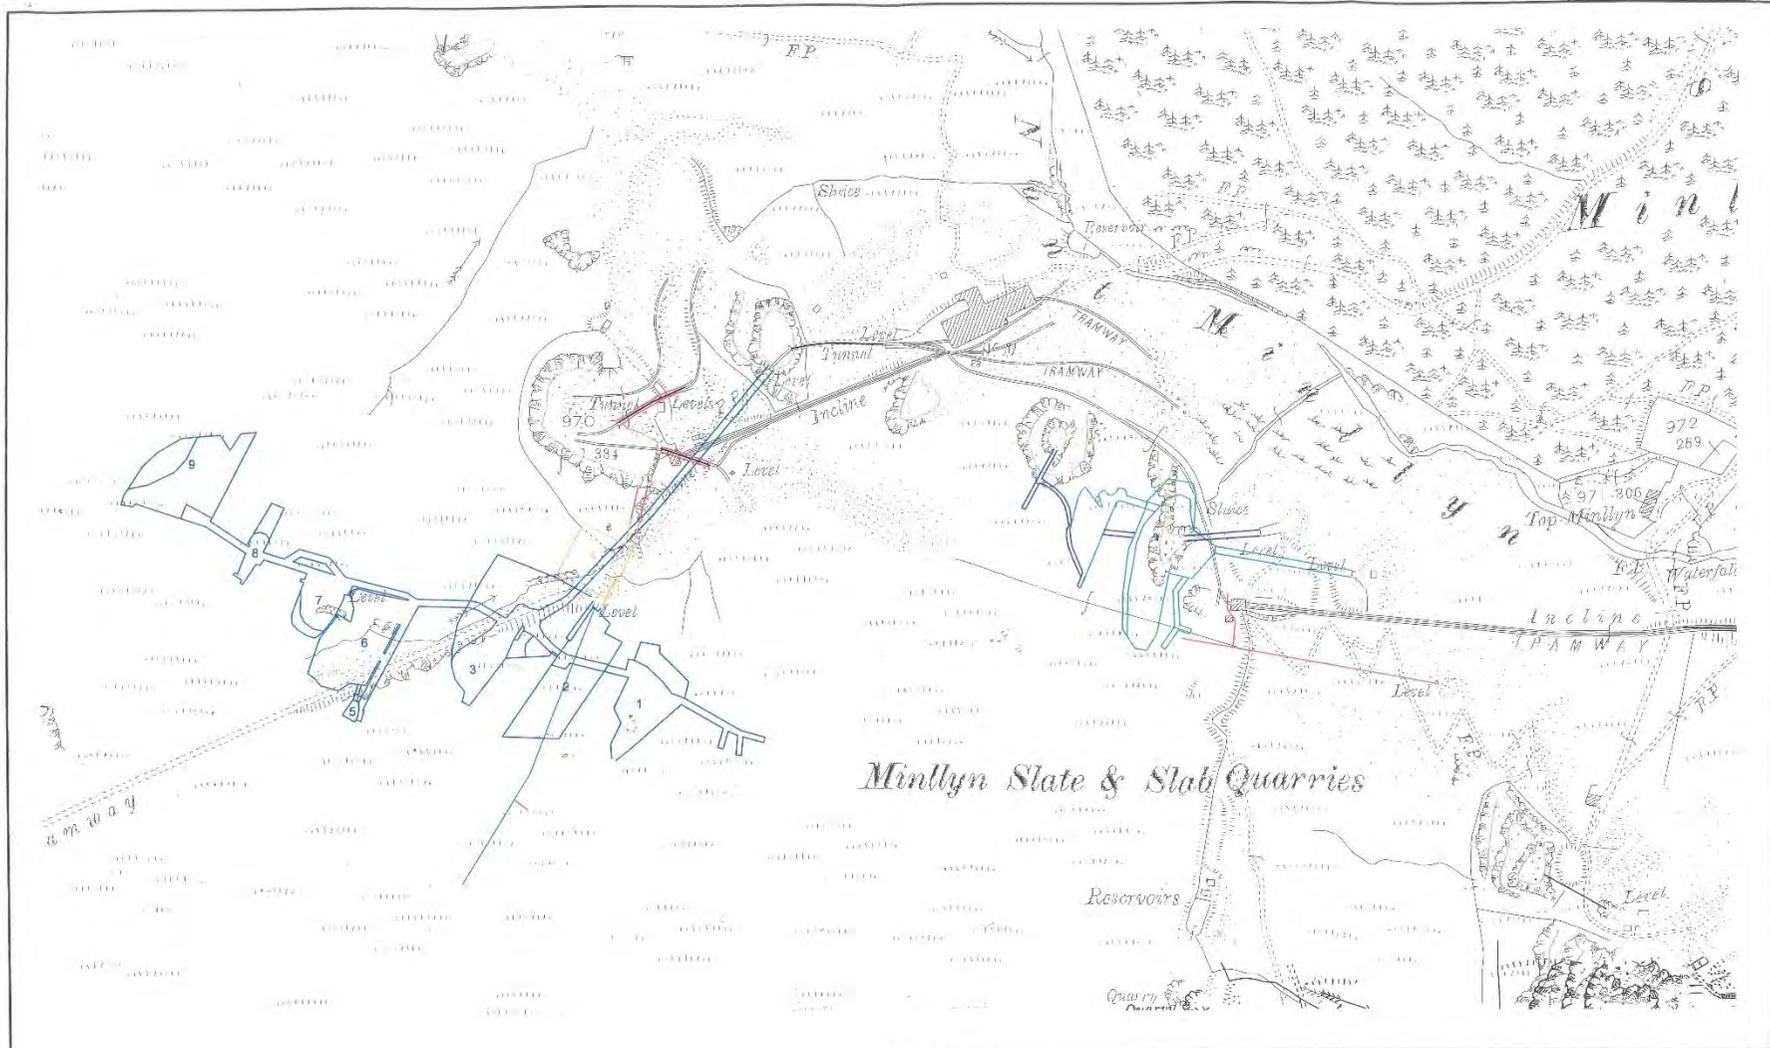
MINLLYN SLATE QUARRY & MILL Dinas Mawddwy Underground Survey	SURVEY PH/AMH/SO
				DATE Aug 2011
			Underground Chambers	DRAWN A.M.Hurrell
				DATE Sept 2011
REV	DETAILS	DATE	DRG No. IA 2011/Sk1	SCALE NTS
				REV No. 1

Site	Minllyn Slate Quarry		Doc No	ML001-7
Subject	Underground plan			
Doc Date	2011	See also	020	
Doc Type	map	Grid ref	SH 853 140	
Drawing Type	map	Scale	red	
Drawing Medium	photocopy	Author(s)	AH, PH, SO	
Doc Material	paper	Source	Plas Course	
Doc Status	complete	Original	Doc Size	A3
Notes

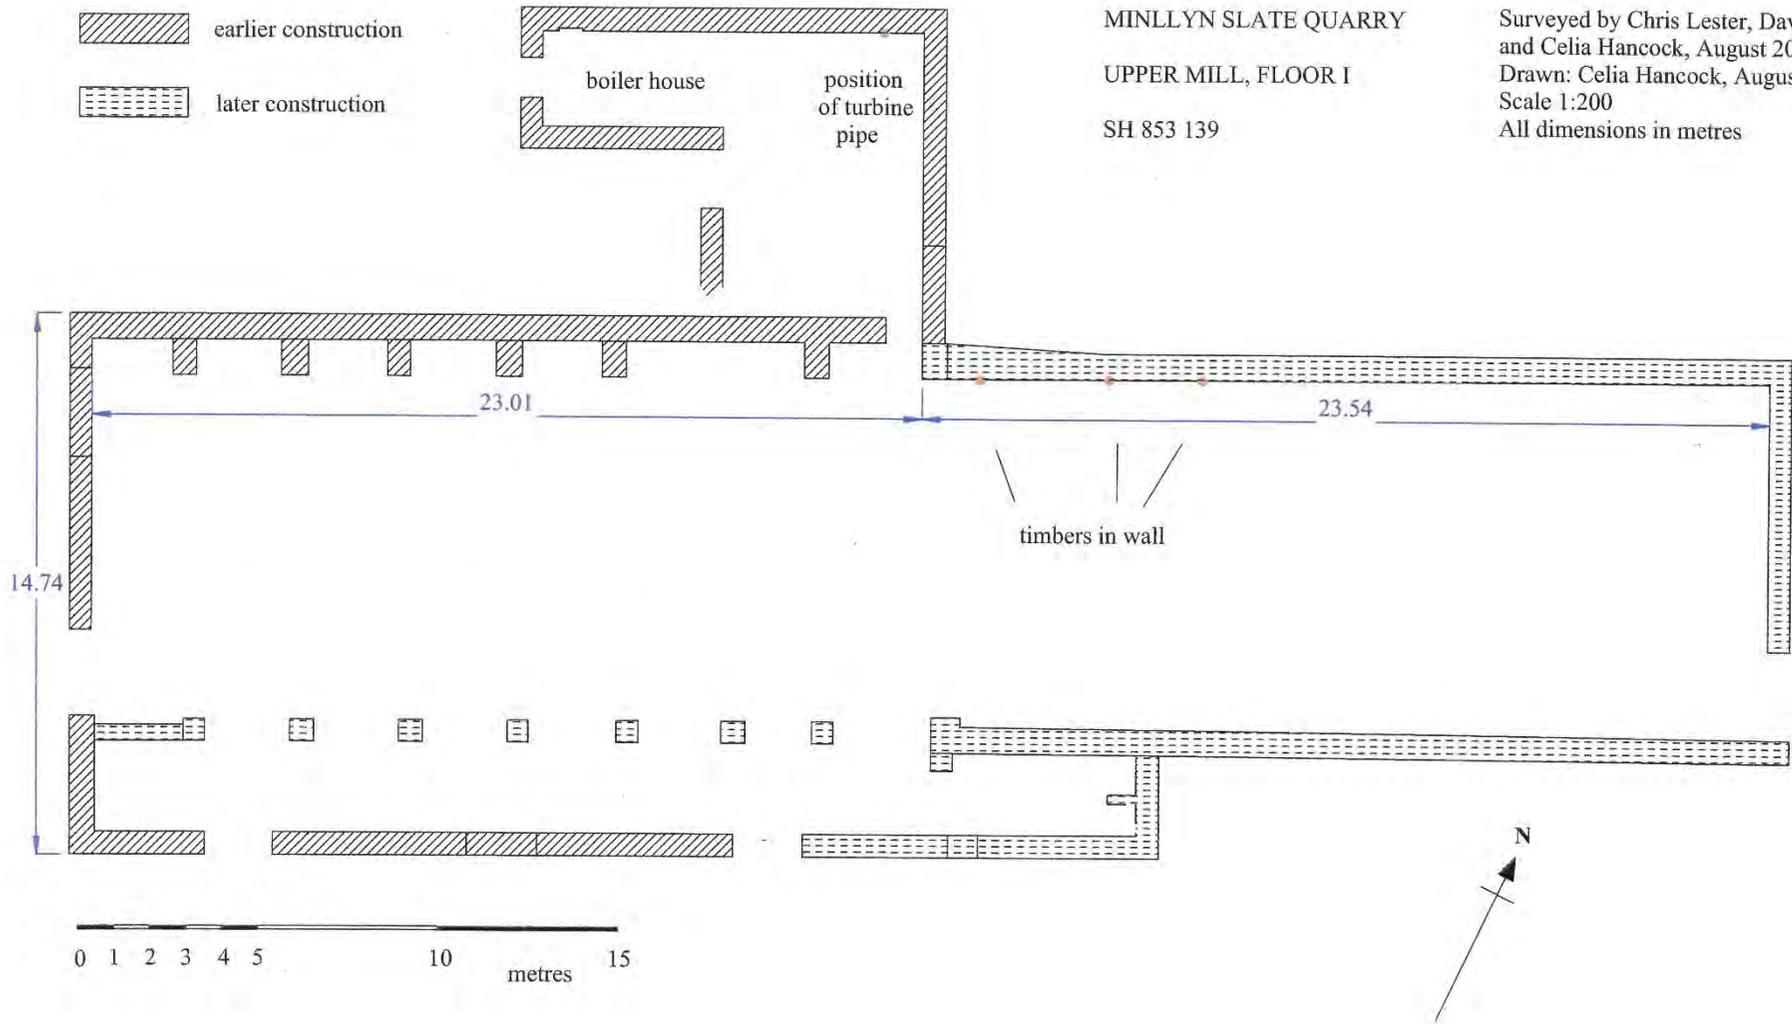
MINLLYN SLATE QUARRY
UPPER MILL, FLOOR I
SH 853 139

Surveyed by Chris Lester, Dave Gunning
and Celia Hancock, August 2011
Drawn: Celia Hancock, August 2011
Scale 1:200
All dimensions in metres

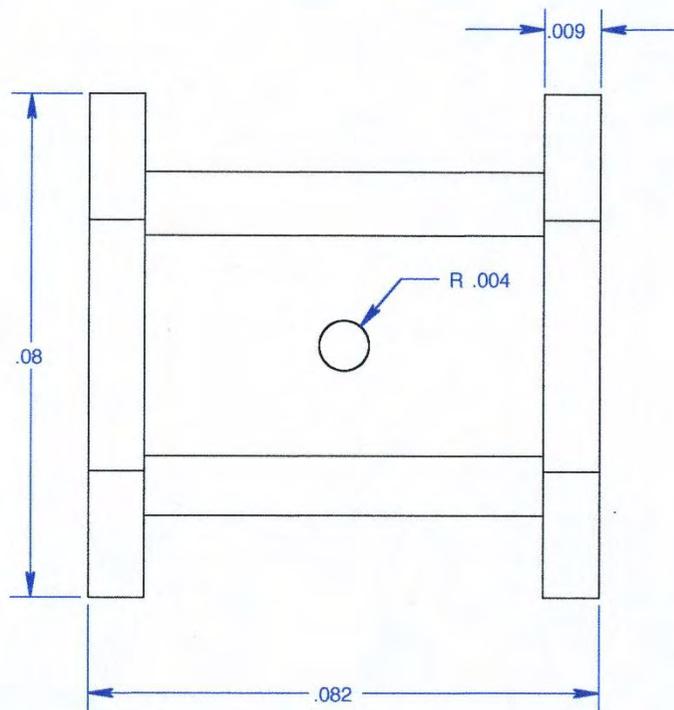
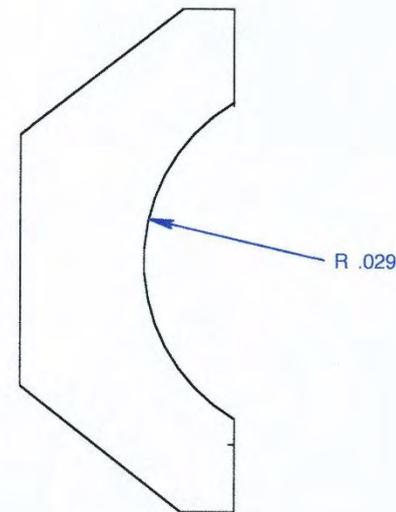
MINLLYN SLATE QUARRY
Broken Gear Upper Mill

Damaged bearing metal drawn from
measurments and photographs

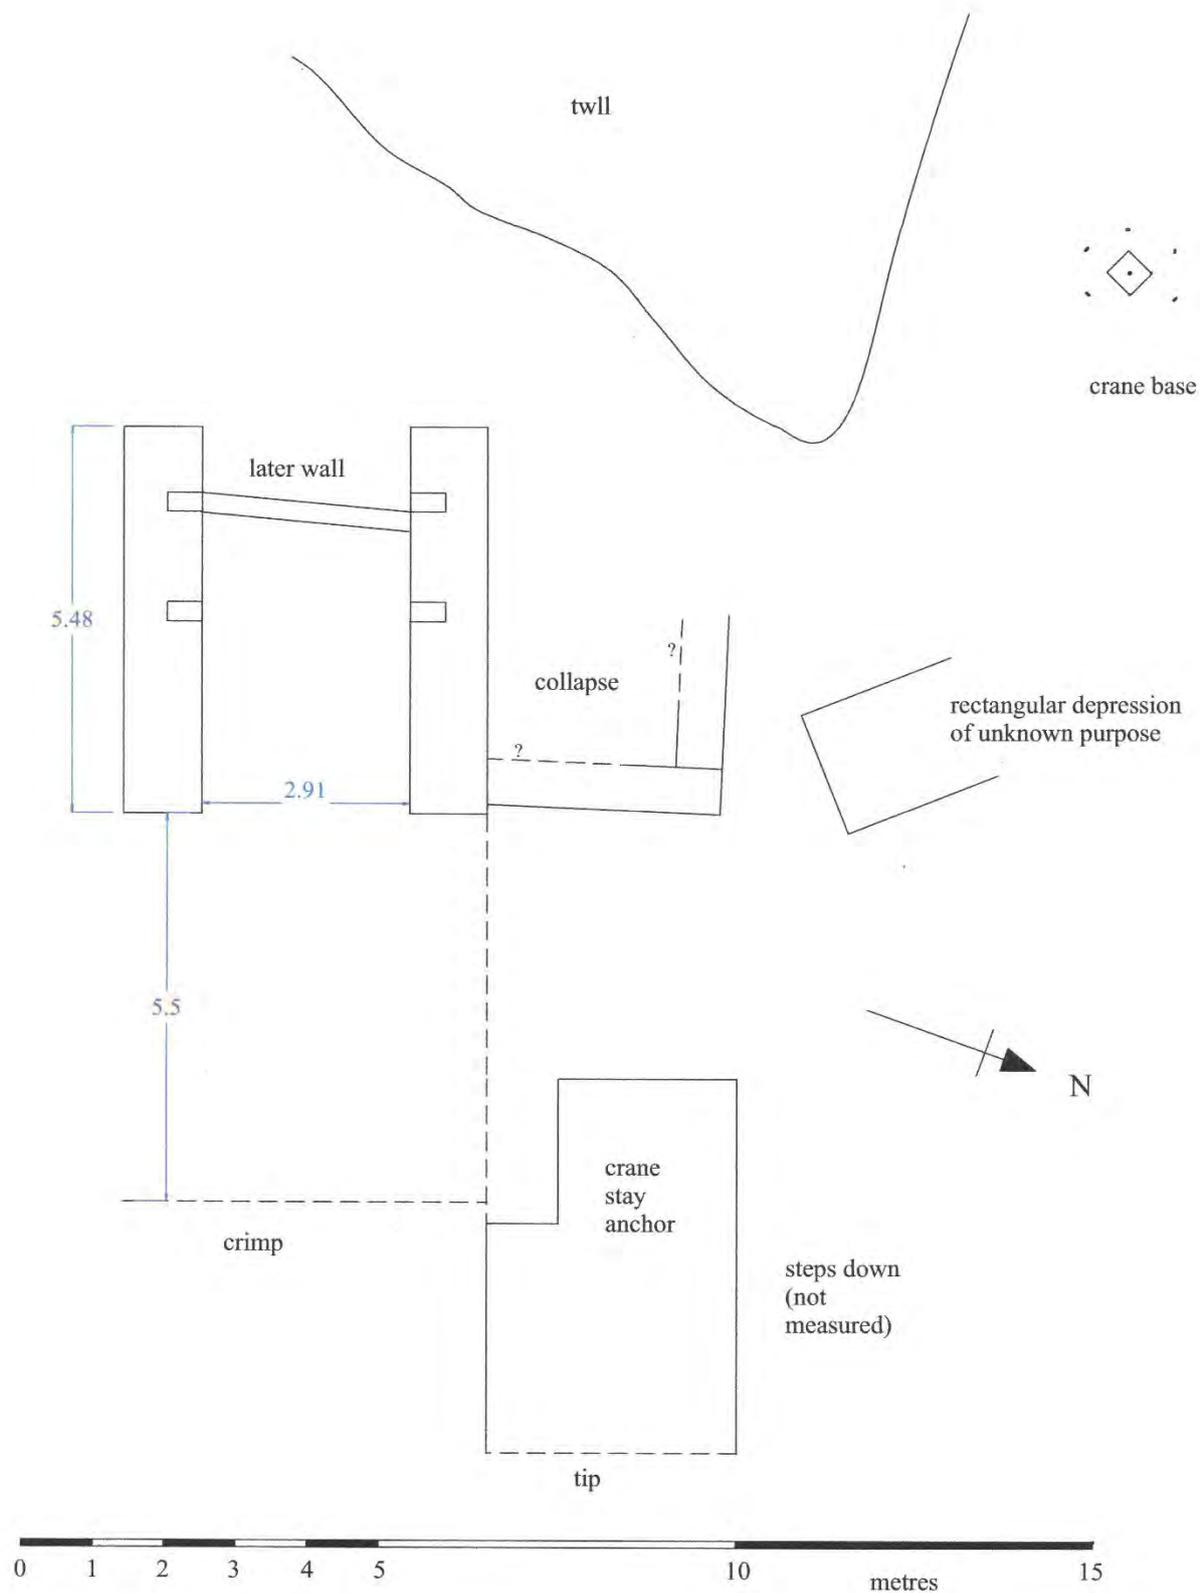
MINLLYN SLATE QUARRY
DRUMHOUSE, FLOOR M
SH 85180 13915

Surveyed by Chris Lester, Dave Gunning
and Celia Hancock, August 2011
Drawn: Celia Hancock, August 2011
Scale 1:100
All dimensions in metres

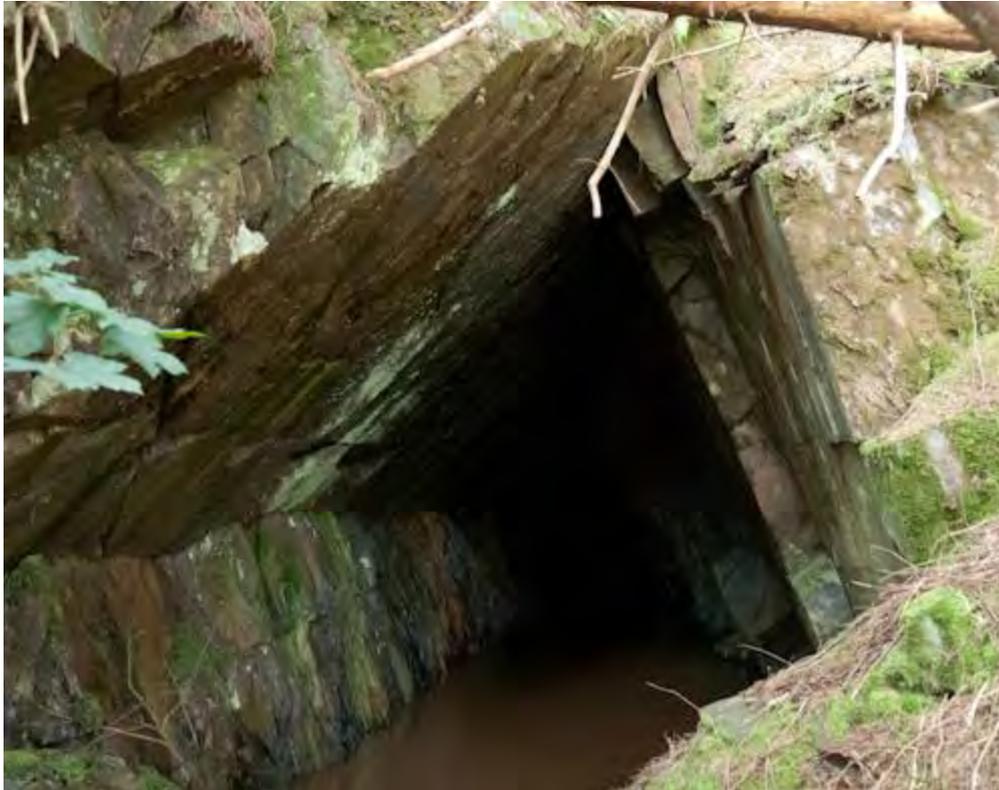
Level G has the most extensive underground workings below the Upper Mill. The adit is to the north of the Exit Incline with an obvious tip immediately outside. A horizontal tramway is still traceable between the adit mouth and the incline. Although the junction is much degraded, it is clear that there could have been a junction with the incline tracks (there is no sign of a landing for a Trunk type incline⁶) and thus allowing rock to be lowered to the lower mill by gravity.

The entrance to the Level G Adit

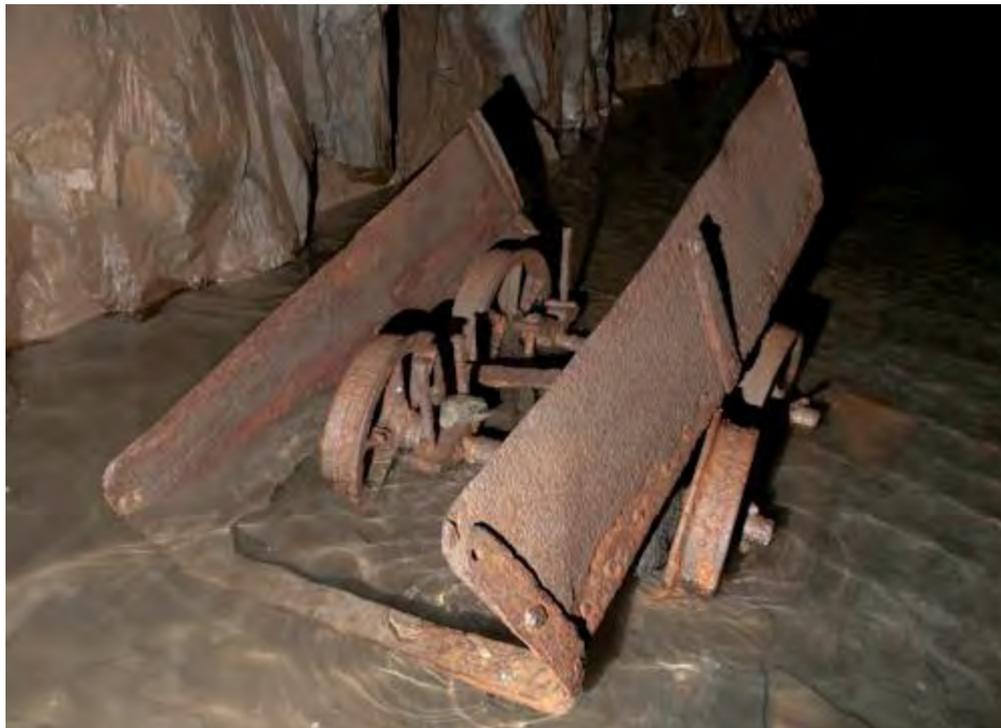
Starting in to the inner section of the adit there is a dilapidated wagon a short distance from the entrance. This is a typical open ended waste wagon with wooden frames and loose wheels on loose axles. It is notable that the end is missing (removed rather than rotted?) and that the wheels are single flanged although one is very heavily worn on the tread. There are no signs of couplings. Apart from the wheels and couplings, this is a typical slate quarry wagon.

The Waste Wagon in Level I adit

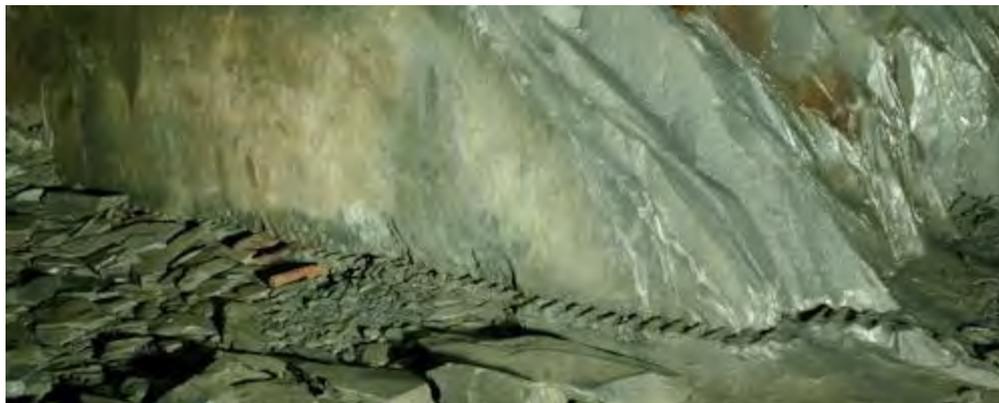
Chamber 1 – This is a medium sized chamber in which production has stopped before it has been fully worked out. Across the north side waste rock has been tipped but the main floor area is generally clear of debris. The rock in the South West corner is clearly the last area to be worked with a shoulder of rock having a ledge cut at high level and an exposed face being undercut at floor level using a channelling machine⁸. A length of chain ladder hangs from the roof (or thereabouts) and more (presumably a broken section) is on the chamber floor directly below. This ladder would have given access to the high-level ledge. A chain (probably a climbing chain) hangs close by the ladder.

Channelling Holes at the base of the working face in Chamber 1

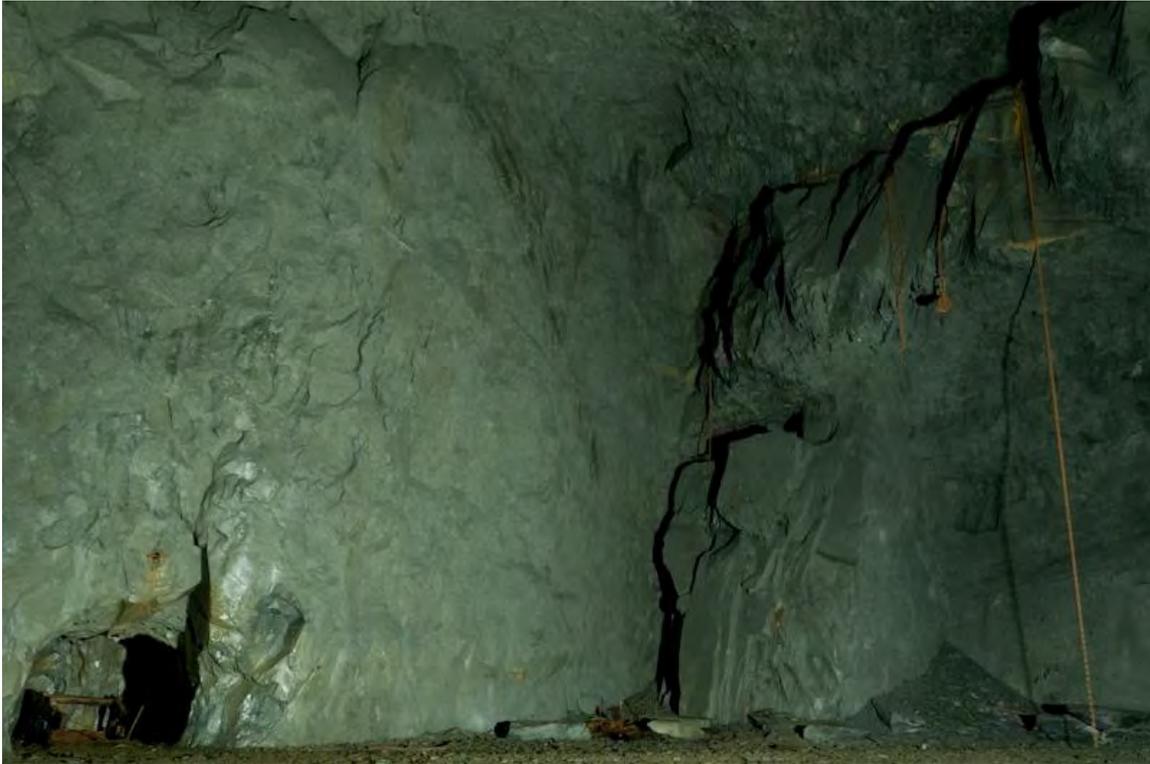
A large opening exists from chamber 6 into the tunnel leading to chamber 5 about half way along its length. Within this opening and partially obstructing the tunnel is a wooden winch frame. The design of the winch is clearly similar to that in chamber 2 but this example lacks most of its working parts and some timber. A number of winch parts are located close by but within the main area of chamber 6. It is possible that these are all the missing parts.

Chamber 6 – Lower Left to Upper Right
Tunnel to Chamber 5 & winch frame

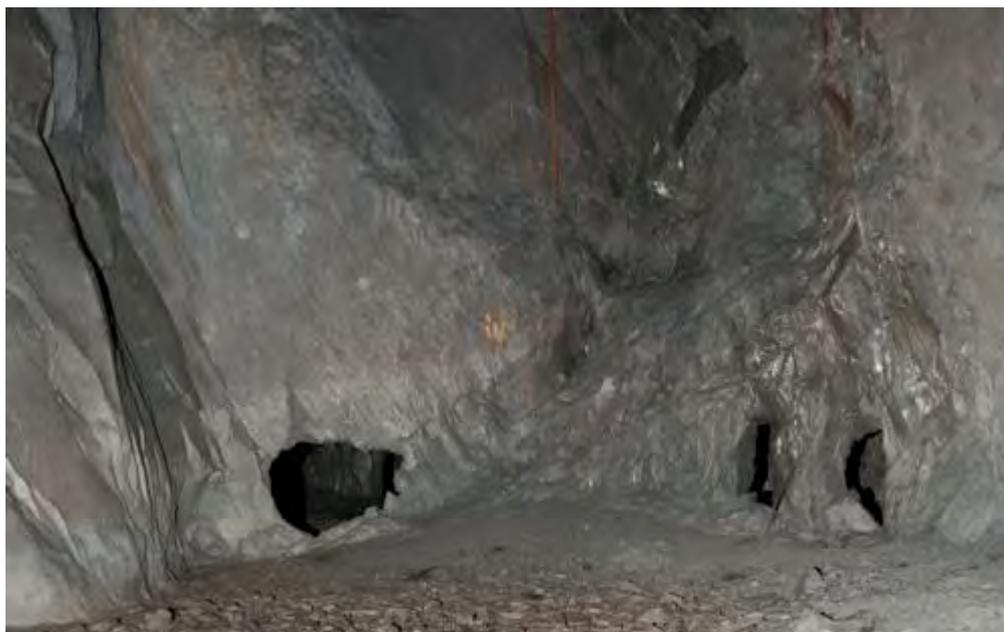
Three small irregular opening have been formed from chamber 6 into the tramway tunnel close to where it connects into chamber 7. Above these are more chains and several iron pins driven into the rockface. One of these chains looks to lead to an opening onto the high-level ledge in chamber 7.

The small openings from Chamber 6.
leading into Chamber 7 (left) and the Tramway bypass tunnel (2 on right)

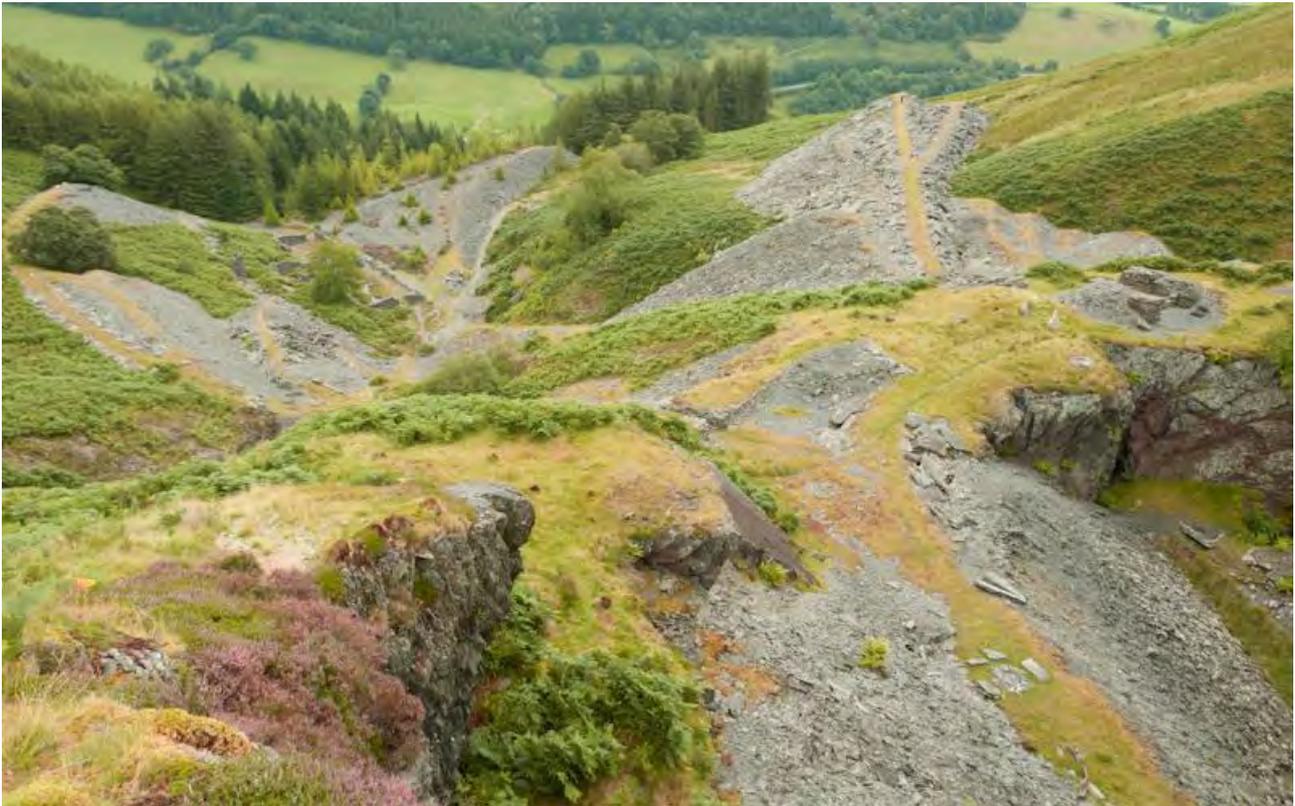
The Upper Workings
The Mill level (I) is left of centre & level L to the right
Pit 4 with level M & L is lower right

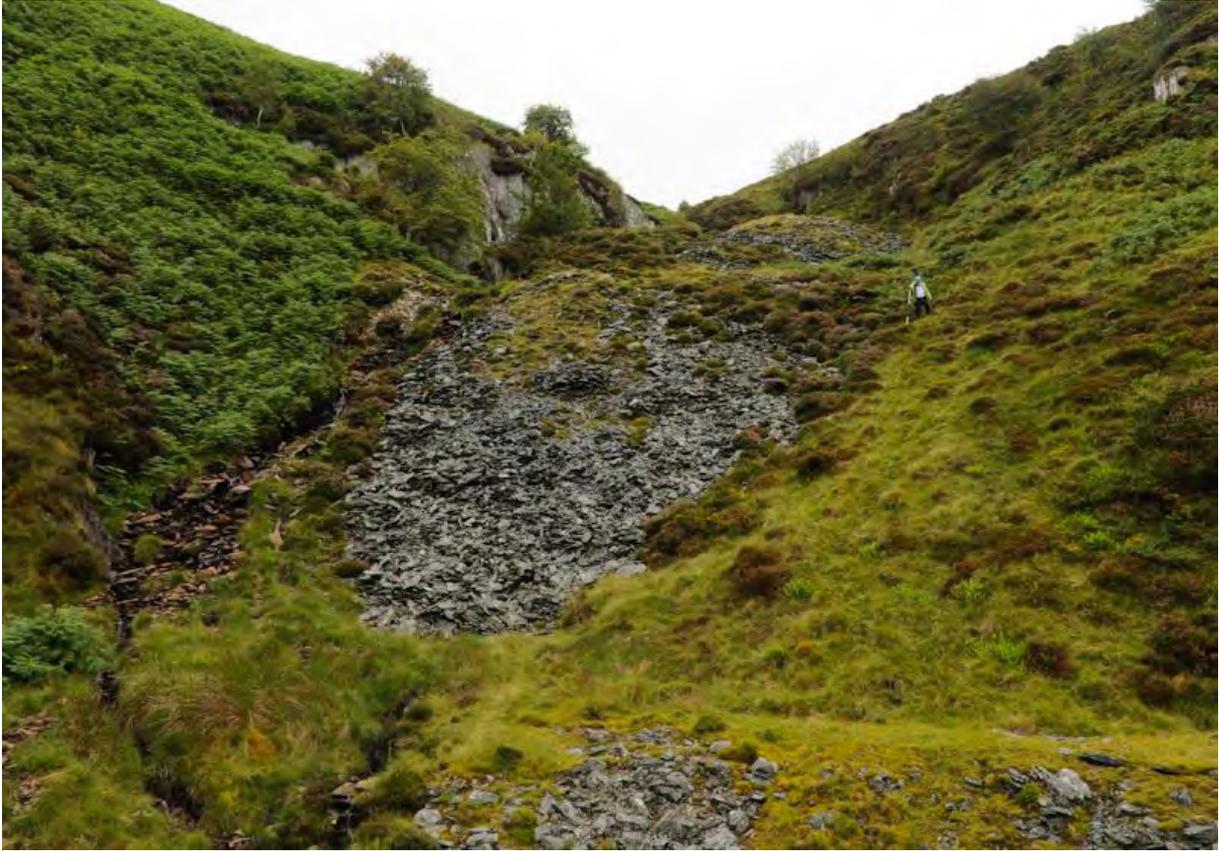
The Gully above and to the North of the main site, seen from Level M
Levels O & P tip runs are visible towards the top of the loose material. Mr Owen adds scale

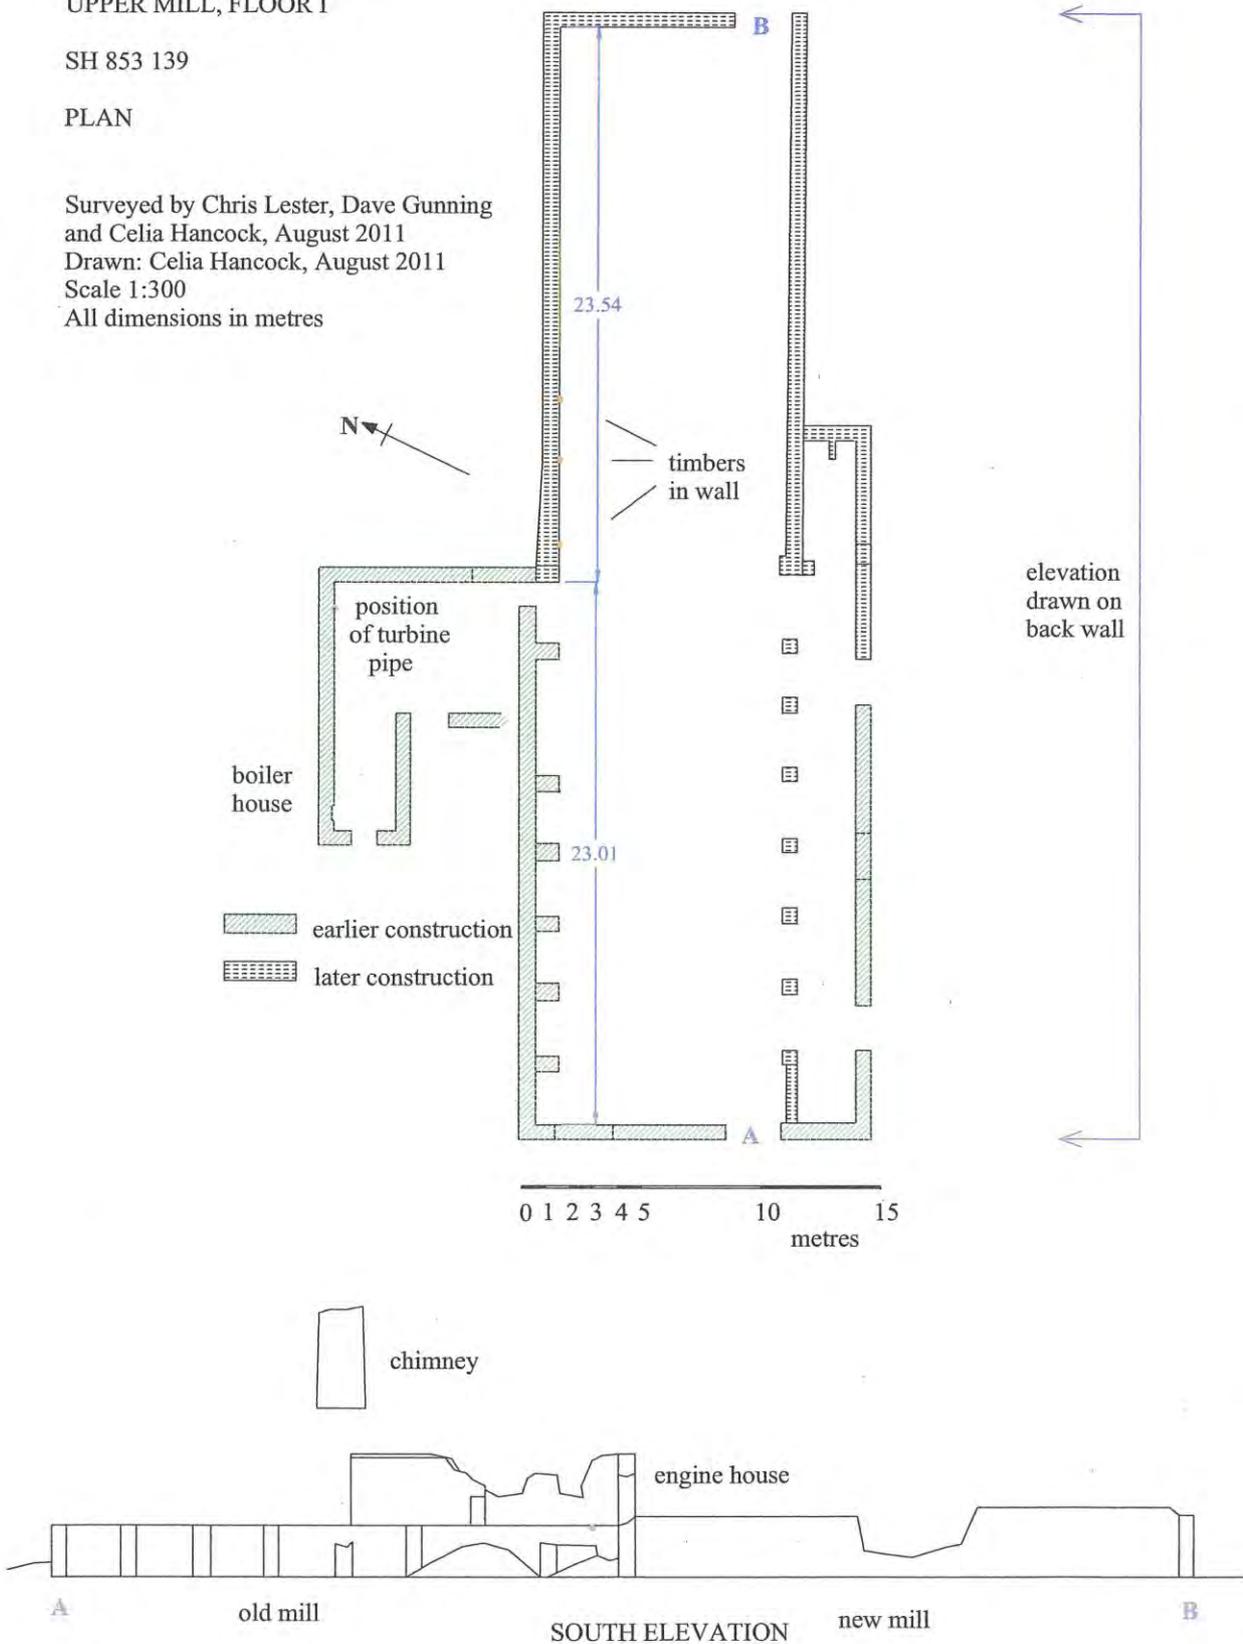
FIGURE 6

Fig 6 is the plan of the mill. The NE part appears to be a later extension and is made from slate from a different source which is stained red from iron. The front wall (south) has two openings and two blocked apertures. The west wall has two apertures, one of which is blocked. Traces of soot were found in the area tentatively identified as a caban in the east end close to the mill wall and an anonymous drawing of 1972 in the DRO indicates a chimney in the corner of this area. Interestingly for a mill of this size and the importance of this floor generally, no traces of a smithy were identified. Figs 7 to 10 illustrate the mill.

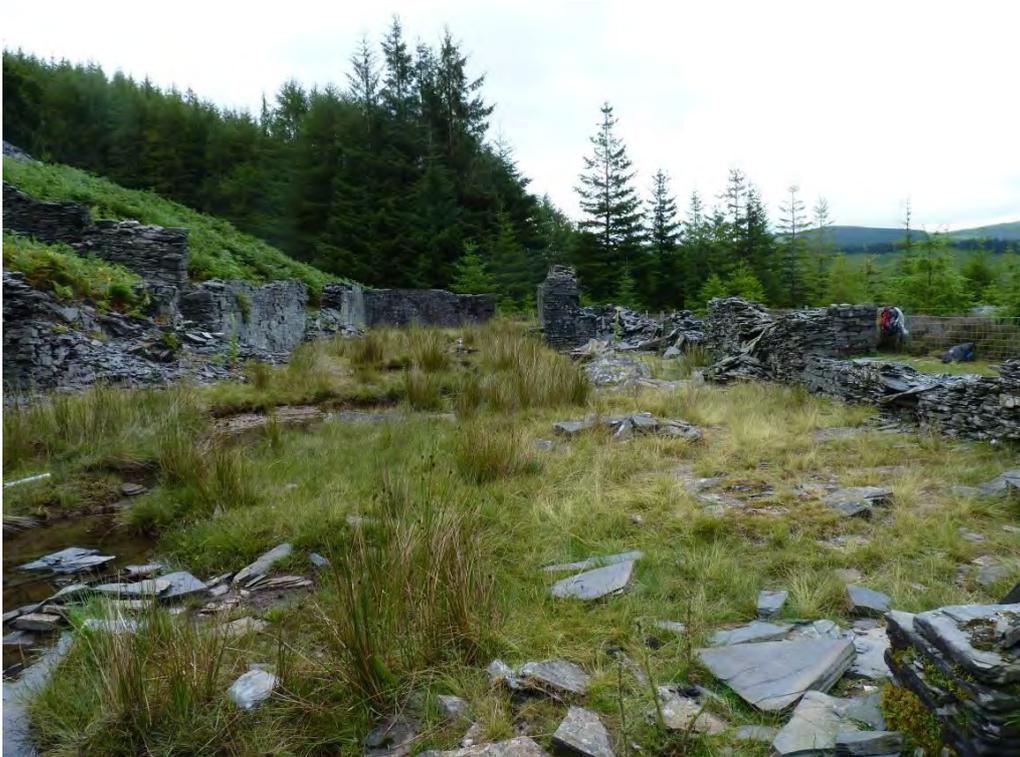
Fig 7. The mill looking NE, later pillars just visible.

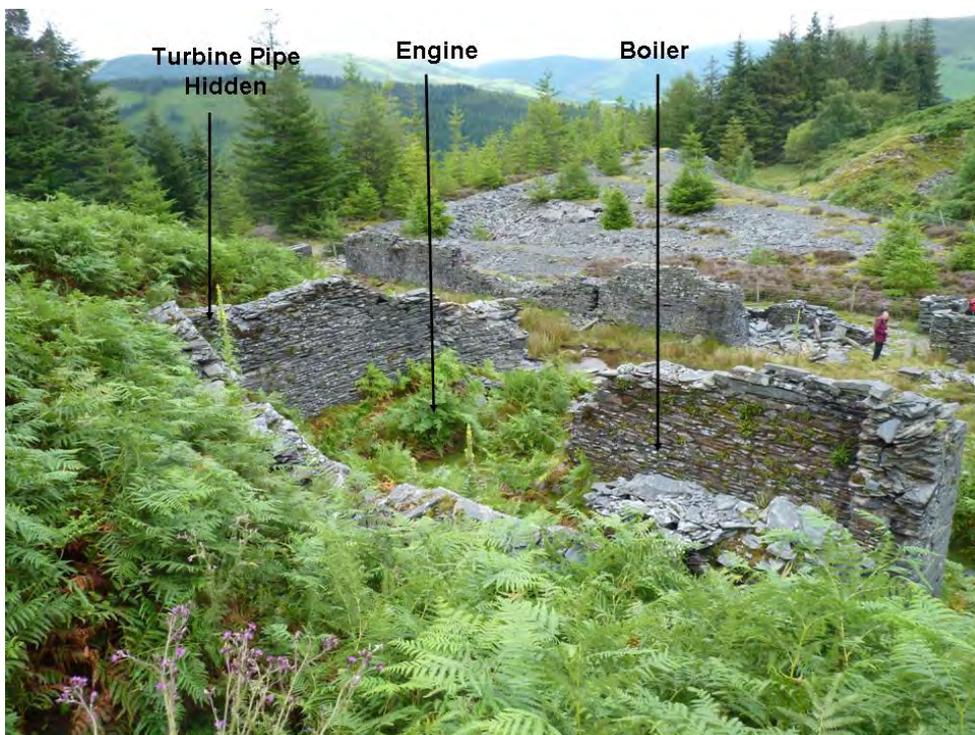
2. Engine House. The engine and boiler house form an L-shaped structure adjacent to the rear wall of the mill on rising ground such that its floor appears to be at about the level of the mill wall plate. The walls, some 0.6 m thick, survive to a height of approx. 2 m. See Fig 11.

Fig 11. Engine and boiler house.

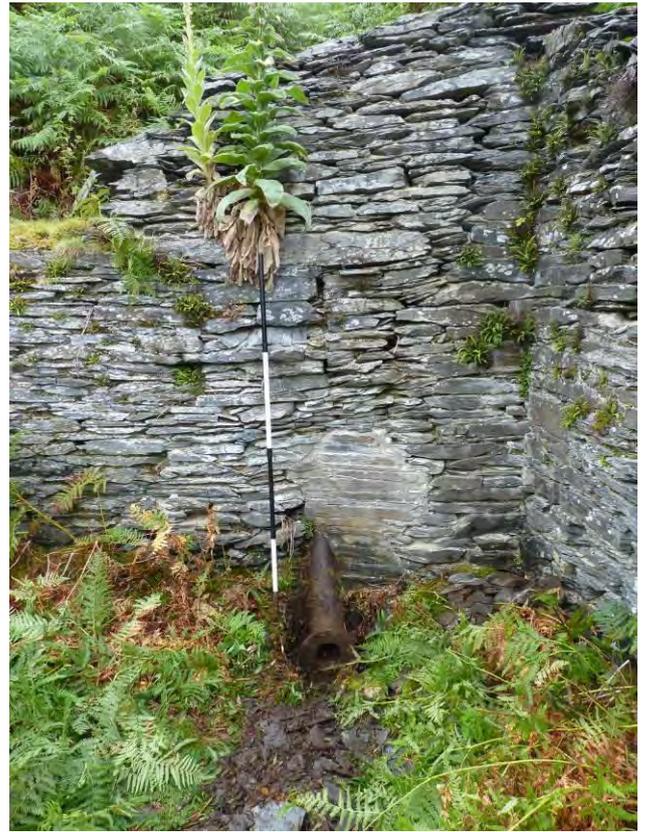
The steam engine was reported in 1845 (see *Notes*) to be manufactured by Blackburn of the Minorities and rated at 6 HP. No trace of this manufacturer has been found using Internet (only) sources. It is believed that after the steam engine was removed the mill was powered by a water turbine using water from a reservoir located at SH 85220 14214, 102 m above the turbine pipe entry level. A high pressure water pipe of 0.15 m internal diameter was found (see Fig 12) and there appeared to be a pit in the floor where the turbine would have been. No other traces of the engine or turbine were found.

Fig 12 Turbine pipe

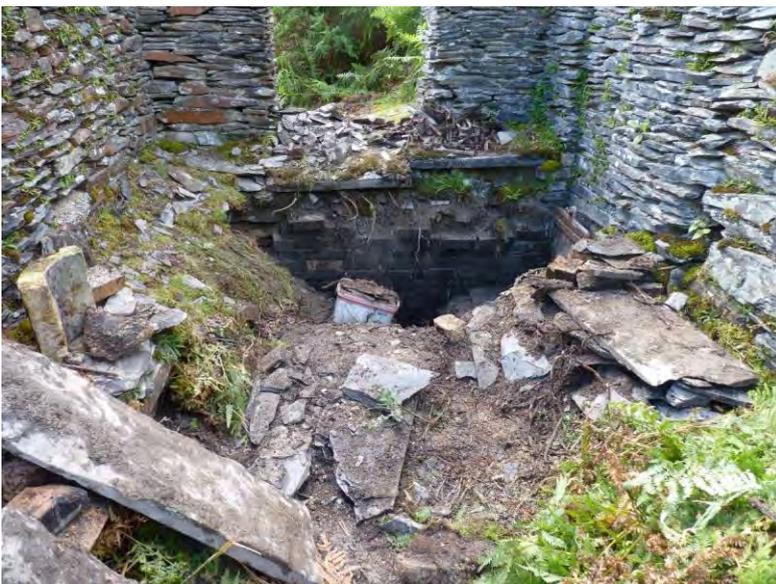
3. Boiler House and Chimney. Excavation of the boiler house floor revealed large numbers of refractory bricks arranged to support a Cornish boiler. The bricks bear the inscription “Lambert, Shrigley, Macclesfield”. This is Lambert of Pott Shrigley, a brick-making business of 1830 to approx 1870. The successor company, William Hammond Ltd., still owns their premises. The flue damper was also found. See Figs 13 and 14 for illustration and Fig 15 for a detailed drawing.

Fig 13. Boiler house.

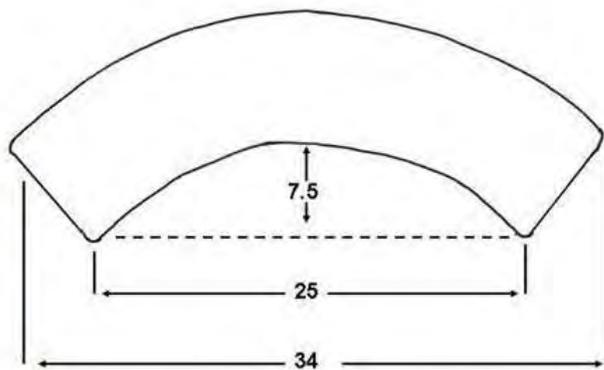
The chimney is located 5.0 m above the boiler house. It stands approx 4.2 m tall and it is 2.0 m at the base. The top of the flue aperture was located but the flue itself was not found. It is thought that the top flue bricks may have been removed and the rest subsequently buried by natural process. However, a flue brick was found in the boiler house. This is illustrated in Fig 16 and the chimney itself in Fig 17. Fig 18 is a cross-sectional drawing of the boiler house, flue and chimney.

Overall length 29.5
 Material: Fireclay

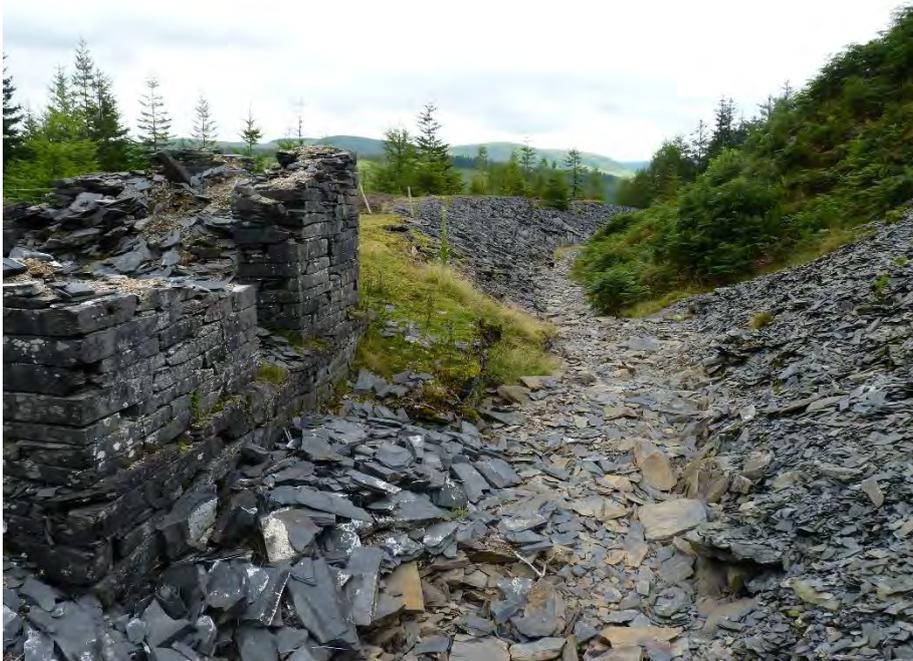
1. **Tramway.** The tramway is some 300 m long and follows the contour of the hillside to reach the drum house at the head of the incline. Although the mill end of the tramway is visible, thereafter approx. half of it is lost in boggy ground. From the east end of the weigh house a profile of the first 23 m was drawn and the rate of descent was found to average around 1 in 14, see Fig 23.

Fig 23 Exit tramway descending behind the tip tramway weighhouse

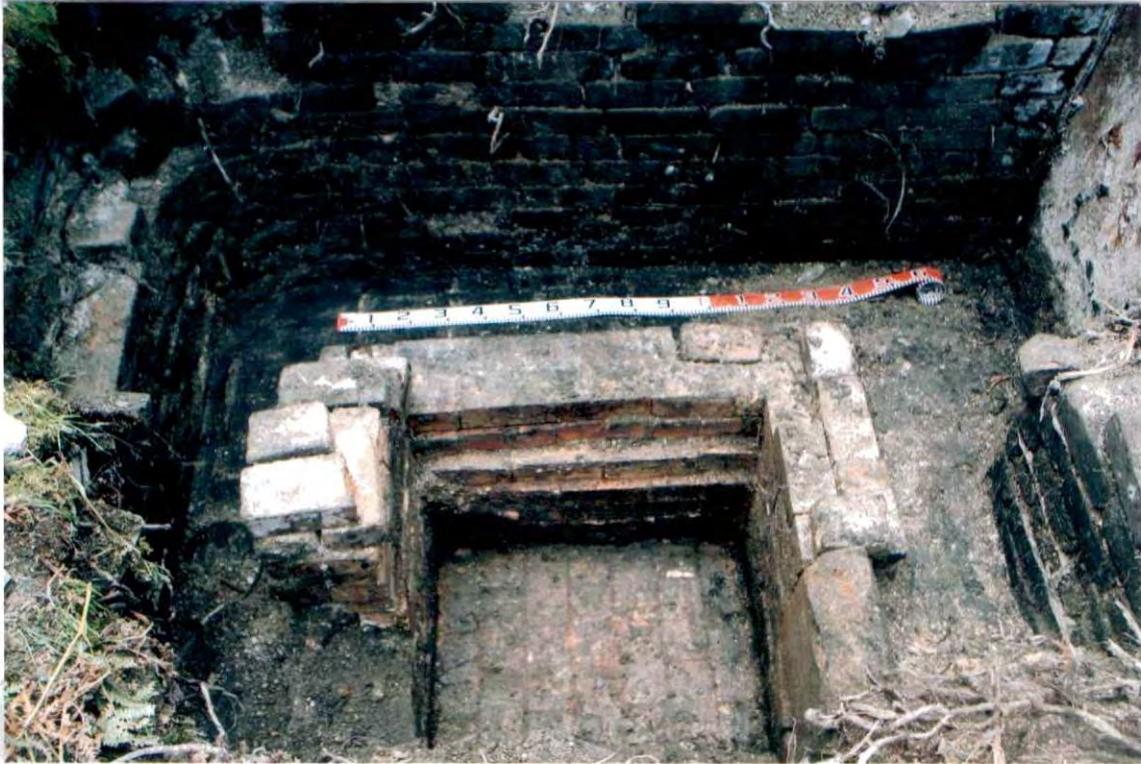
Photo 1. The excavated West end of the boiler flues. The damper to the chimney flue is on the right.

Further excavation will be required to show the length of the boiler and the flue arrangement at its East (firing) end. Further excavation should also show the engine foundations, enabling some idea of the type of engine to be gained.
