**MINLLYN SLATE QUARRY
WITH
CAE ABATTY**

(SH 853 140)

**SURVEY OF AUGUST 2011
REPORTS AND DIAGRAMMS**

Andrew Hurrell, August 2011

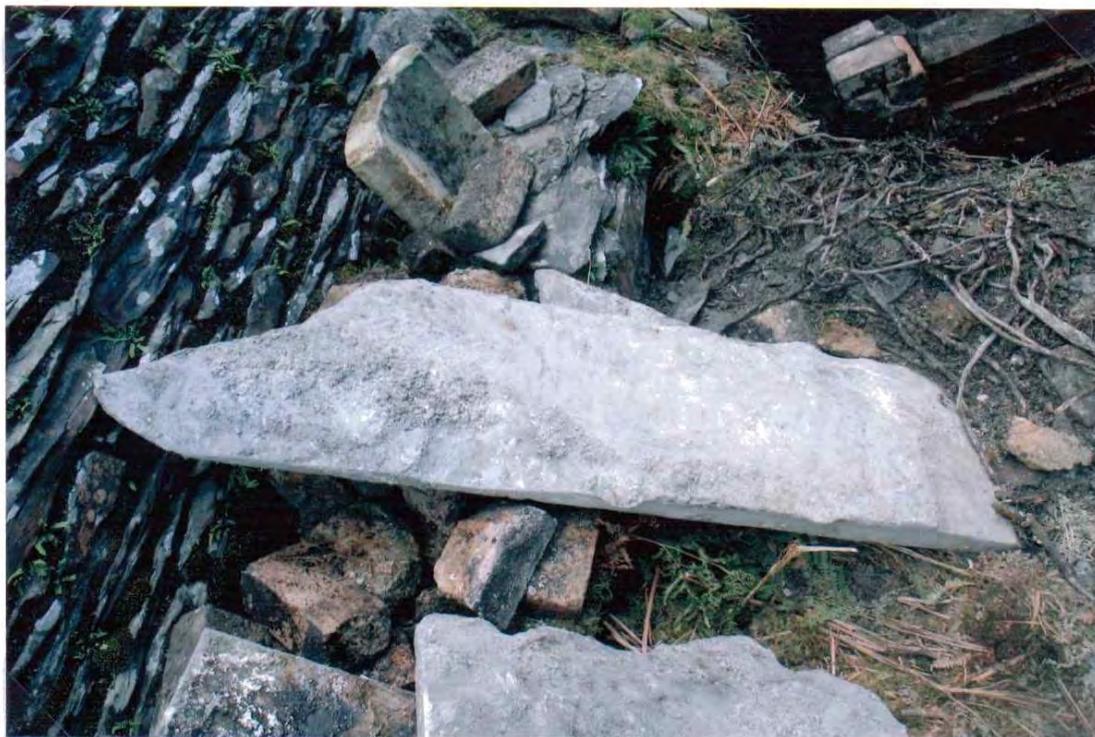
Photo 8. Sand sawn slab found in the boiler house floor.

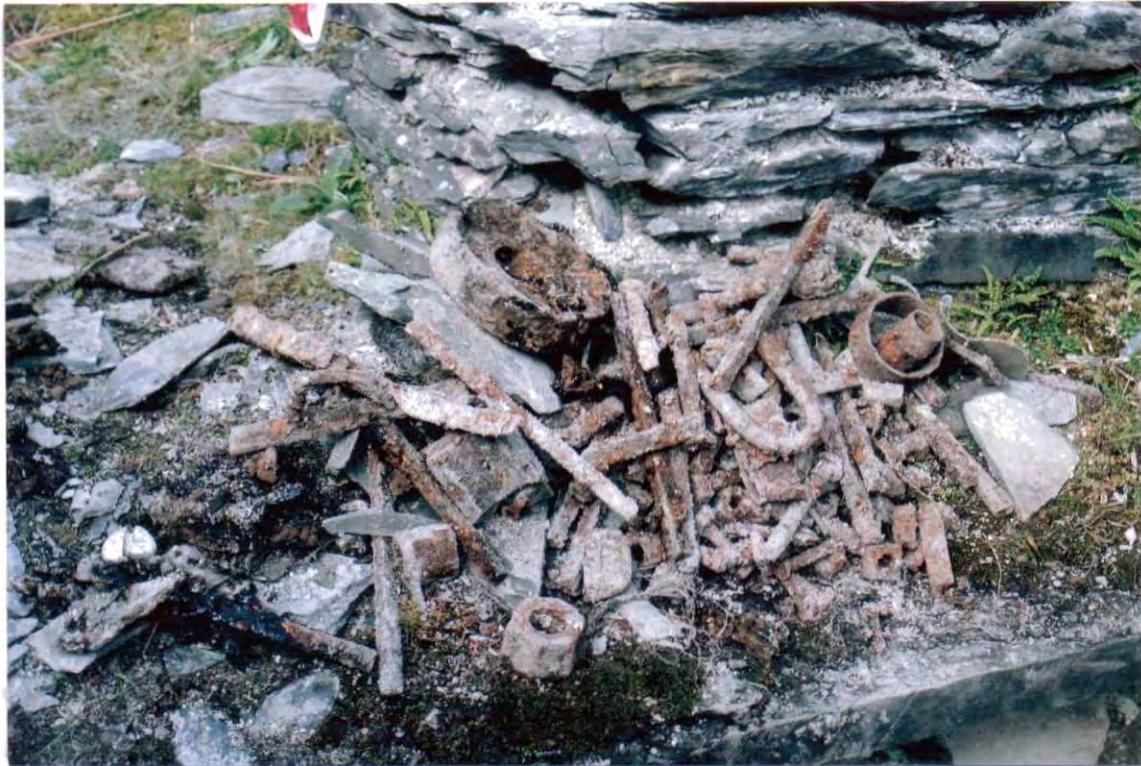
Photo 9. Assorted iron artefacts found amongst the rubble filling the boiler flues.

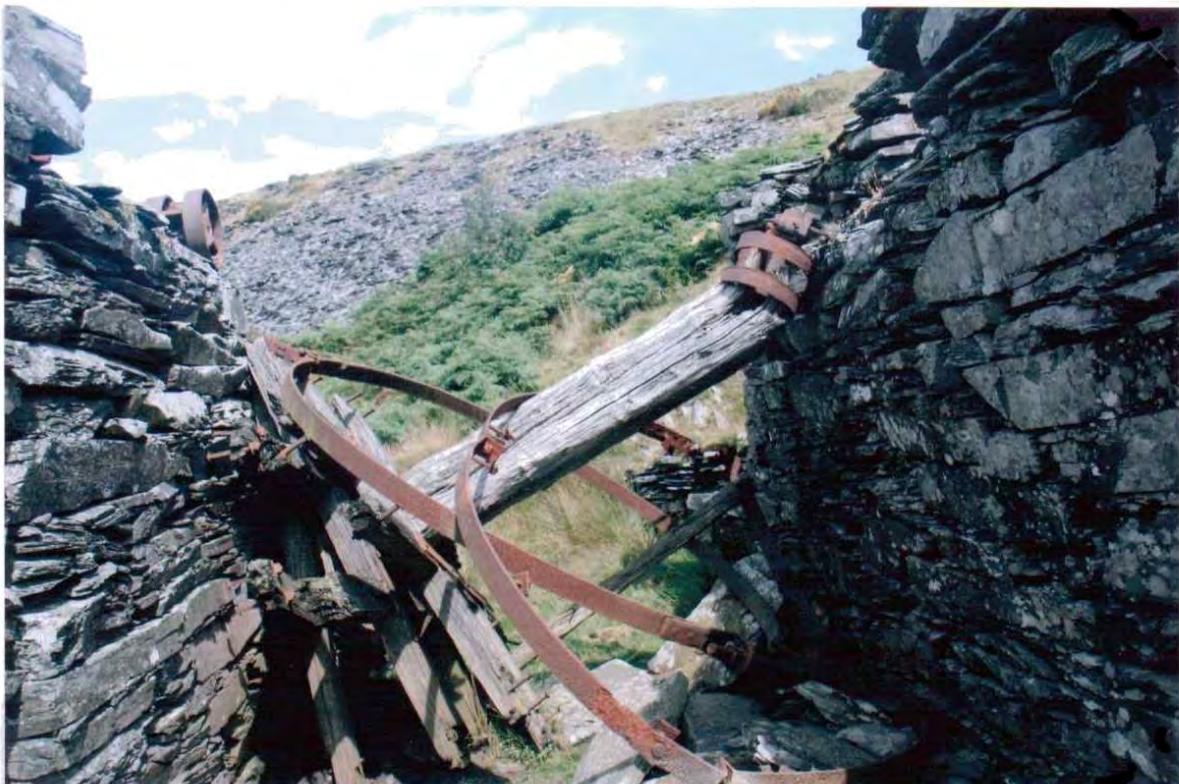
Photo 4. Looking North between the walls of the Cae Abatty Quarry Drumhouse. The drum axle has broken where it enters the West end cap, which is still on the drumhouse wall. The remains of the three drum spiders, the braking surface ring and brake band have fallen towards the West end of the axle.

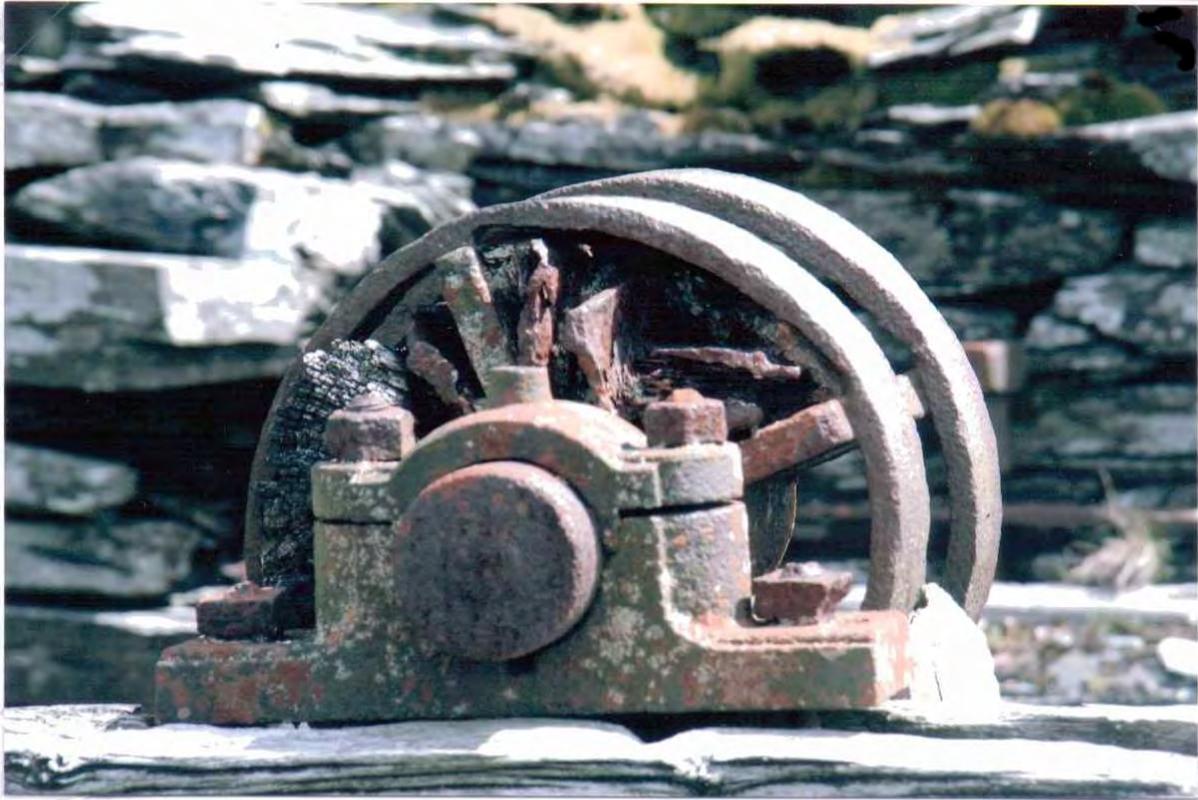
Photo 5. The West axle end cap of the Cae Abatty Quarry Incline Drum, still in place in its bearing block on the drumhouse wall. The remains of the axle within the end cap have rotted away.

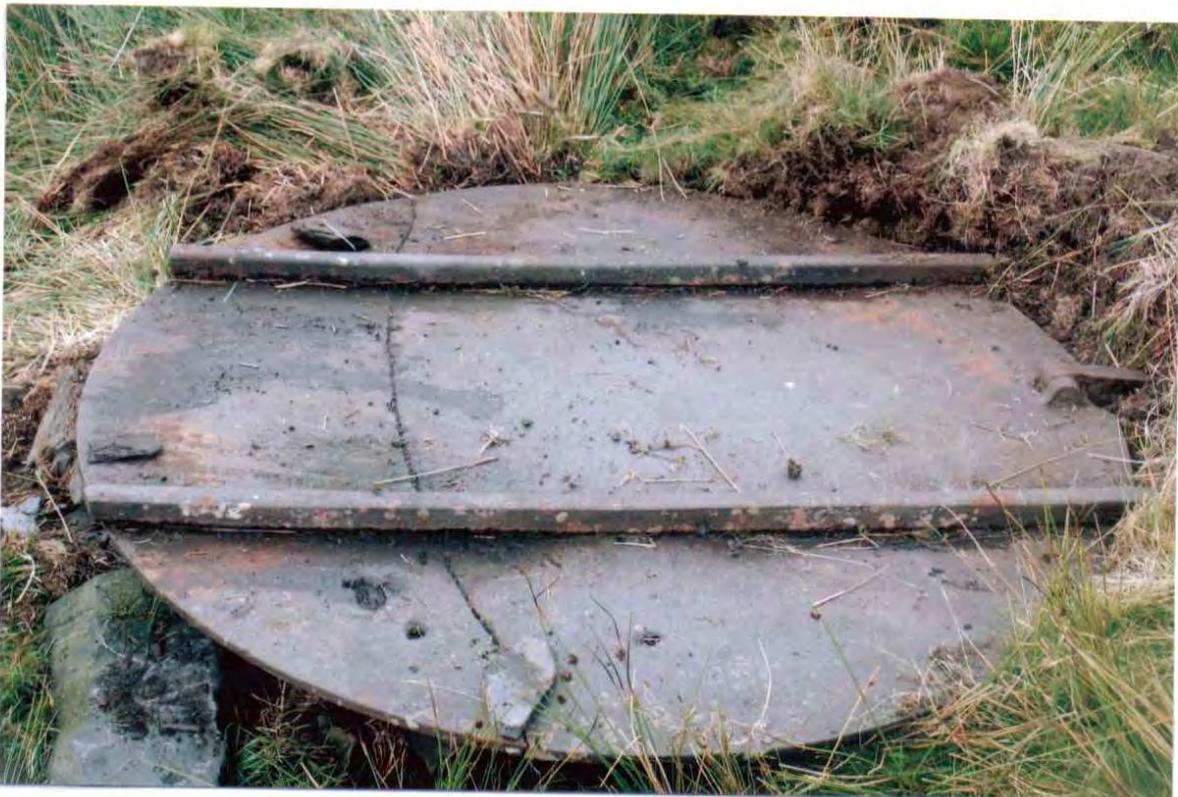
The top of the turntable had previously been found, and measured, beside the summit of the incline (Photograph 16 and Figure 6). The top plate consists of a single casting, 1.54m (5ft) diameter, 2cm ($\frac{3}{4}$ ") thick. Cast into the underside are a 5 cm wide rim, set in from the periphery, and six 2cm wide spokes. The rim would have run on the rollers on the turntable base. The thickness, including the rim and spokes, is 3.5cm. Two cast iron rails 4cm wide and 4.5cm deep are bolted to the plate by three bolts each at a gauge of 66cm (2' 2") between the inner faces of the rails. Centrally between the rails at one side of the turntable top are two lugs, approximately 37cm x 37cm (15" x 15") in section, carrying a locking bar, which can engage in notches in the rim of the turntable base (Photograph 17).

Photo 16. The top of the turntable was found at the summit level of the Cae Abatty tramway. It apparently got broken during removal, and was abandoned. The rails indicate that the gauge used in the quarry was 2' 2".

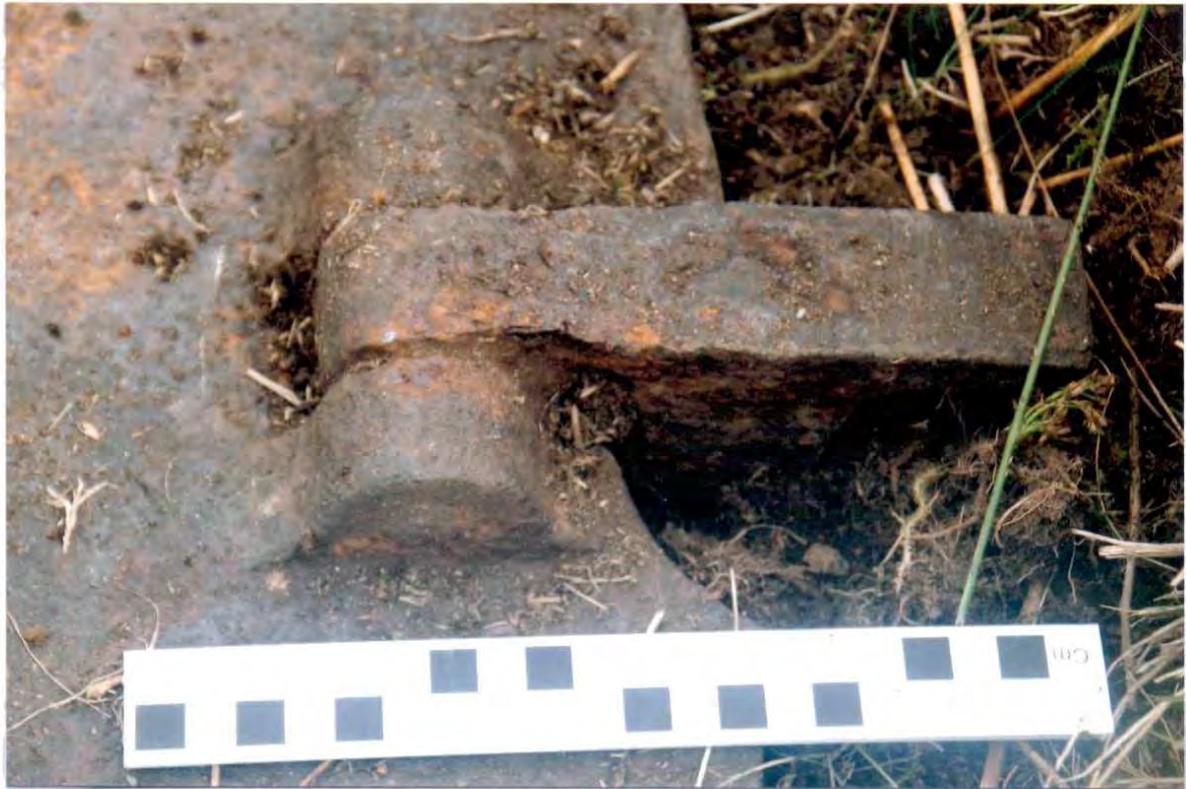
Photo 17. Latch mechanism on the turntable top.

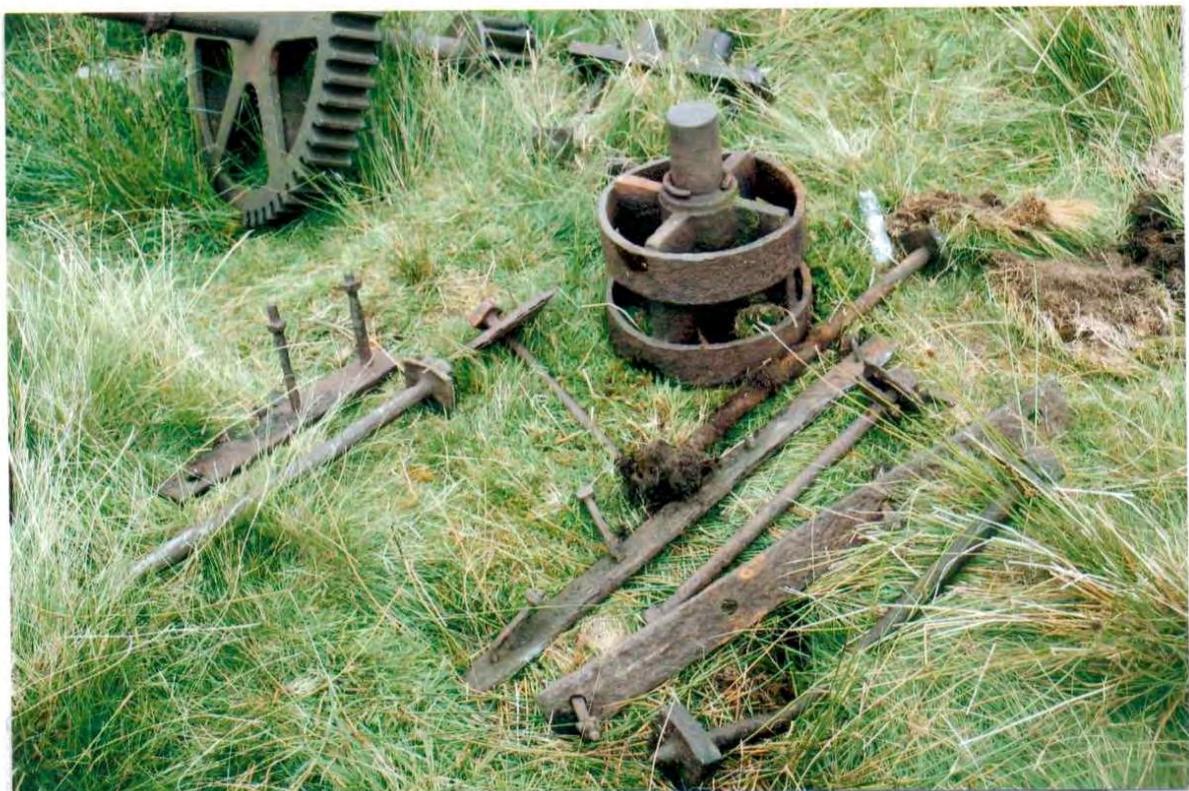
Photo 18. Ironwork found at the summit level of the Cae Abatty Tramway. The holding down bolts and straps indicate that there was a timber structure on the site.

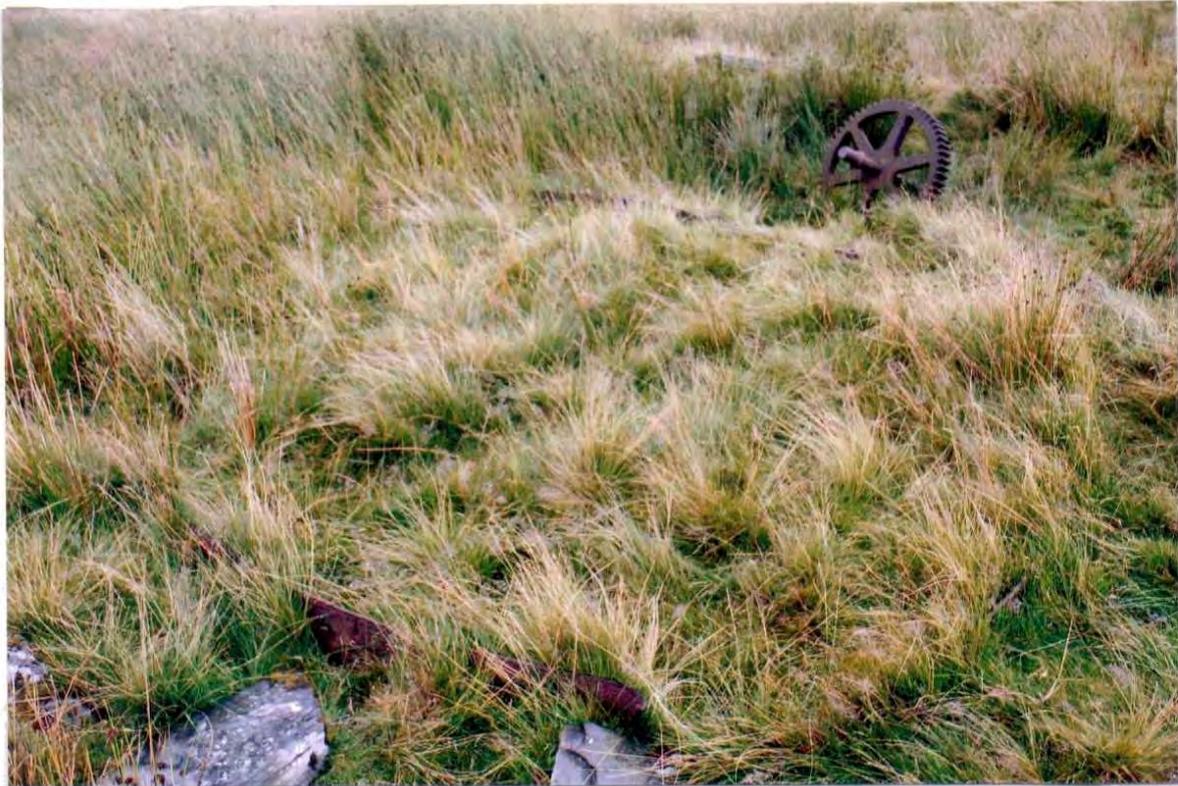
Photo 19. Parts of the brake band and braking surface rim, laid out as a single circle in the grass at the tramway summit

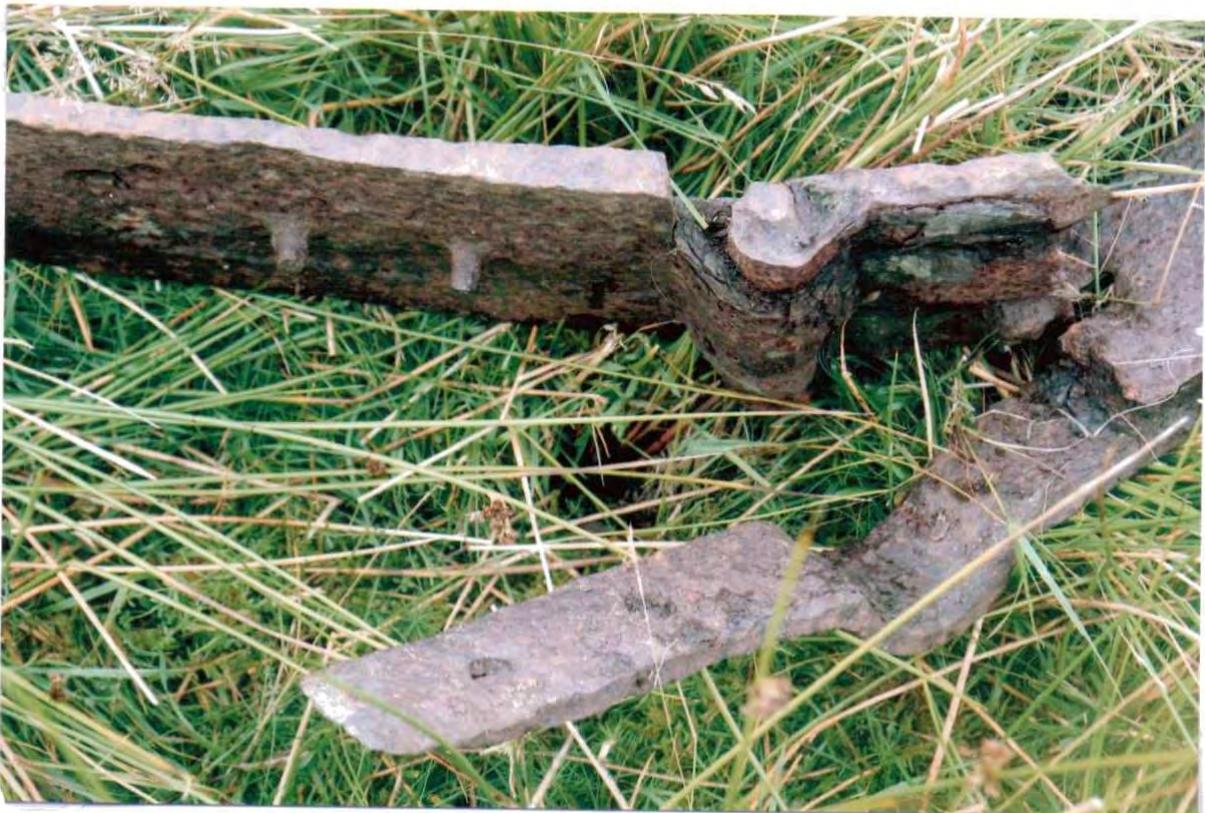
Photo 24. Another of the joints in the brake band has broken, and has been repaired by a strap.

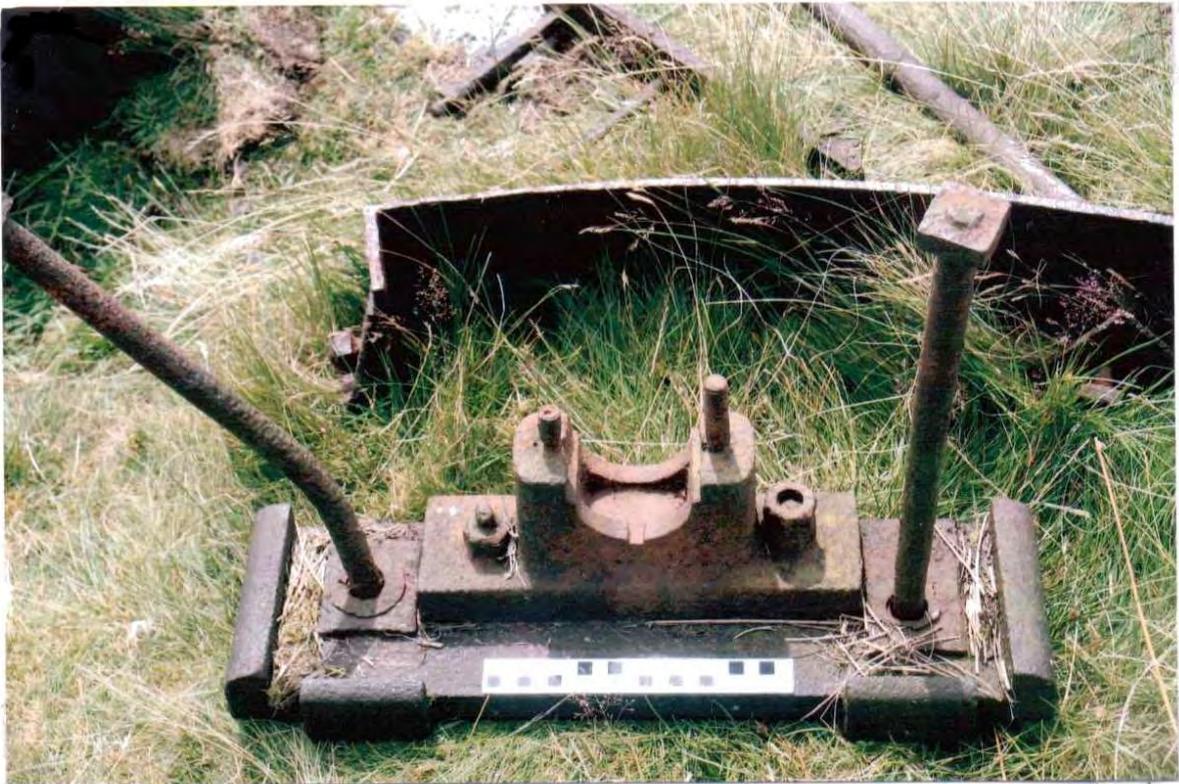
Photo 25. One bearing block found at the summit of the Cae Abatty Tramway is similar to those on the Cae Abatty Quarry Drumhouse, but via a baseplate to 0.4m (16") timbers. The drum end caps run directly iron on iron, but are provided with an oil reservoir.

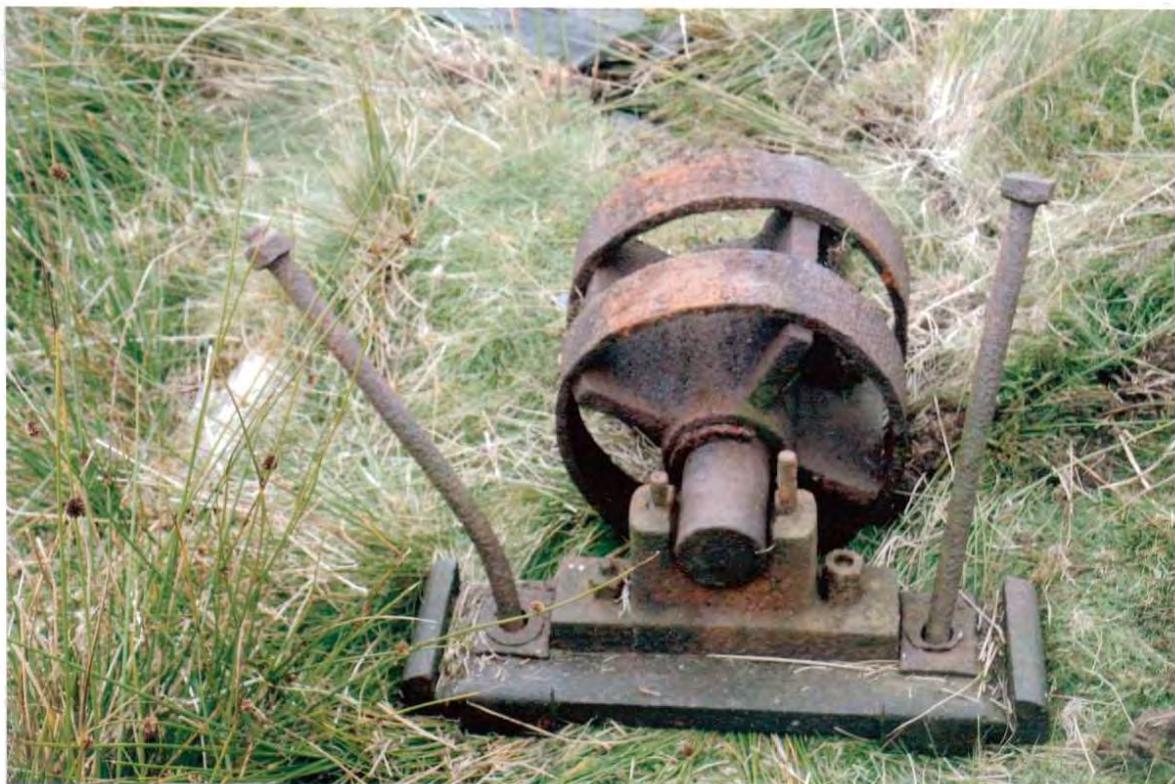
Photo 26. The bearing block, with the axle end cap placed in it.

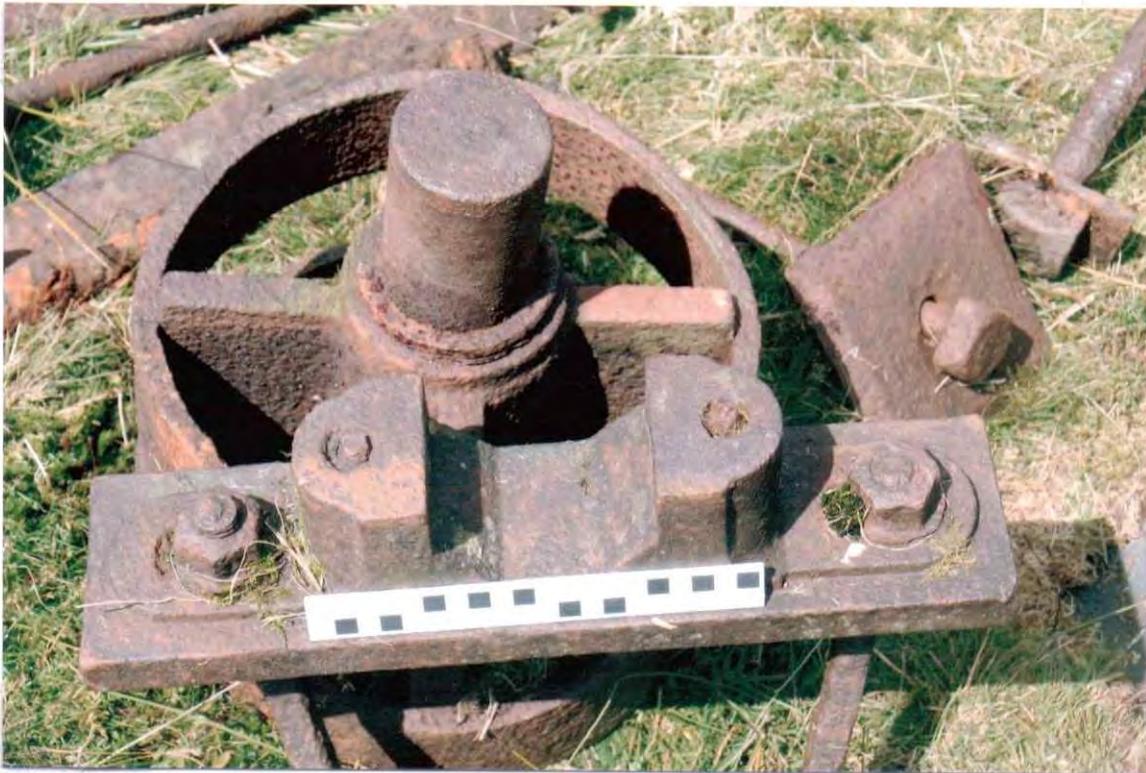
Photo 27. The second bearing blocks found at the summit of the Cae Abatty Tramway, with the axle end cap beyond. Comparison with the bearing blocks on the Cae Abatty Quarry drumhouse suggests that this one was a winch bearing, which was provided with brass bearings.

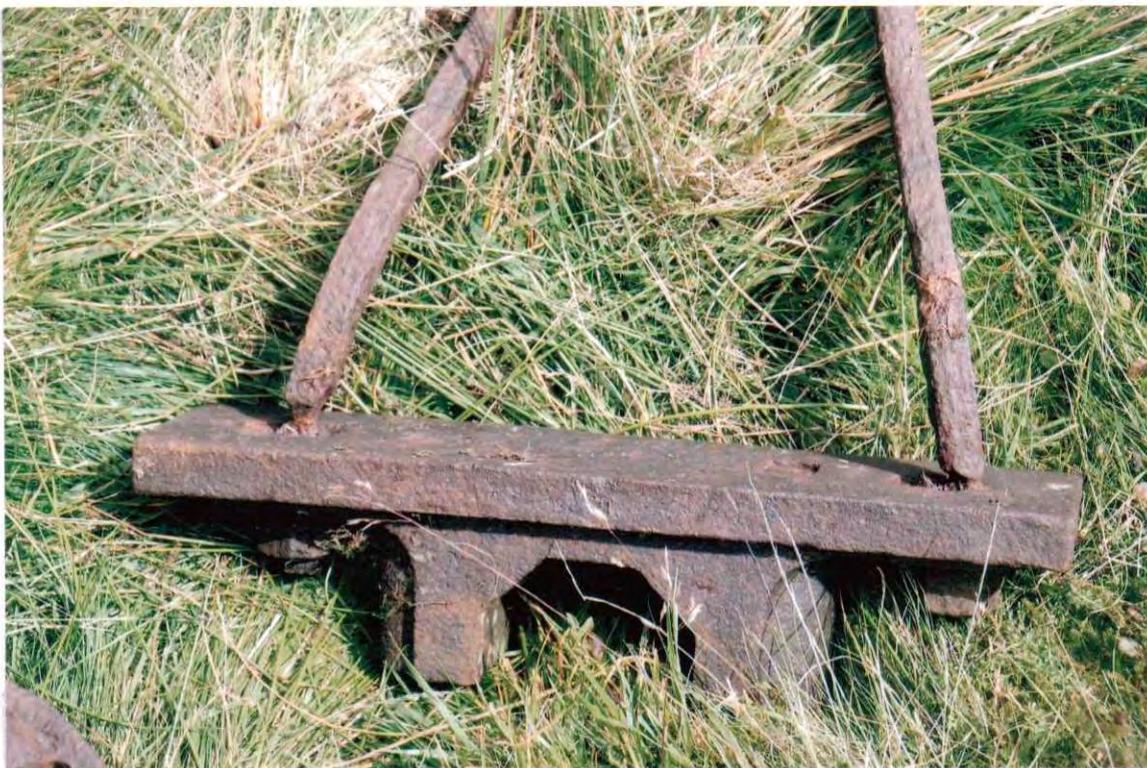
Photo 28. The winch bearing block, with holding down bolts still in place. These indicate that the timbers which carried it were about 0.4m (16") deep.

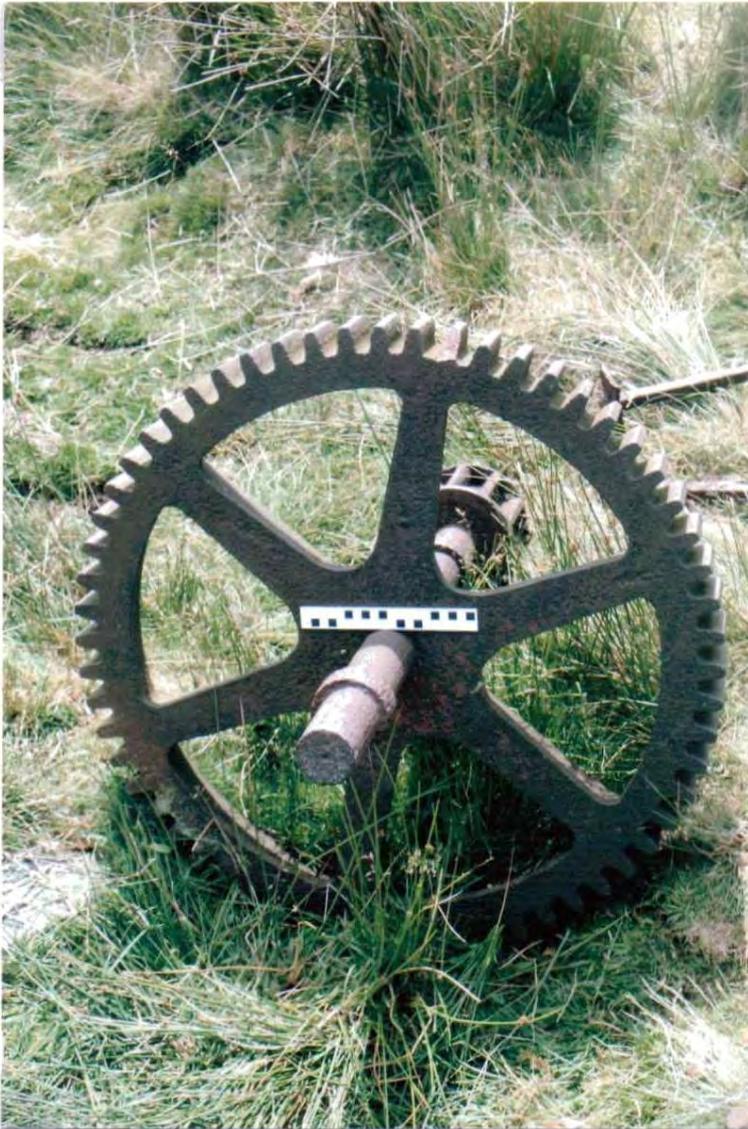
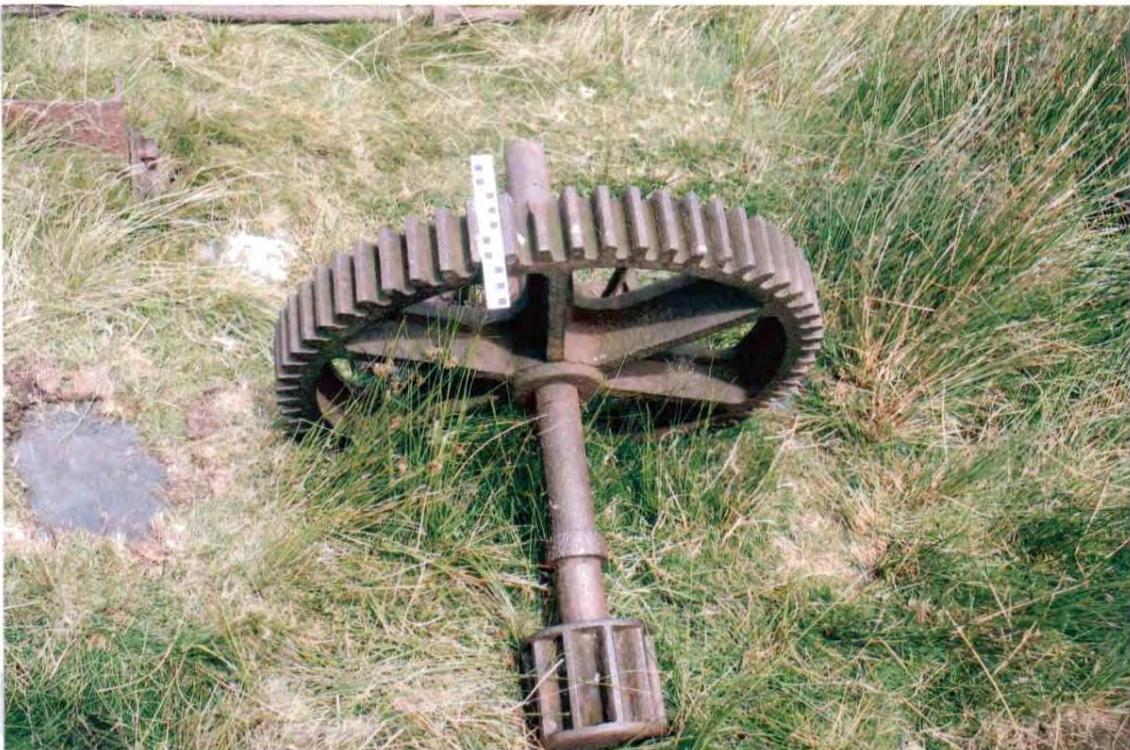
Photos 29 and 30. Intermediate shaft of the winder for the Cae Abatty tramway Incline Drum. The small 10 tooth pinion would have meshed with the large 120 tooth gearwheel, found part way down the East incline. The 62 tooth wheel was probably driven by another small pinion, on the same shaft as the winding handle. There is no provision for handwinding this shaft.

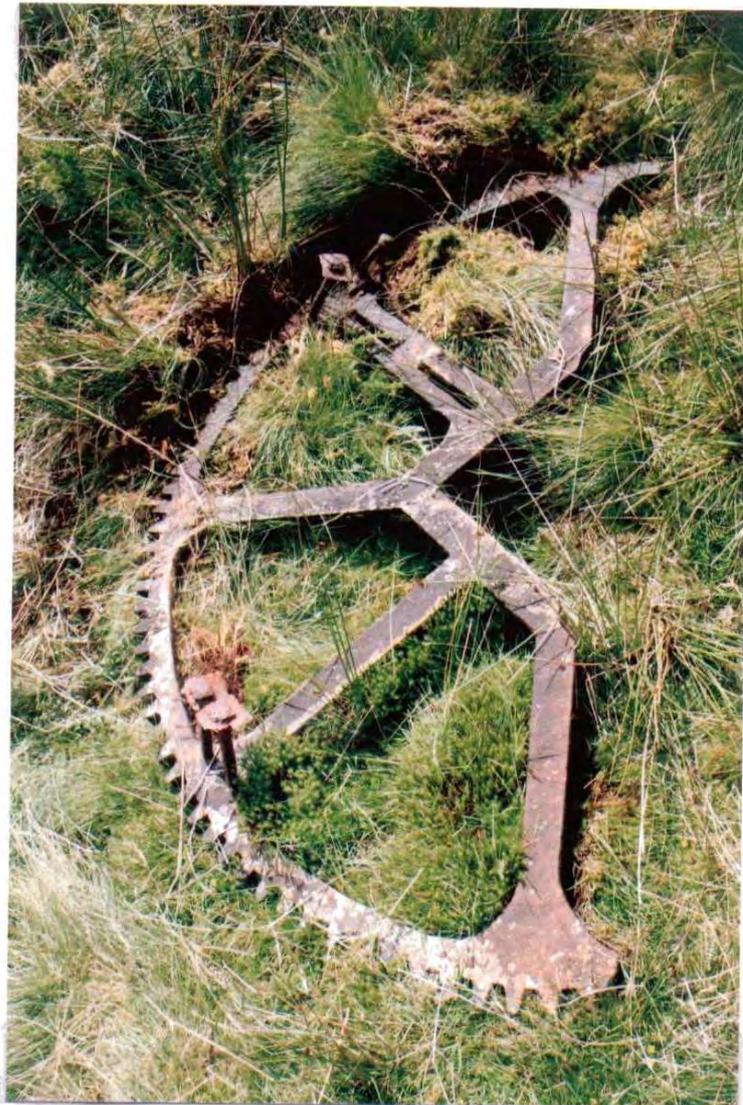
Photo 31. Half of a large 120 tooth gearwheel, found part way down the East incline of the Cae Abatty Tramway. This could have been driven by the small pinion on the shaft found at the summit.

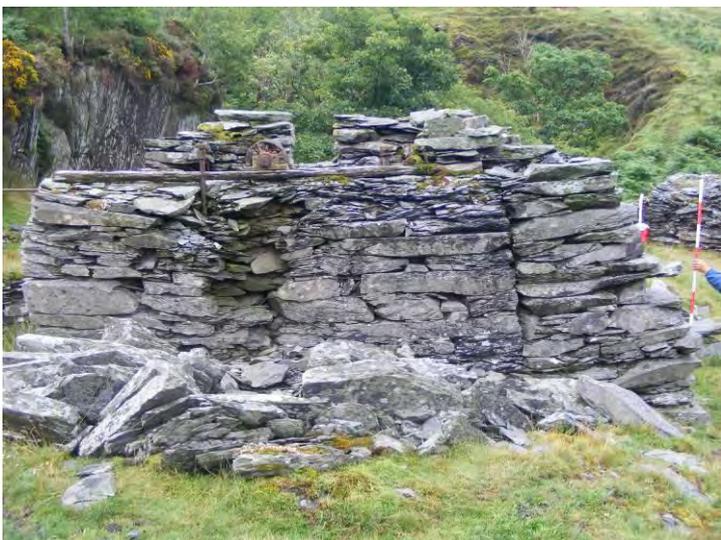
Fig 7
The drum house from the west showing extended wall.
(Scale is in 20cms sections)

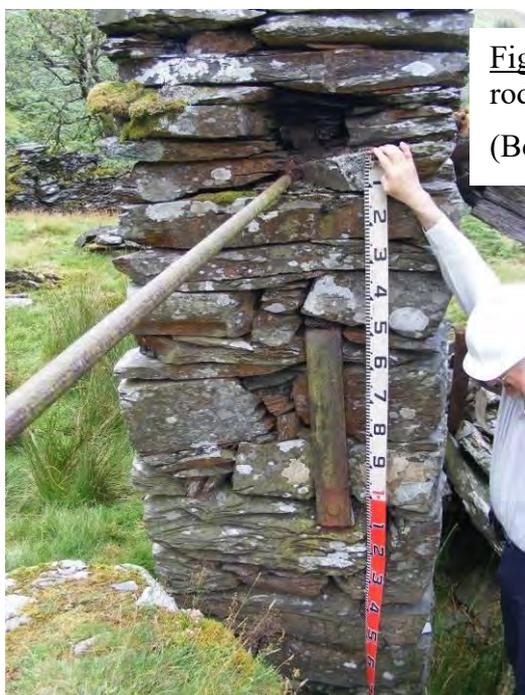
Fig 8 (Left) End of drumhouse wall showing the rod and plate.
(Below) End of rod bolted into the wall.

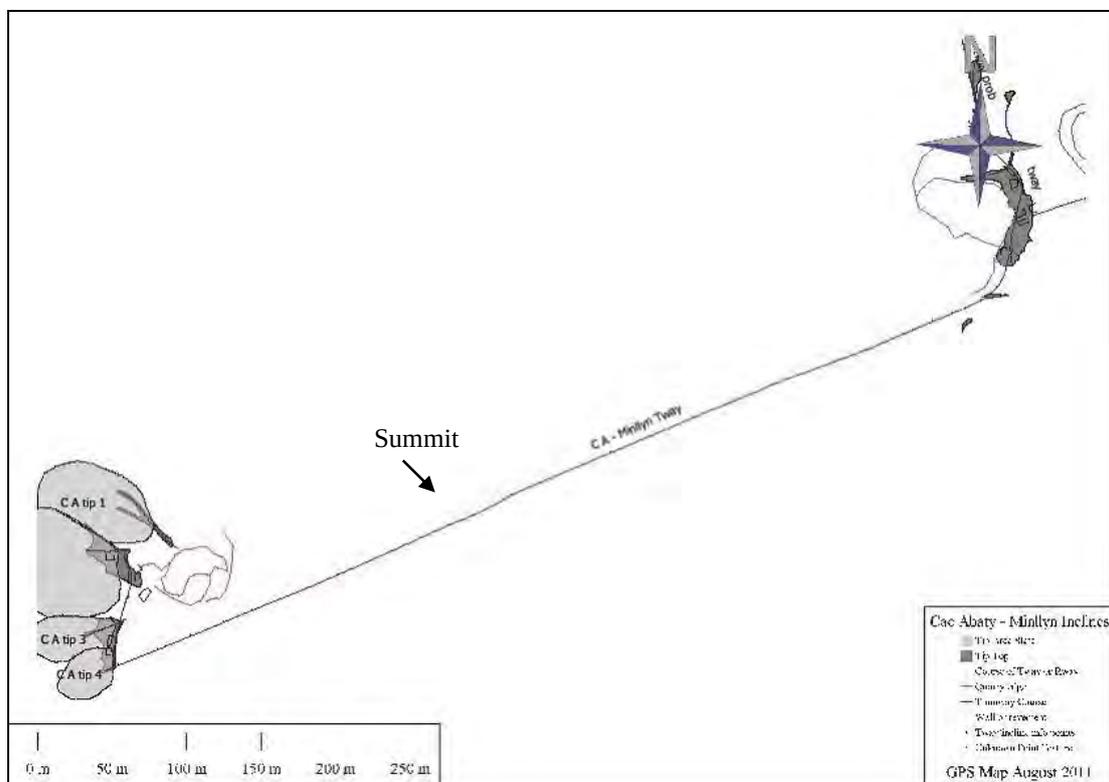
Fig 16 Plan of the Cae-abatty inclines.

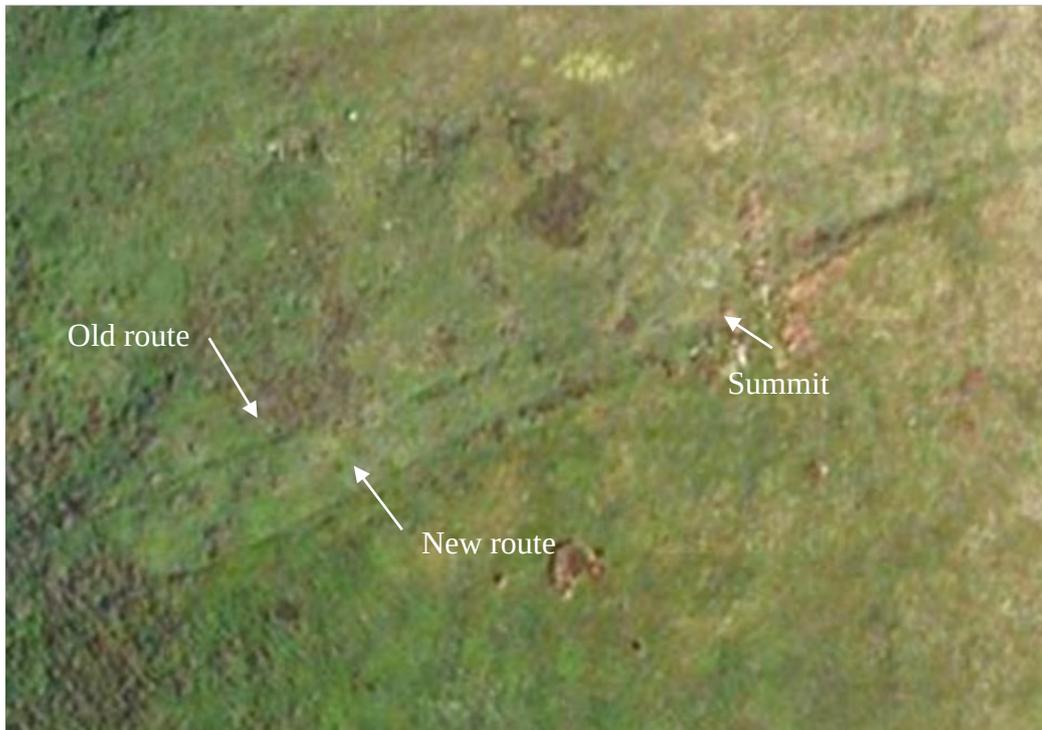
Fig 17. Area around the summit showing an apparent change in the route of the western incline.
