*FLINT CASTLE
archaeological evaluation of sites
to the west of the castle in 1988*

Archaeological evaluation of an area to the west of Flint Castle, Delyn, was carried out over a period of 4 weeks in late November and early December 1988 in response to proposals for future development of the area. The work was sponsored by Delyn Borough Council, and was carried out by the Clwyd-Powys Archaeological Trust in conjunction with Cadw: Welsh Historic Monuments.

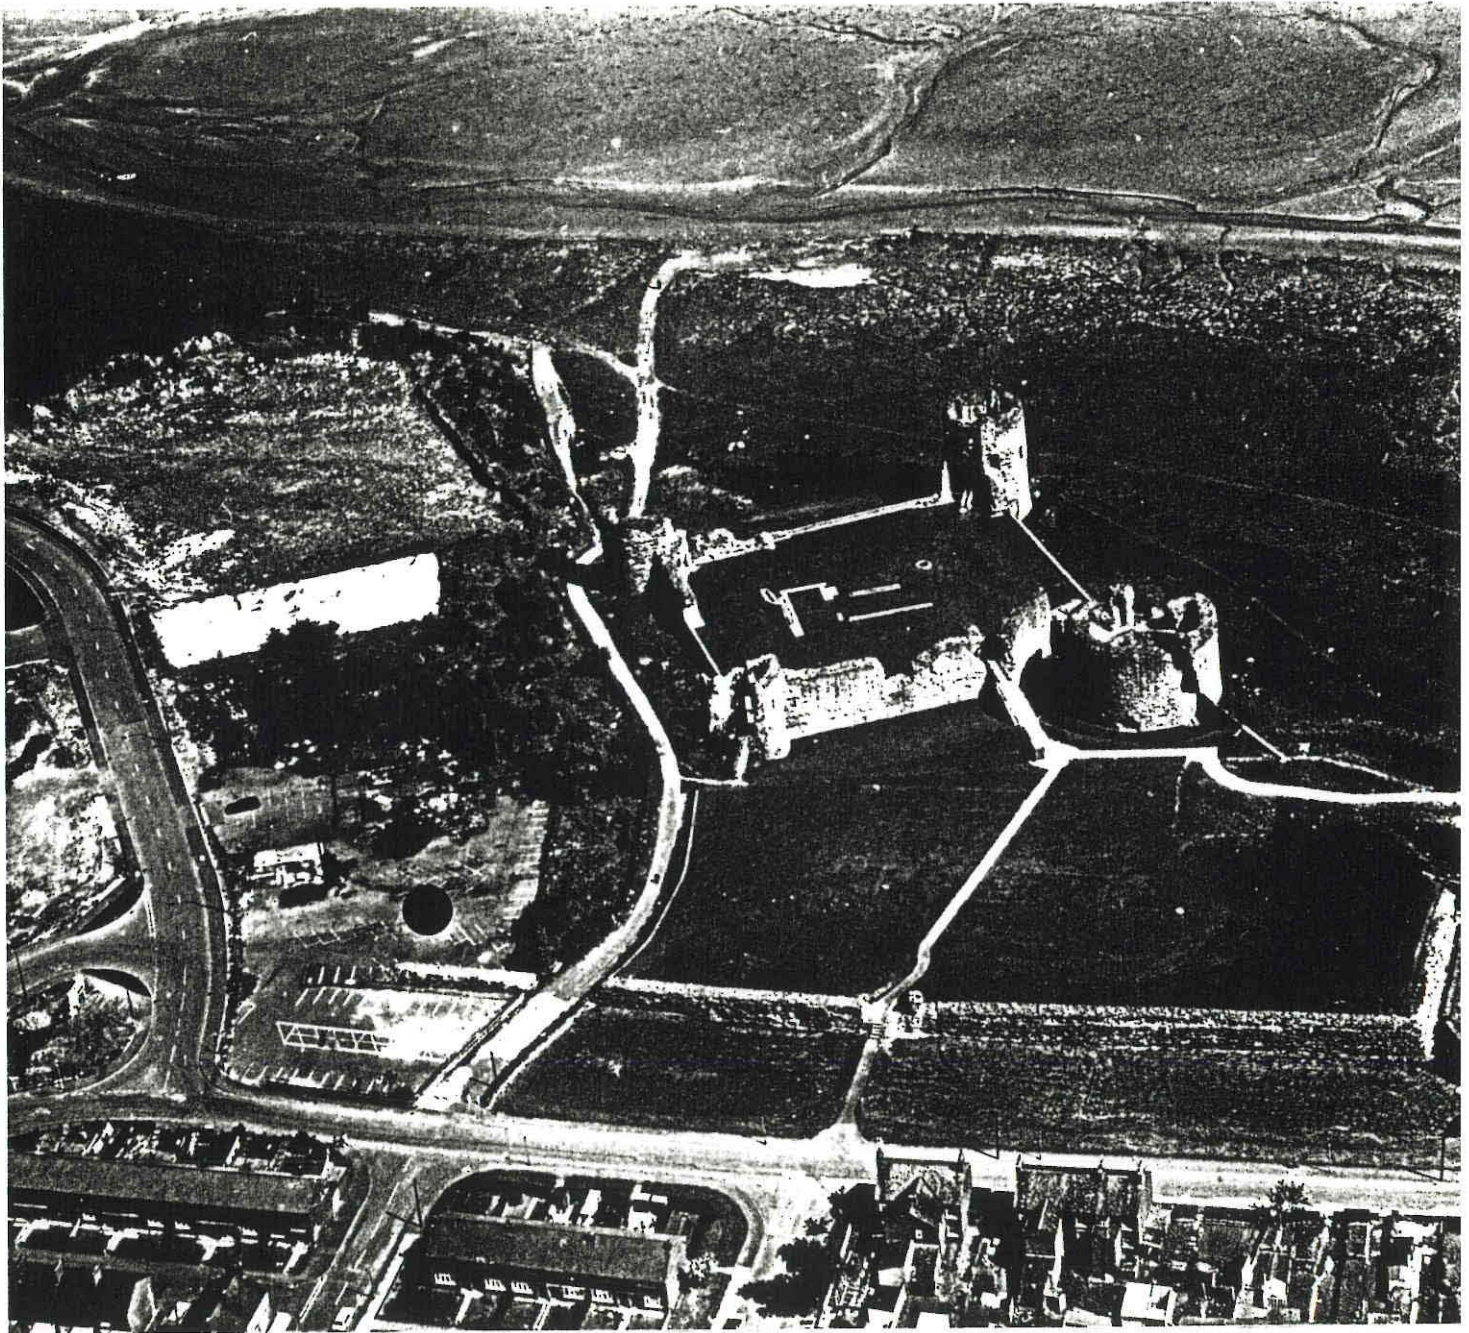
FIGURE 2: aerial photograph of Flint Castle from the south-west, with approximate site of 1988 archaeological excavations marked by black circle in lower left-hand corner (photo: C R Musson, CPAT 87MB559)

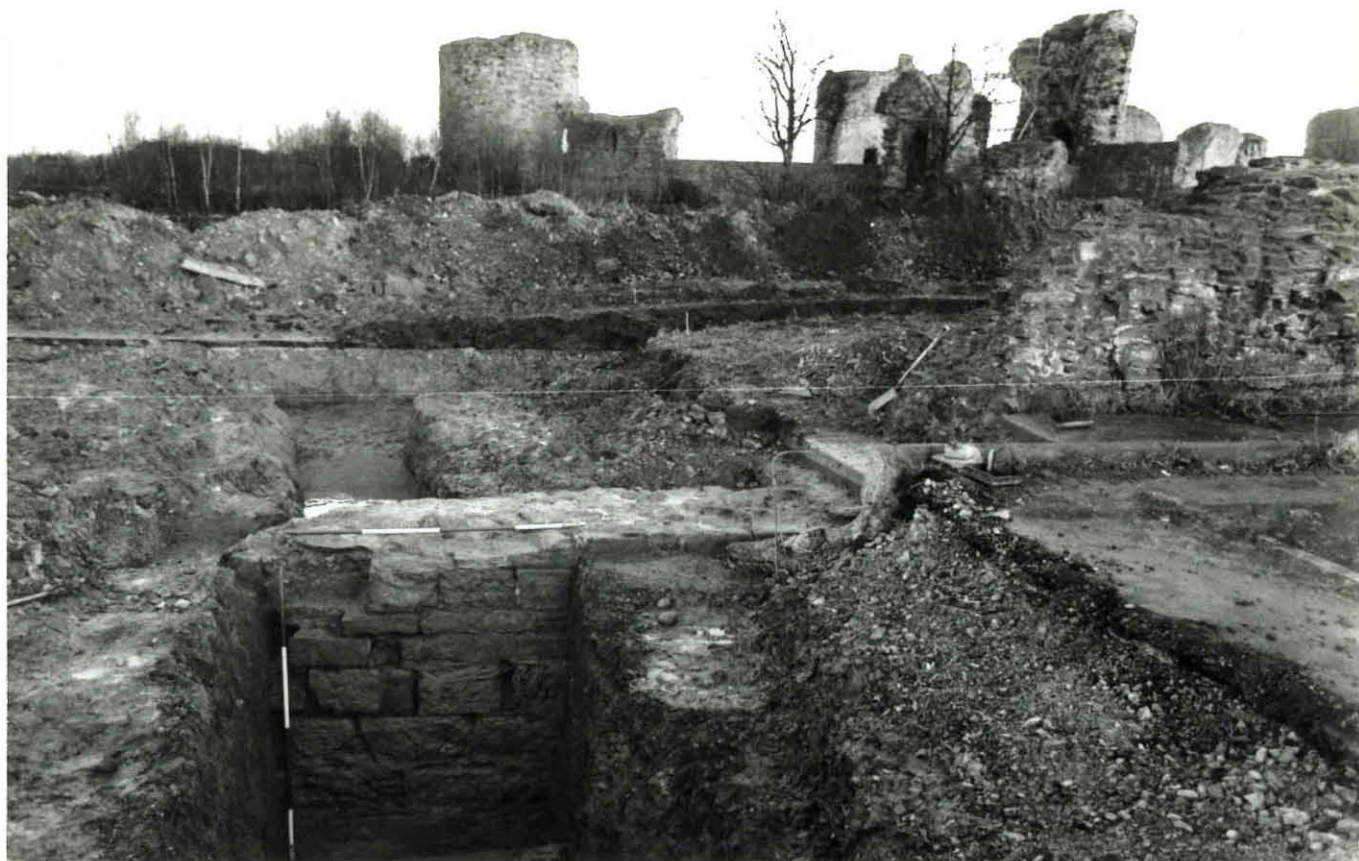
FIGURE 4: elevation of sandstone revetment wall revealed in Trench 2 (scale 2m)

The southern extension to Trench 2 showed that the moat of the outer bailey had almost certainly continued into this area. The isolated stretch of wall was found to survive just below a layer of hardcore make-up of the carpark, and had retained the inner edge of the moat. This continued the line of the upstanding wall further east for a distance of 4 metres, but then turned abruptly through an angle of 45 degrees to the north-west and continued in that direction for at least a further 4 metres.

The inner face of the wall had been terraced into the reddish brown natural clay, whilst the exposed southern face was evenly coursed and built of dressed stone. The outer face of the wall was exposed to a depth of about 2 metres from the surviving upper courses, and auguring suggested that it continues for up to a further 0.7 metres. The thickness of the wall decreases from 1.6 metres at the eastern end of Trench 2 to only 0.9 metres at the western end, which clearly suggests that the wall also decreased in height in that direction.

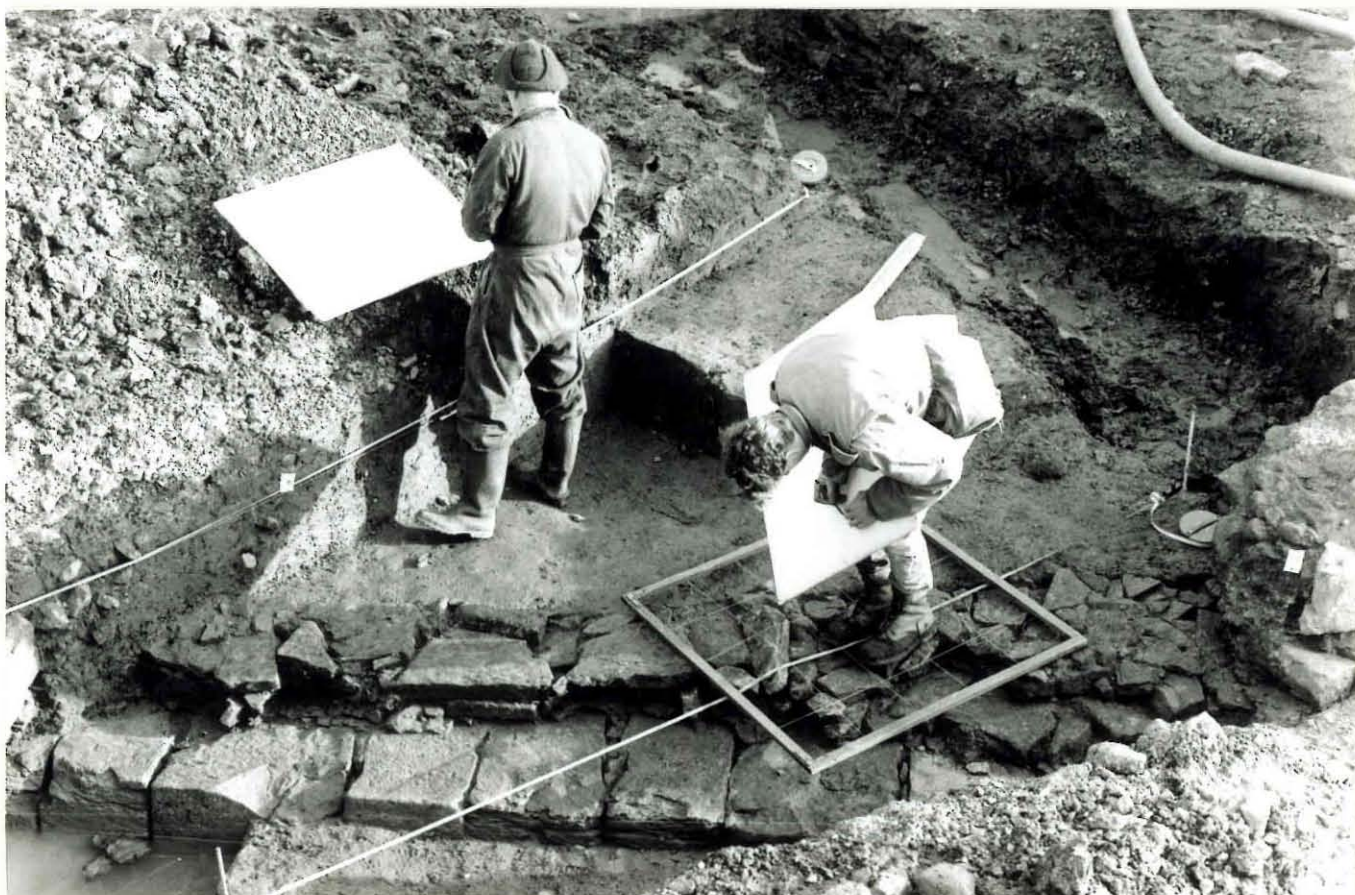
FIGURE 5: upper courses of sandstone revetment wall revealed in Trench 2

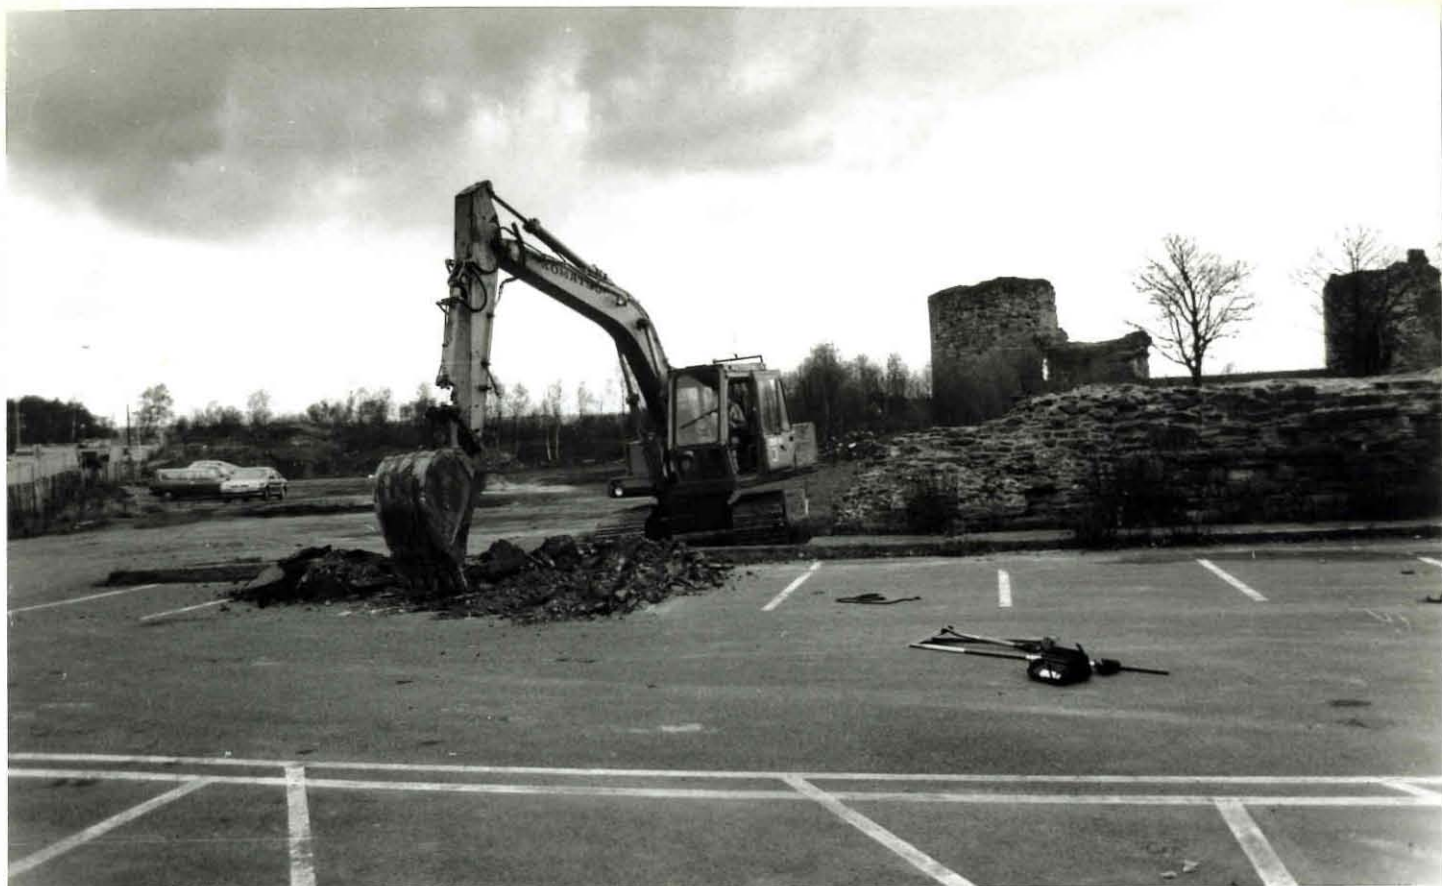
FIGURE 7: surface of carpark being removed by machine adjacent to the isolated stretch of sandstone wall to the southwest of the castle

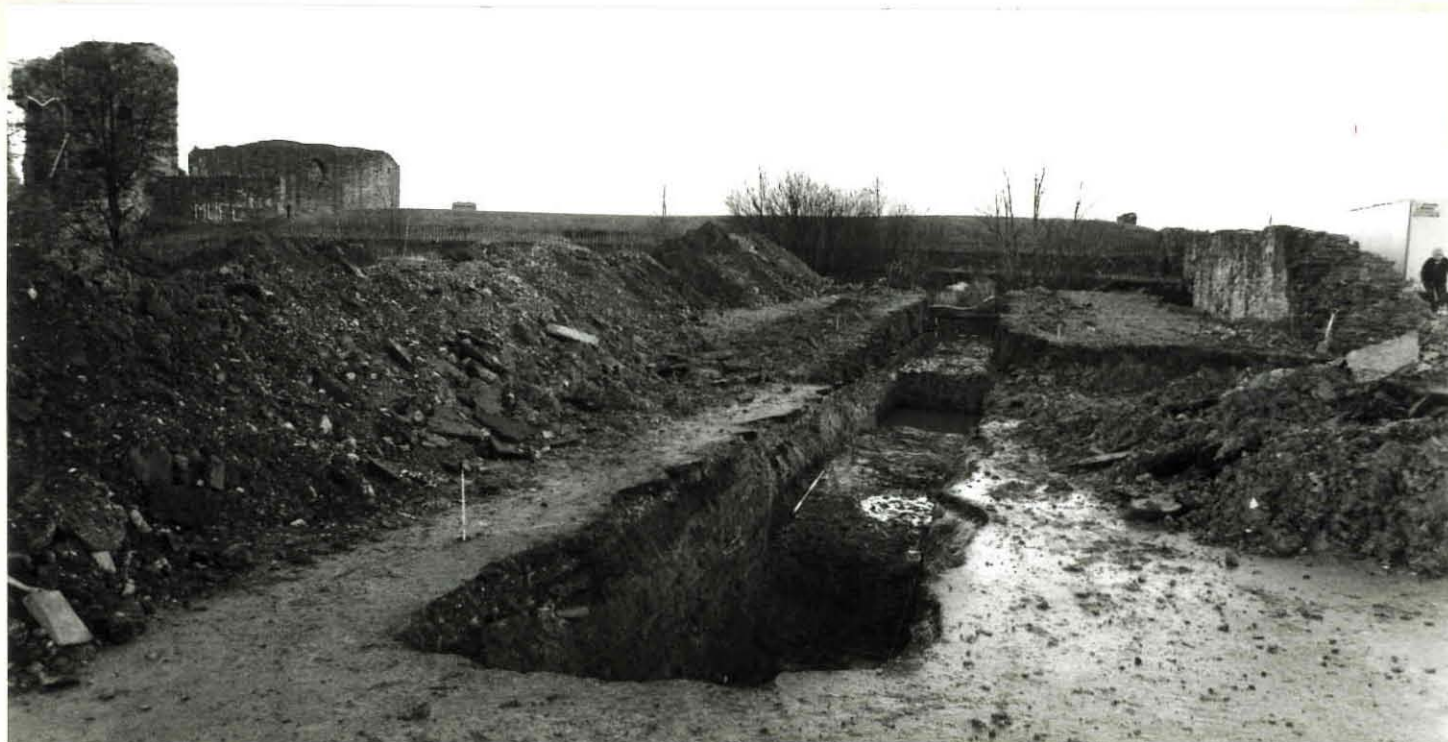
FIGURE 8: Trench 3 viewed from northwest with probable inner edge of moat in foreground

Evidence from Trenches 3 and 5 suggest that from a point slightly to the north of Trench 2 the outer ward had originally curved back around towards the castle on the east. The inner edge of a deep cutting was identified in the western ends of both trenches. In the case of Trench 3 this extended to a depth of over 2.1 metres. The lower filling of the moat at this point was similar to that in Trench 2, and produced some sherds of medieval pottery. Again, like Trench 2 the upper filling was all of post-medieval date. The cutting in Trench 5 extended to a depth of at least 1.5 metres below the top of the sandstone bedrock. The upper post-medieval layers in this instance overlay greyish waterlogged clayey silts probably of medieval date.
