Plas Newydd, Llangollen, Denbighshire

ARCHAEOLOGICAL ASSESSMENT

CPAT Report No 474

Report for Nicholas Pearson Associates/Denbighshire County Council

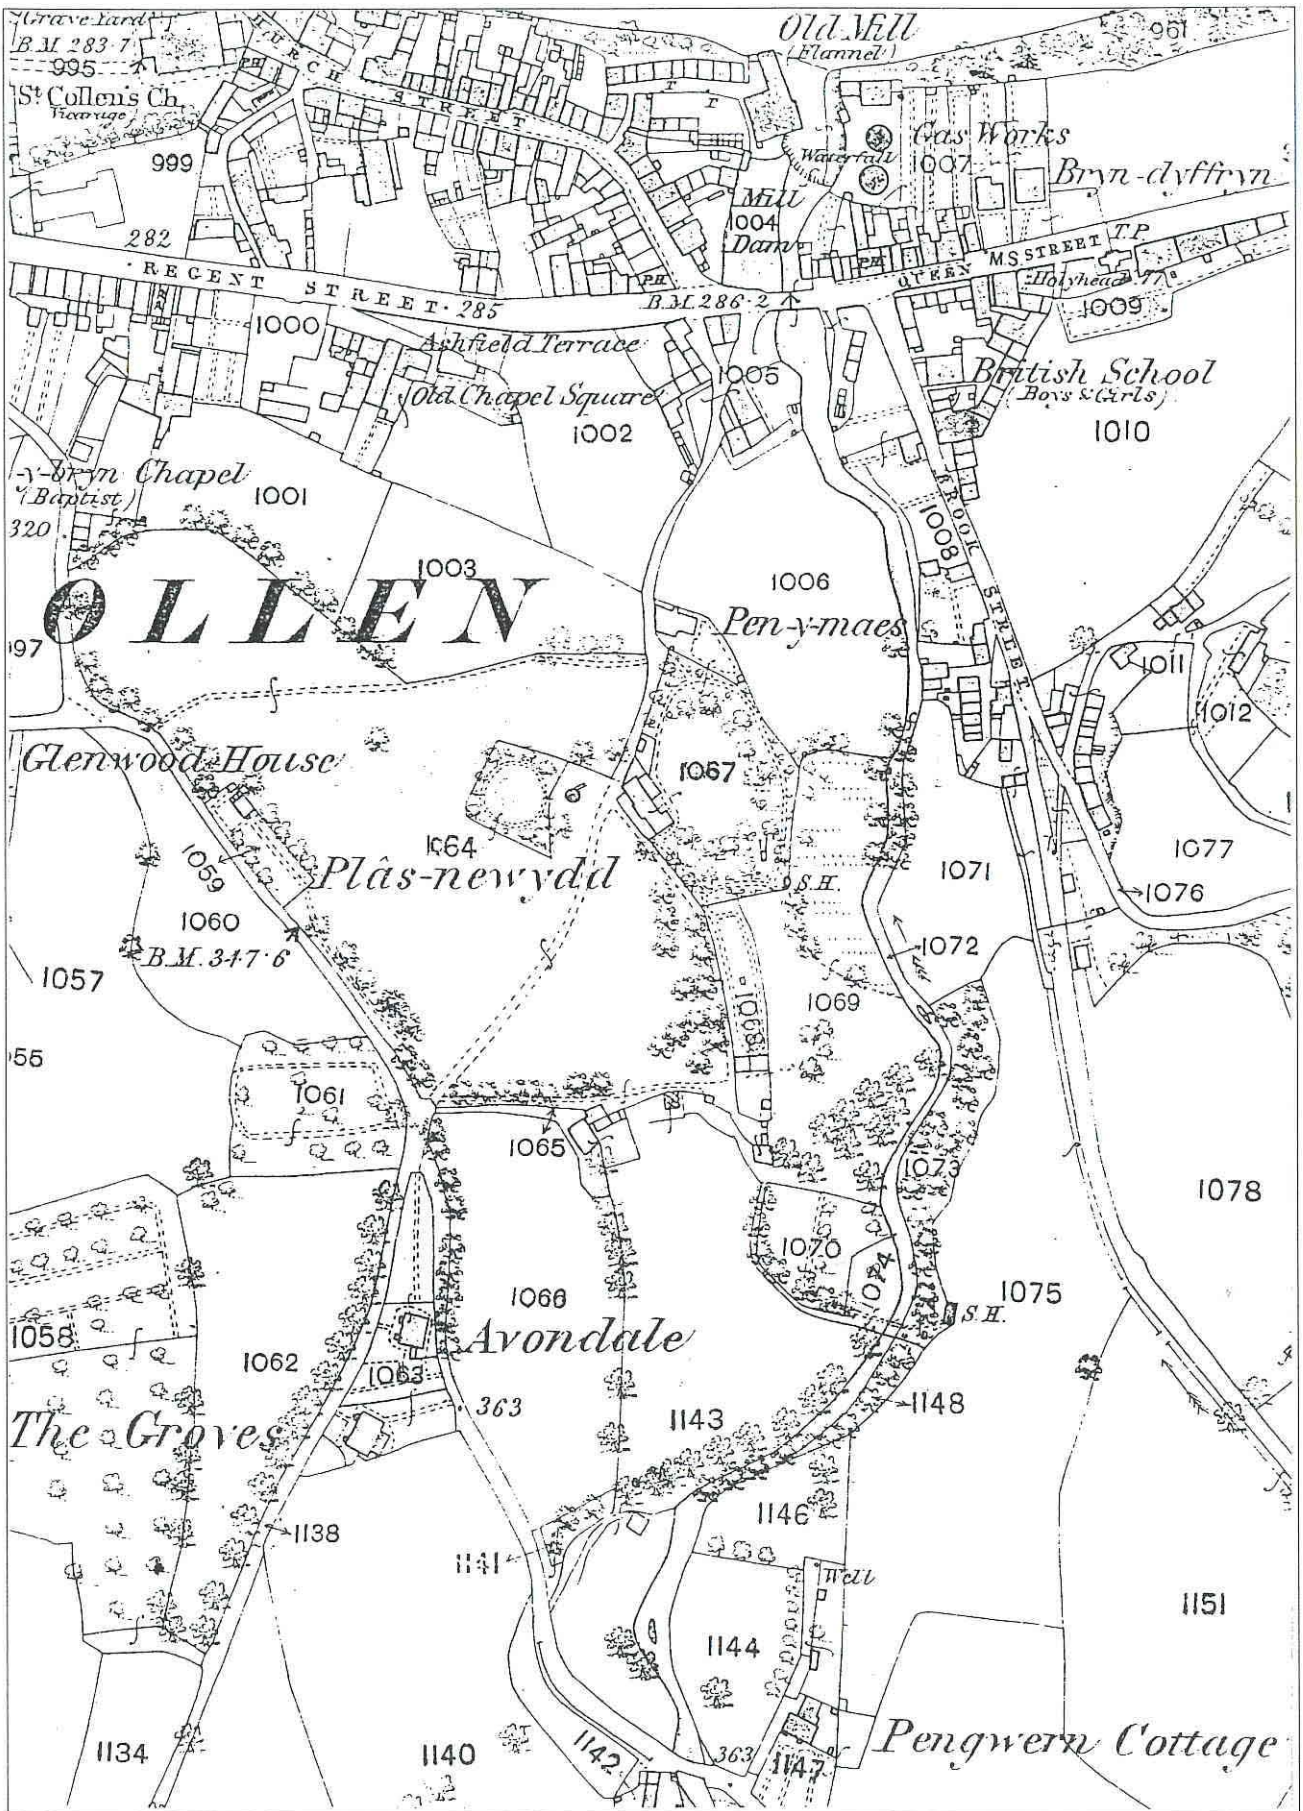
Fig. 1 Ordnance Survey 1st edition 25" 1874

- 2.4 The first detailed plan of the house and gardens is provided by the first edition Ordnance Survey 25" map of 1874 (fig. 1) which shows the area to the east of the house, the shrubbery, as having a path around it, creating a circular walk from the house past a summer-house (S.H.). At the southern end of the gardens a path is shown crossing the Cyflymen and leading to a second summer-house along the eastern boundary.

- 5.1 Three trenches were excavated in the area of the shubbery in an attempt to locate the circular walk depicted by the Ordnance Survey in 1874 (fig. 1). The path was replaced during later modifications to the gardens and had left no visible trace. The excavation trenches were accurately located by total station survey with respect to the existing topographical survey. Visible sections of the later paths were also recorded.
- 5.2 The path appears to have formed part of what the Ladies referred to as the 'Home Circuit' which led through a shrubbery carefully planted with choice specimens. Today the area is very overgrown, particularly with often dense laurel.

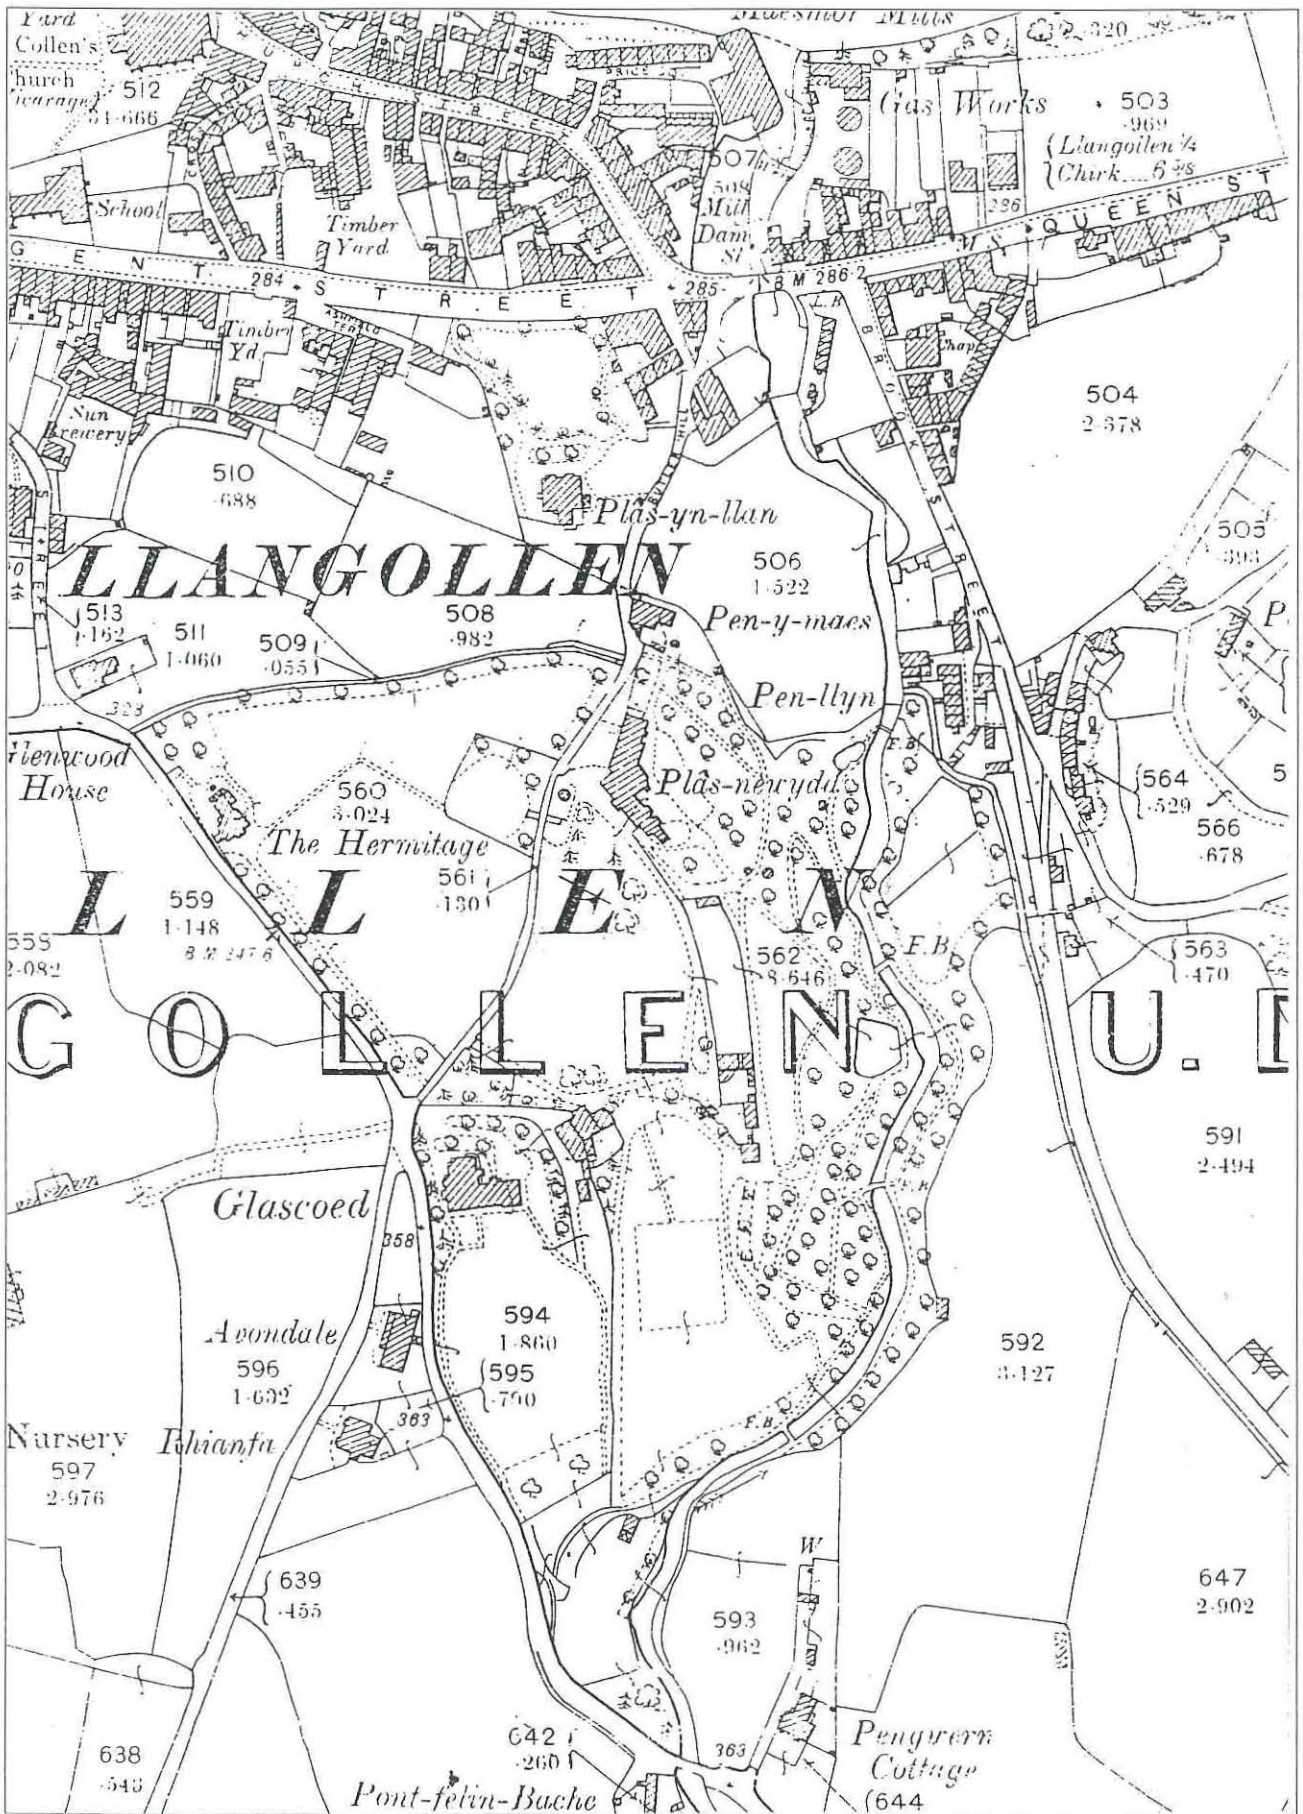
Fig. 2 Ordnance Survey 2nd edition 25" 1900

- 2.6 In general, the gardens appear to have remained relatively unchanged until around 1890 when the Robertsons acquired the house and extended it, together with adding significantly to the gardens, creating a tennis court, croquet lawns, pools and bridges. The changes are clearly illustrated by the second edition Ordnance Survey 25" map of 1900 (fig. 2) which shows the layout of the garden paths and four footbridges crossing the stream, although interestingly the bridge leading to the summer-house has now gone. A reservoir is also shown on the west side of the stream, as well as a pool near the northern boundary.

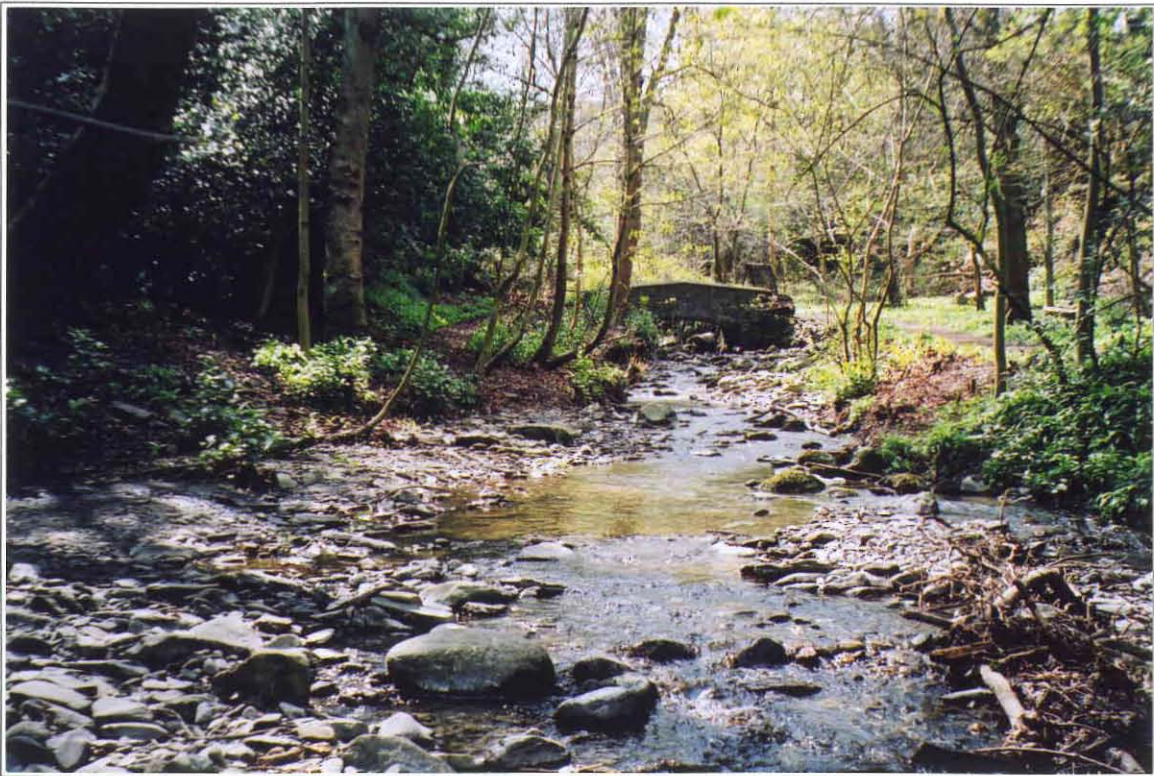
Plate 2 Bridge 3 and Afon Cyflymen. Photo CPAT 1178.09

- 3.4 The effects of recent floods are most apparent below Bridge 3 (pls 2-3). The stream is actively eroding the eastern bank on the bend opposite the reservoir and a comparison with its position in 1912 shows a movement of around 3.5m, washing away the footpath which followed the eastern bank. Further downstream, on the western bank, the opposing footpath is exposed in section and it too has been washed away below the position of Bridge 4, of which there is no trace although some of the eastern retaining wall for the stream survives.

- 6.4 The lower section, however, below Bridge 3, presents a series of management issues relating to controlling the stream and preventing further damage to garden features, which are discussed separately below. There is clearly a need to contain the stream and the decision will have to be taken as to whether to try and re-establish the earlier course, particularly with respect to Bridge 5. Any new retaining walls will have to be well-constructed, but should at least be visually in keeping with the style of original walling. Any works affecting the stream should be conducted following consultation with the Environment Agency.

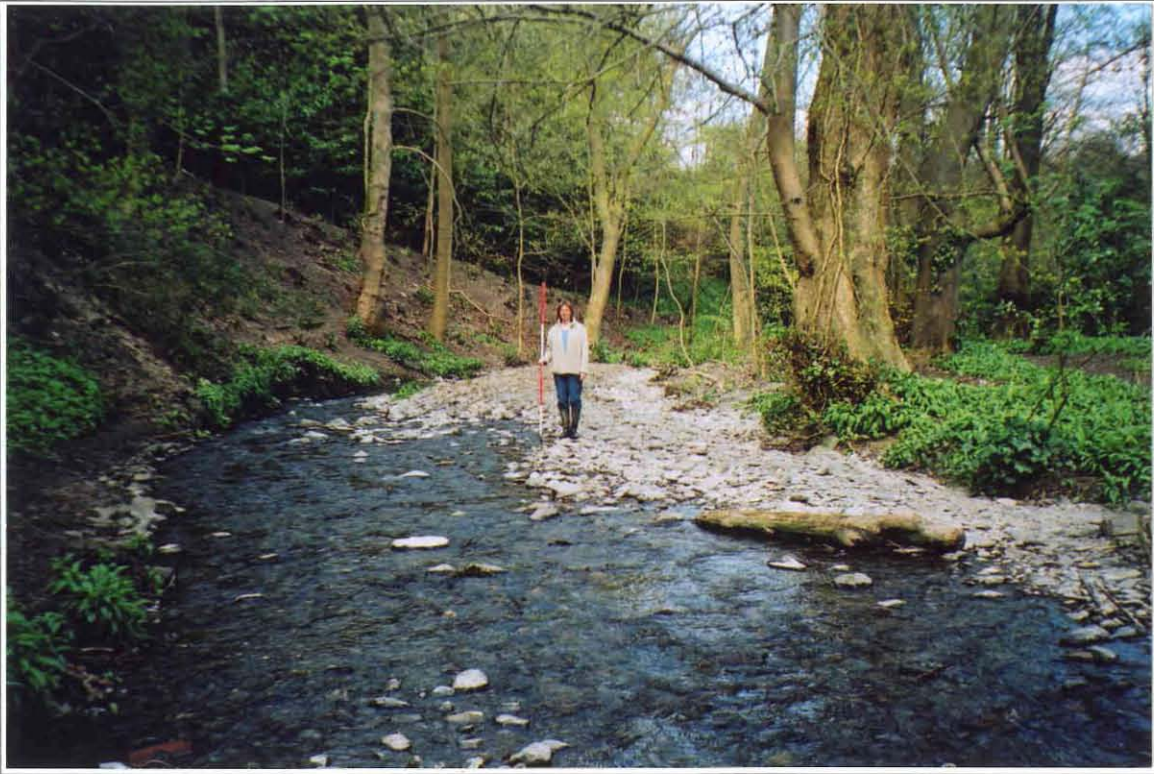
Plate 3 Site of Bridge 4 and new stream channel. Photo CPAT 1178.10

- 3.5 The stream has radically altered its course below the position of Bridge 4 and has formed a new main channel some 4.5m to the west which is actively eroding the western bank on the outside of the bend, with a gravel bank and minor channel on the inside of the bend (pl 3). Part of the retaining wall for the western side of the original course survives along the edge of the gravel bank, opposite which a carved stone water trough (pl 4; see 6.22) has been revealed which presumably lies *in situ*, having originally been located at the side of a path now lost to the stream.

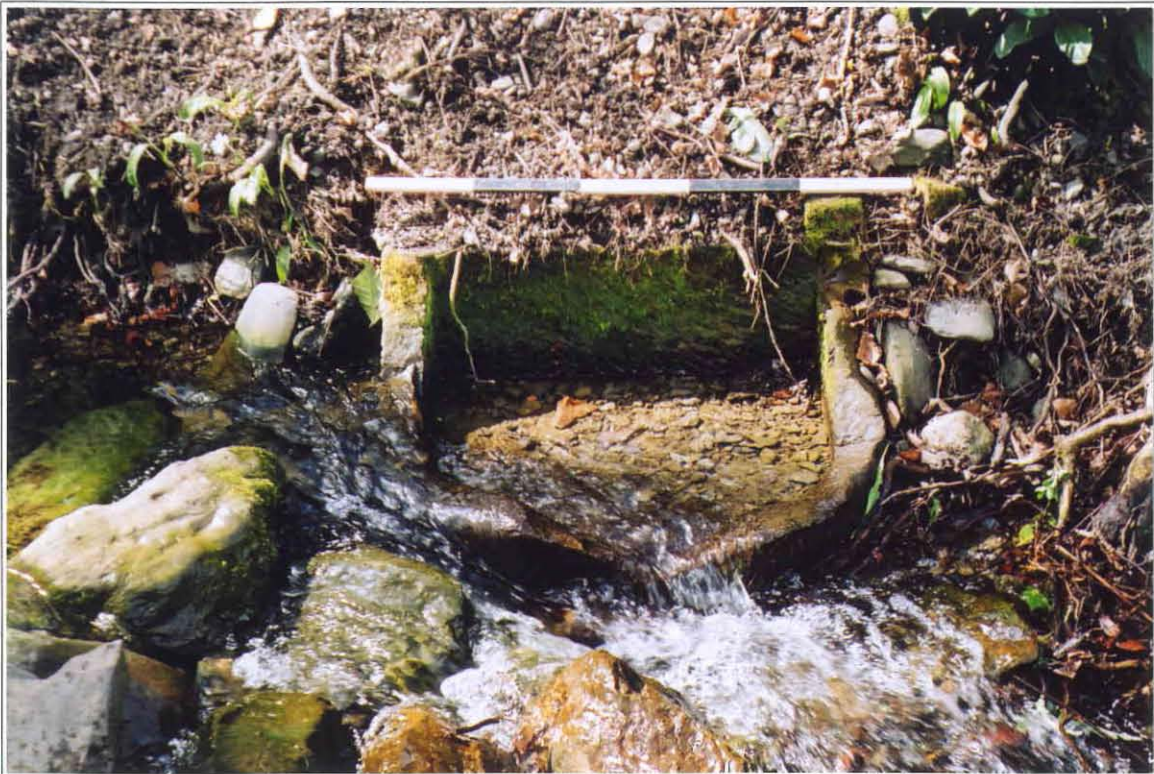
Plate 4 Stone trough. Photo CPAT 1178.11

- 6.22 Recent stream erosion has revealed a carved sandstone water trough (pl 4) which presumably lies *in situ*, having originally been located at the side of a path now lost to the stream. The trough has a central notch at the back, possibly to allow a flow of water, while its basin has incised grooves in the base. The front is broken and any evidence for a spout is lost.

- 6.23 The boundary stone and water trough should be preserved, although the latter is currently at risk from further stream erosion. It may therefore need to be temporarily removed while consolidation work is undertaken regarding the stream and path and subsequently reset in its original position. Consideration should be given to undertaking limited archaeological investigation around the trough to identify any potential associated features such as a water supply.
- 6.24 The nature and location of the two structures depicted on the Tithe Survey Map is unknown and, depending on the restoration proposals, further archaeological investigation may be considered appropriate.

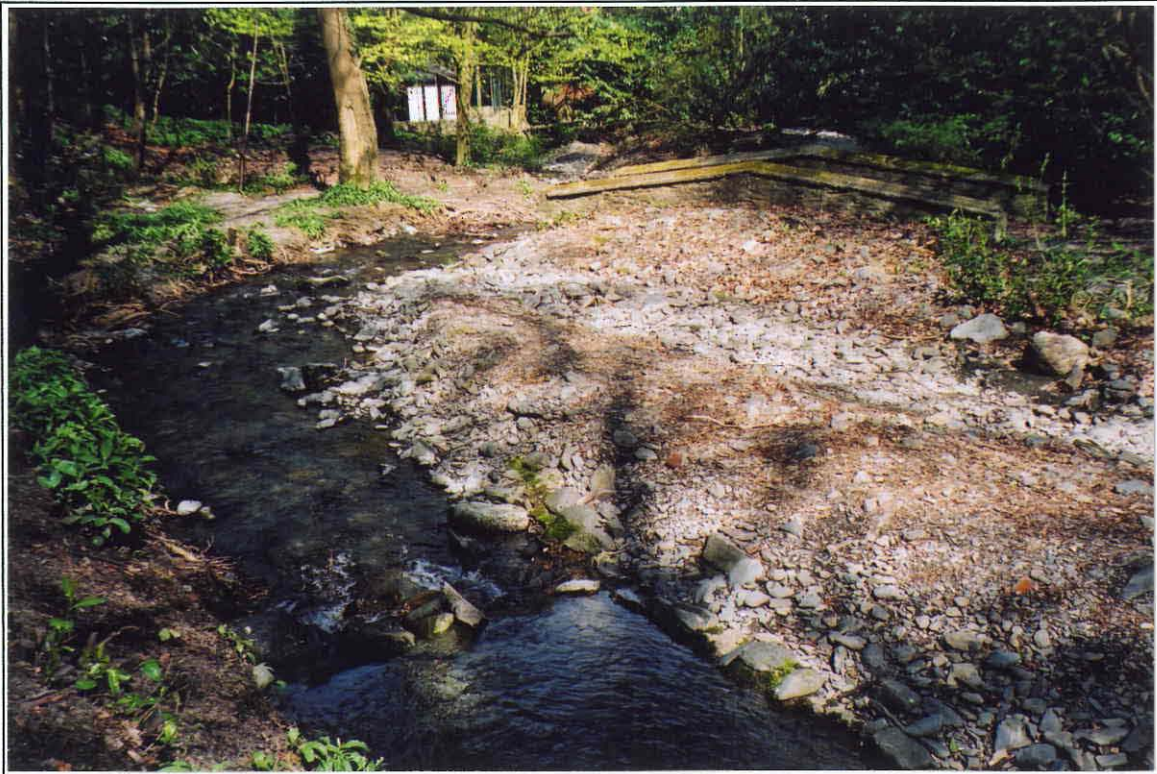
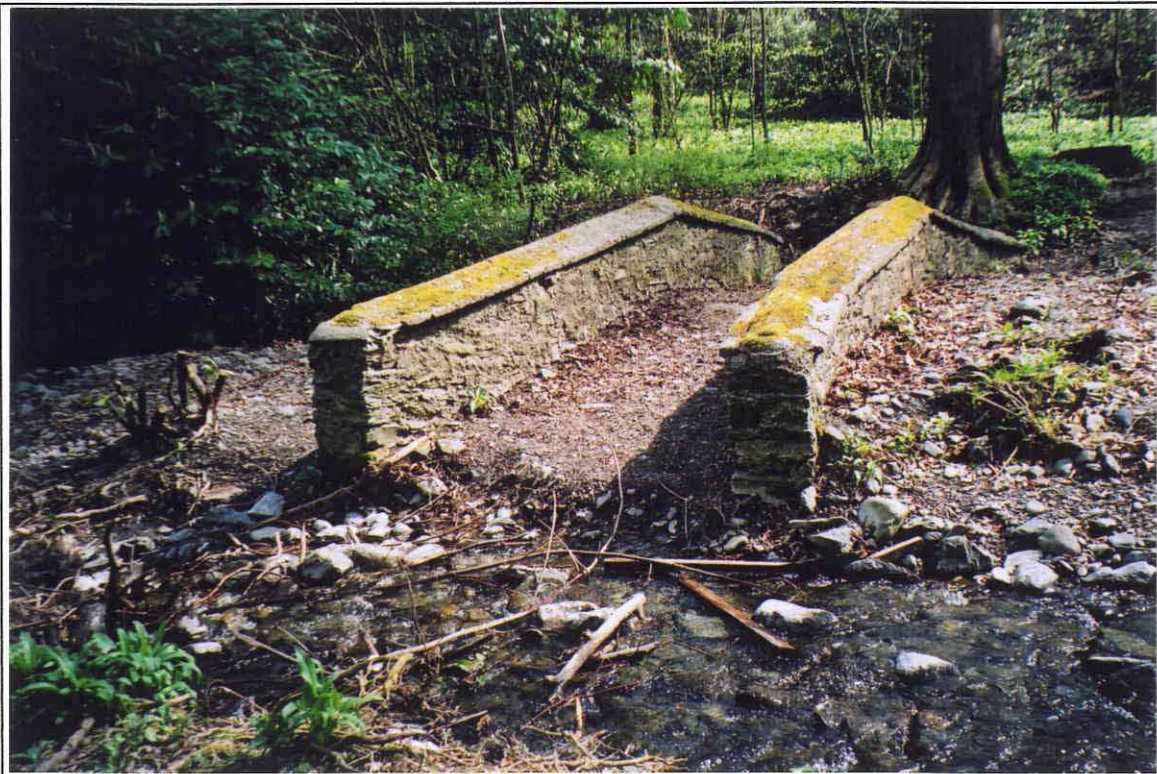
Plate 5 Bridge 5 and new stream channel. Photo CPAT 1178.12

- 3.6 The recent change in course is most clearly demonstrated by Bridge 5 which now lies partly buried by gravel, with the stream flowing around its western end (pls 5-6). Below the bridge the present course diverges with the main channel flowing to the east, around the lower weir.

concrete coping to the parapets, which are splayed at either end. Bridge 2 survives intact, although slightly undercut on the north-west side, while Bridge 5 has been isolated by a change in the stream course, with gravel deposited to the top of the arch.

- 6.8 The surviving bridges should be retained and consolidated where necessary. Remedial action should be taken to prevent further undercutting to Bridge 2, while the structure of Bridge 5 should be assessed in relation to the possibility of re-establishing the course of the stream beneath it.

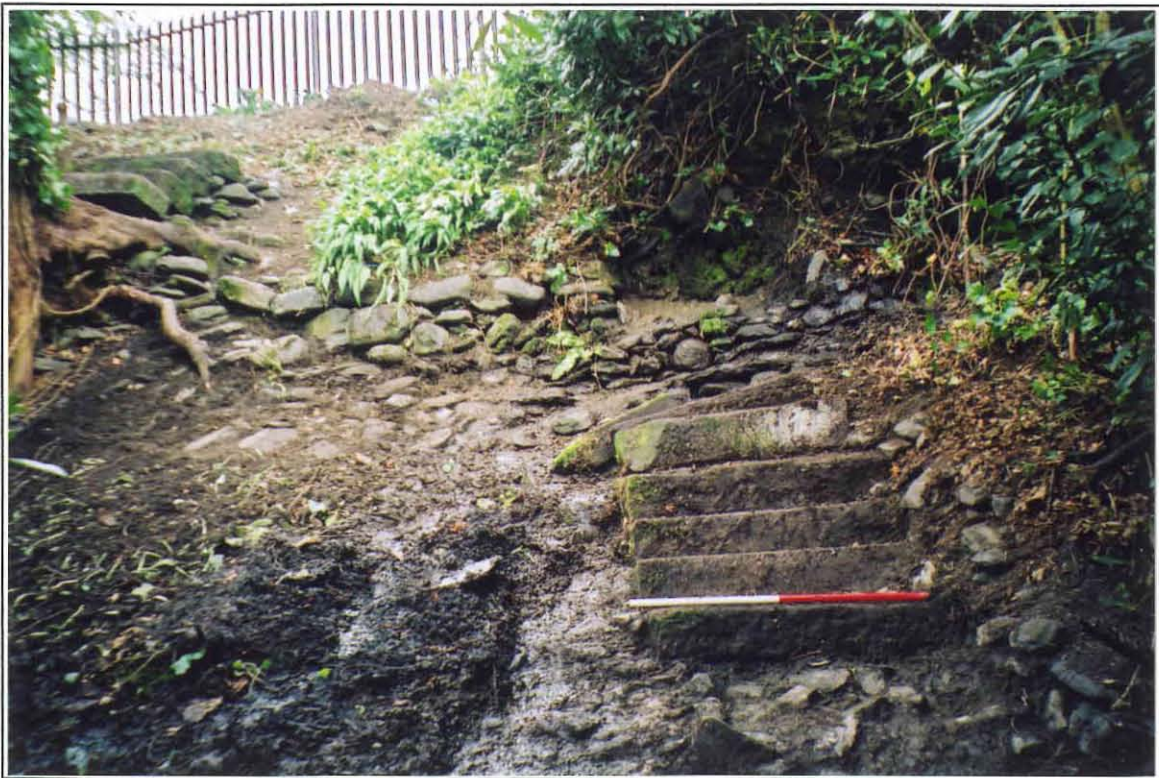
Plate 8 Early 20th-century steps to summer-house. Photo CPAT 1178.18

- 4.7 The lower flight consisted of seven surviving steps, the top two displaced. Each step was formed from a single shaped rectangular block of red sandstone, 1.0m wide, 0.2m high, and 0.3m depth. A small chiselled indentation (up to 30mm deep) had been made in either end of each block, perhaps to enable the use of lifting gear. There was no obvious rubble stone foundation for the steps, but below the lowest surviving step, where the gradient became more gentle, there was a layer of gently sloping stone rubble on two levels, extending for c. 2m towards the bridge. This may perhaps have formed a foundation for further steps, although these could only have been formed of thinner material than the sandstone blocks above. Along the south side of the flight of steps was a roughly built low stone edging wall, c. 0.2m high, retaining the slope to the south.

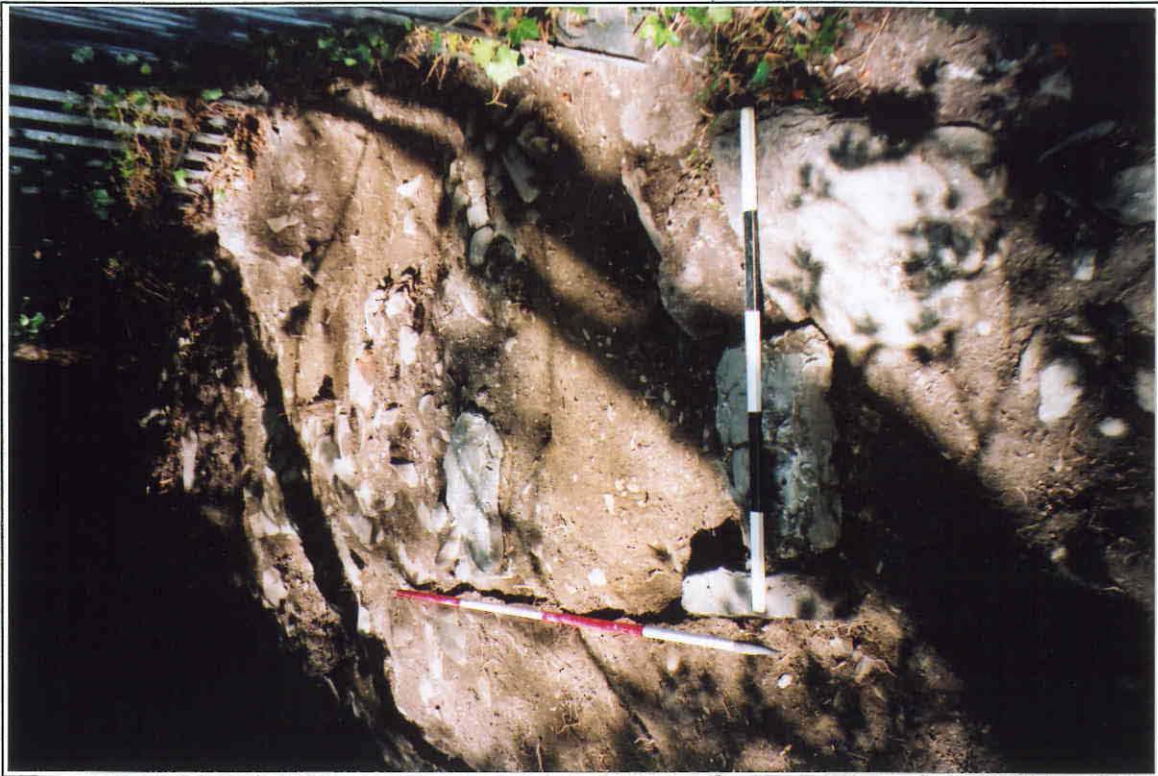
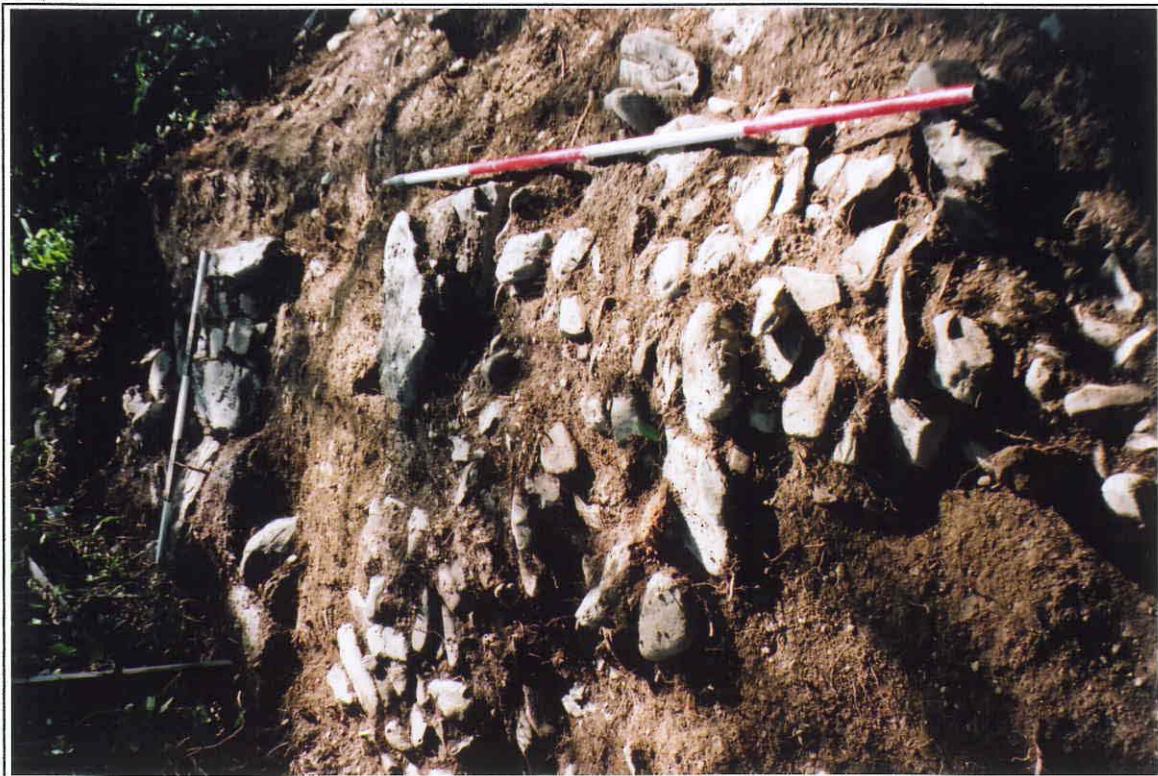
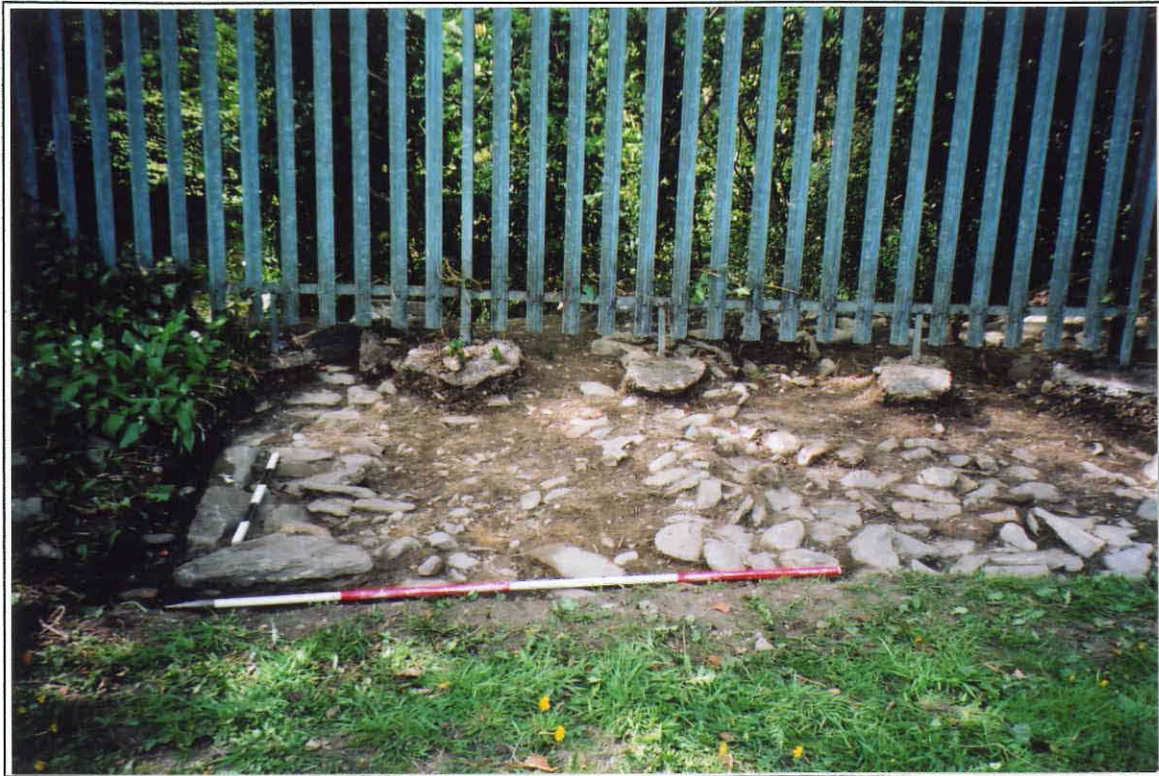
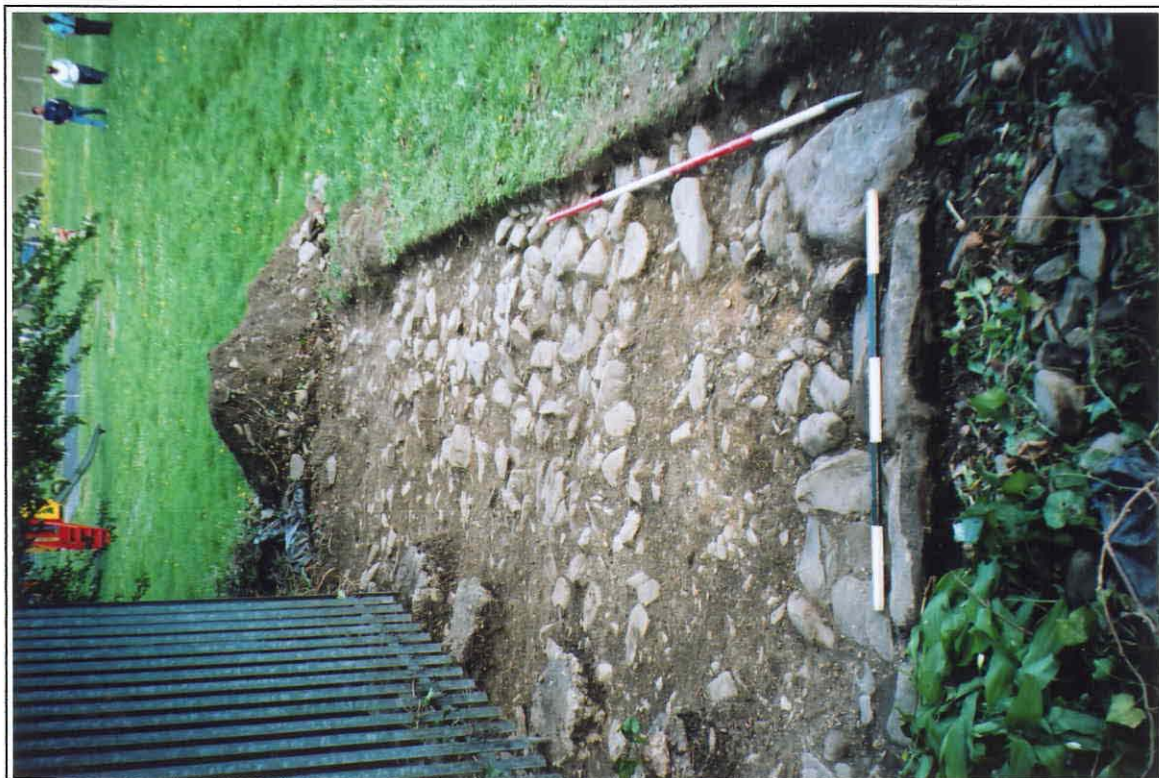
Plate 9 Summer-house foundations, west side. Photo CPAT 1183.09

- 4.3 Up to 0.2m of ivy, roots and modern overburden was removed to reveal the stone foundations of the summer-house (pls 9-12). The surviving remains suggest a structure in excess of 4.4m long (north to south) and approximately 3.35m wide, but narrowing to 3.17m wide at its southernmost end. The Ordnance Survey mapping, however, suggest a building of 6m to 6.5m long. The stone foundations were up to c. 0.55m wide, constructed of rough, random rubble, up to 0.45m across, bonded with lime mortar. The foundations appear to have been constructed by cutting into the slight slope and using a rough facing of larger stone with straighter edges on the exterior and a loose rubble infill of smaller stones behind, but there is no indication of any attempt at making an inner facing. The foundations survive in a very poor and fragmentary condition, standing up to 0.21m high, or at most two courses of stone, although mortar on the upper surfaces of some stones bears the impressions of stones from a higher course, which has now been lost.

- 4.4 The area of the summer-house was generally very disturbed, particularly in the area of the posts erected for security fencing, and also at the northern end of the site, especially on the east side of the fence, where no structural stonework survived *in situ*, although a spread of rubble, presumably resulting from demolition, was identified. Due to circumstances beyond our control it was not possible to fully investigate and record the extent of this rubble. The west wall foundation now stands on the very edge of the steep slope of the valley side, and it would seem likely that the original edge may well have collapsed or been eroded away. Watercolours by Lady Leighton depict a building which appears to have been of either stone or rendered timber construction with a thatched roof and had an open veranda of rustic timber construction with a stone flag floor at the northern end. The excavations revealed no evidence for the superstructure or flooring, although the nature of the foundations might suggest that the interior had a raised timber floor.

- 6.14 The foundations of the summer-house are in a poor state and none of the surviving structure could be incorporated into any reconstruction. Any plans to construct a new summer-house would involve changes to the present boundary and considerable vegetation clearance to permit access and allow views into the Cyflymen valley and beyond. The surviving steps should be retained and re-set, although this would necessitate the felling and complete removal of the large tree at the base of the upper flight of steps. Remedial work should also be undertaken to preserve the niche and adjoining retaining wall, if possible, or replace in the same style.

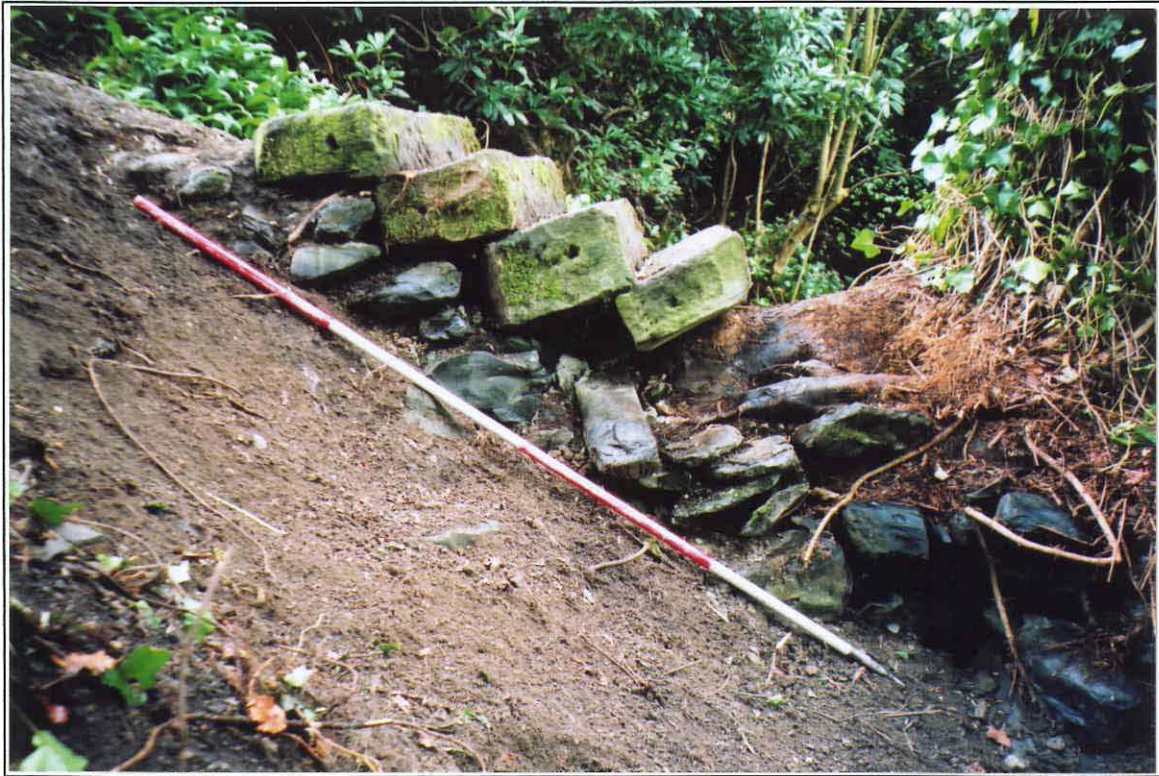
Plate 13 Upper steps to summer-house. Photo CPAT 1183.19

- 4.10 The upper flight consisted of four surviving sandstone steps of a similar nature and size to those of the lower flight, which have been partly displaced by tree roots. Two further sandstone blocks were found below, lying on the ground surface having slid quite some distance downslope. The steps had been laid on a foundation of rubble with traces of lime-mortar, retained by rough walling on either side (pl 14). This foundation survived a little further upslope than the upper surviving block, and formed the base for one further (now missing) step. Above this, the final 2.1m of the slope up to the summer-house had been badly eroded and all further foundation stone and steps were lost. Given the remaining distance, the gradient of the slope, and the average size of the surviving steps, it is estimated that potentially a further seven steps would have been required to reach the summer-house.

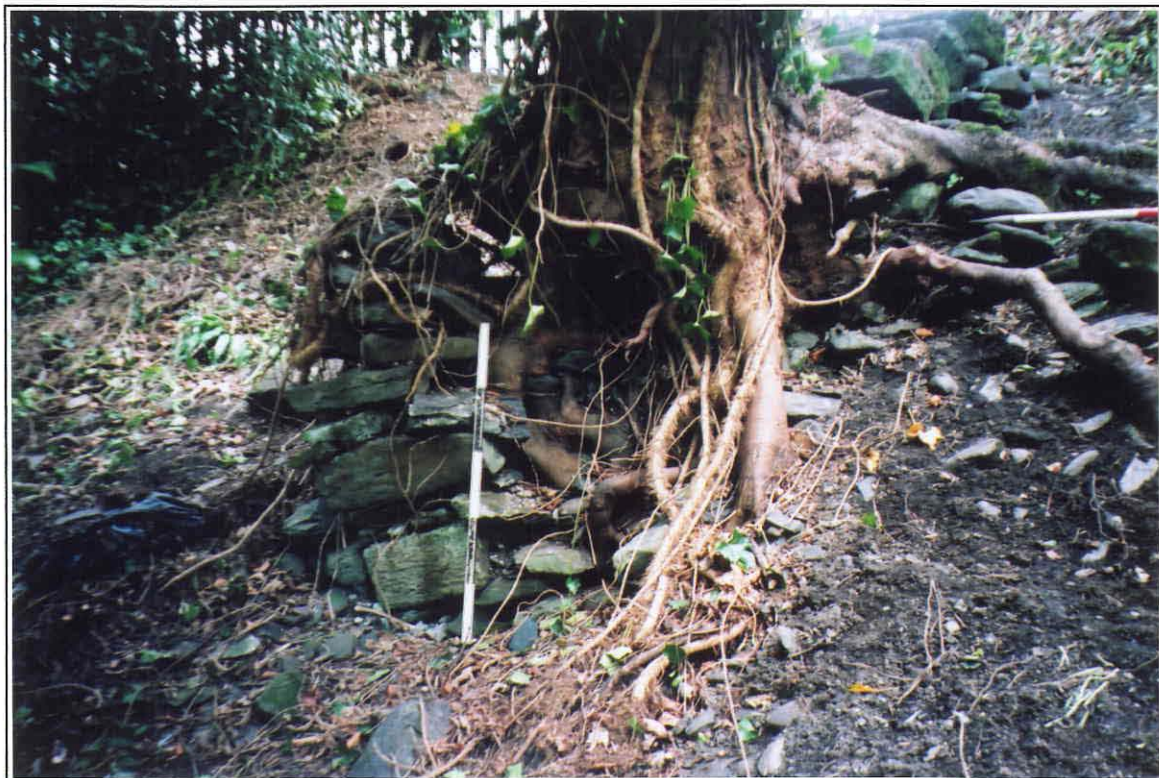
Plate 14 Retaining wall for upper steps. Photo CPAT 1183.08

created by the construction of a substantial retaining wall, 1.3m high and up to 0.7m thick, which has been displaced by a large tree (pl 14). This wall presumably extended to the south to support the path, but has since collapsed leaving an area of rubble as the only evidence.

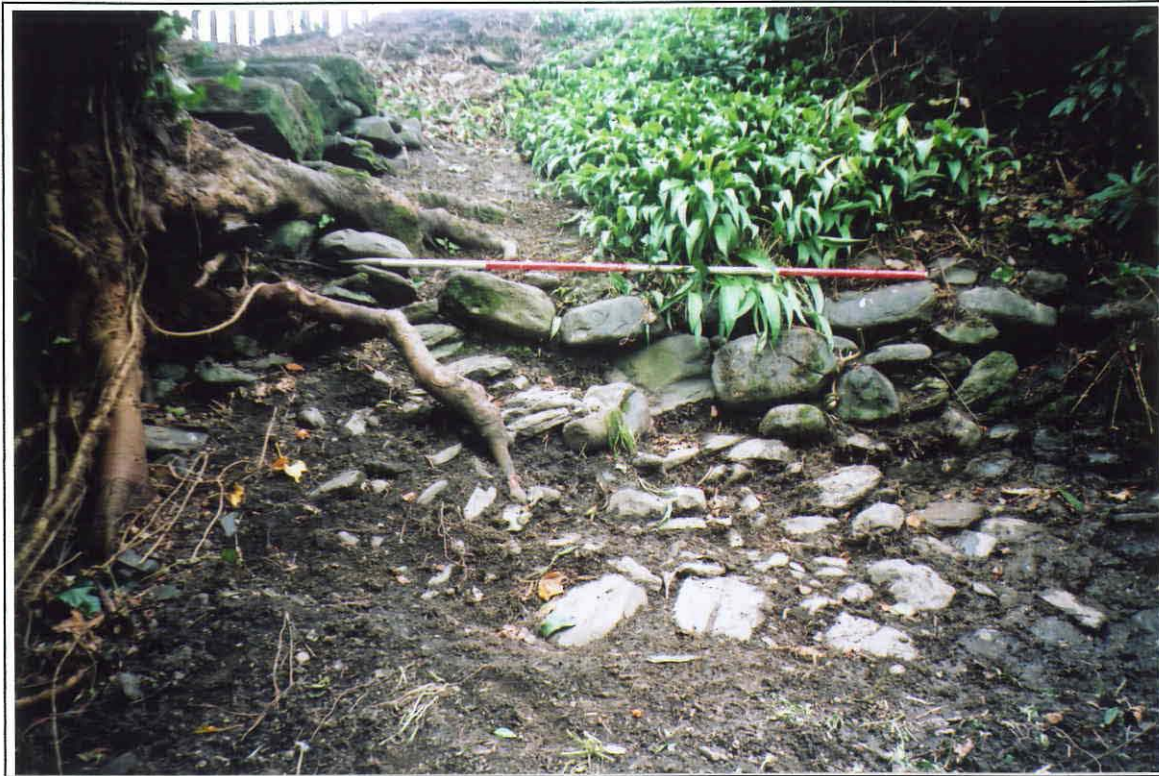
Plate 15 Path and retaining wall between upper and lower steps. Photo CPAT 1183.07

- 4.9 Very little survives of the path connecting the upper and lower flights of steps, although the eastern retaining wall is more or less intact, at the base of which a number of flat stones may be the remains of the path (pl 15). There is some evidence to suggest that several shallow steps, constructed of random stone, may have led to a level platform at the base of the upper flight. The platform had been
