Horsley Hall, Marford

ARCHAEOLOGICAL ASSESSMENT

CPAT Report No 402

R J Silvester
October 2000

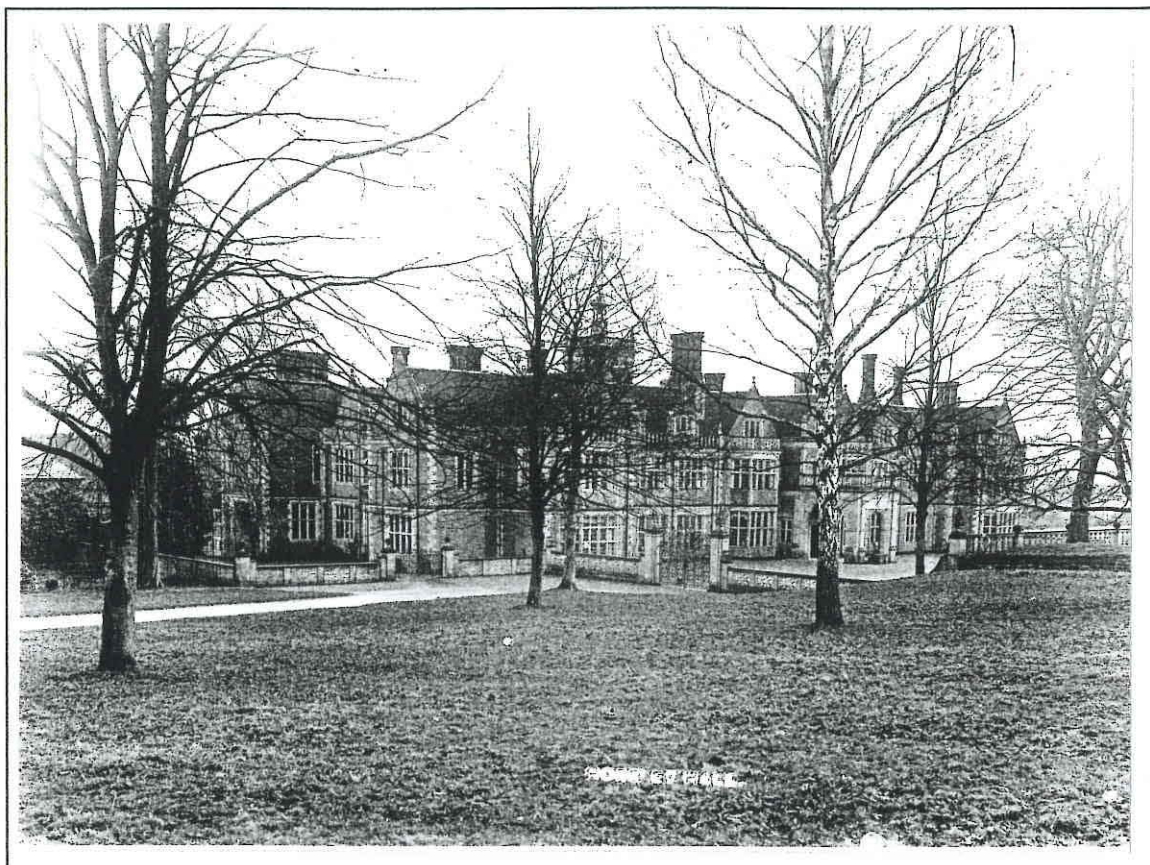
Fig.4: Horsley Hall in the early 20th century. From the Davies Collection in the National Monument Record, RCAHMW, Crown Copyright

- 2.8 In 1898 Potts's son sold the hall to Alfred Ashworth, another High Sheriff of Denbighshire. Between 1907-12 (though c.1904-6, according to Hubbard) the house was remodelled in "Jacobethan" style and much enlarged, by G.H. Kitchin for Mr Philip Ashworth (figs 4 and 6).
