Report 1

Topographic Survey

DINHAM CASTLE

SHIRENEWTON

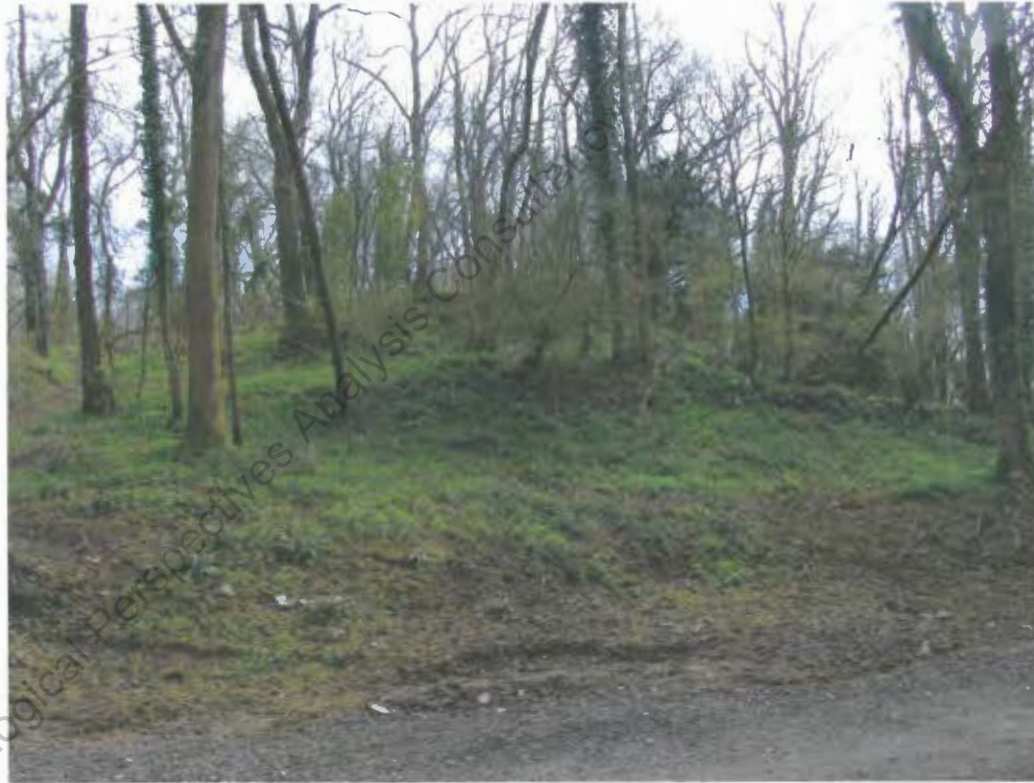
General view of castle from metalled road. The two breaks of slope are associated with tumble, possibly walls.

The topography of the land is a gentle, west facing slope 29% average gradient, covered by trees, mostly ash with some cherry, yew and hazel, *DSC01* & *DSC02*. (Position of the photographs are included on the annotated image sheet or on Survey plan 2). The west of the site is bordered by a stream whilst the east is under plough.

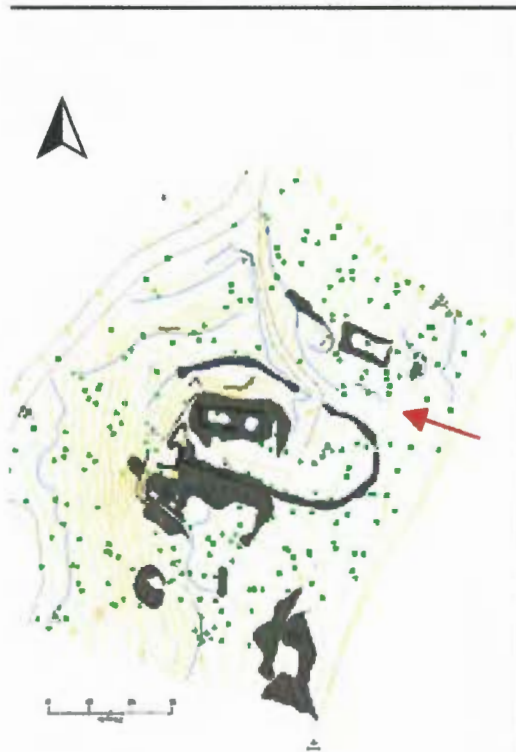
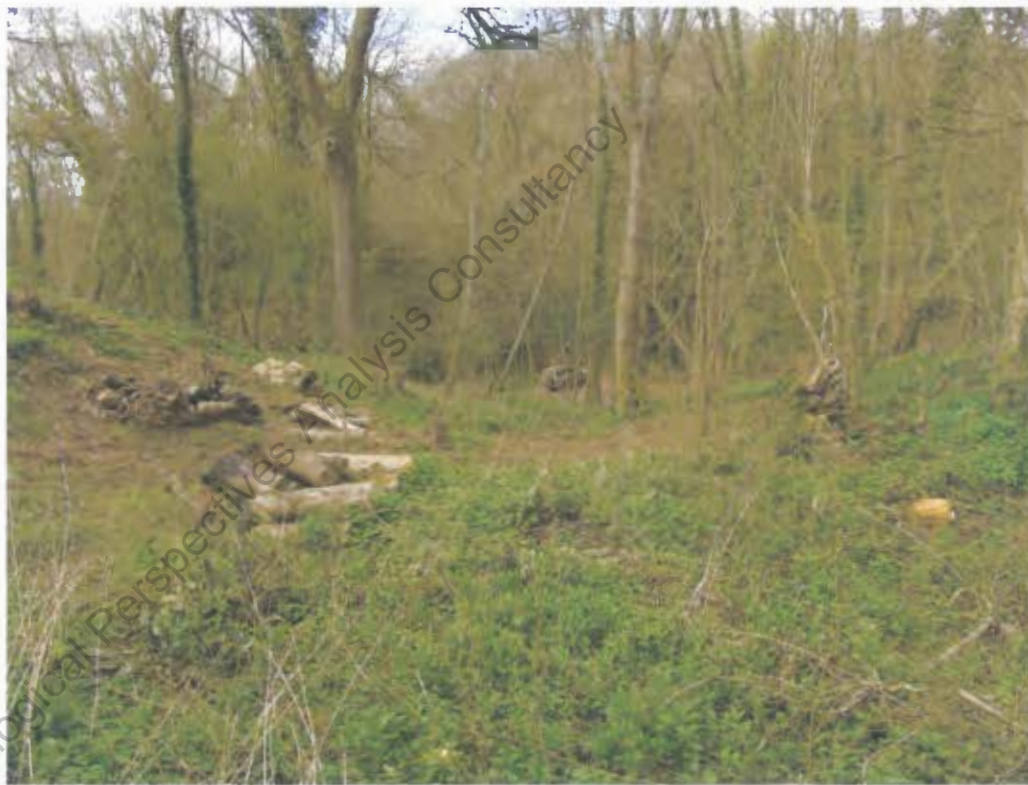
General view of present path from metalled road to castle top.

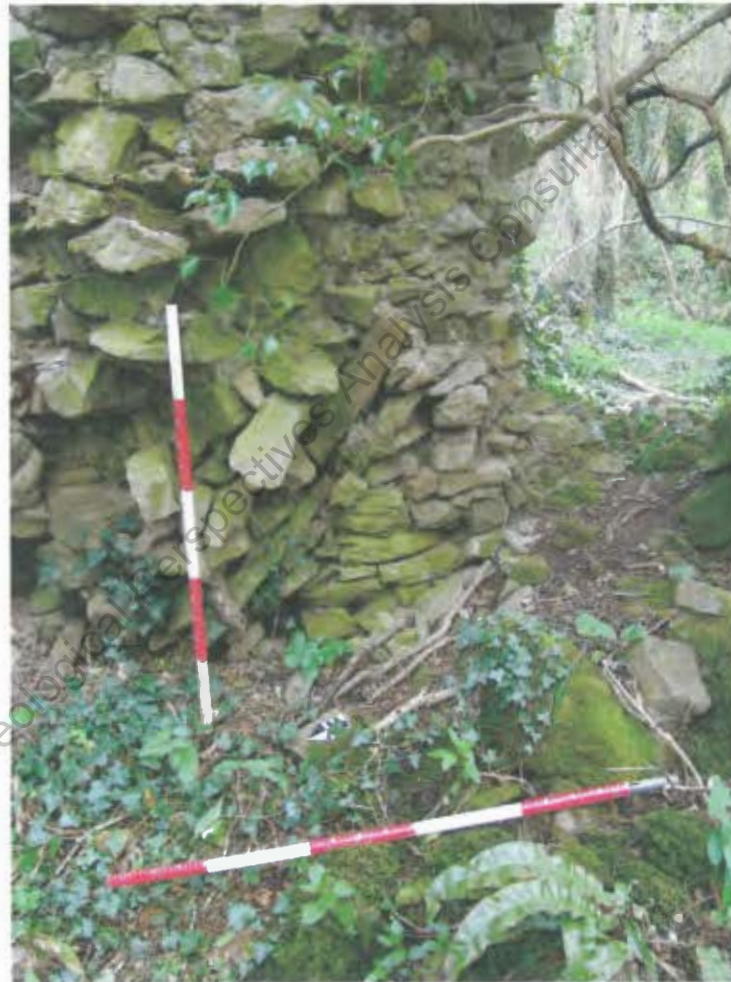
Detail of standing masonry showing different building phases. The sloped courses separate faced courses and seem to be internal to the wall itself.

In the main part of the site, it was possible to identify sections of standing masonry. The area of the south west corner was quite interesting as can be seen in images *DSC03 & DSC04*. Which reveal phased building or repair work?

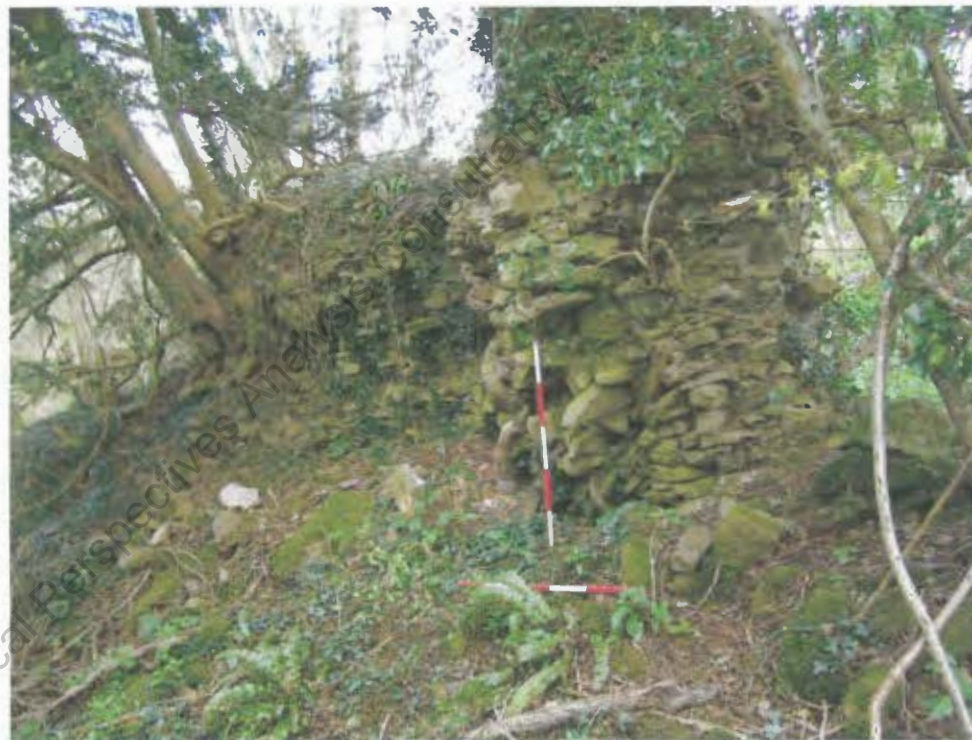
Reason for image General view of standing masonry showing different building phases noticeable at this south west edge. Location view for previous image DSC03

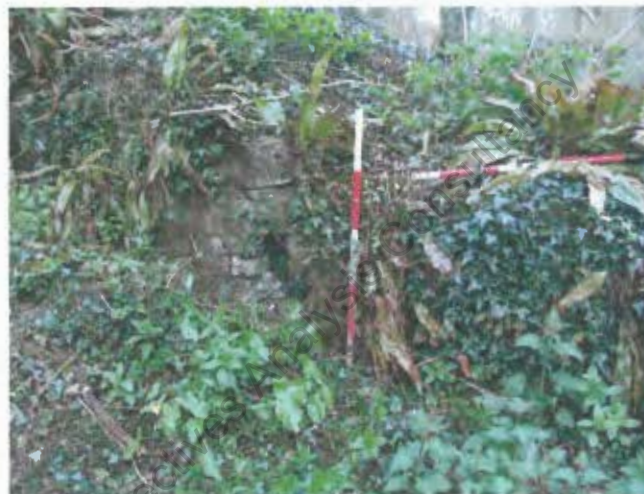
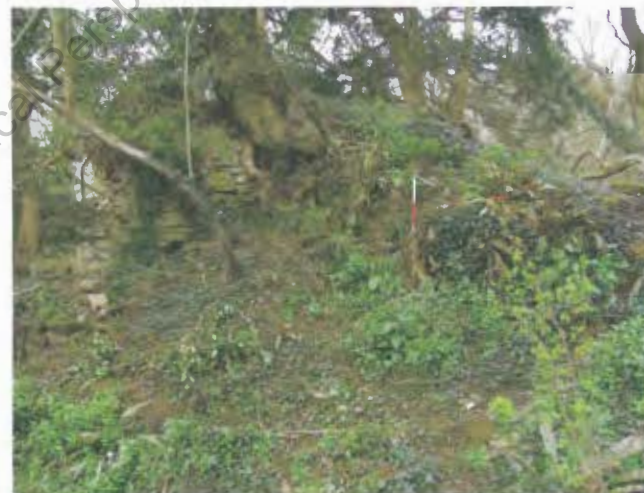
Two standing walls at south west edge of uppermost site.

The walls join and form a what appears to be an internal space.

The annotation shows rectangular spaces built into each wall, at the same height.

These holes would have originally carried the ends of flooring joists. t

The site at this point has a rubble fill and it is assumed that the joist holes denote, at least a depth of rubble consistent with the height of a buried room.

Images *DSC05 & DSC06* also add interesting information; revealing the joist holes for a floor, suggesting a depth of buried structure under the rubble fill.

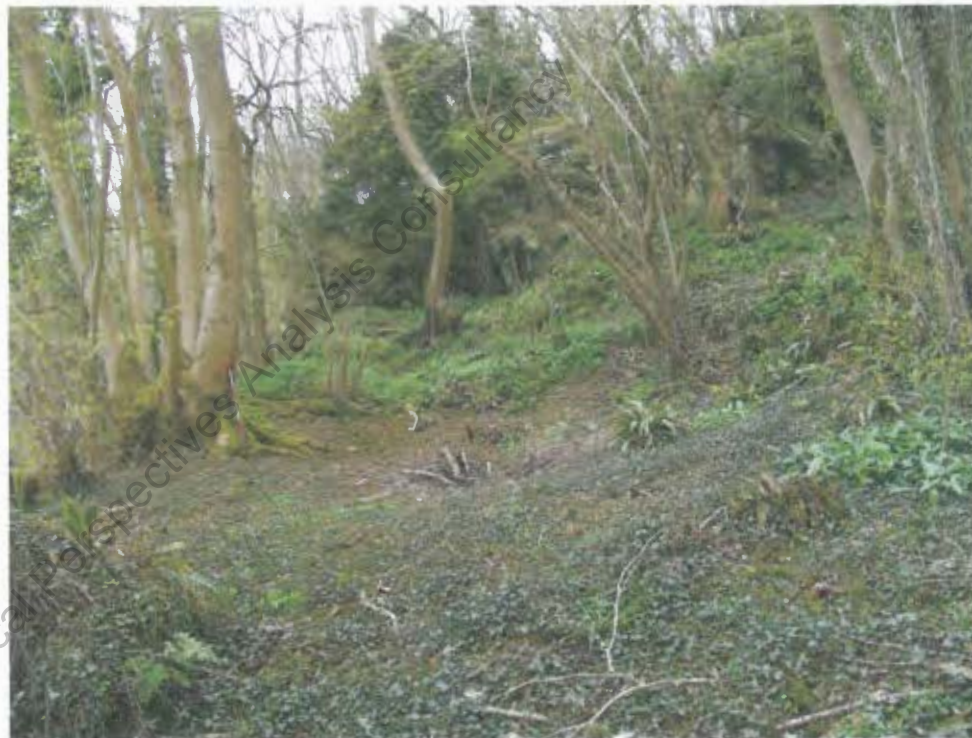
Lower rectangular area to south west of main standing masonry. The outer, possible curtain wall passes along the line of the ranging rods.

Five distinct rectangular depressions were surveyed as probable collapsed building structures. Images *DSC07, DSC08 and DSC09* show three of the more overtly recognisable instances.

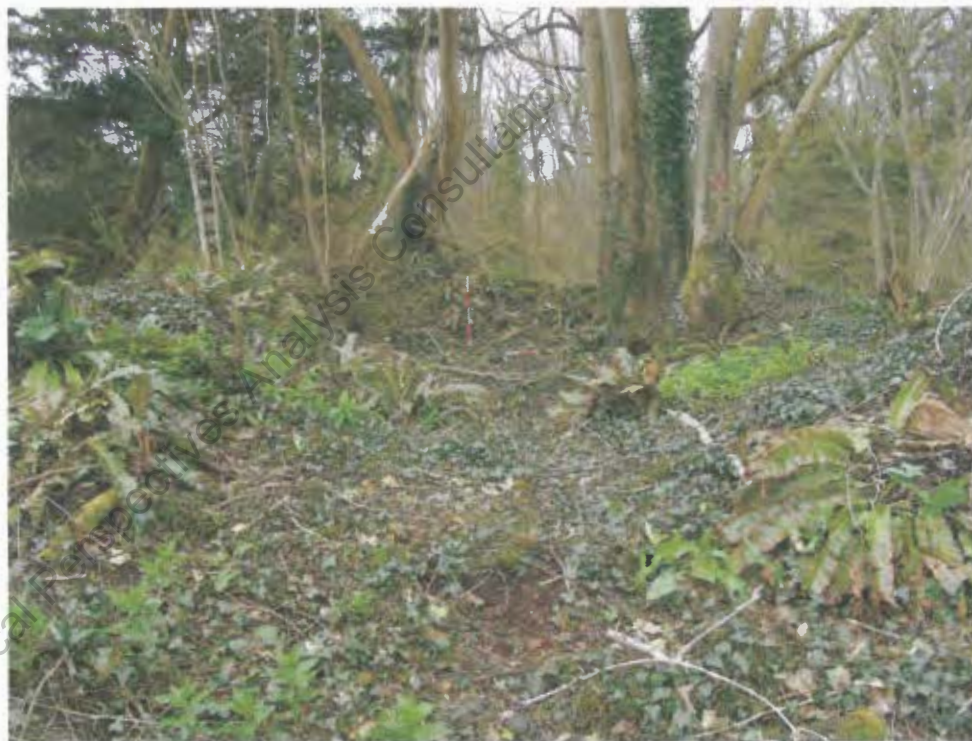
Outer buildings to the north east of the main castle site. The remains consist of linear rubble spreads with right angled corners. Both have internal rectangular depressions.

The north eastern feature (shown) is at a higher elevation than the south western one but appear to share a separating wall.

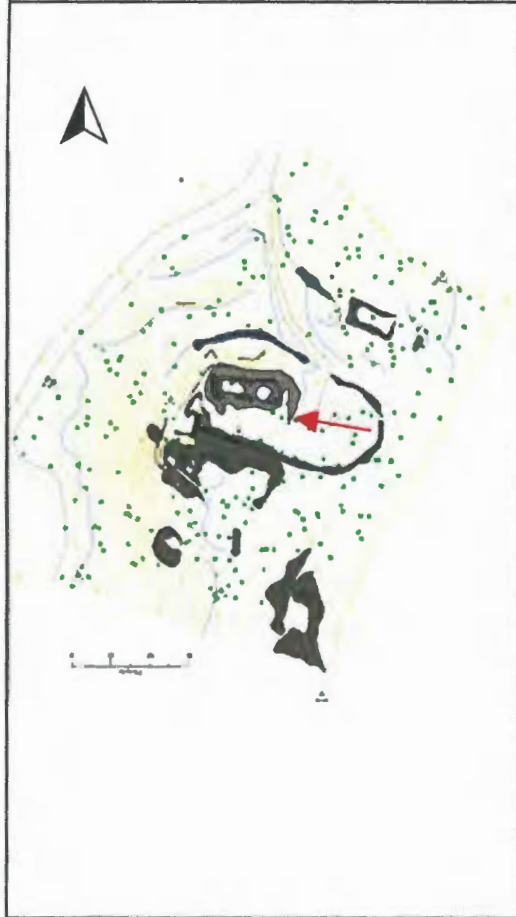
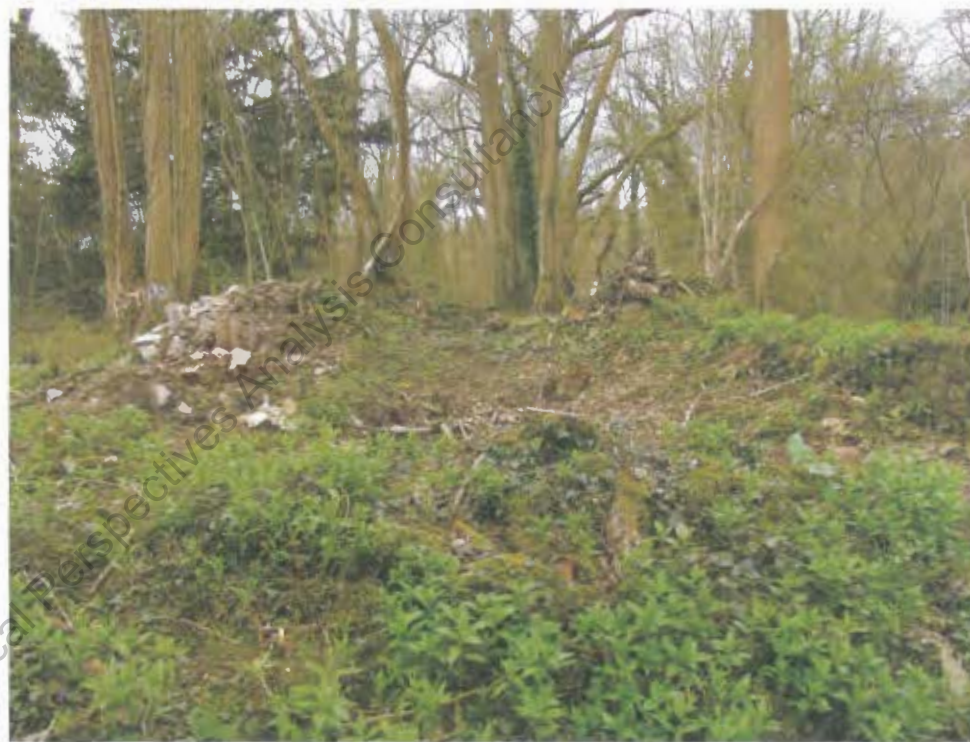
Inner structure with internal rooms. Recent tree damage can be seen on the left of the image.

Some surviving courses of masonry can be seen to the right of the photograph.

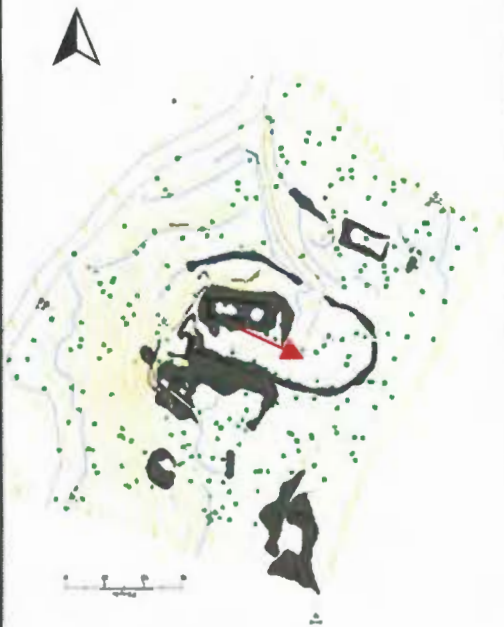
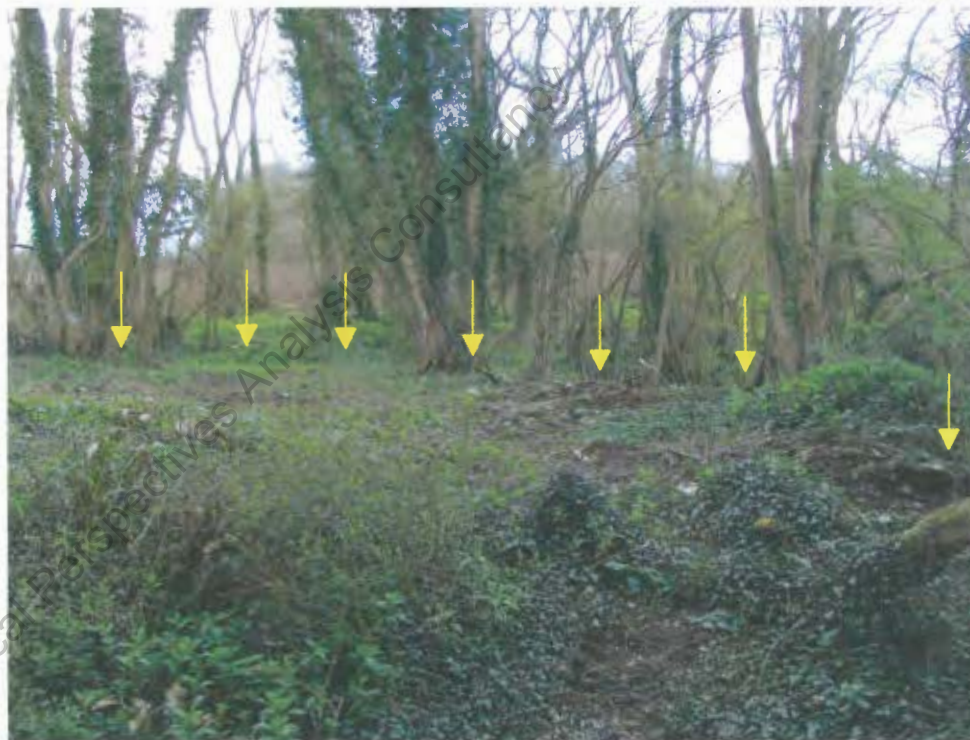
Position of curved wall. For the most part the wall consists of a slight curvilinear rubble mound but there are areas of coursed masonry still evident (see extreme right arrow)

Large linear and curvilinear banks of rubble were also mapped and in plan view can be seen to provide evidence for further structures, *Survey sheets 1 & 2 & DSC10*.

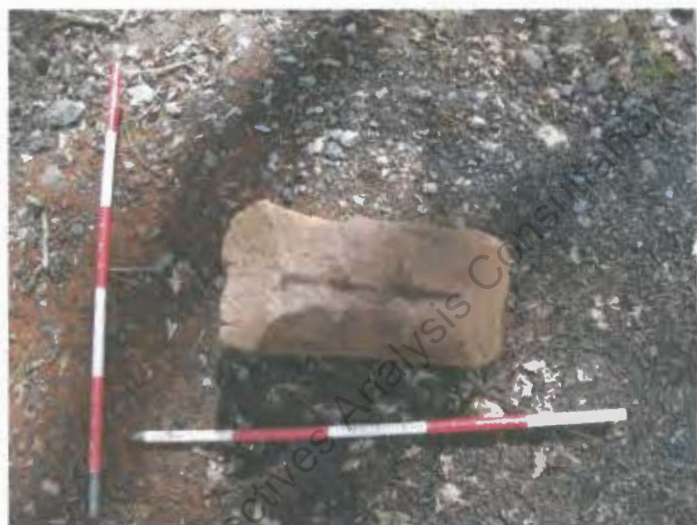
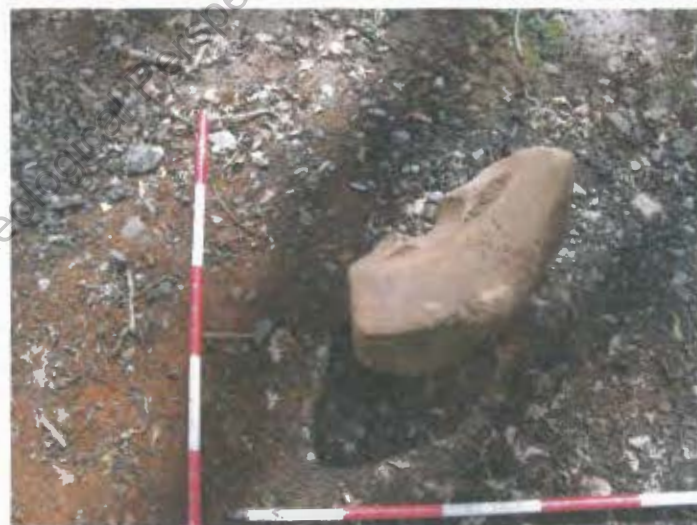
Top portion of ornate window arch.

The sandstone carving was found on the path to the castle (red X on plan) and appears to have recently tumbled from the slope, possibly caused by recent tree collapse.

During the survey a piece of ornate, possibly ecclesiastical sandstone window arch was found at the foot of the northern slope *DSC11 & DSC12*. This may be connected with the suggested church structure (Morgan & Wakeman 1856).
