EROSION CONTROL WORKS AT WAUN MAUN STANDING STONES SAM Pe124

RHIF YR ADRODDIAD / REPORT NO. 2006/16
RHIF Y PROSIECT / PROJECT RECORD NO. 56258

Erosion Control Works at Waun Maun Standing Stones

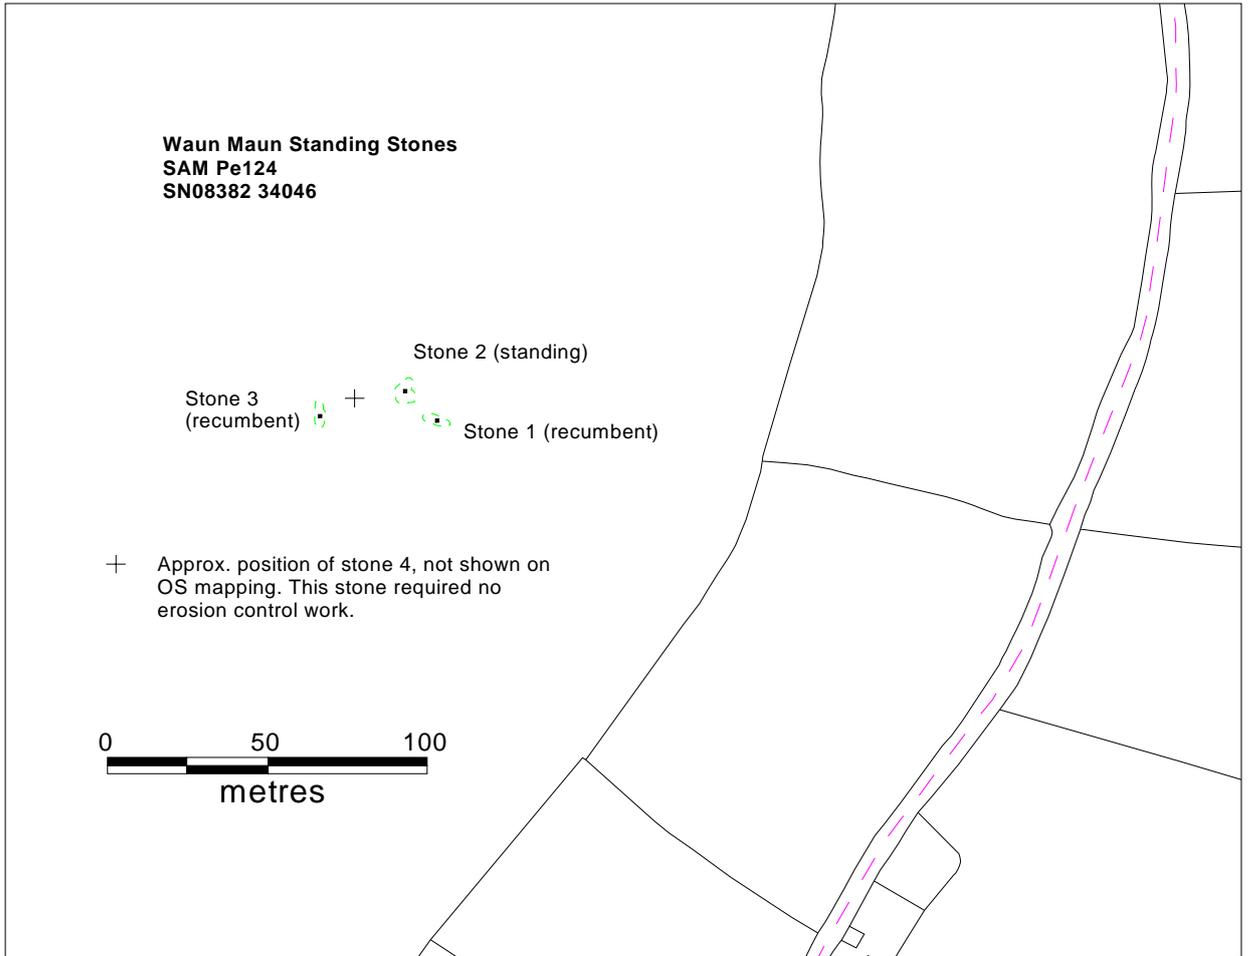
Map showing the positions of the affected stones.

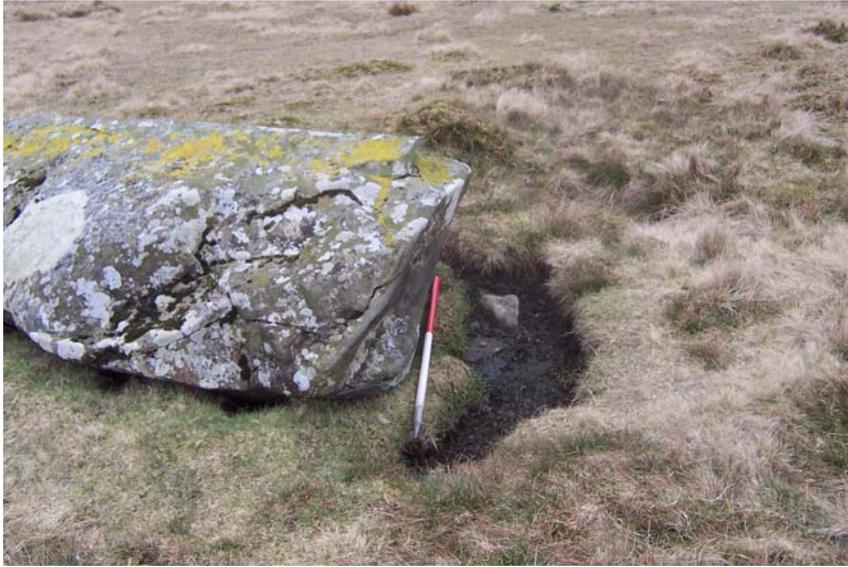
Stone 1

Above: The erosion hollow at the base of the stone.
Below: Work in progress – the terram being laid into the hollow before being trimmed to size.

The hollows were lined with Terram, a porous geo-textile. The textile is designed to allow water to penetrate, in order to promote healthy vegetation growth, but to separate archaeological layers from infill. It will also act as a depth marker, against which to monitor any future erosion. There was no ground disturbance – the sides of the erosion hollows were not cut back, nor were the bases scraped or levelled.

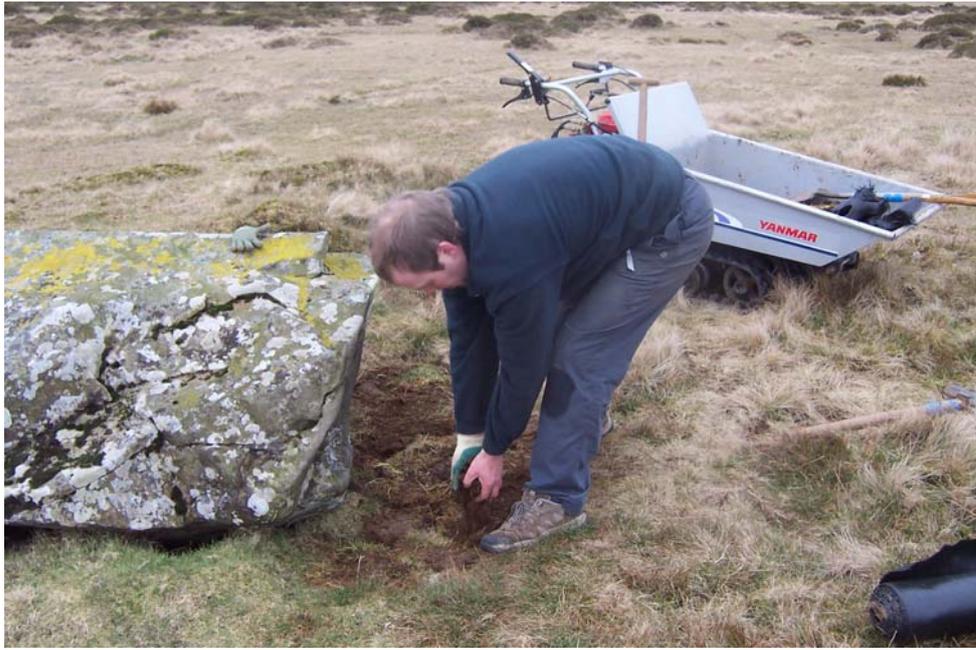
Above: finishing turf laying.
Below: the erosion hollow infilled. A light covering of soil will encourage good growth of the newly laid turf.

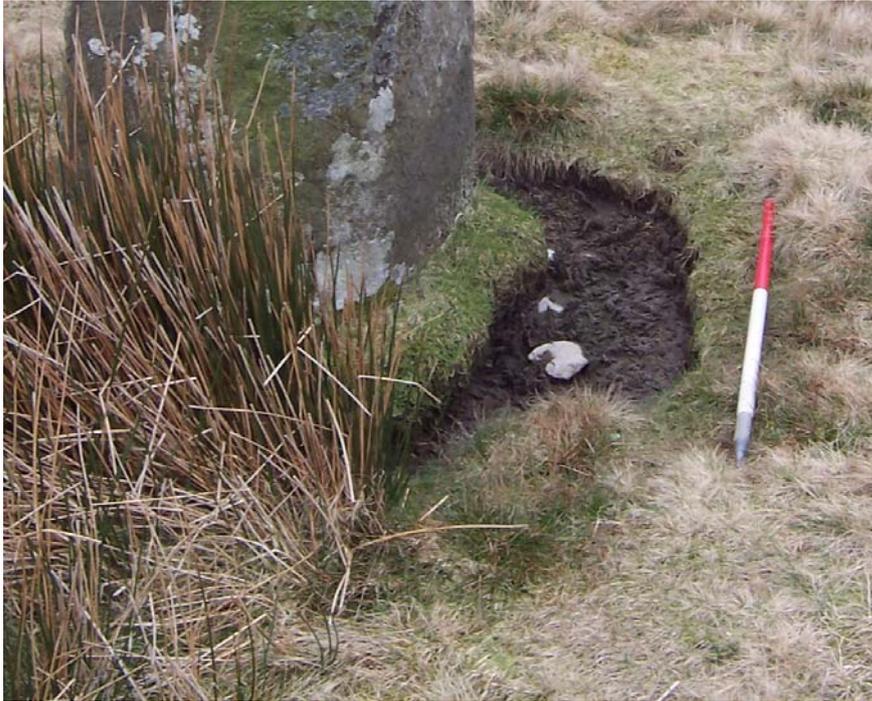
Stone 2

Above: the erosion hollow at the base of the standing stone.

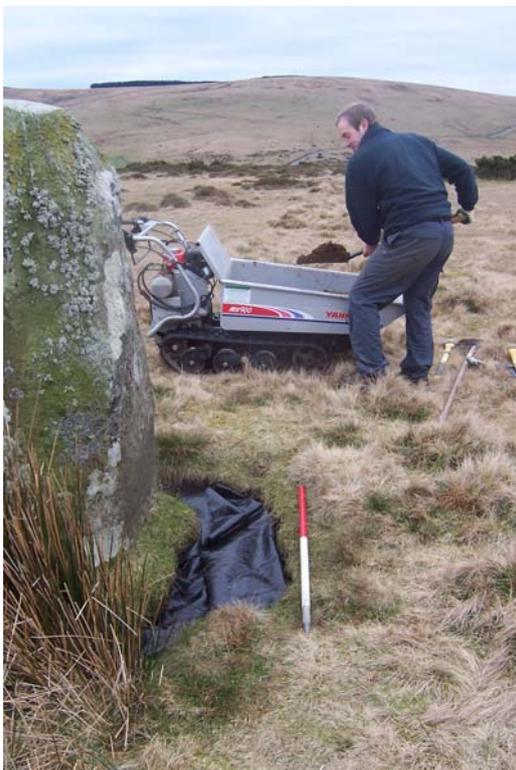
Below left: A terram lining in place, and beginning to infill the hollow with soil and stone.

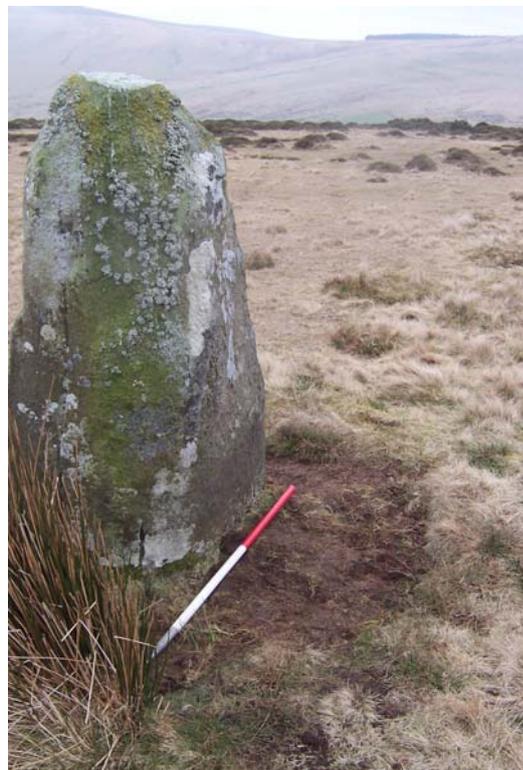
Below right: the infilling completed. The turf is lightly covered with soil to encourage healthy growth.

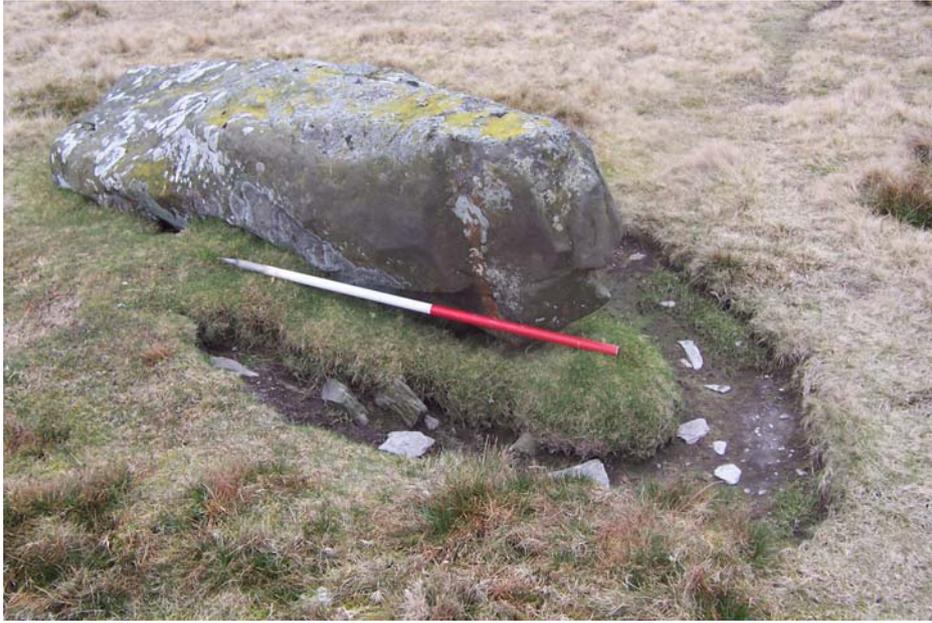
Stone 3

Above: This was the only stone where smaller stones were encountered in the base of the erosion hollow. These stones were firmly bedded into the underlying soil and were left in place when the hollow was infilled.
Below: Terram lining in place.

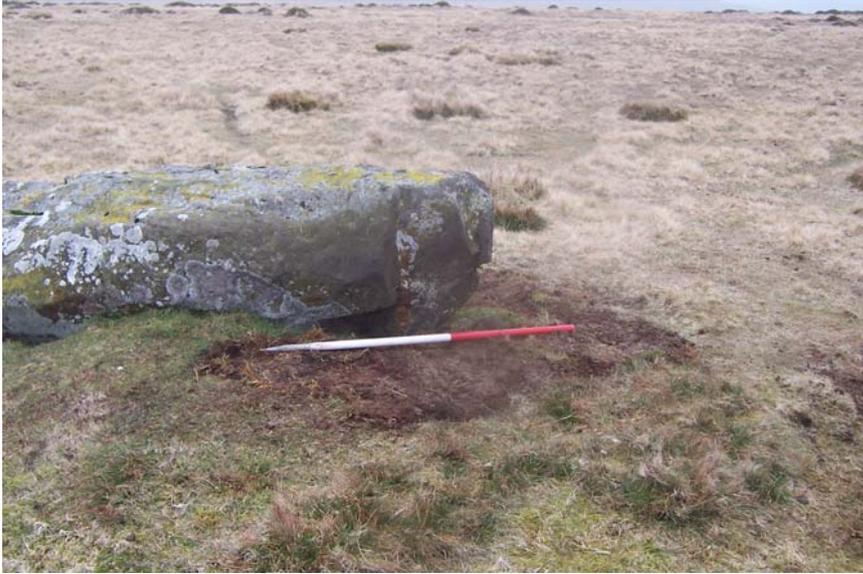
Above: In-filled erosion hollow. This was the only stone which was set in a slight mound of earth and care was taken to follow the profile of the mound.
