**GLAMORGAN-GWENT ARCHAEOLOGICAL TRUST**

**WAUN CIMLA, CEFN CRIBWR:  
AN ARCHAEOLOGICAL SURVEY**

March 1992

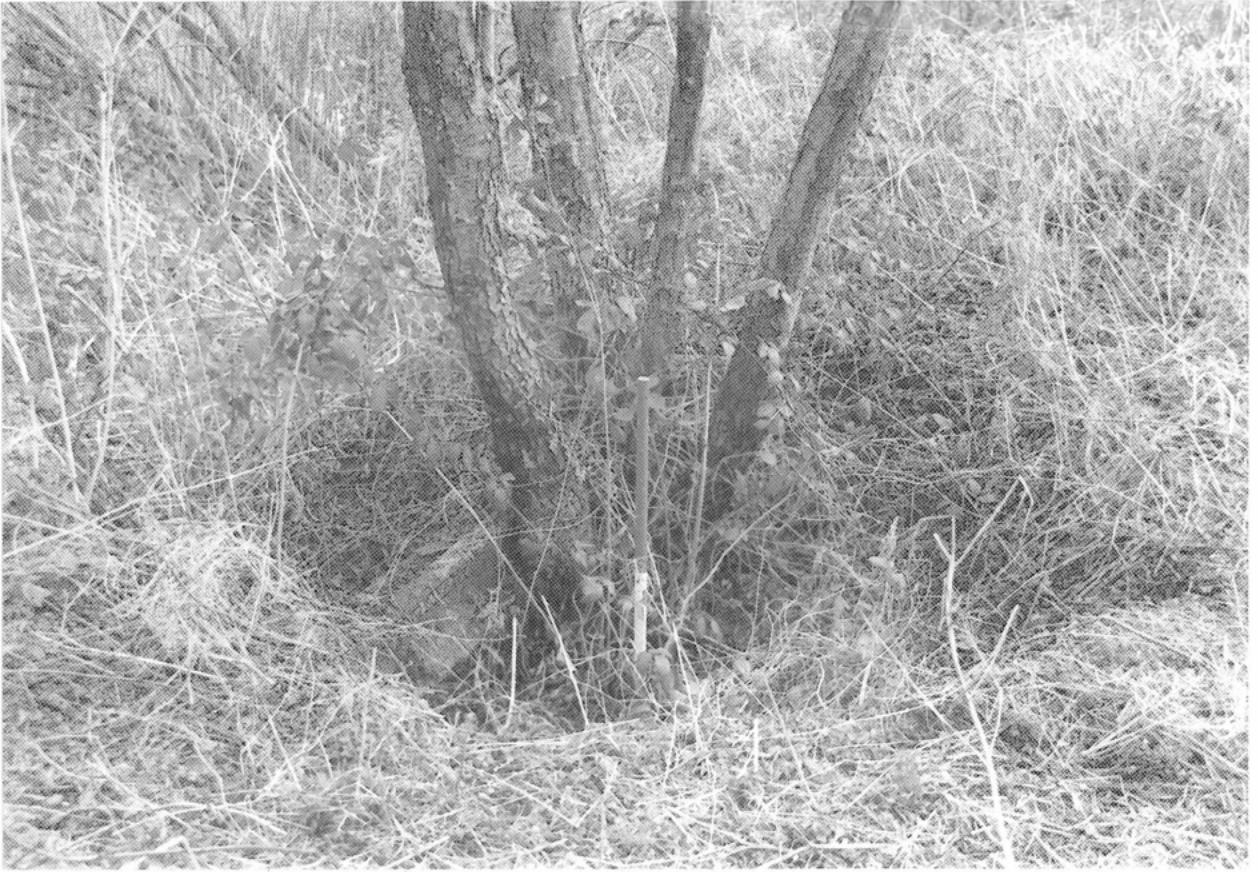
To the south of the two shafts there was evidence of a possible third shaft (S3 in Figure 3, and Plate 1). A tree had subsided into a roughly circular depression approximately 2 metres in diameter. It had subsided to about 0.5m below the surrounding ground level. The subsidence had exposed a length of tram-rail which lay across the hollow. It is likely that the subsidence was caused by the presence of a shaft, or some other void, beneath this area.

**Plate 1:** Cefn Cribwr Colliery: Top of possible shaft with tram-rail

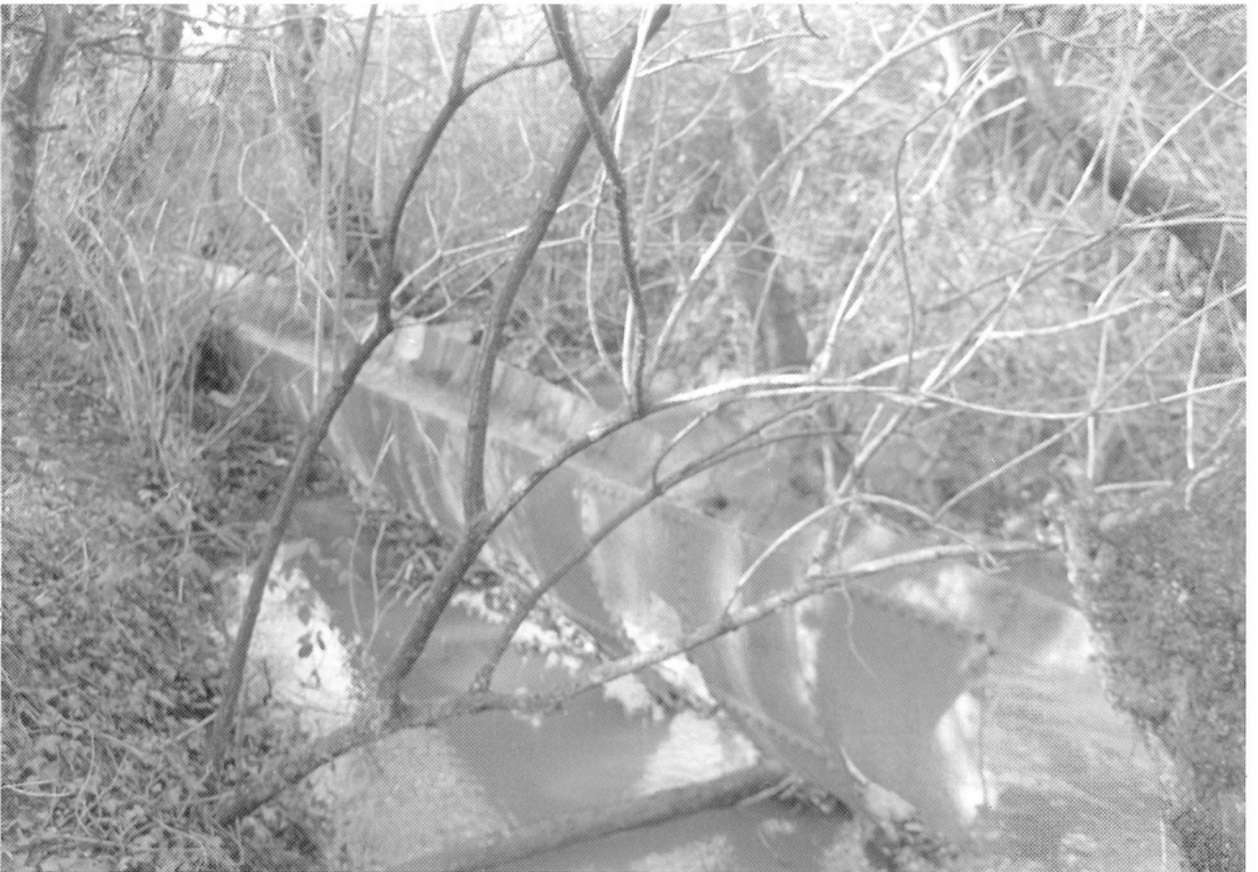
Immediately to the north of the colliery site, the river flows through, and, to some extent, around, an iron chute (Plate 2). This is made up of two lengths each of which is built from rectangular plates rivetted together. It appears that it may have been made by cutting a round tube in half lengthways to form the two parts. The function of this channel was presumably to contain the water in the channel and reduce seepage into the adjacent mine-workings.

**Plate 2:** Iron water channel

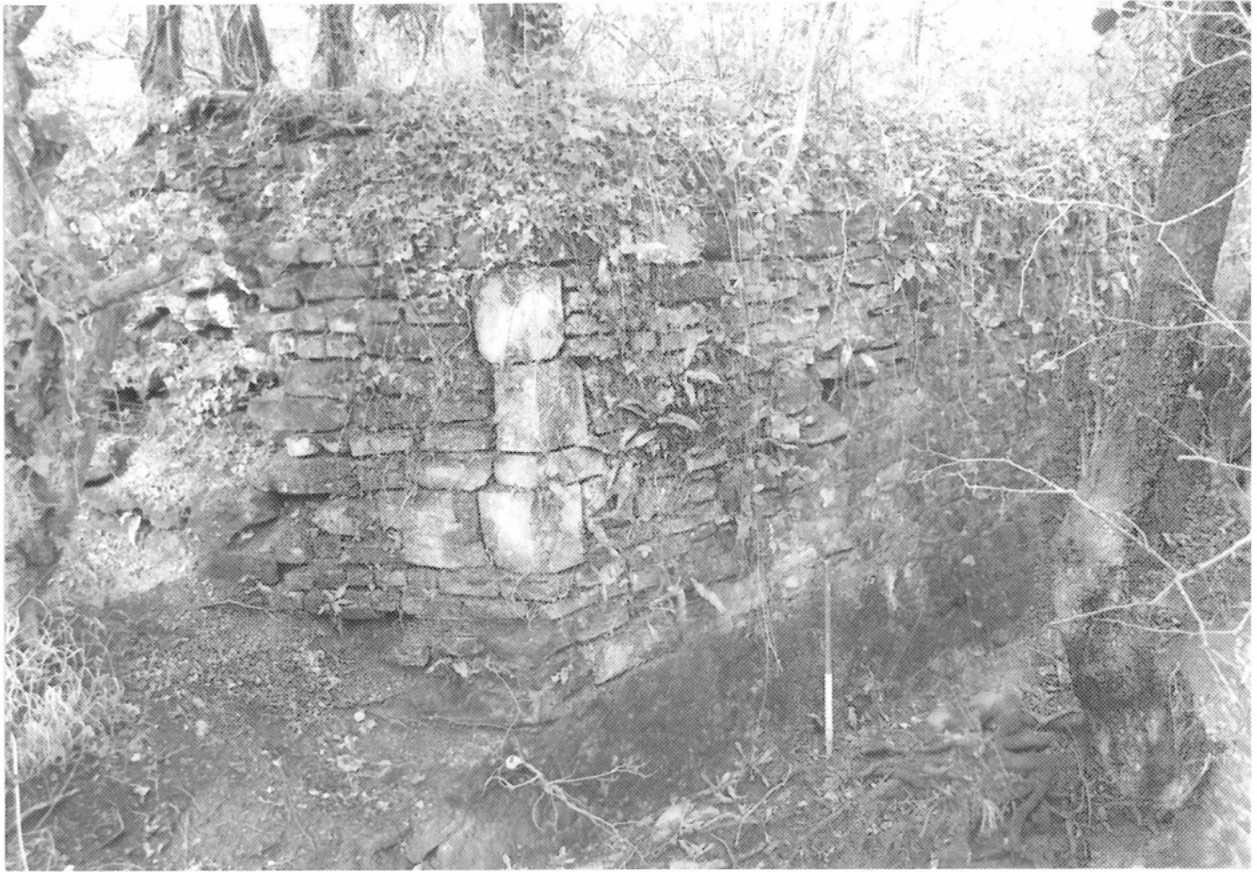
Close to the cottages on Bedford Road, the eastern abutment of the Malins and Rawlinson tramway, and both of the later abutments which were extended to carry the Port Talbot Railway across Bedford Road, still survive in good condition. The latter abutments still support the bridge which carries the present British Rail goods line. On top of the surviving abutment of the Malins and Rawlinson bridge there is a rectangular block of slag which appears to have cooled and hardened in its tramway wagon and been dumped at the end of the bridge.

**Plate 3:** Abutment of tramway bridge

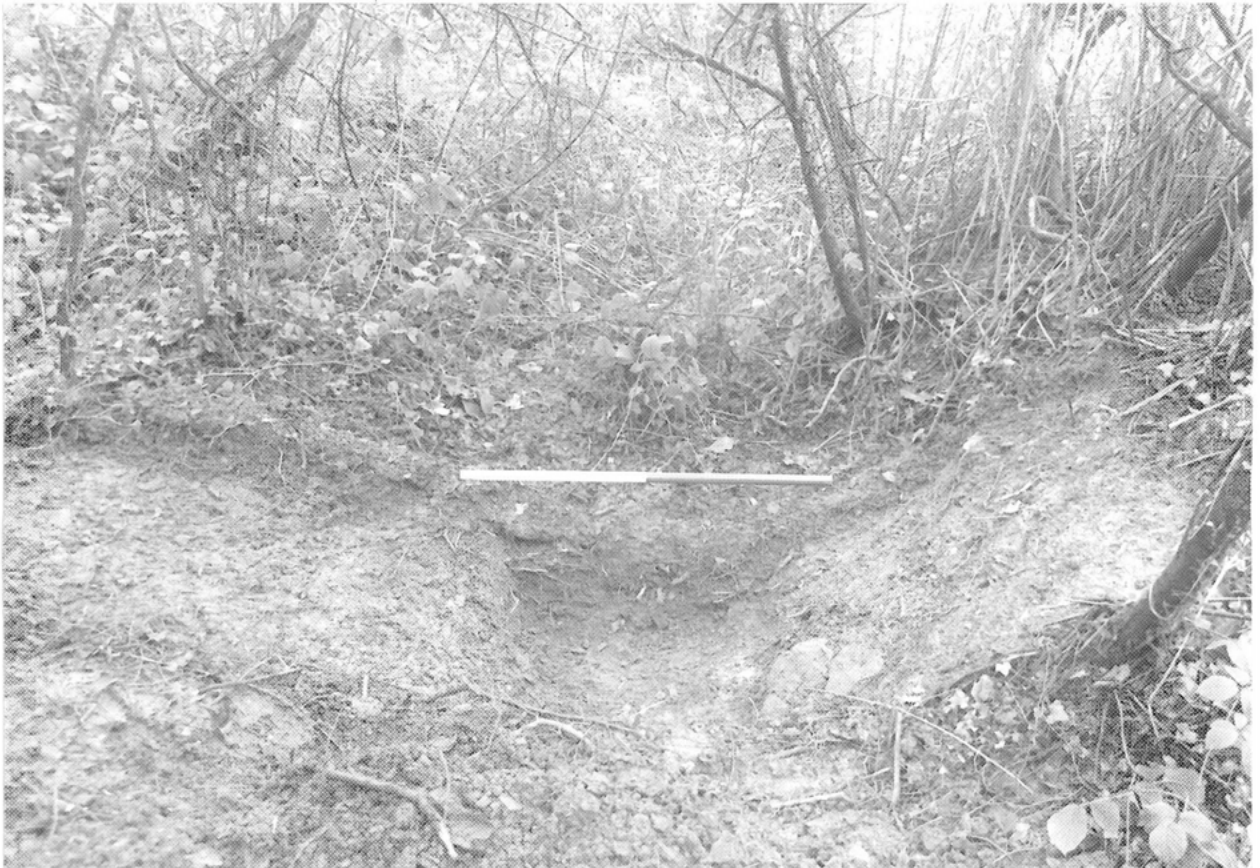
In order to assess the nature of this gully, a small trial section was excavated across it (T3 in Figures 2 & 3, and Plate 4). The trial trench was 3m long and 1m wide. It showed that the gully was approximately 1.1m wide and 42mm deep, with sides which sloped at around 45 degrees, and an almost flat bottom. It was cut into pale greyish yellow clay, and was filled with up to 23mm depth of humic brown silt (context 2). This was overlain by up to 6mm of topsoil. The only artefact to be found during the excavation of this feature was an undiagnostic fragment of a clay tobacco pipe in context 2. The excavation showed that this was a small ditch which, from the nature of its fill, had probably carried water.

**Plate 4:** West-facing section of Trial Trench 3

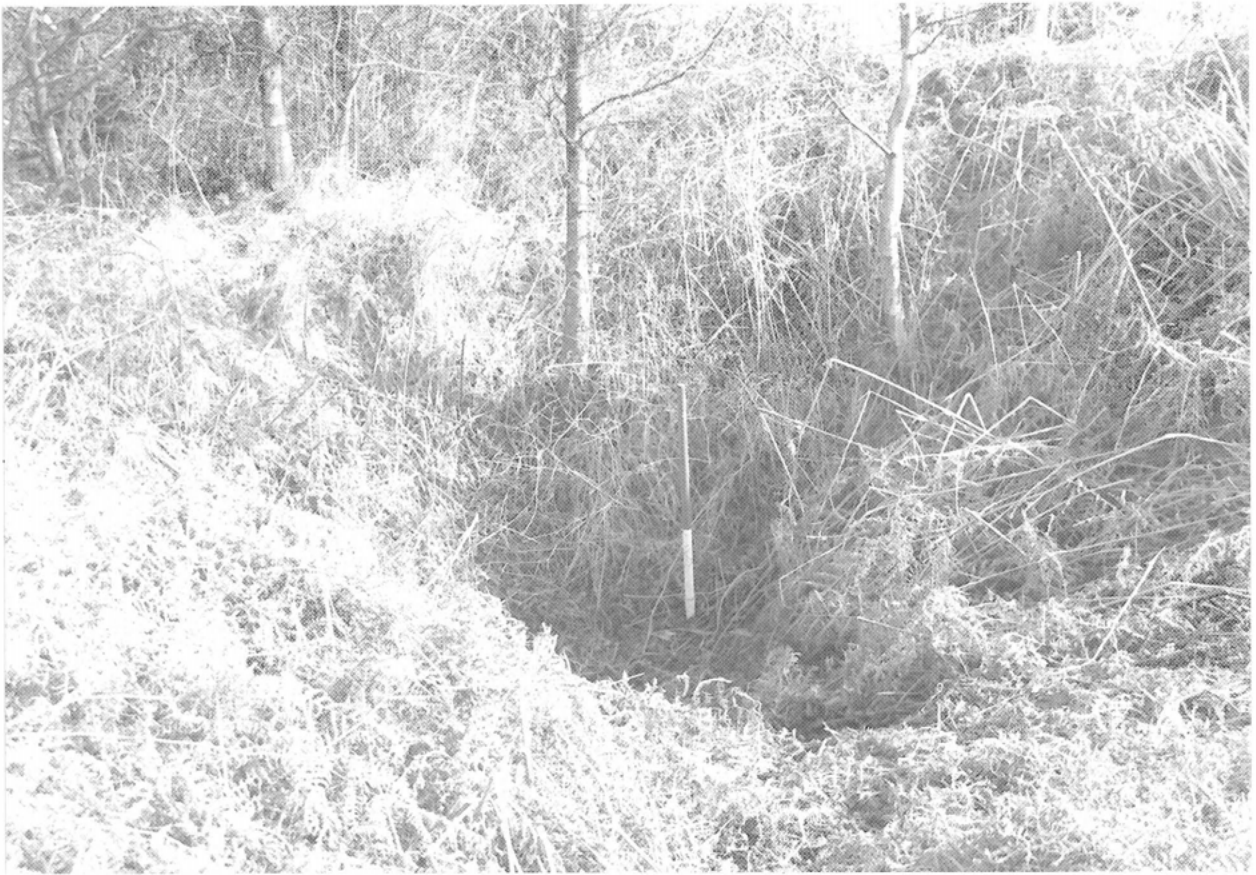
Further evidence of mining activity was found towards the extreme north-western corner of the area in Council ownership. This consisted of three groups of pits surrounded by spoil-tips clustered on the slope above the south bank of the Nant Iorwerth Goch (Figure 4 and Plate 5). The westernmost of the groups lies between the pond, which is recorded on Ordnance Survey maps, and the river. The similar group to the east is divided from it by a ditch and a wide stretch of land which had clearly been subject to recent disturbance. It is therefore possible that these were originally all part of the same, rather larger, group of features, some of which were destroyed by the recent disturbance. A third group was found a little further to the east. It was not

Many of these pits were filled with water, and it was not considered practicable, with the resources available, to excavate any of them. These features were almost certainly bell-pits. These are small-scale mines, probably, in this case, for coal, which would have been worked for a short period and with a minimum of capital or technological input.

**Plate 5:** Bell pit

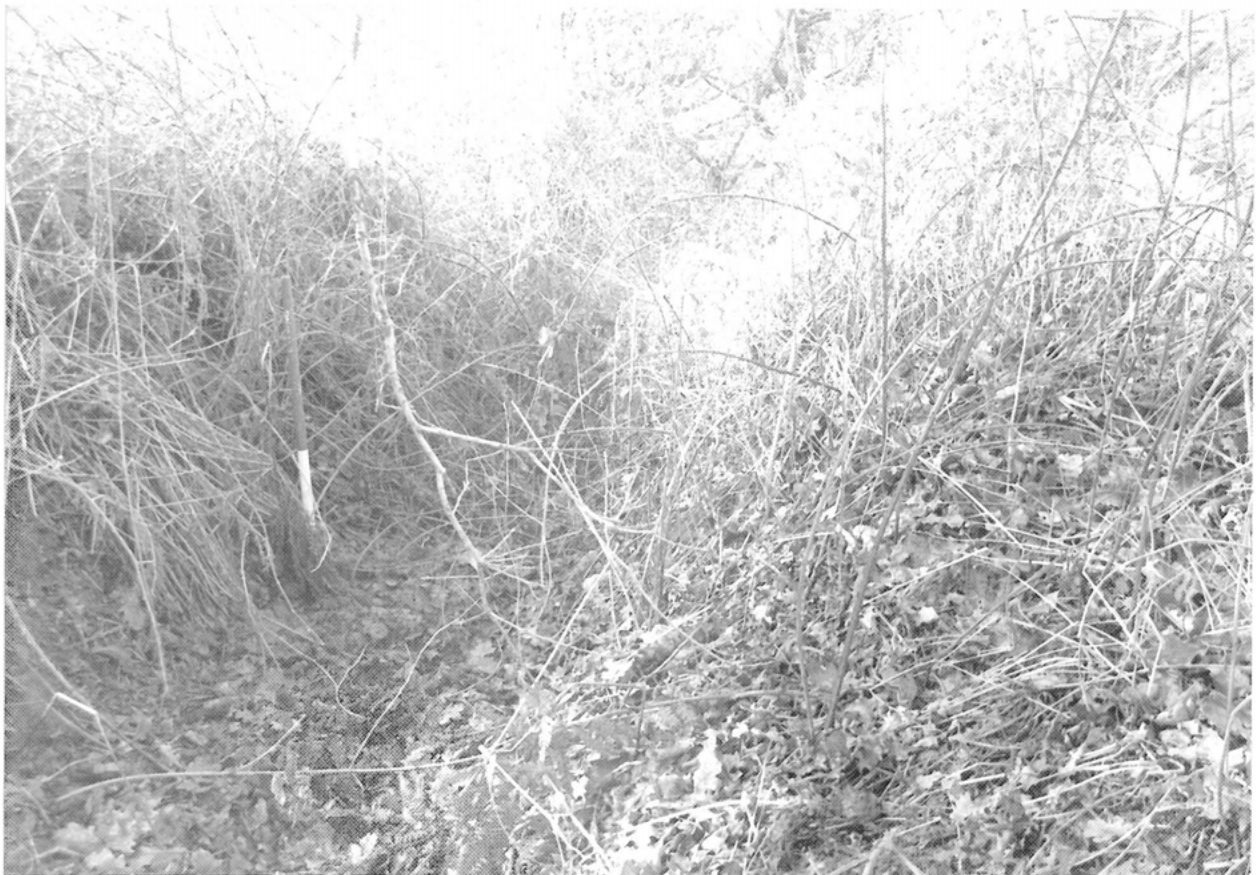
The pond to the south of the western group of bell pits appeared to be artificial. It was probably dug either as a clay pit or as a small opencast coal mine. It appears also, perhaps subsequently, to have been used as part of a water-management scheme. It is connected to the ditch to its east by a gully, now dry (Plate 6).

**Plate 6:** Gully leading to pond
